Site ID: **a-300854** Management with Targeted Refurbishment Survey

Solihull Community Housing
Client ID: **S135 - 4113543**

1-83 Westham House
Forth Drive
Kingshurst
Solihull
West Midlands
B37 6PT
United Kingdom

9th April 2021

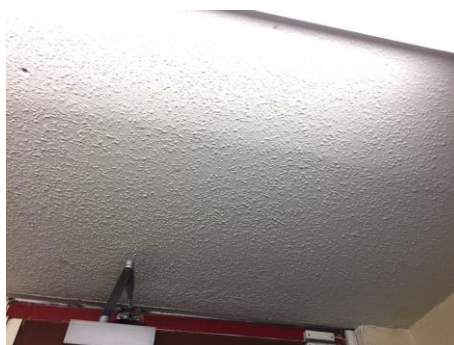
Spatter pattern textured coating.

The material was seen to be in fair condition at the time of the initial inspection.

The condition of the material should be managed by a competent person/company and its presence made aware to those at risk, as part of a Control of Asbestos Regulations (CAR) 2012 compliant management strategy.

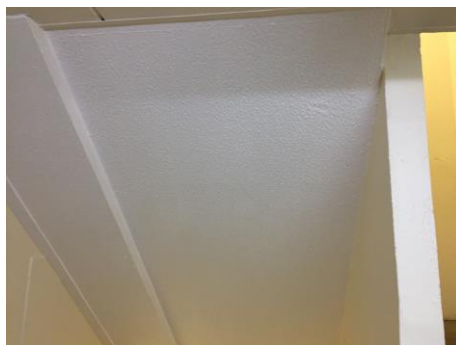
Level: **Twelfth Floor**

Condition..... **Low Damage**

The material was seen to be in fair condition at the time of the initial inspection.

The condition of the material should be managed by a competent person/company and its presence made aware to those at risk, as part of a Control of Asbestos Regulations (CAR) 2012 compliant management strategy.

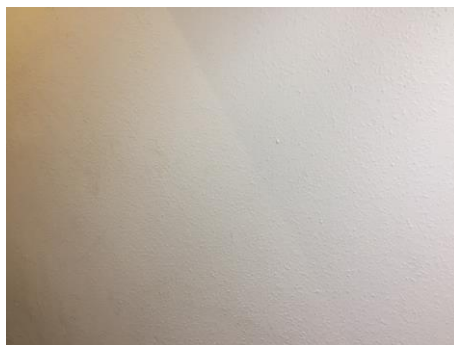
Spatter pattern textured coating.

The material was seen to be in fair condition at the time of the initial inspection.

The condition of the material should be managed by a competent person/company and its presence made aware to those at risk, as part of a Control of Asbestos Regulations (CAR) 2012 compliant management strategy.

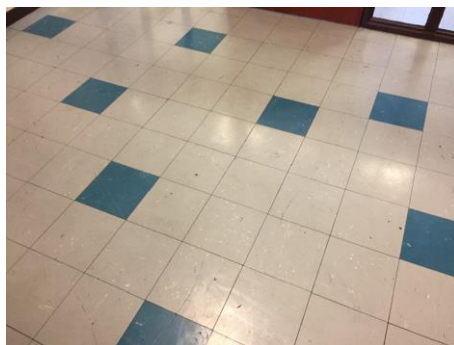
Level: **Twelfth Floor**

Condition **Low Damage**

The material was seen to be in fair condition at the time of the initial inspection.

The condition of the material should be managed by a competent person/company and its presence made aware to those at risk, as part of a Control of Asbestos Regulations (CAR) 2012 compliant management strategy.

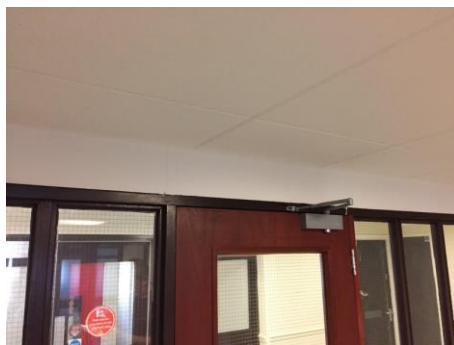
Supalux transom panels over doors to lobbies.

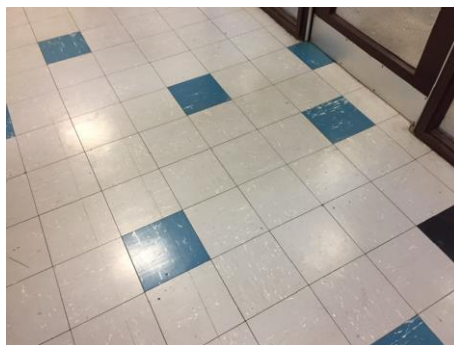
Level: **Twelfth Floor**

Condition..... **Low Damage**

The material was seen to be in fair condition at the time of the initial inspection.

The condition of the material should be managed by a competent person/company and its presence made aware to those at risk, as part of a Control of Asbestos Regulations (CAR) 2012 compliant management strategy.

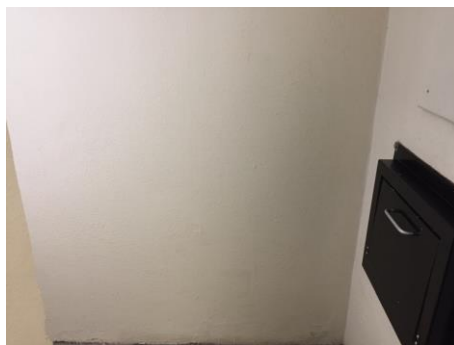
Level: **Twelfth Floor**

Condition **Low Damage**

The material was seen to be in fair condition at the time of the initial inspection.

The condition of the material should be managed by a competent person/company and its presence made aware to those at risk, as part of a Control of Asbestos Regulations (CAR) 2012 compliant management strategy.

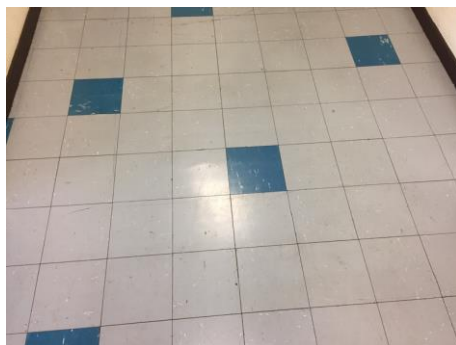
Level: **Twelfth Floor**

Condition **Low Damage**

The material was seen to be in fair condition at the time of the initial inspection.

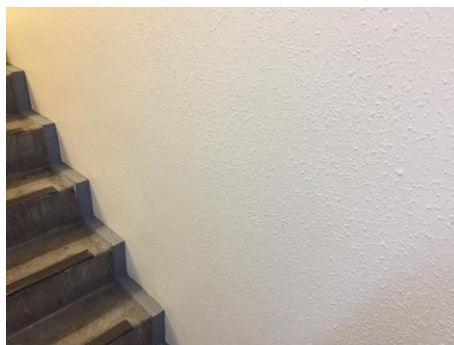
Spatter pattern textured coating.

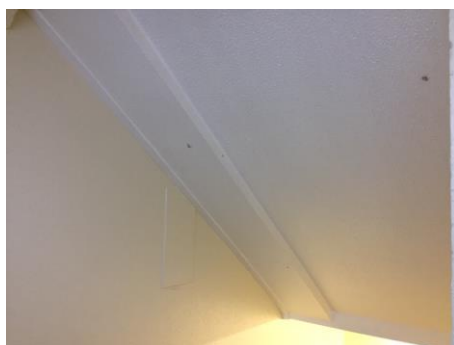
Supalux boxing with textured coating finish to underside of staircase.

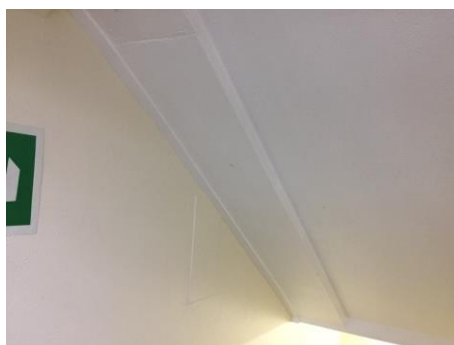
Supalux boxing with textured coating finish to underside of staircase.

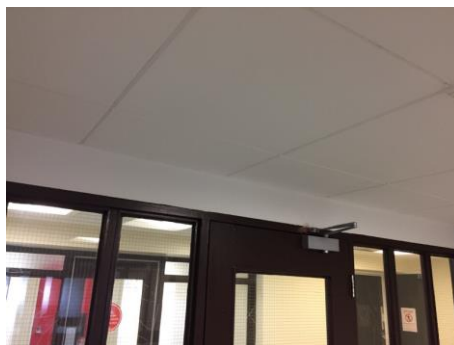
Supalux transom panels over doors to lobbies.

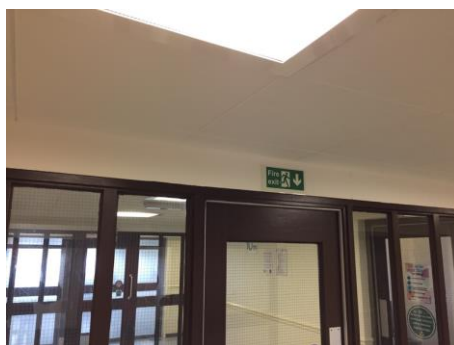
Supalux transom panels over doors to lobbies.

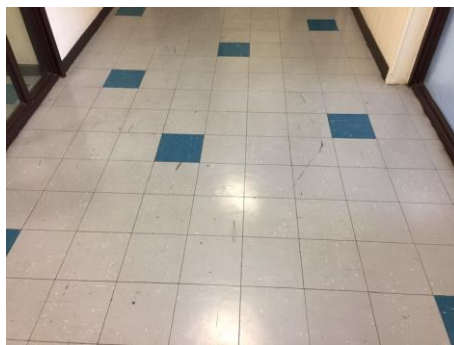
Blue and grey floor tiles.

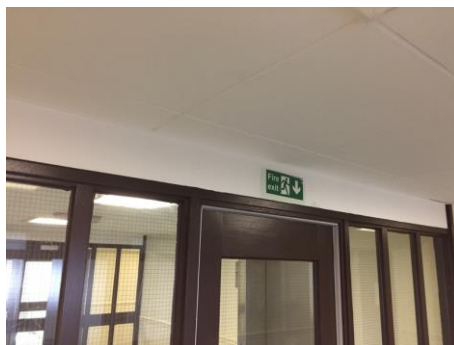
Supalux transom panels over doors to lobbies.

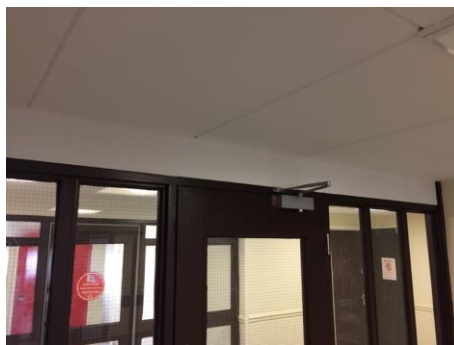
Supalux transom panels over doors to lobbies.

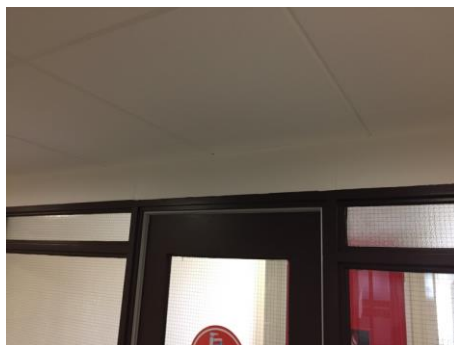
Supalux transom panels over doors to lobbies.

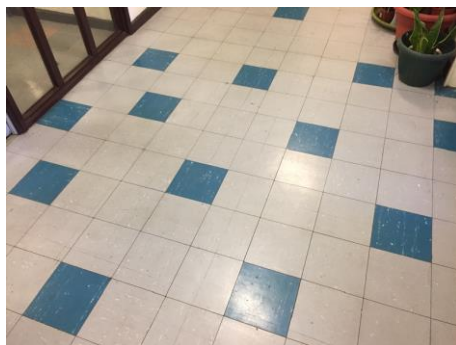
Blue and grey floor tiles.

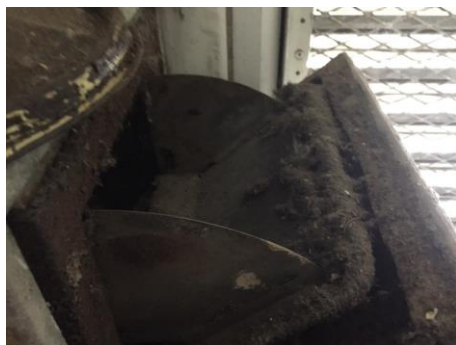
Cement lining to interior of Bunnie incinerator.
