Solihull Community Housing

Asbestos Management Survey Report

**Wingfield House
Kingshurst Way
Kingshurst
B37 6DY**

Date of Report: 05 May 2012

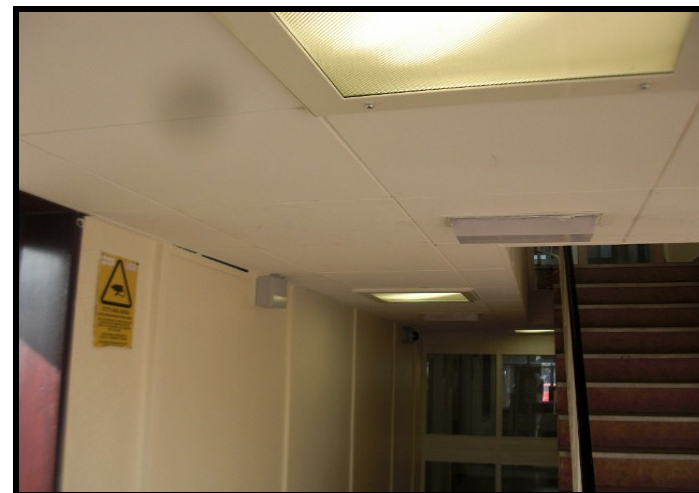
SAMPLE REFERENCE 001

Asbestos not detected in Sample

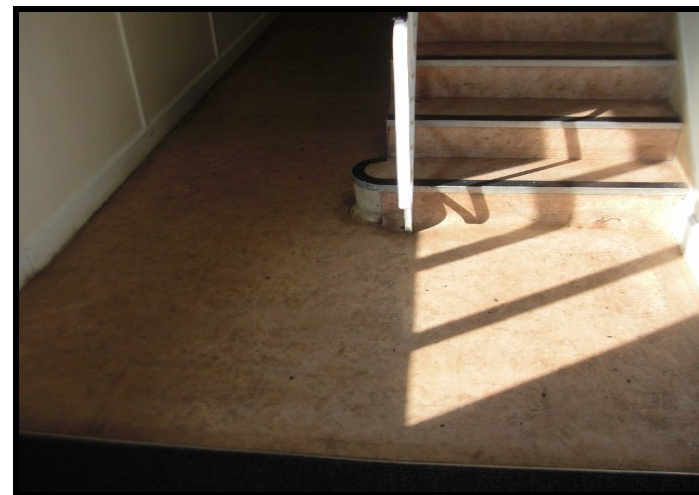
SAMPLE REFERENCE 002

Asbestos not detected in Sample

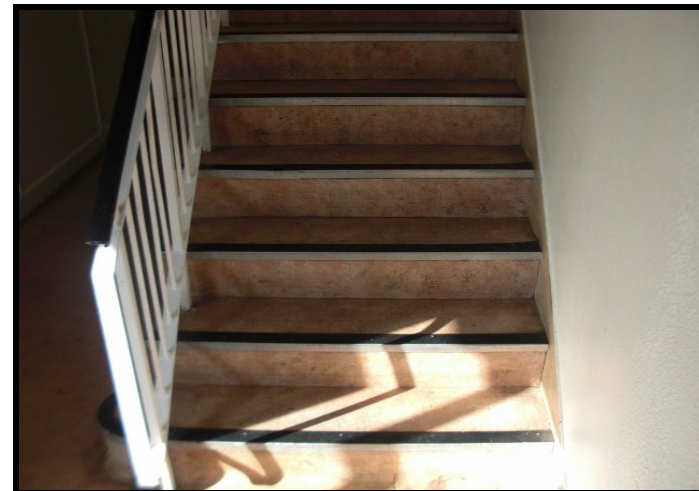
SAMPLE REFERENCE 003

Asbestos not detected in Sample

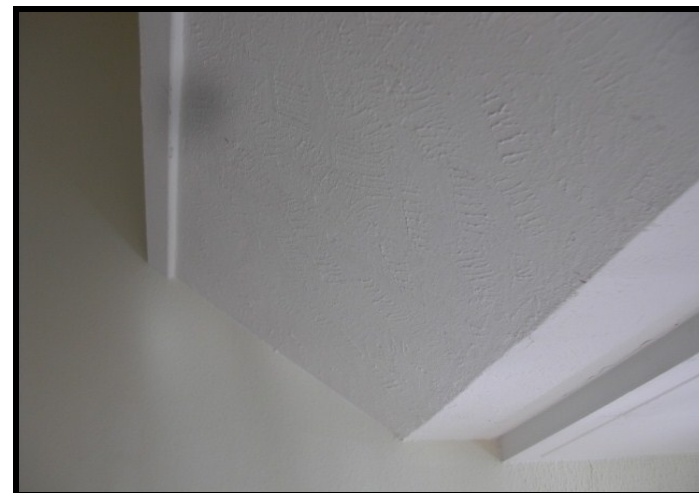
SAMPLE REFERENCE 004

Asbestos not detected in Sample

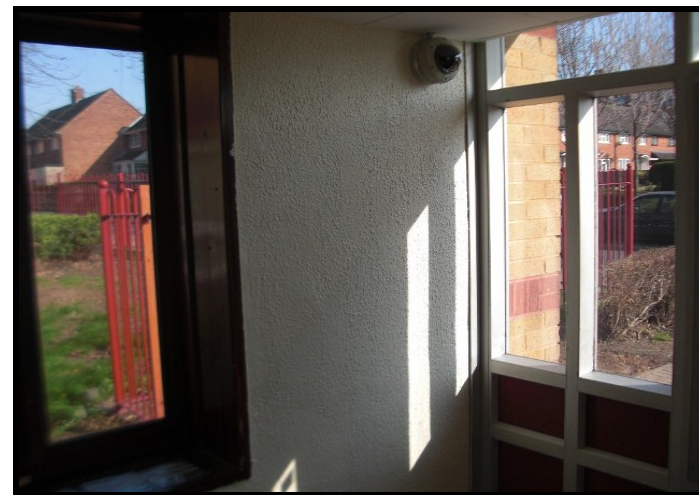
SAMPLE REFERENCE 005

Asbestos not detected in Sample

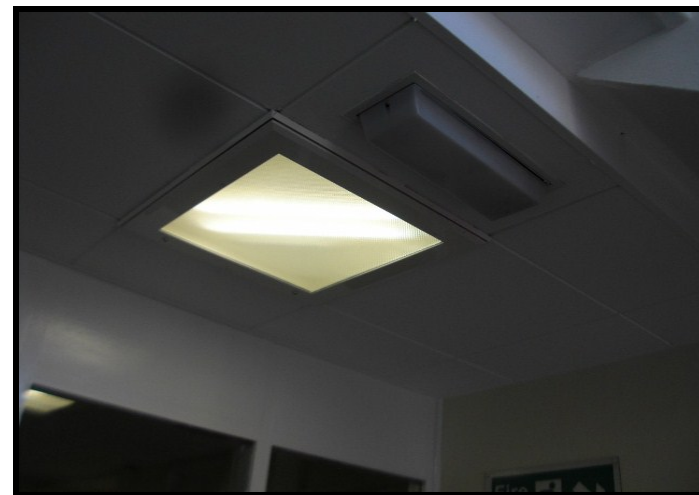
SAMPLE REFERENCE 006

Building	Floor	Room	Location	
Main Building	First Floor	All	Ceiling	
Description				
MATERIAL ASSESSMENT				SCORE
Product Type	Board	Extent of Damage	Good condition	-
Asbestos Type	No Asbestos Detected	Surface Treatment	Sealed Board (Encapsulated)	
PRIORITY ASSESSMENT				SCORE
Occupant Activity	Not Applicable	Extent / Amount	42.00 m2	-
Accessibility	Occasionally disturb	Location	Not Applicable	
Avg Time in Use	Not Applicable	Frequency of Use	Not Applicable	
No. of Occupants	Not Applicable	Secondary Activity	Not Applicable	
Maintenance	Not Applicable	Maintenance Frequency	Not Applicable	
MANAGEMENT ACTION				SCORE
Recommendation	NO ACTION REQUIRED			-
Recommendation Due		Next Inspection	None	
Apply Labels	No	Permit to Work Required	No	
Survey Type	Management	Lead Surveyor	Darryl Stokes	
Survey Date	29 Mar 2012	UKAS Laboratory	NOT SAMPLED (Cross Referenced)	
Site Reference	257910000A	Licensed Material	N/A

No Asbestos Presumed in Sample

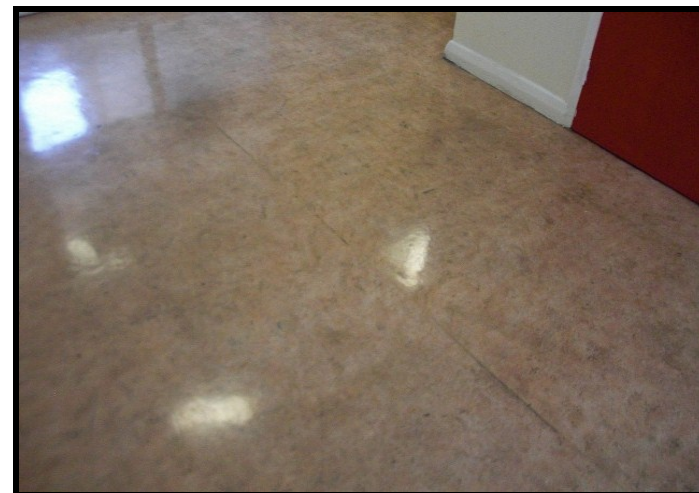
SAMPLE REFERENCE 007

Building	Floor	Room	Location	
Main Building	First Floor	All	Floor	
Description				
MATERIAL ASSESSMENT				SCORE
Product Type	Floor Tiles	Extent of Damage	Good condition	-
Asbestos Type	No Asbestos Detected	Surface Treatment	Composite materials	
PRIORITY ASSESSMENT				SCORE
Occupant Activity	Not Applicable	Extent / Amount	30.00 m2	-
Accessibility	Occasionally disturb	Location	Not Applicable	
Avg Time in Use	Not Applicable	Frequency of Use	Not Applicable	
No. of Occupants	Not Applicable	Secondary Activity	Not Applicable	
Maintenance	Not Applicable	Maintenance Frequency	Not Applicable	
MANAGEMENT ACTION				SCORE
Recommendation	NO ACTION REQUIRED			-
Recommendation Due		Next Inspection	None	
Apply Labels	No	Permit to Work Required	No	
Survey Type	Management	Lead Surveyor	Darryl Stokes	
Survey Date	29 Mar 2012	UKAS Laboratory	NOT SAMPLED (Cross Referenced)	
Site Reference	257910000A	Licensed Material	N/A

No Asbestos Presumed in Sample

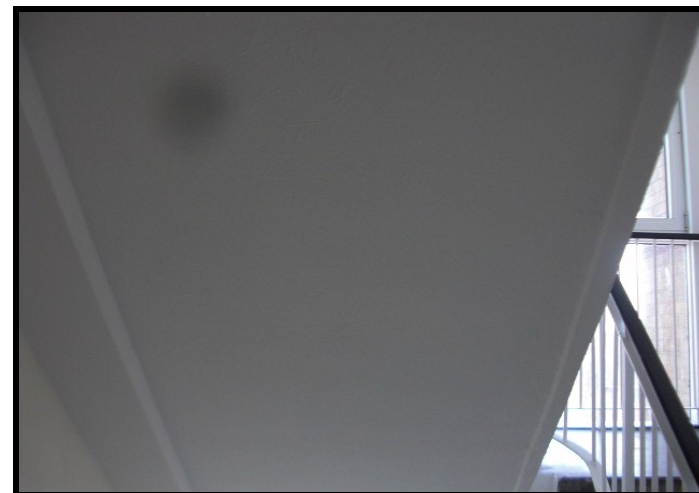
SAMPLE REFERENCE 008

No Asbestos Presumed in Sample

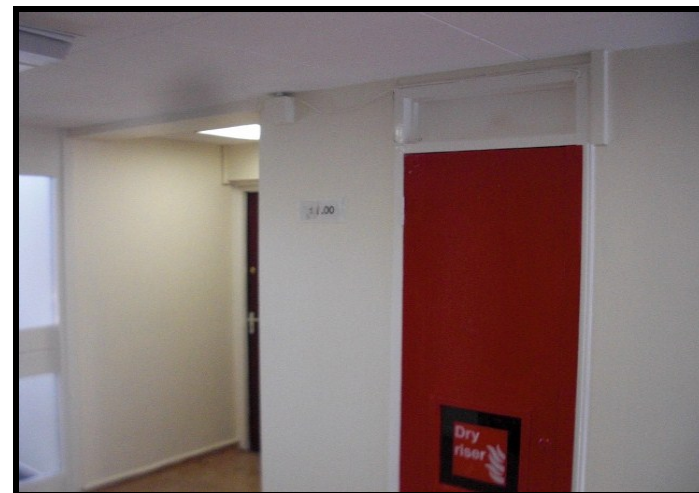
SAMPLE REFERENCE 009

Building	Floor	Room	Location	
Main Building	First Floor	All	Wall	
Description				
MATERIAL ASSESSMENT				SCORE
Product Type	Textured Coating	Extent of Damage	Good condition	-
Asbestos Type	No Asbestos Detected	Surface Treatment	Composite materials	
PRIORITY ASSESSMENT				SCORE
Occupant Activity	Not Applicable	Extent / Amount	60.00 m2	-
Accessibility	Occasionally disturb	Location	Not Applicable	
Avg Time in Use	Not Applicable	Frequency of Use	Not Applicable	
No. of Occupants	Not Applicable	Secondary Activity	Not Applicable	
Maintenance	Not Applicable	Maintenance Frequency	Not Applicable	
MANAGEMENT ACTION				SCORE
Recommendation	NO ACTION REQUIRED			-
Recommendation Due		Next Inspection	None	
Apply Labels	No	Permit to Work Required	No	
Survey Type	Management	Lead Surveyor	Darryl Stokes	
Survey Date	29 Mar 2012	UKAS Laboratory	NOT SAMPLED (Cross Referenced)	
Site Reference	257910000A	Licensed Material	N/A

No Asbestos Presumed in Sample

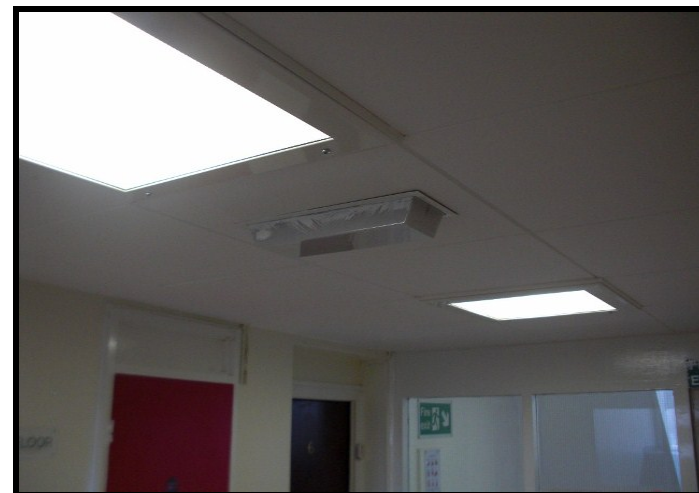
SAMPLE REFERENCE 010

Building	Floor	Room	Location	
Main Building	Second Floor	All	Ceiling	
Description				
MATERIAL ASSESSMENT				SCORE
Product Type	Board	Extent of Damage	Good condition	-
Asbestos Type	No Asbestos Detected	Surface Treatment	Sealed Board (Encapsulated)	
PRIORITY ASSESSMENT				SCORE
Occupant Activity	Not Applicable	Extent / Amount	42.00 m2	-
Accessibility	Occasionally disturb	Location	Not Applicable	
Avg Time in Use	Not Applicable	Frequency of Use	Not Applicable	
No. of Occupants	Not Applicable	Secondary Activity	Not Applicable	
Maintenance	Not Applicable	Maintenance Frequency	Not Applicable	
MANAGEMENT ACTION				SCORE
Recommendation	NO ACTION REQUIRED			-
Recommendation Due		Next Inspection	None	
Apply Labels	No	Permit to Work Required	No	
Survey Type	Management	Lead Surveyor	Darryl Stokes	
Survey Date	29 Mar 2012	UKAS Laboratory	NOT SAMPLED (Cross Referenced)	
Site Reference	257910000A	Licensed Material	N/A

No Asbestos Presumed in Sample

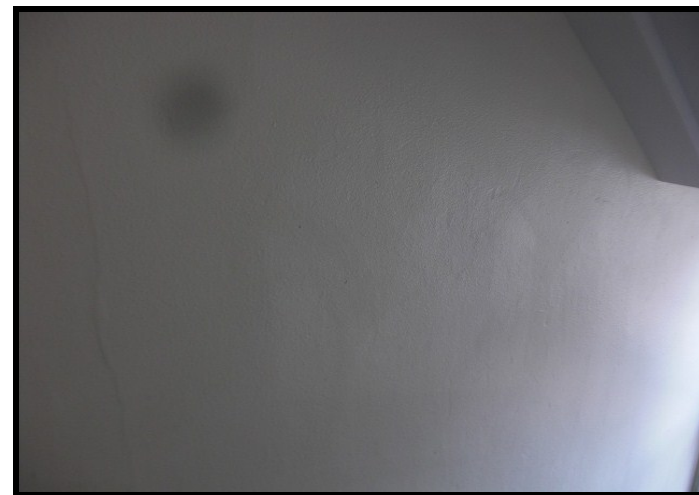
SAMPLE REFERENCE 011

Building	Floor	Room	Location	
Main Building	Second Floor	All	Ceiling	
Description				
MATERIAL ASSESSMENT				SCORE
Product Type	Textured Coating	Extent of Damage	Good condition	-
Asbestos Type	No Asbestos Detected	Surface Treatment	Composite materials	
PRIORITY ASSESSMENT				SCORE
Occupant Activity	Not Applicable	Extent / Amount	24.00 m2	-
Accessibility	Occasionally disturb	Location	Not Applicable	
Avg Time in Use	Not Applicable	Frequency of Use	Not Applicable	
No. of Occupants	Not Applicable	Secondary Activity	Not Applicable	
Maintenance	Not Applicable	Maintenance Frequency	Not Applicable	
MANAGEMENT ACTION				SCORE
Recommendation	NO ACTION REQUIRED			-
Recommendation Due		Next Inspection	None	
Apply Labels	No	Permit to Work Required	No	
Survey Type	Management	Lead Surveyor	Darryl Stokes	
Survey Date	29 Mar 2012	UKAS Laboratory	NOT SAMPLED (Cross Referenced)	
Site Reference	257910000A	Licensed Material	N/A

No Asbestos Presumed in Sample

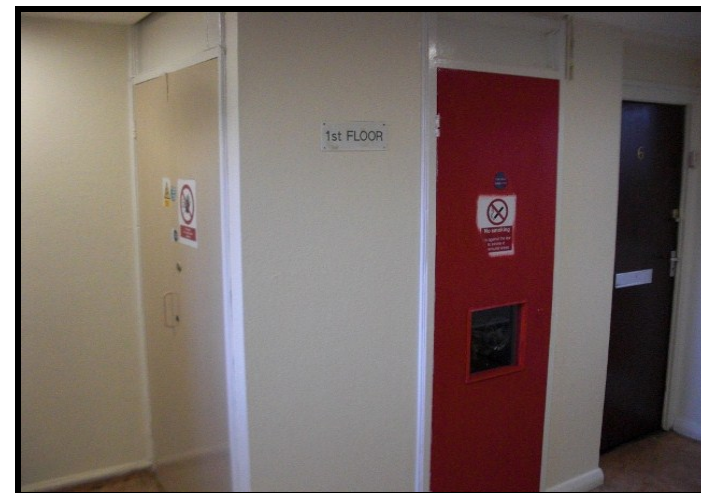
SAMPLE REFERENCE 012

Building	Floor	Room	Location	
Main Building	Second Floor	All	Wall	
Description				
MATERIAL ASSESSMENT				SCORE
Product Type	Textured Coating	Extent of Damage	Good condition	-
Asbestos Type	No Asbestos Detected	Surface Treatment	Composite materials	
PRIORITY ASSESSMENT				SCORE
Occupant Activity	Not Applicable	Extent / Amount	66.00 m2	-
Accessibility	Easily disturbed	Location	Not Applicable	
Avg Time in Use	Not Applicable	Frequency of Use	Not Applicable	
No. of Occupants	Not Applicable	Secondary Activity	Not Applicable	
Maintenance	Not Applicable	Maintenance Frequency	Not Applicable	
MANAGEMENT ACTION				SCORE
Recommendation	NO ACTION REQUIRED			-
Recommendation Due		Next Inspection	None	
Apply Labels	No	Permit to Work Required	No	
Survey Type	Management	Lead Surveyor	Darryl Stokes	
Survey Date	29 Mar 2012	UKAS Laboratory	NOT SAMPLED (Cross Referenced)	
Site Reference	257910000A	Licensed Material	N/A

No Asbestos Presumed in Sample

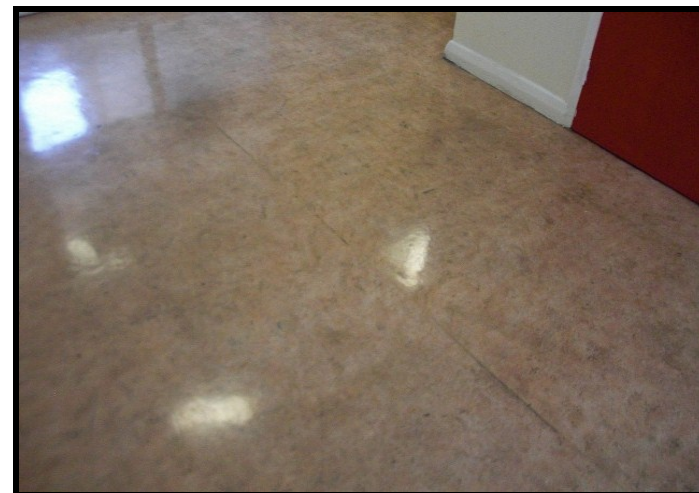
SAMPLE REFERENCE 013

Building	Floor	Room	Location	
Main Building	Second Floor	All	Floor	
Description				
MATERIAL ASSESSMENT				SCORE
Product Type	Floor Tiles	Extent of Damage	Good condition	-
Asbestos Type	No Asbestos Detected	Surface Treatment	Composite materials	
PRIORITY ASSESSMENT				SCORE
Occupant Activity	Not Applicable	Extent / Amount	30.00 m2	-
Accessibility	Occasionally disturb	Location	Not Applicable	
Avg Time in Use	Not Applicable	Frequency of Use	Not Applicable	
No. of Occupants	Not Applicable	Secondary Activity	Not Applicable	
Maintenance	Not Applicable	Maintenance Frequency	Not Applicable	
MANAGEMENT ACTION				SCORE
Recommendation	NO ACTION REQUIRED			-
Recommendation Due		Next Inspection	None	
Apply Labels	No	Permit to Work Required	No	
Survey Type	Management	Lead Surveyor	Darryl Stokes	
Survey Date	29 Mar 2012	UKAS Laboratory	NOT SAMPLED (Cross Referenced)	
Site Reference	257910000A	Licensed Material	N/A

No Asbestos Presumed in Sample

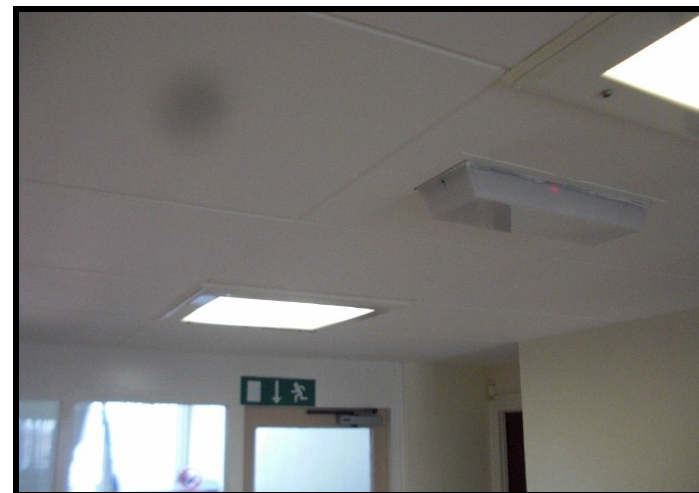
SAMPLE REFERENCE 014

Building	Floor	Room	Location	
Main Building	Third Floor	All	Ceiling	
Description				
MATERIAL ASSESSMENT				SCORE
Product Type	Board	Extent of Damage	Good condition	-
Asbestos Type	No Asbestos Detected	Surface Treatment	Sealed Board (Encapsulated)	
PRIORITY ASSESSMENT				SCORE
Occupant Activity	Not Applicable	Extent / Amount	42.00 m2	-
Accessibility	Occasionally disturb	Location	Not Applicable	
Avg Time in Use	Not Applicable	Frequency of Use	Not Applicable	
No. of Occupants	Not Applicable	Secondary Activity	Not Applicable	
Maintenance	Not Applicable	Maintenance Frequency	Not Applicable	
MANAGEMENT ACTION				SCORE
Recommendation	NO ACTION REQUIRED			-
Recommendation Due		Next Inspection	None	
Apply Labels	No	Permit to Work Required	No	
Survey Type	Management	Lead Surveyor	Darryl Stokes	
Survey Date	29 Mar 2012	UKAS Laboratory	NOT SAMPLED (Cross Referenced)	
Site Reference	257910000A	Licensed Material	N/A

No Asbestos Presumed in Sample

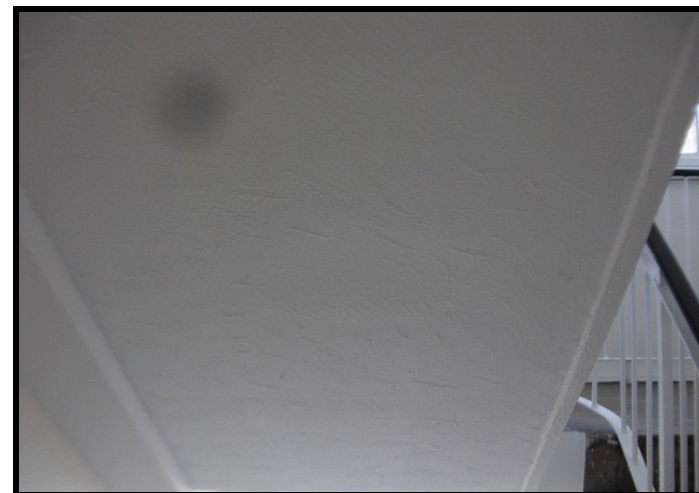
SAMPLE REFERENCE 015

No Asbestos Presumed in Sample

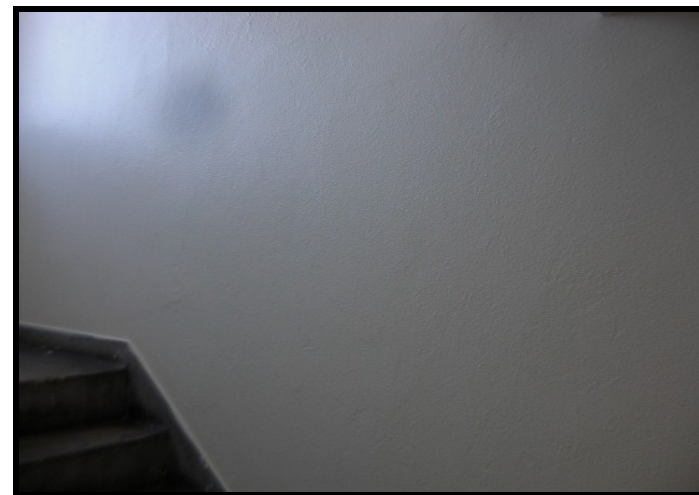
SAMPLE REFERENCE 016

No Asbestos Presumed in Sample

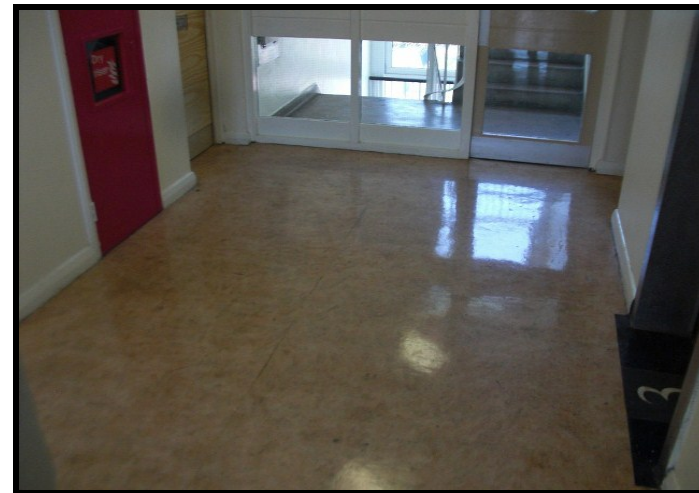
SAMPLE REFERENCE 017

Building	Floor	Room	Location	
Main Building	Third Floor	All	Floor	
Description				
MATERIAL ASSESSMENT				SCORE
Product Type	Floor Tiles	Extent of Damage	Good condition	-
Asbestos Type	No Asbestos Detected	Surface Treatment	Composite materials	
PRIORITY ASSESSMENT				SCORE
Occupant Activity	Not Applicable	Extent / Amount	30.00 m2	-
Accessibility	Occasionally disturb	Location	Not Applicable	
Avg Time in Use	Not Applicable	Frequency of Use	Not Applicable	
No. of Occupants	Not Applicable	Secondary Activity	Not Applicable	
Maintenance	Not Applicable	Maintenance Frequency	Not Applicable	
MANAGEMENT ACTION				SCORE
Recommendation	NO ACTION REQUIRED			-
Recommendation Due		Next Inspection	None	
Apply Labels	No	Permit to Work Required	No	
Survey Type	Management	Lead Surveyor	Darryl Stokes	
Survey Date	29 Mar 2012	UKAS Laboratory	NOT SAMPLED (Cross Referenced)	
Site Reference	257910000A	Licensed Material	N/A

No Asbestos Presumed in Sample

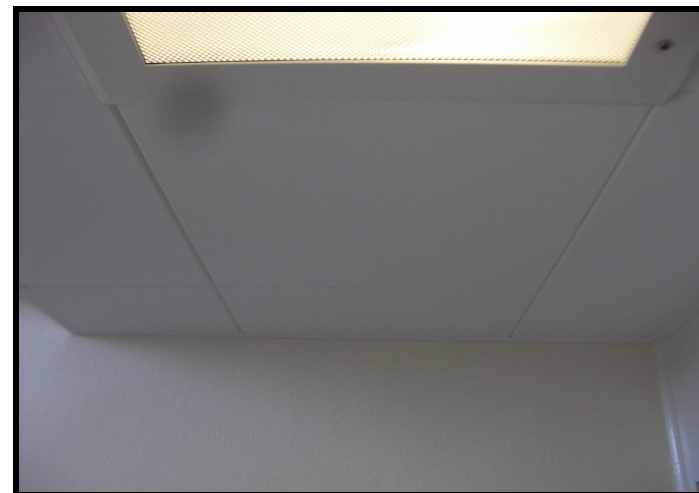
SAMPLE REFERENCE 018

Building	Floor	Room	Location	
Main Building	Fourth Floor	All	Ceiling	
Description				
MATERIAL ASSESSMENT				SCORE
Product Type	Board	Extent of Damage	Good condition	-
Asbestos Type	No Asbestos Detected	Surface Treatment	Sealed Board (Encapsulated)	
PRIORITY ASSESSMENT				SCORE
Occupant Activity	Not Applicable	Extent / Amount	42.00 m2	-
Accessibility	Occasionally disturb	Location	Not Applicable	
Avg Time in Use	Not Applicable	Frequency of Use	Not Applicable	
No. of Occupants	Not Applicable	Secondary Activity	Not Applicable	
Maintenance	Not Applicable	Maintenance Frequency	Not Applicable	
MANAGEMENT ACTION				SCORE
Recommendation	NO ACTION REQUIRED			-
Recommendation Due		Next Inspection	None	
Apply Labels	No	Permit to Work Required	No	
Survey Type	Management	Lead Surveyor	Darryl Stokes	
Survey Date	29 Mar 2012	UKAS Laboratory	NOT SAMPLED (Cross Referenced)	
Site Reference	257910000A	Licensed Material	N/A

No Asbestos Presumed in Sample

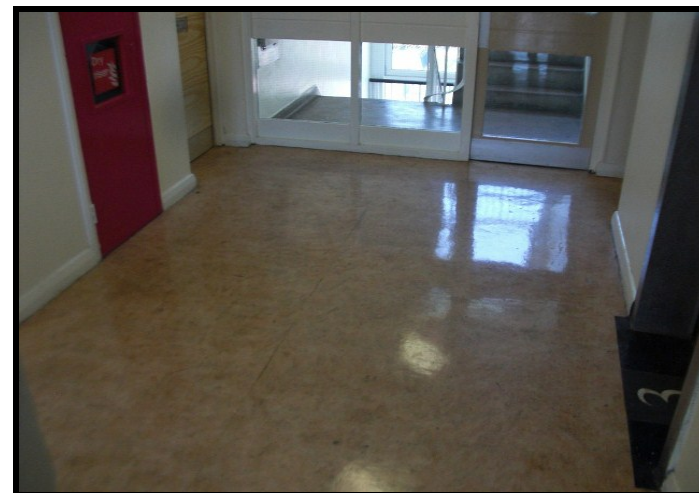
SAMPLE REFERENCE 019

Building	Floor	Room	Location	
Main Building	Fourth Floor	All	Floor	
Description				
MATERIAL ASSESSMENT				SCORE
Product Type	Floor Tiles	Extent of Damage	Good condition	-
Asbestos Type	No Asbestos Detected	Surface Treatment	Composite materials	
PRIORITY ASSESSMENT				SCORE
Occupant Activity	Not Applicable	Extent / Amount	30.00 m2	-
Accessibility	Occasionally disturb	Location	Not Applicable	
Avg Time in Use	Not Applicable	Frequency of Use	Not Applicable	
No. of Occupants	Not Applicable	Secondary Activity	Not Applicable	
Maintenance	Not Applicable	Maintenance Frequency	Not Applicable	
MANAGEMENT ACTION				SCORE
Recommendation	NO ACTION REQUIRED			-
Recommendation Due		Next Inspection	None	
Apply Labels	No	Permit to Work Required	No	
Survey Type	Management	Lead Surveyor	Darryl Stokes	
Survey Date	29 Mar 2012	UKAS Laboratory	NOT SAMPLED (Cross Referenced)	
Site Reference	257910000A	Licensed Material	N/A

No Asbestos Presumed in Sample

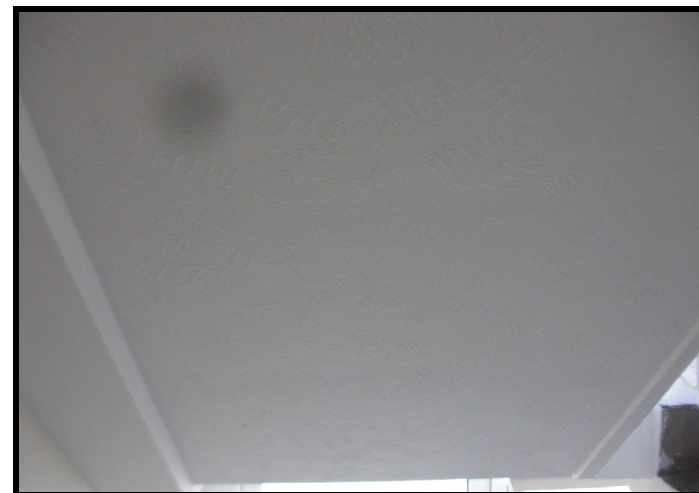
SAMPLE REFERENCE 020

Building	Floor	Room	Location
Main Building	Fourth Floor	All	Ceiling
Description			
MATERIAL ASSESSMENT			
Product Type	Textured Coating	Extent of Damage	Good condition
Asbestos Type	No Asbestos Detected	Surface Treatment	Composite materials
PRIORITY ASSESSMENT			
Occupant Activity	Not Applicable	Extent / Amount	24.00 m2
Accessibility	Occasionally disturb	Location	Not Applicable
Avg Time in Use	Not Applicable	Frequency of Use	Not Applicable
No. of Occupants	Not Applicable	Secondary Activity	Not Applicable
Maintenance	Not Applicable	Maintenance Frequency	Not Applicable
MANAGEMENT ACTION			
Recommendation	NO ACTION REQUIRED		
Recommendation Due		Next Inspection	None
Apply Labels	No	Permit to Work Required	No
Survey Type	Management	Lead Surveyor	Darryl Stokes
Survey Date	29 Mar 2012	UKAS Laboratory	NOT SAMPLED (Cross Referenced)
Site Reference	257910000A	Licensed Material	N/A

No Asbestos Presumed in Sample

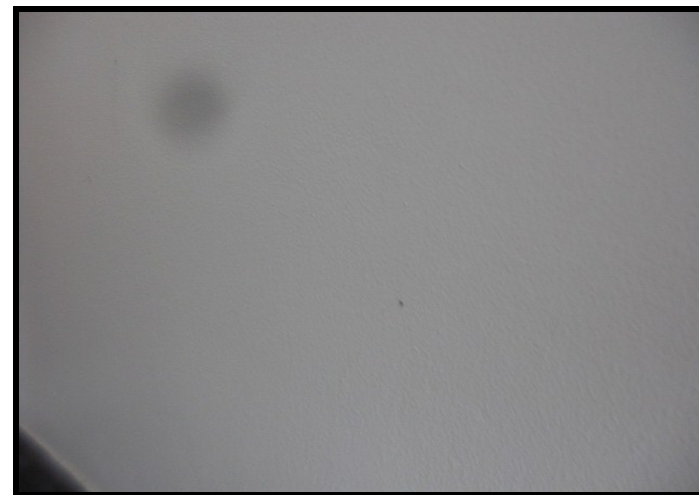
SAMPLE REFERENCE 021

Building	Floor	Room	Location	
Main Building	Fourth Floor	All	Wall	
Description				
MATERIAL ASSESSMENT				SCORE
Product Type	Textured Coating	Extent of Damage	Good condition	-
Asbestos Type	No Asbestos Detected	Surface Treatment	Composite materials	
PRIORITY ASSESSMENT				SCORE
Occupant Activity	Not Applicable	Extent / Amount	60.00 m2	-
Accessibility	Occasionally disturb	Location	Not Applicable	
Avg Time in Use	Not Applicable	Frequency of Use	Not Applicable	
No. of Occupants	Not Applicable	Secondary Activity	Not Applicable	
Maintenance	Not Applicable	Maintenance Frequency	Not Applicable	
MANAGEMENT ACTION				SCORE
Recommendation	NO ACTION REQUIRED			-
Recommendation Due		Next Inspection	None	
Apply Labels	No	Permit to Work Required	No	
Survey Type	Management	Lead Surveyor	Darryl Stokes	
Survey Date	29 Mar 2012	UKAS Laboratory	NOT SAMPLED (Cross Referenced)	
Site Reference	257910000A	Licensed Material	N/A

No Asbestos Presumed in Sample

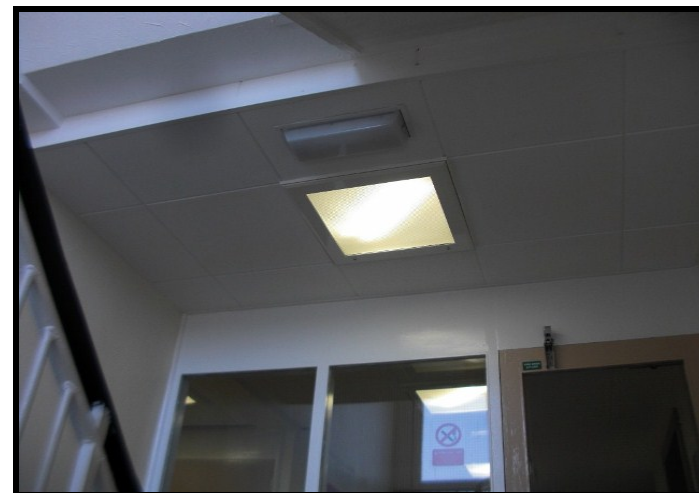
SAMPLE REFERENCE 022

No Asbestos Presumed in Sample

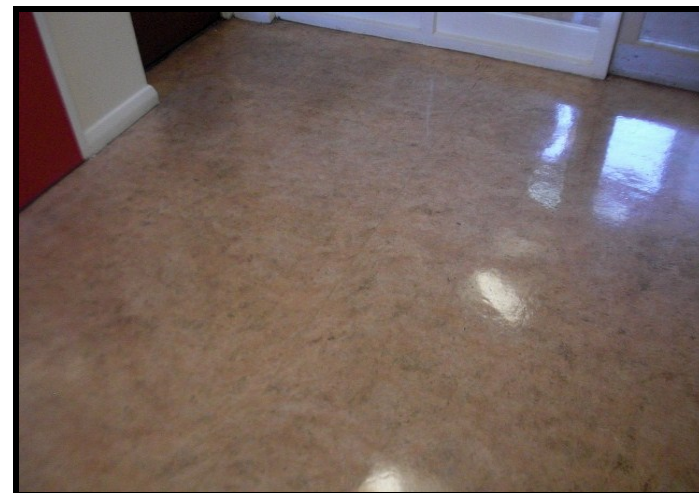
SAMPLE REFERENCE 023

No Asbestos Presumed in Sample

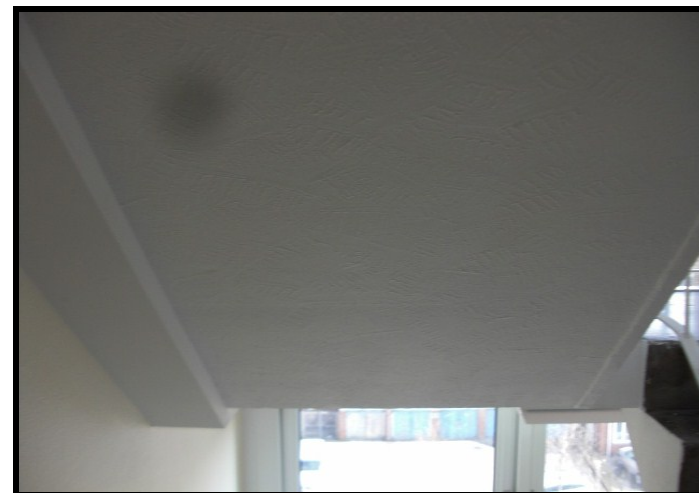
SAMPLE REFERENCE 024

Building	Floor	Room	Location	
Main Building	Fifth Floor	All	Ceiling	
Description				
MATERIAL ASSESSMENT				SCORE
Product Type	Textured Coating	Extent of Damage	Good condition	-
Asbestos Type	No Asbestos Detected	Surface Treatment	Composite materials	
PRIORITY ASSESSMENT				SCORE
Occupant Activity	Not Applicable	Extent / Amount	24.00 m2	-
Accessibility	Occasionally disturb	Location	Not Applicable	
Avg Time in Use	Not Applicable	Frequency of Use	Not Applicable	
No. of Occupants	Not Applicable	Secondary Activity	Not Applicable	
Maintenance	Not Applicable	Maintenance Frequency	Not Applicable	
MANAGEMENT ACTION				SCORE
Recommendation	NO ACTION REQUIRED			-
Recommendation Due		Next Inspection	None	
Apply Labels	No	Permit to Work Required	No	
Survey Type	Management	Lead Surveyor	Darryl Stokes	
Survey Date	29 Mar 2012	UKAS Laboratory	NOT SAMPLED (Cross Referenced)	
Site Reference	257910000A	Licensed Material	N/A

No Asbestos Presumed in Sample

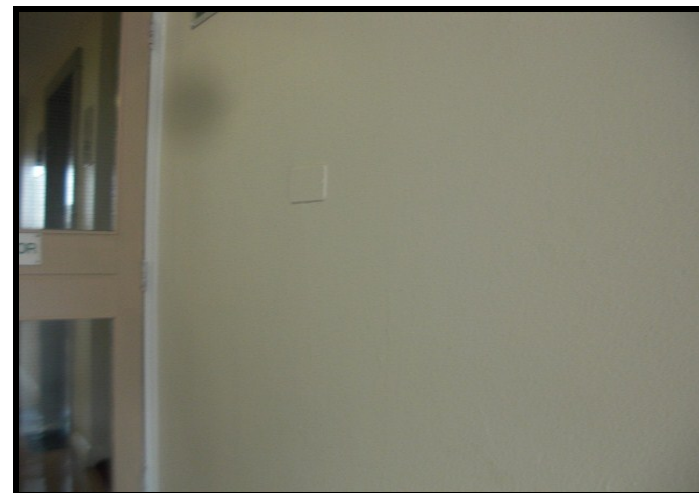
SAMPLE REFERENCE 025

No Asbestos Presumed in Sample

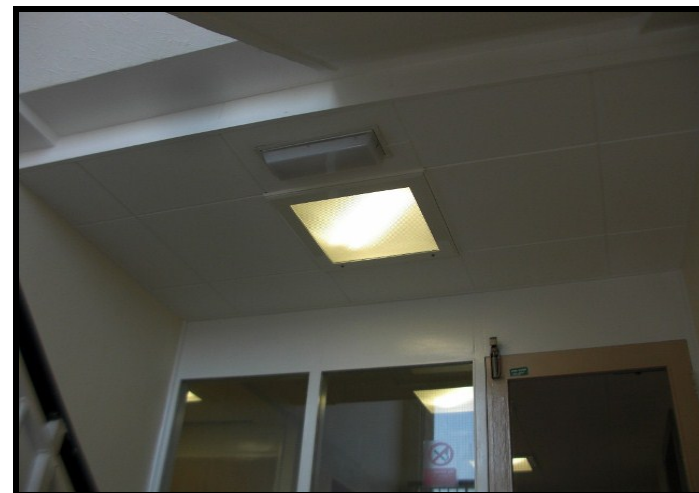
SAMPLE REFERENCE 026

Building	Floor	Room	Location	
Main Building	Sixth Floor	All	Ceiling	
Description				
MATERIAL ASSESSMENT				SCORE
Product Type	Board	Extent of Damage	Good condition	-
Asbestos Type	No Asbestos Detected	Surface Treatment	Sealed Board (Encapsulated)	
PRIORITY ASSESSMENT				SCORE
Occupant Activity	Not Applicable	Extent / Amount	42.00 m2	-
Accessibility	Occasionally disturb	Location	Not Applicable	
Avg Time in Use	Not Applicable	Frequency of Use	Not Applicable	
No. of Occupants	Not Applicable	Secondary Activity	Not Applicable	
Maintenance	Not Applicable	Maintenance Frequency	Not Applicable	
MANAGEMENT ACTION				SCORE
Recommendation	NO ACTION REQUIRED			-
Recommendation Due		Next Inspection	None	
Apply Labels	No	Permit to Work Required	No	
Survey Type	Management	Lead Surveyor	Darryl Stokes	
Survey Date	29 Mar 2012	UKAS Laboratory	NOT SAMPLED (Cross Referenced)	
Site Reference	257910000A	Licensed Material	N/A

No Asbestos Presumed in Sample

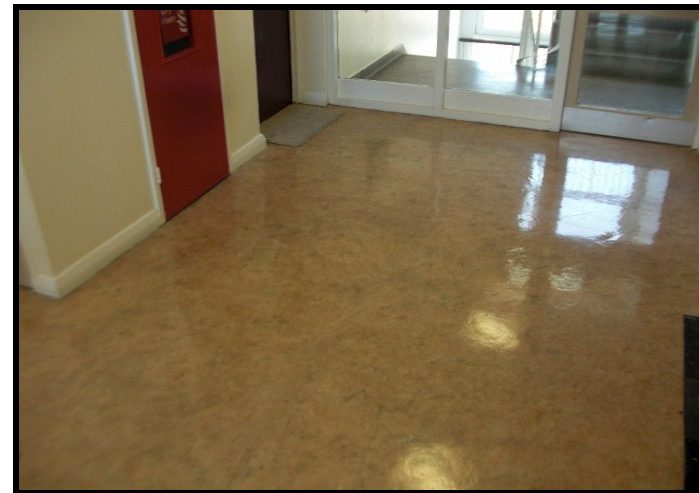
SAMPLE REFERENCE 027

Building	Floor	Room	Location	
Main Building	Sixth Floor	All	Floor	
Description				
MATERIAL ASSESSMENT				SCORE
Product Type	Floor Tiles	Extent of Damage	Good condition	-
Asbestos Type	No Asbestos Detected	Surface Treatment	Composite materials	
PRIORITY ASSESSMENT				SCORE
Occupant Activity	Not Applicable	Extent / Amount	30.00 m2	-
Accessibility	Occasionally disturb	Location	Not Applicable	
Avg Time in Use	Not Applicable	Frequency of Use	Not Applicable	
No. of Occupants	Not Applicable	Secondary Activity	Not Applicable	
Maintenance	Not Applicable	Maintenance Frequency	Not Applicable	
MANAGEMENT ACTION				SCORE
Recommendation	NO ACTION REQUIRED			-
Recommendation Due		Next Inspection	None	
Apply Labels	No	Permit to Work Required	No	
Survey Type	Management	Lead Surveyor	Darryl Stokes	
Survey Date	29 Mar 2012	UKAS Laboratory	NOT SAMPLED (Cross Referenced)	
Site Reference	257910000A	Licensed Material	N/A

No Asbestos Presumed in Sample

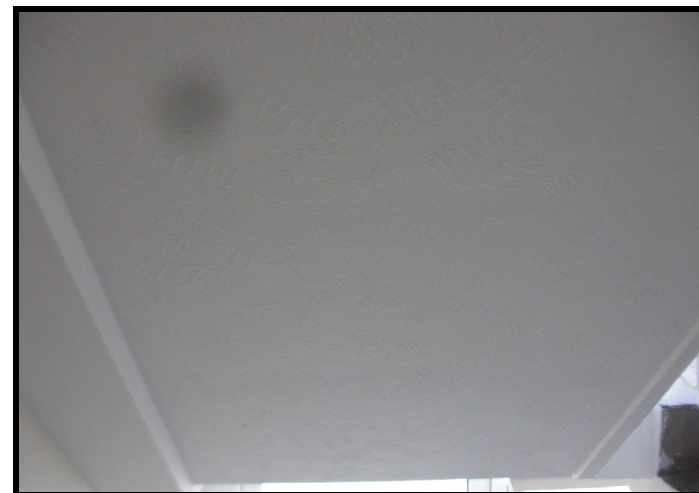
SAMPLE REFERENCE 028

Building	Floor	Room	Location
Main Building	Sixth Floor	All	Ceiling
Description			
MATERIAL ASSESSMENT			
Product Type	Textured Coating	Extent of Damage	Good condition
Asbestos Type	No Asbestos Detected	Surface Treatment	Composite materials
PRIORITY ASSESSMENT			
Occupant Activity	Not Applicable	Extent / Amount	24.00 m2
Accessibility	Occasionally disturb	Location	Not Applicable
Avg Time in Use	Not Applicable	Frequency of Use	Not Applicable
No. of Occupants	Not Applicable	Secondary Activity	Not Applicable
Maintenance	Not Applicable	Maintenance Frequency	Not Applicable
MANAGEMENT ACTION			
Recommendation	NO ACTION REQUIRED		
Recommendation Due		Next Inspection	None
Apply Labels	No	Permit to Work Required	No
Survey Type	Management	Lead Surveyor	Darryl Stokes
Survey Date	29 Mar 2012	UKAS Laboratory	NOT SAMPLED (Cross Referenced)
Site Reference	257910000A	Licensed Material	N/A

No Asbestos Presumed in Sample

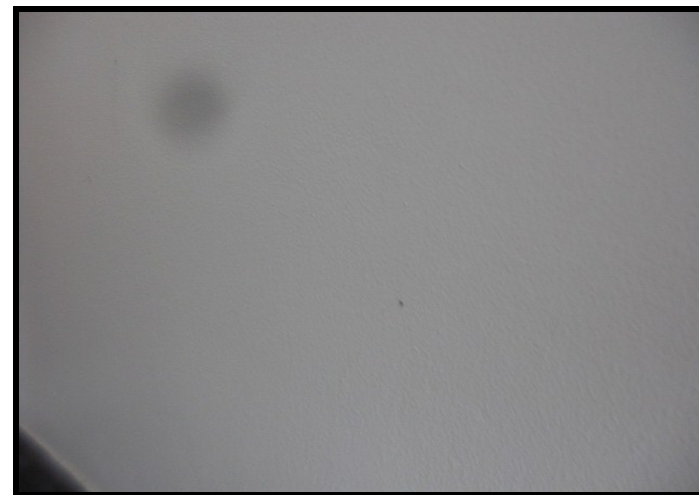
SAMPLE REFERENCE 029

Building	Floor	Room	Location
Main Building	Sixth Floor	All	Wall
Description			
MATERIAL ASSESSMENT			
Product Type	Textured Coating	Extent of Damage	Good condition
Asbestos Type	No Asbestos Detected	Surface Treatment	Composite materials
PRIORITY ASSESSMENT			
Occupant Activity	Not Applicable	Extent / Amount	60.00 m2
Accessibility	Easily disturbed	Location	Not Applicable
Avg Time in Use	Not Applicable	Frequency of Use	Not Applicable
No. of Occupants	Not Applicable	Secondary Activity	Not Applicable
Maintenance	Not Applicable	Maintenance Frequency	Not Applicable
MANAGEMENT ACTION			
Recommendation	NO ACTION REQUIRED		
Recommendation Due		Next Inspection	None
Apply Labels	No	Permit to Work Required	No
Survey Type	Management	Lead Surveyor	Darryl Stokes
Survey Date	29 Mar 2012	UKAS Laboratory	NOT SAMPLED (Cross Referenced)
Site Reference	257910000A	Licensed Material	N/A

No Asbestos Presumed in Sample

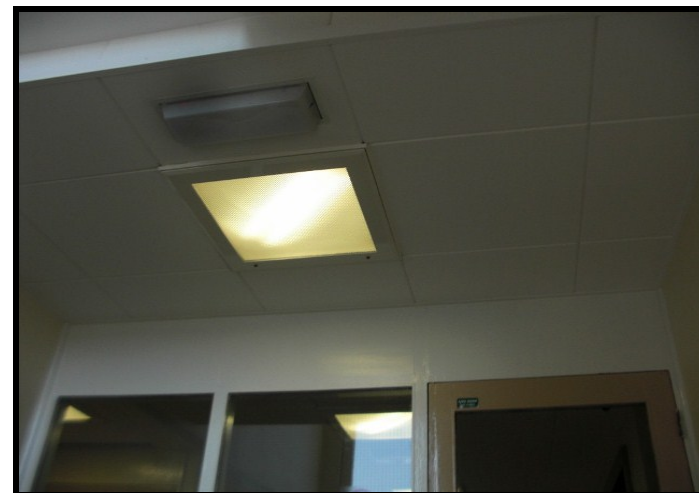
SAMPLE REFERENCE 030

Building	Floor	Room	Location	
Main Building	Seventh Floor	All	Ceiling	
Description				
MATERIAL ASSESSMENT				SCORE
Product Type	Board	Extent of Damage	Good condition	-
Asbestos Type	No Asbestos Detected	Surface Treatment	Composite materials	
PRIORITY ASSESSMENT				SCORE
Occupant Activity	Not Applicable	Extent / Amount	42.00 m2	-
Accessibility	Occasionally disturb	Location	Not Applicable	
Avg Time in Use	Not Applicable	Frequency of Use	Not Applicable	
No. of Occupants	Not Applicable	Secondary Activity	Not Applicable	
Maintenance	Not Applicable	Maintenance Frequency	Not Applicable	
MANAGEMENT ACTION				SCORE
Recommendation	NO ACTION REQUIRED			-
Recommendation Due		Next Inspection	None	
Apply Labels	No	Permit to Work Required	No	
Survey Type	Management	Lead Surveyor	Darryl Stokes	
Survey Date	29 Mar 2012	UKAS Laboratory	NOT SAMPLED (Cross Referenced)	
Site Reference	257910000A	Licensed Material	N/A

No Asbestos Presumed in Sample

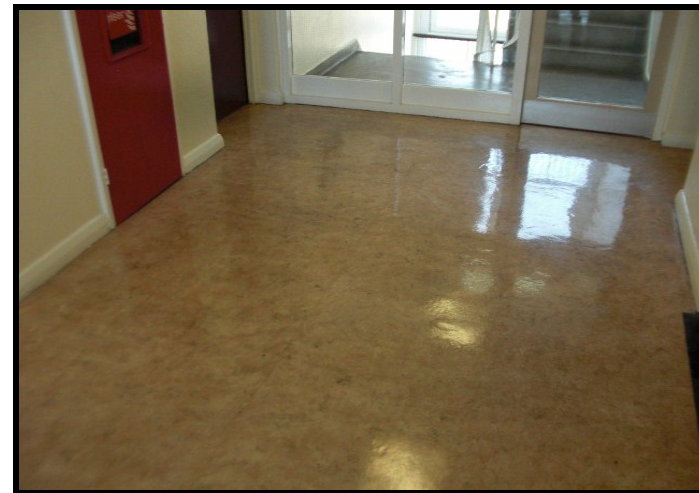
SAMPLE REFERENCE 031

Building	Floor	Room	Location	
Main Building	Seventh Floor	All	Floor	
Description				
MATERIAL ASSESSMENT				SCORE
Product Type	Floor Tiles	Extent of Damage	Good condition	-
Asbestos Type	No Asbestos Detected	Surface Treatment	Composite materials	
PRIORITY ASSESSMENT				SCORE
Occupant Activity	Not Applicable	Extent / Amount	30.00 m2	-
Accessibility	Occasionally disturb	Location	Not Applicable	
Avg Time in Use	Not Applicable	Frequency of Use	Not Applicable	
No. of Occupants	Not Applicable	Secondary Activity	Not Applicable	
Maintenance	Not Applicable	Maintenance Frequency	Not Applicable	
MANAGEMENT ACTION				SCORE
Recommendation	NO ACTION REQUIRED			-
Recommendation Due		Next Inspection	None	
Apply Labels	No	Permit to Work Required	No	
Survey Type	Management	Lead Surveyor	Darryl Stokes	
Survey Date	29 Mar 2012	UKAS Laboratory	NOT SAMPLED (Cross Referenced)	
Site Reference	257910000A	Licensed Material	N/A

No Asbestos Presumed in Sample

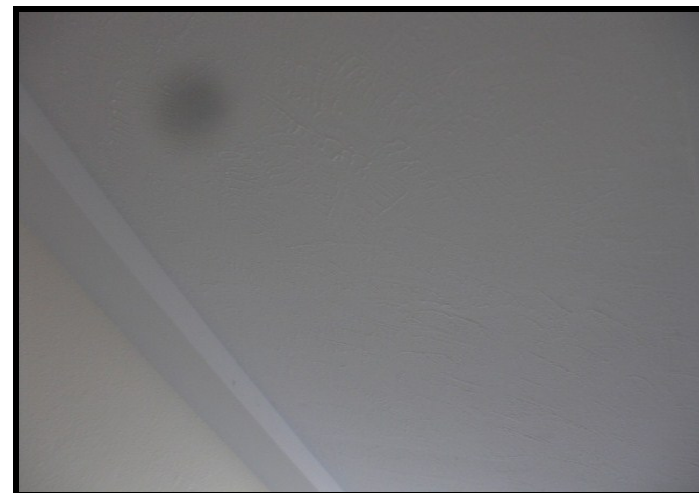
SAMPLE REFERENCE 032

Building	Floor	Room	Location	
Main Building	Seventh Floor	All	Ceiling	
Description				
MATERIAL ASSESSMENT				SCORE
Product Type	Textured Coating	Extent of Damage	Good condition	-
Asbestos Type	No Asbestos Detected	Surface Treatment	Composite materials	
PRIORITY ASSESSMENT				SCORE
Occupant Activity	Not Applicable	Extent / Amount	24.00 m2	-
Accessibility	Occasionally disturb	Location	Not Applicable	
Avg Time in Use	Not Applicable	Frequency of Use	Not Applicable	
No. of Occupants	Not Applicable	Secondary Activity	Not Applicable	
Maintenance	Not Applicable	Maintenance Frequency	Not Applicable	
MANAGEMENT ACTION				SCORE
Recommendation	NO ACTION REQUIRED			-
Recommendation Due		Next Inspection	None	
Apply Labels	No	Permit to Work Required	No	
Survey Type	Management	Lead Surveyor	Darryl Stokes	
Survey Date	29 Mar 2012	UKAS Laboratory	NOT SAMPLED (Cross Referenced)	
Site Reference	257910000A	Licensed Material	N/A

No Asbestos Presumed in Sample

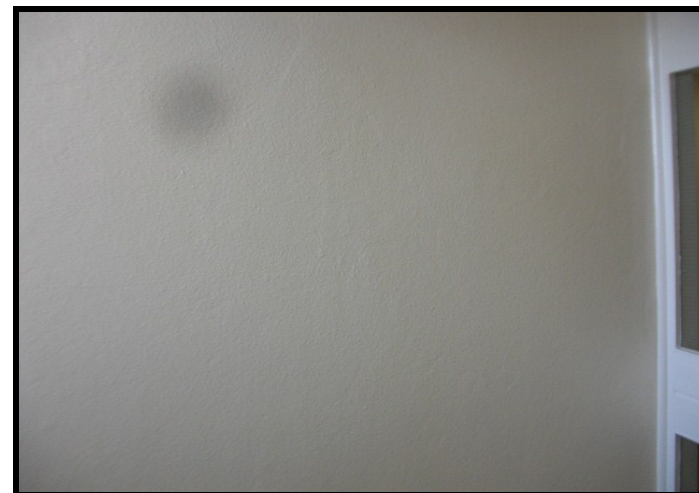
SAMPLE REFERENCE 033

No Asbestos Presumed in Sample

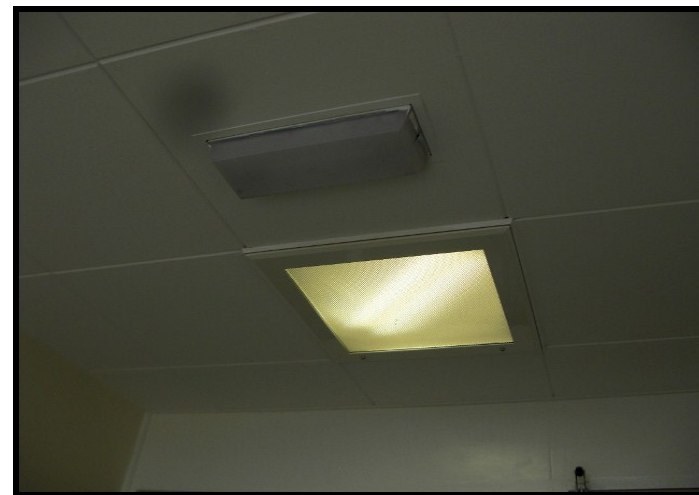
SAMPLE REFERENCE 034

Building	Floor	Room	Location	
Main Building	Eighth Floor	All	Ceiling	
Description				
MATERIAL ASSESSMENT				SCORE
Product Type	Board	Extent of Damage	Good condition	-
Asbestos Type	No Asbestos Detected	Surface Treatment	Sealed Board (Encapsulated)	
PRIORITY ASSESSMENT				SCORE
Occupant Activity	Not Applicable	Extent / Amount	42.00 m2	-
Accessibility	Occasionally disturb	Location	Not Applicable	
Avg Time in Use	Not Applicable	Frequency of Use	Not Applicable	
No. of Occupants	Not Applicable	Secondary Activity	Not Applicable	
Maintenance	Not Applicable	Maintenance Frequency	Not Applicable	
MANAGEMENT ACTION				SCORE
Recommendation	NO ACTION REQUIRED			-
Recommendation Due		Next Inspection	None	
Apply Labels	No	Permit to Work Required	No	
Survey Type	Management	Lead Surveyor	Darryl Stokes	
Survey Date	29 Mar 2012	UKAS Laboratory	NOT SAMPLED (Cross Referenced)	
Site Reference	257910000A	Licensed Material	N/A

No Asbestos Presumed in Sample

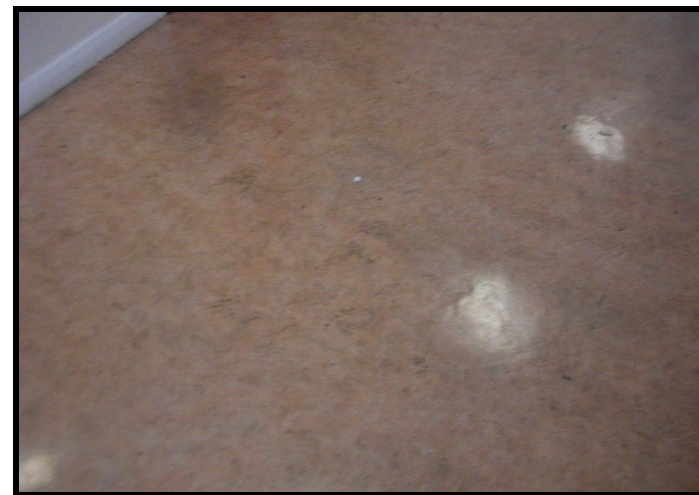
SAMPLE REFERENCE 035

Building	Floor	Room	Location	
Main Building	Eighth Floor	All	Floor	
Description				
MATERIAL ASSESSMENT				
Product Type	Floor Tiles	Extent of Damage	Good condition	-
Asbestos Type	No Asbestos Detected	Surface Treatment	Composite materials	
PRIORITY ASSESSMENT				
Occupant Activity	Not Applicable	Extent / Amount	30.00 m2	-
Accessibility	Occasionally disturb	Location	Not Applicable	
Avg Time in Use	Not Applicable	Frequency of Use	Not Applicable	
No. of Occupants	Not Applicable	Secondary Activity	Not Applicable	
Maintenance	Not Applicable	Maintenance Frequency	Not Applicable	
MANAGEMENT ACTION				
Recommendation	NO ACTION REQUIRED			-
Recommendation Due		Next Inspection	None	
Apply Labels	No	Permit to Work Required	No	
Survey Type	Management	Lead Surveyor	Darryl Stokes	
Survey Date	29 Mar 2012	UKAS Laboratory	NOT SAMPLED (Cross Referenced)	
Site Reference	257910000A	Licensed Material	N/A

No Asbestos Presumed in Sample

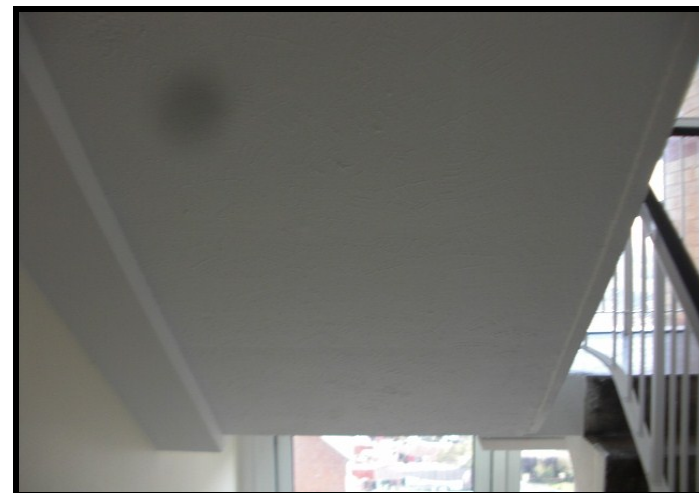
SAMPLE REFERENCE 036

No Asbestos Presumed in Sample

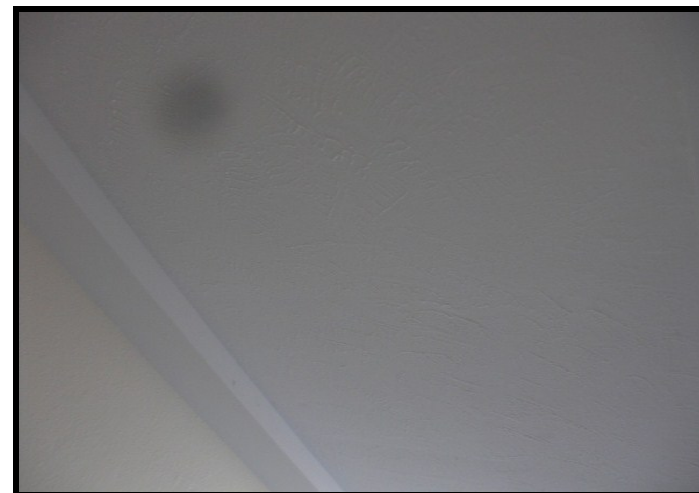
SAMPLE REFERENCE 037

Building	Floor	Room	Location	
Main Building	Eighth Floor	All	Walls	
Description				
MATERIAL ASSESSMENT				SCORE
Product Type	Textured Coating	Extent of Damage	Good condition	-
Asbestos Type	No Asbestos Detected	Surface Treatment	Composite materials	
PRIORITY ASSESSMENT				SCORE
Occupant Activity	Not Applicable	Extent / Amount	60.00 m2	-
Accessibility	Easily disturbed	Location	Not Applicable	
Avg Time in Use	Not Applicable	Frequency of Use	Not Applicable	
No. of Occupants	Not Applicable	Secondary Activity	Not Applicable	
Maintenance	Not Applicable	Maintenance Frequency	Not Applicable	
MANAGEMENT ACTION				SCORE
Recommendation	NO ACTION REQUIRED			-
Recommendation Due		Next Inspection	None	
Apply Labels	No	Permit to Work Required	No	
Survey Type	Management	Lead Surveyor	Darryl Stokes	
Survey Date	29 Mar 2012	UKAS Laboratory	NOT SAMPLED (Cross Referenced)	
Site Reference	257910000A	Licensed Material	N/A

No Asbestos Presumed in Sample

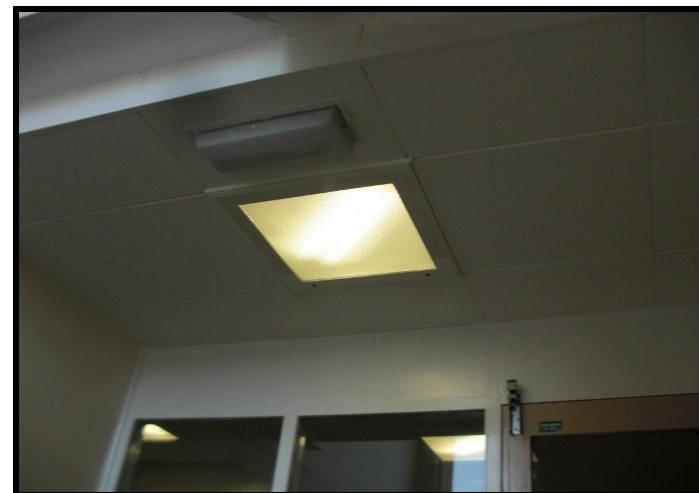
SAMPLE REFERENCE 038

Building	Floor	Room	Location	
Main Building	Ninth Floor	All	Ceiling	
Description				
MATERIAL ASSESSMENT				SCORE
Product Type	Board	Extent of Damage	Good condition	-
Asbestos Type	No Asbestos Detected	Surface Treatment	Sealed Board (Encapsulated)	
PRIORITY ASSESSMENT				SCORE
Occupant Activity	Not Applicable	Extent / Amount	42.00 m2	-
Accessibility	Occasionally disturb	Location	Not Applicable	
Avg Time in Use	Not Applicable	Frequency of Use	Not Applicable	
No. of Occupants	Not Applicable	Secondary Activity	Not Applicable	
Maintenance	Not Applicable	Maintenance Frequency	Not Applicable	
MANAGEMENT ACTION				SCORE
Recommendation	NO ACTION REQUIRED			-
Recommendation Due		Next Inspection	None	
Apply Labels	No	Permit to Work Required	No	
Survey Type	Management	Lead Surveyor	Darryl Stokes	
Survey Date	29 Mar 2012	UKAS Laboratory	NOT SAMPLED (Cross Referenced)	
Site Reference	257910000A	Licensed Material	N/A

No Asbestos Presumed in Sample

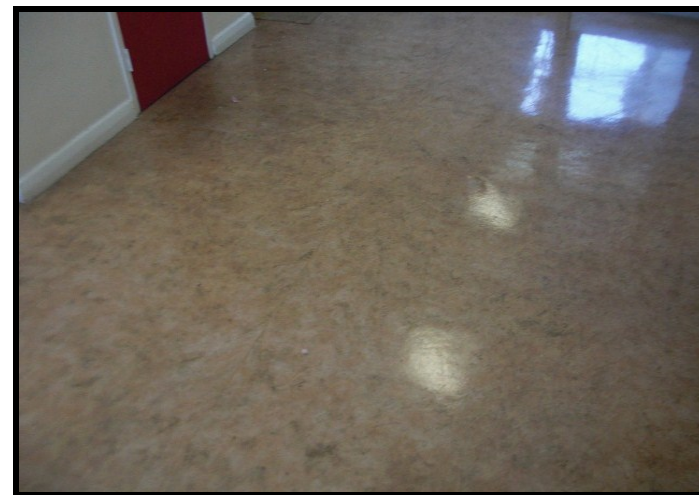
SAMPLE REFERENCE 039

No Asbestos Presumed in Sample

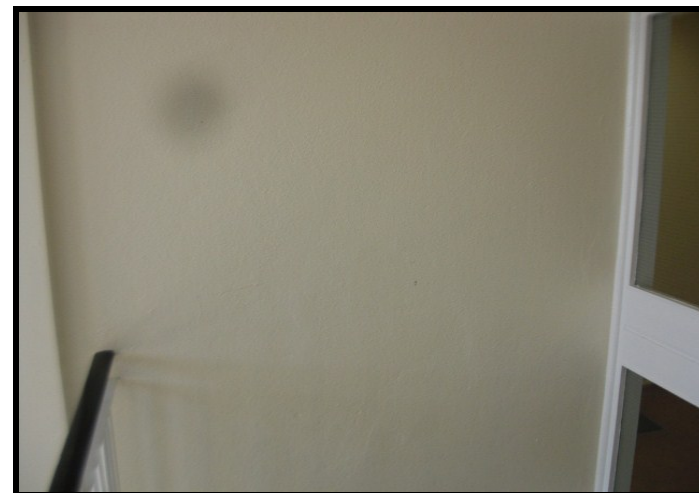
SAMPLE REFERENCE 041

No Asbestos Presumed in Sample

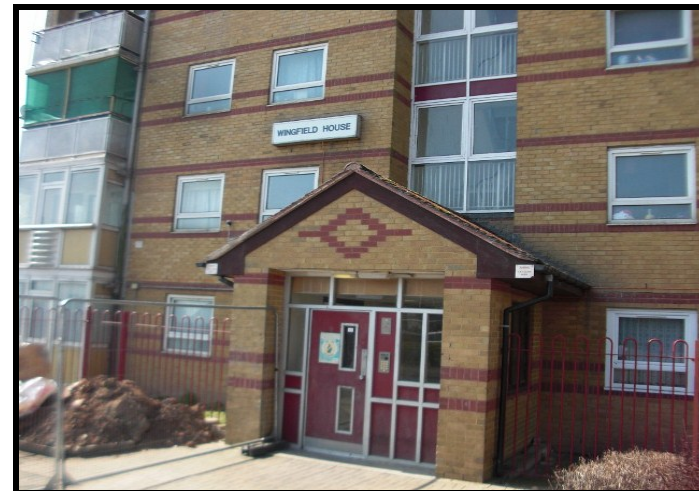
SAMPLE REFERENCE 042

042	Main Building (External)	All	Under Cloaking	Cement	Presumed ACM	6.00m2	Good condition	Sealed (Cement products)	5	0	5	LABEL & MONITOR	29 Mar 2013
043	Main Building (External)	All	Under Cloaking	Cement	Presumed ACM	6.00m2	Good condition	Sealed (Cement products)	5	0	5	LABEL & MONITOR	29 Mar 2013
044	Main Building (Ground Floor)	Boiler House	All Areas	Not Applicable	Not Applicable	N/A	Not Applicable	Not Applicable	-	-	-	NOT APPLICABLE

Asbestos Presumed in Sample

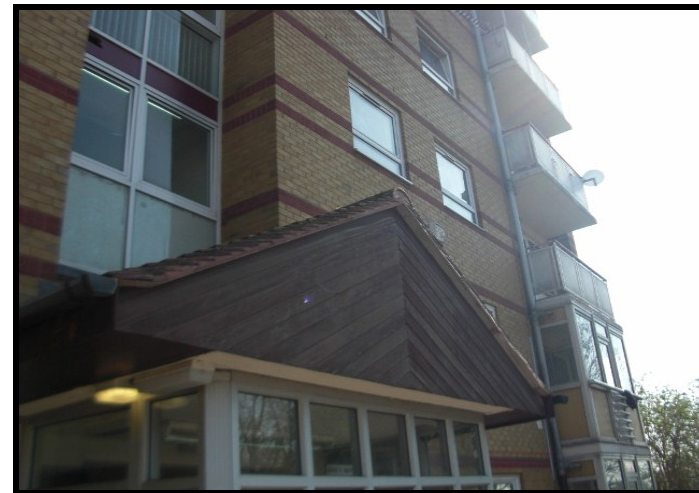
SAMPLE REFERENCE 043

Asbestos Presumed in Sample
