Fire Risk Assessment

Property assessed: 1-65 Avoncroft House Winchester Drive Birmingham B37 5QH
Client: Solihull Community Housing
UPRN: 139470000A
Property Classification: Level 1
Document Print Date: 16/12/2020

FRA Inspection Date: 03/11/2020
FRA Issued to Client: 16/12/2020
FRA valid to: 16/12/2021
FRA completed by: Savills (UK) Ltd,
33 Margaret Street, London W1G 0JD
T: 020 7409 8737
E: fireriskhousing@savills.com

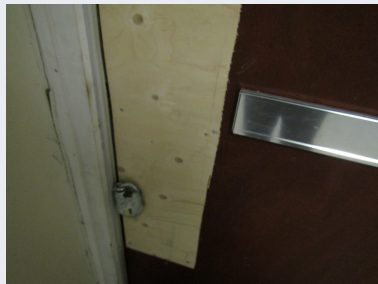
Question	L.2	Comment: Fire-rated flat entrance doors and frames appear to be in good condition except for:- Flats 10 & 16, damage to the doors.

Section	Flat Entrance/Residents' Bedroom/Bedsit Doors			
Action ID	573006			
Quantity		Recommendation: Doors and frames as noted should be replaced with FD30S self-closing fire door sets, installed strictly in accordance with the manufacturer's test certification - Flats 10 & 16.

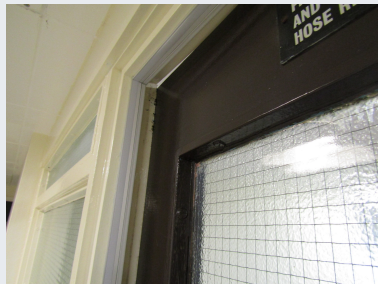
- Known	2			
- Potential	2			
Priority	A	Due Date: 16/03/2021	Client Status: Not Complete	
Question	M.4	Comment: Fanlights/side panels to common area fire doors appear to be the original Georgian-wired fire rated. Current regulation would require glazing to the stairway and accommodation lobby door side panels to be 60-minute. (a) However, a side panel on the fourth floor was damaged. (b) Replacement panel on the third floor - appears satisfactory.

Section	Common Area Fire Doors			
Action ID	573023			
Quantity		Recommendation: 60-minute fire-resisting material should be installed in the side panels to common area fire doors as noted - the fourth floor rear lobby door.

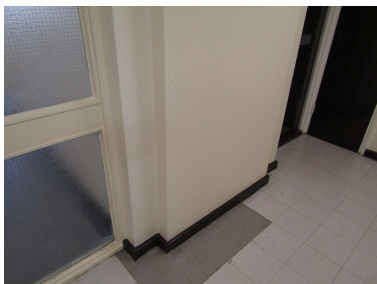
Question	Q.2	Comment: It was not possible to sample inspect the hidden voids identified without causing damage or requiring opening up. (a) Boxed-in areas on the stairs (b) Flush service risers in both flat lobbies on all upper floors (c) Metal trunking throughout the building within the risers (d) Over the false ceiling tiles

Section	Limiting Fire Spread			
Action ID	573026			
Quantity		Recommendation: Management should undertake an intrusive inspection of the hidden voids noted to confirm/ ensure that compartmentation within is adequate.

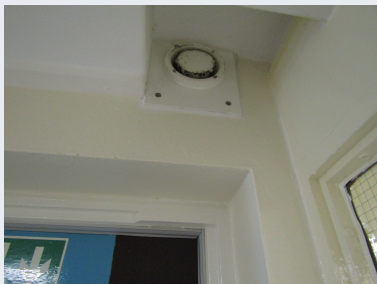
- Known	0			
- Potential	4			
Priority	Man2	Due Date: 16/03/2021	Client Status: Not Complete	
Question	Q.9	Comment: There are circular vents above the fire lobby doors to the stairs on all upper floors within the lift lobby.

Section	Limiting Fire Spread			
Action ID	573044			
Quantity		Recommendation: The mechanical ventilation system should be confirmed as being designed and installed to prevent the transfer of fire and smoke through the building.

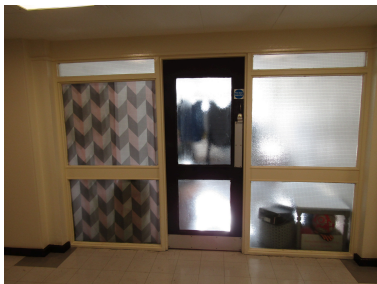
- Known	N/A			
- Potential	N/A			
Priority	Man2	Due Date: 16/03/2021	Client Status: Not Complete	
Question	Q.14	Comment: Compartmentation would not appear to be adequate. There are ventilation grills present from the flats into the waste hopper lobby and into the drying rooms sampled. Unable to access all drying rooms.

Section	Limiting Fire Spread			
Action ID	573041			
Quantity		Recommendation: Check the locked drying rooms for ventilation grills.

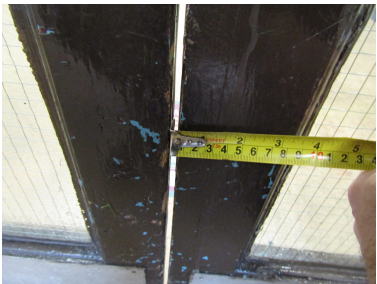
- Known	N/A			
- Potential	N/A			
Priority	Man2	Due Date: 16/03/2021	Client Status: Not Complete	
Question	M.2	Comment: Excessive gaps were noted between the ground floor double fire lobby doors (from the front entrance lobby to the lift lobby) - which will not resist the passage of cold smoke.

Section	Common Area Fire Doors			
Action ID	573022			
Quantity		Recommendation: Minor joinery repairs are required to the door/frame as noted - reduce the gap between the ground floor double fire lobby doors (from the front entrance lobby to the lift lobby)

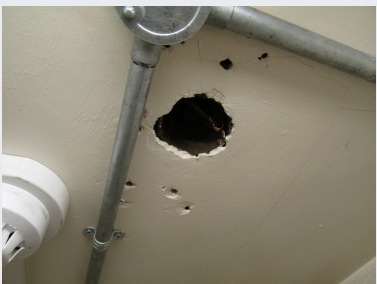
- Known	1			
- Potential	1			
Priority	B	Due Date: 16/12/2021	Client Status: Not Complete	
Question	Q.3	Comment: (a) The areas within the staff-only ground floor areas sampled did not appear to be adequately fire resisting and/or fire-stopped - holes and gaps in the compartmentation, (b) Inappropriate/excessive use has been made of fire-rated expanding foam as a firestopping material. This product is only suitable for narrow linear gaps (typically 15mm) Risers by Flats 15 & 33.

Section	Limiting Fire Spread			
Action ID	573043			
Quantity		Recommendation: The holes noted should be sealed with a suitable fire-stopping material such as an intumescent paste. Period of fire resistance required is 60 minutes.

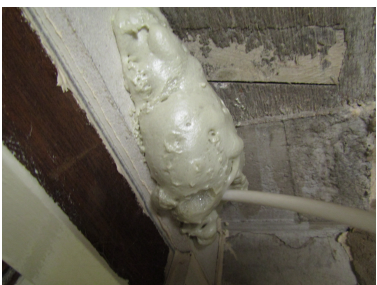
- Known	1			
- Potential	1			
Priority	B	Due Date: 16/12/2021	Client Status: Not Complete	
Question	Q.3	Comment: (a) The areas within the staff-only ground floor areas sampled did not appear to be adequately fire resisting and/or fire-stopped - holes and gaps in the compartmentation, (b) Inappropriate/excessive use has been made of fire-rated expanding foam as a firestopping material. This product is only suitable for narrow linear gaps (typically 15mm) Risers by Flats 15 & 33.

Section	Limiting Fire Spread			
Action ID	573045			
Quantity		Recommendation: The fire-rated expanding foam used inappropriately to firestop/seal fire-resisting construction as noted should be removed and replaced with a suitable product (unless the existing installation can be confirmed as complying with an appropriate fire test certificate) - Risers by Flats 15 & 33.

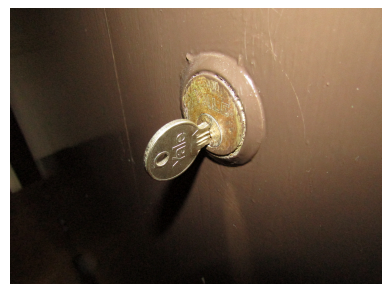
- Known	1			
- Potential	1			
Priority	C	Due Date: 16/06/2022	Client Status: Not Complete	
Question	M.7	<p>Comment: Other common area fire door issues noted at the time of inspection include - Unable to open the double riser door by Flats 3 & 4 - no pull handle provided.</p>

Section	Common Area Fire Doors			
Action ID	573025			
Quantity		<p>Recommendation: Provide a pull handle for the double riser door by Flats 3 & 4</p>

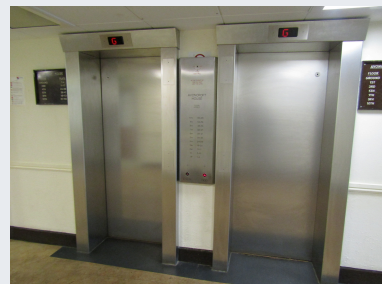
- Known	1			
- Potential	1			
Priority	C	Due Date: 16/06/2022	Client Status: Not Complete	
Question	O.4	<p>Comment: 'In event of fire do not use lifts' signage has not been provided adjacent to the doors to the lift at each floor level. Some floors have the lift signage combined with the fire action notices (no suitable).</p>

Section	Fire Safety Signs and Notices			
Action ID	573012			
Quantity		<p>Recommendation: Provide 'In event of fire do not use lifts' signage adjacent to the doors to the lift at each floor level.</p>

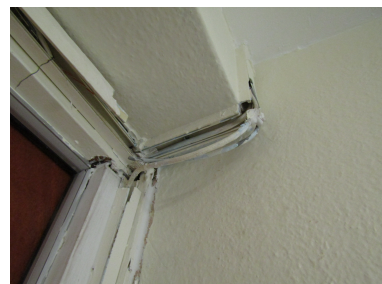
- Known	11			
- Potential	11			
Priority	C	Due Date: 16/06/2022	Client Status: Not Complete	
Question	X.1	<p>Comment: Surface mounted wiring systems contained within plastic trunking were present within the common escape routes but it was not possible to determine if the cables within were adequately supported with fire resisting fixings to prevent premature collapse. Trunking over flat doors - the plastic covers are missing in some sections.</p>

Section	Electrical Services			
Action ID	573040			
Quantity		<p>Recommendation: The cable fixings, conduit or trunking as noted within the common escape route should be replaced with a cable support system which ensures that wiring is not liable to premature collapse in event of a fire (unless the existing clipping system can be confirmed as adequate).</p>

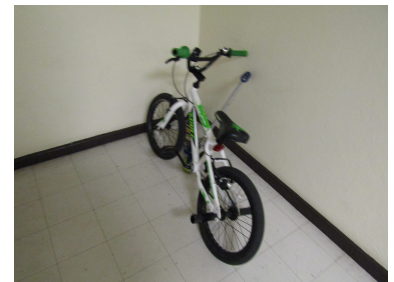
Question - G.4: Are escape routes kept clear of any trip hazards?

Recommendation: Management should contact residents to advise that the common area/escape routes should be kept free from all combustibles and trip hazards. A programme of regular checks should be put in place to ensure that the common area is kept clear.
