Fire Risk Assessment

Property assessed: 1-59 (no 13) Cheshunt House
Moorend Avenue Birmingham B37
5TB

Client: Solihull Community Housing

FRA Inspection Date: 04/11/2020
FRA Issued to Client: 16/12/2020
FRA valid to: 16/12/2021
FRA completed by: Savills (UK) Ltd,
33 Margaret Street, London W1G 0JD
T: 020 7409 8737
E: fireriskhousing@savills.com

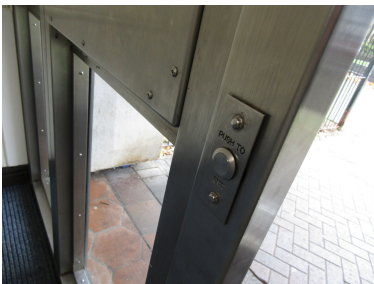
| Question | K.7 | Comment: It could not be ascertained whether the electrical access control systems fitted to escape route doors/gates are provided with override facilities and/or are designed to 'fail safe' on power failure. | | |

| Quantity | | Recommendation: Management should confirm that the secure door entry system continues to operate in the event of a power failure, or fails safe to open. If not, an emergency override facility will be required. | | |

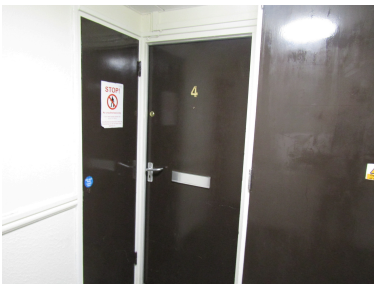
| Question | L.6 | Comment: No access was possible to any of the flat entrance doors to confirm that they are fitted with adequate self-closing devices. | | |

| Quantity | | Recommendation: Management should establish an ongoing rolling programme of checks to all flat entrance doors to confirm that self-closers are fitted and remain effective. | | |

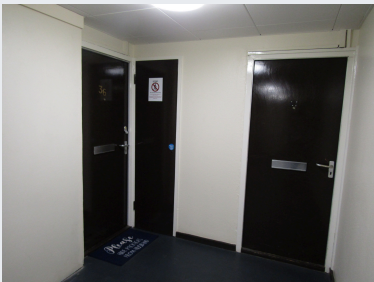
| Question | L.7 | Comment: There was no access possible to any of the flat entrance doors to confirm that they are fitted with intumescent strips and cold smoke seals. | | |

| Quantity | | Recommendation: Management should establish an ongoing rolling programme of checks to all flat entrance doors to confirm that strips and seals are fitted and remain effective. | | |

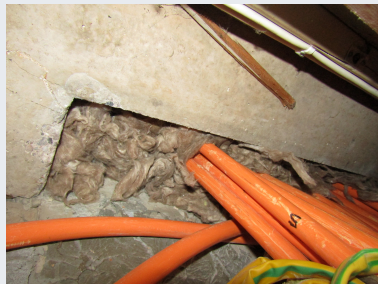
| Question | Q.7 | <p>Comment: The electrical intake/meter enclosures did not appear to be adequately fire-resisting. (a) the two electrical cupboards in the ground floor common areas had gaps and holes where services pass (infilled with insulation materials). (b) the main electrical plant room in the staffed areas - had poorly applied fire paste.</p> | | |

Recommendation: The holes noted should be sealed with a suitable fire-stopping material such as an intumescent paste. Period of fire resistance required is 60 minutes - both common area ground floor electrical cupboards and the main plant area.

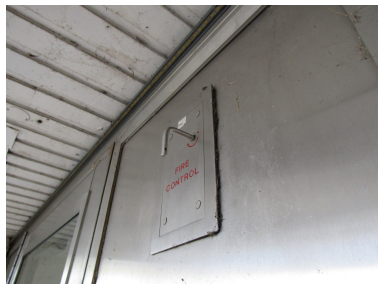
| Question | V.9 | <p>Comment: No information was available to confirm that the drop key switch is inspected tested and maintained in accordance with relevant guidance. The switch did not work satisfactorily when tested.</p> | | |

Recommendation: The defective Fire Service drop key override switch should be repaired.

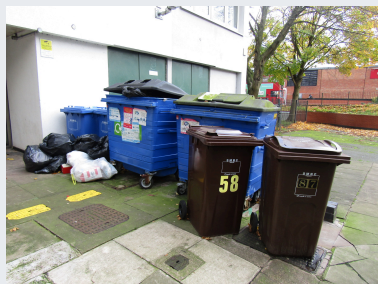
| Question | C.2 | <p>Comment: Paladin bins were stored in an integral bin storage room located at the rear of the building. This room is linked to the waste chute system. However, there were loose recycling Paladin and wheelie bins - with no bin storage area.</p> | | |

Recommendation: A suitable bin storage area should be provided at a safe distance from the building including any necessary hard standing, fencing and security arrangements - for the recycling bins.

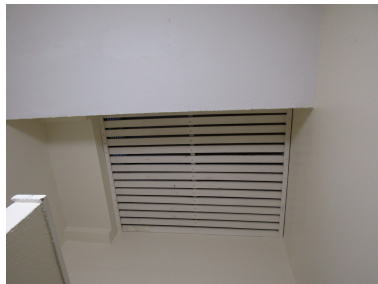
| Question | K.14 | <p>Comment: The flat and stair lobbies are not provided with ventilation openings for the control of smoke. The drying rooms have openable windows with permanent vents above and there are permanent and manually openable vents in the lobbies to the dry riser/waste chute rooms. There are permanent vents to the waste chute rooms. There is a permanently open vent to the head of the stair but this has been slatted over reducing the free area.</p> | | |

Recommendation: The slats to the vent at the head of the stair should be reconfigured so that the vent has a free area of at least 1m².

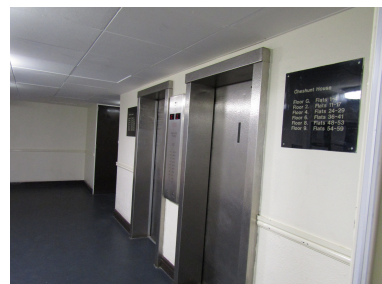
| Question | O.4 | <p>Comment: 'In event of fire do not use lifts' signage has not been provided adjacent to the doors to the lift at each floor level. Some floors have the lift signage combined with the fire action notices (no suitable). Ground floor lifts should also be provided with prominent additional signage.</p> | | |

Recommendation: Provide 'In event of fire do not use lifts' signage adjacent to the doors to the lift at each floor level.

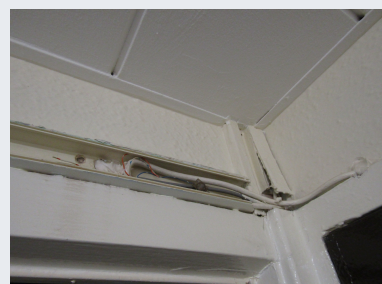
| Question | X.1 | <p>Comment: Surface-mounted wiring systems contained within plastic trunking were present within the common escape routes but it was not possible to determine if the cables within were adequately supported with fire-resisting fixings to prevent premature collapse - above flat doors - the plastic covers are missing in some sections.</p> | | |

Recommendation: The cable fixings, conduit or trunking as noted within the common escape route should be replaced with a cable support system which ensures that wiring is not liable to premature collapse in event of a fire (unless the existing clipping system can be confirmed as adequate).

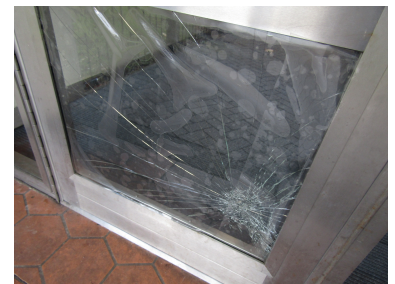
Comment: The entrance door to the premises is self-closing and is fitted with an intercom and door release system and was locked at the time of inspection. There is a concierge button on the door entry system which connects to a remote concierge service who can give access and oversee the premises via CCTV located externally and throughout the premises. However, the front entrance door has a smashed lower glazing panel.

Recommendation: Replace the block entrance door lower glazing panel.

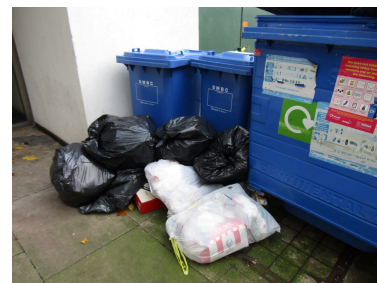
| Details | | Comments/recommendations | | Photo |
|---|---|---|---|---|
| Question | C.4 | <p>Comment: There was unnecessary fire load noted close to the building at the time of inspection. Loose bin bags by the recycling bins. For information, there is a cordoned off area to the rear of the building containing timber cable reels.</p> <p>Recommendation: The combustible items noted should be disposed of safely.</p> | | |

Recommendation: The combustible items noted should be disposed of safely.

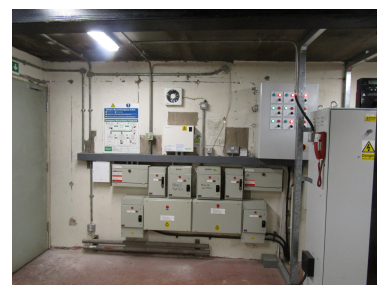
Comment: No evidence was available on-site to confirm regular inspection, testing and servicing of the system is being carried out.

Recommendation: Management should confirm/ensure that the fixed electrical heating appliances in the common area are inspected and tested in accordance with the current edition of the IET Code of Practice for In-service Inspection and Testing of Electrical Equipment and records kept on-site or in a central database.

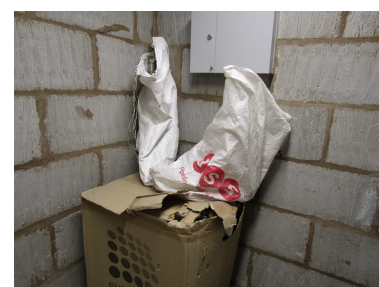
| Details | | Comments/recommendations | | Photo |
|---|---|---|---|---|
| Question | G.2 | <p>Comment: Combustible items were noted close to an ignition source. Storage in the plant room. This issue should be dealt with as soon as possible.</p> <p>Recommendation: All combustible items should be removed from the plant room as soon as possible and the door kept locked.</p> | | |

Recommendation: All combustible items should be removed from the plant room as soon as possible and the door kept locked.

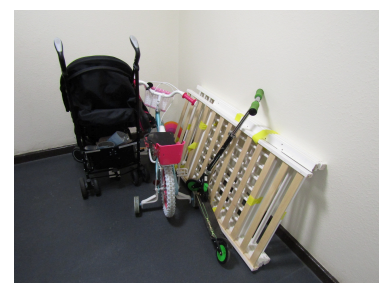
| Details | | Comments/recommendations | | Photo |
|---|---|---|---|---|
| Question | G.3 | <p>Comment: There were combustible items or waste materials in the escape routes. Large quantities of waste and storage on the first, second, fourth and fifth floors. Given the type and substantial quantity involved these should be cleared as soon as possible.</p> <p>Recommendation: The significant combustible items noted should be removed from the common area as soon as possible and a programme of regular checks put in place to ensure that the common area is kept clear.</p> | | |

Recommendation: The significant combustible items noted should be removed from the common area as soon as possible and a programme of regular checks put in place to ensure that the common area is kept clear.

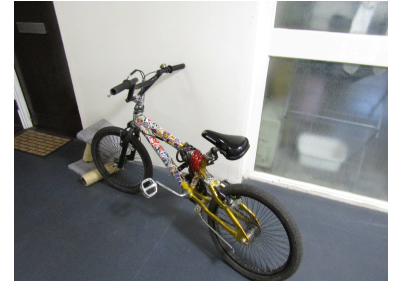
| Question | G.4 | Comment: There were trip hazards noted within the common escape routes at the time of inspection. Bike on the fourth floor. As the quantity involved is relatively minor and the location is non-critical the issue can be dealt with via written contact with the residents. | |

Recommendation: Management should contact residents to advise that the common area/escape routes should be kept free from all trip hazards. A programme of regular checks should be put in place to ensure that the common area is kept clear.

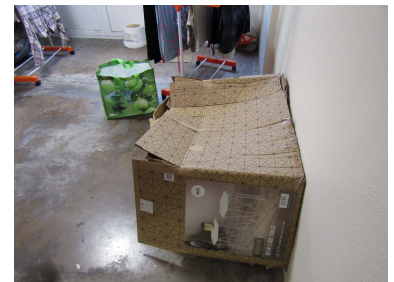
| Details | | Comments/recommendations | | Photo |
|---|---|---|---|---|
| Question | G.6 | <p>Comment: Other house-keeping issues notes at the time of inspection include - The drying rooms have been provided on each upper floor. Unable to access all drying rooms, accessed on the third floor, had storage and waste within.</p> <p>Recommendation: The combustible storage noted within the drying rooms on the third floor should be removed and the area kept clear.</p> | | |

Recommendation: The combustible storage noted within the drying rooms on the third floor should be removed and the area kept clear.

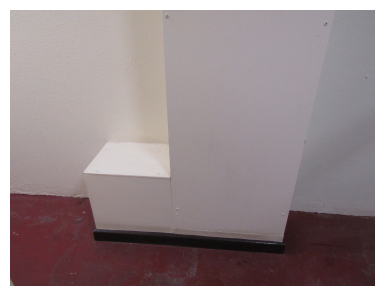
| Question | Q.2 | Comment: It was not possible to sample inspect the hidden voids identified without causing damage or requiring opening up. (a) Boxed-in areas on the stairs (b) Flush service risers in both flat lobbies on all upper floors (c) Metal trunking throughout the building within the risers (d) Over the false ceiling tiles (e) Boxed-in areas in the waste/ dry riser lobbies. | |

Recommendation: Management should undertake an intrusive inspection of the hidden voids noted to confirm/ensure that compartmentation within is adequate.
