Fire Risk Assessment

Property assessed: 1-36 Wingfield House Kingshurst Way Birmingham B37 6DZ
Client: Solihull Community Housing
UPRN: 257910000A
Property Classification: Level 1
Document Print Date: 16/12/2020

FRA Inspection Date: 06/11/2020
FRA Issued to Client: 16/12/2020
FRA valid to: 16/12/2021
FRA completed by: Savills (UK) Ltd,
33 Margaret Street, London W1G 0JD
T: 020 7409 8737
E: fireriskhousing@savills.com

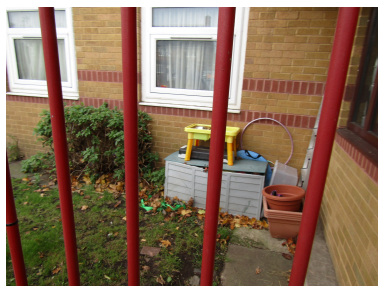
| Details | | Comments/recommendations | | Photo |
|---|---|--|---|---|
| Question | C.4 | Comment: There was unnecessary fire load noted close to the building at the time of inspection. Some storage against the front of the building. | | |

| Details | | Comments/recommendations | | Photo |
|---|---|--|---|---|
| Quantity | | Recommendation: The combustible items noted should be disposed of or removed a safe distance away from the exterior walls of the building. | | |

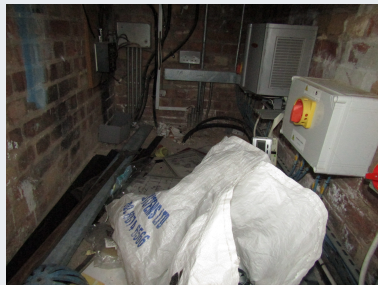
| Details | | Comments/recommendations | | Photo |
|---|---|--|---|---|
| Question | G.2 | Comment: Combustible items were noted close to an ignition source. Minor combustibles in the services cupboard on the flat roof. This issue should be dealt with as soon as possible. | | |

| Details | | Comments/recommendations | | Photo |
|---|---|--|---|---|
| Quantity | | Recommendation: All combustible items should be removed from the services cupboard on the flat roof as soon as possible and the door kept locked. | | |

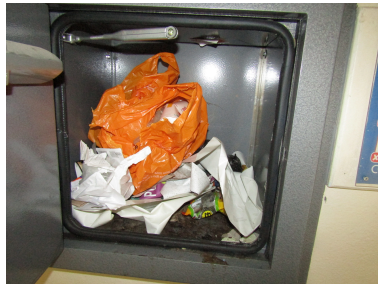
| Details | | Comments/recommendations | | Photo |
|---|---|--|---|---|
| Question | G.6 | Comment: Other house-keeping issues notes at the time of inspection include - the ground and first-floor waste hoppers were blocked with rubbish. | | |

| Details | | Comments/recommendations | | Photo |
|---|---|--|---|---|
| Quantity | | Recommendation: Clear the waste within the ground floor waste hopper. Regular checks should be undertaken to ensure waste hoppers are kept clear. | | |

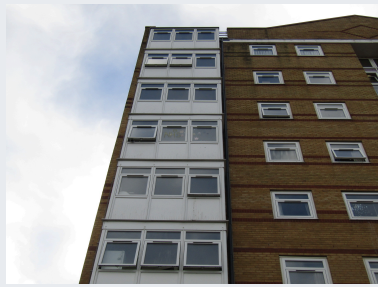
| Details | | Comments/recommendations | | Photo |
|---|---|--|---|---|
| Question | Q.13 | Comment: The exterior envelope of the premises is predominately masonry but there are vertical glazed/curtain wall sections rising full height which contain window spandrel panels of unknown combustibility. Current regulations require such spandrel panels to achieve a reaction to fire class of A2-s1, d0 or class A1. No information was available on site to confirm if the spandrel panels met this requirement of the Building Regulations with regards to limited combustibility and surface fire spread requirements - There appear to be former open flat balconies on all corners of the building and stair window spandrels on both sides of the building. | | |

| Details | | Comments/recommendations | | Photo |
|---|---|--|---|---|
| Quantity | | Recommendation: Management should confirm that the window spandrel panels incorporated in the exterior envelope of the block meet current Building Regulations requirements with regards to limited combustibility and surface fire spread properties - former open flat balconies on all corners of the building and stair window spandrels on both sides of the building. | | |

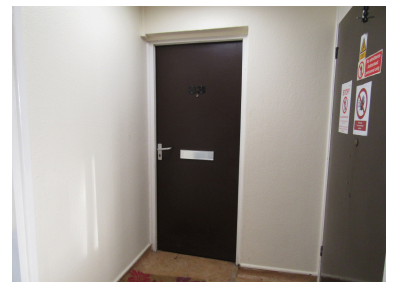
| Question | L.6 | Comment: No access was possible to any of the flat entrance doors to confirm that they are fitted with adequate self-closing devices. | | |

| Quantity | | Recommendation: Management should establish an ongoing rolling programme of checks to all flat entrance doors to confirm that self-closers are fitted and remain effective. | | |

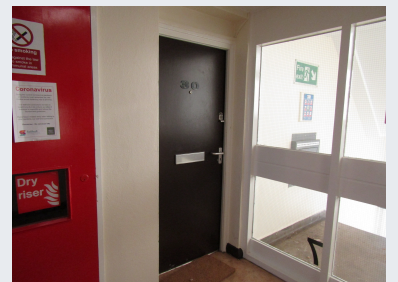
| Question | L.7 | Comment: There was no access possible to any of the flat entrance doors to confirm that they are fitted with intumescent strips and cold smoke seals. | | |

| Quantity | | Recommendation: Management should establish an ongoing rolling programme of checks to all flat entrance doors to confirm that strips and seals are fitted and remain effective. | | |

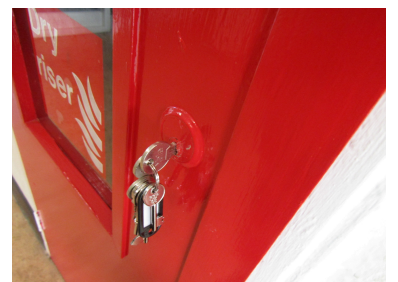
| Question | M.2 | Comment: (a) Door to the AFA cupboard is split at the top (b) Firestopping was missing or inadequate to the back of the frame of common area fire doors as noted:- Service riser doors on the ground, second, third, fifth, sixth and eighth floors. (b) No access to the services riser on the fourth floor. | | |

| Quantity | | Recommendation: A check should be made of the fourth fire door service risers not sampled to confirm that firestopping behind the frames is present and adequate. | | |

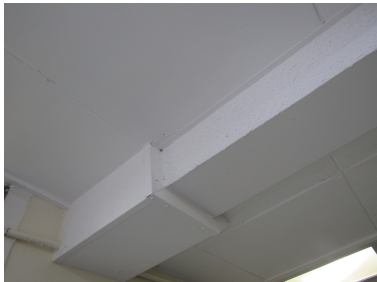
| Question | Q.2 | Comment: It was not possible to sample inspect the hidden voids identified without causing damage or requiring opening up. (a) Boxed-in areas on the stair (b) Metal trunking throughout the building within the risers (c) Over the false ceiling tiles | | |

| Quantity | | Recommendation: Management should undertake an intrusive inspection of the hidden voids noted to confirm/ensure that compartmentation within is adequate - (a) Boxed-in areas on the stair (b) Metal trunking throughout the building within the risers (c) Over the false ceiling tiles | | |

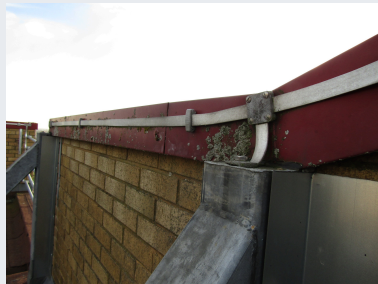
| Question | V.5 | Comment: No evidence was available on-site to confirm regular inspection, testing and servicing of the system is being carried out. | | |

| Quantity | | Recommendation: Management should confirm/ensure that the lightning protection system is tested and serviced annually in accordance with BS EN 62305 and records kept on-site or in a central database. | | |

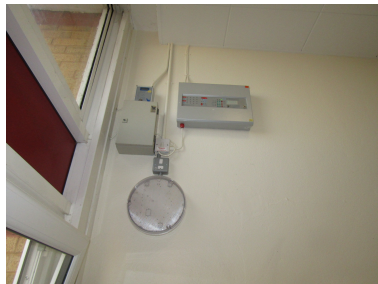
| Question | V.7 | Comment: No evidence was available on-site to confirm regular inspection, testing and servicing of the system is being carried out. | | |

| Quantity | | Recommendation: Management should confirm/ensure that the smoke control system is actuated and inspected weekly, receives a full operational test quarterly, and is serviced and certified annually in accordance BS 9999 and records kept on-site or in a central database. | | |

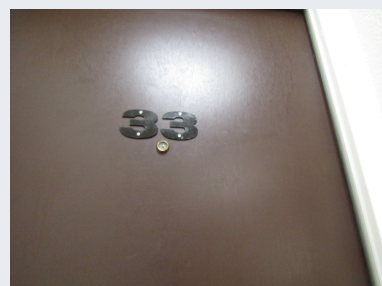
| Question | P.5 | <p>Comment: The resident of Flat 33 stated that her smoke alarm was dated to replace on July 2019. This was not seen by the inspector. The resident was concerned. No access to flats.</p> <p>Recommendation: A Grade D1 LD2 smoke alarm system to BS 5839-6:2019 should be installed in the flat noted - Flat 33.</p> | | |

Recommendation: A Grade D1 LD2 smoke alarm system to BS 5839-6:2019 should be installed in the flat noted - Flat 33.

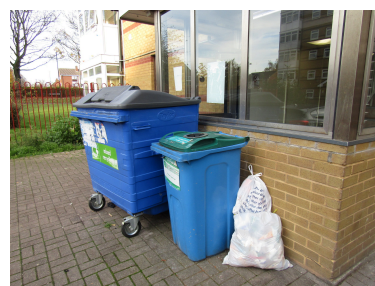
| Question | C.2 | Comment: Paladin bins were stored in an integral bin storage room located at the rear of the building. This room is linked to the waste chute system. However, there were loose recycling Paladin and wheelie bins - with no bin storage area. | |

Recommendation: A suitable bin storage area should be provided at a safe distance from the building including any necessary hard standing, fencing and security arrangements.

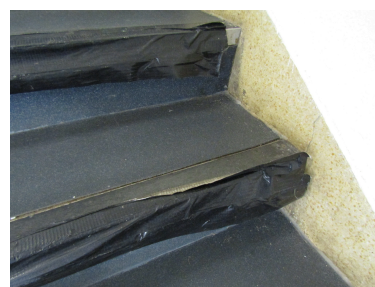
| Question | G.4 | Comment: The defective stair coverings to the escape route are a trip hazard.- the small flight of steps to the ground floor waste hopper. | |

Recommendation: The defective stair coverings to the escape route should be repaired/replaced as required - the small flight of steps to the ground floor waste hopper.

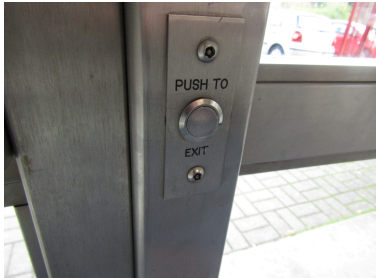
| Comment: It could not be ascertained whether the electrical access control systems fitted to escape route doors/gates are provided with override facilities and/or are designed to 'fail safe' on power failure. | | |

| Recommendation: Management should confirm that the secure door entry system continues to operate in the event of a power failure, or fails safe to open. If not, an emergency override facility will be required. | | |

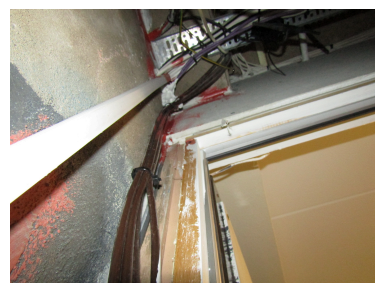
| Question | M.2 | Comment: (a) Door to the AFA cupboard is split at the top (b) Firestopping was missing or inadequate to the back of the frame of common area fire doors as noted:- Service riser doors on the ground, second, third, fifth, sixth and eighth floors. (b) No access to the services riser on the fourth floor. | |

Recommendation: Adequate firestopping should be provided/replaced to the back of the frame of the common area fire door set as noted using a suitable material such as an intumescent paste to ensure 30 minutes fire resistance is achieved - Service riser doors on the ground, second, third, fifth, sixth and eighth floors.
