Solihull Community Housing

Asbestos Management Survey Report

**Balliol House
Grandys Croft
Chelmsley Wood
B37 5BS**

Date of Report: 31 Mar 2012

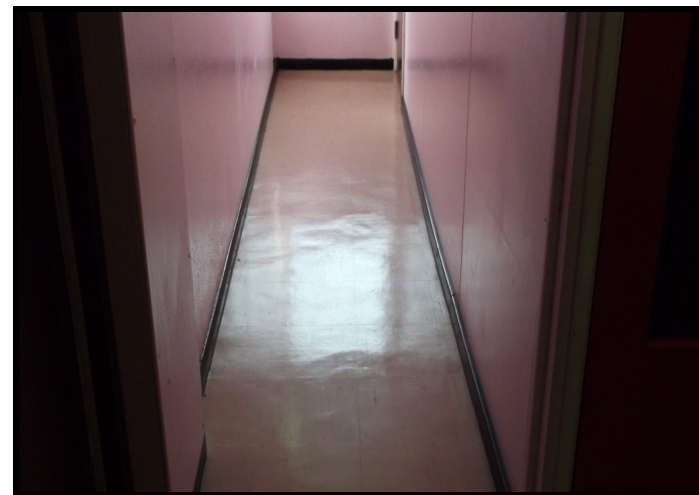
SAMPLE REFERENCE 001

Asbestos not detected in Sample

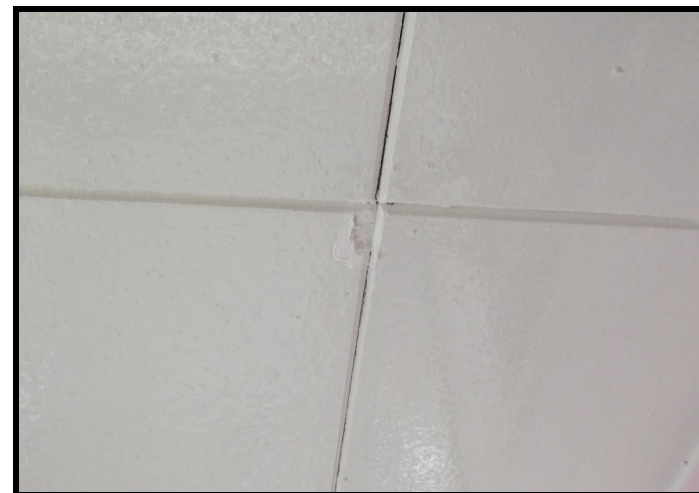
SAMPLE REFERENCE 002

Asbestos not detected in Sample

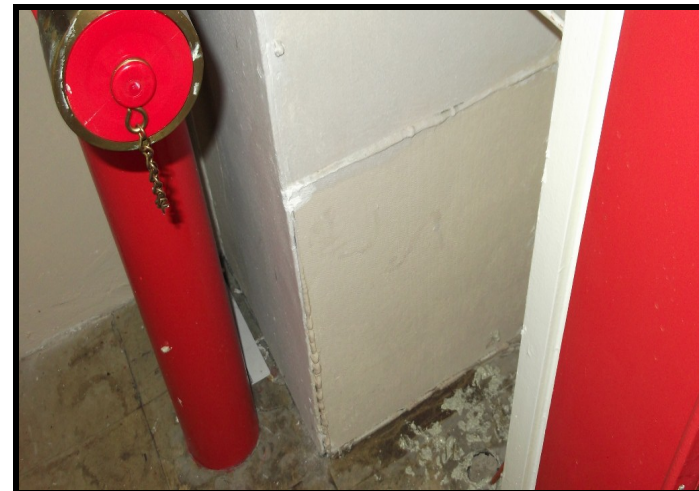
SAMPLE REFERENCE 009

Building	Floor	Room	Location	
Main Building	Tenth Floor	Dry Riser	Boxing	
Description	Low level to boxing			
MATERIAL ASSESSMENT				SCORE
Product Type	Board	Extent of Damage	Good condition	-
Asbestos Type	No Asbestos Detected	Surface Treatment	Sealed Board (Encapsulated)	
PRIORITY ASSESSMENT				SCORE
Occupant Activity	Not Applicable	Extent / Amount	1.00 m2	-
Accessibility	Easily disturbed	Location	Not Applicable	
Avg Time in Use	Not Applicable	Frequency of Use	Not Applicable	
No. of Occupants	Not Applicable	Secondary Activity	Not Applicable	
Maintenance	Not Applicable	Maintenance Frequency	Not Applicable	
MANAGEMENT ACTION				SCORE
Recommendation	NO ACTION REQUIRED			-
Recommendation Due		Next Inspection	None	
Apply Labels	No	Permit to Work Required	No	
Survey Type	Management	Lead Surveyor	Jane Openshaw	
Survey Date	20 Mar 2012	UKAS Laboratory	DMW Environmental Safety Ltd / [P-96019]	
Site Reference	I13070000A	Licensed Material	N/A

Asbestos not detected in Sample

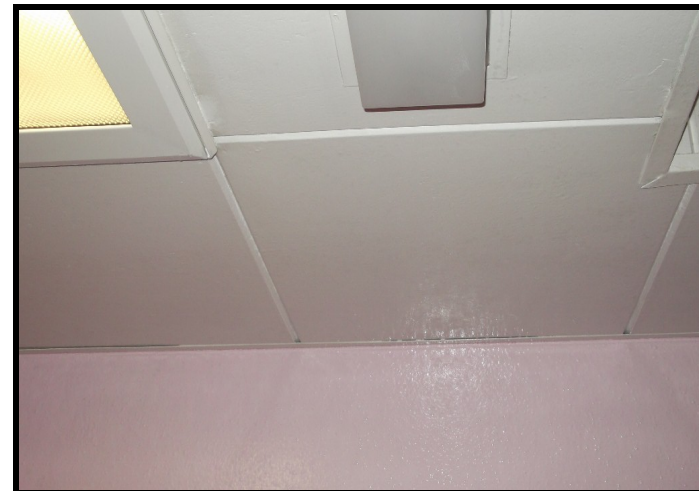
SAMPLE REFERENCE 011

Building	Floor	Room	Location	
Main Building	Tenth Floor	Lobby	Ceiling	
Description	Timber beading to glazing			
MATERIAL ASSESSMENT				SCORE
Product Type	Board	Extent of Damage	Low damage	-
Asbestos Type	No Asbestos Detected	Surface Treatment	Sealed Board (Encapsulated)	
PRIORITY ASSESSMENT				SCORE
Occupant Activity	Not Applicable	Extent / Amount	8.00 m2	-
Accessibility	Unlikely to be disturbed	Location	Not Applicable	
Avg Time in Use	Not Applicable	Frequency of Use	Not Applicable	
No. of Occupants	Not Applicable	Secondary Activity	Not Applicable	
Maintenance	Not Applicable	Maintenance Frequency	Not Applicable	
MANAGEMENT ACTION				SCORE
Recommendation	NO ACTION REQUIRED			-
Recommendation Due		Next Inspection	None	
Apply Labels	No	Permit to Work Required	No	
Survey Type	Management	Lead Surveyor	Jane Openshaw	
Survey Date	20 Mar 2012	UKAS Laboratory	NOT SAMPLED (Cross Referenced)	
Site Reference	I13070000A	Licensed Material	N/A

No Asbestos Presumed in Sample

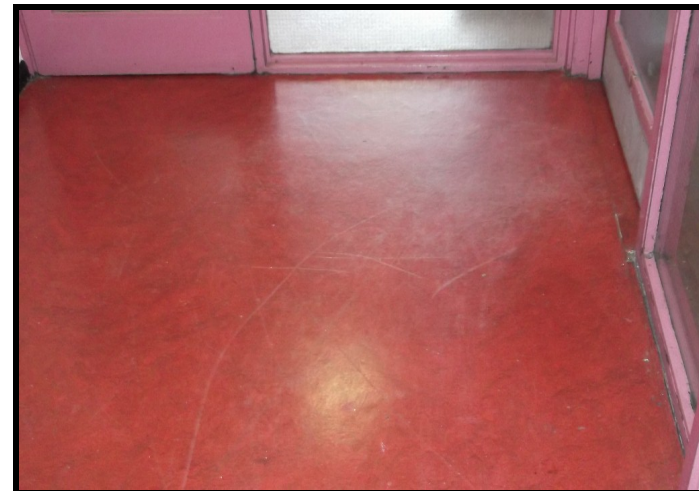
SAMPLE REFERENCE 012

Building	Floor	Room	Location	
Main Building	Tenth Floor	Lobby	Floor	
Description	Red, Timber beading to glazing			
MATERIAL ASSESSMENT				SCORE
Product Type	Paper	Extent of Damage	Low damage	-
Asbestos Type	No Asbestos Detected	Surface Treatment	Sealed (1)	
PRIORITY ASSESSMENT				SCORE
Occupant Activity	Not Applicable	Extent / Amount	8.00 m2	-
Accessibility	Routinely disturbed	Location	Not Applicable	
Avg Time in Use	Not Applicable	Frequency of Use	Not Applicable	
No. of Occupants	Not Applicable	Secondary Activity	Not Applicable	
Maintenance	Not Applicable	Maintenance Frequency	Not Applicable	
MANAGEMENT ACTION				SCORE
Recommendation	NO ACTION REQUIRED			-
Recommendation Due		Next Inspection	None	
Apply Labels	No	Permit to Work Required	No	
Survey Type	Management	Lead Surveyor	Jane Openshaw	
Survey Date	20 Mar 2012	UKAS Laboratory	DMW Environmental Safety Ltd / [P-96019]	
Site Reference	I13070000A	Licensed Material	N/A

Asbestos not detected in Sample

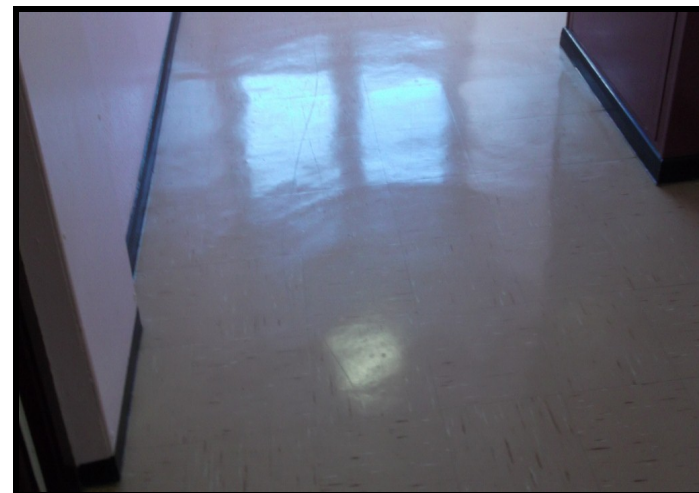
SAMPLE REFERENCE 015

No Asbestos Presumed in Sample

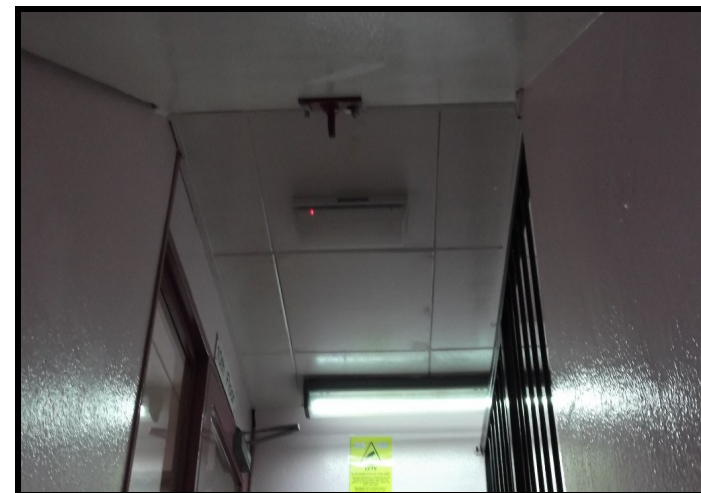
SAMPLE REFERENCE 019

No Asbestos Presumed in Sample

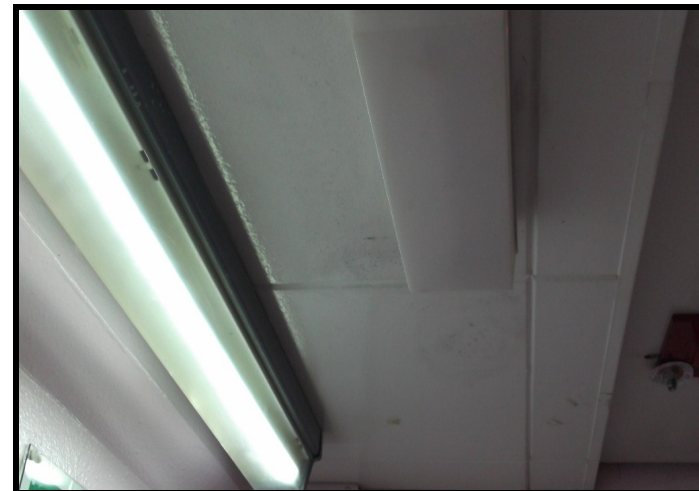
SAMPLE REFERENCE 020

No Asbestos Presumed in Sample

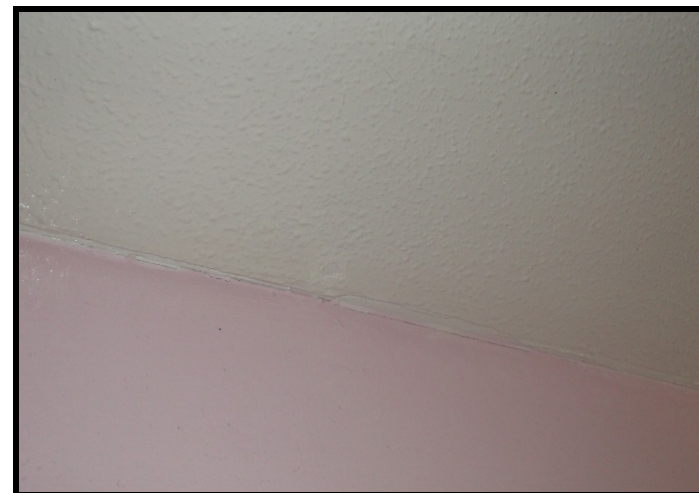
SAMPLE REFERENCE 022

Asbestos not detected in Sample

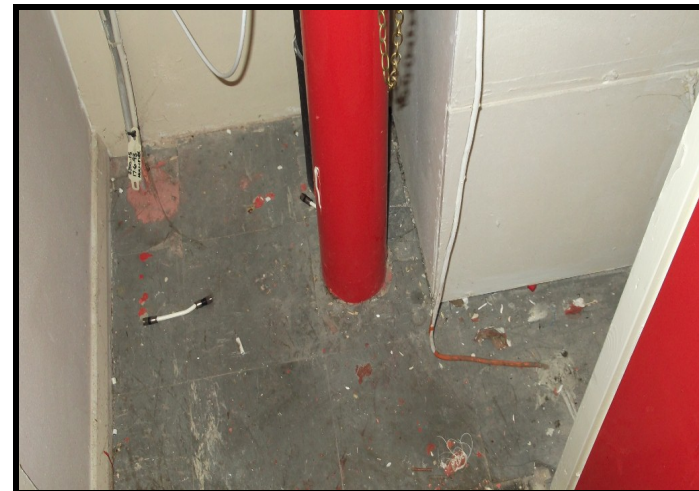
SAMPLE REFERENCE 029

Asbestos detected in Sample

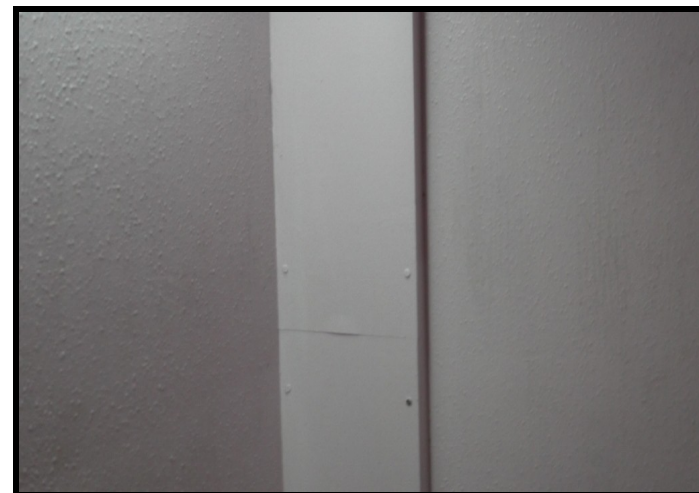
SAMPLE REFERENCE 035

Building	Floor	Room	Location	
Main Building	Ninth Floor	Stairs	Walls	
Description				
MATERIAL ASSESSMENT				SCORE
Product Type	Paint	Extent of Damage	Good condition	-
Asbestos Type	No Asbestos Detected	Surface Treatment	Sealed (1)	
PRIORITY ASSESSMENT				SCORE
Occupant Activity	Not Applicable	Extent / Amount	30.00 m2	-
Accessibility	Easily disturbed	Location	Not Applicable	
Avg Time in Use	Not Applicable	Frequency of Use	Not Applicable	
No. of Occupants	Not Applicable	Secondary Activity	Not Applicable	
Maintenance	Not Applicable	Maintenance Frequency	Not Applicable	
MANAGEMENT ACTION				SCORE
Recommendation	NO ACTION REQUIRED			-
Recommendation Due		Next Inspection	None	
Apply Labels	No	Permit to Work Required	No	
Survey Type	Management	Lead Surveyor	Jane Openshaw	
Survey Date	20 Mar 2012	UKAS Laboratory	NOT SAMPLED (Cross Referenced)	
Site Reference	I13070000A	Licensed Material	N/A

No Asbestos Presumed in Sample

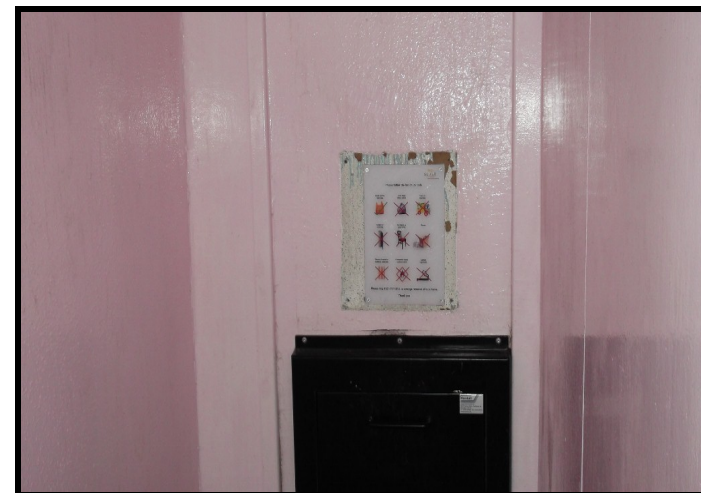
SAMPLE REFERENCE 036

Building	Floor	Room	Location	
Main Building	Eighth Floor	Bin Chute	Wall	
Description				
MATERIAL ASSESSMENT				SCORE
Product Type	Paint	Extent of Damage	Low damage	-
Asbestos Type	No Asbestos Detected	Surface Treatment	Sealed (1)	
PRIORITY ASSESSMENT				SCORE
Occupant Activity	Not Applicable	Extent / Amount	15.00 m2	-
Accessibility	Easily disturbed	Location	Not Applicable	
Avg Time in Use	Not Applicable	Frequency of Use	Not Applicable	
No. of Occupants	Not Applicable	Secondary Activity	Not Applicable	
Maintenance	Not Applicable	Maintenance Frequency	Not Applicable	
MANAGEMENT ACTION				SCORE
Recommendation	NO ACTION REQUIRED			-
Recommendation Due		Next Inspection	None	
Apply Labels	No	Permit to Work Required	No	
Survey Type	Management	Lead Surveyor	Jane Openshaw	
Survey Date	20 Mar 2012	UKAS Laboratory	NOT SAMPLED (Cross Referenced)	
Site Reference	113070000A	Licensed Material	N/A

No Asbestos Presumed in Sample

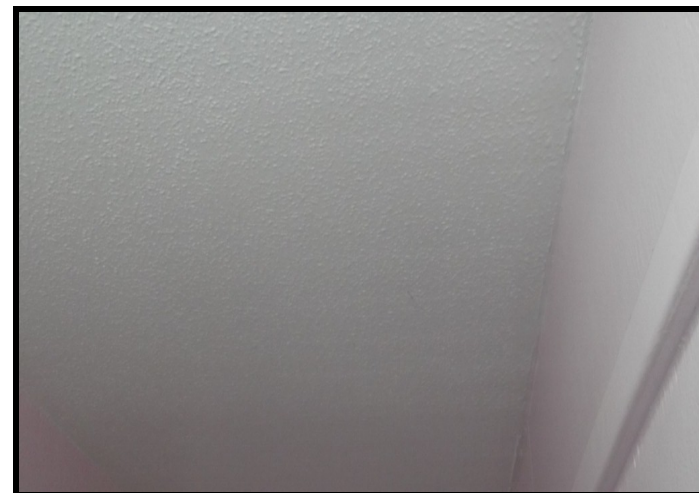
SAMPLE REFERENCE 037

Building	Floor	Room	Location
Main Building	Eighth Floor	Bin Chute	Ceiling
Description			
MATERIAL ASSESSMENT			
Product Type	Paint	Extent of Damage	Good condition
Asbestos Type	No Asbestos Detected	Surface Treatment	Sealed (1)
PRIORITY ASSESSMENT			
Occupant Activity	Not Applicable	Extent / Amount	5.00 m2
Accessibility	Occasionally disturb	Location	Not Applicable
Avg Time in Use	Not Applicable	Frequency of Use	Not Applicable
No. of Occupants	Not Applicable	Secondary Activity	Not Applicable
Maintenance	Not Applicable	Maintenance Frequency	Not Applicable
MANAGEMENT ACTION			
Recommendation	NO ACTION REQUIRED		
Recommendation Due		Next Inspection	None
Apply Labels	No	Permit to Work Required	No
Survey Type	Management	Lead Surveyor	Jane Openshaw
Survey Date	20 Mar 2012	UKAS Laboratory	NOT SAMPLED (Cross Referenced)
Site Reference	113070000A	Licensed Material	N/A

No Asbestos Presumed in Sample

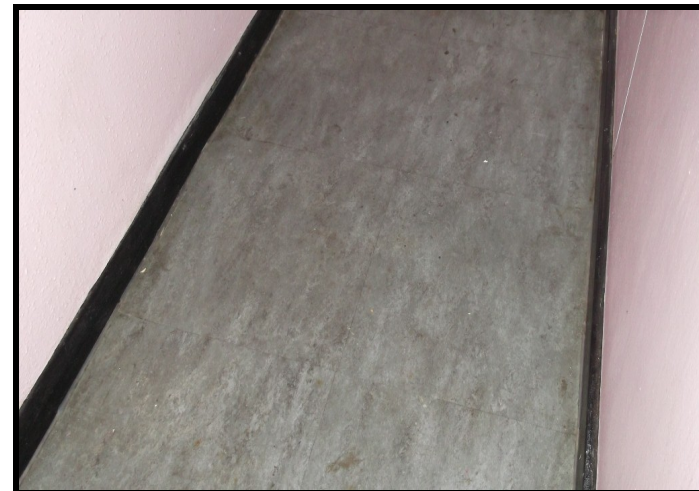
SAMPLE REFERENCE 038

Building	Floor	Room	Location	
Main Building	Eighth Floor	Bin Chute	Floor	
Description	Blue			
MATERIAL ASSESSMENT				SCORE
Product Type	Paper	Extent of Damage	Good condition	-
Asbestos Type	No Asbestos Detected	Surface Treatment	Sealed (1)	
PRIORITY ASSESSMENT				SCORE
Occupant Activity	Not Applicable	Extent / Amount	5.00 m2	-
Accessibility	Unlikely to be disturbed	Location	Not Applicable	
Avg Time in Use	Not Applicable	Frequency of Use	Not Applicable	
No. of Occupants	Not Applicable	Secondary Activity	Not Applicable	
Maintenance	Not Applicable	Maintenance Frequency	Not Applicable	
MANAGEMENT ACTION				SCORE
Recommendation	NO ACTION REQUIRED			-
Recommendation Due		Next Inspection	None	
Apply Labels	No	Permit to Work Required	No	
Survey Type	Management	Lead Surveyor	Jane Openshaw	
Survey Date	20 Mar 2012	UKAS Laboratory	NOT SAMPLED (Cross Referenced)	
Site Reference	I13070000A	Licensed Material	N/A

No Asbestos Presumed in Sample

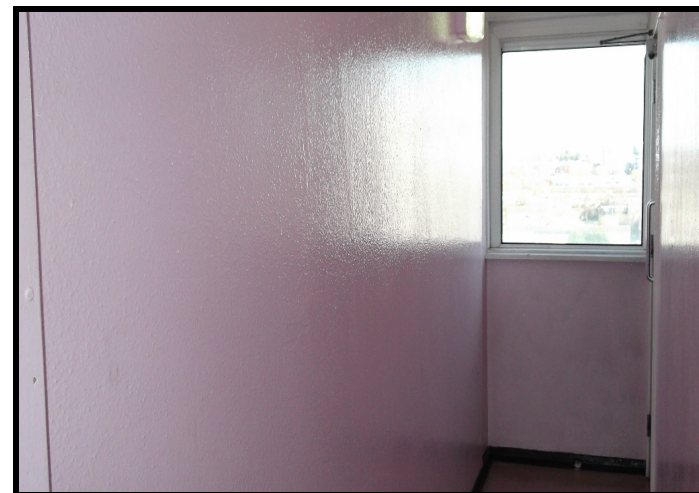
SAMPLE REFERENCE 039

Building	Floor	Room	Location	
Main Building	Eighth Floor	Corridor I	Wall	
Description	Timber boxing adjacent to flat doors			
MATERIAL ASSESSMENT				SCORE
Product Type	Paint	Extent of Damage	Good condition	-
Asbestos Type	No Asbestos Detected	Surface Treatment	Sealed (1)	
PRIORITY ASSESSMENT				SCORE
Occupant Activity	Not Applicable	Extent / Amount	10.00 m2	-
Accessibility	Easily disturbed	Location	Not Applicable	
Avg Time in Use	Not Applicable	Frequency of Use	Not Applicable	
No. of Occupants	Not Applicable	Secondary Activity	Not Applicable	
Maintenance	Not Applicable	Maintenance Frequency	Not Applicable	
MANAGEMENT ACTION				SCORE
Recommendation	NO ACTION REQUIRED			-
Recommendation Due		Next Inspection	None	
Apply Labels	No	Permit to Work Required	No	
Survey Type	Management	Lead Surveyor	Jane Openshaw	
Survey Date	20 Mar 2012	UKAS Laboratory	NOT SAMPLED (Cross Referenced)	
Site Reference	113070000A	Licensed Material	N/A

No Asbestos Presumed in Sample

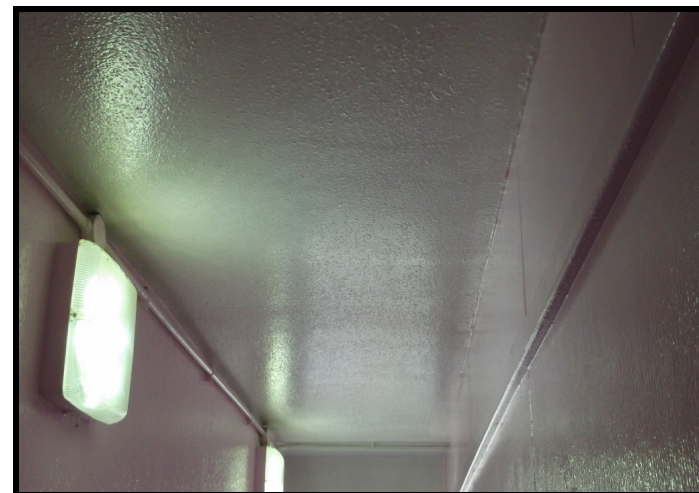
SAMPLE REFERENCE 040

Building	Floor	Room	Location	
Main Building	Eighth Floor	Corridor I	Ceiling	
Description	Timber boxing adjacent to flat doors			
MATERIAL ASSESSMENT				SCORE
Product Type	Paint	Extent of Damage	Good condition	-
Asbestos Type	No Asbestos Detected	Surface Treatment	Sealed (I)	
PRIORITY ASSESSMENT				SCORE
Occupant Activity	Not Applicable	Extent / Amount	5.00 m2	-
Accessibility	Occasionally disturb	Location	Not Applicable	
Avg Time in Use	Not Applicable	Frequency of Use	Not Applicable	
No. of Occupants	Not Applicable	Secondary Activity	Not Applicable	
Maintenance	Not Applicable	Maintenance Frequency	Not Applicable	
MANAGEMENT ACTION				SCORE
Recommendation	NO ACTION REQUIRED			-
Recommendation Due		Next Inspection	None	
Apply Labels	No	Permit to Work Required	No	
Survey Type	Management	Lead Surveyor	Jane Openshaw	
Survey Date	20 Mar 2012	UKAS Laboratory	NOT SAMPLED (Cross Referenced)	
Site Reference	I13070000A	Licensed Material	N/A

No Asbestos Presumed in Sample

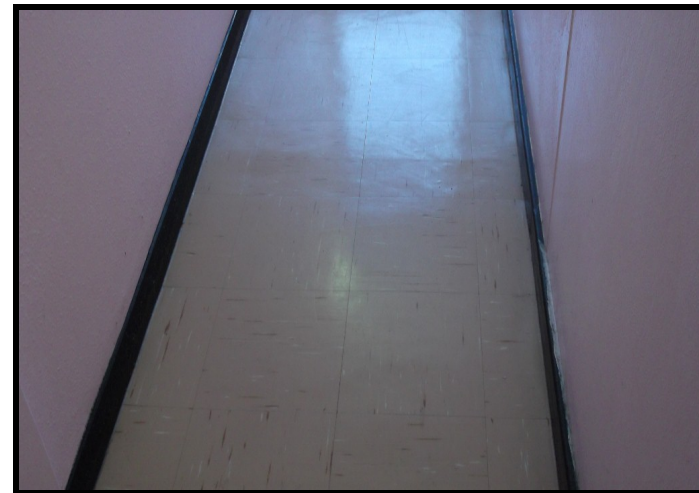
SAMPLE REFERENCE 041

Building	Floor	Room	Location	
Main Building	Eighth Floor	Corridor I	Floor	
Description	Buff, Timber boxing adjacent to flat doors			
MATERIAL ASSESSMENT				SCORE
Product Type	Floor Tiles	Extent of Damage	Good condition	-
Asbestos Type	No Asbestos Detected	Surface Treatment	Composite materials	
PRIORITY ASSESSMENT				SCORE
Occupant Activity	Not Applicable	Extent / Amount	5.00 m2	-
Accessibility	Routinely disturbed	Location	Not Applicable	
Avg Time in Use	Not Applicable	Frequency of Use	Not Applicable	
No. of Occupants	Not Applicable	Secondary Activity	Not Applicable	
Maintenance	Not Applicable	Maintenance Frequency	Not Applicable	
MANAGEMENT ACTION				SCORE
Recommendation	NO ACTION REQUIRED			-
Recommendation Due		Next Inspection	None	
Apply Labels	No	Permit to Work Required	No	
Survey Type	Management	Lead Surveyor	Jane Openshaw	
Survey Date	20 Mar 2012	UKAS Laboratory	NOT SAMPLED (Cross Referenced)	
Site Reference	I13070000A	Licensed Material	N/A

No Asbestos Presumed in Sample

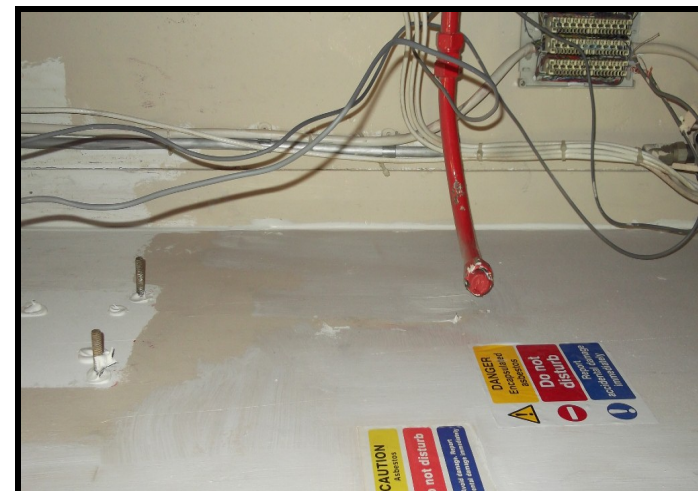
SAMPLE REFERENCE 042

Building	Floor	Room	Location	
Main Building	Eighth Floor	Dry Riser	Ceiling And Walls	
Description	Board to walls and ceiling			
MATERIAL ASSESSMENT				SCORE
Product Type	Board	Extent of Damage	Good condition	5
Asbestos Type	Amosite / Chrysotile	Surface Treatment	Sealed Board (Encapsulated)	
PRIORITY ASSESSMENT				SCORE
Occupant Activity	Not Applicable	Extent / Amount	8.00 m2	1
Accessibility	Occasionally disturb	Location	Not Applicable	
Avg Time in Use	Not Applicable	Frequency of Use	Not Applicable	
No. of Occupants	Not Applicable	Secondary Activity	Not Applicable	
Maintenance	Not Applicable	Maintenance Frequency	Not Applicable	
MANAGEMENT ACTION				SCORE
Recommendation	LABEL & MONITOR			6
Recommendation Due		Next Inspection	20 Sep 2012	
Apply Labels	No	Permit to Work Required	No	
Survey Type	Management	Lead Surveyor	Jane Openshaw	
Survey Date	20 Mar 2012	UKAS Laboratory	NOT SAMPLED (Cross Referenced)	
Site Reference	I13070000A	Licensed Material	Yes

Asbestos Presumed in Sample

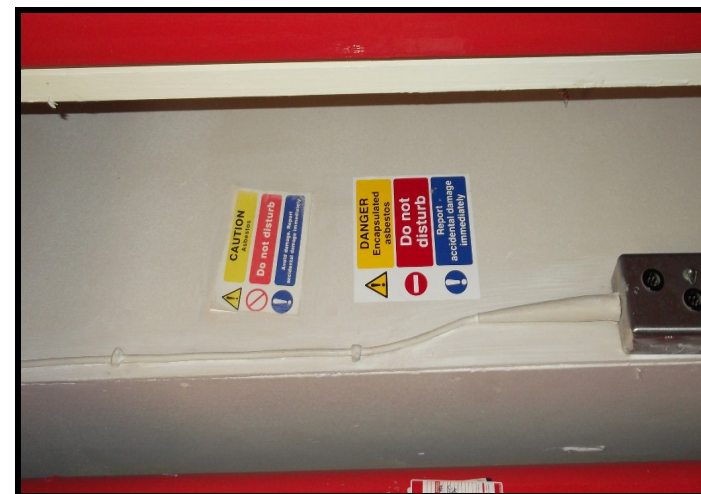
SAMPLE REFERENCE 043

043	Main Building (Eighth Floor)	Dry Riser	Boxing	Board	Amosite / Chrysotile	5.00m2	Good condition	Sealed Board (Encapsulated)	5	0	5	LABEL & MONITOR	20 Sep 2012
044	Main Building (Eighth Floor)	Dry Riser	Floor	Floor Tiles	Chrysotile	1.00m2	Medium damage	Composite materials	4	1	5	REMOVAL BY LICENSED CONTRACTOR	
045	Main Building (Eighth Floor)	Lobby	Walls	Paint	No Asbestos Detected	13.00m2	Good condition	Sealed (1)	-	-	-	NO ACTION REQUIRED

Asbestos Presumed in Sample

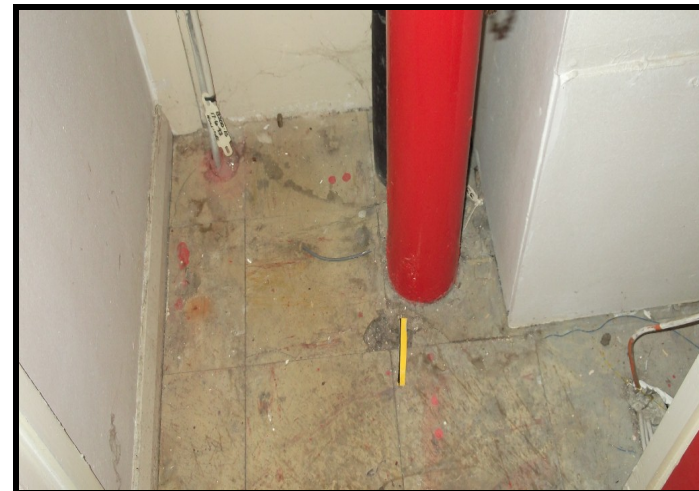
SAMPLE REFERENCE 044

Building	Floor	Room	Location
Main Building	Eighth Floor	Dry Riser	Floor
Description	Yellow floor tile		
MATERIAL ASSESSMENT			
Product Type	Floor Tiles	Extent of Damage	Medium damage
Asbestos Type	Chrysotile	Surface Treatment	Composite materials
PRIORITY ASSESSMENT			
Occupant Activity	Not Applicable	Extent / Amount	1.00 m2
Accessibility	Routinely disturbed	Location	Not Applicable
Avg Time in Use	Not Applicable	Frequency of Use	Not Applicable
No. of Occupants	Not Applicable	Secondary Activity	Not Applicable
Maintenance	Not Applicable	Maintenance Frequency	Not Applicable
MANAGEMENT ACTION			
Recommendation	REMOVAL BY LICENSED CONTRACTOR		
Recommendation Due		Next Inspection	None
Apply Labels	No	Permit to Work Required	No
Survey Type	Management	Lead Surveyor	Jane Openshaw
Survey Date	20 Mar 2012	UKAS Laboratory	NOT SAMPLED (Cross Referenced)
Site Reference	113070000A	Licensed Material	No

Asbestos Presumed in Sample

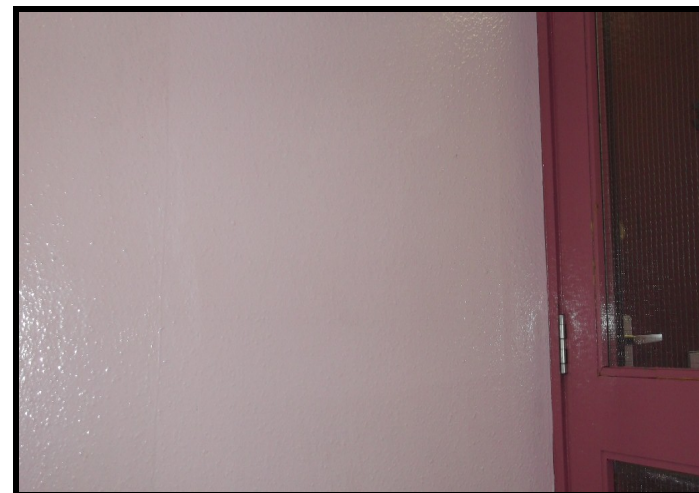
SAMPLE REFERENCE 045

Building	Floor	Room	Location	
Main Building	Eighth Floor	Lobby	Walls	
Description				
MATERIAL ASSESSMENT				SCORE
Product Type	Paint	Extent of Damage	Good condition	-
Asbestos Type	No Asbestos Detected	Surface Treatment	Sealed (1)	
PRIORITY ASSESSMENT				SCORE
Occupant Activity	Not Applicable	Extent / Amount	13.00 m2	-
Accessibility	Easily disturbed	Location	Not Applicable	
Avg Time in Use	Not Applicable	Frequency of Use	Not Applicable	
No. of Occupants	Not Applicable	Secondary Activity	Not Applicable	
Maintenance	Not Applicable	Maintenance Frequency	Not Applicable	
MANAGEMENT ACTION				SCORE
Recommendation	NO ACTION REQUIRED			-
Recommendation Due		Next Inspection	None	
Apply Labels	No	Permit to Work Required	No	
Survey Type	Management	Lead Surveyor	Jane Openshaw	
Survey Date	20 Mar 2012	UKAS Laboratory	NOT SAMPLED (Cross Referenced)	
Site Reference	113070000A	Licensed Material	N/A

No Asbestos Presumed in Sample

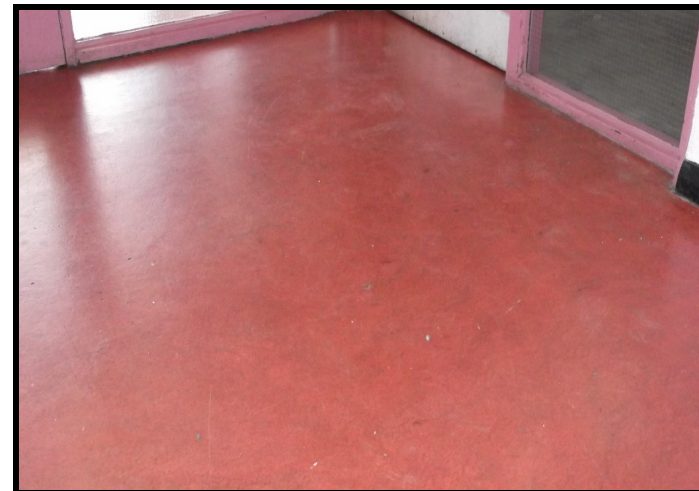
SAMPLE REFERENCE 046

Building	Floor	Room	Location	
Main Building	Eighth Floor	Lobby	Floor	
Description				
MATERIAL ASSESSMENT				SCORE
Product Type	Paper	Extent of Damage	Low damage	-
Asbestos Type	No Asbestos Detected	Surface Treatment	Sealed (1)	
PRIORITY ASSESSMENT				SCORE
Occupant Activity	Not Applicable	Extent / Amount	8.00 m2	-
Accessibility	Unlikely to be disturbed	Location	Not Applicable	
Avg Time in Use	Not Applicable	Frequency of Use	Not Applicable	
No. of Occupants	Not Applicable	Secondary Activity	Not Applicable	
Maintenance	Not Applicable	Maintenance Frequency	Not Applicable	
MANAGEMENT ACTION				SCORE
Recommendation	NO ACTION REQUIRED			-
Recommendation Due		Next Inspection	None	
Apply Labels	No	Permit to Work Required	No	
Survey Type	Management	Lead Surveyor	Jane Openshaw	
Survey Date	20 Mar 2012	UKAS Laboratory	NOT SAMPLED (Cross Referenced)	
Site Reference	113070000A	Licensed Material	N/A

No Asbestos Presumed in Sample

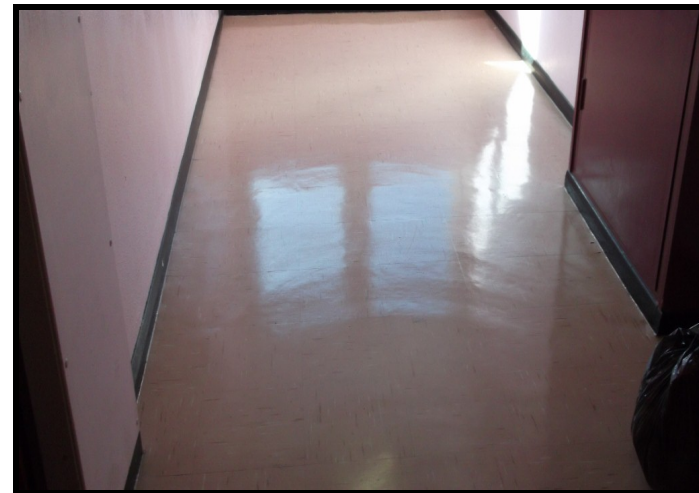
SAMPLE REFERENCE 047

Building	Floor	Room	Location	
Main Building	Eighth Floor	Corridor 2	Floor	
Description	Buff, Timber boxing adjacent to front doors			
MATERIAL ASSESSMENT				SCORE
Product Type	Floor Tiles	Extent of Damage	Good condition	-
Asbestos Type	No Asbestos Detected	Surface Treatment	Composite materials	
PRIORITY ASSESSMENT				SCORE
Occupant Activity	Not Applicable	Extent / Amount	7.00 m2	-
Accessibility	Routinely disturbed	Location	Not Applicable	
Avg Time in Use	Not Applicable	Frequency of Use	Not Applicable	
No. of Occupants	Not Applicable	Secondary Activity	Not Applicable	
Maintenance	Not Applicable	Maintenance Frequency	Not Applicable	
MANAGEMENT ACTION				SCORE
Recommendation	NO ACTION REQUIRED			-
Recommendation Due		Next Inspection	None	
Apply Labels	No	Permit to Work Required	No	
Survey Type	Management	Lead Surveyor	Jane Openshaw	
Survey Date	20 Mar 2012	UKAS Laboratory	NOT SAMPLED (Cross Referenced)	
Site Reference	I13070000A	Licensed Material	N/A

No Asbestos Presumed in Sample

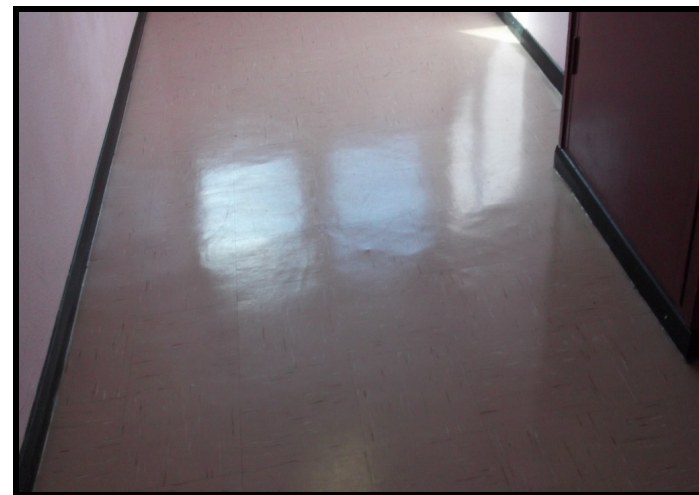
SAMPLE REFERENCE 048

Building	Floor	Room	Location	
Main Building	Eighth Floor	Corridor 2	Floor	
Description	Buff, Timber boxing adjacent to front doors			
MATERIAL ASSESSMENT				SCORE
Product Type	Floor Tiles	Extent of Damage	Good condition	-
Asbestos Type	No Asbestos Detected	Surface Treatment	Composite materials	
PRIORITY ASSESSMENT				SCORE
Occupant Activity	Not Applicable	Extent / Amount	7.00 m2	-
Accessibility	Routinely disturbed	Location	Not Applicable	
Avg Time in Use	Not Applicable	Frequency of Use	Not Applicable	
No. of Occupants	Not Applicable	Secondary Activity	Not Applicable	
Maintenance	Not Applicable	Maintenance Frequency	Not Applicable	
MANAGEMENT ACTION				SCORE
Recommendation	NO ACTION REQUIRED			-
Recommendation Due		Next Inspection	None	
Apply Labels	No	Permit to Work Required	No	
Survey Type	Management	Lead Surveyor	Jane Openshaw	
Survey Date	20 Mar 2012	UKAS Laboratory	NOT SAMPLED (Cross Referenced)	
Site Reference	I13070000A	Licensed Material	N/A

No Asbestos Presumed in Sample

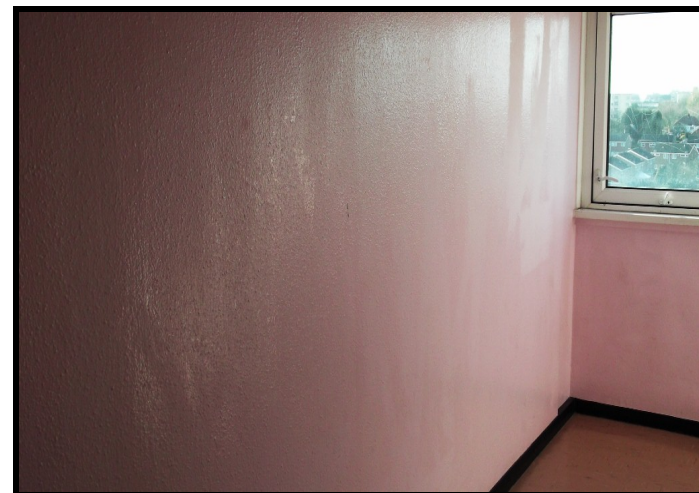
SAMPLE REFERENCE 049

Building	Floor	Room	Location	
Main Building	Eighth Floor	Corridor 2	Walls	
Description	Timber boxing adjacent to front doors			
MATERIAL ASSESSMENT				SCORE
Product Type	Paint	Extent of Damage	Good condition	-
Asbestos Type	No Asbestos Detected	Surface Treatment	Sealed (1)	
PRIORITY ASSESSMENT				SCORE
Occupant Activity	Not Applicable	Extent / Amount	13.00 m2	-
Accessibility	Easily disturbed	Location	Not Applicable	
Avg Time in Use	Not Applicable	Frequency of Use	Not Applicable	
No. of Occupants	Not Applicable	Secondary Activity	Not Applicable	
Maintenance	Not Applicable	Maintenance Frequency	Not Applicable	
MANAGEMENT ACTION				SCORE
Recommendation	NO ACTION REQUIRED			-
Recommendation Due		Next Inspection	None	
Apply Labels	No	Permit to Work Required	No	
Survey Type	Management	Lead Surveyor	Jane Openshaw	
Survey Date	20 Mar 2012	UKAS Laboratory	NOT SAMPLED (Cross Referenced)	
Site Reference	113070000A	Licensed Material	N/A

No Asbestos Presumed in Sample

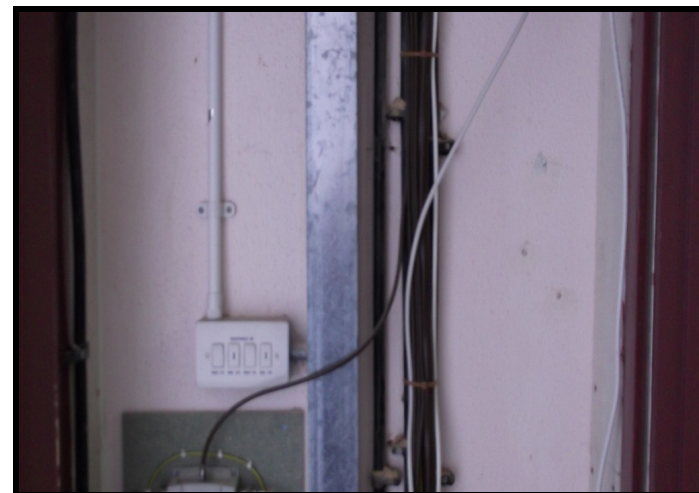
SAMPLE REFERENCE 050

Building	Floor	Room	Location	
Main Building	Eighth Floor	Service Riser	Walls	
Description				
MATERIAL ASSESSMENT				SCORE
Product Type	Paint	Extent of Damage	Good condition	-
Asbestos Type	No Asbestos Detected	Surface Treatment	Sealed (1)	
PRIORITY ASSESSMENT				SCORE
Occupant Activity	Not Applicable	Extent / Amount	3.00 m2	-
Accessibility	Easily disturbed	Location	Not Applicable	
Avg Time in Use	Not Applicable	Frequency of Use	Not Applicable	
No. of Occupants	Not Applicable	Secondary Activity	Not Applicable	
Maintenance	Not Applicable	Maintenance Frequency	Not Applicable	
MANAGEMENT ACTION				SCORE
Recommendation	NO ACTION REQUIRED			-
Recommendation Due		Next Inspection	None	
Apply Labels	No	Permit to Work Required	No	
Survey Type	Management	Lead Surveyor	Jane Openshaw	
Survey Date	20 Mar 2012	UKAS Laboratory	NOT SAMPLED (Cross Referenced)	
Site Reference	113070000A	Licensed Material	N/A

No Asbestos Presumed in Sample

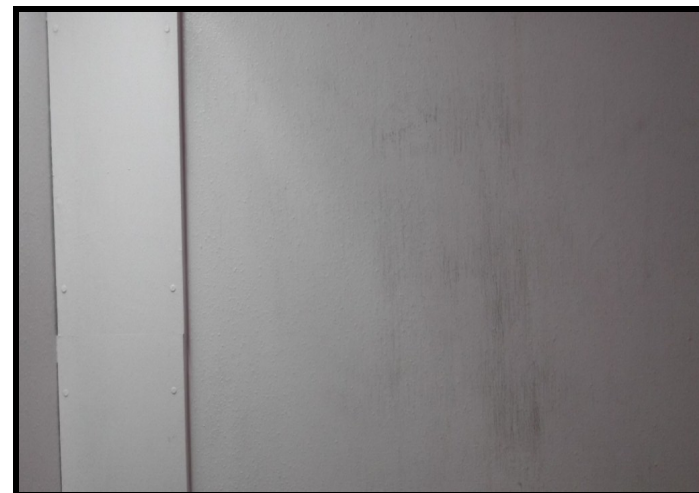
SAMPLE REFERENCE 051

Building	Floor	Room	Location	
Main Building	Eighth Floor	Stairs	Walls	
Description				
MATERIAL ASSESSMENT				SCORE
Product Type	Paint	Extent of Damage	Good condition	-
Asbestos Type	No Asbestos Detected	Surface Treatment	Sealed (1)	
PRIORITY ASSESSMENT				SCORE
Occupant Activity	Not Applicable	Extent / Amount	30.00 m2	-
Accessibility	Easily disturbed	Location	Not Applicable	
Avg Time in Use	Not Applicable	Frequency of Use	Not Applicable	
No. of Occupants	Not Applicable	Secondary Activity	Not Applicable	
Maintenance	Not Applicable	Maintenance Frequency	Not Applicable	
MANAGEMENT ACTION				SCORE
Recommendation	NO ACTION REQUIRED			-
Recommendation Due		Next Inspection	None	
Apply Labels	No	Permit to Work Required	No	
Survey Type	Management	Lead Surveyor	Jane Openshaw	
Survey Date	20 Mar 2012	UKAS Laboratory	NOT SAMPLED (Cross Referenced)	
Site Reference	113070000A	Licensed Material	N/A

No Asbestos Presumed in Sample

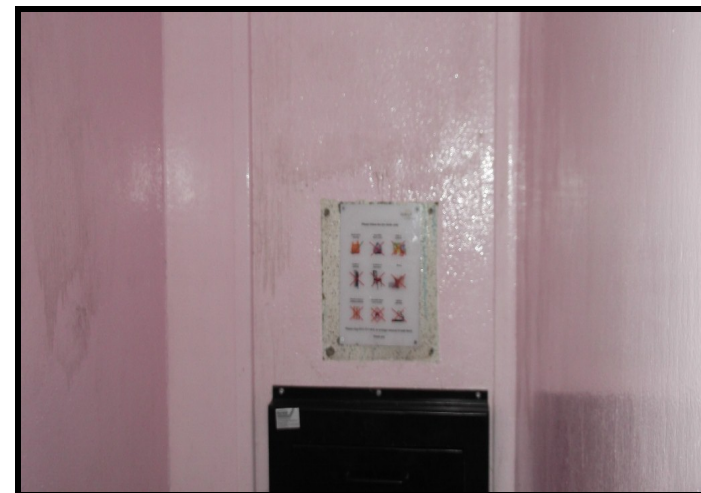
SAMPLE REFERENCE 052

Building	Floor	Room	Location	
Main Building	Seventh Floor	Bin Chute	Walls	
Description				
MATERIAL ASSESSMENT				SCORE
Product Type	Paint	Extent of Damage	Low damage	-
Asbestos Type	No Asbestos Detected	Surface Treatment	Sealed (1)	
PRIORITY ASSESSMENT				SCORE
Occupant Activity	Not Applicable	Extent / Amount	15.00 m2	-
Accessibility	Easily disturbed	Location	Not Applicable	
Avg Time in Use	Not Applicable	Frequency of Use	Not Applicable	
No. of Occupants	Not Applicable	Secondary Activity	Not Applicable	
Maintenance	Not Applicable	Maintenance Frequency	Not Applicable	
MANAGEMENT ACTION				SCORE
Recommendation	NO ACTION REQUIRED			-
Recommendation Due		Next Inspection	None	
Apply Labels	No	Permit to Work Required	No	
Survey Type	Management	Lead Surveyor	Jane Openshaw	
Survey Date	20 Mar 2012	UKAS Laboratory	NOT SAMPLED (Cross Referenced)	
Site Reference	113070000A	Licensed Material	N/A

No Asbestos Presumed in Sample

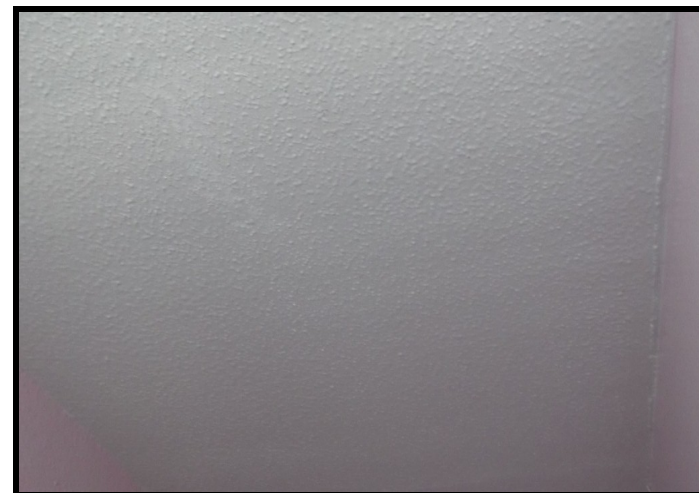
SAMPLE REFERENCE 053

No Asbestos Presumed in Sample

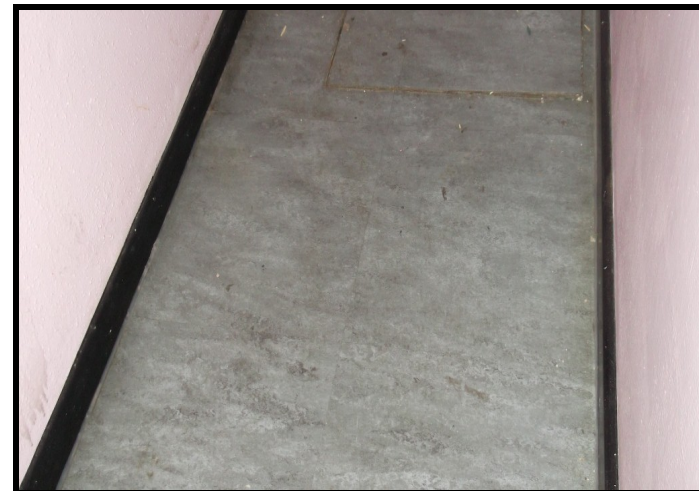
SAMPLE REFERENCE 054

Building	Floor	Room	Location	
Main Building	Seventh Floor	Bin Chute	Floor	
Description	Blue			
MATERIAL ASSESSMENT				SCORE
Product Type	Paper	Extent of Damage	Good condition	-
Asbestos Type	No Asbestos Detected	Surface Treatment	Sealed (1)	
PRIORITY ASSESSMENT				SCORE
Occupant Activity	Not Applicable	Extent / Amount	5.00 m2	-
Accessibility	Unlikely to be disturbed	Location	Not Applicable	
Avg Time in Use	Not Applicable	Frequency of Use	Not Applicable	
No. of Occupants	Not Applicable	Secondary Activity	Not Applicable	
Maintenance	Not Applicable	Maintenance Frequency	Not Applicable	
MANAGEMENT ACTION				SCORE
Recommendation	NO ACTION REQUIRED			-
Recommendation Due		Next Inspection	None	
Apply Labels	No	Permit to Work Required	No	
Survey Type	Management	Lead Surveyor	Jane Openshaw	
Survey Date	20 Mar 2012	UKAS Laboratory	NOT SAMPLED (Cross Referenced)	
Site Reference	I13070000A	Licensed Material	N/A

No Asbestos Presumed in Sample

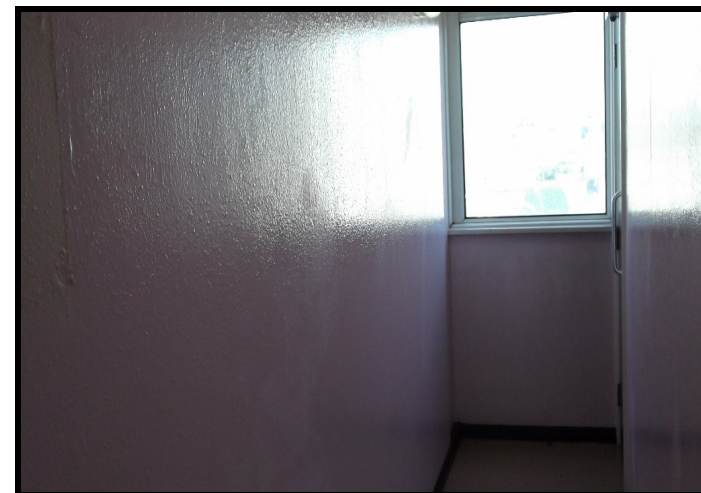
SAMPLE REFERENCE 055

Building	Floor	Room	Location	
Main Building	Seventh Floor	Corridor I	Walls	
Description	Timber boxing adjacent to flats			
MATERIAL ASSESSMENT				SCORE
Product Type	Paint	Extent of Damage	Good condition	-
Asbestos Type	No Asbestos Detected	Surface Treatment	Sealed (1)	
PRIORITY ASSESSMENT				SCORE
Occupant Activity	Not Applicable	Extent / Amount	10.00 m2	-
Accessibility	Easily disturbed	Location	Not Applicable	
Avg Time in Use	Not Applicable	Frequency of Use	Not Applicable	
No. of Occupants	Not Applicable	Secondary Activity	Not Applicable	
Maintenance	Not Applicable	Maintenance Frequency	Not Applicable	
MANAGEMENT ACTION				SCORE
Recommendation	NO ACTION REQUIRED			-
Recommendation Due		Next Inspection	None	
Apply Labels	No	Permit to Work Required	No	
Survey Type	Management	Lead Surveyor	Jane Openshaw	
Survey Date	20 Mar 2012	UKAS Laboratory	NOT SAMPLED (Cross Referenced)	
Site Reference	113070000A	Licensed Material	N/A

No Asbestos Presumed in Sample

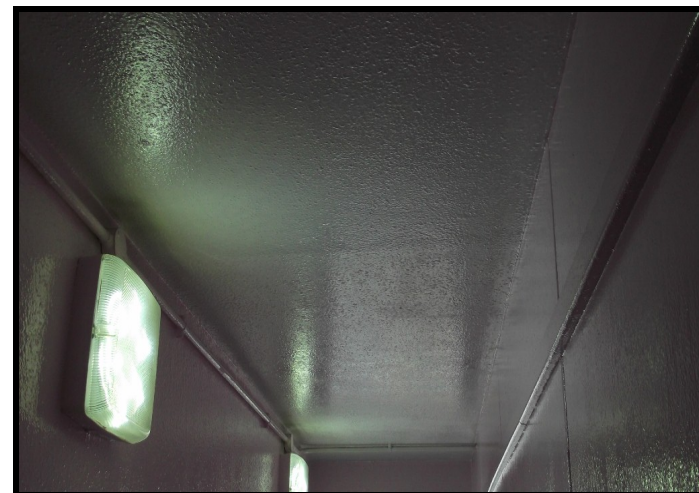
SAMPLE REFERENCE 056

Building	Floor	Room	Location	
Main Building	Seventh Floor	Corridor I	Ceiling	
Description	Timber boxing adjacent to flats			
MATERIAL ASSESSMENT				SCORE
Product Type	Paint	Extent of Damage	Good condition	-
Asbestos Type	No Asbestos Detected	Surface Treatment	Sealed (I)	
PRIORITY ASSESSMENT				SCORE
Occupant Activity	Not Applicable	Extent / Amount	5.00 m2	-
Accessibility	Occasionally disturb	Location	Not Applicable	
Avg Time in Use	Not Applicable	Frequency of Use	Not Applicable	
No. of Occupants	Not Applicable	Secondary Activity	Not Applicable	
Maintenance	Not Applicable	Maintenance Frequency	Not Applicable	
MANAGEMENT ACTION				SCORE
Recommendation	NO ACTION REQUIRED			-
Recommendation Due		Next Inspection	None	
Apply Labels	No	Permit to Work Required	No	
Survey Type	Management	Lead Surveyor	Jane Openshaw	
Survey Date	20 Mar 2012	UKAS Laboratory	NOT SAMPLED (Cross Referenced)	
Site Reference	I13070000A	Licensed Material	N/A

No Asbestos Presumed in Sample

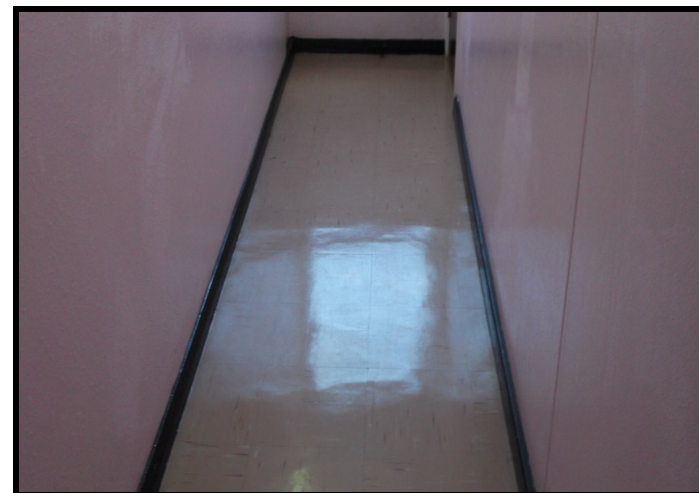
SAMPLE REFERENCE 057

Building	Floor	Room	Location	
Main Building	Seventh Floor	Corridor I	Floor	
Description	Buff, Timber boxing adjacent to flats			
MATERIAL ASSESSMENT				SCORE
Product Type	Floor Tiles	Extent of Damage	Good condition	-
Asbestos Type	No Asbestos Detected	Surface Treatment	Composite materials	
PRIORITY ASSESSMENT				SCORE
Occupant Activity	Not Applicable	Extent / Amount	5.00 m2	-
Accessibility	Routinely disturbed	Location	Not Applicable	
Avg Time in Use	Not Applicable	Frequency of Use	Not Applicable	
No. of Occupants	Not Applicable	Secondary Activity	Not Applicable	
Maintenance	Not Applicable	Maintenance Frequency	Not Applicable	
MANAGEMENT ACTION				SCORE
Recommendation	NO ACTION REQUIRED			-
Recommendation Due		Next Inspection	None	
Apply Labels	No	Permit to Work Required	No	
Survey Type	Management	Lead Surveyor	Jane Openshaw	
Survey Date	20 Mar 2012	UKAS Laboratory	NOT SAMPLED (Cross Referenced)	
Site Reference	I13070000A	Licensed Material	N/A

No Asbestos Presumed in Sample

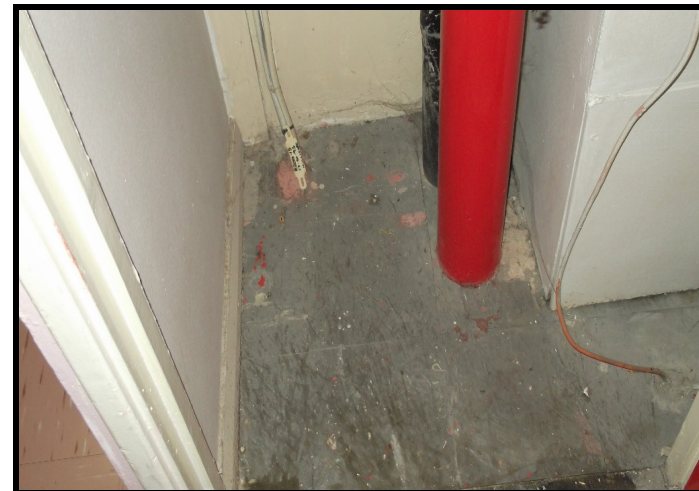
SAMPLE REFERENCE 060

Building	Floor	Room	Location
Main Building	Seventh Floor	Dry Riser	Floor
Description	Blue		
MATERIAL ASSESSMENT			
Product Type	Floor Tiles	Extent of Damage	Good condition
Asbestos Type	Chrysotile	Surface Treatment	Composite materials
PRIORITY ASSESSMENT			
Occupant Activity	Not Applicable	Extent / Amount	1.00 m2
Accessibility	Routinely disturbed	Location	Not Applicable
Avg Time in Use	Not Applicable	Frequency of Use	Not Applicable
No. of Occupants	Not Applicable	Secondary Activity	Not Applicable
Maintenance	Not Applicable	Maintenance Frequency	Not Applicable
MANAGEMENT ACTION			
Recommendation	LABEL & MONITOR		
Recommendation Due		Next Inspection	20 Mar 2013
Apply Labels	No	Permit to Work Required	No
Survey Type	Management	Lead Surveyor	Jane Openshaw
Survey Date	20 Mar 2012	UKAS Laboratory	NOT SAMPLED (Cross Referenced)
Site Reference	113070000A	Licensed Material	No

Asbestos Presumed in Sample

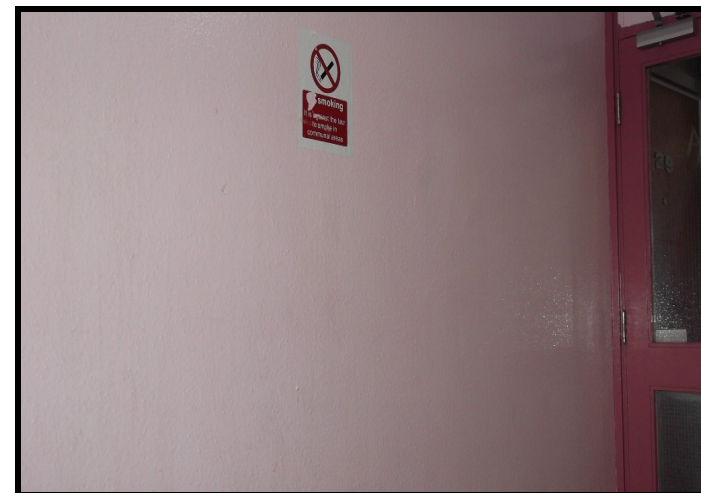
SAMPLE REFERENCE 061

Building	Floor	Room	Location
Main Building	Seventh Floor	Lobby	Walls
Description			
MATERIAL ASSESSMENT			
Product Type	Paint	Extent of Damage	Good condition
Asbestos Type	No Asbestos Detected	Surface Treatment	Sealed (1)
PRIORITY ASSESSMENT			
Occupant Activity	Not Applicable	Extent / Amount	13.00 m2
Accessibility	Easily disturbed	Location	Not Applicable
Avg Time in Use	Not Applicable	Frequency of Use	Not Applicable
No. of Occupants	Not Applicable	Secondary Activity	Not Applicable
Maintenance	Not Applicable	Maintenance Frequency	Not Applicable
MANAGEMENT ACTION			
Recommendation	NO ACTION REQUIRED		
Recommendation Due		Next Inspection	None
Apply Labels	No	Permit to Work Required	No
Survey Type	Management	Lead Surveyor	Jane Openshaw
Survey Date	20 Mar 2012	UKAS Laboratory	NOT SAMPLED (Cross Referenced)
Site Reference	113070000A	Licensed Material	N/A

No Asbestos Presumed in Sample

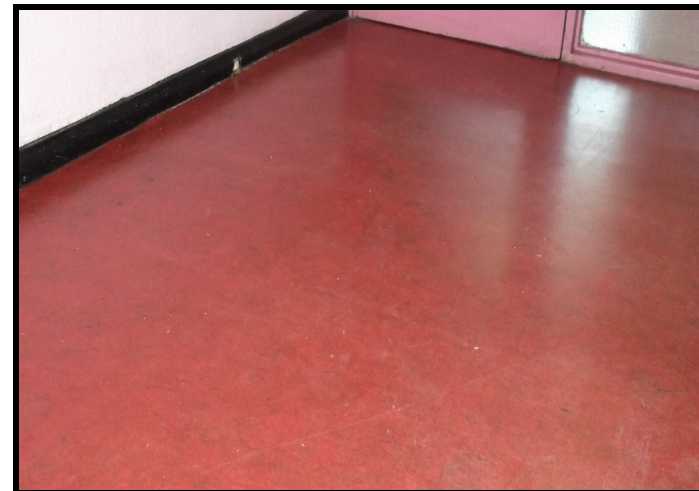
SAMPLE REFERENCE 062

Building	Floor	Room	Location	
Main Building	Seventh Floor	Lobby	Floor	
Description				
MATERIAL ASSESSMENT				SCORE
Product Type	Paper	Extent of Damage	Good condition	-
Asbestos Type	No Asbestos Detected	Surface Treatment	Sealed (1)	
PRIORITY ASSESSMENT				SCORE
Occupant Activity	Not Applicable	Extent / Amount	8.00 m2	-
Accessibility	Unlikely to be disturbed	Location	Not Applicable	
Avg Time in Use	Not Applicable	Frequency of Use	Not Applicable	
No. of Occupants	Not Applicable	Secondary Activity	Not Applicable	
Maintenance	Not Applicable	Maintenance Frequency	Not Applicable	
MANAGEMENT ACTION				SCORE
Recommendation	NO ACTION REQUIRED			-
Recommendation Due		Next Inspection	None	
Apply Labels	No	Permit to Work Required	No	
Survey Type	Management	Lead Surveyor	Jane Openshaw	
Survey Date	20 Mar 2012	UKAS Laboratory	NOT SAMPLED (Cross Referenced)	
Site Reference	113070000A	Licensed Material	N/A

No Asbestos Presumed in Sample

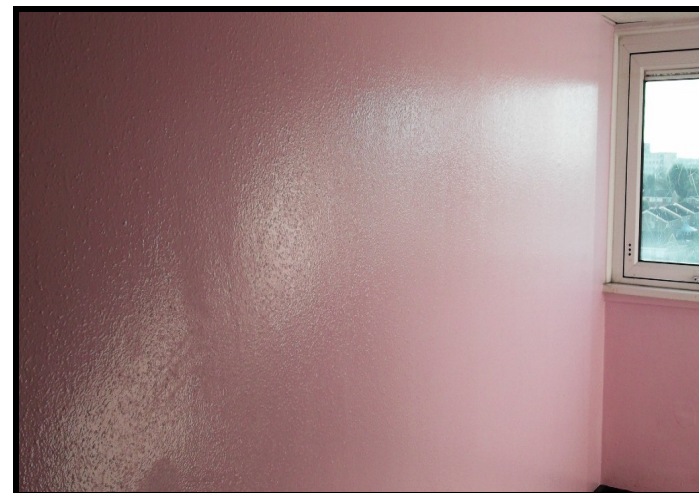
SAMPLE REFERENCE 063

Building	Floor	Room	Location	
Main Building	Seventh Floor	Corridor 2	Walls	
Description	Timber boxing adjacent to front doors			
MATERIAL ASSESSMENT				SCORE
Product Type	Paint	Extent of Damage	Good condition	-
Asbestos Type	No Asbestos Detected	Surface Treatment	Sealed (1)	
PRIORITY ASSESSMENT				SCORE
Occupant Activity	Not Applicable	Extent / Amount	13.00 m2	-
Accessibility	Easily disturbed	Location	Not Applicable	
Avg Time in Use	Not Applicable	Frequency of Use	Not Applicable	
No. of Occupants	Not Applicable	Secondary Activity	Not Applicable	
Maintenance	Not Applicable	Maintenance Frequency	Not Applicable	
MANAGEMENT ACTION				SCORE
Recommendation	NO ACTION REQUIRED			-
Recommendation Due		Next Inspection	None	
Apply Labels	No	Permit to Work Required	No	
Survey Type	Management	Lead Surveyor	Jane Openshaw	
Survey Date	20 Mar 2012	UKAS Laboratory	NOT SAMPLED (Cross Referenced)	
Site Reference	113070000A	Licensed Material	N/A

No Asbestos Presumed in Sample

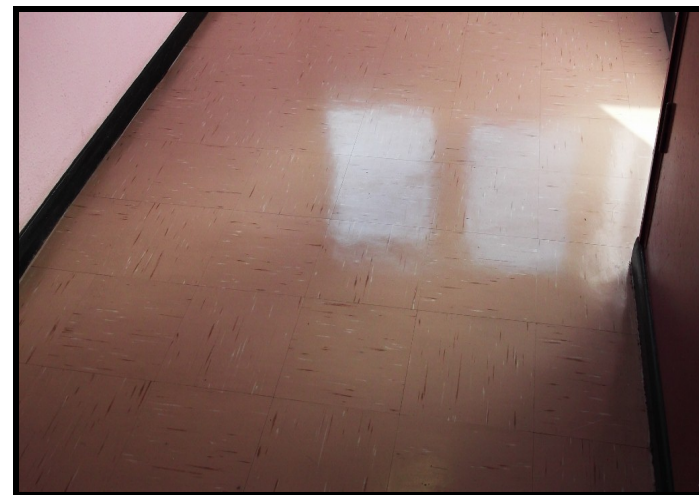
SAMPLE REFERENCE 064

Building	Floor	Room	Location	
Main Building	Seventh Floor	Corridor 2	Floor	
Description	Buff, Timber boxing adjacent to front doors			
MATERIAL ASSESSMENT				SCORE
Product Type	Floor Tiles	Extent of Damage	No visible damage	-
Asbestos Type	No Asbestos Detected	Surface Treatment	Composite materials	
PRIORITY ASSESSMENT				SCORE
Occupant Activity	Not Applicable	Extent / Amount	7.00 m2	-
Accessibility	Routinely disturbed	Location	Not Applicable	
Avg Time in Use	Not Applicable	Frequency of Use	Not Applicable	
No. of Occupants	Not Applicable	Secondary Activity	Not Applicable	
Maintenance	Not Applicable	Maintenance Frequency	Not Applicable	
MANAGEMENT ACTION				SCORE
Recommendation	NO ACTION REQUIRED			-
Recommendation Due		Next Inspection	None	
Apply Labels	No	Permit to Work Required	No	
Survey Type	Management	Lead Surveyor	Jane Openshaw	
Survey Date	20 Mar 2012	UKAS Laboratory	NOT SAMPLED (Cross Referenced)	
Site Reference	I13070000A	Licensed Material	N/A

No Asbestos Presumed in Sample

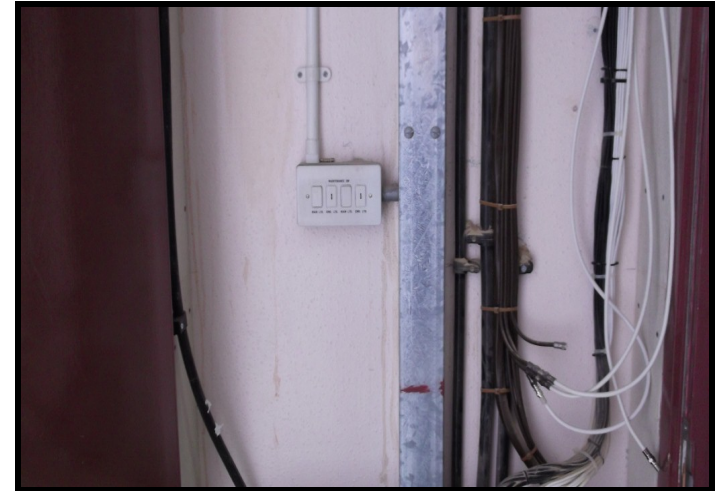
SAMPLE REFERENCE 065

Building	Floor	Room	Location	
Main Building	Seventh Floor	Service Riser	Walls	
Description				
MATERIAL ASSESSMENT				SCORE
Product Type	Paint	Extent of Damage	Good condition	-
Asbestos Type	No Asbestos Detected	Surface Treatment	Sealed (1)	
PRIORITY ASSESSMENT				SCORE
Occupant Activity	Not Applicable	Extent / Amount	3.00 m2	-
Accessibility	Easily disturbed	Location	Not Applicable	
Avg Time in Use	Not Applicable	Frequency of Use	Not Applicable	
No. of Occupants	Not Applicable	Secondary Activity	Not Applicable	
Maintenance	Not Applicable	Maintenance Frequency	Not Applicable	
MANAGEMENT ACTION				SCORE
Recommendation	NO ACTION REQUIRED			-
Recommendation Due		Next Inspection	None	
Apply Labels	No	Permit to Work Required	No	
Survey Type	Management	Lead Surveyor	Jane Openshaw	
Survey Date	20 Mar 2012	UKAS Laboratory	NOT SAMPLED (Cross Referenced)	
Site Reference	113070000A	Licensed Material	N/A

No Asbestos Presumed in Sample
