Solihull Community Housing

Asbestos Management Survey Report

**Balliol House
Grandys Croft
Chelmsley Wood
B37 5BS**

Date of Report: 31 Mar 2012

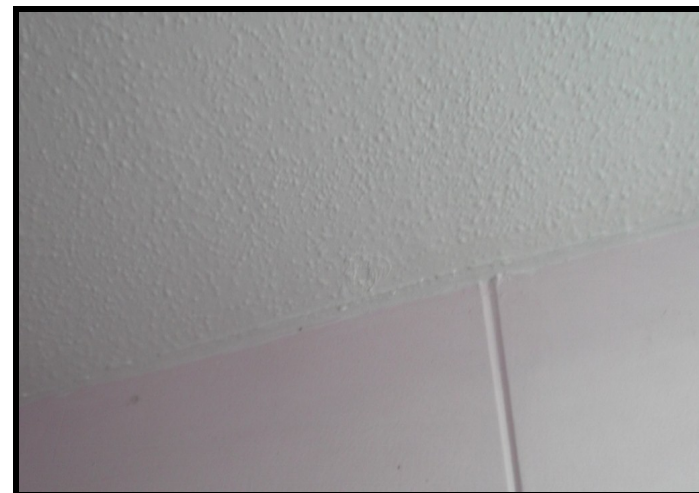
SAMPLE REFERENCE 067

Building	Floor	Room	Location	
Main Building	Sixth Floor	Bin Chute	Ceiling	
Description				
MATERIAL ASSESSMENT				SCORE
Product Type	Paint	Extent of Damage	Good condition	-
Asbestos Type	No Asbestos Detected	Surface Treatment	Sealed (1)	
PRIORITY ASSESSMENT				SCORE
Occupant Activity	Not Applicable	Extent / Amount	4.00 m2	-
Accessibility	Occasionally disturb	Location	Not Applicable	
Avg Time in Use	Not Applicable	Frequency of Use	Not Applicable	
No. of Occupants	Not Applicable	Secondary Activity	Not Applicable	
Maintenance	Not Applicable	Maintenance Frequency	Not Applicable	
MANAGEMENT ACTION				SCORE
Recommendation	NO ACTION REQUIRED			-
Recommendation Due		Next Inspection	None	
Apply Labels	No	Permit to Work Required	No	
Survey Type	Management	Lead Surveyor	Jane Openshaw	
Survey Date	20 Mar 2012	UKAS Laboratory	DMW Environmental Safety Ltd / [P-96019]	
Site Reference	113070000A	Licensed Material	N/A

Asbestos not detected in Sample

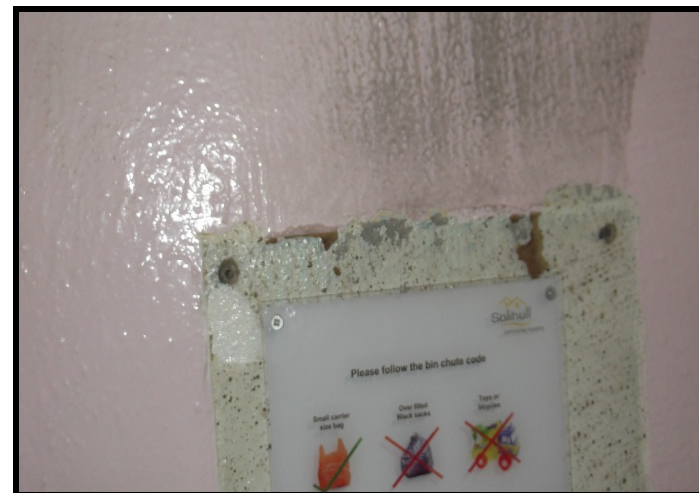
SAMPLE REFERENCE 068

Building	Floor	Room	Location	
Main Building	Sixth Floor	Bin Chute	Walls	
Description				
MATERIAL ASSESSMENT				SCORE
Product Type	Paint	Extent of Damage	Low damage	-
Asbestos Type	No Asbestos Detected	Surface Treatment	Sealed (1)	
PRIORITY ASSESSMENT				SCORE
Occupant Activity	Not Applicable	Extent / Amount	14.00 m2	-
Accessibility	Easily disturbed	Location	Not Applicable	
Avg Time in Use	Not Applicable	Frequency of Use	Not Applicable	
No. of Occupants	Not Applicable	Secondary Activity	Not Applicable	
Maintenance	Not Applicable	Maintenance Frequency	Not Applicable	
MANAGEMENT ACTION				SCORE
Recommendation	NO ACTION REQUIRED			-
Recommendation Due		Next Inspection	None	
Apply Labels	No	Permit to Work Required	No	
Survey Type	Management	Lead Surveyor	Jane Openshaw	
Survey Date	20 Mar 2012	UKAS Laboratory	DMW Environmental Safety Ltd / [P-96019]	
Site Reference	113070000A	Licensed Material	N/A

Asbestos not detected in Sample

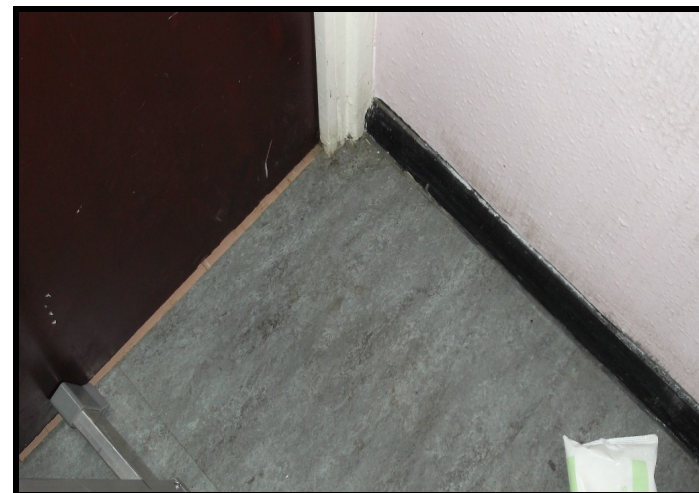
SAMPLE REFERENCE 069

Building	Floor	Room	Location	
Main Building	Sixth Floor	Bin Chute	Floor	
Description	Blue			
MATERIAL ASSESSMENT				SCORE
Product Type	Floor Tiles	Extent of Damage	Good condition	-
Asbestos Type	No Asbestos Detected	Surface Treatment	Composite materials	
PRIORITY ASSESSMENT				SCORE
Occupant Activity	Not Applicable	Extent / Amount	4.00 m2	-
Accessibility	Routinely disturbed	Location	Not Applicable	
Avg Time in Use	Not Applicable	Frequency of Use	Not Applicable	
No. of Occupants	Not Applicable	Secondary Activity	Not Applicable	
Maintenance	Not Applicable	Maintenance Frequency	Not Applicable	
MANAGEMENT ACTION				SCORE
Recommendation	NO ACTION REQUIRED			-
Recommendation Due		Next Inspection	None	
Apply Labels	No	Permit to Work Required	No	
Survey Type	Management	Lead Surveyor	Jane Openshaw	
Survey Date	20 Mar 2012	UKAS Laboratory	DMW Environmental Safety Ltd / [P-96019]	
Site Reference	I13070000A	Licensed Material	N/A

Asbestos not detected in Sample

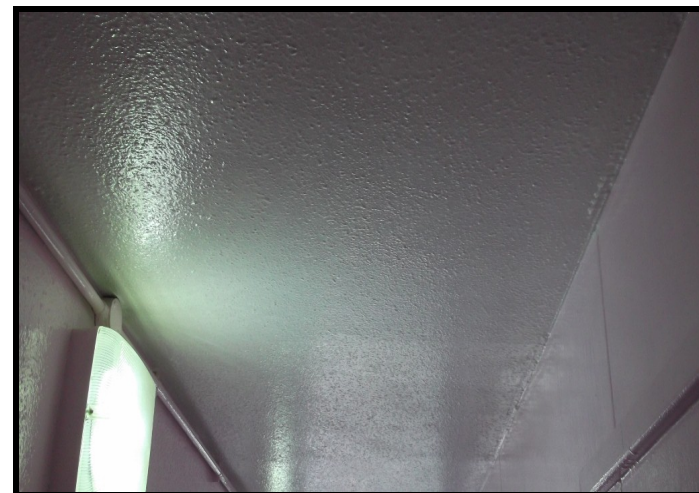
SAMPLE REFERENCE 072

Building	Floor	Room	Location	
Main Building	Sixth Floor	Corridor I	Ceiling	
Description	Timber boxing adjacent to flats			
MATERIAL ASSESSMENT				SCORE
Product Type	Paint	Extent of Damage	Good condition	-
Asbestos Type	No Asbestos Detected	Surface Treatment	Sealed (I)	
PRIORITY ASSESSMENT				SCORE
Occupant Activity	Not Applicable	Extent / Amount	5.00 m2	-
Accessibility	Occasionally disturb	Location	Not Applicable	
Avg Time in Use	Not Applicable	Frequency of Use	Not Applicable	
No. of Occupants	Not Applicable	Secondary Activity	Not Applicable	
Maintenance	Not Applicable	Maintenance Frequency	Not Applicable	
MANAGEMENT ACTION				SCORE
Recommendation	NO ACTION REQUIRED			-
Recommendation Due		Next Inspection	None	
Apply Labels	No	Permit to Work Required	No	
Survey Type	Management	Lead Surveyor	Jane Openshaw	
Survey Date	20 Mar 2012	UKAS Laboratory	NOT SAMPLED (Cross Referenced)	
Site Reference	I13070000A	Licensed Material	N/A

No Asbestos Presumed in Sample

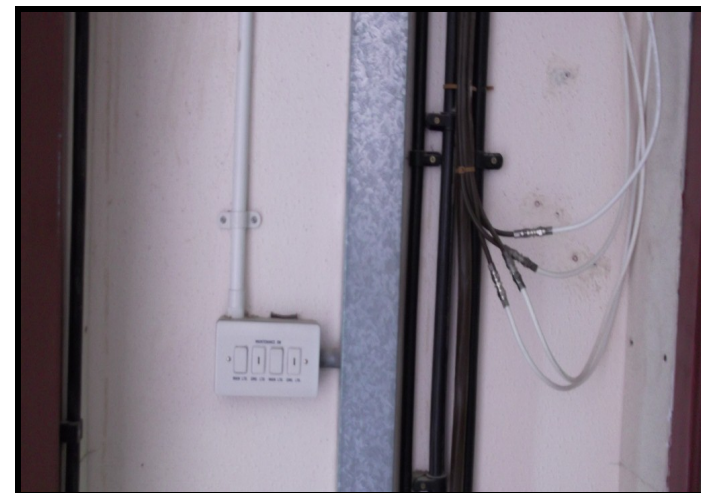
SAMPLE REFERENCE 073

MATERIAL ASSESSMENT				SCORE
Product Type	Paint	Extent of Damage	Good condition	-
Asbestos Type	No Asbestos Detected	Surface Treatment	Sealed (1)

No Asbestos Presumed in Sample

MANAGEMENT ACTION				SCORE
Recommendation	NO ACTION REQUIRED			-
Recommendation Due		Next Inspection	None	
Apply Labels	No	Permit to Work Required	No

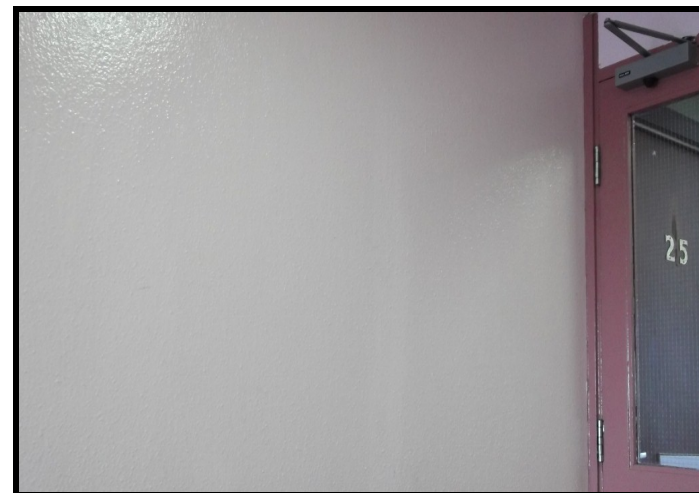
SAMPLE REFERENCE 074

MATERIAL ASSESSMENT				SCORE
Product Type	Paint	Extent of Damage	Good condition	-
Asbestos Type	No Asbestos Detected	Surface Treatment	Sealed (1)

No Asbestos Presumed in Sample

MANAGEMENT ACTION				SCORE
Recommendation	NO ACTION REQUIRED			-
Recommendation Due		Next Inspection	None	
Apply Labels	No	Permit to Work Required	No

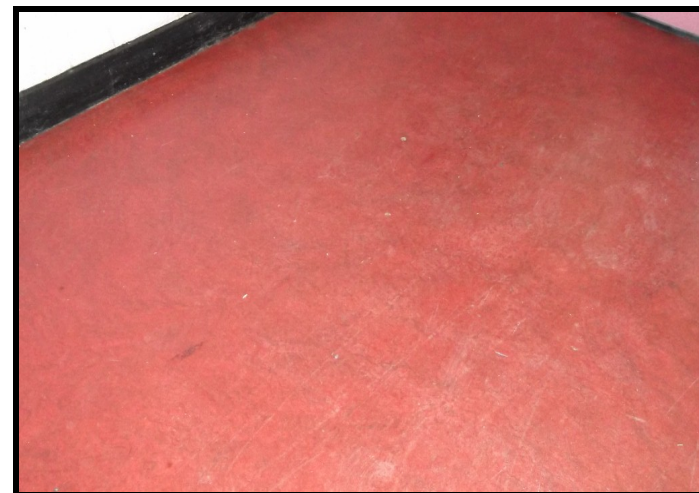
SAMPLE REFERENCE 075

Building	Floor	Room	Location	
Main Building	Sixth Floor	Lobby	Floor	
Description	Red			
MATERIAL ASSESSMENT				SCORE
Product Type	Paper	Extent of Damage	Good condition	-
Asbestos Type	No Asbestos Detected	Surface Treatment	Sealed (1)	
PRIORITY ASSESSMENT				SCORE
Occupant Activity	Not Applicable	Extent / Amount	8.00 m2	-
Accessibility	Unlikely to be disturbed	Location	Not Applicable	
Avg Time in Use	Not Applicable	Frequency of Use	Not Applicable	
No. of Occupants	Not Applicable	Secondary Activity	Not Applicable	
Maintenance	Not Applicable	Maintenance Frequency	Not Applicable	
MANAGEMENT ACTION				SCORE
Recommendation	NO ACTION REQUIRED			-
Recommendation Due		Next Inspection	None	
Apply Labels	No	Permit to Work Required	No	
Survey Type	Management	Lead Surveyor	Jane Openshaw	
Survey Date	20 Mar 2012	UKAS Laboratory	DMW Environmental Safety Ltd / [P-96019]	
Site Reference	113070000A	Licensed Material	N/A

Asbestos not detected in Sample

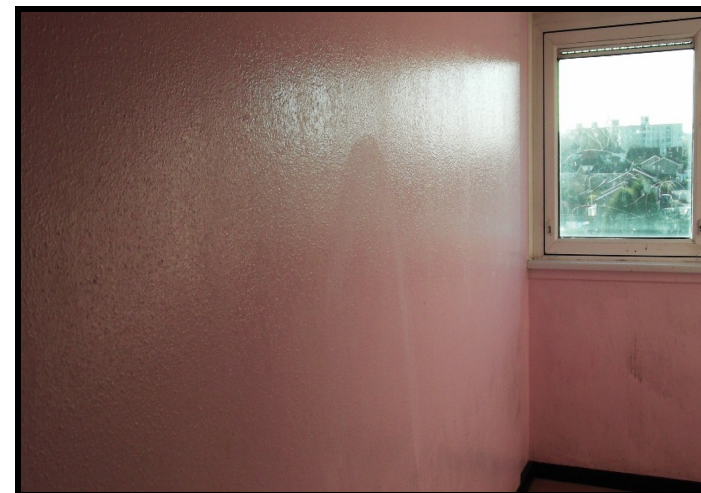
SAMPLE REFERENCE 076

Building	Floor	Room	Location	
Main Building	Sixth Floor	Corridor 2	Walls	
Description	Timber boxing adjacent to front doors			
MATERIAL ASSESSMENT				SCORE
Product Type	Paint	Extent of Damage	Good condition	-
Asbestos Type	No Asbestos Detected	Surface Treatment	Sealed (1)	
PRIORITY ASSESSMENT				SCORE
Occupant Activity	Not Applicable	Extent / Amount	13.00 m2	-
Accessibility	Easily disturbed	Location	Not Applicable	
Avg Time in Use	Not Applicable	Frequency of Use	Not Applicable	
No. of Occupants	Not Applicable	Secondary Activity	Not Applicable	
Maintenance	Not Applicable	Maintenance Frequency	Not Applicable	
MANAGEMENT ACTION				SCORE
Recommendation	NO ACTION REQUIRED			-
Recommendation Due		Next Inspection	None	
Apply Labels	No	Permit to Work Required	No	
Survey Type	Management	Lead Surveyor	Jane Openshaw	
Survey Date	20 Mar 2012	UKAS Laboratory	NOT SAMPLED (Cross Referenced)	
Site Reference	113070000A	Licensed Material	N/A

No Asbestos Presumed in Sample

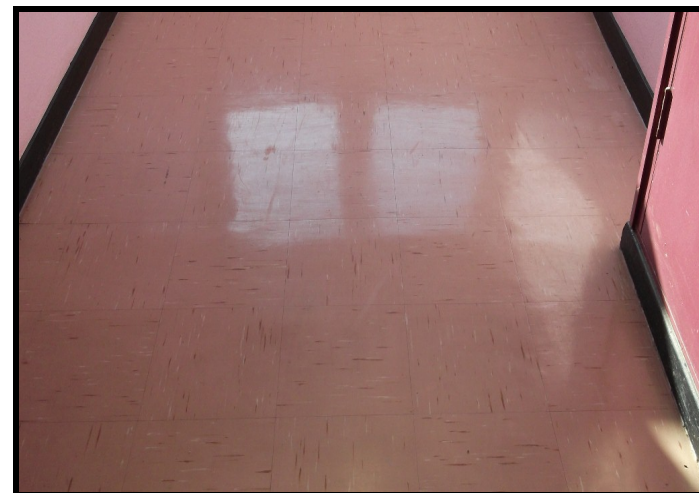
SAMPLE REFERENCE 077

Building	Floor	Room	Location
Main Building	Sixth Floor	Corridor 2	Floor
Description	Buff, Timber boxing adjacent to front doors		
MATERIAL ASSESSMENT			
Product Type	Floor Tiles	Extent of Damage	Good condition
Asbestos Type	No Asbestos Detected	Surface Treatment	Composite materials
PRIORITY ASSESSMENT			
Occupant Activity	Not Applicable	Extent / Amount	7.00 m2
Accessibility	Routinely disturbed	Location	Not Applicable
Avg Time in Use	Not Applicable	Frequency of Use	Not Applicable
No. of Occupants	Not Applicable	Secondary Activity	Not Applicable
Maintenance	Not Applicable	Maintenance Frequency	Not Applicable
MANAGEMENT ACTION			
Recommendation	NO ACTION REQUIRED		
Recommendation Due		Next Inspection	None
Apply Labels	No	Permit to Work Required	No
Survey Type	Management	Lead Surveyor	Jane Openshaw
Survey Date	20 Mar 2012	UKAS Laboratory	NOT SAMPLED (Cross Referenced)
Site Reference	I13070000A	Licensed Material	N/A

No Asbestos Presumed in Sample

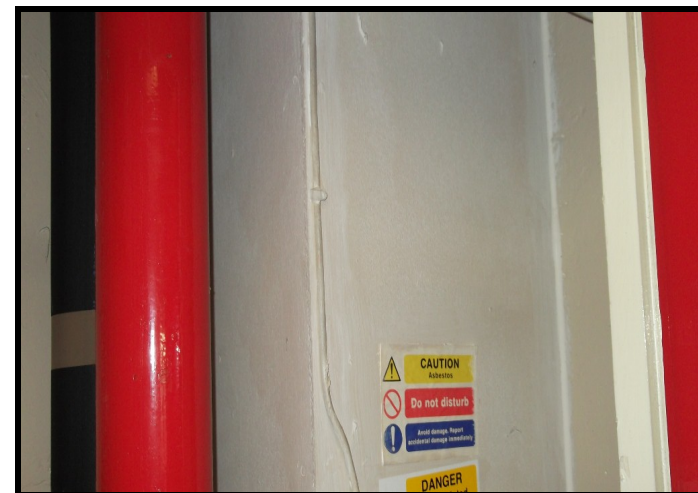
SAMPLE REFERENCE 078

Building	Floor	Room	Location	
Main Building	Sixth Floor	Dry Riser	Riser	
Description				
MATERIAL ASSESSMENT				SCORE
Product Type	Board	Extent of Damage	Good condition	5
Asbestos Type	Amosite / Chrysotile	Surface Treatment	Sealed Board (Encapsulated)	
PRIORITY ASSESSMENT				SCORE
Occupant Activity	Not Applicable	Extent / Amount	5.00 m2	0
Accessibility	Unlikely to be disturbed	Location	Not Applicable	
Avg Time in Use	Not Applicable	Frequency of Use	Not Applicable	
No. of Occupants	Not Applicable	Secondary Activity	Not Applicable	
Maintenance	Not Applicable	Maintenance Frequency	Not Applicable	
MANAGEMENT ACTION				SCORE
Recommendation	LABEL & MONITOR			5
Recommendation Due		Next Inspection	03 Oct 2012	
Apply Labels	No	Permit to Work Required	No	
Survey Type	Management	Lead Surveyor	Jane Openshaw	
Survey Date	20 Mar 2012	UKAS Laboratory	DMW Environmental Safety Ltd / [P-96019]	
Site Reference	I13070000A	Licensed Material	Yes

Asbestos detected in Sample

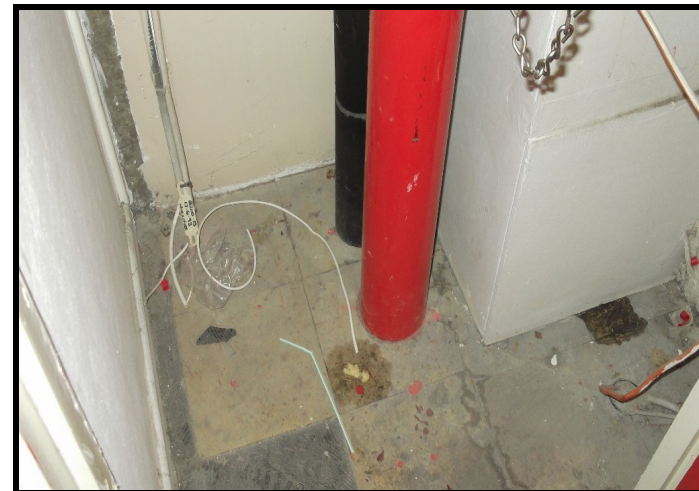
SAMPLE REFERENCE 079

Building	Floor	Room	Location	
Main Building	Sixth Floor	Dry Riser	Floor	
Description	Yellow			
MATERIAL ASSESSMENT				SCORE
Product Type	Floor Tiles	Extent of Damage	Low damage	3
Asbestos Type	Chrysotile	Surface Treatment	Composite materials	
PRIORITY ASSESSMENT				SCORE
Occupant Activity	Not Applicable	Extent / Amount	1.00 m2	1
Accessibility	Routinely disturbed	Location	Not Applicable	
Avg Time in Use	Not Applicable	Frequency of Use	Not Applicable	
No. of Occupants	Not Applicable	Secondary Activity	Not Applicable	
Maintenance	Not Applicable	Maintenance Frequency	Not Applicable	
MANAGEMENT ACTION				SCORE
Recommendation	LABEL & MONITOR			4
Recommendation Due		Next Inspection	03 Apr 2013	
Apply Labels	No	Permit to Work Required	No	
Survey Type	Management	Lead Surveyor	Jane Openshaw	
Survey Date	20 Mar 2012	UKAS Laboratory	DMW Environmental Safety Ltd / [P-96019]	
Site Reference	I13070000A	Licensed Material	No

Asbestos detected in Sample

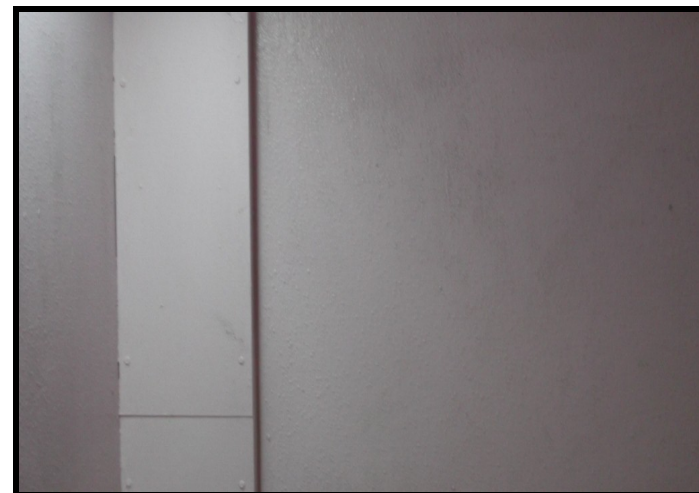
SAMPLE REFERENCE 080

Building	Floor	Room	Location
Main Building	Sixth Floor	Stairs	Walls
Description			
MATERIAL ASSESSMENT			
Product Type	Paint	Extent of Damage	Good condition
Asbestos Type	No Asbestos Detected	Surface Treatment	Sealed (1)
PRIORITY ASSESSMENT			
Occupant Activity	Not Applicable	Extent / Amount	30.00 m2
Accessibility	Easily disturbed	Location	Not Applicable
Avg Time in Use	Not Applicable	Frequency of Use	Not Applicable
No. of Occupants	Not Applicable	Secondary Activity	Not Applicable
Maintenance	Not Applicable	Maintenance Frequency	Not Applicable
MANAGEMENT ACTION			
Recommendation	NO ACTION REQUIRED		
Recommendation Due		Next Inspection	None
Apply Labels	No	Permit to Work Required	No
Survey Type	Management	Lead Surveyor	Jane Openshaw
Survey Date	20 Mar 2012	UKAS Laboratory	NOT SAMPLED (Cross Referenced)
Site Reference	I13070000A	Licensed Material	N/A

No Asbestos Presumed in Sample

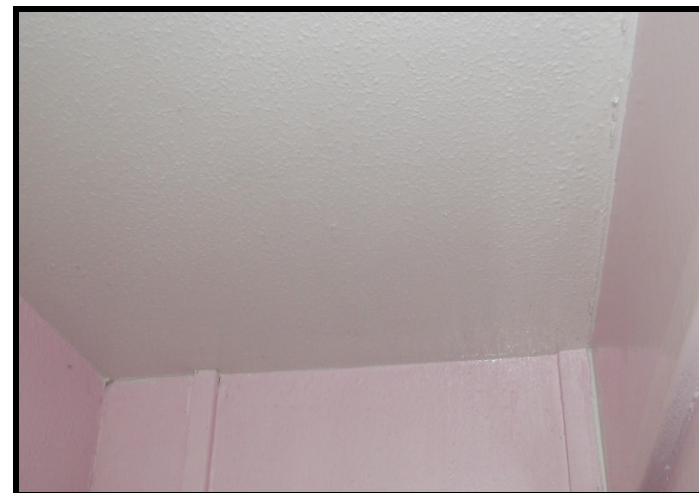
SAMPLE REFERENCE 081

Building	Floor	Room	Location	
Main Building	Fifth Floor	Bin Chute	Ceiling	
Description				
MATERIAL ASSESSMENT				SCORE
Product Type	Paint	Extent of Damage	Good condition	-
Asbestos Type	No Asbestos Detected	Surface Treatment	Sealed (1)	
PRIORITY ASSESSMENT				SCORE
Occupant Activity	Not Applicable	Extent / Amount	4.00 m2	-
Accessibility	Occasionally disturb	Location	Not Applicable	
Avg Time in Use	Not Applicable	Frequency of Use	Not Applicable	
No. of Occupants	Not Applicable	Secondary Activity	Not Applicable	
Maintenance	Not Applicable	Maintenance Frequency	Not Applicable	
MANAGEMENT ACTION				SCORE
Recommendation	NO ACTION REQUIRED			-
Recommendation Due		Next Inspection	None	
Apply Labels	No	Permit to Work Required	No	
Survey Type	Management	Lead Surveyor	Jane Openshaw	
Survey Date	20 Mar 2012	UKAS Laboratory	NOT SAMPLED (Cross Referenced)	
Site Reference	I13070000A	Licensed Material	N/A

No Asbestos Presumed in Sample

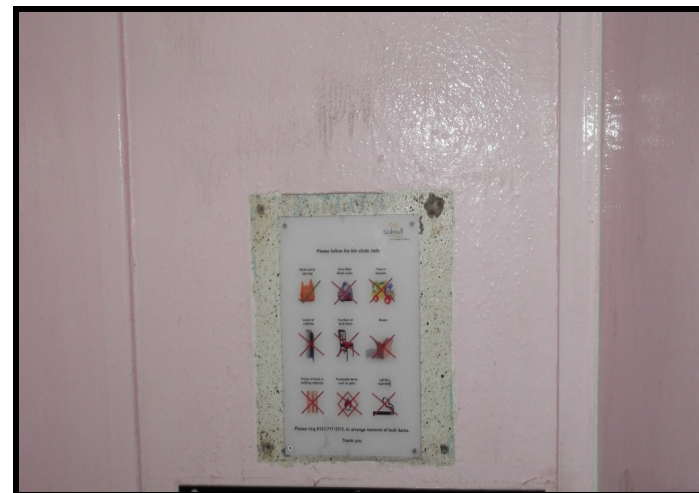
SAMPLE REFERENCE 082

Building	Floor	Room	Location	
Main Building	Fifth Floor	Bin Chute	Walls	
Description				
MATERIAL ASSESSMENT				SCORE
Product Type	Paint	Extent of Damage	Low damage	-
Asbestos Type	No Asbestos Detected	Surface Treatment	Sealed (1)	
PRIORITY ASSESSMENT				SCORE
Occupant Activity	Not Applicable	Extent / Amount	14.00 m2	-
Accessibility	Easily disturbed	Location	Not Applicable	
Avg Time in Use	Not Applicable	Frequency of Use	Not Applicable	
No. of Occupants	Not Applicable	Secondary Activity	Not Applicable	
Maintenance	Not Applicable	Maintenance Frequency	Not Applicable	
MANAGEMENT ACTION				SCORE
Recommendation	NO ACTION REQUIRED			-
Recommendation Due		Next Inspection	None	
Apply Labels	No	Permit to Work Required	No	
Survey Type	Management	Lead Surveyor	Jane Openshaw	
Survey Date	20 Mar 2012	UKAS Laboratory	NOT SAMPLED (Cross Referenced)	
Site Reference	113070000A	Licensed Material	N/A

No Asbestos Presumed in Sample

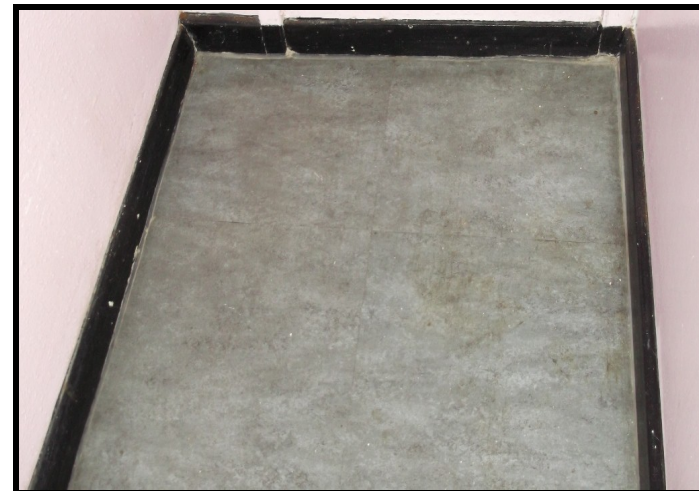
SAMPLE REFERENCE 083

Building	Floor	Room	Location	
Main Building	Fifth Floor	Bin Chute	Floor	
Description	Blue			
MATERIAL ASSESSMENT				SCORE
Product Type	Floor Tiles	Extent of Damage	Good condition	-
Asbestos Type	No Asbestos Detected	Surface Treatment	Composite materials	
PRIORITY ASSESSMENT				SCORE
Occupant Activity	Not Applicable	Extent / Amount	4.00 m2	-
Accessibility	Routinely disturbed	Location	Not Applicable	
Avg Time in Use	Not Applicable	Frequency of Use	Not Applicable	
No. of Occupants	Not Applicable	Secondary Activity	Not Applicable	
Maintenance	Not Applicable	Maintenance Frequency	Not Applicable	
MANAGEMENT ACTION				SCORE
Recommendation	NO ACTION REQUIRED			-
Recommendation Due		Next Inspection	None	
Apply Labels	No	Permit to Work Required	No	
Survey Type	Management	Lead Surveyor	Jane Openshaw	
Survey Date	20 Mar 2012	UKAS Laboratory	NOT SAMPLED (Cross Referenced)	
Site Reference	I13070000A	Licensed Material	N/A

No Asbestos Presumed in Sample

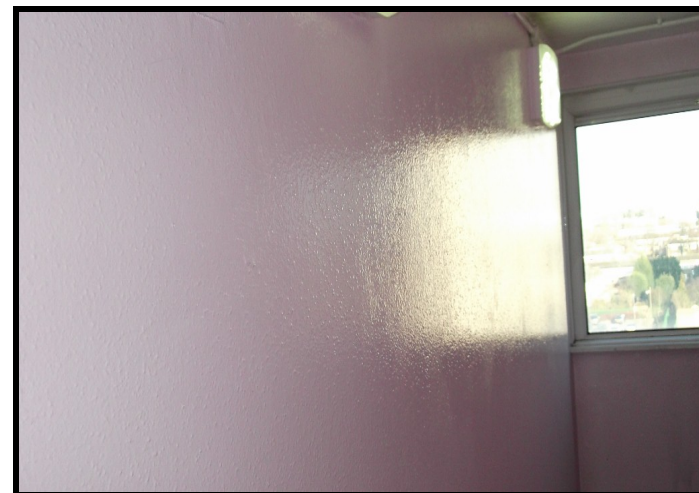
SAMPLE REFERENCE 084

Building	Floor	Room	Location	
Main Building	Fifth Floor	Corridor I	Walls	
Description	Timber boxing adjacent to flats			
MATERIAL ASSESSMENT				SCORE
Product Type	Paint	Extent of Damage	Good condition	-
Asbestos Type	No Asbestos Detected	Surface Treatment	Sealed (I)	
PRIORITY ASSESSMENT				SCORE
Occupant Activity	Not Applicable	Extent / Amount	10.00 m2	-
Accessibility	Easily disturbed	Location	Not Applicable	
Avg Time in Use	Not Applicable	Frequency of Use	Not Applicable	
No. of Occupants	Not Applicable	Secondary Activity	Not Applicable	
Maintenance	Not Applicable	Maintenance Frequency	Not Applicable	
MANAGEMENT ACTION				SCORE
Recommendation	NO ACTION REQUIRED			-
Recommendation Due		Next Inspection	None	
Apply Labels	No	Permit to Work Required	No	
Survey Type	Management	Lead Surveyor	Jane Openshaw	
Survey Date	20 Mar 2012	UKAS Laboratory	NOT SAMPLED (Cross Referenced)	
Site Reference	I13070000A	Licensed Material	N/A

No Asbestos Presumed in Sample

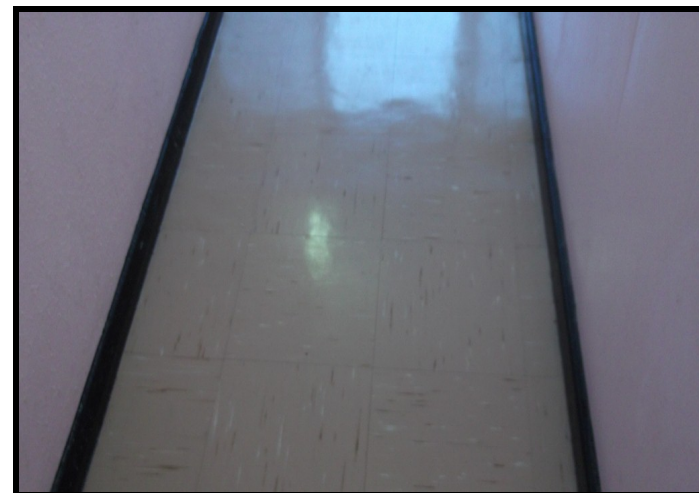
SAMPLE REFERENCE 085

Building	Floor	Room	Location	
Main Building	Fifth Floor	Corridor I	Floor	
Description	To floor buff, Timber boxing adjacent to flats			
MATERIAL ASSESSMENT				SCORE
Product Type	Floor Tiles	Extent of Damage	Good condition	-
Asbestos Type	No Asbestos Detected	Surface Treatment	Composite materials	
PRIORITY ASSESSMENT				SCORE
Occupant Activity	Not Applicable	Extent / Amount	7.00 m2	-
Accessibility	Routinely disturbed	Location	Not Applicable	
Avg Time in Use	Not Applicable	Frequency of Use	Not Applicable	
No. of Occupants	Not Applicable	Secondary Activity	Not Applicable	
Maintenance	Not Applicable	Maintenance Frequency	Not Applicable	
MANAGEMENT ACTION				SCORE
Recommendation	NO ACTION REQUIRED			-
Recommendation Due		Next Inspection	None	
Apply Labels	No	Permit to Work Required	No	
Survey Type	Management	Lead Surveyor	Jane Openshaw	
Survey Date	20 Mar 2012	UKAS Laboratory	NOT SAMPLED (Cross Referenced)	
Site Reference	I13070000A	Licensed Material	N/A

No Asbestos Presumed in Sample

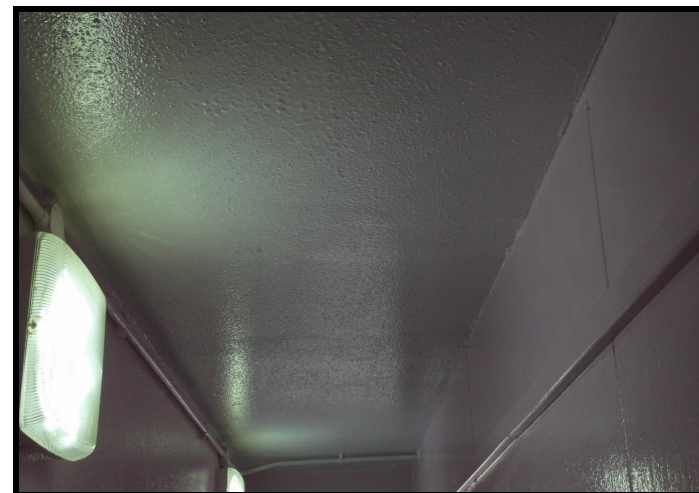
SAMPLE REFERENCE 086

Building	Floor	Room	Location	
Main Building	Fifth Floor	Corridor I	Ceiling	
Description	Timber boxing adjacent to flats			
MATERIAL ASSESSMENT				SCORE
Product Type	Paint	Extent of Damage	Good condition	-
Asbestos Type	No Asbestos Detected	Surface Treatment	Sealed (I)	
PRIORITY ASSESSMENT				SCORE
Occupant Activity	Not Applicable	Extent / Amount	5.00 m2	-
Accessibility	Occasionally disturb	Location	Not Applicable	
Avg Time in Use	Not Applicable	Frequency of Use	Not Applicable	
No. of Occupants	Not Applicable	Secondary Activity	Not Applicable	
Maintenance	Not Applicable	Maintenance Frequency	Not Applicable	
MANAGEMENT ACTION				SCORE
Recommendation	NO ACTION REQUIRED			-
Recommendation Due		Next Inspection	None	
Apply Labels	No	Permit to Work Required	No	
Survey Type	Management	Lead Surveyor	Jane Openshaw	
Survey Date	20 Mar 2012	UKAS Laboratory	NOT SAMPLED (Cross Referenced)	
Site Reference	I13070000A	Licensed Material	N/A

No Asbestos Presumed in Sample

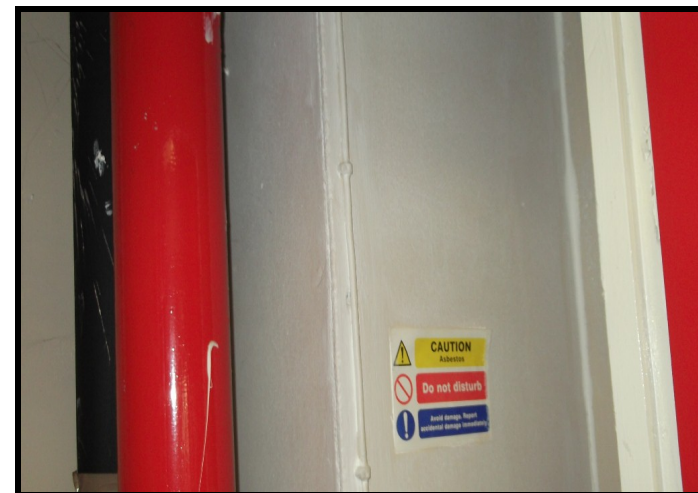
SAMPLE REFERENCE 088

Building	Floor	Room	Location	
Main Building	Fifth Floor	Dry Riser	Riser	
Description				
MATERIAL ASSESSMENT				SCORE
Product Type	Board	Extent of Damage	Good condition	5
Asbestos Type	Amosite / Chrysotile	Surface Treatment	Sealed Board (Encapsulated)	
PRIORITY ASSESSMENT				SCORE
Occupant Activity	Not Applicable	Extent / Amount	5.00 m2	0
Accessibility	Unlikely to be disturbed	Location	Not Applicable	
Avg Time in Use	Not Applicable	Frequency of Use	Not Applicable	
No. of Occupants	Not Applicable	Secondary Activity	Not Applicable	
Maintenance	Not Applicable	Maintenance Frequency	Not Applicable	
MANAGEMENT ACTION				SCORE
Recommendation	LABEL & MONITOR			5
Recommendation Due		Next Inspection	20 Oct 2012	
Apply Labels	No	Permit to Work Required	No	
Survey Type	Management	Lead Surveyor	Jane Openshaw	
Survey Date	20 Mar 2012	UKAS Laboratory	NOT SAMPLED (Cross Referenced)	
Site Reference	I13070000A	Licensed Material	Yes

Asbestos Presumed in Sample

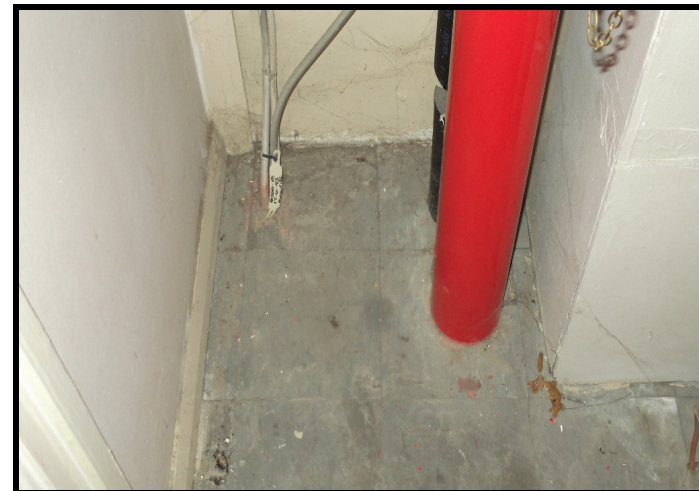
SAMPLE REFERENCE 089

Building	Floor	Room	Location	
Main Building	Fifth Floor	Dry Riser	Floor	
Description	Blue			
MATERIAL ASSESSMENT				SCORE
Product Type	Floor Tiles	Extent of Damage	Good condition	2
Asbestos Type	Chrysotile	Surface Treatment	Composite materials	
PRIORITY ASSESSMENT				SCORE
Occupant Activity	Not Applicable	Extent / Amount	1.00 m2	1
Accessibility	Routinely disturbed	Location	Not Applicable	
Avg Time in Use	Not Applicable	Frequency of Use	Not Applicable	
No. of Occupants	Not Applicable	Secondary Activity	Not Applicable	
Maintenance	Not Applicable	Maintenance Frequency	Not Applicable	
MANAGEMENT ACTION				SCORE
Recommendation	LABEL & MONITOR			3
Recommendation Due		Next Inspection	20 Mar 2013	
Apply Labels	No	Permit to Work Required	No	
Survey Type	Management	Lead Surveyor	Jane Openshaw	
Survey Date	20 Mar 2012	UKAS Laboratory	DMW Environmental Safety Ltd / [P-96019]	
Site Reference	I13070000A	Licensed Material	No

Asbestos detected in Sample

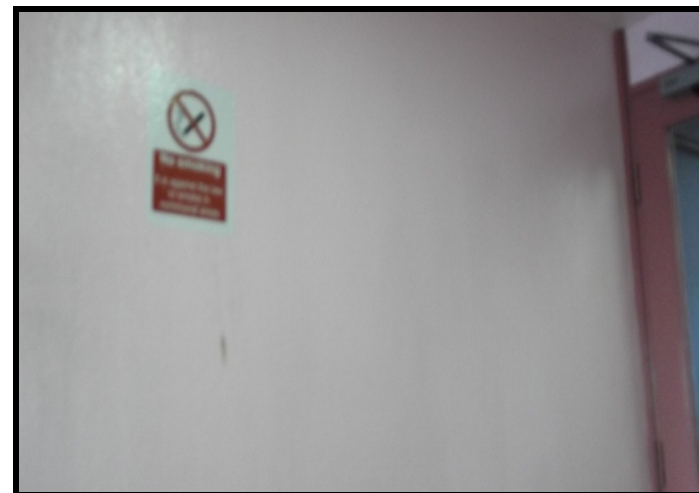
SAMPLE REFERENCE 090

Building	Floor	Room	Location	
Main Building	Fifth Floor	Lobby	Walls	
Description				
MATERIAL ASSESSMENT				SCORE
Product Type	Paint	Extent of Damage	Good condition	-
Asbestos Type	No Asbestos Detected	Surface Treatment	Sealed (1)	
PRIORITY ASSESSMENT				SCORE
Occupant Activity	Not Applicable	Extent / Amount	13.00 m2	-
Accessibility	Easily disturbed	Location	Not Applicable	
Avg Time in Use	Not Applicable	Frequency of Use	Not Applicable	
No. of Occupants	Not Applicable	Secondary Activity	Not Applicable	
Maintenance	Not Applicable	Maintenance Frequency	Not Applicable	
MANAGEMENT ACTION				SCORE
Recommendation	NO ACTION REQUIRED			-
Recommendation Due		Next Inspection	None	
Apply Labels	No	Permit to Work Required	No	
Survey Type	Management	Lead Surveyor	Jane Openshaw	
Survey Date	20 Mar 2012	UKAS Laboratory	NOT SAMPLED (Cross Referenced)	
Site Reference	113070000A	Licensed Material	N/A

No Asbestos Presumed in Sample

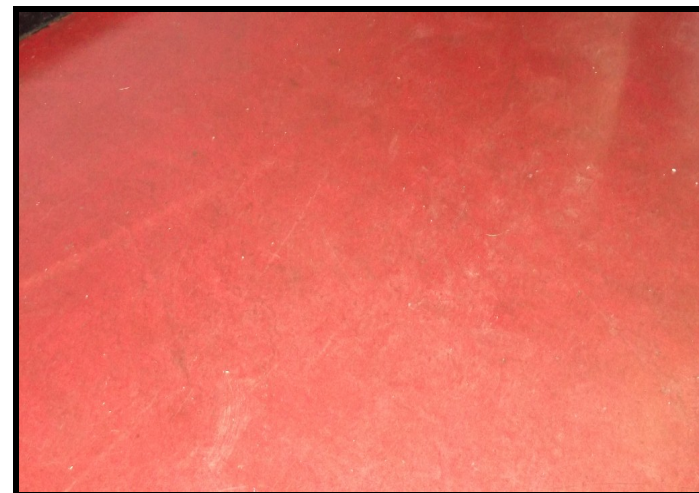
SAMPLE REFERENCE 091

Building	Floor	Room	Location	
Main Building	Fifth Floor	Lobby	Floor	
Description	Red			
MATERIAL ASSESSMENT				SCORE
Product Type	Paper	Extent of Damage	Good condition	-
Asbestos Type	No Asbestos Detected	Surface Treatment	Sealed (1)	
PRIORITY ASSESSMENT				SCORE
Occupant Activity	Not Applicable	Extent / Amount	8.00 m2	-
Accessibility	Unlikely to be disturbed	Location	Not Applicable	
Avg Time in Use	Not Applicable	Frequency of Use	Not Applicable	
No. of Occupants	Not Applicable	Secondary Activity	Not Applicable	
Maintenance	Not Applicable	Maintenance Frequency	Not Applicable	
MANAGEMENT ACTION				SCORE
Recommendation	NO ACTION REQUIRED			-
Recommendation Due		Next Inspection	None	
Apply Labels	No	Permit to Work Required	No	
Survey Type	Management	Lead Surveyor	Jane Openshaw	
Survey Date	20 Mar 2012	UKAS Laboratory	NOT SAMPLED (Cross Referenced)	
Site Reference	113070000A	Licensed Material	N/A

No Asbestos Presumed in Sample

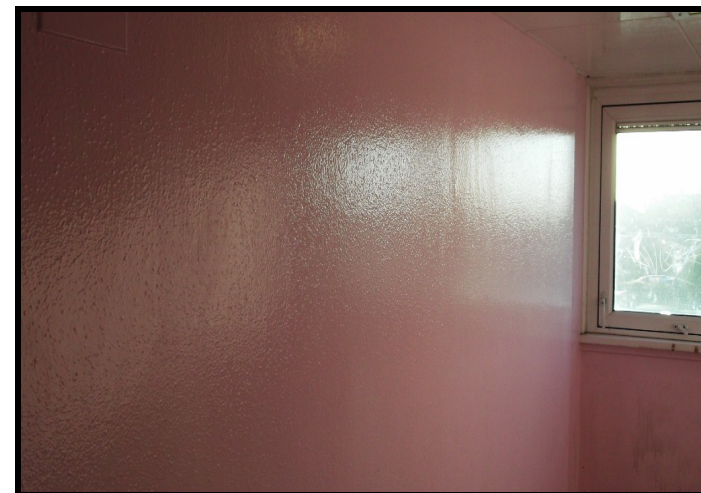
SAMPLE REFERENCE 092

Building	Floor	Room	Location	
Main Building	Fifth Floor	Corridor 2	Walls	
Description	Timber boxing adjacent to front doors			
MATERIAL ASSESSMENT				SCORE
Product Type	Paint	Extent of Damage	Good condition	-
Asbestos Type	No Asbestos Detected	Surface Treatment	Sealed (1)	
PRIORITY ASSESSMENT				SCORE
Occupant Activity	Not Applicable	Extent / Amount	13.00 m2	-
Accessibility	Easily disturbed	Location	Not Applicable	
Avg Time in Use	Not Applicable	Frequency of Use	Not Applicable	
No. of Occupants	Not Applicable	Secondary Activity	Not Applicable	
Maintenance	Not Applicable	Maintenance Frequency	Not Applicable	
MANAGEMENT ACTION				SCORE
Recommendation	NO ACTION REQUIRED			-
Recommendation Due		Next Inspection	None	
Apply Labels	No	Permit to Work Required	No	
Survey Type	Management	Lead Surveyor	Jane Openshaw	
Survey Date	20 Mar 2012	UKAS Laboratory	NOT SAMPLED (Cross Referenced)	
Site Reference	113070000A	Licensed Material	N/A

No Asbestos Presumed in Sample

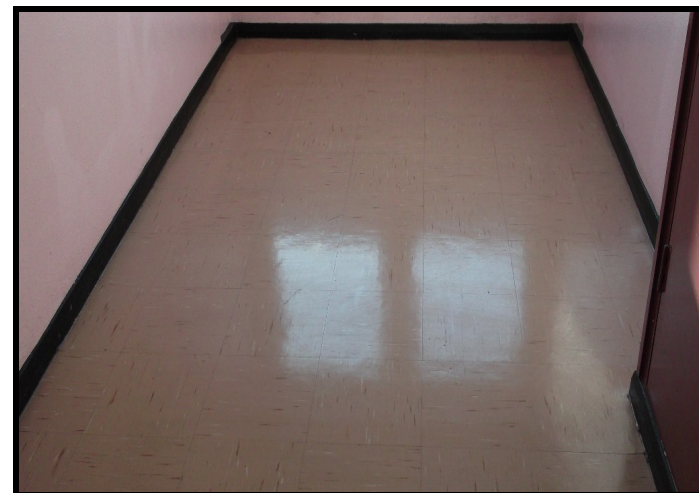
SAMPLE REFERENCE 093

Building	Floor	Room	Location	
Main Building	Fifth Floor	Corridor 2	Floor	
Description	Buff, Timber boxing adjacent to front doors			
MATERIAL ASSESSMENT				SCORE
Product Type	Floor Tiles	Extent of Damage	Good condition	-
Asbestos Type	No Asbestos Detected	Surface Treatment	Composite materials	
PRIORITY ASSESSMENT				SCORE
Occupant Activity	Not Applicable	Extent / Amount	7.00 m2	-
Accessibility	Routinely disturbed	Location	Not Applicable	
Avg Time in Use	Not Applicable	Frequency of Use	Not Applicable	
No. of Occupants	Not Applicable	Secondary Activity	Not Applicable	
Maintenance	Not Applicable	Maintenance Frequency	Not Applicable	
MANAGEMENT ACTION				SCORE
Recommendation	NO ACTION REQUIRED			-
Recommendation Due		Next Inspection	None	
Apply Labels	No	Permit to Work Required	No	
Survey Type	Management	Lead Surveyor	Jane Openshaw	
Survey Date	20 Mar 2012	UKAS Laboratory	NOT SAMPLED (Cross Referenced)	
Site Reference	I13070000A	Licensed Material	N/A

No Asbestos Presumed in Sample

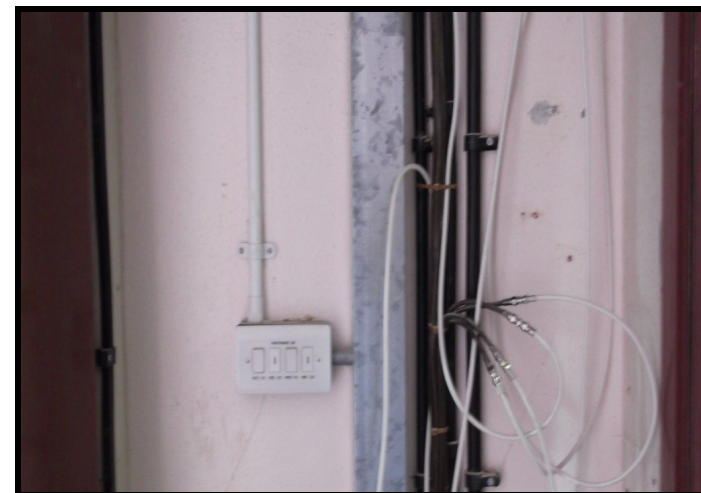
SAMPLE REFERENCE 094

Building	Floor	Room	Location	
Main Building	Fifth Floor	Service Riser	Walls	
Description				
MATERIAL ASSESSMENT				SCORE
Product Type	Paint	Extent of Damage	Good condition	-
Asbestos Type	No Asbestos Detected	Surface Treatment	Sealed (1)	
PRIORITY ASSESSMENT				SCORE
Occupant Activity	Not Applicable	Extent / Amount	3.00 m2	-
Accessibility	Easily disturbed	Location	Not Applicable	
Avg Time in Use	Not Applicable	Frequency of Use	Not Applicable	
No. of Occupants	Not Applicable	Secondary Activity	Not Applicable	
Maintenance	Not Applicable	Maintenance Frequency	Not Applicable	
MANAGEMENT ACTION				SCORE
Recommendation	NO ACTION REQUIRED			-
Recommendation Due		Next Inspection	None	
Apply Labels	No	Permit to Work Required	No	
Survey Type	Management	Lead Surveyor	Jane Openshaw	
Survey Date	20 Mar 2012	UKAS Laboratory	NOT SAMPLED (Cross Referenced)	
Site Reference	113070000A	Licensed Material	N/A

No Asbestos Presumed in Sample

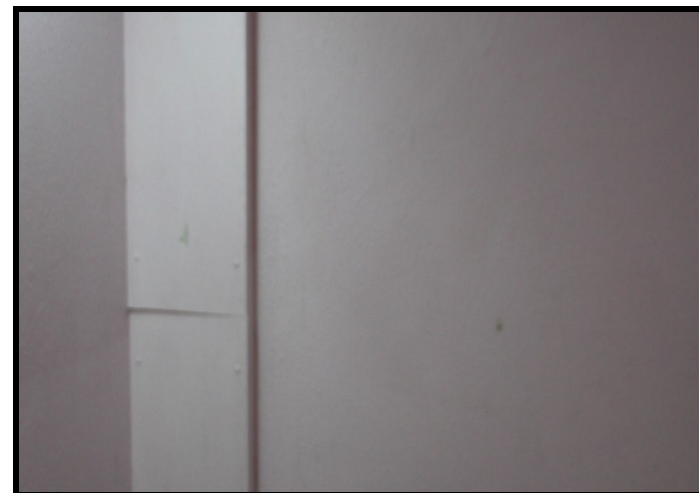
SAMPLE REFERENCE 095

Building	Floor	Room	Location
Main Building	Fifth Floor	Stairs	Walls
Description			
MATERIAL ASSESSMENT			
Product Type	Paint	Extent of Damage	Good condition
Asbestos Type	No Asbestos Detected	Surface Treatment	Sealed (1)
PRIORITY ASSESSMENT			
Occupant Activity	Not Applicable	Extent / Amount	30.00 m2
Accessibility	Easily disturbed	Location	Not Applicable
Avg Time in Use	Not Applicable	Frequency of Use	Not Applicable
No. of Occupants	Not Applicable	Secondary Activity	Not Applicable
Maintenance	Not Applicable	Maintenance Frequency	Not Applicable
MANAGEMENT ACTION			
Recommendation	NO ACTION REQUIRED		
Recommendation Due		Next Inspection	None
Apply Labels	No	Permit to Work Required	No
Survey Type	Management	Lead Surveyor	Jane Openshaw
Survey Date	20 Mar 2012	UKAS Laboratory	NOT SAMPLED (Cross Referenced)
Site Reference	113070000A	Licensed Material	N/A

No Asbestos Presumed in Sample

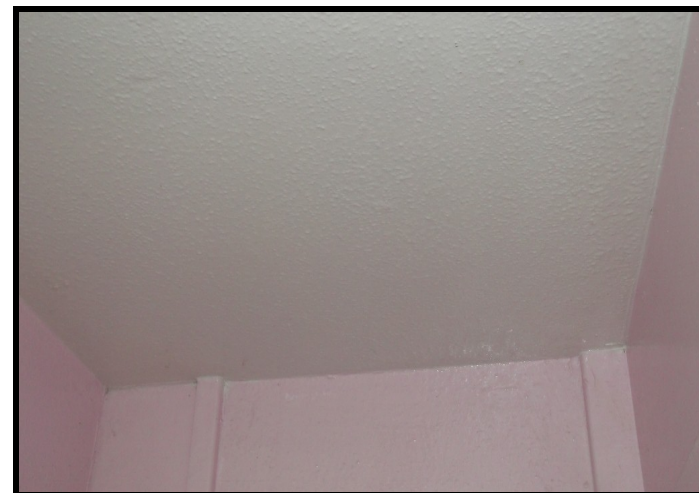
SAMPLE REFERENCE 096

Building	Floor	Room	Location	
Main Building	Fourth Floor	Bin Chute	Ceiling	
Description				
MATERIAL ASSESSMENT				SCORE
Product Type	Paint	Extent of Damage	Good condition	-
Asbestos Type	No Asbestos Detected	Surface Treatment	Sealed (1)	
PRIORITY ASSESSMENT				SCORE
Occupant Activity	Not Applicable	Extent / Amount	4.00 m2	-
Accessibility	Occasionally disturb	Location	Not Applicable	
Avg Time in Use	Not Applicable	Frequency of Use	Not Applicable	
No. of Occupants	Not Applicable	Secondary Activity	Not Applicable	
Maintenance	Not Applicable	Maintenance Frequency	Not Applicable	
MANAGEMENT ACTION				SCORE
Recommendation	NO ACTION REQUIRED			-
Recommendation Due		Next Inspection	None	
Apply Labels	No	Permit to Work Required	No	
Survey Type	Management	Lead Surveyor	Jane Openshaw	
Survey Date	20 Mar 2012	UKAS Laboratory	NOT SAMPLED (Cross Referenced)	
Site Reference	113070000A	Licensed Material	N/A

No Asbestos Presumed in Sample

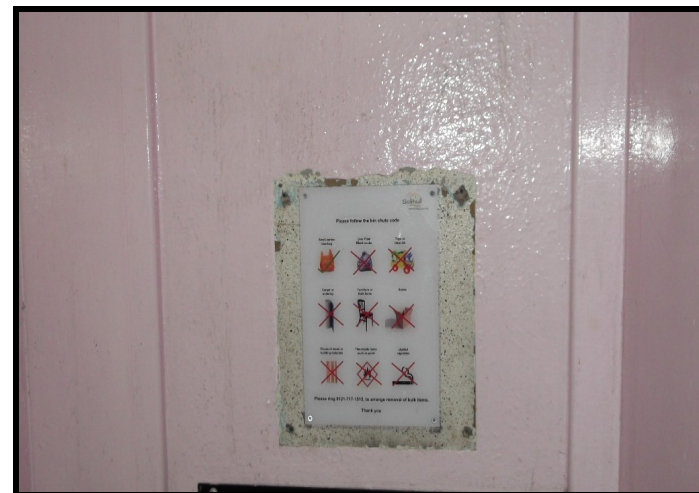
SAMPLE REFERENCE 097

Building	Floor	Room	Location	
Main Building	Fourth Floor	Bin Chute	Walls	
Description				
MATERIAL ASSESSMENT				SCORE
Product Type	Paint	Extent of Damage	Low damage	-
Asbestos Type	No Asbestos Detected	Surface Treatment	Sealed (1)	
PRIORITY ASSESSMENT				SCORE
Occupant Activity	Not Applicable	Extent / Amount	14.00 m2	-
Accessibility	Easily disturbed	Location	Not Applicable	
Avg Time in Use	Not Applicable	Frequency of Use	Not Applicable	
No. of Occupants	Not Applicable	Secondary Activity	Not Applicable	
Maintenance	Not Applicable	Maintenance Frequency	Not Applicable	
MANAGEMENT ACTION				SCORE
Recommendation	NO ACTION REQUIRED			-
Recommendation Due		Next Inspection	None	
Apply Labels	No	Permit to Work Required	No	
Survey Type	Management	Lead Surveyor	Jane Openshaw	
Survey Date	20 Mar 2012	UKAS Laboratory	NOT SAMPLED (Cross Referenced)	
Site Reference	113070000A	Licensed Material	N/A

No Asbestos Presumed in Sample

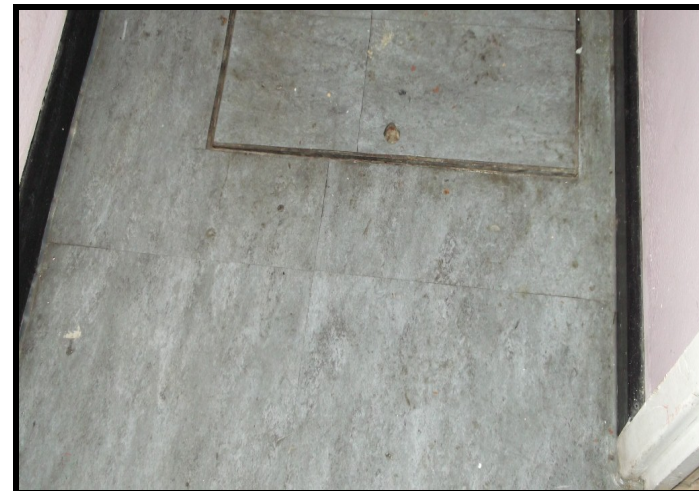
SAMPLE REFERENCE 098

MATERIAL ASSESSMENT				SCORE
Product Type	Floor Tiles	Extent of Damage	Good condition	-
Asbestos Type	No Asbestos Detected	Surface Treatment	Composite materials

No Asbestos Presumed in Sample

MANAGEMENT ACTION				SCORE
Recommendation	NO ACTION REQUIRED			-
Recommendation Due		Next Inspection	None	
Apply Labels	No	Permit to Work Required	No

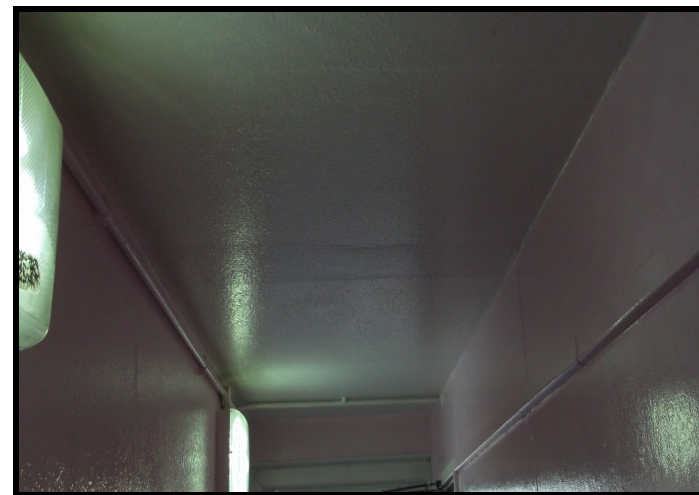
SAMPLE REFERENCE 099

Building	Floor	Room	Location	
Main Building	Fourth Floor	Corridor I	Ceiling	
Description	Timber boxing adjacent to flats			
MATERIAL ASSESSMENT				SCORE
Product Type	Paint	Extent of Damage	Good condition	-
Asbestos Type	No Asbestos Detected	Surface Treatment	Sealed (I)	
PRIORITY ASSESSMENT				SCORE
Occupant Activity	Not Applicable	Extent / Amount	5.00 m2	-
Accessibility	Occasionally disturb	Location	Not Applicable	
Avg Time in Use	Not Applicable	Frequency of Use	Not Applicable	
No. of Occupants	Not Applicable	Secondary Activity	Not Applicable	
Maintenance	Not Applicable	Maintenance Frequency	Not Applicable	
MANAGEMENT ACTION				SCORE
Recommendation	NO ACTION REQUIRED			-
Recommendation Due		Next Inspection	None	
Apply Labels	No	Permit to Work Required	No	
Survey Type	Management	Lead Surveyor	Jane Openshaw	
Survey Date	20 Mar 2012	UKAS Laboratory	NOT SAMPLED (Cross Referenced)	
Site Reference	I13070000A	Licensed Material	N/A

No Asbestos Presumed in Sample

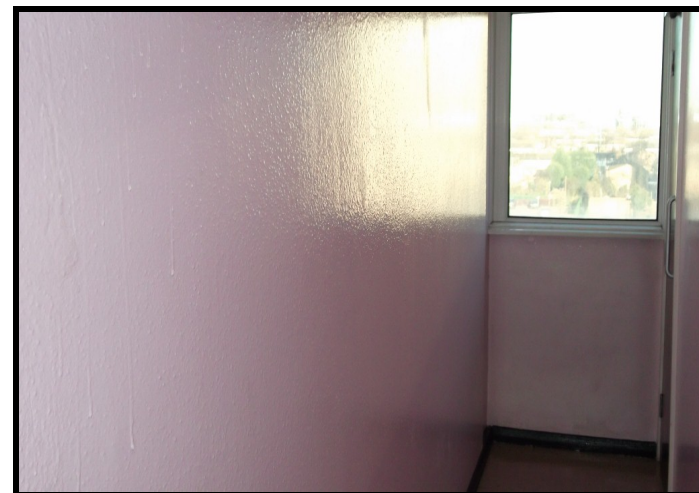
SAMPLE REFERENCE 100

Building	Floor	Room	Location	
Main Building	Fourth Floor	Corridor I	Walls	
Description	Timber boxing adjacent to flats			
MATERIAL ASSESSMENT				SCORE
Product Type	Paint	Extent of Damage	Good condition	-
Asbestos Type	No Asbestos Detected	Surface Treatment	Sealed (1)	
PRIORITY ASSESSMENT				SCORE
Occupant Activity	Not Applicable	Extent / Amount	10.00 m2	-
Accessibility	Easily disturbed	Location	Not Applicable	
Avg Time in Use	Not Applicable	Frequency of Use	Not Applicable	
No. of Occupants	Not Applicable	Secondary Activity	Not Applicable	
Maintenance	Not Applicable	Maintenance Frequency	Not Applicable	
MANAGEMENT ACTION				SCORE
Recommendation	NO ACTION REQUIRED			-
Recommendation Due		Next Inspection	None	
Apply Labels	No	Permit to Work Required	No	
Survey Type	Management	Lead Surveyor	Jane Openshaw	
Survey Date	20 Mar 2012	UKAS Laboratory	NOT SAMPLED (Cross Referenced)	
Site Reference	113070000A	Licensed Material	N/A

No Asbestos Presumed in Sample

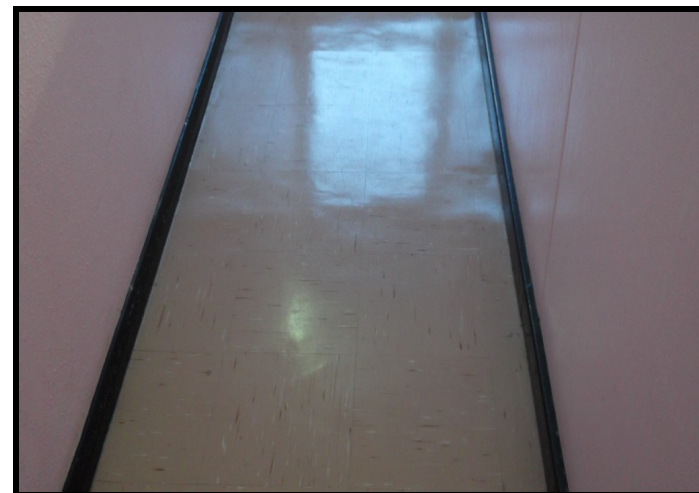
SAMPLE REFERENCE 101

Building	Floor	Room	Location	
Main Building	Fourth Floor	Corridor I	Floor	
Description	Timber boxing adjacent to flats, Buff			
MATERIAL ASSESSMENT				SCORE
Product Type	Floor Tiles	Extent of Damage	Good condition	-
Asbestos Type	No Asbestos Detected	Surface Treatment	Composite materials	
PRIORITY ASSESSMENT				SCORE
Occupant Activity	Not Applicable	Extent / Amount	7.00 m2	-
Accessibility	Routinely disturbed	Location	Not Applicable	
Avg Time in Use	Not Applicable	Frequency of Use	Not Applicable	
No. of Occupants	Not Applicable	Secondary Activity	Not Applicable	
Maintenance	Not Applicable	Maintenance Frequency	Not Applicable	
MANAGEMENT ACTION				SCORE
Recommendation	NO ACTION REQUIRED			-
Recommendation Due		Next Inspection	None	
Apply Labels	No	Permit to Work Required	No	
Survey Type	Management	Lead Surveyor	Jane Openshaw	
Survey Date	20 Mar 2012	UKAS Laboratory	NOT SAMPLED (Cross Referenced)	
Site Reference	I13070000A	Licensed Material	N/A

No Asbestos Presumed in Sample

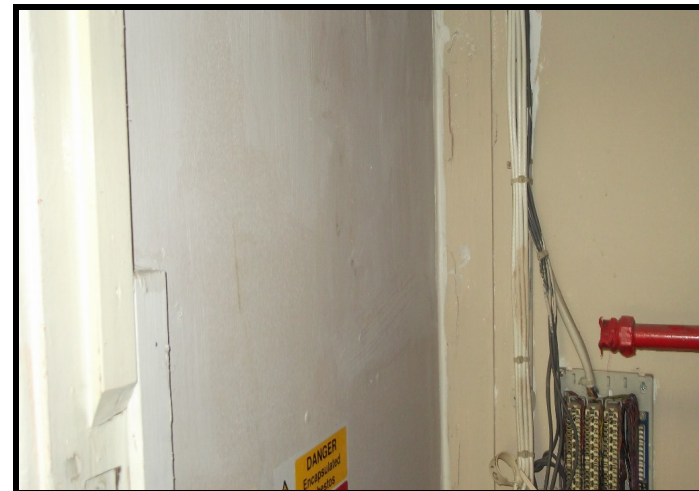
SAMPLE REFERENCE 102

Building	Floor	Room	Location	
Main Building	Fourth Floor	Dry Riser	Ceiling And Walls	
Description				
MATERIAL ASSESSMENT				SCORE
Product Type	Board	Extent of Damage	Good condition	5
Asbestos Type	Amosite / Chrysotile	Surface Treatment	Sealed Board (Encapsulated)	
PRIORITY ASSESSMENT				SCORE
Occupant Activity	Not Applicable	Extent / Amount	8.00 m2	1
Accessibility	Occasionally disturb	Location	Not Applicable	
Avg Time in Use	Not Applicable	Frequency of Use	Not Applicable	
No. of Occupants	Not Applicable	Secondary Activity	Not Applicable	
Maintenance	Not Applicable	Maintenance Frequency	Not Applicable	
MANAGEMENT ACTION				SCORE
Recommendation	LABEL & MONITOR			6
Recommendation Due		Next Inspection	20 Sep 2012	
Apply Labels	No	Permit to Work Required	No	
Survey Type	Management	Lead Surveyor	Jane Openshaw	
Survey Date	20 Mar 2012	UKAS Laboratory	NOT SAMPLED (Cross Referenced)	
Site Reference	I13070000A	Licensed Material	Yes

Asbestos Presumed in Sample

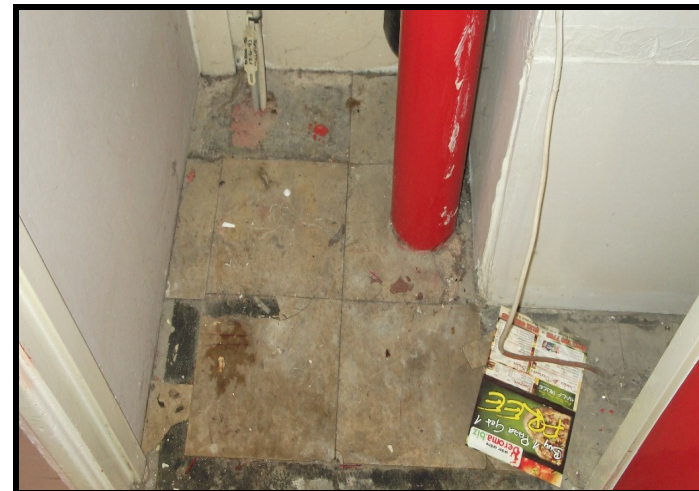
SAMPLE REFERENCE 104

Building	Floor	Room	Location	
Main Building	Fourth Floor	Dry Riser	Floor	
Description	Yellow			
MATERIAL ASSESSMENT				SCORE
Product Type	Floor Tiles	Extent of Damage	Good condition	2
Asbestos Type	Chrysotile	Surface Treatment	Composite materials	
PRIORITY ASSESSMENT				SCORE
Occupant Activity	Not Applicable	Extent / Amount	1.00 m2	1
Accessibility	Routinely disturbed	Location	Not Applicable	
Avg Time in Use	Not Applicable	Frequency of Use	Not Applicable	
No. of Occupants	Not Applicable	Secondary Activity	Not Applicable	
Maintenance	Not Applicable	Maintenance Frequency	Not Applicable	
MANAGEMENT ACTION				SCORE
Recommendation	LABEL & MONITOR			3
Recommendation Due		Next Inspection	20 Mar 2013	
Apply Labels	No	Permit to Work Required	No	
Survey Type	Management	Lead Surveyor	Jane Openshaw	
Survey Date	20 Mar 2012	UKAS Laboratory	NOT SAMPLED (Cross Referenced)	
Site Reference	I13070000A	Licensed Material	No

Asbestos Presumed in Sample

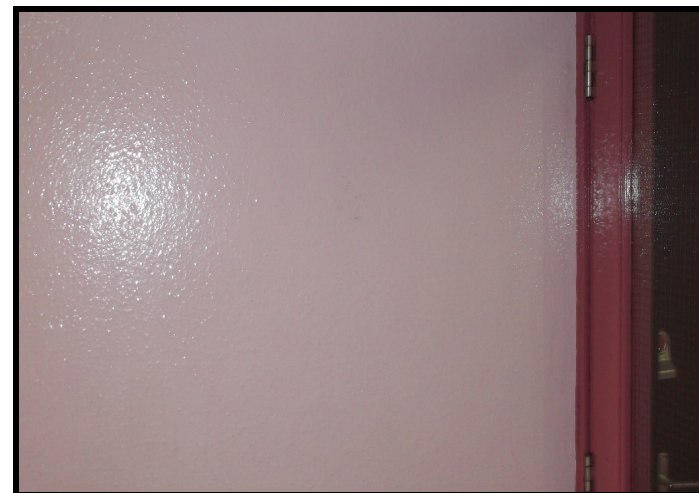
SAMPLE REFERENCE 105

Building	Floor	Room	Location	
Main Building	Fourth Floor	Lobby	Walls	
Description				
MATERIAL ASSESSMENT				SCORE
Product Type	Paint	Extent of Damage	Good condition	-
Asbestos Type	No Asbestos Detected	Surface Treatment	Sealed (1)	
PRIORITY ASSESSMENT				SCORE
Occupant Activity	Not Applicable	Extent / Amount	13.00 m2	-
Accessibility	Easily disturbed	Location	Not Applicable	
Avg Time in Use	Not Applicable	Frequency of Use	Not Applicable	
No. of Occupants	Not Applicable	Secondary Activity	Not Applicable	
Maintenance	Not Applicable	Maintenance Frequency	Not Applicable	
MANAGEMENT ACTION				SCORE
Recommendation	NO ACTION REQUIRED			-
Recommendation Due		Next Inspection	None	
Apply Labels	No	Permit to Work Required	No	
Survey Type	Management	Lead Surveyor	Jane Openshaw	
Survey Date	20 Mar 2012	UKAS Laboratory	NOT SAMPLED (Cross Referenced)	
Site Reference	113070000A	Licensed Material	N/A

No Asbestos Presumed in Sample

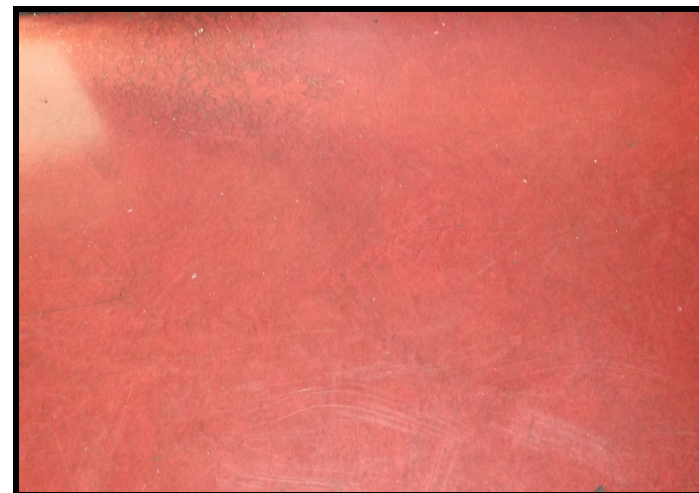
SAMPLE REFERENCE 106

MATERIAL ASSESSMENT				SCORE
Product Type	Paper	Extent of Damage	Good condition	-
Asbestos Type	No Asbestos Detected	Surface Treatment	Sealed (1)

MANAGEMENT ACTION				SCORE
Recommendation	NO ACTION REQUIRED			-
Recommendation Due		Next Inspection	None	
Apply Labels	No	Permit to Work Required	No

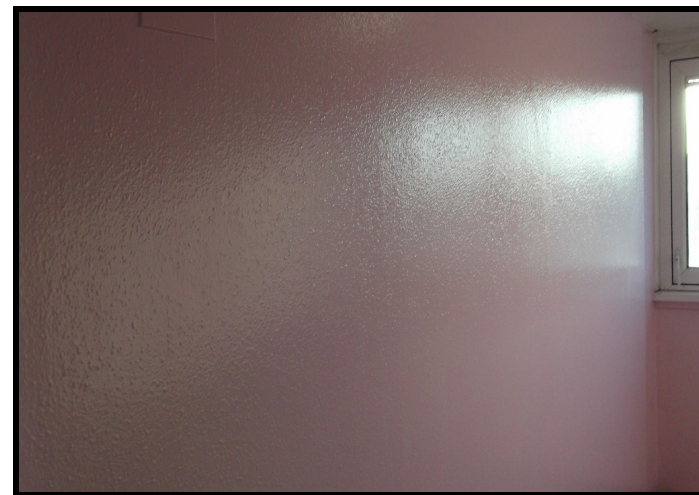
SAMPLE REFERENCE 107

Building	Floor	Room	Location	
Main Building	Fourth Floor	Corridor 2	Walls	
Description	Timber boxing adjacent to flats			
MATERIAL ASSESSMENT				SCORE
Product Type	Paint	Extent of Damage	Good condition	-
Asbestos Type	No Asbestos Detected	Surface Treatment	Sealed (1)	
PRIORITY ASSESSMENT				SCORE
Occupant Activity	Not Applicable	Extent / Amount	13.00 m2	-
Accessibility	Easily disturbed	Location	Not Applicable	
Avg Time in Use	Not Applicable	Frequency of Use	Not Applicable	
No. of Occupants	Not Applicable	Secondary Activity	Not Applicable	
Maintenance	Not Applicable	Maintenance Frequency	Not Applicable	
MANAGEMENT ACTION				SCORE
Recommendation	NO ACTION REQUIRED			-
Recommendation Due		Next Inspection	None	
Apply Labels	No	Permit to Work Required	No	
Survey Type	Management	Lead Surveyor	Jane Openshaw	
Survey Date	20 Mar 2012	UKAS Laboratory	NOT SAMPLED (Cross Referenced)	
Site Reference	113070000A	Licensed Material	N/A

No Asbestos Presumed in Sample
