Solihull Community Housing

Asbestos Management Survey Report

**Balliol House
Grandys Croft
Chelmsley Wood
B37 5BS**

Date of Report: 31 Mar 2012

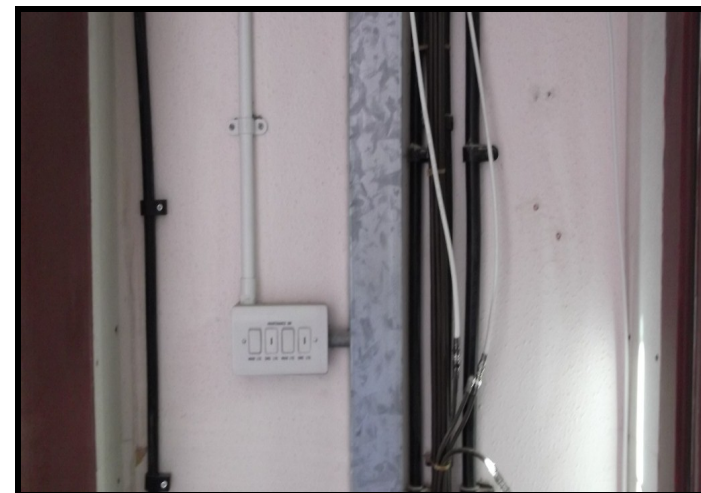
SAMPLE REFERENCE 109

Building	Floor	Room	Location	
Main Building	Fourth Floor	Service Riser	Walls	
Description				
MATERIAL ASSESSMENT				SCORE
Product Type	Paint	Extent of Damage	Good condition	-
Asbestos Type	No Asbestos Detected	Surface Treatment	Sealed (1)	
PRIORITY ASSESSMENT				SCORE
Occupant Activity	Not Applicable	Extent / Amount	3.00 m2	-
Accessibility	Easily disturbed	Location	Not Applicable	
Avg Time in Use	Not Applicable	Frequency of Use	Not Applicable	
No. of Occupants	Not Applicable	Secondary Activity	Not Applicable	
Maintenance	Not Applicable	Maintenance Frequency	Not Applicable	
MANAGEMENT ACTION				SCORE
Recommendation	NO ACTION REQUIRED			-
Recommendation Due		Next Inspection	None	
Apply Labels	No	Permit to Work Required	No	
Survey Type	Management	Lead Surveyor	Jane Openshaw	
Survey Date	20 Mar 2012	UKAS Laboratory	NOT SAMPLED (Cross Referenced)	
Site Reference	113070000A	Licensed Material	N/A

No Asbestos Presumed in Sample

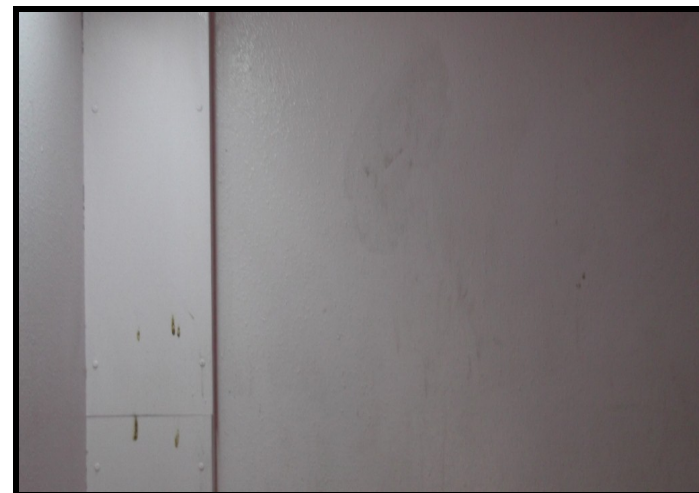
SAMPLE REFERENCE 110

Building	Floor	Room	Location	
Main Building	Fourth Floor	Stairs	Walls	
Description				
MATERIAL ASSESSMENT				SCORE
Product Type	Paint	Extent of Damage	Good condition	-
Asbestos Type	No Asbestos Detected	Surface Treatment	Sealed (1)	
PRIORITY ASSESSMENT				SCORE
Occupant Activity	Not Applicable	Extent / Amount	30.00 m2	-
Accessibility	Easily disturbed	Location	Not Applicable	
Avg Time in Use	Not Applicable	Frequency of Use	Not Applicable	
No. of Occupants	Not Applicable	Secondary Activity	Not Applicable	
Maintenance	Not Applicable	Maintenance Frequency	Not Applicable	
MANAGEMENT ACTION				SCORE
Recommendation	NO ACTION REQUIRED			-
Recommendation Due		Next Inspection	None	
Apply Labels	No	Permit to Work Required	No	
Survey Type	Management	Lead Surveyor	Jane Openshaw	
Survey Date	20 Mar 2012	UKAS Laboratory	NOT SAMPLED (Cross Referenced)	
Site Reference	113070000A	Licensed Material	N/A

No Asbestos Presumed in Sample

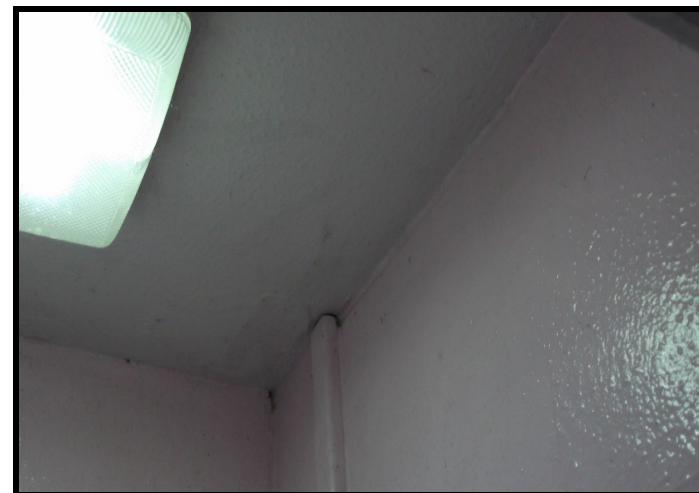
SAMPLE REFERENCE III

MATERIAL ASSESSMENT				SCORE
Product Type	Paint	Extent of Damage	Good condition	-
Asbestos Type	No Asbestos Detected	Surface Treatment	Sealed (1)

No Asbestos Presumed in Sample

MANAGEMENT ACTION				SCORE
Recommendation	NO ACTION REQUIRED			-
Recommendation Due		Next Inspection	None	
Apply Labels	No	Permit to Work Required	No

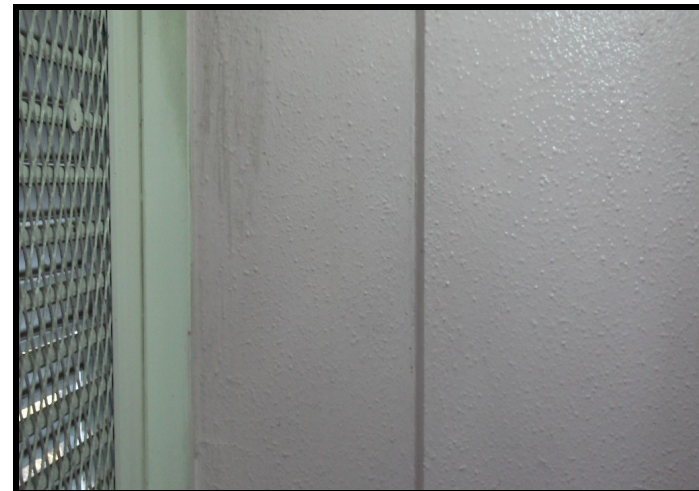
SAMPLE REFERENCE 112

MATERIAL ASSESSMENT				SCORE
Product Type	Paint	Extent of Damage	Good condition	-
Asbestos Type	No Asbestos Detected	Surface Treatment	Sealed (1)

No Asbestos Presumed in Sample

MANAGEMENT ACTION				SCORE
Recommendation	NO ACTION REQUIRED			-
Recommendation Due		Next Inspection	None	
Apply Labels	No	Permit to Work Required	No

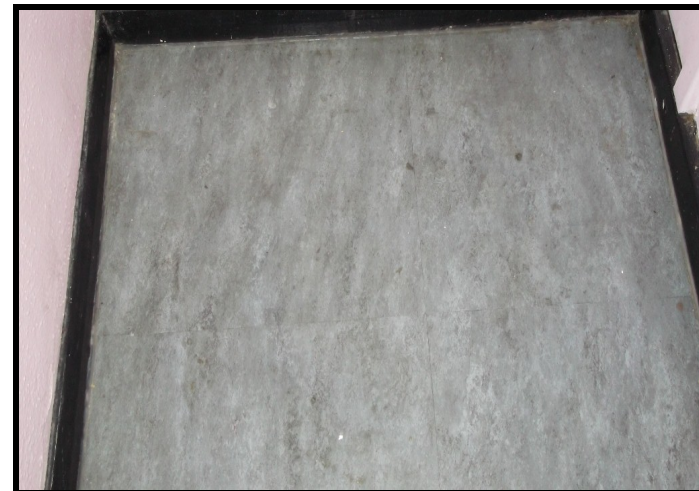
SAMPLE REFERENCE I13

Building	Floor	Room	Location	
Main Building	Third Floor	Bin Chute	Floor	
Description	Blue			
MATERIAL ASSESSMENT				SCORE
Product Type	Floor Tiles	Extent of Damage	Good condition	-
Asbestos Type	No Asbestos Detected	Surface Treatment	Composite materials	
PRIORITY ASSESSMENT				SCORE
Occupant Activity	Not Applicable	Extent / Amount	1.00 m2	-
Accessibility	Routinely disturbed	Location	Not Applicable	
Avg Time in Use	Not Applicable	Frequency of Use	Not Applicable	
No. of Occupants	Not Applicable	Secondary Activity	Not Applicable	
Maintenance	Not Applicable	Maintenance Frequency	Not Applicable	
MANAGEMENT ACTION				SCORE
Recommendation	NO ACTION REQUIRED			-
Recommendation Due		Next Inspection	None	
Apply Labels	No	Permit to Work Required	No	
Survey Type	Management	Lead Surveyor	Jane Openshaw	
Survey Date	20 Mar 2012	UKAS Laboratory	NOT SAMPLED (Cross Referenced)	
Site Reference	I13070000A	Licensed Material	N/A

No Asbestos Presumed in Sample

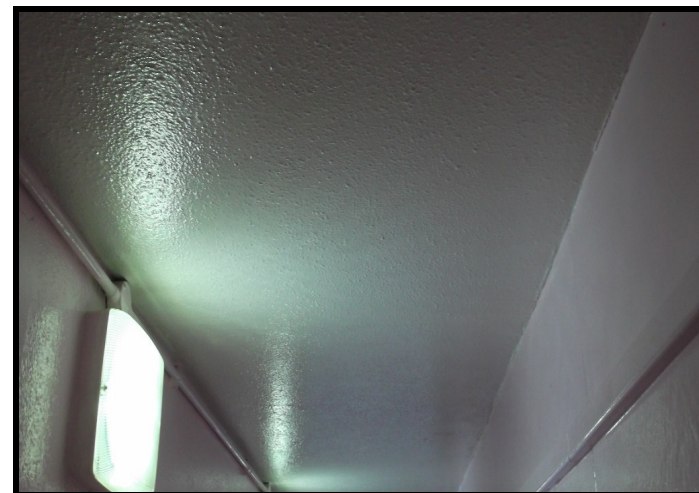
SAMPLE REFERENCE I14

Building	Floor	Room	Location	
Main Building	Third Floor	Corridor I	Ceiling	
Description	Timber boxing adjacent to flats			
MATERIAL ASSESSMENT				SCORE
Product Type	Paint	Extent of Damage	Good condition	-
Asbestos Type	No Asbestos Detected	Surface Treatment	Sealed (I)	
PRIORITY ASSESSMENT				SCORE
Occupant Activity	Not Applicable	Extent / Amount	5.00 m2	-
Accessibility	Occasionally disturb	Location	Not Applicable	
Avg Time in Use	Not Applicable	Frequency of Use	Not Applicable	
No. of Occupants	Not Applicable	Secondary Activity	Not Applicable	
Maintenance	Not Applicable	Maintenance Frequency	Not Applicable	
MANAGEMENT ACTION				SCORE
Recommendation	NO ACTION REQUIRED			-
Recommendation Due		Next Inspection	None	
Apply Labels	No	Permit to Work Required	No	
Survey Type	Management	Lead Surveyor	Jane Openshaw	
Survey Date	20 Mar 2012	UKAS Laboratory	NOT SAMPLED (Cross Referenced)	
Site Reference	I13070000A	Licensed Material	N/A

No Asbestos Presumed in Sample

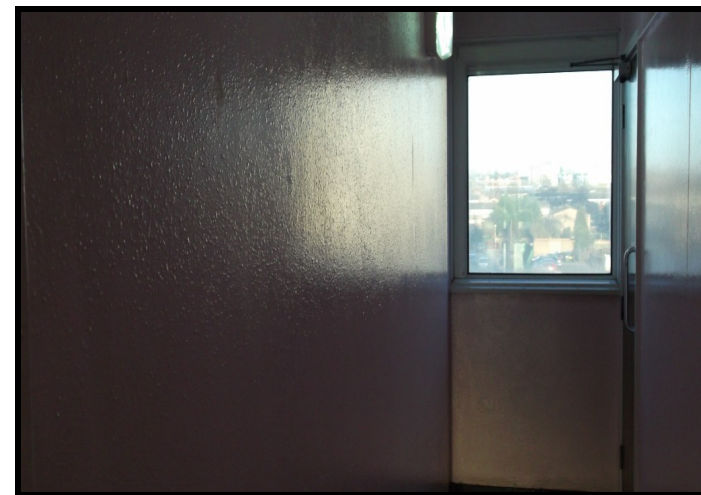
SAMPLE REFERENCE I15

Building	Floor	Room	Location	
Main Building	Third Floor	Corridor I	Walls	
Description	Timber boxing adjacent to flats			
MATERIAL ASSESSMENT				SCORE
Product Type	Paint	Extent of Damage	Good condition	-
Asbestos Type	No Asbestos Detected	Surface Treatment	Sealed (I)	
PRIORITY ASSESSMENT				SCORE
Occupant Activity	Not Applicable	Extent / Amount	10.00 m2	-
Accessibility	Easily disturbed	Location	Not Applicable	
Avg Time in Use	Not Applicable	Frequency of Use	Not Applicable	
No. of Occupants	Not Applicable	Secondary Activity	Not Applicable	
Maintenance	Not Applicable	Maintenance Frequency	Not Applicable	
MANAGEMENT ACTION				SCORE
Recommendation	NO ACTION REQUIRED			-
Recommendation Due		Next Inspection	None	
Apply Labels	No	Permit to Work Required	No	
Survey Type	Management	Lead Surveyor	Jane Openshaw	
Survey Date	20 Mar 2012	UKAS Laboratory	NOT SAMPLED (Cross Referenced)	
Site Reference	I13070000A	Licensed Material	N/A

No Asbestos Presumed in Sample

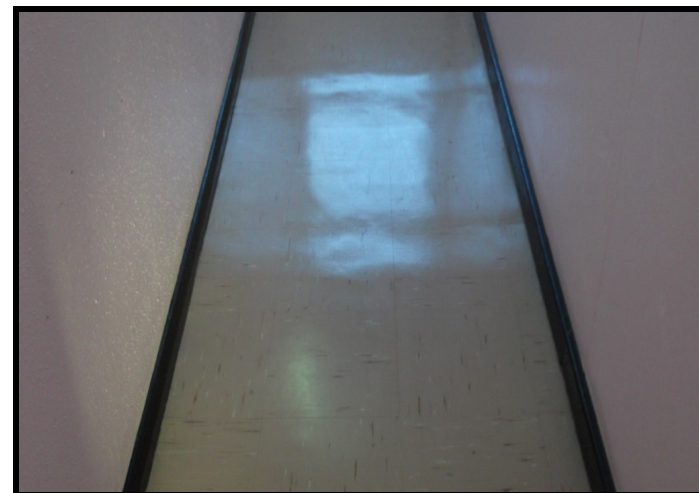
SAMPLE REFERENCE I16

Building	Floor	Room	Location	
Main Building	Third Floor	Corridor I	Floor	
Description	Buff, Timber boxing adjacent to flats			
MATERIAL ASSESSMENT				SCORE
Product Type	Floor Tiles	Extent of Damage	Good condition	-
Asbestos Type	No Asbestos Detected	Surface Treatment	Composite materials	
PRIORITY ASSESSMENT				SCORE
Occupant Activity	Not Applicable	Extent / Amount	7.00 m2	-
Accessibility	Routinely disturbed	Location	Not Applicable	
Avg Time in Use	Not Applicable	Frequency of Use	Not Applicable	
No. of Occupants	Not Applicable	Secondary Activity	Not Applicable	
Maintenance	Not Applicable	Maintenance Frequency	Not Applicable	
MANAGEMENT ACTION				SCORE
Recommendation	NO ACTION REQUIRED			-
Recommendation Due		Next Inspection	None	
Apply Labels	No	Permit to Work Required	No	
Survey Type	Management	Lead Surveyor	Jane Openshaw	
Survey Date	20 Mar 2012	UKAS Laboratory	NOT SAMPLED (Cross Referenced)	
Site Reference	I13070000A	Licensed Material	N/A

No Asbestos Presumed in Sample

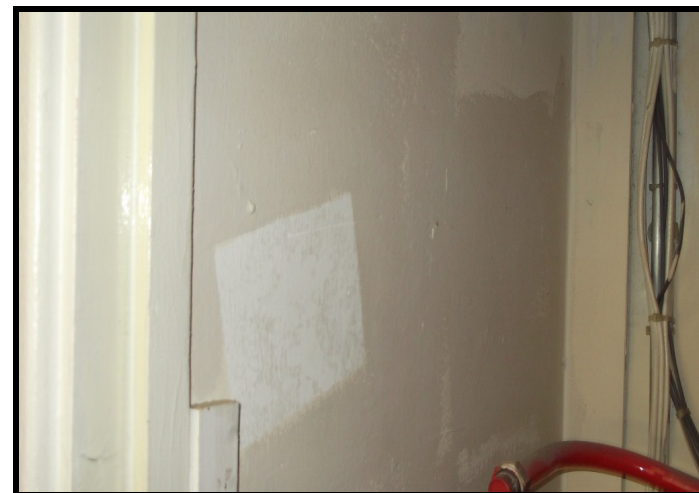
SAMPLE REFERENCE I17

Building	Floor	Room	Location	
Main Building	Third Floor	Dry Riser	Ceiling And Walls	
Description				
MATERIAL ASSESSMENT				SCORE
Product Type	Board	Extent of Damage	Good condition	5
Asbestos Type	Amosite / Chrysotile	Surface Treatment	Sealed Board (Encapsulated)	
PRIORITY ASSESSMENT				SCORE
Occupant Activity	Not Applicable	Extent / Amount	8.00 m2	1
Accessibility	Occasionally disturb	Location	Not Applicable	
Avg Time in Use	Not Applicable	Frequency of Use	Not Applicable	
No. of Occupants	Not Applicable	Secondary Activity	Not Applicable	
Maintenance	Not Applicable	Maintenance Frequency	Not Applicable	
MANAGEMENT ACTION				SCORE
Recommendation	LABEL & MONITOR			6
Recommendation Due		Next Inspection	20 Sep 2012	
Apply Labels	No	Permit to Work Required	No	
Survey Type	Management	Lead Surveyor	Jane Openshaw	
Survey Date	20 Mar 2012	UKAS Laboratory	NOT SAMPLED (Cross Referenced)	
Site Reference	I13070000A	Licensed Material	Yes

Asbestos Presumed in Sample

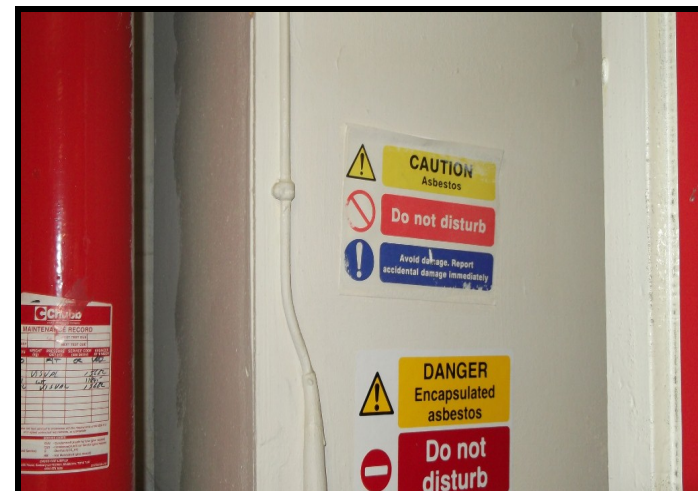
SAMPLE REFERENCE 118

MATERIAL ASSESSMENT				SCORE
Product Type	Board	Extent of Damage	Good condition	5
Asbestos Type	Amosite / Chrysotile	Surface Treatment	Sealed Board (Encapsulated)

Asbestos Presumed in Sample

MANAGEMENT ACTION				SCORE
Recommendation	LABEL & MONITOR			5
Recommendation Due		Next Inspection	20 Oct 2012	
Apply Labels	No	Permit to Work Required	No

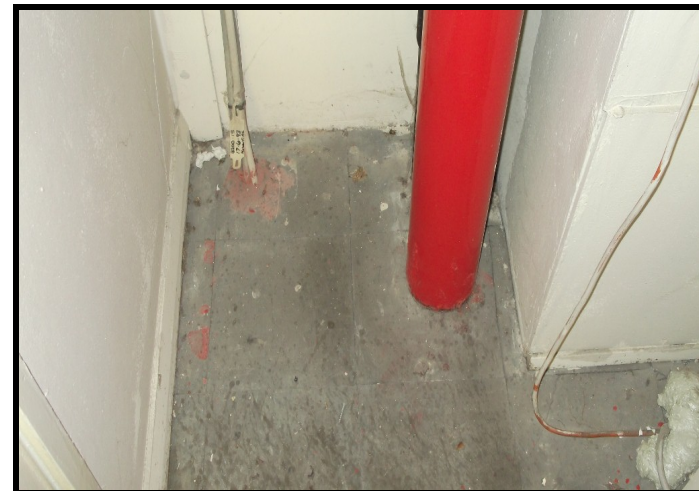
SAMPLE REFERENCE 119

Building	Floor	Room	Location
Main Building	Third Floor	Dry Riser	Floor
Description	Blue		
MATERIAL ASSESSMENT			
Product Type	Floor Tiles	Extent of Damage	Good condition
Asbestos Type	Chrysotile	Surface Treatment	Composite materials
PRIORITY ASSESSMENT			
Occupant Activity	Not Applicable	Extent / Amount	1.00 m2
Accessibility	Routinely disturbed	Location	Not Applicable
Avg Time in Use	Not Applicable	Frequency of Use	Not Applicable
No. of Occupants	Not Applicable	Secondary Activity	Not Applicable
Maintenance	Not Applicable	Maintenance Frequency	Not Applicable
MANAGEMENT ACTION			
Recommendation	LABEL & MONITOR		
Recommendation Due		Next Inspection	20 Mar 2013
Apply Labels	No	Permit to Work Required	No
Survey Type	Management	Lead Surveyor	Jane Openshaw
Survey Date	20 Mar 2012	UKAS Laboratory	NOT SAMPLED (Cross Referenced)
Site Reference	113070000A	Licensed Material	No

Asbestos Presumed in Sample

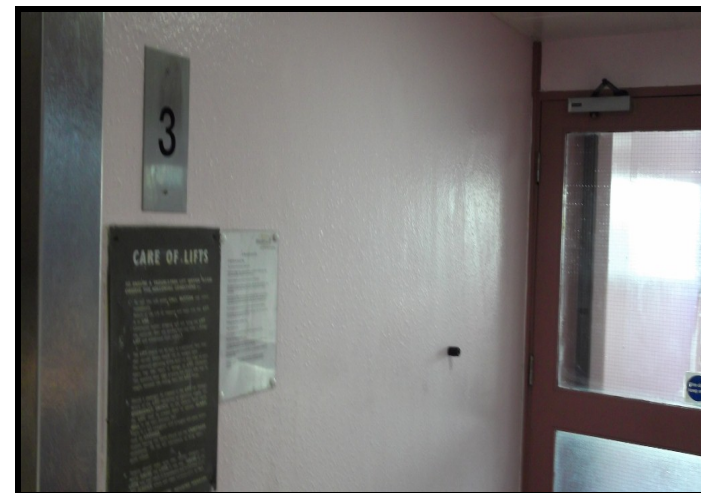
SAMPLE REFERENCE 120

Building	Floor	Room	Location	
Main Building	Third Floor	Lobby	Walls	
Description				
MATERIAL ASSESSMENT				SCORE
Product Type	Paint	Extent of Damage	Good condition	-
Asbestos Type	No Asbestos Detected	Surface Treatment	Sealed (1)	
PRIORITY ASSESSMENT				SCORE
Occupant Activity	Not Applicable	Extent / Amount	13.00 m2	-
Accessibility	Easily disturbed	Location	Not Applicable	
Avg Time in Use	Not Applicable	Frequency of Use	Not Applicable	
No. of Occupants	Not Applicable	Secondary Activity	Not Applicable	
Maintenance	Not Applicable	Maintenance Frequency	Not Applicable	
MANAGEMENT ACTION				SCORE
Recommendation	NO ACTION REQUIRED			-
Recommendation Due		Next Inspection	None	
Apply Labels	No	Permit to Work Required	No	
Survey Type	Management	Lead Surveyor	Jane Openshaw	
Survey Date	20 Mar 2012	UKAS Laboratory	NOT SAMPLED (Cross Referenced)	
Site Reference	113070000A	Licensed Material	N/A

No Asbestos Presumed in Sample

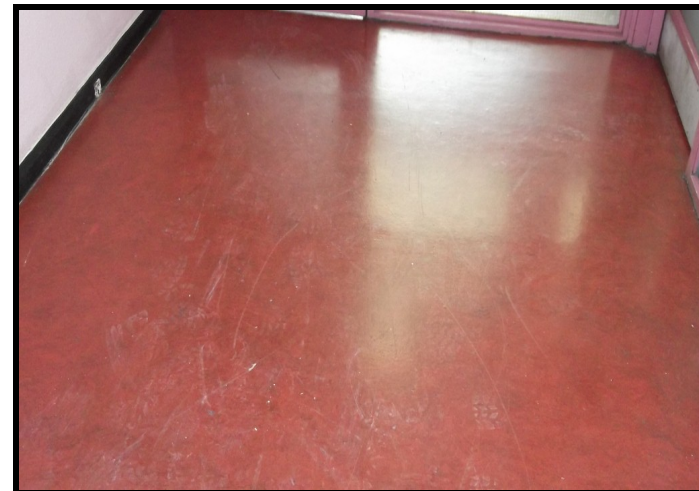
SAMPLE REFERENCE 121

MATERIAL ASSESSMENT				SCORE
Product Type	Paper	Extent of Damage	Good condition	-
Asbestos Type	No Asbestos Detected	Surface Treatment	Sealed (1)

No Asbestos Presumed in Sample

MANAGEMENT ACTION				SCORE
Recommendation	NO ACTION REQUIRED			-
Recommendation Due		Next Inspection	None	
Apply Labels	No	Permit to Work Required	No

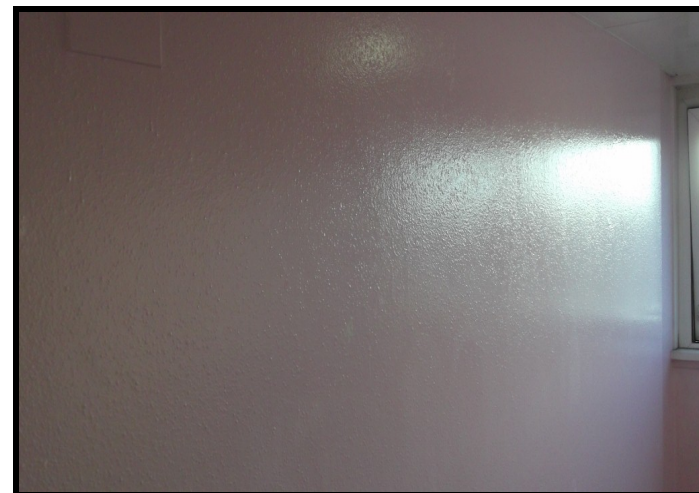
SAMPLE REFERENCE 122

Building	Floor	Room	Location	
Main Building	Third Floor	Corridor 2	Walls	
Description	Timber boxing adjacent to front door			
MATERIAL ASSESSMENT				SCORE
Product Type	Paint	Extent of Damage	Good condition	-
Asbestos Type	No Asbestos Detected	Surface Treatment	Sealed (1)	
PRIORITY ASSESSMENT				SCORE
Occupant Activity	Not Applicable	Extent / Amount	13.00 m2	-
Accessibility	Easily disturbed	Location	Not Applicable	
Avg Time in Use	Not Applicable	Frequency of Use	Not Applicable	
No. of Occupants	Not Applicable	Secondary Activity	Not Applicable	
Maintenance	Not Applicable	Maintenance Frequency	Not Applicable	
MANAGEMENT ACTION				SCORE
Recommendation	NO ACTION REQUIRED			-
Recommendation Due		Next Inspection	None	
Apply Labels	No	Permit to Work Required	No	
Survey Type	Management	Lead Surveyor	Jane Openshaw	
Survey Date	20 Mar 2012	UKAS Laboratory	NOT SAMPLED (Cross Referenced)	
Site Reference	113070000A	Licensed Material	N/A

No Asbestos Presumed in Sample

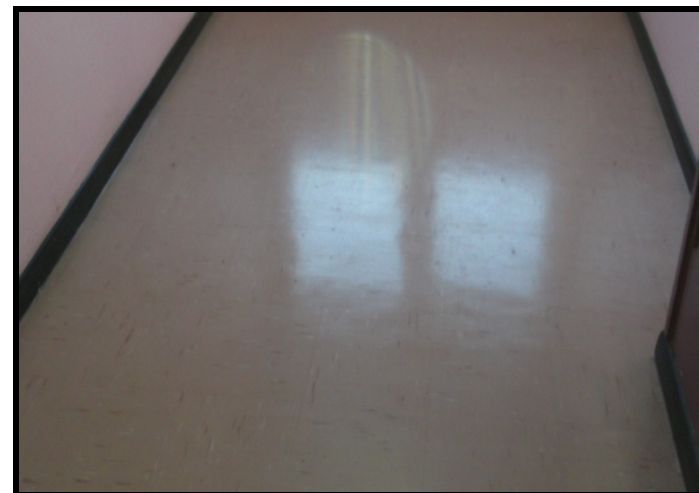
SAMPLE REFERENCE 123

Building	Floor	Room	Location
Main Building	Third Floor	Corridor 2	Floor
Description	Buff, Timber boxing adjacent to front door		
MATERIAL ASSESSMENT			
Product Type	Floor Tiles	Extent of Damage	Good condition
Asbestos Type	No Asbestos Detected	Surface Treatment	Composite materials
PRIORITY ASSESSMENT			
Occupant Activity	Not Applicable	Extent / Amount	7.00 m2
Accessibility	Routinely disturbed	Location	Not Applicable
Avg Time in Use	Not Applicable	Frequency of Use	Not Applicable
No. of Occupants	Not Applicable	Secondary Activity	Not Applicable
Maintenance	Not Applicable	Maintenance Frequency	Not Applicable
MANAGEMENT ACTION			
Recommendation	NO ACTION REQUIRED		
Recommendation Due		Next Inspection	None
Apply Labels	No	Permit to Work Required	No
Survey Type	Management	Lead Surveyor	Jane Openshaw
Survey Date	20 Mar 2012	UKAS Laboratory	NOT SAMPLED (Cross Referenced)
Site Reference	I13070000A	Licensed Material	N/A

No Asbestos Presumed in Sample

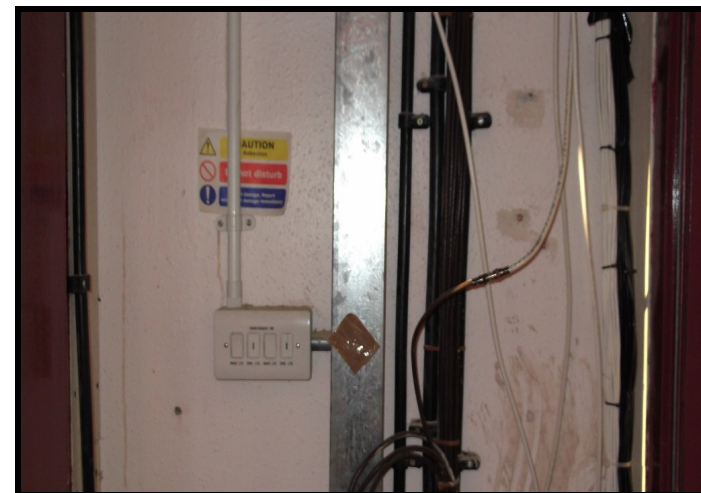
SAMPLE REFERENCE 124

Building	Floor	Room	Location	
Main Building	Third Floor	Service Riser	Walls	
Description				
MATERIAL ASSESSMENT				SCORE
Product Type	Paint	Extent of Damage	Good condition	-
Asbestos Type	No Asbestos Detected	Surface Treatment	Sealed (1)	
PRIORITY ASSESSMENT				SCORE
Occupant Activity	Not Applicable	Extent / Amount	3.00 m2	-
Accessibility	Easily disturbed	Location	Not Applicable	
Avg Time in Use	Not Applicable	Frequency of Use	Not Applicable	
No. of Occupants	Not Applicable	Secondary Activity	Not Applicable	
Maintenance	Not Applicable	Maintenance Frequency	Not Applicable	
MANAGEMENT ACTION				SCORE
Recommendation	NO ACTION REQUIRED			-
Recommendation Due		Next Inspection	None	
Apply Labels	No	Permit to Work Required	No	
Survey Type	Management	Lead Surveyor	Jane Openshaw	
Survey Date	20 Mar 2012	UKAS Laboratory	NOT SAMPLED (Cross Referenced)	
Site Reference	113070000A	Licensed Material	N/A

No Asbestos Presumed in Sample

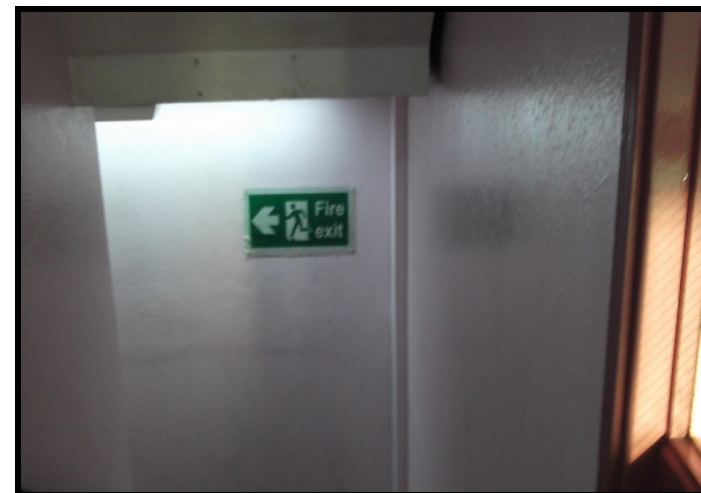
SAMPLE REFERENCE 125

Building	Floor	Room	Location	
Main Building	Third Floor	Stairs	Walls	
Description				
MATERIAL ASSESSMENT				SCORE
Product Type	Paint	Extent of Damage	Good condition	-
Asbestos Type	No Asbestos Detected	Surface Treatment	Sealed (1)	
PRIORITY ASSESSMENT				SCORE
Occupant Activity	Not Applicable	Extent / Amount	30.00 m2	-
Accessibility	Easily disturbed	Location	Not Applicable	
Avg Time in Use	Not Applicable	Frequency of Use	Not Applicable	
No. of Occupants	Not Applicable	Secondary Activity	Not Applicable	
Maintenance	Not Applicable	Maintenance Frequency	Not Applicable	
MANAGEMENT ACTION				SCORE
Recommendation	NO ACTION REQUIRED			-
Recommendation Due		Next Inspection	None	
Apply Labels	No	Permit to Work Required	No	
Survey Type	Management	Lead Surveyor	Jane Openshaw	
Survey Date	20 Mar 2012	UKAS Laboratory	NOT SAMPLED (Cross Referenced)	
Site Reference	113070000A	Licensed Material	N/A

No Asbestos Presumed in Sample

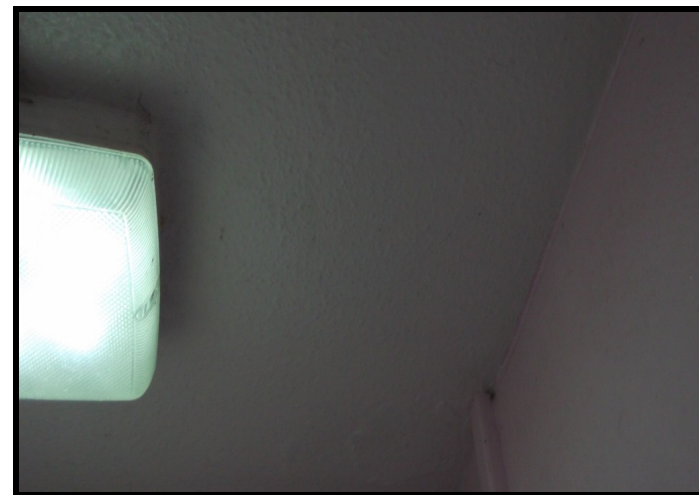
SAMPLE REFERENCE 126

Building	Floor	Room	Location	
Main Building	Second Floor	Bin Chute	Ceiling	
Description	Polyflex to ceiling, Metal cage to window			
MATERIAL ASSESSMENT				SCORE
Product Type	Paint	Extent of Damage	Good condition	-
Asbestos Type	No Asbestos Detected	Surface Treatment	Sealed (1)	
PRIORITY ASSESSMENT				SCORE
Occupant Activity	Not Applicable	Extent / Amount	1.00 m2	-
Accessibility	Occasionally disturb	Location	Not Applicable	
Avg Time in Use	Not Applicable	Frequency of Use	Not Applicable	
No. of Occupants	Not Applicable	Secondary Activity	Not Applicable	
Maintenance	Not Applicable	Maintenance Frequency	Not Applicable	
MANAGEMENT ACTION				SCORE
Recommendation	NO ACTION REQUIRED			-
Recommendation Due		Next Inspection	None	
Apply Labels	No	Permit to Work Required	No	
Survey Type	Management	Lead Surveyor	Jane Openshaw	
Survey Date	20 Mar 2012	UKAS Laboratory	DMW Environmental Safety Ltd / [P-96019]	
Site Reference	113070000A	Licensed Material	N/A

Asbestos not detected in Sample

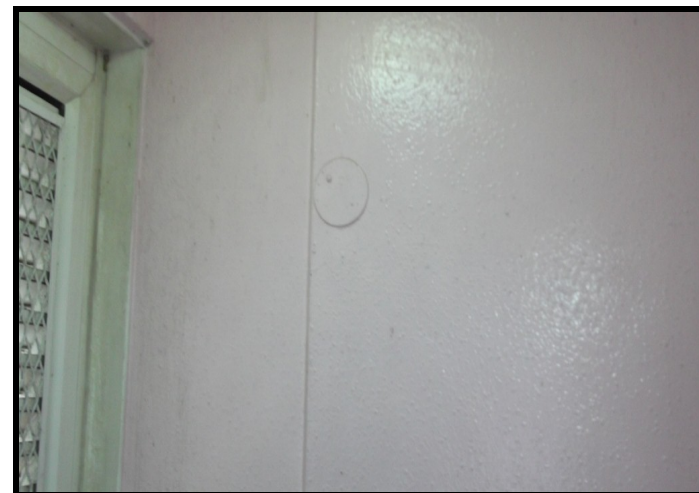
SAMPLE REFERENCE 127

Building	Floor	Room	Location	
Main Building	Second Floor	Bin Chute	Walls	
Description	metal cage to window			
MATERIAL ASSESSMENT				SCORE
Product Type	Paint	Extent of Damage	Low damage	-
Asbestos Type	No Asbestos Detected	Surface Treatment	Sealed (1)	
PRIORITY ASSESSMENT				SCORE
Occupant Activity	Not Applicable	Extent / Amount	5.00 m2	-
Accessibility	Easily disturbed	Location	Not Applicable	
Avg Time in Use	Not Applicable	Frequency of Use	Not Applicable	
No. of Occupants	Not Applicable	Secondary Activity	Not Applicable	
Maintenance	Not Applicable	Maintenance Frequency	Not Applicable	
MANAGEMENT ACTION				SCORE
Recommendation	NO ACTION REQUIRED			-
Recommendation Due		Next Inspection	None	
Apply Labels	No	Permit to Work Required	No	
Survey Type	Management	Lead Surveyor	Jane Openshaw	
Survey Date	20 Mar 2012	UKAS Laboratory	DMW Environmental Safety Ltd / [P-96019]	
Site Reference	113070000A	Licensed Material	N/A

Asbestos not detected in Sample

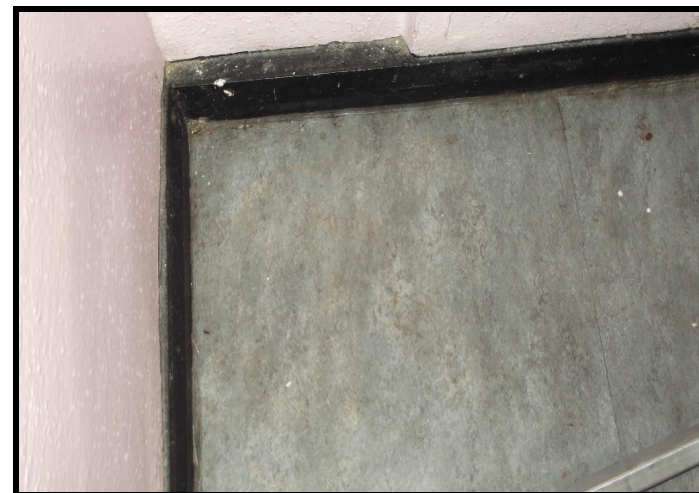
SAMPLE REFERENCE 128

Building	Floor	Room	Location	
Main Building	Second Floor	Bin Chute	Floor	
Description	Blue			
MATERIAL ASSESSMENT				SCORE
Product Type	Paper	Extent of Damage	Good condition	-
Asbestos Type	No Asbestos Detected	Surface Treatment	Sealed (1)	
PRIORITY ASSESSMENT				SCORE
Occupant Activity	Not Applicable	Extent / Amount	1.00 m2	-
Accessibility	Unlikely to be disturbed	Location	Not Applicable	
Avg Time in Use	Not Applicable	Frequency of Use	Not Applicable	
No. of Occupants	Not Applicable	Secondary Activity	Not Applicable	
Maintenance	Not Applicable	Maintenance Frequency	Not Applicable	
MANAGEMENT ACTION				SCORE
Recommendation	NO ACTION REQUIRED			-
Recommendation Due		Next Inspection	None	
Apply Labels	No	Permit to Work Required	No	
Survey Type	Management	Lead Surveyor	Jane Openshaw	
Survey Date	20 Mar 2012	UKAS Laboratory	DMW Environmental Safety Ltd / [P-96019]	
Site Reference	113070000A	Licensed Material	N/A

Asbestos not detected in Sample

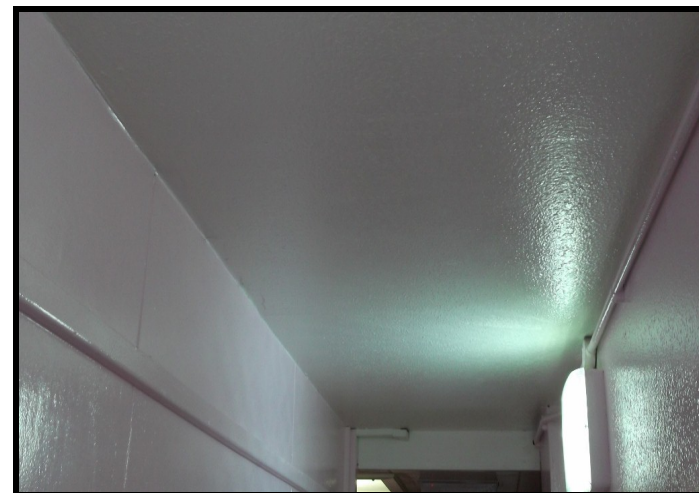
SAMPLE REFERENCE 129

Building	Floor	Room	Location	
Main Building	Second Floor	Corridor I	Ceiling	
Description	Timber boxing adjacent to flat entrances			
MATERIAL ASSESSMENT				SCORE
Product Type	Paint	Extent of Damage	Good condition	-
Asbestos Type	No Asbestos Detected	Surface Treatment	Sealed (I)	
PRIORITY ASSESSMENT				SCORE
Occupant Activity	Not Applicable	Extent / Amount	5.00 m2	-
Accessibility	Occasionally disturb	Location	Not Applicable	
Avg Time in Use	Not Applicable	Frequency of Use	Not Applicable	
No. of Occupants	Not Applicable	Secondary Activity	Not Applicable	
Maintenance	Not Applicable	Maintenance Frequency	Not Applicable	
MANAGEMENT ACTION				SCORE
Recommendation	NO ACTION REQUIRED			-
Recommendation Due		Next Inspection	None	
Apply Labels	No	Permit to Work Required	No	
Survey Type	Management	Lead Surveyor	Jane Openshaw	
Survey Date	20 Mar 2012	UKAS Laboratory	NOT SAMPLED (Cross Referenced)	
Site Reference	I13070000A	Licensed Material	N/A

No Asbestos Presumed in Sample

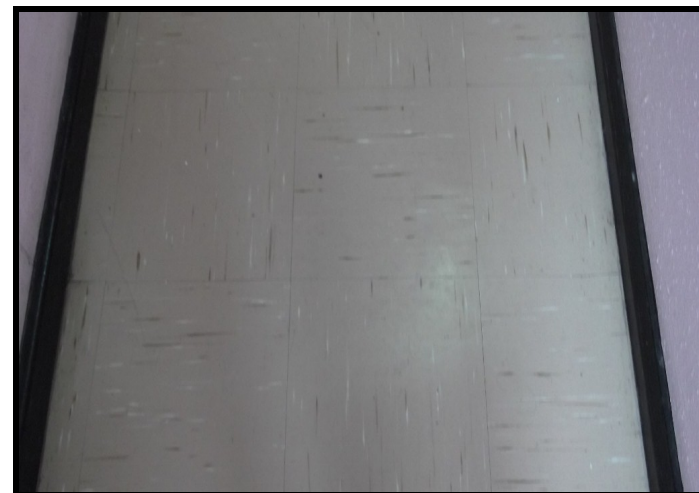
SAMPLE REFERENCE I30

Building	Floor	Room	Location	
Main Building	Second Floor	Corridor I	Floor	
Description	Buff, Timber boxing adjacent to flat entrances			
MATERIAL ASSESSMENT				SCORE
Product Type	Floor Tiles	Extent of Damage	Good condition	-
Asbestos Type	No Asbestos Detected	Surface Treatment	Composite materials	
PRIORITY ASSESSMENT				SCORE
Occupant Activity	Not Applicable	Extent / Amount	7.00 m2	-
Accessibility	Routinely disturbed	Location	Not Applicable	
Avg Time in Use	Not Applicable	Frequency of Use	Not Applicable	
No. of Occupants	Not Applicable	Secondary Activity	Not Applicable	
Maintenance	Not Applicable	Maintenance Frequency	Not Applicable	
MANAGEMENT ACTION				SCORE
Recommendation	NO ACTION REQUIRED			-
Recommendation Due		Next Inspection	None	
Apply Labels	No	Permit to Work Required	No	
Survey Type	Management	Lead Surveyor	Jane Openshaw	
Survey Date	20 Mar 2012	UKAS Laboratory	DMW Environmental Safety Ltd / [P-96019]

Asbestos not detected in Sample

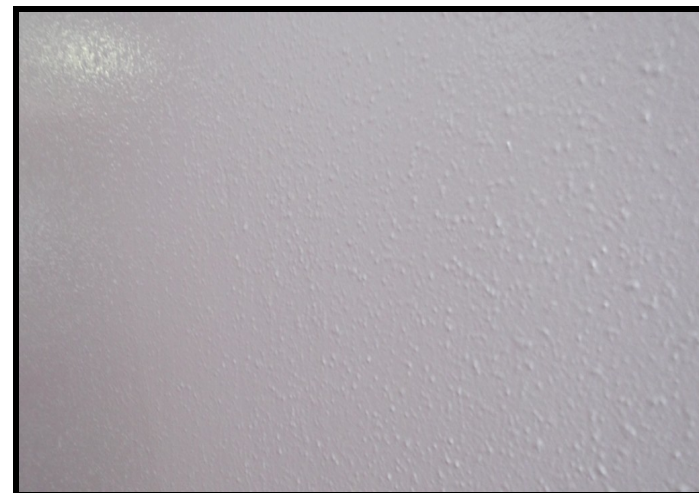
SAMPLE REFERENCE 131

Building	Floor	Room	Location	
Main Building	Second Floor	Corridor I	Walls	
Description	Timber boxing adjacent to flat entrances			
MATERIAL ASSESSMENT				SCORE
Product Type	Paint	Extent of Damage	Good condition	-
Asbestos Type	No Asbestos Detected	Surface Treatment	Sealed (1)	
PRIORITY ASSESSMENT				SCORE
Occupant Activity	Not Applicable	Extent / Amount	10.00 m2	-
Accessibility	Easily disturbed	Location	Not Applicable	
Avg Time in Use	Not Applicable	Frequency of Use	Not Applicable	
No. of Occupants	Not Applicable	Secondary Activity	Not Applicable	
Maintenance	Not Applicable	Maintenance Frequency	Not Applicable	
MANAGEMENT ACTION				SCORE
Recommendation	NO ACTION REQUIRED			-
Recommendation Due		Next Inspection	None	
Apply Labels	No	Permit to Work Required	No	
Survey Type	Management	Lead Surveyor	Jane Openshaw	
Survey Date	20 Mar 2012	UKAS Laboratory	NOT SAMPLED (Cross Referenced)	
Site Reference	113070000A	Licensed Material	N/A

No Asbestos Presumed in Sample

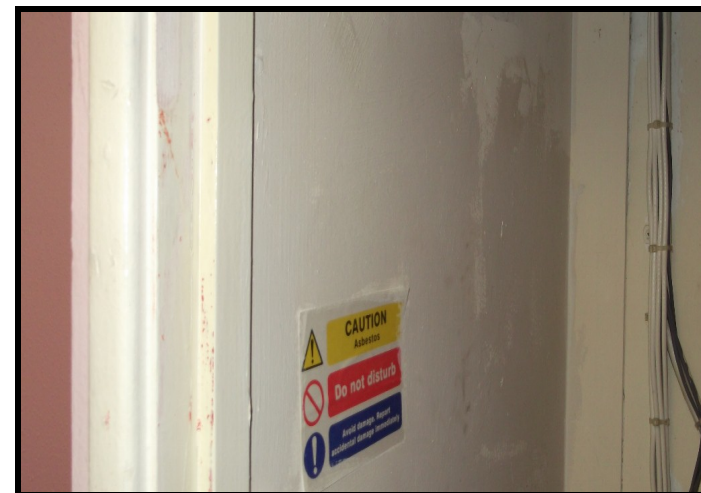
SAMPLE REFERENCE 132

MATERIAL ASSESSMENT				SCORE
Product Type	Board	Extent of Damage	Good condition	5
Asbestos Type	Amosite / Chrysotile	Surface Treatment	Sealed Board (Encapsulated)

Asbestos Presumed in Sample

MANAGEMENT ACTION				SCORE
Recommendation	LABEL & MONITOR			6
Recommendation Due		Next Inspection	20 Sep 2012	
Apply Labels	No	Permit to Work Required	No

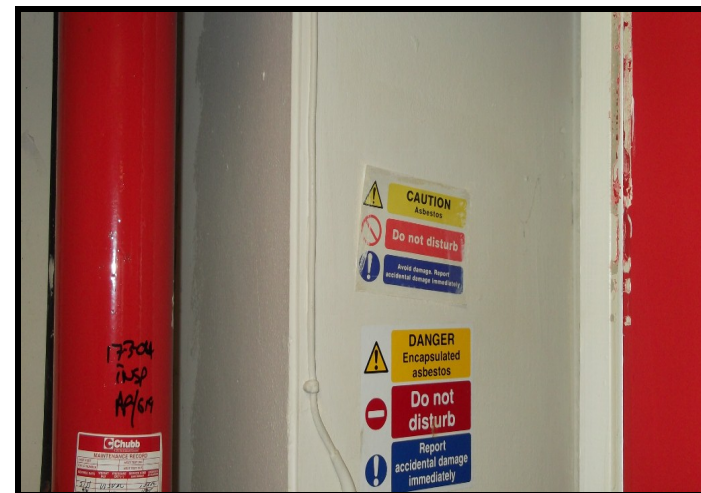
SAMPLE REFERENCE 133

MATERIAL ASSESSMENT				SCORE
Product Type	Board	Extent of Damage	Good condition	5
Asbestos Type	Amosite / Chrysotile	Surface Treatment	Sealed Board (Encapsulated)

Asbestos Presumed in Sample

MANAGEMENT ACTION				SCORE
Recommendation	LABEL & MONITOR			5
Recommendation Due		Next Inspection	20 Sep 2012	
Apply Labels	No	Permit to Work Required	No

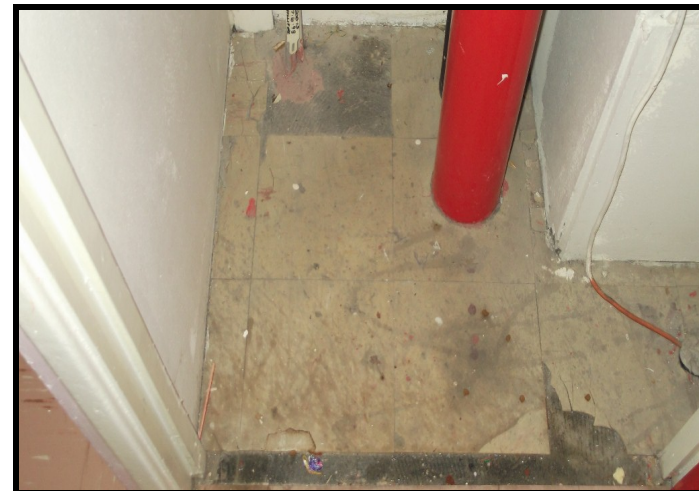
SAMPLE REFERENCE 134

Building	Floor	Room	Location
Main Building	Second Floor	Dry Riser	Floor
Description	Yellow		
MATERIAL ASSESSMENT			
Product Type	Floor Tiles	Extent of Damage	Medium damage
Asbestos Type	Chrysotile	Surface Treatment	Composite materials
PRIORITY ASSESSMENT			
Occupant Activity	Not Applicable	Extent / Amount	1.00 m2
Accessibility	Routinely disturbed	Location	Not Applicable
Avg Time in Use	Not Applicable	Frequency of Use	Not Applicable
No. of Occupants	Not Applicable	Secondary Activity	Not Applicable
Maintenance	Not Applicable	Maintenance Frequency	Not Applicable
MANAGEMENT ACTION			
Recommendation	ENCAPSULATE, LABEL & MONITOR		
Recommendation Due		Next Inspection	20 Mar 2013
Apply Labels	No	Permit to Work Required	No
Survey Type	Management	Lead Surveyor	Jane Openshaw
Survey Date	20 Mar 2012	UKAS Laboratory	NOT SAMPLED (Cross Referenced)
Site Reference	113070000A	Licensed Material	No

Asbestos Presumed in Sample

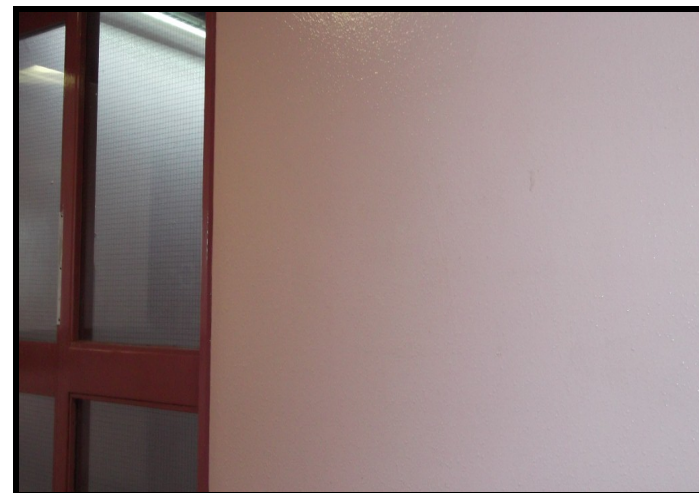
SAMPLE REFERENCE 135

Building	Floor	Room	Location	
Main Building	Second Floor	Lobby	Walls	
Description	Timber glazed beading to partitions and doors			
MATERIAL ASSESSMENT				SCORE
Product Type	Paint	Extent of Damage	Good condition	-
Asbestos Type	No Asbestos Detected	Surface Treatment	Sealed (1)	
PRIORITY ASSESSMENT				SCORE
Occupant Activity	Not Applicable	Extent / Amount	1.00 m2	-
Accessibility	Easily disturbed	Location	Not Applicable	
Avg Time in Use	Not Applicable	Frequency of Use	Not Applicable	
No. of Occupants	Not Applicable	Secondary Activity	Not Applicable	
Maintenance	Not Applicable	Maintenance Frequency	Not Applicable	
MANAGEMENT ACTION				SCORE
Recommendation	NO ACTION REQUIRED			-
Recommendation Due		Next Inspection	None	
Apply Labels	No	Permit to Work Required	No	
Survey Type	Management	Lead Surveyor	Jane Openshaw	
Survey Date	20 Mar 2012	UKAS Laboratory	NOT SAMPLED (Cross Referenced)	
Site Reference	113070000A	Licensed Material	N/A

No Asbestos Presumed in Sample

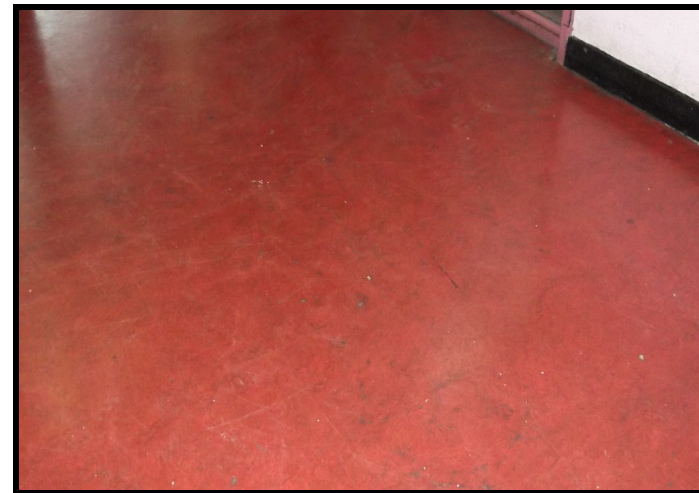
SAMPLE REFERENCE 136

Building	Floor	Room	Location	
Main Building	Second Floor	Lobby	Floor	
Description	Red, Timber glazed beading to partitions and doors			
MATERIAL ASSESSMENT				SCORE
Product Type	Paper	Extent of Damage	Good condition	-
Asbestos Type	No Asbestos Detected	Surface Treatment	Sealed (1)	
PRIORITY ASSESSMENT				SCORE
Occupant Activity	Not Applicable	Extent / Amount	8.00 m2	-
Accessibility	Unlikely to be disturbed	Location	Not Applicable	
Avg Time in Use	Not Applicable	Frequency of Use	Not Applicable	
No. of Occupants	Not Applicable	Secondary Activity	Not Applicable	
Maintenance	Not Applicable	Maintenance Frequency	Not Applicable	
MANAGEMENT ACTION				SCORE
Recommendation	NO ACTION REQUIRED			-
Recommendation Due		Next Inspection	None	
Apply Labels	No	Permit to Work Required	No	
Survey Type	Management	Lead Surveyor	Jane Openshaw	
Survey Date	20 Mar 2012	UKAS Laboratory	DMW Environmental Safety Ltd / [P-96019]	
Site Reference	113070000A	Licensed Material	N/A

Asbestos not detected in Sample

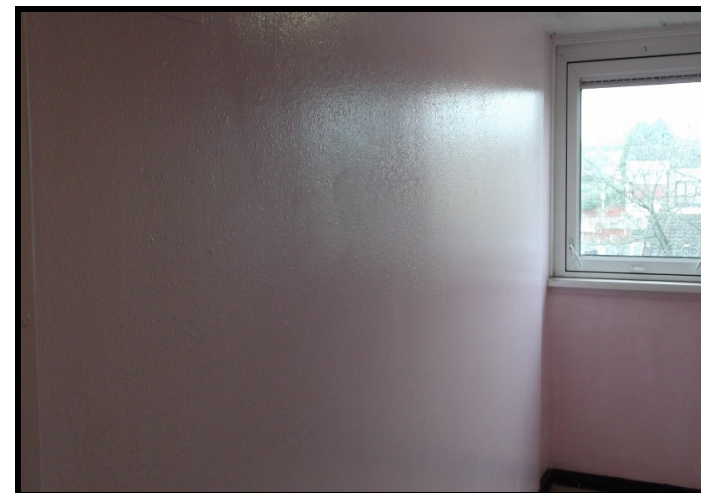
SAMPLE REFERENCE 137

Building	Floor	Room	Location	
Main Building	Second Floor	Corridor 2	Walls	
Description	Timber boxing adjacent to front entrances, Timber beading to glazed partitions and doors			
MATERIAL ASSESSMENT				SCORE
Product Type	Paint	Extent of Damage	Good condition	-
Asbestos Type	No Asbestos Detected	Surface Treatment	Sealed (1)	
PRIORITY ASSESSMENT				SCORE
Occupant Activity	Not Applicable	Extent / Amount	13.00 m2	-
Accessibility	Easily disturbed	Location	Not Applicable	
Avg Time in Use	Not Applicable	Frequency of Use	Not Applicable	
No. of Occupants	Not Applicable	Secondary Activity	Not Applicable	
Maintenance	Not Applicable	Maintenance Frequency	Not Applicable	
MANAGEMENT ACTION				SCORE
Recommendation	NO ACTION REQUIRED			-
Recommendation Due		Next Inspection	None	
Apply Labels	No	Permit to Work Required	No	
Survey Type	Management	Lead Surveyor	Jane Openshaw	
Survey Date	20 Mar 2012	UKAS Laboratory	NOT SAMPLED (Cross Referenced)

No Asbestos Presumed in Sample

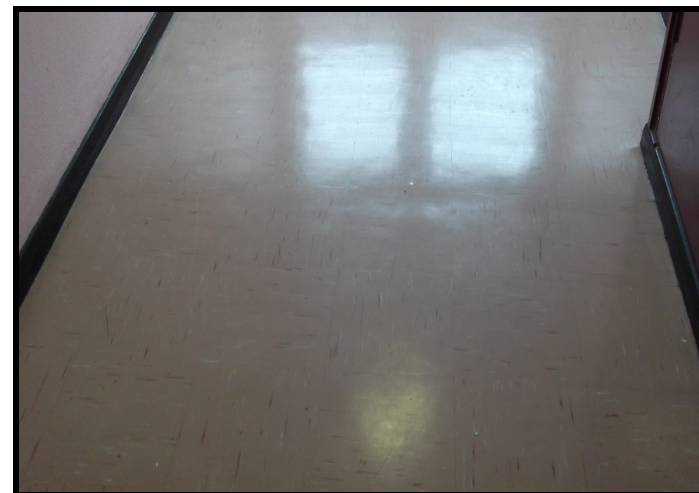
SAMPLE REFERENCE 138

Building	Floor	Room	Location	
Main Building	Second Floor	Corridor 2	Floor	
Description	Timber boxing adjacent to front entrances, Timber beading to glazed partitions and doors			
MATERIAL ASSESSMENT				SCORE
Product Type	Floor Tiles	Extent of Damage	Good condition	-
Asbestos Type	No Asbestos Detected	Surface Treatment	Composite materials	
PRIORITY ASSESSMENT				SCORE
Occupant Activity	Not Applicable	Extent / Amount	7.00 m2	-
Accessibility	Routinely disturbed	Location	Not Applicable	
Avg Time in Use	Not Applicable	Frequency of Use	Not Applicable	
No. of Occupants	Not Applicable	Secondary Activity	Not Applicable	
Maintenance	Not Applicable	Maintenance Frequency	Not Applicable	
MANAGEMENT ACTION				SCORE
Recommendation	NO ACTION REQUIRED			-
Recommendation Due		Next Inspection	None	
Apply Labels	No	Permit to Work Required	No	
Survey Type	Management	Lead Surveyor	Jane Openshaw	
Survey Date	20 Mar 2012	UKAS Laboratory	NOT SAMPLED (Cross Referenced)

No Asbestos Presumed in Sample

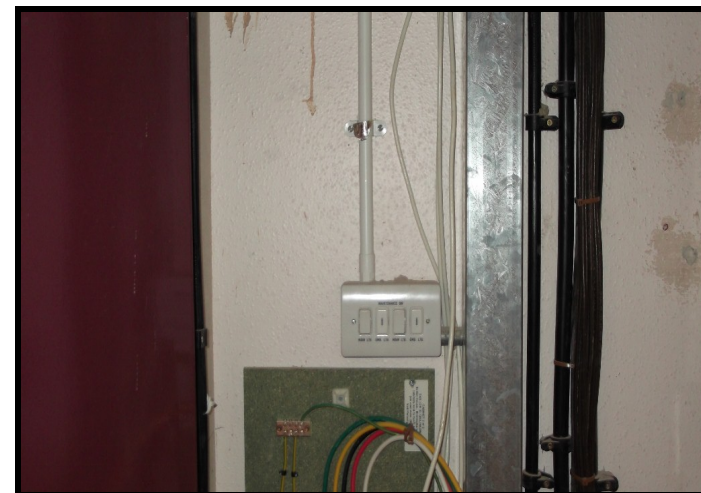
SAMPLE REFERENCE 139

Building	Floor	Room	Location	
Main Building	Second Floor	Service Riser	Wall	
Description	Timber beading to glazed partitions and doors			
MATERIAL ASSESSMENT				SCORE
Product Type	Paint	Extent of Damage	Good condition	-
Asbestos Type	No Asbestos Detected	Surface Treatment	Sealed (1)	
PRIORITY ASSESSMENT				SCORE
Occupant Activity	Not Applicable	Extent / Amount	3.00 m2	-
Accessibility	Easily disturbed	Location	Not Applicable	
Avg Time in Use	Not Applicable	Frequency of Use	Not Applicable	
No. of Occupants	Not Applicable	Secondary Activity	Not Applicable	
Maintenance	Not Applicable	Maintenance Frequency	Not Applicable	
MANAGEMENT ACTION				SCORE
Recommendation	NO ACTION REQUIRED			-
Recommendation Due		Next Inspection	None	
Apply Labels	No	Permit to Work Required	No	
Survey Type	Management	Lead Surveyor	Jane Openshaw	
Survey Date	20 Mar 2012	UKAS Laboratory	NOT SAMPLED (Cross Referenced)	
Site Reference	113070000A	Licensed Material	N/A

No Asbestos Presumed in Sample

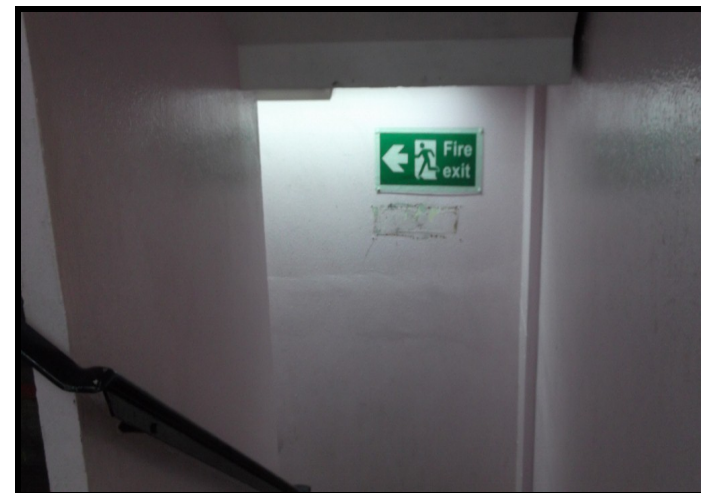
SAMPLE REFERENCE 140

Building	Floor	Room	Location	
Main Building	Second Floor	Stairs	Walls	
Description	Timber beading to glazed partitions and doors			
MATERIAL ASSESSMENT				SCORE
Product Type	Paint	Extent of Damage	Good condition	-
Asbestos Type	No Asbestos Detected	Surface Treatment	Sealed (1)	
PRIORITY ASSESSMENT				SCORE
Occupant Activity	Not Applicable	Extent / Amount	30.00 m2	-
Accessibility	Easily disturbed	Location	Not Applicable	
Avg Time in Use	Not Applicable	Frequency of Use	Not Applicable	
No. of Occupants	Not Applicable	Secondary Activity	Not Applicable	
Maintenance	Not Applicable	Maintenance Frequency	Not Applicable	
MANAGEMENT ACTION				SCORE
Recommendation	NO ACTION REQUIRED			-
Recommendation Due		Next Inspection	None	
Apply Labels	No	Permit to Work Required	No	
Survey Type	Management	Lead Surveyor	Jane Openshaw	
Survey Date	20 Mar 2012	UKAS Laboratory	NOT SAMPLED (Cross Referenced)	
Site Reference	113070000A	Licensed Material	N/A

No Asbestos Presumed in Sample

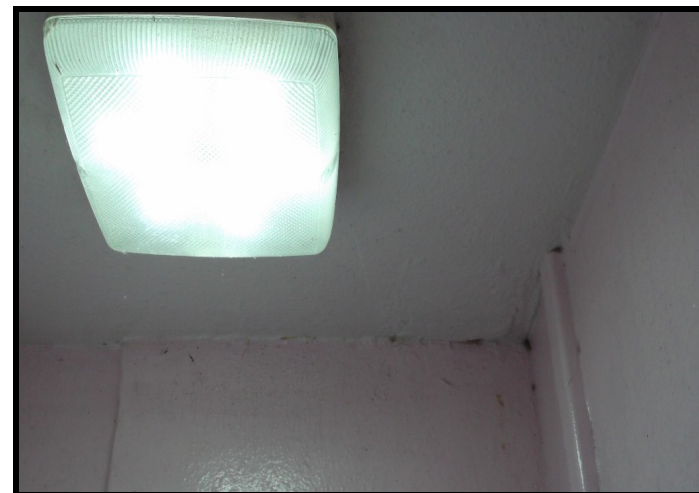
SAMPLE REFERENCE 141

Building	Floor	Room	Location	
Main Building	First Floor	Bin Chute	Ceiling	
Description				
MATERIAL ASSESSMENT				SCORE
Product Type	Paint	Extent of Damage	Good condition	-
Asbestos Type	No Asbestos Detected	Surface Treatment	Sealed (1)	
PRIORITY ASSESSMENT				SCORE
Occupant Activity	Not Applicable	Extent / Amount	1.00 m2	-
Accessibility	Occasionally disturb	Location	Not Applicable	
Avg Time in Use	Not Applicable	Frequency of Use	Not Applicable	
No. of Occupants	Not Applicable	Secondary Activity	Not Applicable	
Maintenance	Not Applicable	Maintenance Frequency	Not Applicable	
MANAGEMENT ACTION				SCORE
Recommendation	NO ACTION REQUIRED			-
Recommendation Due		Next Inspection	None	
Apply Labels	No	Permit to Work Required	No	
Survey Type	Management	Lead Surveyor	Jane Openshaw	
Survey Date	20 Mar 2012	UKAS Laboratory	NOT SAMPLED (Cross Referenced)	
Site Reference	113070000A	Licensed Material	N/A

No Asbestos Presumed in Sample

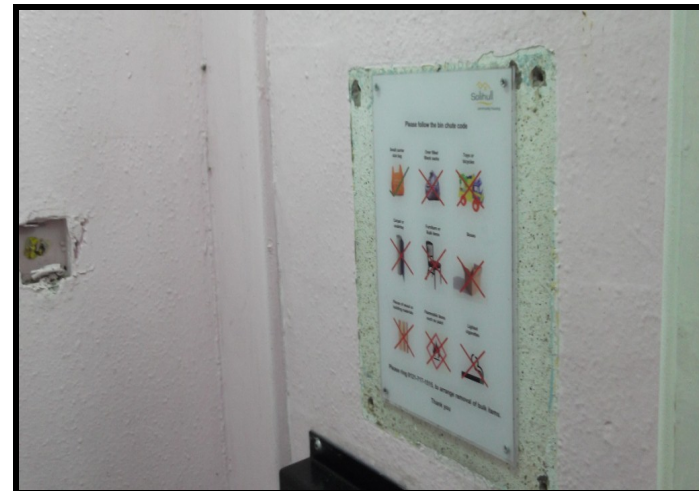
SAMPLE REFERENCE 142

Building	Floor	Room	Location	
Main Building	First Floor	Bin Chute	Walls	
Description				
MATERIAL ASSESSMENT				SCORE
Product Type	Paint	Extent of Damage	Low damage	-
Asbestos Type	No Asbestos Detected	Surface Treatment	Sealed (1)	
PRIORITY ASSESSMENT				SCORE
Occupant Activity	Not Applicable	Extent / Amount	5.00 m2	-
Accessibility	Easily disturbed	Location	Not Applicable	
Avg Time in Use	Not Applicable	Frequency of Use	Not Applicable	
No. of Occupants	Not Applicable	Secondary Activity	Not Applicable	
Maintenance	Not Applicable	Maintenance Frequency	Not Applicable	
MANAGEMENT ACTION				SCORE
Recommendation	NO ACTION REQUIRED			-
Recommendation Due		Next Inspection	None	
Apply Labels	No	Permit to Work Required	No	
Survey Type	Management	Lead Surveyor	Jane Openshaw	
Survey Date	20 Mar 2012	UKAS Laboratory	NOT SAMPLED (Cross Referenced)	
Site Reference	I13070000A	Licensed Material	N/A

No Asbestos Presumed in Sample

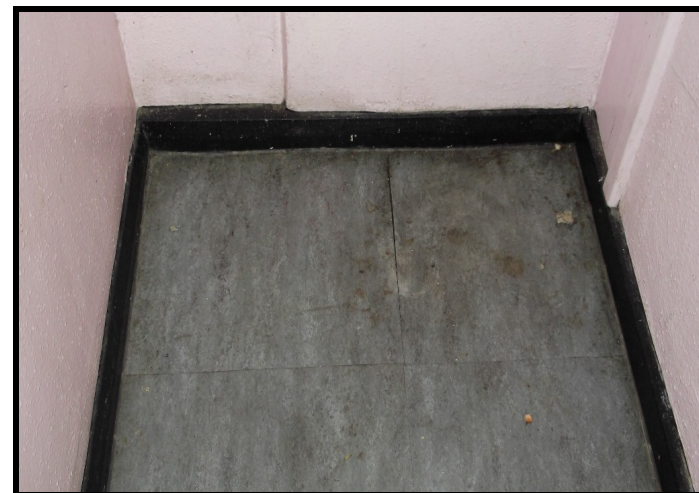
SAMPLE REFERENCE 143

Building	Floor	Room	Location	
Main Building	First Floor	Bin Chute	Floor	
Description	Blue			
MATERIAL ASSESSMENT				SCORE
Product Type	Paper	Extent of Damage	Low damage	-
Asbestos Type	No Asbestos Detected	Surface Treatment	Sealed (1)	
PRIORITY ASSESSMENT				SCORE
Occupant Activity	Not Applicable	Extent / Amount	1.00 m2	-
Accessibility	Unlikely to be disturbed	Location	Not Applicable	
Avg Time in Use	Not Applicable	Frequency of Use	Not Applicable	
No. of Occupants	Not Applicable	Secondary Activity	Not Applicable	
Maintenance	Not Applicable	Maintenance Frequency	Not Applicable	
MANAGEMENT ACTION				SCORE
Recommendation	NO ACTION REQUIRED			-
Recommendation Due		Next Inspection	None	
Apply Labels	No	Permit to Work Required	No	
Survey Type	Management	Lead Surveyor	Jane Openshaw	
Survey Date	20 Mar 2012	UKAS Laboratory	NOT SAMPLED (Cross Referenced)	
Site Reference	113070000A	Licensed Material	N/A

No Asbestos Presumed in Sample

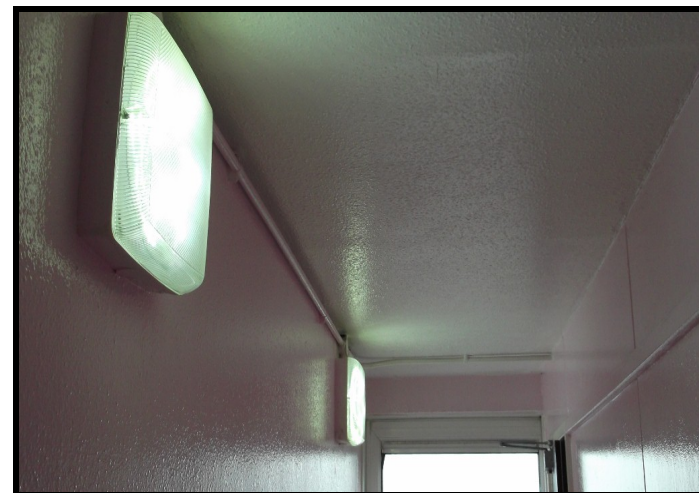
SAMPLE REFERENCE 144

Building	Floor	Room	Location	
Main Building	First Floor	Corridor I	Ceiling	
Description	Timber boxing adjacent to flat entrances			
MATERIAL ASSESSMENT				SCORE
Product Type	Paint	Extent of Damage	Good condition	-
Asbestos Type	No Asbestos Detected	Surface Treatment	Sealed (1)	
PRIORITY ASSESSMENT				SCORE
Occupant Activity	Not Applicable	Extent / Amount	5.00 m2	-
Accessibility	Occasionally disturb	Location	Not Applicable	
Avg Time in Use	Not Applicable	Frequency of Use	Not Applicable	
No. of Occupants	Not Applicable	Secondary Activity	Not Applicable	
Maintenance	Not Applicable	Maintenance Frequency	Not Applicable	
MANAGEMENT ACTION				SCORE
Recommendation	NO ACTION REQUIRED			-
Recommendation Due		Next Inspection	None	
Apply Labels	No	Permit to Work Required	No	
Survey Type	Management	Lead Surveyor	Jane Openshaw	
Survey Date	20 Mar 2012	UKAS Laboratory	NOT SAMPLED (Cross Referenced)	
Site Reference	I13070000A	Licensed Material	N/A

No Asbestos Presumed in Sample

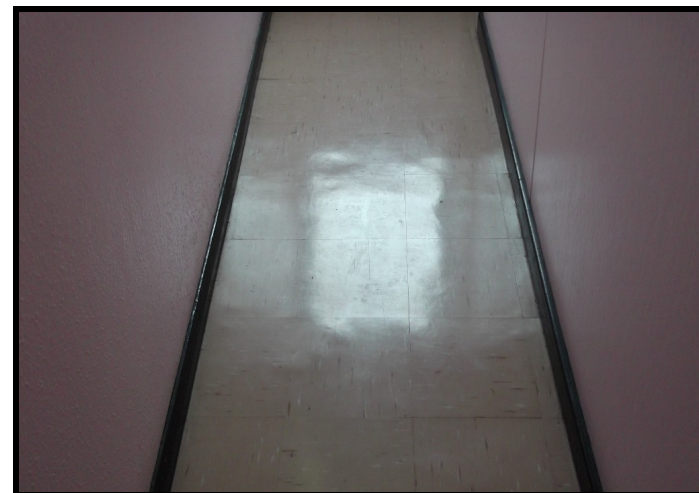
SAMPLE REFERENCE 145

Building	Floor	Room	Location	
Main Building	First Floor	Corridor I	Floor	
Description	Buff, Timber boxing adjacent to flat entrances			
MATERIAL ASSESSMENT				SCORE
Product Type	Floor Tiles	Extent of Damage	Good condition	-
Asbestos Type	No Asbestos Detected	Surface Treatment	Composite materials	
PRIORITY ASSESSMENT				SCORE
Occupant Activity	Not Applicable	Extent / Amount	7.00 m2	-
Accessibility	Routinely disturbed	Location	Not Applicable	
Avg Time in Use	Not Applicable	Frequency of Use	Not Applicable	
No. of Occupants	Not Applicable	Secondary Activity	Not Applicable	
Maintenance	Not Applicable	Maintenance Frequency	Not Applicable	
MANAGEMENT ACTION				SCORE
Recommendation	NO ACTION REQUIRED			-
Recommendation Due		Next Inspection	None	
Apply Labels	No	Permit to Work Required	No	
Survey Type	Management	Lead Surveyor	Jane Openshaw	
Survey Date	20 Mar 2012	UKAS Laboratory	NOT SAMPLED (Cross Referenced)	
Site Reference	I13070000A	Licensed Material	N/A

No Asbestos Presumed in Sample
