Solihull Community Housing

Asbestos Management Survey Report

**Balliol House
Grandys Croft
Chelmsley Wood
B37 5BS**

Date of Report: 31 Mar 2012

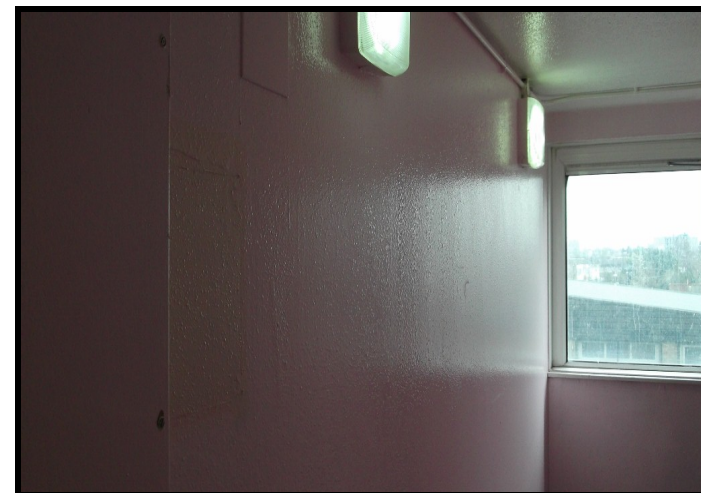
SAMPLE REFERENCE 146

Building	Floor	Room	Location	
Main Building	First Floor	Corridor I	Walls	
Description	Timber boxing adjacent to flat entrances			
MATERIAL ASSESSMENT				SCORE
Product Type	Paint	Extent of Damage	Good condition	-
Asbestos Type	No Asbestos Detected	Surface Treatment	Sealed (1)	
PRIORITY ASSESSMENT				SCORE
Occupant Activity	Not Applicable	Extent / Amount	10.00 m2	-
Accessibility	Easily disturbed	Location	Not Applicable	
Avg Time in Use	Not Applicable	Frequency of Use	Not Applicable	
No. of Occupants	Not Applicable	Secondary Activity	Not Applicable	
Maintenance	Not Applicable	Maintenance Frequency	Not Applicable	
MANAGEMENT ACTION				SCORE
Recommendation	NO ACTION REQUIRED			-
Recommendation Due		Next Inspection	None	
Apply Labels	No	Permit to Work Required	No	
Survey Type	Management	Lead Surveyor	Jane Openshaw	
Survey Date	20 Mar 2012	UKAS Laboratory	NOT SAMPLED (Cross Referenced)	
Site Reference	113070000A	Licensed Material	N/A

No Asbestos Presumed in Sample

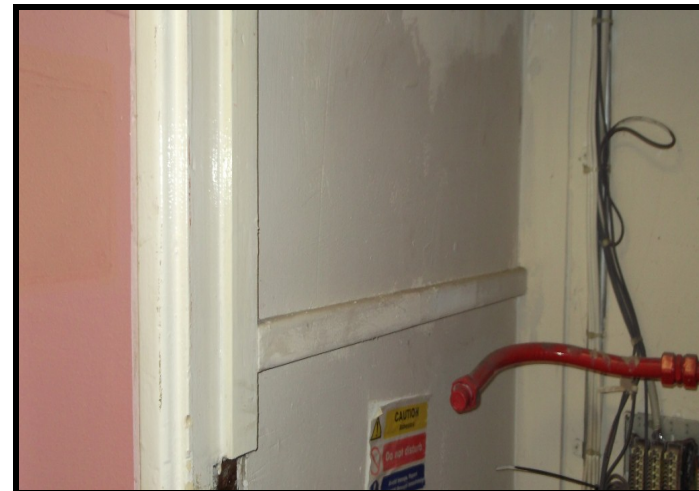
SAMPLE REFERENCE 147

MATERIAL ASSESSMENT				SCORE
Product Type	Board	Extent of Damage	Good condition	5
Asbestos Type	Amosite / Chrysotile	Surface Treatment	Sealed Board (Encapsulated)

Asbestos Presumed in Sample

MANAGEMENT ACTION				SCORE
Recommendation	LABEL & MONITOR			6
Recommendation Due		Next Inspection	20 Sep 2012	
Apply Labels	No	Permit to Work Required	No

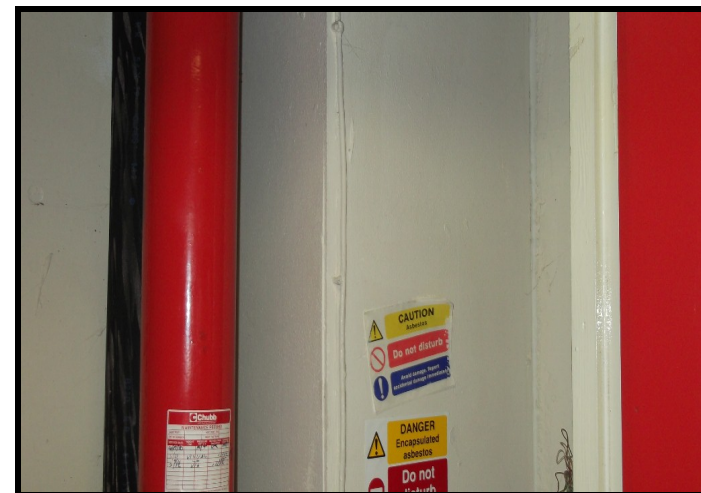
SAMPLE REFERENCE 148

Asbestos Presumed in Sample

MANAGEMENT ACTION				SCORE
Recommendation	LABEL & MONITOR			5
Recommendation Due		Next Inspection	20 Sep 2012	
Apply Labels	No	Permit to Work Required	No

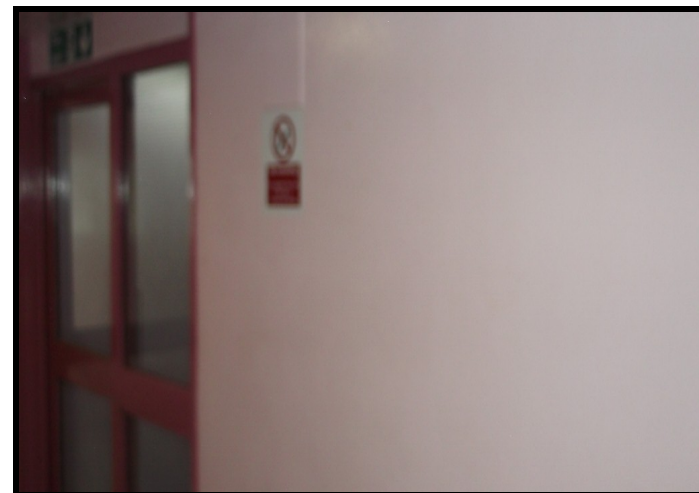
SAMPLE REFERENCE 150

Building	Floor	Room	Location	
Main Building	First Floor	Lobby	Walls	
Description	Timber glazed beading to partitions and doors			
MATERIAL ASSESSMENT				SCORE
Product Type	Paint	Extent of Damage	Good condition	-
Asbestos Type	No Asbestos Detected	Surface Treatment	Sealed (1)	
PRIORITY ASSESSMENT				SCORE
Occupant Activity	Not Applicable	Extent / Amount	13.00 m2	-
Accessibility	Easily disturbed	Location	Not Applicable	
Avg Time in Use	Not Applicable	Frequency of Use	Not Applicable	
No. of Occupants	Not Applicable	Secondary Activity	Not Applicable	
Maintenance	Not Applicable	Maintenance Frequency	Not Applicable	
MANAGEMENT ACTION				SCORE
Recommendation	NO ACTION REQUIRED			-
Recommendation Due		Next Inspection	None	
Apply Labels	No	Permit to Work Required	No	
Survey Type	Management	Lead Surveyor	Jane Openshaw	
Survey Date	20 Mar 2012	UKAS Laboratory	NOT SAMPLED (Cross Referenced)	
Site Reference	113070000A	Licensed Material	N/A

No Asbestos Presumed in Sample

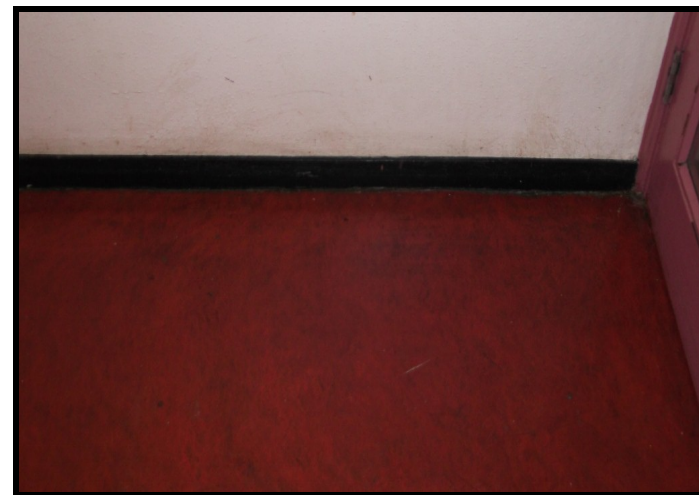
SAMPLE REFERENCE 151

Building	Floor	Room	Location	
Main Building	First Floor	Lobby	Floor	
Description	Red, Timber glazed beading to partitions and doors			
MATERIAL ASSESSMENT				SCORE
Product Type	Paper	Extent of Damage	Good condition	-
Asbestos Type	No Asbestos Detected	Surface Treatment	Sealed (1)	
PRIORITY ASSESSMENT				SCORE
Occupant Activity	Not Applicable	Extent / Amount	8.00 m2	-
Accessibility	Unlikely to be disturbed	Location	Not Applicable	
Avg Time in Use	Not Applicable	Frequency of Use	Not Applicable	
No. of Occupants	Not Applicable	Secondary Activity	Not Applicable	
Maintenance	Not Applicable	Maintenance Frequency	Not Applicable	
MANAGEMENT ACTION				SCORE
Recommendation	NO ACTION REQUIRED			-
Recommendation Due		Next Inspection	None	
Apply Labels	No	Permit to Work Required	No	
Survey Type	Management	Lead Surveyor	Jane Openshaw	
Survey Date	20 Mar 2012	UKAS Laboratory	NOT SAMPLED (Cross Referenced)	
Site Reference	I13070000A	Licensed Material	N/A

No Asbestos Presumed in Sample

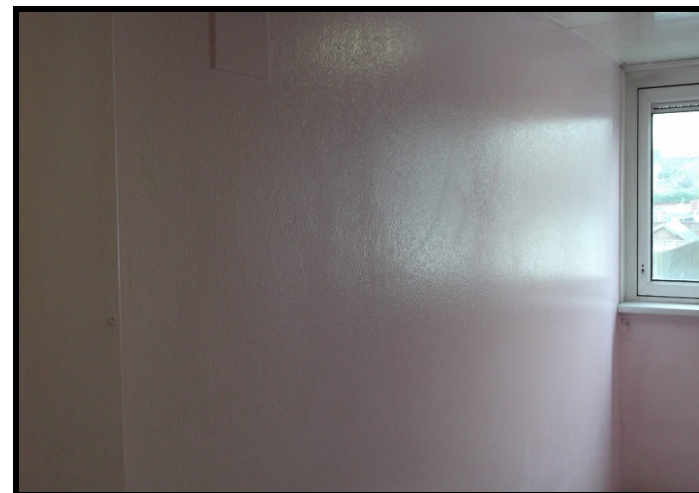
SAMPLE REFERENCE 152

Building	Floor	Room	Location	
Main Building	First Floor	Corridor 2	Walls	
Description	Timber boxing adjacent to flat entrances, Timber glazed beading to partitions and doors			
MATERIAL ASSESSMENT				SCORE
Product Type	Paint	Extent of Damage	Good condition	-
Asbestos Type	No Asbestos Detected	Surface Treatment	Sealed (1)	
PRIORITY ASSESSMENT				SCORE
Occupant Activity	Not Applicable	Extent / Amount	13.00 m2	-
Accessibility	Easily disturbed	Location	Not Applicable	
Avg Time in Use	Not Applicable	Frequency of Use	Not Applicable	
No. of Occupants	Not Applicable	Secondary Activity	Not Applicable	
Maintenance	Not Applicable	Maintenance Frequency	Not Applicable	
MANAGEMENT ACTION				SCORE
Recommendation	NO ACTION REQUIRED			-
Recommendation Due		Next Inspection	None	
Apply Labels	No	Permit to Work Required	No	
Survey Type	Management	Lead Surveyor	Jane Openshaw	
Survey Date	20 Mar 2012	UKAS Laboratory	NOT SAMPLED (Cross Referenced)

No Asbestos Presumed in Sample

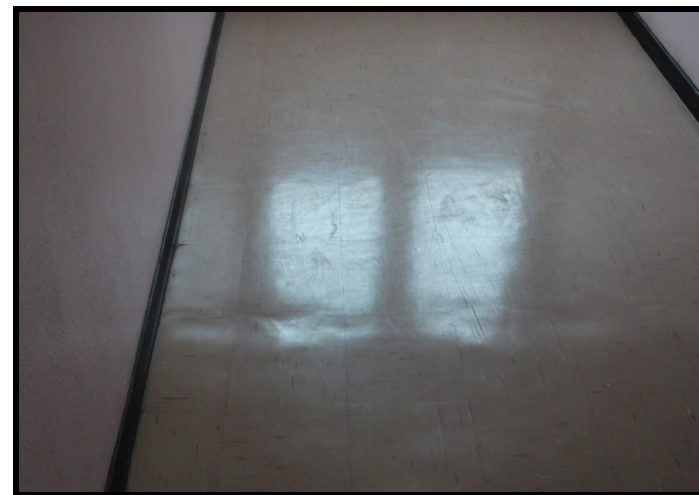
SAMPLE REFERENCE 153

Building	Floor	Room	Location	
Main Building	First Floor	Corridor 2	Floor	
Description	Buff, Timber boxing adjacent to flat entrances, Timber glazed beading to partitions and doors			
MATERIAL ASSESSMENT				SCORE
Product Type	Floor Tiles	Extent of Damage	Good condition	-
Asbestos Type	No Asbestos Detected	Surface Treatment	Composite materials	
PRIORITY ASSESSMENT				SCORE
Occupant Activity	Not Applicable	Extent / Amount	7.00 m2	-
Accessibility	Routinely disturbed	Location	Not Applicable	
Avg Time in Use	Not Applicable	Frequency of Use	Not Applicable	
No. of Occupants	Not Applicable	Secondary Activity	Not Applicable	
Maintenance	Not Applicable	Maintenance Frequency	Not Applicable	
MANAGEMENT ACTION				SCORE
Recommendation	NO ACTION REQUIRED			-
Recommendation Due		Next Inspection	None	
Apply Labels	No	Permit to Work Required	No	
Survey Type	Management	Lead Surveyor	Jane Openshaw	
Survey Date	20 Mar 2012	UKAS Laboratory	NOT SAMPLED (Cross Referenced)

No Asbestos Presumed in Sample

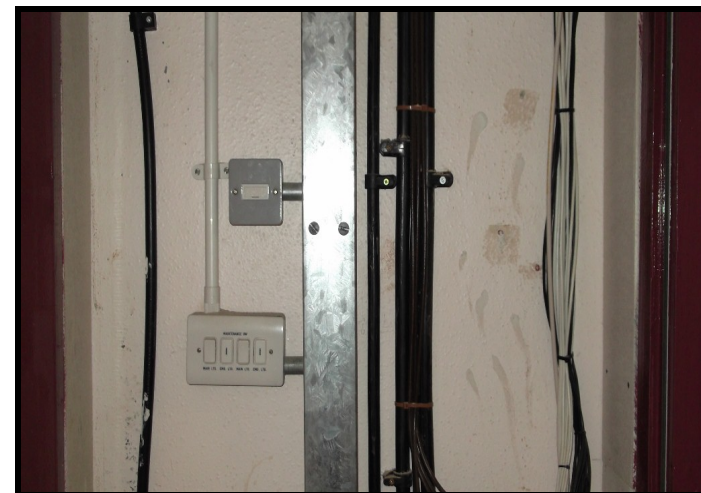
SAMPLE REFERENCE 154

Building	Floor	Room	Location	
Main Building	First Floor	Service Riser	Walls	
Description	Timber glazed beading to partitions and doors			
MATERIAL ASSESSMENT				SCORE
Product Type	Paint	Extent of Damage	Good condition	-
Asbestos Type	No Asbestos Detected	Surface Treatment	Sealed (1)	
PRIORITY ASSESSMENT				SCORE
Occupant Activity	Not Applicable	Extent / Amount	3.00 m2	-
Accessibility	Easily disturbed	Location	Not Applicable	
Avg Time in Use	Not Applicable	Frequency of Use	Not Applicable	
No. of Occupants	Not Applicable	Secondary Activity	Not Applicable	
Maintenance	Not Applicable	Maintenance Frequency	Not Applicable	
MANAGEMENT ACTION				SCORE
Recommendation	NO ACTION REQUIRED			-
Recommendation Due		Next Inspection	None	
Apply Labels	No	Permit to Work Required	No	
Survey Type	Management	Lead Surveyor	Jane Openshaw	
Survey Date	20 Mar 2012	UKAS Laboratory	NOT SAMPLED (Cross Referenced)	
Site Reference	I13070000A	Licensed Material	N/A

No Asbestos Presumed in Sample

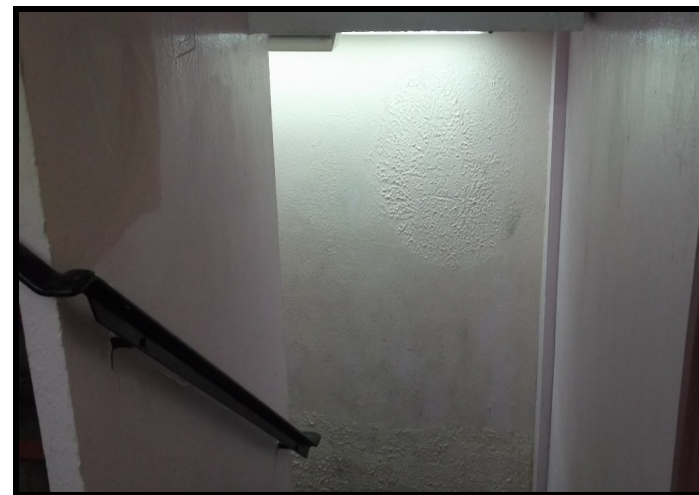
SAMPLE REFERENCE 155

Building	Floor	Room	Location	
Main Building	First Floor	Stairs	Wall	
Description	Timber glazed beading to partitions and doors			
MATERIAL ASSESSMENT				SCORE
Product Type	Paint	Extent of Damage	Good condition	-
Asbestos Type	No Asbestos Detected	Surface Treatment	Sealed (1)	
PRIORITY ASSESSMENT				SCORE
Occupant Activity	Not Applicable	Extent / Amount	30.00 m2	-
Accessibility	Easily disturbed	Location	Not Applicable	
Avg Time in Use	Not Applicable	Frequency of Use	Not Applicable	
No. of Occupants	Not Applicable	Secondary Activity	Not Applicable	
Maintenance	Not Applicable	Maintenance Frequency	Not Applicable	
MANAGEMENT ACTION				SCORE
Recommendation	NO ACTION REQUIRED			-
Recommendation Due		Next Inspection	None	
Apply Labels	No	Permit to Work Required	No	
Survey Type	Management	Lead Surveyor	Jane Openshaw	
Survey Date	20 Mar 2012	UKAS Laboratory	NOT SAMPLED (Cross Referenced)	
Site Reference	I13070000A	Licensed Material	N/A

No Asbestos Presumed in Sample

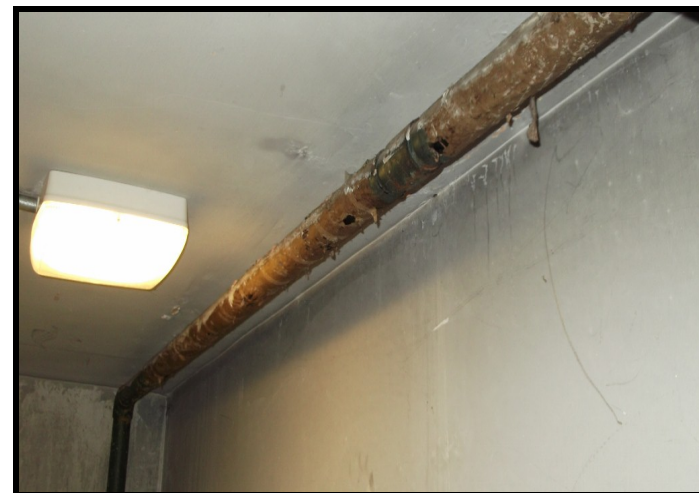
SAMPLE REFERENCE 158

Building	Floor	Room	Location	
Main Building	Ground Floor	Shed 4	Pipe Work	
Description	Unlagged pipe work, same as shed 17			
MATERIAL ASSESSMENT				SCORE
Product Type	Paper	Extent of Damage	Medium damage	-
Asbestos Type	No Asbestos Detected	Surface Treatment	Unsealed (2)	
PRIORITY ASSESSMENT				SCORE
Occupant Activity	Not Applicable	Extent / Amount	6.00 lm	-
Accessibility	Unlikely to be disturbed	Location	Not Applicable	
Avg Time in Use	Not Applicable	Frequency of Use	Not Applicable	
No. of Occupants	Not Applicable	Secondary Activity	Not Applicable	
Maintenance	Not Applicable	Maintenance Frequency	Not Applicable	
MANAGEMENT ACTION				SCORE
Recommendation	NO ACTION REQUIRED			-
Recommendation Due		Next Inspection	None	
Apply Labels	No	Permit to Work Required	No	
Survey Type	Management	Lead Surveyor	Jane Openshaw	
Survey Date	20 Mar 2012	UKAS Laboratory	DMW Environmental Safety Ltd / [P-96019]	
Site Reference	I13070000A	Licensed Material	N/A

Asbestos not detected in Sample

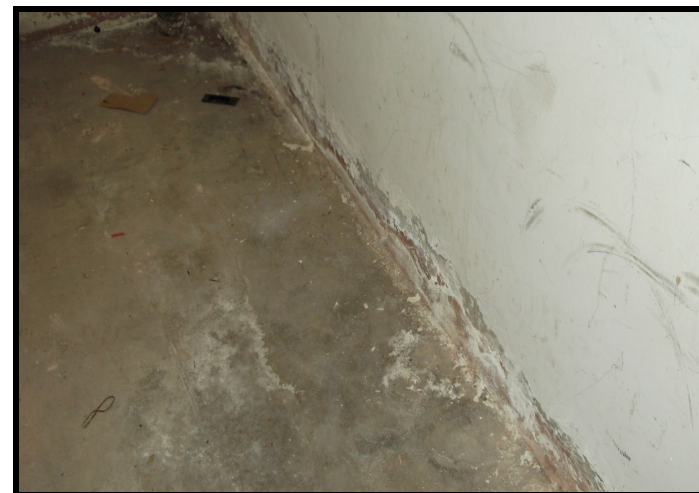
SAMPLE REFERENCE 159

Building	Floor	Room	Location	
Main Building	Ground Floor	Shed 4	Floor	
Description	Unlagged pipe work			
MATERIAL ASSESSMENT				SCORE
Product Type	Debris	Extent of Damage	High damage	-
Asbestos Type	No Asbestos Detected	Surface Treatment	Unsealed (3)	
PRIORITY ASSESSMENT				SCORE
Occupant Activity	Not Applicable	Extent / Amount	2.00 m2	-
Accessibility	Easily disturbed	Location	Not Applicable	
Avg Time in Use	Not Applicable	Frequency of Use	Not Applicable	
No. of Occupants	Not Applicable	Secondary Activity	Not Applicable	
Maintenance	Not Applicable	Maintenance Frequency	Not Applicable	
MANAGEMENT ACTION				SCORE
Recommendation	NO ACTION REQUIRED			-
Recommendation Due		Next Inspection	None	
Apply Labels	No	Permit to Work Required	No	
Survey Type	Management	Lead Surveyor	Jane Openshaw	
Survey Date	20 Mar 2012	UKAS Laboratory	DMW Environmental Safety Ltd / [P-96019]	
Site Reference	I13070000A	Licensed Material	N/A

Asbestos not detected in Sample

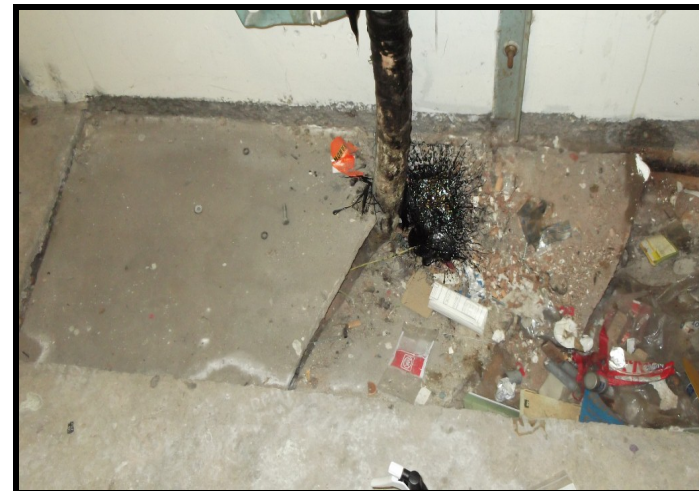
SAMPLE REFERENCE 161

Building	Floor	Room	Location	
Main Building	Ground Floor	MEB	Floor	
Description	To floor around income			
MATERIAL ASSESSMENT				SCORE
Product Type	Board	Extent of Damage	Medium damage	-
Asbestos Type	No Asbestos Detected	Surface Treatment	Unsealed (Board)	
PRIORITY ASSESSMENT				SCORE
Occupant Activity	Not Applicable	Extent / Amount	2.00 m2	-
Accessibility	Routinely disturbed	Location	Not Applicable	
Avg Time in Use	Not Applicable	Frequency of Use	Not Applicable	
No. of Occupants	Not Applicable	Secondary Activity	Not Applicable	
Maintenance	Not Applicable	Maintenance Frequency	Not Applicable	
MANAGEMENT ACTION				SCORE
Recommendation	NO ACTION REQUIRED			-
Recommendation Due		Next Inspection	None	
Apply Labels	No	Permit to Work Required	No	
Survey Type	Management	Lead Surveyor	Jane Openshaw	
Survey Date	20 Mar 2012	UKAS Laboratory	DMW Environmental Safety Ltd / [P-96019]	
Site Reference	I13070000A	Licensed Material	N/A

Asbestos not detected in Sample

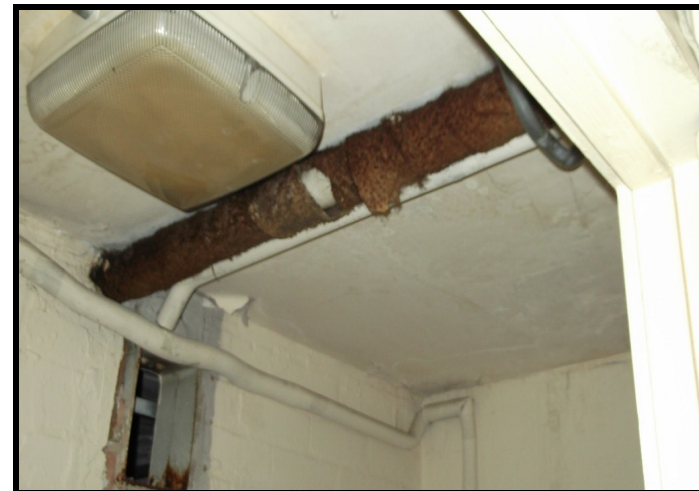
SAMPLE REFERENCE 163

Building	Floor	Room	Location	
Main Building	Ground Floor	W.C	Pipe Work	
Description	High level pipe work,			
MATERIAL ASSESSMENT				SCORE
Product Type	Rope	Extent of Damage	Medium damage	-
Asbestos Type	No Asbestos Detected	Surface Treatment	Unsealed (2)	
PRIORITY ASSESSMENT				SCORE
Occupant Activity	Not Applicable	Extent / Amount	21.00 lm	-
Accessibility	Unlikely to be disturbed	Location	Not Applicable	
Avg Time in Use	Not Applicable	Frequency of Use	Not Applicable	
No. of Occupants	Not Applicable	Secondary Activity	Not Applicable	
Maintenance	Not Applicable	Maintenance Frequency	Not Applicable	
MANAGEMENT ACTION				SCORE
Recommendation	NO ACTION REQUIRED			-
Recommendation Due		Next Inspection	None	
Apply Labels	No	Permit to Work Required	No	
Survey Type	Management	Lead Surveyor	Jane Openshaw	
Survey Date	20 Mar 2012	UKAS Laboratory	NOT SAMPLED (Cross Referenced)	
Site Reference	I13070000A	Licensed Material	N/A

No Asbestos Presumed in Sample

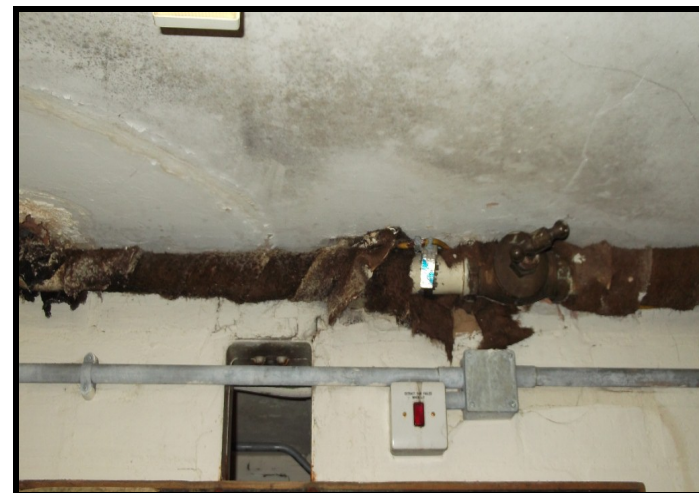
SAMPLE REFERENCE 164

Building	Floor	Room	Location	
Main Building	Ground Floor	Kitchen	Pipe Work	
Description	To high level pipe work, Timber built in cupboard			
MATERIAL ASSESSMENT				SCORE
Product Type	Rope	Extent of Damage	High damage	-
Asbestos Type	No Asbestos Detected	Surface Treatment	Unsealed (2)	
PRIORITY ASSESSMENT				SCORE
Occupant Activity	Not Applicable	Extent / Amount	31.00 lm	-
Accessibility	Unlikely to be disturbed	Location	Not Applicable	
Avg Time in Use	Not Applicable	Frequency of Use	Not Applicable	
No. of Occupants	Not Applicable	Secondary Activity	Not Applicable	
Maintenance	Not Applicable	Maintenance Frequency	Not Applicable	
MANAGEMENT ACTION				SCORE
Recommendation	NO ACTION REQUIRED			-
Recommendation Due		Next Inspection	None	
Apply Labels	No	Permit to Work Required	No	
Survey Type	Management	Lead Surveyor	Jane Openshaw	
Survey Date	20 Mar 2012	UKAS Laboratory	DMW Environmental Safety Ltd / [P-96019]

Asbestos not detected in Sample

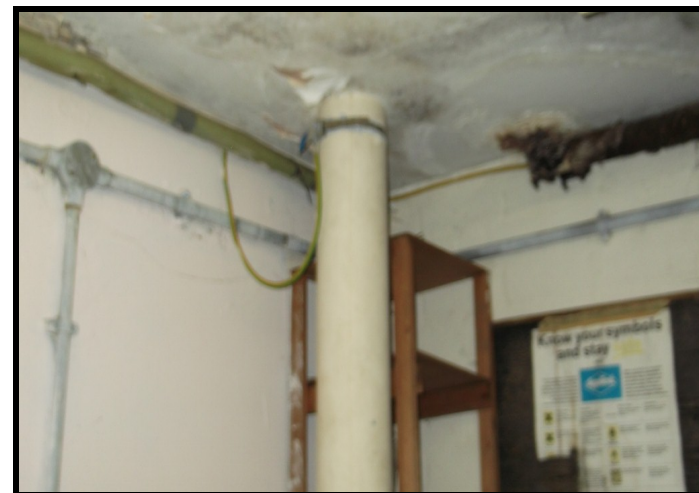
SAMPLE REFERENCE 165

Building	Floor	Room	Location	
Main Building	Ground Floor	Kitchen	Pipe Work	
Description	Pipe oppisite door, Timber built in cupboard, Old wall mounted electric bar heater			
MATERIAL ASSESSMENT				SCORE
Product Type	Cement	Extent of Damage	Good condition	5
Asbestos Type	Presumed ACM	Surface Treatment	Sealed (Cement products)	
PRIORITY ASSESSMENT				SCORE
Occupant Activity	Not Applicable	Extent / Amount	31.00 lm	1
Accessibility	Unlikely to be disturbed	Location	Not Applicable	
Avg Time in Use	Not Applicable	Frequency of Use	Not Applicable	
No. of Occupants	Not Applicable	Secondary Activity	Not Applicable	
Maintenance	Not Applicable	Maintenance Frequency	Not Applicable	
MANAGEMENT ACTION				SCORE
Recommendation	LABEL & MONITOR			6
Recommendation Due		Next Inspection	None	
Apply Labels	No	Permit to Work Required	No	
Survey Type	Management	Lead Surveyor	Jane Openshaw	
Survey Date	20 Mar 2012	UKAS Laboratory	NOT SAMPLED

Asbestos Presumed in Sample

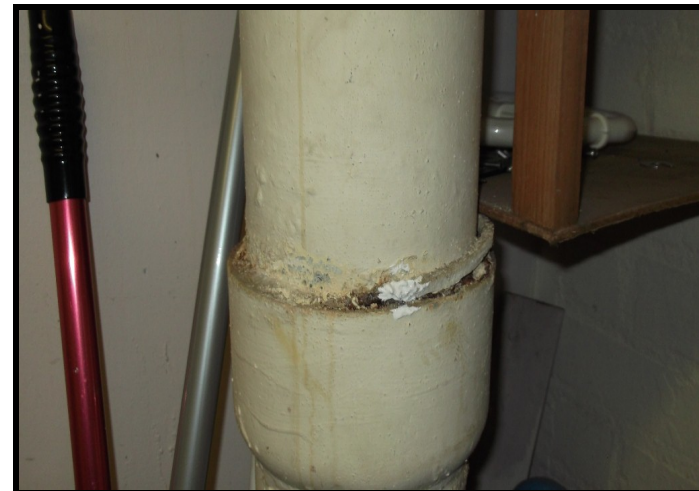
SAMPLE REFERENCE 166

Building	Floor	Room	Location	
Main Building	Ground Floor	Kitchen	Pipe Work	
Description	To down pipe, Timber built in cupboard, Old wall mounted electric bar heater			
MATERIAL ASSESSMENT				SCORE
Product Type	Gasket	Extent of Damage	Medium damage	-
Asbestos Type	No Asbestos Detected	Surface Treatment	Unsealed (2)	
PRIORITY ASSESSMENT				SCORE
Occupant Activity	Not Applicable	Extent / Amount	1.00 m2	-
Accessibility	Unlikely to be disturbed	Location	Not Applicable	
Avg Time in Use	Not Applicable	Frequency of Use	Not Applicable	
No. of Occupants	Not Applicable	Secondary Activity	Not Applicable	
Maintenance	Not Applicable	Maintenance Frequency	Not Applicable	
MANAGEMENT ACTION				SCORE
Recommendation	NO ACTION REQUIRED			-
Recommendation Due		Next Inspection	None	
Apply Labels	No	Permit to Work Required	No	
Survey Type	Management	Lead Surveyor	Jane Openshaw	
Survey Date	20 Mar 2012	UKAS Laboratory	DMW Environmental Safety Ltd / [P-96019]

Asbestos not detected in Sample

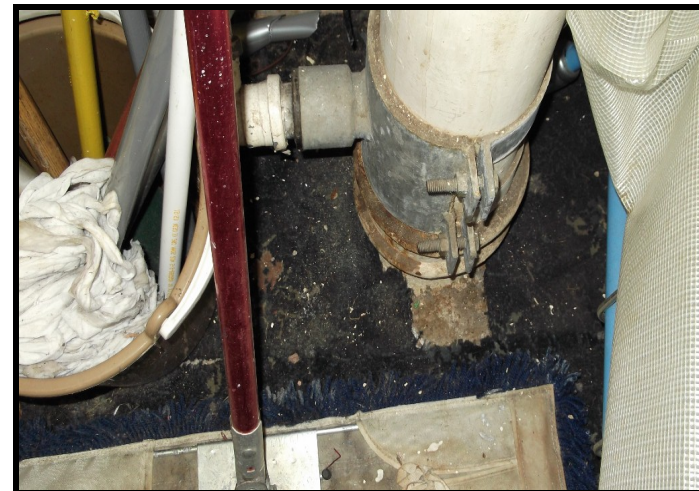
SAMPLE REFERENCE 167

Building	Floor	Room	Location	
Main Building	Ground Floor	Kitchen	Pipe Work	
Description	Near pipe, Timber built in cupboard, Old wall mounted electric bar heater			
MATERIAL ASSESSMENT				SCORE
Product Type	Debris	Extent of Damage	Medium damage	-
Asbestos Type	No Asbestos Detected	Surface Treatment	Unsealed (3)	
PRIORITY ASSESSMENT				SCORE
Occupant Activity	Not Applicable	Extent / Amount	1.00 m2	-
Accessibility	Easily disturbed	Location	Not Applicable	
Avg Time in Use	Not Applicable	Frequency of Use	Not Applicable	
No. of Occupants	Not Applicable	Secondary Activity	Not Applicable	
Maintenance	Not Applicable	Maintenance Frequency	Not Applicable	
MANAGEMENT ACTION				SCORE
Recommendation	NO ACTION REQUIRED			-
Recommendation Due		Next Inspection	None	
Apply Labels	No	Permit to Work Required	No	
Survey Type	Management	Lead Surveyor	Jane Openshaw	
Survey Date	20 Mar 2012	UKAS Laboratory	DMW Environmental Safety Ltd / [P-96019]

Asbestos not detected in Sample

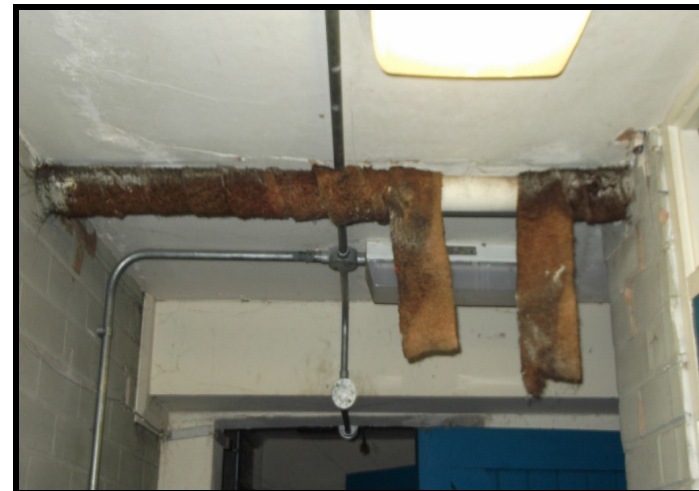
SAMPLE REFERENCE 172

Building	Floor	Room	Location	
Main Building	Ground Floor	Corridor 3	Pipe Work	
Description	To high level pipe, Timber boxing to pipe work			
MATERIAL ASSESSMENT				SCORE
Product Type	Rope	Extent of Damage	High damage	-
Asbestos Type	No Asbestos Detected	Surface Treatment	Unsealed (2)	
PRIORITY ASSESSMENT				SCORE
Occupant Activity	Not Applicable	Extent / Amount	21.00 lm	-
Accessibility	Unlikely to be disturbed	Location	Not Applicable	
Avg Time in Use	Not Applicable	Frequency of Use	Not Applicable	
No. of Occupants	Not Applicable	Secondary Activity	Not Applicable	
Maintenance	Not Applicable	Maintenance Frequency	Not Applicable	
MANAGEMENT ACTION				SCORE
Recommendation	NO ACTION REQUIRED			-
Recommendation Due		Next Inspection	None	
Apply Labels	No	Permit to Work Required	No	
Survey Type	Management	Lead Surveyor	Jane Openshaw	
Survey Date	20 Mar 2012	UKAS Laboratory	NOT SAMPLED (Cross Referenced)	
Site Reference	I13070000A	Licensed Material	N/A

No Asbestos Presumed in Sample

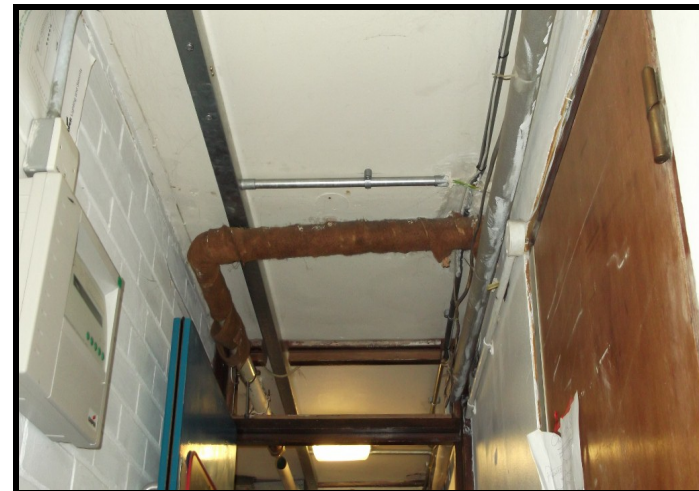
SAMPLE REFERENCE 173

Building	Floor	Room	Location	
Main Building	Ground Floor	Corridor 3	Pipe Work	
Description	To high level pipe, Timber boxing to pipe work			
MATERIAL ASSESSMENT				SCORE
Product Type	Rope	Extent of Damage	High damage	-
Asbestos Type	No Asbestos Detected	Surface Treatment	Unsealed (2)	
PRIORITY ASSESSMENT				SCORE
Occupant Activity	Not Applicable	Extent / Amount	31.00 lm	-
Accessibility	Unlikely to be disturbed	Location	Not Applicable	
Avg Time in Use	Not Applicable	Frequency of Use	Not Applicable	
No. of Occupants	Not Applicable	Secondary Activity	Not Applicable	
Maintenance	Not Applicable	Maintenance Frequency	Not Applicable	
MANAGEMENT ACTION				SCORE
Recommendation	NO ACTION REQUIRED			-
Recommendation Due		Next Inspection	None	
Apply Labels	No	Permit to Work Required	No	
Survey Type	Management	Lead Surveyor	Jane Openshaw	
Survey Date	20 Mar 2012	UKAS Laboratory	NOT SAMPLED (Cross Referenced)	
Site Reference	I13070000A	Licensed Material	N/A

No Asbestos Presumed in Sample

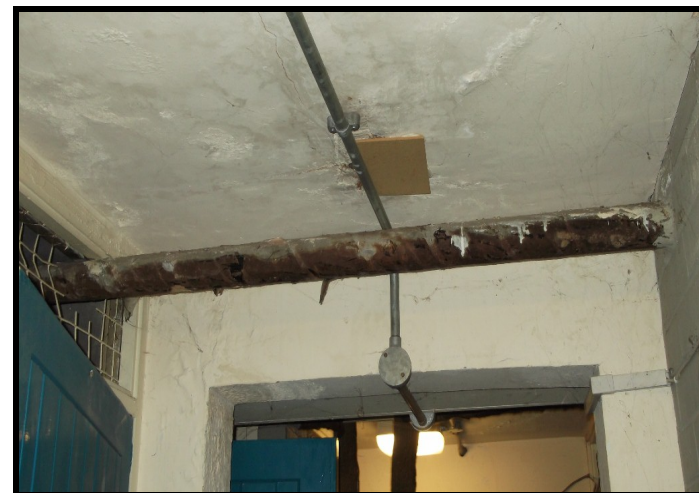
SAMPLE REFERENCE 174

Building	Floor	Room	Location	
Main Building	Ground Floor	Corridor 3	Pipe Work	
Description	To pipe, Timber boxing to pipe work			
MATERIAL ASSESSMENT				SCORE
Product Type	Paper	Extent of Damage	Medium damage	-
Asbestos Type	No Asbestos Detected	Surface Treatment	Unsealed (I)	
PRIORITY ASSESSMENT				SCORE
Occupant Activity	Not Applicable	Extent / Amount	21.00 lm	-
Accessibility	Unlikely to be disturbed	Location	Not Applicable	
Avg Time in Use	Not Applicable	Frequency of Use	Not Applicable	
No. of Occupants	Not Applicable	Secondary Activity	Not Applicable	
Maintenance	Not Applicable	Maintenance Frequency	Not Applicable	
MANAGEMENT ACTION				SCORE
Recommendation	NO ACTION REQUIRED			-
Recommendation Due		Next Inspection	None	
Apply Labels	No	Permit to Work Required	No	
Survey Type	Management	Lead Surveyor	Jane Openshaw	
Survey Date	20 Mar 2012	UKAS Laboratory	NOT SAMPLED (Cross Referenced)	
Site Reference	I13070000A	Licensed Material	N/A

No Asbestos Presumed in Sample

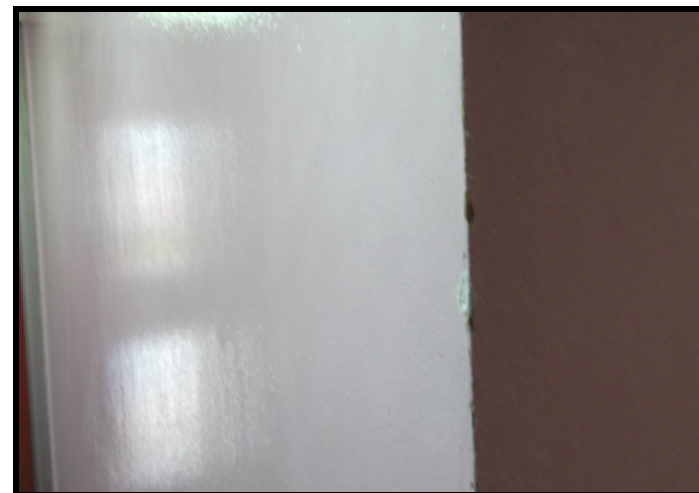
SAMPLE REFERENCE 175

Building	Floor	Room	Location	
Main Building	Ground Floor	Corridor I	Walls	
Description				
MATERIAL ASSESSMENT				SCORE
Product Type	Paint	Extent of Damage	Low damage	-
Asbestos Type	No Asbestos Detected	Surface Treatment	Sealed (I)	
PRIORITY ASSESSMENT				SCORE
Occupant Activity	Not Applicable	Extent / Amount	20.00 m2	-
Accessibility	Easily disturbed	Location	Not Applicable	
Avg Time in Use	Not Applicable	Frequency of Use	Not Applicable	
No. of Occupants	Not Applicable	Secondary Activity	Not Applicable	
Maintenance	Not Applicable	Maintenance Frequency	Not Applicable	
MANAGEMENT ACTION				SCORE
Recommendation	NO ACTION REQUIRED			-
Recommendation Due		Next Inspection	None	
Apply Labels	No	Permit to Work Required	No	
Survey Type	Management	Lead Surveyor	Jane Openshaw	
Survey Date	20 Mar 2012	UKAS Laboratory	DMW Environmental Safety Ltd / [P-96019]	
Site Reference	I13070000A	Licensed Material	N/A

Asbestos not detected in Sample

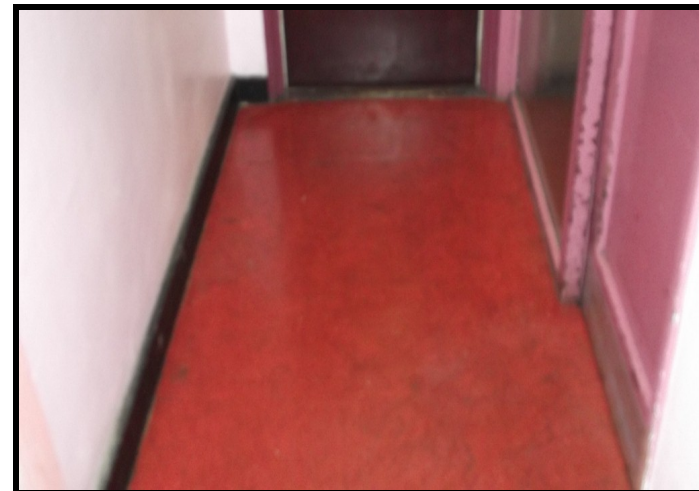
SAMPLE REFERENCE 176

Building	Floor	Room	Location	
Main Building	Ground Floor	Corridor I	Floor	
Description	Red,			
MATERIAL ASSESSMENT				SCORE
Product Type	Paper	Extent of Damage	Low damage	-
Asbestos Type	No Asbestos Detected	Surface Treatment	Sealed (1)	
PRIORITY ASSESSMENT				SCORE
Occupant Activity	Not Applicable	Extent / Amount	8.00 m2	-
Accessibility	Unlikely to be disturbed	Location	Not Applicable	
Avg Time in Use	Not Applicable	Frequency of Use	Not Applicable	
No. of Occupants	Not Applicable	Secondary Activity	Not Applicable	
Maintenance	Not Applicable	Maintenance Frequency	Not Applicable	
MANAGEMENT ACTION				SCORE
Recommendation	NO ACTION REQUIRED			-
Recommendation Due		Next Inspection	None	
Apply Labels	No	Permit to Work Required	No	
Survey Type	Management	Lead Surveyor	Jane Openshaw	
Survey Date	20 Mar 2012	UKAS Laboratory	NOT SAMPLED (Cross Referenced)	
Site Reference	I13070000A	Licensed Material	N/A

No Asbestos Presumed in Sample

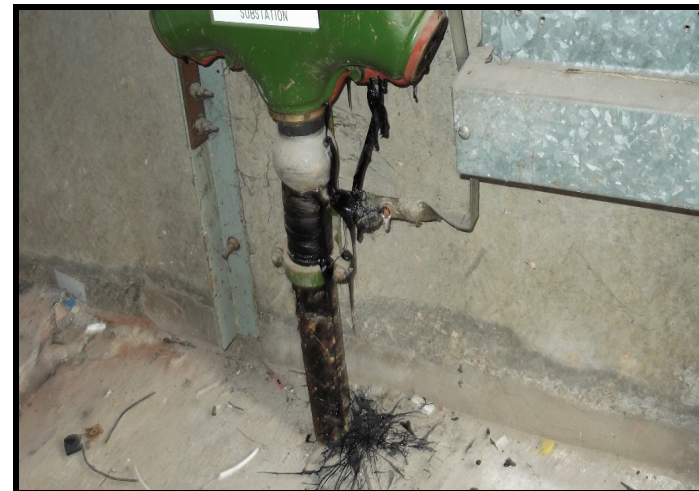
SAMPLE REFERENCE 178

MATERIAL ASSESSMENT				SCORE
Product Type	Bitumen	Extent of Damage	Good condition	4
Asbestos Type	Presumed ACM	Surface Treatment	Composite materials

Asbestos Presumed in Sample

MANAGEMENT ACTION				SCORE
Recommendation	LABEL & MONITOR			4
Recommendation Due		Next Inspection	None	
Apply Labels	No	Permit to Work Required	No

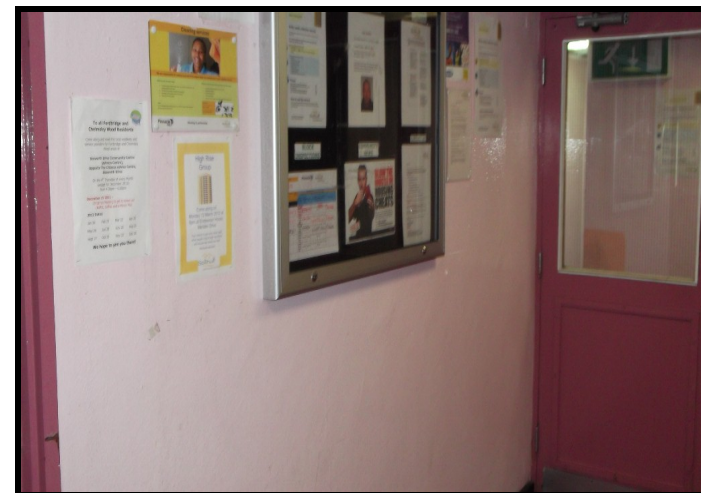
SAMPLE REFERENCE 179

Building	Floor	Room	Location	
Main Building	Ground Floor	Lift Lobby	Walls	
Description				
MATERIAL ASSESSMENT				SCORE
Product Type	Paint	Extent of Damage	Low damage	-
Asbestos Type	No Asbestos Detected	Surface Treatment	Sealed (1)	
PRIORITY ASSESSMENT				SCORE
Occupant Activity	Not Applicable	Extent / Amount	11.00 m2	-
Accessibility	Easily disturbed	Location	Not Applicable	
Avg Time in Use	Not Applicable	Frequency of Use	Not Applicable	
No. of Occupants	Not Applicable	Secondary Activity	Not Applicable	
Maintenance	Not Applicable	Maintenance Frequency	Not Applicable	
MANAGEMENT ACTION				SCORE
Recommendation	NO ACTION REQUIRED			-
Recommendation Due		Next Inspection	None	
Apply Labels	No	Permit to Work Required	No	
Survey Type	Management	Lead Surveyor	Jane Openshaw	
Survey Date	20 Mar 2012	UKAS Laboratory	NOT SAMPLED (Cross Referenced)	
Site Reference	113070000A	Licensed Material	N/A

No Asbestos Presumed in Sample

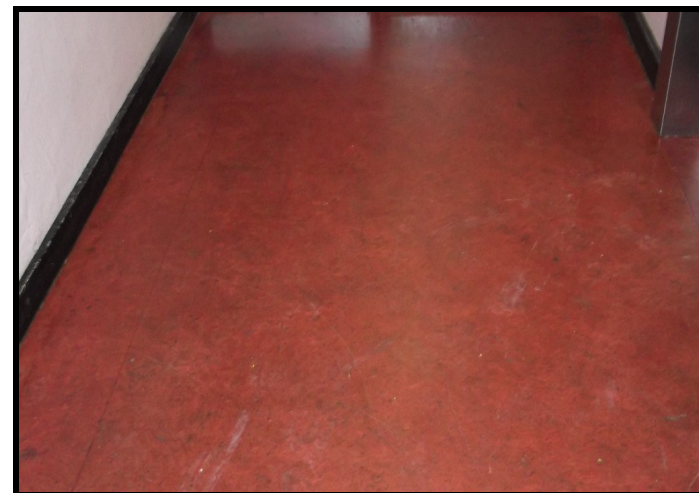
SAMPLE REFERENCE 180

Building	Floor	Room	Location	
Main Building	Ground Floor	Lift Lobby	Floor	
Description	Red			
MATERIAL ASSESSMENT				SCORE
Product Type	Paper	Extent of Damage	Good condition	-
Asbestos Type	No Asbestos Detected	Surface Treatment	Sealed (1)	
PRIORITY ASSESSMENT				SCORE
Occupant Activity	Not Applicable	Extent / Amount	10.00 m2	-
Accessibility	Unlikely to be disturbed	Location	Not Applicable	
Avg Time in Use	Not Applicable	Frequency of Use	Not Applicable	
No. of Occupants	Not Applicable	Secondary Activity	Not Applicable	
Maintenance	Not Applicable	Maintenance Frequency	Not Applicable	
MANAGEMENT ACTION				SCORE
Recommendation	NO ACTION REQUIRED			-
Recommendation Due		Next Inspection	None	
Apply Labels	No	Permit to Work Required	No	
Survey Type	Management	Lead Surveyor	Jane Openshaw	
Survey Date	20 Mar 2012	UKAS Laboratory	NOT SAMPLED (Cross Referenced)	
Site Reference	113070000A	Licensed Material	N/A

No Asbestos Presumed in Sample

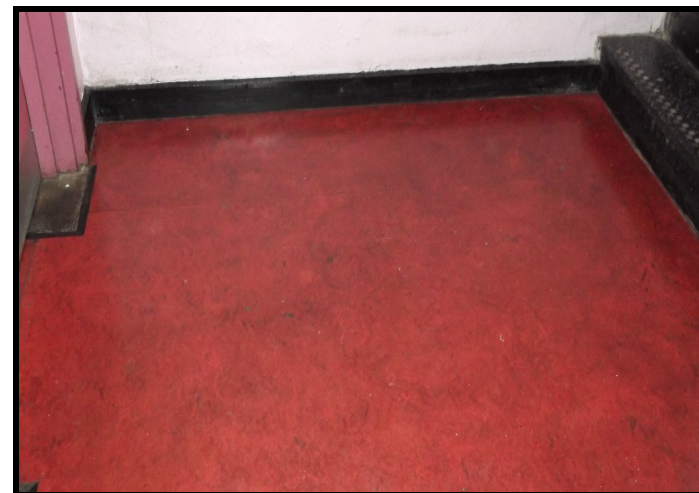
SAMPLE REFERENCE 181

Building	Floor	Room	Location	
Main Building	Ground Floor	Stairs	Floor	
Description	Red			
MATERIAL ASSESSMENT				SCORE
Product Type	Paper	Extent of Damage	Good condition	-
Asbestos Type	No Asbestos Detected	Surface Treatment	Sealed (1)	
PRIORITY ASSESSMENT				SCORE
Occupant Activity	Not Applicable	Extent / Amount	8.00 m2	-
Accessibility	Unlikely to be disturbed	Location	Not Applicable	
Avg Time in Use	Not Applicable	Frequency of Use	Not Applicable	
No. of Occupants	Not Applicable	Secondary Activity	Not Applicable	
Maintenance	Not Applicable	Maintenance Frequency	Not Applicable	
MANAGEMENT ACTION				SCORE
Recommendation	NO ACTION REQUIRED			-
Recommendation Due		Next Inspection	None	
Apply Labels	No	Permit to Work Required	No	
Survey Type	Management	Lead Surveyor	Jane Openshaw	
Survey Date	20 Mar 2012	UKAS Laboratory	NOT SAMPLED (Cross Referenced)	
Site Reference	I13070000A	Licensed Material	N/A

No Asbestos Presumed in Sample

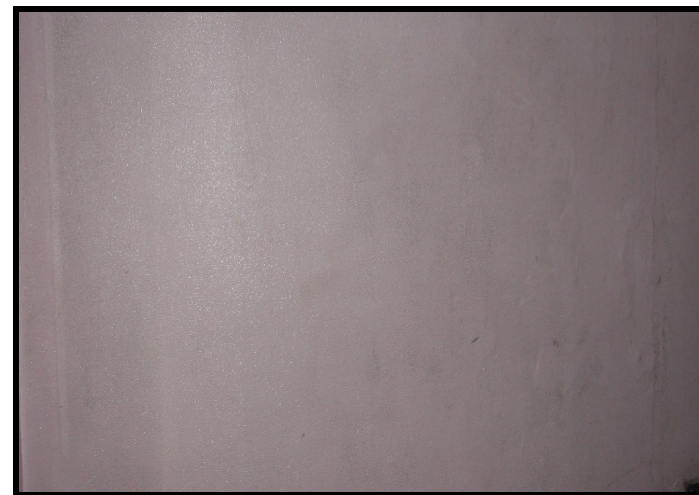
SAMPLE REFERENCE 182

MATERIAL ASSESSMENT				SCORE
Product Type	Paint	Extent of Damage	Good condition	-
Asbestos Type	No Asbestos Detected	Surface Treatment	Sealed (1)

MANAGEMENT ACTION				SCORE
Recommendation	NO ACTION REQUIRED			-
Recommendation Due		Next Inspection	None	
Apply Labels	No	Permit to Work Required	No

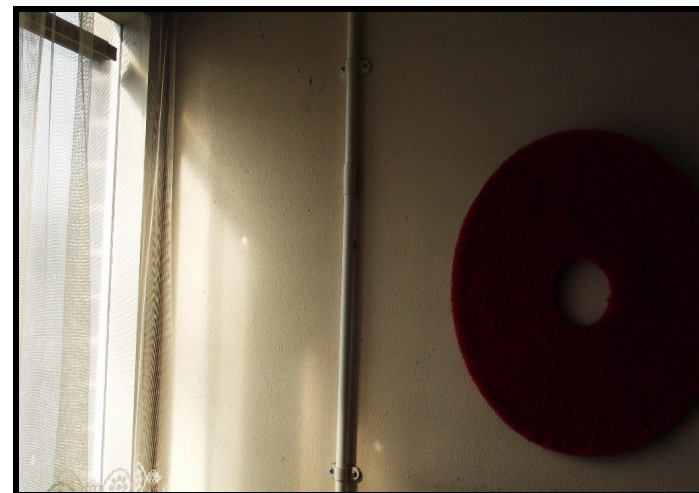
SAMPLE REFERENCE 183

Building	Floor	Room	Location	
Main Building	Ground Floor	Corridor 2	Walls	
Description				
MATERIAL ASSESSMENT				SCORE
Product Type	Paint	Extent of Damage	Good condition	-
Asbestos Type	No Asbestos Detected	Surface Treatment	Sealed (1)	
PRIORITY ASSESSMENT				SCORE
Occupant Activity	Not Applicable	Extent / Amount	20.00 m2	-
Accessibility	Easily disturbed	Location	Not Applicable	
Avg Time in Use	Not Applicable	Frequency of Use	Not Applicable	
No. of Occupants	Not Applicable	Secondary Activity	Not Applicable	
Maintenance	Not Applicable	Maintenance Frequency	Not Applicable	
MANAGEMENT ACTION				SCORE
Recommendation	NO ACTION REQUIRED			-
Recommendation Due		Next Inspection	None	
Apply Labels	No	Permit to Work Required	No	
Survey Type	Management	Lead Surveyor	Jane Openshaw	
Survey Date	20 Mar 2012	UKAS Laboratory	NOT SAMPLED (Cross Referenced)	
Site Reference	I13070000A	Licensed Material	N/A

No Asbestos Presumed in Sample

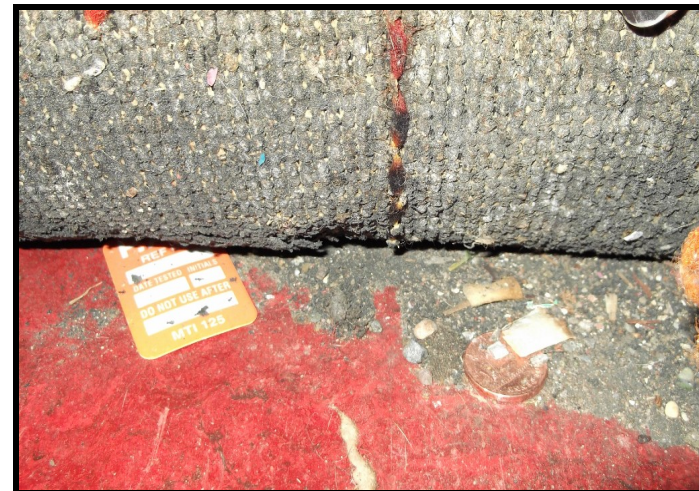
SAMPLE REFERENCE 184

Building	Floor	Room	Location	
Main Building	Ground Floor	Corridor 2	Floor	
Description	Red			
MATERIAL ASSESSMENT				SCORE
Product Type	Paper	Extent of Damage	Good condition	-
Asbestos Type	No Asbestos Detected	Surface Treatment	Sealed (1)	
PRIORITY ASSESSMENT				SCORE
Occupant Activity	Not Applicable	Extent / Amount	18.00 m2	-
Accessibility	Unlikely to be disturbed	Location	Not Applicable	
Avg Time in Use	Not Applicable	Frequency of Use	Not Applicable	
No. of Occupants	Not Applicable	Secondary Activity	Not Applicable	
Maintenance	Not Applicable	Maintenance Frequency	Not Applicable	
MANAGEMENT ACTION				SCORE
Recommendation	NO ACTION REQUIRED			-
Recommendation Due		Next Inspection	None	
Apply Labels	No	Permit to Work Required	No	
Survey Type	Management	Lead Surveyor	Jane Openshaw	
Survey Date	20 Mar 2012	UKAS Laboratory	NOT SAMPLED (Cross Referenced)	
Site Reference	113070000A	Licensed Material	N/A

No Asbestos Presumed in Sample

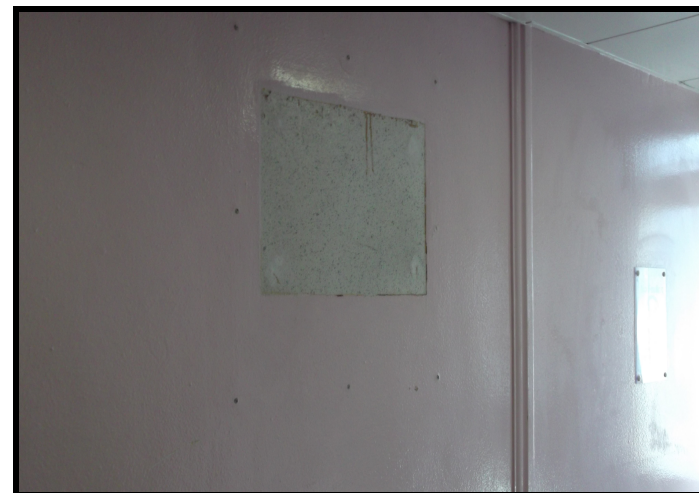
SAMPLE REFERENCE 188

Building	Floor	Room	Location	
Main Building	Ground Floor	Cleaners Room	Walls	
Description				
MATERIAL ASSESSMENT				SCORE
Product Type	Paint	Extent of Damage	Good condition	-
Asbestos Type	No Asbestos Detected	Surface Treatment	Sealed (1)	
PRIORITY ASSESSMENT				SCORE
Occupant Activity	Not Applicable	Extent / Amount	20.00 m2	-
Accessibility	Easily disturbed	Location	Not Applicable	
Avg Time in Use	Not Applicable	Frequency of Use	Not Applicable	
No. of Occupants	Not Applicable	Secondary Activity	Not Applicable	
Maintenance	Not Applicable	Maintenance Frequency	Not Applicable	
MANAGEMENT ACTION				SCORE
Recommendation	NO ACTION REQUIRED			-
Recommendation Due		Next Inspection	None	
Apply Labels	No	Permit to Work Required	No	
Survey Type	Management	Lead Surveyor	Jane Openshaw	
Survey Date	20 Mar 2012	UKAS Laboratory	NOT SAMPLED (Cross Referenced)	
Site Reference	113070000A	Licensed Material	N/A

No Asbestos Presumed in Sample

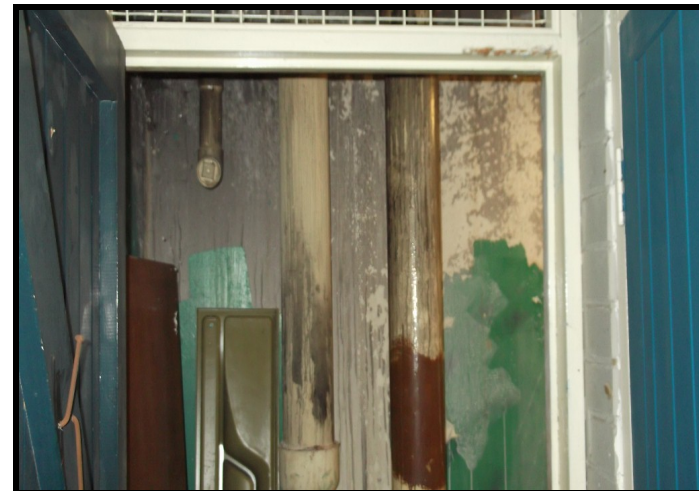
SAMPLE REFERENCE 190

Building	Floor	Room	Location
Main Building	Ground Floor	Shed 17	Pipe Work
Description	Left pipe		
MATERIAL ASSESSMENT			
Product Type	Cement	Extent of Damage	Good condition
Asbestos Type	Presumed ACM	Surface Treatment	Sealed (Cement products)
			5
PRIORITY ASSESSMENT			
Occupant Activity	Not Applicable	Extent / Amount	31.00 lm
Accessibility	Unlikely to be disturbed	Location	Not Applicable
Avg Time in Use	Not Applicable	Frequency of Use	Not Applicable
No. of Occupants	Not Applicable	Secondary Activity	Not Applicable
Maintenance	Not Applicable	Maintenance Frequency	Not Applicable
			1
MANAGEMENT ACTION			
Recommendation	LABEL & MONITOR		
Recommendation Due		Next Inspection	20 Mar 2013
Apply Labels	No	Permit to Work Required	No
			6
Survey Type	Management	Lead Surveyor	Jane Openshaw
Survey Date	20 Mar 2012	UKAS Laboratory	NOT SAMPLED
Site Reference	113070000A	Licensed Material	No

Asbestos Presumed in Sample

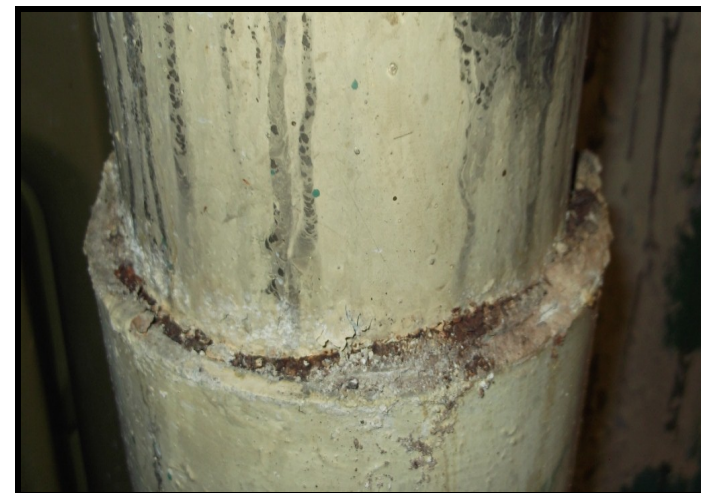
SAMPLE REFERENCE 191

Building	Floor	Room	Location	
Main Building	Ground Floor	Shed 17	Pipe Work	
Description	To down pipe			
MATERIAL ASSESSMENT				SCORE
Product Type	Gasket	Extent of Damage	Low damage	-
Asbestos Type	No Asbestos Detected	Surface Treatment	Sealed (1)	
PRIORITY ASSESSMENT				SCORE
Occupant Activity	Not Applicable	Extent / Amount	1.00 m2	-
Accessibility	Unlikely to be disturbed	Location	Not Applicable	
Avg Time in Use	Not Applicable	Frequency of Use	Not Applicable	
No. of Occupants	Not Applicable	Secondary Activity	Not Applicable	
Maintenance	Not Applicable	Maintenance Frequency	Not Applicable	
MANAGEMENT ACTION				SCORE
Recommendation	NO ACTION REQUIRED			-
Recommendation Due		Next Inspection	None	
Apply Labels	No	Permit to Work Required	No	
Survey Type	Management	Lead Surveyor	Jane Openshaw	
Survey Date	20 Mar 2012	UKAS Laboratory	NOT SAMPLED (Cross Referenced)	
Site Reference	113070000A	Licensed Material	N/A

No Asbestos Presumed in Sample

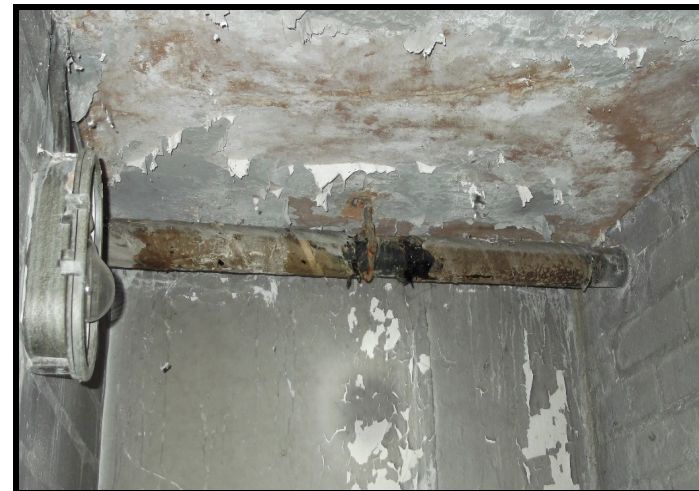
SAMPLE REFERENCE 192

Building	Floor	Room	Location	
Main Building	Ground Floor	Shed 13	Pipe Work	
Description	To pipe			
MATERIAL ASSESSMENT				SCORE
Product Type	Paper	Extent of Damage	Medium damage	-
Asbestos Type	No Asbestos Detected	Surface Treatment	Unsealed (2)	
PRIORITY ASSESSMENT				SCORE
Occupant Activity	Not Applicable	Extent / Amount	1.00 m2	-
Accessibility	Unlikely to be disturbed	Location	Not Applicable	
Avg Time in Use	Not Applicable	Frequency of Use	Not Applicable	
No. of Occupants	Not Applicable	Secondary Activity	Not Applicable	
Maintenance	Not Applicable	Maintenance Frequency	Not Applicable	
MANAGEMENT ACTION				SCORE
Recommendation	NO ACTION REQUIRED			-
Recommendation Due		Next Inspection	None	
Apply Labels	No	Permit to Work Required	No	
Survey Type	Management	Lead Surveyor	Jane Openshaw	
Survey Date	20 Mar 2012	UKAS Laboratory	NOT SAMPLED (Cross Referenced)	
Site Reference	I13070000A	Licensed Material	N/A

No Asbestos Presumed in Sample
