# Solihull Community Housing

## Asbestos Management Survey Report

**Catesby House I-36 (Communal)**  
**Kingshurst Way**  
**Solihull**  
**B37 6DZ**

**Date of Report:** 15 Jan 2015  
**Survey Ref:** 257900000A

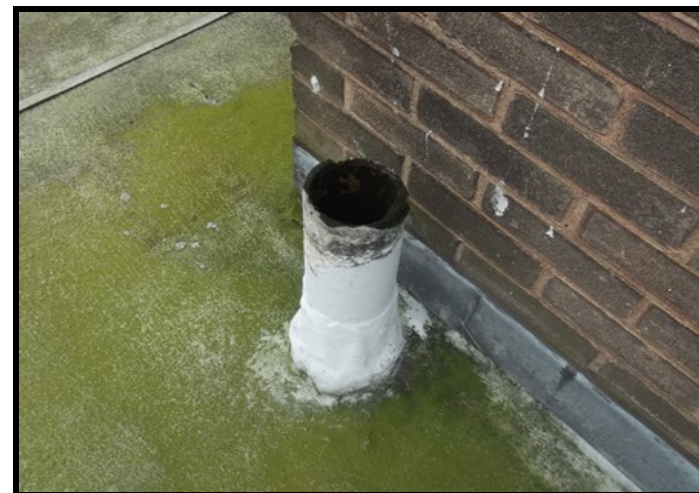
## SAMPLE REFERENCE 002

**Asbestos detected in Sample**

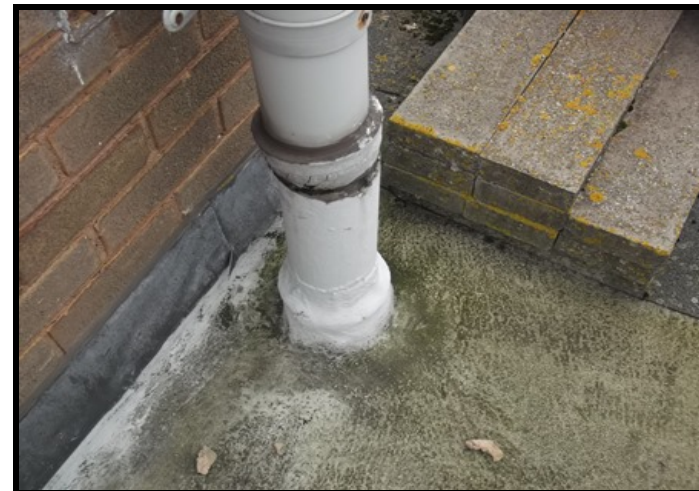
## SAMPLE REFERENCE 002a

**Asbestos detected in Sample**

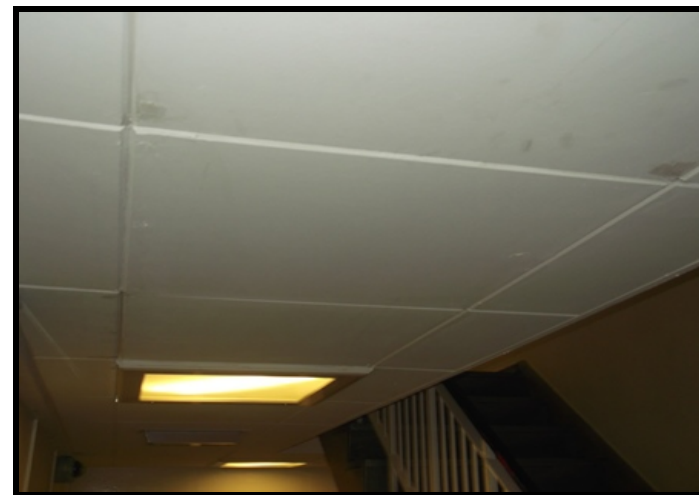
## SAMPLE REFERENCE 004

Asbestos not detected in Sample

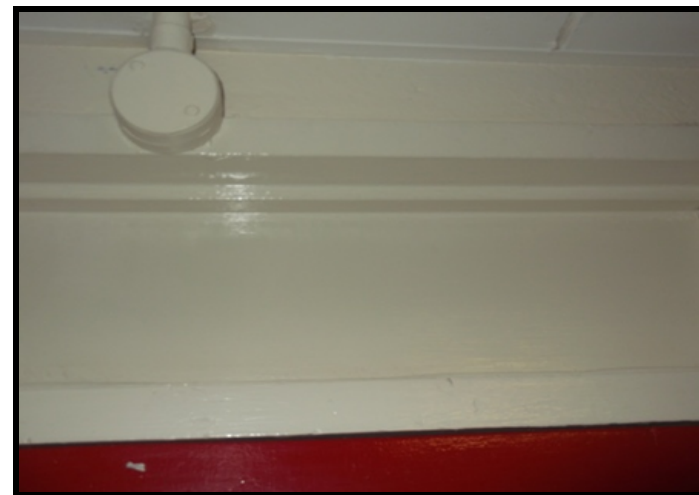
## SAMPLE REFERENCE 012

Asbestos not detected in Sample

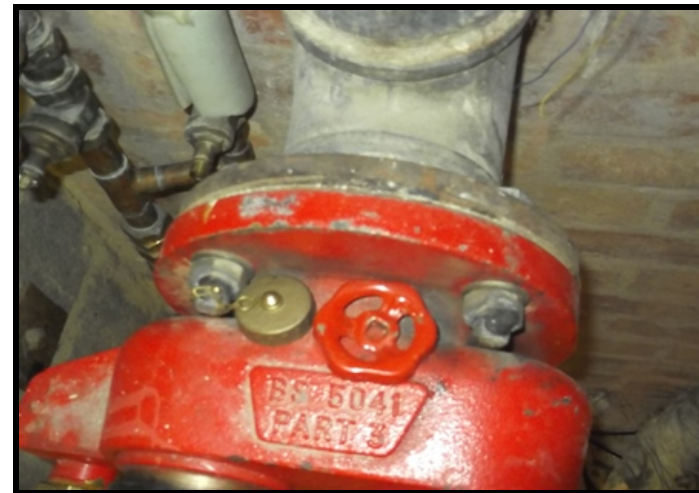
## SAMPLE REFERENCE 012a

Asbestos not detected in Sample

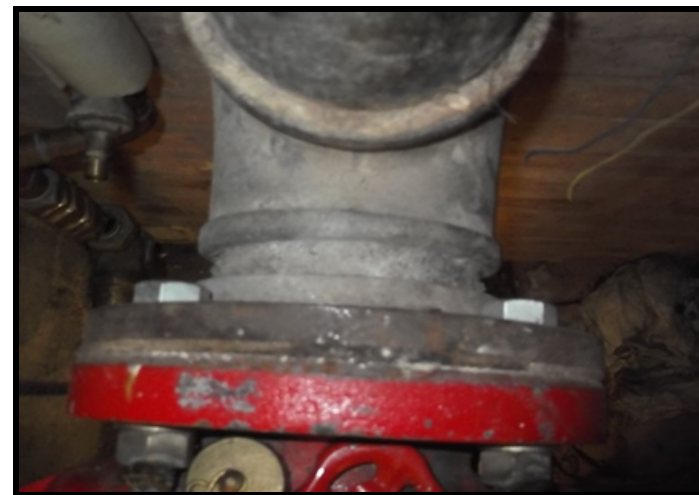
## SAMPLE REFERENCE 012b

Asbestos not detected in Sample

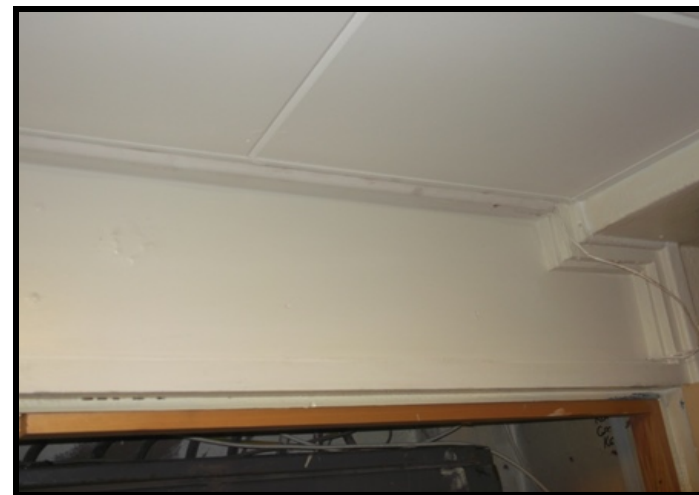
## SAMPLE REFERENCE 013

Asbestos not detected in Sample

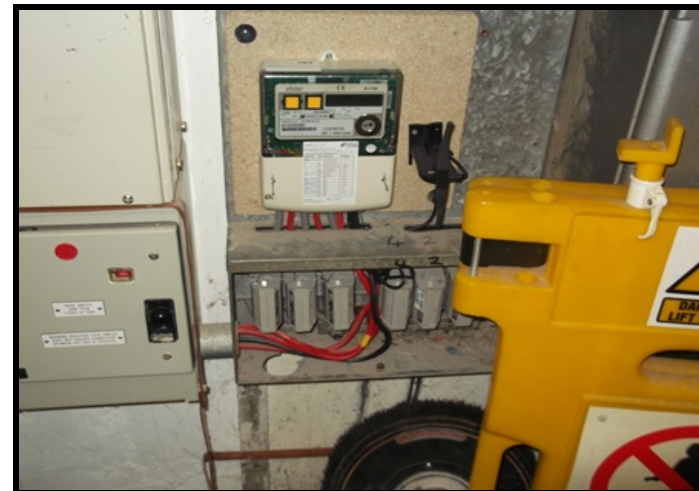
## SAMPLE REFERENCE 013a

**Asbestos Presumed**

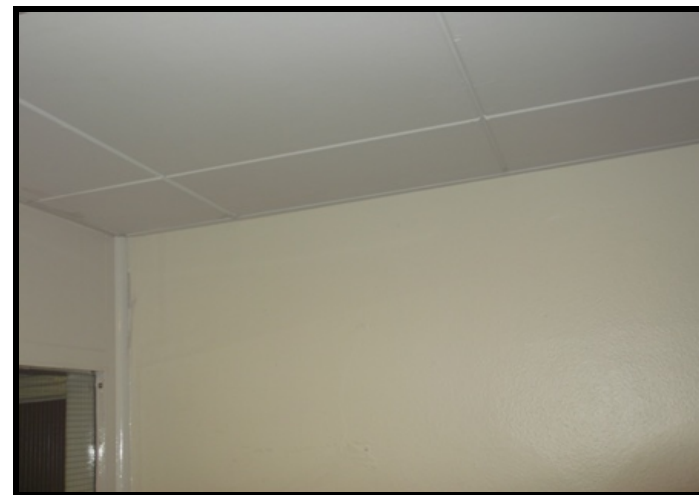
## SAMPLE REFERENCE 014

**No Asbestos Presumed in Sample**

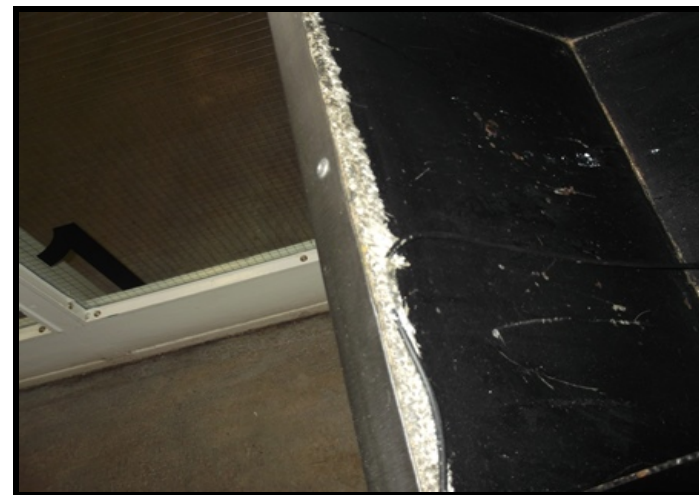
## SAMPLE REFERENCE 014a

**No Asbestos Presumed in Sample**

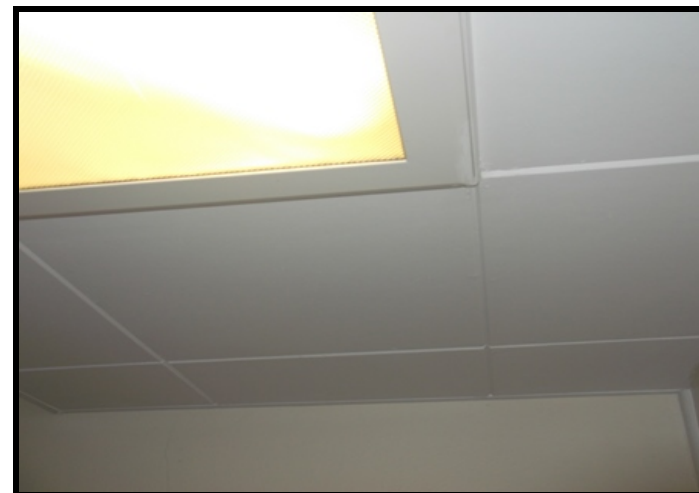
## SAMPLE REFERENCE 018

**No Asbestos Presumed in Sample**

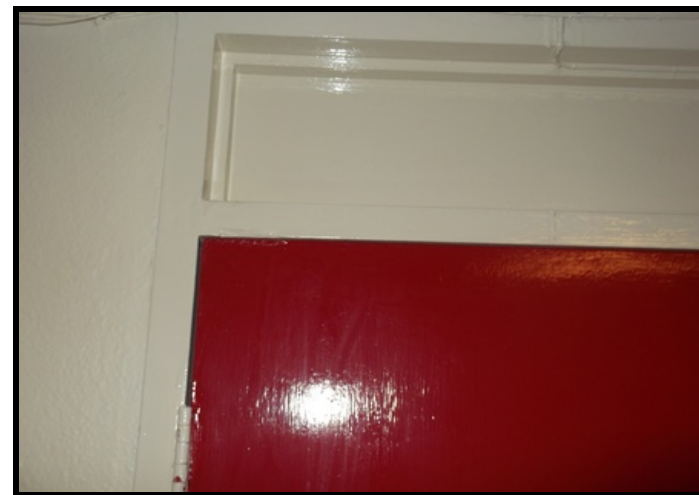
## SAMPLE REFERENCE 022

**No Asbestos Presumed in Sample**

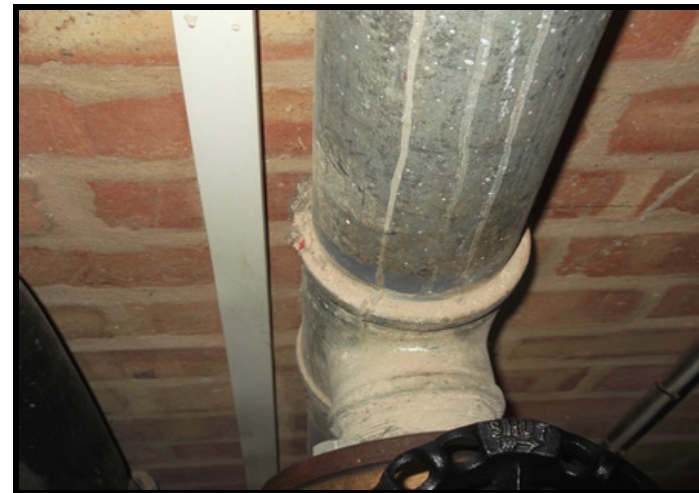
## SAMPLE REFERENCE 022a

**No Asbestos Presumed in Sample**

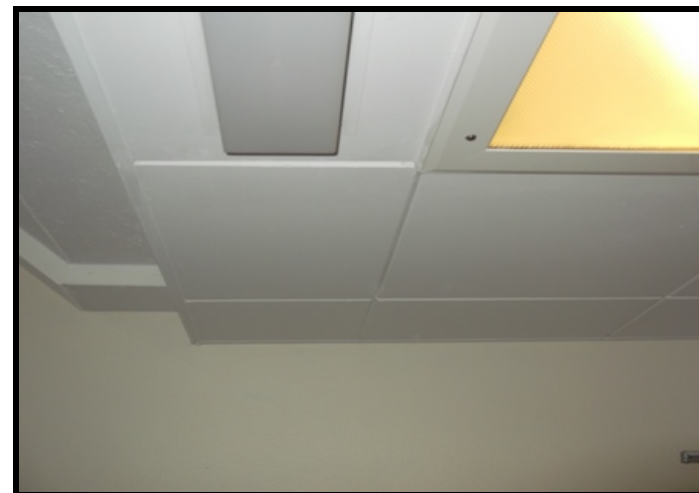
## SAMPLE REFERENCE 024

**No Asbestos Presumed in Sample**

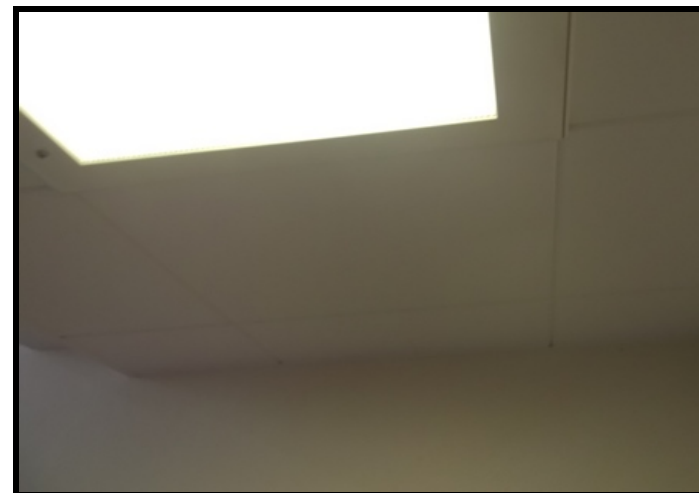
## SAMPLE REFERENCE 027

**No Asbestos Presumed in Sample**

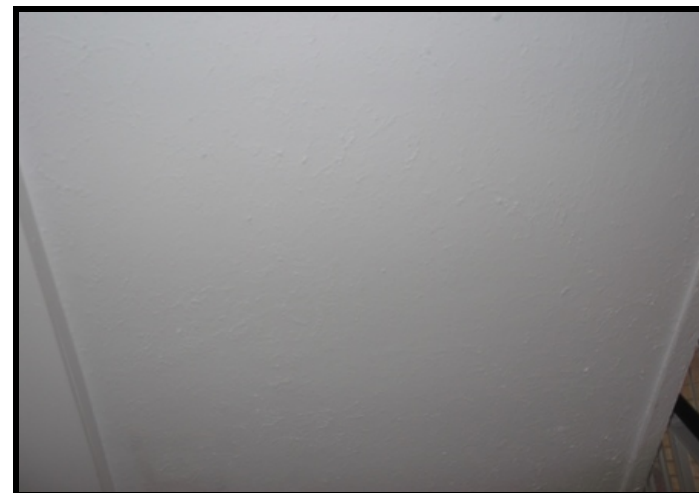
## SAMPLE REFERENCE 030

**No Asbestos Presumed in Sample**

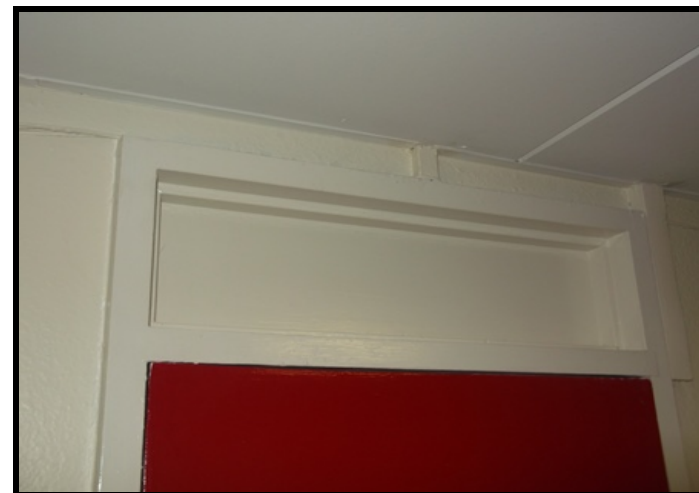
## SAMPLE REFERENCE 031

**No Asbestos Presumed in Sample**

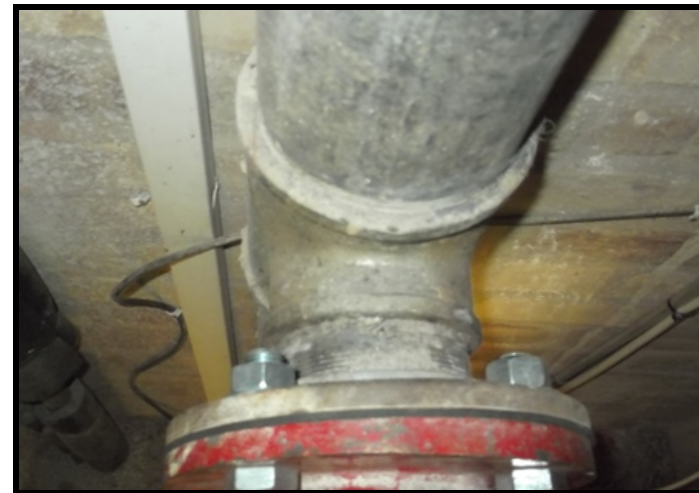
## SAMPLE REFERENCE 031a

**No Asbestos Presumed in Sample**

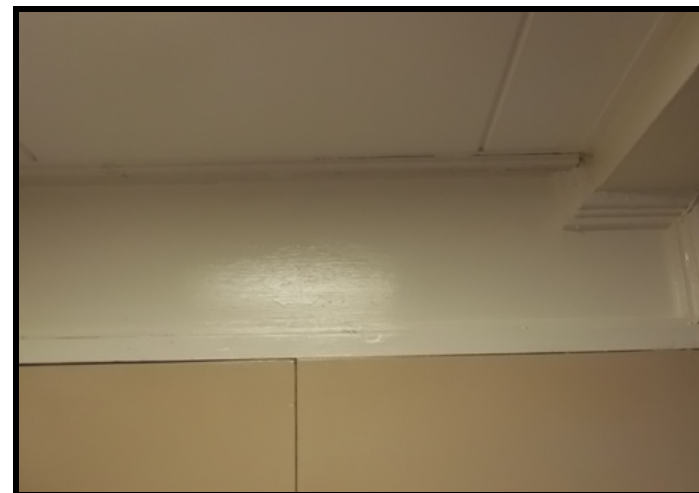
## SAMPLE REFERENCE 032

**No Asbestos Presumed in Sample**

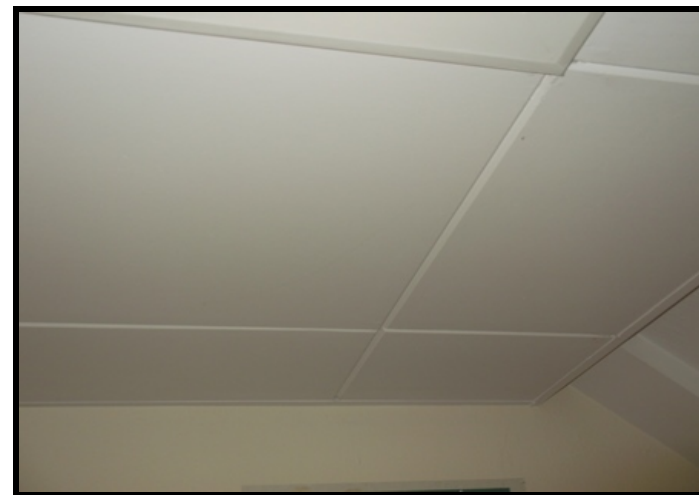
## SAMPLE REFERENCE 033

**No Asbestos Presumed in Sample**

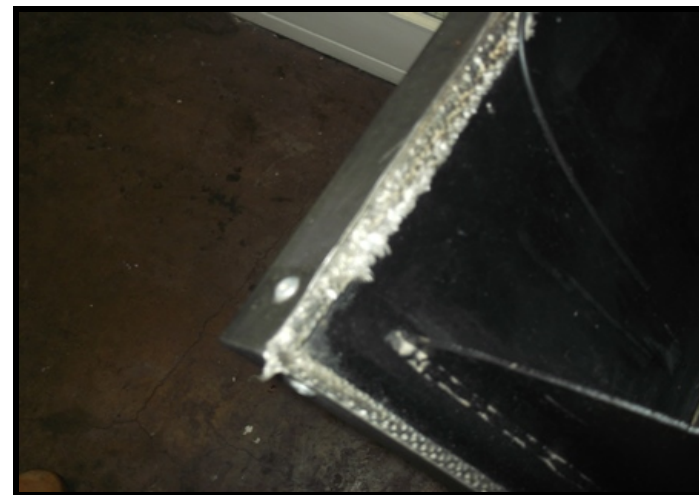
## SAMPLE REFERENCE 033a

**No Asbestos Presumed in Sample**

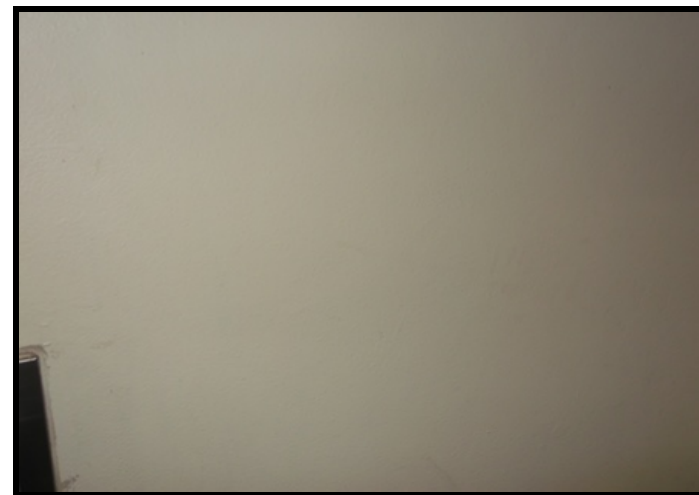
## SAMPLE REFERENCE 034

**No Asbestos Presumed in Sample**

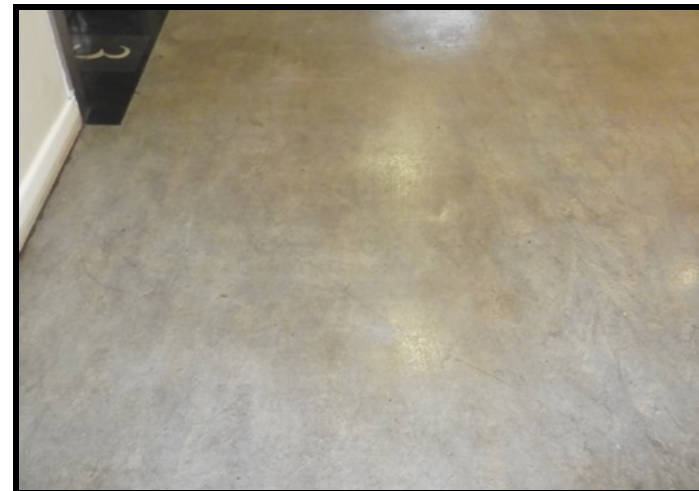
## SAMPLE REFERENCE 035

**No Asbestos Presumed in Sample**

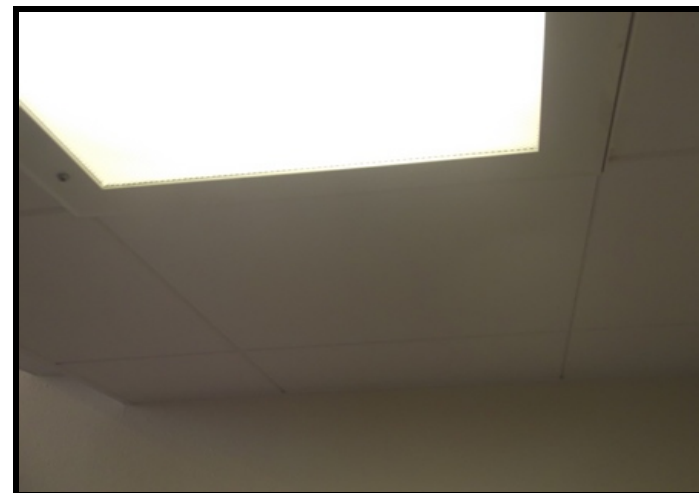
## SAMPLE REFERENCE 036

**No Asbestos Presumed in Sample**

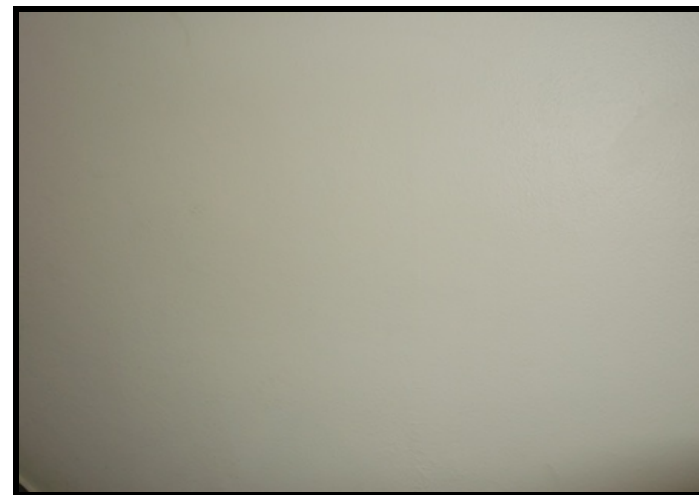
## SAMPLE REFERENCE 037

**No Asbestos Presumed in Sample**

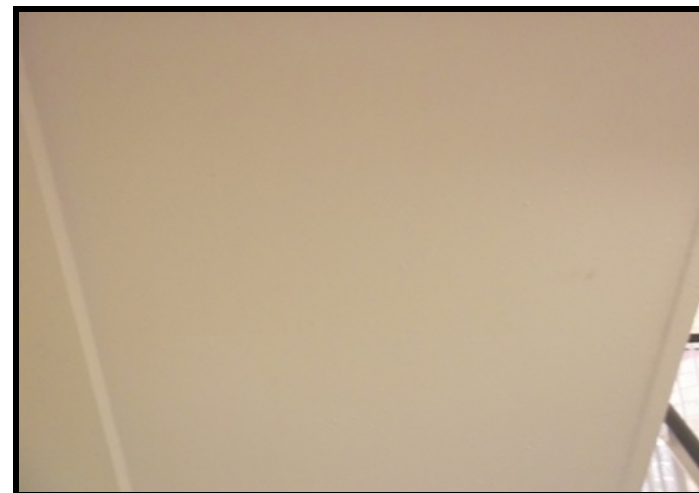
## SAMPLE REFERENCE 039

**No Asbestos Presumed in Sample**

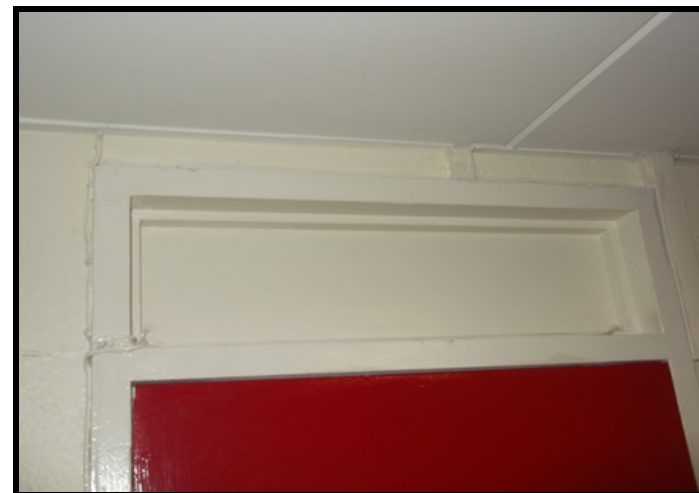
## SAMPLE REFERENCE 040

**No Asbestos Presumed in Sample**

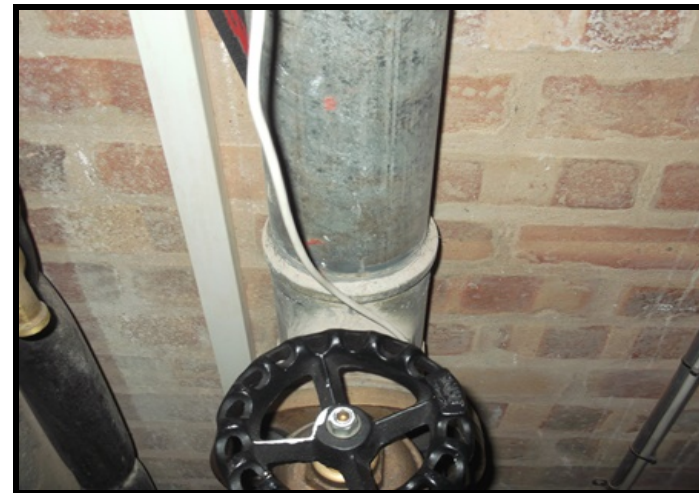
## SAMPLE REFERENCE 040a

**No Asbestos Presumed in Sample**

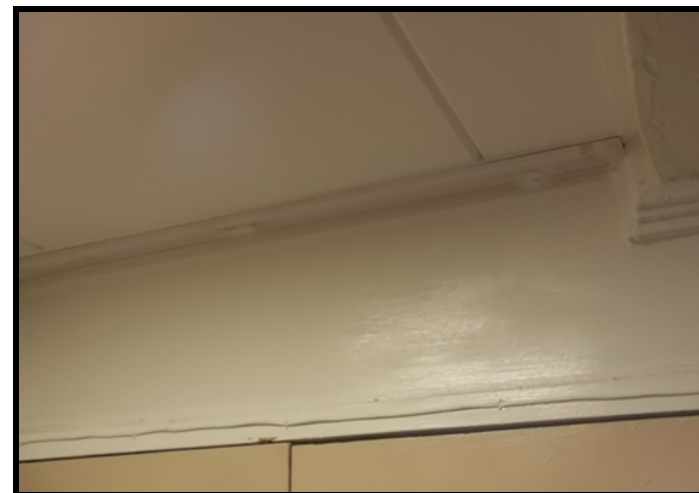
## SAMPLE REFERENCE 041

**No Asbestos Presumed in Sample**

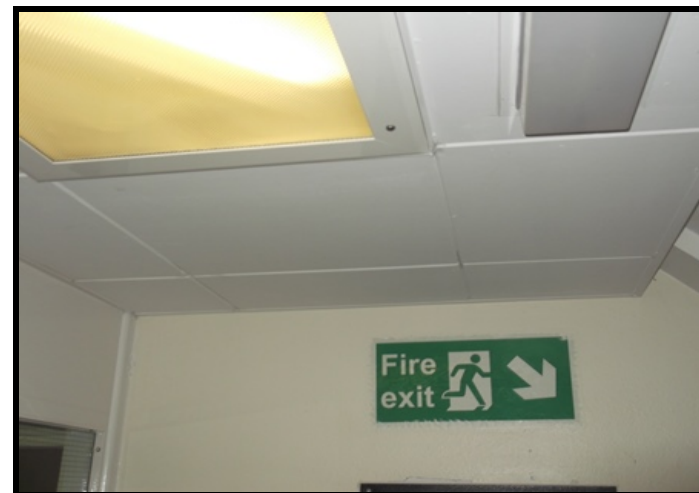
## SAMPLE REFERENCE 042

**No Asbestos Presumed in Sample**

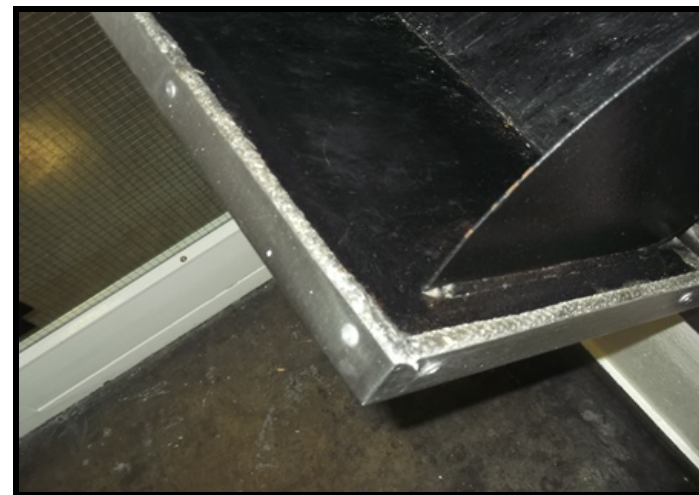
## SAMPLE REFERENCE 042a

**No Asbestos Presumed in Sample**

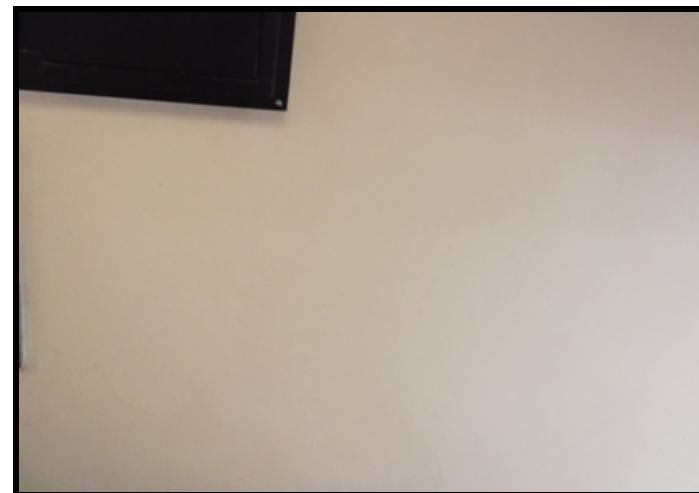
## SAMPLE REFERENCE 043

**No Asbestos Presumed in Sample**

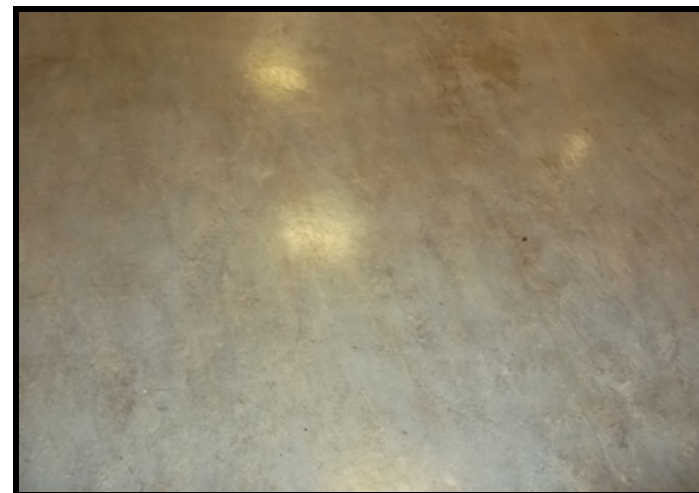
## SAMPLE REFERENCE 044

**No Asbestos Presumed in Sample**

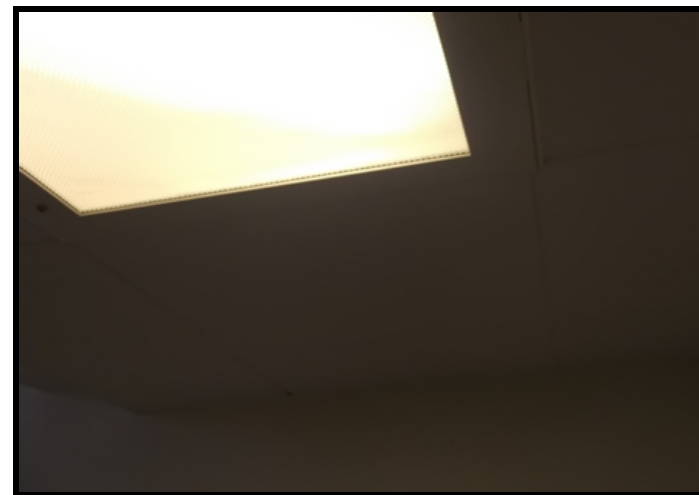
## SAMPLE REFERENCE 045

**No Asbestos Presumed in Sample**

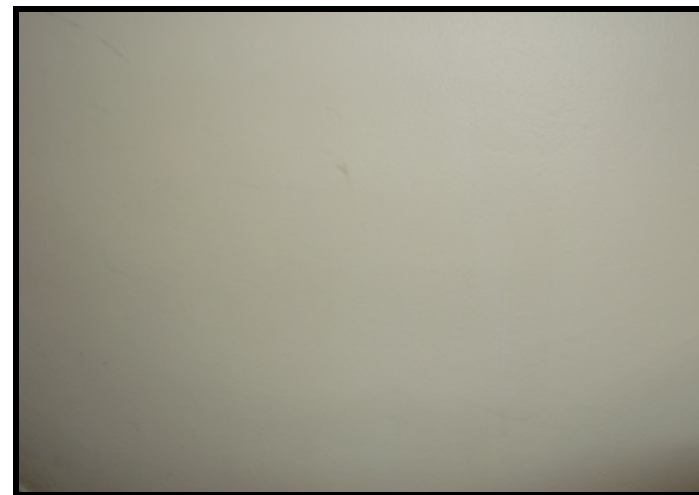
## SAMPLE REFERENCE 046

Building	Floor	Room	Location		
Main Building	Fourth Floor	Stairs	Wall		
Description					
MATERIAL ASSESSMENT					SCORE
Product Type	Textured Coating	Extent of Damage	Good condition		-
Asbestos Type	No Asbestos Detected	Surface Treatment	Textured Coating		
PRIORITY ASSESSMENT					SCORE
Occupant Activity	Not Applicable	Extent / Amount	15.00 m2		-
Accessibility	Easily disturbed	Location	Not Applicable		
Avg Time in Use	Not Applicable	Frequency of Use	Not Applicable		
No. of Occupants	Not Applicable	Secondary Activity	Not Applicable		
Maintenance	Not Applicable	Maintenance Frequency	Not Applicable		
MANAGEMENT ACTION					SCORE
Recommendation	NO ACTION REQUIRED				-
Recommendation Due		Next Inspection	None		
Apply Labels	No	Permit to Work Required	No		
Survey Type	Management	Lead Surveyor	Adam James		
Survey Date	09 Dec 2014	UKAS Laboratory	NOT SAMPLED (Cross Referenced)		
Site Reference	257900000A	Licensed Material	N/A	Notifiable Non Licensed Work	N/A

**No Asbestos Presumed in Sample**

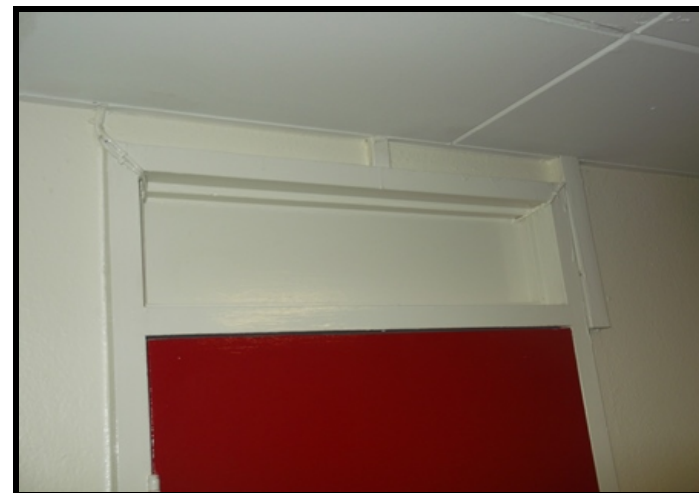
## SAMPLE REFERENCE 049

Building	Floor	Room	Location		
Main Building	Fourth Floor	Dry Riser	Transom Panel		
Description					
MATERIAL ASSESSMENT					SCORE
Product Type	Insulation Board	Extent of Damage	Good condition		-
Asbestos Type	No Asbestos Detected	Surface Treatment	Sealed Board (Encapsulated)		
PRIORITY ASSESSMENT					SCORE
Occupant Activity	Not Applicable	Extent / Amount	1.00 m2		-
Accessibility	Occasionally disturb	Location	Not Applicable		
Avg Time in Use	Not Applicable	Frequency of Use	Not Applicable		
No. of Occupants	Not Applicable	Secondary Activity	Not Applicable		
Maintenance	Not Applicable	Maintenance Frequency	Not Applicable		
MANAGEMENT ACTION					SCORE
Recommendation	NO ACTION REQUIRED				-
Recommendation Due		Next Inspection	None		
Apply Labels	No	Permit to Work Required	No		
Survey Type	Management	Lead Surveyor	Adam James		
Survey Date	09 Dec 2014	UKAS Laboratory	NOT SAMPLED (Cross Referenced)		
Site Reference	257900000A	Licensed Material	N/A	Notifiable Non Licensed Work	N/A

**No Asbestos Presumed in Sample**

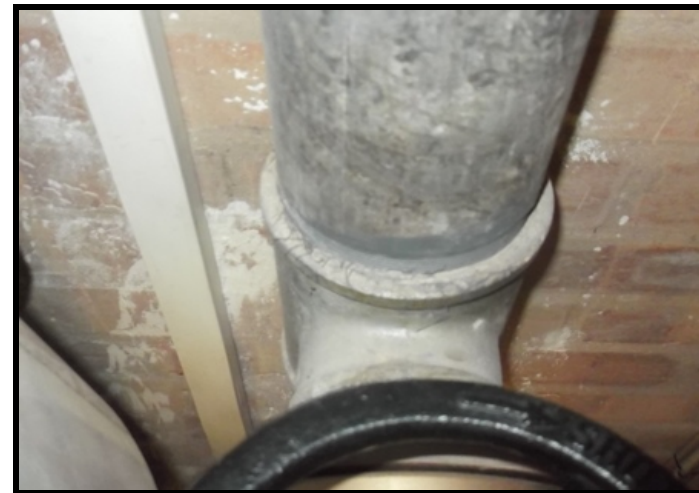
## SAMPLE REFERENCE 049a

MATERIAL ASSESSMENT				SCORE
<b>Product Type</b>	Lagging	<b>Extent of Damage</b>	Low damage	-
<b>Asbestos Type</b>	No Asbestos Detected	<b>Surface Treatment</b>	Unsealed (I)

**No Asbestos Presumed in Sample**

MANAGEMENT ACTION				SCORE
<b>Recommendation</b>	NO ACTION REQUIRED			-
<b>Recommendation Due</b>		<b>Next Inspection</b>	None	
<b>Apply Labels</b>	No	<b>Permit to Work Required</b>	No

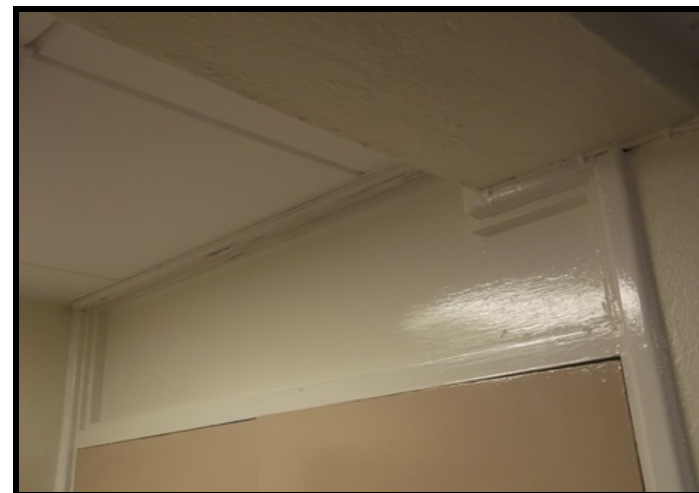
## SAMPLE REFERENCE 050

Building	Floor	Room	Location		
Main Building	Fourth Floor	Electricity Riser	Transom Panel		
Description					
MATERIAL ASSESSMENT					SCORE
Product Type	Insulation Board	Extent of Damage	Good condition		-
Asbestos Type	No Asbestos Detected	Surface Treatment	Sealed Board (Encapsulated)		
PRIORITY ASSESSMENT					SCORE
Occupant Activity	Not Applicable	Extent / Amount	1.00 m2		-
Accessibility	Occasionally disturb	Location	Not Applicable		
Avg Time in Use	Not Applicable	Frequency of Use	Not Applicable		
No. of Occupants	Not Applicable	Secondary Activity	Not Applicable		
Maintenance	Not Applicable	Maintenance Frequency	Not Applicable		
MANAGEMENT ACTION					SCORE
Recommendation	NO ACTION REQUIRED				-
Recommendation Due		Next Inspection	None		
Apply Labels	No	Permit to Work Required	No		
Survey Type	Management	Lead Surveyor	Adam James		
Survey Date	09 Dec 2014	UKAS Laboratory	NOT SAMPLED (Cross Referenced)		
Site Reference	257900000A	Licensed Material	N/A	Notifiable Non Licensed Work	N/A

**No Asbestos Presumed in Sample**

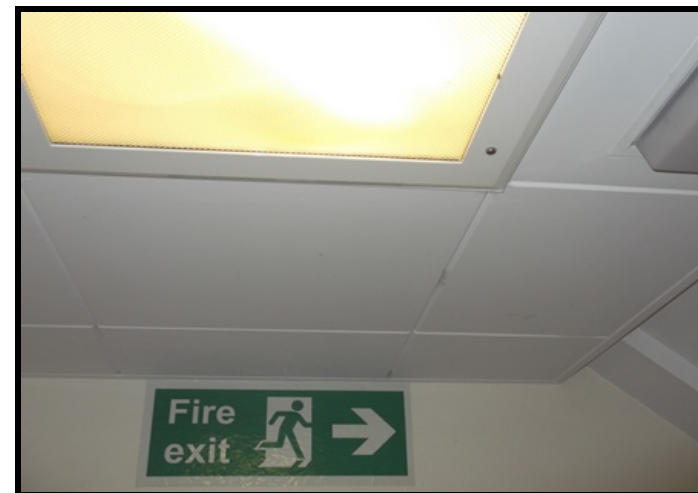
## SAMPLE REFERENCE 051

Building	Floor	Room	Location			
Main Building	Fifth Floor	Landing/Stairs	Ceiling			
Description						
MATERIAL ASSESSMENT				SCORE		
Product Type	Insulation Board	Extent of Damage	Good condition		-	
Asbestos Type	No Asbestos Detected	Surface Treatment	Sealed Board (Encapsulated)			
PRIORITY ASSESSMENT				SCORE		
Occupant Activity	Not Applicable	Extent / Amount	10.00 m2		-	
Accessibility	Occasionally disturb	Location	Not Applicable			
Avg Time in Use	Not Applicable	Frequency of Use	Not Applicable			
No. of Occupants	Not Applicable	Secondary Activity	Not Applicable			
Maintenance	Not Applicable	Maintenance Frequency	Not Applicable			
MANAGEMENT ACTION				SCORE		
Recommendation	NO ACTION REQUIRED			-		
Recommendation Due		Next Inspection	None			
Apply Labels	No	Permit to Work Required	No			
Survey Type	Management	Lead Surveyor	Adam James			
Survey Date	09 Dec 2014	UKAS Laboratory	NOT SAMPLED (Cross Referenced)

**No Asbestos Presumed in Sample**

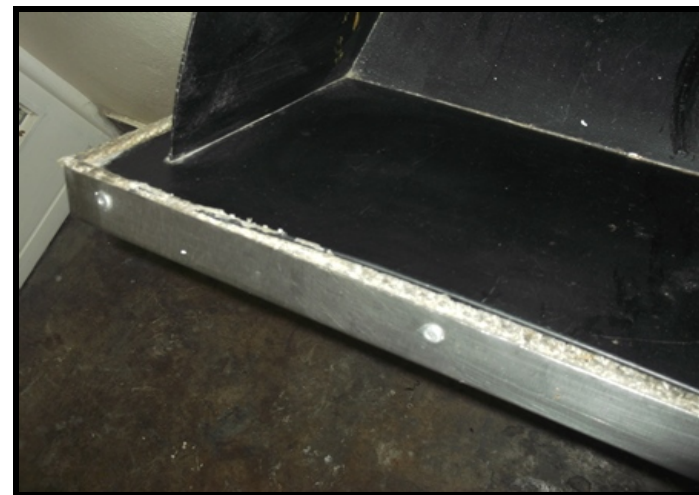
## SAMPLE REFERENCE 051a

Building	Floor	Room	Location			
Main Building	Fifth Floor	Landing/Stairs	Pipe Work			
Description						
MATERIAL ASSESSMENT				SCORE		
Product Type	Rope	Extent of Damage	Low damage		-	
Asbestos Type	No Asbestos Detected	Surface Treatment	Unsealed (1)			
PRIORITY ASSESSMENT				SCORE		
Occupant Activity	Not Applicable	Extent / Amount	1.00 m2		-	
Accessibility	Occasionally disturb	Location	Not Applicable			
Avg Time in Use	Not Applicable	Frequency of Use	Not Applicable			
No. of Occupants	Not Applicable	Secondary Activity	Not Applicable			
Maintenance	Not Applicable	Maintenance Frequency	Not Applicable			
MANAGEMENT ACTION				SCORE		
Recommendation	NO ACTION REQUIRED			-		
Recommendation Due		Next Inspection	None			
Apply Labels	No	Permit to Work Required	No			
Survey Type	Management	Lead Surveyor	Adam James			
Survey Date	09 Dec 2014	UKAS Laboratory	NOT SAMPLED (Cross Referenced)			
Site Reference	257900000A	Licensed Material	N/A	Notifiable Non Licensed Work	N/A

**No Asbestos Presumed in Sample**

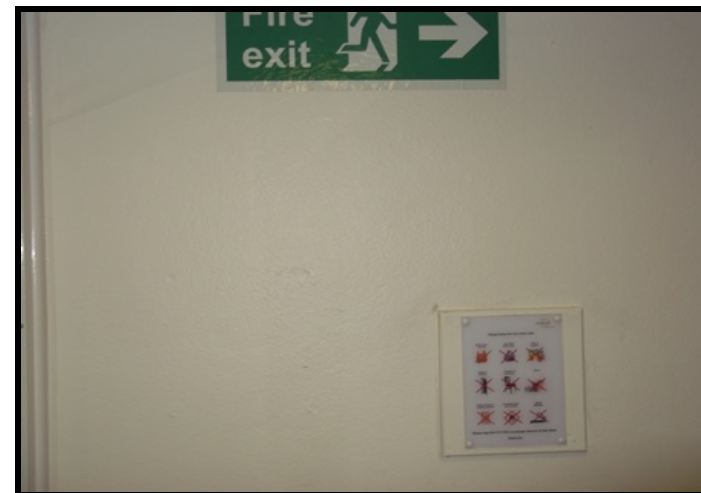
## SAMPLE REFERENCE 052

Building	Floor	Room	Location		
Main Building	Fifth Floor	Landing/Stairs	Wall		
Description					
MATERIAL ASSESSMENT					SCORE
Product Type	Textured Coating	Extent of Damage	Good condition		-
Asbestos Type	No Asbestos Detected	Surface Treatment	Textured Coating		
PRIORITY ASSESSMENT					SCORE
Occupant Activity	Not Applicable	Extent / Amount	15.00 m2		-
Accessibility	Easily disturbed	Location	Not Applicable		
Avg Time in Use	Not Applicable	Frequency of Use	Not Applicable		
No. of Occupants	Not Applicable	Secondary Activity	Not Applicable		
Maintenance	Not Applicable	Maintenance Frequency	Not Applicable		
MANAGEMENT ACTION					SCORE
Recommendation	NO ACTION REQUIRED				-
Recommendation Due		Next Inspection	None		
Apply Labels	No	Permit to Work Required	No		
Survey Type	Management	Lead Surveyor	Adam James		
Survey Date	09 Dec 2014	UKAS Laboratory	NOT SAMPLED (Cross Referenced)		
Site Reference	257900000A	Licensed Material	N/A	Notifiable Non Licensed Work	N/A

**No Asbestos Presumed in Sample**

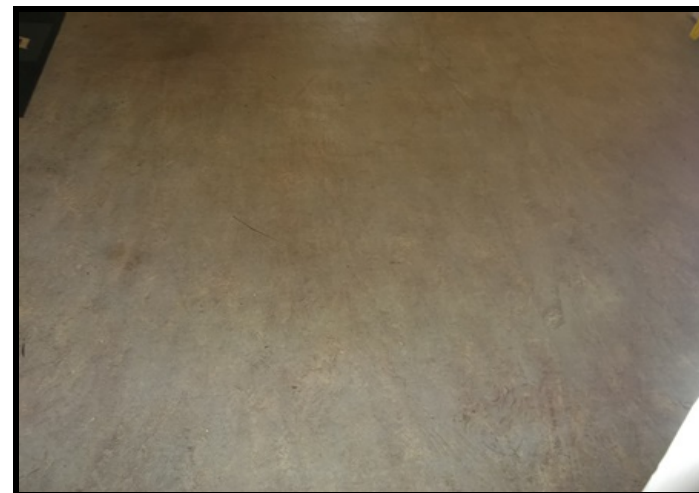
## SAMPLE REFERENCE 053

Building	Floor	Room	Location		
Main Building	Fifth Floor	Landing/Stairs	Floor		
Description	Paper backing to lino				
MATERIAL ASSESSMENT					SCORE
Product Type	Paper	Extent of Damage	Good condition		-
Asbestos Type	No Asbestos Detected	Surface Treatment	Sealed (0)		
PRIORITY ASSESSMENT					SCORE
Occupant Activity	Not Applicable	Extent / Amount	10.00 m2		-
Accessibility	Occasionally disturb	Location	Not Applicable		
Avg Time in Use	Not Applicable	Frequency of Use	Not Applicable		
No. of Occupants	Not Applicable	Secondary Activity	Not Applicable		
Maintenance	Not Applicable	Maintenance Frequency	Not Applicable		
MANAGEMENT ACTION					SCORE
Recommendation	NO ACTION REQUIRED				-
Recommendation Due		Next Inspection	None		
Apply Labels	No	Permit to Work Required	No		
Survey Type	Management	Lead Surveyor	Adam James		
Survey Date	09 Dec 2014	UKAS Laboratory	NOT SAMPLED (Cross Referenced)		
Site Reference	257900000A	Licensed Material	N/A	Notifiable Non Licensed Work	N/A

**No Asbestos Presumed in Sample**

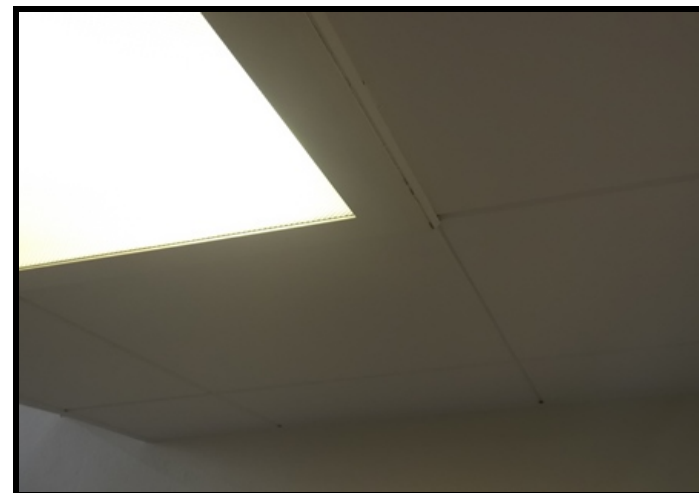
## SAMPLE REFERENCE 054

MATERIAL ASSESSMENT				SCORE
<b>Product Type</b>	Insulation Board	<b>Extent of Damage</b>	Good condition	-
<b>Asbestos Type</b>	<b>No Asbestos Detected</b>	<b>Surface Treatment</b>	Sealed Board (Encapsulated)

**No Asbestos Presumed in Sample**

MANAGEMENT ACTION				SCORE
<b>Recommendation</b>	NO ACTION REQUIRED			-
<b>Recommendation Due</b>		<b>Next Inspection</b>	None	
<b>Apply Labels</b>	No	<b>Permit to Work Required</b>	No

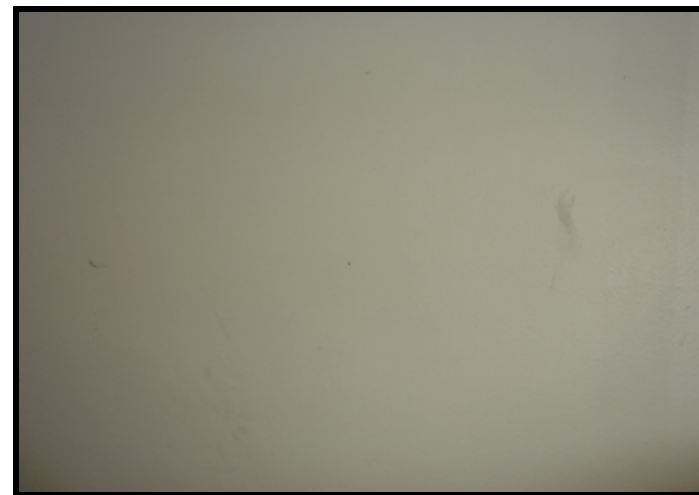
## SAMPLE REFERENCE 055

MATERIAL ASSESSMENT				SCORE
<b>Product Type</b>	Textured Coating	<b>Extent of Damage</b>	Good condition	-
<b>Asbestos Type</b>	No Asbestos Detected	<b>Surface Treatment</b>	Textured Coating

MANAGEMENT ACTION				SCORE
<b>Recommendation</b>	NO ACTION REQUIRED			-
<b>Recommendation Due</b>		<b>Next Inspection</b>	None	
<b>Apply Labels</b>	No	<b>Permit to Work Required</b>	No

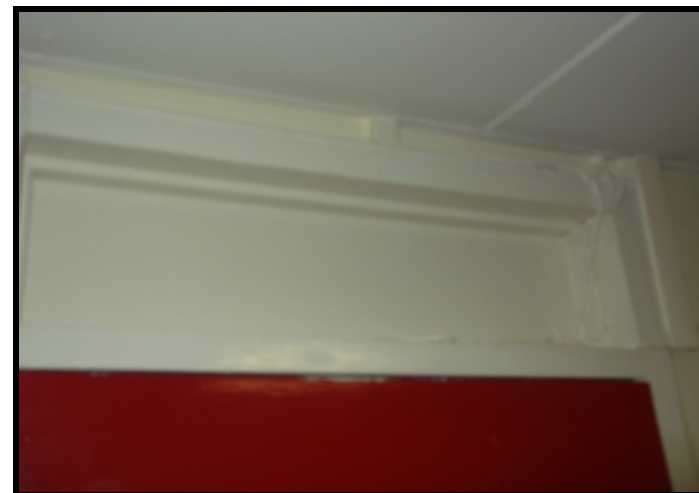
## SAMPLE REFERENCE 058

MATERIAL ASSESSMENT				SCORE
<b>Product Type</b>	Insulation Board	<b>Extent of Damage</b>	Good condition	-
<b>Asbestos Type</b>	<b>No Asbestos Detected</b>	<b>Surface Treatment</b>	Sealed Board (Encapsulated)

**No Asbestos Presumed in Sample**

MANAGEMENT ACTION				SCORE
<b>Recommendation</b>	NO ACTION REQUIRED			-
<b>Recommendation Due</b>		<b>Next Inspection</b>	None	
<b>Apply Labels</b>	No	<b>Permit to Work Required</b>	No

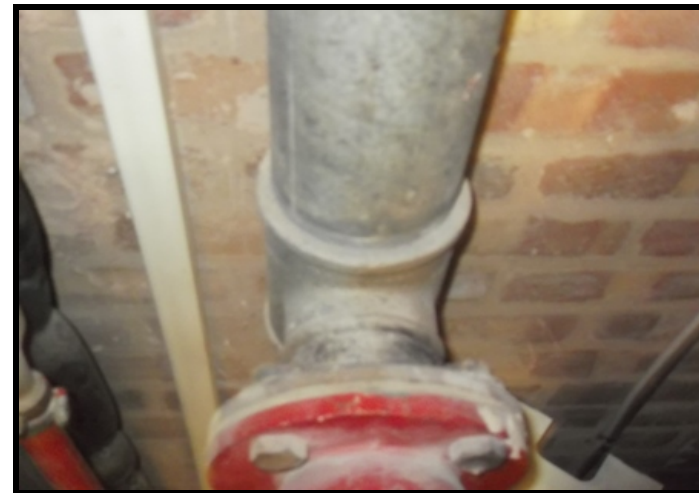
## SAMPLE REFERENCE 058a

MATERIAL ASSESSMENT				SCORE
<b>Product Type</b>	Lagging	<b>Extent of Damage</b>	Low damage	-
<b>Asbestos Type</b>	No Asbestos Detected	<b>Surface Treatment</b>	Unsealed (1)

**No Asbestos Presumed in Sample**

MANAGEMENT ACTION				SCORE
<b>Recommendation</b>	NO ACTION REQUIRED			-
<b>Recommendation Due</b>		<b>Next Inspection</b>	None	
<b>Apply Labels</b>	No	<b>Permit to Work Required</b>	No

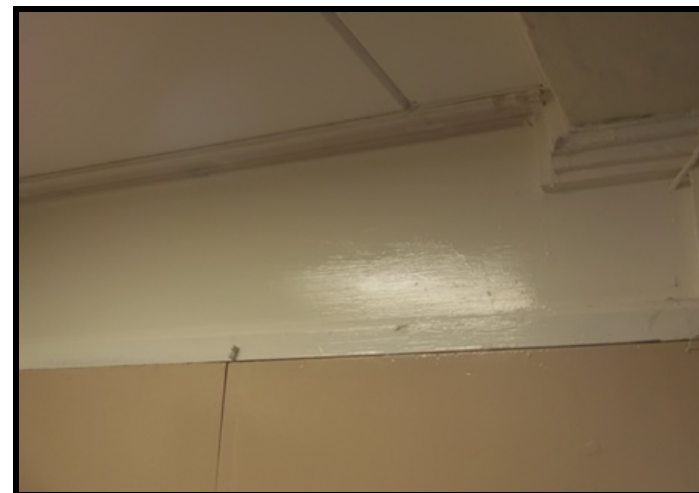
## SAMPLE REFERENCE 059

Building	Floor	Room	Location		
Main Building	Fifth Floor	Electricity Riser	Transom Panel		
Description					
MATERIAL ASSESSMENT					SCORE
Product Type	Insulation Board	Extent of Damage	Good condition		-
Asbestos Type	No Asbestos Detected	Surface Treatment	Sealed Board (Encapsulated)		
PRIORITY ASSESSMENT					SCORE
Occupant Activity	Not Applicable	Extent / Amount	1.00 m2		-
Accessibility	Occasionally disturb	Location	Not Applicable		
Avg Time in Use	Not Applicable	Frequency of Use	Not Applicable		
No. of Occupants	Not Applicable	Secondary Activity	Not Applicable		
Maintenance	Not Applicable	Maintenance Frequency	Not Applicable		
MANAGEMENT ACTION					SCORE
Recommendation	NO ACTION REQUIRED				-
Recommendation Due		Next Inspection	None		
Apply Labels	No	Permit to Work Required	No		
Survey Type	Management	Lead Surveyor	Adam James		
Survey Date	09 Dec 2014	UKAS Laboratory	NOT SAMPLED (Cross Referenced)		
Site Reference	257900000A	Licensed Material	N/A	Notifiable Non Licensed Work	N/A

**No Asbestos Presumed in Sample**

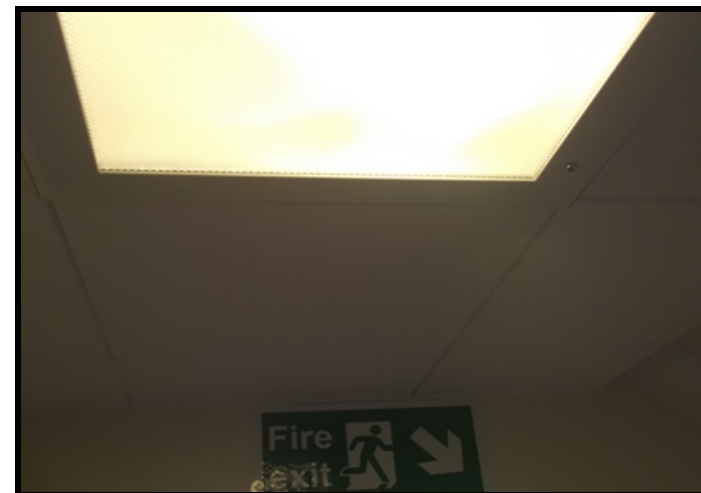
## SAMPLE REFERENCE 060

MATERIAL ASSESSMENT				SCORE
<b>Product Type</b>	Insulation Board	<b>Extent of Damage</b>	Good condition	-
<b>Asbestos Type</b>	<b>No Asbestos Detected</b>	<b>Surface Treatment</b>	Sealed Board (Encapsulated)

**No Asbestos Presumed in Sample**

MANAGEMENT ACTION				SCORE
<b>Recommendation</b>	NO ACTION REQUIRED			-
<b>Recommendation Due</b>		<b>Next Inspection</b>	None	
<b>Apply Labels</b>	No	<b>Permit to Work Required</b>	No

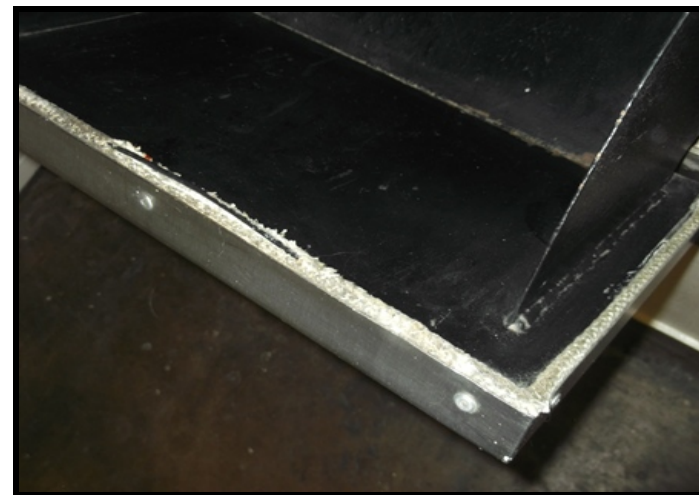
## SAMPLE REFERENCE 060a

MATERIAL ASSESSMENT				SCORE
<b>Product Type</b>	Rope	<b>Extent of Damage</b>	Low damage	-
<b>Asbestos Type</b>	No Asbestos Detected	<b>Surface Treatment</b>	Unsealed (I)

**No Asbestos Presumed in Sample**

MANAGEMENT ACTION				SCORE
<b>Recommendation</b>	NO ACTION REQUIRED			-
<b>Recommendation Due</b>		<b>Next Inspection</b>	None	
<b>Apply Labels</b>	No	<b>Permit to Work Required</b>	No

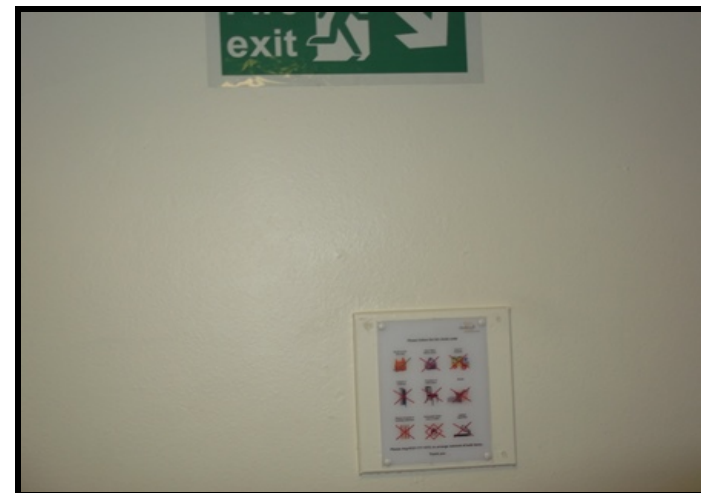
## SAMPLE REFERENCE 061

Building	Floor	Room	Location		
Main Building	Sixth Floor	Landing/Stairs	Wall		
Description					
MATERIAL ASSESSMENT					SCORE
Product Type	Textured Coating	Extent of Damage	Good condition		-
Asbestos Type	No Asbestos Detected	Surface Treatment	Textured Coating		
PRIORITY ASSESSMENT					SCORE
Occupant Activity	Not Applicable	Extent / Amount	15.00 m2		-
Accessibility	Easily disturbed	Location	Not Applicable		
Avg Time in Use	Not Applicable	Frequency of Use	Not Applicable		
No. of Occupants	Not Applicable	Secondary Activity	Not Applicable		
Maintenance	Not Applicable	Maintenance Frequency	Not Applicable		
MANAGEMENT ACTION					SCORE
Recommendation	NO ACTION REQUIRED				-
Recommendation Due		Next Inspection	None		
Apply Labels	No	Permit to Work Required	No		
Survey Type	Management	Lead Surveyor	Adam James		
Survey Date	09 Dec 2014	UKAS Laboratory	NOT SAMPLED (Cross Referenced)		
Site Reference	257900000A	Licensed Material	N/A	Notifiable Non Licensed Work	N/A

**No Asbestos Presumed in Sample**

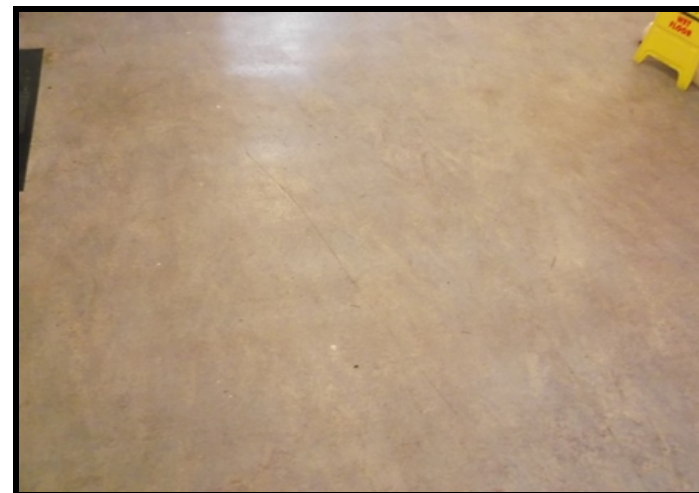
## SAMPLE REFERENCE 062

Building	Floor	Room	Location		
Main Building	Sixth Floor	Landing/Stairs	Wall		
Description	Paper backing to lino				
MATERIAL ASSESSMENT				SCORE	
Product Type	Paper	Extent of Damage	Good condition		-
Asbestos Type	No Asbestos Detected	Surface Treatment	Sealed (0)		
PRIORITY ASSESSMENT				SCORE	
Occupant Activity	Not Applicable	Extent / Amount	10.00 m2		-
Accessibility	Occasionally disturb	Location	Not Applicable		
Avg Time in Use	Not Applicable	Frequency of Use	Not Applicable		
No. of Occupants	Not Applicable	Secondary Activity	Not Applicable		
Maintenance	Not Applicable	Maintenance Frequency	Not Applicable		
MANAGEMENT ACTION				SCORE	
Recommendation	NO ACTION REQUIRED				-
Recommendation Due		Next Inspection	None		
Apply Labels	No	Permit to Work Required	No		
Survey Type	Management	Lead Surveyor	Adam James		
Survey Date	09 Dec 2014	UKAS Laboratory	NOT SAMPLED (Cross Referenced)		
Site Reference	257900000A	Licensed Material	N/A	Notifiable Non Licensed Work	N/A

**No Asbestos Presumed in Sample**

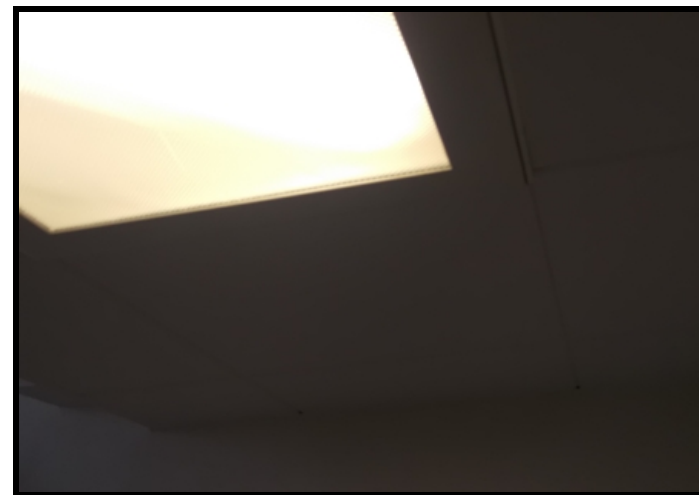
## SAMPLE REFERENCE 063

Building	Floor	Room	Location			
Main Building	Sixth Floor	Stairs	Ceiling			
Description						
MATERIAL ASSESSMENT				SCORE		
Product Type	Insulation Board	Extent of Damage	Good condition		-	
Asbestos Type	No Asbestos Detected	Surface Treatment	Sealed Board (Encapsulated)			
PRIORITY ASSESSMENT				SCORE		
Occupant Activity	Not Applicable	Extent / Amount	10.00 m2		-	
Accessibility	Occasionally disturb	Location	Not Applicable			
Avg Time in Use	Not Applicable	Frequency of Use	Not Applicable			
No. of Occupants	Not Applicable	Secondary Activity	Not Applicable			
Maintenance	Not Applicable	Maintenance Frequency	Not Applicable			
MANAGEMENT ACTION				SCORE		
Recommendation	NO ACTION REQUIRED			-		
Recommendation Due		Next Inspection	None			
Apply Labels	No	Permit to Work Required	No			
Survey Type	Management	Lead Surveyor	Adam James			
Survey Date	09 Dec 2014	UKAS Laboratory	NOT SAMPLED (Cross Referenced)			
Site Reference	257900000A	Licensed Material	N/A	Notifiable Non Licensed Work	N/A

**No Asbestos Presumed in Sample**
