# Solihull Community Housing

## Asbestos Management Survey Report

**Catesby House I-36 (Communal)**  
**Kingshurst Way**  
**Solihull**  
**B37 6DZ**

**Date of Report:** 15 Jan 2015  
**Survey Ref:** 257900000A

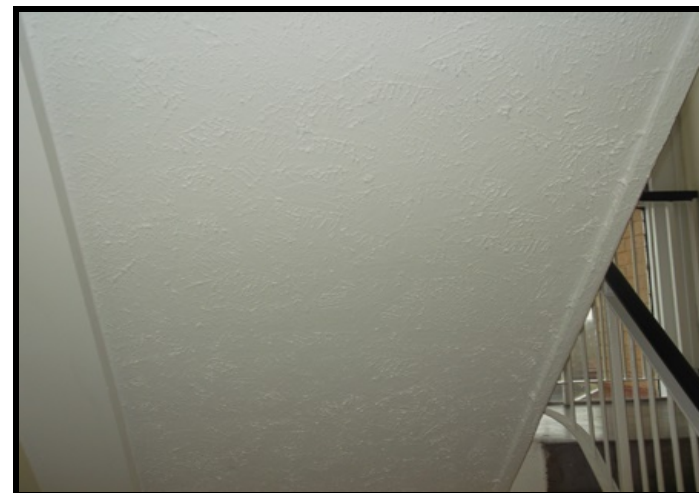
## SAMPLE REFERENCE 066

Building	Floor	Room	Location		
Main Building	Sixth Floor	Stairs	Ceiling		
Description					
MATERIAL ASSESSMENT					SCORE
Product Type	Textured Coating	Extent of Damage	Good condition		-
Asbestos Type	No Asbestos Detected	Surface Treatment	Textured Coating		
PRIORITY ASSESSMENT					SCORE
Occupant Activity	Not Applicable	Extent / Amount	4.00 m2		-
Accessibility	Occasionally disturb	Location	Not Applicable		
Avg Time in Use	Not Applicable	Frequency of Use	Not Applicable		
No. of Occupants	Not Applicable	Secondary Activity	Not Applicable		
Maintenance	Not Applicable	Maintenance Frequency	Not Applicable		
MANAGEMENT ACTION					SCORE
Recommendation	NO ACTION REQUIRED				-
Recommendation Due		Next Inspection	None		
Apply Labels	No	Permit to Work Required	No		
Survey Type	Management	Lead Surveyor	Adam James		
Survey Date	09 Dec 2014	UKAS Laboratory	NOT SAMPLED (Cross Referenced)		
Site Reference	257900000A	Licensed Material	N/A	Notifiable Non Licensed Work	N/A

**No Asbestos Presumed in Sample**

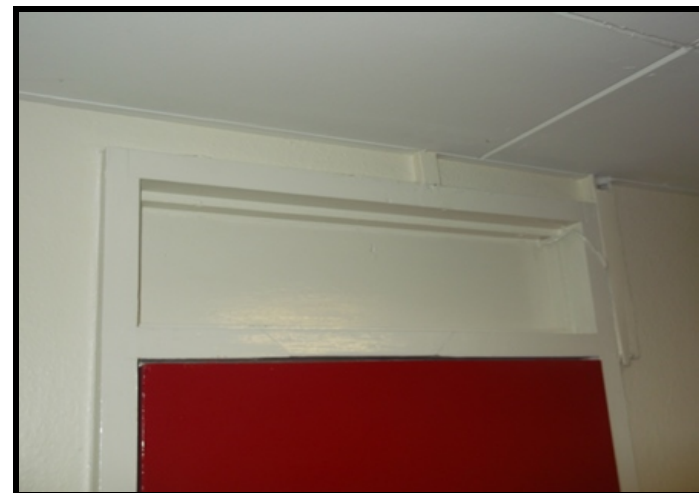
## SAMPLE REFERENCE 067

Building	Floor	Room	Location			
Main Building	Sixth Floor	Dry Riser	Transom Panel			
Description						
MATERIAL ASSESSMENT				SCORE		
Product Type	Insulation Board	Extent of Damage	Good condition		-	
Asbestos Type	No Asbestos Detected	Surface Treatment	Sealed Board (Encapsulated)			
PRIORITY ASSESSMENT				SCORE		
Occupant Activity	Not Applicable	Extent / Amount	1.00 m2		-	
Accessibility	Occasionally disturb	Location	Not Applicable			
Avg Time in Use	Not Applicable	Frequency of Use	Not Applicable			
No. of Occupants	Not Applicable	Secondary Activity	Not Applicable			
Maintenance	Not Applicable	Maintenance Frequency	Not Applicable			
MANAGEMENT ACTION				SCORE		
Recommendation	NO ACTION REQUIRED			-		
Recommendation Due		Next Inspection	None			
Apply Labels	No	Permit to Work Required	No			
Survey Type	Management	Lead Surveyor	Adam James			
Survey Date	09 Dec 2014	UKAS Laboratory	NOT SAMPLED (Cross Referenced)

**No Asbestos Presumed in Sample**

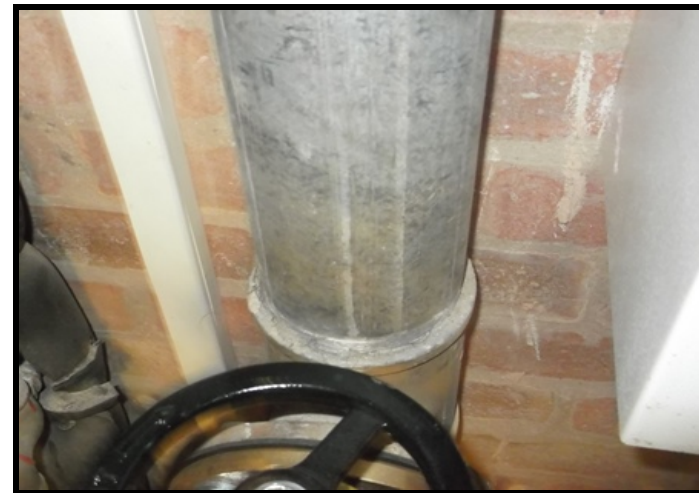
## SAMPLE REFERENCE 067a

Building	Floor	Room	Location			
Main Building	Sixth Floor	Dry Riser	Pipe Work			
Description						
MATERIAL ASSESSMENT				SCORE		
Product Type	Lagging	Extent of Damage	Not Applicable		-	
Asbestos Type	No Asbestos Detected	Surface Treatment	Unsealed (3)			
PRIORITY ASSESSMENT				SCORE		
Occupant Activity	Not Applicable	Extent / Amount	1.00 m2		-	
Accessibility	Occasionally disturb	Location	Not Applicable			
Avg Time in Use	Not Applicable	Frequency of Use	Not Applicable			
No. of Occupants	Not Applicable	Secondary Activity	Not Applicable			
Maintenance	Not Applicable	Maintenance Frequency	Not Applicable			
MANAGEMENT ACTION				SCORE		
Recommendation	NO ACTION REQUIRED			-		
Recommendation Due		Next Inspection	None			
Apply Labels	No	Permit to Work Required	No			
Survey Type	Management	Lead Surveyor	Adam James			
Survey Date	09 Dec 2014	UKAS Laboratory	NOT SAMPLED (Cross Referenced)			
Site Reference	257900000A	Licensed Material	N/A	Notifiable Non Licensed Work	N/A

**No Asbestos Presumed in Sample**

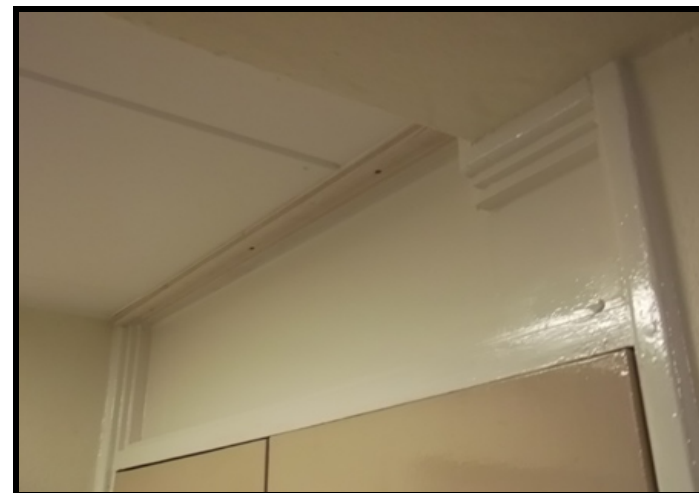
## SAMPLE REFERENCE 068

Building	Floor	Room	Location			
Main Building	Sixth Floor	Electricity Riser	Transom Panel			
Description						
MATERIAL ASSESSMENT				SCORE		
Product Type	Insulation Board	Extent of Damage	Good condition		-	
Asbestos Type	No Asbestos Detected	Surface Treatment	Sealed Board (Encapsulated)			
PRIORITY ASSESSMENT				SCORE		
Occupant Activity	Not Applicable	Extent / Amount	1.00 m2		-	
Accessibility	Occasionally disturb	Location	Not Applicable			
Avg Time in Use	Not Applicable	Frequency of Use	Not Applicable			
No. of Occupants	Not Applicable	Secondary Activity	Not Applicable			
Maintenance	Not Applicable	Maintenance Frequency	Not Applicable			
MANAGEMENT ACTION				SCORE		
Recommendation	NO ACTION REQUIRED			-		
Recommendation Due		Next Inspection	None			
Apply Labels	No	Permit to Work Required	No			
Survey Type	Management	Lead Surveyor	Adam James			
Survey Date	09 Dec 2014	UKAS Laboratory	NOT SAMPLED (Cross Referenced)

**No Asbestos Presumed in Sample**

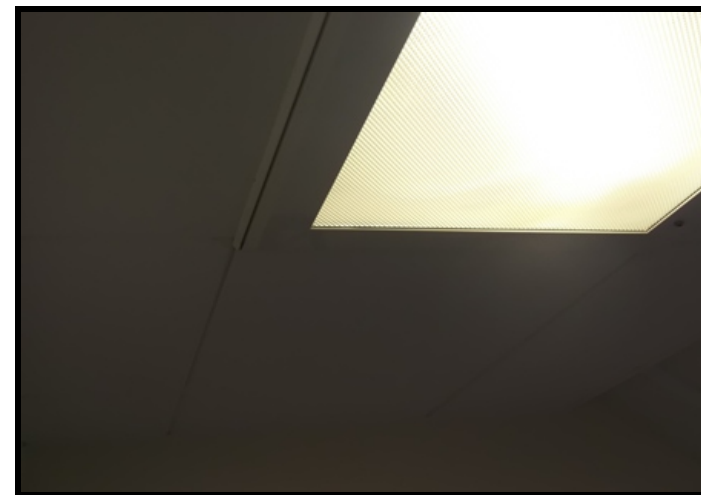
## SAMPLE REFERENCE 069

Building	Floor	Room	Location		
Main Building	Seventh Floor	Landing/Stairs	Ceiling		
Description					
MATERIAL ASSESSMENT					SCORE
Product Type	Insulation Board	Extent of Damage	Good condition		-
Asbestos Type	No Asbestos Detected	Surface Treatment	Sealed Board (Encapsulated)		
PRIORITY ASSESSMENT					SCORE
Occupant Activity	Not Applicable	Extent / Amount	10.00 m2		-
Accessibility	Occasionally disturb	Location	Not Applicable		
Avg Time in Use	Not Applicable	Frequency of Use	Not Applicable		
No. of Occupants	Not Applicable	Secondary Activity	Not Applicable		
Maintenance	Not Applicable	Maintenance Frequency	Not Applicable		
MANAGEMENT ACTION					SCORE
Recommendation	NO ACTION REQUIRED				-
Recommendation Due		Next Inspection	None		
Apply Labels	No	Permit to Work Required	No		
Survey Type	Management	Lead Surveyor	Adam James		
Survey Date	09 Dec 2014	UKAS Laboratory	NOT SAMPLED (Cross Referenced)		
Site Reference	257900000A	Licensed Material	N/A	Notifiable Non Licensed Work	N/A

**No Asbestos Presumed in Sample**

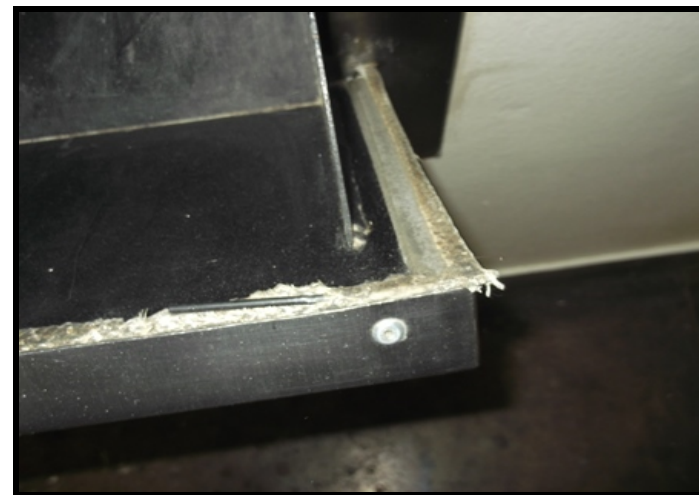
SAMPLE REFERENCE 069a

Building	Floor	Room	Location			
Main Building	Seventh Floor	Landing/Stairs	Pipe Work			
Description						
MATERIAL ASSESSMENT				SCORE		
Product Type	Rope	Extent of Damage	Low damage		-	
Asbestos Type	No Asbestos Detected	Surface Treatment	Unsealed (I)			
PRIORITY ASSESSMENT				SCORE		
Occupant Activity	Not Applicable	Extent / Amount	1.00 m2		-	
Accessibility	Occasionally disturb	Location	Not Applicable			
Avg Time in Use	Not Applicable	Frequency of Use	Not Applicable			
No. of Occupants	Not Applicable	Secondary Activity	Not Applicable			
Maintenance	Not Applicable	Maintenance Frequency	Not Applicable			
MANAGEMENT ACTION				SCORE		
Recommendation	NO ACTION REQUIRED			-		
Recommendation Due		Next Inspection	None			
Apply Labels	No	Permit to Work Required	No			
Survey Type	Management	Lead Surveyor	Adam James			
Survey Date	09 Dec 2014	UKAS Laboratory	NOT SAMPLED (Cross Referenced)			
Site Reference	257900000A	Licensed Material	N/A	Notifiable Non Licensed Work	N/A

**No Asbestos Presumed in Sample**

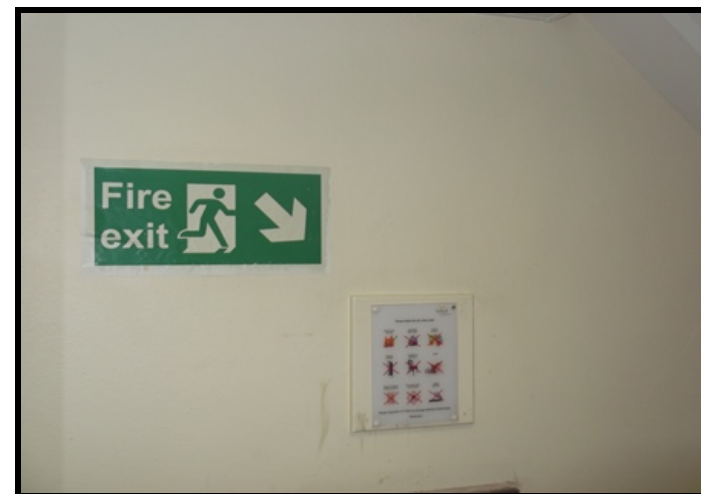
## SAMPLE REFERENCE 070

Building	Floor	Room	Location		
Main Building	Seventh Floor	Landing/Stairs	Wall		
Description					
MATERIAL ASSESSMENT					SCORE
Product Type	Textured Coating	Extent of Damage	Good condition		-
Asbestos Type	No Asbestos Detected	Surface Treatment	Textured Coating		
PRIORITY ASSESSMENT					SCORE
Occupant Activity	Not Applicable	Extent / Amount	15.00 m2		-
Accessibility	Easily disturbed	Location	Not Applicable		
Avg Time in Use	Not Applicable	Frequency of Use	Not Applicable		
No. of Occupants	Not Applicable	Secondary Activity	Not Applicable		
Maintenance	Not Applicable	Maintenance Frequency	Not Applicable		
MANAGEMENT ACTION					SCORE
Recommendation	NO ACTION REQUIRED				-
Recommendation Due		Next Inspection	None		
Apply Labels	No	Permit to Work Required	No		
Survey Type	Management	Lead Surveyor	Adam James		
Survey Date	09 Dec 2014	UKAS Laboratory	NOT SAMPLED (Cross Referenced)		
Site Reference	257900000A	Licensed Material	N/A	Notifiable Non Licensed Work	N/A

**No Asbestos Presumed in Sample**

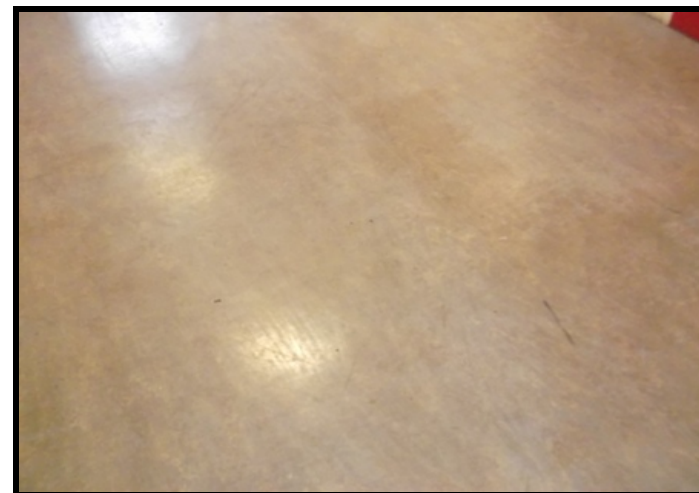
## SAMPLE REFERENCE 071

Building	Floor	Room	Location
Main Building	Seventh Floor	Landing/Stairs	Floor
<b>Description</b>	Paper backing to lino		
MATERIAL ASSESSMENT			
<b>Product Type</b>	Paper	<b>Extent of Damage</b>	Good condition
<b>Asbestos Type</b>	<b>No Asbestos Detected</b>	<b>Surface Treatment</b>	Sealed (0)
PRIORITY ASSESSMENT			
<b>Occupant Activity</b>	Not Applicable	<b>Extent / Amount</b>	10.00 m2
<b>Accessibility</b>	Occasionally disturb	<b>Location</b>	Not Applicable
<b>Avg Time in Use</b>	Not Applicable	<b>Frequency of Use</b>	Not Applicable
<b>No. of Occupants</b>	Not Applicable	<b>Secondary Activity</b>	Not Applicable
<b>Maintenance</b>	Not Applicable	<b>Maintenance Frequency</b>	Not Applicable
MANAGEMENT ACTION			
<b>Recommendation</b>	NO ACTION REQUIRED		
<b>Recommendation Due</b>		<b>Next Inspection</b>	None
<b>Apply Labels</b>	No	<b>Permit to Work Required</b>	No
<b>Survey Type</b>	Management	<b>Lead Surveyor</b>	Adam James

**No Asbestos Presumed in Sample**

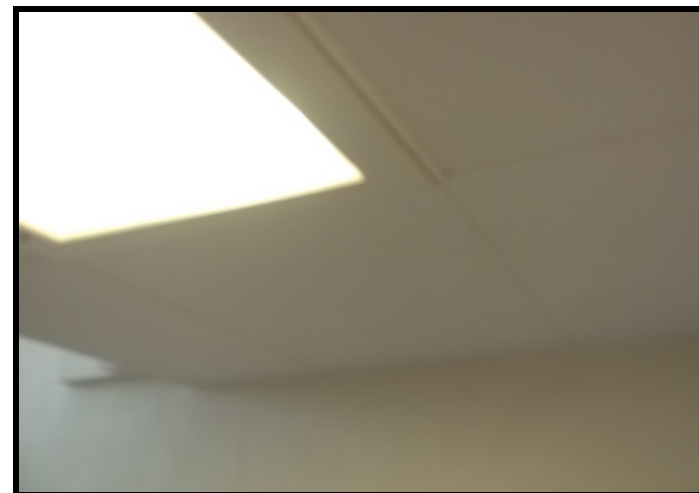
## SAMPLE REFERENCE 072

Building	Floor	Room	Location		
Main Building	Seventh Floor	Stairs	Ceiling		
Description					
MATERIAL ASSESSMENT					SCORE
Product Type	Insulation Board	Extent of Damage	Good condition		-
Asbestos Type	No Asbestos Detected	Surface Treatment	Sealed Board (Encapsulated)		
PRIORITY ASSESSMENT					SCORE
Occupant Activity	Not Applicable	Extent / Amount	10.00 m2		-
Accessibility	Occasionally disturb	Location	Not Applicable		
Avg Time in Use	Not Applicable	Frequency of Use	Not Applicable		
No. of Occupants	Not Applicable	Secondary Activity	Not Applicable		
Maintenance	Not Applicable	Maintenance Frequency	Not Applicable		
MANAGEMENT ACTION					SCORE
Recommendation	NO ACTION REQUIRED				-
Recommendation Due		Next Inspection	None		
Apply Labels	No	Permit to Work Required	No		
Survey Type	Management	Lead Surveyor	Adam James		
Survey Date	09 Dec 2014	UKAS Laboratory	NOT SAMPLED (Cross Referenced)		
Site Reference	257900000A	Licensed Material	N/A	Notifiable Non Licensed Work	N/A

**No Asbestos Presumed in Sample**

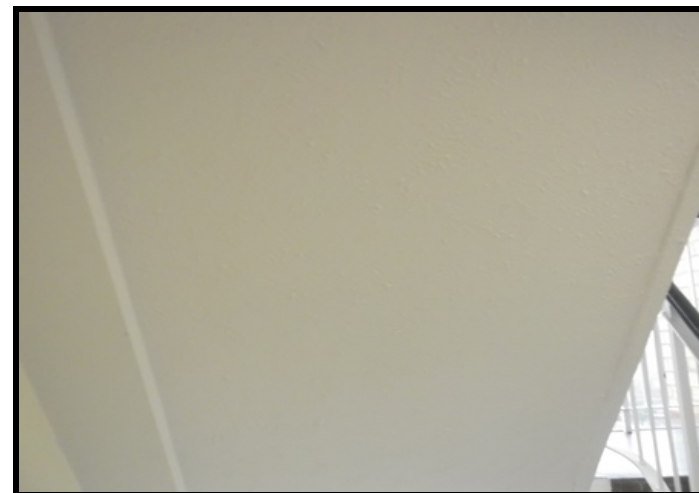
## SAMPLE REFERENCE 075

Building	Floor	Room	Location		
Main Building	Seventh Floor	Stairs	Ceiling		
Description					
MATERIAL ASSESSMENT					SCORE
Product Type	Textured Coating	Extent of Damage	Good condition		-
Asbestos Type	No Asbestos Detected	Surface Treatment	Textured Coating		
PRIORITY ASSESSMENT					SCORE
Occupant Activity	Not Applicable	Extent / Amount	4.00 m2		-
Accessibility	Occasionally disturb	Location	Not Applicable		
Avg Time in Use	Not Applicable	Frequency of Use	Not Applicable		
No. of Occupants	Not Applicable	Secondary Activity	Not Applicable		
Maintenance	Not Applicable	Maintenance Frequency	Not Applicable		
MANAGEMENT ACTION					SCORE
Recommendation	NO ACTION REQUIRED				-
Recommendation Due		Next Inspection	None		
Apply Labels	No	Permit to Work Required	No		
Survey Type	Management	Lead Surveyor	Adam James		
Survey Date	09 Dec 2014	UKAS Laboratory	NOT SAMPLED (Cross Referenced)		
Site Reference	257900000A	Licensed Material	N/A	Notifiable Non Licensed Work	N/A

**No Asbestos Presumed in Sample**

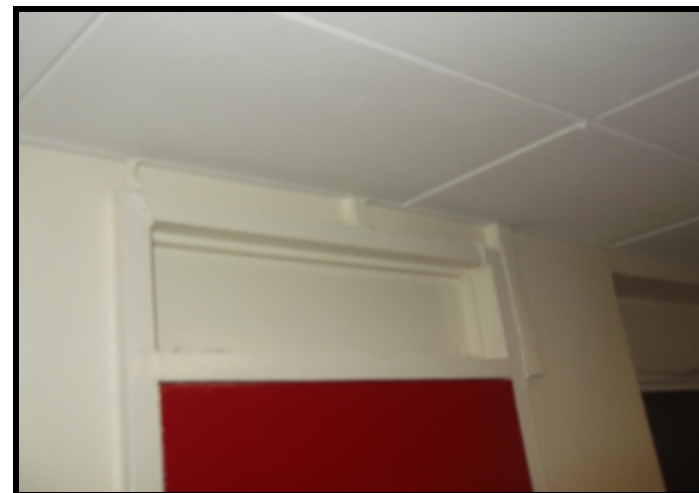
## SAMPLE REFERENCE 076

Building	Floor	Room	Location			
Main Building	Seventh Floor	Dry Riser	Transom Panel			
Description						
MATERIAL ASSESSMENT				SCORE		
Product Type	Insulation Board	Extent of Damage	Good condition		-	
Asbestos Type	No Asbestos Detected	Surface Treatment	Sealed Board (Encapsulated)			
PRIORITY ASSESSMENT				SCORE		
Occupant Activity	Not Applicable	Extent / Amount	1.00 m2		-	
Accessibility	Occasionally disturb	Location	Not Applicable			
Avg Time in Use	Not Applicable	Frequency of Use	Not Applicable			
No. of Occupants	Not Applicable	Secondary Activity	Not Applicable			
Maintenance	Not Applicable	Maintenance Frequency	Not Applicable			
MANAGEMENT ACTION				SCORE		
Recommendation	NO ACTION REQUIRED			-		
Recommendation Due		Next Inspection	None			
Apply Labels	No	Permit to Work Required	No			
Survey Type	Management	Lead Surveyor	Adam James			
Survey Date	09 Dec 2014	UKAS Laboratory	NOT SAMPLED (Cross Referenced)

**No Asbestos Presumed in Sample**

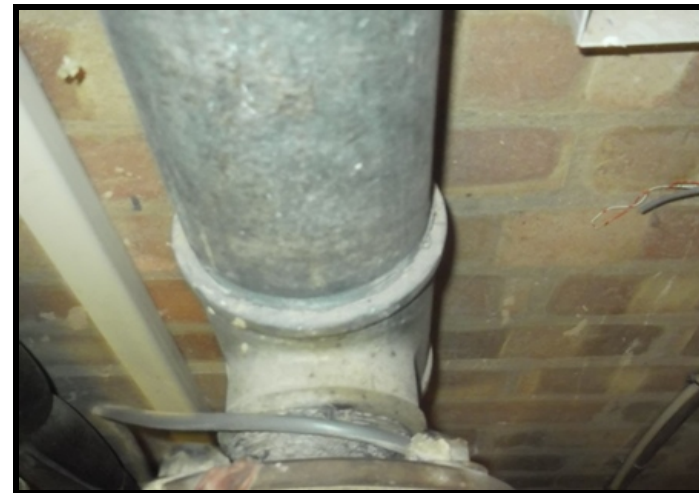
## SAMPLE REFERENCE 076a

MATERIAL ASSESSMENT				SCORE
<b>Product Type</b>	Lagging	<b>Extent of Damage</b>	Low damage	-
<b>Asbestos Type</b>	No Asbestos Detected	<b>Surface Treatment</b>	Unsealed (1)

**No Asbestos Presumed in Sample**

MANAGEMENT ACTION				SCORE
<b>Recommendation</b>	NO ACTION REQUIRED			-
<b>Recommendation Due</b>		<b>Next Inspection</b>	None	
<b>Apply Labels</b>	No	<b>Permit to Work Required</b>	No

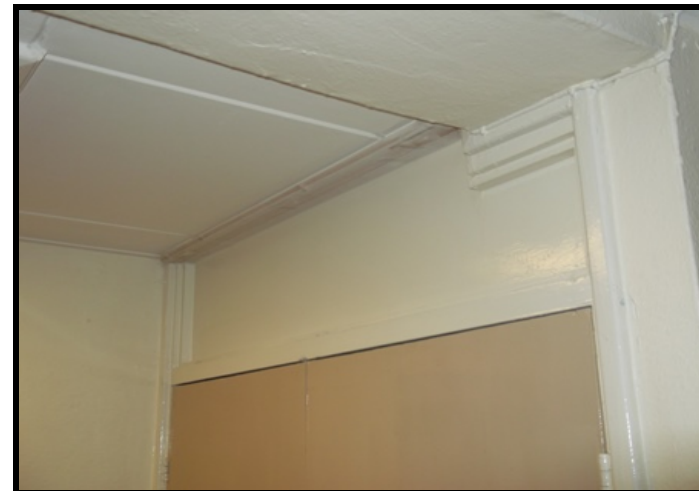
## SAMPLE REFERENCE 077

MATERIAL ASSESSMENT				SCORE
<b>Product Type</b>	Insulation Board	<b>Extent of Damage</b>	Good condition	-
<b>Asbestos Type</b>	<b>No Asbestos Detected</b>	<b>Surface Treatment</b>	Sealed Board (Encapsulated)

**No Asbestos Presumed in Sample**

MANAGEMENT ACTION				SCORE
<b>Recommendation</b>	NO ACTION REQUIRED			-
<b>Recommendation Due</b>		<b>Next Inspection</b>	None	
<b>Apply Labels</b>	No	<b>Permit to Work Required</b>	No

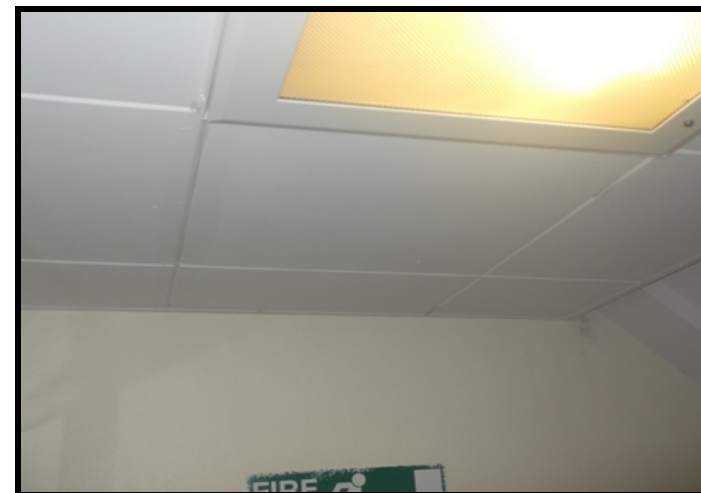
## SAMPLE REFERENCE 078

MATERIAL ASSESSMENT				SCORE
<b>Product Type</b>	Insulation Board	<b>Extent of Damage</b>	Good condition	-
<b>Asbestos Type</b>	<b>No Asbestos Detected</b>	<b>Surface Treatment</b>	Sealed Board (Encapsulated)

**No Asbestos Presumed in Sample**

MANAGEMENT ACTION				SCORE
<b>Recommendation</b>	NO ACTION REQUIRED			-
<b>Recommendation Due</b>		<b>Next Inspection</b>	None	
<b>Apply Labels</b>	No	<b>Permit to Work Required</b>	No

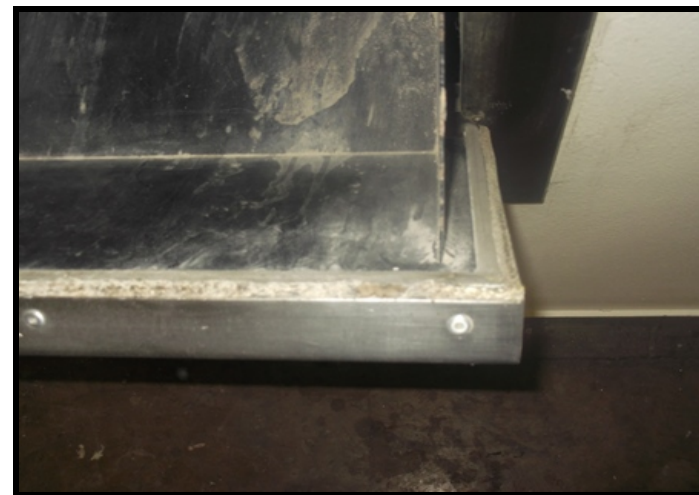
## SAMPLE REFERENCE 078a

MATERIAL ASSESSMENT				SCORE
<b>Product Type</b>	Rope	<b>Extent of Damage</b>	Low damage	-
<b>Asbestos Type</b>	No Asbestos Detected	<b>Surface Treatment</b>	Unsealed (1)

**No Asbestos Presumed in Sample**

MANAGEMENT ACTION				SCORE
<b>Recommendation</b>	NO ACTION REQUIRED			-
<b>Recommendation Due</b>		<b>Next Inspection</b>	None	
<b>Apply Labels</b>	No	<b>Permit to Work Required</b>	No

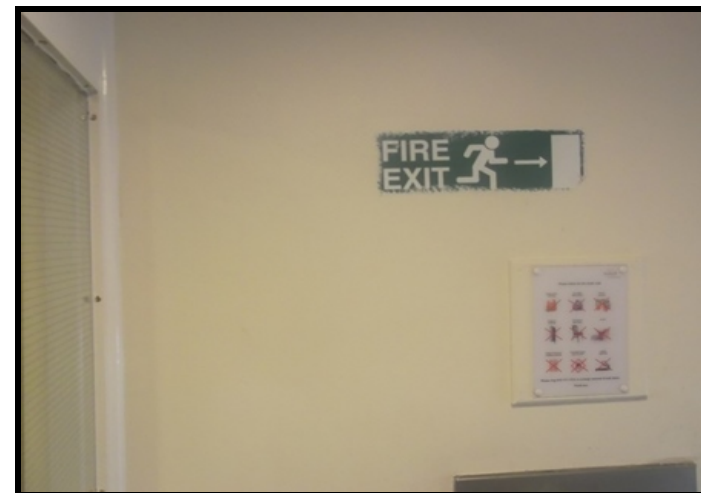
## SAMPLE REFERENCE 079

Building	Floor	Room	Location		
Main Building	Eighth Floor	Landing/Stairs	Wall		
Description					
MATERIAL ASSESSMENT					SCORE
Product Type	Textured Coating	Extent of Damage	Good condition		-
Asbestos Type	No Asbestos Detected	Surface Treatment	Textured Coating		
PRIORITY ASSESSMENT					SCORE
Occupant Activity	Not Applicable	Extent / Amount	15.00 m2		-
Accessibility	Occasionally disturb	Location	Not Applicable		
Avg Time in Use	Not Applicable	Frequency of Use	Not Applicable		
No. of Occupants	Not Applicable	Secondary Activity	Not Applicable		
Maintenance	Not Applicable	Maintenance Frequency	Not Applicable		
MANAGEMENT ACTION					SCORE
Recommendation	NO ACTION REQUIRED				-
Recommendation Due		Next Inspection	None		
Apply Labels	No	Permit to Work Required	No		
Survey Type	Management	Lead Surveyor	Adam James		
Survey Date	09 Dec 2014	UKAS Laboratory	NOT SAMPLED (Cross Referenced)		
Site Reference	257900000A	Licensed Material	N/A	Notifiable Non Licensed Work	N/A

**No Asbestos Presumed in Sample**

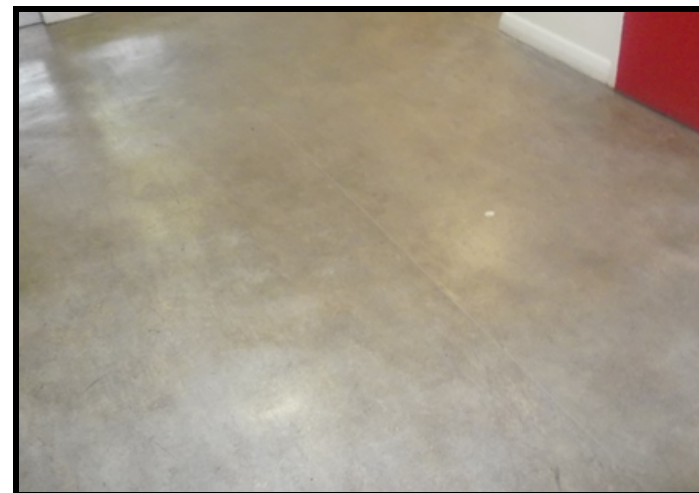
## SAMPLE REFERENCE 080

Building	Floor	Room	Location		
Main Building	Eighth Floor	Landing/Stairs	Floor		
Description	Paper backing to lino				
MATERIAL ASSESSMENT					SCORE
Product Type	Paper	Extent of Damage	Good condition		-
Asbestos Type	No Asbestos Detected	Surface Treatment	Sealed (0)		
PRIORITY ASSESSMENT					SCORE
Occupant Activity	Not Applicable	Extent / Amount	10.00 m2		-
Accessibility	Occasionally disturb	Location	Not Applicable		
Avg Time in Use	Not Applicable	Frequency of Use	Not Applicable		
No. of Occupants	Not Applicable	Secondary Activity	Not Applicable		
Maintenance	Not Applicable	Maintenance Frequency	Not Applicable		
MANAGEMENT ACTION					SCORE
Recommendation	NO ACTION REQUIRED				-
Recommendation Due		Next Inspection	None		
Apply Labels	No	Permit to Work Required	No		
Survey Type	Management	Lead Surveyor	Adam James		
Survey Date	09 Dec 2014	UKAS Laboratory	NOT SAMPLED (Cross Referenced)		
Site Reference	257900000A	Licensed Material	N/A	Notifiable Non Licensed Work	N/A

**No Asbestos Presumed in Sample**

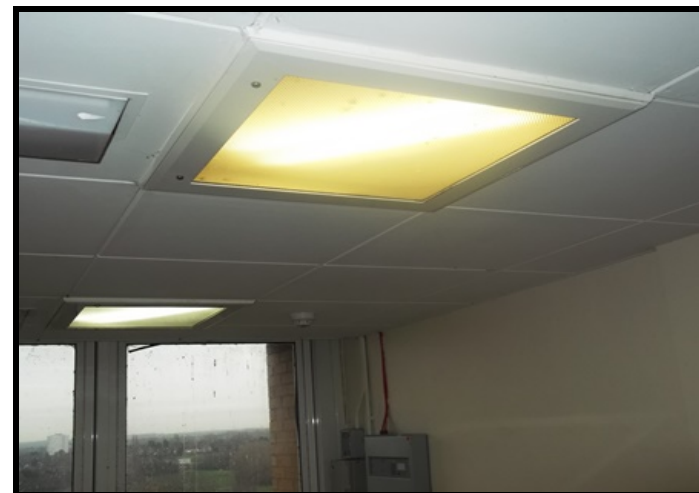
## SAMPLE REFERENCE 081

Building	Floor	Room	Location			
Main Building	Eighth Floor	Stairs	Ceiling			
Description						
MATERIAL ASSESSMENT				SCORE		
Product Type	Insulation Board	Extent of Damage	Good condition		-	
Asbestos Type	No Asbestos Detected	Surface Treatment	Sealed Board (Encapsulated)			
PRIORITY ASSESSMENT				SCORE		
Occupant Activity	Not Applicable	Extent / Amount	10.00 m2		-	
Accessibility	Occasionally disturb	Location	Not Applicable			
Avg Time in Use	Not Applicable	Frequency of Use	Not Applicable			
No. of Occupants	Not Applicable	Secondary Activity	Not Applicable			
Maintenance	Not Applicable	Maintenance Frequency	Not Applicable			
MANAGEMENT ACTION				SCORE		
Recommendation	NO ACTION REQUIRED			-		
Recommendation Due		Next Inspection	None			
Apply Labels	No	Permit to Work Required	No			
Survey Type	Management	Lead Surveyor	Adam James			
Survey Date	09 Dec 2014	UKAS Laboratory	NOT SAMPLED (Cross Referenced)			
Site Reference	257900000A	Licensed Material	N/A	Notifiable Non Licensed Work	N/A

**No Asbestos Presumed in Sample**

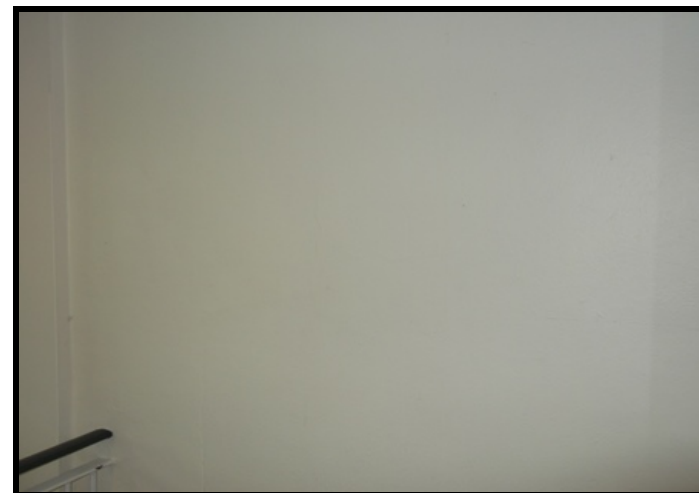
## SAMPLE REFERENCE 082

Building	Floor	Room	Location			
Main Building	Eighth Floor	Stairs	Wall			
Description						
MATERIAL ASSESSMENT				SCORE		
Product Type	Textured Coating	Extent of Damage	Good condition		-	
Asbestos Type	No Asbestos Detected	Surface Treatment	Textured Coating			
PRIORITY ASSESSMENT				SCORE		
Occupant Activity	Not Applicable	Extent / Amount	15.00 m2		-	
Accessibility	Easily disturbed	Location	Not Applicable			
Avg Time in Use	Not Applicable	Frequency of Use	Not Applicable			
No. of Occupants	Not Applicable	Secondary Activity	Not Applicable			
Maintenance	Not Applicable	Maintenance Frequency	Not Applicable			
MANAGEMENT ACTION				SCORE		
Recommendation	NO ACTION REQUIRED			-		
Recommendation Due		Next Inspection	None			
Apply Labels	No	Permit to Work Required	No			
Survey Type	Management	Lead Surveyor	Adam James			
Survey Date	09 Dec 2014	UKAS Laboratory	NOT SAMPLED (Cross Referenced)			
Site Reference	257900000A	Licensed Material	N/A	Notifiable Non Licensed Work	N/A

**No Asbestos Presumed in Sample**

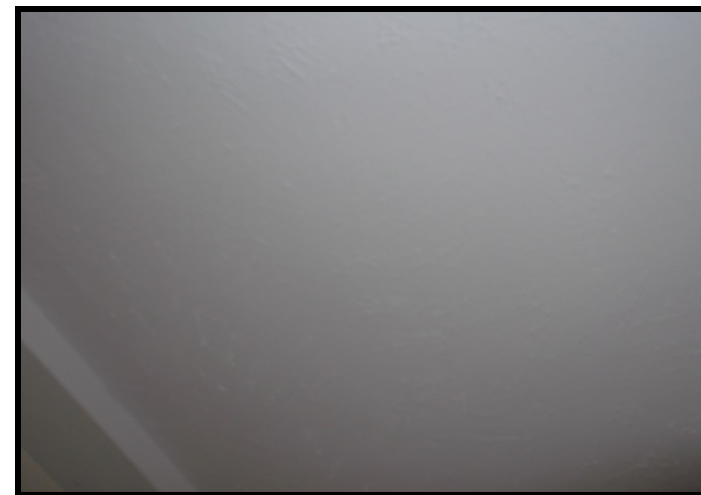
## SAMPLE REFERENCE 084

Building	Floor	Room	Location		
Main Building	Eighth Floor	Stairs	Ceiling		
Description					
MATERIAL ASSESSMENT					SCORE
Product Type	Textured Coating	Extent of Damage	Good condition		-
Asbestos Type	No Asbestos Detected	Surface Treatment	Textured Coating		
PRIORITY ASSESSMENT					SCORE
Occupant Activity	Not Applicable	Extent / Amount	4.00 m2		-
Accessibility	Occasionally disturb	Location	Not Applicable		
Avg Time in Use	Not Applicable	Frequency of Use	Not Applicable		
No. of Occupants	Not Applicable	Secondary Activity	Not Applicable		
Maintenance	Not Applicable	Maintenance Frequency	Not Applicable		
MANAGEMENT ACTION					SCORE
Recommendation	NO ACTION REQUIRED				-
Recommendation Due		Next Inspection	None		
Apply Labels	No	Permit to Work Required	No		
Survey Type	Management	Lead Surveyor	Adam James		
Survey Date	09 Dec 2014	UKAS Laboratory	NOT SAMPLED (Cross Referenced)		
Site Reference	257900000A	Licensed Material	N/A	Notifiable Non Licensed Work	N/A

**No Asbestos Presumed in Sample**

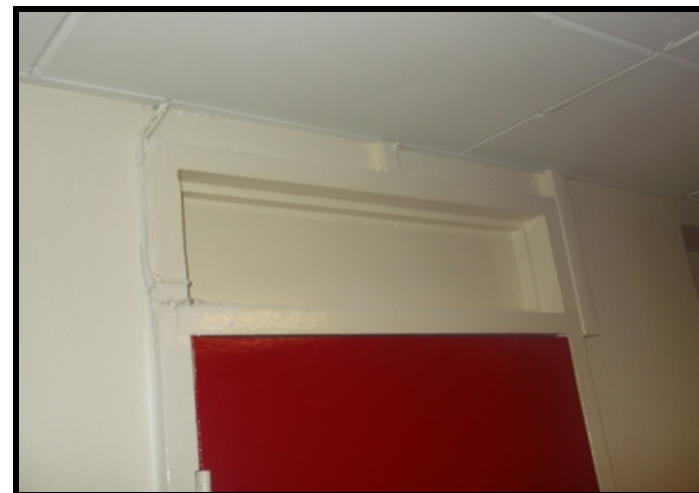
## SAMPLE REFERENCE 085

Building	Floor	Room	Location			
Main Building	Eighth Floor	Dry Riser	Transom Panel			
Description						
MATERIAL ASSESSMENT				SCORE		
Product Type	Insulation Board	Extent of Damage	Good condition		-	
Asbestos Type	No Asbestos Detected	Surface Treatment	Sealed Board (Encapsulated)			
PRIORITY ASSESSMENT				SCORE		
Occupant Activity	Not Applicable	Extent / Amount	1.00 m2		-	
Accessibility	Occasionally disturb	Location	Not Applicable			
Avg Time in Use	Not Applicable	Frequency of Use	Not Applicable			
No. of Occupants	Not Applicable	Secondary Activity	Not Applicable			
Maintenance	Not Applicable	Maintenance Frequency	Not Applicable			
MANAGEMENT ACTION				SCORE		
Recommendation	NO ACTION REQUIRED			-		
Recommendation Due		Next Inspection	None			
Apply Labels	No	Permit to Work Required	No			
Survey Type	Management	Lead Surveyor	Adam James			
Survey Date	09 Dec 2014	UKAS Laboratory	NOT SAMPLED (Cross Referenced)

**No Asbestos Presumed in Sample**

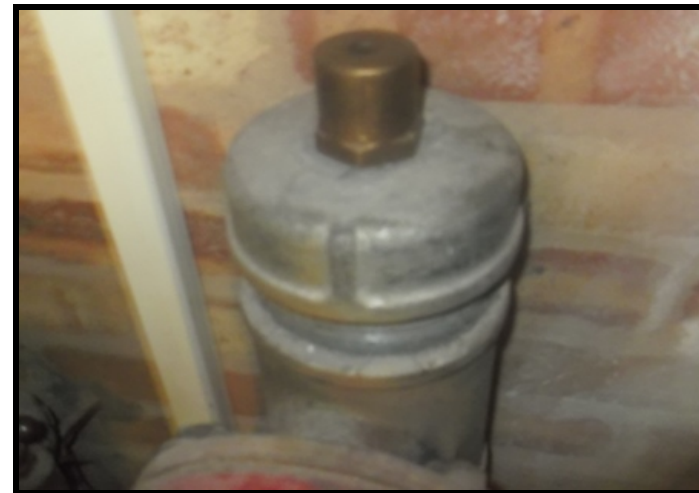
## SAMPLE REFERENCE 085a

MATERIAL ASSESSMENT				SCORE
<b>Product Type</b>	Lagging	<b>Extent of Damage</b>	Low damage	-
<b>Asbestos Type</b>	No Asbestos Detected	<b>Surface Treatment</b>	Unsealed (1)

**No Asbestos Presumed in Sample**

MANAGEMENT ACTION				SCORE
<b>Recommendation</b>	NO ACTION REQUIRED			-
<b>Recommendation Due</b>		<b>Next Inspection</b>	None	
<b>Apply Labels</b>	No	<b>Permit to Work Required</b>	No

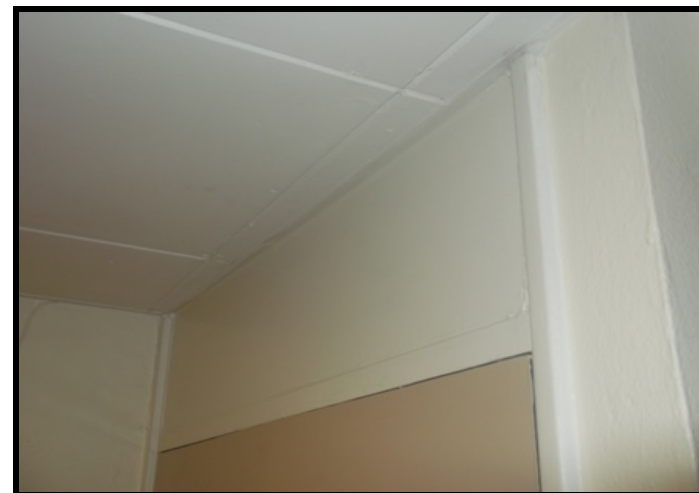
## SAMPLE REFERENCE 086

Building	Floor	Room	Location		
Main Building	Eighth Floor	Electricity Riser	Transom Panel		
Description					
MATERIAL ASSESSMENT					SCORE
Product Type	Insulation Board	Extent of Damage	Good condition		-
Asbestos Type	No Asbestos Detected	Surface Treatment	Sealed Board (Encapsulated)		
PRIORITY ASSESSMENT					SCORE
Occupant Activity	Not Applicable	Extent / Amount	1.00 m2		-
Accessibility	Occasionally disturb	Location	Not Applicable		
Avg Time in Use	Not Applicable	Frequency of Use	Not Applicable		
No. of Occupants	Not Applicable	Secondary Activity	Not Applicable		
Maintenance	Not Applicable	Maintenance Frequency	Not Applicable		
MANAGEMENT ACTION					SCORE
Recommendation	NO ACTION REQUIRED				-
Recommendation Due		Next Inspection	None		
Apply Labels	No	Permit to Work Required	No		
Survey Type	Management	Lead Surveyor	Adam James		
Survey Date	09 Dec 2014	UKAS Laboratory	NOT SAMPLED (Cross Referenced)		
Site Reference	257900000A	Licensed Material	N/A	Notifiable Non Licensed Work	N/A

**No Asbestos Presumed in Sample**

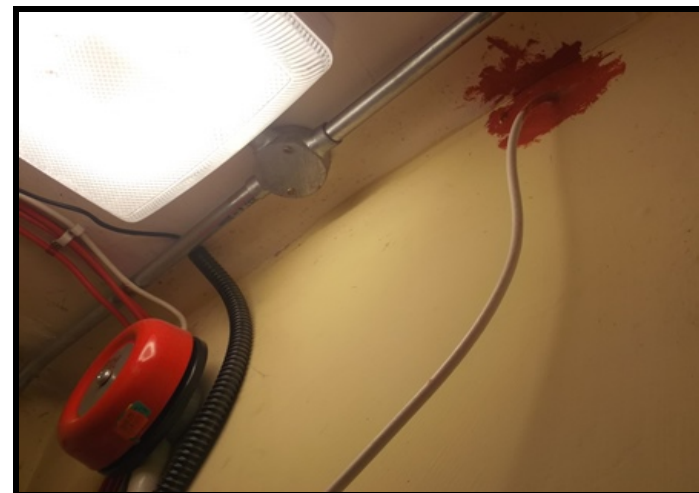
## SAMPLE REFERENCE 087

MATERIAL ASSESSMENT				SCORE
<b>Product Type</b>	Not Applicable	<b>Extent of Damage</b>	Not Applicable	0
<b>Asbestos Type</b>	<b>Not Applicable</b>	<b>Surface Treatment</b>	Not Applicable

**No Asbestos Containing Materials Identified**

MANAGEMENT ACTION				SCORE
<b>Recommendation</b>	NOT APPLICABLE			0
<b>Recommendation Due</b>		<b>Next Inspection</b>	None	
<b>Apply Labels</b>	No	<b>Permit to Work Required</b>	No

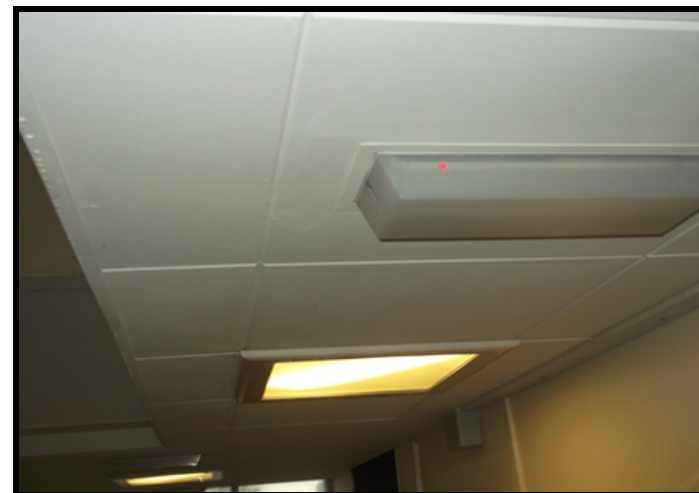
## SAMPLE REFERENCE 089

Building	Floor	Room	Location		
Main Building	Ground Floor	Landing/Stairs	Ceiling		
Description					
MATERIAL ASSESSMENT					SCORE
Product Type	Insulation Board	Extent of Damage	Good condition		-
Asbestos Type	No Asbestos Detected	Surface Treatment	Sealed Board (Encapsulated)		
PRIORITY ASSESSMENT					SCORE
Occupant Activity	Not Applicable	Extent / Amount	5.00 m2		-
Accessibility	Occasionally disturb	Location	Not Applicable		
Avg Time in Use	Not Applicable	Frequency of Use	Not Applicable		
No. of Occupants	Not Applicable	Secondary Activity	Not Applicable		
Maintenance	Not Applicable	Maintenance Frequency	Not Applicable		
MANAGEMENT ACTION					SCORE
Recommendation	NO ACTION REQUIRED				-
Recommendation Due		Next Inspection	None		
Apply Labels	No	Permit to Work Required	No		
Survey Type	Management	Lead Surveyor	Adam James		
Survey Date	09 Dec 2014	UKAS Laboratory	NOT SAMPLED (Cross Referenced)		
Site Reference	257900000A	Licensed Material	N/A	Notifiable Non Licensed Work	N/A

**No Asbestos Presumed in Sample**

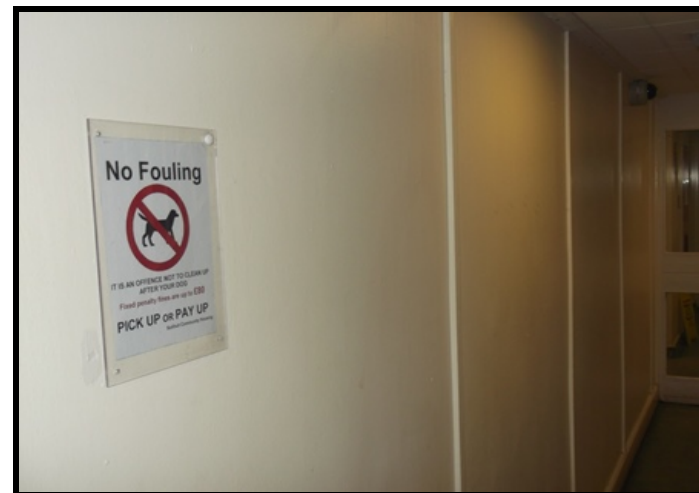
## SAMPLE REFERENCE 089a

Building	Floor	Room	Location		
Main Building	Ground Floor	Landing/Stairs	Wall		
Description	Panels to wall				
MATERIAL ASSESSMENT					SCORE
Product Type	Insulation Board	Extent of Damage	Good condition		-
Asbestos Type	No Asbestos Detected	Surface Treatment	Sealed Board (Encapsulated)		
PRIORITY ASSESSMENT					SCORE
Occupant Activity	Not Applicable	Extent / Amount	15.00 m2		-
Accessibility	Easily disturbed	Location	Not Applicable		
Avg Time in Use	Not Applicable	Frequency of Use	Not Applicable		
No. of Occupants	Not Applicable	Secondary Activity	Not Applicable		
Maintenance	Not Applicable	Maintenance Frequency	Not Applicable		
MANAGEMENT ACTION					SCORE
Recommendation	NO ACTION REQUIRED				-
Recommendation Due		Next Inspection	None		
Apply Labels	No	Permit to Work Required	No		
Survey Type	Management	Lead Surveyor	Adam James		
Survey Date	09 Dec 2014	UKAS Laboratory	Not Applicable / [A-8971]		
Site Reference	257900000A	Licensed Material	N/A	Notifiable Non Licensed Work	N/A

**Asbestos not detected in Sample**

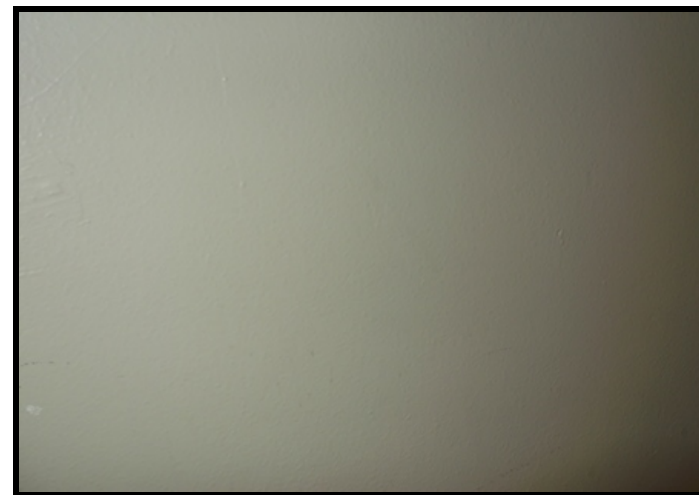
## SAMPLE REFERENCE 090

Building	Floor	Room	Location		
Main Building	Ground Floor	Landing/Stairs	Wall		
Description					
MATERIAL ASSESSMENT					SCORE
Product Type	Textured Coating	Extent of Damage	Good condition		-
Asbestos Type	No Asbestos Detected	Surface Treatment	Textured Coating		
PRIORITY ASSESSMENT					SCORE
Occupant Activity	Not Applicable	Extent / Amount	10.00 m2		-
Accessibility	Easily disturbed	Location	Not Applicable		
Avg Time in Use	Not Applicable	Frequency of Use	Not Applicable		
No. of Occupants	Not Applicable	Secondary Activity	Not Applicable		
Maintenance	Not Applicable	Maintenance Frequency	Not Applicable		
MANAGEMENT ACTION					SCORE
Recommendation	NO ACTION REQUIRED				-
Recommendation Due		Next Inspection	None		
Apply Labels	No	Permit to Work Required	No		
Survey Type	Management	Lead Surveyor	Adam James		
Survey Date	09 Dec 2014	UKAS Laboratory	NOT SAMPLED (Cross Referenced)		
Site Reference	257900000A	Licensed Material	N/A	Notifiable Non Licensed Work	N/A

**No Asbestos Presumed in Sample**

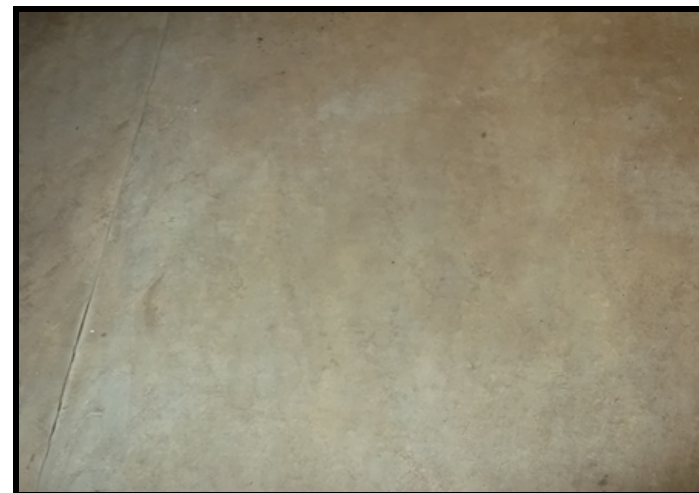
## SAMPLE REFERENCE 091

Building	Floor	Room	Location		
Main Building	Ground Floor	Landing/Stairs	Floor		
Description	Paper backing to lino				
MATERIAL ASSESSMENT				SCORE	
Product Type	Paper	Extent of Damage	Good condition		-
Asbestos Type	No Asbestos Detected	Surface Treatment	Sealed (0)		
PRIORITY ASSESSMENT				SCORE	
Occupant Activity	Not Applicable	Extent / Amount	5.00 m2		-
Accessibility	Occasionally disturb	Location	Not Applicable		
Avg Time in Use	Not Applicable	Frequency of Use	Not Applicable		
No. of Occupants	Not Applicable	Secondary Activity	Not Applicable		
Maintenance	Not Applicable	Maintenance Frequency	Not Applicable		
MANAGEMENT ACTION				SCORE	
Recommendation	NO ACTION REQUIRED				-
Recommendation Due		Next Inspection	None		
Apply Labels	No	Permit to Work Required	No		
Survey Type	Management	Lead Surveyor	Adam James		
Survey Date	09 Dec 2014	UKAS Laboratory	NOT SAMPLED (Cross Referenced)		
Site Reference	257900000A	Licensed Material	N/A	Notifiable Non Licensed Work	N/A

**No Asbestos Presumed in Sample**

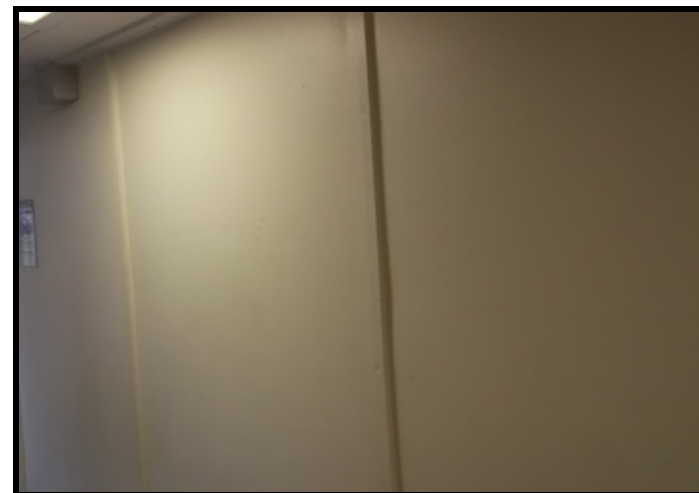
## SAMPLE REFERENCE 092

Building	Floor	Room	Location		
Main Building	Ground Floor	Landing/Stairs	Wall		
Description					
MATERIAL ASSESSMENT					SCORE
Product Type	Cement	Extent of Damage	Good condition		-
Asbestos Type	No Asbestos Detected	Surface Treatment	Sealed (Cement products)		
PRIORITY ASSESSMENT					SCORE
Occupant Activity	Not Applicable	Extent / Amount	10.00 m2		-
Accessibility	Easily disturbed	Location	Not Applicable		
Avg Time in Use	Not Applicable	Frequency of Use	Not Applicable		
No. of Occupants	Not Applicable	Secondary Activity	Not Applicable		
Maintenance	Not Applicable	Maintenance Frequency	Not Applicable		
MANAGEMENT ACTION					SCORE
Recommendation	NO ACTION REQUIRED				-
Recommendation Due		Next Inspection	None		
Apply Labels	No	Permit to Work Required	No		
Survey Type	Management	Lead Surveyor	Adam James		
Survey Date	09 Dec 2014	UKAS Laboratory	DMW Environmental Safety Ltd / [A-8971]		
Site Reference	257900000A	Licensed Material	N/A	Notifiable Non Licensed Work	N/A

Asbestos not detected in Sample

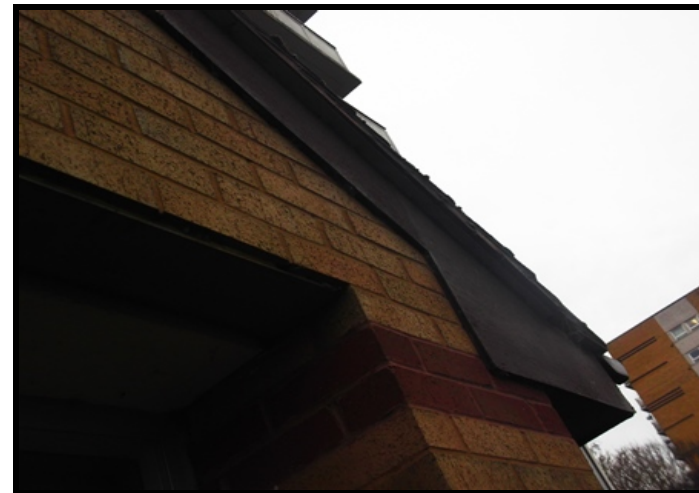
## SAMPLE REFERENCE 093

Building	Floor	Room	Location			
Main Building	External	Ground Floor	Under Cloaking			
Description	Under cloaking to front and rear entrances.					
MATERIAL ASSESSMENT				SCORE		
Product Type	Cement	Extent of Damage	Good condition		3	
Asbestos Type	Chrysotile	Surface Treatment	Sealed (Cement products)			
PRIORITY ASSESSMENT				SCORE		
Occupant Activity	Not Applicable	Extent / Amount	12.00 m2		1	
Accessibility	Occasionally disturb	Location	Not Applicable			
Avg Time in Use	Not Applicable	Frequency of Use	Not Applicable			
No. of Occupants	Not Applicable	Secondary Activity	Not Applicable			
Maintenance	Not Applicable	Maintenance Frequency	Not Applicable			
MANAGEMENT ACTION				SCORE		
Recommendation	LABEL & MONITOR			4		
Recommendation Due		Next Inspection	09 Dec 2015			
Apply Labels	No	Permit to Work Required	No			
Survey Type	Management	Lead Surveyor	Adam James			
Survey Date	09 Dec 2014	UKAS Laboratory	DMW Environmental Safety Ltd / [A-8971]

Asbestos detected in Sample

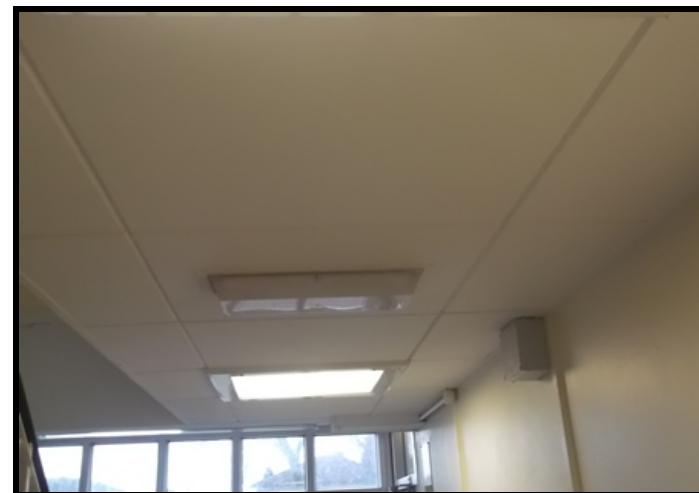
## SAMPLE REFERENCE 094

Building	Floor	Room	Location			
Main Building	Ground Floor	Rear Entrance	Ceiling			
Description						
MATERIAL ASSESSMENT				SCORE		
Product Type	Insulation Board	Extent of Damage	Good condition		-	
Asbestos Type	No Asbestos Detected	Surface Treatment	Sealed Board (Encapsulated)			
PRIORITY ASSESSMENT				SCORE		
Occupant Activity	Not Applicable	Extent / Amount	5.00 m2		-	
Accessibility	Occasionally disturb	Location	Not Applicable			
Avg Time in Use	Not Applicable	Frequency of Use	Not Applicable			
No. of Occupants	Not Applicable	Secondary Activity	Not Applicable			
Maintenance	Not Applicable	Maintenance Frequency	Not Applicable			
MANAGEMENT ACTION				SCORE		
Recommendation	NO ACTION REQUIRED			-		
Recommendation Due		Next Inspection	None			
Apply Labels	No	Permit to Work Required	No			
Survey Type	Management	Lead Surveyor	Adam James			
Survey Date	09 Dec 2014	UKAS Laboratory	NOT SAMPLED (Cross Referenced)

**No Asbestos Presumed in Sample**

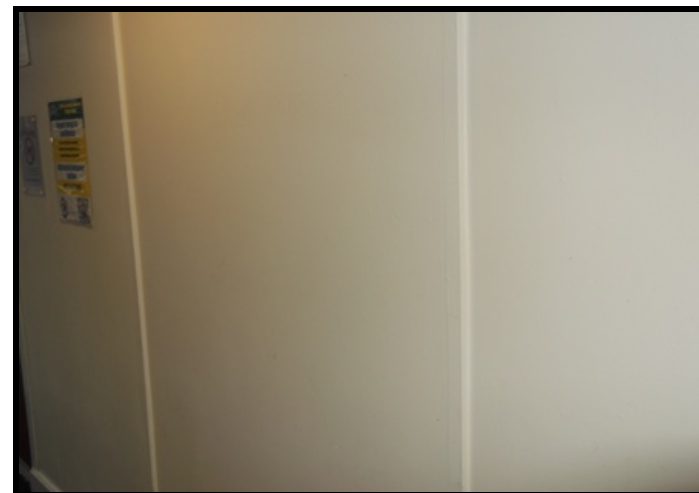
## SAMPLE REFERENCE 094a

Building	Floor	Room	Location		
Main Building	Ground Floor	Rear Entrance	Wall		
Description	Panels to wall				
MATERIAL ASSESSMENT					SCORE
Product Type	Insulation Board	Extent of Damage	Good condition		-
Asbestos Type	No Asbestos Detected	Surface Treatment	Sealed Board (Encapsulated)		
PRIORITY ASSESSMENT					SCORE
Occupant Activity	Not Applicable	Extent / Amount	15.00 m2		-
Accessibility	Easily disturbed	Location	Not Applicable		
Avg Time in Use	Not Applicable	Frequency of Use	Not Applicable		
No. of Occupants	Not Applicable	Secondary Activity	Not Applicable		
Maintenance	Not Applicable	Maintenance Frequency	Not Applicable		
MANAGEMENT ACTION					SCORE
Recommendation	NO ACTION REQUIRED				-
Recommendation Due		Next Inspection	None		
Apply Labels	No	Permit to Work Required	No		
Survey Type	Management	Lead Surveyor	Adam James		
Survey Date	09 Dec 2014	UKAS Laboratory	NOT SAMPLED (Cross Referenced)		
Site Reference	257900000A	Licensed Material	N/A	Notifiable Non Licensed Work	N/A

**No Asbestos Presumed in Sample**

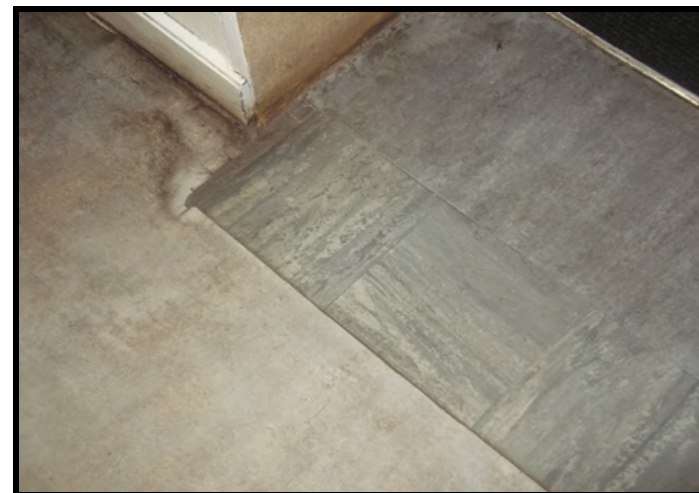
## SAMPLE REFERENCE 094b

Building	Floor	Room	Location		
Main Building	Ground Floor	Rear Entrance	Floor		
Description					
MATERIAL ASSESSMENT					SCORE
Product Type	Floor Tiles & Adhesive	Extent of Damage	Low damage		-
Asbestos Type	No Asbestos Detected	Surface Treatment	Composite materials		
PRIORITY ASSESSMENT					SCORE
Occupant Activity	Not Applicable	Extent / Amount	2.00 m2		-
Accessibility	Easily disturbed	Location	Not Applicable		
Avg Time in Use	Not Applicable	Frequency of Use	Not Applicable		
No. of Occupants	Not Applicable	Secondary Activity	Not Applicable		
Maintenance	Not Applicable	Maintenance Frequency	Not Applicable		
MANAGEMENT ACTION					SCORE
Recommendation	NO ACTION REQUIRED				-
Recommendation Due		Next Inspection	None		
Apply Labels	No	Permit to Work Required	No		
Survey Type	Management	Lead Surveyor	Adam James		
Survey Date	09 Dec 2014	UKAS Laboratory	Not Applicable / [A-8971]		
Site Reference	257900000A	Licensed Material	N/A	Notifiable Non Licensed Work	N/A

Asbestos not detected in Sample

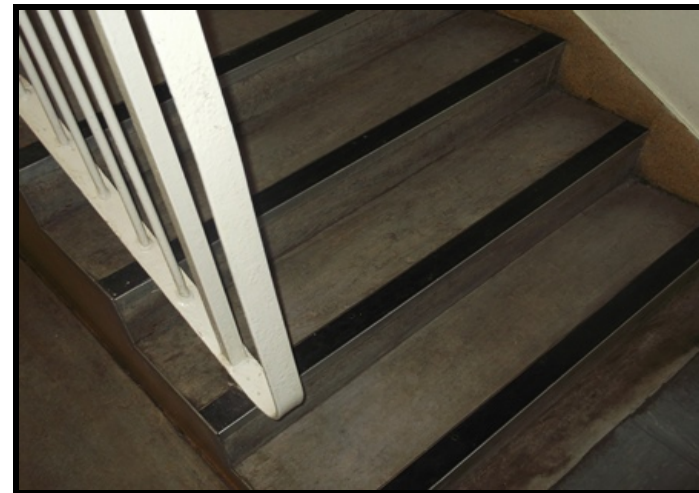
## SAMPLE REFERENCE 094c

Building	Floor	Room	Location		
Main Building	Ground Floor	Rear Entrance	Staircase		
Description	Stair nosing				
MATERIAL ASSESSMENT				SCORE	
Product Type	Bitumen	Extent of Damage	Low damage		-
Asbestos Type	No Asbestos Detected	Surface Treatment	Composite materials		
PRIORITY ASSESSMENT				SCORE	
Occupant Activity	Not Applicable	Extent / Amount	18.00 small item(s)		-
Accessibility	Routinely disturbed	Location	Not Applicable		
Avg Time in Use	Not Applicable	Frequency of Use	Not Applicable		
No. of Occupants	Not Applicable	Secondary Activity	Not Applicable		
Maintenance	Not Applicable	Maintenance Frequency	Not Applicable		
MANAGEMENT ACTION				SCORE	
Recommendation	NO ACTION REQUIRED				-
Recommendation Due		Next Inspection	None		
Apply Labels	No	Permit to Work Required	No		
Survey Type	Management	Lead Surveyor	Adam James		
Survey Date	09 Dec 2014	UKAS Laboratory	Not Applicable / [A-8971]		
Site Reference	257900000A	Licensed Material	N/A	Notifiable Non Licensed Work	N/A

Asbestos not detected in Sample

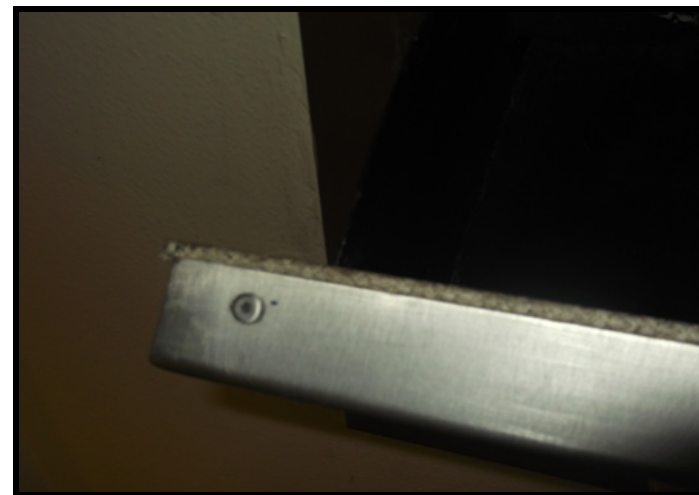
## SAMPLE REFERENCE 094d

Building	Floor	Room	Location		
Main Building	Ground Floor	Rear Entrance	Pipe Work		
Description	Rope seal to bin chute				
MATERIAL ASSESSMENT				SCORE	
Product Type	Rope	Extent of Damage	Low damage		-
Asbestos Type	No Asbestos Detected	Surface Treatment	Unsealed (I)		
PRIORITY ASSESSMENT				SCORE	
Occupant Activity	Not Applicable	Extent / Amount	1.00 small item(s)		-
Accessibility	Easily disturbed	Location	Not Applicable		
Avg Time in Use	Not Applicable	Frequency of Use	Not Applicable		
No. of Occupants	Not Applicable	Secondary Activity	Not Applicable		
Maintenance	Not Applicable	Maintenance Frequency	Not Applicable		
MANAGEMENT ACTION				SCORE	
Recommendation	NO ACTION REQUIRED				-
Recommendation Due		Next Inspection	None		
Apply Labels	No	Permit to Work Required	No		
Survey Type	Management	Lead Surveyor	Adam James		
Survey Date	09 Dec 2014	UKAS Laboratory	Not Applicable / [A-8971]		
Site Reference	257900000A	Licensed Material	N/A	Notifiable Non Licensed Work	N/A

Asbestos not detected in Sample

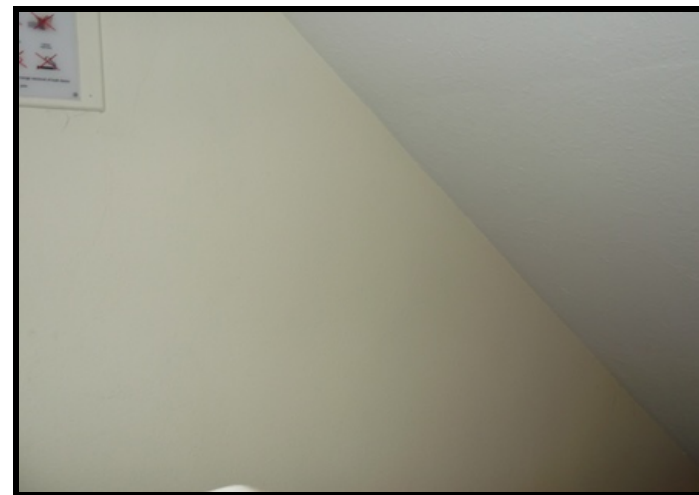
## SAMPLE REFERENCE 095

MATERIAL ASSESSMENT				SCORE
<b>Product Type</b>	Textured Coating	<b>Extent of Damage</b>	Good condition	-
<b>Asbestos Type</b>	<b>No Asbestos Detected</b>	<b>Surface Treatment</b>	Textured Coating

**No Asbestos Presumed in Sample**

MANAGEMENT ACTION				SCORE
<b>Recommendation</b>	NO ACTION REQUIRED			-
<b>Recommendation Due</b>		<b>Next Inspection</b>	None	
<b>Apply Labels</b>	No	<b>Permit to Work Required</b>	No

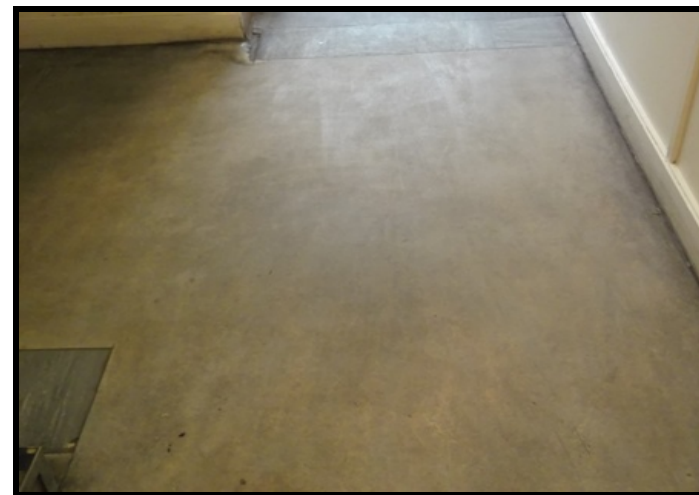
## SAMPLE REFERENCE 096

Building	Floor	Room	Location		
Main Building	Ground Floor	Rear Entrance	Floor		
Description	Paper backing to lino				
MATERIAL ASSESSMENT				SCORE	
Product Type	Paper	Extent of Damage	Good condition		-
Asbestos Type	No Asbestos Detected	Surface Treatment	Sealed (0)		
PRIORITY ASSESSMENT				SCORE	
Occupant Activity	Not Applicable	Extent / Amount	5.00 m2		-
Accessibility	Occasionally disturb	Location	Not Applicable		
Avg Time in Use	Not Applicable	Frequency of Use	Not Applicable		
No. of Occupants	Not Applicable	Secondary Activity	Not Applicable		
Maintenance	Not Applicable	Maintenance Frequency	Not Applicable		
MANAGEMENT ACTION				SCORE	
Recommendation	NO ACTION REQUIRED				-
Recommendation Due		Next Inspection	None		
Apply Labels	No	Permit to Work Required	No		
Survey Type	Management	Lead Surveyor	Adam James		
Survey Date	09 Dec 2014	UKAS Laboratory	NOT SAMPLED (Cross Referenced)		
Site Reference	257900000A	Licensed Material	N/A	Notifiable Non Licensed Work	N/A

**No Asbestos Presumed in Sample**
