# Solihull Community Housing

## Asbestos Management Survey Report

**Catesby House I-36 (Communal)**  
**Kingshurst Way**  
**Solihull**  
**B37 6DZ**

**Date of Report:** 15 Jan 2015  
**Survey Ref:** 257900000A

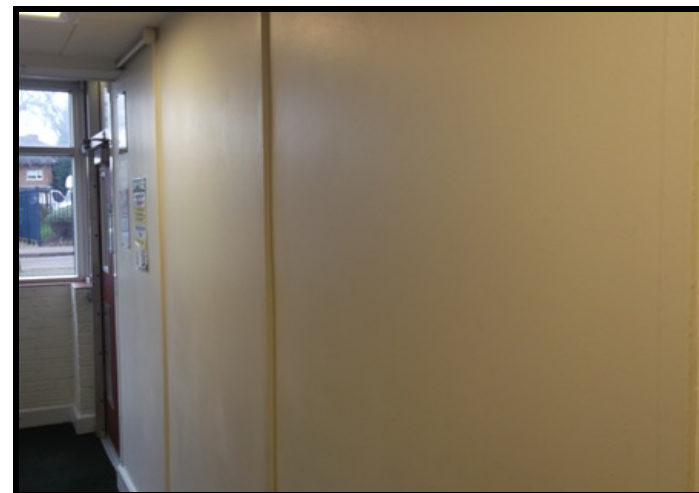
## SAMPLE REFERENCE 097

Building	Floor	Room	Location		
Main Building	Ground Floor	Rear Entrance	Wall		
Description					
MATERIAL ASSESSMENT					SCORE
Product Type	Cement	Extent of Damage	Good condition		-
Asbestos Type	No Asbestos Detected	Surface Treatment	Sealed (Cement products)		
PRIORITY ASSESSMENT					SCORE
Occupant Activity	Not Applicable	Extent / Amount	10.00 m2		-
Accessibility	Easily disturbed	Location	Not Applicable		
Avg Time in Use	Not Applicable	Frequency of Use	Not Applicable		
No. of Occupants	Not Applicable	Secondary Activity	Not Applicable		
Maintenance	Not Applicable	Maintenance Frequency	Not Applicable		
MANAGEMENT ACTION					SCORE
Recommendation	NO ACTION REQUIRED				-
Recommendation Due		Next Inspection	None		
Apply Labels	No	Permit to Work Required	No		
Survey Type	Management	Lead Surveyor	Adam James		
Survey Date	09 Dec 2014	UKAS Laboratory	NOT SAMPLED (Cross Referenced)		
Site Reference	257900000A	Licensed Material	N/A	Notifiable Non Licensed Work	N/A

**No Asbestos Presumed in Sample**
