Solihull Community Housing

Asbestos Management Survey Report

**Cheshunt House
Kington Gardens
Chelmsley Wood
B37 5TB**

Date of Report: 27 Apr 2012

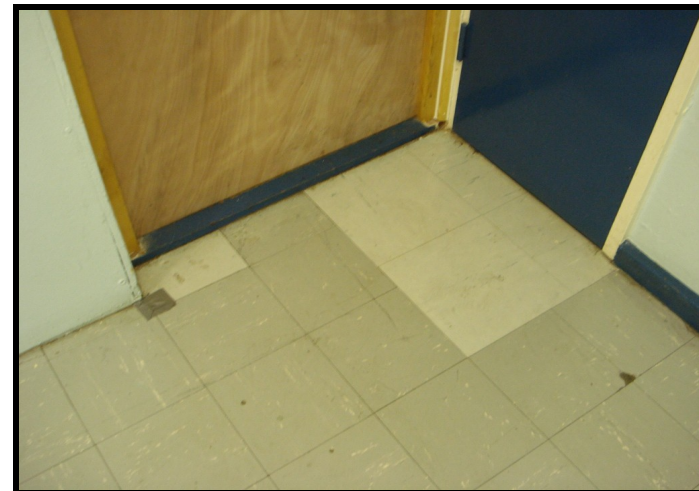
SAMPLE REFERENCE 013

Building	Floor	Room	Location
Main Building	Nineth Floor	Corridor I	Floor
Description			
MATERIAL ASSESSMENT			
Product Type	Floor Tiles	Extent of Damage	Good condition
Asbestos Type	No Asbestos Detected	Surface Treatment	Composite materials
PRIORITY ASSESSMENT			
Occupant Activity	Not Applicable	Extent / Amount	1.00 m2
Accessibility	Routinely disturbed	Location	Not Applicable
Avg Time in Use	Not Applicable	Frequency of Use	Not Applicable
No. of Occupants	Not Applicable	Secondary Activity	Not Applicable
Maintenance	Not Applicable	Maintenance Frequency	Not Applicable
MANAGEMENT ACTION			
Recommendation	NO ACTION REQUIRED		
Recommendation Due		Next Inspection	None
Apply Labels	No	Permit to Work Required	No
Survey Type	Management	Lead Surveyor	Jane Openshaw
Survey Date	22 Mar 2012	UKAS Laboratory	DMW Environmental Safety Ltd / [P-96015]
Site Reference	I49620000A	Licensed Material	N/A

Asbestos not detected in Sample

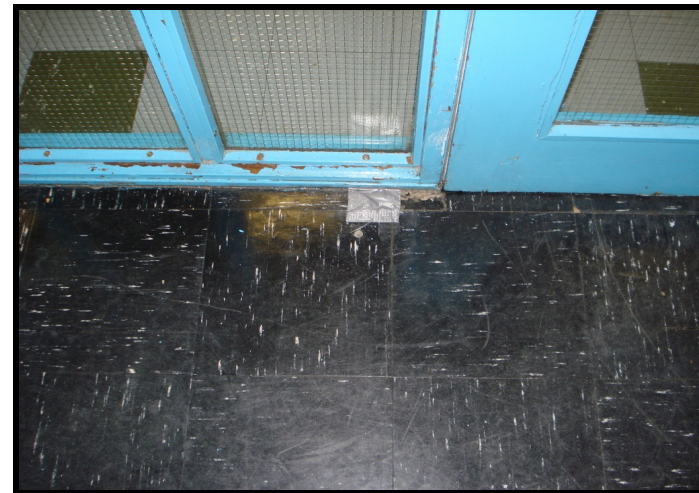
SAMPLE REFERENCE 017

Asbestos not detected in Sample

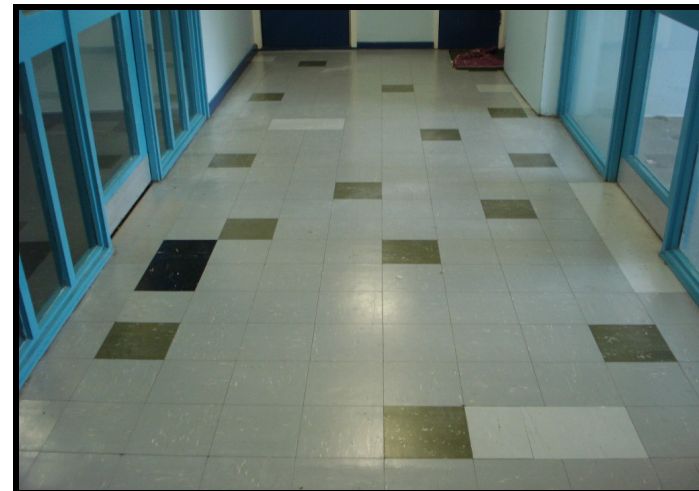
SAMPLE REFERENCE 021

Building	Floor	Room	Location	
Main Building	Nineth Floor	Corridor 2	Floor	
Description				
MATERIAL ASSESSMENT				SCORE
Product Type	Floor Tiles	Extent of Damage	Good condition	-
Asbestos Type	No Asbestos Detected	Surface Treatment	Composite materials	
PRIORITY ASSESSMENT				SCORE
Occupant Activity	Not Applicable	Extent / Amount	1.00 m2	-
Accessibility	Routinely disturbed	Location	Not Applicable	
Avg Time in Use	Not Applicable	Frequency of Use	Not Applicable	
No. of Occupants	Not Applicable	Secondary Activity	Not Applicable	
Maintenance	Not Applicable	Maintenance Frequency	Not Applicable	
MANAGEMENT ACTION				SCORE
Recommendation	NO ACTION REQUIRED			-
Recommendation Due		Next Inspection	None	
Apply Labels	No	Permit to Work Required	No	
Survey Type	Management	Lead Surveyor	Jane Openshaw	
Survey Date	22 Mar 2012	UKAS Laboratory	NOT SAMPLED (Cross Referenced)	
Site Reference	I49620000A	Licensed Material	N/A

No Asbestos Presumed in Sample

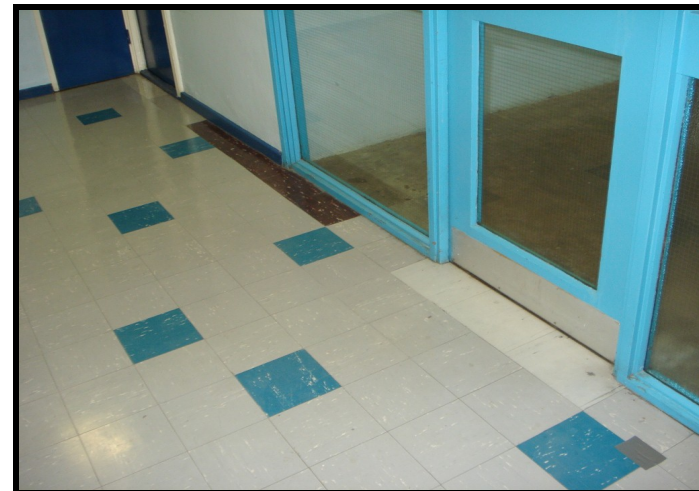
SAMPLE REFERENCE 033

Building	Floor	Room	Location	
Main Building	Eighth Floor	Corridor I	Floor	
Description				
MATERIAL ASSESSMENT				SCORE
Product Type	Floor Tiles	Extent of Damage	Good condition	2
Asbestos Type	Chrysotile	Surface Treatment	Composite materials	
PRIORITY ASSESSMENT				SCORE
Occupant Activity	Not Applicable	Extent / Amount	18.00 m2	2
Accessibility	Routinely disturbed	Location	Not Applicable	
Avg Time in Use	Not Applicable	Frequency of Use	Not Applicable	
No. of Occupants	Not Applicable	Secondary Activity	Not Applicable	
Maintenance	Not Applicable	Maintenance Frequency	Not Applicable	
MANAGEMENT ACTION				SCORE
Recommendation	LABEL & MONITOR			4
Recommendation Due		Next Inspection	22 Mar 2013	
Apply Labels	No	Permit to Work Required	No	
Survey Type	Management	Lead Surveyor	Jane Openshaw	
Survey Date	22 Mar 2012	UKAS Laboratory	NOT SAMPLED (Cross Referenced)	
Site Reference	I49620000A	Licensed Material	No

Asbestos Presumed in Sample

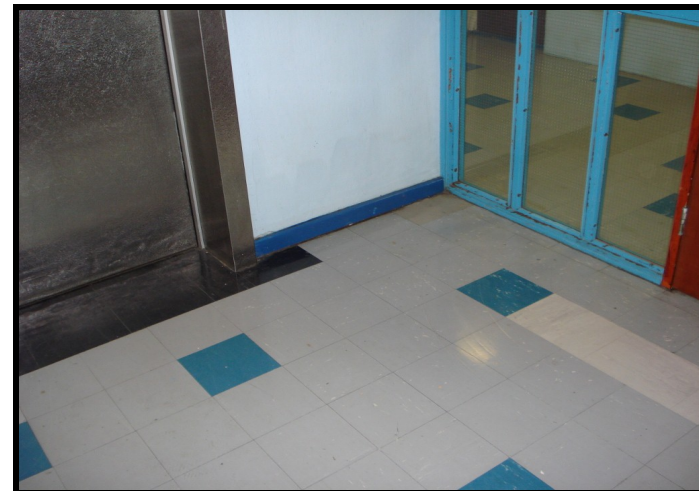
SAMPLE REFERENCE 042

Asbestos Presumed in Sample

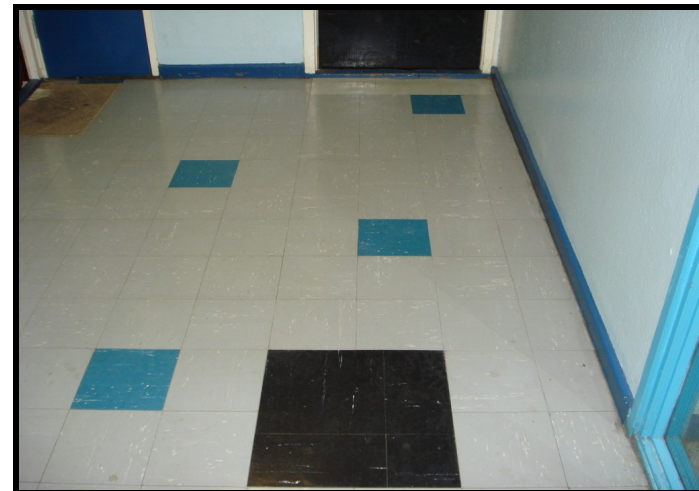
SAMPLE REFERENCE 048

No Asbestos Presumed in Sample

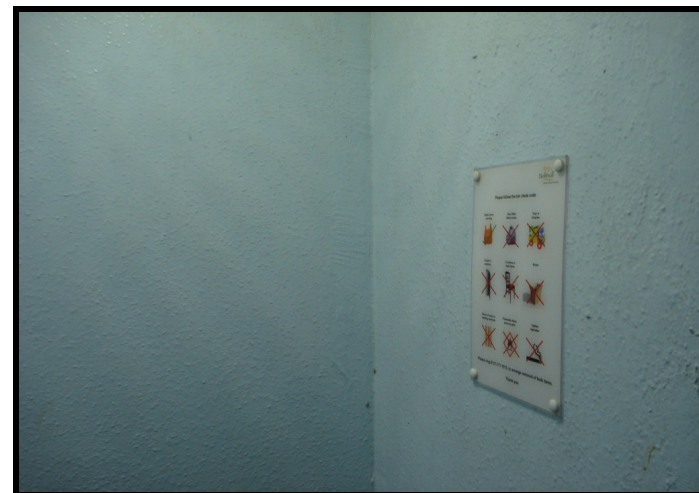
SAMPLE REFERENCE 100

Building	Floor	Room	Location	
Main Building	Fifth Floor	Bin Chute	Walls	
Description				
MATERIAL ASSESSMENT				SCORE
Product Type	Paint	Extent of Damage	Good condition	-
Asbestos Type	No Asbestos Detected	Surface Treatment	Sealed (1)	
PRIORITY ASSESSMENT				SCORE
Occupant Activity	Not Applicable	Extent / Amount	20.00 m2	-
Accessibility	Easily disturbed	Location	Not Applicable	
Avg Time in Use	Not Applicable	Frequency of Use	Not Applicable	
No. of Occupants	Not Applicable	Secondary Activity	Not Applicable	
Maintenance	Not Applicable	Maintenance Frequency	Not Applicable	
MANAGEMENT ACTION				SCORE
Recommendation	NO ACTION REQUIRED			-
Recommendation Due		Next Inspection	None	
Apply Labels	No	Permit to Work Required	No	
Survey Type	Management	Lead Surveyor	Jane Openshaw	
Survey Date	22 Mar 2012	UKAS Laboratory	NOT SAMPLED (Cross Referenced)	
Site Reference	I49620000A	Licensed Material	N/A

No Asbestos Presumed in Sample

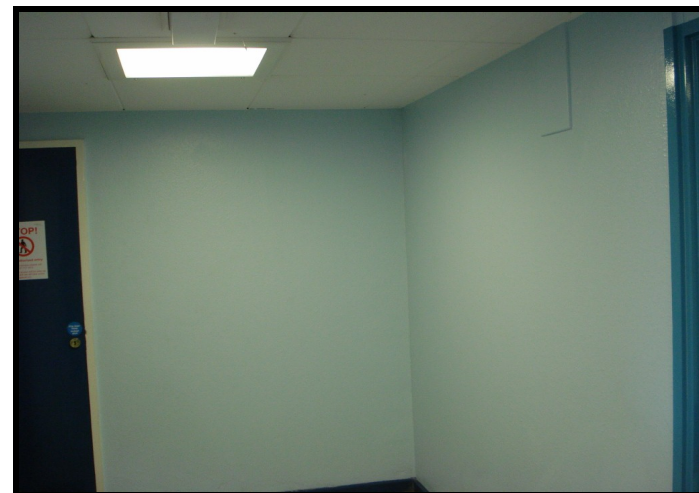
SAMPLE REFERENCE 103

Building	Floor	Room	Location	
Main Building	Fifth Floor	Corridor I	Walls	
Description				
MATERIAL ASSESSMENT				SCORE
Product Type	Paint	Extent of Damage	Good condition	-
Asbestos Type	No Asbestos Detected	Surface Treatment	Sealed (I)	
PRIORITY ASSESSMENT				SCORE
Occupant Activity	Not Applicable	Extent / Amount	25.00 m2	-
Accessibility	Easily disturbed	Location	Not Applicable	
Avg Time in Use	Not Applicable	Frequency of Use	Not Applicable	
No. of Occupants	Not Applicable	Secondary Activity	Not Applicable	
Maintenance	Not Applicable	Maintenance Frequency	Not Applicable	
MANAGEMENT ACTION				SCORE
Recommendation	NO ACTION REQUIRED			-
Recommendation Due		Next Inspection	None	
Apply Labels	No	Permit to Work Required	No	
Survey Type	Management	Lead Surveyor	Jane Openshaw	
Survey Date	22 Mar 2012	UKAS Laboratory	NOT SAMPLED (Cross Referenced)	
Site Reference	I49620000A	Licensed Material	N/A

No Asbestos Presumed in Sample

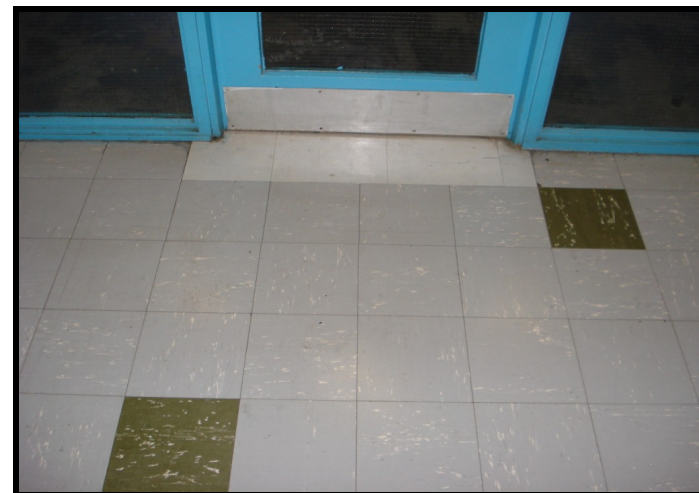
SAMPLE REFERENCE 105

Building	Floor	Room	Location
Main Building	Fifth Floor	Corridor I	Floor
Description			
MATERIAL ASSESSMENT			
Product Type	Floor Tiles	Extent of Damage	Low damage
Asbestos Type	Chrysotile	Surface Treatment	Composite materials
PRIORITY ASSESSMENT			
Occupant Activity	Not Applicable	Extent / Amount	2.00 m2
Accessibility	Routinely disturbed	Location	Not Applicable
Avg Time in Use	Not Applicable	Frequency of Use	Not Applicable
No. of Occupants	Not Applicable	Secondary Activity	Not Applicable
Maintenance	Not Applicable	Maintenance Frequency	Not Applicable
MANAGEMENT ACTION			
Recommendation	LABEL & MONITOR		
Recommendation Due		Next Inspection	22 Mar 2013
Apply Labels	No	Permit to Work Required	No
Survey Type	Management	Lead Surveyor	Jane Openshaw
Survey Date	22 Mar 2012	UKAS Laboratory	NOT SAMPLED (Cross Referenced)
Site Reference	I49620000A	Licensed Material	No

Asbestos Presumed in Sample

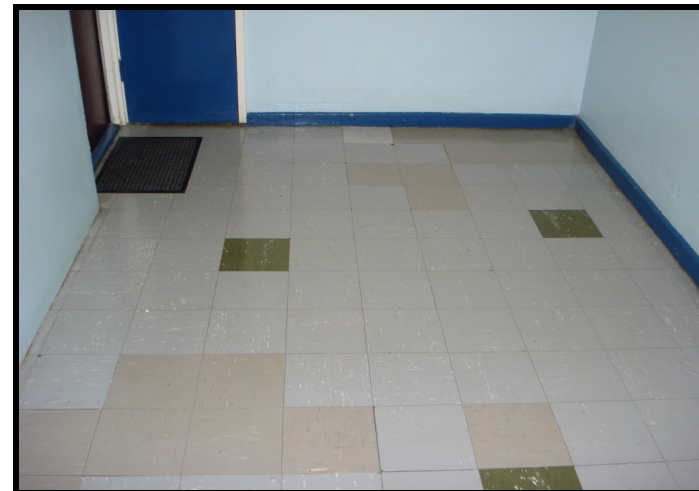
SAMPLE REFERENCE 107

Building	Floor	Room	Location	
Main Building	Fifth Floor	Corridor I	Floor	
Description				
MATERIAL ASSESSMENT				SCORE
Product Type	Floor Tiles	Extent of Damage	Low damage	-
Asbestos Type	No Asbestos Detected	Surface Treatment	Composite materials	
PRIORITY ASSESSMENT				SCORE
Occupant Activity	Not Applicable	Extent / Amount	3.00 m2	-
Accessibility	Routinely disturbed	Location	Not Applicable	
Avg Time in Use	Not Applicable	Frequency of Use	Not Applicable	
No. of Occupants	Not Applicable	Secondary Activity	Not Applicable	
Maintenance	Not Applicable	Maintenance Frequency	Not Applicable	
MANAGEMENT ACTION				SCORE
Recommendation	NO ACTION REQUIRED			-
Recommendation Due		Next Inspection	None	
Apply Labels	No	Permit to Work Required	No	
Survey Type	Management	Lead Surveyor	Jane Openshaw	
Survey Date	22 Mar 2012	UKAS Laboratory	NOT SAMPLED (Cross Referenced)	
Site Reference	I49620000A	Licensed Material	N/A

No Asbestos Presumed in Sample

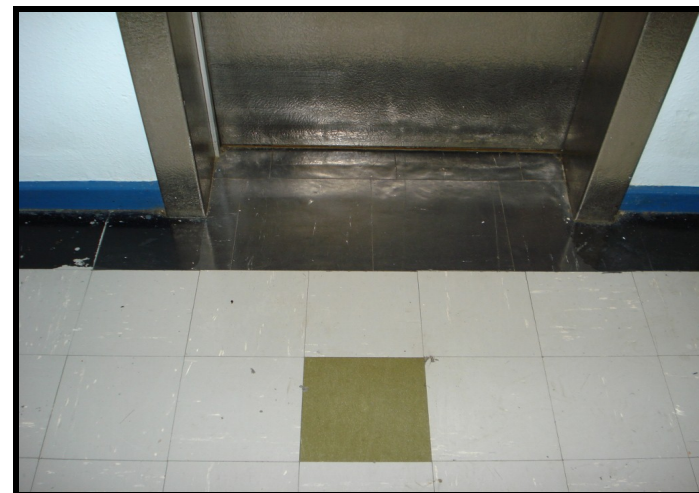
SAMPLE REFERENCE I I I

Building	Floor	Room	Location
Main Building	Fifth Floor	Lift Lobby	Floor
Description			
MATERIAL ASSESSMENT			
Product Type	Floor Tiles	Extent of Damage	Low damage
Asbestos Type	Chrysotile	Surface Treatment	Composite materials
PRIORITY ASSESSMENT			
Occupant Activity	Not Applicable	Extent / Amount	18.00 m2
Accessibility	Routinely disturbed	Location	Not Applicable
Avg Time in Use	Not Applicable	Frequency of Use	Not Applicable
No. of Occupants	Not Applicable	Secondary Activity	Not Applicable
Maintenance	Not Applicable	Maintenance Frequency	Not Applicable
MANAGEMENT ACTION			
Recommendation	LABEL & MONITOR		
Recommendation Due		Next Inspection	22 Mar 2013
Apply Labels	No	Permit to Work Required	No
Survey Type	Management	Lead Surveyor	Jane Openshaw
Survey Date	22 Mar 2012	UKAS Laboratory	NOT SAMPLED (Cross Referenced)
Site Reference	I49620000A	Licensed Material	No

Asbestos Presumed in Sample

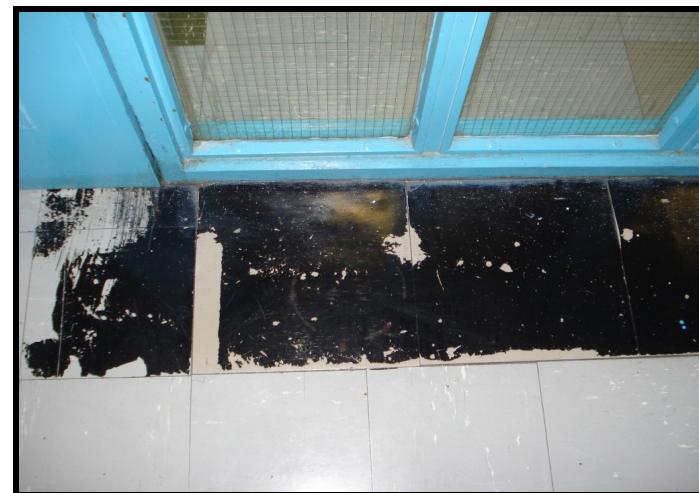
SAMPLE REFERENCE I I 4

Building	Floor	Room	Location	
Main Building	Fifth Floor	Lift Lobby	Floor	
Description				
MATERIAL ASSESSMENT				SCORE
Product Type	Floor Tiles	Extent of Damage	Good condition	-
Asbestos Type	No Asbestos Detected	Surface Treatment	Composite materials	
PRIORITY ASSESSMENT				SCORE
Occupant Activity	Not Applicable	Extent / Amount	4.00 m2	-
Accessibility	Routinely disturbed	Location	Not Applicable	
Avg Time in Use	Not Applicable	Frequency of Use	Not Applicable	
No. of Occupants	Not Applicable	Secondary Activity	Not Applicable	
Maintenance	Not Applicable	Maintenance Frequency	Not Applicable	
MANAGEMENT ACTION				SCORE
Recommendation	NO ACTION REQUIRED			-
Recommendation Due		Next Inspection	None	
Apply Labels	No	Permit to Work Required	No	
Survey Type	Management	Lead Surveyor	Jane Openshaw	
Survey Date	22 Mar 2012	UKAS Laboratory	NOT SAMPLED (Cross Referenced)	
Site Reference	I49620000A	Licensed Material	N/A

No Asbestos Presumed in Sample

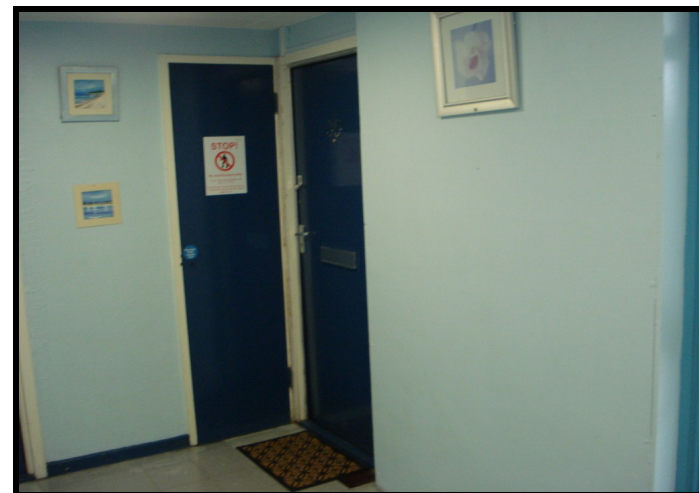
SAMPLE REFERENCE I I 5

Building	Floor	Room	Location	
Main Building	Fifth Floor	Corridor 2	Walls	
Description				
MATERIAL ASSESSMENT				SCORE
Product Type	Paint	Extent of Damage	Good condition	-
Asbestos Type	No Asbestos Detected	Surface Treatment	Sealed (1)	
PRIORITY ASSESSMENT				SCORE
Occupant Activity	Not Applicable	Extent / Amount	25.00 m2	-
Accessibility	Easily disturbed	Location	Not Applicable	
Avg Time in Use	Not Applicable	Frequency of Use	Not Applicable	
No. of Occupants	Not Applicable	Secondary Activity	Not Applicable	
Maintenance	Not Applicable	Maintenance Frequency	Not Applicable	
MANAGEMENT ACTION				SCORE
Recommendation	NO ACTION REQUIRED			-
Recommendation Due		Next Inspection	None	
Apply Labels	No	Permit to Work Required	No	
Survey Type	Management	Lead Surveyor	Jane Openshaw	
Survey Date	22 Mar 2012	UKAS Laboratory	NOT SAMPLED (Cross Referenced)	
Site Reference	I49620000A	Licensed Material	N/A

No Asbestos Presumed in Sample

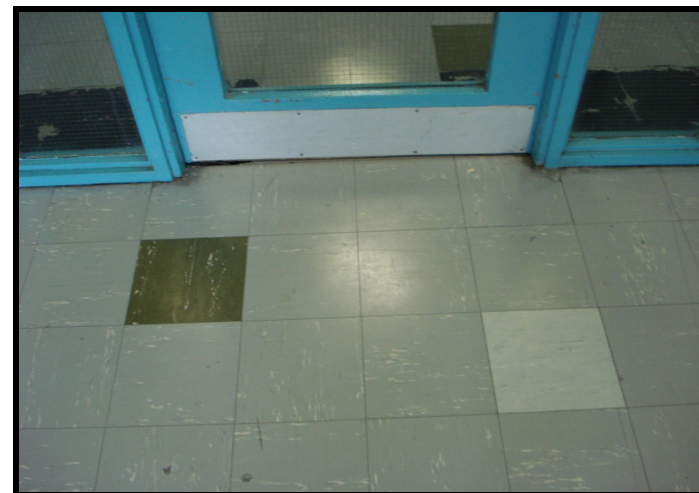
SAMPLE REFERENCE I I 6

Asbestos Presumed in Sample

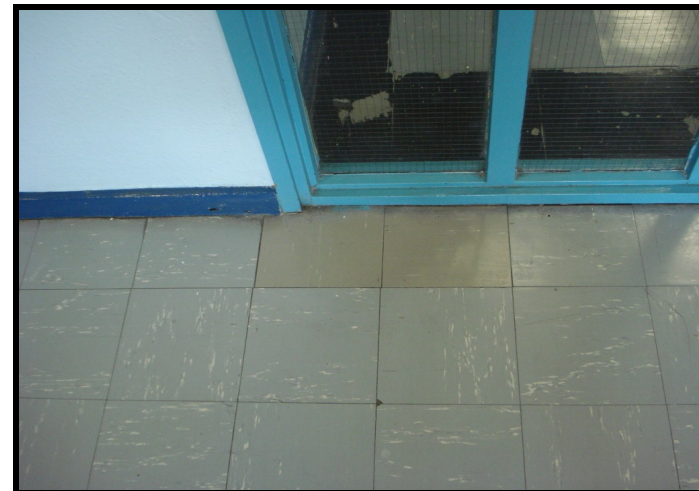
SAMPLE REFERENCE I 19

No Asbestos Presumed in Sample

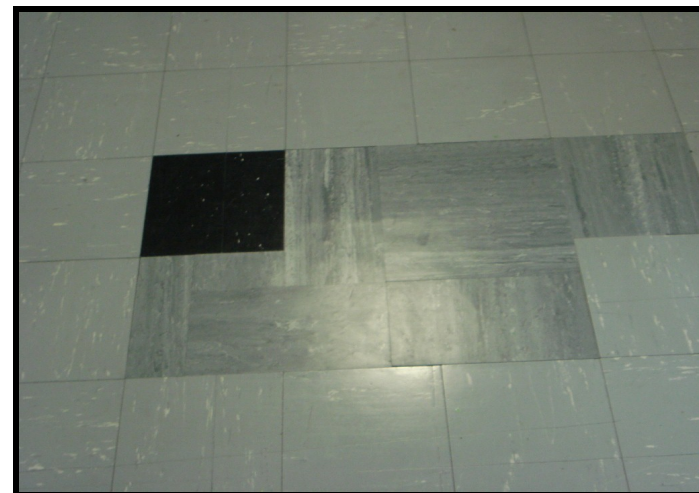
SAMPLE REFERENCE 120

No Asbestos Presumed in Sample

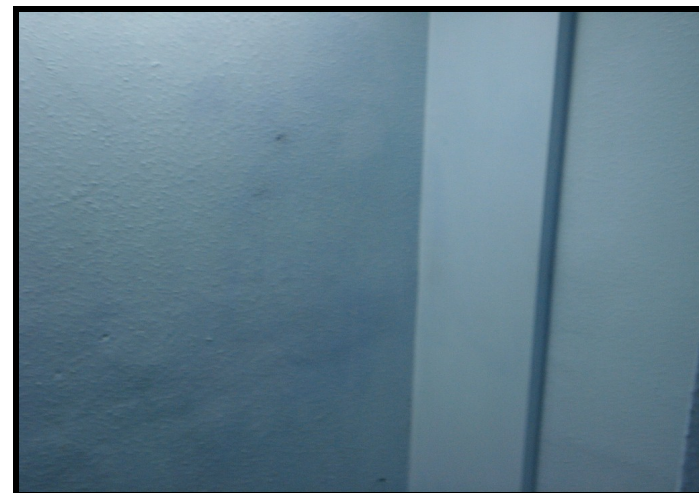
SAMPLE REFERENCE 122

Building	Floor	Room	Location	
Main Building	Fifth Floor	Stairs	Walls	
Description				
MATERIAL ASSESSMENT				SCORE
Product Type	Paint	Extent of Damage	Good condition	-
Asbestos Type	No Asbestos Detected	Surface Treatment	Sealed (1)	
PRIORITY ASSESSMENT				SCORE
Occupant Activity	Not Applicable	Extent / Amount	40.00 m2	-
Accessibility	Easily disturbed	Location	Not Applicable	
Avg Time in Use	Not Applicable	Frequency of Use	Not Applicable	
No. of Occupants	Not Applicable	Secondary Activity	Not Applicable	
Maintenance	Not Applicable	Maintenance Frequency	Not Applicable	
MANAGEMENT ACTION				SCORE
Recommendation	NO ACTION REQUIRED			-
Recommendation Due		Next Inspection	None	
Apply Labels	No	Permit to Work Required	No	
Survey Type	Management	Lead Surveyor	Jane Openshaw	
Survey Date	22 Mar 2012	UKAS Laboratory	NOT SAMPLED (Cross Referenced)	
Site Reference	I49620000A	Licensed Material	N/A

No Asbestos Presumed in Sample

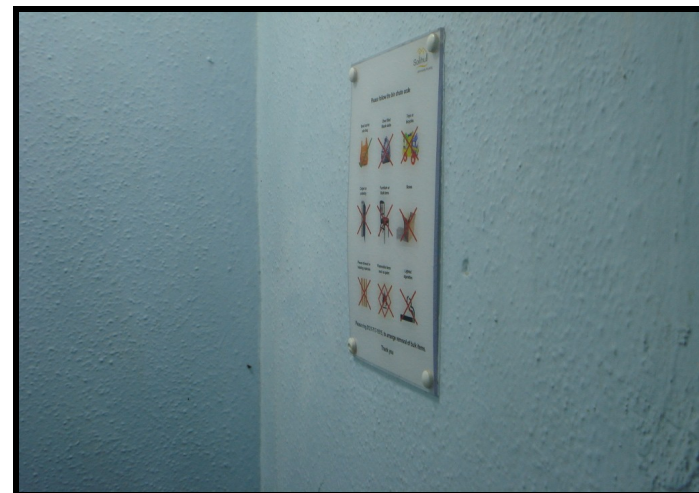
SAMPLE REFERENCE 124

Building	Floor	Room	Location	
Main Building	Fourth Floor	Bin Chute	Walls	
Description				
MATERIAL ASSESSMENT				SCORE
Product Type	Paint	Extent of Damage	Good condition	-
Asbestos Type	No Asbestos Detected	Surface Treatment	Sealed (1)	
PRIORITY ASSESSMENT				SCORE
Occupant Activity	Not Applicable	Extent / Amount	11.00 m2	-
Accessibility	Easily disturbed	Location	Not Applicable	
Avg Time in Use	Not Applicable	Frequency of Use	Not Applicable	
No. of Occupants	Not Applicable	Secondary Activity	Not Applicable	
Maintenance	Not Applicable	Maintenance Frequency	Not Applicable	
MANAGEMENT ACTION				SCORE
Recommendation	NO ACTION REQUIRED			-
Recommendation Due		Next Inspection	None	
Apply Labels	No	Permit to Work Required	No	
Survey Type	Management	Lead Surveyor	Jane Openshaw	
Survey Date	22 Mar 2012	UKAS Laboratory	NOT SAMPLED (Cross Referenced)	
Site Reference	I49620000A	Licensed Material	N/A

No Asbestos Presumed in Sample

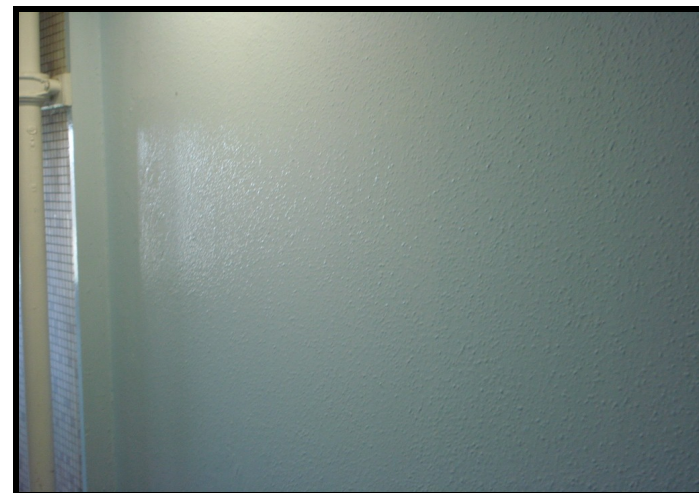
SAMPLE REFERENCE 125

Building	Floor	Room	Location	
Main Building	Fourth Floor	Lobby	Walls	
Description				
MATERIAL ASSESSMENT				SCORE
Product Type	Paint	Extent of Damage	Good condition	-
Asbestos Type	No Asbestos Detected	Surface Treatment	Sealed (1)	
PRIORITY ASSESSMENT				SCORE
Occupant Activity	Not Applicable	Extent / Amount	30.00 m2	-
Accessibility	Easily disturbed	Location	Not Applicable	
Avg Time in Use	Not Applicable	Frequency of Use	Not Applicable	
No. of Occupants	Not Applicable	Secondary Activity	Not Applicable	
Maintenance	Not Applicable	Maintenance Frequency	Not Applicable	
MANAGEMENT ACTION				SCORE
Recommendation	NO ACTION REQUIRED			-
Recommendation Due		Next Inspection	None	
Apply Labels	No	Permit to Work Required	No	
Survey Type	Management	Lead Surveyor	Jane Openshaw	
Survey Date	22 Mar 2012	UKAS Laboratory	NOT SAMPLED (Cross Referenced)	
Site Reference	I49620000A	Licensed Material	N/A

No Asbestos Presumed in Sample

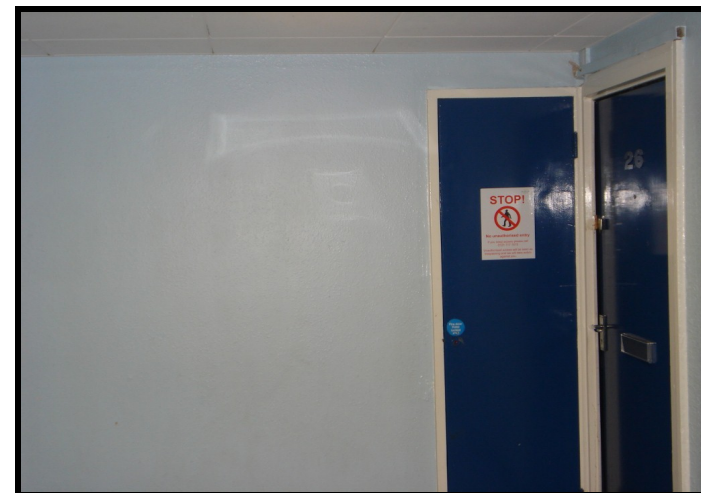
SAMPLE REFERENCE 127

No Asbestos Presumed in Sample

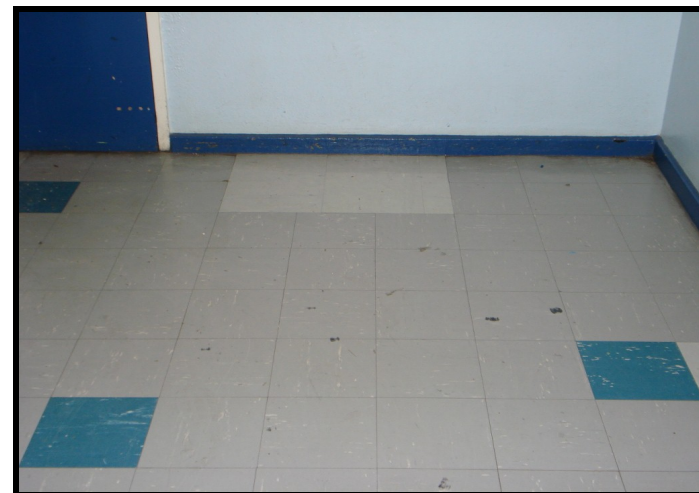
SAMPLE REFERENCE 128

Building	Floor	Room	Location
Main Building	Fourth Floor	Corridor I	Floor
Description			
MATERIAL ASSESSMENT			
Product Type	Floor Tiles	Extent of Damage	Low damage
Asbestos Type	Chrysotile	Surface Treatment	Composite materials
PRIORITY ASSESSMENT			
Occupant Activity	Not Applicable	Extent / Amount	18.00 m2
Accessibility	Routinely disturbed	Location	Not Applicable
Avg Time in Use	Not Applicable	Frequency of Use	Not Applicable
No. of Occupants	Not Applicable	Secondary Activity	Not Applicable
Maintenance	Not Applicable	Maintenance Frequency	Not Applicable
MANAGEMENT ACTION			
Recommendation	LABEL & MONITOR		
Recommendation Due		Next Inspection	22 Mar 2013
Apply Labels	No	Permit to Work Required	No
Survey Type	Management	Lead Surveyor	Jane Openshaw
Survey Date	22 Mar 2012	UKAS Laboratory	NOT SAMPLED (Cross Referenced)
Site Reference	I49620000A	Licensed Material	No

Asbestos Presumed in Sample

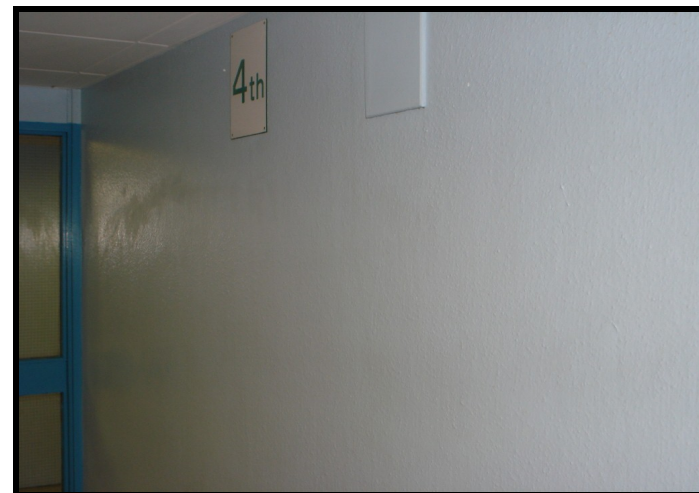
SAMPLE REFERENCE 133

Building	Floor	Room	Location	
Main Building	Fourth Floor	Lift Lobby	Walls	
Description				
MATERIAL ASSESSMENT				SCORE
Product Type	Paint	Extent of Damage	Good condition	-
Asbestos Type	No Asbestos Detected	Surface Treatment	Sealed (1)	
PRIORITY ASSESSMENT				SCORE
Occupant Activity	Not Applicable	Extent / Amount	20.00 m2	-
Accessibility	Easily disturbed	Location	Not Applicable	
Avg Time in Use	Not Applicable	Frequency of Use	Not Applicable	
No. of Occupants	Not Applicable	Secondary Activity	Not Applicable	
Maintenance	Not Applicable	Maintenance Frequency	Not Applicable	
MANAGEMENT ACTION				SCORE
Recommendation	NO ACTION REQUIRED			-
Recommendation Due		Next Inspection	None	
Apply Labels	No	Permit to Work Required	No	
Survey Type	Management	Lead Surveyor	Jane Openshaw	
Survey Date	22 Mar 2012	UKAS Laboratory	NOT SAMPLED (Cross Referenced)	
Site Reference	I49620000A	Licensed Material	N/A

No Asbestos Presumed in Sample

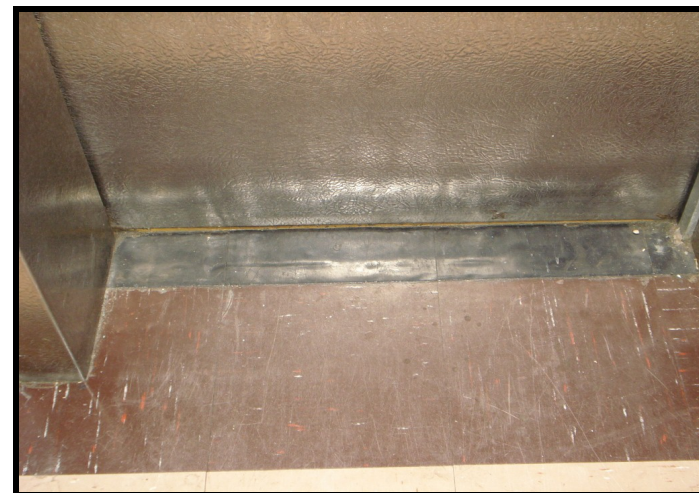
SAMPLE REFERENCE 136

Building	Floor	Room	Location
Main Building	Fourth Floor	Lift Lobby	Floor
Description			
MATERIAL ASSESSMENT			
Product Type	Floor Tiles	Extent of Damage	Good condition
Asbestos Type	No Asbestos Detected	Surface Treatment	Composite materials
PRIORITY ASSESSMENT			
Occupant Activity	Not Applicable	Extent / Amount	1.00 m2
Accessibility	Routinely disturbed	Location	Not Applicable
Avg Time in Use	Not Applicable	Frequency of Use	Not Applicable
No. of Occupants	Not Applicable	Secondary Activity	Not Applicable
Maintenance	Not Applicable	Maintenance Frequency	Not Applicable
MANAGEMENT ACTION			
Recommendation	NO ACTION REQUIRED		
Recommendation Due		Next Inspection	None
Apply Labels	No	Permit to Work Required	No
Survey Type	Management	Lead Surveyor	Jane Openshaw
Survey Date	22 Mar 2012	UKAS Laboratory	NOT SAMPLED (Cross Referenced)
Site Reference	I49620000A	Licensed Material	N/A

No Asbestos Presumed in Sample

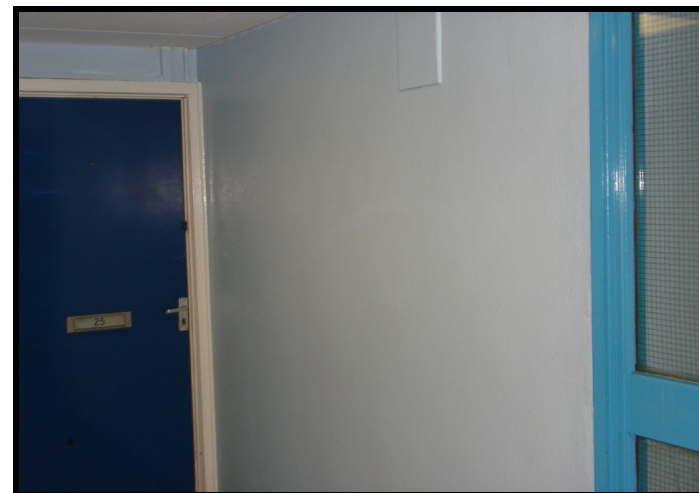
SAMPLE REFERENCE 137

Building	Floor	Room	Location	
Main Building	Fourth Floor	Corridor 2	Walls	
Description				
MATERIAL ASSESSMENT				SCORE
Product Type	Paint	Extent of Damage	Good condition	-
Asbestos Type	No Asbestos Detected	Surface Treatment	Sealed (1)	
PRIORITY ASSESSMENT				SCORE
Occupant Activity	Not Applicable	Extent / Amount	25.00 m2	-
Accessibility	Easily disturbed	Location	Not Applicable	
Avg Time in Use	Not Applicable	Frequency of Use	Not Applicable	
No. of Occupants	Not Applicable	Secondary Activity	Not Applicable	
Maintenance	Not Applicable	Maintenance Frequency	Not Applicable	
MANAGEMENT ACTION				SCORE
Recommendation	NO ACTION REQUIRED			-
Recommendation Due		Next Inspection	None	
Apply Labels	No	Permit to Work Required	No	
Survey Type	Management	Lead Surveyor	Jane Openshaw	
Survey Date	22 Mar 2012	UKAS Laboratory	NOT SAMPLED (Cross Referenced)	
Site Reference	I49620000A	Licensed Material	N/A

No Asbestos Presumed in Sample

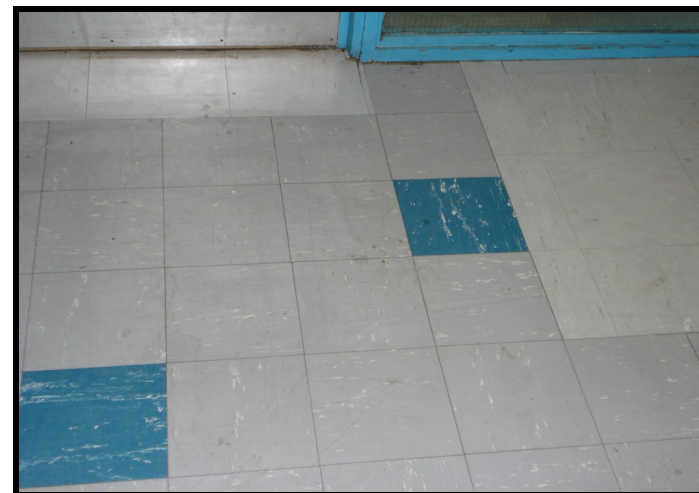
SAMPLE REFERENCE I38

Building	Floor	Room	Location
Main Building	Fourth Floor	Corridor 2	Floor
Description			
MATERIAL ASSESSMENT			
Product Type	Floor Tiles	Extent of Damage	Low damage
Asbestos Type	Chrysotile	Surface Treatment	Composite materials
PRIORITY ASSESSMENT			
Occupant Activity	Not Applicable	Extent / Amount	14.00 m2
Accessibility	Routinely disturbed	Location	Not Applicable
Avg Time in Use	Not Applicable	Frequency of Use	Not Applicable
No. of Occupants	Not Applicable	Secondary Activity	Not Applicable
Maintenance	Not Applicable	Maintenance Frequency	Not Applicable
MANAGEMENT ACTION			
Recommendation	LABEL & MONITOR		
Recommendation Due		Next Inspection	22 Mar 2013
Apply Labels	No	Permit to Work Required	No
Survey Type	Management	Lead Surveyor	Jane Openshaw
Survey Date	22 Mar 2012	UKAS Laboratory	NOT SAMPLED (Cross Referenced)
Site Reference	I49620000A	Licensed Material	No

Asbestos Presumed in Sample

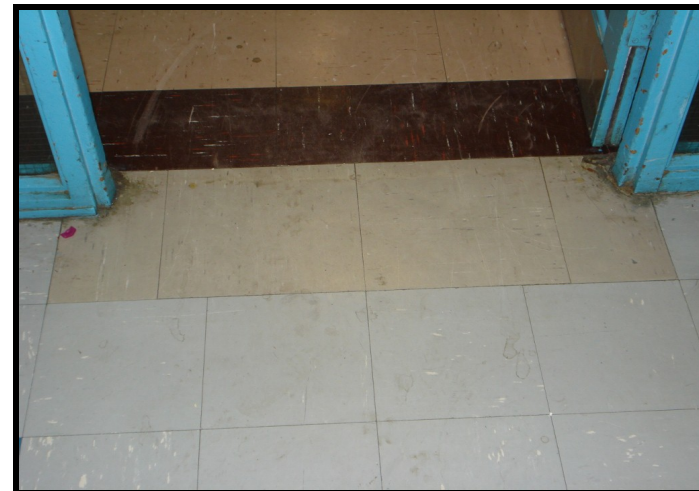
SAMPLE REFERENCE I4I

No Asbestos Presumed in Sample

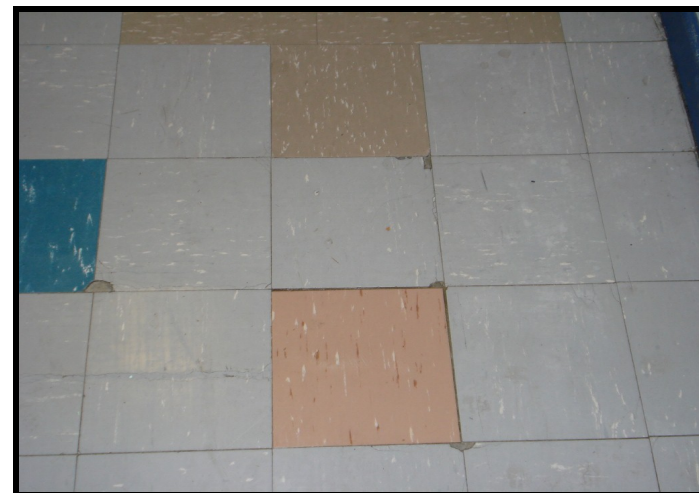
SAMPLE REFERENCE I42

Asbestos Presumed in Sample

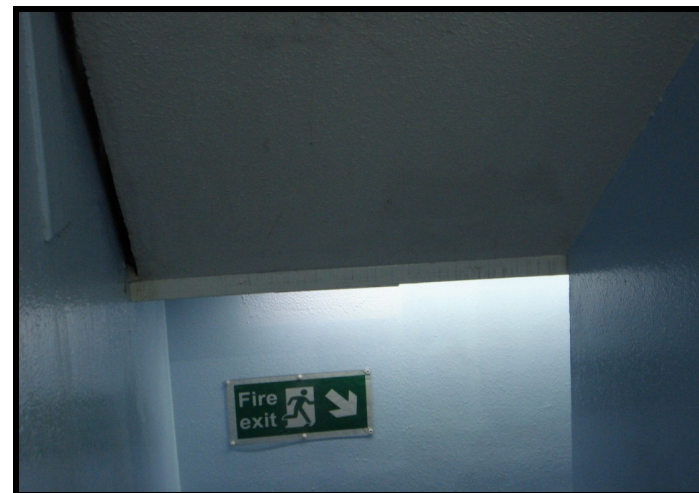
SAMPLE REFERENCE 147

Building	Floor	Room	Location	
Main Building	Fourth Floor	Stairs	Walls	
Description				
MATERIAL ASSESSMENT				SCORE
Product Type	Paint	Extent of Damage	Good condition	-
Asbestos Type	No Asbestos Detected	Surface Treatment	Sealed (1)	
PRIORITY ASSESSMENT				SCORE
Occupant Activity	Not Applicable	Extent / Amount	40.00 m2	-
Accessibility	Easily disturbed	Location	Not Applicable	
Avg Time in Use	Not Applicable	Frequency of Use	Not Applicable	
No. of Occupants	Not Applicable	Secondary Activity	Not Applicable	
Maintenance	Not Applicable	Maintenance Frequency	Not Applicable	
MANAGEMENT ACTION				SCORE
Recommendation	NO ACTION REQUIRED			-
Recommendation Due		Next Inspection	None	
Apply Labels	No	Permit to Work Required	No	
Survey Type	Management	Lead Surveyor	Jane Openshaw	
Survey Date	22 Mar 2012	UKAS Laboratory	NOT SAMPLED (Cross Referenced)	
Site Reference	I49620000A	Licensed Material	N/A

No Asbestos Presumed in Sample

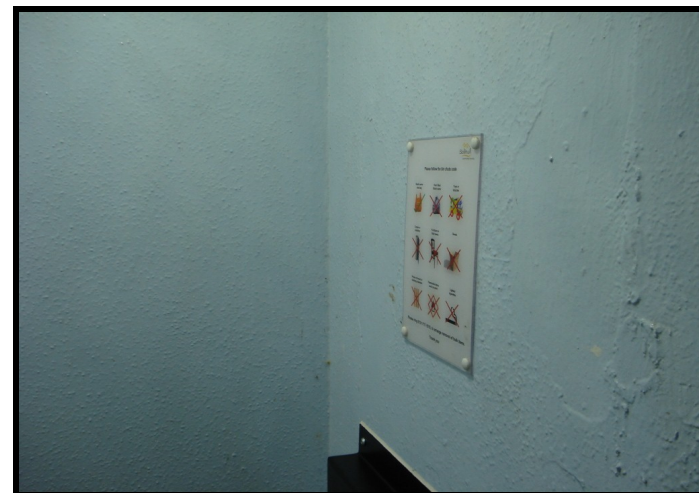
SAMPLE REFERENCE 148

Building	Floor	Room	Location	
Main Building	Third Floor	Bin Chute	Walls	
Description				
MATERIAL ASSESSMENT				SCORE
Product Type	Paint	Extent of Damage	Good condition	-
Asbestos Type	No Asbestos Detected	Surface Treatment	Sealed (1)	
PRIORITY ASSESSMENT				SCORE
Occupant Activity	Not Applicable	Extent / Amount	11.00 m2	-
Accessibility	Easily disturbed	Location	Not Applicable	
Avg Time in Use	Not Applicable	Frequency of Use	Not Applicable	
No. of Occupants	Not Applicable	Secondary Activity	Not Applicable	
Maintenance	Not Applicable	Maintenance Frequency	Not Applicable	
MANAGEMENT ACTION				SCORE
Recommendation	NO ACTION REQUIRED			-
Recommendation Due		Next Inspection	None	
Apply Labels	No	Permit to Work Required	No	
Survey Type	Management	Lead Surveyor	Jane Openshaw	
Survey Date	22 Mar 2012	UKAS Laboratory	NOT SAMPLED (Cross Referenced)	
Site Reference	I49620000A	Licensed Material	N/A

No Asbestos Presumed in Sample

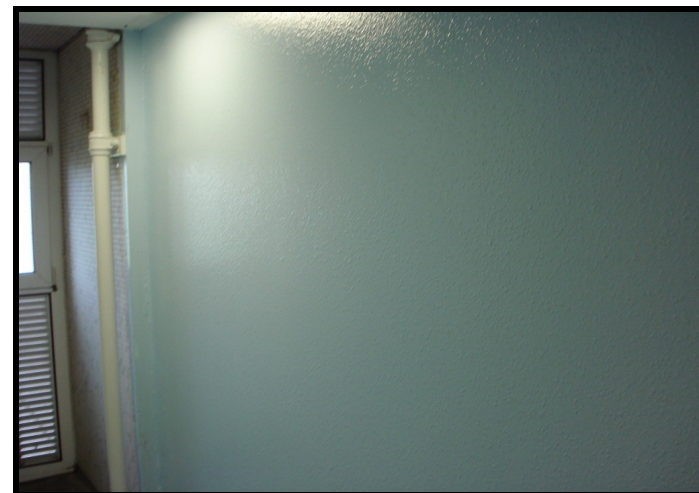
SAMPLE REFERENCE I49

Building	Floor	Room	Location	
Main Building	Third Floor	Lobby	Walls	
Description				
MATERIAL ASSESSMENT				SCORE
Product Type	Paint	Extent of Damage	Good condition	-
Asbestos Type	No Asbestos Detected	Surface Treatment	Sealed (1)	
PRIORITY ASSESSMENT				SCORE
Occupant Activity	Not Applicable	Extent / Amount	30.00 m2	-
Accessibility	Easily disturbed	Location	Not Applicable	
Avg Time in Use	Not Applicable	Frequency of Use	Not Applicable	
No. of Occupants	Not Applicable	Secondary Activity	Not Applicable	
Maintenance	Not Applicable	Maintenance Frequency	Not Applicable	
MANAGEMENT ACTION				SCORE
Recommendation	NO ACTION REQUIRED			-
Recommendation Due		Next Inspection	None	
Apply Labels	No	Permit to Work Required	No	
Survey Type	Management	Lead Surveyor	Jane Openshaw	
Survey Date	22 Mar 2012	UKAS Laboratory	NOT SAMPLED (Cross Referenced)	
Site Reference	I49620000A	Licensed Material	N/A

No Asbestos Presumed in Sample

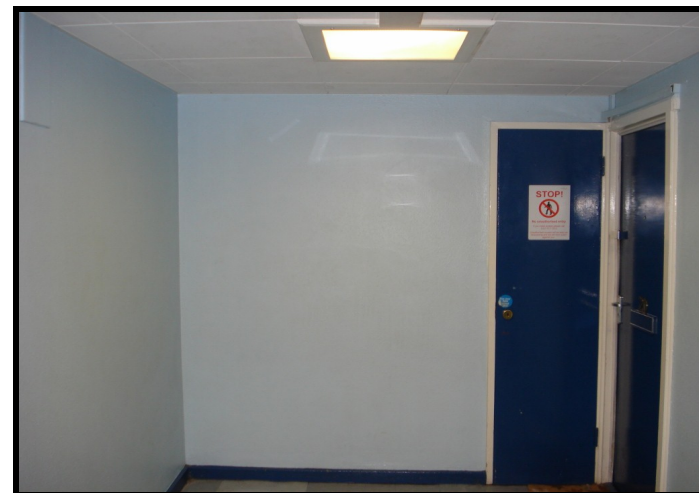
SAMPLE REFERENCE 151

Building	Floor	Room	Location	
Main Building	Third Floor	Corridor I	Walls	
Description				
MATERIAL ASSESSMENT				SCORE
Product Type	Paint	Extent of Damage	Good condition	-
Asbestos Type	No Asbestos Detected	Surface Treatment	Sealed (I)	
PRIORITY ASSESSMENT				SCORE
Occupant Activity	Not Applicable	Extent / Amount	25.00 m2	-
Accessibility	Easily disturbed	Location	Not Applicable	
Avg Time in Use	Not Applicable	Frequency of Use	Not Applicable	
No. of Occupants	Not Applicable	Secondary Activity	Not Applicable	
Maintenance	Not Applicable	Maintenance Frequency	Not Applicable	
MANAGEMENT ACTION				SCORE
Recommendation	NO ACTION REQUIRED			-
Recommendation Due		Next Inspection	None	
Apply Labels	No	Permit to Work Required	No	
Survey Type	Management	Lead Surveyor	Jane Openshaw	
Survey Date	22 Mar 2012	UKAS Laboratory	NOT SAMPLED (Cross Referenced)	
Site Reference	I49620000A	Licensed Material	N/A

No Asbestos Presumed in Sample

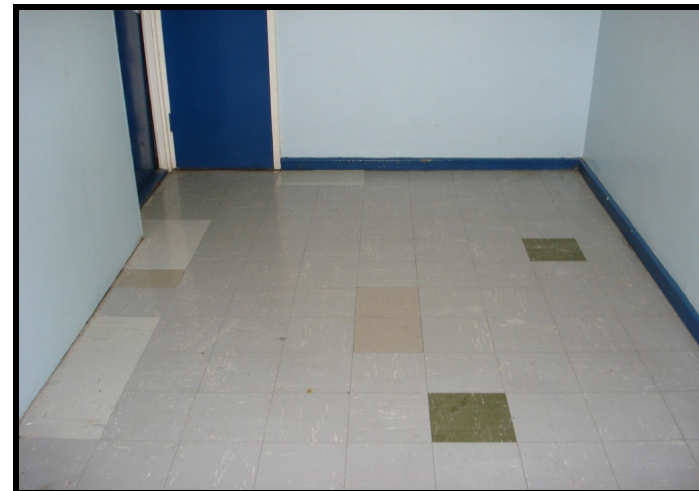
SAMPLE REFERENCE 152

MATERIAL ASSESSMENT				SCORE
Product Type	Floor Tiles	Extent of Damage	Low damage	3
Asbestos Type	Chrysotile	Surface Treatment	Composite materials

Asbestos Presumed in Sample

MANAGEMENT ACTION				SCORE
Recommendation	LABEL & MONITOR			5
Recommendation Due		Next Inspection	22 Mar 2013	
Apply Labels	No	Permit to Work Required	No

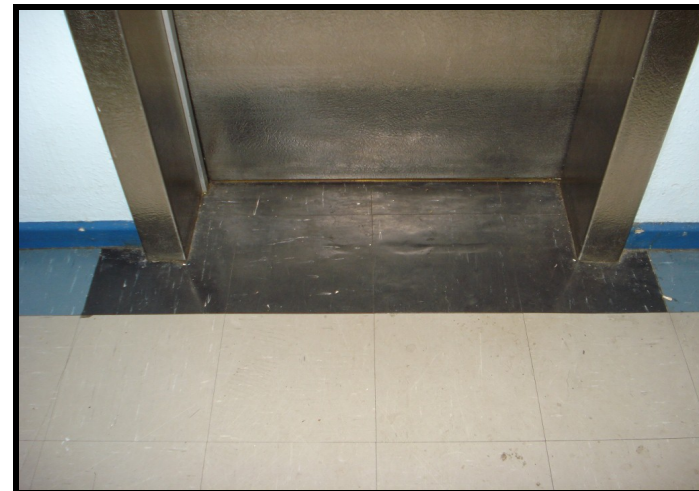
SAMPLE REFERENCE 159

Building	Floor	Room	Location	
Main Building	Third Floor	Lift Lobby	Floor	
Description				
MATERIAL ASSESSMENT				SCORE
Product Type	Floor Tiles	Extent of Damage	Good condition	-
Asbestos Type	No Asbestos Detected	Surface Treatment	Composite materials	
PRIORITY ASSESSMENT				SCORE
Occupant Activity	Not Applicable	Extent / Amount	18.00 m2	-
Accessibility	Routinely disturbed	Location	Not Applicable	
Avg Time in Use	Not Applicable	Frequency of Use	Not Applicable	
No. of Occupants	Not Applicable	Secondary Activity	Not Applicable	
Maintenance	Not Applicable	Maintenance Frequency	Not Applicable	
MANAGEMENT ACTION				SCORE
Recommendation	NO ACTION REQUIRED			-
Recommendation Due		Next Inspection	None	
Apply Labels	No	Permit to Work Required	No	
Survey Type	Management	Lead Surveyor	Jane Openshaw	
Survey Date	22 Mar 2012	UKAS Laboratory	NOT SAMPLED (Cross Referenced)	
Site Reference	I49620000A	Licensed Material	N/A

No Asbestos Presumed in Sample

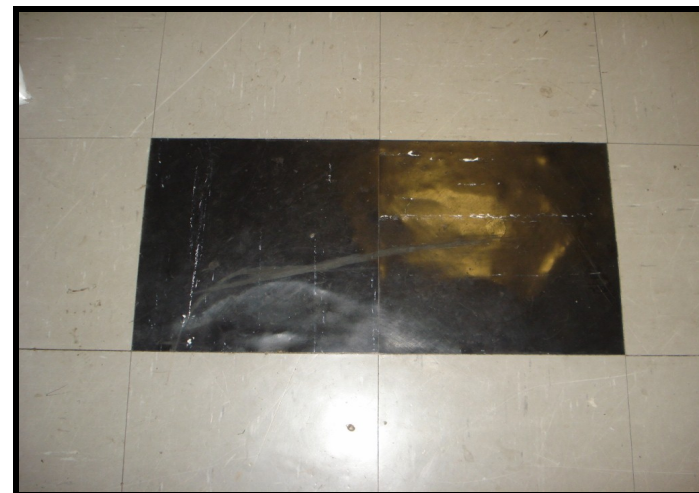
SAMPLE REFERENCE 161

MATERIAL ASSESSMENT				SCORE
Product Type	Floor Tiles	Extent of Damage	Good condition	-
Asbestos Type	No Asbestos Detected	Surface Treatment	Composite materials

No Asbestos Presumed in Sample

MANAGEMENT ACTION				SCORE
Recommendation	NO ACTION REQUIRED			-
Recommendation Due		Next Inspection	None	
Apply Labels	No	Permit to Work Required	No

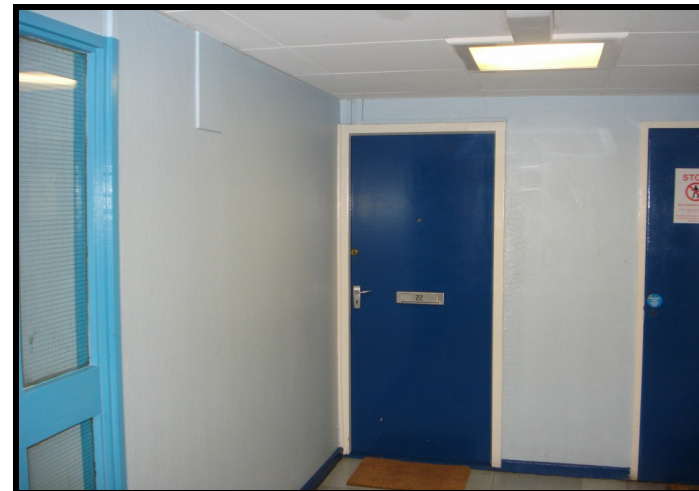
SAMPLE REFERENCE I62

Building	Floor	Room	Location	
Main Building	Third Floor	Corridor 2	Walls	
Description				
MATERIAL ASSESSMENT				SCORE
Product Type	Paint	Extent of Damage	Good condition	-
Asbestos Type	No Asbestos Detected	Surface Treatment	Sealed (1)	
PRIORITY ASSESSMENT				SCORE
Occupant Activity	Not Applicable	Extent / Amount	25.00 m2	-
Accessibility	Easily disturbed	Location	Not Applicable	
Avg Time in Use	Not Applicable	Frequency of Use	Not Applicable	
No. of Occupants	Not Applicable	Secondary Activity	Not Applicable	
Maintenance	Not Applicable	Maintenance Frequency	Not Applicable	
MANAGEMENT ACTION				SCORE
Recommendation	NO ACTION REQUIRED			-
Recommendation Due		Next Inspection	None	
Apply Labels	No	Permit to Work Required	No	
Survey Type	Management	Lead Surveyor	Jane Openshaw	
Survey Date	22 Mar 2012	UKAS Laboratory	NOT SAMPLED (Cross Referenced)	
Site Reference	I49620000A	Licensed Material	N/A

No Asbestos Presumed in Sample

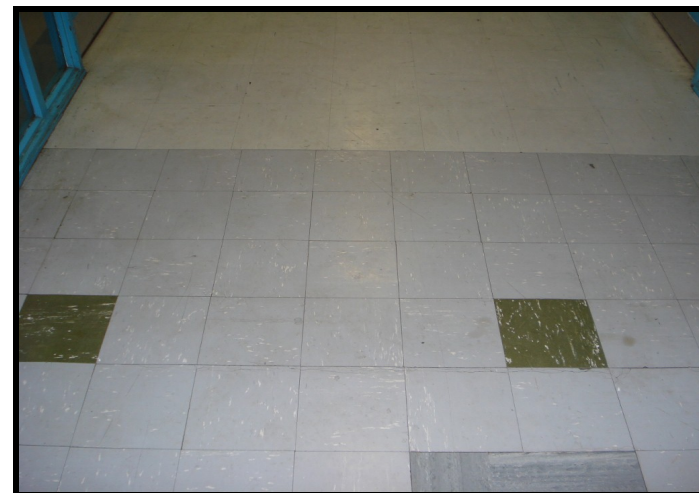
SAMPLE REFERENCE 163

Building	Floor	Room	Location
Main Building	Third Floor	Corridor 2	Floor
Description			
MATERIAL ASSESSMENT			
Product Type	Floor Tiles	Extent of Damage	Low damage
Asbestos Type	Chrysotile	Surface Treatment	Composite materials
PRIORITY ASSESSMENT			
Occupant Activity	Not Applicable	Extent / Amount	15.00 m2
Accessibility	Routinely disturbed	Location	Not Applicable
Avg Time in Use	Not Applicable	Frequency of Use	Not Applicable
No. of Occupants	Not Applicable	Secondary Activity	Not Applicable
Maintenance	Not Applicable	Maintenance Frequency	Not Applicable
MANAGEMENT ACTION			
Recommendation	LABEL & MONITOR		
Recommendation Due		Next Inspection	22 Mar 2013
Apply Labels	No	Permit to Work Required	No
Survey Type	Management	Lead Surveyor	Jane Openshaw
Survey Date	22 Mar 2012	UKAS Laboratory	NOT SAMPLED (Cross Referenced)
Site Reference	I49620000A	Licensed Material	No

Asbestos Presumed in Sample

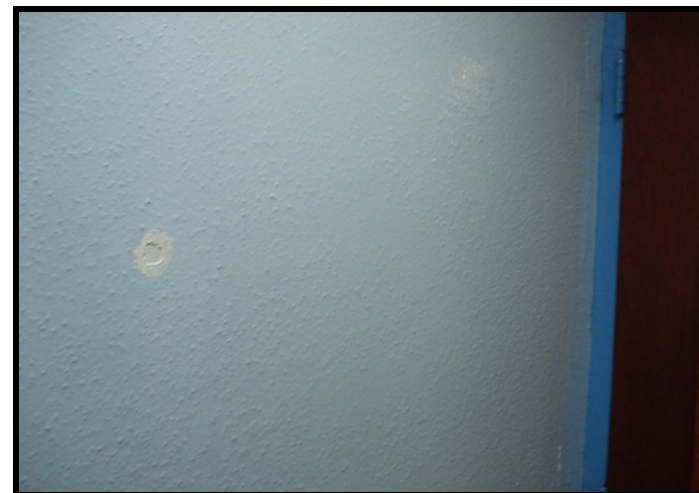
SAMPLE REFERENCE 170

Building	Floor	Room	Location	
Main Building	Third Floor	Stairs	Walls	
Description				
MATERIAL ASSESSMENT				SCORE
Product Type	Paint	Extent of Damage	Good condition	-
Asbestos Type	No Asbestos Detected	Surface Treatment	Sealed (1)	
PRIORITY ASSESSMENT				SCORE
Occupant Activity	Not Applicable	Extent / Amount	40.00 m2	-
Accessibility	Easily disturbed	Location	Not Applicable	
Avg Time in Use	Not Applicable	Frequency of Use	Not Applicable	
No. of Occupants	Not Applicable	Secondary Activity	Not Applicable	
Maintenance	Not Applicable	Maintenance Frequency	Not Applicable	
MANAGEMENT ACTION				SCORE
Recommendation	NO ACTION REQUIRED			-
Recommendation Due		Next Inspection	None	
Apply Labels	No	Permit to Work Required	No	
Survey Type	Management	Lead Surveyor	Jane Openshaw	
Survey Date	22 Mar 2012	UKAS Laboratory	DMW Environmental Safety Ltd / [P-96015]	
Site Reference	I49620000A	Licensed Material	N/A

Asbestos not detected in Sample

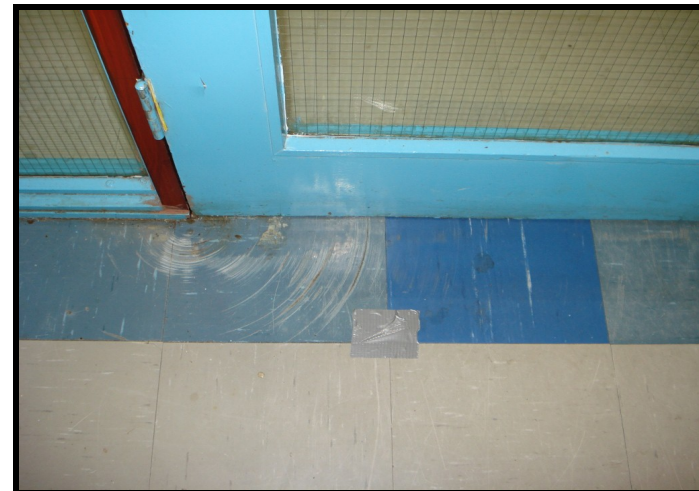
SAMPLE REFERENCE 171

Building	Floor	Room	Location
Main Building	Third Floor	Lift Lobby	Floor
Description			
MATERIAL ASSESSMENT			
Product Type	Bitumen	Extent of Damage	Low damage
Asbestos Type	Chrysotile	Surface Treatment	Composite materials
PRIORITY ASSESSMENT			
Occupant Activity	Not Applicable	Extent / Amount	1.00 m2
Accessibility	Routinely disturbed	Location	Not Applicable
Avg Time in Use	Not Applicable	Frequency of Use	Not Applicable
No. of Occupants	Not Applicable	Secondary Activity	Not Applicable
Maintenance	Not Applicable	Maintenance Frequency	Not Applicable
MANAGEMENT ACTION			
Recommendation	LABEL & MONITOR		
Recommendation Due		Next Inspection	22 Mar 2013
Apply Labels	No	Permit to Work Required	No
Survey Type	Management	Lead Surveyor	Jane Openshaw
Survey Date	22 Mar 2012	UKAS Laboratory	DMW Environmental Safety Ltd / [P-96015]
Site Reference	I49620000A	Licensed Material	No

Asbestos detected in Sample

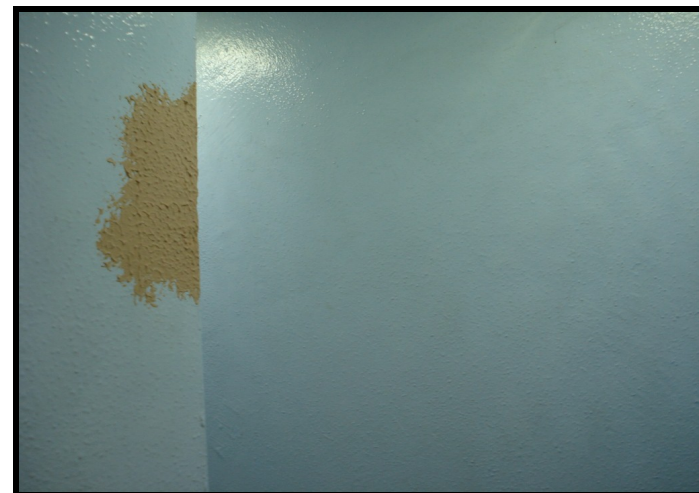
SAMPLE REFERENCE 173

Building	Floor	Room	Location	
Main Building	Second Floor	Bin Chute	Walls	
Description				
MATERIAL ASSESSMENT				SCORE
Product Type	Paint	Extent of Damage	Good condition	-
Asbestos Type	No Asbestos Detected	Surface Treatment	Sealed (1)	
PRIORITY ASSESSMENT				SCORE
Occupant Activity	Not Applicable	Extent / Amount	11.00 m2	-
Accessibility	Easily disturbed	Location	Not Applicable	
Avg Time in Use	Not Applicable	Frequency of Use	Not Applicable	
No. of Occupants	Not Applicable	Secondary Activity	Not Applicable	
Maintenance	Not Applicable	Maintenance Frequency	Not Applicable	
MANAGEMENT ACTION				SCORE
Recommendation	NO ACTION REQUIRED			-
Recommendation Due		Next Inspection	None	
Apply Labels	No	Permit to Work Required	No	
Survey Type	Management	Lead Surveyor	Jane Openshaw	
Survey Date	22 Mar 2012	UKAS Laboratory	NOT SAMPLED (Cross Referenced)	
Site Reference	I49620000A	Licensed Material	N/A

No Asbestos Presumed in Sample

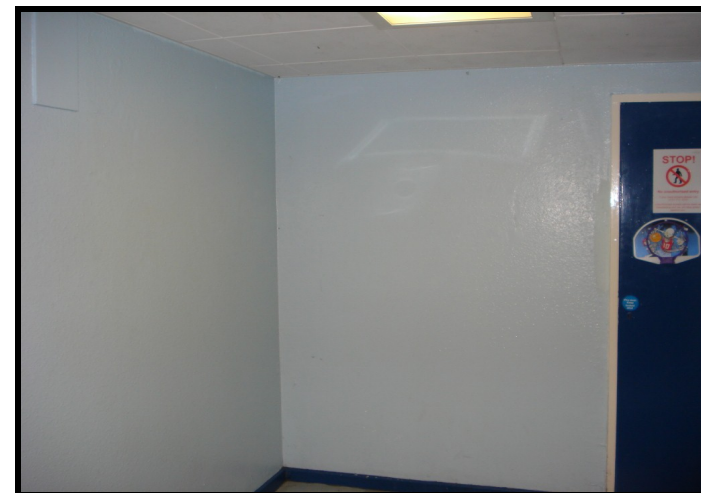
SAMPLE REFERENCE 176

MATERIAL ASSESSMENT				SCORE
Product Type	Paint	Extent of Damage	Good condition	-
Asbestos Type	No Asbestos Detected	Surface Treatment	Sealed (I)

No Asbestos Presumed in Sample

MANAGEMENT ACTION				SCORE
Recommendation	NO ACTION REQUIRED			-
Recommendation Due		Next Inspection	None	
Apply Labels	No	Permit to Work Required	No

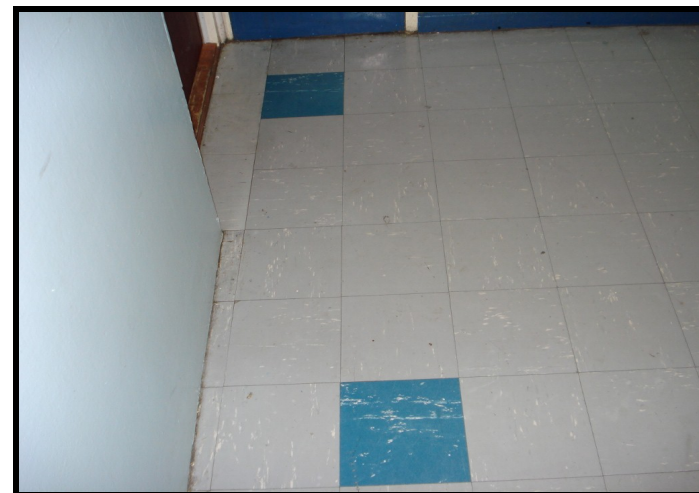
SAMPLE REFERENCE 177

MATERIAL ASSESSMENT				SCORE
Product Type	Floor Tiles	Extent of Damage	Low damage	3
Asbestos Type	Chrysotile	Surface Treatment	Composite materials

Asbestos Presumed in Sample

MANAGEMENT ACTION				SCORE
Recommendation	LABEL & MONITOR			4
Recommendation Due		Next Inspection	22 Mar 2013	
Apply Labels	No	Permit to Work Required	No
