Solihull Community Housing

Asbestos Management Survey Report

**Cheshunt House
Kington Gardens
Chelmsley Wood
B37 5TB**

Date of Report: 27 Apr 2012

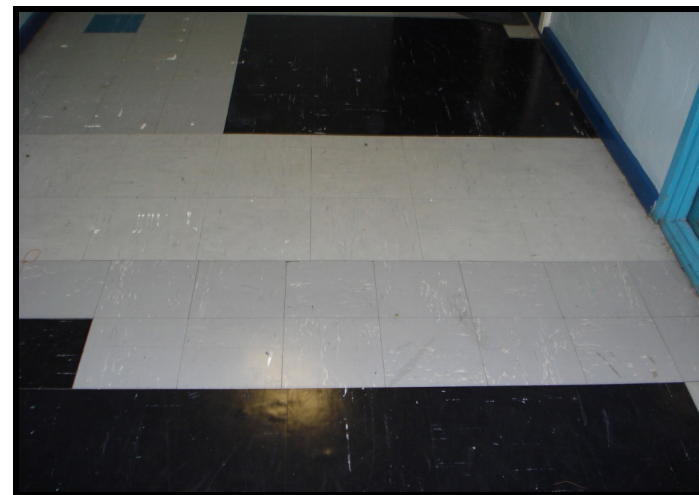
SAMPLE REFERENCE 179

MATERIAL ASSESSMENT				SCORE
Product Type	Floor Tiles	Extent of Damage	Good condition	-
Asbestos Type	No Asbestos Detected	Surface Treatment	Composite materials

No Asbestos Presumed in Sample

MANAGEMENT ACTION				SCORE
Recommendation	NO ACTION REQUIRED			-
Recommendation Due		Next Inspection	None	
Apply Labels	No	Permit to Work Required	No

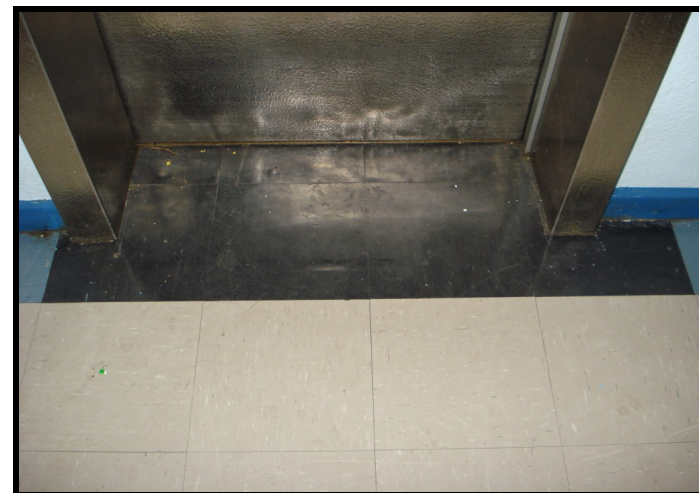
SAMPLE REFERENCE 184

Building	Floor	Room	Location	
Main Building	Second Floor	Lift Lobby	Floor	
Description				
MATERIAL ASSESSMENT				SCORE
Product Type	Floor Tiles	Extent of Damage	Low damage	-
Asbestos Type	No Asbestos Detected	Surface Treatment	Composite materials	
PRIORITY ASSESSMENT				SCORE
Occupant Activity	Not Applicable	Extent / Amount	20.00 m2	-
Accessibility	Routinely disturbed	Location	Not Applicable	
Avg Time in Use	Not Applicable	Frequency of Use	Not Applicable	
No. of Occupants	Not Applicable	Secondary Activity	Not Applicable	
Maintenance	Not Applicable	Maintenance Frequency	Not Applicable	
MANAGEMENT ACTION				SCORE
Recommendation	NO ACTION REQUIRED			-
Recommendation Due		Next Inspection	None	
Apply Labels	No	Permit to Work Required	No	
Survey Type	Management	Lead Surveyor	Jane Openshaw	
Survey Date	22 Mar 2012	UKAS Laboratory	NOT SAMPLED (Cross Referenced)	
Site Reference	I49620000A	Licensed Material	N/A

No Asbestos Presumed in Sample

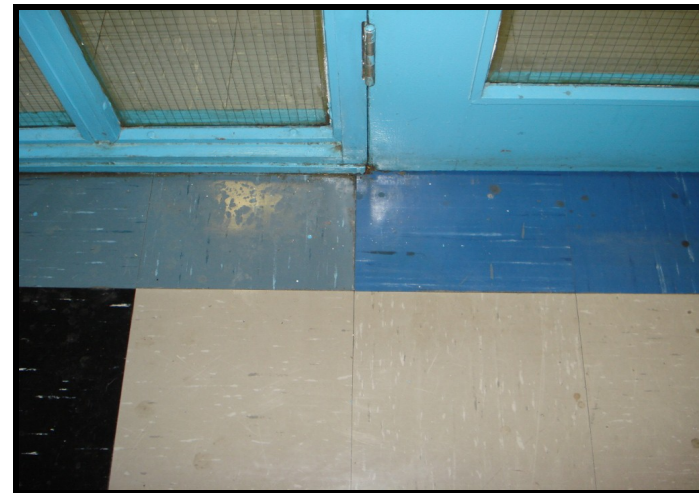
SAMPLE REFERENCE 185

MATERIAL ASSESSMENT				SCORE
Product Type	Bitumen	Extent of Damage	Low damage	3
Asbestos Type	Chrysotile	Surface Treatment	Composite materials

Asbestos Presumed in Sample

MANAGEMENT ACTION				SCORE
Recommendation	LABEL & MONITOR			4
Recommendation Due		Next Inspection	22 Mar 2013	
Apply Labels	No	Permit to Work Required	No

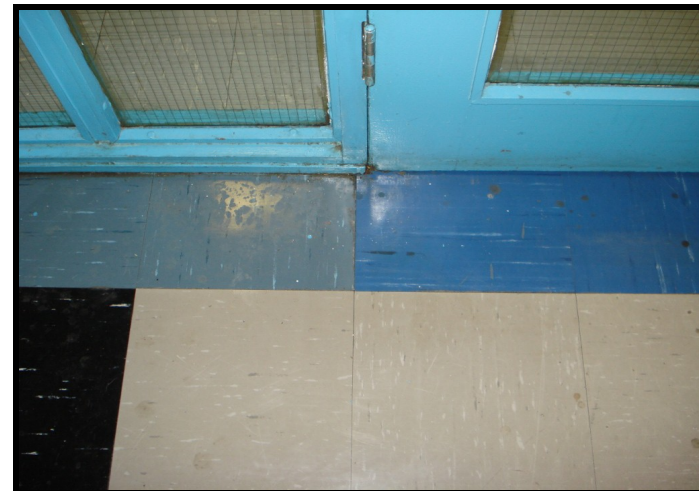
SAMPLE REFERENCE 186

Building	Floor	Room	Location
Main Building	Second Floor	Lift Lobby	Floor
Description			
MATERIAL ASSESSMENT			
Product Type	Bitumen	Extent of Damage	Good condition
Asbestos Type	Chrysotile	Surface Treatment	Composite materials
PRIORITY ASSESSMENT			
Occupant Activity	Not Applicable	Extent / Amount	0.25 m2
Accessibility	Routinely disturbed	Location	Not Applicable
Avg Time in Use	Not Applicable	Frequency of Use	Not Applicable
No. of Occupants	Not Applicable	Secondary Activity	Not Applicable
Maintenance	Not Applicable	Maintenance Frequency	Not Applicable
MANAGEMENT ACTION			
Recommendation	LABEL & MONITOR		
Recommendation Due		Next Inspection	22 Mar 2013
Apply Labels	No	Permit to Work Required	No
Survey Type	Management	Lead Surveyor	Jane Openshaw
Survey Date	22 Mar 2012	UKAS Laboratory	NOT SAMPLED (Cross Referenced)
Site Reference	I49620000A	Licensed Material	No

Asbestos Presumed in Sample

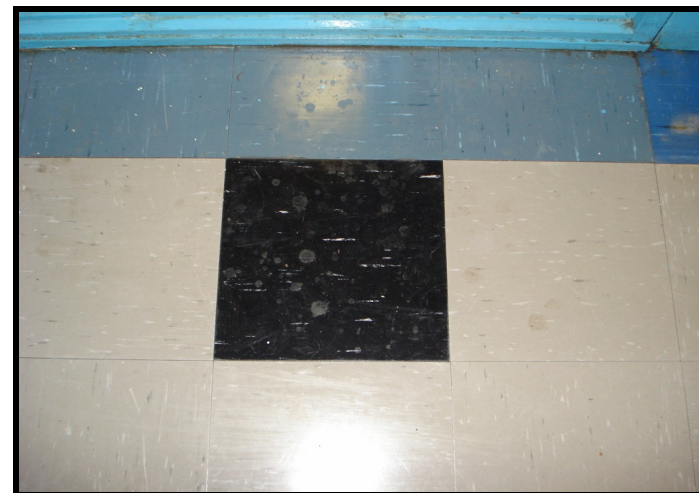
SAMPLE REFERENCE 187

Building	Floor	Room	Location	
Main Building	Second Floor	Lift Lobby	Floor	
Description				
MATERIAL ASSESSMENT				SCORE
Product Type	Bitumen	Extent of Damage	Good condition	2
Asbestos Type	Chrysotile	Surface Treatment	Composite materials	
PRIORITY ASSESSMENT				SCORE
Occupant Activity	Not Applicable	Extent / Amount	0.50 m2	1
Accessibility	Routinely disturbed	Location	Not Applicable	
Avg Time in Use	Not Applicable	Frequency of Use	Not Applicable	
No. of Occupants	Not Applicable	Secondary Activity	Not Applicable	
Maintenance	Not Applicable	Maintenance Frequency	Not Applicable	
MANAGEMENT ACTION				SCORE
Recommendation	LABEL & MONITOR			3
Recommendation Due		Next Inspection	22 Mar 2013	
Apply Labels	No	Permit to Work Required	No	
Survey Type	Management	Lead Surveyor	Jane Openshaw	
Survey Date	22 Mar 2012	UKAS Laboratory	NOT SAMPLED (Cross Referenced)	
Site Reference	I49620000A	Licensed Material	No

Asbestos Presumed in Sample

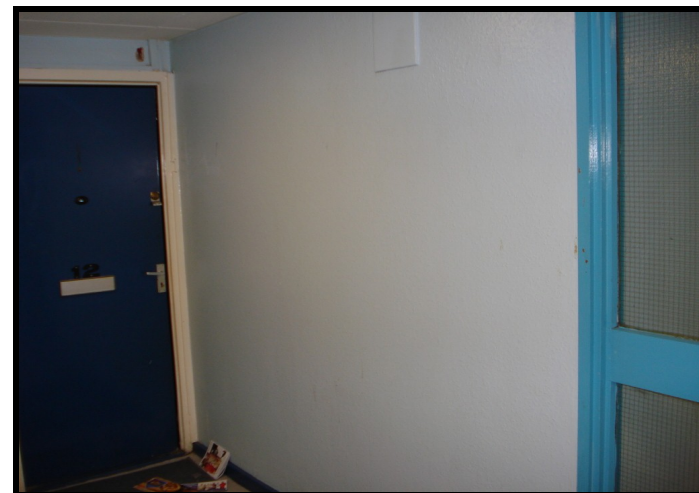
SAMPLE REFERENCE 189

Building	Floor	Room	Location	
Main Building	Second Floor	Corridor 2	Walls	
Description				
MATERIAL ASSESSMENT				SCORE
Product Type	Paint	Extent of Damage	Good condition	-
Asbestos Type	No Asbestos Detected	Surface Treatment	Sealed (1)	
PRIORITY ASSESSMENT				SCORE
Occupant Activity	Not Applicable	Extent / Amount	25.00 m2	-
Accessibility	Easily disturbed	Location	Not Applicable	
Avg Time in Use	Not Applicable	Frequency of Use	Not Applicable	
No. of Occupants	Not Applicable	Secondary Activity	Not Applicable	
Maintenance	Not Applicable	Maintenance Frequency	Not Applicable	
MANAGEMENT ACTION				SCORE
Recommendation	NO ACTION REQUIRED			-
Recommendation Due		Next Inspection	None	
Apply Labels	No	Permit to Work Required	No	
Survey Type	Management	Lead Surveyor	Jane Openshaw	
Survey Date	22 Mar 2012	UKAS Laboratory	NOT SAMPLED (Cross Referenced)	
Site Reference	I49620000A	Licensed Material	N/A

No Asbestos Presumed in Sample

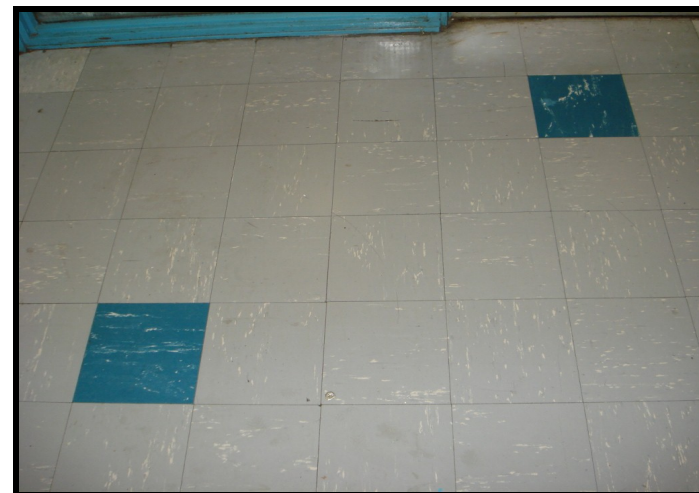
SAMPLE REFERENCE 190

Building	Floor	Room	Location
Main Building	Second Floor	Corridor 2	Floor
Description			
MATERIAL ASSESSMENT			
Product Type	Floor Tiles	Extent of Damage	Low damage
Asbestos Type	Chrysotile	Surface Treatment	Composite materials
PRIORITY ASSESSMENT			
Occupant Activity	Not Applicable	Extent / Amount	15.00 m2
Accessibility	Routinely disturbed	Location	Not Applicable
Avg Time in Use	Not Applicable	Frequency of Use	Not Applicable
No. of Occupants	Not Applicable	Secondary Activity	Not Applicable
Maintenance	Not Applicable	Maintenance Frequency	Not Applicable
MANAGEMENT ACTION			
Recommendation	LABEL & MONITOR		
Recommendation Due		Next Inspection	22 Mar 2013
Apply Labels	No	Permit to Work Required	No
Survey Type	Management	Lead Surveyor	Jane Openshaw
Survey Date	22 Mar 2012	UKAS Laboratory	NOT SAMPLED (Cross Referenced)
Site Reference	I49620000A	Licensed Material	No

Asbestos Presumed in Sample

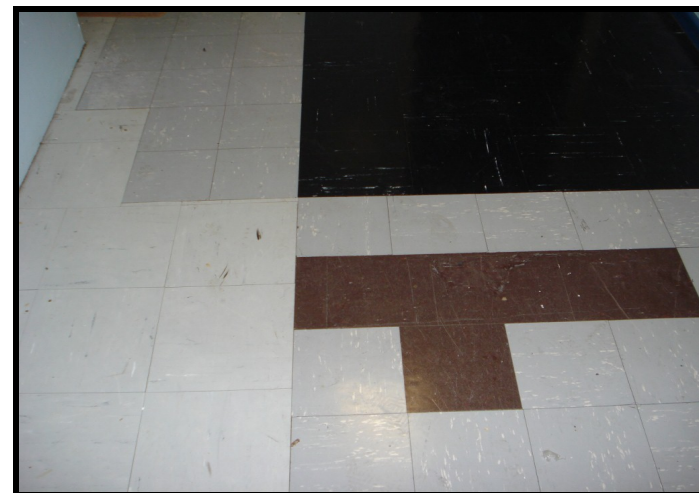
SAMPLE REFERENCE 192

Building	Floor	Room	Location	
Main Building	Second Floor	Corridor 2	Floor	
Description				
MATERIAL ASSESSMENT				SCORE
Product Type	Floor Tiles	Extent of Damage	Good condition	-
Asbestos Type	No Asbestos Detected	Surface Treatment	Composite materials	
PRIORITY ASSESSMENT				SCORE
Occupant Activity	Not Applicable	Extent / Amount	2.00 m2	-
Accessibility	Routinely disturbed	Location	Not Applicable	
Avg Time in Use	Not Applicable	Frequency of Use	Not Applicable	
No. of Occupants	Not Applicable	Secondary Activity	Not Applicable	
Maintenance	Not Applicable	Maintenance Frequency	Not Applicable	
MANAGEMENT ACTION				SCORE
Recommendation	NO ACTION REQUIRED			-
Recommendation Due		Next Inspection	None	
Apply Labels	No	Permit to Work Required	No	
Survey Type	Management	Lead Surveyor	Jane Openshaw	
Survey Date	22 Mar 2012	UKAS Laboratory	NOT SAMPLED (Cross Referenced)	
Site Reference	I49620000A	Licensed Material	N/A

No Asbestos Presumed in Sample

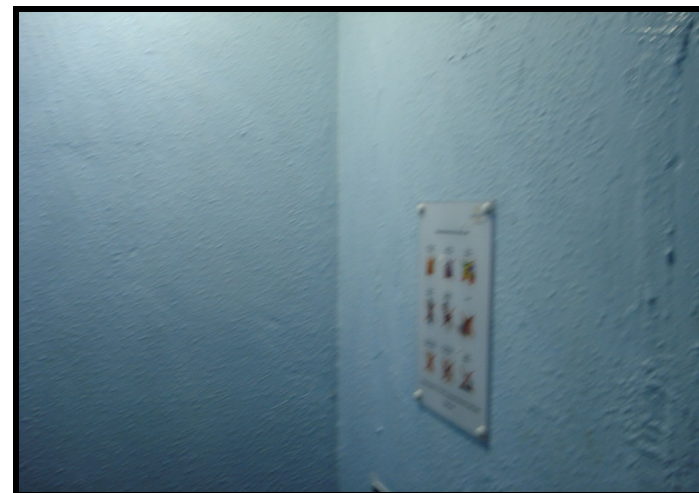
SAMPLE REFERENCE 200

Building	Floor	Room	Location	
Main Building	First Floor	Bin Chute	Walls	
Description				
MATERIAL ASSESSMENT				SCORE
Product Type	Bitumen	Extent of Damage	Good condition	2
Asbestos Type	Chrysotile	Surface Treatment	Composite materials	
PRIORITY ASSESSMENT				SCORE
Occupant Activity	Not Applicable	Extent / Amount	11.00 m2	1
Accessibility	Easily disturbed	Location	Not Applicable	
Avg Time in Use	Not Applicable	Frequency of Use	Not Applicable	
No. of Occupants	Not Applicable	Secondary Activity	Not Applicable	
Maintenance	Not Applicable	Maintenance Frequency	Not Applicable	
MANAGEMENT ACTION				SCORE
Recommendation	LABEL & MONITOR			3
Recommendation Due		Next Inspection	22 Mar 2013	
Apply Labels	No	Permit to Work Required	No	
Survey Type	Management	Lead Surveyor	Jane Openshaw	
Survey Date	22 Mar 2012	UKAS Laboratory	NOT SAMPLED (Cross Referenced)	
Site Reference	I49620000A	Licensed Material	No

Asbestos Presumed in Sample

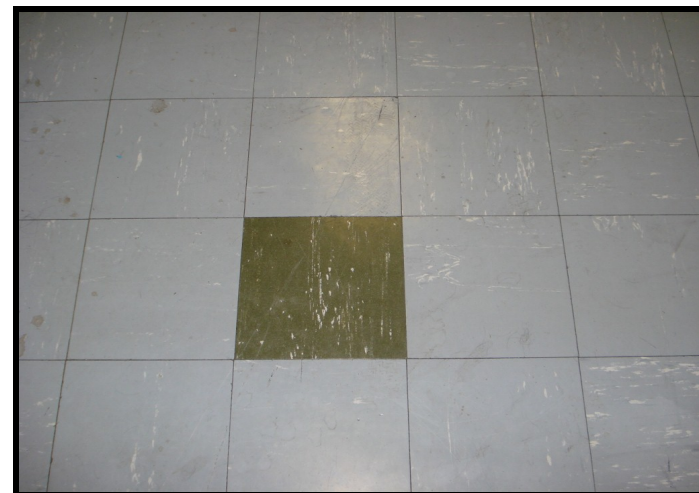
SAMPLE REFERENCE 205

Building	Floor	Room	Location
Main Building	First Floor	Corridor I	Floor
Description			
MATERIAL ASSESSMENT			
Product Type	Floor Tiles	Extent of Damage	Low damage
Asbestos Type	Chrysotile	Surface Treatment	Composite materials
PRIORITY ASSESSMENT			
Occupant Activity	Not Applicable	Extent / Amount	1.00 m2
Accessibility	Routinely disturbed	Location	Not Applicable
Avg Time in Use	Not Applicable	Frequency of Use	Not Applicable
No. of Occupants	Not Applicable	Secondary Activity	Not Applicable
Maintenance	Not Applicable	Maintenance Frequency	Not Applicable
MANAGEMENT ACTION			
Recommendation	LABEL & MONITOR		
Recommendation Due		Next Inspection	22 Mar 2013
Apply Labels	No	Permit to Work Required	No
Survey Type	Management	Lead Surveyor	Jane Openshaw
Survey Date	22 Mar 2012	UKAS Laboratory	NOT SAMPLED (Cross Referenced)
Site Reference	I49620000A	Licensed Material	No

Asbestos Presumed in Sample

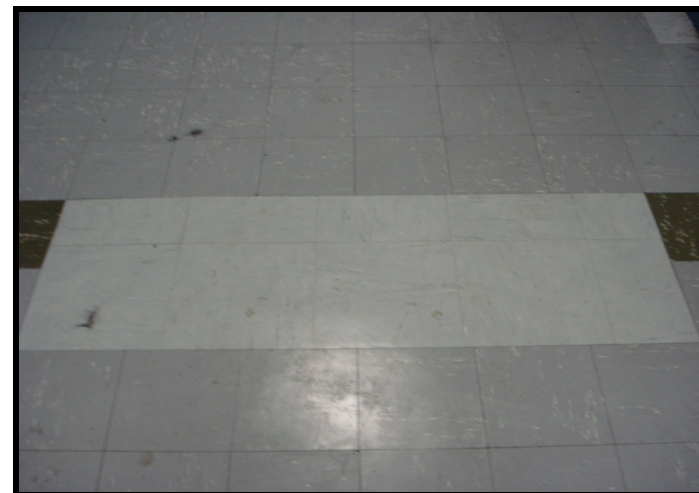
SAMPLE REFERENCE 206

Building	Floor	Room	Location	
Main Building	First Floor	Corridor I	Floor	
Description				
MATERIAL ASSESSMENT				SCORE
Product Type	Floor Tiles	Extent of Damage	Good condition	-
Asbestos Type	No Asbestos Detected	Surface Treatment	Composite materials	
PRIORITY ASSESSMENT				SCORE
Occupant Activity	Not Applicable	Extent / Amount	2.00 m2	-
Accessibility	Routinely disturbed	Location	Not Applicable	
Avg Time in Use	Not Applicable	Frequency of Use	Not Applicable	
No. of Occupants	Not Applicable	Secondary Activity	Not Applicable	
Maintenance	Not Applicable	Maintenance Frequency	Not Applicable	
MANAGEMENT ACTION				SCORE
Recommendation	NO ACTION REQUIRED			-
Recommendation Due		Next Inspection	None	
Apply Labels	No	Permit to Work Required	No	
Survey Type	Management	Lead Surveyor	Jane Openshaw	
Survey Date	22 Mar 2012	UKAS Laboratory	NOT SAMPLED (Cross Referenced)	
Site Reference	I49620000A	Licensed Material	N/A

No Asbestos Presumed in Sample

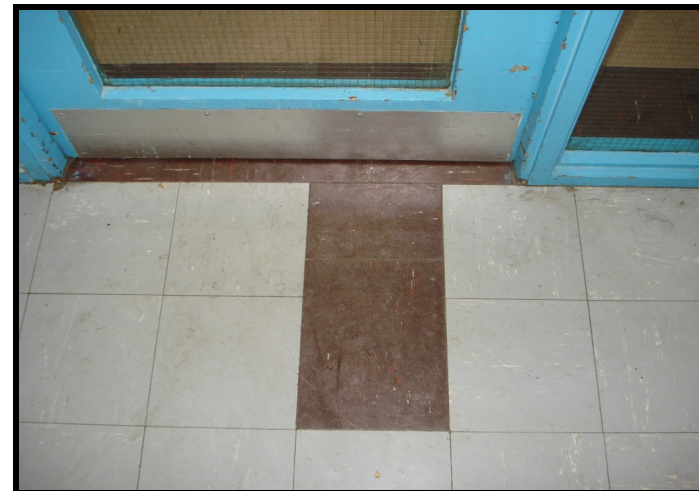
SAMPLE REFERENCE 207

Asbestos Presumed in Sample

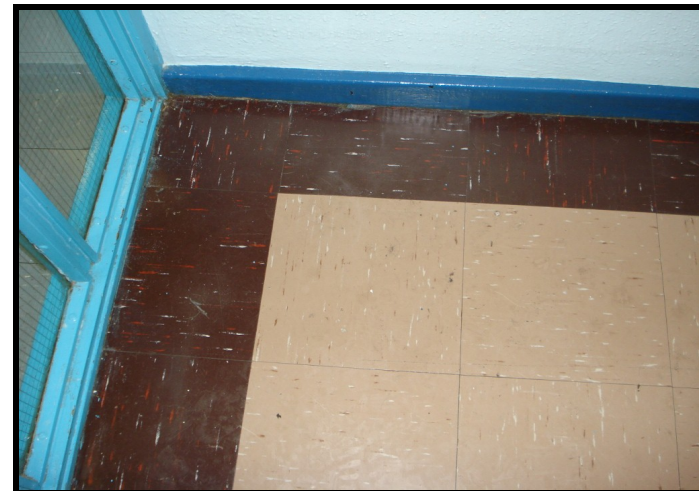
SAMPLE REFERENCE 211

Building	Floor	Room	Location
Main Building	First Floor	Lift Lobby	Floor
Description			
MATERIAL ASSESSMENT			
Product Type	Bitumen	Extent of Damage	Medium damage
Asbestos Type	Chrysotile	Surface Treatment	Composite materials
PRIORITY ASSESSMENT			
Occupant Activity	Not Applicable	Extent / Amount	20.00 m2
Accessibility	Routinely disturbed	Location	Not Applicable
Avg Time in Use	Not Applicable	Frequency of Use	Not Applicable
No. of Occupants	Not Applicable	Secondary Activity	Not Applicable
Maintenance	Not Applicable	Maintenance Frequency	Not Applicable
MANAGEMENT ACTION			
Recommendation	LABEL & MONITOR		
Recommendation Due		Next Inspection	22 Mar 2013
Apply Labels	No	Permit to Work Required	No
Survey Type	Management	Lead Surveyor	Jane Openshaw
Survey Date	22 Mar 2012	UKAS Laboratory	NOT SAMPLED (Cross Referenced)
Site Reference	I49620000A	Licensed Material	No

Asbestos Presumed in Sample

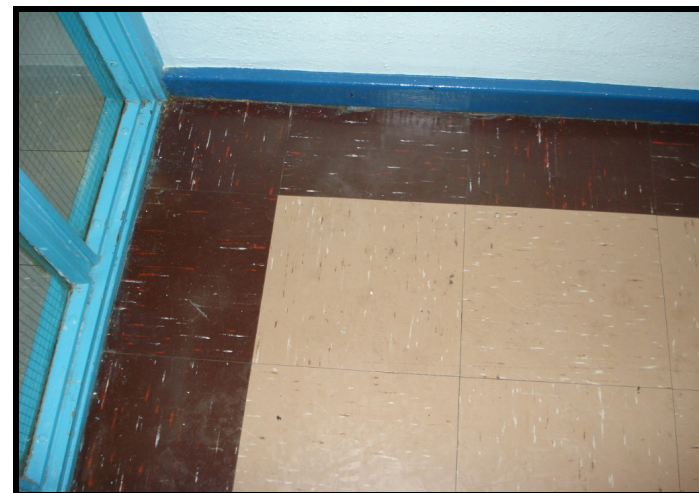
SAMPLE REFERENCE 212

Building	Floor	Room	Location
Main Building	First Floor	Lift Lobby	Floor
Description			
MATERIAL ASSESSMENT			
Product Type	Bitumen	Extent of Damage	Good condition
Asbestos Type	Chrysotile	Surface Treatment	Composite materials
PRIORITY ASSESSMENT			
Occupant Activity	Not Applicable	Extent / Amount	5.00 m2
Accessibility	Routinely disturbed	Location	Not Applicable
Avg Time in Use	Not Applicable	Frequency of Use	Not Applicable
No. of Occupants	Not Applicable	Secondary Activity	Not Applicable
Maintenance	Not Applicable	Maintenance Frequency	Not Applicable
MANAGEMENT ACTION			
Recommendation	LABEL & MONITOR		
Recommendation Due		Next Inspection	22 Mar 2013
Apply Labels	No	Permit to Work Required	No
Survey Type	Management	Lead Surveyor	Jane Openshaw
Survey Date	22 Mar 2012	UKAS Laboratory	NOT SAMPLED (Cross Referenced)
Site Reference	I49620000A	Licensed Material	No

Asbestos Presumed in Sample

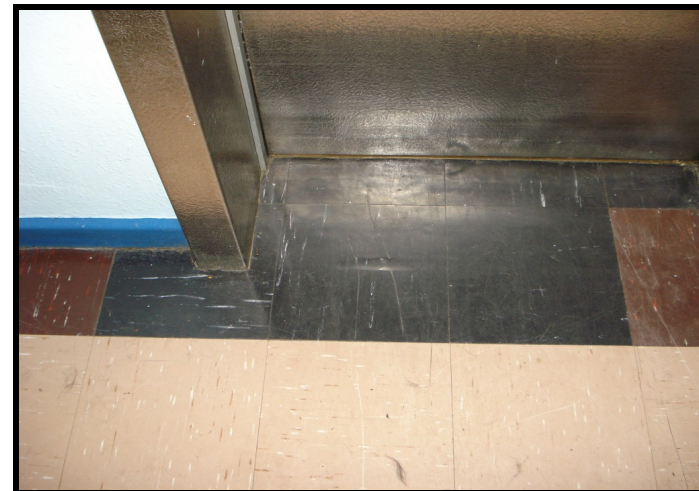
SAMPLE REFERENCE 213

No Asbestos Presumed in Sample

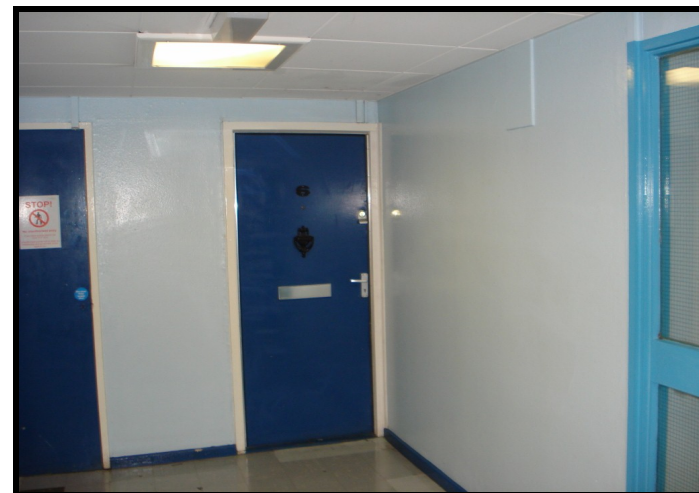
SAMPLE REFERENCE 214

Building	Floor	Room	Location	
Main Building	First Floor	Corridor 2	Walls	
Description				
MATERIAL ASSESSMENT				SCORE
Product Type	Paint	Extent of Damage	Good condition	-
Asbestos Type	No Asbestos Detected	Surface Treatment	Sealed (1)	
PRIORITY ASSESSMENT				SCORE
Occupant Activity	Not Applicable	Extent / Amount	25.00 m2	-
Accessibility	Easily disturbed	Location	Not Applicable	
Avg Time in Use	Not Applicable	Frequency of Use	Not Applicable	
No. of Occupants	Not Applicable	Secondary Activity	Not Applicable	
Maintenance	Not Applicable	Maintenance Frequency	Not Applicable	
MANAGEMENT ACTION				SCORE
Recommendation	NO ACTION REQUIRED			-
Recommendation Due		Next Inspection	None	
Apply Labels	No	Permit to Work Required	No	
Survey Type	Management	Lead Surveyor	Jane Openshaw	
Survey Date	22 Mar 2012	UKAS Laboratory	NOT SAMPLED (Cross Referenced)	
Site Reference	I49620000A	Licensed Material	N/A

No Asbestos Presumed in Sample

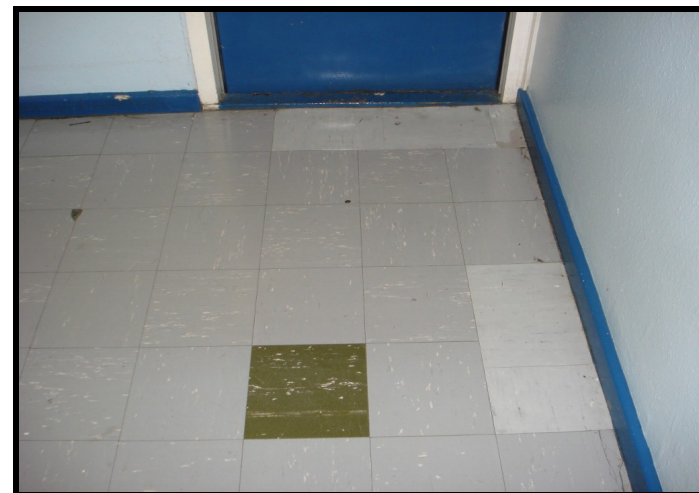
SAMPLE REFERENCE 215

Asbestos Presumed in Sample

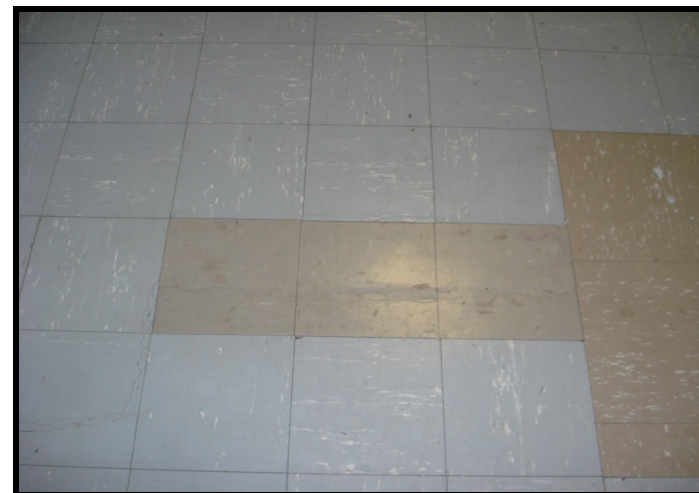
SAMPLE REFERENCE 218

Building	Floor	Room	Location	
Main Building	First Floor	Corridor 2	Floor	
Description				
MATERIAL ASSESSMENT				SCORE
Product Type	Floor Tiles	Extent of Damage	Good condition	-
Asbestos Type	No Asbestos Detected	Surface Treatment	Composite materials	
PRIORITY ASSESSMENT				SCORE
Occupant Activity	Not Applicable	Extent / Amount	1.00 m2	-
Accessibility	Routinely disturbed	Location	Not Applicable	
Avg Time in Use	Not Applicable	Frequency of Use	Not Applicable	
No. of Occupants	Not Applicable	Secondary Activity	Not Applicable	
Maintenance	Not Applicable	Maintenance Frequency	Not Applicable	
MANAGEMENT ACTION				SCORE
Recommendation	NO ACTION REQUIRED			-
Recommendation Due		Next Inspection	None	
Apply Labels	No	Permit to Work Required	No	
Survey Type	Management	Lead Surveyor	Jane Openshaw	
Survey Date	22 Mar 2012	UKAS Laboratory	NOT SAMPLED (Cross Referenced)	
Site Reference	I49620000A	Licensed Material	N/A

No Asbestos Presumed in Sample

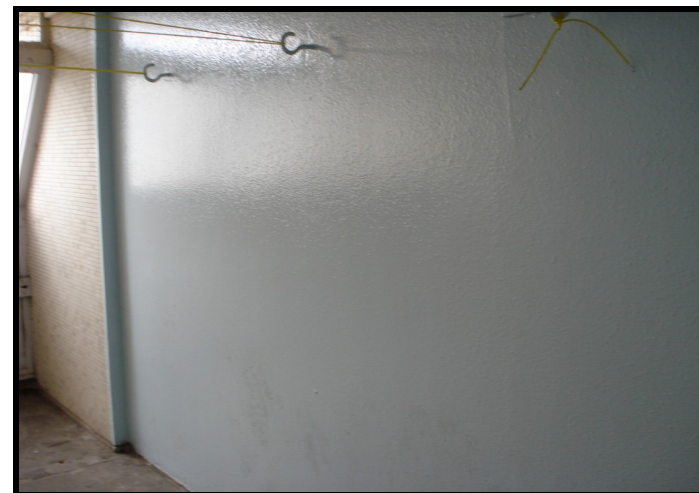
SAMPLE REFERENCE 221

Building	Floor	Room	Location	
Main Building	First Floor	Drying Area	Walls	
Description				
MATERIAL ASSESSMENT				SCORE
Product Type	Paint	Extent of Damage	Good condition	-
Asbestos Type	No Asbestos Detected	Surface Treatment	Sealed (1)	
PRIORITY ASSESSMENT				SCORE
Occupant Activity	Not Applicable	Extent / Amount	18.00 m2	-
Accessibility	Easily disturbed	Location	Not Applicable	
Avg Time in Use	Not Applicable	Frequency of Use	Not Applicable	
No. of Occupants	Not Applicable	Secondary Activity	Not Applicable	
Maintenance	Not Applicable	Maintenance Frequency	Not Applicable	
MANAGEMENT ACTION				SCORE
Recommendation	NO ACTION REQUIRED			-
Recommendation Due		Next Inspection	None	
Apply Labels	No	Permit to Work Required	No	
Survey Type	Management	Lead Surveyor	Jane Openshaw	
Survey Date	22 Mar 2012	UKAS Laboratory	NOT SAMPLED (Cross Referenced)	
Site Reference	I49620000A	Licensed Material	N/A

No Asbestos Presumed in Sample

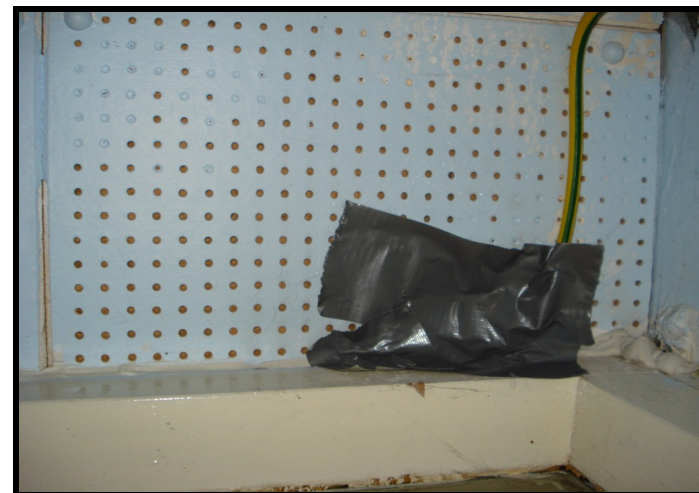
SAMPLE REFERENCE 233

Building	Floor	Room	Location	
Main Building	Ground Floor	Dry Riser	Ceiling	
Description				
MATERIAL ASSESSMENT				SCORE
Product Type	Board	Extent of Damage	Low damage	-
Asbestos Type	No Asbestos Detected	Surface Treatment	Unsealed (Board)	
PRIORITY ASSESSMENT				SCORE
Occupant Activity	Not Applicable	Extent / Amount	2.00 m2	-
Accessibility	Occasionally disturb	Location	Not Applicable	
Avg Time in Use	Not Applicable	Frequency of Use	Not Applicable	
No. of Occupants	Not Applicable	Secondary Activity	Not Applicable	
Maintenance	Not Applicable	Maintenance Frequency	Not Applicable	
MANAGEMENT ACTION				SCORE
Recommendation	NO ACTION REQUIRED			-
Recommendation Due		Next Inspection	None	
Apply Labels	No	Permit to Work Required	No	
Survey Type	Management	Lead Surveyor	Jane Openshaw	
Survey Date	22 Mar 2012	UKAS Laboratory	DMW Environmental Safety Ltd / [P-96015]	
Site Reference	I49620000A	Licensed Material	N/A

Asbestos not detected in Sample

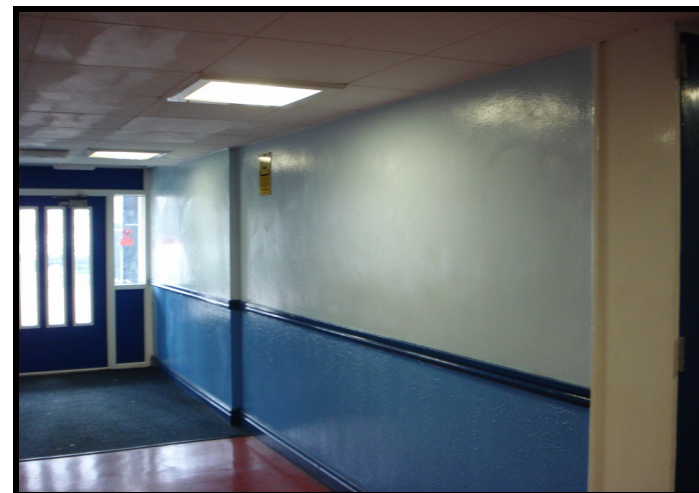
SAMPLE REFERENCE 234

Building	Floor	Room	Location	
Main Building	Ground Floor	Main Entrance Lobby	Walls	
Description				
MATERIAL ASSESSMENT				SCORE
Product Type	Paint	Extent of Damage	Good condition	-
Asbestos Type	No Asbestos Detected	Surface Treatment	Sealed (1)	
PRIORITY ASSESSMENT				SCORE
Occupant Activity	Not Applicable	Extent / Amount	40.00 m2	-
Accessibility	Easily disturbed	Location	Not Applicable	
Avg Time in Use	Not Applicable	Frequency of Use	Not Applicable	
No. of Occupants	Not Applicable	Secondary Activity	Not Applicable	
Maintenance	Not Applicable	Maintenance Frequency	Not Applicable	
MANAGEMENT ACTION				SCORE
Recommendation	NO ACTION REQUIRED			-
Recommendation Due		Next Inspection	None	
Apply Labels	No	Permit to Work Required	No	
Survey Type	Management	Lead Surveyor	Jane Openshaw	
Survey Date	22 Mar 2012	UKAS Laboratory	NOT SAMPLED (Cross Referenced)	
Site Reference	I49620000A	Licensed Material	N/A

No Asbestos Presumed in Sample
