Solihull Community Housing

Asbestos Management Survey Report

Darwin House I-37 (Communal)
Alder Court
Solihull
B37 7QF

Date of Report: 27 Feb 2015

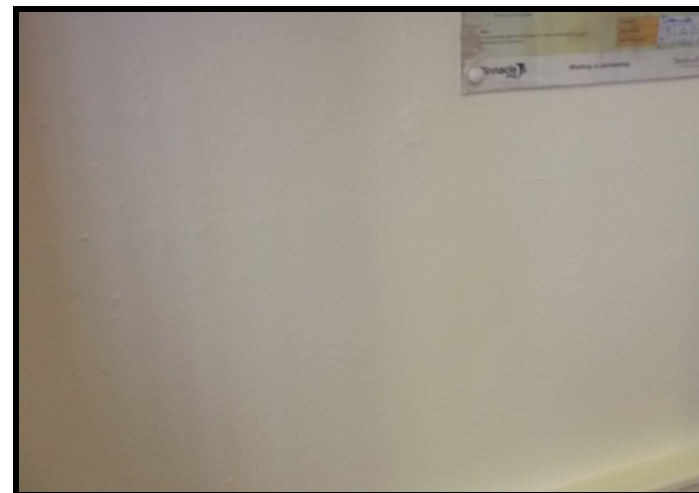
SAMPLE REFERENCE 002

Asbestos not detected in Sample

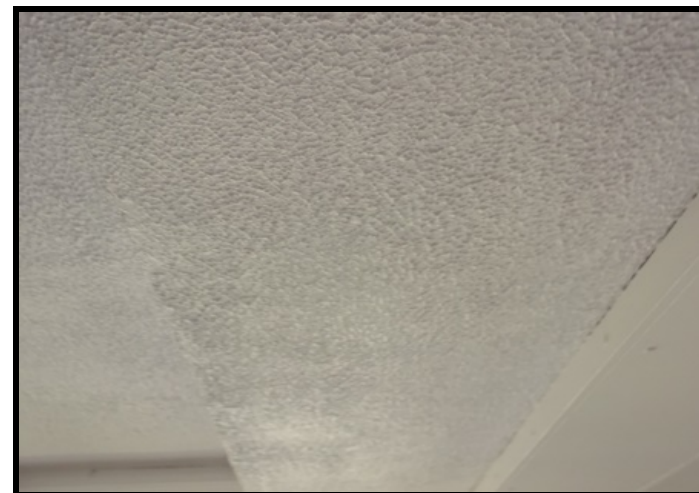
SAMPLE REFERENCE 003

Asbestos not detected in Sample

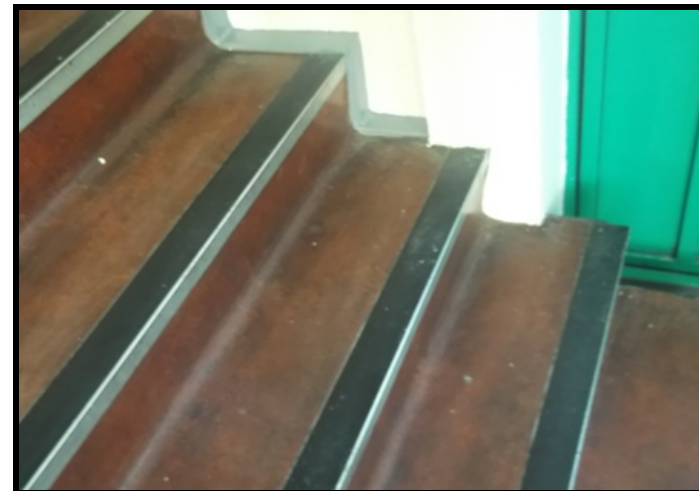
SAMPLE REFERENCE 004

Asbestos not detected in Sample

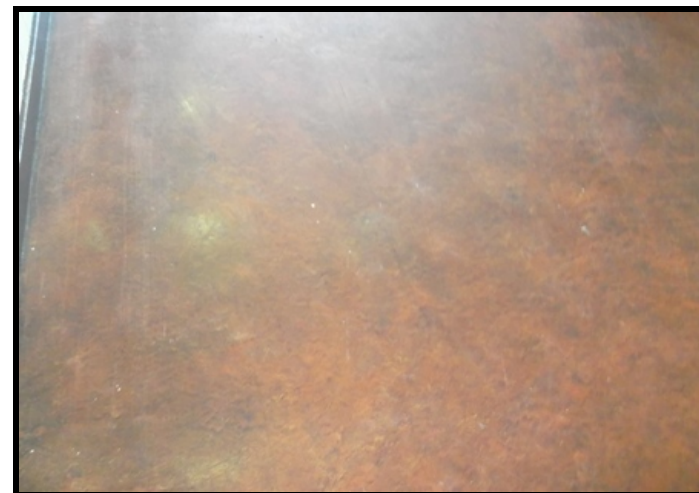
SAMPLE REFERENCE 005

Asbestos not detected in Sample

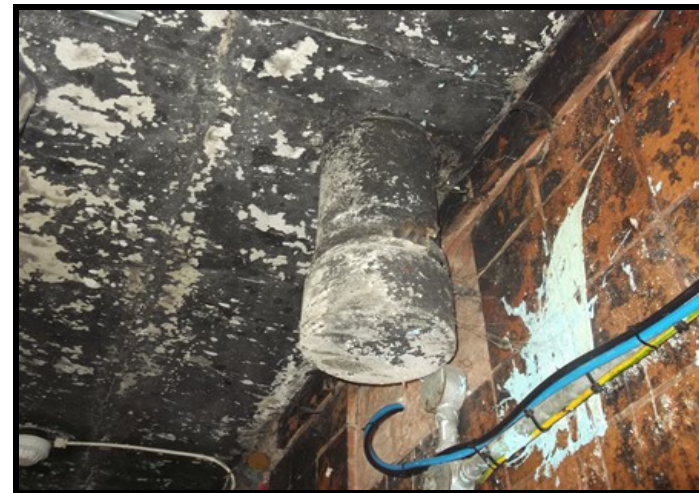
SAMPLE REFERENCE 006a

Asbestos detected in Sample

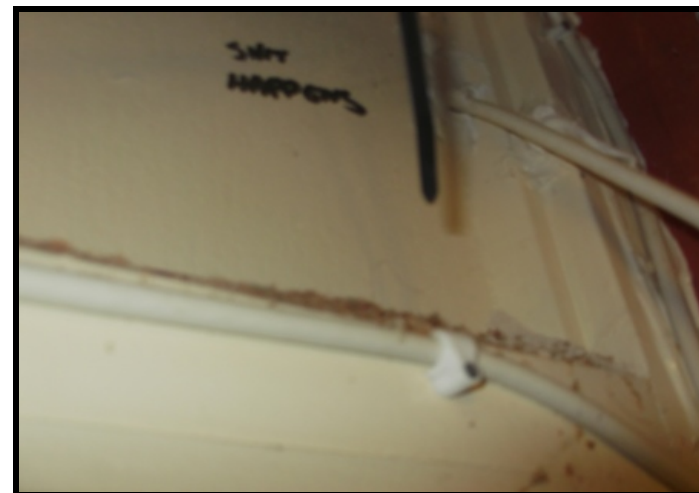
SAMPLE REFERENCE 014

No Asbestos Presumed in Sample

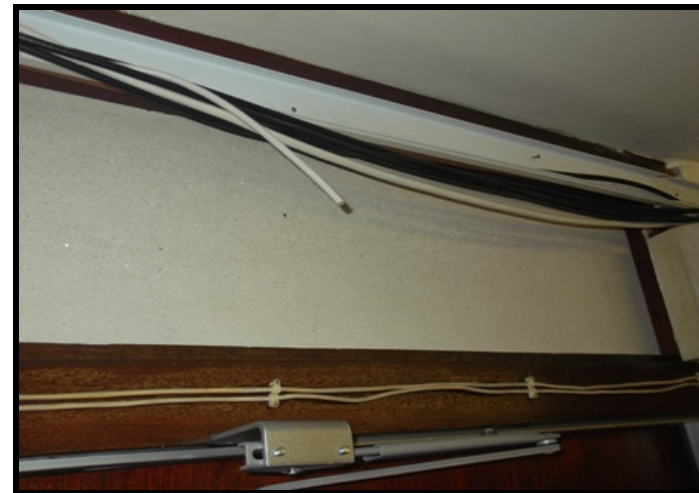
SAMPLE REFERENCE 020

No Asbestos Presumed in Sample

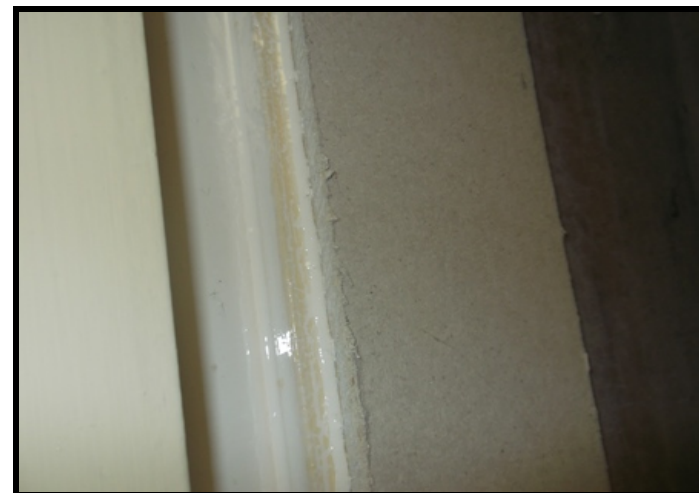
SAMPLE REFERENCE 022

Asbestos not detected in Sample

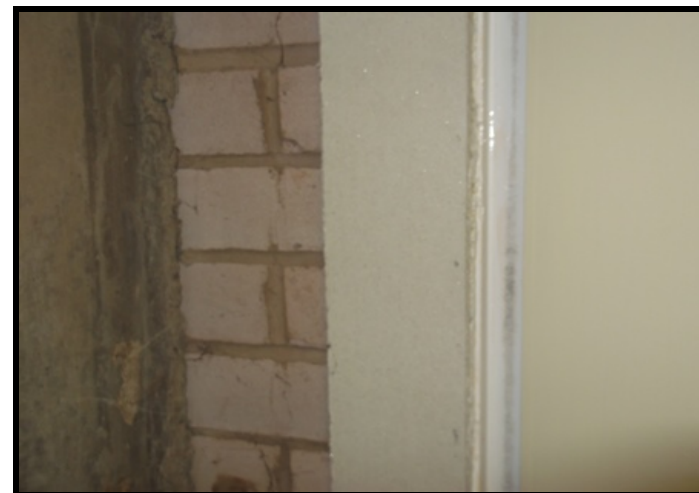
SAMPLE REFERENCE 023

No Asbestos Presumed in Sample

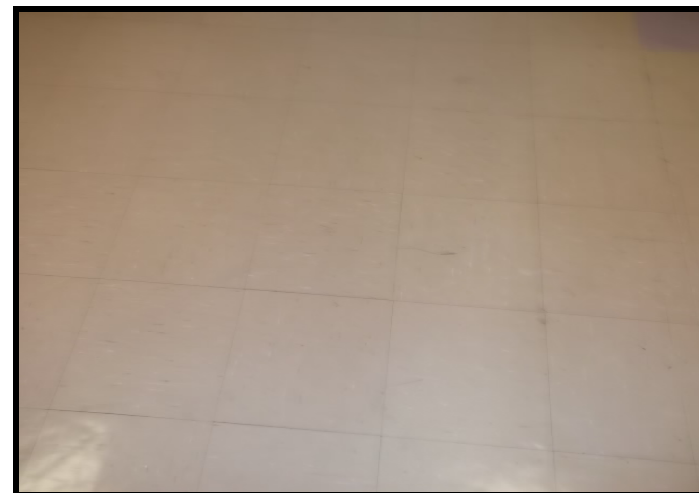
SAMPLE REFERENCE 025a

No Asbestos Presumed in Sample

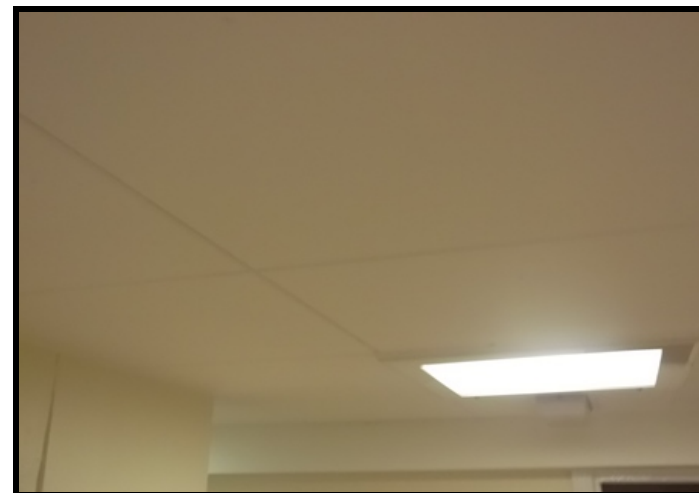
SAMPLE REFERENCE 025b

No Asbestos Presumed in Sample

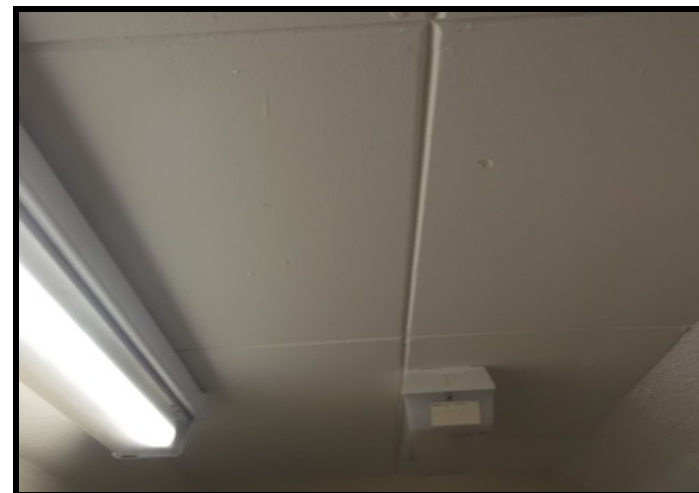
SAMPLE REFERENCE 026

No Asbestos Presumed in Sample

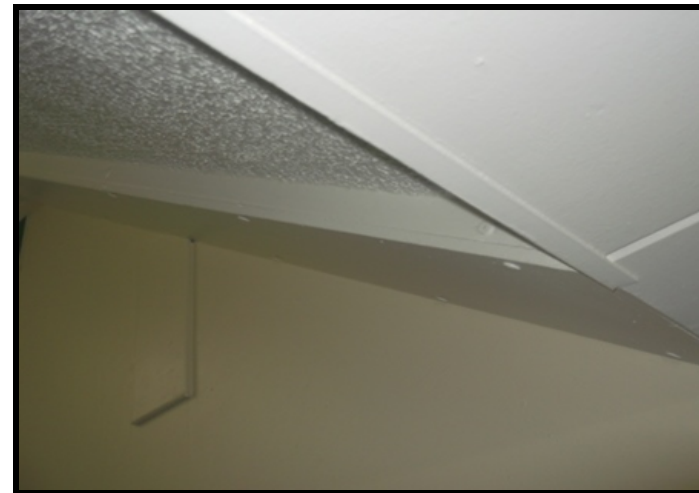
SAMPLE REFERENCE 029

Asbestos not detected in Sample

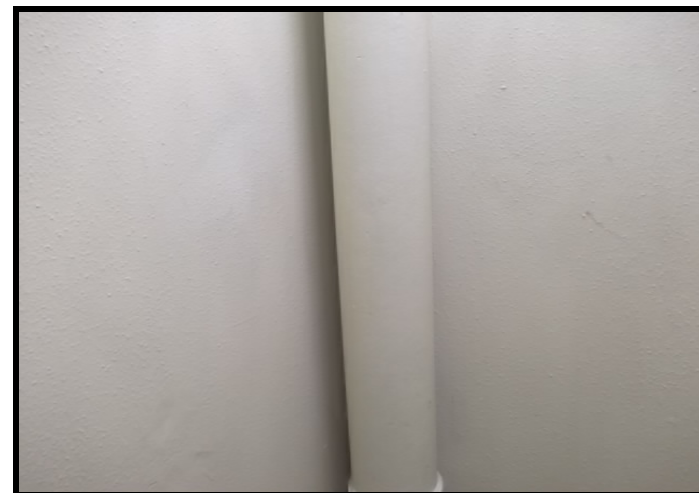
SAMPLE REFERENCE 034

Asbestos detected in Sample

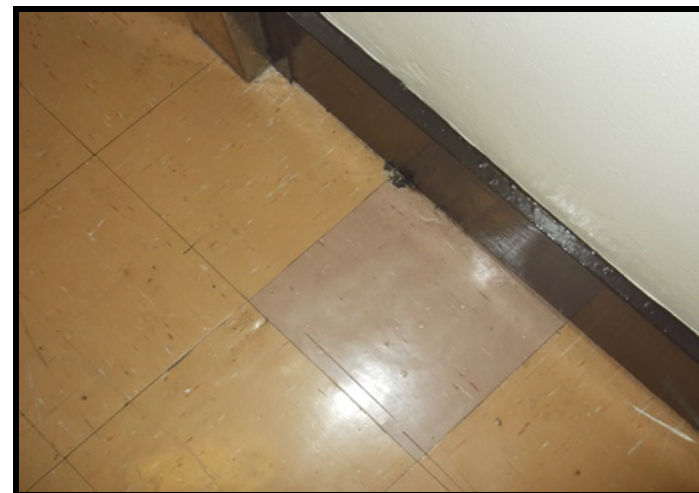
SAMPLE REFERENCE 036a

Asbestos detected in Sample

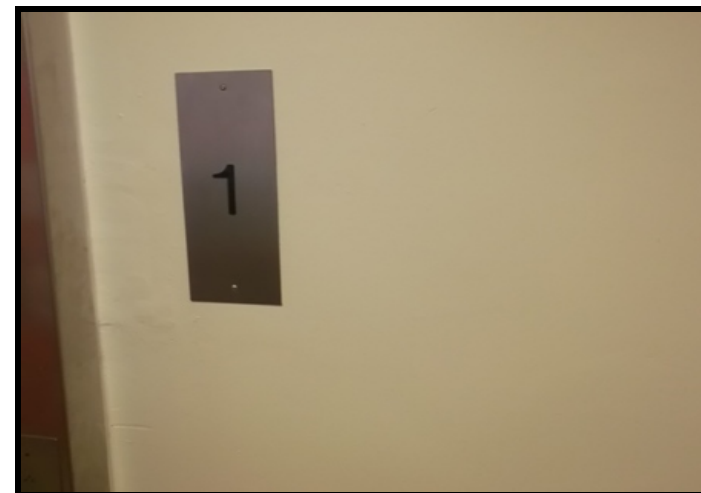
SAMPLE REFERENCE 037

No Asbestos Presumed in Sample

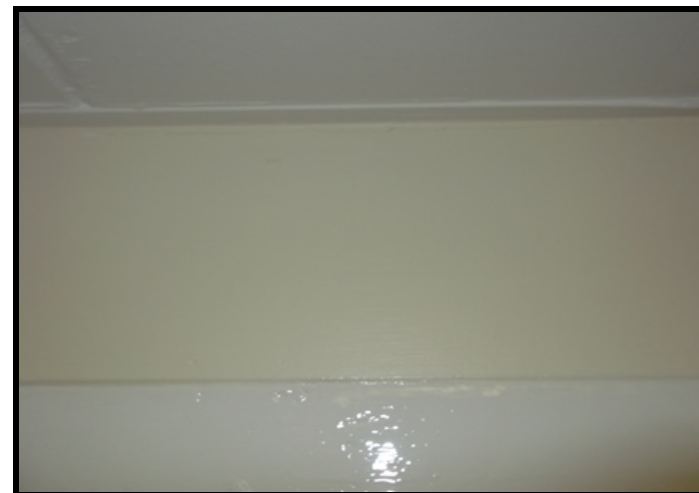
SAMPLE REFERENCE 038

No Asbestos Presumed in Sample

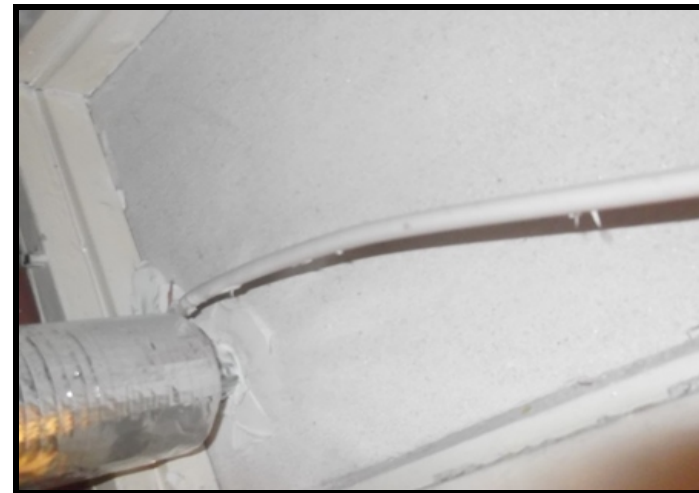
SAMPLE REFERENCE 042

No Asbestos Presumed in Sample

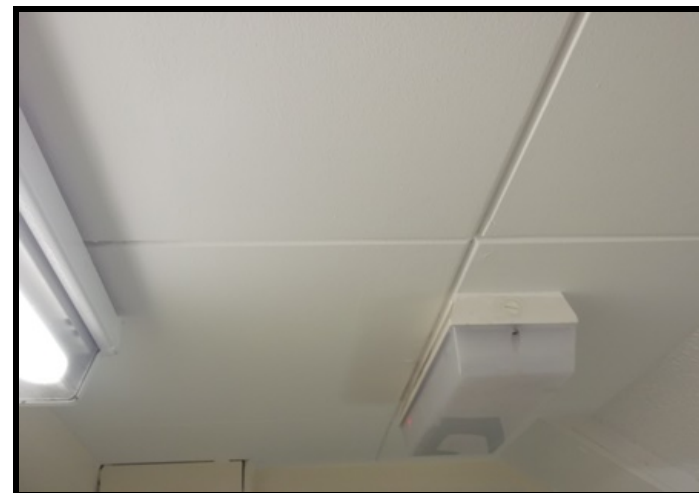
SAMPLE REFERENCE 043

No Asbestos Presumed in Sample

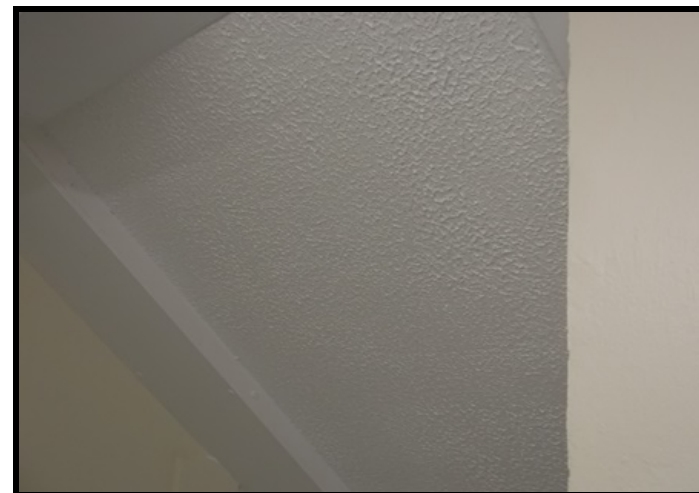
SAMPLE REFERENCE 045

No Asbestos Presumed in Sample

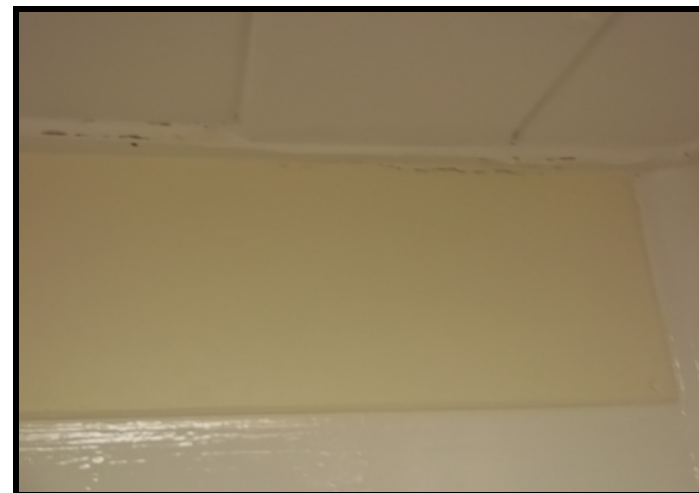
SAMPLE REFERENCE 052

No Asbestos Presumed in Sample

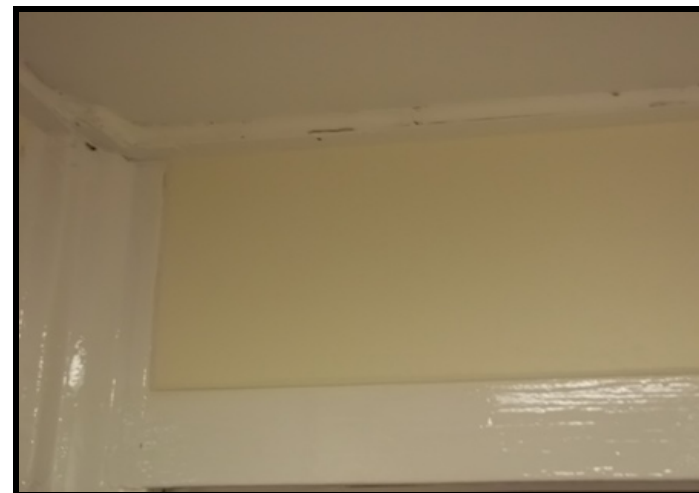
SAMPLE REFERENCE 053

No Asbestos Presumed in Sample

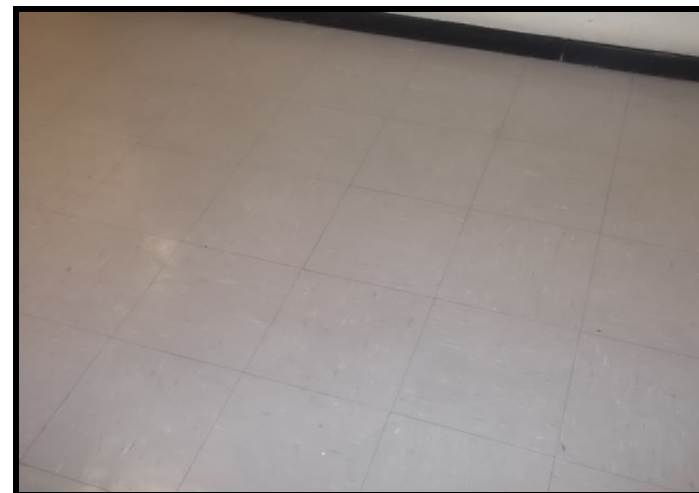
SAMPLE REFERENCE 053a

No Asbestos Presumed in Sample

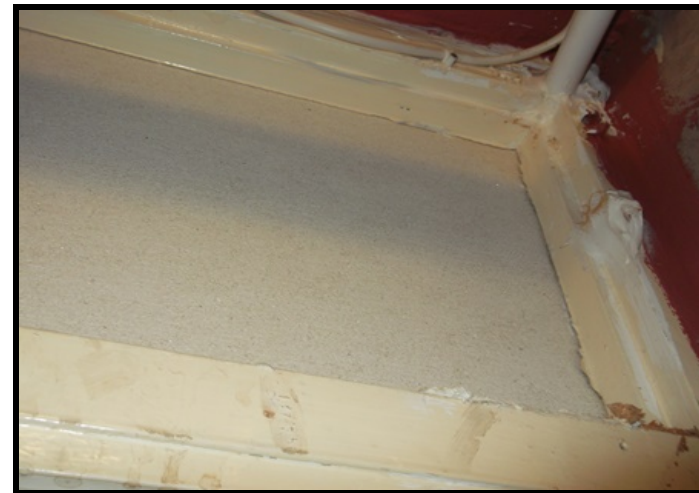
SAMPLE REFERENCE 055

No Asbestos Presumed in Sample

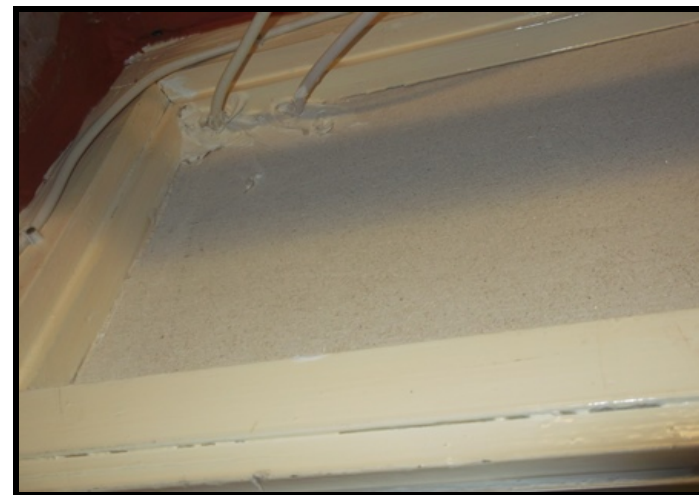
SAMPLE REFERENCE 056

No Asbestos Presumed in Sample

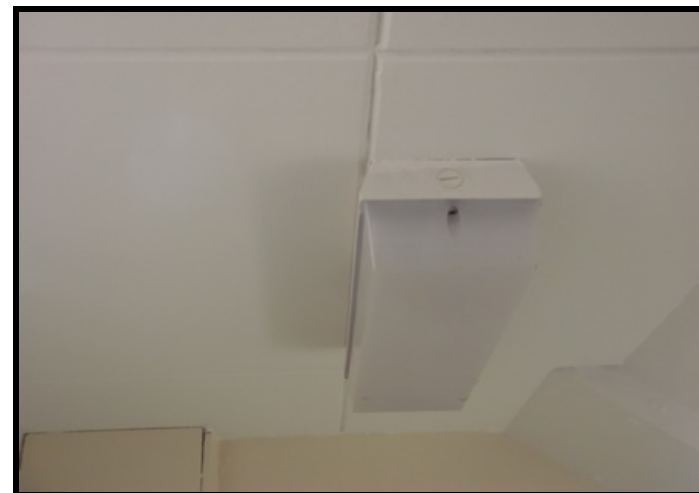
SAMPLE REFERENCE 057

No Asbestos Presumed in Sample

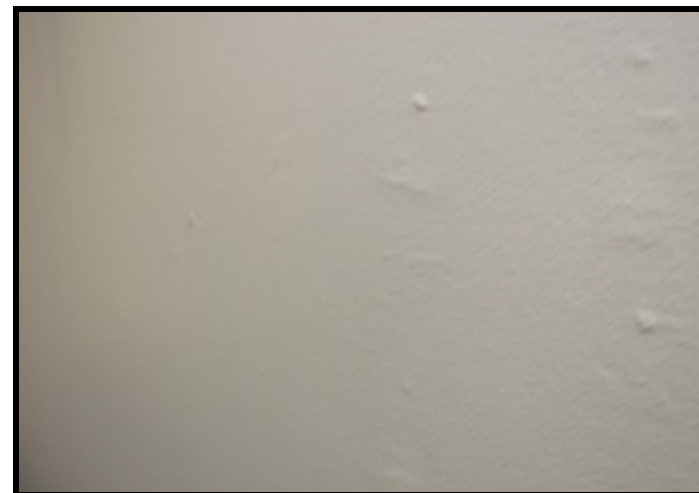
SAMPLE REFERENCE 058

No Asbestos Presumed in Sample

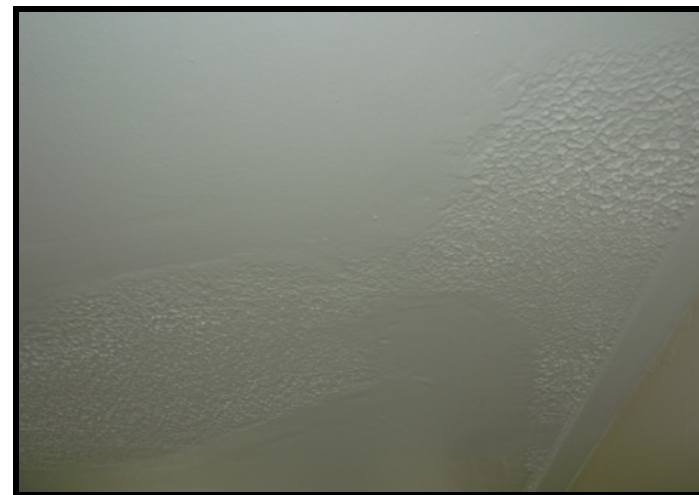
SAMPLE REFERENCE 059

No Asbestos Presumed in Sample

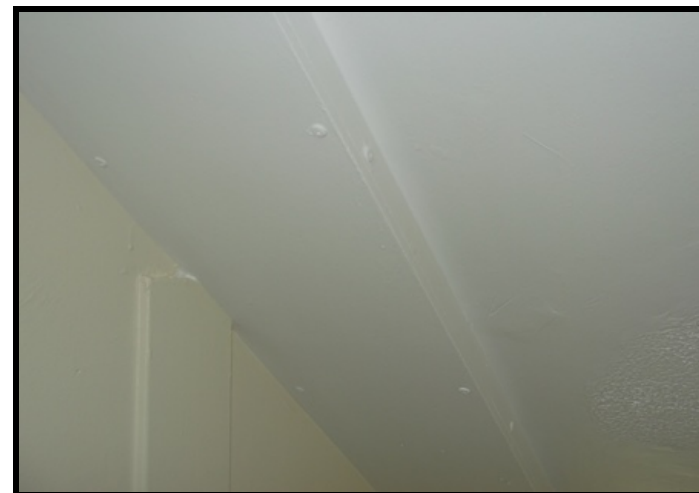
SAMPLE REFERENCE 060

No Asbestos Presumed in Sample

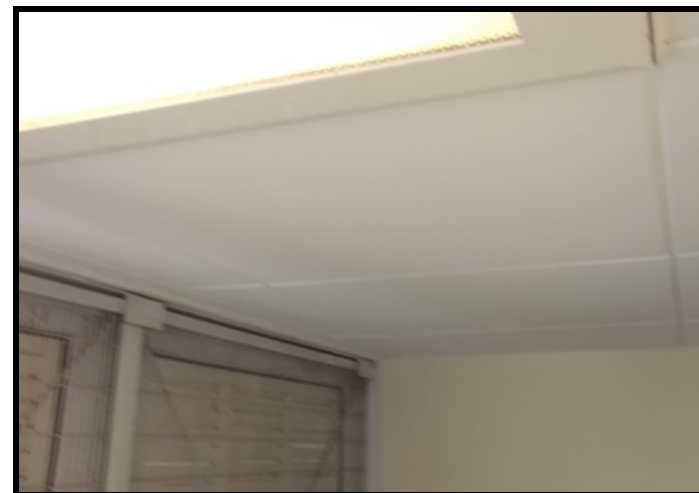
SAMPLE REFERENCE 061

No Asbestos Presumed in Sample

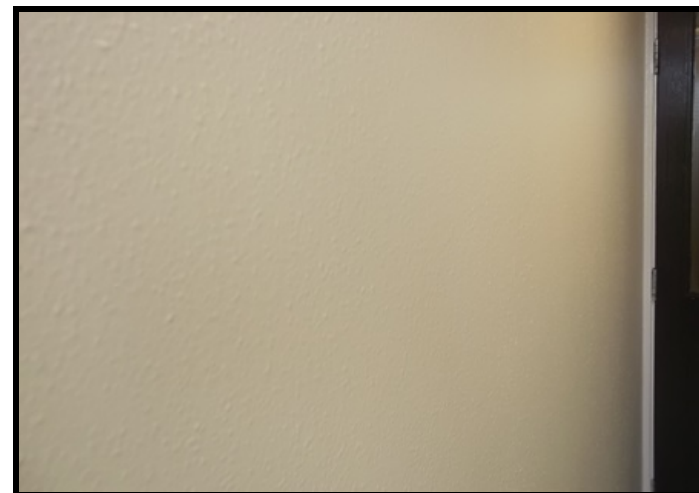
SAMPLE REFERENCE 062

No Asbestos Presumed in Sample

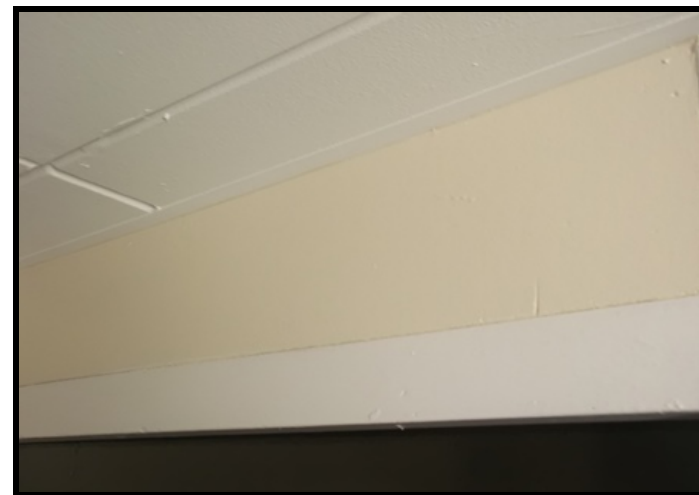
SAMPLE REFERENCE 064

No Asbestos Presumed in Sample

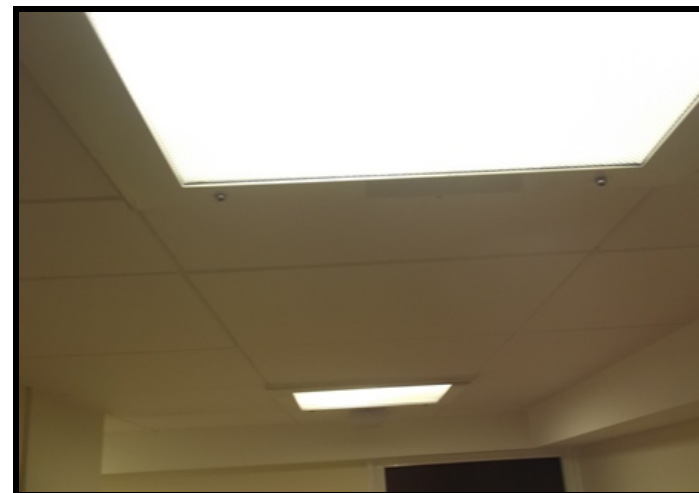
SAMPLE REFERENCE 065

No Asbestos Presumed in Sample

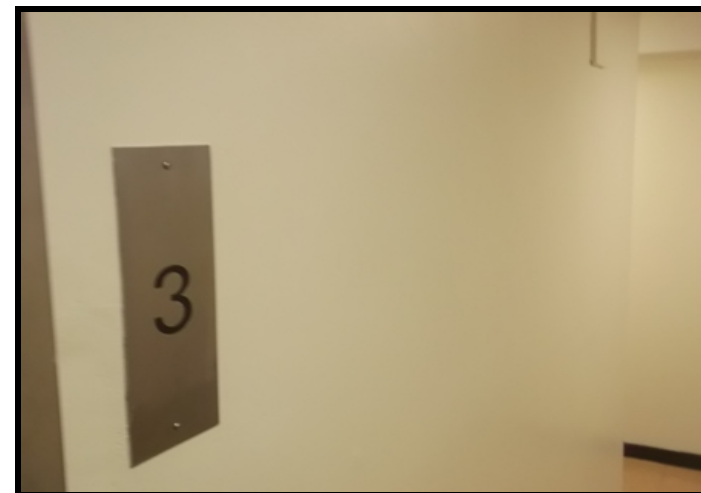
SAMPLE REFERENCE 066

No Asbestos Presumed in Sample

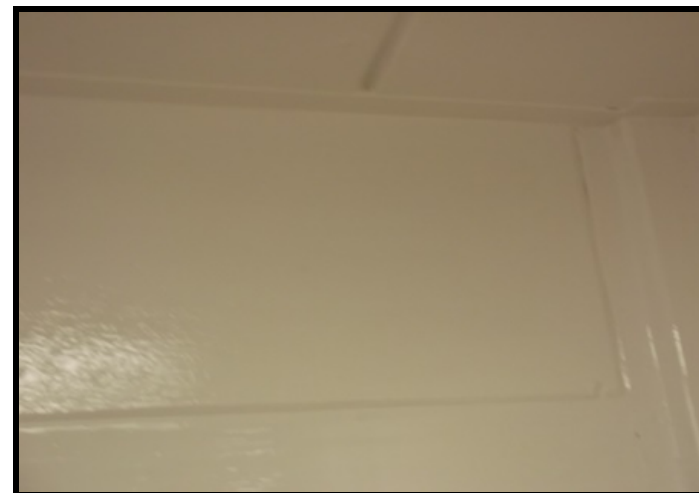
SAMPLE REFERENCE 067

No Asbestos Presumed in Sample

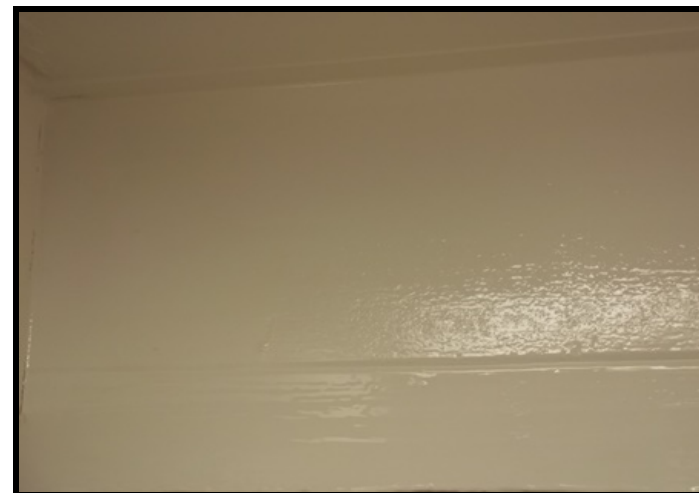
SAMPLE REFERENCE 068

No Asbestos Presumed in Sample

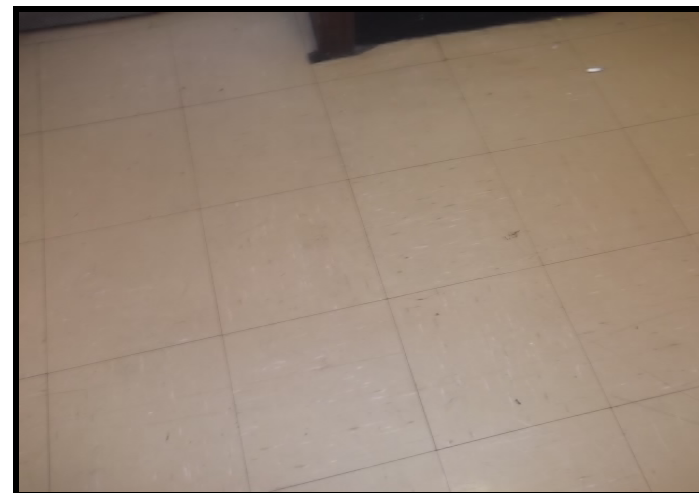
SAMPLE REFERENCE 068a

No Asbestos Presumed in Sample

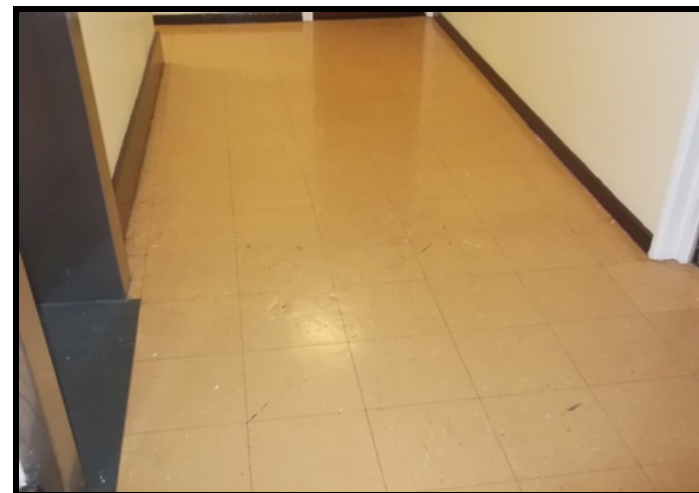
SAMPLE REFERENCE 068b

Building	Floor	Room	Location
Main Building	Third Floor	Lift Landing	Floor
Description			
MATERIAL ASSESSMENT			
Product Type	Bitumen	Extent of Damage	Low damage
Asbestos Type	Chrysotile	Surface Treatment	Composite materials
PRIORITY ASSESSMENT			
Occupant Activity	Not Applicable	Extent / Amount	4.00 m2
Accessibility	Easily disturbed	Location	Not Applicable
Avg Time in Use	Not Applicable	Frequency of Use	Not Applicable
No. of Occupants	Not Applicable	Secondary Activity	Not Applicable
Maintenance	Not Applicable	Maintenance Frequency	Not Applicable
MANAGEMENT ACTION			
Recommendation	LABEL & MONITOR		
Recommendation Due		Next Inspection	19 Dec 2015
Apply Labels	No	Permit to Work Required	No
Survey Type	Management	Lead Surveyor	Gavin Hooper
Survey Date	19 Dec 2014	UKAS Laboratory	NOT SAMPLED (Cross Referenced)
Site Reference	133510000A	Licensed Material	No
		Notifiable Non Licensed Work	No

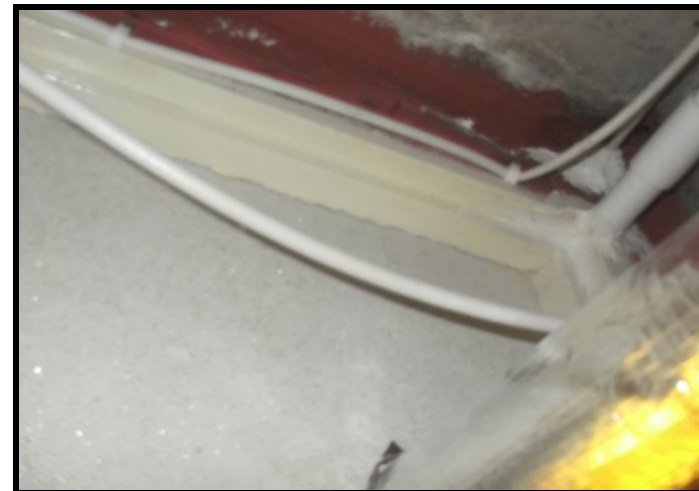
SAMPLE REFERENCE 070

No Asbestos Presumed in Sample

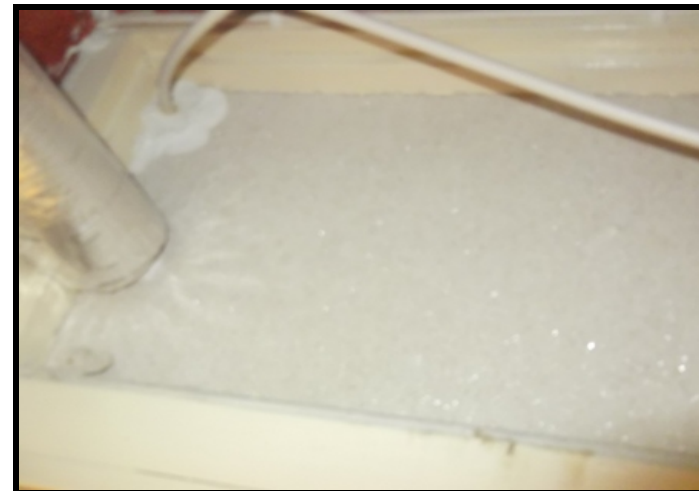
SAMPLE REFERENCE 071

No Asbestos Presumed in Sample

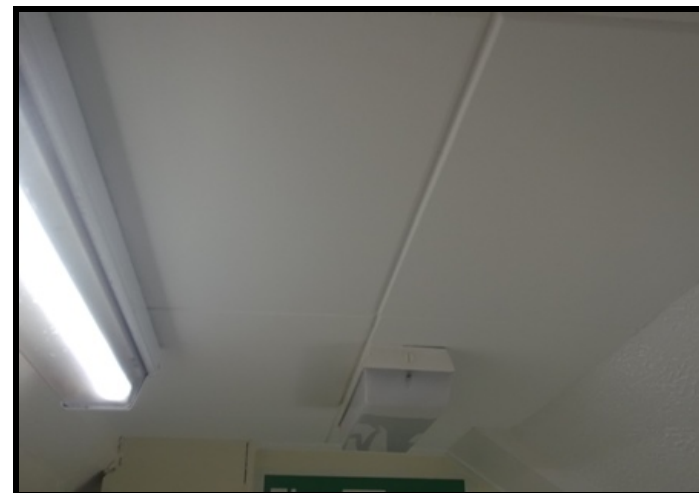
SAMPLE REFERENCE 072

Building	Floor	Room	Location			
Main Building	Fourth Floor	Stairs and Landing	Ceiling			
Description	No access within insulation board boxing					
MATERIAL ASSESSMENT				SCORE		
Product Type	Insulation Board	Extent of Damage	Good condition		-	
Asbestos Type	No Asbestos Detected	Surface Treatment	Sealed Board (Encapsulated)			
PRIORITY ASSESSMENT				SCORE		
Occupant Activity	Not Applicable	Extent / Amount	10.00 m2		-	
Accessibility	Occasionally disturb	Location	Not Applicable			
Avg Time in Use	Not Applicable	Frequency of Use	Not Applicable			
No. of Occupants	Not Applicable	Secondary Activity	Not Applicable			
Maintenance	Not Applicable	Maintenance Frequency	Not Applicable			
MANAGEMENT ACTION				SCORE		
Recommendation	NO ACTION REQUIRED			-		
Recommendation Due		Next Inspection	None			
Apply Labels	No	Permit to Work Required	No			
Survey Type	Management	Lead Surveyor	Gavin Hooper			
Survey Date	19 Dec 2014	UKAS Laboratory	NOT SAMPLED (Cross Referenced)

No Asbestos Presumed in Sample

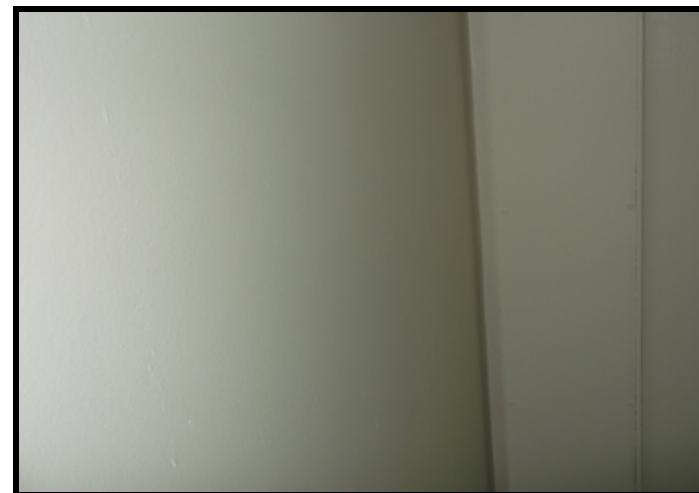
SAMPLE REFERENCE 073

Building	Floor	Room	Location			
Main Building	Fourth Floor	Stairs and Landing	Wall			
Description	No access within insulation board boxing					
MATERIAL ASSESSMENT				SCORE		
Product Type	Textured Coating	Extent of Damage	Good condition		-	
Asbestos Type	No Asbestos Detected	Surface Treatment	Textured Coating			
PRIORITY ASSESSMENT				SCORE		
Occupant Activity	Not Applicable	Extent / Amount	10.00 m2		-	
Accessibility	Easily disturbed	Location	Not Applicable			
Avg Time in Use	Not Applicable	Frequency of Use	Not Applicable			
No. of Occupants	Not Applicable	Secondary Activity	Not Applicable			
Maintenance	Not Applicable	Maintenance Frequency	Not Applicable			
MANAGEMENT ACTION				SCORE		
Recommendation	NO ACTION REQUIRED			-		
Recommendation Due		Next Inspection	None			
Apply Labels	No	Permit to Work Required	No			
Survey Type	Management	Lead Surveyor	Gavin Hooper			
Survey Date	19 Dec 2014	UKAS Laboratory	NOT SAMPLED (Cross Referenced)

No Asbestos Presumed in Sample

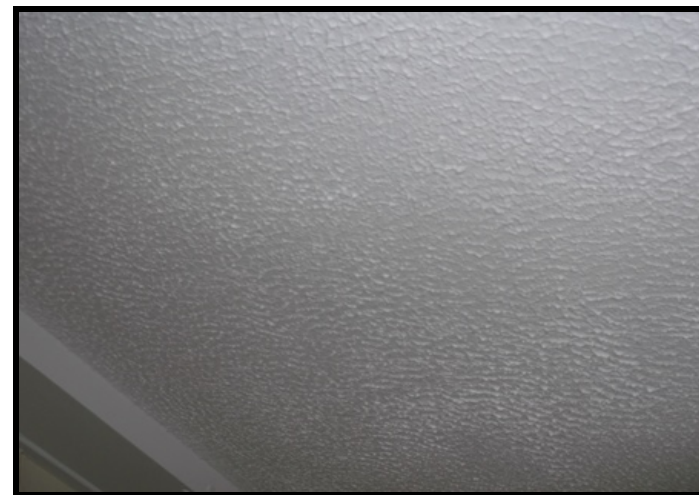
SAMPLE REFERENCE 074

Building	Floor	Room	Location			
Main Building	Fourth Floor	Stairs and Landing	Ceiling			
Description	No access within insulation board boxing					
MATERIAL ASSESSMENT				SCORE		
Product Type	Textured Coating	Extent of Damage	Good condition		-	
Asbestos Type	No Asbestos Detected	Surface Treatment	Textured Coating			
PRIORITY ASSESSMENT				SCORE		
Occupant Activity	Not Applicable	Extent / Amount	10.00 m2		-	
Accessibility	Occasionally disturb	Location	Not Applicable			
Avg Time in Use	Not Applicable	Frequency of Use	Not Applicable			
No. of Occupants	Not Applicable	Secondary Activity	Not Applicable			
Maintenance	Not Applicable	Maintenance Frequency	Not Applicable			
MANAGEMENT ACTION				SCORE		
Recommendation	NO ACTION REQUIRED			-		
Recommendation Due		Next Inspection	None			
Apply Labels	No	Permit to Work Required	No			
Survey Type	Management	Lead Surveyor	Gavin Hooper			
Survey Date	19 Dec 2014	UKAS Laboratory	NOT SAMPLED (Cross Referenced)

No Asbestos Presumed in Sample

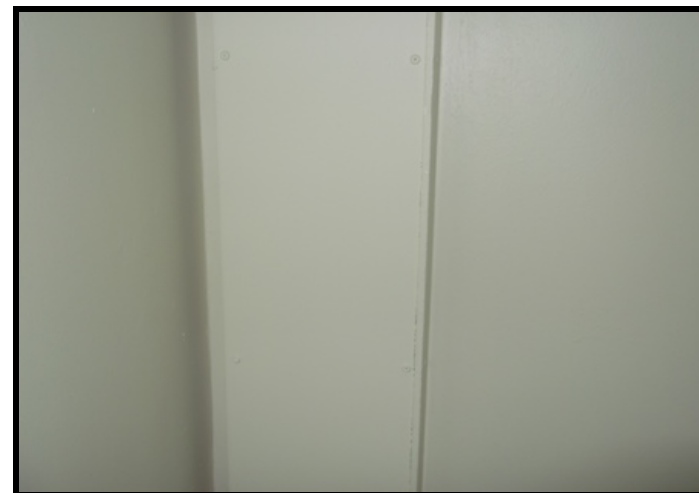
SAMPLE REFERENCE 075

Building	Floor	Room	Location		
Main Building	Fourth Floor	Stairs and Landing	Boxing		
Description	To ceiling and walls. No access within insulation board boxing				
MATERIAL ASSESSMENT				SCORE	
Product Type	Insulation Board	Extent of Damage	Good condition		-
Asbestos Type	No Asbestos Detected	Surface Treatment	Sealed Board (Encapsulated)		
PRIORITY ASSESSMENT				SCORE	
Occupant Activity	Not Applicable	Extent / Amount	4.00 m2		-
Accessibility	Easily disturbed	Location	Not Applicable		
Avg Time in Use	Not Applicable	Frequency of Use	Not Applicable		
No. of Occupants	Not Applicable	Secondary Activity	Not Applicable		
Maintenance	Not Applicable	Maintenance Frequency	Not Applicable		
MANAGEMENT ACTION				SCORE	
Recommendation	NO ACTION REQUIRED			-	
Recommendation Due		Next Inspection	None		
Apply Labels	No	Permit to Work Required	No		
Survey Type	Management	Lead Surveyor	Gavin Hooper		
Survey Date	19 Dec 2014	UKAS Laboratory	NOT SAMPLED (Cross Referenced)

No Asbestos Presumed in Sample

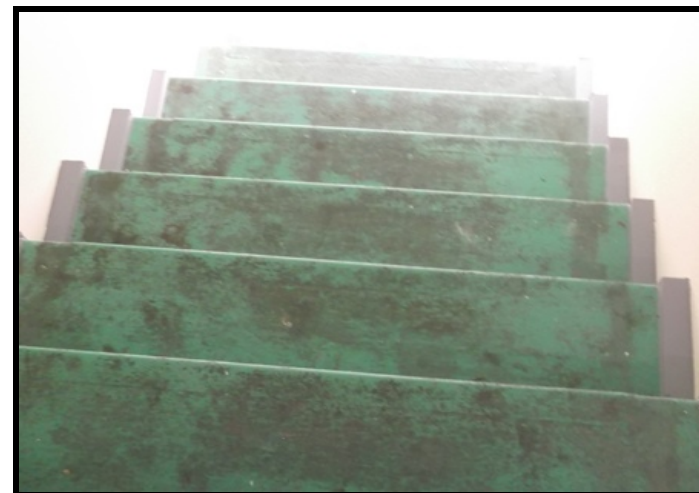
SAMPLE REFERENCE 075a

Building	Floor	Room	Location
Main Building	Fourth Floor	Stairs and Landing	Floor
Description			
MATERIAL ASSESSMENT			
Product Type	Bitumen	Extent of Damage	Low damage
Asbestos Type	Chrysotile	Surface Treatment	Composite materials
PRIORITY ASSESSMENT			
Occupant Activity	Not Applicable	Extent / Amount	2.00 m2
Accessibility	Easily disturbed	Location	Not Applicable
Avg Time in Use	Not Applicable	Frequency of Use	Not Applicable
No. of Occupants	Not Applicable	Secondary Activity	Not Applicable
Maintenance	Not Applicable	Maintenance Frequency	Not Applicable
MANAGEMENT ACTION			
Recommendation	LABEL & MONITOR		
Recommendation Due		Next Inspection	19 Dec 2015
Apply Labels	No	Permit to Work Required	No
Survey Type	Management	Lead Surveyor	Gavin Hooper
Survey Date	19 Dec 2014	UKAS Laboratory	NOT SAMPLED (Cross Referenced)
Site Reference	133510000A	Licensed Material	No
		Notifiable Non Licensed Work	No

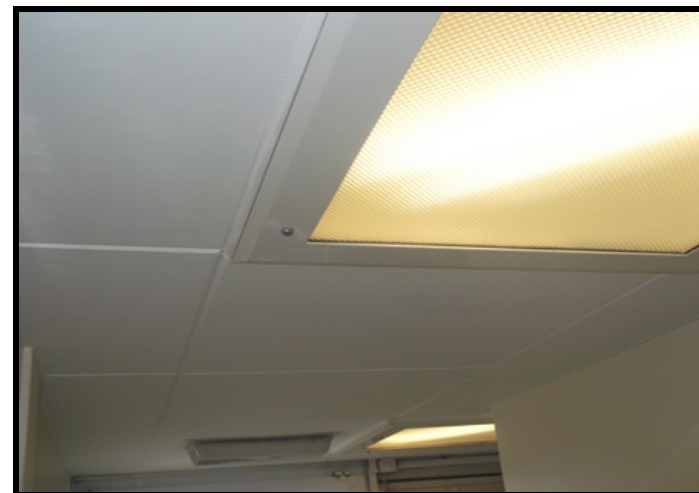
SAMPLE REFERENCE 076

Building	Floor	Room	Location		
Main Building	Fourth Floor	Waste Area	Ceiling		
Description					
MATERIAL ASSESSMENT					SCORE
Product Type	Insulation Board	Extent of Damage	Good condition		-
Asbestos Type	No Asbestos Detected	Surface Treatment	Sealed Board (Encapsulated)		
PRIORITY ASSESSMENT					SCORE
Occupant Activity	Not Applicable	Extent / Amount	10.00 m2		-
Accessibility	Occasionally disturb	Location	Not Applicable		
Avg Time in Use	Not Applicable	Frequency of Use	Not Applicable		
No. of Occupants	Not Applicable	Secondary Activity	Not Applicable		
Maintenance	Not Applicable	Maintenance Frequency	Not Applicable		
MANAGEMENT ACTION					SCORE
Recommendation	NO ACTION REQUIRED				-
Recommendation Due		Next Inspection	None		
Apply Labels	No	Permit to Work Required	No		
Survey Type	Management	Lead Surveyor	Gavin Hooper		
Survey Date	19 Dec 2014	UKAS Laboratory	NOT SAMPLED (Cross Referenced)		
Site Reference	I33510000A	Licensed Material	N/A	Notifiable Non Licensed Work	N/A

No Asbestos Presumed in Sample

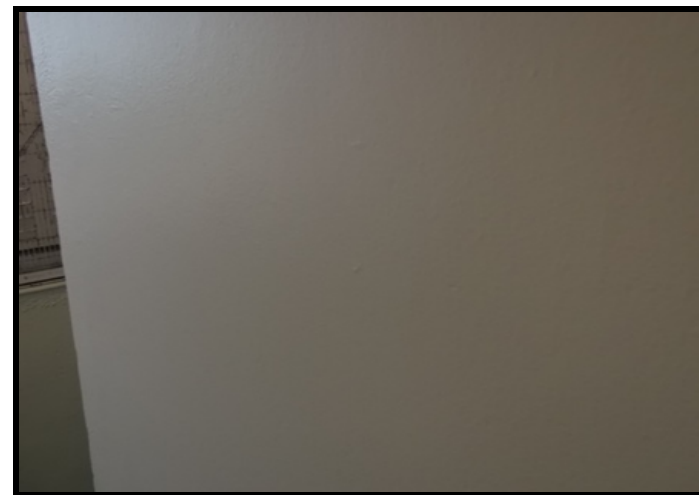
SAMPLE REFERENCE 077

Building	Floor	Room	Location		
Main Building	Fourth Floor	Waste Area	Wall		
Description					
MATERIAL ASSESSMENT					SCORE
Product Type	Textured Coating	Extent of Damage	Good condition		-
Asbestos Type	No Asbestos Detected	Surface Treatment	Textured Coating		
PRIORITY ASSESSMENT					SCORE
Occupant Activity	Not Applicable	Extent / Amount	10.00 m2		-
Accessibility	Easily disturbed	Location	Not Applicable		
Avg Time in Use	Not Applicable	Frequency of Use	Not Applicable		
No. of Occupants	Not Applicable	Secondary Activity	Not Applicable		
Maintenance	Not Applicable	Maintenance Frequency	Not Applicable		
MANAGEMENT ACTION					SCORE
Recommendation	NO ACTION REQUIRED				-
Recommendation Due		Next Inspection	None		
Apply Labels	No	Permit to Work Required	No		
Survey Type	Management	Lead Surveyor	Gavin Hooper		
Survey Date	19 Dec 2014	UKAS Laboratory	NOT SAMPLED (Cross Referenced)		
Site Reference	I33510000A	Licensed Material	N/A	Notifiable Non Licensed Work	N/A

No Asbestos Presumed in Sample

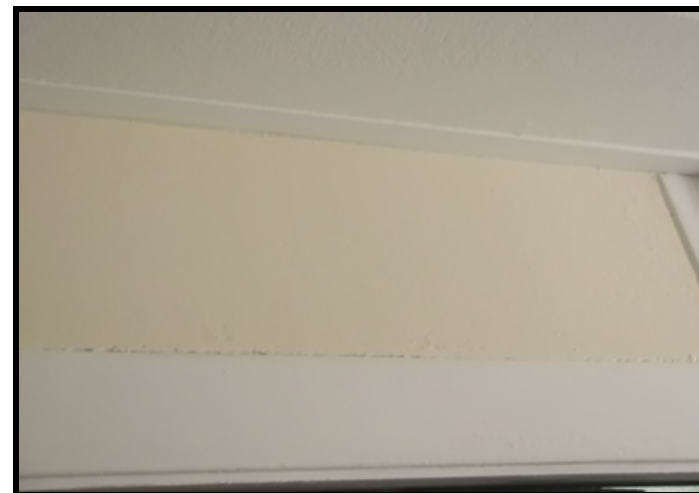
SAMPLE REFERENCE 079

Building	Floor	Room	Location		
Main Building	Fourth Floor	Waste Area	Transom Panel		
Description					
MATERIAL ASSESSMENT				SCORE	
Product Type	Insulation Board	Extent of Damage	Good condition		-
Asbestos Type	No Asbestos Detected	Surface Treatment	Sealed Board (Encapsulated)		
PRIORITY ASSESSMENT				SCORE	
Occupant Activity	Not Applicable	Extent / Amount	1.00 m2		-
Accessibility	Occasionally disturb	Location	Not Applicable		
Avg Time in Use	Not Applicable	Frequency of Use	Not Applicable		
No. of Occupants	Not Applicable	Secondary Activity	Not Applicable		
Maintenance	Not Applicable	Maintenance Frequency	Not Applicable		
MANAGEMENT ACTION				SCORE	
Recommendation	NO ACTION REQUIRED				-
Recommendation Due		Next Inspection	None		
Apply Labels	No	Permit to Work Required	No		
Survey Type	Management	Lead Surveyor	Gavin Hooper		
Survey Date	19 Dec 2014	UKAS Laboratory	NOT SAMPLED (Cross Referenced)		
Site Reference	I33510000A	Licensed Material	N/A	Notifiable Non Licensed Work	N/A

No Asbestos Presumed in Sample

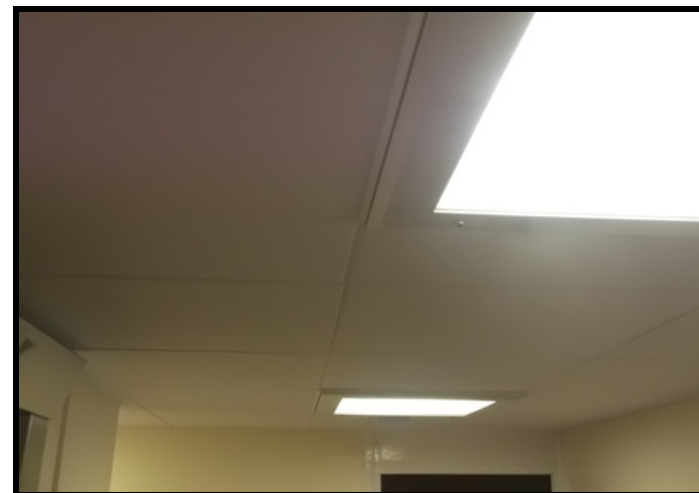
SAMPLE REFERENCE 080

Building	Floor	Room	Location		
Main Building	Fourth Floor	Lift Landing	Ceiling		
Description					
MATERIAL ASSESSMENT					SCORE
Product Type	Insulation Board	Extent of Damage	Good condition		-
Asbestos Type	No Asbestos Detected	Surface Treatment	Sealed Board (Encapsulated)		
PRIORITY ASSESSMENT					SCORE
Occupant Activity	Not Applicable	Extent / Amount	40.00 m2		-
Accessibility	Occasionally disturb	Location	Not Applicable		
Avg Time in Use	Not Applicable	Frequency of Use	Not Applicable		
No. of Occupants	Not Applicable	Secondary Activity	Not Applicable		
Maintenance	Not Applicable	Maintenance Frequency	Not Applicable		
MANAGEMENT ACTION					SCORE
Recommendation	NO ACTION REQUIRED				-
Recommendation Due		Next Inspection	None		
Apply Labels	No	Permit to Work Required	No		
Survey Type	Management	Lead Surveyor	Gavin Hooper		
Survey Date	19 Dec 2014	UKAS Laboratory	NOT SAMPLED (Cross Referenced)		
Site Reference	I33510000A	Licensed Material	N/A	Notifiable Non Licensed Work	N/A

No Asbestos Presumed in Sample

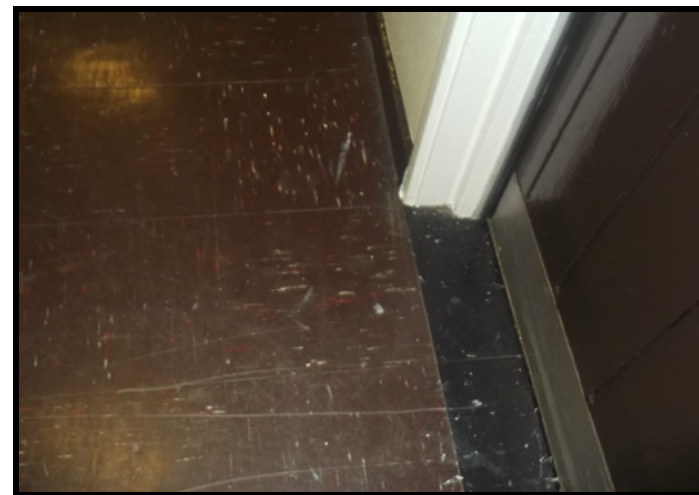
SAMPLE REFERENCE 080a

Building	Floor	Room	Location
Main Building	Fourth Floor	Lift Landing	Floor
Description	Brown floor tiles and adhesive		
MATERIAL ASSESSMENT			
Product Type	Bitumen	Extent of Damage	Good condition
Asbestos Type	Chrysotile	Surface Treatment	Composite materials
			2
PRIORITY ASSESSMENT			
Occupant Activity	Not Applicable	Extent / Amount	20.00 m2
Accessibility	Easily disturbed	Location	Not Applicable
Avg Time in Use	Not Applicable	Frequency of Use	Not Applicable
No. of Occupants	Not Applicable	Secondary Activity	Not Applicable
Maintenance	Not Applicable	Maintenance Frequency	Not Applicable
			1
MANAGEMENT ACTION			
Recommendation	LABEL & MONITOR		
Recommendation Due		Next Inspection	19 Dec 2015
Apply Labels	No	Permit to Work Required	No
			3
Survey Type	Management	Lead Surveyor	Gavin Hooper
Survey Date	19 Dec 2014	UKAS Laboratory	DMW Environmental Safety Ltd / [A-10222]
Site Reference	I33510000A	Licensed Material	No

Asbestos detected in Sample

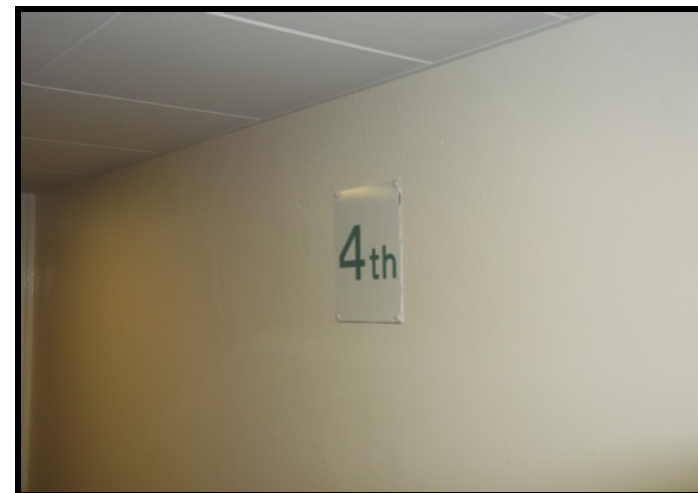
SAMPLE REFERENCE 081

Building	Floor	Room	Location		
Main Building	Fourth Floor	Lift Landing	Wall		
Description					
MATERIAL ASSESSMENT					SCORE
Product Type	Textured Coating	Extent of Damage	Good condition		-
Asbestos Type	No Asbestos Detected	Surface Treatment	Textured Coating		
PRIORITY ASSESSMENT					SCORE
Occupant Activity	Not Applicable	Extent / Amount	40.00 m2		-
Accessibility	Easily disturbed	Location	Not Applicable		
Avg Time in Use	Not Applicable	Frequency of Use	Not Applicable		
No. of Occupants	Not Applicable	Secondary Activity	Not Applicable		
Maintenance	Not Applicable	Maintenance Frequency	Not Applicable		
MANAGEMENT ACTION					SCORE
Recommendation	NO ACTION REQUIRED				-
Recommendation Due		Next Inspection	None		
Apply Labels	No	Permit to Work Required	No		
Survey Type	Management	Lead Surveyor	Gavin Hooper		
Survey Date	19 Dec 2014	UKAS Laboratory	NOT SAMPLED (Cross Referenced)		
Site Reference	I33510000A	Licensed Material	N/A	Notifiable Non Licensed Work	N/A

No Asbestos Presumed in Sample

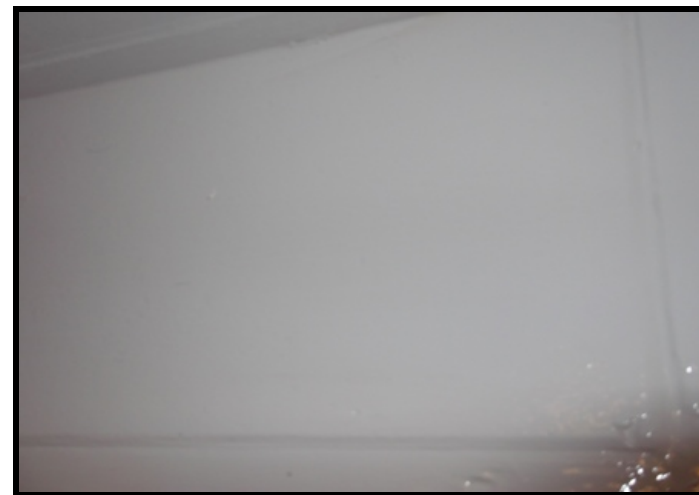
SAMPLE REFERENCE 082

Building	Floor	Room	Location
Main Building	Fourth Floor	Lift Landing	Transom Panel
Description	Above doors to flats.		
MATERIAL ASSESSMENT			
Product Type	Insulation Board	Extent of Damage	Good condition
Asbestos Type	No Asbestos Detected	Surface Treatment	Sealed Board (Encapsulated)
PRIORITY ASSESSMENT			
Occupant Activity	Not Applicable	Extent / Amount	1.00 m2
Accessibility	Occasionally disturb	Location	Not Applicable
Avg Time in Use	Not Applicable	Frequency of Use	Not Applicable
No. of Occupants	Not Applicable	Secondary Activity	Not Applicable
Maintenance	Not Applicable	Maintenance Frequency	Not Applicable
MANAGEMENT ACTION			
Recommendation	NO ACTION REQUIRED		
Recommendation Due		Next Inspection	None
Apply Labels	No	Permit to Work Required	No
Survey Type	Management	Lead Surveyor	Gavin Hooper
Survey Date	19 Dec 2014	UKAS Laboratory	NOT SAMPLED (Cross Referenced)
Site Reference	I33510000A	Licensed Material	N/A

No Asbestos Presumed in Sample

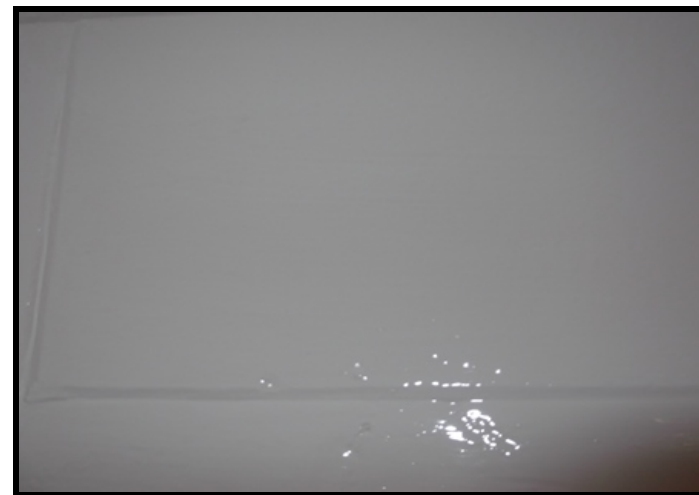
SAMPLE REFERENCE 083

Building	Floor	Room	Location		
Main Building	Fourth Floor	Lift Landing	Transom Panel		
Description	Above doors to risers.				
MATERIAL ASSESSMENT					SCORE
Product Type	Insulation Board	Extent of Damage	Good condition		-
Asbestos Type	No Asbestos Detected	Surface Treatment	Sealed Board (Encapsulated)		
PRIORITY ASSESSMENT					SCORE
Occupant Activity	Not Applicable	Extent / Amount	1.00 m2		-
Accessibility	Occasionally disturb	Location	Not Applicable		
Avg Time in Use	Not Applicable	Frequency of Use	Not Applicable		
No. of Occupants	Not Applicable	Secondary Activity	Not Applicable		
Maintenance	Not Applicable	Maintenance Frequency	Not Applicable		
MANAGEMENT ACTION					SCORE
Recommendation	NO ACTION REQUIRED				-
Recommendation Due		Next Inspection	None		
Apply Labels	No	Permit to Work Required	No		
Survey Type	Management	Lead Surveyor	Gavin Hooper		
Survey Date	19 Dec 2014	UKAS Laboratory	NOT SAMPLED (Cross Referenced)

No Asbestos Presumed in Sample
