Solihull Community Housing

Asbestos Management Survey Report

Darwin House I-37 (Communal)
Alder Court
Solihull
B37 7QF

Date of Report: 27 Feb 2015

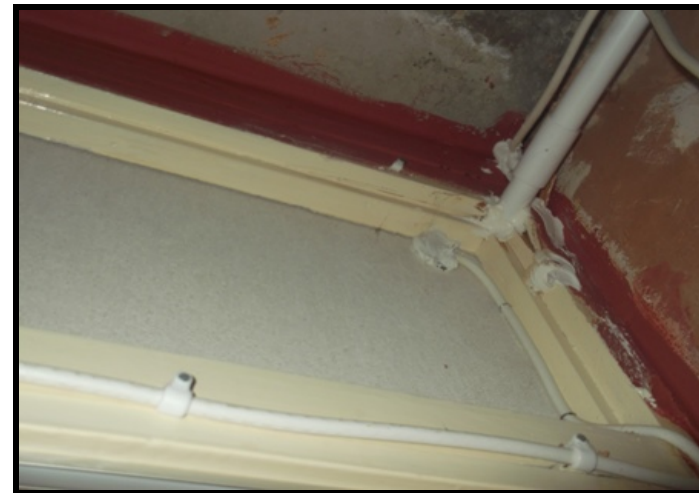
SAMPLE REFERENCE 085

Building	Floor	Room	Location			
Main Building	Fourth Floor	Dry Riser 1	Transom Panel			
Description						
MATERIAL ASSESSMENT				SCORE		
Product Type	Insulation Board	Extent of Damage	Good condition		-	
Asbestos Type	No Asbestos Detected	Surface Treatment	Sealed Board (Encapsulated)			
PRIORITY ASSESSMENT				SCORE		
Occupant Activity	Not Applicable	Extent / Amount	1.00 m2		-	
Accessibility	Occasionally disturb	Location	Not Applicable			
Avg Time in Use	Not Applicable	Frequency of Use	Not Applicable			
No. of Occupants	Not Applicable	Secondary Activity	Not Applicable			
Maintenance	Not Applicable	Maintenance Frequency	Not Applicable			
MANAGEMENT ACTION				SCORE		
Recommendation	NO ACTION REQUIRED			-		
Recommendation Due		Next Inspection	None			
Apply Labels	No	Permit to Work Required	No			
Survey Type	Management	Lead Surveyor	Gavin Hooper			
Survey Date	19 Dec 2014	UKAS Laboratory	NOT SAMPLED (Cross Referenced)

No Asbestos Presumed in Sample

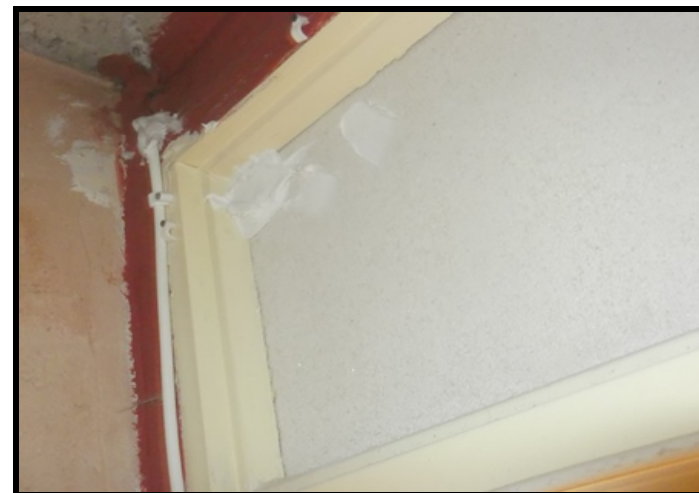
SAMPLE REFERENCE 086

Building	Floor	Room	Location			
Main Building	Fourth Floor	Dry Riser 2	Transom Panel			
Description						
MATERIAL ASSESSMENT				SCORE		
Product Type	Insulation Board	Extent of Damage	Good condition		-	
Asbestos Type	No Asbestos Detected	Surface Treatment	Sealed Board (Encapsulated)			
PRIORITY ASSESSMENT				SCORE		
Occupant Activity	Not Applicable	Extent / Amount	1.00 m2		-	
Accessibility	Occasionally disturb	Location	Not Applicable			
Avg Time in Use	Not Applicable	Frequency of Use	Not Applicable			
No. of Occupants	Not Applicable	Secondary Activity	Not Applicable			
Maintenance	Not Applicable	Maintenance Frequency	Not Applicable			
MANAGEMENT ACTION				SCORE		
Recommendation	NO ACTION REQUIRED			-		
Recommendation Due		Next Inspection	None			
Apply Labels	No	Permit to Work Required	No			
Survey Type	Management	Lead Surveyor	Gavin Hooper			
Survey Date	19 Dec 2014	UKAS Laboratory	NOT SAMPLED (Cross Referenced)

No Asbestos Presumed in Sample

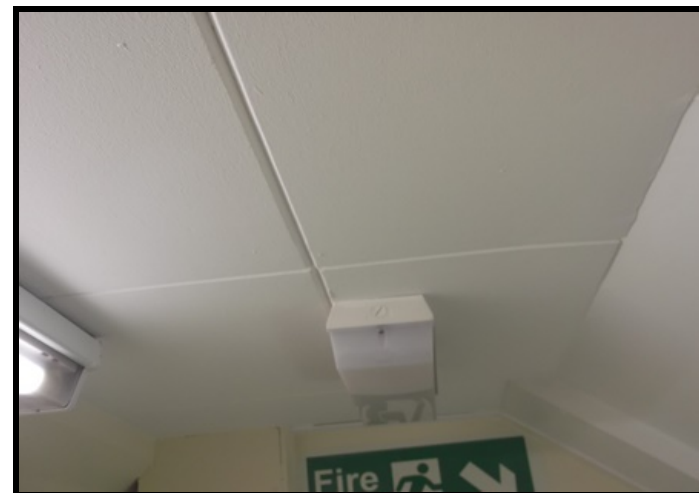
SAMPLE REFERENCE 087

Building	Floor	Room	Location			
Main Building	Fifth Floor	Stairs and Landing	Ceiling			
Description	No access within insulation board boxing.					
MATERIAL ASSESSMENT				SCORE		
Product Type	Insulation Board	Extent of Damage	Good condition		-	
Asbestos Type	No Asbestos Detected	Surface Treatment	Sealed Board (Encapsulated)			
PRIORITY ASSESSMENT				SCORE		
Occupant Activity	Not Applicable	Extent / Amount	10.00 m2		-	
Accessibility	Occasionally disturb	Location	Not Applicable			
Avg Time in Use	Not Applicable	Frequency of Use	Not Applicable			
No. of Occupants	Not Applicable	Secondary Activity	Not Applicable			
Maintenance	Not Applicable	Maintenance Frequency	Not Applicable			
MANAGEMENT ACTION				SCORE		
Recommendation	NO ACTION REQUIRED			-		
Recommendation Due		Next Inspection	None			
Apply Labels	No	Permit to Work Required	No			
Survey Type	Management	Lead Surveyor	Gavin Hooper			
Survey Date	19 Dec 2014	UKAS Laboratory	NOT SAMPLED (Cross Referenced)

No Asbestos Presumed in Sample

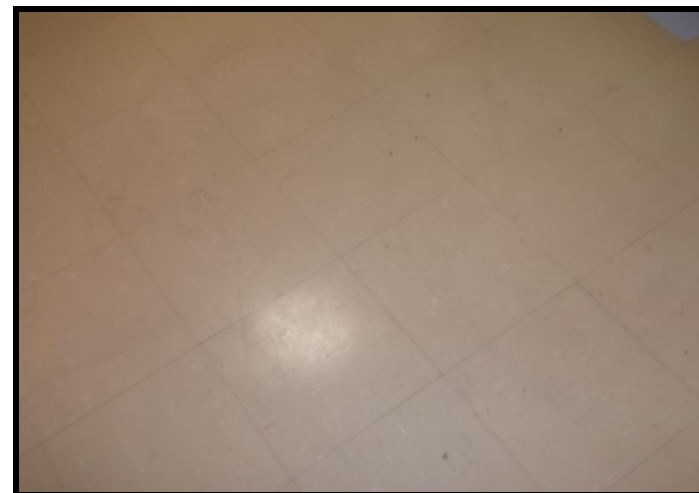
SAMPLE REFERENCE 087a

Building	Floor	Room	Location		
Main Building	Fifth Floor	Lift Landing	Floor		
Description					
MATERIAL ASSESSMENT					SCORE
Product Type	Floor Tiles	Extent of Damage	Good condition		-
Asbestos Type	No Asbestos Detected	Surface Treatment	Composite materials		
PRIORITY ASSESSMENT					SCORE
Occupant Activity	Not Applicable	Extent / Amount	40.00 m2		-
Accessibility	Occasionally disturb	Location	Not Applicable		
Avg Time in Use	Not Applicable	Frequency of Use	Not Applicable		
No. of Occupants	Not Applicable	Secondary Activity	Not Applicable		
Maintenance	Not Applicable	Maintenance Frequency	Not Applicable		
MANAGEMENT ACTION					SCORE
Recommendation	NO ACTION REQUIRED				-
Recommendation Due		Next Inspection	None		
Apply Labels	No	Permit to Work Required	No		
Survey Type	Management	Lead Surveyor	Richard Saunders		
Survey Date	21 Mar 2011	UKAS Laboratory	NOT SAMPLED (Cross Referenced)		
Site Reference	I33510000A	Licensed Material	N/A	Notifiable Non Licensed Work	N/A

No Asbestos Presumed in Sample

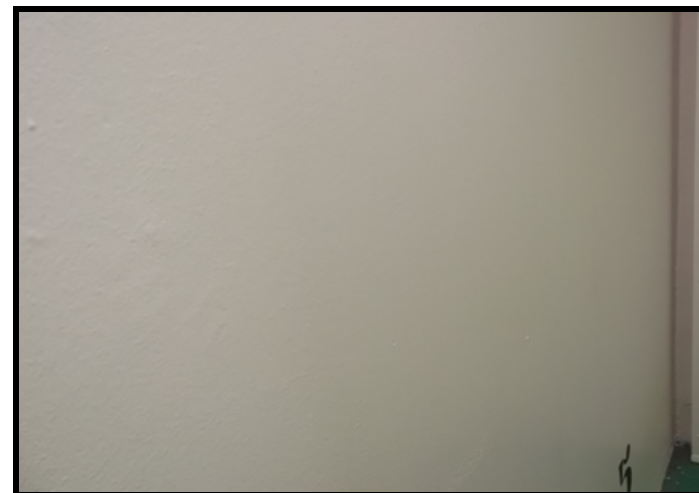
SAMPLE REFERENCE 088

Building	Floor	Room	Location			
Main Building	Fifth Floor	Stairs and Landing	Wall			
Description	No access within insulation board boxing.					
MATERIAL ASSESSMENT				SCORE		
Product Type	Textured Coating	Extent of Damage	Good condition		-	
Asbestos Type	No Asbestos Detected	Surface Treatment	Textured Coating			
PRIORITY ASSESSMENT				SCORE		
Occupant Activity	Not Applicable	Extent / Amount	10.00 m2		-	
Accessibility	Easily disturbed	Location	Not Applicable			
Avg Time in Use	Not Applicable	Frequency of Use	Not Applicable			
No. of Occupants	Not Applicable	Secondary Activity	Not Applicable			
Maintenance	Not Applicable	Maintenance Frequency	Not Applicable			
MANAGEMENT ACTION				SCORE		
Recommendation	NO ACTION REQUIRED			-		
Recommendation Due		Next Inspection	None			
Apply Labels	No	Permit to Work Required	No			
Survey Type	Management	Lead Surveyor	Gavin Hooper			
Survey Date	19 Dec 2014	UKAS Laboratory	NOT SAMPLED (Cross Referenced)

No Asbestos Presumed in Sample

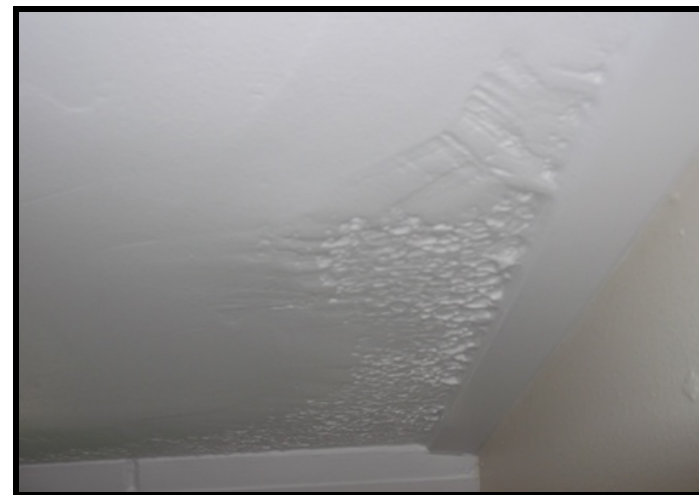
SAMPLE REFERENCE 089

Building	Floor	Room	Location		
Main Building	Fifth Floor	Stairs and Landing	Ceiling		
Description	No access within insulation board boxing.				
MATERIAL ASSESSMENT					SCORE
Product Type	Textured Coating	Extent of Damage	Good condition		-
Asbestos Type	No Asbestos Detected	Surface Treatment	Textured Coating		
PRIORITY ASSESSMENT					SCORE
Occupant Activity	Not Applicable	Extent / Amount	10.00 m2		-
Accessibility	Occasionally disturb	Location	Not Applicable		
Avg Time in Use	Not Applicable	Frequency of Use	Not Applicable		
No. of Occupants	Not Applicable	Secondary Activity	Not Applicable		
Maintenance	Not Applicable	Maintenance Frequency	Not Applicable		
MANAGEMENT ACTION					SCORE
Recommendation	NO ACTION REQUIRED				-
Recommendation Due		Next Inspection	None		
Apply Labels	No	Permit to Work Required	No		
Survey Type	Management	Lead Surveyor	Gavin Hooper		
Survey Date	19 Dec 2014	UKAS Laboratory	NOT SAMPLED (Cross Referenced)

No Asbestos Presumed in Sample

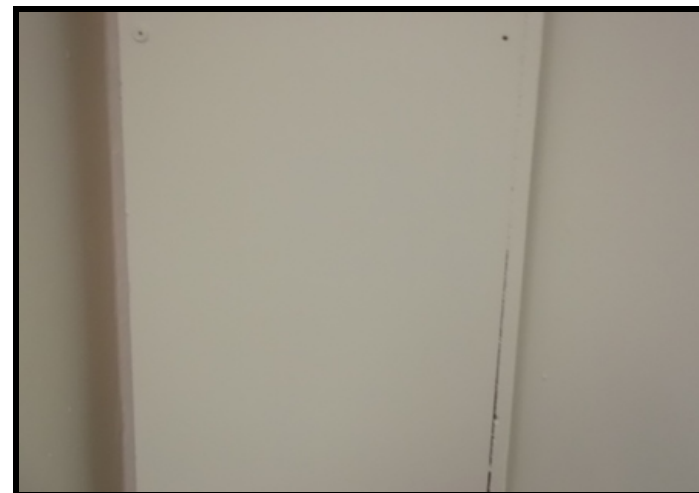
SAMPLE REFERENCE 090

Building	Floor	Room	Location		
Main Building	Fifth Floor	Stairs and Landing	Boxing		
Description	To ceiling and walls. No access within insulation board boxing.				
MATERIAL ASSESSMENT				SCORE	
Product Type	Insulation Board	Extent of Damage	Good condition		-
Asbestos Type	No Asbestos Detected	Surface Treatment	Sealed Board (Encapsulated)		
PRIORITY ASSESSMENT				SCORE	
Occupant Activity	Not Applicable	Extent / Amount	4.00 m2		-
Accessibility	Easily disturbed	Location	Not Applicable		
Avg Time in Use	Not Applicable	Frequency of Use	Not Applicable		
No. of Occupants	Not Applicable	Secondary Activity	Not Applicable		
Maintenance	Not Applicable	Maintenance Frequency	Not Applicable		
MANAGEMENT ACTION				SCORE	
Recommendation	NO ACTION REQUIRED			-	
Recommendation Due		Next Inspection	None		
Apply Labels	No	Permit to Work Required	No		
Survey Type	Management	Lead Surveyor	Gavin Hooper		
Survey Date	19 Dec 2014	UKAS Laboratory	NOT SAMPLED (Cross Referenced)

No Asbestos Presumed in Sample

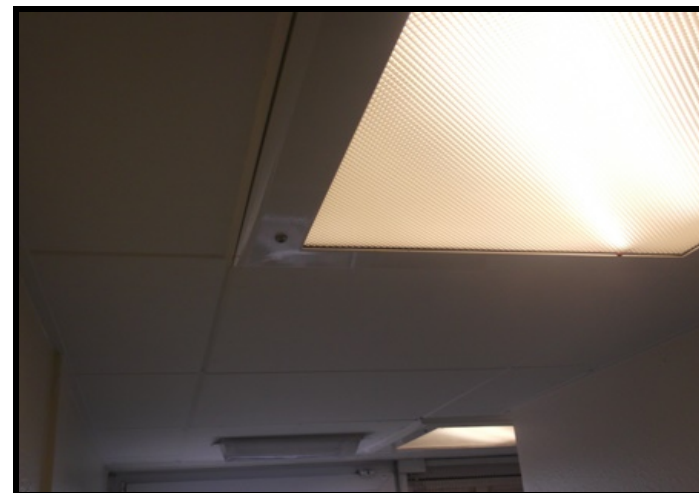
SAMPLE REFERENCE 091

Building	Floor	Room	Location		
Main Building	Fifth Floor	Waste Area	Ceiling		
Description					
MATERIAL ASSESSMENT					SCORE
Product Type	Insulation Board	Extent of Damage	Good condition		-
Asbestos Type	No Asbestos Detected	Surface Treatment	Sealed Board (Encapsulated)		
PRIORITY ASSESSMENT					SCORE
Occupant Activity	Not Applicable	Extent / Amount	10.00 m2		-
Accessibility	Occasionally disturb	Location	Not Applicable		
Avg Time in Use	Not Applicable	Frequency of Use	Not Applicable		
No. of Occupants	Not Applicable	Secondary Activity	Not Applicable		
Maintenance	Not Applicable	Maintenance Frequency	Not Applicable		
MANAGEMENT ACTION					SCORE
Recommendation	NO ACTION REQUIRED				-
Recommendation Due		Next Inspection	None		
Apply Labels	No	Permit to Work Required	No		
Survey Type	Management	Lead Surveyor	Gavin Hooper		
Survey Date	19 Dec 2014	UKAS Laboratory	NOT SAMPLED (Cross Referenced)		
Site Reference	I33510000A	Licensed Material	N/A	Notifiable Non Licensed Work	N/A

No Asbestos Presumed in Sample

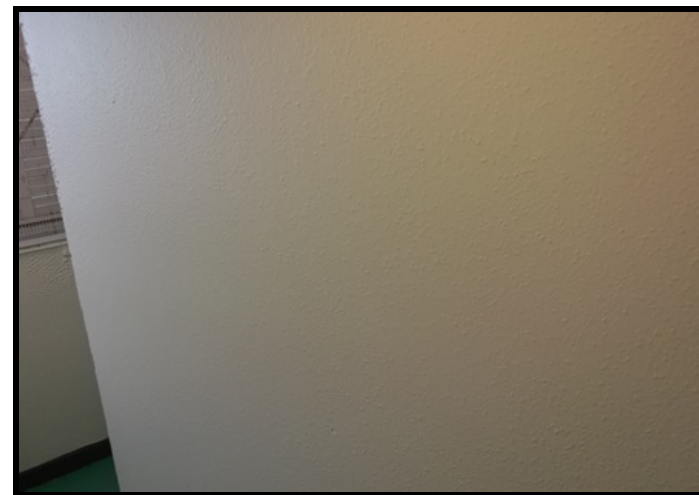
SAMPLE REFERENCE 092

Building	Floor	Room	Location
Main Building	Fifth Floor	Waste Area	Wall
Description			
MATERIAL ASSESSMENT			
Product Type	Textured Coating	Extent of Damage	Good condition
Asbestos Type	No Asbestos Detected	Surface Treatment	Textured Coating
PRIORITY ASSESSMENT			
Occupant Activity	Not Applicable	Extent / Amount	10.00 m2
Accessibility	Easily disturbed	Location	Not Applicable
Avg Time in Use	Not Applicable	Frequency of Use	Not Applicable
No. of Occupants	Not Applicable	Secondary Activity	Not Applicable
Maintenance	Not Applicable	Maintenance Frequency	Not Applicable
MANAGEMENT ACTION			
Recommendation	NO ACTION REQUIRED		
Recommendation Due		Next Inspection	None
Apply Labels	No	Permit to Work Required	No
Survey Type	Management	Lead Surveyor	Gavin Hooper
Survey Date	19 Dec 2014	UKAS Laboratory	NOT SAMPLED (Cross Referenced)
Site Reference	133510000A	Licensed Material	N/A
		Notifiable Non Licensed Work	N/A

No Asbestos Presumed in Sample

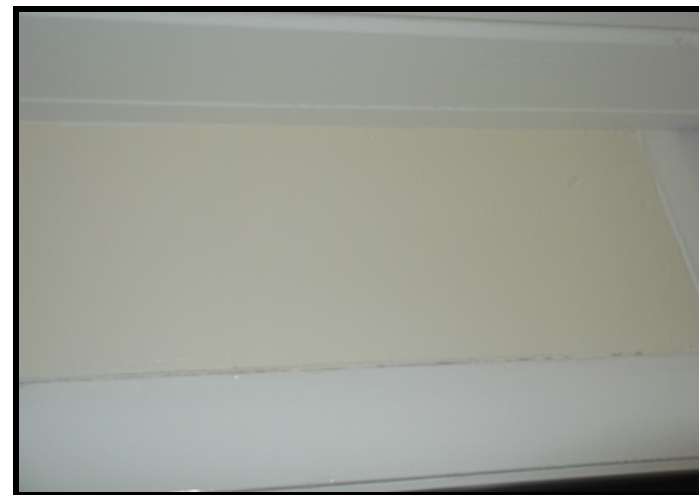
SAMPLE REFERENCE 094

Building	Floor	Room	Location			
Main Building	Fifth Floor	Waste Area	Transom Panel			
Description						
MATERIAL ASSESSMENT				SCORE		
Product Type	Insulation Board	Extent of Damage	Good condition		-	
Asbestos Type	No Asbestos Detected	Surface Treatment	Sealed Board (Encapsulated)			
PRIORITY ASSESSMENT				SCORE		
Occupant Activity	Not Applicable	Extent / Amount	1.00 m2		-	
Accessibility	Occasionally disturb	Location	Not Applicable			
Avg Time in Use	Not Applicable	Frequency of Use	Not Applicable			
No. of Occupants	Not Applicable	Secondary Activity	Not Applicable			
Maintenance	Not Applicable	Maintenance Frequency	Not Applicable			
MANAGEMENT ACTION				SCORE		
Recommendation	NO ACTION REQUIRED			-		
Recommendation Due		Next Inspection	None			
Apply Labels	No	Permit to Work Required	No			
Survey Type	Management	Lead Surveyor	Gavin Hooper			
Survey Date	19 Dec 2014	UKAS Laboratory	NOT SAMPLED (Cross Referenced)

No Asbestos Presumed in Sample

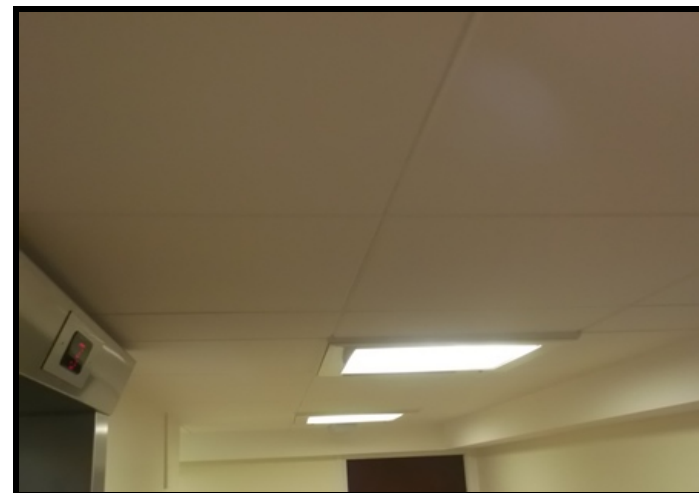
SAMPLE REFERENCE 095

Building	Floor	Room	Location			
Main Building	Fifth Floor	Lift Landing	Ceiling			
Description						
MATERIAL ASSESSMENT				SCORE		
Product Type	Insulation Board	Extent of Damage	Good condition		-	
Asbestos Type	No Asbestos Detected	Surface Treatment	Sealed Board (Encapsulated)			
PRIORITY ASSESSMENT				SCORE		
Occupant Activity	Not Applicable	Extent / Amount	40.00 m2		-	
Accessibility	Occasionally disturb	Location	Not Applicable			
Avg Time in Use	Not Applicable	Frequency of Use	Not Applicable			
No. of Occupants	Not Applicable	Secondary Activity	Not Applicable			
Maintenance	Not Applicable	Maintenance Frequency	Not Applicable			
MANAGEMENT ACTION				SCORE		
Recommendation	NO ACTION REQUIRED			-		
Recommendation Due		Next Inspection	None			
Apply Labels	No	Permit to Work Required	No			
Survey Type	Management	Lead Surveyor	Gavin Hooper			
Survey Date	19 Dec 2014	UKAS Laboratory	NOT SAMPLED (Cross Referenced)

No Asbestos Presumed in Sample

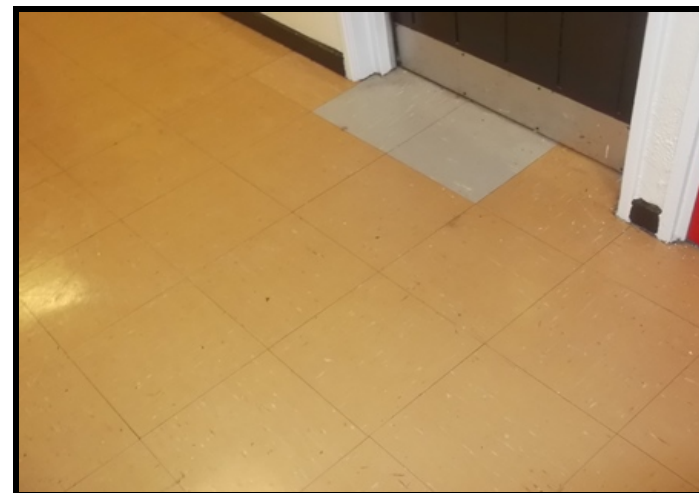
SAMPLE REFERENCE 095a

Building	Floor	Room	Location			
Main Building	Fifth Floor	Lift Landing	Floor			
Description	Buff and grey floor tiles and adhesive					
MATERIAL ASSESSMENT				SCORE		
Product Type	Bitumen	Extent of Damage	Good condition		2	
Asbestos Type	Chrysotile	Surface Treatment	Composite materials			
PRIORITY ASSESSMENT				SCORE		
Occupant Activity	Not Applicable	Extent / Amount	20.00 m2		1	
Accessibility	Easily disturbed	Location	Not Applicable			
Avg Time in Use	Not Applicable	Frequency of Use	Not Applicable			
No. of Occupants	Not Applicable	Secondary Activity	Not Applicable			
Maintenance	Not Applicable	Maintenance Frequency	Not Applicable			
MANAGEMENT ACTION				SCORE		
Recommendation	LABEL & MONITOR			3		
Recommendation Due		Next Inspection	19 Dec 2015			
Apply Labels	No	Permit to Work Required	No			
Survey Type	Management	Lead Surveyor	Gavin Hooper			
Survey Date	19 Dec 2014	UKAS Laboratory	DMW Environmental Safety Ltd / [A-10222]

Asbestos detected in Sample

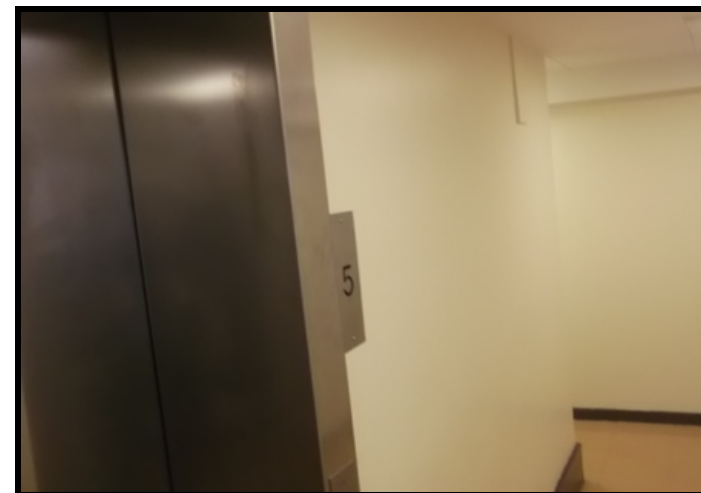
SAMPLE REFERENCE 096

Building	Floor	Room	Location		
Main Building	Fifth Floor	Lift Landing	Wall		
Description					
MATERIAL ASSESSMENT					SCORE
Product Type	Textured Coating	Extent of Damage	Good condition		-
Asbestos Type	No Asbestos Detected	Surface Treatment	Textured Coating		
PRIORITY ASSESSMENT					SCORE
Occupant Activity	Not Applicable	Extent / Amount	40.00 m2		-
Accessibility	Easily disturbed	Location	Not Applicable		
Avg Time in Use	Not Applicable	Frequency of Use	Not Applicable		
No. of Occupants	Not Applicable	Secondary Activity	Not Applicable		
Maintenance	Not Applicable	Maintenance Frequency	Not Applicable		
MANAGEMENT ACTION					SCORE
Recommendation	NO ACTION REQUIRED				-
Recommendation Due		Next Inspection	None		
Apply Labels	No	Permit to Work Required	No		
Survey Type	Management	Lead Surveyor	Gavin Hooper		
Survey Date	19 Dec 2014	UKAS Laboratory	NOT SAMPLED (Cross Referenced)		
Site Reference	I33510000A	Licensed Material	N/A	Notifiable Non Licensed Work	N/A

No Asbestos Presumed in Sample

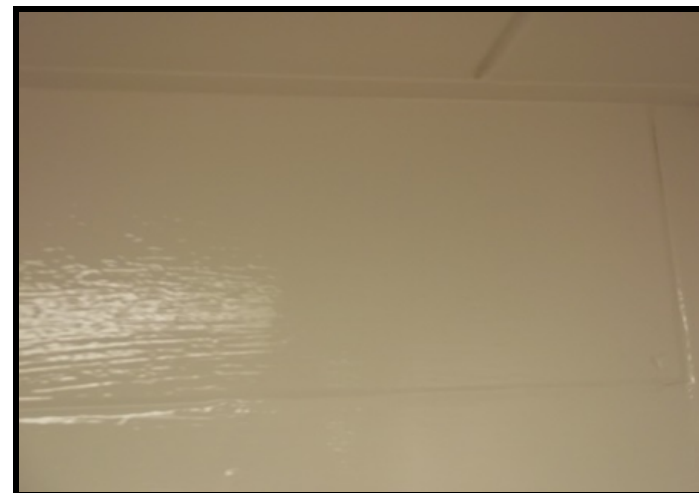
SAMPLE REFERENCE 097

Building	Floor	Room	Location			
Main Building	Fifth Floor	Lift Landing	Transom Panel			
Description	Above doors to flats.					
MATERIAL ASSESSMENT				SCORE		
Product Type	Insulation Board	Extent of Damage	Good condition		-	
Asbestos Type	No Asbestos Detected	Surface Treatment	Sealed Board (Encapsulated)			
PRIORITY ASSESSMENT				SCORE		
Occupant Activity	Not Applicable	Extent / Amount	1.00 m2		-	
Accessibility	Occasionally disturb	Location	Not Applicable			
Avg Time in Use	Not Applicable	Frequency of Use	Not Applicable			
No. of Occupants	Not Applicable	Secondary Activity	Not Applicable			
Maintenance	Not Applicable	Maintenance Frequency	Not Applicable			
MANAGEMENT ACTION				SCORE		
Recommendation	NO ACTION REQUIRED			-		
Recommendation Due		Next Inspection	None			
Apply Labels	No	Permit to Work Required	No			
Survey Type	Management	Lead Surveyor	Gavin Hooper			
Survey Date	19 Dec 2014	UKAS Laboratory	NOT SAMPLED (Cross Referenced)

No Asbestos Presumed in Sample

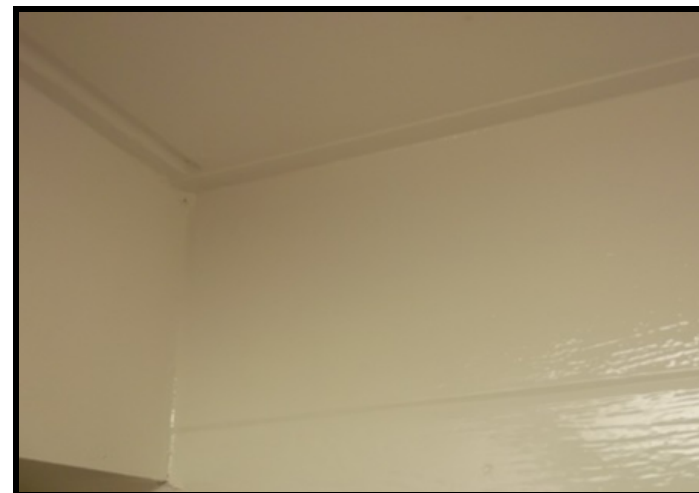
SAMPLE REFERENCE 098

Building	Floor	Room	Location			
Main Building	Fifth Floor	Lift Landing	Transom Panel			
Description	Above doors to risers.					
MATERIAL ASSESSMENT				SCORE		
Product Type	Insulation Board	Extent of Damage	Good condition		-	
Asbestos Type	No Asbestos Detected	Surface Treatment	Sealed Board (Encapsulated)			
PRIORITY ASSESSMENT				SCORE		
Occupant Activity	Not Applicable	Extent / Amount	1.00 m2		-	
Accessibility	Occasionally disturb	Location	Not Applicable			
Avg Time in Use	Not Applicable	Frequency of Use	Not Applicable			
No. of Occupants	Not Applicable	Secondary Activity	Not Applicable			
Maintenance	Not Applicable	Maintenance Frequency	Not Applicable			
MANAGEMENT ACTION				SCORE		
Recommendation	NO ACTION REQUIRED			-		
Recommendation Due		Next Inspection	None			
Apply Labels	No	Permit to Work Required	No			
Survey Type	Management	Lead Surveyor	Gavin Hooper			
Survey Date	19 Dec 2014	UKAS Laboratory	NOT SAMPLED (Cross Referenced)

No Asbestos Presumed in Sample

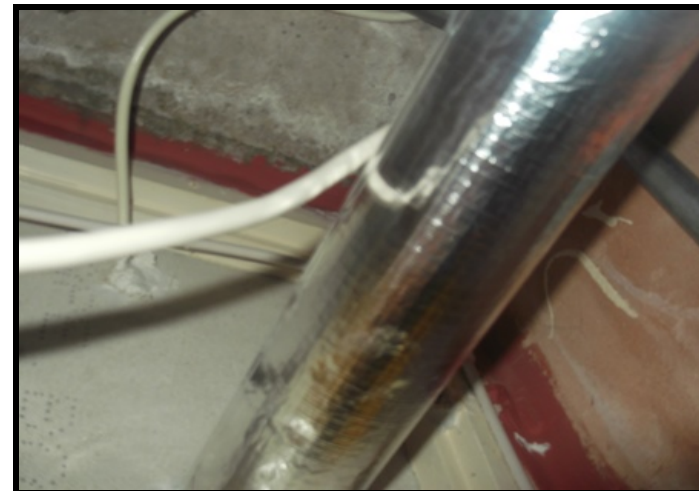
SAMPLE REFERENCE 099

Building	Floor	Room	Location		
Main Building	Fifth Floor	Dry Riser 1	Transom Panel		
Description					
MATERIAL ASSESSMENT				SCORE	
Product Type	Insulation Board	Extent of Damage	Good condition		-
Asbestos Type	No Asbestos Detected	Surface Treatment	Sealed Board (Encapsulated)		
PRIORITY ASSESSMENT				SCORE	
Occupant Activity	Not Applicable	Extent / Amount	1.00 m2		-
Accessibility	Occasionally disturb	Location	Not Applicable		
Avg Time in Use	Not Applicable	Frequency of Use	Not Applicable		
No. of Occupants	Not Applicable	Secondary Activity	Not Applicable		
Maintenance	Not Applicable	Maintenance Frequency	Not Applicable		
MANAGEMENT ACTION				SCORE	
Recommendation	NO ACTION REQUIRED				-
Recommendation Due		Next Inspection	None		
Apply Labels	No	Permit to Work Required	No		
Survey Type	Management	Lead Surveyor	Gavin Hooper		
Survey Date	19 Dec 2014	UKAS Laboratory	NOT SAMPLED (Cross Referenced)		
Site Reference	I33510000A	Licensed Material	N/A	Notifiable Non Licensed Work	N/A

No Asbestos Presumed in Sample

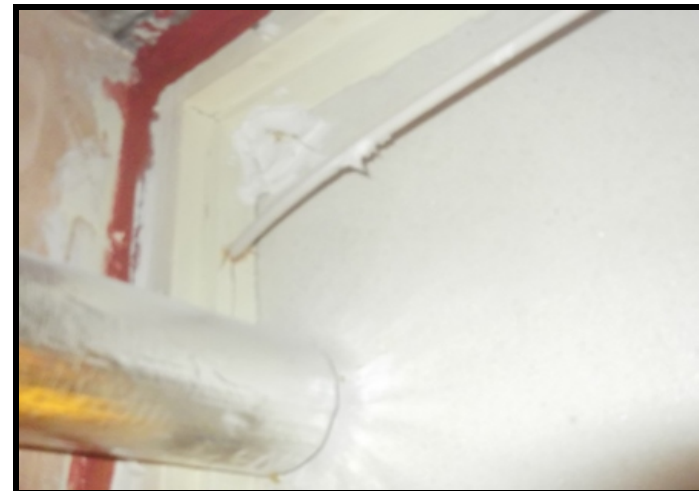
SAMPLE REFERENCE 100

Building	Floor	Room	Location			
Main Building	Fifth Floor	Dry Riser 2	Transom Panel			
Description						
MATERIAL ASSESSMENT				SCORE		
Product Type	Insulation Board	Extent of Damage	Good condition		-	
Asbestos Type	No Asbestos Detected	Surface Treatment	Sealed Board (Encapsulated)			
PRIORITY ASSESSMENT				SCORE		
Occupant Activity	Not Applicable	Extent / Amount	1.00 m2		-	
Accessibility	Occasionally disturb	Location	Not Applicable			
Avg Time in Use	Not Applicable	Frequency of Use	Not Applicable			
No. of Occupants	Not Applicable	Secondary Activity	Not Applicable			
Maintenance	Not Applicable	Maintenance Frequency	Not Applicable			
MANAGEMENT ACTION				SCORE		
Recommendation	NO ACTION REQUIRED			-		
Recommendation Due		Next Inspection	None			
Apply Labels	No	Permit to Work Required	No			
Survey Type	Management	Lead Surveyor	Gavin Hooper			
Survey Date	19 Dec 2014	UKAS Laboratory	NOT SAMPLED (Cross Referenced)

No Asbestos Presumed in Sample

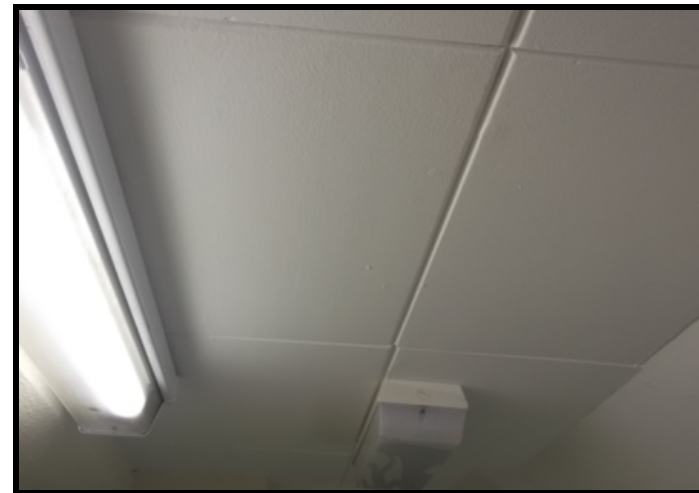
SAMPLE REFERENCE 102

Building	Floor	Room	Location			
Main Building	Sixth Floor	Stairs and Landing	Ceiling			
Description	No access within insulation board boxing					
MATERIAL ASSESSMENT				SCORE		
Product Type	Insulation Board	Extent of Damage	Good condition		-	
Asbestos Type	No Asbestos Detected	Surface Treatment	Sealed Board (Encapsulated)			
PRIORITY ASSESSMENT				SCORE		
Occupant Activity	Not Applicable	Extent / Amount	10.00 m2		-	
Accessibility	Occasionally disturb	Location	Not Applicable			
Avg Time in Use	Not Applicable	Frequency of Use	Not Applicable			
No. of Occupants	Not Applicable	Secondary Activity	Not Applicable			
Maintenance	Not Applicable	Maintenance Frequency	Not Applicable			
MANAGEMENT ACTION				SCORE		
Recommendation	NO ACTION REQUIRED			-		
Recommendation Due		Next Inspection	None			
Apply Labels	No	Permit to Work Required	No			
Survey Type	Management	Lead Surveyor	Gavin Hooper			
Survey Date	19 Dec 2014	UKAS Laboratory	NOT SAMPLED (Cross Referenced)

No Asbestos Presumed in Sample

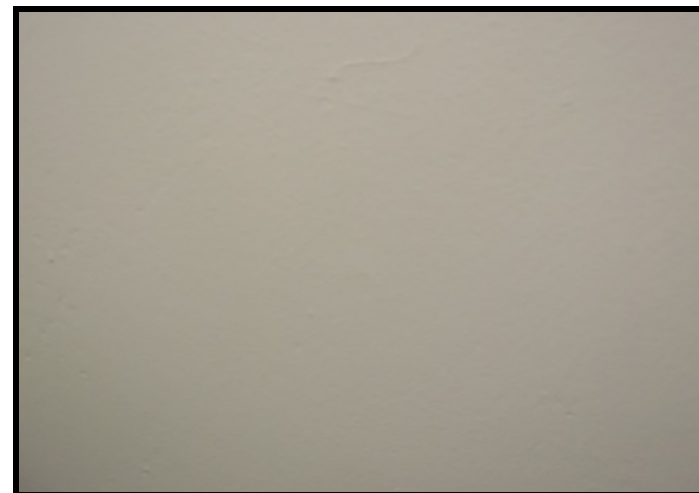
SAMPLE REFERENCE 103

Building	Floor	Room	Location		
Main Building	Sixth Floor	Stairs and Landing	Wall		
Description	No access within insulation board boxing				
MATERIAL ASSESSMENT				SCORE	
Product Type	Textured Coating	Extent of Damage	Good condition		-
Asbestos Type	No Asbestos Detected	Surface Treatment	Textured Coating		
PRIORITY ASSESSMENT				SCORE	
Occupant Activity	Not Applicable	Extent / Amount	10.00 m2		-
Accessibility	Easily disturbed	Location	Not Applicable		
Avg Time in Use	Not Applicable	Frequency of Use	Not Applicable		
No. of Occupants	Not Applicable	Secondary Activity	Not Applicable		
Maintenance	Not Applicable	Maintenance Frequency	Not Applicable		
MANAGEMENT ACTION				SCORE	
Recommendation	NO ACTION REQUIRED			-	
Recommendation Due		Next Inspection	None		
Apply Labels	No	Permit to Work Required	No		
Survey Type	Management	Lead Surveyor	Gavin Hooper		
Survey Date	19 Dec 2014	UKAS Laboratory	NOT SAMPLED (Cross Referenced)

No Asbestos Presumed in Sample

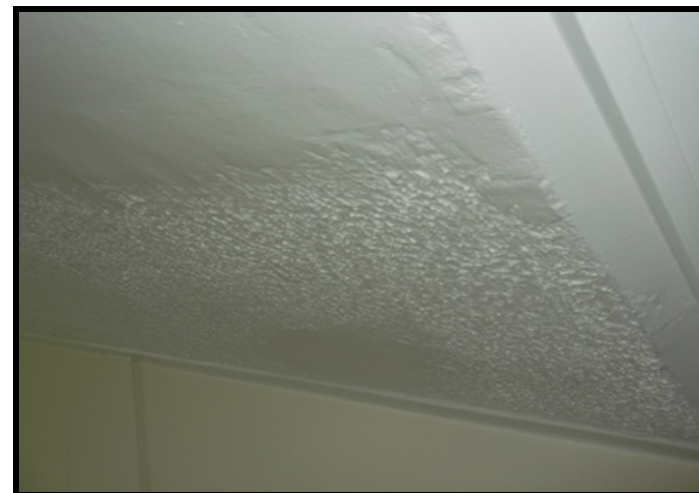
SAMPLE REFERENCE 104

No Asbestos Presumed in Sample

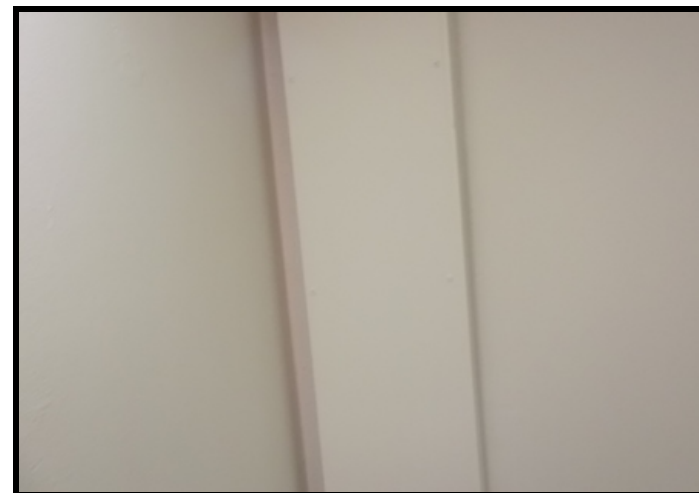
SAMPLE REFERENCE 105

No Asbestos Presumed in Sample

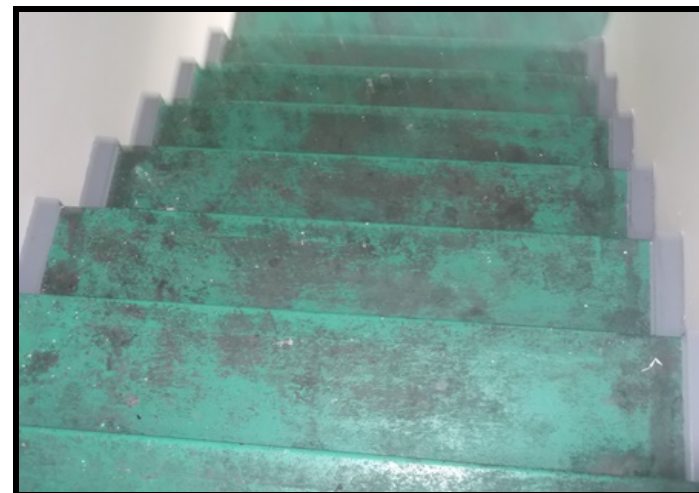
SAMPLE REFERENCE I05a

Building	Floor	Room	Location
Main Building	Sixth Floor	Stairs and Landing	Floor
Description			
MATERIAL ASSESSMENT			
Product Type	Bitumen	Extent of Damage	Low damage
Asbestos Type	Chrysotile	Surface Treatment	Composite materials
PRIORITY ASSESSMENT			
Occupant Activity	Not Applicable	Extent / Amount	10.00 m2
Accessibility	Easily disturbed	Location	Not Applicable
Avg Time in Use	Not Applicable	Frequency of Use	Not Applicable
No. of Occupants	Not Applicable	Secondary Activity	Not Applicable
Maintenance	Not Applicable	Maintenance Frequency	Not Applicable
MANAGEMENT ACTION			
Recommendation	LABEL & MONITOR		
Recommendation Due		Next Inspection	19 Dec 2015
Apply Labels	No	Permit to Work Required	No
Survey Type	Management	Lead Surveyor	Gavin Hooper
Survey Date	19 Dec 2014	UKAS Laboratory	NOT SAMPLED (Cross Referenced)
Site Reference	133510000A	Licensed Material	No
		Notifiable Non Licensed Work	No

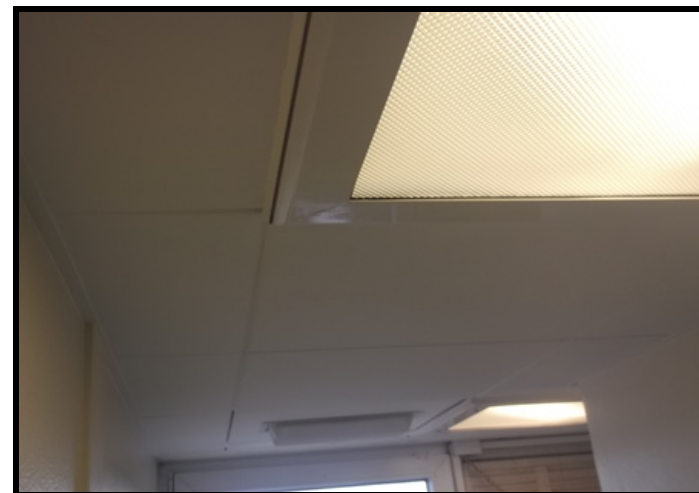
SAMPLE REFERENCE 106

No Asbestos Presumed in Sample

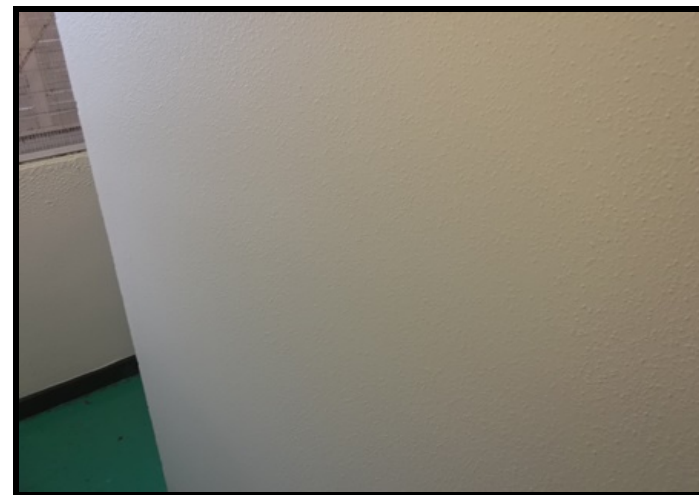
SAMPLE REFERENCE 107

No Asbestos Presumed in Sample

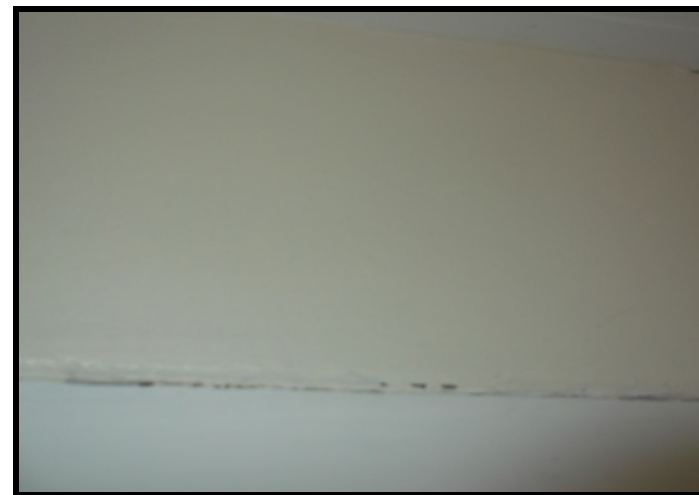
SAMPLE REFERENCE 109

No Asbestos Presumed in Sample

Building	Floor	Room	Location			
Main Building	Sixth Floor	Lift Landing	Ceiling			
Description						
MATERIAL ASSESSMENT				SCORE		
Product Type	Insulation Board	Extent of Damage	Good condition		-	
Asbestos Type	No Asbestos Detected	Surface Treatment	Sealed Board (Encapsulated)			
PRIORITY ASSESSMENT				SCORE		
Occupant Activity	Not Applicable	Extent / Amount	40.00 m2		-	
Accessibility	Occasionally disturb	Location	Not Applicable			
Avg Time in Use	Not Applicable	Frequency of Use	Not Applicable			
No. of Occupants	Not Applicable	Secondary Activity	Not Applicable			
Maintenance	Not Applicable	Maintenance Frequency	Not Applicable			
MANAGEMENT ACTION				SCORE		
Recommendation	NO ACTION REQUIRED			-		
Recommendation Due		Next Inspection	None			
Apply Labels	No	Permit to Work Required	No			
Survey Type	Management	Lead Surveyor	Gavin Hooper			
Survey Date	19 Dec 2014	UKAS Laboratory	NOT SAMPLED (Cross Referenced)

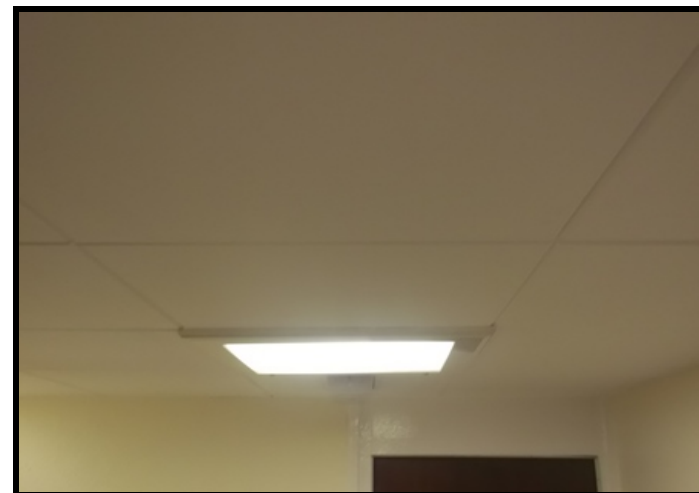
SAMPLE REFERENCE I 10

No Asbestos Presumed in Sample

Building	Floor	Room	Location		
Main Building	Sixth Floor	Lift Landing	Wall		
Description					
MATERIAL ASSESSMENT					SCORE
Product Type	Textured Coating	Extent of Damage	Good condition		-
Asbestos Type	No Asbestos Detected	Surface Treatment	Textured Coating		
PRIORITY ASSESSMENT					SCORE
Occupant Activity	Not Applicable	Extent / Amount	40.00 m2		-
Accessibility	Easily disturbed	Location	Not Applicable		
Avg Time in Use	Not Applicable	Frequency of Use	Not Applicable		
No. of Occupants	Not Applicable	Secondary Activity	Not Applicable		
Maintenance	Not Applicable	Maintenance Frequency	Not Applicable		
MANAGEMENT ACTION					SCORE
Recommendation	NO ACTION REQUIRED				-
Recommendation Due		Next Inspection	None		
Apply Labels	No	Permit to Work Required	No		
Survey Type	Management	Lead Surveyor	Gavin Hooper		
Survey Date	19 Dec 2014	UKAS Laboratory	NOT SAMPLED (Cross Referenced)		
Site Reference	I33510000A	Licensed Material	N/A	Notifiable Non Licensed Work	N/A

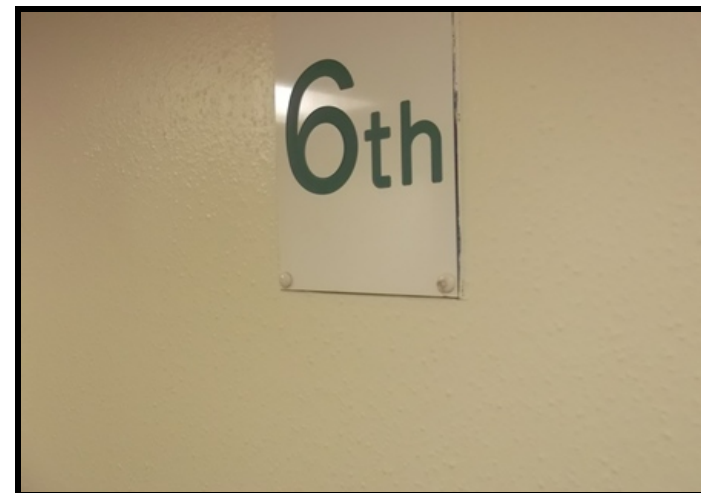
SAMPLE REFERENCE I I I

No Asbestos Presumed in Sample

Building	Floor	Room	Location		
Main Building	Sixth Floor	Lift Landing	Floor		
Description					
MATERIAL ASSESSMENT					SCORE
Product Type	Floor Tiles	Extent of Damage	Good condition		-
Asbestos Type	No Asbestos Detected	Surface Treatment	Composite materials		
PRIORITY ASSESSMENT					SCORE
Occupant Activity	Not Applicable	Extent / Amount	40.00 m2		-
Accessibility	Occasionally disturb	Location	Not Applicable		
Avg Time in Use	Not Applicable	Frequency of Use	Not Applicable		
No. of Occupants	Not Applicable	Secondary Activity	Not Applicable		
Maintenance	Not Applicable	Maintenance Frequency	Not Applicable		
MANAGEMENT ACTION					SCORE
Recommendation	NO ACTION REQUIRED				-
Recommendation Due		Next Inspection	None		
Apply Labels	No	Permit to Work Required	No		
Survey Type	Management	Lead Surveyor	Richard Saunders		
Survey Date	21 Mar 2011	UKAS Laboratory	DMW Environmental Safety Ltd / [P-75209]		
Site Reference	I33510000A	Licensed Material	N/A	Notifiable Non Licensed Work	N/A

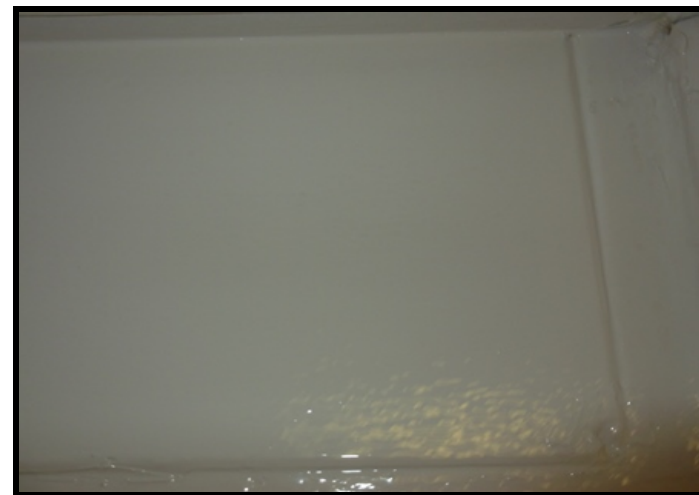
SAMPLE REFERENCE I 12

No Asbestos Presumed in Sample

Building	Floor	Room	Location		
Main Building	Sixth Floor	Lift Landing	Transom Panel		
Description	Above doors to risers.				
MATERIAL ASSESSMENT					SCORE
Product Type	Insulation Board	Extent of Damage	Good condition		-
Asbestos Type	No Asbestos Detected	Surface Treatment	Sealed Board (Encapsulated)		
PRIORITY ASSESSMENT					SCORE
Occupant Activity	Not Applicable	Extent / Amount	1.00 m2		-
Accessibility	Occasionally disturb	Location	Not Applicable		
Avg Time in Use	Not Applicable	Frequency of Use	Not Applicable		
No. of Occupants	Not Applicable	Secondary Activity	Not Applicable		
Maintenance	Not Applicable	Maintenance Frequency	Not Applicable		
MANAGEMENT ACTION					SCORE
Recommendation	NO ACTION REQUIRED				-
Recommendation Due		Next Inspection	None		
Apply Labels	No	Permit to Work Required	No		
Survey Type	Management	Lead Surveyor	Gavin Hooper		
Survey Date	19 Dec 2014	UKAS Laboratory	NOT SAMPLED (Cross Referenced)

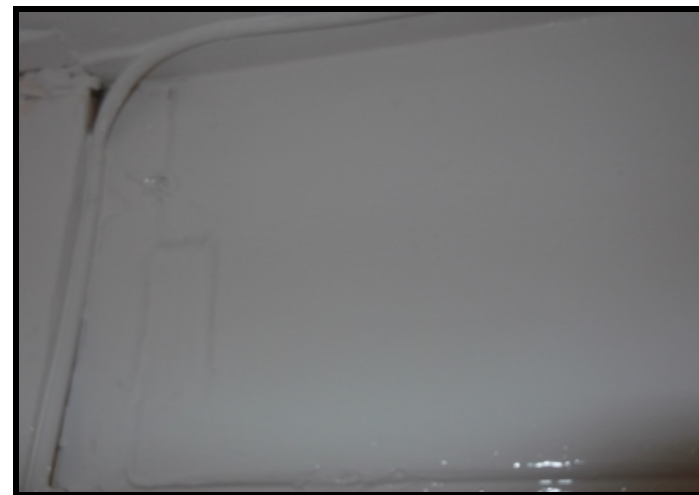
SAMPLE REFERENCE I 13

No Asbestos Presumed in Sample

Building	Floor	Room	Location
Main Building	Sixth Floor	Lift Landing	Floor
Description			
MATERIAL ASSESSMENT			
Product Type	Bitumen	Extent of Damage	Low damage
Asbestos Type	Chrysotile	Surface Treatment	Composite materials
PRIORITY ASSESSMENT			
Occupant Activity	Not Applicable	Extent / Amount	2.00 m2
Accessibility	Easily disturbed	Location	Not Applicable
Avg Time in Use	Not Applicable	Frequency of Use	Not Applicable
No. of Occupants	Not Applicable	Secondary Activity	Not Applicable
Maintenance	Not Applicable	Maintenance Frequency	Not Applicable
MANAGEMENT ACTION			
Recommendation	LABEL & MONITOR		
Recommendation Due		Next Inspection	19 Dec 2015
Apply Labels	No	Permit to Work Required	No
Survey Type	Management	Lead Surveyor	Gavin Hooper
Survey Date	19 Dec 2014	UKAS Laboratory	NOT SAMPLED (Cross Referenced)
Site Reference	I33510000A	Licensed Material	No
		Notifiable Non Licensed Work	No

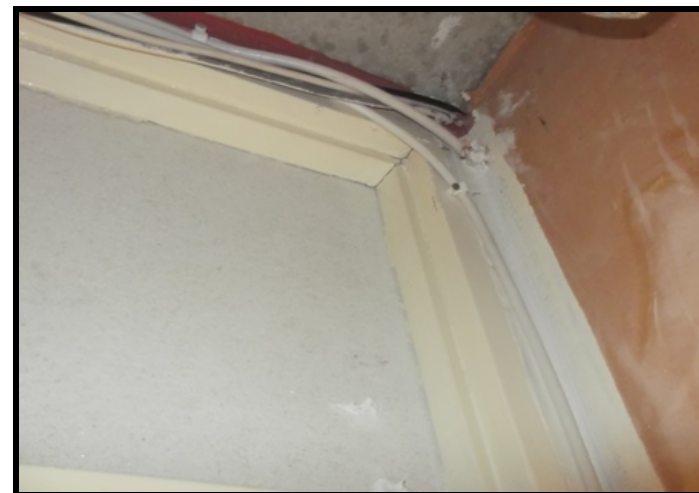
SAMPLE REFERENCE I 14

No Asbestos Presumed in Sample

Building	Floor	Room	Location			
Main Building	Sixth Floor	Dry Riser 2	Transom Panel			
Description						
MATERIAL ASSESSMENT				SCORE		
Product Type	Insulation Board	Extent of Damage	Good condition		-	
Asbestos Type	No Asbestos Detected	Surface Treatment	Sealed Board (Encapsulated)			
PRIORITY ASSESSMENT				SCORE		
Occupant Activity	Not Applicable	Extent / Amount	1.00 m2		-	
Accessibility	Occasionally disturb	Location	Not Applicable			
Avg Time in Use	Not Applicable	Frequency of Use	Not Applicable			
No. of Occupants	Not Applicable	Secondary Activity	Not Applicable			
Maintenance	Not Applicable	Maintenance Frequency	Not Applicable			
MANAGEMENT ACTION				SCORE		
Recommendation	NO ACTION REQUIRED			-		
Recommendation Due		Next Inspection	None			
Apply Labels	No	Permit to Work Required	No			
Survey Type	Management	Lead Surveyor	Gavin Hooper			
Survey Date	19 Dec 2014	UKAS Laboratory	NOT SAMPLED (Cross Referenced)

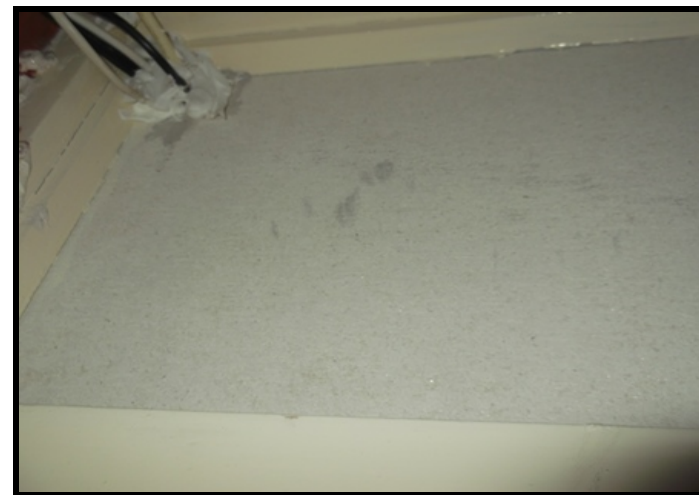
SAMPLE REFERENCE I 15

No Asbestos Presumed in Sample

Building	Floor	Room	Location
Main Building	Sixth Floor	Main Fire Dry Riser	All Areas
Description			
MATERIAL ASSESSMENT			
Product Type	Not Applicable	Extent of Damage	Not Applicable
Asbestos Type	Not Applicable	Surface Treatment	Not Applicable
PRIORITY ASSESSMENT			
Occupant Activity	Not Applicable	Extent / Amount	N/A
Accessibility	Not Applicable	Location	Not Applicable
Avg Time in Use	Not Applicable	Frequency of Use	Not Applicable
No. of Occupants	Not Applicable	Secondary Activity	Not Applicable
Maintenance	Not Applicable	Maintenance Frequency	Not Applicable
MANAGEMENT ACTION			
Recommendation	NOT APPLICABLE		
Recommendation Due		Next Inspection	None
Apply Labels	No	Permit to Work Required	No
Survey Type	Management	Lead Surveyor	Gavin Hooper
Survey Date	19 Dec 2014	UKAS Laboratory	NOT SAMPLED
Site Reference	133510000A	Licensed Material	N/A
		Notifiable Non Licensed Work	N/A

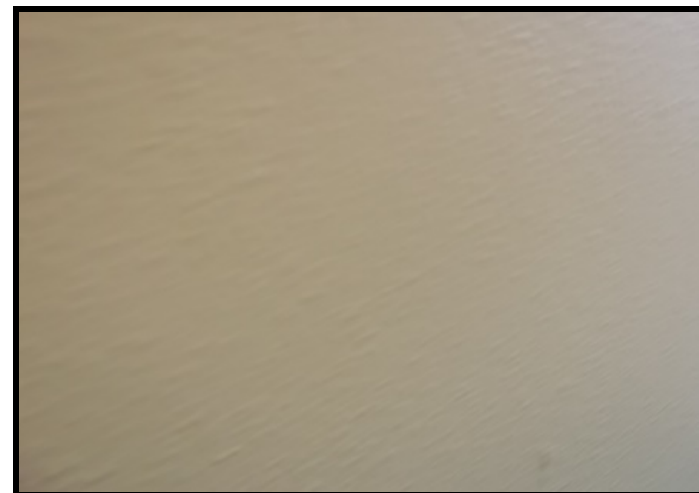
SAMPLE REFERENCE 122

No Asbestos Presumed in Sample

Building	Floor	Room	Location			
Main Building	Seventh Floor	Waste Area	Pipe Work			
Description	Pipe work now boxed in					
MATERIAL ASSESSMENT				SCORE		
Product Type	Cement	Extent of Damage	Good condition		3	
Asbestos Type	Chrysotile	Surface Treatment	Sealed (Cement products)			
PRIORITY ASSESSMENT				SCORE		
Occupant Activity	Not Applicable	Extent / Amount	3.00 lm		1	
Accessibility	Occasionally disturb	Location	Not Applicable			
Avg Time in Use	Not Applicable	Frequency of Use	Not Applicable			
No. of Occupants	Not Applicable	Secondary Activity	Not Applicable			
Maintenance	Not Applicable	Maintenance Frequency	Not Applicable			
MANAGEMENT ACTION				SCORE		
Recommendation	LABEL & MONITOR			4		
Recommendation Due		Next Inspection	19 Dec 2015			
Apply Labels	No	Permit to Work Required	No			
Survey Type	Management	Lead Surveyor	Gavin Hooper			
Survey Date	19 Dec 2014	UKAS Laboratory	NOT SAMPLED (Cross Referenced)

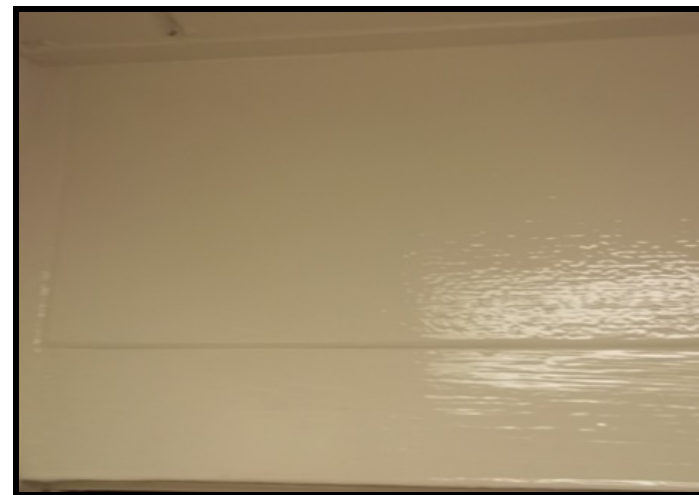
SAMPLE REFERENCE 127

No Asbestos Presumed in Sample

Building	Floor	Room	Location		
Main Building	Seventh Floor	Lift Landing	Floor		
Description					
MATERIAL ASSESSMENT					SCORE
Product Type	Floor Tiles	Extent of Damage	Good condition		-
Asbestos Type	No Asbestos Detected	Surface Treatment	Composite materials		
PRIORITY ASSESSMENT					SCORE
Occupant Activity	Not Applicable	Extent / Amount	40.00 m2		-
Accessibility	Occasionally disturb	Location	Not Applicable		
Avg Time in Use	Not Applicable	Frequency of Use	Not Applicable		
No. of Occupants	Not Applicable	Secondary Activity	Not Applicable		
Maintenance	Not Applicable	Maintenance Frequency	Not Applicable		
MANAGEMENT ACTION					SCORE
Recommendation	NO ACTION REQUIRED				-
Recommendation Due		Next Inspection	None		
Apply Labels	No	Permit to Work Required	No		
Survey Type	Management	Lead Surveyor	Richard Saunders		
Survey Date	21 Mar 2011	UKAS Laboratory	NOT SAMPLED (Cross Referenced)		
Site Reference	I33510000A	Licensed Material	N/A	Notifiable Non Licensed Work	N/A

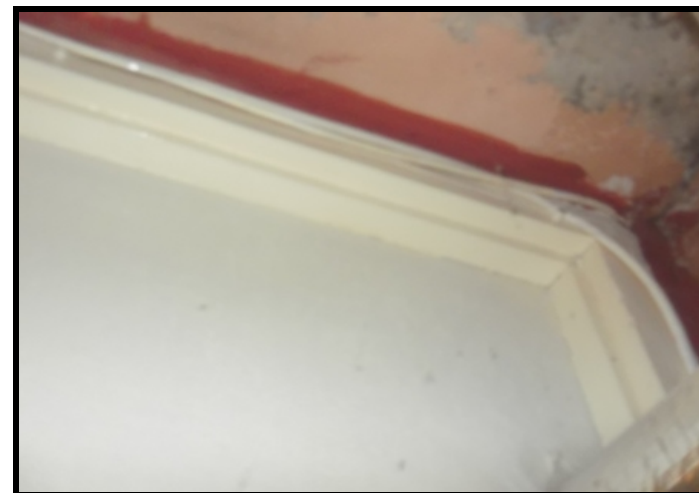
SAMPLE REFERENCE 129

No Asbestos Presumed in Sample

Building	Floor	Room	Location			
Main Building	Seventh Floor	Dry Riser 2	Transom Panel			
Description						
MATERIAL ASSESSMENT				SCORE		
Product Type	Insulation Board	Extent of Damage	Good condition		-	
Asbestos Type	No Asbestos Detected	Surface Treatment	Sealed Board (Encapsulated)			
PRIORITY ASSESSMENT				SCORE		
Occupant Activity	Not Applicable	Extent / Amount	1.00 m2		-	
Accessibility	Occasionally disturb	Location	Not Applicable			
Avg Time in Use	Not Applicable	Frequency of Use	Not Applicable			
No. of Occupants	Not Applicable	Secondary Activity	Not Applicable			
Maintenance	Not Applicable	Maintenance Frequency	Not Applicable			
MANAGEMENT ACTION				SCORE		
Recommendation	NO ACTION REQUIRED			-		
Recommendation Due		Next Inspection	None			
Apply Labels	No	Permit to Work Required	No			
Survey Type	Management	Lead Surveyor	Gavin Hooper			
Survey Date	19 Dec 2014	UKAS Laboratory	NOT SAMPLED (Cross Referenced)

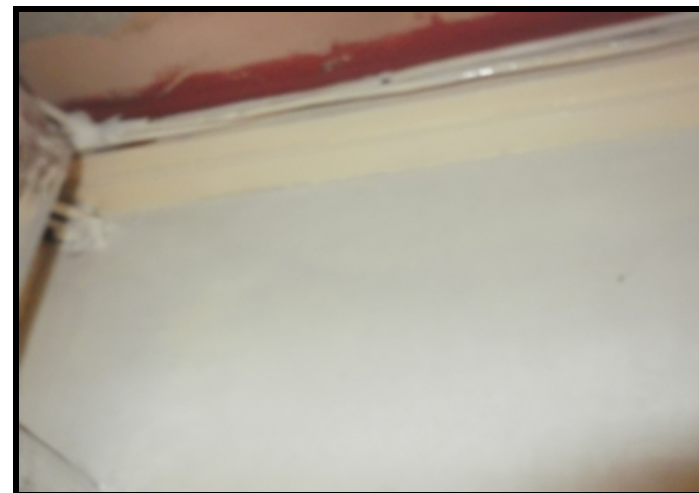
SAMPLE REFERENCE 130

No Asbestos Presumed in Sample

Building	Floor	Room	Location
Main Building	Seventh Floor	Main Fire Dry Riser	All Areas
Description			
MATERIAL ASSESSMENT			
Product Type	Not Applicable	Extent of Damage	Not Applicable
Asbestos Type	Not Applicable	Surface Treatment	Not Applicable
PRIORITY ASSESSMENT			
Occupant Activity	Not Applicable	Extent / Amount	N/A
Accessibility	Not Applicable	Location	Not Applicable
Avg Time in Use	Not Applicable	Frequency of Use	Not Applicable
No. of Occupants	Not Applicable	Secondary Activity	Not Applicable
Maintenance	Not Applicable	Maintenance Frequency	Not Applicable
MANAGEMENT ACTION			
Recommendation	NOT APPLICABLE		
Recommendation Due		Next Inspection	None
Apply Labels	No	Permit to Work Required	No
Survey Type	Management	Lead Surveyor	Gavin Hooper
Survey Date	19 Dec 2014	UKAS Laboratory	NOT SAMPLED
Site Reference	133510000A	Licensed Material	N/A
		Notifiable Non Licensed Work	N/A

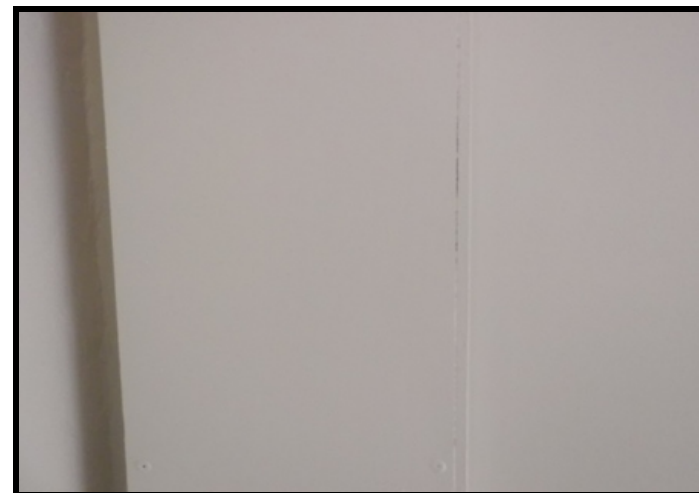
SAMPLE REFERENCE I35

No Asbestos Presumed in Sample

Building	Floor	Room	Location		
Main Building	Eighth Floor	Waste Area	Ceiling		
Description					
MATERIAL ASSESSMENT					SCORE
Product Type	Insulation Board	Extent of Damage	Good condition		-
Asbestos Type	No Asbestos Detected	Surface Treatment	Sealed Board (Encapsulated)		
PRIORITY ASSESSMENT					SCORE
Occupant Activity	Not Applicable	Extent / Amount	10.00 m2		-
Accessibility	Occasionally disturb	Location	Not Applicable		
Avg Time in Use	Not Applicable	Frequency of Use	Not Applicable		
No. of Occupants	Not Applicable	Secondary Activity	Not Applicable		
Maintenance	Not Applicable	Maintenance Frequency	Not Applicable		
MANAGEMENT ACTION					SCORE
Recommendation	NO ACTION REQUIRED				-
Recommendation Due		Next Inspection	None		
Apply Labels	No	Permit to Work Required	No		
Survey Type	Management	Lead Surveyor	Gavin Hooper		
Survey Date	19 Dec 2014	UKAS Laboratory	NOT SAMPLED (Cross Referenced)		
Site Reference	I33510000A	Licensed Material	N/A	Notifiable Non Licensed Work	N/A

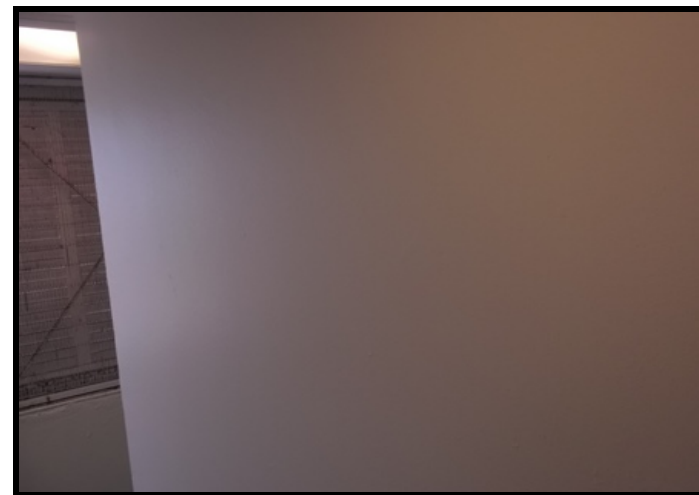
SAMPLE REFERENCE 137

No Asbestos Presumed in Sample

Building	Floor	Room	Location
Main Building	Eighth Floor	Waste Area	Pipe Work
Description	Pipe work now boxed in		
MATERIAL ASSESSMENT			
Product Type	Cement	Extent of Damage	Good condition
Asbestos Type	Chrysotile	Surface Treatment	Sealed (Cement products)
SCORE			
3			
PRIORITY ASSESSMENT			
Occupant Activity	Not Applicable	Extent / Amount	3.00 lm
Accessibility	Occasionally disturb	Location	Not Applicable
Avg Time in Use	Not Applicable	Frequency of Use	Not Applicable
No. of Occupants	Not Applicable	Secondary Activity	Not Applicable
Maintenance	Not Applicable	Maintenance Frequency	Not Applicable
SCORE			
1			
MANAGEMENT ACTION			
Recommendation	LABEL & MONITOR		
Recommendation Due		Next Inspection	19 Dec 2015
Apply Labels	No	Permit to Work Required	No
SCORE			
4			
Survey Type	Management	Lead Surveyor	Gavin Hooper
Survey Date	19 Dec 2014	UKAS Laboratory	NOT SAMPLED (Cross Referenced)
Site Reference	I33510000A	Licensed Material	No
