Solihull Community Housing

Asbestos Management Survey Report

Darwin House I-37 (Communal)
Alder Court
Solihull
B37 7QF

Date of Report: 27 Feb 2015

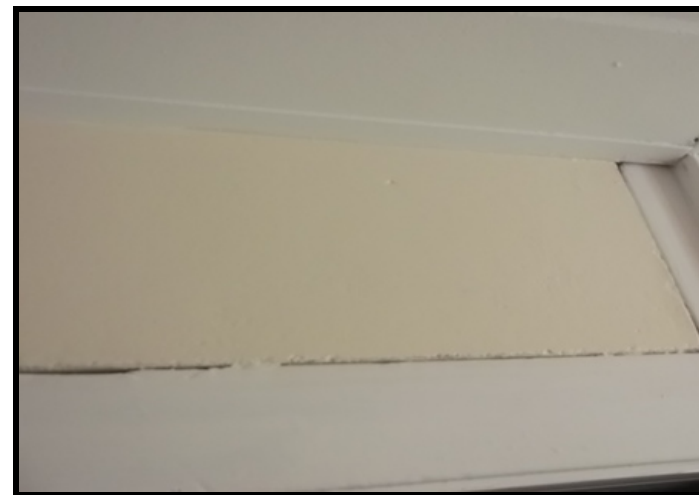
SAMPLE REFERENCE 139

No Asbestos Presumed in Sample

Building	Floor	Room	Location		
Main Building	Eighth Floor	Lift Landing	Ceiling		
Description	No access within timber ceiling hatch doors and behind timber panels.				
MATERIAL ASSESSMENT				SCORE	
Product Type	Insulation Board	Extent of Damage	Good condition		-
Asbestos Type	No Asbestos Detected	Surface Treatment	Sealed Board (Encapsulated)		
PRIORITY ASSESSMENT				SCORE	
Occupant Activity	Not Applicable	Extent / Amount	40.00 m2		-
Accessibility	Occasionally disturb	Location	Not Applicable		
Avg Time in Use	Not Applicable	Frequency of Use	Not Applicable		
No. of Occupants	Not Applicable	Secondary Activity	Not Applicable		
Maintenance	Not Applicable	Maintenance Frequency	Not Applicable		
MANAGEMENT ACTION				SCORE	
Recommendation	NO ACTION REQUIRED				-
Recommendation Due		Next Inspection	None		
Apply Labels	No	Permit to Work Required	No		
Survey Type	Management	Lead Surveyor	Gavin Hooper		
Survey Date	19 Dec 2014	UKAS Laboratory	NOT SAMPLED (Cross Referenced)

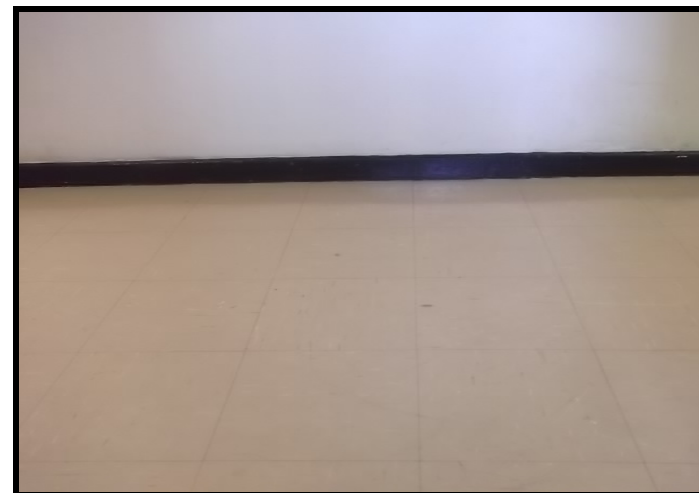
SAMPLE REFERENCE I 40a

Asbestos not detected in Sample

Building	Floor	Room	Location
Main Building	Eighth Floor	Lift Landing	Floor
Description			
MATERIAL ASSESSMENT			
Product Type	Bitumen	Extent of Damage	Low damage
Asbestos Type	Chrysotile	Surface Treatment	Composite materials
PRIORITY ASSESSMENT			
Occupant Activity	Not Applicable	Extent / Amount	6.00 m2
Accessibility	Easily disturbed	Location	Not Applicable
Avg Time in Use	Not Applicable	Frequency of Use	Not Applicable
No. of Occupants	Not Applicable	Secondary Activity	Not Applicable
Maintenance	Not Applicable	Maintenance Frequency	Not Applicable
MANAGEMENT ACTION			
Recommendation	LABEL & MONITOR		
Recommendation Due		Next Inspection	19 Dec 2015
Apply Labels	No	Permit to Work Required	No
Survey Type	Management	Lead Surveyor	Gavin Hooper
Survey Date	19 Dec 2014	UKAS Laboratory	NOT SAMPLED (Cross Referenced)
Site Reference	133510000A	Licensed Material	No
		Notifiable Non Licensed Work	No

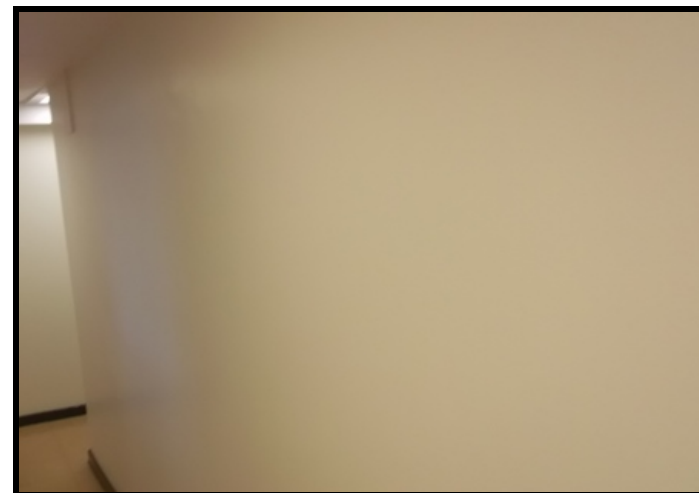
SAMPLE REFERENCE 141

No Asbestos Presumed in Sample

Building	Floor	Room	Location		
Main Building	Eighth Floor	Lift Landing	Transom Panel		
Description	Above doors to flats. No access within timber ceiling hatch doors and behind timber panels.				
MATERIAL ASSESSMENT				SCORE	
Product Type	Insulation Board	Extent of Damage	Good condition		-
Asbestos Type	No Asbestos Detected	Surface Treatment	Sealed Board (Encapsulated)		
PRIORITY ASSESSMENT				SCORE	
Occupant Activity	Not Applicable	Extent / Amount	1.00 m2		-
Accessibility	Occasionally disturb	Location	Not Applicable		
Avg Time in Use	Not Applicable	Frequency of Use	Not Applicable		
No. of Occupants	Not Applicable	Secondary Activity	Not Applicable		
Maintenance	Not Applicable	Maintenance Frequency	Not Applicable		
MANAGEMENT ACTION				SCORE	
Recommendation	NO ACTION REQUIRED				-
Recommendation Due		Next Inspection	None		
Apply Labels	No	Permit to Work Required	No		
Survey Type	Management	Lead Surveyor	Gavin Hooper

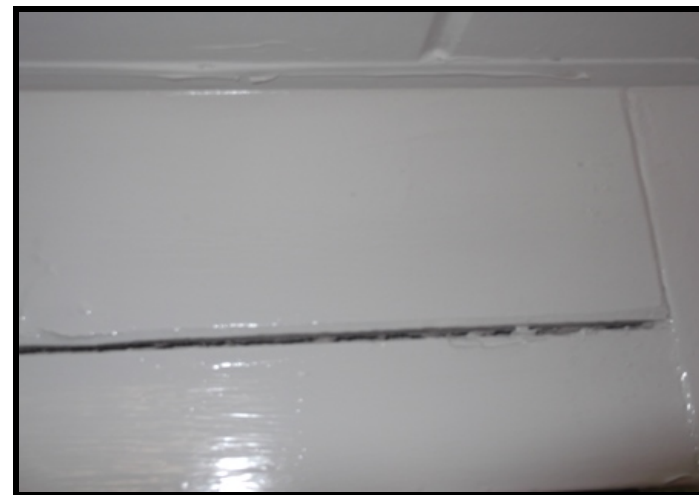
SAMPLE REFERENCE 142

No Asbestos Presumed in Sample

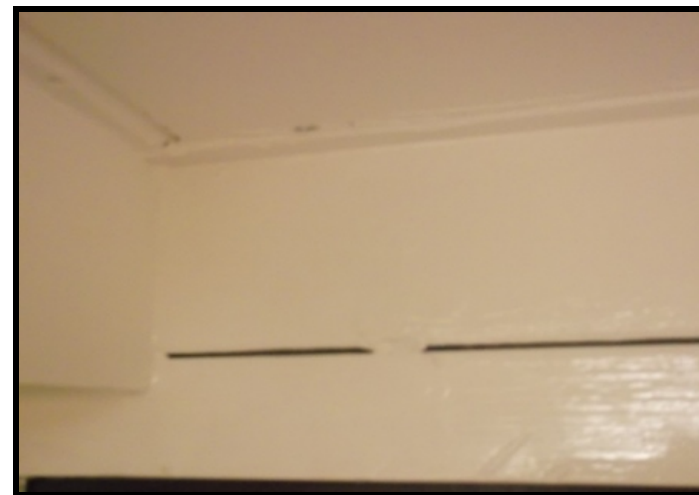
SAMPLE REFERENCE 143

No Asbestos Presumed in Sample

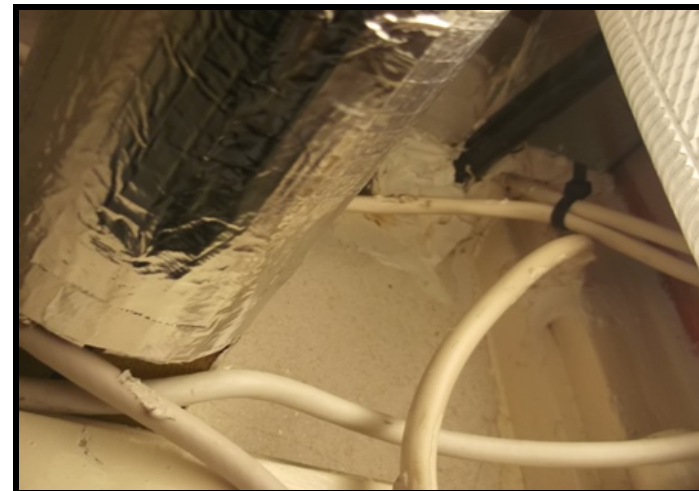
SAMPLE REFERENCE 144

No Asbestos Presumed in Sample

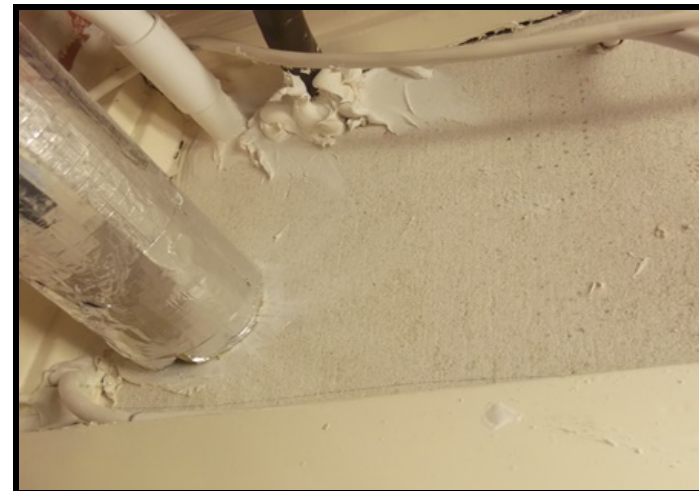
SAMPLE REFERENCE 145

No Asbestos Presumed in Sample

MATERIAL ASSESSMENT				SCORE
Product Type	Cement	Extent of Damage	Good condition	3
Asbestos Type	Chrysotile	Surface Treatment	Sealed (Cement products)

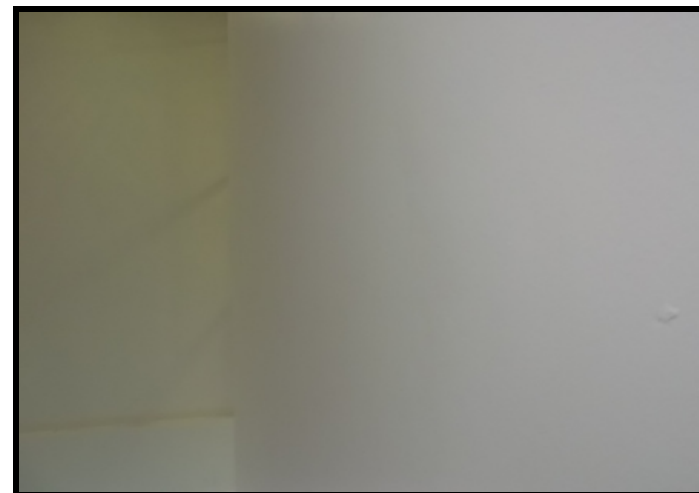
SAMPLE REFERENCE 147

Building	Floor	Room	Location		
Main Building	Eighth Floor Roof Access	Stairwell	Wall		
Description					
MATERIAL ASSESSMENT					SCORE
Product Type	Textured Coating	Extent of Damage	Good condition		-
Asbestos Type	No Asbestos Detected	Surface Treatment	Textured Coating		
PRIORITY ASSESSMENT					SCORE
Occupant Activity	Not Applicable	Extent / Amount	20.00 m2		-
Accessibility	Easily disturbed	Location	Not Applicable		
Avg Time in Use	Not Applicable	Frequency of Use	Not Applicable		
No. of Occupants	Not Applicable	Secondary Activity	Not Applicable		
Maintenance	Not Applicable	Maintenance Frequency	Not Applicable		
MANAGEMENT ACTION					SCORE
Recommendation	NO ACTION REQUIRED				-
Recommendation Due		Next Inspection	None		
Apply Labels	No	Permit to Work Required	No		
Survey Type	Management	Lead Surveyor	Gavin Hooper		
Survey Date	19 Dec 2014	UKAS Laboratory	NOT SAMPLED (Cross Referenced)		
Site Reference	I33510000A	Licensed Material	N/A	Notifiable Non Licensed Work	N/A

No Asbestos Presumed in Sample

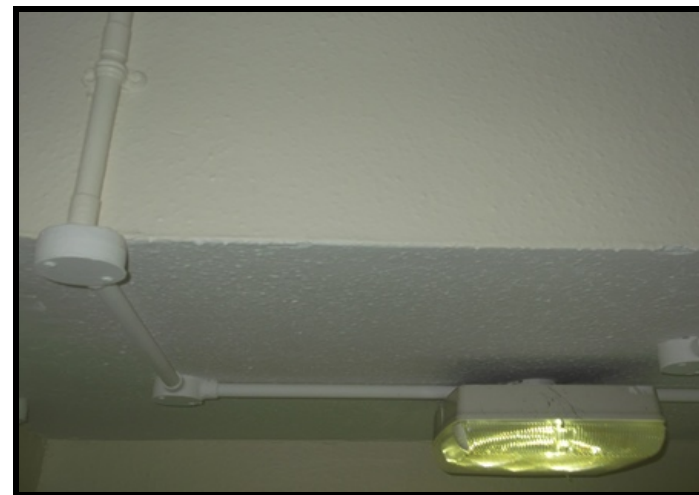
SAMPLE REFERENCE I48

Building	Floor	Room	Location		
Main Building	Eighth Floor Roof Access	Stairwell	Ceiling		
Description					
MATERIAL ASSESSMENT					SCORE
Product Type	Textured Coating	Extent of Damage	Good condition		-
Asbestos Type	No Asbestos Detected	Surface Treatment	Textured Coating		
PRIORITY ASSESSMENT					SCORE
Occupant Activity	Not Applicable	Extent / Amount	20.00 m2		-
Accessibility	Occasionally disturb	Location	Not Applicable		
Avg Time in Use	Not Applicable	Frequency of Use	Not Applicable		
No. of Occupants	Not Applicable	Secondary Activity	Not Applicable		
Maintenance	Not Applicable	Maintenance Frequency	Not Applicable		
MANAGEMENT ACTION					SCORE
Recommendation	NO ACTION REQUIRED				-
Recommendation Due		Next Inspection	None		
Apply Labels	No	Permit to Work Required	No		
Survey Type	Management	Lead Surveyor	Gavin Hooper		
Survey Date	19 Dec 2014	UKAS Laboratory	NOT SAMPLED (Cross Referenced)		
Site Reference	I33510000A	Licensed Material	N/A	Notifiable Non Licensed Work	N/A

No Asbestos Presumed in Sample

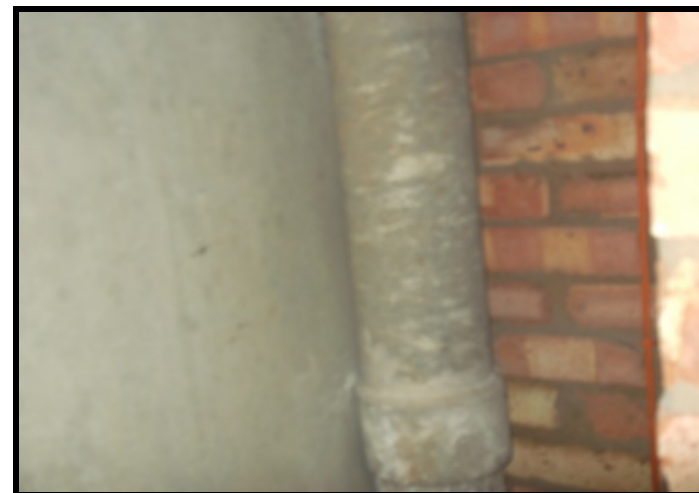
SAMPLE REFERENCE 154

MATERIAL ASSESSMENT				SCORE
Product Type	Cement	Extent of Damage	Good condition	3
Asbestos Type	Chrysotile	Surface Treatment	Unsealed (Cement products)

Asbestos detected in Sample

MANAGEMENT ACTION				SCORE
Recommendation	LABEL & MONITOR			4
Recommendation Due		Next Inspection	19 Dec 2015	
Apply Labels	No	Permit to Work Required	No
