Solihull Community Housing

Asbestos Management Survey Report

I-36 (Communal) Digby House
Colletts Grove
Solihull
B37 6JE

Date of Report: 11 Apr 2011

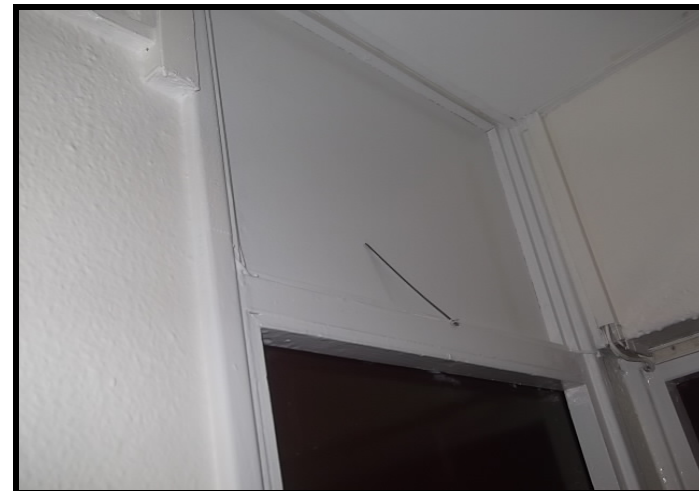
SAMPLE REFERENCE 010

Building	Floor	Room	Location	
Main	Ground Floor	Store Room	Transom Panel	
Description				
MATERIAL ASSESSMENT				SCORE
Product Type	Board	Extent of Damage	Good condition	-
Asbestos Type	No Asbestos Detected	Surface Treatment	Sealed Board (Encapsulated)	
PRIORITY ASSESSMENT				SCORE
Occupant Activity	Not Applicable	Extent / Amount	1.00 m2	-
Accessibility	Occasionally disturb	Location	Not Applicable	
Avg Time in Use	Not Applicable	Frquency of Use	Not Applicable	
No. of Occupants	Not Applicable	Secondary Activity	Not Applicable	
Maintenance	Not Applicable	Maintenace Frequency	Not Applicable	
MANAGEMENT ACTION				SCORE
Recommendation	NO ACTION REQUIRED			-
Recommendation Due		Next Inspection	None	
Apply Labels	No	Permit to Work Required	No	
Survey Type	Management	Lead Surveyor	Richard Saunders	
Survey Date	23 Mar 2011	UKAS Laboratory	DMW Environmental Safety Ltd / [P-75203]	
Site Reference	257810000A	Licensed Material	N/A

Asbestos not detected in Sample

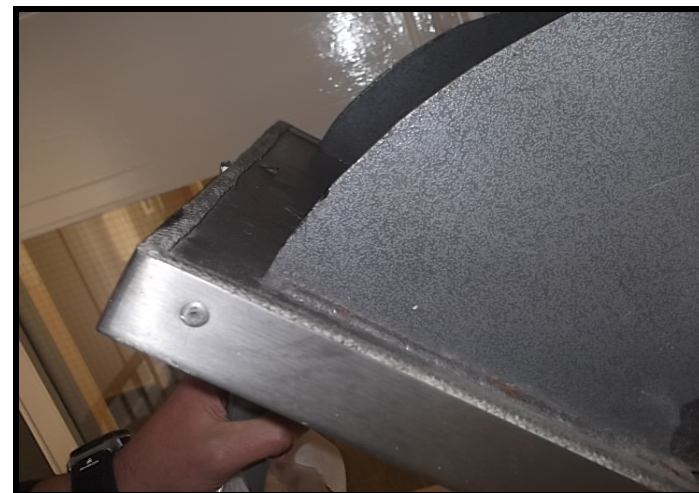
SAMPLE REFERENCE 021

Asbestos not detected in Sample

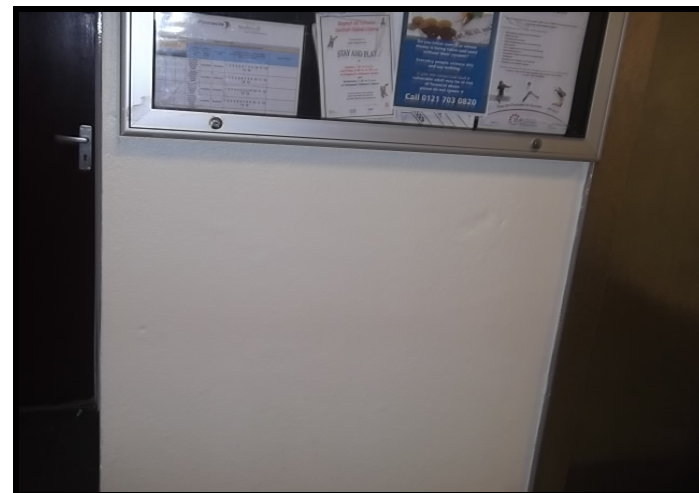
SAMPLE REFERENCE 023

No Asbestos Presumed in Sample

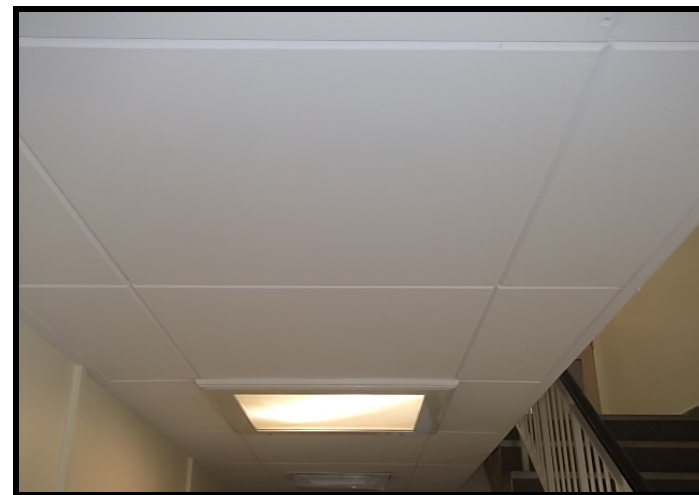
SAMPLE REFERENCE 036

Building	Floor	Room	Location	
Main	Second-Third Floor	Stairs and Landings	Ceiling	
Description				
MATERIAL ASSESSMENT				SCORE
Product Type	Board	Extent of Damage	Good condition	-
Asbestos Type	No Asbestos Detected	Surface Treatment	Sealed Board (Encapsulated)	
PRIORITY ASSESSMENT				SCORE
Occupant Activity	Not Applicable	Extent / Amount	40.00 m2	-
Accessibility	Occasionally disturb	Location	Not Applicable	
Avg Time in Use	Not Applicable	Frquency of Use	Not Applicable	
No. of Occupants	Not Applicable	Secondary Activity	Not Applicable	
Maintenance	Not Applicable	Maintenace Frequency	Not Applicable	
MANAGEMENT ACTION				SCORE
Recommendation	NO ACTION REQUIRED			-
Recommendation Due		Next Inspection	None	
Apply Labels	No	Permit to Work Required	No	
Survey Type	Management	Lead Surveyor	Richard Saunders	
Survey Date	23 Mar 2011	UKAS Laboratory	NOT SAMPLED (Cross Referenced)	
Site Reference	257810000A	Licensed Material	N/A

No Asbestos Presumed in Sample

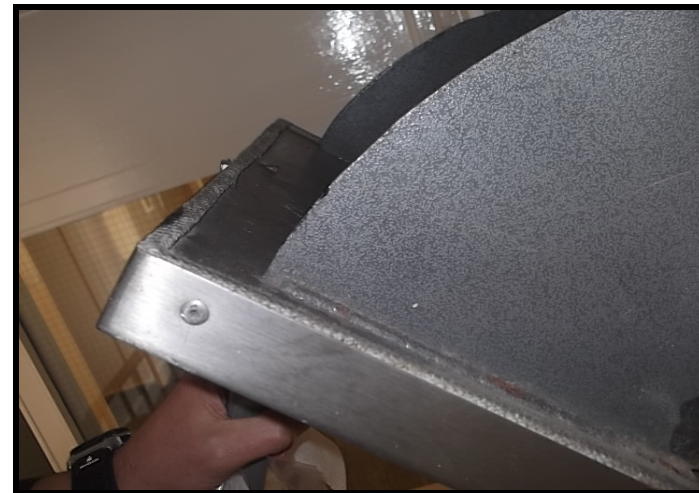
SAMPLE REFERENCE 048

No Asbestos Presumed in Sample

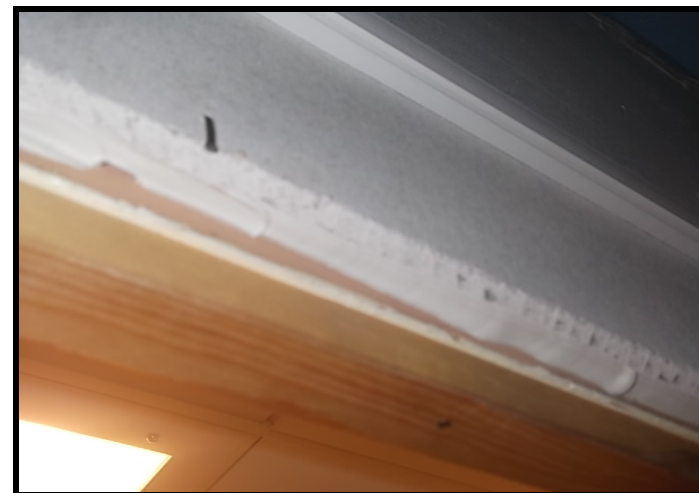
SAMPLE REFERENCE 070

Building	Floor	Room	Location	
Main	Sixth Floor	Electric Cupboard	Transom Panel	
Description				
MATERIAL ASSESSMENT				SCORE
Product Type	Board	Extent of Damage	Good condition	-
Asbestos Type	No Asbestos Detected	Surface Treatment	Sealed Board (Encapsulated)	
PRIORITY ASSESSMENT				SCORE
Occupant Activity	Not Applicable	Extent / Amount	1.00 m2	-
Accessibility	Occasionally disturb	Location	Not Applicable	
Avg Time in Use	Not Applicable	Frquency of Use	Not Applicable	
No. of Occupants	Not Applicable	Secondary Activity	Not Applicable	
Maintenance	Not Applicable	Maintenace Frequency	Not Applicable	
MANAGEMENT ACTION				SCORE
Recommendation	NO ACTION REQUIRED			-
Recommendation Due		Next Inspection	None	
Apply Labels	No	Permit to Work Required	No	
Survey Type	Management	Lead Surveyor	Richard Saunders	
Survey Date	23 Mar 2011	UKAS Laboratory	NOT SAMPLED (Cross Referenced)	
Site Reference	257810000A	Licensed Material	N/A

No Asbestos Presumed in Sample

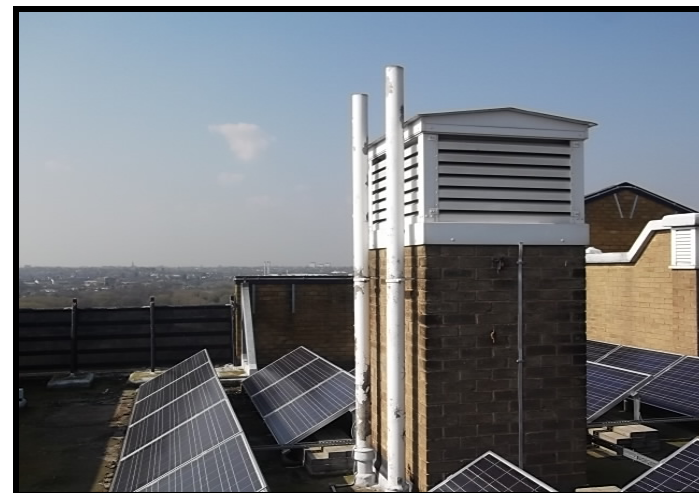
SAMPLE REFERENCE 090

Building	Floor	Room	Location	
Main	Roof	Roof Area	Pipe Work	
Description	Pipes x4.			
MATERIAL ASSESSMENT				SCORE
Product Type	Cement Pipe	Extent of Damage	Low damage	4
Asbestos Type	Chrysotile	Surface Treatment	Unsealed (Cement products)	
PRIORITY ASSESSMENT				SCORE
Occupant Activity	Not Applicable	Extent / Amount	18.00 lm	1
Accessibility	Occasionally disturb	Location	Not Applicable	
Avg Time in Use	Not Applicable	Frquency of Use	Not Applicable	
No. of Occupants	Not Applicable	Secondary Activity	Not Applicable	
Maintenance	Not Applicable	Maintenace Frequency	Not Applicable	
MANAGEMENT ACTION				SCORE
Recommendation	ENCAPSULATE, LABEL & MONITOR			5
Recommendation Due		Next Inspection	23 Mar 2012	
Apply Labels	No	Permit to Work Required	No	
Survey Type	Management	Lead Surveyor	Richard Saunders	
Survey Date	23 Mar 2011	UKAS Laboratory	DMW Environmental Safety Ltd / [P-75203]	
Site Reference	257810000A	Licensed Material	No

Asbestos detected in Sample

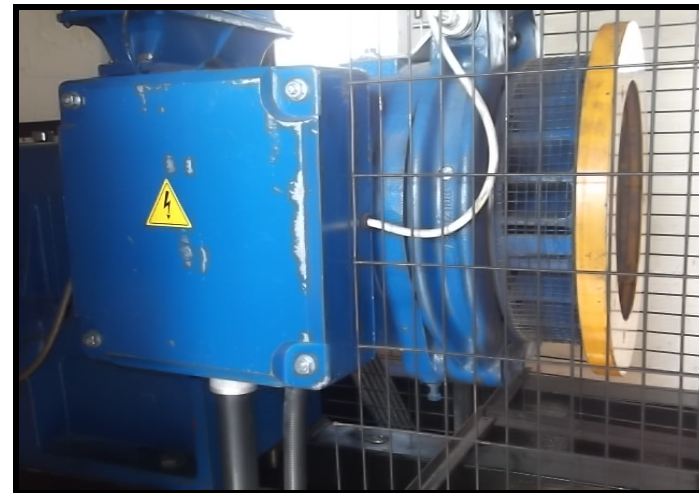
SAMPLE REFERENCE 091

Asbestos Presumed in Sample

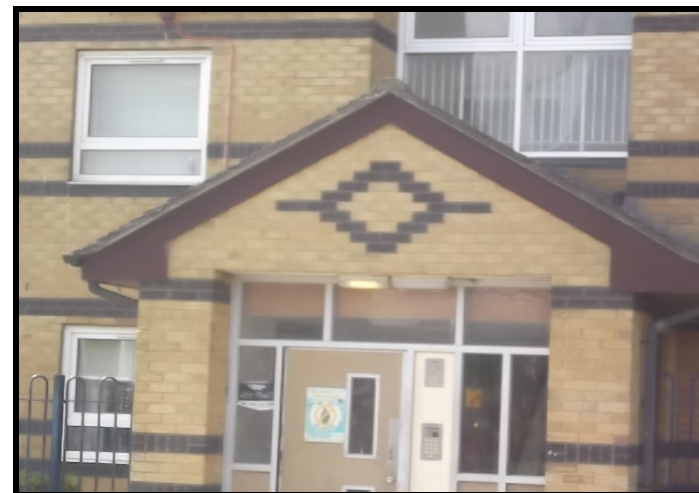
SAMPLE REFERENCE 092

Building	Floor	Room	Location	
Main	External	Ground Floor	Under Cloaking	
Description				
MATERIAL ASSESSMENT				SCORE
Product Type	Cement Board	Extent of Damage	Good condition	3
Asbestos Type	Chrysotile	Surface Treatment	Cement Board	
PRIORITY ASSESSMENT				SCORE
Occupant Activity	Not Applicable	Extent / Amount	12.00 m2	1
Accessibility	Occasionally disturb	Location	Not Applicable	
Avg Time in Use	Not Applicable	Frquency of Use	Not Applicable	
No. of Occupants	Not Applicable	Secondary Activity	Not Applicable	
Maintenance	Not Applicable	Maintenace Frequency	Not Applicable	
MANAGEMENT ACTION				SCORE
Recommendation	LABEL & MONITOR			4
Recommendation Due		Next Inspection	23 Mar 2012	
Apply Labels	No	Permit to Work Required	No	
Survey Type	Management	Lead Surveyor	Richard Saunders	
Survey Date	23 Mar 2011	UKAS Laboratory	DMW Environmental Safety Ltd / [P-75203]	
Site Reference	257810000A	Licensed Material	No

Asbestos detected in Sample
