Solihull Community Housing

Asbestos Management Survey Report

Merton House I-43 (Communal)
Crabtree Drive
Solihull
B37 5BX

Date of Report: 25 Feb 2015

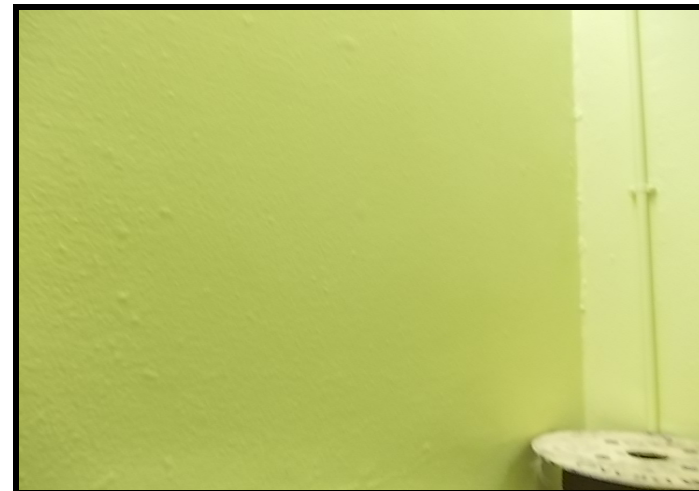
SAMPLE REFERENCE 003

Building	Floor	Room	Location		
Main Building	Roof - 10th Floor	Stairwell	Wall		
Description					
MATERIAL ASSESSMENT					SCORE
Product Type	Textured Coating	Extent of Damage	Low damage		-
Asbestos Type	No Asbestos Detected	Surface Treatment	Textured Coating		
PRIORITY ASSESSMENT					SCORE
Occupant Activity	Not Applicable	Extent / Amount	10.00 m2		-
Accessibility	Occasionally disturb	Location	Not Applicable		
Avg Time in Use	Not Applicable	Frequency of Use	Not Applicable		
No. of Occupants	Not Applicable	Secondary Activity	Not Applicable		
Maintenance	Not Applicable	Maintenance Frequency	Not Applicable		
MANAGEMENT ACTION					SCORE
Recommendation	NO ACTION REQUIRED				-
Recommendation Due		Next Inspection	None		
Apply Labels	No	Permit to Work Required	No		
Survey Type	Management	Lead Surveyor	Gavin Hooper		
Survey Date	11 Dec 2014	UKAS Laboratory	DMW Environmental Safety Ltd / [A-9279]		
Site Reference	113030000A	Licensed Material	N/A	Notifiable Non Licensed Work	N/A

Asbestos not detected in Sample

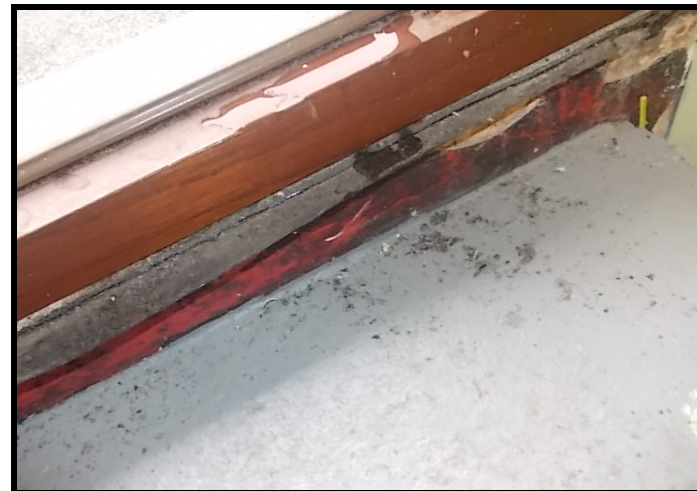
SAMPLE REFERENCE 003b

Asbestos not detected in Sample

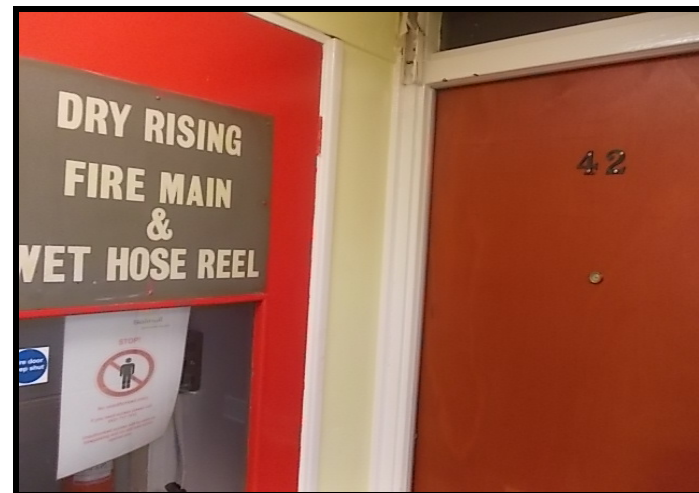
SAMPLE REFERENCE 005a

Asbestos detected in Sample

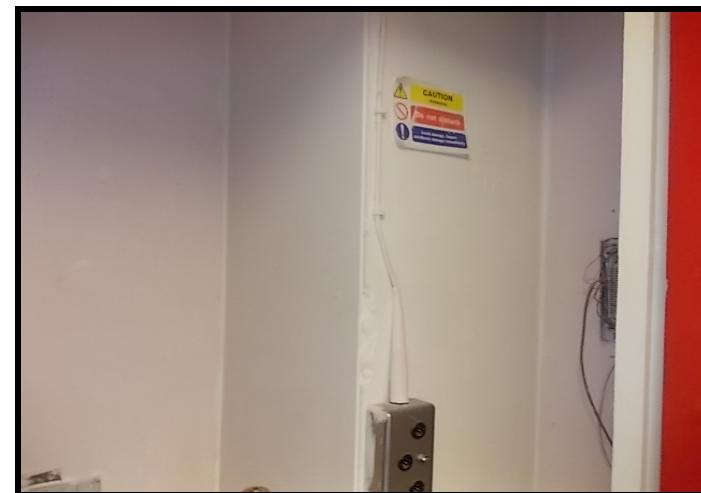
SAMPLE REFERENCE 013

Asbestos detected in Sample

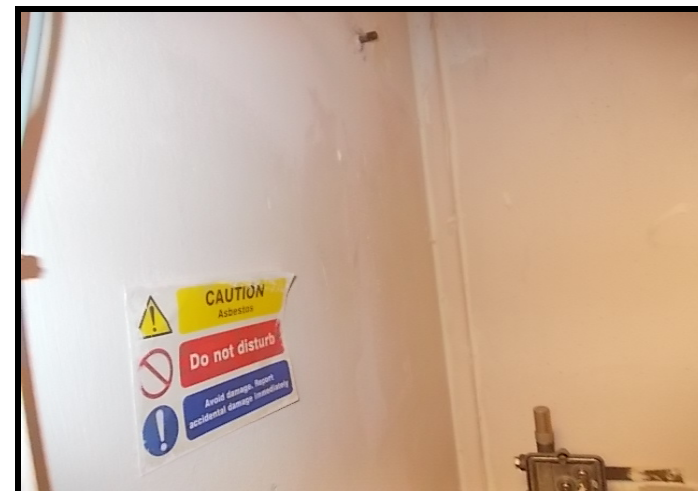
SAMPLE REFERENCE 014

Asbestos detected in Sample

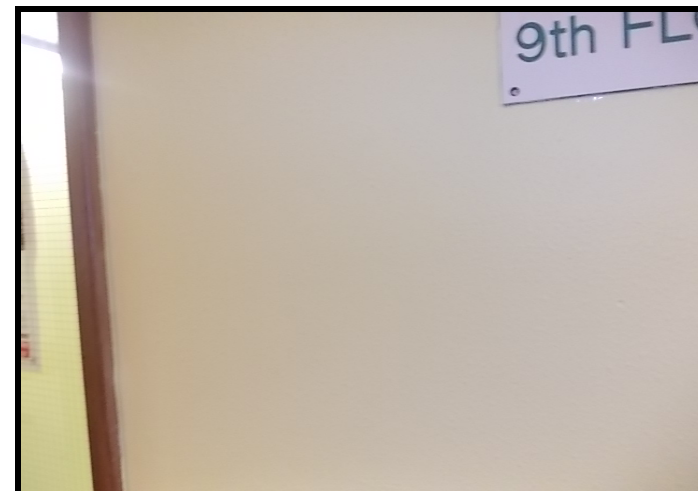
SAMPLE REFERENCE 018

Building	Floor	Room	Location		
Main Building	9th Floor	Lift Lobby I	Wall		
Description					
MATERIAL ASSESSMENT					SCORE
Product Type	Textured Coating	Extent of Damage	Low damage		-
Asbestos Type	No Asbestos Detected	Surface Treatment	Textured Coating		
PRIORITY ASSESSMENT					SCORE
Occupant Activity	Not Applicable	Extent / Amount	10.00 m2		-
Accessibility	Occasionally disturb	Location	Not Applicable		
Avg Time in Use	Not Applicable	Frequency of Use	Not Applicable		
No. of Occupants	Not Applicable	Secondary Activity	Not Applicable		
Maintenance	Not Applicable	Maintenance Frequency	Not Applicable		
MANAGEMENT ACTION					SCORE
Recommendation	NO ACTION REQUIRED				-
Recommendation Due		Next Inspection	None		
Apply Labels	No	Permit to Work Required	No		
Survey Type	Management	Lead Surveyor	Gavin Hooper		
Survey Date	11 Dec 2014	UKAS Laboratory	NOT SAMPLED (Cross Referenced)		
Site Reference	113030000A	Licensed Material	N/A	Notifiable Non Licensed Work	N/A

No Asbestos Presumed in Sample

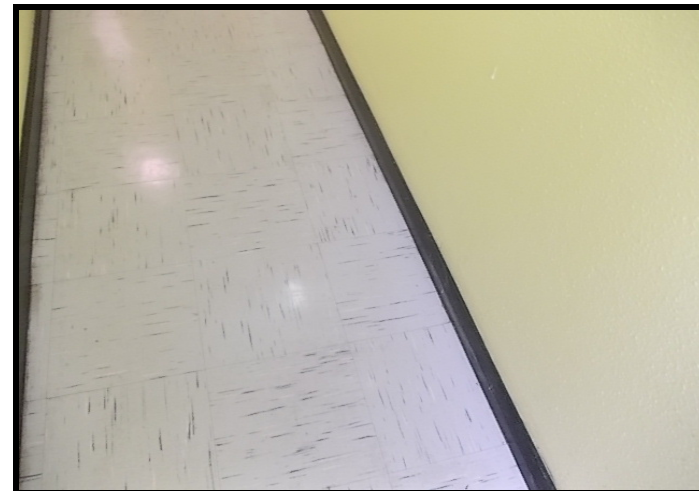
SAMPLE REFERENCE 022

Building	Floor	Room	Location
Main Building	9th Floor	Bin Shute	Floor
Description			
MATERIAL ASSESSMENT			
Product Type	Floor Tiles	Extent of Damage	Low damage
Asbestos Type	Chrysotile	Surface Treatment	Composite materials
PRIORITY ASSESSMENT			
Occupant Activity	Not Applicable	Extent / Amount	5.00 m2
Accessibility	Easily disturbed	Location	Not Applicable
Avg Time in Use	Not Applicable	Frequency of Use	Not Applicable
No. of Occupants	Not Applicable	Secondary Activity	Not Applicable
Maintenance	Not Applicable	Maintenance Frequency	Not Applicable
MANAGEMENT ACTION			
Recommendation	LABEL & MONITOR		
Recommendation Due		Next Inspection	11 Dec 2015
Apply Labels	No	Permit to Work Required	No
Survey Type	Management	Lead Surveyor	Gavin Hooper
Survey Date	11 Dec 2014	UKAS Laboratory	NOT SAMPLED (Cross Referenced)
Site Reference	113030000A	Licensed Material	No
		Notifiable Non Licensed Work	No

Asbestos Presumed

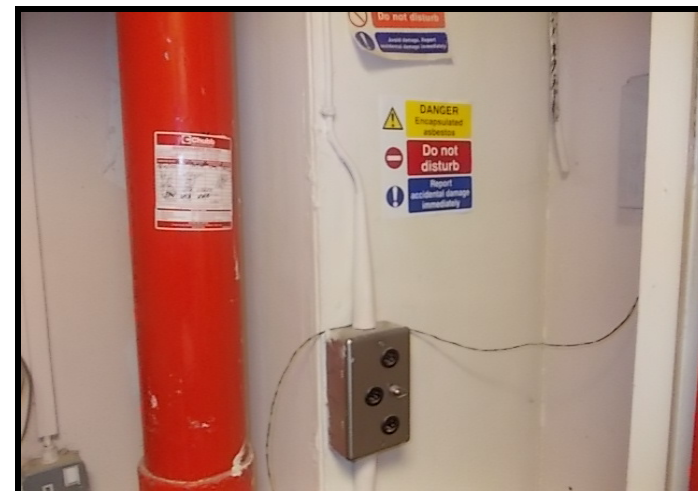
SAMPLE REFERENCE 024

Asbestos Presumed

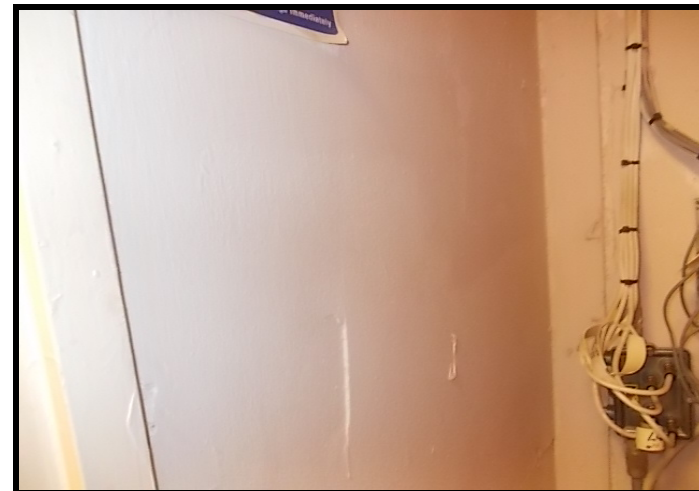
SAMPLE REFERENCE 025

Asbestos Presumed

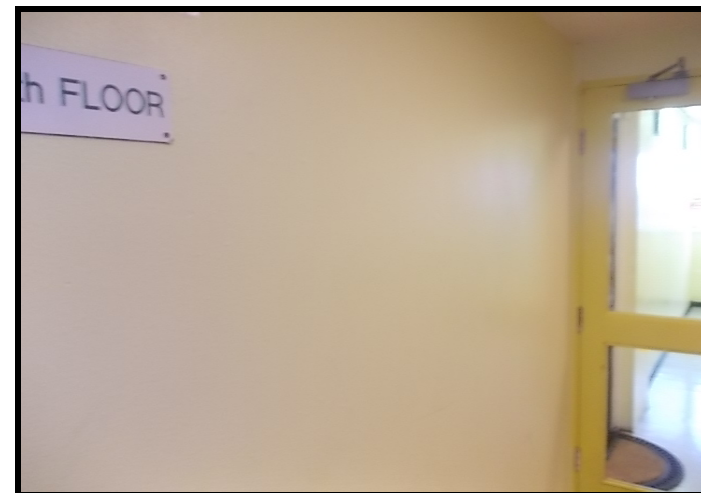
SAMPLE REFERENCE 030

Building	Floor	Room	Location		
Main Building	9th - 8th Floor	Stairwell	Wall		
Description					
MATERIAL ASSESSMENT					SCORE
Product Type	Textured Coating	Extent of Damage	Low damage		-
Asbestos Type	No Asbestos Detected	Surface Treatment	Textured Coating		
PRIORITY ASSESSMENT					SCORE
Occupant Activity	Not Applicable	Extent / Amount	10.00 m2		-
Accessibility	Occasionally disturb	Location	Not Applicable		
Avg Time in Use	Not Applicable	Frequency of Use	Not Applicable		
No. of Occupants	Not Applicable	Secondary Activity	Not Applicable		
Maintenance	Not Applicable	Maintenance Frequency	Not Applicable		
MANAGEMENT ACTION					SCORE
Recommendation	NO ACTION REQUIRED				-
Recommendation Due		Next Inspection	None		
Apply Labels	No	Permit to Work Required	No		
Survey Type	Management	Lead Surveyor	Gavin Hooper		
Survey Date	11 Dec 2014	UKAS Laboratory	NOT SAMPLED (Cross Referenced)		
Site Reference	113030000A	Licensed Material	N/A	Notifiable Non Licensed Work	N/A

No Asbestos Presumed in Sample

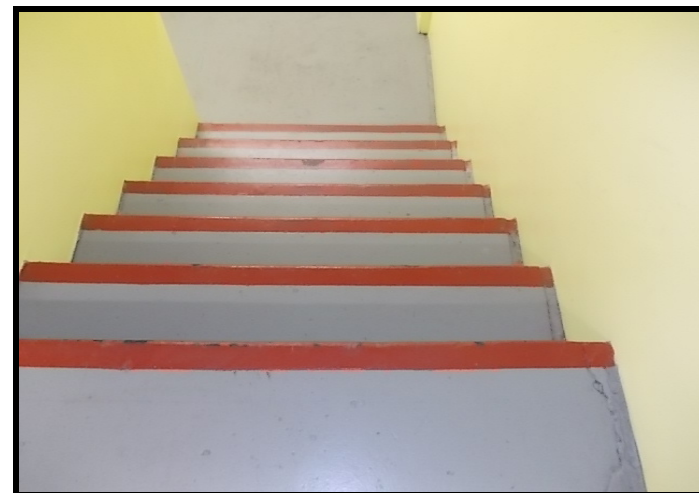
SAMPLE REFERENCE 031a

Building	Floor	Room	Location
Main Building	9th - 8th Floor	Stairwell	Staircase
Description			
MATERIAL ASSESSMENT			
Product Type	Bitumen	Extent of Damage	Low damage
Asbestos Type	Chrysotile	Surface Treatment	Composite materials
PRIORITY ASSESSMENT			
Occupant Activity	Not Applicable	Extent / Amount	14.00 small item(s)
Accessibility	Routinely disturbed	Location	Not Applicable
Avg Time in Use	Not Applicable	Frequency of Use	Not Applicable
No. of Occupants	Not Applicable	Secondary Activity	Not Applicable
Maintenance	Not Applicable	Maintenance Frequency	Not Applicable
MANAGEMENT ACTION			
Recommendation	LABEL & MONITOR		
Recommendation Due		Next Inspection	11 Dec 2015
Apply Labels	No	Permit to Work Required	No
Survey Type	Management	Lead Surveyor	Gavin Hooper
Survey Date	11 Dec 2014	UKAS Laboratory	NOT SAMPLED (Cross Referenced)
Site Reference	113030000A	Licensed Material	No
		Notifiable Non Licensed Work	No

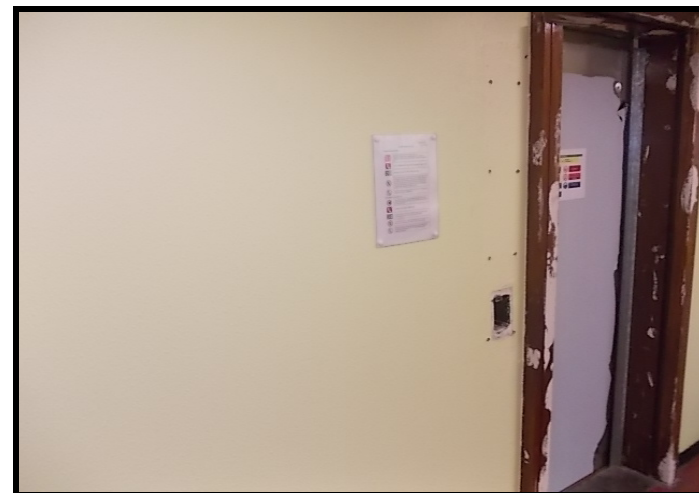
SAMPLE REFERENCE 032

Building	Floor	Room	Location		
Main Building	8th Floor	Lobby 1	Wall		
Description					
MATERIAL ASSESSMENT					SCORE
Product Type	Textured Coating	Extent of Damage	Low damage		-
Asbestos Type	No Asbestos Detected	Surface Treatment	Textured Coating		
PRIORITY ASSESSMENT					SCORE
Occupant Activity	Not Applicable	Extent / Amount	10.00 m2		-
Accessibility	Easily disturbed	Location	Not Applicable		
Avg Time in Use	Not Applicable	Frequency of Use	Not Applicable		
No. of Occupants	Not Applicable	Secondary Activity	Not Applicable		
Maintenance	Not Applicable	Maintenance Frequency	Not Applicable		
MANAGEMENT ACTION					SCORE
Recommendation	NO ACTION REQUIRED				-
Recommendation Due		Next Inspection	None		
Apply Labels	No	Permit to Work Required	No		
Survey Type	Management	Lead Surveyor	Gavin Hooper		
Survey Date	11 Dec 2014	UKAS Laboratory	NOT SAMPLED (Cross Referenced)		
Site Reference	113030000A	Licensed Material	N/A	Notifiable Non Licensed Work	N/A

No Asbestos Presumed in Sample

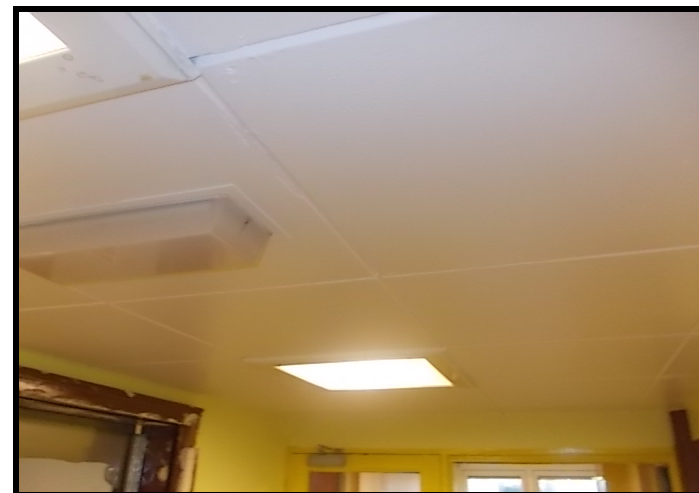
SAMPLE REFERENCE 033

Building	Floor	Room	Location		
Main Building	8th Floor	Lobby 1	Ceiling		
Description					
MATERIAL ASSESSMENT					SCORE
Product Type	Textured Coating	Extent of Damage	Low damage		-
Asbestos Type	No Asbestos Detected	Surface Treatment	Textured Coating		
PRIORITY ASSESSMENT					SCORE
Occupant Activity	Not Applicable	Extent / Amount	10.00 m2		-
Accessibility	Easily disturbed	Location	Not Applicable		
Avg Time in Use	Not Applicable	Frequency of Use	Not Applicable		
No. of Occupants	Not Applicable	Secondary Activity	Not Applicable		
Maintenance	Not Applicable	Maintenance Frequency	Not Applicable		
MANAGEMENT ACTION					SCORE
Recommendation	NO ACTION REQUIRED				-
Recommendation Due		Next Inspection	None		
Apply Labels	No	Permit to Work Required	No		
Survey Type	Management	Lead Surveyor	Gavin Hooper		
Survey Date	11 Dec 2014	UKAS Laboratory	NOT SAMPLED (Cross Referenced)		
Site Reference	113030000A	Licensed Material	N/A	Notifiable Non Licensed Work	N/A

No Asbestos Presumed in Sample

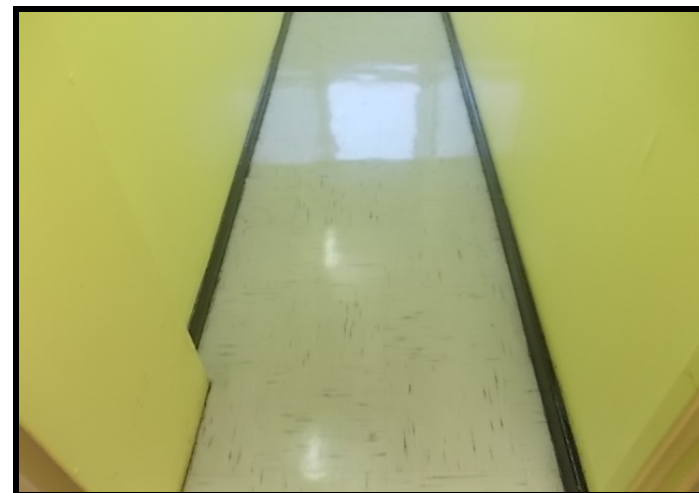
SAMPLE REFERENCE 033a

Building	Floor	Room	Location
Main Building	8th Floor	Lobby 1	Floor
Description			
MATERIAL ASSESSMENT			
Product Type	Floor Tiles	Extent of Damage	Low damage
Asbestos Type	Chrysotile	Surface Treatment	Composite materials
PRIORITY ASSESSMENT			
Occupant Activity	Not Applicable	Extent / Amount	10.00 m2
Accessibility	Easily disturbed	Location	Not Applicable
Avg Time in Use	Not Applicable	Frequency of Use	Not Applicable
No. of Occupants	Not Applicable	Secondary Activity	Not Applicable
Maintenance	Not Applicable	Maintenance Frequency	Not Applicable
MANAGEMENT ACTION			
Recommendation	LABEL & MONITOR		
Recommendation Due		Next Inspection	11 Dec 2015
Apply Labels	No	Permit to Work Required	No
Survey Type	Management	Lead Surveyor	Gavin Hooper
Survey Date	11 Dec 2014	UKAS Laboratory	NOT SAMPLED (Cross Referenced)
Site Reference	113030000A	Licensed Material	No
		Notifiable Non Licensed Work	No

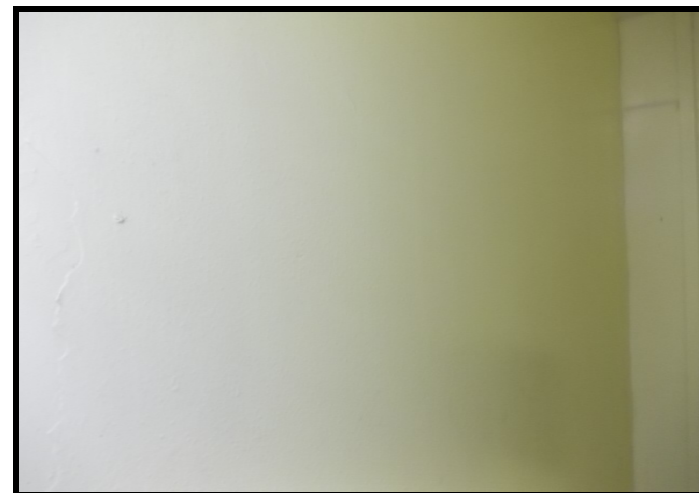
SAMPLE REFERENCE 034

Building	Floor	Room	Location
Main Building	8th Floor	Bin Shute	Wall
Description			
MATERIAL ASSESSMENT			
Product Type	Textured Coating	Extent of Damage	Low damage
Asbestos Type	No Asbestos Detected	Surface Treatment	Textured Coating
PRIORITY ASSESSMENT			
Occupant Activity	Not Applicable	Extent / Amount	10.00 m2
Accessibility	Occasionally disturb	Location	Not Applicable
Avg Time in Use	Not Applicable	Frequency of Use	Not Applicable
No. of Occupants	Not Applicable	Secondary Activity	Not Applicable
Maintenance	Not Applicable	Maintenance Frequency	Not Applicable
MANAGEMENT ACTION			
Recommendation	NO ACTION REQUIRED		
Recommendation Due		Next Inspection	None
Apply Labels	No	Permit to Work Required	No
Survey Type	Management	Lead Surveyor	Gavin Hooper
Survey Date	11 Dec 2014	UKAS Laboratory	NOT SAMPLED (Cross Referenced)
Site Reference	113030000A	Licensed Material	N/A
		Notifiable Non Licensed Work	N/A

No Asbestos Presumed in Sample

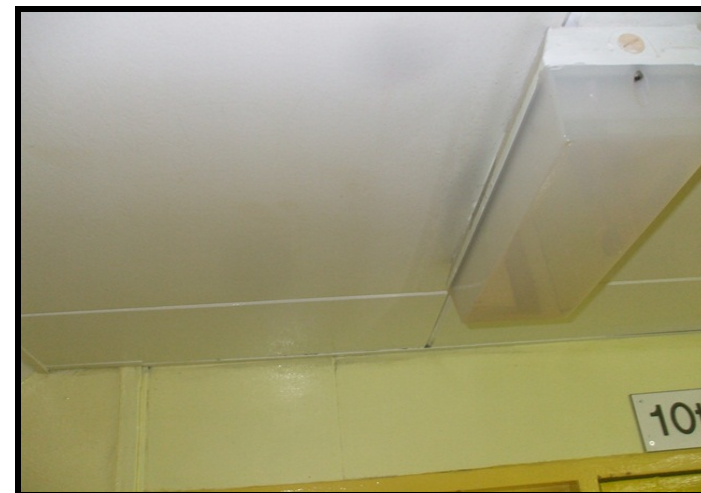
SAMPLE REFERENCE 035

No Asbestos Presumed in Sample

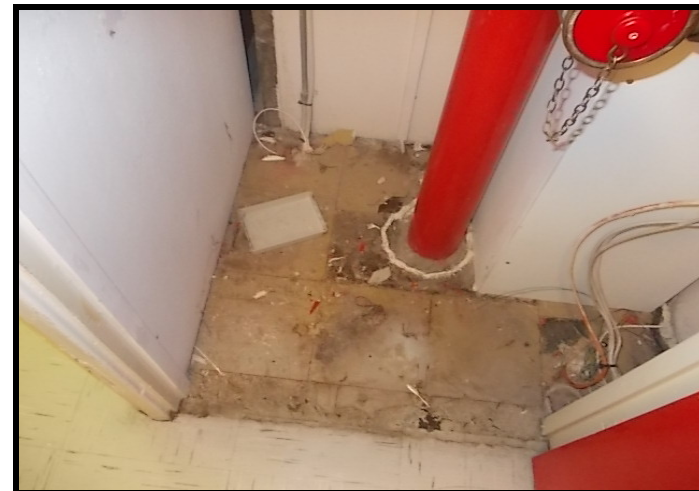
SAMPLE REFERENCE 037a

Asbestos detected in Sample

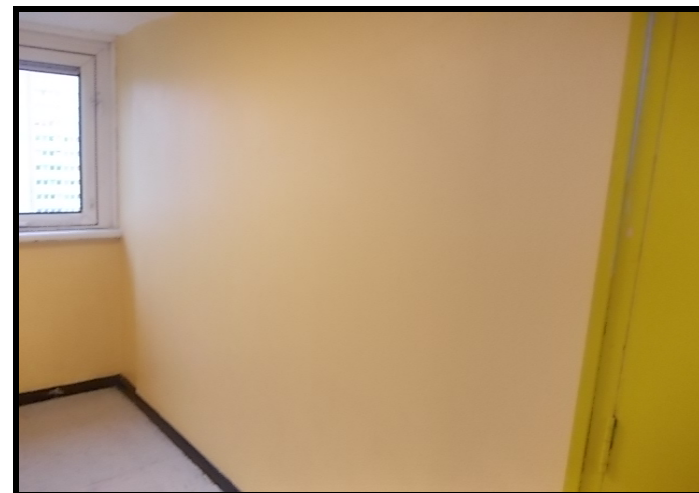
SAMPLE REFERENCE 038

Building	Floor	Room	Location		
Main Building	8th Floor	Lobby 2	Wall		
Description					
MATERIAL ASSESSMENT					SCORE
Product Type	Textured Coating	Extent of Damage	Low damage		-
Asbestos Type	No Asbestos Detected	Surface Treatment	Textured Coating		
PRIORITY ASSESSMENT					SCORE
Occupant Activity	Not Applicable	Extent / Amount	10.00 m2		-
Accessibility	Occasionally disturb	Location	Not Applicable		
Avg Time in Use	Not Applicable	Frequency of Use	Not Applicable		
No. of Occupants	Not Applicable	Secondary Activity	Not Applicable		
Maintenance	Not Applicable	Maintenance Frequency	Not Applicable		
MANAGEMENT ACTION					SCORE
Recommendation	NO ACTION REQUIRED				-
Recommendation Due		Next Inspection	None		
Apply Labels	No	Permit to Work Required	No		
Survey Type	Management	Lead Surveyor	Gavin Hooper		
Survey Date	11 Dec 2014	UKAS Laboratory	NOT SAMPLED (Cross Referenced)		
Site Reference	113030000A	Licensed Material	N/A	Notifiable Non Licensed Work	N/A

No Asbestos Presumed in Sample

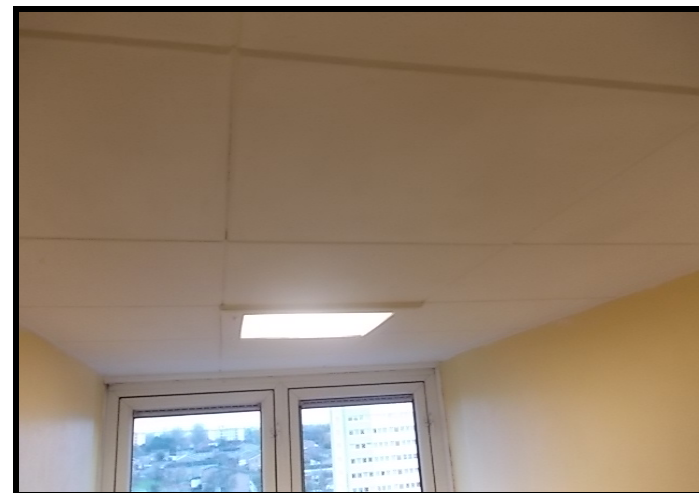
SAMPLE REFERENCE 039

Building	Floor	Room	Location		
Main Building	8th Floor	Lobby 2	Ceiling		
Description					
MATERIAL ASSESSMENT					SCORE
Product Type	Insulation Board	Extent of Damage	Low damage		-
Asbestos Type	No Asbestos Detected	Surface Treatment	Sealed Board (Encapsulated)		
PRIORITY ASSESSMENT					SCORE
Occupant Activity	Not Applicable	Extent / Amount	10.00 m2		-
Accessibility	Easily disturbed	Location	Not Applicable		
Avg Time in Use	Not Applicable	Frequency of Use	Not Applicable		
No. of Occupants	Not Applicable	Secondary Activity	Not Applicable		
Maintenance	Not Applicable	Maintenance Frequency	Not Applicable		
MANAGEMENT ACTION					SCORE
Recommendation	NO ACTION REQUIRED				-
Recommendation Due		Next Inspection	None		
Apply Labels	No	Permit to Work Required	No		
Survey Type	Management	Lead Surveyor	Gavin Hooper		
Survey Date	11 Dec 2014	UKAS Laboratory	NOT SAMPLED (Cross Referenced)		
Site Reference	113030000A	Licensed Material	N/A	Notifiable Non Licensed Work	N/A

No Asbestos Presumed in Sample

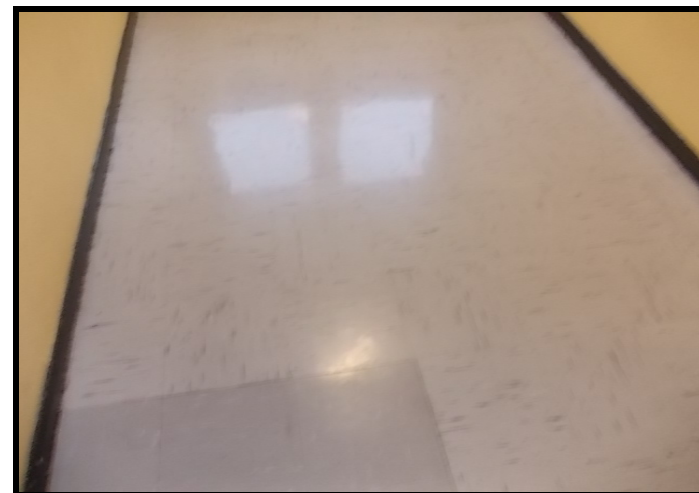
SAMPLE REFERENCE 040

Building	Floor	Room	Location		
Main Building	8th Floor	Lobby 2	Floor		
Description					
MATERIAL ASSESSMENT				SCORE	
Product Type	Floor Tiles	Extent of Damage	Low damage	3	
Asbestos Type	Chrysotile	Surface Treatment	Composite materials		
PRIORITY ASSESSMENT				SCORE	
Occupant Activity	Not Applicable	Extent / Amount	10.00 m2	1	
Accessibility	Easily disturbed	Location	Not Applicable		
Avg Time in Use	Not Applicable	Frequency of Use	Not Applicable		
No. of Occupants	Not Applicable	Secondary Activity	Not Applicable		
Maintenance	Not Applicable	Maintenance Frequency	Not Applicable		
MANAGEMENT ACTION				SCORE	
Recommendation	LABEL & MONITOR			4	
Recommendation Due		Next Inspection	11 Dec 2015		
Apply Labels	No	Permit to Work Required	No		
Survey Type	Management	Lead Surveyor	Gavin Hooper		
Survey Date	11 Dec 2014	UKAS Laboratory	NOT SAMPLED (Cross Referenced)		
Site Reference	113030000A	Licensed Material	No	Notifiable Non Licensed Work	No

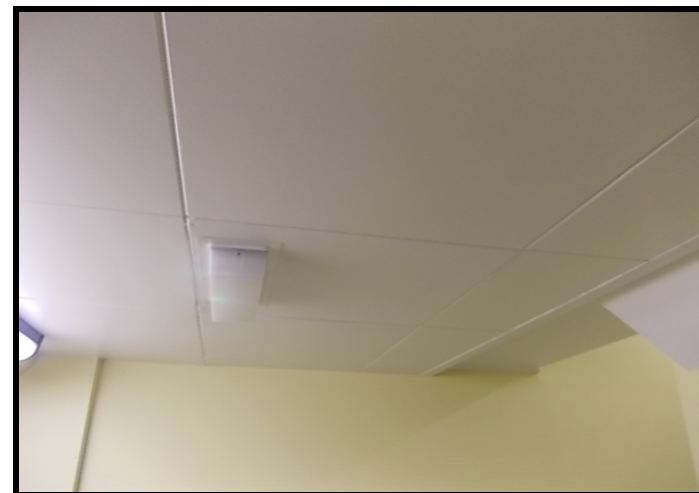
SAMPLE REFERENCE 043

Building	Floor	Room	Location		
Main Building	8th - 7th Floor	Stairwell	Ceiling		
Description					
MATERIAL ASSESSMENT					SCORE
Product Type	Insulation Board	Extent of Damage	Low damage		-
Asbestos Type	No Asbestos Detected	Surface Treatment	Sealed Board (Encapsulated)		
PRIORITY ASSESSMENT					SCORE
Occupant Activity	Not Applicable	Extent / Amount	10.00 m2		-
Accessibility	Easily disturbed	Location	Not Applicable		
Avg Time in Use	Not Applicable	Frequency of Use	Not Applicable		
No. of Occupants	Not Applicable	Secondary Activity	Not Applicable		
Maintenance	Not Applicable	Maintenance Frequency	Not Applicable		
MANAGEMENT ACTION					SCORE
Recommendation	NO ACTION REQUIRED				-
Recommendation Due		Next Inspection	None		
Apply Labels	No	Permit to Work Required	No		
Survey Type	Management	Lead Surveyor	Gavin Hooper		
Survey Date	11 Dec 2014	UKAS Laboratory	NOT SAMPLED (Cross Referenced)		
Site Reference	113030000A	Licensed Material	N/A	Notifiable Non Licensed Work	N/A

No Asbestos Presumed in Sample

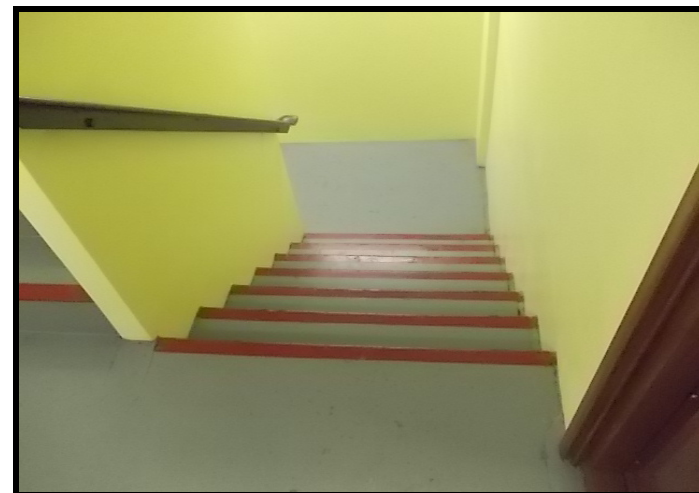
SAMPLE REFERENCE 043a

Building	Floor	Room	Location
Main Building	8th - 7th Floor	Stairwell	Floor
Description			
MATERIAL ASSESSMENT			
Product Type	Bitumen	Extent of Damage	Low damage
Asbestos Type	Chrysotile	Surface Treatment	Composite materials
PRIORITY ASSESSMENT			
Occupant Activity	Not Applicable	Extent / Amount	14.00 small item(s)
Accessibility	Easily disturbed	Location	Not Applicable
Avg Time in Use	Not Applicable	Frequency of Use	Not Applicable
No. of Occupants	Not Applicable	Secondary Activity	Not Applicable
Maintenance	Not Applicable	Maintenance Frequency	Not Applicable
MANAGEMENT ACTION			
Recommendation	LABEL & MONITOR		
Recommendation Due		Next Inspection	11 Dec 2015
Apply Labels	No	Permit to Work Required	No
Survey Type	Management	Lead Surveyor	Gavin Hooper
Survey Date	11 Dec 2014	UKAS Laboratory	NOT SAMPLED (Cross Referenced)
Site Reference	113030000A	Licensed Material	No
		Notifiable Non Licensed Work	No

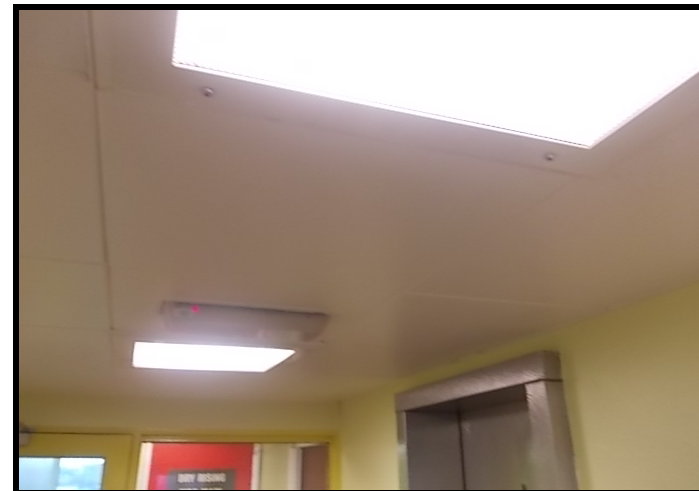
SAMPLE REFERENCE 045

Building	Floor	Room	Location		
Main Building	7th Floor	Lift Lobby	Ceiling		
Description					
MATERIAL ASSESSMENT					SCORE
Product Type	Insulation Board	Extent of Damage	Low damage		-
Asbestos Type	No Asbestos Detected	Surface Treatment	Sealed Board (Encapsulated)		
PRIORITY ASSESSMENT					SCORE
Occupant Activity	Not Applicable	Extent / Amount	10.00 m2		-
Accessibility	Easily disturbed	Location	Not Applicable		
Avg Time in Use	Not Applicable	Frequency of Use	Not Applicable		
No. of Occupants	Not Applicable	Secondary Activity	Not Applicable		
Maintenance	Not Applicable	Maintenance Frequency	Not Applicable		
MANAGEMENT ACTION					SCORE
Recommendation	NO ACTION REQUIRED				-
Recommendation Due		Next Inspection	None		
Apply Labels	No	Permit to Work Required	No		
Survey Type	Management	Lead Surveyor	Gavin Hooper		
Survey Date	11 Dec 2014	UKAS Laboratory	NOT SAMPLED (Cross Referenced)		
Site Reference	113030000A	Licensed Material	N/A	Notifiable Non Licensed Work	N/A

No Asbestos Presumed in Sample

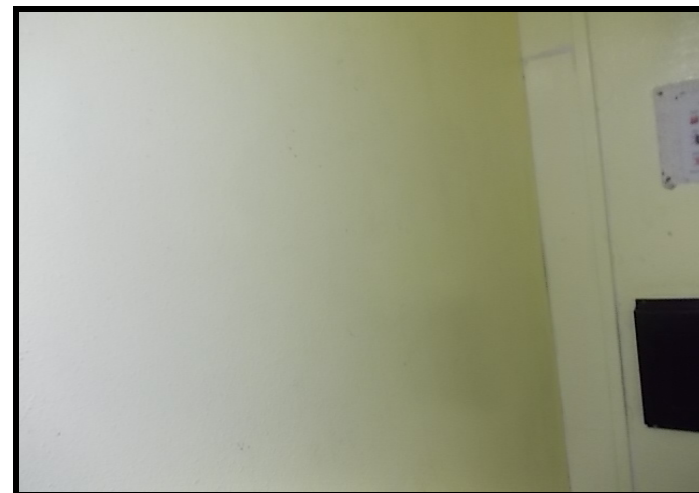
SAMPLE REFERENCE 046

Building	Floor	Room	Location
Main Building	7th Floor	Bin Shute	Wall
Description			
MATERIAL ASSESSMENT			
Product Type	Textured Coating	Extent of Damage	Low damage
Asbestos Type	No Asbestos Detected	Surface Treatment	Textured Coating
PRIORITY ASSESSMENT			
Occupant Activity	Not Applicable	Extent / Amount	10.00 m2
Accessibility	Occasionally disturb	Location	Not Applicable
Avg Time in Use	Not Applicable	Frequency of Use	Not Applicable
No. of Occupants	Not Applicable	Secondary Activity	Not Applicable
Maintenance	Not Applicable	Maintenance Frequency	Not Applicable
MANAGEMENT ACTION			
Recommendation	NO ACTION REQUIRED		
Recommendation Due		Next Inspection	None
Apply Labels	No	Permit to Work Required	No
Survey Type	Management	Lead Surveyor	Gavin Hooper
Survey Date	11 Dec 2014	UKAS Laboratory	NOT SAMPLED (Cross Referenced)
Site Reference	113030000A	Licensed Material	N/A
		Notifiable Non Licensed Work	N/A

No Asbestos Presumed in Sample

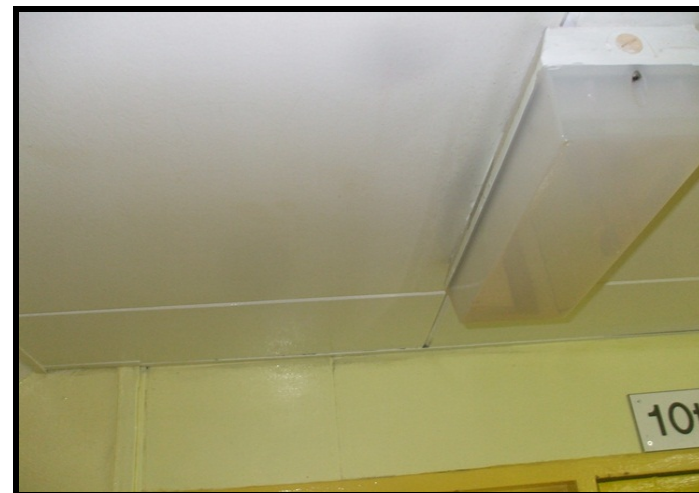
SAMPLE REFERENCE 047

No Asbestos Presumed in Sample

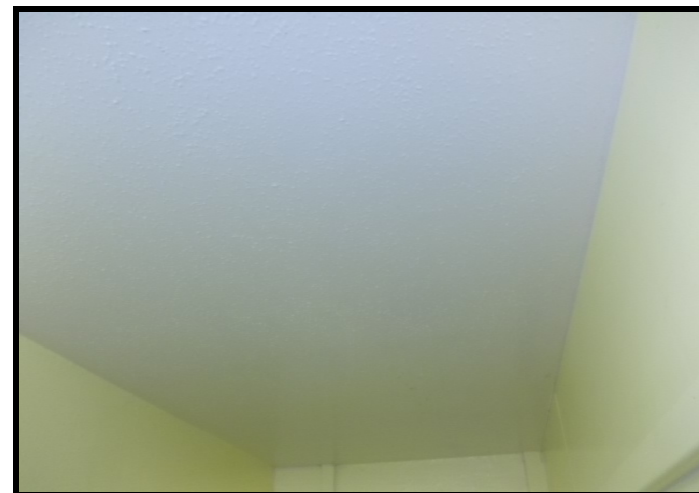
SAMPLE REFERENCE 048

Building	Floor	Room	Location		
Main Building	7th Floor	Bin Shute	Ceiling		
Description					
MATERIAL ASSESSMENT					SCORE
Product Type	Textured Coating	Extent of Damage	Low damage		-
Asbestos Type	No Asbestos Detected	Surface Treatment	Textured Coating		
PRIORITY ASSESSMENT					SCORE
Occupant Activity	Not Applicable	Extent / Amount	8.00 m2		-
Accessibility	Occasionally disturb	Location	Not Applicable		
Avg Time in Use	Not Applicable	Frequency of Use	Not Applicable		
No. of Occupants	Not Applicable	Secondary Activity	Not Applicable		
Maintenance	Not Applicable	Maintenance Frequency	Not Applicable		
MANAGEMENT ACTION					SCORE
Recommendation	NO ACTION REQUIRED				-
Recommendation Due		Next Inspection	None		
Apply Labels	No	Permit to Work Required	No		
Survey Type	Management	Lead Surveyor	Gavin Hooper		
Survey Date	11 Dec 2014	UKAS Laboratory	NOT SAMPLED (Cross Referenced)		
Site Reference	113030000A	Licensed Material	N/A	Notifiable Non Licensed Work	N/A

No Asbestos Presumed in Sample

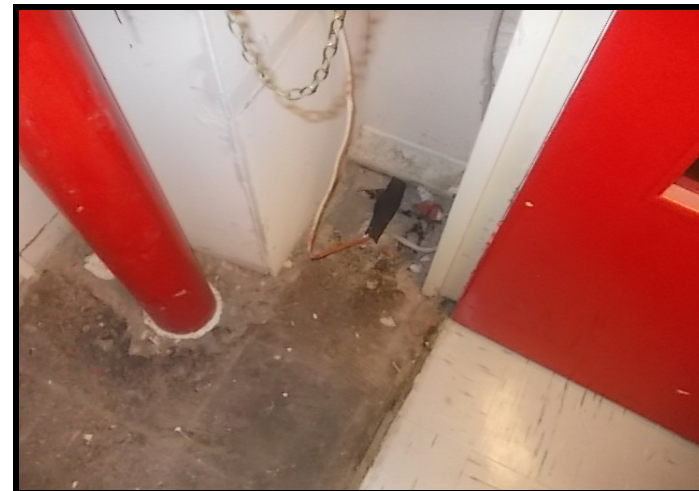
SAMPLE REFERENCE 049a

Building	Floor	Room	Location		
Main Building	7th Floor	Dry Riser	Floor		
Description					
MATERIAL ASSESSMENT					
Product Type	Floor Tiles	Extent of Damage	Medium damage		
Asbestos Type	Chrysotile	Surface Treatment	Composite materials		
PRIORITY ASSESSMENT					
Occupant Activity	Not Applicable	Extent / Amount	1.00 m2		
Accessibility	Easily disturbed	Location	Not Applicable		
Avg Time in Use	Not Applicable	Frequency of Use	Not Applicable		
No. of Occupants	Not Applicable	Secondary Activity	Not Applicable		
Maintenance	Not Applicable	Maintenance Frequency	Not Applicable		
MANAGEMENT ACTION					
Recommendation	REMOVAL BY COMPETENT PERSON				
Recommendation Due		Next Inspection	None		
Apply Labels	No	Permit to Work Required	No		
Survey Type	Management	Lead Surveyor	Gavin Hooper		
Survey Date	11 Dec 2014	UKAS Laboratory	DMW Environmental Safety Ltd / [A-9279]		
Site Reference	113030000A	Licensed Material	No	Notifiable Non Licensed Work	No

Asbestos detected in Sample

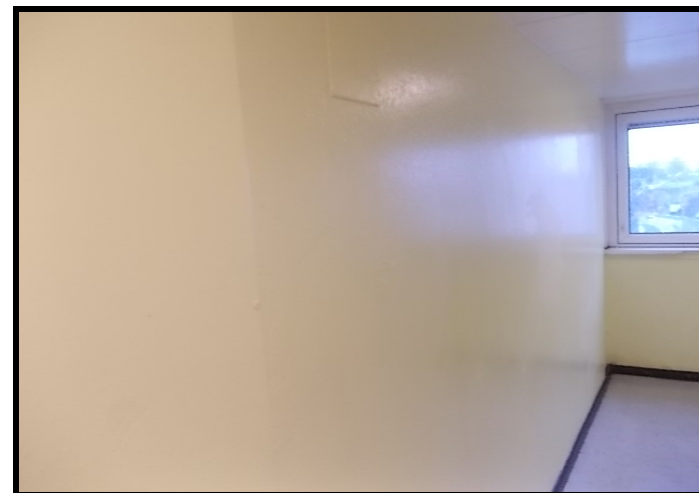
SAMPLE REFERENCE 050

Building	Floor	Room	Location		
Main Building	7th Floor	Lobby 2	Wall		
Description					
MATERIAL ASSESSMENT					SCORE
Product Type	Textured Coating	Extent of Damage	Low damage		-
Asbestos Type	No Asbestos Detected	Surface Treatment	Textured Coating		
PRIORITY ASSESSMENT					SCORE
Occupant Activity	Not Applicable	Extent / Amount	10.00 m2		-
Accessibility	Occasionally disturb	Location	Not Applicable		
Avg Time in Use	Not Applicable	Frequency of Use	Not Applicable		
No. of Occupants	Not Applicable	Secondary Activity	Not Applicable		
Maintenance	Not Applicable	Maintenance Frequency	Not Applicable		
MANAGEMENT ACTION					SCORE
Recommendation	NO ACTION REQUIRED				-
Recommendation Due		Next Inspection	None		
Apply Labels	No	Permit to Work Required	No		
Survey Type	Management	Lead Surveyor	Gavin Hooper		
Survey Date	11 Dec 2014	UKAS Laboratory	NOT SAMPLED (Cross Referenced)		
Site Reference	113030000A	Licensed Material	N/A	Notifiable Non Licensed Work	N/A

No Asbestos Presumed in Sample

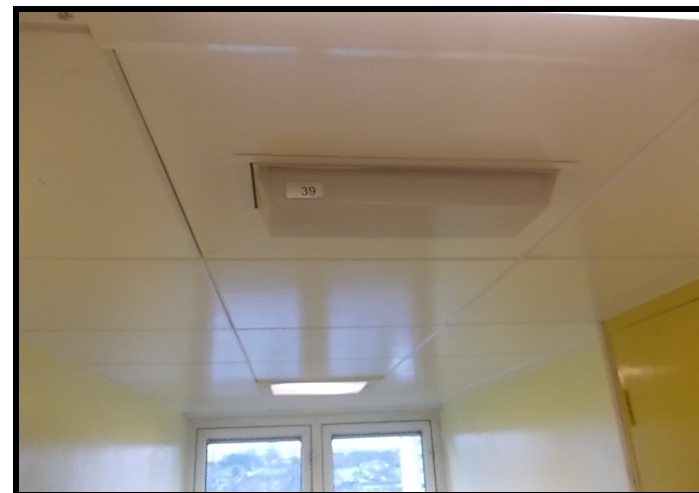
SAMPLE REFERENCE 051

Building	Floor	Room	Location		
Main Building	7th Floor	Lobby 2	Ceiling		
Description					
MATERIAL ASSESSMENT					SCORE
Product Type	Insulation Board	Extent of Damage	Low damage		-
Asbestos Type	No Asbestos Detected	Surface Treatment	Sealed Board (Encapsulated)		
PRIORITY ASSESSMENT					SCORE
Occupant Activity	Not Applicable	Extent / Amount	10.00 m2		-
Accessibility	Easily disturbed	Location	Not Applicable		
Avg Time in Use	Not Applicable	Frequency of Use	Not Applicable		
No. of Occupants	Not Applicable	Secondary Activity	Not Applicable		
Maintenance	Not Applicable	Maintenance Frequency	Not Applicable		
MANAGEMENT ACTION					SCORE
Recommendation	NO ACTION REQUIRED				-
Recommendation Due		Next Inspection	None		
Apply Labels	No	Permit to Work Required	No		
Survey Type	Management	Lead Surveyor	Gavin Hooper		
Survey Date	11 Dec 2014	UKAS Laboratory	NOT SAMPLED (Cross Referenced)		
Site Reference	113030000A	Licensed Material	N/A	Notifiable Non Licensed Work	N/A

No Asbestos Presumed in Sample

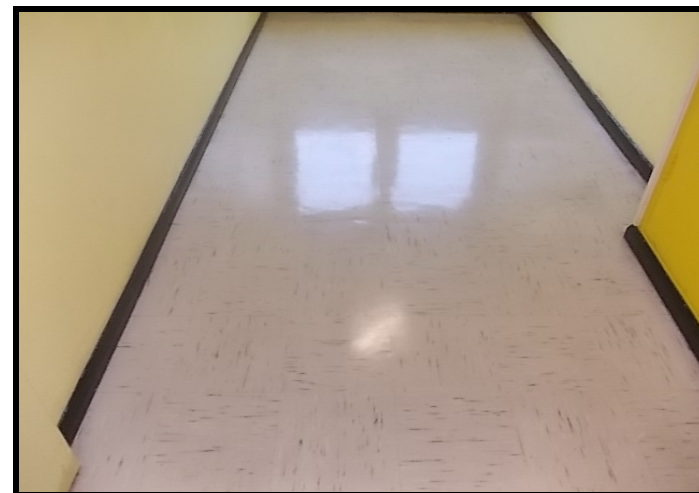
SAMPLE REFERENCE 052

Building	Floor	Room	Location
Main Building	7th Floor	Lobby 2	Floor
Description			
MATERIAL ASSESSMENT			
Product Type	Floor Tiles	Extent of Damage	Low damage
Asbestos Type	Chrysotile	Surface Treatment	Composite materials
PRIORITY ASSESSMENT			
Occupant Activity	Not Applicable	Extent / Amount	10.00 m2
Accessibility	Easily disturbed	Location	Not Applicable
Avg Time in Use	Not Applicable	Frequency of Use	Not Applicable
No. of Occupants	Not Applicable	Secondary Activity	Not Applicable
Maintenance	Not Applicable	Maintenance Frequency	Not Applicable
MANAGEMENT ACTION			
Recommendation	LABEL & MONITOR		
Recommendation Due		Next Inspection	11 Dec 2015
Apply Labels	No	Permit to Work Required	No
Survey Type	Management	Lead Surveyor	Gavin Hooper
Survey Date	11 Dec 2014	UKAS Laboratory	NOT SAMPLED (Cross Referenced)
Site Reference	113030000A	Licensed Material	No
		Notifiable Non Licensed Work	No

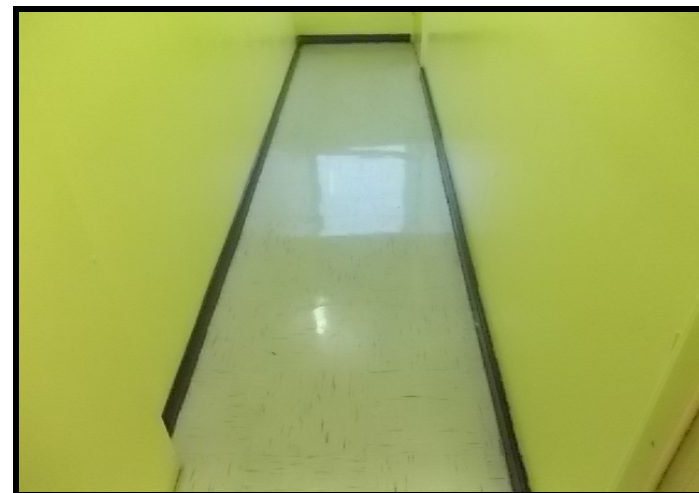
SAMPLE REFERENCE 052c

Building	Floor	Room	Location
Main Building	7th Floor	Lobby I	Floor
Description			
MATERIAL ASSESSMENT			
Product Type	Floor Tiles	Extent of Damage	Low damage
Asbestos Type	Chrysotile	Surface Treatment	Composite materials
PRIORITY ASSESSMENT			
Occupant Activity	Not Applicable	Extent / Amount	10.00 m2
Accessibility	Easily disturbed	Location	Not Applicable
Avg Time in Use	Not Applicable	Frequency of Use	Not Applicable
No. of Occupants	Not Applicable	Secondary Activity	Not Applicable
Maintenance	Not Applicable	Maintenance Frequency	Not Applicable
MANAGEMENT ACTION			
Recommendation	LABEL & MONITOR		
Recommendation Due		Next Inspection	11 Dec 2015
Apply Labels	No	Permit to Work Required	No
Survey Type	Management	Lead Surveyor	Gavin Hooper
Survey Date	11 Dec 2014	UKAS Laboratory	NOT SAMPLED (Cross Referenced)
Site Reference	113030000A	Licensed Material	No
		Notifiable Non Licensed Work	No

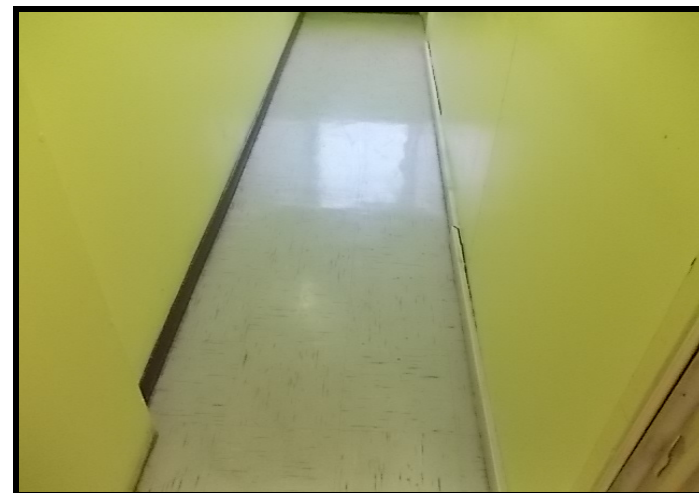
SAMPLE REFERENCE 057c

Building	Floor	Room	Location
Main Building	6th Floor	Lobby 1	Floor
Description			
MATERIAL ASSESSMENT			
Product Type	Floor Tiles	Extent of Damage	Not Applicable
Asbestos Type	Chrysotile	Surface Treatment	Asbestos cement sheets etc
PRIORITY ASSESSMENT			
Occupant Activity	Not Applicable	Extent / Amount	10.00 m2
Accessibility	Easily disturbed	Location	Not Applicable
Avg Time in Use	Not Applicable	Frequency of Use	Not Applicable
No. of Occupants	Not Applicable	Secondary Activity	Not Applicable
Maintenance	Not Applicable	Maintenance Frequency	Not Applicable
MANAGEMENT ACTION			
Recommendation	LABEL & MONITOR		
Recommendation Due		Next Inspection	11 Dec 2015
Apply Labels	No	Permit to Work Required	No
Survey Type	Management	Lead Surveyor	Gavin Hooper
Survey Date	11 Dec 2014	UKAS Laboratory	NOT SAMPLED (Cross Referenced)
Site Reference	113030000A	Licensed Material	No
		Notifiable Non Licensed Work	No

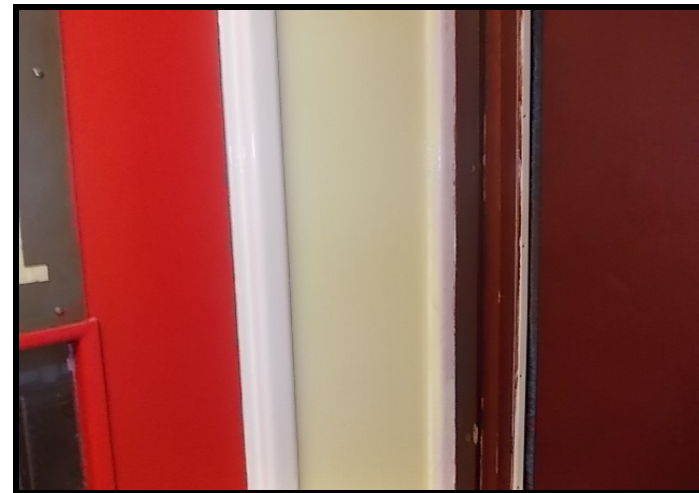
SAMPLE REFERENCE 057d

MATERIAL ASSESSMENT				SCORE
Product Type	Cement	Extent of Damage	Low damage	4
Asbestos Type	Chrysotile	Surface Treatment	Sealed (Cement products)

MANAGEMENT ACTION				SCORE
Recommendation	LABEL & MONITOR			5
Recommendation Due		Next Inspection	11 Dec 2015	
Apply Labels	No	Permit to Work Required	No

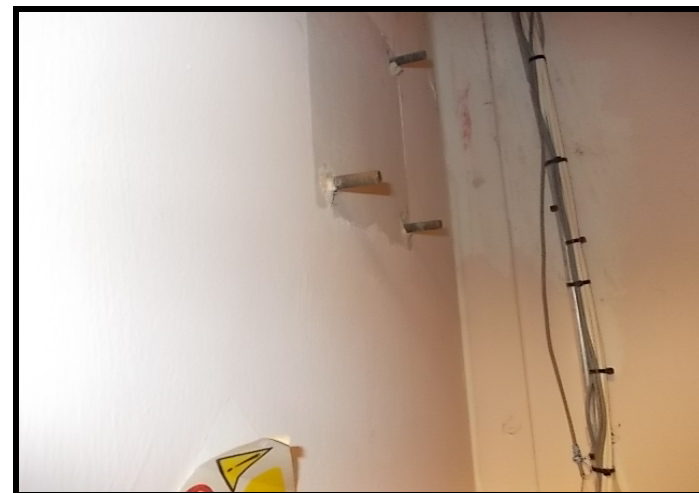
SAMPLE REFERENCE 061

Building	Floor	Room	Location
Main Building	6th Floor	Dry Riser	Wall
Description			
MATERIAL ASSESSMENT			
Product Type	Insulation Board	Extent of Damage	Low damage
Asbestos Type	Amosite / Chrysotile	Surface Treatment	Sealed Board (Encapsulated)
PRIORITY ASSESSMENT			
Occupant Activity	Not Applicable	Extent / Amount	3.00 m2
Accessibility	Occasionally disturb	Location	Not Applicable
Avg Time in Use	Not Applicable	Frequency of Use	Not Applicable
No. of Occupants	Not Applicable	Secondary Activity	Not Applicable
Maintenance	Not Applicable	Maintenance Frequency	Not Applicable
MANAGEMENT ACTION			
Recommendation	LABEL & MONITOR		
Recommendation Due		Next Inspection	11 Jun 2015
Apply Labels	No	Permit to Work Required	No
Survey Type	Management	Lead Surveyor	Gavin Hooper
Survey Date	11 Dec 2014	UKAS Laboratory	NOT SAMPLED (Cross Referenced)
Site Reference	113030000A	Licensed Material	Yes
		Notifiable Non Licensed Work	No

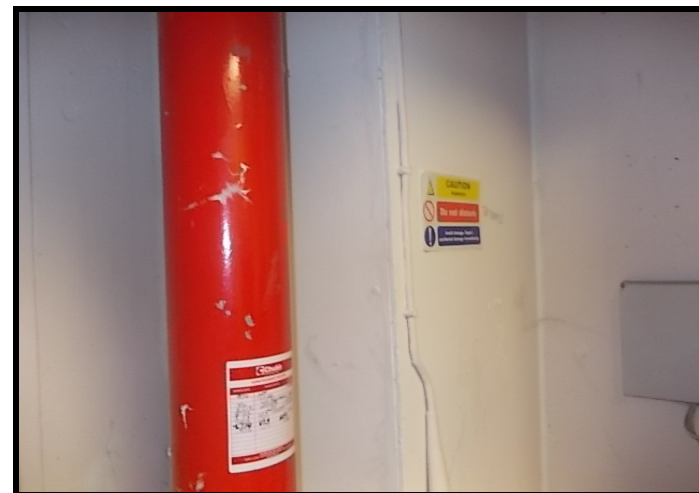
SAMPLE REFERENCE 061a

MATERIAL ASSESSMENT				SCORE
Product Type	Insulation Board	Extent of Damage	Low damage	6
Asbestos Type	Amosite / Chrysotile	Surface Treatment	Sealed Board (Encapsulated)

MANAGEMENT ACTION				SCORE
Recommendation	LABEL & MONITOR			7
Recommendation Due		Next Inspection	11 Jun 2015	
Apply Labels	No	Permit to Work Required	No

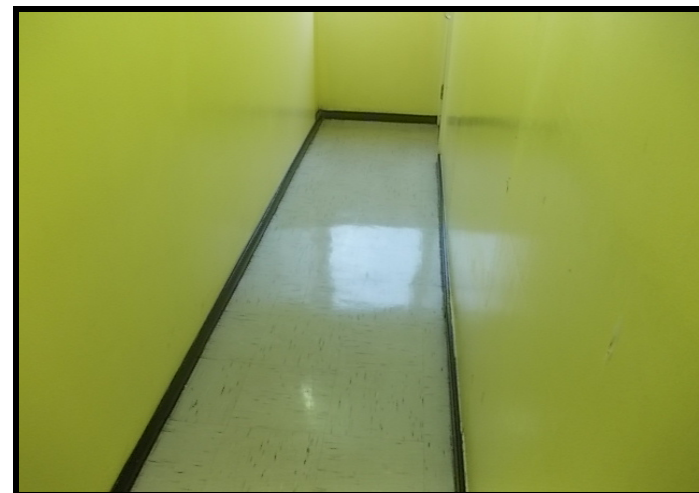
SAMPLE REFERENCE 072a

Building	Floor	Room	Location
Main Building	5th Floor	Lobby 1	Floor
Description			
MATERIAL ASSESSMENT			
Product Type	Floor Tiles	Extent of Damage	Low damage
Asbestos Type	Chrysotile	Surface Treatment	Composite materials
PRIORITY ASSESSMENT			
Occupant Activity	Not Applicable	Extent / Amount	10.00 m2
Accessibility	Easily disturbed	Location	Not Applicable
Avg Time in Use	Not Applicable	Frequency of Use	Not Applicable
No. of Occupants	Not Applicable	Secondary Activity	Not Applicable
Maintenance	Not Applicable	Maintenance Frequency	Not Applicable
MANAGEMENT ACTION			
Recommendation	LABEL & MONITOR		
Recommendation Due		Next Inspection	11 Dec 2015
Apply Labels	No	Permit to Work Required	No
Survey Type	Management	Lead Surveyor	Gavin Hooper
Survey Date	11 Dec 2014	UKAS Laboratory	NOT SAMPLED (Cross Referenced)
Site Reference	113030000A	Licensed Material	No
		Notifiable Non Licensed Work	No

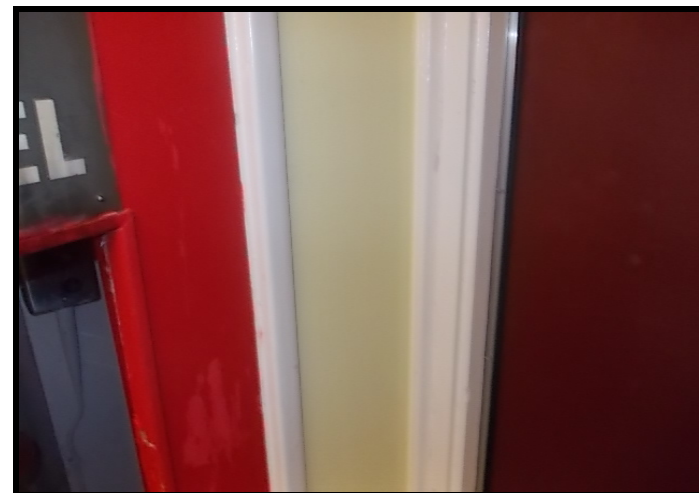
SAMPLE REFERENCE 072d

Building	Floor	Room	Location
Main Building	5th Floor	Lobby 1	Panel
Description			
MATERIAL ASSESSMENT			
Product Type	Cement	Extent of Damage	Low damage
Asbestos Type	Chrysotile	Surface Treatment	Sealed (Cement products)
PRIORITY ASSESSMENT			
Occupant Activity	Not Applicable	Extent / Amount	2.00 m2
Accessibility	Easily disturbed	Location	Not Applicable
Avg Time in Use	Not Applicable	Frequency of Use	Not Applicable
No. of Occupants	Not Applicable	Secondary Activity	Not Applicable
Maintenance	Not Applicable	Maintenance Frequency	Not Applicable
MANAGEMENT ACTION			
Recommendation	LABEL & MONITOR		
Recommendation Due		Next Inspection	None
Apply Labels	No	Permit to Work Required	No
Survey Type	Management	Lead Surveyor	Gavin Hooper
Survey Date	11 Dec 2014	UKAS Laboratory	NOT SAMPLED (Cross Referenced)
Site Reference	113030000A	Licensed Material	No
		Notifiable Non Licensed Work	No

Asbestos Presumed

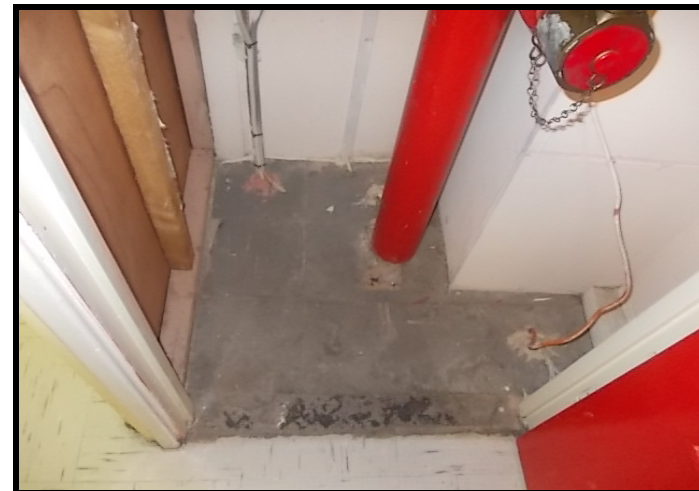
SAMPLE REFERENCE 073

MATERIAL ASSESSMENT				SCORE
Product Type	Floor Tiles	Extent of Damage	Low damage	3
Asbestos Type	Chrysotile	Surface Treatment	Composite materials

Asbestos Presumed

MANAGEMENT ACTION				SCORE
Recommendation	LABEL & MONITOR			4
Recommendation Due		Next Inspection	11 Dec 2015	
Apply Labels	No	Permit to Work Required	No

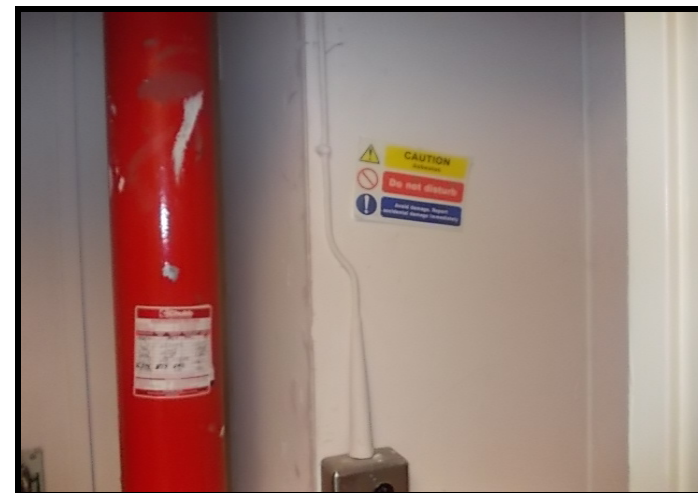
SAMPLE REFERENCE 074

Building	Floor	Room	Location			
Main Building	5th Floor	Dry Riser	Boxing			
Description						
MATERIAL ASSESSMENT				SCORE		
Product Type	Insulation Board	Extent of Damage	Low damage		6	
Asbestos Type	Amosite / Chrysotile	Surface Treatment	Sealed Board (Encapsulated)			
PRIORITY ASSESSMENT				SCORE		
Occupant Activity	Not Applicable	Extent / Amount	3.00 m2		1	
Accessibility	Easily disturbed	Location	Not Applicable			
Avg Time in Use	Not Applicable	Frequency of Use	Not Applicable			
No. of Occupants	Not Applicable	Secondary Activity	Not Applicable			
Maintenance	Not Applicable	Maintenance Frequency	Not Applicable			
MANAGEMENT ACTION				SCORE		
Recommendation	LABEL & MONITOR			7		
Recommendation Due		Next Inspection	11 Jun 2015			
Apply Labels	No	Permit to Work Required	No			
Survey Type	Management	Lead Surveyor	Gavin Hooper			
Survey Date	11 Dec 2014	UKAS Laboratory	NOT SAMPLED (Cross Referenced)			
Site Reference	113030000A	Licensed Material	Yes	Notifiable Non Licensed Work	No

Asbestos Presumed

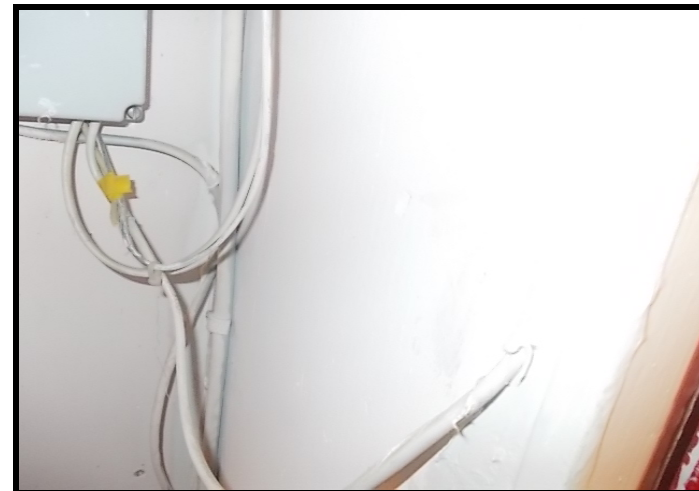
SAMPLE REFERENCE 074a

Building	Floor	Room	Location
Main Building	5th Floor	Dry Riser	Wall
Description			
MATERIAL ASSESSMENT			
Product Type	Insulation Board	Extent of Damage	Low damage
Asbestos Type	Amosite / Chrysotile	Surface Treatment	Sealed Board (Encapsulated)
PRIORITY ASSESSMENT			
Occupant Activity	Not Applicable	Extent / Amount	4.00 m2
Accessibility	Occasionally disturb	Location	Not Applicable
Avg Time in Use	Not Applicable	Frequency of Use	Not Applicable
No. of Occupants	Not Applicable	Secondary Activity	Not Applicable
Maintenance	Not Applicable	Maintenance Frequency	Not Applicable
MANAGEMENT ACTION			
Recommendation	LABEL & MONITOR		
Recommendation Due		Next Inspection	11 Jun 2015
Apply Labels	No	Permit to Work Required	No
Survey Type	Management	Lead Surveyor	Gavin Hooper
Survey Date	11 Dec 2014	UKAS Laboratory	NOT SAMPLED (Cross Referenced)
Site Reference	113030000A	Licensed Material	Yes
		Notifiable Non Licensed Work	No

Asbestos Presumed
