Solihull Community Housing

Asbestos Management Survey Report

Merton House I-43 (Communal)
Crabtree Drive
Solihull
B37 5BX

Date of Report: 25 Feb 2015

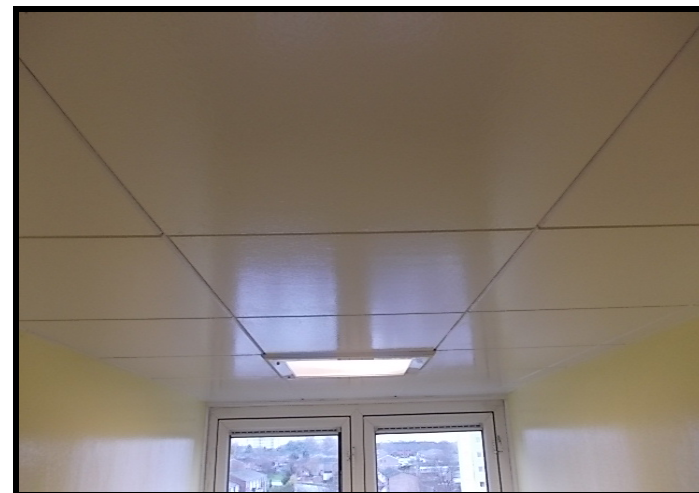
SAMPLE REFERENCE 076

Building	Floor	Room	Location		
Main Building	5th Floor	Lobby 2	Ceiling		
Description					
MATERIAL ASSESSMENT					SCORE
Product Type	Insulation Board	Extent of Damage	Low damage		-
Asbestos Type	No Asbestos Detected	Surface Treatment	Sealed Board (Encapsulated)		
PRIORITY ASSESSMENT					SCORE
Occupant Activity	Not Applicable	Extent / Amount	10.00 m2		-
Accessibility	Easily disturbed	Location	Not Applicable		
Avg Time in Use	Not Applicable	Frequency of Use	Not Applicable		
No. of Occupants	Not Applicable	Secondary Activity	Not Applicable		
Maintenance	Not Applicable	Maintenance Frequency	Not Applicable		
MANAGEMENT ACTION					SCORE
Recommendation	NO ACTION REQUIRED				-
Recommendation Due		Next Inspection	None		
Apply Labels	No	Permit to Work Required	No		
Survey Type	Management	Lead Surveyor	Gavin Hooper		
Survey Date	11 Dec 2014	UKAS Laboratory	NOT SAMPLED (Cross Referenced)		
Site Reference	113030000A	Licensed Material	N/A	Notifiable Non Licensed Work	N/A

No Asbestos Presumed in Sample

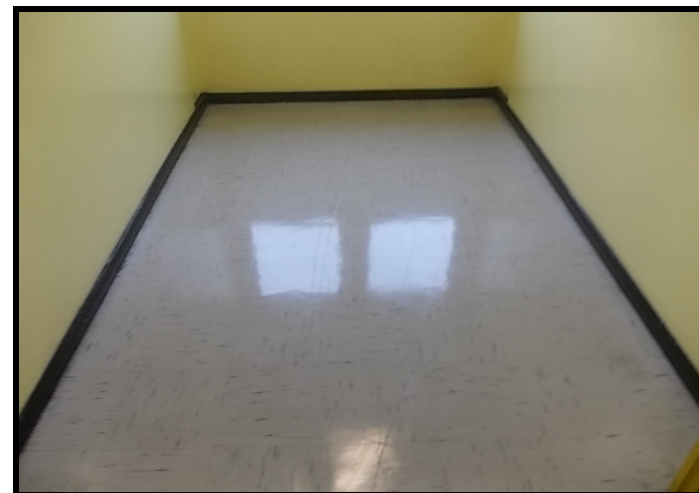
SAMPLE REFERENCE 077

MATERIAL ASSESSMENT				SCORE
Product Type	Floor Tiles	Extent of Damage	Low damage	3
Asbestos Type	Chrysotile	Surface Treatment	Composite materials

MANAGEMENT ACTION				SCORE
Recommendation	LABEL & MONITOR			4
Recommendation Due		Next Inspection	11 Dec 2015	
Apply Labels	No	Permit to Work Required	No

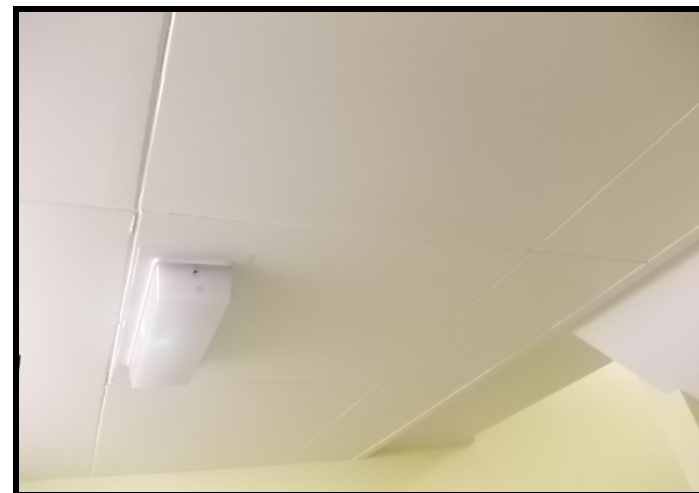
SAMPLE REFERENCE 080

MATERIAL ASSESSMENT				SCORE
Product Type	Insulation Board	Extent of Damage	Low damage	-
Asbestos Type	No Asbestos Detected	Surface Treatment	Sealed Board (Encapsulated)

No Asbestos Presumed in Sample

MANAGEMENT ACTION				SCORE
Recommendation	NO ACTION REQUIRED			-
Recommendation Due		Next Inspection	None	
Apply Labels	No	Permit to Work Required	No

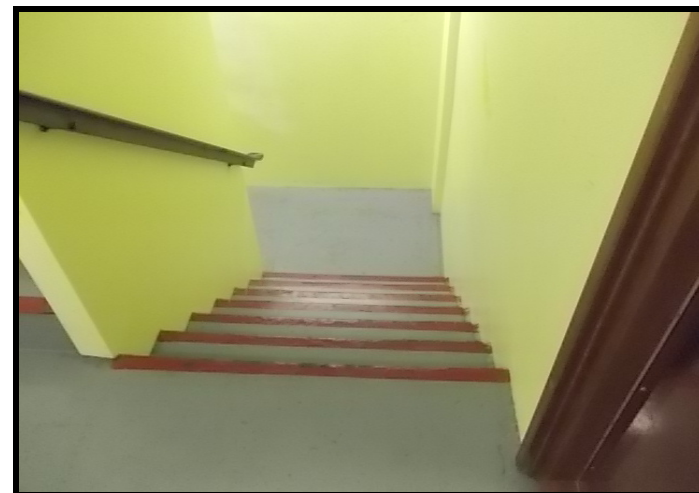
SAMPLE REFERENCE 080a

MATERIAL ASSESSMENT				SCORE
Product Type	Bitumen	Extent of Damage	Low damage	3
Asbestos Type	Chrysotile	Surface Treatment	Composite materials

MANAGEMENT ACTION				SCORE
Recommendation	LABEL & MONITOR			4
Recommendation Due		Next Inspection	11 Dec 2015	
Apply Labels	No	Permit to Work Required	No

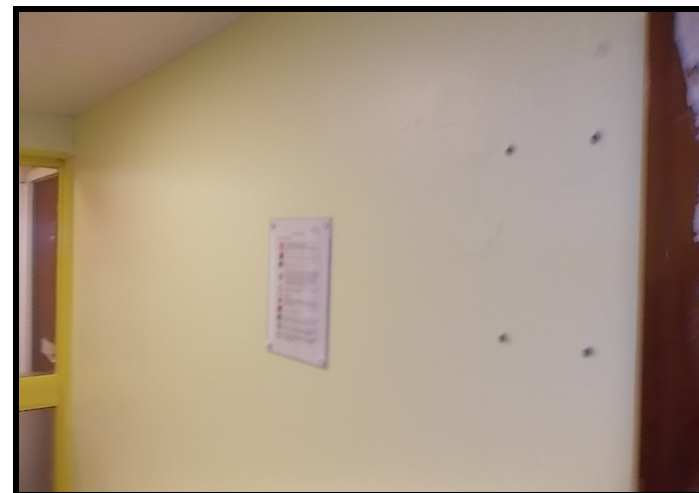
SAMPLE REFERENCE 081

Building	Floor	Room	Location		
Main Building	4th Floor	Lobby 1	Wall		
Description					
MATERIAL ASSESSMENT					SCORE
Product Type	Textured Coating	Extent of Damage	Low damage		-
Asbestos Type	No Asbestos Detected	Surface Treatment	Textured Coating		
PRIORITY ASSESSMENT					SCORE
Occupant Activity	Not Applicable	Extent / Amount	10.00 m2		-
Accessibility	Occasionally disturb	Location	Not Applicable		
Avg Time in Use	Not Applicable	Frequency of Use	Not Applicable		
No. of Occupants	Not Applicable	Secondary Activity	Not Applicable		
Maintenance	Not Applicable	Maintenance Frequency	Not Applicable		
MANAGEMENT ACTION					SCORE
Recommendation	NO ACTION REQUIRED				-
Recommendation Due		Next Inspection	None		
Apply Labels	No	Permit to Work Required	No		
Survey Type	Management	Lead Surveyor	Gavin Hooper		
Survey Date	11 Dec 2014	UKAS Laboratory	NOT SAMPLED (Cross Referenced)		
Site Reference	113030000A	Licensed Material	N/A	Notifiable Non Licensed Work	N/A

No Asbestos Presumed in Sample

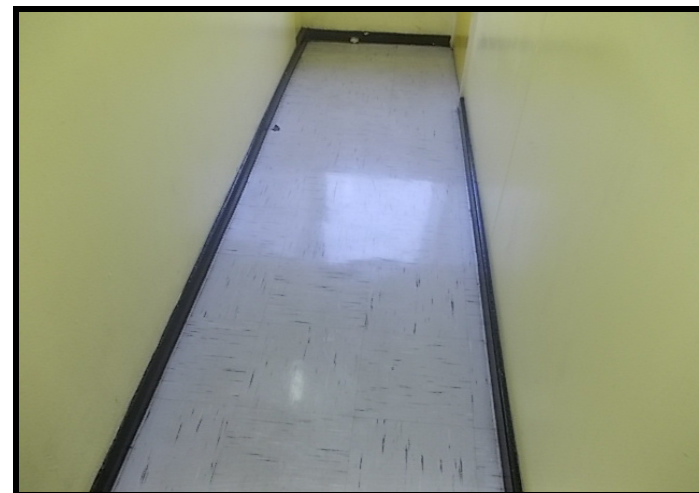
SAMPLE REFERENCE 082a

Building	Floor	Room	Location
Main Building	4th Floor	Lobby 1	Floor
Description			
MATERIAL ASSESSMENT			
Product Type	Floor Tiles	Extent of Damage	Low damage
Asbestos Type	Chrysotile	Surface Treatment	Composite materials
PRIORITY ASSESSMENT			
Occupant Activity	Not Applicable	Extent / Amount	10.00 m2
Accessibility	Easily disturbed	Location	Not Applicable
Avg Time in Use	Not Applicable	Frequency of Use	Not Applicable
No. of Occupants	Not Applicable	Secondary Activity	Not Applicable
Maintenance	Not Applicable	Maintenance Frequency	Not Applicable
MANAGEMENT ACTION			
Recommendation	LABEL & MONITOR		
Recommendation Due		Next Inspection	11 Dec 2015
Apply Labels	No	Permit to Work Required	No
Survey Type	Management	Lead Surveyor	Gavin Hooper
Survey Date	11 Dec 2014	UKAS Laboratory	NOT SAMPLED (Cross Referenced)
Site Reference	113030000A	Licensed Material	No
		Notifiable Non Licensed Work	No

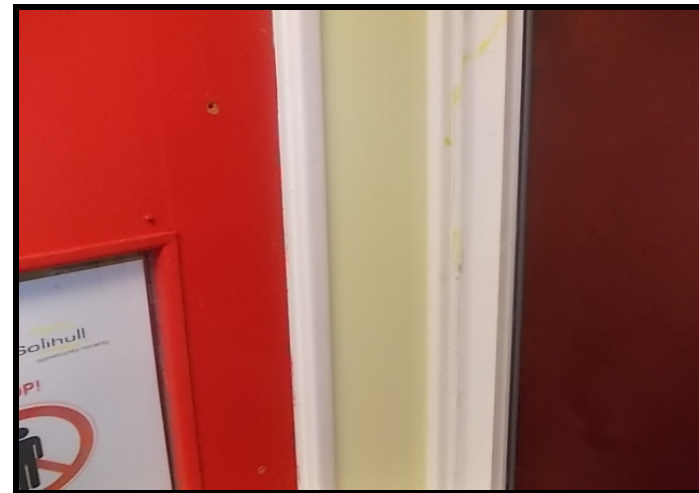
SAMPLE REFERENCE 082b

MATERIAL ASSESSMENT				SCORE
Product Type	Cement	Extent of Damage	Low damage	4
Asbestos Type	Chrysotile	Surface Treatment	Sealed (Cement products)

MANAGEMENT ACTION				SCORE
Recommendation	LABEL & MONITOR			5
Recommendation Due		Next Inspection	11 Dec 2015	
Apply Labels	No	Permit to Work Required	No

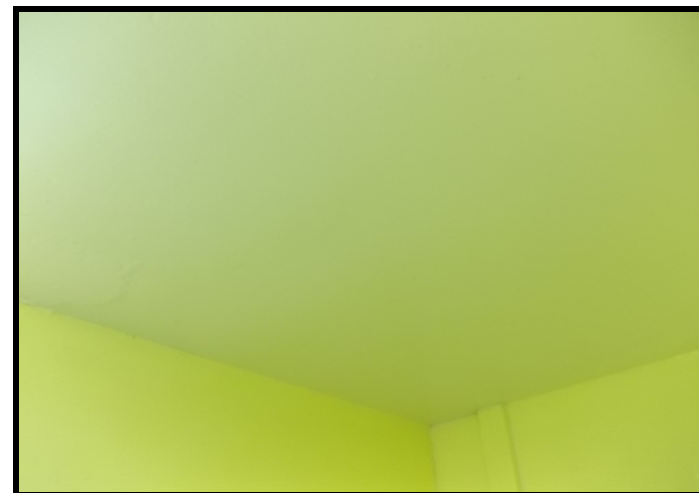
SAMPLE REFERENCE 085

Building	Floor	Room	Location		
Main Building	4th Floor	Bin Shute	Ceiling		
Description					
MATERIAL ASSESSMENT					SCORE
Product Type	Textured Coating	Extent of Damage	Low damage		-
Asbestos Type	No Asbestos Detected	Surface Treatment	Textured Coating		
PRIORITY ASSESSMENT					SCORE
Occupant Activity	Not Applicable	Extent / Amount	8.00 m2		-
Accessibility	Occasionally disturb	Location	Not Applicable		
Avg Time in Use	Not Applicable	Frequency of Use	Not Applicable		
No. of Occupants	Not Applicable	Secondary Activity	Not Applicable		
Maintenance	Not Applicable	Maintenance Frequency	Not Applicable		
MANAGEMENT ACTION					SCORE
Recommendation	NO ACTION REQUIRED				-
Recommendation Due		Next Inspection	None		
Apply Labels	No	Permit to Work Required	No		
Survey Type	Management	Lead Surveyor	Gavin Hooper		
Survey Date	11 Dec 2014	UKAS Laboratory	NOT SAMPLED (Cross Referenced)		
Site Reference	113030000A	Licensed Material	N/A	Notifiable Non Licensed Work	N/A

No Asbestos Presumed in Sample

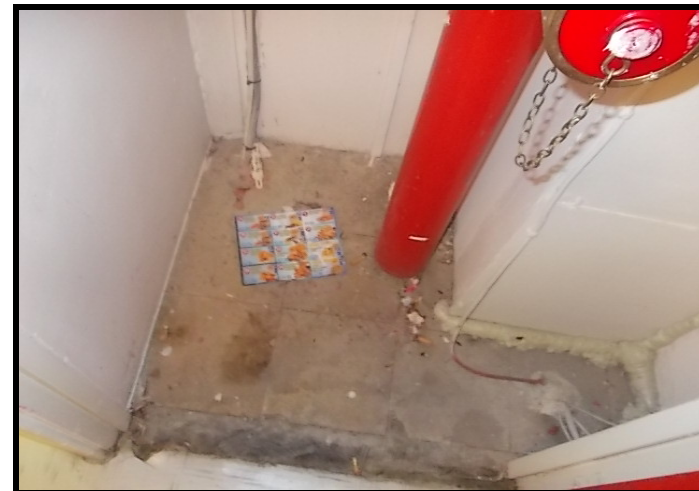
SAMPLE REFERENCE 086

Building	Floor	Room	Location		
Main Building	4th Floor	Dry Riser	Floor		
Description					
MATERIAL ASSESSMENT				SCORE	
Product Type	Floor Tiles	Extent of Damage	Low damage	3	
Asbestos Type	Chrysotile	Surface Treatment	Composite materials		
PRIORITY ASSESSMENT				SCORE	
Occupant Activity	Not Applicable	Extent / Amount	5.00 m2	1	
Accessibility	Easily disturbed	Location	Not Applicable		
Avg Time in Use	Not Applicable	Frequency of Use	Not Applicable		
No. of Occupants	Not Applicable	Secondary Activity	Not Applicable		
Maintenance	Not Applicable	Maintenance Frequency	Not Applicable		
MANAGEMENT ACTION				SCORE	
Recommendation	LABEL & MONITOR			4	
Recommendation Due		Next Inspection	11 Dec 2015		
Apply Labels	No	Permit to Work Required	No		
Survey Type	Management	Lead Surveyor	Gavin Hooper		
Survey Date	11 Dec 2014	UKAS Laboratory	NOT SAMPLED (Cross Referenced)		
Site Reference	113030000A	Licensed Material	No	Notifiable Non Licensed Work	No

Asbestos Presumed

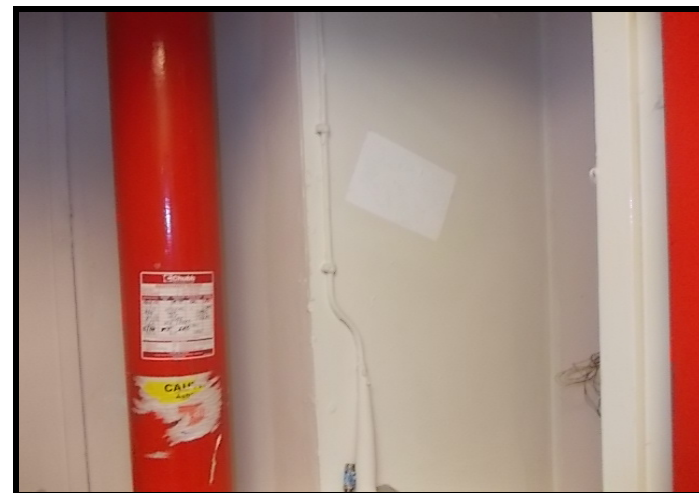
SAMPLE REFERENCE 087

MATERIAL ASSESSMENT				SCORE
Product Type	Insulation Board	Extent of Damage	Low damage	6
Asbestos Type	Amosite / Chrysotile	Surface Treatment	Sealed Board (Encapsulated)

MANAGEMENT ACTION				SCORE
Recommendation	LABEL & MONITOR			7
Recommendation Due		Next Inspection	11 Jun 2015	
Apply Labels	No	Permit to Work Required	No

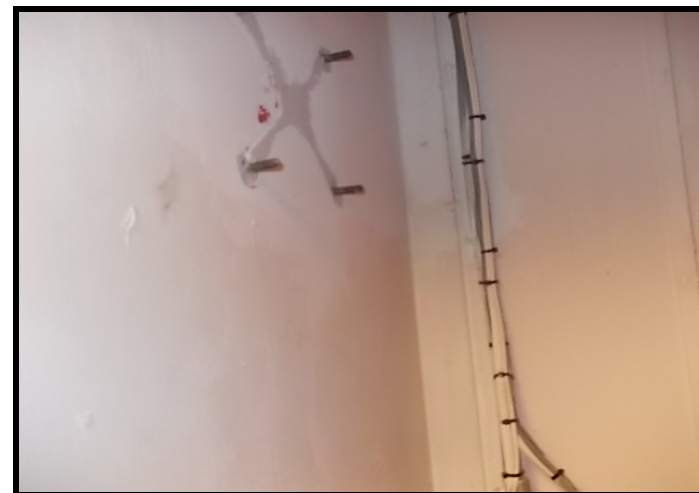
SAMPLE REFERENCE 088

MATERIAL ASSESSMENT				SCORE
Product Type	Insulation Board	Extent of Damage	Low damage	6
Asbestos Type	Amosite / Chrysotile	Surface Treatment	Sealed Board (Encapsulated)

MANAGEMENT ACTION				SCORE
Recommendation	LABEL & MONITOR			7
Recommendation Due		Next Inspection	11 Jun 2015	
Apply Labels	No	Permit to Work Required	No

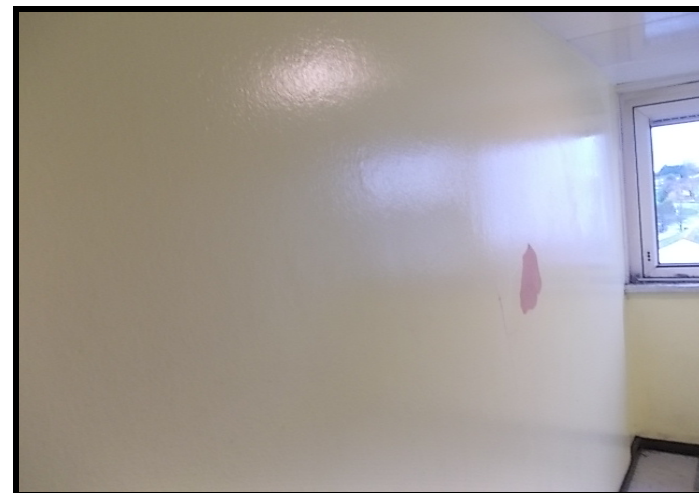
SAMPLE REFERENCE 089

Building	Floor	Room	Location		
Main Building	4th Floor	Lobby 2	Wall		
Description					
MATERIAL ASSESSMENT					SCORE
Product Type	Textured Coating	Extent of Damage	Low damage		-
Asbestos Type	No Asbestos Detected	Surface Treatment	Textured Coating		
PRIORITY ASSESSMENT					SCORE
Occupant Activity	Not Applicable	Extent / Amount	10.00 m2		-
Accessibility	Occasionally disturb	Location	Not Applicable		
Avg Time in Use	Not Applicable	Frequency of Use	Not Applicable		
No. of Occupants	Not Applicable	Secondary Activity	Not Applicable		
Maintenance	Not Applicable	Maintenance Frequency	Not Applicable		
MANAGEMENT ACTION					SCORE
Recommendation	NO ACTION REQUIRED				-
Recommendation Due		Next Inspection	None		
Apply Labels	No	Permit to Work Required	No		
Survey Type	Management	Lead Surveyor	Gavin Hooper		
Survey Date	11 Dec 2014	UKAS Laboratory	NOT SAMPLED (Cross Referenced)		
Site Reference	113030000A	Licensed Material	N/A	Notifiable Non Licensed Work	N/A

No Asbestos Presumed in Sample

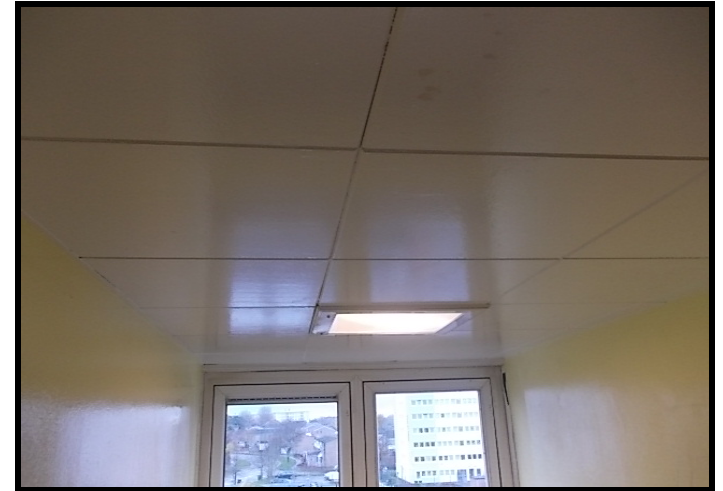
SAMPLE REFERENCE 090

Building	Floor	Room	Location			
Main Building	4th Floor	Lobby 2	Ceiling			
Description						
MATERIAL ASSESSMENT				SCORE		
Product Type	Insulation Board	Extent of Damage	Low damage		-	
Asbestos Type	No Asbestos Detected	Surface Treatment	Sealed Board (Encapsulated)			
PRIORITY ASSESSMENT				SCORE		
Occupant Activity	Not Applicable	Extent / Amount	10.00 m2		-	
Accessibility	Easily disturbed	Location	Not Applicable			
Avg Time in Use	Not Applicable	Frequency of Use	Not Applicable			
No. of Occupants	Not Applicable	Secondary Activity	Not Applicable			
Maintenance	Not Applicable	Maintenance Frequency	Not Applicable			
MANAGEMENT ACTION				SCORE		
Recommendation	NO ACTION REQUIRED			-		
Recommendation Due		Next Inspection	None			
Apply Labels	No	Permit to Work Required	No			
Survey Type	Management	Lead Surveyor	Gavin Hooper			
Survey Date	11 Dec 2014	UKAS Laboratory	NOT SAMPLED (Cross Referenced)			
Site Reference	113030000A	Licensed Material	N/A	Notifiable Non Licensed Work	N/A

No Asbestos Presumed in Sample

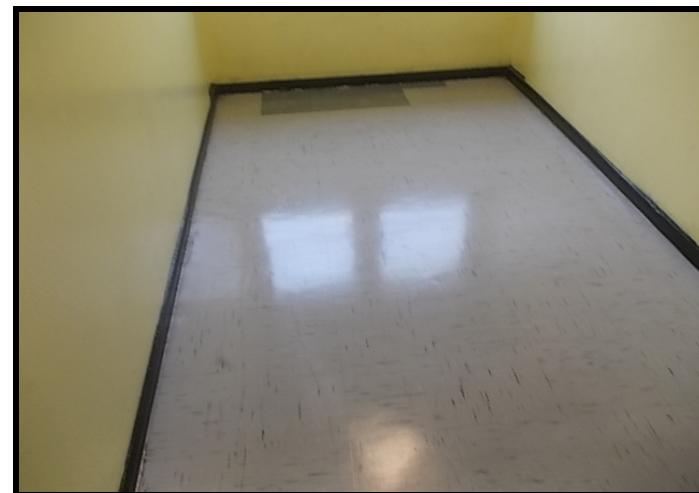
SAMPLE REFERENCE 091

MATERIAL ASSESSMENT				SCORE
Product Type	Floor Tiles	Extent of Damage	Low damage	3
Asbestos Type	Chrysotile	Surface Treatment	Composite materials

MANAGEMENT ACTION				SCORE
Recommendation	LABEL & MONITOR			4
Recommendation Due		Next Inspection	11 Dec 2015	
Apply Labels	No	Permit to Work Required	No

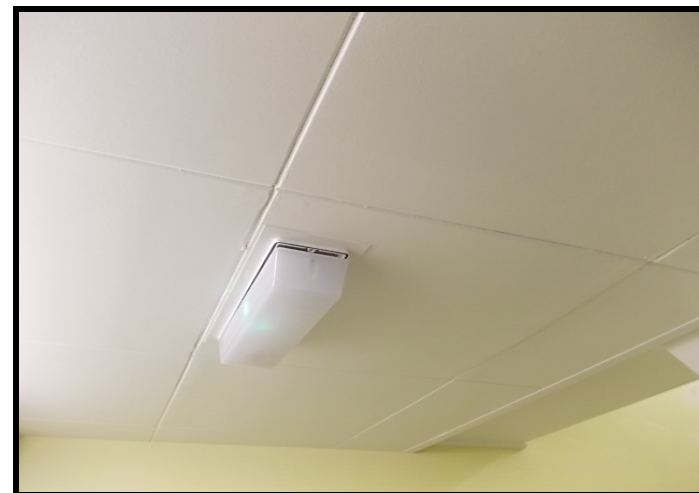
SAMPLE REFERENCE 094

Building	Floor	Room	Location		
Main Building	4th - 3rd Floor	Stairwell	Ceiling		
Description					
MATERIAL ASSESSMENT					SCORE
Product Type	Insulation Board	Extent of Damage	Low damage		-
Asbestos Type	No Asbestos Detected	Surface Treatment	Sealed Board (Encapsulated)		
PRIORITY ASSESSMENT					SCORE
Occupant Activity	Not Applicable	Extent / Amount	10.00 m2		-
Accessibility	Easily disturbed	Location	Not Applicable		
Avg Time in Use	Not Applicable	Frequency of Use	Not Applicable		
No. of Occupants	Not Applicable	Secondary Activity	Not Applicable		
Maintenance	Not Applicable	Maintenance Frequency	Not Applicable		
MANAGEMENT ACTION					SCORE
Recommendation	NO ACTION REQUIRED				-
Recommendation Due		Next Inspection	None		
Apply Labels	No	Permit to Work Required	No		
Survey Type	Management	Lead Surveyor	Gavin Hooper		
Survey Date	11 Dec 2014	UKAS Laboratory	NOT SAMPLED (Cross Referenced)		
Site Reference	113030000A	Licensed Material	N/A	Notifiable Non Licensed Work	N/A

No Asbestos Presumed in Sample

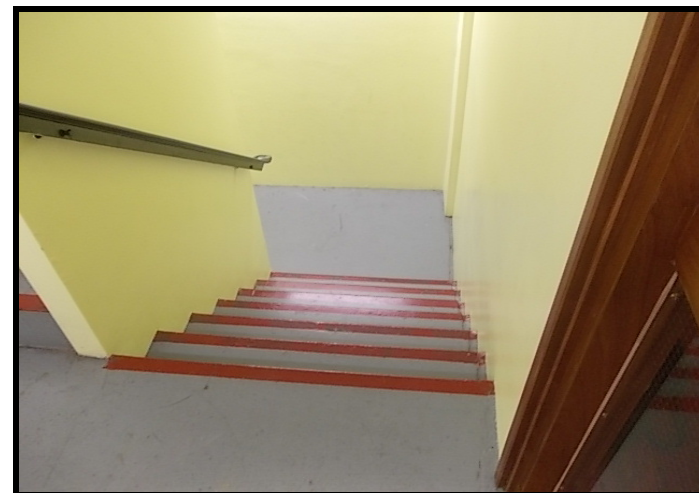
SAMPLE REFERENCE 094a

Building	Floor	Room	Location
Main Building	4th - 3rd Floor	Stairwell	Staircase
Description			
MATERIAL ASSESSMENT			
Product Type	Bitumen	Extent of Damage	Low damage
Asbestos Type	Chrysotile	Surface Treatment	Composite materials
PRIORITY ASSESSMENT			
Occupant Activity	Not Applicable	Extent / Amount	14.00 small item(s)
Accessibility	Routinely disturbed	Location	Not Applicable
Avg Time in Use	Not Applicable	Frequency of Use	Not Applicable
No. of Occupants	Not Applicable	Secondary Activity	Not Applicable
Maintenance	Not Applicable	Maintenance Frequency	Not Applicable
MANAGEMENT ACTION			
Recommendation	LABEL & MONITOR		
Recommendation Due		Next Inspection	11 Dec 2015
Apply Labels	No	Permit to Work Required	No
Survey Type	Management	Lead Surveyor	Gavin Hooper
Survey Date	11 Dec 2014	UKAS Laboratory	NOT SAMPLED (Cross Referenced)
Site Reference	113030000A	Licensed Material	No
		Notifiable Non Licensed Work	No

Asbestos Presumed

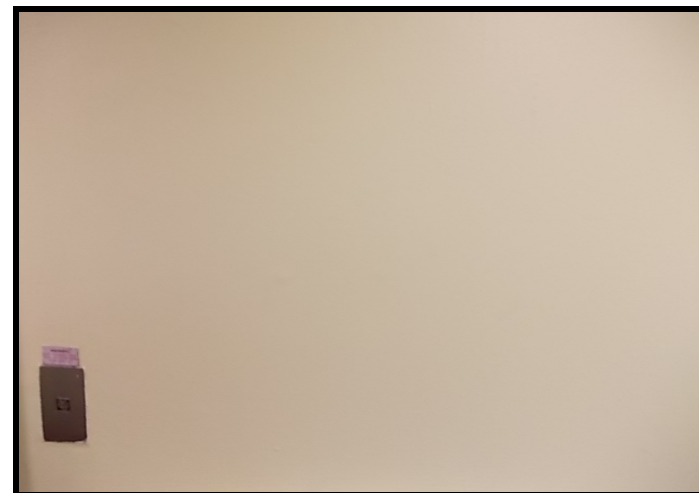
SAMPLE REFERENCE 095

Building	Floor	Room	Location		
Main Building	3rd Floor	Lift Lobby	Wall		
Description					
MATERIAL ASSESSMENT					SCORE
Product Type	Textured Coating	Extent of Damage	Low damage		-
Asbestos Type	No Asbestos Detected	Surface Treatment	Textured Coating		
PRIORITY ASSESSMENT					SCORE
Occupant Activity	Not Applicable	Extent / Amount	10.00 m2		-
Accessibility	Occasionally disturb	Location	Not Applicable		
Avg Time in Use	Not Applicable	Frequency of Use	Not Applicable		
No. of Occupants	Not Applicable	Secondary Activity	Not Applicable		
Maintenance	Not Applicable	Maintenance Frequency	Not Applicable		
MANAGEMENT ACTION					SCORE
Recommendation	NO ACTION REQUIRED				-
Recommendation Due		Next Inspection	None		
Apply Labels	No	Permit to Work Required	No		
Survey Type	Management	Lead Surveyor	Gavin Hooper		
Survey Date	11 Dec 2014	UKAS Laboratory	NOT SAMPLED (Cross Referenced)		
Site Reference	113030000A	Licensed Material	N/A	Notifiable Non Licensed Work	N/A

No Asbestos Presumed in Sample

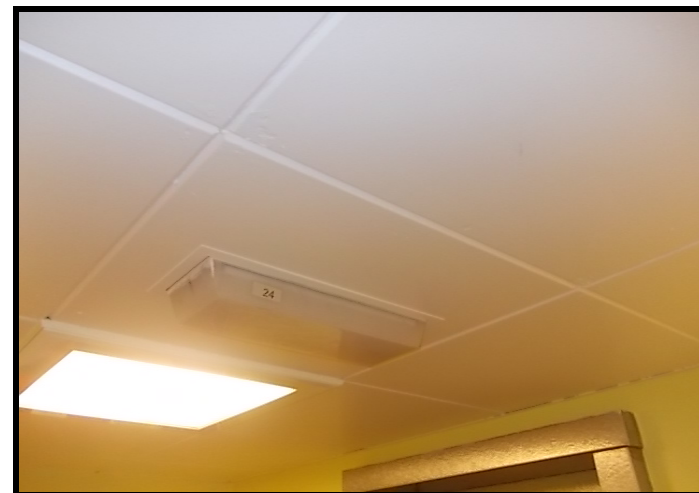
SAMPLE REFERENCE 096

Building	Floor	Room	Location		
Main Building	3rd Floor	Lift Lobby	Ceiling		
Description					
MATERIAL ASSESSMENT					SCORE
Product Type	Insulation Board	Extent of Damage	Low damage		-
Asbestos Type	No Asbestos Detected	Surface Treatment	Sealed Board (Encapsulated)		
PRIORITY ASSESSMENT					SCORE
Occupant Activity	Not Applicable	Extent / Amount	10.00 m2		-
Accessibility	Easily disturbed	Location	Not Applicable		
Avg Time in Use	Not Applicable	Frequency of Use	Not Applicable		
No. of Occupants	Not Applicable	Secondary Activity	Not Applicable		
Maintenance	Not Applicable	Maintenance Frequency	Not Applicable		
MANAGEMENT ACTION					SCORE
Recommendation	NO ACTION REQUIRED				-
Recommendation Due		Next Inspection	None		
Apply Labels	No	Permit to Work Required	No		
Survey Type	Management	Lead Surveyor	Gavin Hooper		
Survey Date	11 Dec 2014	UKAS Laboratory	NOT SAMPLED (Cross Referenced)		
Site Reference	113030000A	Licensed Material	N/A	Notifiable Non Licensed Work	N/A

No Asbestos Presumed in Sample

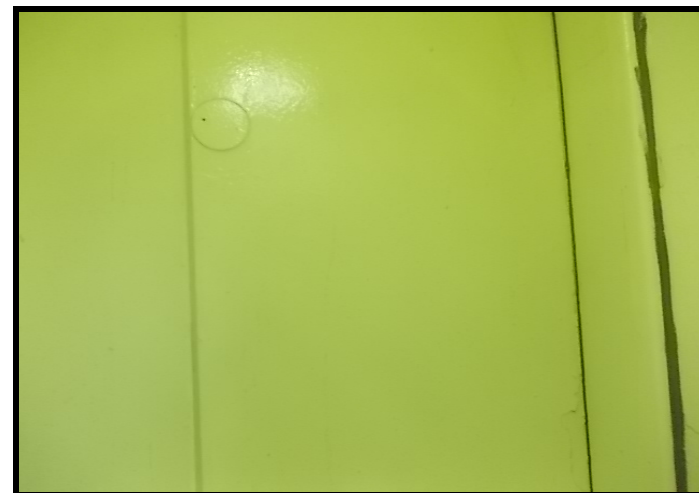
SAMPLE REFERENCE 097

MATERIAL ASSESSMENT				SCORE
Product Type	Textured Coating	Extent of Damage	Low damage	-
Asbestos Type	No Asbestos Detected	Surface Treatment	Textured Coating

No Asbestos Presumed in Sample

MANAGEMENT ACTION				SCORE
Recommendation	NO ACTION REQUIRED			-
Recommendation Due		Next Inspection	None	
Apply Labels	No	Permit to Work Required	No

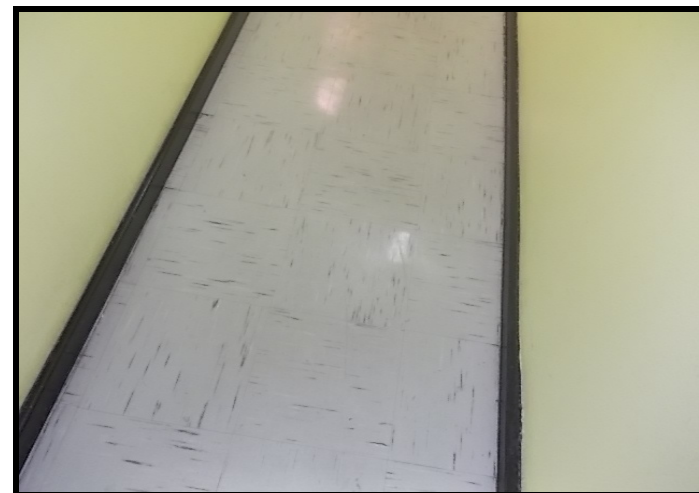
SAMPLE REFERENCE 098

Building	Floor	Room	Location
Main Building	3rd Floor	Lobby 1	Floor
Description			
MATERIAL ASSESSMENT			
Product Type	Floor Tiles	Extent of Damage	Low damage
Asbestos Type	Chrysotile	Surface Treatment	Composite materials
PRIORITY ASSESSMENT			
Occupant Activity	Not Applicable	Extent / Amount	5.00 m2
Accessibility	Easily disturbed	Location	Not Applicable
Avg Time in Use	Not Applicable	Frequency of Use	Not Applicable
No. of Occupants	Not Applicable	Secondary Activity	Not Applicable
Maintenance	Not Applicable	Maintenance Frequency	Not Applicable
MANAGEMENT ACTION			
Recommendation	LABEL & MONITOR		
Recommendation Due		Next Inspection	11 Dec 2015
Apply Labels	No	Permit to Work Required	No
Survey Type	Management	Lead Surveyor	Gavin Hooper
Survey Date	11 Dec 2014	UKAS Laboratory	NOT SAMPLED (Cross Referenced)
Site Reference	113030000A	Licensed Material	No
		Notifiable Non Licensed Work	No

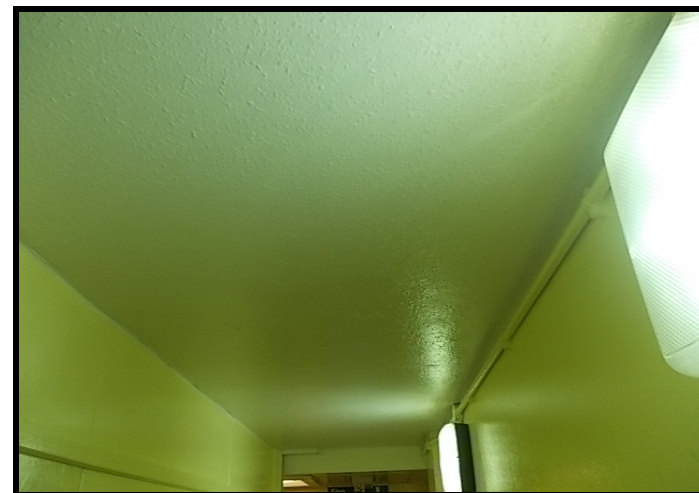
SAMPLE REFERENCE 099

Building	Floor	Room	Location		
Main Building	3rd Floor	Lobby 1	Ceiling		
Description					
MATERIAL ASSESSMENT					SCORE
Product Type	Textured Coating	Extent of Damage	Low damage		-
Asbestos Type	No Asbestos Detected	Surface Treatment	Textured Coating		
PRIORITY ASSESSMENT					SCORE
Occupant Activity	Not Applicable	Extent / Amount	8.00 m2		-
Accessibility	Occasionally disturb	Location	Not Applicable		
Avg Time in Use	Not Applicable	Frequency of Use	Not Applicable		
No. of Occupants	Not Applicable	Secondary Activity	Not Applicable		
Maintenance	Not Applicable	Maintenance Frequency	Not Applicable		
MANAGEMENT ACTION					SCORE
Recommendation	NO ACTION REQUIRED				-
Recommendation Due		Next Inspection	None		
Apply Labels	No	Permit to Work Required	No		
Survey Type	Management	Lead Surveyor	Gavin Hooper		
Survey Date	11 Dec 2014	UKAS Laboratory	NOT SAMPLED (Cross Referenced)		
Site Reference	113030000A	Licensed Material	N/A	Notifiable Non Licensed Work	N/A

No Asbestos Presumed in Sample

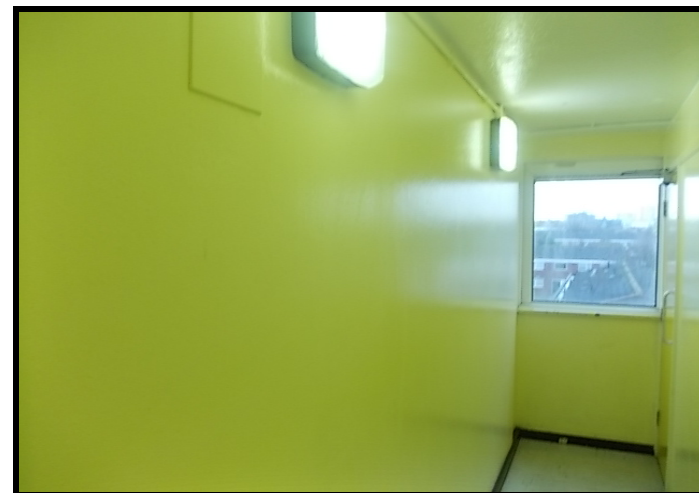
SAMPLE REFERENCE 099a

Building	Floor	Room	Location		
Main Building	3rd Floor	Lobby I	Wall		
Description					
MATERIAL ASSESSMENT					SCORE
Product Type	Textured Coating	Extent of Damage	Low damage		-
Asbestos Type	No Asbestos Detected	Surface Treatment	Textured Coating		
PRIORITY ASSESSMENT					SCORE
Occupant Activity	Not Applicable	Extent / Amount	10.00 m2		-
Accessibility	Easily disturbed	Location	Not Applicable		
Avg Time in Use	Not Applicable	Frequency of Use	Not Applicable		
No. of Occupants	Not Applicable	Secondary Activity	Not Applicable		
Maintenance	Not Applicable	Maintenance Frequency	Not Applicable		
MANAGEMENT ACTION					SCORE
Recommendation	NO ACTION REQUIRED				-
Recommendation Due		Next Inspection	None		
Apply Labels	No	Permit to Work Required	No		
Survey Type	Management	Lead Surveyor	Gavin Hooper		
Survey Date	11 Dec 2014	UKAS Laboratory	NOT SAMPLED (Cross Referenced)		
Site Reference	113030000A	Licensed Material	N/A	Notifiable Non Licensed Work	N/A

No Asbestos Presumed in Sample

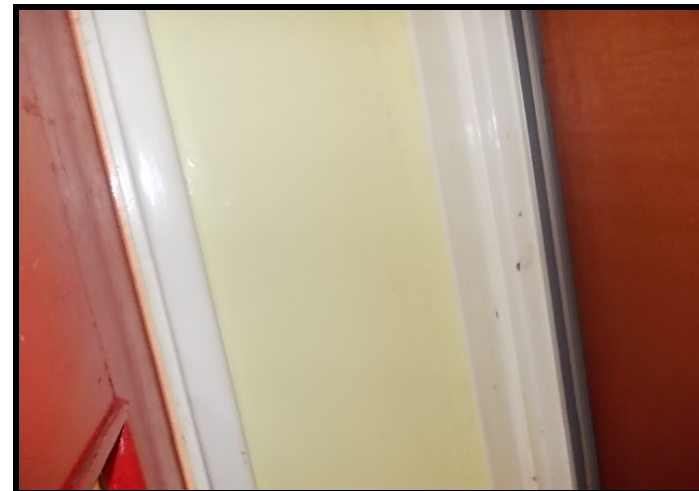
SAMPLE REFERENCE 099b

Building	Floor	Room	Location		
Main Building	3rd Floor	Lobby 1	Panel		
Description					
MATERIAL ASSESSMENT				SCORE	
Product Type	Cement	Extent of Damage	Low damage	4	
Asbestos Type	Chrysotile	Surface Treatment	Sealed (Cement products)		
PRIORITY ASSESSMENT				SCORE	
Occupant Activity	Not Applicable	Extent / Amount	2.00 m2	1	
Accessibility	Easily disturbed	Location	Not Applicable		
Avg Time in Use	Not Applicable	Frequency of Use	Not Applicable		
No. of Occupants	Not Applicable	Secondary Activity	Not Applicable		
Maintenance	Not Applicable	Maintenance Frequency	Not Applicable		
MANAGEMENT ACTION				SCORE	
Recommendation	LABEL & MONITOR			5	
Recommendation Due		Next Inspection	11 Dec 2015		
Apply Labels	No	Permit to Work Required	No		
Survey Type	Management	Lead Surveyor	Gavin Hooper		
Survey Date	11 Dec 2014	UKAS Laboratory	NOT SAMPLED (Cross Referenced)		
Site Reference	113030000A	Licensed Material	No	Notifiable Non Licensed Work	No

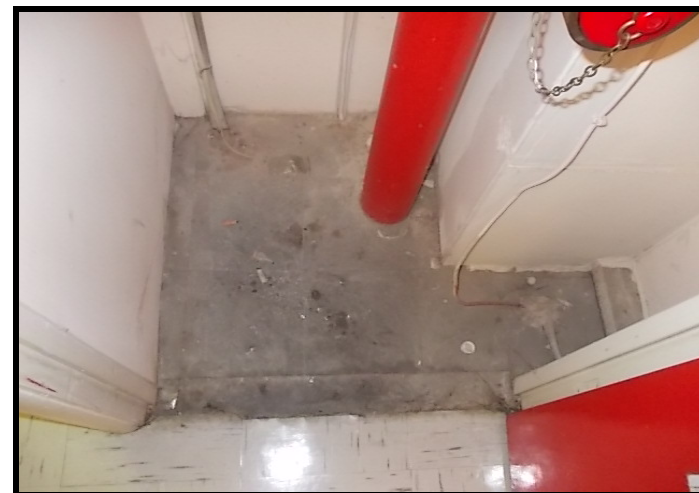
SAMPLE REFERENCE 100

Building	Floor	Room	Location
Main Building	3rd Floor	Dry Riser	Floor
Description			
MATERIAL ASSESSMENT			
Product Type	Floor Tiles	Extent of Damage	Low damage
Asbestos Type	Chrysotile	Surface Treatment	Composite materials
PRIORITY ASSESSMENT			
Occupant Activity	Not Applicable	Extent / Amount	5.00 m2
Accessibility	Easily disturbed	Location	Not Applicable
Avg Time in Use	Not Applicable	Frequency of Use	Not Applicable
No. of Occupants	Not Applicable	Secondary Activity	Not Applicable
Maintenance	Not Applicable	Maintenance Frequency	Not Applicable
MANAGEMENT ACTION			
Recommendation	LABEL & MONITOR		
Recommendation Due		Next Inspection	11 Dec 2015
Apply Labels	No	Permit to Work Required	No
Survey Type	Management	Lead Surveyor	Gavin Hooper
Survey Date	11 Dec 2014	UKAS Laboratory	NOT SAMPLED (Cross Referenced)
Site Reference	113030000A	Licensed Material	No
		Notifiable Non Licensed Work	No

Asbestos Presumed

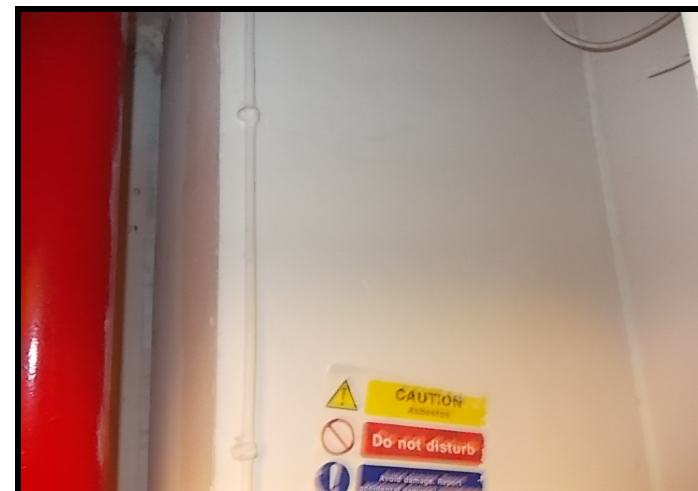
SAMPLE REFERENCE 101

MATERIAL ASSESSMENT				SCORE
Product Type	Insulation Board	Extent of Damage	Low damage	6
Asbestos Type	Amosite / Chrysotile	Surface Treatment	Sealed Board (Encapsulated)

Asbestos Presumed

MANAGEMENT ACTION				SCORE
Recommendation	LABEL & MONITOR			7
Recommendation Due		Next Inspection	11 Jun 2015	
Apply Labels	No	Permit to Work Required	No

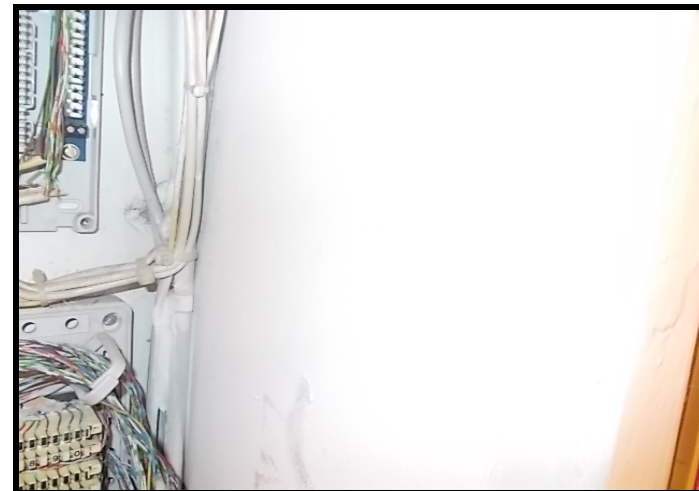
SAMPLE REFERENCE 101a

MATERIAL ASSESSMENT				SCORE
Product Type	Insulation Board	Extent of Damage	Low damage	6
Asbestos Type	Amosite / Chrysotile	Surface Treatment	Sealed Board (Encapsulated)

MANAGEMENT ACTION				SCORE
Recommendation	LABEL & MONITOR			7
Recommendation Due		Next Inspection	11 Jun 2015	
Apply Labels	No	Permit to Work Required	No

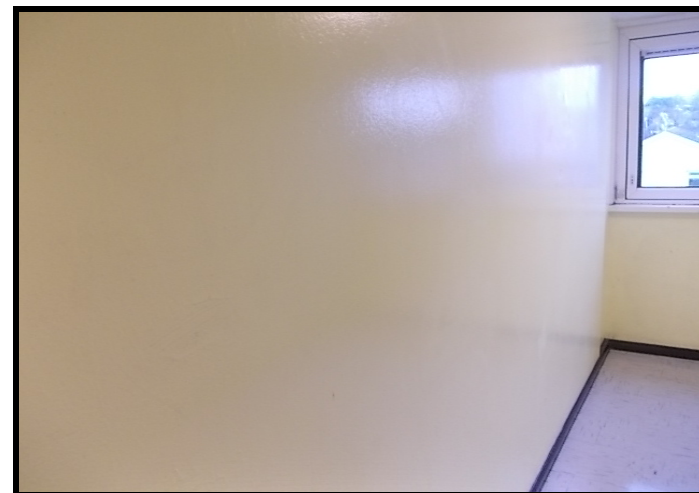
SAMPLE REFERENCE 102

Building	Floor	Room	Location		
Main Building	3rd Floor	Lobby 2	Wall		
Description					
MATERIAL ASSESSMENT					SCORE
Product Type	Textured Coating	Extent of Damage	Low damage		-
Asbestos Type	No Asbestos Detected	Surface Treatment	Textured Coating		
PRIORITY ASSESSMENT					SCORE
Occupant Activity	Not Applicable	Extent / Amount	10.00 m2		-
Accessibility	Occasionally disturb	Location	Not Applicable		
Avg Time in Use	Not Applicable	Frequency of Use	Not Applicable		
No. of Occupants	Not Applicable	Secondary Activity	Not Applicable		
Maintenance	Not Applicable	Maintenance Frequency	Not Applicable		
MANAGEMENT ACTION					SCORE
Recommendation	NO ACTION REQUIRED				-
Recommendation Due		Next Inspection	None		
Apply Labels	No	Permit to Work Required	No		
Survey Type	Management	Lead Surveyor	Gavin Hooper		
Survey Date	11 Dec 2014	UKAS Laboratory	NOT SAMPLED (Cross Referenced)		
Site Reference	113030000A	Licensed Material	N/A	Notifiable Non Licensed Work	N/A

No Asbestos Presumed in Sample

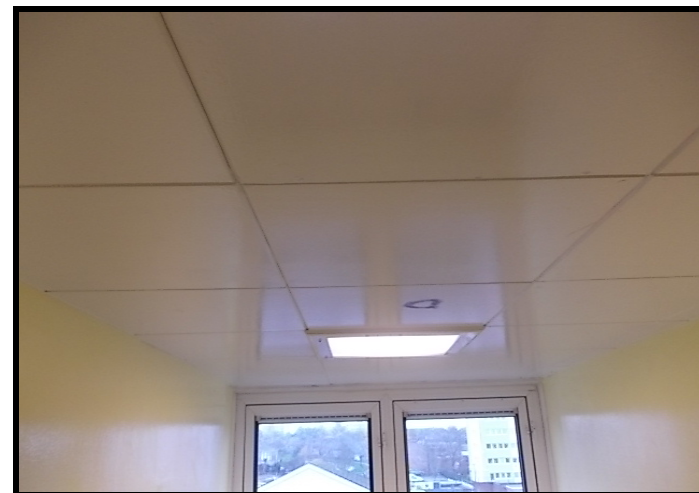
SAMPLE REFERENCE 103

Building	Floor	Room	Location		
Main Building	3rd Floor	Lobby 2	Ceiling		
Description					
MATERIAL ASSESSMENT					SCORE
Product Type	Insulation Board	Extent of Damage	Low damage		-
Asbestos Type	No Asbestos Detected	Surface Treatment	Sealed Board (Encapsulated)		
PRIORITY ASSESSMENT					SCORE
Occupant Activity	Not Applicable	Extent / Amount	10.00 m2		-
Accessibility	Easily disturbed	Location	Not Applicable		
Avg Time in Use	Not Applicable	Frequency of Use	Not Applicable		
No. of Occupants	Not Applicable	Secondary Activity	Not Applicable		
Maintenance	Not Applicable	Maintenance Frequency	Not Applicable		
MANAGEMENT ACTION					SCORE
Recommendation	NO ACTION REQUIRED				-
Recommendation Due		Next Inspection	None		
Apply Labels	No	Permit to Work Required	No		
Survey Type	Management	Lead Surveyor	Gavin Hooper		
Survey Date	11 Dec 2014	UKAS Laboratory	NOT SAMPLED (Cross Referenced)		
Site Reference	113030000A	Licensed Material	N/A	Notifiable Non Licensed Work	N/A

No Asbestos Presumed in Sample

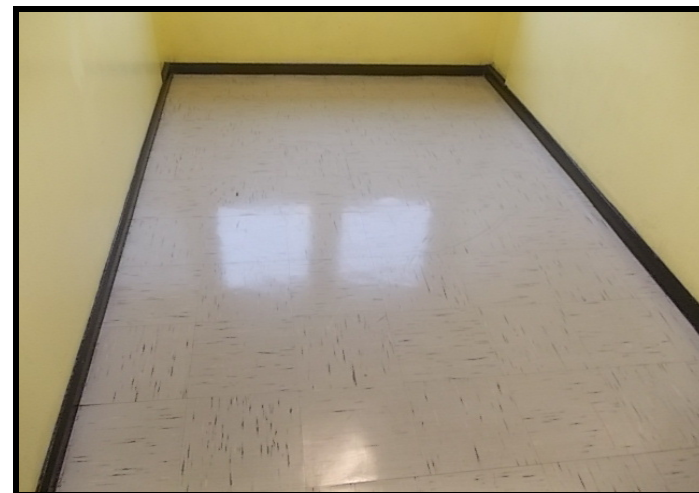
SAMPLE REFERENCE 104

Building	Floor	Room	Location		
Main Building	3rd Floor	Lobby 2	Floor		
Description					
MATERIAL ASSESSMENT					
Product Type	Floor Tiles	Extent of Damage	Low damage		
Asbestos Type	Chrysotile	Surface Treatment	Composite materials		
PRIORITY ASSESSMENT					
Occupant Activity	Not Applicable	Extent / Amount	10.00 m2		
Accessibility	Easily disturbed	Location	Not Applicable		
Avg Time in Use	Not Applicable	Frequency of Use	Not Applicable		
No. of Occupants	Not Applicable	Secondary Activity	Not Applicable		
Maintenance	Not Applicable	Maintenance Frequency	Not Applicable		
MANAGEMENT ACTION					
Recommendation	LABEL & MONITOR				
Recommendation Due		Next Inspection	11 Dec 2015		
Apply Labels	No	Permit to Work Required	No		
Survey Type	Management	Lead Surveyor	Gavin Hooper		
Survey Date	11 Dec 2014	UKAS Laboratory	NOT SAMPLED (Cross Referenced)		
Site Reference	113030000A	Licensed Material	No	Notifiable Non Licensed Work	No

Asbestos Presumed

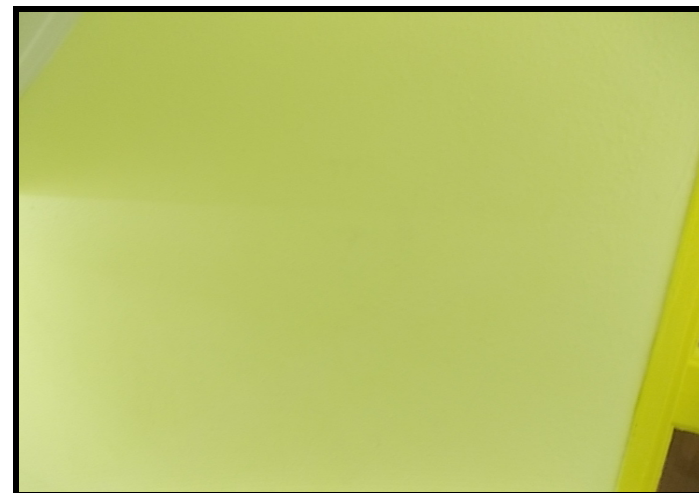
SAMPLE REFERENCE 106

Building	Floor	Room	Location		
Main Building	3rd - 2nd Floor	Stairwell	Wall		
Description					
MATERIAL ASSESSMENT					SCORE
Product Type	Textured Coating	Extent of Damage	Low damage		-
Asbestos Type	No Asbestos Detected	Surface Treatment	Textured Coating		
PRIORITY ASSESSMENT					SCORE
Occupant Activity	Not Applicable	Extent / Amount	10.00 m2		-
Accessibility	Occasionally disturb	Location	Not Applicable		
Avg Time in Use	Not Applicable	Frequency of Use	Not Applicable		
No. of Occupants	Not Applicable	Secondary Activity	Not Applicable		
Maintenance	Not Applicable	Maintenance Frequency	Not Applicable		
MANAGEMENT ACTION					SCORE
Recommendation	NO ACTION REQUIRED				-
Recommendation Due		Next Inspection	None		
Apply Labels	No	Permit to Work Required	No		
Survey Type	Management	Lead Surveyor	Gavin Hooper		
Survey Date	11 Dec 2014	UKAS Laboratory	NOT SAMPLED (Cross Referenced)		
Site Reference	113030000A	Licensed Material	N/A	Notifiable Non Licensed Work	N/A

No Asbestos Presumed in Sample

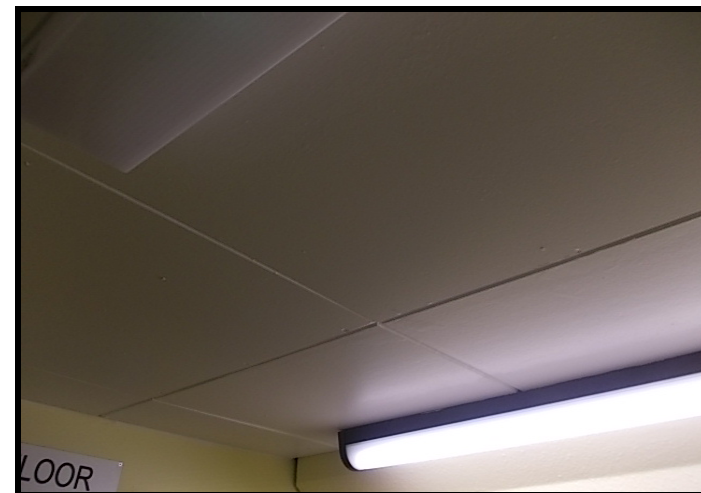
SAMPLE REFERENCE 107

Building	Floor	Room	Location			
Main Building	3rd - 2nd Floor	Stairwell	Ceiling			
Description						
MATERIAL ASSESSMENT				SCORE		
Product Type	Insulation Board	Extent of Damage	Low damage		-	
Asbestos Type	No Asbestos Detected	Surface Treatment	Sealed Board (Encapsulated)			
PRIORITY ASSESSMENT				SCORE		
Occupant Activity	Not Applicable	Extent / Amount	10.00 m2		-	
Accessibility	Easily disturbed	Location	Not Applicable			
Avg Time in Use	Not Applicable	Frequency of Use	Not Applicable			
No. of Occupants	Not Applicable	Secondary Activity	Not Applicable			
Maintenance	Not Applicable	Maintenance Frequency	Not Applicable			
MANAGEMENT ACTION				SCORE		
Recommendation	NO ACTION REQUIRED			-		
Recommendation Due		Next Inspection	None			
Apply Labels	No	Permit to Work Required	No			
Survey Type	Management	Lead Surveyor	Gavin Hooper			
Survey Date	11 Dec 2014	UKAS Laboratory	NOT SAMPLED (Cross Referenced)			
Site Reference	113030000A	Licensed Material	N/A	Notifiable Non Licensed Work	N/A

No Asbestos Presumed in Sample

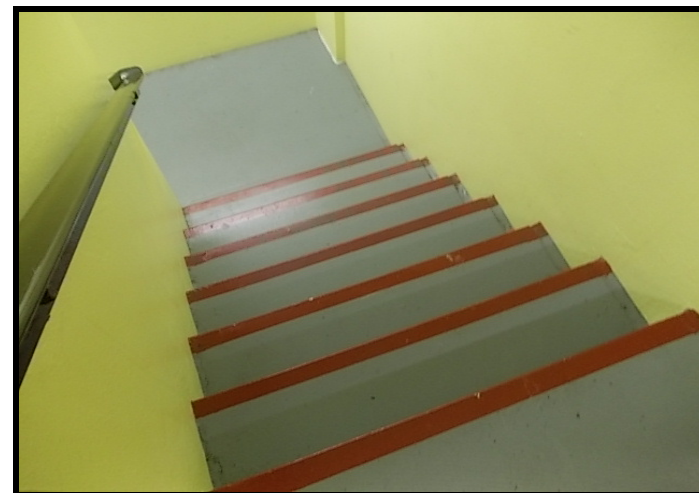
SAMPLE REFERENCE 107a

Building	Floor	Room	Location
Main Building	3rd - 2nd Floor	Stairwell	Staircase
Description			
MATERIAL ASSESSMENT			
Product Type	Bitumen	Extent of Damage	Low damage
Asbestos Type	Chrysotile	Surface Treatment	Composite materials
PRIORITY ASSESSMENT			
Occupant Activity	Not Applicable	Extent / Amount	14.00 small item(s)
Accessibility	Routinely disturbed	Location	Not Applicable
Avg Time in Use	Not Applicable	Frequency of Use	Not Applicable
No. of Occupants	Not Applicable	Secondary Activity	Not Applicable
Maintenance	Not Applicable	Maintenance Frequency	Not Applicable
MANAGEMENT ACTION			
Recommendation	LABEL & MONITOR		
Recommendation Due		Next Inspection	11 Dec 2015
Apply Labels	No	Permit to Work Required	No
Survey Type	Management	Lead Surveyor	Gavin Hooper
Survey Date	11 Dec 2014	UKAS Laboratory	NOT SAMPLED (Cross Referenced)
Site Reference	113030000A	Licensed Material	No
		Notifiable Non Licensed Work	No

Asbestos Presumed

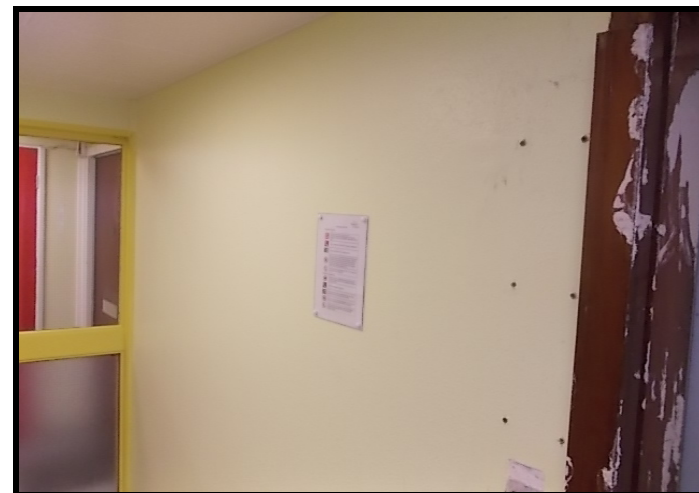
SAMPLE REFERENCE 108

Building	Floor	Room	Location		
Main Building	2nd Floor	Lift lobby	Wall		
Description					
MATERIAL ASSESSMENT					SCORE
Product Type	Textured Coating	Extent of Damage	Low damage		-
Asbestos Type	No Asbestos Detected	Surface Treatment	Textured Coating		
PRIORITY ASSESSMENT					SCORE
Occupant Activity	Not Applicable	Extent / Amount	10.00 m2		-
Accessibility	Occasionally disturb	Location	Not Applicable		
Avg Time in Use	Not Applicable	Frequency of Use	Not Applicable		
No. of Occupants	Not Applicable	Secondary Activity	Not Applicable		
Maintenance	Not Applicable	Maintenance Frequency	Not Applicable		
MANAGEMENT ACTION					SCORE
Recommendation	NO ACTION REQUIRED				-
Recommendation Due		Next Inspection	None		
Apply Labels	No	Permit to Work Required	No		
Survey Type	Management	Lead Surveyor	Gavin Hooper		
Survey Date	11 Dec 2014	UKAS Laboratory	NOT SAMPLED (Cross Referenced)		
Site Reference	113030000A	Licensed Material	N/A	Notifiable Non Licensed Work	N/A

No Asbestos Presumed in Sample

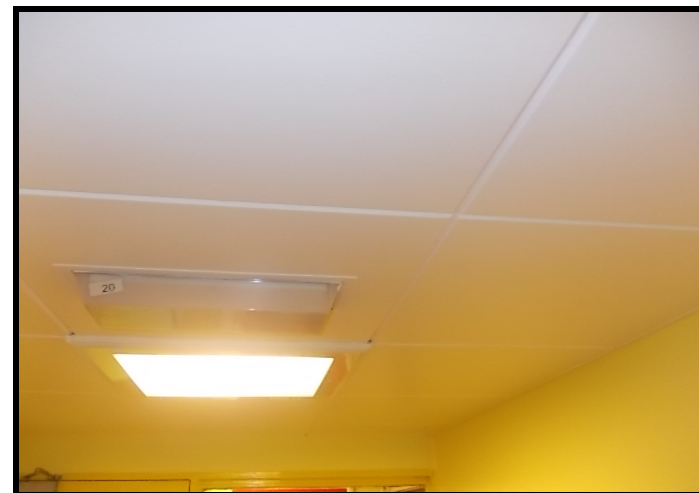
SAMPLE REFERENCE 109

Building	Floor	Room	Location		
Main Building	2nd Floor	Lift lobby	Ceiling		
Description					
MATERIAL ASSESSMENT					SCORE
Product Type	Insulation Board	Extent of Damage	Low damage		-
Asbestos Type	No Asbestos Detected	Surface Treatment	Sealed Board (Encapsulated)		
PRIORITY ASSESSMENT					SCORE
Occupant Activity	Not Applicable	Extent / Amount	10.00 m2		-
Accessibility	Easily disturbed	Location	Not Applicable		
Avg Time in Use	Not Applicable	Frequency of Use	Not Applicable		
No. of Occupants	Not Applicable	Secondary Activity	Not Applicable		
Maintenance	Not Applicable	Maintenance Frequency	Not Applicable		
MANAGEMENT ACTION					SCORE
Recommendation	NO ACTION REQUIRED				-
Recommendation Due		Next Inspection	None		
Apply Labels	No	Permit to Work Required	No		
Survey Type	Management	Lead Surveyor	Gavin Hooper		
Survey Date	11 Dec 2014	UKAS Laboratory	NOT SAMPLED (Cross Referenced)		
Site Reference	113030000A	Licensed Material	N/A	Notifiable Non Licensed Work	N/A

No Asbestos Presumed in Sample

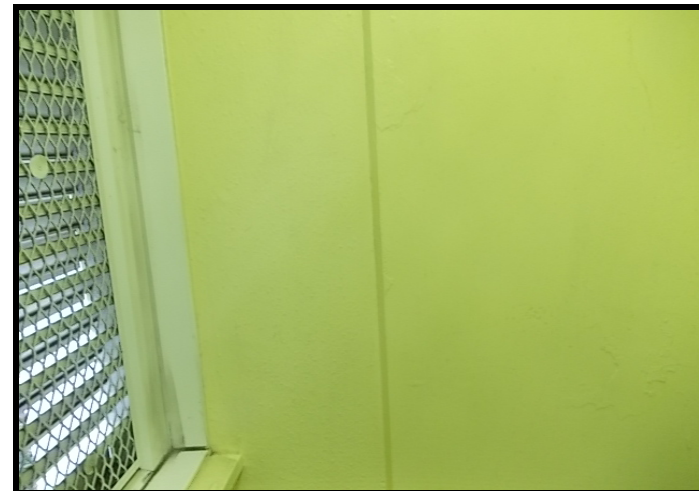
SAMPLE REFERENCE 110

Building	Floor	Room	Location		
Main Building	2nd Floor	Bin Shute	Wall		
Description					
MATERIAL ASSESSMENT					SCORE
Product Type	Textured Coating	Extent of Damage	Low damage		-
Asbestos Type	No Asbestos Detected	Surface Treatment	Textured Coating		
PRIORITY ASSESSMENT					SCORE
Occupant Activity	Not Applicable	Extent / Amount	10.00 m2		-
Accessibility	Occasionally disturb	Location	Not Applicable		
Avg Time in Use	Not Applicable	Frequency of Use	Not Applicable		
No. of Occupants	Not Applicable	Secondary Activity	Not Applicable		
Maintenance	Not Applicable	Maintenance Frequency	Not Applicable		
MANAGEMENT ACTION					SCORE
Recommendation	NO ACTION REQUIRED				-
Recommendation Due		Next Inspection	None		
Apply Labels	No	Permit to Work Required	No		
Survey Type	Management	Lead Surveyor	Gavin Hooper		
Survey Date	11 Dec 2014	UKAS Laboratory	NOT SAMPLED (Cross Referenced)		
Site Reference	113030000A	Licensed Material	N/A	Notifiable Non Licensed Work	N/A

No Asbestos Presumed in Sample

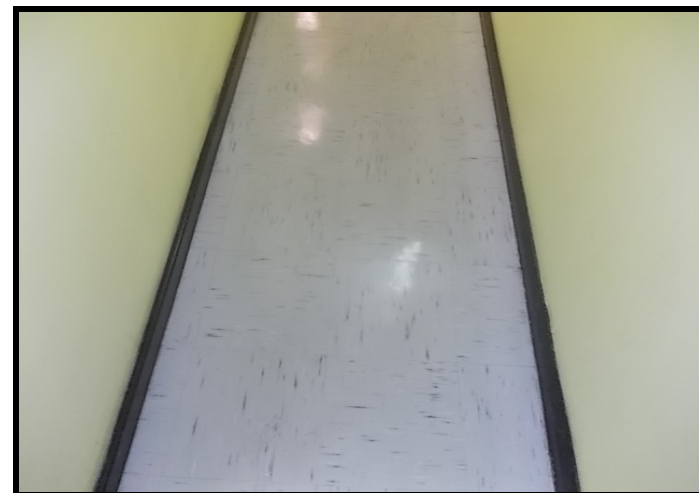
SAMPLE REFERENCE 111

Building	Floor	Room	Location		
Main Building	2nd Floor	Lobby 1	Floor		
Description					
MATERIAL ASSESSMENT				SCORE	
Product Type	Floor Tiles	Extent of Damage	Low damage	3	
Asbestos Type	Chrysotile	Surface Treatment	Composite materials		
PRIORITY ASSESSMENT				SCORE	
Occupant Activity	Not Applicable	Extent / Amount	5.00 m2	1	
Accessibility	Easily disturbed	Location	Not Applicable		
Avg Time in Use	Not Applicable	Frequency of Use	Not Applicable		
No. of Occupants	Not Applicable	Secondary Activity	Not Applicable		
Maintenance	Not Applicable	Maintenance Frequency	Not Applicable		
MANAGEMENT ACTION				SCORE	
Recommendation	LABEL & MONITOR			4	
Recommendation Due		Next Inspection	11 Dec 2015		
Apply Labels	No	Permit to Work Required	No		
Survey Type	Management	Lead Surveyor	Gavin Hooper		
Survey Date	11 Dec 2014	UKAS Laboratory	NOT SAMPLED (Cross Referenced)		
Site Reference	113030000A	Licensed Material	No	Notifiable Non Licensed Work	No

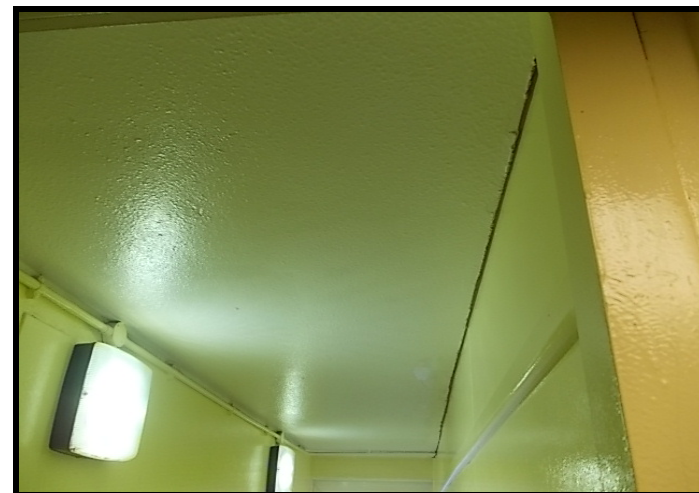
SAMPLE REFERENCE 111a

MATERIAL ASSESSMENT				SCORE
Product Type	Textured Coating	Extent of Damage	Low damage	-
Asbestos Type	No Asbestos Detected	Surface Treatment	Textured Coating

No Asbestos Presumed in Sample

MANAGEMENT ACTION				SCORE
Recommendation	NO ACTION REQUIRED			-
Recommendation Due		Next Inspection	None	
Apply Labels	No	Permit to Work Required	No

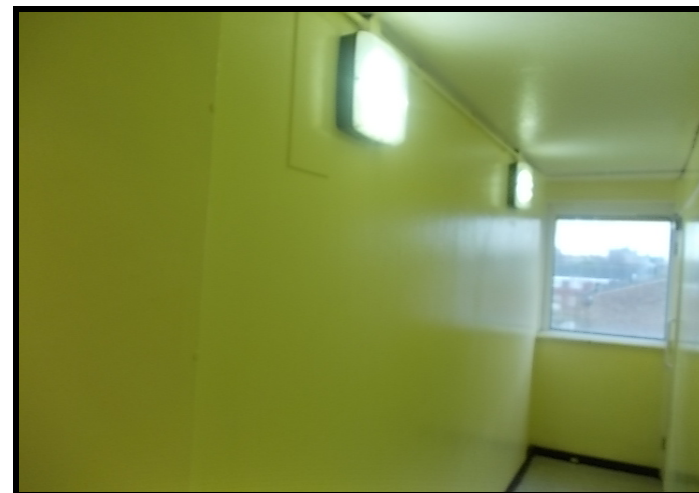
SAMPLE REFERENCE 111b

Building	Floor	Room	Location		
Main Building	2nd Floor	Lobby 1	Wall		
Description					
MATERIAL ASSESSMENT					SCORE
Product Type	Textured Coating	Extent of Damage	Low damage		-
Asbestos Type	No Asbestos Detected	Surface Treatment	Textured Coating		
PRIORITY ASSESSMENT					SCORE
Occupant Activity	Not Applicable	Extent / Amount	10.00 m2		-
Accessibility	Easily disturbed	Location	Not Applicable		
Avg Time in Use	Not Applicable	Frequency of Use	Not Applicable		
No. of Occupants	Not Applicable	Secondary Activity	Not Applicable		
Maintenance	Not Applicable	Maintenance Frequency	Not Applicable		
MANAGEMENT ACTION					SCORE
Recommendation	NO ACTION REQUIRED				-
Recommendation Due		Next Inspection	None		
Apply Labels	No	Permit to Work Required	No		
Survey Type	Management	Lead Surveyor	Gavin Hooper		
Survey Date	11 Dec 2014	UKAS Laboratory	NOT SAMPLED (Cross Referenced)		
Site Reference	113030000A	Licensed Material	N/A	Notifiable Non Licensed Work	N/A

No Asbestos Presumed in Sample

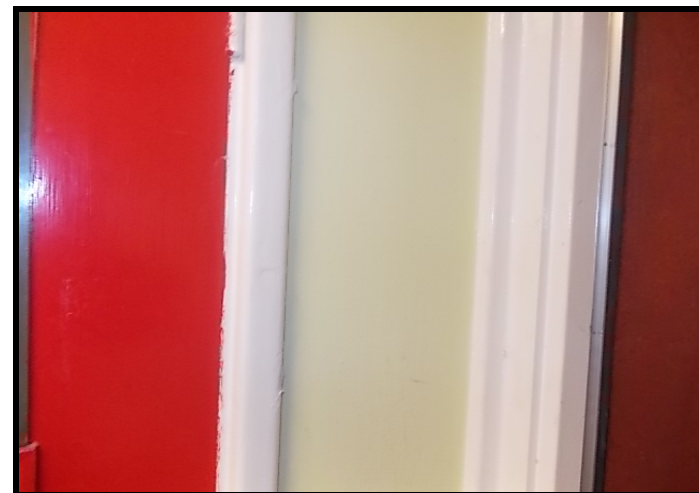
SAMPLE REFERENCE 111c

MATERIAL ASSESSMENT				SCORE
Product Type	Cement	Extent of Damage	Low damage	4
Asbestos Type	Chrysotile	Surface Treatment	Sealed (Cement products)

MANAGEMENT ACTION				SCORE
Recommendation	LABEL & MONITOR			5
Recommendation Due		Next Inspection	11 Dec 2015	
Apply Labels	No	Permit to Work Required	No
