Solihull Community Housing

Asbestos Management Survey Report

Merton House I-43 (Communal)
Crabtree Drive
Solihull
B37 5BX

Date of Report: 25 Feb 2015

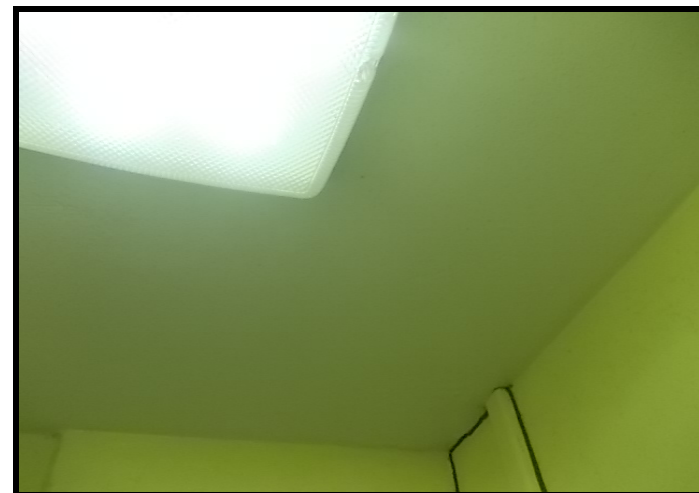
SAMPLE REFERENCE 112

Building	Floor	Room	Location		
Main Building	2nd Floor	Bin Shute	Ceiling		
Description					
MATERIAL ASSESSMENT					SCORE
Product Type	Textured Coating	Extent of Damage	Low damage		-
Asbestos Type	No Asbestos Detected	Surface Treatment	Textured Coating		
PRIORITY ASSESSMENT					SCORE
Occupant Activity	Not Applicable	Extent / Amount	8.00 m2		-
Accessibility	Not Applicable	Location	Not Applicable		
Avg Time in Use	Not Applicable	Frequency of Use	Not Applicable		
No. of Occupants	Not Applicable	Secondary Activity	Not Applicable		
Maintenance	Not Applicable	Maintenance Frequency	Not Applicable		
MANAGEMENT ACTION					SCORE
Recommendation	NO ACTION REQUIRED				-
Recommendation Due		Next Inspection	None		
Apply Labels	No	Permit to Work Required	No		
Survey Type	Management	Lead Surveyor	Gavin Hooper		
Survey Date	11 Dec 2014	UKAS Laboratory	NOT SAMPLED (Cross Referenced)		
Site Reference	113030000A	Licensed Material	N/A	Notifiable Non Licensed Work	N/A

No Asbestos Presumed in Sample

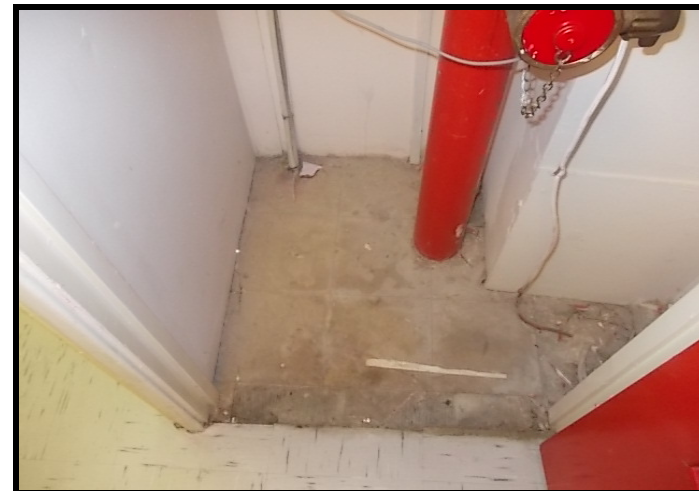
SAMPLE REFERENCE 113

Building	Floor	Room	Location
Main Building	2nd Floor	Dry Riser	Floor
Description			
MATERIAL ASSESSMENT			
Product Type	Floor Tiles	Extent of Damage	Low damage
Asbestos Type	Chrysotile	Surface Treatment	Composite materials
PRIORITY ASSESSMENT			
Occupant Activity	Not Applicable	Extent / Amount	5.00 m2
Accessibility	Easily disturbed	Location	Not Applicable
Avg Time in Use	Not Applicable	Frequency of Use	Not Applicable
No. of Occupants	Not Applicable	Secondary Activity	Not Applicable
Maintenance	Not Applicable	Maintenance Frequency	Not Applicable
MANAGEMENT ACTION			
Recommendation	LABEL & MONITOR		
Recommendation Due		Next Inspection	11 Dec 2015
Apply Labels	No	Permit to Work Required	No
Survey Type	Management	Lead Surveyor	Gavin Hooper
Survey Date	11 Dec 2014	UKAS Laboratory	NOT SAMPLED (Cross Referenced)
Site Reference	113030000A	Licensed Material	No
		Notifiable Non Licensed Work	No

Asbestos Presumed

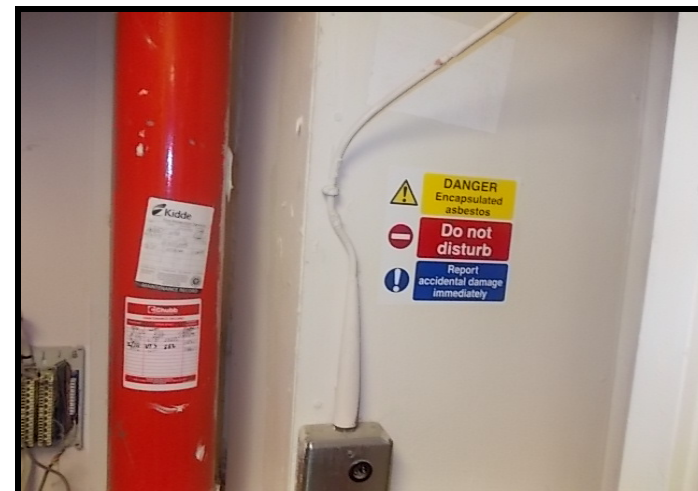
SAMPLE REFERENCE 114

MATERIAL ASSESSMENT				SCORE
Product Type	Insulation Board	Extent of Damage	Low damage	6
Asbestos Type	Amosite / Chrysotile	Surface Treatment	Sealed Board (Encapsulated)

Asbestos Presumed

MANAGEMENT ACTION				SCORE
Recommendation	LABEL & MONITOR			7
Recommendation Due		Next Inspection	11 Jun 2015	
Apply Labels	No	Permit to Work Required	No

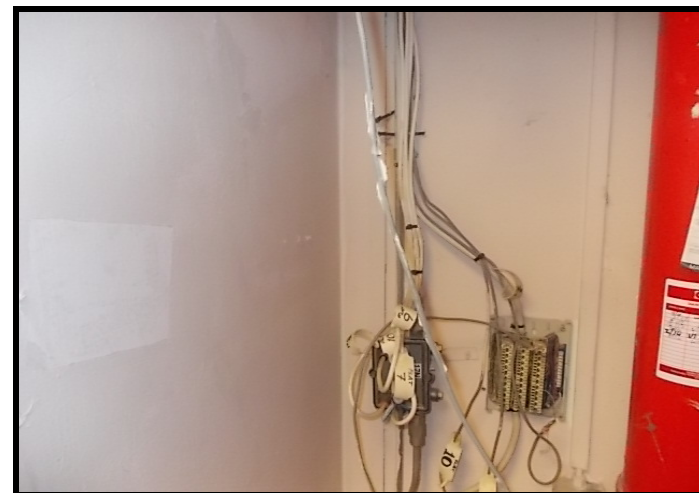
SAMPLE REFERENCE 115

MATERIAL ASSESSMENT				SCORE
Product Type	Insulation Board	Extent of Damage	Low damage	6
Asbestos Type	Amosite / Chrysotile	Surface Treatment	Sealed Board (Encapsulated)

Asbestos Presumed

MANAGEMENT ACTION				SCORE
Recommendation	LABEL & MONITOR			7
Recommendation Due		Next Inspection	11 Jun 2015	
Apply Labels	No	Permit to Work Required	No

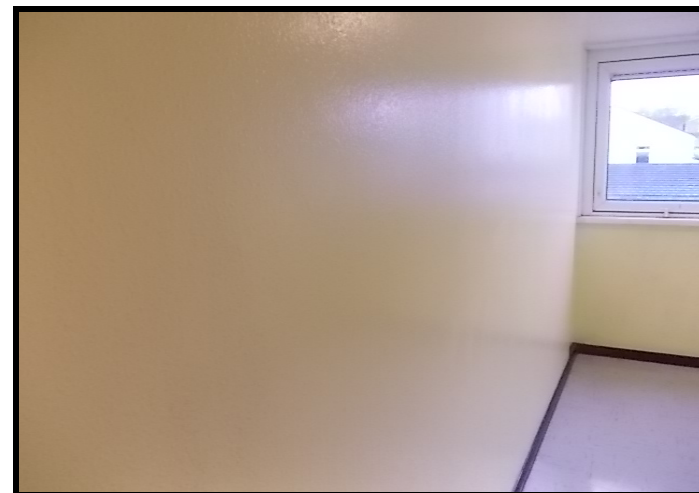
SAMPLE REFERENCE 116

Building	Floor	Room	Location		
Main Building	2nd Floor	Lobby 2	Wall		
Description					
MATERIAL ASSESSMENT					SCORE
Product Type	Textured Coating	Extent of Damage	Low damage		-
Asbestos Type	No Asbestos Detected	Surface Treatment	Textured Coating		
PRIORITY ASSESSMENT					SCORE
Occupant Activity	Not Applicable	Extent / Amount	10.00 m2		-
Accessibility	Occasionally disturb	Location	Not Applicable		
Avg Time in Use	Not Applicable	Frequency of Use	Not Applicable		
No. of Occupants	Not Applicable	Secondary Activity	Not Applicable		
Maintenance	Not Applicable	Maintenance Frequency	Not Applicable		
MANAGEMENT ACTION					SCORE
Recommendation	NO ACTION REQUIRED				-
Recommendation Due		Next Inspection	None		
Apply Labels	No	Permit to Work Required	No		
Survey Type	Management	Lead Surveyor	Gavin Hooper		
Survey Date	11 Dec 2014	UKAS Laboratory	NOT SAMPLED (Cross Referenced)		
Site Reference	113030000A	Licensed Material	N/A	Notifiable Non Licensed Work	N/A

No Asbestos Presumed in Sample

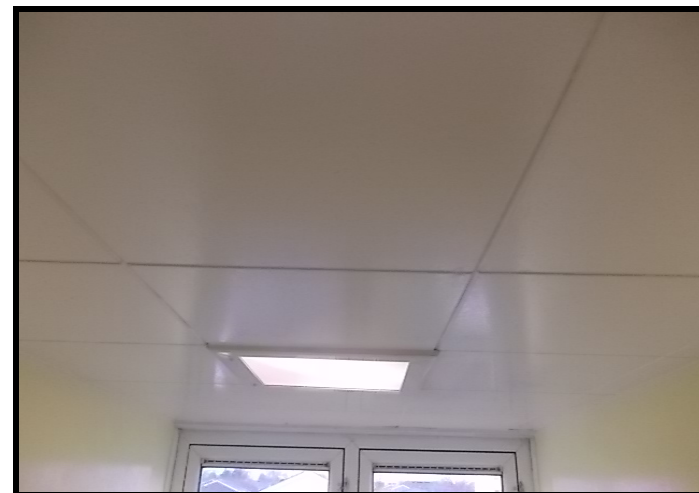
SAMPLE REFERENCE 117

Building	Floor	Room	Location		
Main Building	2nd Floor	Lobby 2	Ceiling		
Description					
MATERIAL ASSESSMENT					SCORE
Product Type	Insulation Board	Extent of Damage	Low damage		-
Asbestos Type	No Asbestos Detected	Surface Treatment	Sealed Board (Encapsulated)		
PRIORITY ASSESSMENT					SCORE
Occupant Activity	Not Applicable	Extent / Amount	10.00 m2		-
Accessibility	Easily disturbed	Location	Not Applicable		
Avg Time in Use	Not Applicable	Frequency of Use	Not Applicable		
No. of Occupants	Not Applicable	Secondary Activity	Not Applicable		
Maintenance	Not Applicable	Maintenance Frequency	Not Applicable		
MANAGEMENT ACTION					SCORE
Recommendation	NO ACTION REQUIRED				-
Recommendation Due		Next Inspection	None		
Apply Labels	No	Permit to Work Required	No		
Survey Type	Management	Lead Surveyor	Gavin Hooper		
Survey Date	11 Dec 2014	UKAS Laboratory	NOT SAMPLED (Cross Referenced)		
Site Reference	113030000A	Licensed Material	N/A	Notifiable Non Licensed Work	N/A

No Asbestos Presumed in Sample

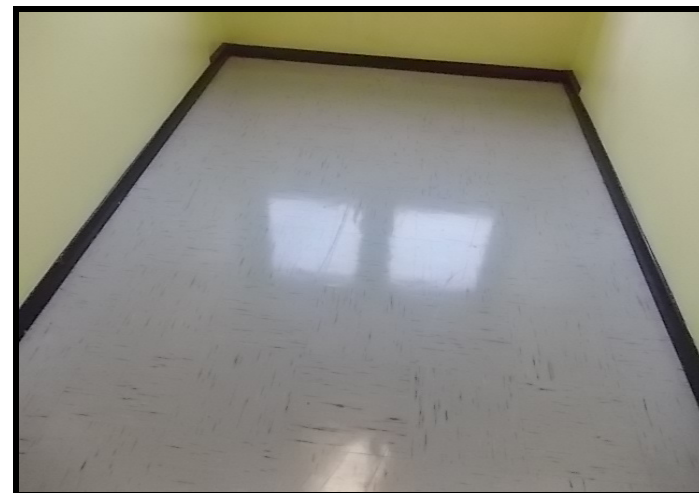
SAMPLE REFERENCE 118

Building	Floor	Room	Location		
Main Building	2nd Floor	Lobby 2	Floor		
Description					
MATERIAL ASSESSMENT				SCORE	
Product Type	Floor Tiles	Extent of Damage	Low damage	3	
Asbestos Type	Chrysotile	Surface Treatment	Composite materials		
PRIORITY ASSESSMENT				SCORE	
Occupant Activity	Not Applicable	Extent / Amount	10.00 m2	1	
Accessibility	Easily disturbed	Location	Not Applicable		
Avg Time in Use	Not Applicable	Frequency of Use	Not Applicable		
No. of Occupants	Not Applicable	Secondary Activity	Not Applicable		
Maintenance	Not Applicable	Maintenance Frequency	Not Applicable		
MANAGEMENT ACTION				SCORE	
Recommendation	LABEL & MONITOR			4	
Recommendation Due		Next Inspection	11 Dec 2015		
Apply Labels	No	Permit to Work Required	No		
Survey Type	Management	Lead Surveyor	Gavin Hooper		
Survey Date	11 Dec 2014	UKAS Laboratory	NOT SAMPLED (Cross Referenced)		
Site Reference	113030000A	Licensed Material	No	Notifiable Non Licensed Work	No

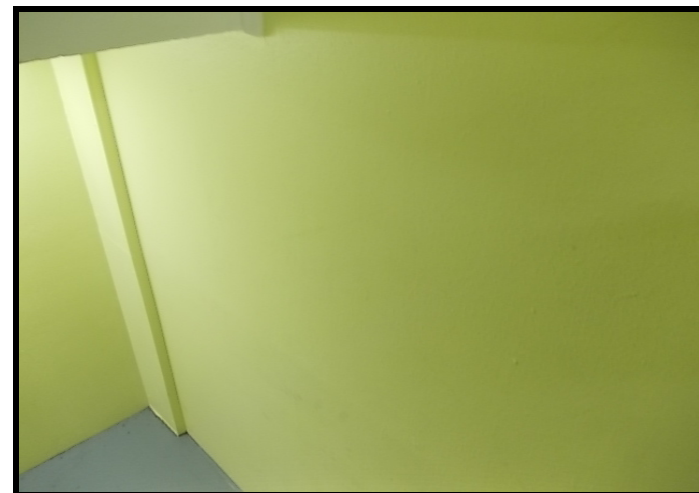
SAMPLE REFERENCE 120

Building	Floor	Room	Location
Main Building	2nd - 1st Floor	Stairwell	Wall
Description			
MATERIAL ASSESSMENT			
Product Type	Textured Coating	Extent of Damage	Low damage
Asbestos Type	No Asbestos Detected	Surface Treatment	Textured Coating
PRIORITY ASSESSMENT			
Occupant Activity	Not Applicable	Extent / Amount	10.00 m2
Accessibility	Occasionally disturb	Location	Not Applicable
Avg Time in Use	Not Applicable	Frequency of Use	Not Applicable
No. of Occupants	Not Applicable	Secondary Activity	Not Applicable
Maintenance	Not Applicable	Maintenance Frequency	Not Applicable
MANAGEMENT ACTION			
Recommendation	NO ACTION REQUIRED		
Recommendation Due		Next Inspection	None
Apply Labels	No	Permit to Work Required	No
Survey Type	Management	Lead Surveyor	Gavin Hooper
Survey Date	11 Dec 2014	UKAS Laboratory	NOT SAMPLED (Cross Referenced)
Site Reference	113030000A	Licensed Material	N/A
		Notifiable Non Licensed Work	N/A

No Asbestos Presumed in Sample

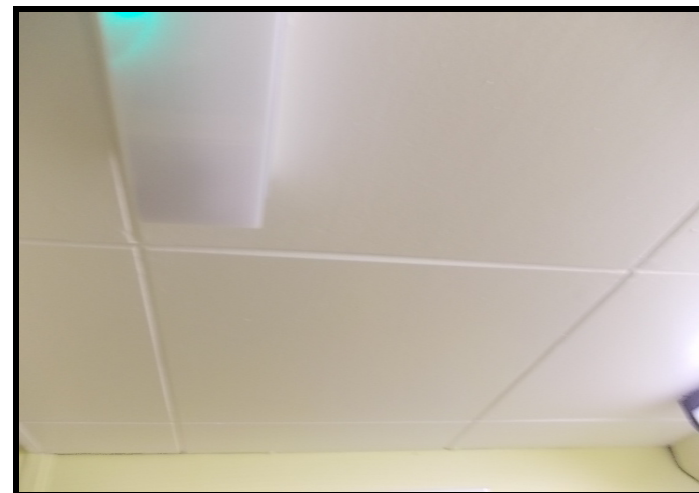
SAMPLE REFERENCE 121

MATERIAL ASSESSMENT				SCORE
Product Type	Insulation Board	Extent of Damage	Low damage	-
Asbestos Type	No Asbestos Detected	Surface Treatment	Sealed Board (Encapsulated)

No Asbestos Presumed in Sample

MANAGEMENT ACTION				SCORE
Recommendation	NO ACTION REQUIRED			-
Recommendation Due		Next Inspection	None	
Apply Labels	No	Permit to Work Required	No

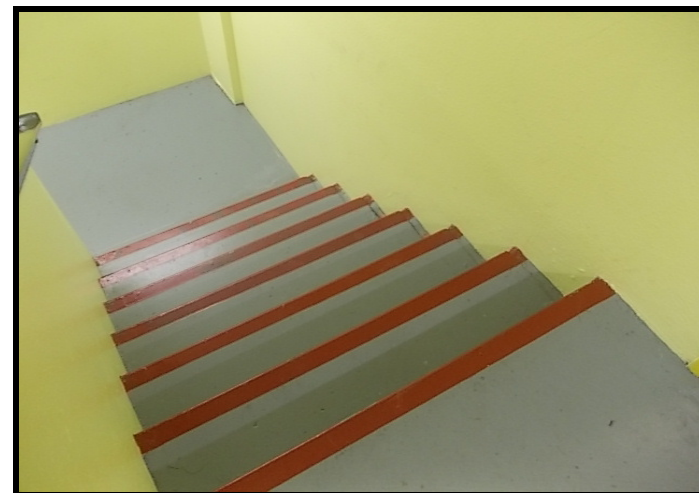
SAMPLE REFERENCE 121a

Building	Floor	Room	Location
Main Building	2nd - 1st Floor	Stairwell	Staircase
Description			
MATERIAL ASSESSMENT			
Product Type	Bitumen	Extent of Damage	Low damage
Asbestos Type	Chrysotile	Surface Treatment	Composite materials
PRIORITY ASSESSMENT			
Occupant Activity	Not Applicable	Extent / Amount	14.00 small item(s)
Accessibility	Routinely disturbed	Location	Not Applicable
Avg Time in Use	Not Applicable	Frequency of Use	Not Applicable
No. of Occupants	Not Applicable	Secondary Activity	Not Applicable
Maintenance	Not Applicable	Maintenance Frequency	Not Applicable
MANAGEMENT ACTION			
Recommendation	LABEL & MONITOR		
Recommendation Due		Next Inspection	11 Dec 2015
Apply Labels	No	Permit to Work Required	No
Survey Type	Management	Lead Surveyor	Gavin Hooper
Survey Date	11 Dec 2014	UKAS Laboratory	NOT SAMPLED (Cross Referenced)
Site Reference	113030000A	Licensed Material	No
		Notifiable Non Licensed Work	No

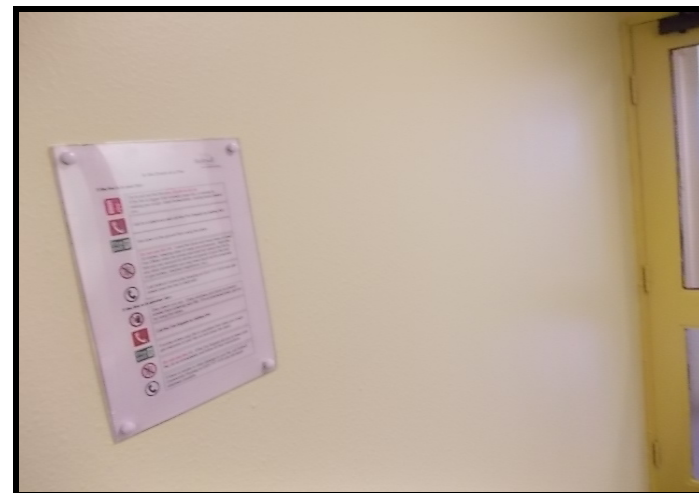
SAMPLE REFERENCE 122

Building	Floor	Room	Location		
Main Building	1st Floor	Lift lobby	Wall		
Description					
MATERIAL ASSESSMENT					SCORE
Product Type	Textured Coating	Extent of Damage	Low damage		-
Asbestos Type	No Asbestos Detected	Surface Treatment	Textured Coating		
PRIORITY ASSESSMENT					SCORE
Occupant Activity	Not Applicable	Extent / Amount	10.00 m2		-
Accessibility	Occasionally disturb	Location	Not Applicable		
Avg Time in Use	Not Applicable	Frequency of Use	Not Applicable		
No. of Occupants	Not Applicable	Secondary Activity	Not Applicable		
Maintenance	Not Applicable	Maintenance Frequency	Not Applicable		
MANAGEMENT ACTION					SCORE
Recommendation	NO ACTION REQUIRED				-
Recommendation Due		Next Inspection	None		
Apply Labels	No	Permit to Work Required	No		
Survey Type	Management	Lead Surveyor	Gavin Hooper		
Survey Date	11 Dec 2014	UKAS Laboratory	NOT SAMPLED (Cross Referenced)		
Site Reference	113030000A	Licensed Material	N/A	Notifiable Non Licensed Work	N/A

No Asbestos Presumed in Sample

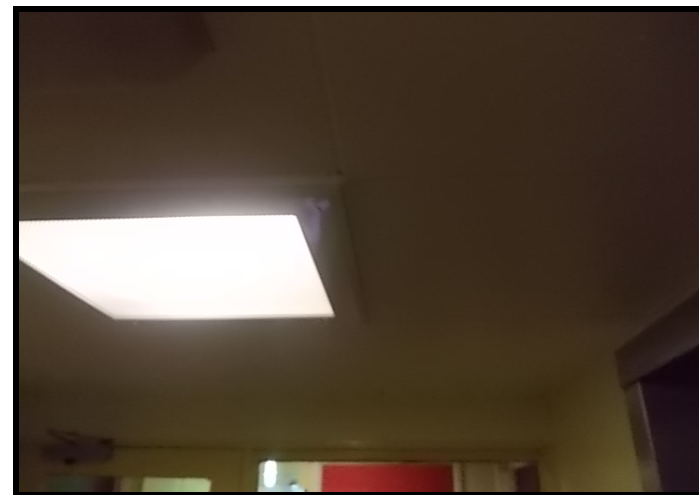
SAMPLE REFERENCE 122a

Building	Floor	Room	Location		
Main Building	1st Floor	Lift lobby	Ceiling		
Description					
MATERIAL ASSESSMENT					SCORE
Product Type	Insulation Board	Extent of Damage	Low damage		-
Asbestos Type	No Asbestos Detected	Surface Treatment	Sealed Board (Encapsulated)		
PRIORITY ASSESSMENT					SCORE
Occupant Activity	Not Applicable	Extent / Amount	10.00 m2		-
Accessibility	Easily disturbed	Location	Not Applicable		
Avg Time in Use	Not Applicable	Frequency of Use	Not Applicable		
No. of Occupants	Not Applicable	Secondary Activity	Not Applicable		
Maintenance	Not Applicable	Maintenance Frequency	Not Applicable		
MANAGEMENT ACTION					SCORE
Recommendation	NO ACTION REQUIRED				-
Recommendation Due		Next Inspection	None		
Apply Labels	No	Permit to Work Required	No		
Survey Type	Management	Lead Surveyor	Gavin Hooper		
Survey Date	11 Dec 2014	UKAS Laboratory	NOT SAMPLED (Cross Referenced)		
Site Reference	113030000A	Licensed Material	N/A	Notifiable Non Licensed Work	N/A

No Asbestos Presumed in Sample

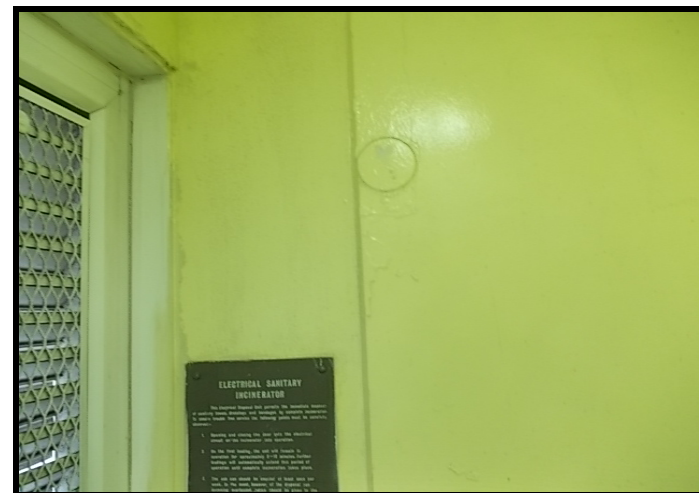
SAMPLE REFERENCE 124

Building	Floor	Room	Location		
Main Building	1st Floor	Bin Shute	Wall		
Description					
MATERIAL ASSESSMENT					SCORE
Product Type	Textured Coating	Extent of Damage	Low damage		-
Asbestos Type	No Asbestos Detected	Surface Treatment	Textured Coating		
PRIORITY ASSESSMENT					SCORE
Occupant Activity	Not Applicable	Extent / Amount	10.00 m2		-
Accessibility	Occasionally disturb	Location	Not Applicable		
Avg Time in Use	Not Applicable	Frequency of Use	Not Applicable		
No. of Occupants	Not Applicable	Secondary Activity	Not Applicable		
Maintenance	Not Applicable	Maintenance Frequency	Not Applicable		
MANAGEMENT ACTION					SCORE
Recommendation	NO ACTION REQUIRED				-
Recommendation Due		Next Inspection	None		
Apply Labels	No	Permit to Work Required	No		
Survey Type	Management	Lead Surveyor	Gavin Hooper		
Survey Date	11 Dec 2014	UKAS Laboratory	NOT SAMPLED (Cross Referenced)		
Site Reference	113030000A	Licensed Material	N/A	Notifiable Non Licensed Work	N/A

No Asbestos Presumed in Sample

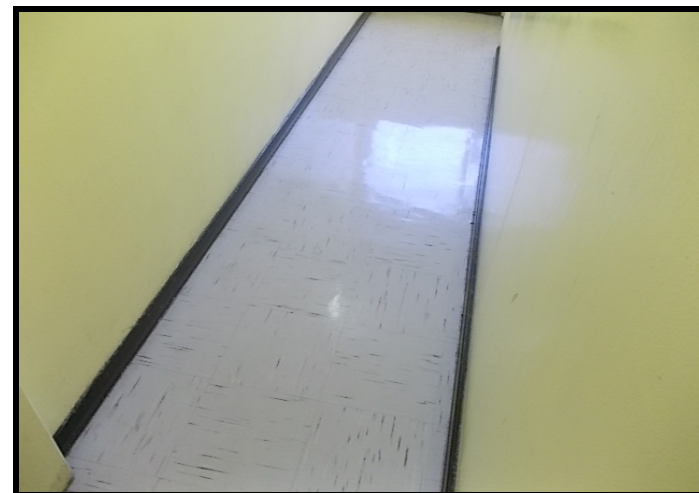
SAMPLE REFERENCE 125

MATERIAL ASSESSMENT				SCORE
Product Type	Floor Tiles	Extent of Damage	Low damage	3
Asbestos Type	Chrysotile	Surface Treatment	Composite materials

MANAGEMENT ACTION				SCORE
Recommendation	LABEL & MONITOR			4
Recommendation Due		Next Inspection	11 Dec 2015	
Apply Labels	No	Permit to Work Required	No

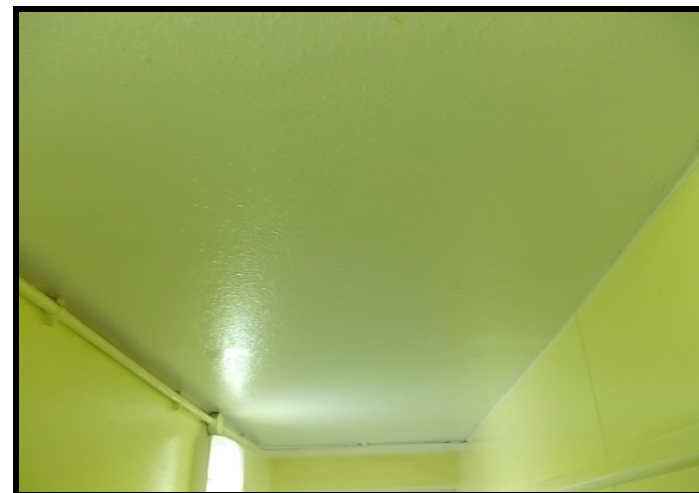
SAMPLE REFERENCE 125a

Building	Floor	Room	Location		
Main Building	1st Floor	Lobby 1	Ceiling		
Description					
MATERIAL ASSESSMENT					SCORE
Product Type	Textured Coating	Extent of Damage	Low damage		-
Asbestos Type	No Asbestos Detected	Surface Treatment	Textured Coating		
PRIORITY ASSESSMENT					SCORE
Occupant Activity	Not Applicable	Extent / Amount	10.00 m2		-
Accessibility	Easily disturbed	Location	Not Applicable		
Avg Time in Use	Not Applicable	Frequency of Use	Not Applicable		
No. of Occupants	Not Applicable	Secondary Activity	Not Applicable		
Maintenance	Not Applicable	Maintenance Frequency	Not Applicable		
MANAGEMENT ACTION					SCORE
Recommendation	NO ACTION REQUIRED				-
Recommendation Due		Next Inspection	None		
Apply Labels	No	Permit to Work Required	No		
Survey Type	Management	Lead Surveyor	Gavin Hooper		
Survey Date	11 Dec 2014	UKAS Laboratory	NOT SAMPLED (Cross Referenced)		
Site Reference	113030000A	Licensed Material	N/A	Notifiable Non Licensed Work	N/A

No Asbestos Presumed in Sample

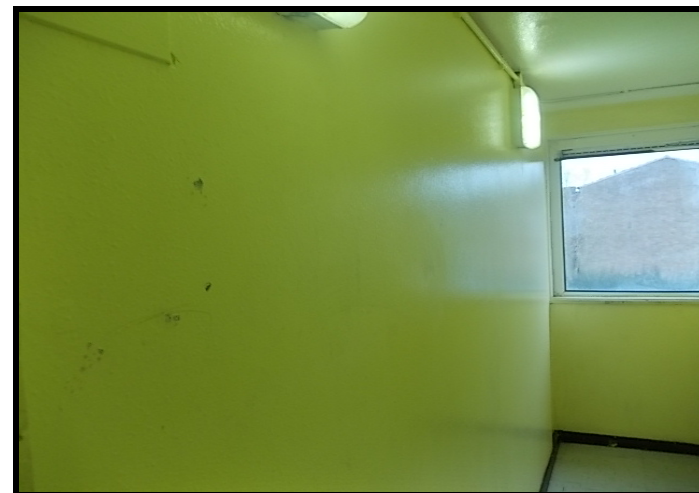
SAMPLE REFERENCE 125b

Building	Floor	Room	Location		
Main Building	1st Floor	Lobby 1	Wall		
Description					
MATERIAL ASSESSMENT					SCORE
Product Type	Textured Coating	Extent of Damage	Low damage		-
Asbestos Type	No Asbestos Detected	Surface Treatment	Textured Coating		
PRIORITY ASSESSMENT					SCORE
Occupant Activity	Not Applicable	Extent / Amount	10.00 m2		-
Accessibility	Easily disturbed	Location	Not Applicable		
Avg Time in Use	Not Applicable	Frequency of Use	Not Applicable		
No. of Occupants	Not Applicable	Secondary Activity	Not Applicable		
Maintenance	Not Applicable	Maintenance Frequency	Not Applicable		
MANAGEMENT ACTION					SCORE
Recommendation	NO ACTION REQUIRED				-
Recommendation Due		Next Inspection	None		
Apply Labels	No	Permit to Work Required	No		
Survey Type	Management	Lead Surveyor	Gavin Hooper		
Survey Date	11 Dec 2014	UKAS Laboratory	NOT SAMPLED (Cross Referenced)		
Site Reference	113030000A	Licensed Material	N/A	Notifiable Non Licensed Work	N/A

No Asbestos Presumed in Sample

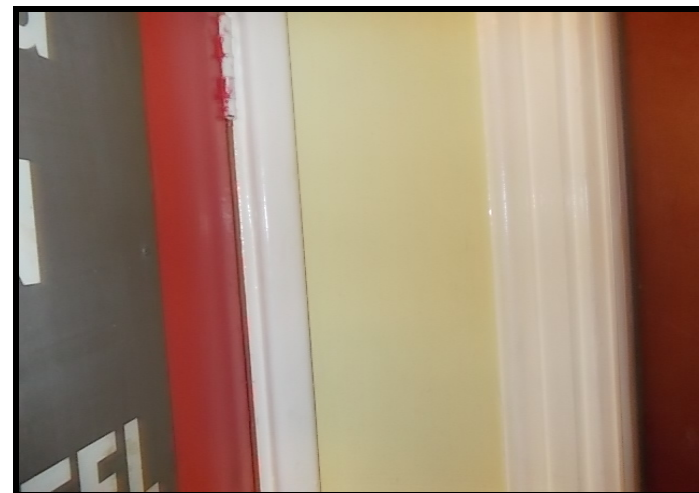
SAMPLE REFERENCE 125c

Building	Floor	Room	Location
Main Building	1st Floor	Lobby 1	Panel
Description			
MATERIAL ASSESSMENT			
Product Type	Cement	Extent of Damage	Low damage
Asbestos Type	Chrysotile	Surface Treatment	Sealed (Cement products)
PRIORITY ASSESSMENT			
Occupant Activity	Not Applicable	Extent / Amount	2.00 m2
Accessibility	Easily disturbed	Location	Not Applicable
Avg Time in Use	Not Applicable	Frequency of Use	Not Applicable
No. of Occupants	Not Applicable	Secondary Activity	Not Applicable
Maintenance	Not Applicable	Maintenance Frequency	Not Applicable
MANAGEMENT ACTION			
Recommendation	LABEL & MONITOR		
Recommendation Due		Next Inspection	11 Dec 2015
Apply Labels	No	Permit to Work Required	No
Survey Type	Management	Lead Surveyor	Gavin Hooper
Survey Date	11 Dec 2014	UKAS Laboratory	NOT SAMPLED (Cross Referenced)
Site Reference	113030000A	Licensed Material	No
		Notifiable Non Licensed Work	No

Asbestos Presumed

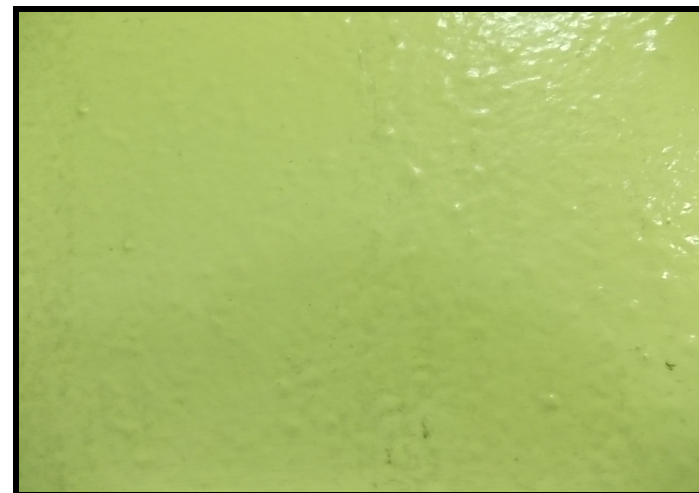
SAMPLE REFERENCE 126

Building	Floor	Room	Location		
Main Building	1st Floor	Bin Shute	Caulking		
Description					
MATERIAL ASSESSMENT					SCORE
Product Type	Textured Coating	Extent of Damage	Low damage		-
Asbestos Type	No Asbestos Detected	Surface Treatment	Textured Coating		
PRIORITY ASSESSMENT					SCORE
Occupant Activity	Not Applicable	Extent / Amount	8.00 m2		-
Accessibility	Occasionally disturb	Location	Not Applicable		
Avg Time in Use	Not Applicable	Frequency of Use	Not Applicable		
No. of Occupants	Not Applicable	Secondary Activity	Not Applicable		
Maintenance	Not Applicable	Maintenance Frequency	Not Applicable		
MANAGEMENT ACTION					SCORE
Recommendation	NO ACTION REQUIRED				-
Recommendation Due		Next Inspection	None		
Apply Labels	No	Permit to Work Required	No		
Survey Type	Management	Lead Surveyor	Gavin Hooper		
Survey Date	11 Dec 2014	UKAS Laboratory	NOT SAMPLED (Cross Referenced)		
Site Reference	113030000A	Licensed Material	N/A	Notifiable Non Licensed Work	N/A

No Asbestos Presumed in Sample

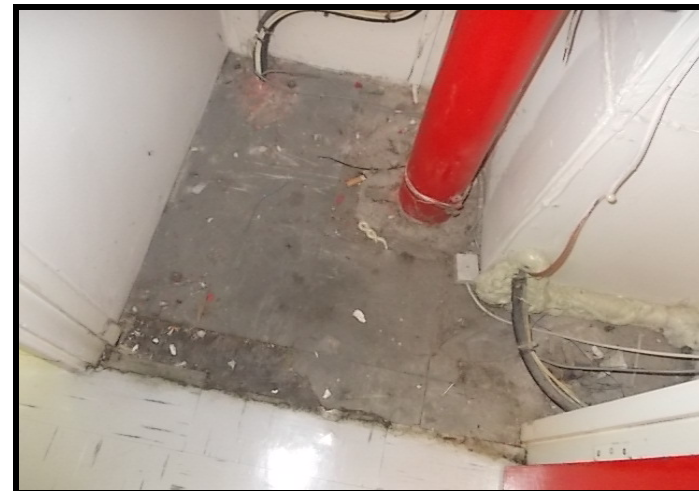
SAMPLE REFERENCE 127

Building	Floor	Room	Location
Main Building	1st Floor	Dry Riser	Floor
Description			
MATERIAL ASSESSMENT			
Product Type	Floor Tiles	Extent of Damage	Low damage
Asbestos Type	Chrysotile	Surface Treatment	Composite materials
PRIORITY ASSESSMENT			
Occupant Activity	Not Applicable	Extent / Amount	5.00 m2
Accessibility	Easily disturbed	Location	Not Applicable
Avg Time in Use	Not Applicable	Frequency of Use	Not Applicable
No. of Occupants	Not Applicable	Secondary Activity	Not Applicable
Maintenance	Not Applicable	Maintenance Frequency	Not Applicable
MANAGEMENT ACTION			
Recommendation	LABEL & MONITOR		
Recommendation Due		Next Inspection	11 Dec 2015
Apply Labels	No	Permit to Work Required	No
Survey Type	Management	Lead Surveyor	Gavin Hooper
Survey Date	11 Dec 2014	UKAS Laboratory	NOT SAMPLED (Cross Referenced)
Site Reference	113030000A	Licensed Material	No
		Notifiable Non Licensed Work	No

Asbestos Presumed

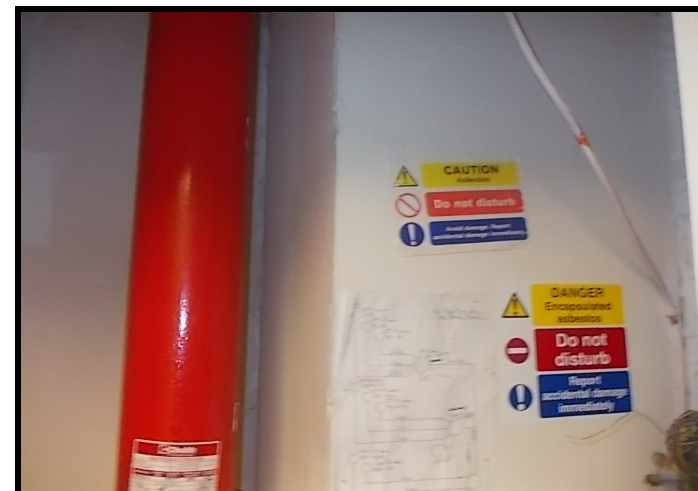
SAMPLE REFERENCE 128

MATERIAL ASSESSMENT				SCORE
Product Type	Insulation Board	Extent of Damage	Low damage	6
Asbestos Type	Amosite / Chrysotile	Surface Treatment	Sealed Board (Encapsulated)

Asbestos Presumed

MANAGEMENT ACTION				SCORE
Recommendation	LABEL & MONITOR			7
Recommendation Due		Next Inspection	11 Jun 2015	
Apply Labels	No	Permit to Work Required	No

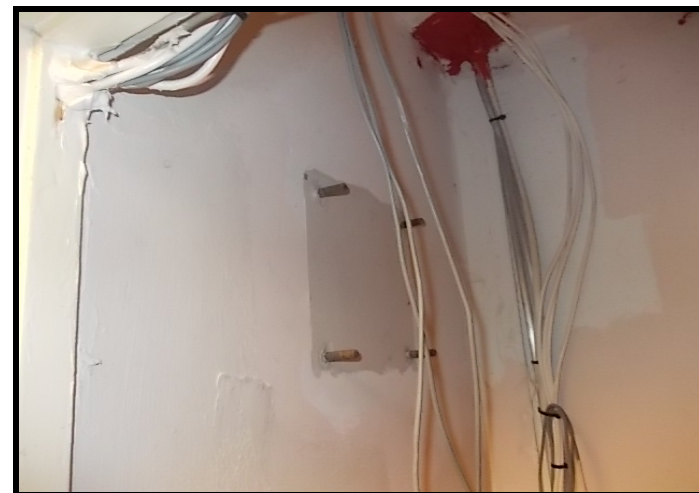
SAMPLE REFERENCE 129

Building	Floor	Room	Location		
Main Building	1st Floor	Dry Riser	Walls		
Description					
MATERIAL ASSESSMENT					
Product Type	Insulation Board	Extent of Damage	Low damage		
Asbestos Type	Amosite / Chrysotile	Surface Treatment	Sealed Board (Encapsulated)		
PRIORITY ASSESSMENT					
Occupant Activity	Not Applicable	Extent / Amount	3.00 m2		
Accessibility	Easily disturbed	Location	Not Applicable		
Avg Time in Use	Not Applicable	Frequency of Use	Not Applicable		
No. of Occupants	Not Applicable	Secondary Activity	Not Applicable		
Maintenance	Not Applicable	Maintenance Frequency	Not Applicable		
MANAGEMENT ACTION					
Recommendation	LABEL & MONITOR				
Recommendation Due		Next Inspection	11 Jun 2015		
Apply Labels	No	Permit to Work Required	No		
Survey Type	Management	Lead Surveyor	Gavin Hooper		
Survey Date	11 Dec 2014	UKAS Laboratory	NOT SAMPLED (Cross Referenced)		
Site Reference	113030000A	Licensed Material	Yes	Notifiable Non Licensed Work	No

Asbestos Presumed

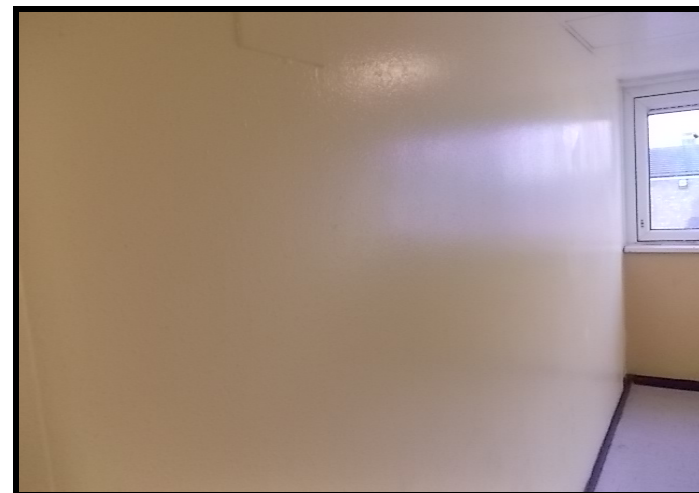
SAMPLE REFERENCE 130

Building	Floor	Room	Location		
Main Building	1st Floor	Lobby 2	Wall		
Description					
MATERIAL ASSESSMENT					SCORE
Product Type	Textured Coating	Extent of Damage	Low damage		-
Asbestos Type	No Asbestos Detected	Surface Treatment	Textured Coating		
PRIORITY ASSESSMENT					SCORE
Occupant Activity	Not Applicable	Extent / Amount	10.00 m2		-
Accessibility	Occasionally disturb	Location	Not Applicable		
Avg Time in Use	Not Applicable	Frequency of Use	Not Applicable		
No. of Occupants	Not Applicable	Secondary Activity	Not Applicable		
Maintenance	Not Applicable	Maintenance Frequency	Not Applicable		
MANAGEMENT ACTION					SCORE
Recommendation	NO ACTION REQUIRED				-
Recommendation Due		Next Inspection	None		
Apply Labels	No	Permit to Work Required	No		
Survey Type	Management	Lead Surveyor	Gavin Hooper		
Survey Date	11 Dec 2014	UKAS Laboratory	NOT SAMPLED (Cross Referenced)		
Site Reference	113030000A	Licensed Material	N/A	Notifiable Non Licensed Work	N/A

No Asbestos Presumed in Sample

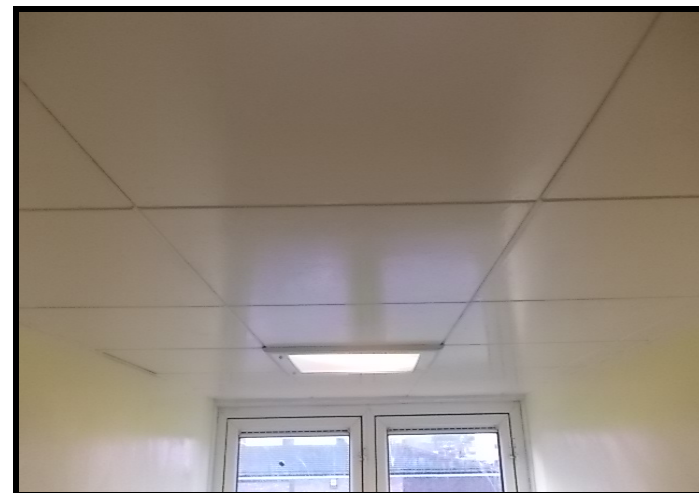
SAMPLE REFERENCE 131

Building	Floor	Room	Location		
Main Building	1st Floor	Lobby 2	Ceiling		
Description					
MATERIAL ASSESSMENT					SCORE
Product Type	Insulation Board	Extent of Damage	Low damage		-
Asbestos Type	No Asbestos Detected	Surface Treatment	Sealed Board (Encapsulated)		
PRIORITY ASSESSMENT					SCORE
Occupant Activity	Not Applicable	Extent / Amount	10.00 m2		-
Accessibility	Easily disturbed	Location	Not Applicable		
Avg Time in Use	Not Applicable	Frequency of Use	Not Applicable		
No. of Occupants	Not Applicable	Secondary Activity	Not Applicable		
Maintenance	Not Applicable	Maintenance Frequency	Not Applicable		
MANAGEMENT ACTION					SCORE
Recommendation	NO ACTION REQUIRED				-
Recommendation Due		Next Inspection	None		
Apply Labels	No	Permit to Work Required	No		
Survey Type	Management	Lead Surveyor	Gavin Hooper		
Survey Date	11 Dec 2014	UKAS Laboratory	NOT SAMPLED (Cross Referenced)		
Site Reference	113030000A	Licensed Material	N/A	Notifiable Non Licensed Work	N/A

No Asbestos Presumed in Sample

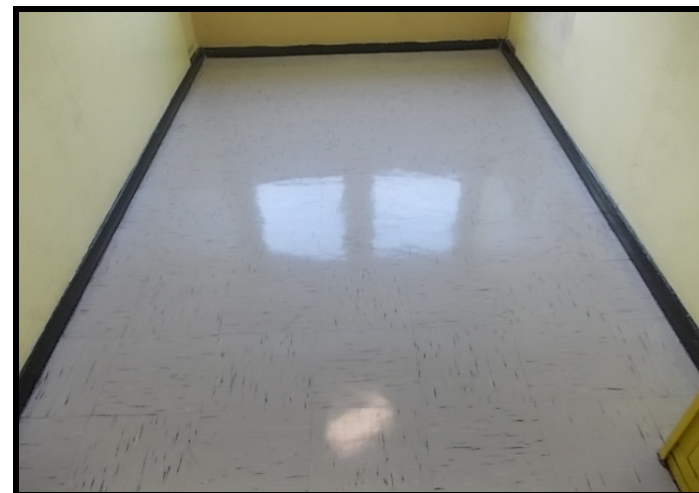
SAMPLE REFERENCE 132

MATERIAL ASSESSMENT				SCORE
Product Type	Floor Tiles	Extent of Damage	Low damage	3
Asbestos Type	Chrysotile	Surface Treatment	Composite materials

MANAGEMENT ACTION				SCORE
Recommendation	LABEL & MONITOR			4
Recommendation Due		Next Inspection	11 Dec 2015	
Apply Labels	No	Permit to Work Required	No

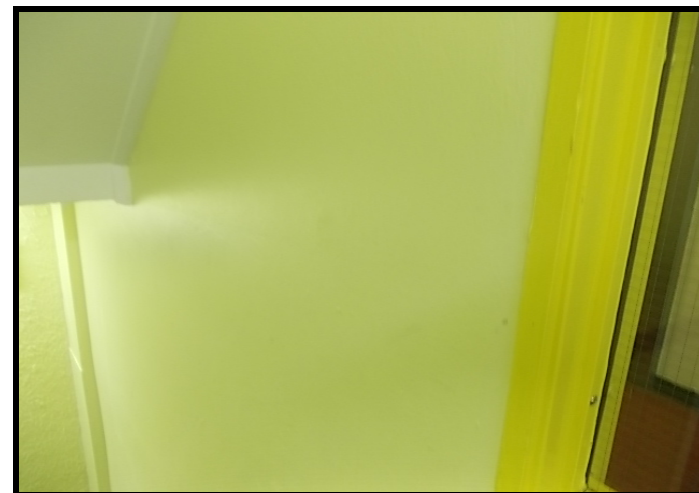
SAMPLE REFERENCE 134

Building	Floor	Room	Location		
Main Building	1st - Ground Floor	Stairwell	Wall		
Description					
MATERIAL ASSESSMENT					SCORE
Product Type	Textured Coating	Extent of Damage	Low damage		-
Asbestos Type	No Asbestos Detected	Surface Treatment	Textured Coating		
PRIORITY ASSESSMENT					SCORE
Occupant Activity	Not Applicable	Extent / Amount	10.00 m2		-
Accessibility	Occasionally disturb	Location	Not Applicable		
Avg Time in Use	Not Applicable	Frequency of Use	Not Applicable		
No. of Occupants	Not Applicable	Secondary Activity	Not Applicable		
Maintenance	Not Applicable	Maintenance Frequency	Not Applicable		
MANAGEMENT ACTION					SCORE
Recommendation	NO ACTION REQUIRED				-
Recommendation Due		Next Inspection	11 Dec 2015		
Apply Labels	No	Permit to Work Required	No		
Survey Type	Management	Lead Surveyor	Gavin Hooper		
Survey Date	11 Dec 2014	UKAS Laboratory	NOT SAMPLED (Cross Referenced)		
Site Reference	113030000A	Licensed Material	N/A	Notifiable Non Licensed Work	N/A

No Asbestos Presumed in Sample

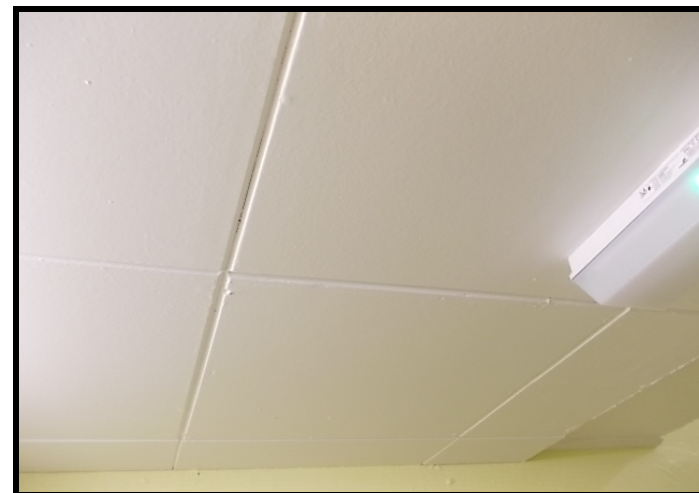
SAMPLE REFERENCE 135

Building	Floor	Room	Location		
Main Building	1st - Ground Floor	Stairwell	Ceiling		
Description					
MATERIAL ASSESSMENT					SCORE
Product Type	Insulation Board	Extent of Damage	Low damage		-
Asbestos Type	No Asbestos Detected	Surface Treatment	Sealed Board (Encapsulated)		
PRIORITY ASSESSMENT					SCORE
Occupant Activity	Not Applicable	Extent / Amount	10.00 m2		-
Accessibility	Easily disturbed	Location	Not Applicable		
Avg Time in Use	Not Applicable	Frequency of Use	Not Applicable		
No. of Occupants	Not Applicable	Secondary Activity	Not Applicable		
Maintenance	Not Applicable	Maintenance Frequency	Not Applicable		
MANAGEMENT ACTION					SCORE
Recommendation	NO ACTION REQUIRED				-
Recommendation Due		Next Inspection	None		
Apply Labels	No	Permit to Work Required	No		
Survey Type	Management	Lead Surveyor	Gavin Hooper		
Survey Date	11 Dec 2014	UKAS Laboratory	NOT SAMPLED (Cross Referenced)		
Site Reference	113030000A	Licensed Material	N/A	Notifiable Non Licensed Work	N/A

No Asbestos Presumed in Sample

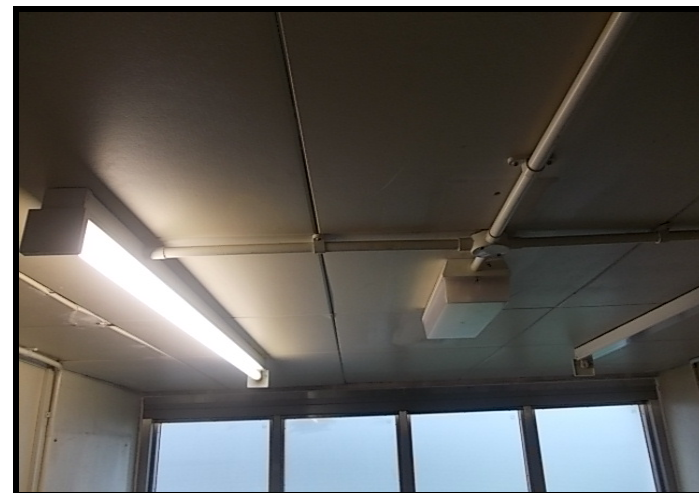
SAMPLE REFERENCE 137

Building	Floor	Room	Location		
Main Building	Ground Floor	Cleaners Cupboard	Ceiling		
Description					
MATERIAL ASSESSMENT					SCORE
Product Type	Insulation Board	Extent of Damage	Not Applicable		-
Asbestos Type	No Asbestos Detected	Surface Treatment	Sealed Board (Encapsulated)		
PRIORITY ASSESSMENT					SCORE
Occupant Activity	Not Applicable	Extent / Amount	5.00 m2		-
Accessibility	Easily disturbed	Location	Not Applicable		
Avg Time in Use	Not Applicable	Frequency of Use	Not Applicable		
No. of Occupants	Not Applicable	Secondary Activity	Not Applicable		
Maintenance	Not Applicable	Maintenance Frequency	Not Applicable		
MANAGEMENT ACTION					SCORE
Recommendation	NO ACTION REQUIRED				-
Recommendation Due		Next Inspection	None		
Apply Labels	No	Permit to Work Required	No		
Survey Type	Management	Lead Surveyor	Gavin Hooper		
Survey Date	11 Dec 2014	UKAS Laboratory	NOT SAMPLED (Cross Referenced)		
Site Reference	113030000A	Licensed Material	N/A	Notifiable Non Licensed Work	N/A

No Asbestos Presumed in Sample

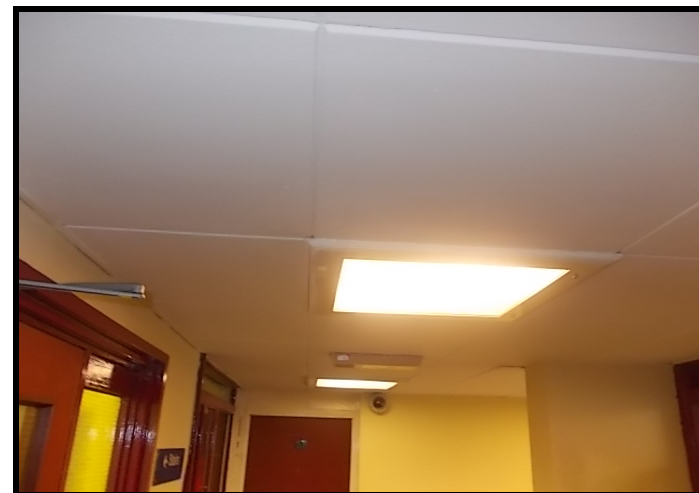
SAMPLE REFERENCE 139

Building	Floor	Room	Location		
Main Building	Ground Floor	Front Entrance	Ceiling		
Description					
MATERIAL ASSESSMENT					SCORE
Product Type	Insulation Board	Extent of Damage	Low damage		-
Asbestos Type	No Asbestos Detected	Surface Treatment	Sealed Board (Encapsulated)		
PRIORITY ASSESSMENT					SCORE
Occupant Activity	Not Applicable	Extent / Amount	10.00 m2		-
Accessibility	Easily disturbed	Location	Not Applicable		
Avg Time in Use	Not Applicable	Frequency of Use	Not Applicable		
No. of Occupants	Not Applicable	Secondary Activity	Not Applicable		
Maintenance	Not Applicable	Maintenance Frequency	Not Applicable		
MANAGEMENT ACTION					SCORE
Recommendation	NO ACTION REQUIRED				-
Recommendation Due		Next Inspection	None		
Apply Labels	No	Permit to Work Required	No		
Survey Type	Management	Lead Surveyor	Gavin Hooper		
Survey Date	11 Dec 2014	UKAS Laboratory	NOT SAMPLED (Cross Referenced)		
Site Reference	113030000A	Licensed Material	N/A	Notifiable Non Licensed Work	N/A

No Asbestos Presumed in Sample

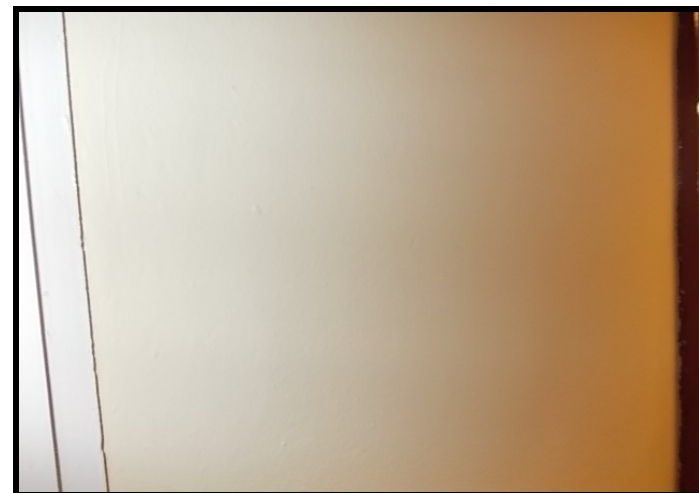
SAMPLE REFERENCE 139a

Building	Floor	Room	Location		
Main Building	Ground Floor	Front Entrance	Wall		
Description					
MATERIAL ASSESSMENT					SCORE
Product Type	Textured Coating	Extent of Damage	Low damage		-
Asbestos Type	No Asbestos Detected	Surface Treatment	Textured Coating		
PRIORITY ASSESSMENT					SCORE
Occupant Activity	Not Applicable	Extent / Amount	15.00 m2		-
Accessibility	Easily disturbed	Location	Not Applicable		
Avg Time in Use	Not Applicable	Frequency of Use	Not Applicable		
No. of Occupants	Not Applicable	Secondary Activity	Not Applicable		
Maintenance	Not Applicable	Maintenance Frequency	Not Applicable		
MANAGEMENT ACTION					SCORE
Recommendation	NO ACTION REQUIRED				-
Recommendation Due		Next Inspection	None		
Apply Labels	No	Permit to Work Required	No		
Survey Type	Management	Lead Surveyor	Gavin Hooper		
Survey Date	11 Dec 2014	UKAS Laboratory	NOT SAMPLED (Cross Referenced)		
Site Reference	113030000A	Licensed Material	N/A	Notifiable Non Licensed Work	N/A

No Asbestos Presumed in Sample

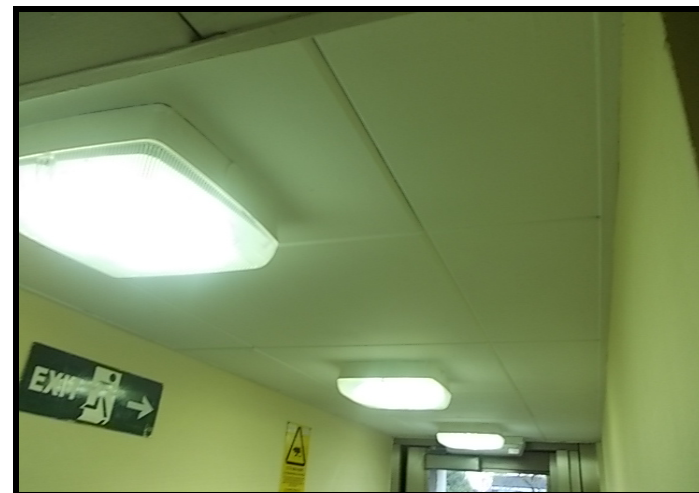
SAMPLE REFERENCE 140

Building	Floor	Room	Location		
Main Building	Ground Floor	Rear Entrance	Ceiling		
Description					
MATERIAL ASSESSMENT					SCORE
Product Type	Insulation Board	Extent of Damage	Low damage		-
Asbestos Type	No Asbestos Detected	Surface Treatment	Sealed Board (Encapsulated)		
PRIORITY ASSESSMENT					SCORE
Occupant Activity	Not Applicable	Extent / Amount	10.00 m2		-
Accessibility	Easily disturbed	Location	Not Applicable		
Avg Time in Use	Not Applicable	Frequency of Use	Not Applicable		
No. of Occupants	Not Applicable	Secondary Activity	Not Applicable		
Maintenance	Not Applicable	Maintenance Frequency	Not Applicable		
MANAGEMENT ACTION					SCORE
Recommendation	NO ACTION REQUIRED				-
Recommendation Due		Next Inspection	None		
Apply Labels	No	Permit to Work Required	No		
Survey Type	Management	Lead Surveyor	Gavin Hooper		
Survey Date	11 Dec 2014	UKAS Laboratory	NOT SAMPLED (Cross Referenced)		
Site Reference	113030000A	Licensed Material	N/A	Notifiable Non Licensed Work	N/A

No Asbestos Presumed in Sample

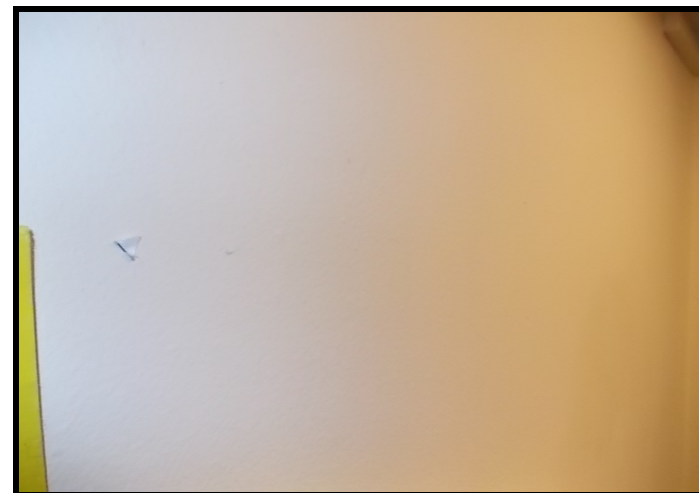
SAMPLE REFERENCE 140a

Building	Floor	Room	Location		
Main Building	Ground Floor	Rear Entrance	Wall		
Description					
MATERIAL ASSESSMENT					SCORE
Product Type	Textured Coating	Extent of Damage	Low damage		-
Asbestos Type	No Asbestos Detected	Surface Treatment	Textured Coating		
PRIORITY ASSESSMENT					SCORE
Occupant Activity	Not Applicable	Extent / Amount	10.00 m2		-
Accessibility	Easily disturbed	Location	Not Applicable		
Avg Time in Use	Not Applicable	Frequency of Use	Not Applicable		
No. of Occupants	Not Applicable	Secondary Activity	Not Applicable		
Maintenance	Not Applicable	Maintenance Frequency	Not Applicable		
MANAGEMENT ACTION					SCORE
Recommendation	NO ACTION REQUIRED				-
Recommendation Due		Next Inspection	None		
Apply Labels	No	Permit to Work Required	No		
Survey Type	Management	Lead Surveyor	Gavin Hooper		
Survey Date	11 Dec 2014	UKAS Laboratory	NOT SAMPLED (Cross Referenced)		
Site Reference	113030000A	Licensed Material	N/A	Notifiable Non Licensed Work	N/A

No Asbestos Presumed in Sample

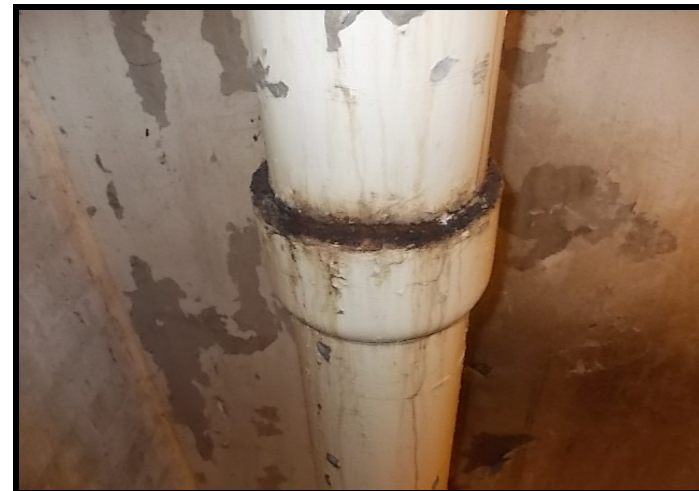
SAMPLE REFERENCE 143

Building	Floor	Room	Location		
Main Building	Ground Floor	Riser Cupboard	Pipe Work		
Description					
MATERIAL ASSESSMENT					
Product Type	Lagging	Extent of Damage	Low damage		
Asbestos Type	Amosite	Surface Treatment	Unsealed (3)		
PRIORITY ASSESSMENT					
Occupant Activity	Not Applicable	Extent / Amount	1.00 m2		
Accessibility	Occasionally disturb	Location	Not Applicable		
Avg Time in Use	Not Applicable	Frequency of Use	Not Applicable		
No. of Occupants	Not Applicable	Secondary Activity	Not Applicable		
Maintenance	Not Applicable	Maintenance Frequency	Not Applicable		
MANAGEMENT ACTION					
Recommendation	LABEL & MONITOR				
Recommendation Due		Next Inspection	11 Jun 2015		
Apply Labels	No	Permit to Work Required	No		
Survey Type	Management	Lead Surveyor	Gavin Hooper		
Survey Date	11 Dec 2014	UKAS Laboratory	DMW Environmental Safety Ltd / [A-9279]		
Site Reference	113030000A	Licensed Material	Yes	Notifiable Non Licensed Work	No

Asbestos detected in Sample

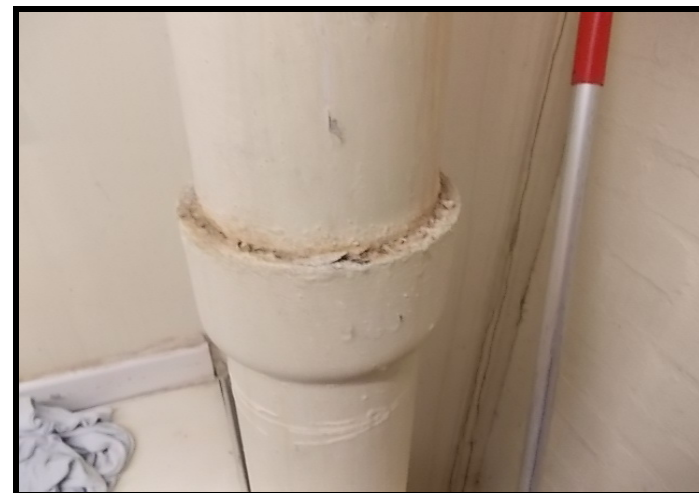
SAMPLE REFERENCE 144

MATERIAL ASSESSMENT				SCORE
Product Type	Lagging	Extent of Damage	Low damage	9
Asbestos Type	Amosite	Surface Treatment	Unsealed (3)

Asbestos detected in Sample

MANAGEMENT ACTION				SCORE
Recommendation	LABEL & MONITOR			10
Recommendation Due		Next Inspection	11 Jun 2015	
Apply Labels	No	Permit to Work Required	No

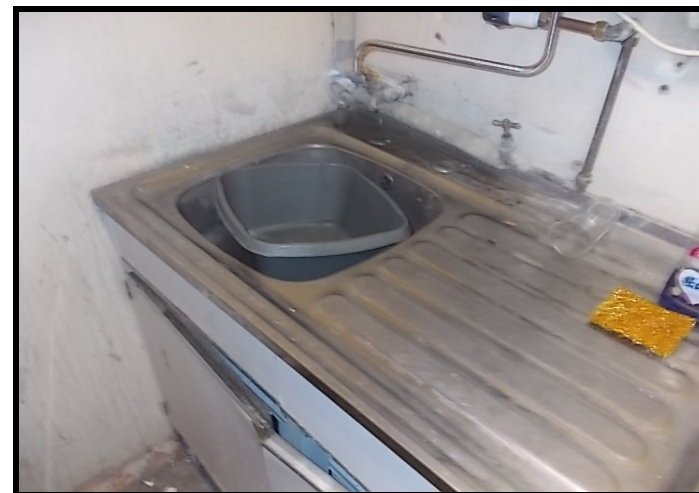
SAMPLE REFERENCE 145

Building	Floor	Room	Location		
Main Building	Ground Floor	Kitchen	Sink		
Description					
MATERIAL ASSESSMENT					SCORE
Product Type	Bitumen	Extent of Damage	Medium damage		-
Asbestos Type	No Asbestos Detected	Surface Treatment	Composite materials		
PRIORITY ASSESSMENT					SCORE
Occupant Activity	Not Applicable	Extent / Amount	1.00 m2		-
Accessibility	Occasionally disturb	Location	Not Applicable		
Avg Time in Use	Not Applicable	Frequency of Use	Not Applicable		
No. of Occupants	Not Applicable	Secondary Activity	Not Applicable		
Maintenance	Not Applicable	Maintenance Frequency	Not Applicable		
MANAGEMENT ACTION					SCORE
Recommendation	NO ACTION REQUIRED				-
Recommendation Due		Next Inspection	None		
Apply Labels	No	Permit to Work Required	No		
Survey Type	Management	Lead Surveyor	Gavin Hooper		
Survey Date	11 Dec 2014	UKAS Laboratory	DMW Environmental Safety Ltd / [A-9279]		
Site Reference	113030000A	Licensed Material	N/A	Notifiable Non Licensed Work	N/A

Asbestos not detected in Sample
