Management with Targeted Refurbishment Survey – PART 2

1-61 Pembroke House
Barle Grove
Chelmsley Wood
Solihull
B36 0UA
United Kingdom

12th June 2021

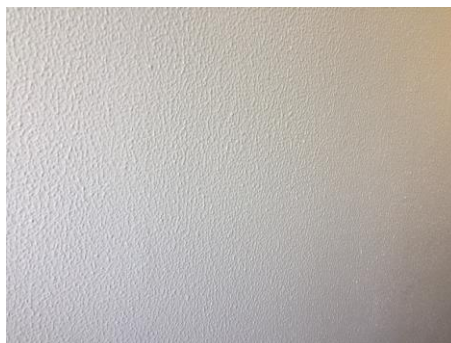
Stipple pattern textured coating.

The material was seen to be in fair condition at the time of the initial inspection.

The condition of the material should be managed by a competent person/company and its presence made aware to those at risk, as part of a Control of Asbestos Regulations (CAR) 2012 compliant management strategy.

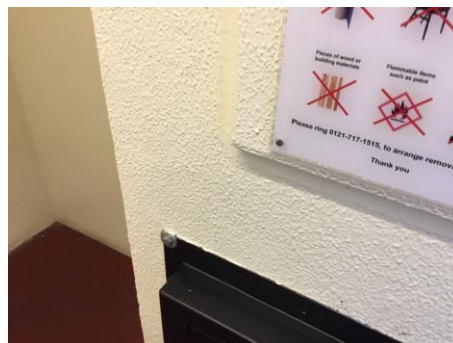
Stipple pattern textured coating.

The material was seen to be in fair condition at the time of the initial inspection.

The condition of the material should be managed by a competent person/company and its presence made aware to those at risk, as part of a Control of Asbestos Regulations (CAR) 2012 compliant management strategy.

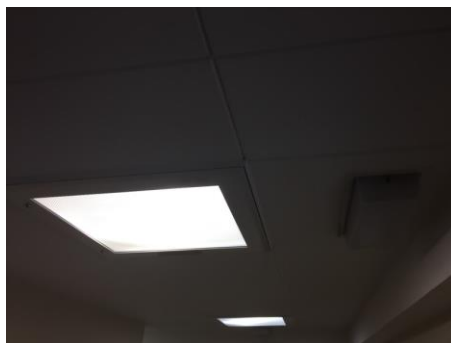
Spatter pattern textured coating above suspended ceiling.

The material was seen to be in fair condition at the time of the initial inspection.

The condition of the material should be managed by a competent person/company and its presence made aware to those at risk, as part of a Control of Asbestos Regulations (CAR) 2012 compliant management strategy.

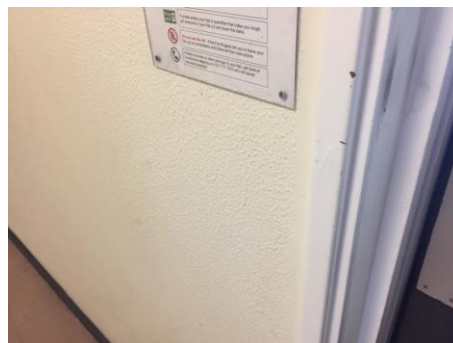
Stipple pattern textured coating.

The material was seen to be in fair condition at the time of the initial inspection.

The condition of the material should be managed by a competent person/company and its presence made aware to those at risk, as part of a Control of Asbestos Regulations (CAR) 2012 compliant management strategy.

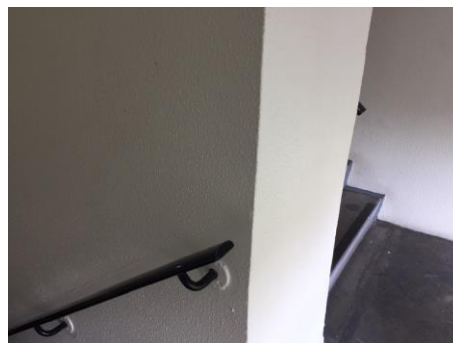
Stipple pattern textured coating.

The material was seen to be in fair condition at the time of the initial inspection.

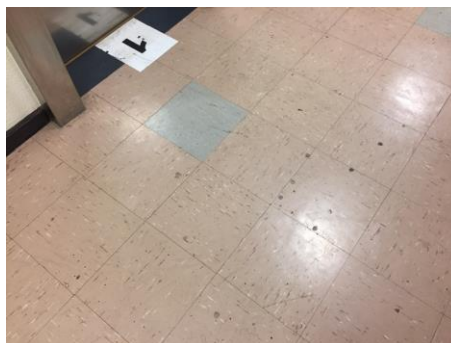
Pink and grey floor tiles.

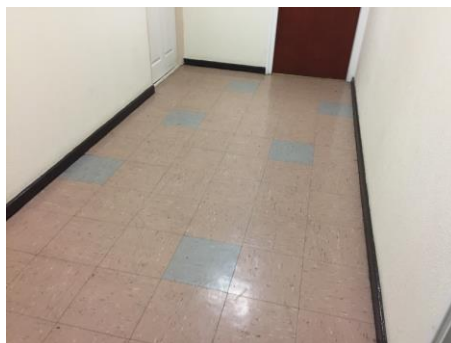
Bitumen adhesive beneath floor tiles.

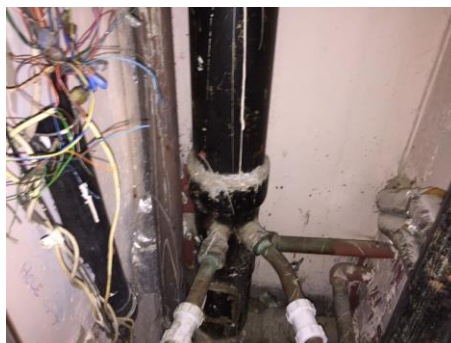
Condition **High Damage**

Lagging packing to joints of soil pipe.

The material was seen to be in fair condition at the time of the initial inspection.

The condition of the material should be managed by a competent person/company and its presence made aware to those at risk, as part of a Control of Asbestos Regulations (CAR) 2012 compliant management strategy.

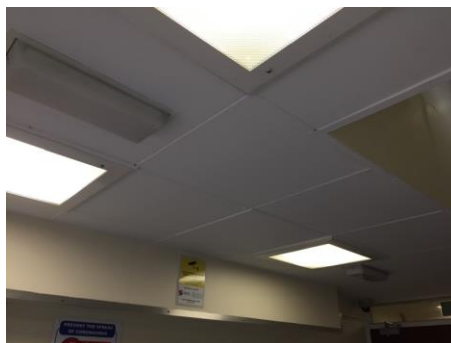
Condition **Low Damage**

Spatter pattern textured coating above suspended ceiling.

The material was seen to be in fair condition at the time of the initial inspection.

The condition of the material should be managed by a competent person/company and its presence made aware to those at risk, as part of a Control of Asbestos Regulations (CAR) 2012 compliant management strategy.

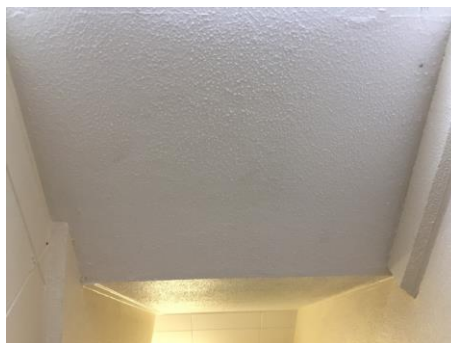
Condition **Low Damage**

Stipple pattern textured coating over stairs.

The material was seen to be in fair condition at the time of the initial inspection.

The condition of the material should be managed by a competent person/company and its presence made aware to those at risk, as part of a Control of Asbestos Regulations (CAR) 2012 compliant management strategy.

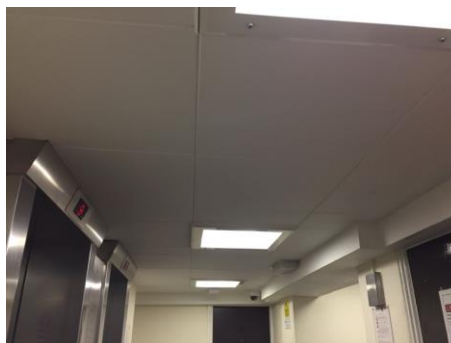
Condition **Low Damage**

Spatter pattern textured coating above suspended ceiling.

The material was seen to be in fair condition at the time of the initial inspection.

The condition of the material should be managed by a competent person/company and its presence made aware to those at risk, as part of a Control of Asbestos Regulations (CAR) 2012 compliant management strategy.

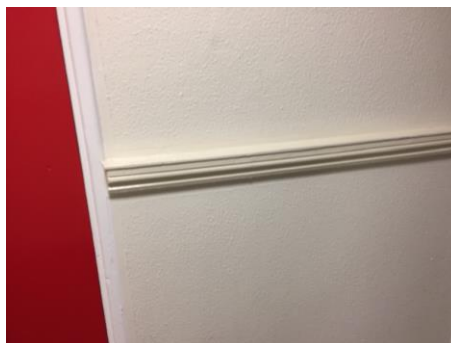
Stipple pattern textured coating.

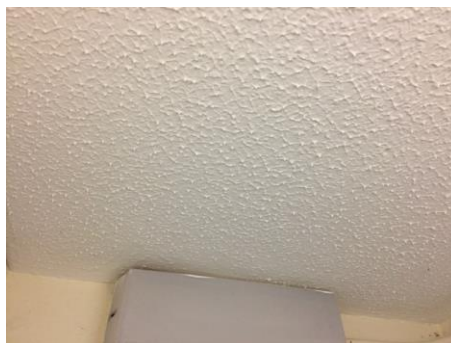
Condition **Low Damage**

Spatter pattern with modern stipple pattern applied over textured coating.

The material was seen to be in fair condition at the time of the initial inspection.

The condition of the material should be managed by a competent person/company and its presence made aware to those at risk, as part of a Control of Asbestos Regulations (CAR) 2012 compliant management strategy.

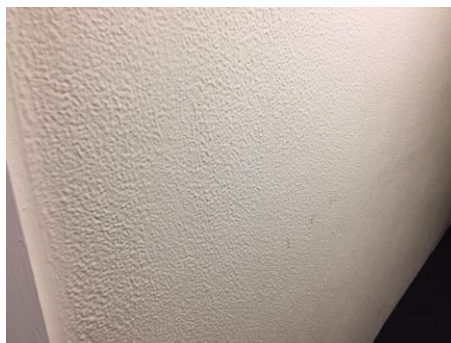
Stipple pattern textured coating.

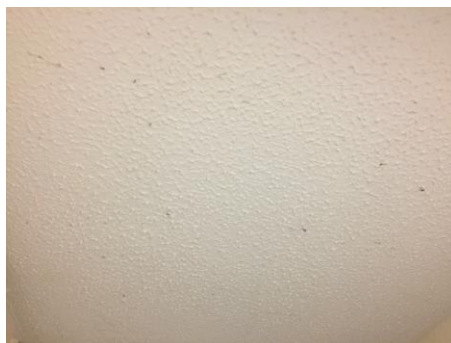
Condition **Low Damage**

Spatter pattern with modern stipple pattern applied over textured coating.

The material was seen to be in fair condition at the time of the initial inspection.

The condition of the material should be managed by a competent person/company and its presence made aware to those at risk, as part of a Control of Asbestos Regulations (CAR) 2012 compliant management strategy.

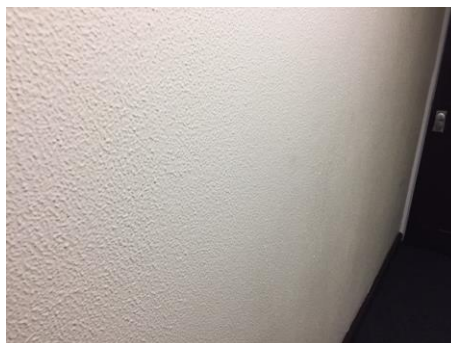
Stipple pattern textured coating.

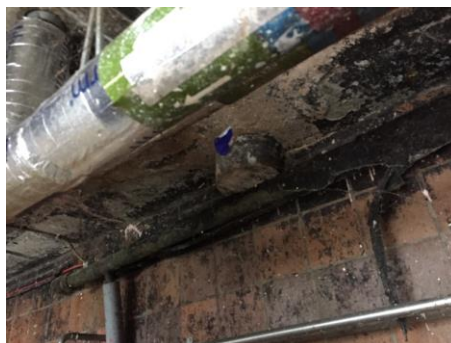
Condition **Low Damage**

Cement incinerator flue cap.

The material was seen to be in fair condition at the time of the initial inspection.

The condition of the material should be managed by a competent person/company and its presence made aware to those at risk, as part of a Control of Asbestos Regulations (CAR) 2012 compliant management strategy.
