# **Solihull Community Housing**

## **Asbestos Management Survey Report**

**I-49 Richmond House  
(Communal)  
Marlene Croft  
Solihull  
B37 7JS**

**Date of Report: 06 Feb 2015**

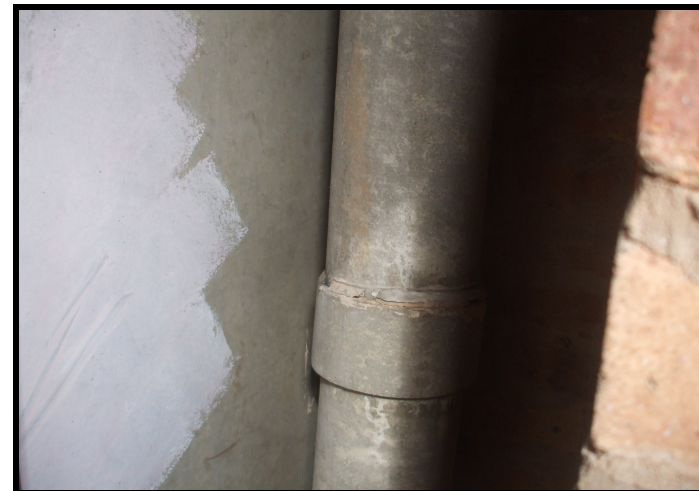
## SAMPLE REFERENCE 009

Asbestos Presumed

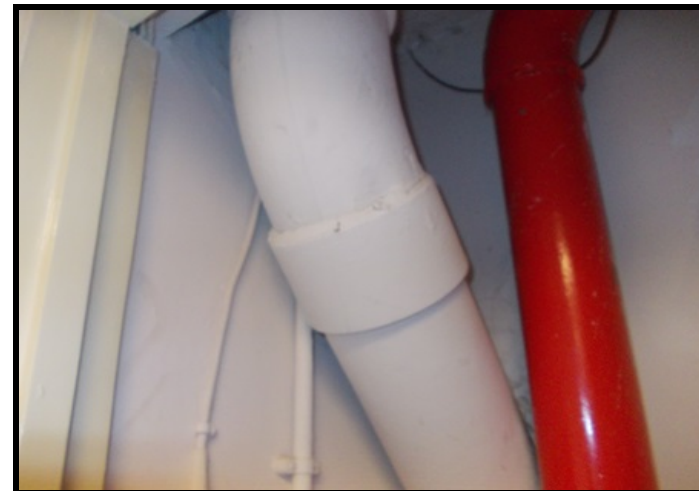
## SAMPLE REFERENCE 014

Asbestos Presumed

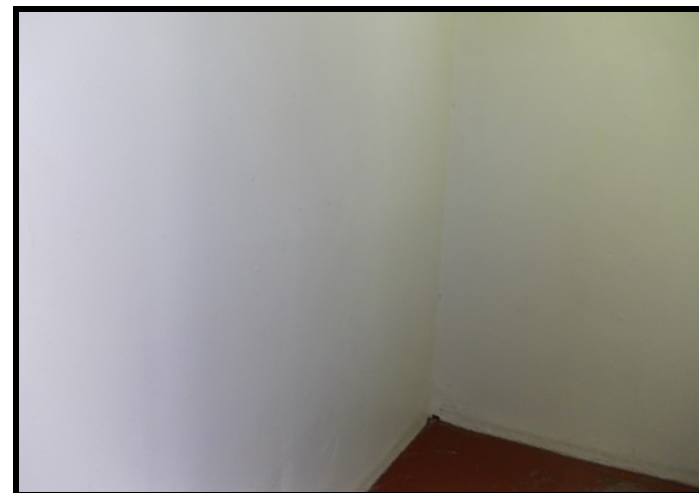
## SAMPLE REFERENCE 025

**No Asbestos Presumed in Sample**

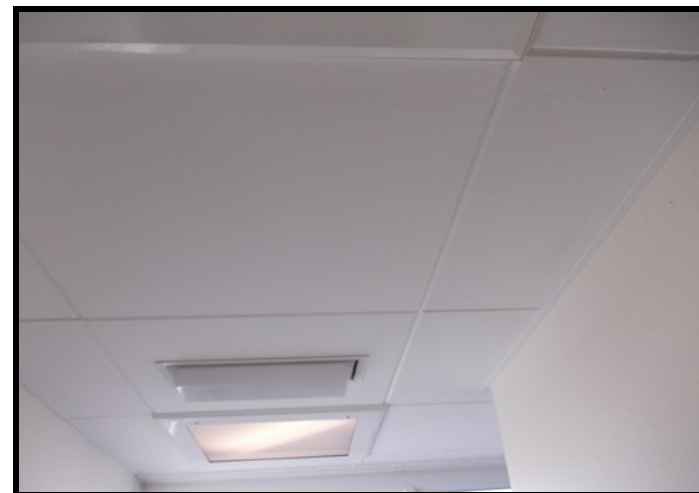
## SAMPLE REFERENCE 026

**No Asbestos Presumed in Sample**

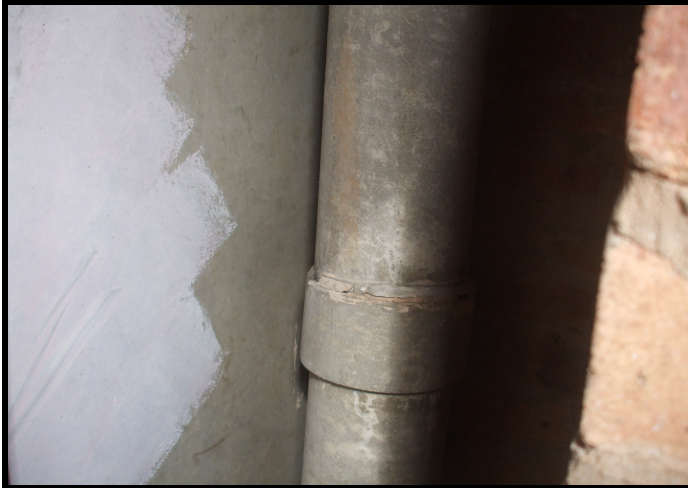
SAMPLE REFERENCE 032

SURVEYORS COMMENTS	
<p><b>Asbestos Presumed</b></p>

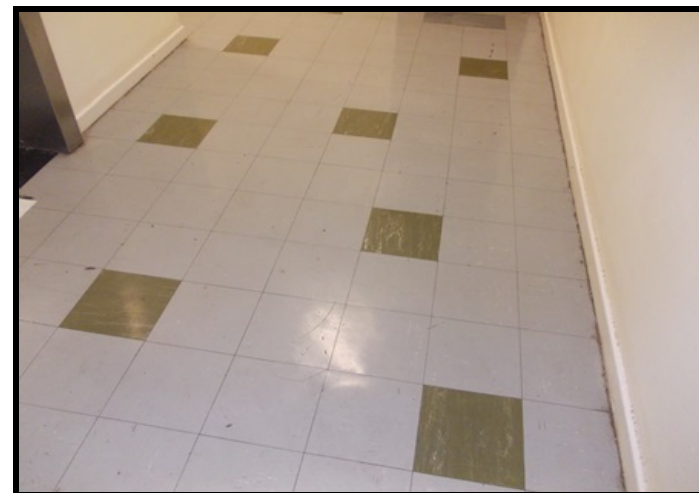
## SAMPLE REFERENCE 049

**Asbestos detected in Sample**

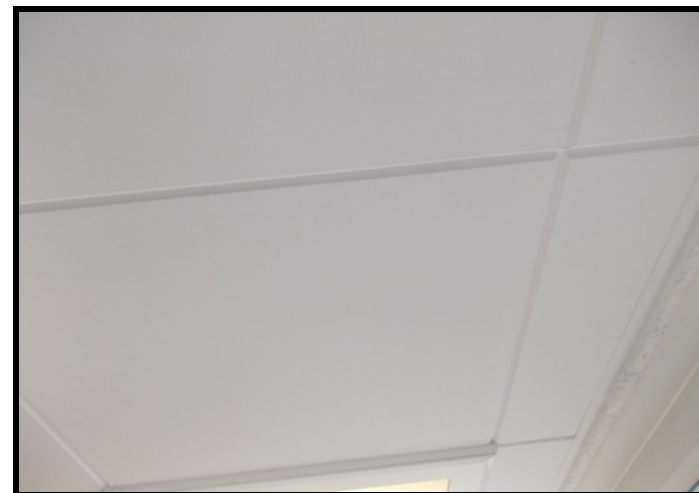
## SAMPLE REFERENCE 069

**No Asbestos Presumed in Sample**

MATERIAL ASSESSMENT				SCORE
<b>Product Type</b>	Textured Coating	<b>Extent of Damage</b>	Low damage	-
<b>Asbestos Type</b>	<b>No Asbestos Detected</b>	<b>Surface Treatment</b>	Textured Coating

MANAGEMENT ACTION				SCORE
<b>Recommendation</b>	NO ACTION REQUIRED			-
<b>Recommendation Due</b>		<b>Next Inspection</b>	None	
<b>Apply Labels</b>	No	<b>Permit to Work Required</b>	No

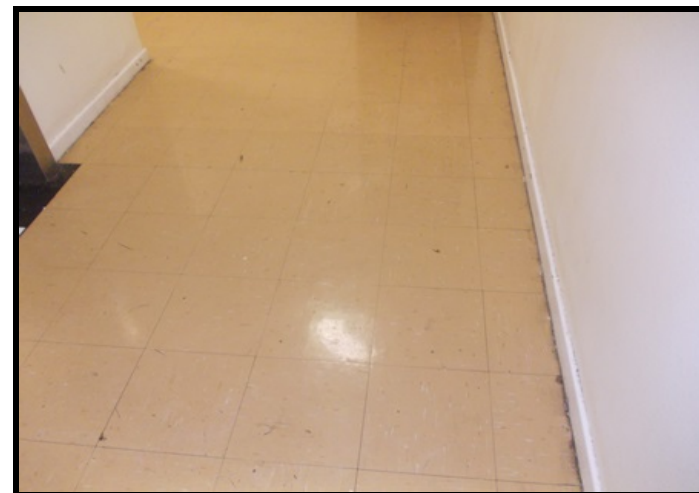
## SAMPLE REFERENCE 072

**No Asbestos Presumed in Sample**

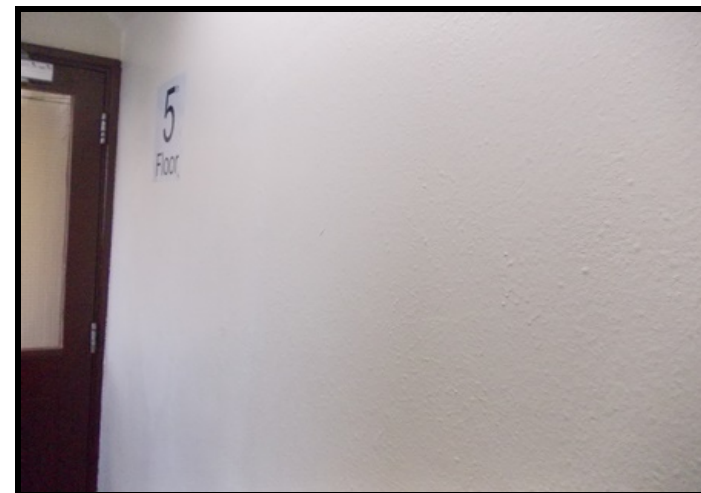
## SAMPLE REFERENCE 076

**No Asbestos Presumed in Sample**

Building	Floor	Room	Location
Main Building	Fifth Floor	Stairwell	Ceiling
<b>Description</b>			
<b>MATERIAL ASSESSMENT</b>			
<b>Product Type</b>	Textured Coating	<b>Extent of Damage</b>	Low damage
<b>Asbestos Type</b>	<b>No Asbestos Detected</b>	<b>Surface Treatment</b>	Textured Coating
<b>PRIORITY ASSESSMENT</b>			
<b>Occupant Activity</b>	Not Applicable	<b>Extent / Amount</b>	6.00 m2
<b>Accessibility</b>	Occasionally disturb	<b>Location</b>	Not Applicable
<b>Avg Time in Use</b>	Not Applicable	<b>Frequency of Use</b>	Not Applicable
<b>No. of Occupants</b>	Not Applicable	<b>Secondary Activity</b>	Not Applicable
<b>Maintenance</b>	Not Applicable	<b>Maintenance Frequency</b>	Not Applicable
<b>MANAGEMENT ACTION</b>			
<b>Recommendation</b>	NO ACTION REQUIRED		
<b>Recommendation Due</b>		<b>Next Inspection</b>	None
<b>Apply Labels</b>	No	<b>Permit to Work Required</b>	No
<b>Survey Type</b>	Management	<b>Lead Surveyor</b>	Gavin Hooper

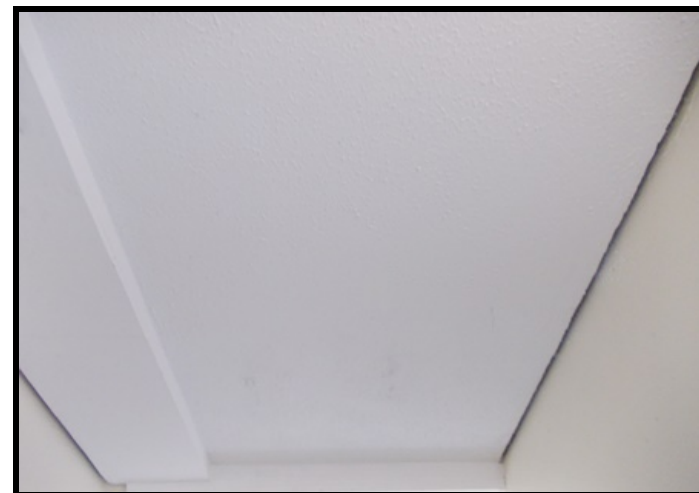
## SAMPLE REFERENCE 077

**No Asbestos Presumed in Sample**

Building	Floor	Room	Location
Main Building	Fifth Floor	Stairwell	Ceiling
<b>Description</b>			
<b>MATERIAL ASSESSMENT</b>			
<b>Product Type</b>	Insulation Board	<b>Extent of Damage</b>	Low damage
<b>Asbestos Type</b>	<b>No Asbestos Detected</b>	<b>Surface Treatment</b>	Sealed Board (Encapsulated)
<b>PRIORITY ASSESSMENT</b>			
<b>Occupant Activity</b>	Not Applicable	<b>Extent / Amount</b>	6.00 m2
<b>Accessibility</b>	Occasionally disturb	<b>Location</b>	Not Applicable
<b>Avg Time in Use</b>	Not Applicable	<b>Frequency of Use</b>	Not Applicable
<b>No. of Occupants</b>	Not Applicable	<b>Secondary Activity</b>	Not Applicable
<b>Maintenance</b>	Not Applicable	<b>Maintenance Frequency</b>	Not Applicable
<b>MANAGEMENT ACTION</b>			
<b>Recommendation</b>	NO ACTION REQUIRED		
<b>Recommendation Due</b>		<b>Next Inspection</b>	None
<b>Apply Labels</b>	No	<b>Permit to Work Required</b>	No
<b>Survey Type</b>	Management	<b>Lead Surveyor</b>	Gavin Hooper

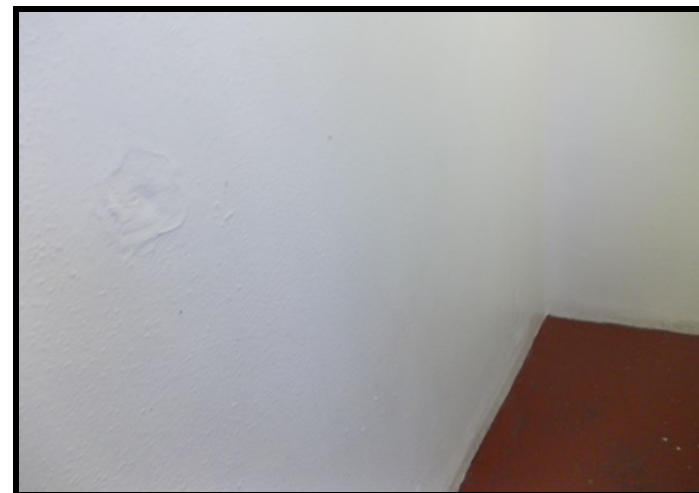
## SAMPLE REFERENCE 080

**No Asbestos Presumed in Sample**

Building	Floor	Room	Location			
Main Building	Fifth Floor	Bin Chute	Ceiling			
Description						
MATERIAL ASSESSMENT				SCORE		
Product Type	Insulation Board	Extent of Damage	Low damage		-	
Asbestos Type	No Asbestos Detected	Surface Treatment	Sealed Board (Encapsulated)			
PRIORITY ASSESSMENT				SCORE		
Occupant Activity	Not Applicable	Extent / Amount	6.00 m2		-	
Accessibility	Occasionally disturb	Location	Not Applicable			
Avg Time in Use	Not Applicable	Frequency of Use	Not Applicable			
No. of Occupants	Not Applicable	Secondary Activity	Not Applicable			
Maintenance	Not Applicable	Maintenance Frequency	Not Applicable			
MANAGEMENT ACTION				SCORE		
Recommendation	NO ACTION REQUIRED			-		
Recommendation Due		Next Inspection	None			
Apply Labels	No	Permit to Work Required	No			
Survey Type	Management	Lead Surveyor	Gavin Hooper			
Survey Date	29 Jan 2015	UKAS Laboratory	NOT SAMPLED (Cross Referenced)			
Site Reference	I43760000A	Licensed Material	N/A	Notifiable Non Licensed Work	N/A

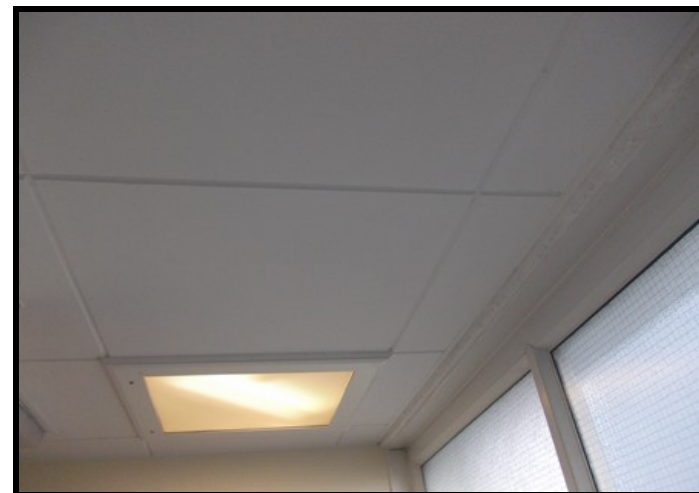
## SAMPLE REFERENCE 081

**No Asbestos Presumed in Sample**

MATERIAL ASSESSMENT				SCORE
<b>Product Type</b>	Textured Coating	<b>Extent of Damage</b>	Low damage	-
<b>Asbestos Type</b>	No Asbestos Detected	<b>Surface Treatment</b>	Textured Coating

MANAGEMENT ACTION				SCORE
<b>Recommendation</b>	NO ACTION REQUIRED			-
<b>Recommendation Due</b>		<b>Next Inspection</b>	None	
<b>Apply Labels</b>	No	<b>Permit to Work Required</b>	No

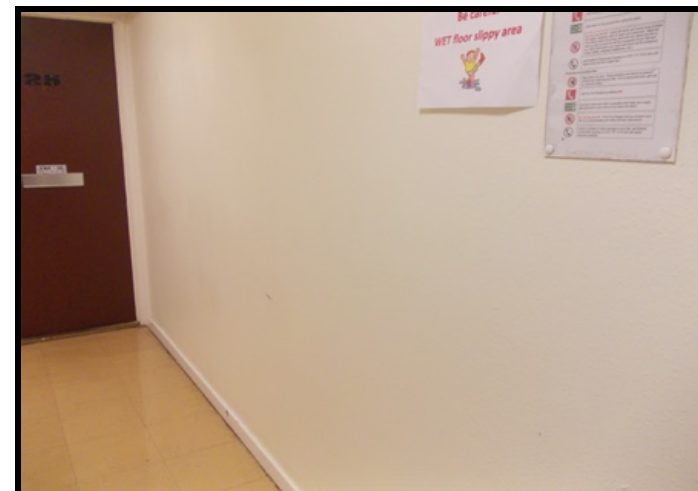
## SAMPLE REFERENCE 082

**No Asbestos Presumed in Sample**

Building	Floor	Room	Location
Main Building	Fifth Floor	Lobby	Ceiling
<b>Description</b>			
<b>MATERIAL ASSESSMENT</b>			
<b>Product Type</b>	Insulation Board	<b>Extent of Damage</b>	Low damage
<b>Asbestos Type</b>	<b>No Asbestos Detected</b>	<b>Surface Treatment</b>	Sealed Board (Encapsulated)
<b>PRIORITY ASSESSMENT</b>			
<b>Occupant Activity</b>	Not Applicable	<b>Extent / Amount</b>	20.00 m2
<b>Accessibility</b>	Occasionally disturb	<b>Location</b>	Not Applicable
<b>Avg Time in Use</b>	Not Applicable	<b>Frequency of Use</b>	Not Applicable
<b>No. of Occupants</b>	Not Applicable	<b>Secondary Activity</b>	Not Applicable
<b>Maintenance</b>	Not Applicable	<b>Maintenance Frequency</b>	Not Applicable
<b>MANAGEMENT ACTION</b>			
<b>Recommendation</b>	NO ACTION REQUIRED		
<b>Recommendation Due</b>		<b>Next Inspection</b>	None
<b>Apply Labels</b>	No	<b>Permit to Work Required</b>	No
<b>Survey Type</b>	Management	<b>Lead Surveyor</b>	Gavin Hooper

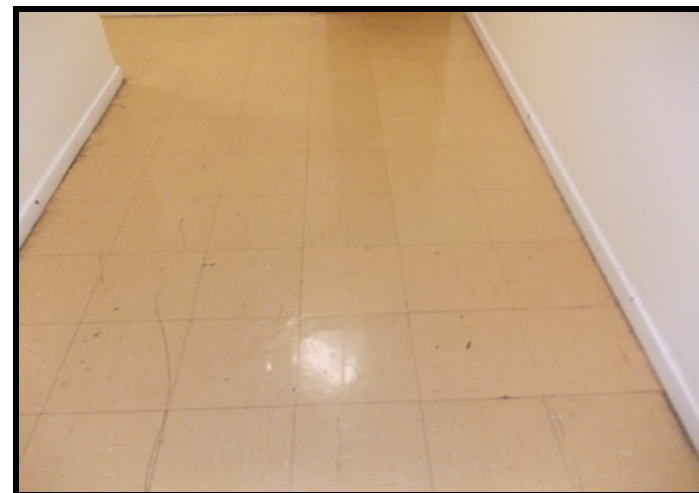
## SAMPLE REFERENCE 084

**No Asbestos Presumed in Sample**

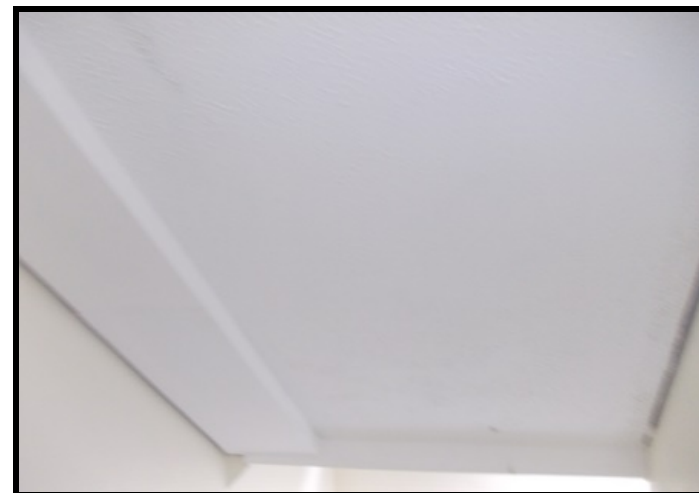
## SAMPLE REFERENCE 089

**No Asbestos Presumed in Sample**

MATERIAL ASSESSMENT				SCORE
<b>Product Type</b>	Insulation Board	<b>Extent of Damage</b>	Low damage	-
<b>Asbestos Type</b>	<b>No Asbestos Detected</b>	<b>Surface Treatment</b>	Sealed Board (Encapsulated)

MANAGEMENT ACTION				SCORE
<b>Recommendation</b>	NO ACTION REQUIRED			-
<b>Recommendation Due</b>		<b>Next Inspection</b>	None	
<b>Apply Labels</b>	No	<b>Permit to Work Required</b>	No

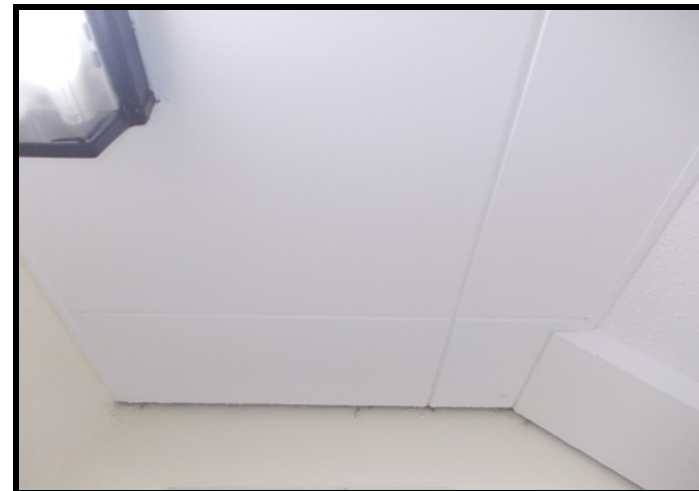
## SAMPLE REFERENCE 090

**No Asbestos Presumed in Sample**

Building	Floor	Room	Location			
Main Building	Fourth Floor	Bin Chute	Pipe Work			
Description	Flue has now been boxed in					
MATERIAL ASSESSMENT				SCORE		
Product Type	Cement Flue	Extent of Damage	Low damage		4	
Asbestos Type	Chrysotile	Surface Treatment	Unsealed (Cement products)			
PRIORITY ASSESSMENT				SCORE		
Occupant Activity	Not Applicable	Extent / Amount	6.00 lm		1	
Accessibility	Occasionally disturb	Location	Not Applicable			
Avg Time in Use	Not Applicable	Frequency of Use	Not Applicable			
No. of Occupants	Not Applicable	Secondary Activity	Not Applicable			
Maintenance	Not Applicable	Maintenance Frequency	Not Applicable			
MANAGEMENT ACTION				SCORE		
Recommendation	LABEL & MONITOR			5		
Recommendation Due		Next Inspection	29 Jan 2016			
Apply Labels	No	Permit to Work Required	No			
Survey Type	Management	Lead Surveyor	Gavin Hooper			
Survey Date	29 Jan 2015	UKAS Laboratory	NOT SAMPLED (Cross Referenced)

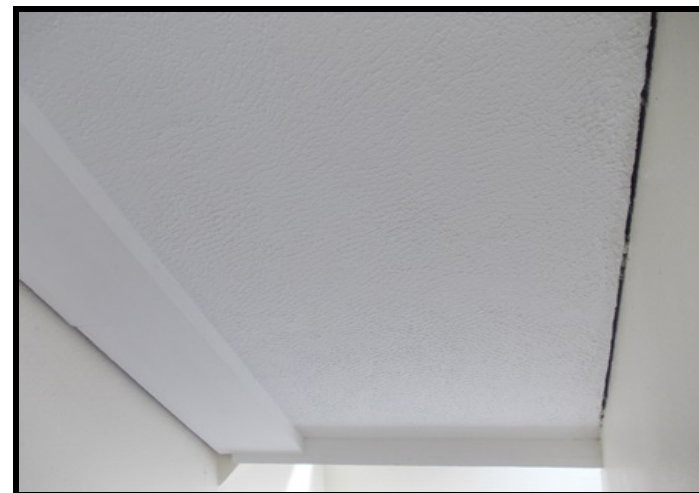
## SAMPLE REFERENCE 101

**No Asbestos Presumed in Sample**

MATERIAL ASSESSMENT				SCORE
<b>Product Type</b>	Insulation Board	<b>Extent of Damage</b>	Low damage	-
<b>Asbestos Type</b>	No Asbestos Detected	<b>Surface Treatment</b>	Sealed Board (Encapsulated)

MANAGEMENT ACTION				SCORE
<b>Recommendation</b>	NO ACTION REQUIRED			-
<b>Recommendation Due</b>		<b>Next Inspection</b>	None	
<b>Apply Labels</b>	No	<b>Permit to Work Required</b>	No

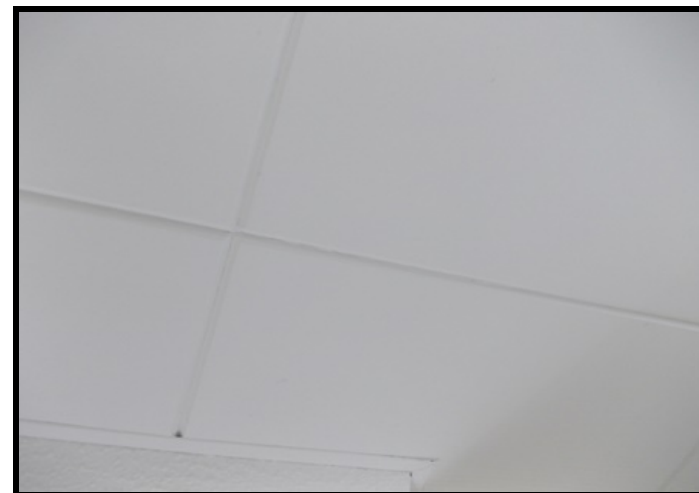
## SAMPLE REFERENCE 102

**No Asbestos Presumed in Sample**

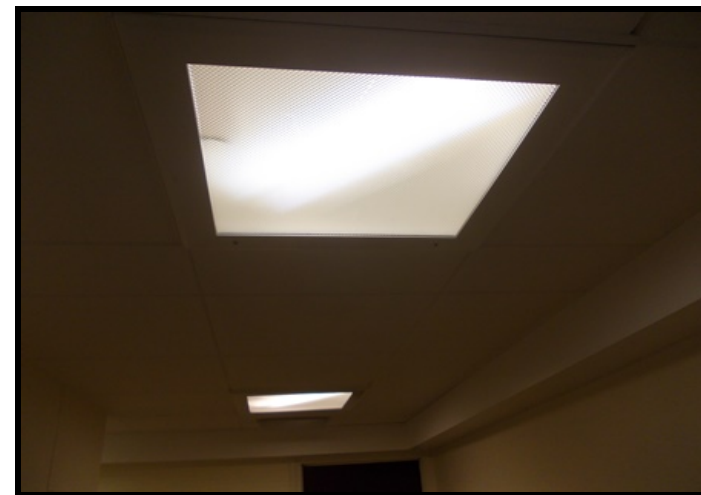
SAMPLE REFERENCE 107

**No Asbestos Presumed in Sample**

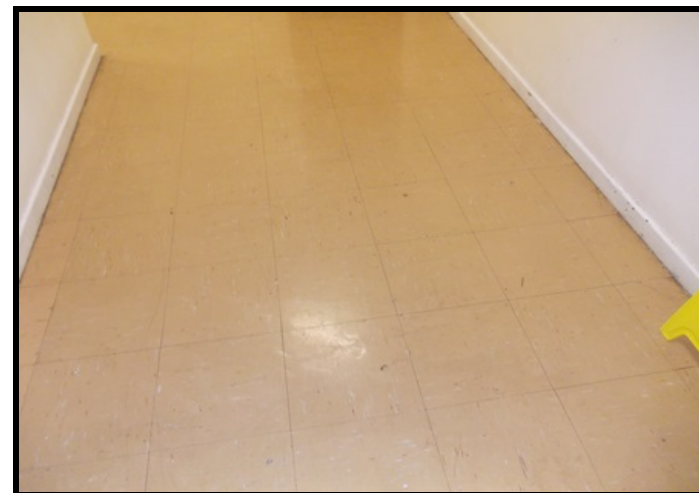
## SAMPLE REFERENCE 108

**No Asbestos Presumed in Sample**

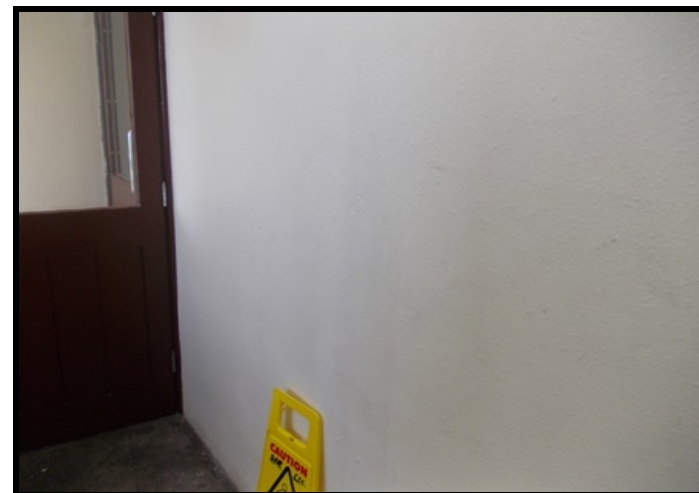
## SAMPLE REFERENCE I12

**No Asbestos Presumed in Sample**

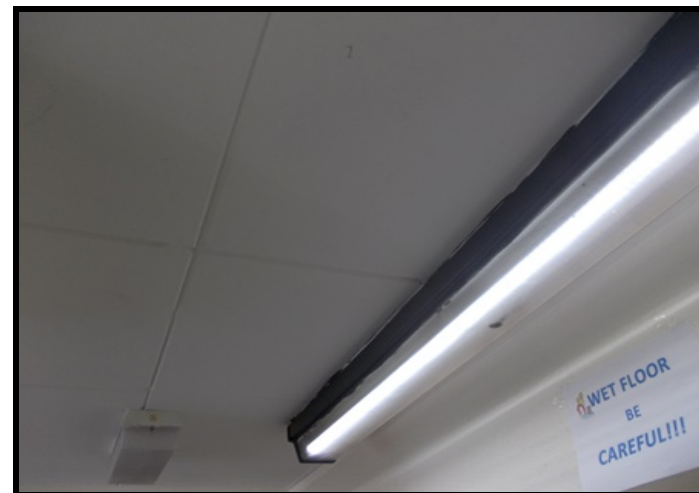
## SAMPLE REFERENCE I 14

Building	Floor	Room	Location		
Main Building	Second Floor	Stairwell	Ceiling		
Description					
MATERIAL ASSESSMENT					SCORE
Product Type	Insulation Board	Extent of Damage	Low damage		-
Asbestos Type	No Asbestos Detected	Surface Treatment	Sealed Board (Encapsulated)		
PRIORITY ASSESSMENT					SCORE
Occupant Activity	Not Applicable	Extent / Amount	6.00 m2		-
Accessibility	Occasionally disturb	Location	Not Applicable		
Avg Time in Use	Not Applicable	Frequency of Use	Not Applicable		
No. of Occupants	Not Applicable	Secondary Activity	Not Applicable		
Maintenance	Not Applicable	Maintenance Frequency	Not Applicable		
MANAGEMENT ACTION					SCORE
Recommendation	NO ACTION REQUIRED				-
Recommendation Due		Next Inspection	None		
Apply Labels	No	Permit to Work Required	No		
Survey Type	Management	Lead Surveyor	Gavin Hooper		
Survey Date	29 Jan 2015	UKAS Laboratory	NOT SAMPLED (Cross Referenced)		
Site Reference	I43760000A	Licensed Material	N/A	Notifiable Non Licensed Work	N/A

**No Asbestos Presumed in Sample**

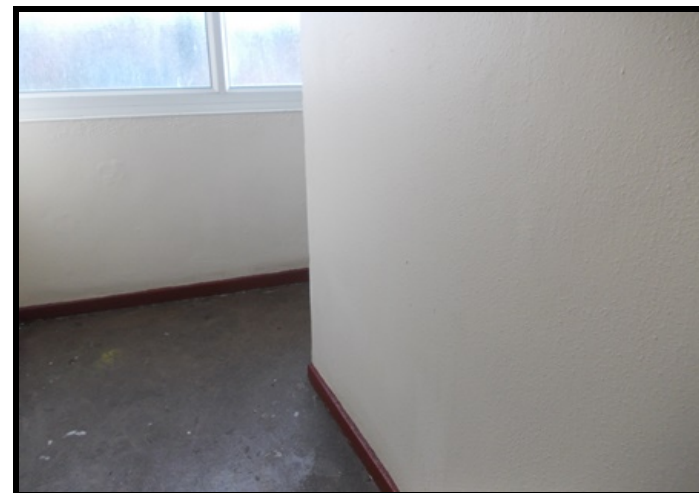
## SAMPLE REFERENCE I 16

Building	Floor	Room	Location		
Main Building	Second Floor	Bin Chute	Wall		
Description					
MATERIAL ASSESSMENT					SCORE
Product Type	Textured Coating	Extent of Damage	Low damage		-
Asbestos Type	No Asbestos Detected	Surface Treatment	Textured Coating		
PRIORITY ASSESSMENT					SCORE
Occupant Activity	Not Applicable	Extent / Amount	30.00 m2		-
Accessibility	Easily disturbed	Location	Not Applicable		
Avg Time in Use	Not Applicable	Frequency of Use	Not Applicable		
No. of Occupants	Not Applicable	Secondary Activity	Not Applicable		
Maintenance	Not Applicable	Maintenance Frequency	Not Applicable		
MANAGEMENT ACTION					SCORE
Recommendation	NO ACTION REQUIRED				-
Recommendation Due		Next Inspection	None		
Apply Labels	No	Permit to Work Required	No		
Survey Type	Management	Lead Surveyor	Gavin Hooper		
Survey Date	29 Jan 2015	UKAS Laboratory	NOT SAMPLED (Cross Referenced)		
Site Reference	I43760000A	Licensed Material	N/A	Notifiable Non Licensed Work	N/A

**No Asbestos Presumed in Sample**

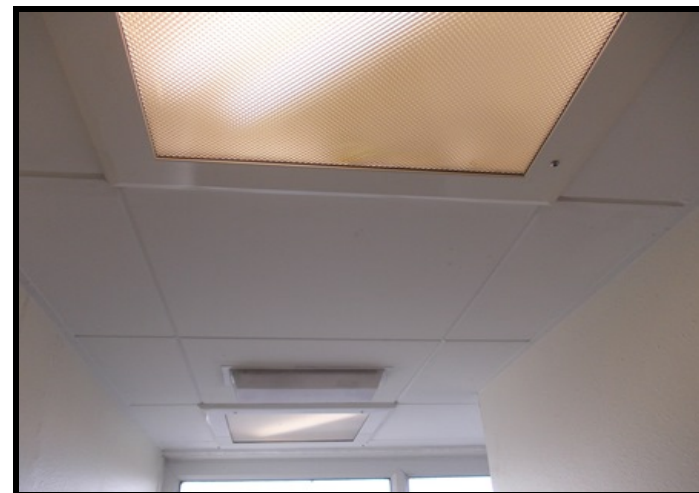
## SAMPLE REFERENCE I I 7

Building	Floor	Room	Location		
Main Building	Second Floor	Bin Chute	Ceiling		
Description					
MATERIAL ASSESSMENT					SCORE
Product Type	Insulation Board	Extent of Damage	Low damage		-
Asbestos Type	No Asbestos Detected	Surface Treatment	Sealed Board (Encapsulated)		
PRIORITY ASSESSMENT					SCORE
Occupant Activity	Not Applicable	Extent / Amount	6.00 m2		-
Accessibility	Occasionally disturb	Location	Not Applicable		
Avg Time in Use	Not Applicable	Frequency of Use	Not Applicable		
No. of Occupants	Not Applicable	Secondary Activity	Not Applicable		
Maintenance	Not Applicable	Maintenance Frequency	Not Applicable		
MANAGEMENT ACTION					SCORE
Recommendation	NO ACTION REQUIRED				-
Recommendation Due		Next Inspection	None		
Apply Labels	No	Permit to Work Required	No		
Survey Type	Management	Lead Surveyor	Gavin Hooper		
Survey Date	29 Jan 2015	UKAS Laboratory	NOT SAMPLED (Cross Referenced)		
Site Reference	I43760000A	Licensed Material	N/A	Notifiable Non Licensed Work	N/A

**No Asbestos Presumed in Sample**

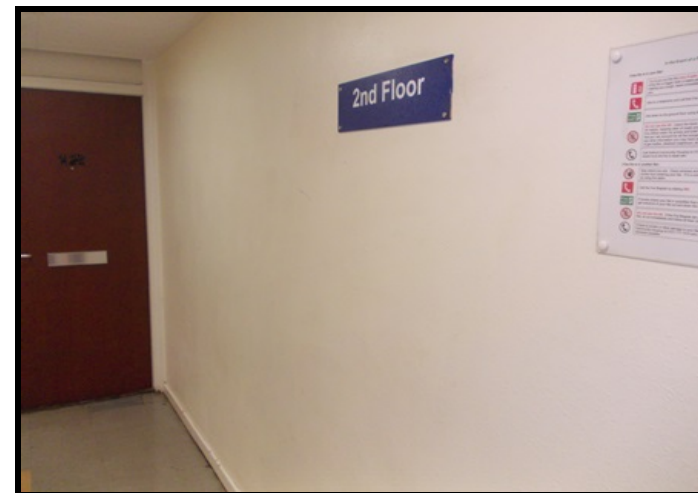
## SAMPLE REFERENCE I 18

Building	Floor	Room	Location		
Main Building	Second Floor	Lobby	Wall		
Description					
MATERIAL ASSESSMENT					SCORE
Product Type	Textured Coating	Extent of Damage	Low damage		-
Asbestos Type	No Asbestos Detected	Surface Treatment	Textured Coating		
PRIORITY ASSESSMENT					SCORE
Occupant Activity	Not Applicable	Extent / Amount	30.00 m2		-
Accessibility	Easily disturbed	Location	Not Applicable		
Avg Time in Use	Not Applicable	Frequency of Use	Not Applicable		
No. of Occupants	Not Applicable	Secondary Activity	Not Applicable		
Maintenance	Not Applicable	Maintenance Frequency	Not Applicable		
MANAGEMENT ACTION					SCORE
Recommendation	NO ACTION REQUIRED				-
Recommendation Due		Next Inspection	None		
Apply Labels	No	Permit to Work Required	No		
Survey Type	Management	Lead Surveyor	Gavin Hooper		
Survey Date	29 Jan 2015	UKAS Laboratory	NOT SAMPLED (Cross Referenced)		
Site Reference	I43760000A	Licensed Material	N/A	Notifiable Non Licensed Work	N/A

**No Asbestos Presumed in Sample**

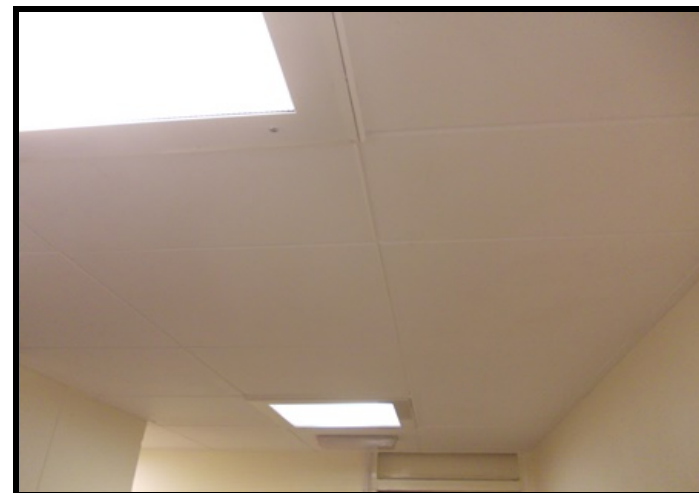
## SAMPLE REFERENCE I 19

Building	Floor	Room	Location		
Main Building	Second Floor	Lobby	Ceiling		
Description					
MATERIAL ASSESSMENT					SCORE
Product Type	Insulation Board	Extent of Damage	Low damage		-
Asbestos Type	No Asbestos Detected	Surface Treatment	Sealed Board (Encapsulated)		
PRIORITY ASSESSMENT					SCORE
Occupant Activity	Not Applicable	Extent / Amount	20.00 m2		-
Accessibility	Occasionally disturb	Location	Not Applicable		
Avg Time in Use	Not Applicable	Frequency of Use	Not Applicable		
No. of Occupants	Not Applicable	Secondary Activity	Not Applicable		
Maintenance	Not Applicable	Maintenance Frequency	Not Applicable		
MANAGEMENT ACTION					SCORE
Recommendation	NO ACTION REQUIRED				-
Recommendation Due		Next Inspection	None		
Apply Labels	No	Permit to Work Required	No		
Survey Type	Management	Lead Surveyor	Gavin Hooper		
Survey Date	29 Jan 2015	UKAS Laboratory	NOT SAMPLED (Cross Referenced)		
Site Reference	I43760000A	Licensed Material	N/A	Notifiable Non Licensed Work	N/A

**No Asbestos Presumed in Sample**

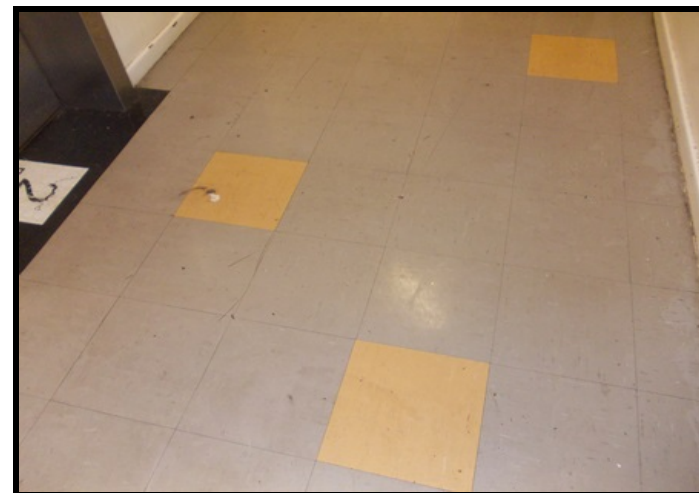
## SAMPLE REFERENCE 120

MATERIAL ASSESSMENT				SCORE
<b>Product Type</b>	Floor Tiles	<b>Extent of Damage</b>	Low damage	-
<b>Asbestos Type</b>	<b>No Asbestos Detected</b>	<b>Surface Treatment</b>	Composite materials

**No Asbestos Presumed in Sample**

MANAGEMENT ACTION				SCORE
<b>Recommendation</b>	NO ACTION REQUIRED			-
<b>Recommendation Due</b>		<b>Next Inspection</b>	None	
<b>Apply Labels</b>	No	<b>Permit to Work Required</b>	No

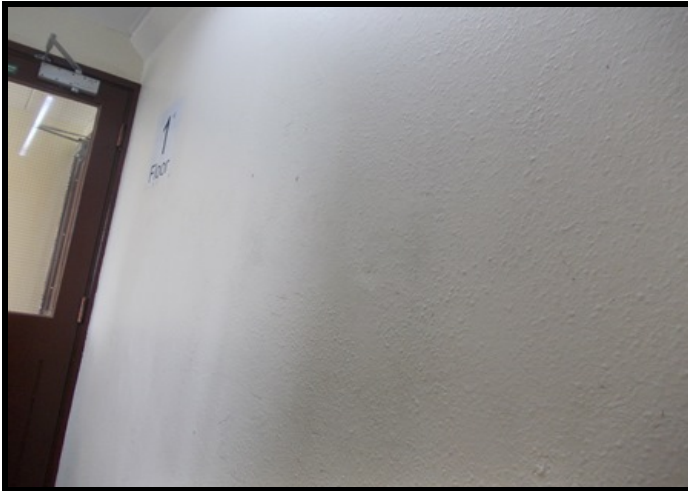
SAMPLE REFERENCE 124

Building	Floor	Room	Location		
Main Building	First Floor	Stairwell	Wall		
Description					
MATERIAL ASSESSMENT					SCORE
Product Type	Textured Coating	Extent of Damage	Low damage		-
Asbestos Type	No Asbestos Detected	Surface Treatment	Textured Coating		
PRIORITY ASSESSMENT					SCORE
Occupant Activity	Not Applicable	Extent / Amount	16.00 m2		-
Accessibility	Easily disturbed	Location	Not Applicable		
Avg Time in Use	Not Applicable	Frequency of Use	Not Applicable		
No. of Occupants	Not Applicable	Secondary Activity	Not Applicable		
Maintenance	Not Applicable	Maintenance Frequency	Not Applicable		
MANAGEMENT ACTION					SCORE
Recommendation	NO ACTION REQUIRED				-
Recommendation Due		Next Inspection	None		
Apply Labels	No	Permit to Work Required	No		
Survey Type	Management	Lead Surveyor	Gavin Hooper		
Survey Date	29 Jan 2015	UKAS Laboratory	NOT SAMPLED (Cross Referenced)		
Site Reference	I43760000A	Licensed Material	N/A	Notifiable Non Licensed Work	N/A

**No Asbestos Presumed in Sample**

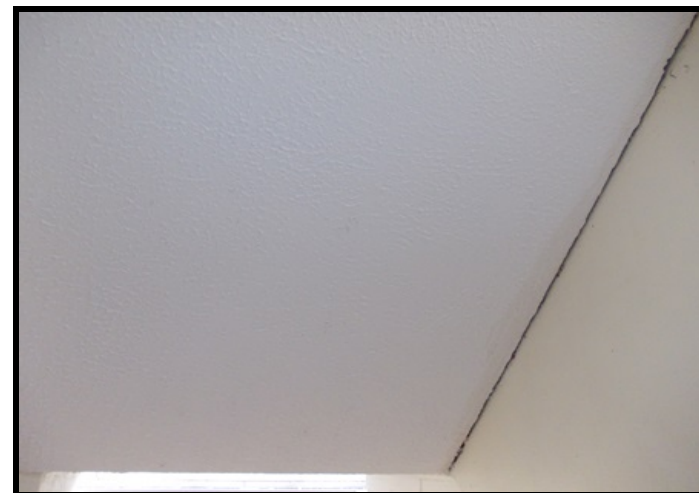
## SAMPLE REFERENCE 125

Building	Floor	Room	Location
Main Building	First Floor	Stairwell	Ceiling
<b>Description</b>			
<b>MATERIAL ASSESSMENT</b>			
<b>Product Type</b>	Textured Coating	<b>Extent of Damage</b>	Low damage
<b>Asbestos Type</b>	<b>No Asbestos Detected</b>	<b>Surface Treatment</b>	Textured Coating
<b>PRIORITY ASSESSMENT</b>			
<b>Occupant Activity</b>	Not Applicable	<b>Extent / Amount</b>	3.00 m2
<b>Accessibility</b>	Occasionally disturb	<b>Location</b>	Not Applicable
<b>Avg Time in Use</b>	Not Applicable	<b>Frequency of Use</b>	Not Applicable
<b>No. of Occupants</b>	Not Applicable	<b>Secondary Activity</b>	Not Applicable
<b>Maintenance</b>	Not Applicable	<b>Maintenance Frequency</b>	Not Applicable
<b>MANAGEMENT ACTION</b>			
<b>Recommendation</b>	NO ACTION REQUIRED		
<b>Recommendation Due</b>		<b>Next Inspection</b>	None
<b>Apply Labels</b>	No	<b>Permit to Work Required</b>	No
<b>Survey Type</b>	Management	<b>Lead Surveyor</b>	Gavin Hooper

**No Asbestos Presumed in Sample**

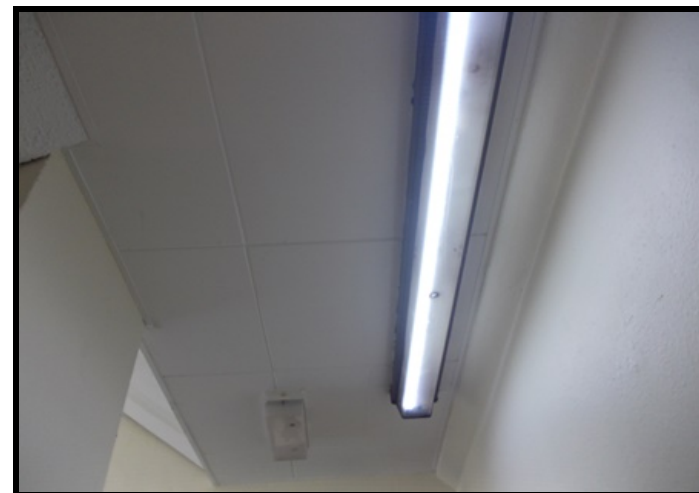
## SAMPLE REFERENCE 126

Building	Floor	Room	Location		
Main Building	First Floor	Stairwell	Ceiling		
Description					
MATERIAL ASSESSMENT					SCORE
Product Type	Insulation Board	Extent of Damage	Low damage		-
Asbestos Type	No Asbestos Detected	Surface Treatment	Sealed Board (Encapsulated)		
PRIORITY ASSESSMENT					SCORE
Occupant Activity	Not Applicable	Extent / Amount	6.00 m2		-
Accessibility	Occasionally disturb	Location	Not Applicable		
Avg Time in Use	Not Applicable	Frequency of Use	Not Applicable		
No. of Occupants	Not Applicable	Secondary Activity	Not Applicable		
Maintenance	Not Applicable	Maintenance Frequency	Not Applicable		
MANAGEMENT ACTION					SCORE
Recommendation	NO ACTION REQUIRED				-
Recommendation Due		Next Inspection	None		
Apply Labels	No	Permit to Work Required	No		
Survey Type	Management	Lead Surveyor	Gavin Hooper		
Survey Date	29 Jan 2015	UKAS Laboratory	NOT SAMPLED (Cross Referenced)		
Site Reference	I43760000A	Licensed Material	N/A	Notifiable Non Licensed Work	N/A

**No Asbestos Presumed in Sample**

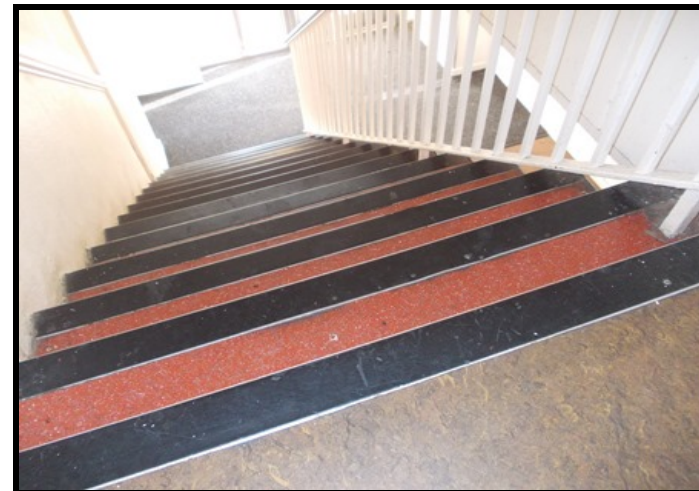
SAMPLE REFERENCE I26a

Building	Floor	Room	Location		
Main Building	First Floor	Stairwell	Staircase		
Description	From first floor stairwell to ground floor stairwell				
MATERIAL ASSESSMENT				SCORE	
Product Type	Bitumen	Extent of Damage	Low damage		-
Asbestos Type	No Asbestos Detected	Surface Treatment	Composite materials		
PRIORITY ASSESSMENT				SCORE	
Occupant Activity	Not Applicable	Extent / Amount	14.00 small item(s)		-
Accessibility	Routinely disturbed	Location	Not Applicable		
Avg Time in Use	Not Applicable	Frequency of Use	Not Applicable		
No. of Occupants	Not Applicable	Secondary Activity	Not Applicable		
Maintenance	Not Applicable	Maintenance Frequency	Not Applicable		
MANAGEMENT ACTION				SCORE	
Recommendation	NO ACTION REQUIRED				-
Recommendation Due		Next Inspection	None		
Apply Labels	No	Permit to Work Required	No		
Survey Type	Management	Lead Surveyor	Gavin Hooper		
Survey Date	29 Jan 2015	UKAS Laboratory	DMW Environmental Safety Ltd / [A-13971]

**Asbestos not detected in Sample**

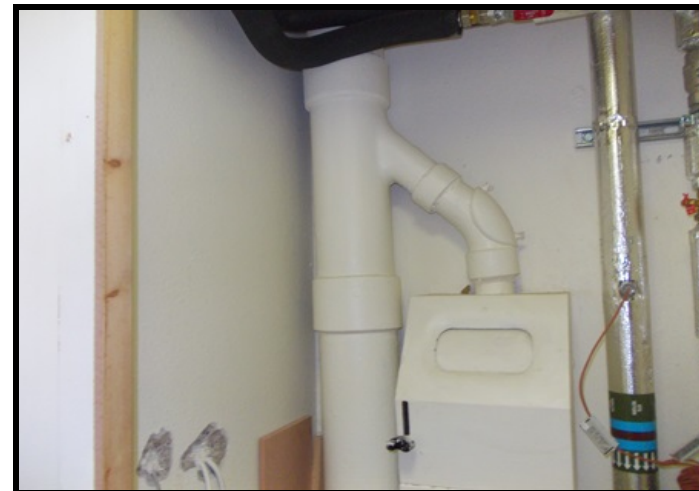
## SAMPLE REFERENCE 127

MATERIAL ASSESSMENT				SCORE
<b>Product Type</b>	Cement Flue	<b>Extent of Damage</b>	Low damage	4
<b>Asbestos Type</b>	Chrysotile	<b>Surface Treatment</b>	Unsealed (Cement products)

Asbestos Presumed

MANAGEMENT ACTION				SCORE
<b>Recommendation</b>	LABEL & MONITOR			4
<b>Recommendation Due</b>		<b>Next Inspection</b>	29 Jan 2016	
<b>Apply Labels</b>	No	<b>Permit to Work Required</b>	No

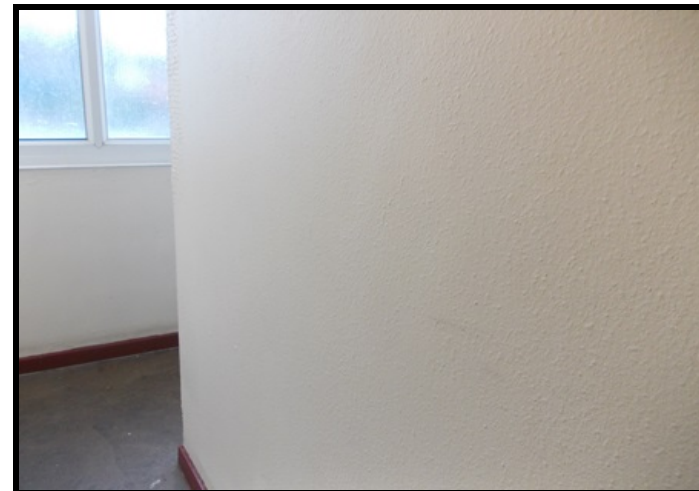
## SAMPLE REFERENCE 128

Building	Floor	Room	Location		
Main Building	First Floor	Bin Chute	Wall		
Description					
MATERIAL ASSESSMENT					SCORE
Product Type	Textured Coating	Extent of Damage	Low damage		-
Asbestos Type	No Asbestos Detected	Surface Treatment	Textured Coating		
PRIORITY ASSESSMENT					SCORE
Occupant Activity	Not Applicable	Extent / Amount	30.00 m2		-
Accessibility	Easily disturbed	Location	Not Applicable		
Avg Time in Use	Not Applicable	Frequency of Use	Not Applicable		
No. of Occupants	Not Applicable	Secondary Activity	Not Applicable		
Maintenance	Not Applicable	Maintenance Frequency	Not Applicable		
MANAGEMENT ACTION					SCORE
Recommendation	NO ACTION REQUIRED				-
Recommendation Due		Next Inspection	None		
Apply Labels	No	Permit to Work Required	No		
Survey Type	Management	Lead Surveyor	Gavin Hooper		
Survey Date	29 Jan 2015	UKAS Laboratory	NOT SAMPLED (Cross Referenced)		
Site Reference	I43760000A	Licensed Material	N/A	Notifiable Non Licensed Work	N/A

**No Asbestos Presumed in Sample**

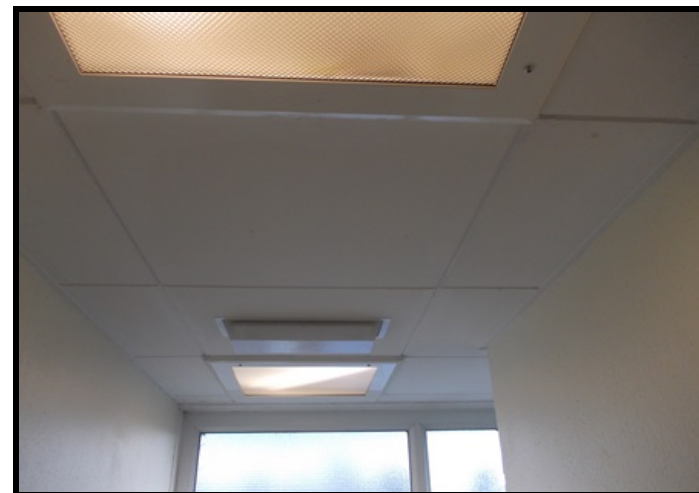
## SAMPLE REFERENCE 129

Building	Floor	Room	Location		
Main Building	First Floor	Bin Chute	Ceiling		
Description					
MATERIAL ASSESSMENT					SCORE
Product Type	Insulation Board	Extent of Damage	Low damage		-
Asbestos Type	No Asbestos Detected	Surface Treatment	Sealed Board (Encapsulated)		
PRIORITY ASSESSMENT					SCORE
Occupant Activity	Not Applicable	Extent / Amount	6.00 m2		-
Accessibility	Occasionally disturb	Location	Not Applicable		
Avg Time in Use	Not Applicable	Frequency of Use	Not Applicable		
No. of Occupants	Not Applicable	Secondary Activity	Not Applicable		
Maintenance	Not Applicable	Maintenance Frequency	Not Applicable		
MANAGEMENT ACTION					SCORE
Recommendation	NO ACTION REQUIRED				-
Recommendation Due		Next Inspection	None		
Apply Labels	No	Permit to Work Required	No		
Survey Type	Management	Lead Surveyor	Gavin Hooper		
Survey Date	29 Jan 2015	UKAS Laboratory	NOT SAMPLED (Cross Referenced)		
Site Reference	I43760000A	Licensed Material	N/A	Notifiable Non Licensed Work	N/A

**No Asbestos Presumed in Sample**

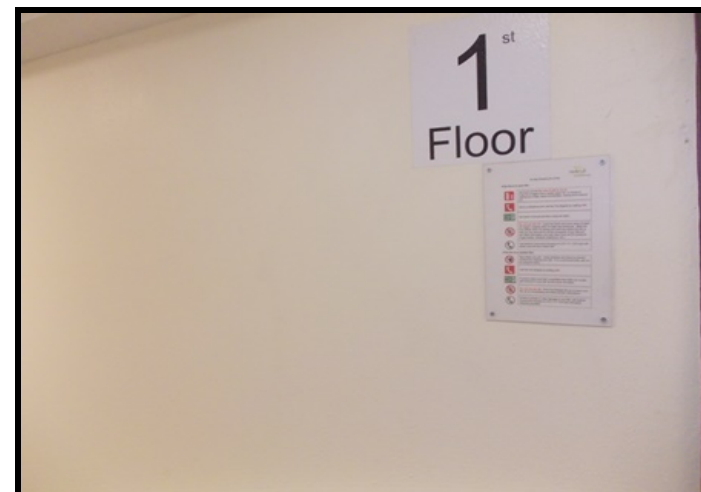
## SAMPLE REFERENCE 130

Building	Floor	Room	Location		
Main Building	First Floor	Lobby	Wall		
Description					
MATERIAL ASSESSMENT					SCORE
Product Type	Textured Coating	Extent of Damage	Low damage		-
Asbestos Type	No Asbestos Detected	Surface Treatment	Textured Coating		
PRIORITY ASSESSMENT					SCORE
Occupant Activity	Not Applicable	Extent / Amount	30.00 m2		-
Accessibility	Easily disturbed	Location	Not Applicable		
Avg Time in Use	Not Applicable	Frequency of Use	Not Applicable		
No. of Occupants	Not Applicable	Secondary Activity	Not Applicable		
Maintenance	Not Applicable	Maintenance Frequency	Not Applicable		
MANAGEMENT ACTION					SCORE
Recommendation	NO ACTION REQUIRED				-
Recommendation Due		Next Inspection	None		
Apply Labels	No	Permit to Work Required	No		
Survey Type	Management	Lead Surveyor	Gavin Hooper		
Survey Date	29 Jan 2015	UKAS Laboratory	NOT SAMPLED (Cross Referenced)		
Site Reference	I43760000A	Licensed Material	N/A	Notifiable Non Licensed Work	N/A

**No Asbestos Presumed in Sample**

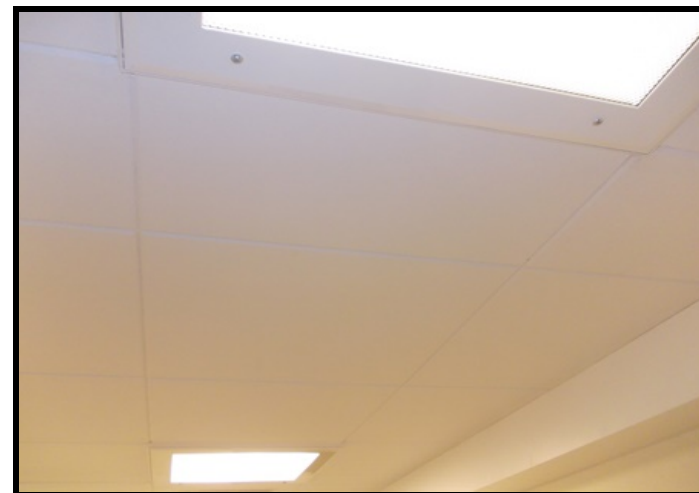
## SAMPLE REFERENCE 131

Building	Floor	Room	Location		
Main Building	First Floor	Lobby	Ceiling		
Description					
MATERIAL ASSESSMENT					SCORE
Product Type	Insulation Board	Extent of Damage	Low damage		-
Asbestos Type	No Asbestos Detected	Surface Treatment	Sealed Board (Encapsulated)		
PRIORITY ASSESSMENT					SCORE
Occupant Activity	Not Applicable	Extent / Amount	20.00 m2		-
Accessibility	Occasionally disturb	Location	Not Applicable		
Avg Time in Use	Not Applicable	Frequency of Use	Not Applicable		
No. of Occupants	Not Applicable	Secondary Activity	Not Applicable		
Maintenance	Not Applicable	Maintenance Frequency	Not Applicable		
MANAGEMENT ACTION					SCORE
Recommendation	NO ACTION REQUIRED				-
Recommendation Due		Next Inspection	None		
Apply Labels	No	Permit to Work Required	No		
Survey Type	Management	Lead Surveyor	Gavin Hooper		
Survey Date	29 Jan 2015	UKAS Laboratory	NOT SAMPLED (Cross Referenced)		
Site Reference	I43760000A	Licensed Material	N/A	Notifiable Non Licensed Work	N/A

No Asbestos Presumed in Sample

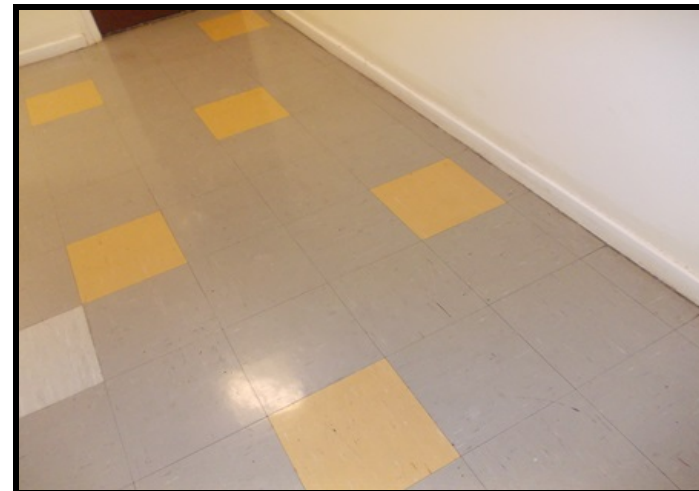
## SAMPLE REFERENCE 132

MATERIAL ASSESSMENT				SCORE
<b>Product Type</b>	Floor Tiles	<b>Extent of Damage</b>	Low damage	-
<b>Asbestos Type</b>	<b>No Asbestos Detected</b>	<b>Surface Treatment</b>	Composite materials

**No Asbestos Presumed in Sample**

MANAGEMENT ACTION				SCORE
<b>Recommendation</b>	NO ACTION REQUIRED			-
<b>Recommendation Due</b>		<b>Next Inspection</b>	None	
<b>Apply Labels</b>	No	<b>Permit to Work Required</b>	No

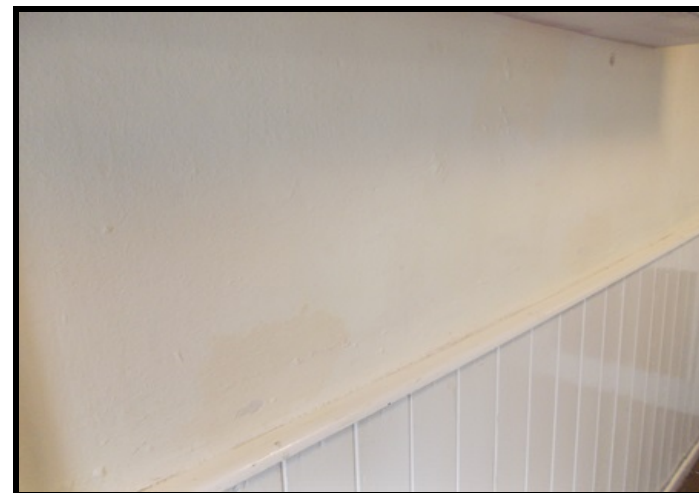
## SAMPLE REFERENCE 136

MATERIAL ASSESSMENT				SCORE
<b>Product Type</b>	Textured Coating	<b>Extent of Damage</b>	Low damage	-
<b>Asbestos Type</b>	No Asbestos Detected	<b>Surface Treatment</b>	Textured Coating

**No Asbestos Presumed in Sample**

MANAGEMENT ACTION				SCORE
<b>Recommendation</b>	NO ACTION REQUIRED			-
<b>Recommendation Due</b>		<b>Next Inspection</b>	None	
<b>Apply Labels</b>	No	<b>Permit to Work Required</b>	No

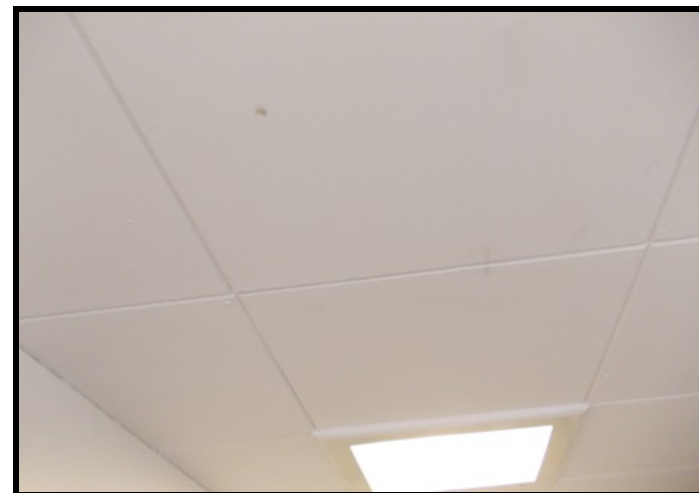
## SAMPLE REFERENCE 139

Building	Floor	Room	Location		
Main Building	Ground Floor	Front Entrance	Ceiling		
Description					
MATERIAL ASSESSMENT					SCORE
Product Type	Insulation Board	Extent of Damage	Low damage		-
Asbestos Type	No Asbestos Detected	Surface Treatment	Sealed Board (Encapsulated)		
PRIORITY ASSESSMENT					SCORE
Occupant Activity	Not Applicable	Extent / Amount	15.00 m2		-
Accessibility	Occasionally disturb	Location	Not Applicable		
Avg Time in Use	Not Applicable	Frequency of Use	Not Applicable		
No. of Occupants	Not Applicable	Secondary Activity	Not Applicable		
Maintenance	Not Applicable	Maintenance Frequency	Not Applicable		
MANAGEMENT ACTION					SCORE
Recommendation	NO ACTION REQUIRED				-
Recommendation Due		Next Inspection	None		
Apply Labels	No	Permit to Work Required	No		
Survey Type	Management	Lead Surveyor	Gavin Hooper		
Survey Date	29 Jan 2015	UKAS Laboratory	NOT SAMPLED (Cross Referenced)		
Site Reference	I43760000A	Licensed Material	N/A	Notifiable Non Licensed Work	N/A

**No Asbestos Presumed in Sample**

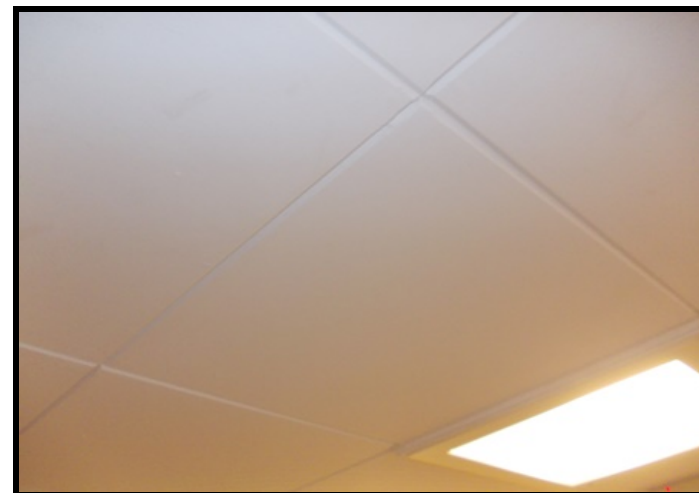
## SAMPLE REFERENCE 140

Building	Floor	Room	Location		
Main Building	Ground Floor	Lift Lobby	Ceiling		
Description					
MATERIAL ASSESSMENT					SCORE
Product Type	Insulation Board	Extent of Damage	Low damage		-
Asbestos Type	No Asbestos Detected	Surface Treatment	Sealed Board (Encapsulated)		
PRIORITY ASSESSMENT					SCORE
Occupant Activity	Not Applicable	Extent / Amount	20.00 m2		-
Accessibility	Occasionally disturb	Location	Not Applicable		
Avg Time in Use	Not Applicable	Frequency of Use	Not Applicable		
No. of Occupants	Not Applicable	Secondary Activity	Not Applicable		
Maintenance	Not Applicable	Maintenance Frequency	Not Applicable		
MANAGEMENT ACTION					SCORE
Recommendation	NO ACTION REQUIRED				-
Recommendation Due		Next Inspection	None		
Apply Labels	No	Permit to Work Required	No		
Survey Type	Management	Lead Surveyor	Gavin Hooper		
Survey Date	29 Jan 2015	UKAS Laboratory	NOT SAMPLED (Cross Referenced)		
Site Reference	I43760000A	Licensed Material	N/A	Notifiable Non Licensed Work	N/A

**No Asbestos Presumed in Sample**

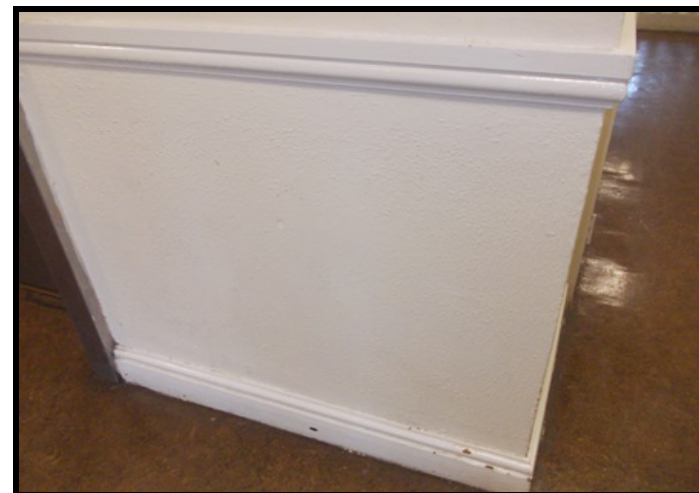
## SAMPLE REFERENCE I40a

MATERIAL ASSESSMENT				SCORE
<b>Product Type</b>	Textured Coating	<b>Extent of Damage</b>	Low damage	-
<b>Asbestos Type</b>	No Asbestos Detected	<b>Surface Treatment</b>	Textured Coating

**No Asbestos Presumed in Sample**

MANAGEMENT ACTION				SCORE
<b>Recommendation</b>	NO ACTION REQUIRED			-
<b>Recommendation Due</b>		<b>Next Inspection</b>	None	
<b>Apply Labels</b>	No	<b>Permit to Work Required</b>	No

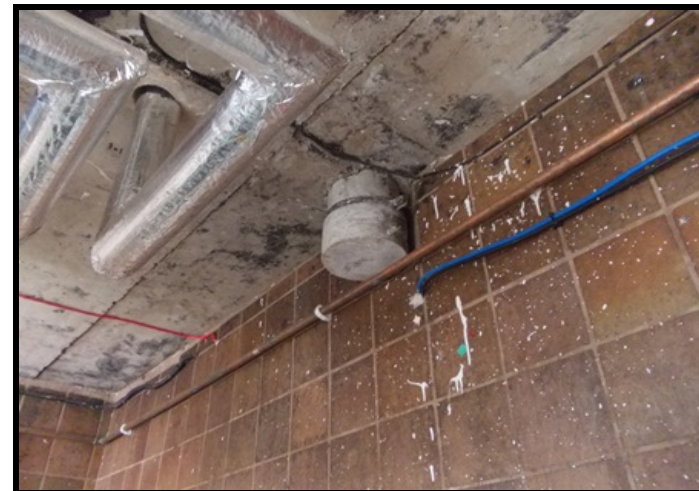
## SAMPLE REFERENCE 148

MATERIAL ASSESSMENT				SCORE
<b>Product Type</b>	Cement Pipe	<b>Extent of Damage</b>	Low damage	4
<b>Asbestos Type</b>	Chrysotile	<b>Surface Treatment</b>	Unsealed (Cement products)

Asbestos detected in Sample

MANAGEMENT ACTION				SCORE
<b>Recommendation</b>	LABEL & MONITOR			4
<b>Recommendation Due</b>		<b>Next Inspection</b>	29 Jan 2016	
<b>Apply Labels</b>	No	<b>Permit to Work Required</b>	No

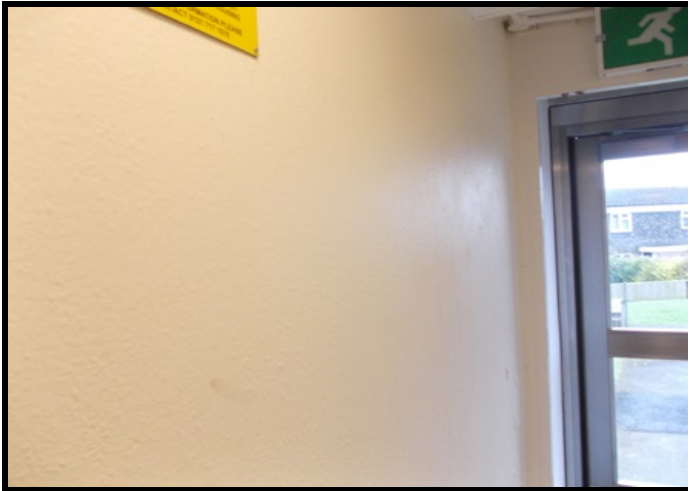
SAMPLE REFERENCE 149

Building	Floor	Room	Location		
Main Building	Ground Floor	Rear exit 1	Walls		
Description					
MATERIAL ASSESSMENT					SCORE
Product Type	Textured Coating	Extent of Damage	Low damage		-
Asbestos Type	No Asbestos Detected	Surface Treatment	Textured Coating		
PRIORITY ASSESSMENT					SCORE
Occupant Activity	Not Applicable	Extent / Amount	20.00 m2		-
Accessibility	Occasionally disturb	Location	Not Applicable		
Avg Time in Use	Not Applicable	Frequency of Use	Not Applicable		
No. of Occupants	Not Applicable	Secondary Activity	Not Applicable		
Maintenance	Not Applicable	Maintenance Frequency	Not Applicable		
MANAGEMENT ACTION					SCORE
Recommendation	NO ACTION REQUIRED				-
Recommendation Due		Next Inspection	None		
Apply Labels	No	Permit to Work Required	No		
Survey Type	Management	Lead Surveyor	Gavin Hooper		
Survey Date	29 Jan 2015	UKAS Laboratory	NOT SAMPLED (Cross Referenced)		
Site Reference	I43760000A	Licensed Material	N/A	Notifiable Non Licensed Work	N/A

SURVEYORS COMMENTS
No Asbestos Presumed in Sample
