# **Solihull Community Housing**

## **Asbestos Management Survey Report**

**I-49 Richmond House  
(Communal)  
Marlene Croft  
Solihull  
B37 7JS**

**Date of Report: 06 Feb 2015**

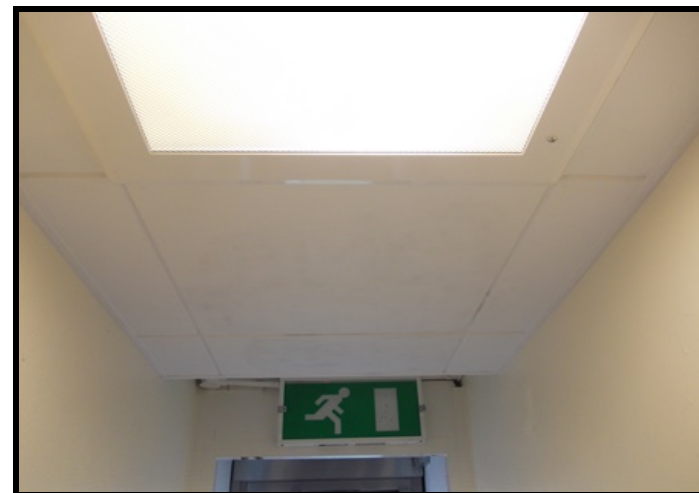
## SAMPLE REFERENCE I49a

MATERIAL ASSESSMENT				SCORE
<b>Product Type</b>	Insulation Board	<b>Extent of Damage</b>	Low damage	-
<b>Asbestos Type</b>	<b>No Asbestos Detected</b>	<b>Surface Treatment</b>	Sealed Board (Encapsulated)

**No Asbestos Presumed in Sample**

MANAGEMENT ACTION				SCORE
<b>Recommendation</b>	NO ACTION REQUIRED			-
<b>Recommendation Due</b>		<b>Next Inspection</b>	None	
<b>Apply Labels</b>	No	<b>Permit to Work Required</b>	No

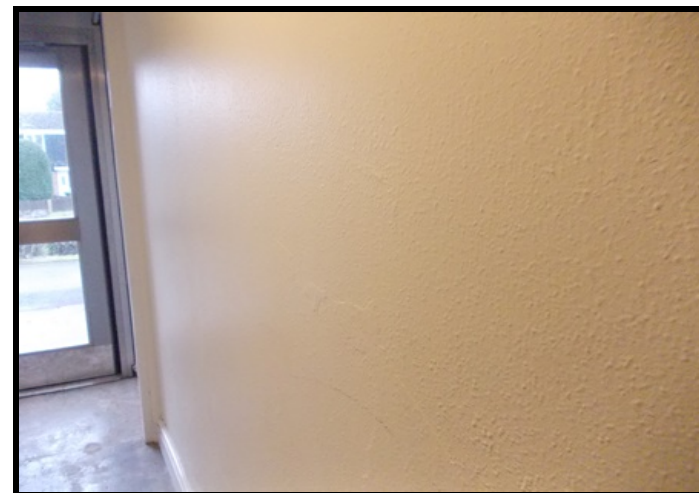
## SAMPLE REFERENCE 150

Building	Floor	Room	Location		
Main Building	Ground Floor	Rear exit 2	Walls		
Description					
MATERIAL ASSESSMENT					SCORE
Product Type	Textured Coating	Extent of Damage	Low damage		-
Asbestos Type	No Asbestos Detected	Surface Treatment	Textured Coating		
PRIORITY ASSESSMENT					SCORE
Occupant Activity	Not Applicable	Extent / Amount	20.00 m2		-
Accessibility	Occasionally disturb	Location	Not Applicable		
Avg Time in Use	Not Applicable	Frequency of Use	Not Applicable		
No. of Occupants	Not Applicable	Secondary Activity	Not Applicable		
Maintenance	Not Applicable	Maintenance Frequency	Not Applicable		
MANAGEMENT ACTION					SCORE
Recommendation	NO ACTION REQUIRED				-
Recommendation Due		Next Inspection	None		
Apply Labels	No	Permit to Work Required	No		
Survey Type	Management	Lead Surveyor	Gavin Hooper		
Survey Date	29 Jan 2015	UKAS Laboratory	NOT SAMPLED (Cross Referenced)		
Site Reference	I43760000A	Licensed Material	N/A	Notifiable Non Licensed Work	N/A

**No Asbestos Presumed in Sample**

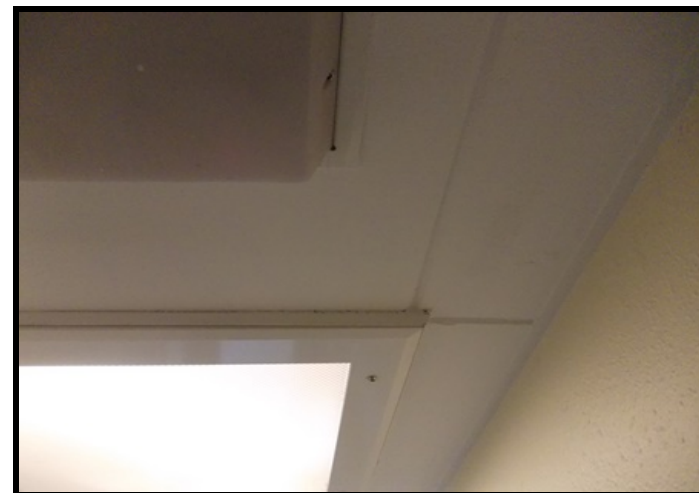
## SAMPLE REFERENCE I50a

Building	Floor	Room	Location		
Main Building	Ground Floor	Rear exit 2	Ceiling		
Description					
MATERIAL ASSESSMENT					SCORE
Product Type	Insulation Board	Extent of Damage	Low damage		-
Asbestos Type	No Asbestos Detected	Surface Treatment	Sealed Board (Encapsulated)		
PRIORITY ASSESSMENT					SCORE
Occupant Activity	Not Applicable	Extent / Amount	5.00 m2		-
Accessibility	Occasionally disturb	Location	Not Applicable		
Avg Time in Use	Not Applicable	Frequency of Use	Not Applicable		
No. of Occupants	Not Applicable	Secondary Activity	Not Applicable		
Maintenance	Not Applicable	Maintenance Frequency	Not Applicable		
MANAGEMENT ACTION					SCORE
Recommendation	NO ACTION REQUIRED				-
Recommendation Due		Next Inspection	None		
Apply Labels	No	Permit to Work Required	No		
Survey Type	Management	Lead Surveyor	Gavin Hooper		
Survey Date	29 Jan 2015	UKAS Laboratory	NOT SAMPLED (Cross Referenced)		
Site Reference	I43760000A	Licensed Material	N/A	Notifiable Non Licensed Work	N/A

**No Asbestos Presumed in Sample**
