Site ID: **a-300854** Management with Targeted Refurbishment Survey

Solihull Community Housing
Client ID: **S135 - 4113543**

1-83 Westham House
Forth Drive
Kingshurst
Solihull
West Midlands
B37 6PT
United Kingdom

9th April 2021

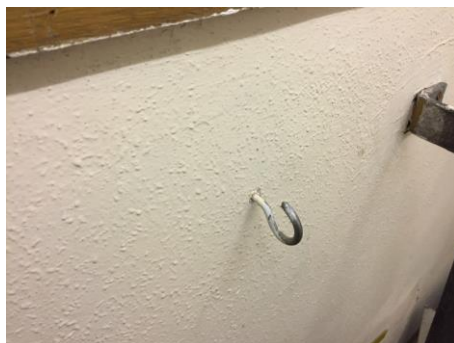
Level: **Fourteenth Floor**

Condition **Low Damage**

The material was seen to be in fair condition at the time of the initial inspection.

The condition of the material should be managed by a competent person/company and its presence made aware to those at risk, as part of a Control of Asbestos Regulations (CAR) 2012 compliant management strategy.

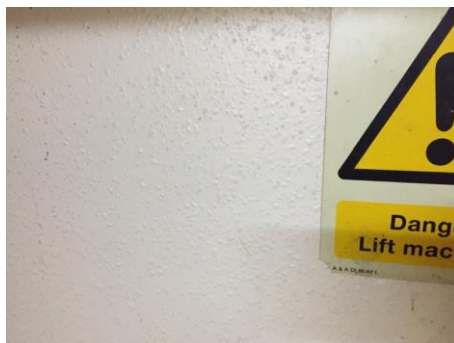
Condition..... **Low Damage**

Spatter pattern textured coating.

The material was seen to be in fair condition at the time of the initial inspection.

The condition of the material should be managed by a competent person/company and its presence made aware to those at risk, as part of a Control of Asbestos Regulations (CAR) 2012 compliant management strategy.

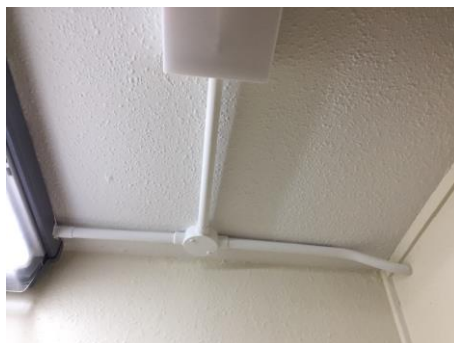
Level: **Thirteenth Floor**

Condition..... **Low Damage**

The material was seen to be in fair condition at the time of the initial inspection.

The condition of the material should be managed by a competent person/company and its presence made aware to those at risk, as part of a Control of Asbestos Regulations (CAR) 2012 compliant management strategy.

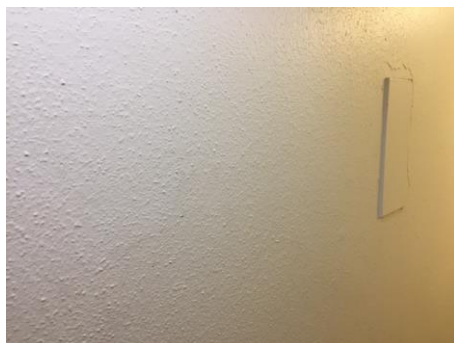
Level: **Thirteenth Floor**

Condition **Low Damage**

The material was seen to be in fair condition at the time of the initial inspection.

The condition of the material should be managed by a competent person/company and its presence made aware to those at risk, as part of a Control of Asbestos Regulations (CAR) 2012 compliant management strategy.

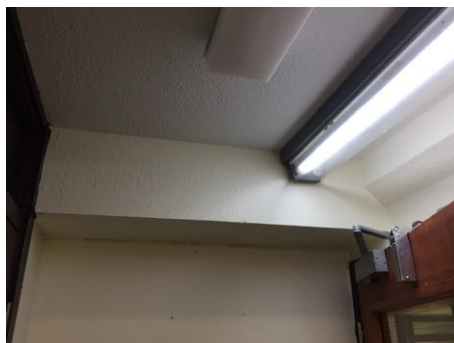
Level: **Thirteenth Floor**

Condition..... **Low Damage**

The material was seen to be in fair condition at the time of the initial inspection.

The condition of the material should be managed by a competent person/company and its presence made aware to those at risk, as part of a Control of Asbestos Regulations (CAR) 2012 compliant management strategy.

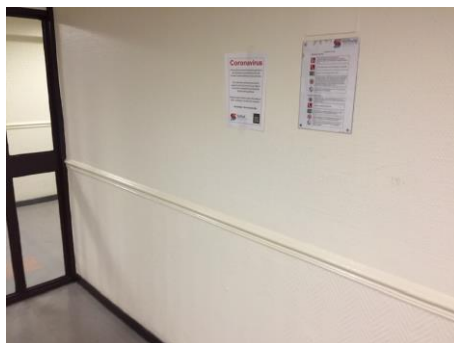
Level: **Thirteenth Floor**

Condition **Low Damage**

The material was seen to be in fair condition at the time of the initial inspection.

The condition of the material should be managed by a competent person/company and its presence made aware to those at risk, as part of a Control of Asbestos Regulations (CAR) 2012 compliant management strategy.

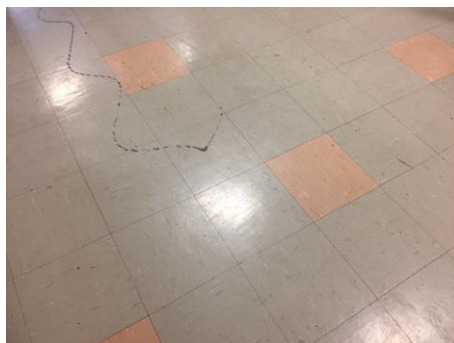
Level: **Thirteenth Floor**

Condition **Low Damage**

The material was seen to be in fair condition at the time of the initial inspection.

The condition of the material should be managed by a competent person/company and its presence made aware to those at risk, as part of a Control of Asbestos Regulations (CAR) 2012 compliant management strategy.

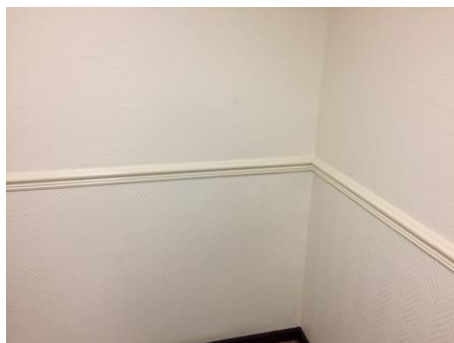
Level: **Thirteenth Floor**

Condition **Low Damage**

The material was seen to be in fair condition at the time of the initial inspection.

The condition of the material should be managed by a competent person/company and its presence made aware to those at risk, as part of a Control of Asbestos Regulations (CAR) 2012 compliant management strategy.

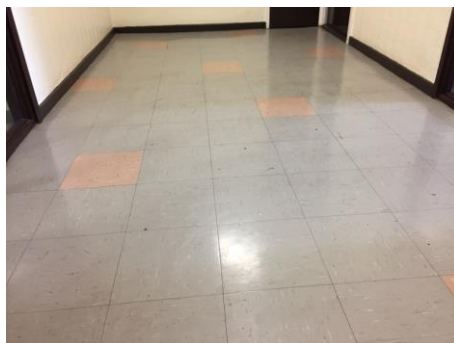
Level: **Thirteenth Floor**

Condition **Low Damage**

The material was seen to be in fair condition at the time of the initial inspection.

The condition of the material should be managed by a competent person/company and its presence made aware to those at risk, as part of a Control of Asbestos Regulations (CAR) 2012 compliant management strategy.

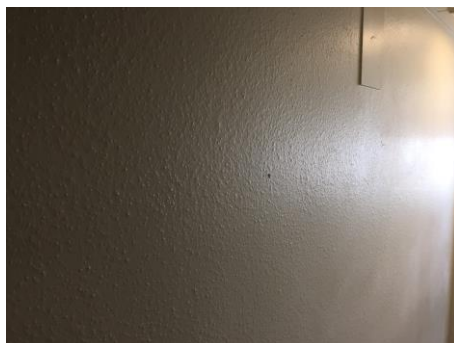
Level: **Thirteenth Floor**

Condition **Low Damage**

The material was seen to be in fair condition at the time of the initial inspection.

The condition of the material should be managed by a competent person/company and its presence made aware to those at risk, as part of a Control of Asbestos Regulations (CAR) 2012 compliant management strategy.

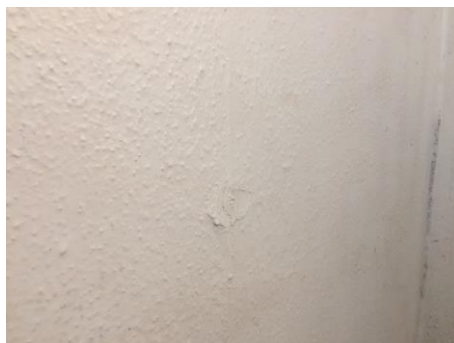
Level: **Thirteenth Floor**

Condition **Low Damage**

The material was seen to be in fair condition at the time of the initial inspection.

The condition of the material should be managed by a competent person/company and its presence made aware to those at risk, as part of a Control of Asbestos Regulations (CAR) 2012 compliant management strategy.

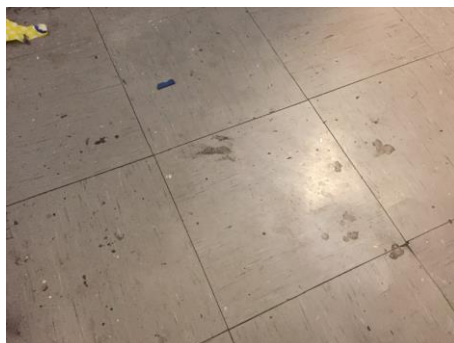
Level: **Thirteenth Floor**

Condition **Low Damage**

The material was seen to be in fair condition at the time of the initial inspection.

The condition of the material should be managed by a competent person/company and its presence made aware to those at risk, as part of a Control of Asbestos Regulations (CAR) 2012 compliant management strategy.

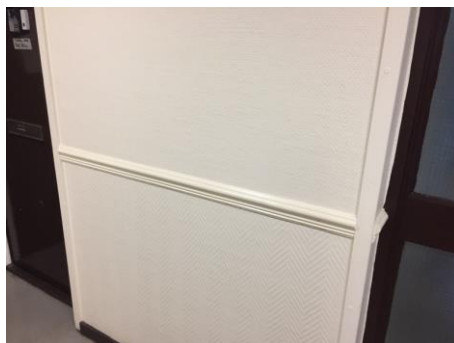
Level: **Thirteenth Floor**

Condition **Low Damage**

The material was seen to be in fair condition at the time of the initial inspection.

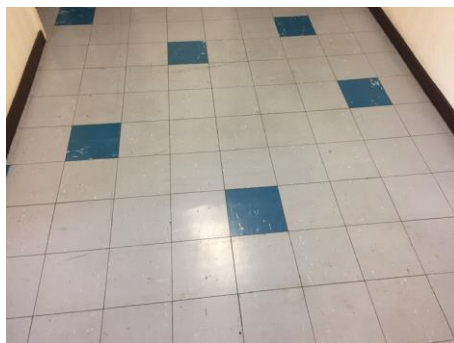
Level: **Twelfth Floor**

Condition..... **Low Damage**

The material was seen to be in fair condition at the time of the initial inspection.

The condition of the material should be managed by a competent person/company and its presence made aware to those at risk, as part of a Control of Asbestos Regulations (CAR) 2012 compliant management strategy.

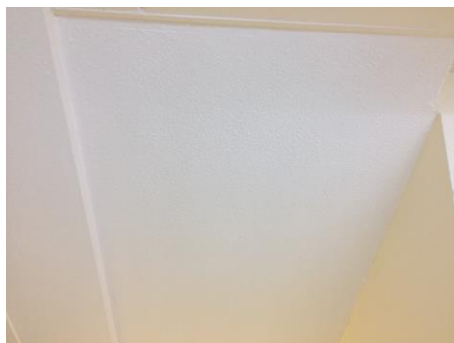
Condition..... **Low Damage**

Spatter pattern textured coating.

The material was seen to be in fair condition at the time of the initial inspection.

The condition of the material should be managed by a competent person/company and its presence made aware to those at risk, as part of a Control of Asbestos Regulations (CAR) 2012 compliant management strategy.

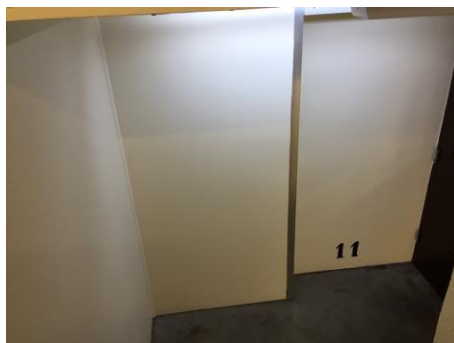
Level: **Eleventh Floor**

Condition **Low Damage**

The material was seen to be in fair condition at the time of the initial inspection.

The condition of the material should be managed by a competent person/company and its presence made aware to those at risk, as part of a Control of Asbestos Regulations (CAR) 2012 compliant management strategy.

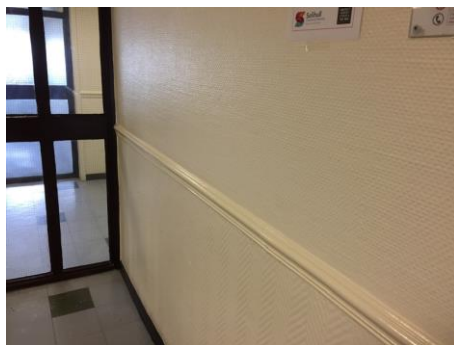
Level: **Eleventh Floor**

Condition **Low Damage**

The material was seen to be in fair condition at the time of the initial inspection.

The condition of the material should be managed by a competent person/company and its presence made aware to those at risk, as part of a Control of Asbestos Regulations (CAR) 2012 compliant management strategy.

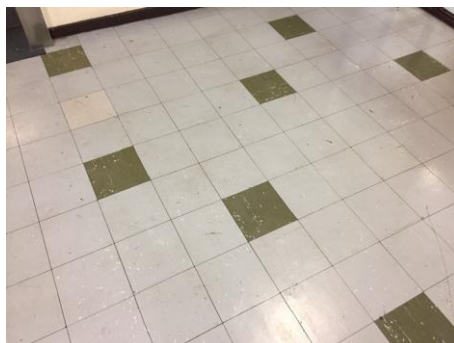
Level: **Eleventh Floor**

Condition **Low Damage**

The material was seen to be in fair condition at the time of the initial inspection.

The condition of the material should be managed by a competent person/company and its presence made aware to those at risk, as part of a Control of Asbestos Regulations (CAR) 2012 compliant management strategy.

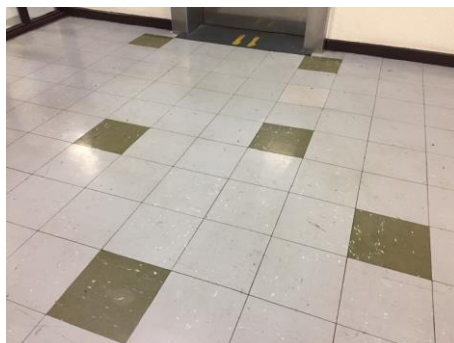
Level: **Eleventh Floor**

Condition **Low Damage**

The material was seen to be in fair condition at the time of the initial inspection.

The condition of the material should be managed by a competent person/company and its presence made aware to those at risk, as part of a Control of Asbestos Regulations (CAR) 2012 compliant management strategy.

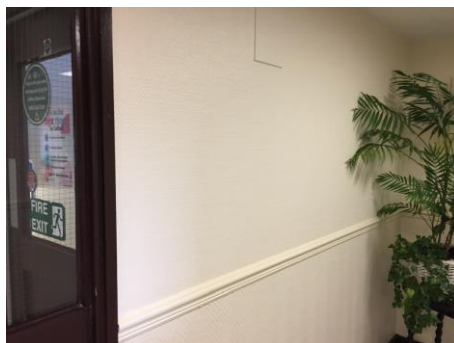
Level: **Eleventh Floor**

Condition..... **Low Damage**

The material was seen to be in fair condition at the time of the initial inspection.

The condition of the material should be managed by a competent person/company and its presence made aware to those at risk, as part of a Control of Asbestos Regulations (CAR) 2012 compliant management strategy.

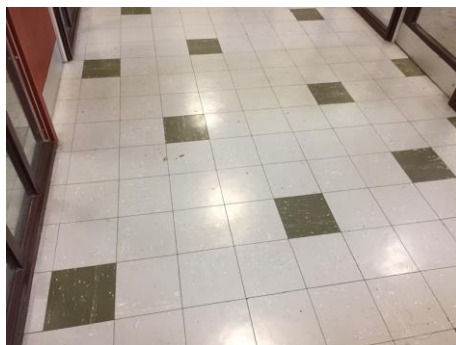
Level: **Eleventh Floor**

Condition..... **Low Damage**

The material was seen to be in fair condition at the time of the initial inspection.

The condition of the material should be managed by a competent person/company and its presence made aware to those at risk, as part of a Control of Asbestos Regulations (CAR) 2012 compliant management strategy.

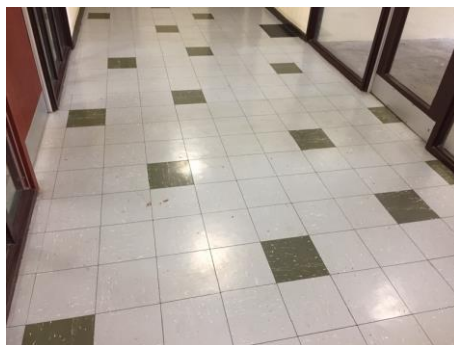
Level: **Eleventh Floor**

Condition..... **Low Damage**

The material was seen to be in fair condition at the time of the initial inspection.

The condition of the material should be managed by a competent person/company and its presence made aware to those at risk, as part of a Control of Asbestos Regulations (CAR) 2012 compliant management strategy.

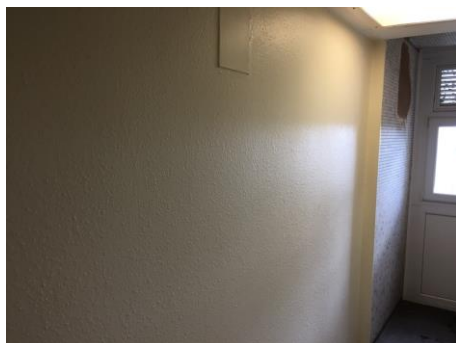
Level: **Thirteenth Floor**

Condition **Low Damage**

The material was seen to be in fair condition at the time of the initial inspection.

The condition of the material should be managed by a competent person/company and its presence made aware to those at risk, as part of a Control of Asbestos Regulations (CAR) 2012 compliant management strategy.

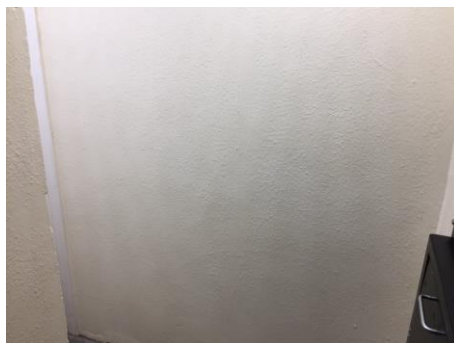
Level: **Eleventh Floor**

Condition **Low Damage**

The material was seen to be in fair condition at the time of the initial inspection.

The condition of the material should be managed by a competent person/company and its presence made aware to those at risk, as part of a Control of Asbestos Regulations (CAR) 2012 compliant management strategy.

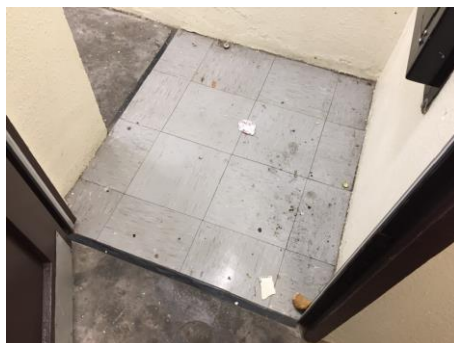
Level: **Eleventh Floor**

Condition **Low Damage**

The material was seen to be in fair condition at the time of the initial inspection.

The condition of the material should be managed by a competent person/company and its presence made aware to those at risk, as part of a Control of Asbestos Regulations (CAR) 2012 compliant management strategy.

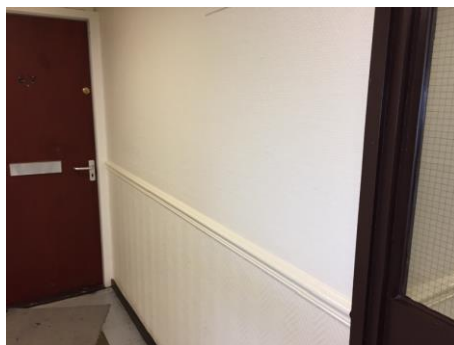
Level: **Eleventh Floor**

Condition **Low Damage**

The material was seen to be in fair condition at the time of the initial inspection.

The condition of the material should be managed by a competent person/company and its presence made aware to those at risk, as part of a Control of Asbestos Regulations (CAR) 2012 compliant management strategy.

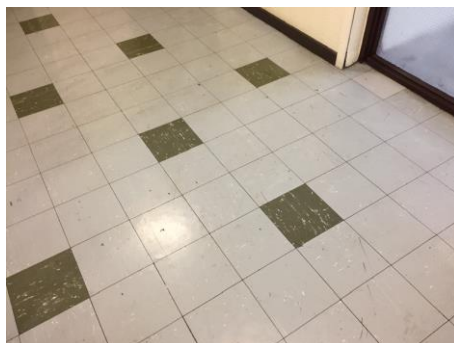
Level: **Eleventh Floor**

Condition..... **Low Damage**

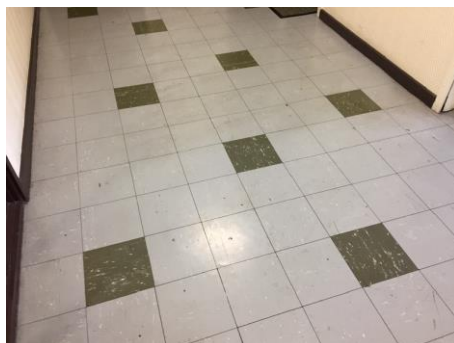
Level: **Eleventh Floor**

Condition **Low Damage**

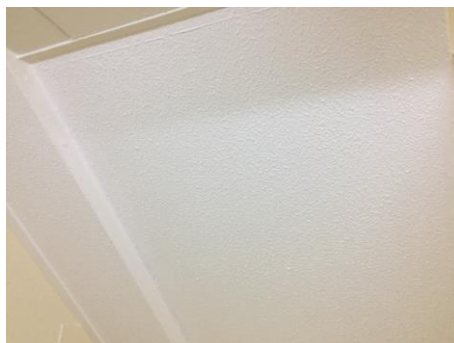
Spatter pattern textured coating.

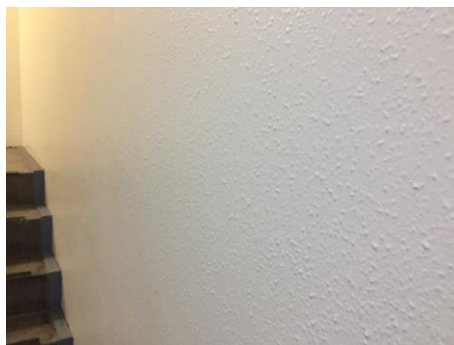
Condition **Low Damage**

The material was seen to be in fair condition at the time of the initial inspection.

The condition of the material should be managed by a competent person/company and its presence made aware to those at risk, as part of a Control of Asbestos Regulations (CAR) 2012 compliant management strategy.

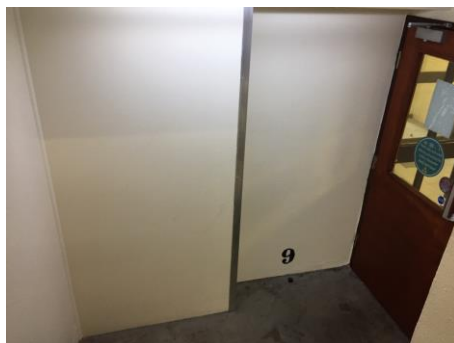
Condition **Low Damage**

The material was seen to be in fair condition at the time of the initial inspection.

The condition of the material should be managed by a competent person/company and its presence made aware to those at risk, as part of a Control of Asbestos Regulations (CAR) 2012 compliant management strategy.

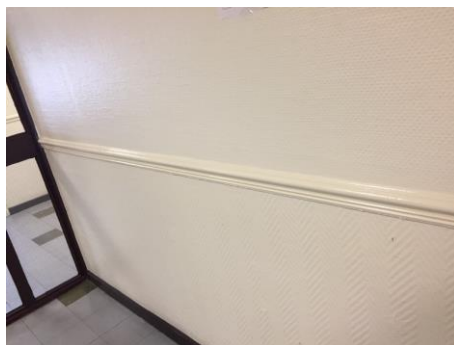
Condition..... **Low Damage**

The material was seen to be in fair condition at the time of the initial inspection.

The condition of the material should be managed by a competent person/company and its presence made aware to those at risk, as part of a Control of Asbestos Regulations (CAR) 2012 compliant management strategy.

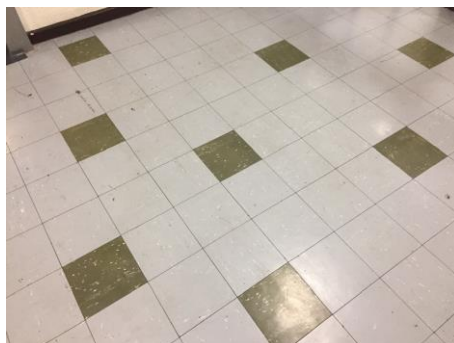
Condition..... **Low Damage**

The material was seen to be in fair condition at the time of the initial inspection.

The condition of the material should be managed by a competent person/company and its presence made aware to those at risk, as part of a Control of Asbestos Regulations (CAR) 2012 compliant management strategy.

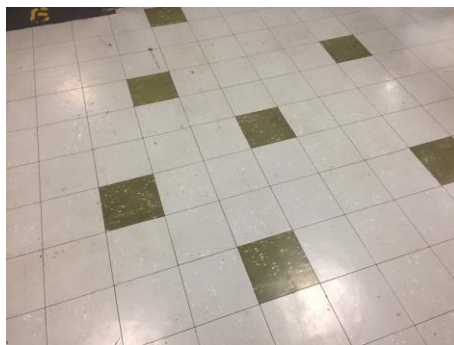
Condition **Low Damage**

The material was seen to be in fair condition at the time of the initial inspection.

The condition of the material should be managed by a competent person/company and its presence made aware to those at risk, as part of a Control of Asbestos Regulations (CAR) 2012 compliant management strategy.

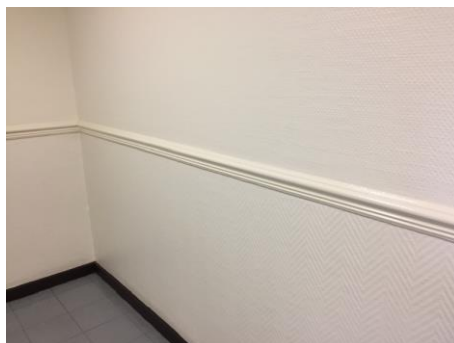
Condition **Low Damage**

The material was seen to be in fair condition at the time of the initial inspection.

The condition of the material should be managed by a competent person/company and its presence made aware to those at risk, as part of a Control of Asbestos Regulations (CAR) 2012 compliant management strategy.

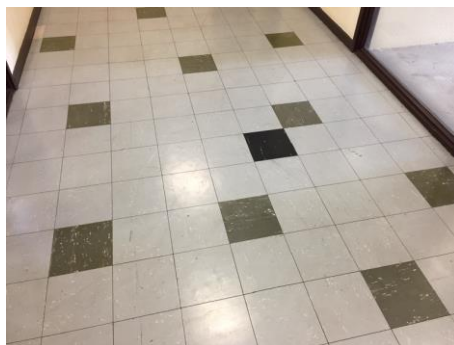
Condition **Low Damage**

The material was seen to be in fair condition at the time of the initial inspection.

The condition of the material should be managed by a competent person/company and its presence made aware to those at risk, as part of a Control of Asbestos Regulations (CAR) 2012 compliant management strategy.

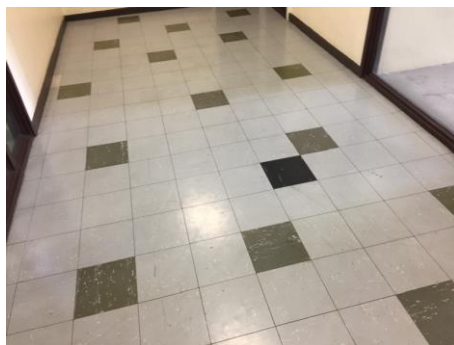
Condition **Low Damage**

The material was seen to be in fair condition at the time of the initial inspection.

The condition of the material should be managed by a competent person/company and its presence made aware to those at risk, as part of a Control of Asbestos Regulations (CAR) 2012 compliant management strategy.

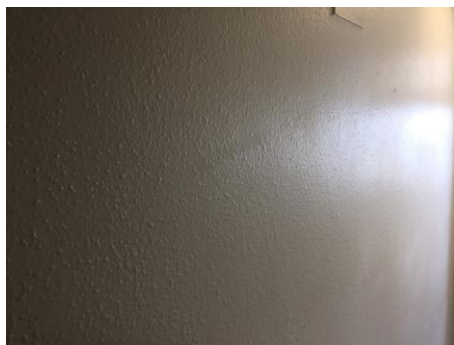
Condition **Low Damage**

The material was seen to be in fair condition at the time of the initial inspection.

The condition of the material should be managed by a competent person/company and its presence made aware to those at risk, as part of a Control of Asbestos Regulations (CAR) 2012 compliant management strategy.

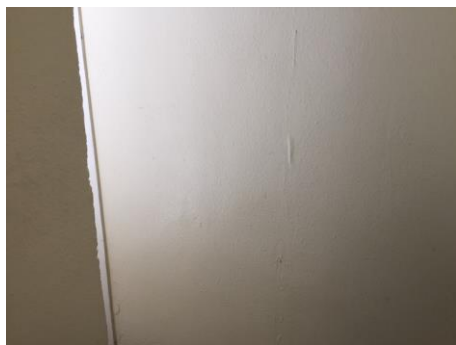
Condition **Low Damage**

The material was seen to be in fair condition at the time of the initial inspection.

The condition of the material should be managed by a competent person/company and its presence made aware to those at risk, as part of a Control of Asbestos Regulations (CAR) 2012 compliant management strategy.

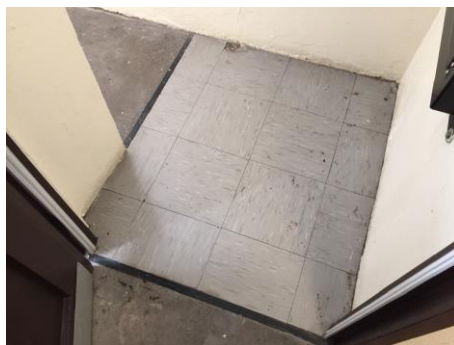
Condition..... **Low Damage**

The material was seen to be in fair condition at the time of the initial inspection.

The condition of the material should be managed by a competent person/company and its presence made aware to those at risk, as part of a Control of Asbestos Regulations (CAR) 2012 compliant management strategy.

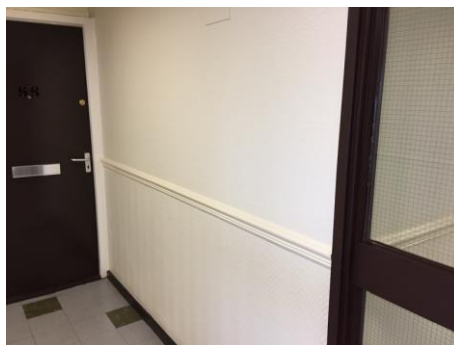
Condition **Low Damage**

The material was seen to be in fair condition at the time of the initial inspection.

The condition of the material should be managed by a competent person/company and its presence made aware to those at risk, as part of a Control of Asbestos Regulations (CAR) 2012 compliant management strategy.

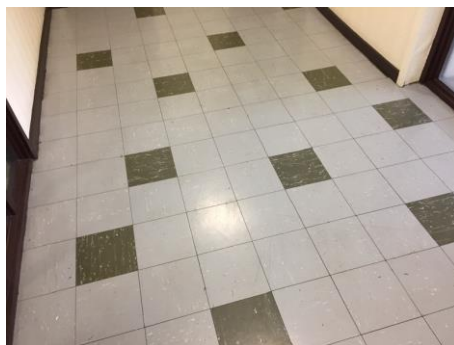
Condition **Low Damage**

The material was seen to be in fair condition at the time of the initial inspection.

The condition of the material should be managed by a competent person/company and its presence made aware to those at risk, as part of a Control of Asbestos Regulations (CAR) 2012 compliant management strategy.

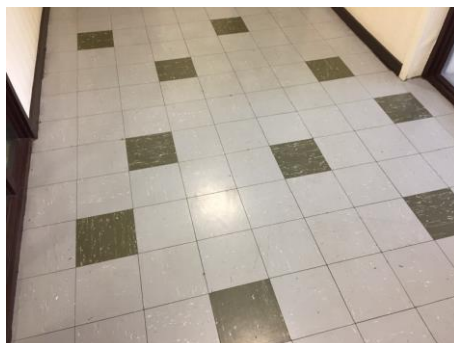
Condition **Low Damage**

The material was seen to be in fair condition at the time of the initial inspection.

The condition of the material should be managed by a competent person/company and its presence made aware to those at risk, as part of a Control of Asbestos Regulations (CAR) 2012 compliant management strategy.

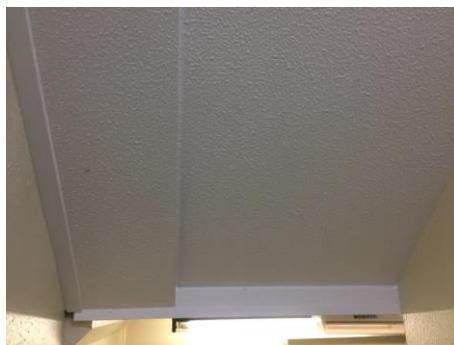
Condition..... **Low Damage**

Spatter pattern textured coating.

The material was seen to be in fair condition at the time of the initial inspection.

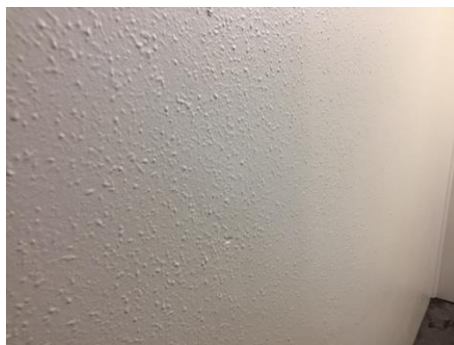
Condition **Low Damage**

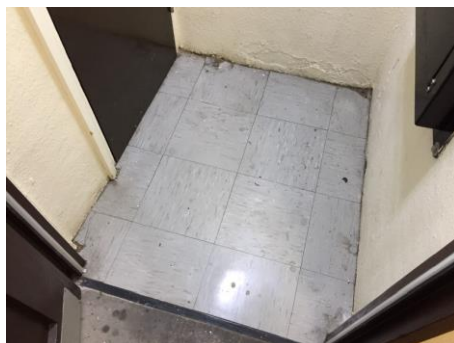
Condition..... **Low Damage**

The material was seen to be in fair condition at the time of the initial inspection.

The condition of the material should be managed by a competent person/company and its presence made aware to those at risk, as part of a Control of Asbestos Regulations (CAR) 2012 compliant management strategy.

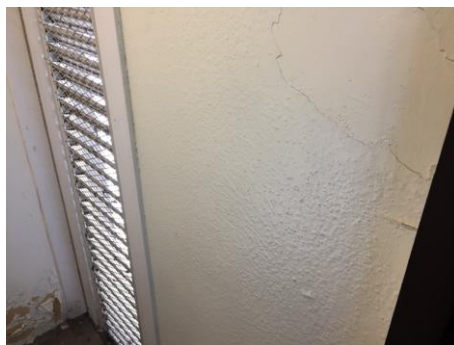
Condition..... **Low Damage**

The material was seen to be in fair condition at the time of the initial inspection.

The condition of the material should be managed by a competent person/company and its presence made aware to those at risk, as part of a Control of Asbestos Regulations (CAR) 2012 compliant management strategy.

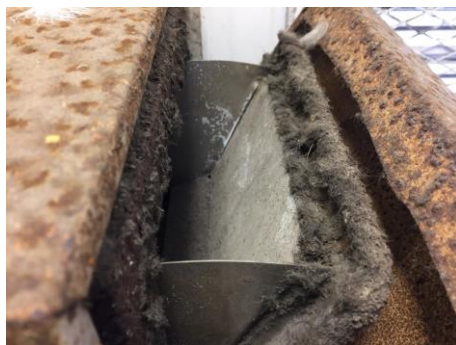
Condition **Low Damage**

The material was seen to be in fair condition at the time of the initial inspection.

The condition of the material should be managed by a competent person/company and its presence made aware to those at risk, as part of a Control of Asbestos Regulations (CAR) 2012 compliant management strategy.

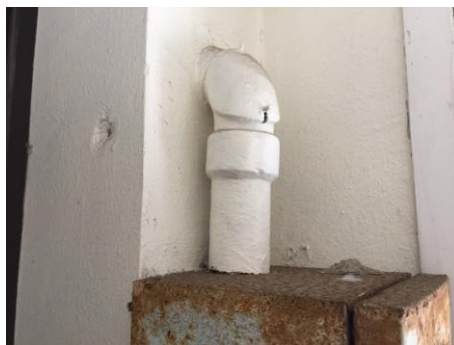
Condition **Low Damage**

The material was seen to be in fair condition at the time of the initial inspection.

The condition of the material should be managed by a competent person/company and its presence made aware to those at risk, as part of a Control of Asbestos Regulations (CAR) 2012 compliant management strategy.

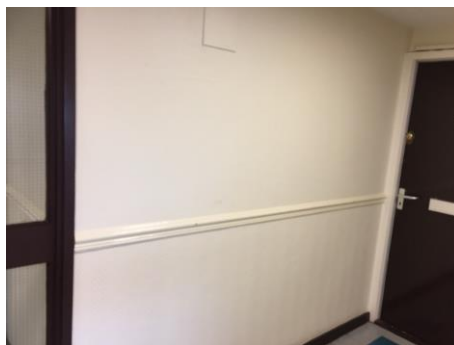
Condition **Low Damage**

The material was seen to be in fair condition at the time of the initial inspection.

The condition of the material should be managed by a competent person/company and its presence made aware to those at risk, as part of a Control of Asbestos Regulations (CAR) 2012 compliant management strategy.

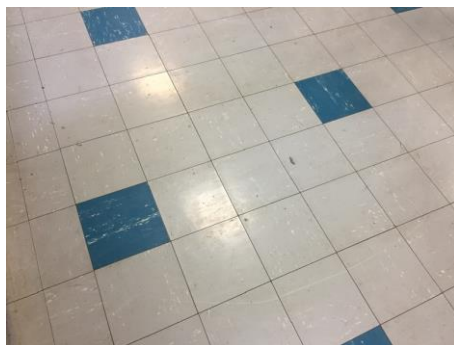
Blue and grey floor tiles.

The material was seen to be in fair condition at the time of the initial inspection.

The condition of the material should be managed by a competent person/company and its presence made aware to those at risk, as part of a Control of Asbestos Regulations (CAR) 2012 compliant management strategy.

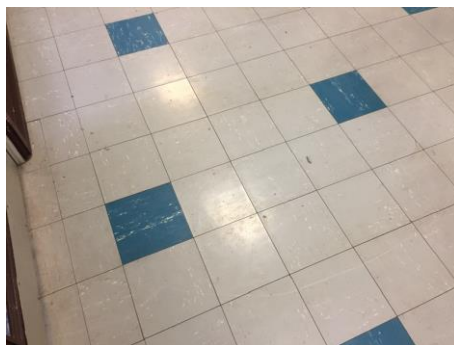
Bitumen adhesive beneath floor tiles.

The material was seen to be in fair condition at the time of the initial inspection.

The condition of the material should be managed by a competent person/company and its presence made aware to those at risk, as part of a Control of Asbestos Regulations (CAR) 2012 compliant management strategy.

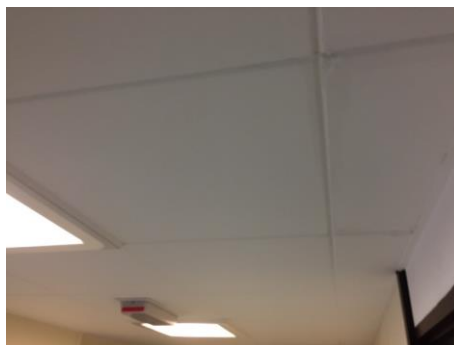
Spatter pattern textured coating above Supalux suspended ceiling.

The material was seen to be in fair condition at the time of the initial inspection.

The condition of the material should be managed by a competent person/company and its presence made aware to those at risk, as part of a Control of Asbestos Regulations (CAR) 2012 compliant management strategy.

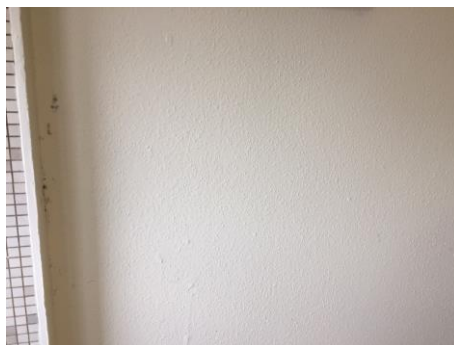
Condition **Low Damage**

The material was seen to be in fair condition at the time of the initial inspection.

The condition of the material should be managed by a competent person/company and its presence made aware to those at risk, as part of a Control of Asbestos Regulations (CAR) 2012 compliant management strategy.

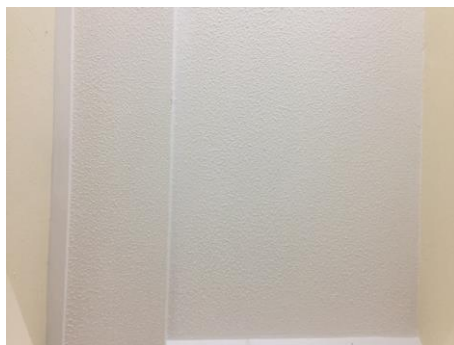
Condition..... **Low Damage**

The material was seen to be in fair condition at the time of the initial inspection.

The condition of the material should be managed by a competent person/company and its presence made aware to those at risk, as part of a Control of Asbestos Regulations (CAR) 2012 compliant management strategy.

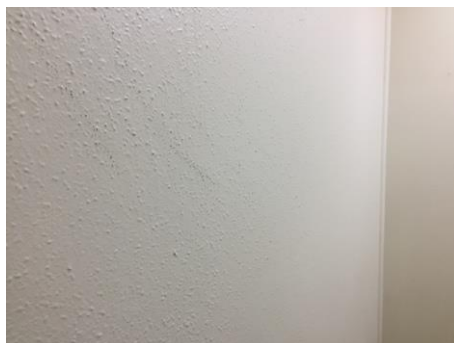
Condition **Low Damage**

The material was seen to be in fair condition at the time of the initial inspection.

The condition of the material should be managed by a competent person/company and its presence made aware to those at risk, as part of a Control of Asbestos Regulations (CAR) 2012 compliant management strategy.

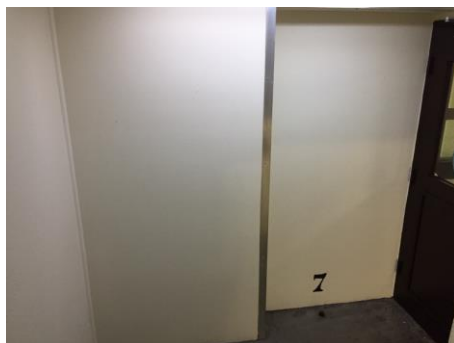
Condition **Low Damage**

The material was seen to be in fair condition at the time of the initial inspection.

The condition of the material should be managed by a competent person/company and its presence made aware to those at risk, as part of a Control of Asbestos Regulations (CAR) 2012 compliant management strategy.

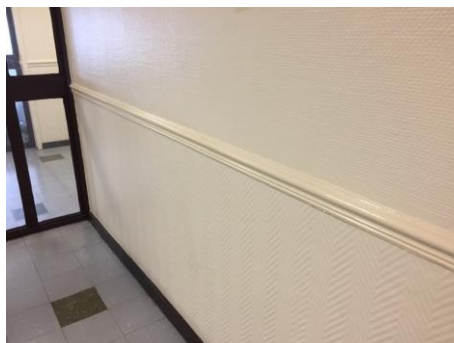
Condition **Low Damage**

The material was seen to be in fair condition at the time of the initial inspection.

The condition of the material should be managed by a competent person/company and its presence made aware to those at risk, as part of a Control of Asbestos Regulations (CAR) 2012 compliant management strategy.

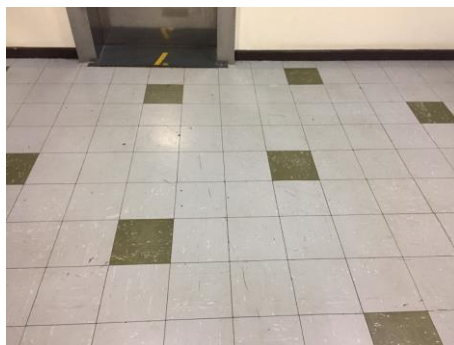
Condition..... **Low Damage**

The material was seen to be in fair condition at the time of the initial inspection.

The condition of the material should be managed by a competent person/company and its presence made aware to those at risk, as part of a Control of Asbestos Regulations (CAR) 2012 compliant management strategy.

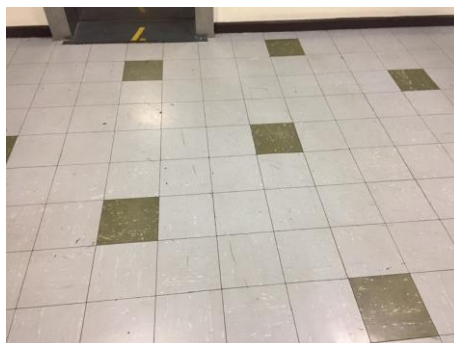
Condition **Low Damage**

The material was seen to be in fair condition at the time of the initial inspection.

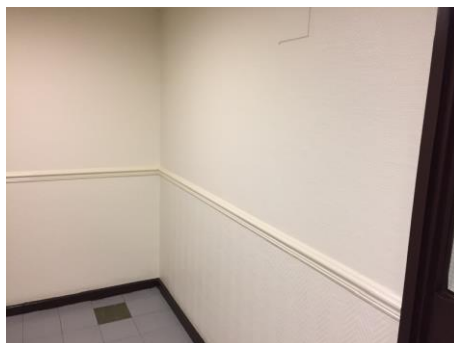
Condition **Low Damage**

The material was seen to be in fair condition at the time of the initial inspection.

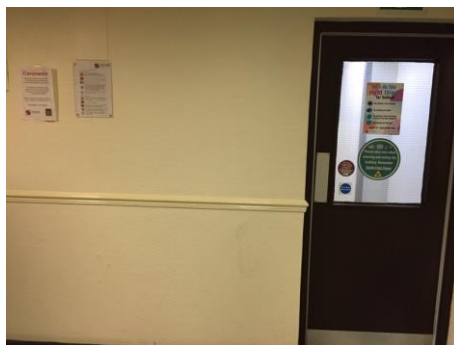
Spatter pattern textured coating behind embossed glass fibre wallpaper.

The material was seen to be in fair condition at the time of the initial inspection.

The condition of the material should be managed by a competent person/company and its presence made aware to those at risk, as part of a Control of Asbestos Regulations (CAR) 2012 compliant management strategy.

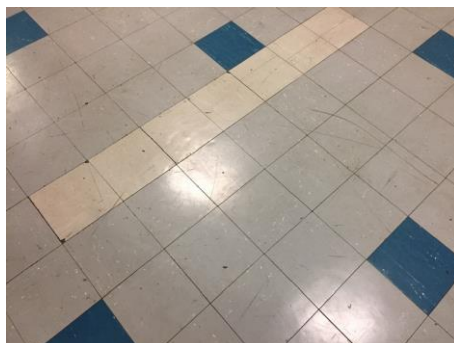
Condition..... **Low Damage**

The material was seen to be in fair condition at the time of the initial inspection.

The condition of the material should be managed by a competent person/company and its presence made aware to those at risk, as part of a Control of Asbestos Regulations (CAR) 2012 compliant management strategy.

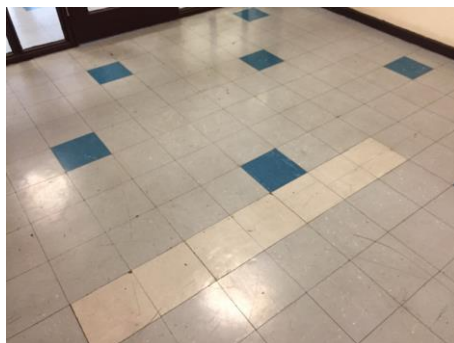
Condition **Low Damage**

The material was seen to be in fair condition at the time of the initial inspection.

The condition of the material should be managed by a competent person/company and its presence made aware to those at risk, as part of a Control of Asbestos Regulations (CAR) 2012 compliant management strategy.

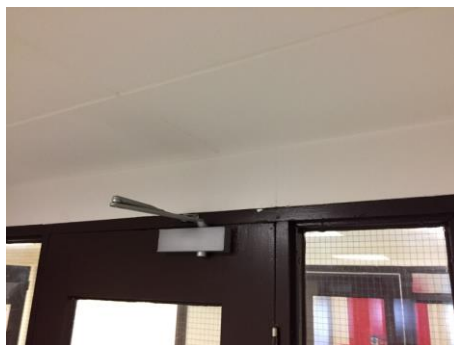
Supalux transom panels over doors to lobbies.

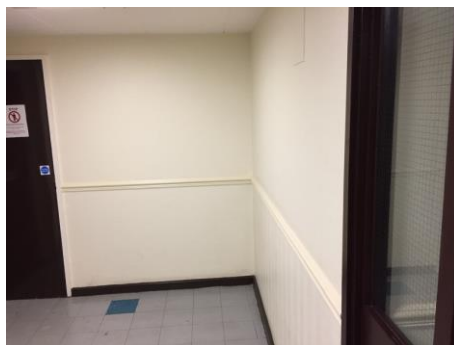
Condition **Low Damage**

The material was seen to be in fair condition at the time of the initial inspection.

The condition of the material should be managed by a competent person/company and its presence made aware to those at risk, as part of a Control of Asbestos Regulations (CAR) 2012 compliant management strategy.

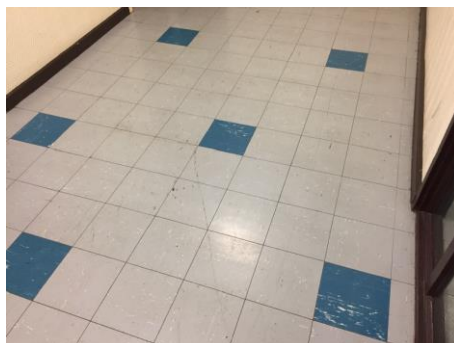
Condition..... **Low Damage**

The material was seen to be in fair condition at the time of the initial inspection.

The condition of the material should be managed by a competent person/company and its presence made aware to those at risk, as part of a Control of Asbestos Regulations (CAR) 2012 compliant management strategy.

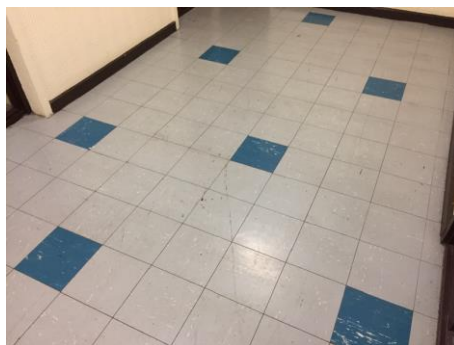
Condition **Low Damage**

The material was seen to be in fair condition at the time of the initial inspection.

The condition of the material should be managed by a competent person/company and its presence made aware to those at risk, as part of a Control of Asbestos Regulations (CAR) 2012 compliant management strategy.

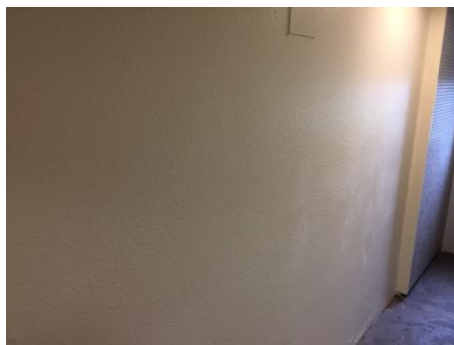
Condition **Low Damage**

The material was seen to be in fair condition at the time of the initial inspection.

The condition of the material should be managed by a competent person/company and its presence made aware to those at risk, as part of a Control of Asbestos Regulations (CAR) 2012 compliant management strategy.

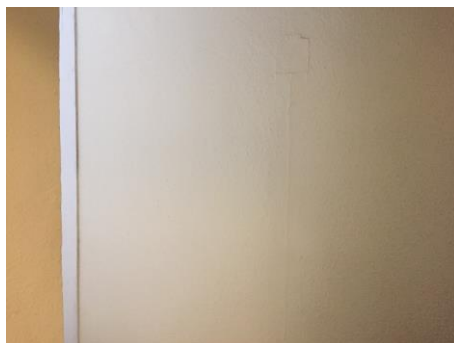
Condition **Low Damage**

The material was seen to be in fair condition at the time of the initial inspection.

The condition of the material should be managed by a competent person/company and its presence made aware to those at risk, as part of a Control of Asbestos Regulations (CAR) 2012 compliant management strategy.

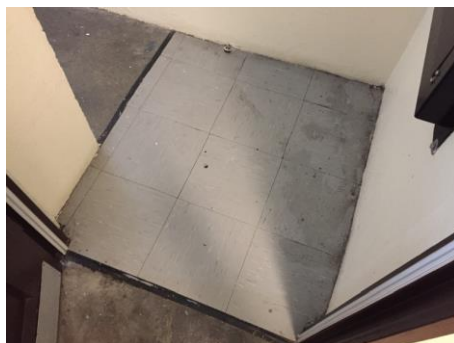
Condition **Low Damage**

The material was seen to be in fair condition at the time of the initial inspection.

The condition of the material should be managed by a competent person/company and its presence made aware to those at risk, as part of a Control of Asbestos Regulations (CAR) 2012 compliant management strategy.

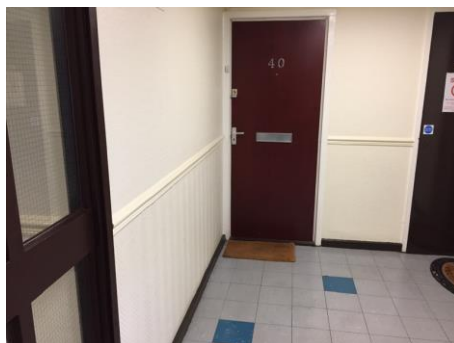
Condition **Low Damage**

The material was seen to be in fair condition at the time of the initial inspection.

The condition of the material should be managed by a competent person/company and its presence made aware to those at risk, as part of a Control of Asbestos Regulations (CAR) 2012 compliant management strategy.

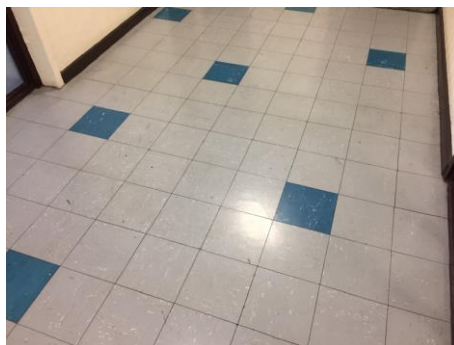
Condition..... **Low Damage**

The material was seen to be in fair condition at the time of the initial inspection.

The condition of the material should be managed by a competent person/company and its presence made aware to those at risk, as part of a Control of Asbestos Regulations (CAR) 2012 compliant management strategy.

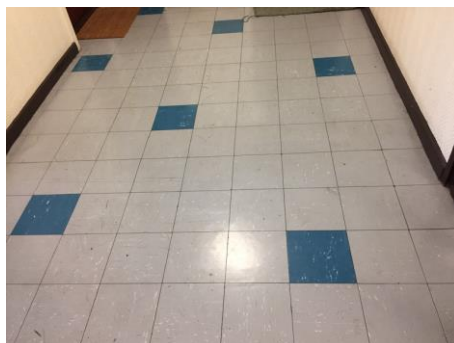
Condition..... **Low Damage**

The material was seen to be in fair condition at the time of the initial inspection.

The condition of the material should be managed by a competent person/company and its presence made aware to those at risk, as part of a Control of Asbestos Regulations (CAR) 2012 compliant management strategy.

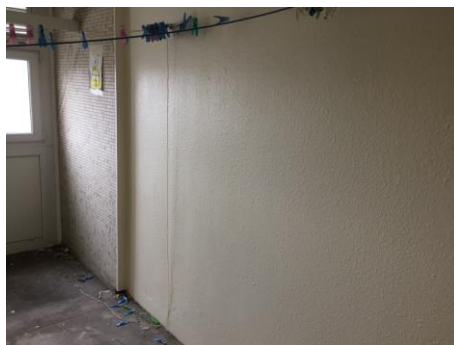
Condition **Low Damage**

The material was seen to be in fair condition at the time of the initial inspection.

The condition of the material should be managed by a competent person/company and its presence made aware to those at risk, as part of a Control of Asbestos Regulations (CAR) 2012 compliant management strategy.

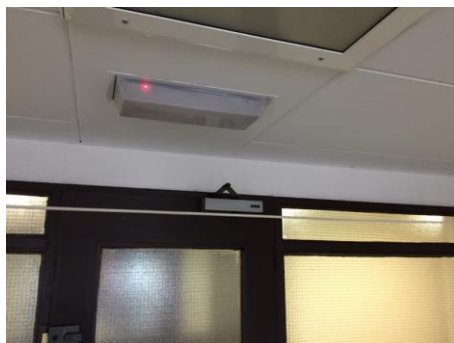
Supalux transom panels over door.

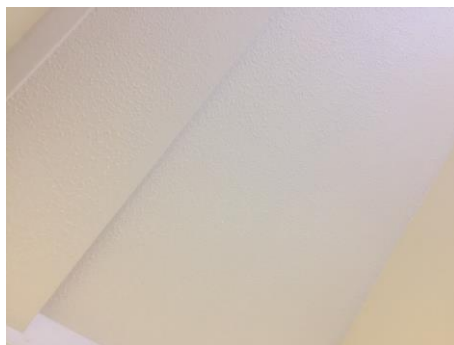
Spatter pattern textured coating.

The material was seen to be in fair condition at the time of the initial inspection.

The condition of the material should be managed by a competent person/company and its presence made aware to those at risk, as part of a Control of Asbestos Regulations (CAR) 2012 compliant management strategy.

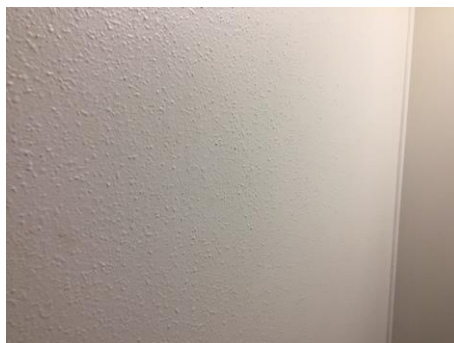
Condition **Low Damage**

The material was seen to be in fair condition at the time of the initial inspection.

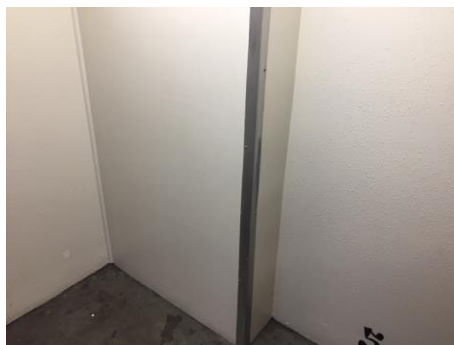
Insulating board panel to back of timber riser panel.

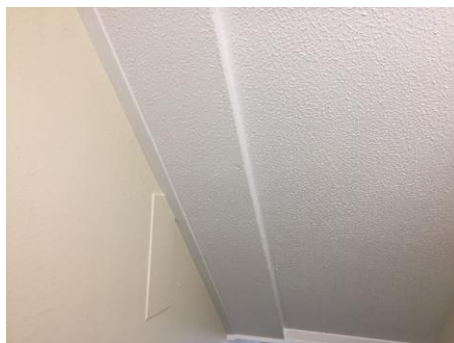
Supalux boxing with textured coating finish to underside of staircase.

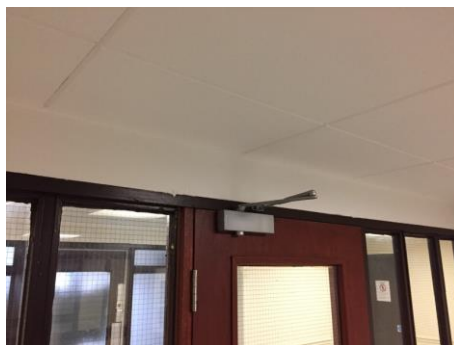
Supalux transom panels over doors to lobbies.

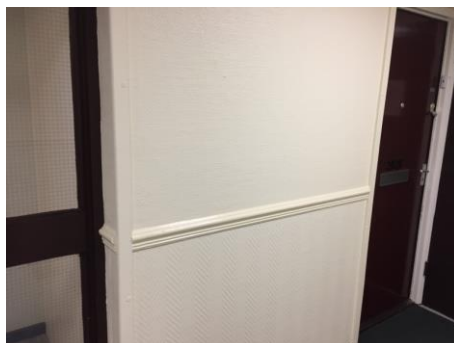
Spatter pattern textured coating behind embossed glass fibre wallpaper.

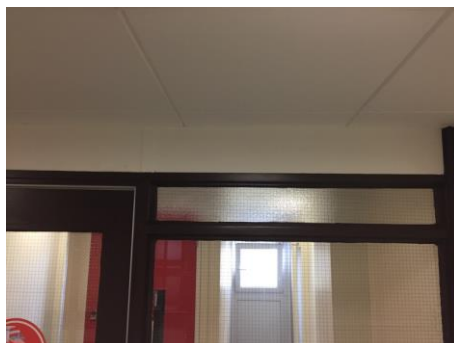
Supalux transom panels over doors to lobbies.

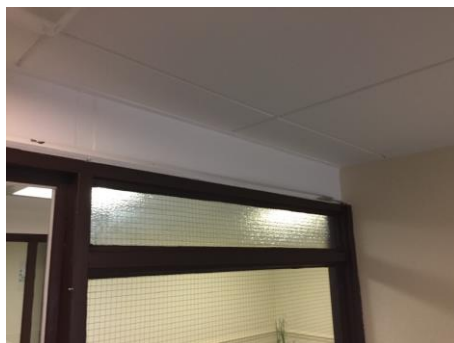
Supalux transom panels over doors.

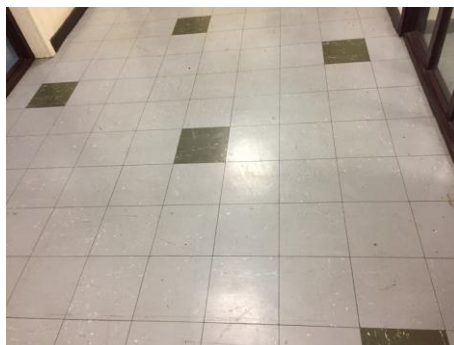
Condition..... **Low Damage**

The material was seen to be in fair condition at the time of the initial inspection.

The condition of the material should be managed by a competent person/company and its presence made aware to those at risk, as part of a Control of Asbestos Regulations (CAR) 2012 compliant management strategy.

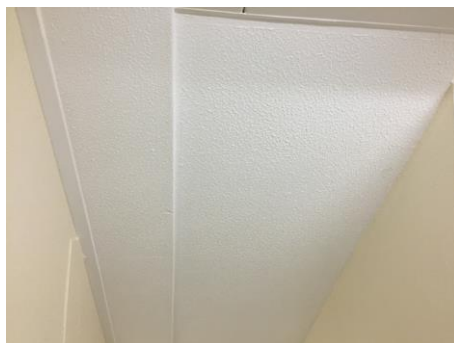
Condition..... **Low Damage**

The material was seen to be in fair condition at the time of the initial inspection.

The condition of the material should be managed by a competent person/company and its presence made aware to those at risk, as part of a Control of Asbestos Regulations (CAR) 2012 compliant management strategy.

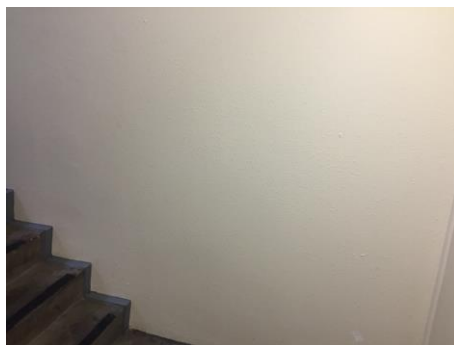
Spatter pattern textured coating.

The material was seen to be in fair condition at the time of the initial inspection.

The condition of the material should be managed by a competent person/company and its presence made aware to those at risk, as part of a Control of Asbestos Regulations (CAR) 2012 compliant management strategy.

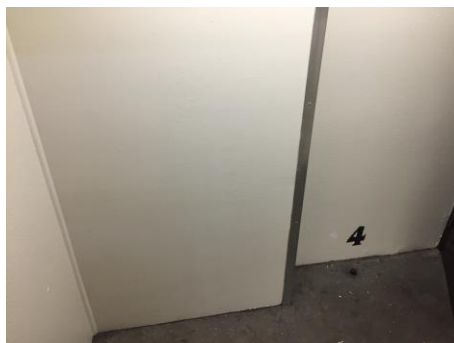
Condition **Low Damage**

The material was seen to be in fair condition at the time of the initial inspection.

The condition of the material should be managed by a competent person/company and its presence made aware to those at risk, as part of a Control of Asbestos Regulations (CAR) 2012 compliant management strategy.

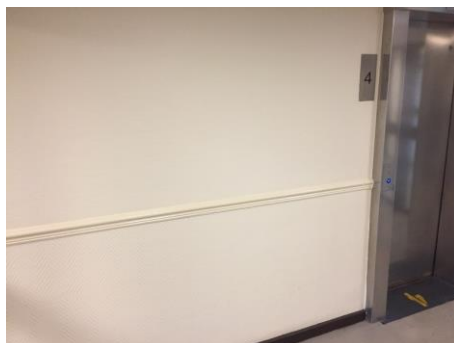
Condition **Low Damage**

The material was seen to be in fair condition at the time of the initial inspection.

The condition of the material should be managed by a competent person/company and its presence made aware to those at risk, as part of a Control of Asbestos Regulations (CAR) 2012 compliant management strategy.

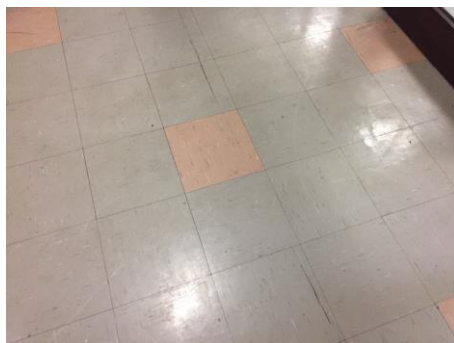
Condition **Low Damage**

The material was seen to be in fair condition at the time of the initial inspection.

The condition of the material should be managed by a competent person/company and its presence made aware to those at risk, as part of a Control of Asbestos Regulations (CAR) 2012 compliant management strategy.

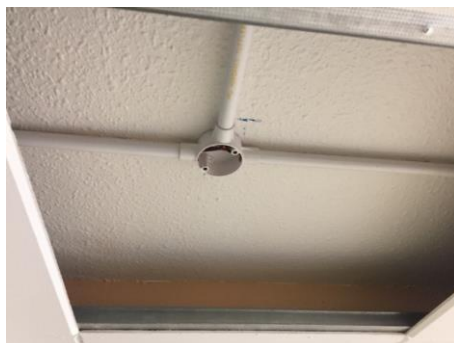
Condition..... **Low Damage**

The material was seen to be in fair condition at the time of the initial inspection.

The condition of the material should be managed by a competent person/company and its presence made aware to those at risk, as part of a Control of Asbestos Regulations (CAR) 2012 compliant management strategy.

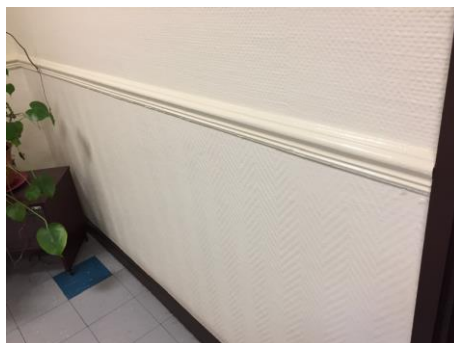
Condition **Low Damage**

The material was seen to be in fair condition at the time of the initial inspection.

The condition of the material should be managed by a competent person/company and its presence made aware to those at risk, as part of a Control of Asbestos Regulations (CAR) 2012 compliant management strategy.

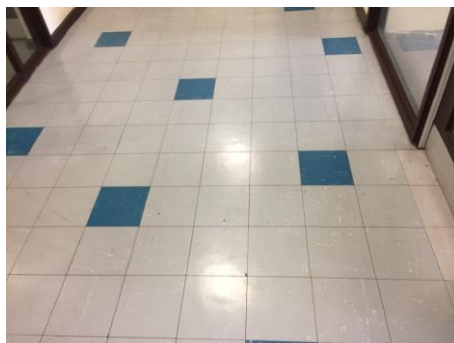
Condition..... **Low Damage**

The material was seen to be in fair condition at the time of the initial inspection.

The condition of the material should be managed by a competent person/company and its presence made aware to those at risk, as part of a Control of Asbestos Regulations (CAR) 2012 compliant management strategy.

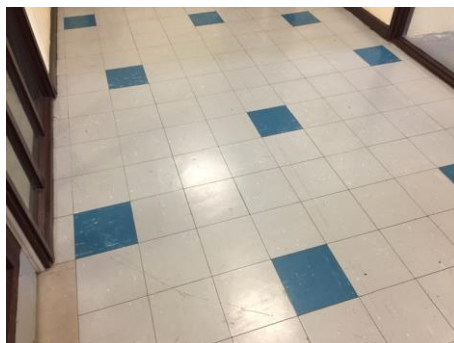
Condition..... **Low Damage**

The material was seen to be in fair condition at the time of the initial inspection.

The condition of the material should be managed by a competent person/company and its presence made aware to those at risk, as part of a Control of Asbestos Regulations (CAR) 2012 compliant management strategy.

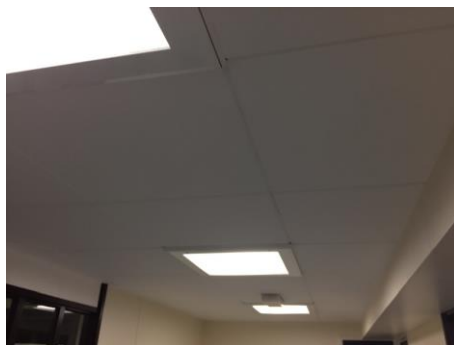
Spatter pattern textured coating above Supalux suspended ceiling.

The material was seen to be in fair condition at the time of the initial inspection.

The condition of the material should be managed by a competent person/company and its presence made aware to those at risk, as part of a Control of Asbestos Regulations (CAR) 2012 compliant management strategy.
