Site ID: **a-300854** Management with Targeted Refurbishment Survey

Solihull Community Housing
Client ID: **S135 - 4113543**

1-83 Westham House
Forth Drive
Kingshurst
Solihull
West Midlands
B37 6PT
United Kingdom

9th April 2021

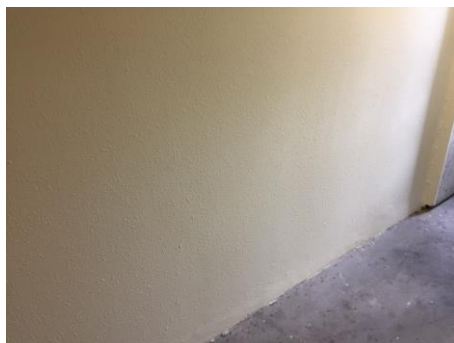
Condition..... **Low Damage**

The material was seen to be in fair condition at the time of the initial inspection.

The condition of the material should be managed by a competent person/company and its presence made aware to those at risk, as part of a Control of Asbestos Regulations (CAR) 2012 compliant management strategy.

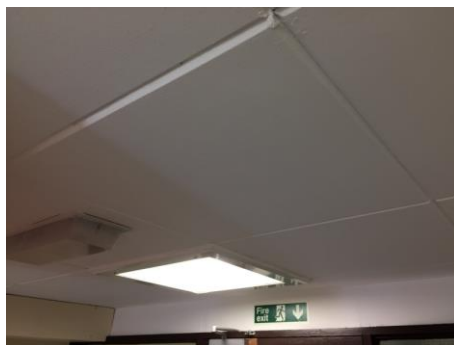
Condition..... **Low Damage**

The material was seen to be in fair condition at the time of the initial inspection.

The condition of the material should be managed by a competent person/company and its presence made aware to those at risk, as part of a Control of Asbestos Regulations (CAR) 2012 compliant management strategy.

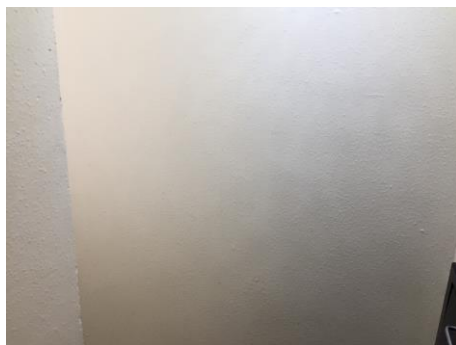
Condition **Low Damage**

The material was seen to be in fair condition at the time of the initial inspection.

The condition of the material should be managed by a competent person/company and its presence made aware to those at risk, as part of a Control of Asbestos Regulations (CAR) 2012 compliant management strategy.

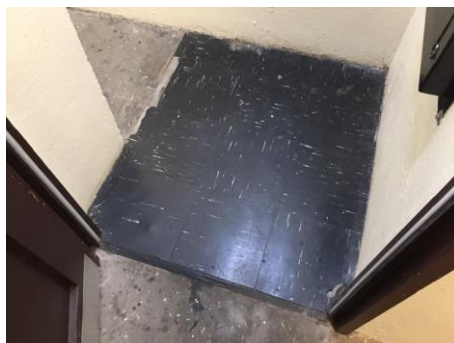
Condition..... **Low Damage**

The material was seen to be in fair condition at the time of the initial inspection.

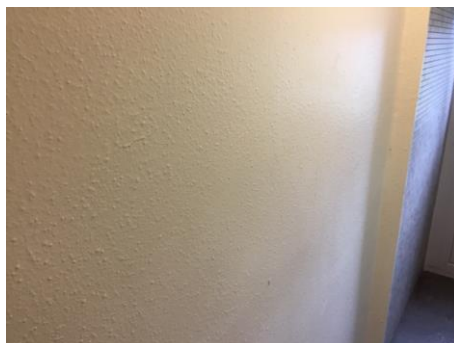
Level: **Third Floor**

Condition **Low Damage**

The material was seen to be in fair condition at the time of the initial inspection.

The condition of the material should be managed by a competent person/company and its presence made aware to those at risk, as part of a Control of Asbestos Regulations (CAR) 2012 compliant management strategy.

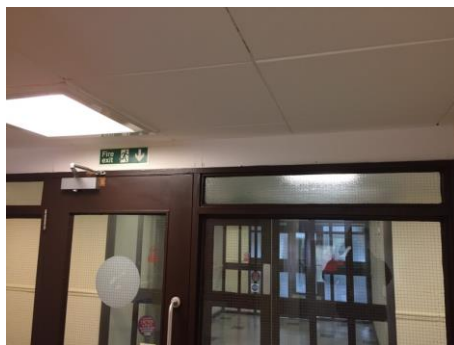
Supalux transom panels over doors.

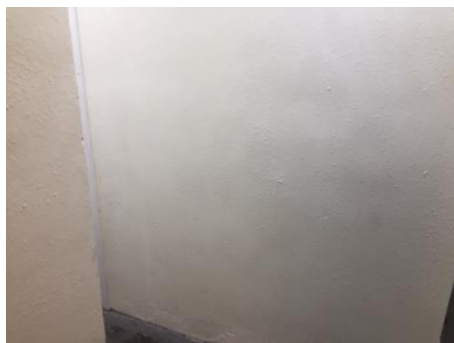
Level: **Third Floor**

Condition **Low Damage**

The material was seen to be in fair condition at the time of the initial inspection.

The condition of the material should be managed by a competent person/company and its presence made aware to those at risk, as part of a Control of Asbestos Regulations (CAR) 2012 compliant management strategy.

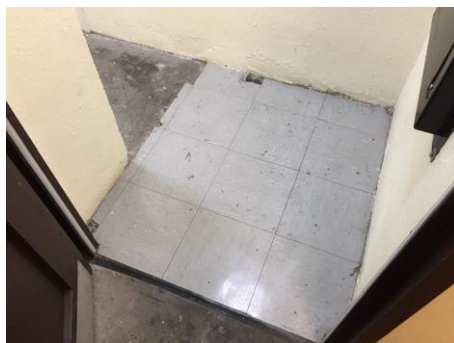
Level: **Third Floor**

Condition..... **Low Damage**

The material was seen to be in fair condition at the time of the initial inspection.

The condition of the material should be managed by a competent person/company and its presence made aware to those at risk, as part of a Control of Asbestos Regulations (CAR) 2012 compliant management strategy.

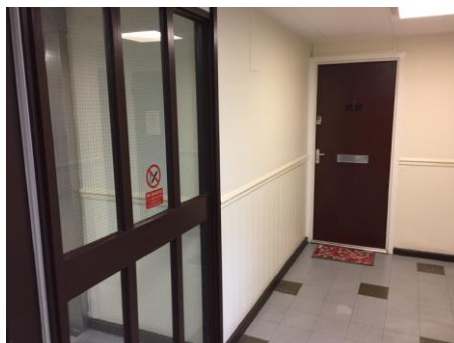
Level: **Third Floor**

Condition **Low Damage**

The material was seen to be in fair condition at the time of the initial inspection.

The condition of the material should be managed by a competent person/company and its presence made aware to those at risk, as part of a Control of Asbestos Regulations (CAR) 2012 compliant management strategy.

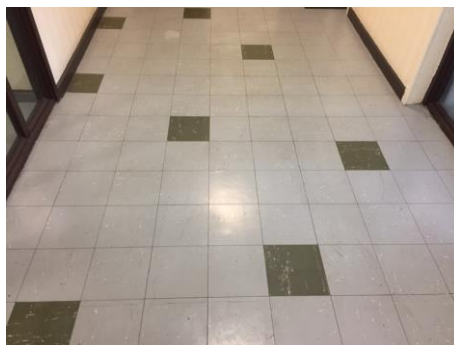
Level: **Third Floor**

Condition..... **Low Damage**

The material was seen to be in fair condition at the time of the initial inspection.

The condition of the material should be managed by a competent person/company and its presence made aware to those at risk, as part of a Control of Asbestos Regulations (CAR) 2012 compliant management strategy.

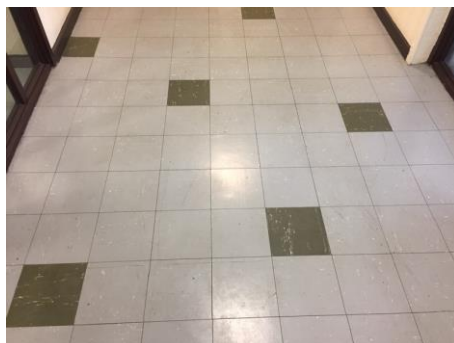
Level: **Third Floor**

Condition **Low Damage**

The material was seen to be in fair condition at the time of the initial inspection.

The condition of the material should be managed by a competent person/company and its presence made aware to those at risk, as part of a Control of Asbestos Regulations (CAR) 2012 compliant management strategy.

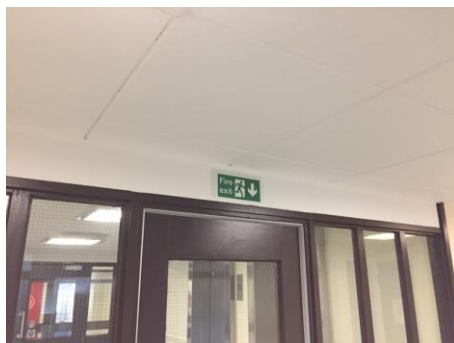
Supalux transom panels over doors to lobbies.

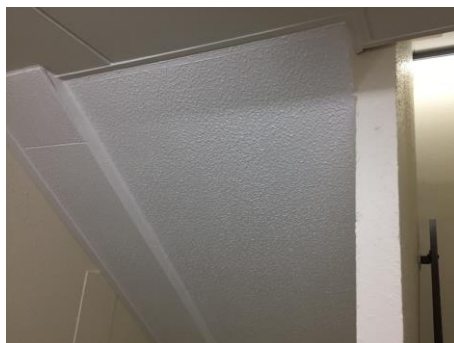
Condition..... **Low Damage**

Spatter pattern textured coating.

The material was seen to be in fair condition at the time of the initial inspection.

The condition of the material should be managed by a competent person/company and its presence made aware to those at risk, as part of a Control of Asbestos Regulations (CAR) 2012 compliant management strategy.

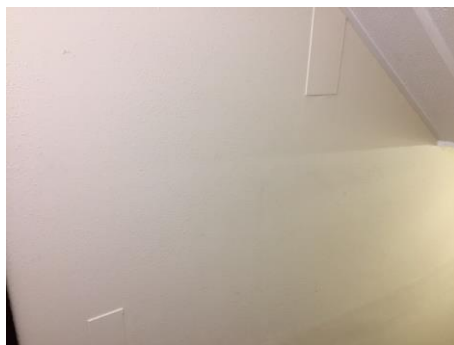
Level: **Second Floor**

Condition **Low Damage**

The material was seen to be in fair condition at the time of the initial inspection.

The condition of the material should be managed by a competent person/company and its presence made aware to those at risk, as part of a Control of Asbestos Regulations (CAR) 2012 compliant management strategy.

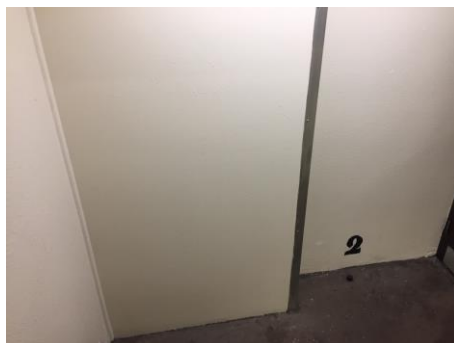
Level: **Second Floor**

Condition **Low Damage**

The material was seen to be in fair condition at the time of the initial inspection.

The condition of the material should be managed by a competent person/company and its presence made aware to those at risk, as part of a Control of Asbestos Regulations (CAR) 2012 compliant management strategy.

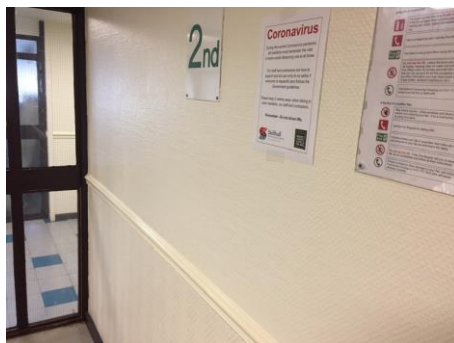
Level: **Second Floor**

Condition..... **Low Damage**

The material was seen to be in fair condition at the time of the initial inspection.

The condition of the material should be managed by a competent person/company and its presence made aware to those at risk, as part of a Control of Asbestos Regulations (CAR) 2012 compliant management strategy.

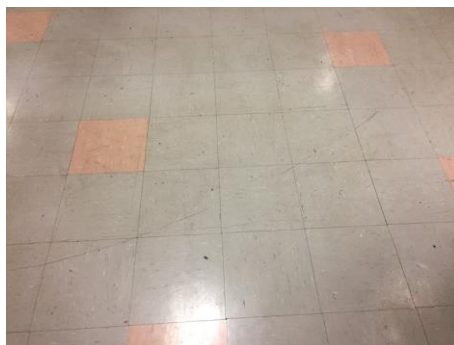
Level: **Second Floor**

Condition **Low Damage**

The material was seen to be in fair condition at the time of the initial inspection.

The condition of the material should be managed by a competent person/company and its presence made aware to those at risk, as part of a Control of Asbestos Regulations (CAR) 2012 compliant management strategy.

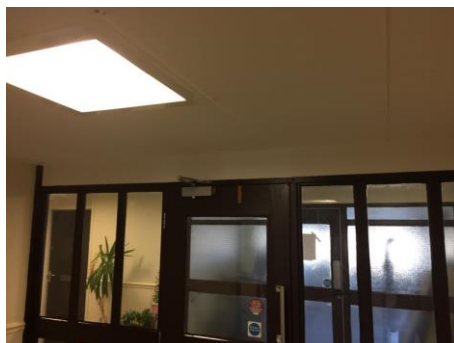
Supalux transom panels over doors to lobbies.

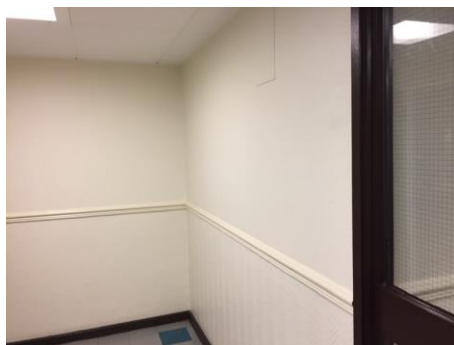
Level: **Second Floor**

Condition **Low Damage**

The material was seen to be in fair condition at the time of the initial inspection.

The condition of the material should be managed by a competent person/company and its presence made aware to those at risk, as part of a Control of Asbestos Regulations (CAR) 2012 compliant management strategy.

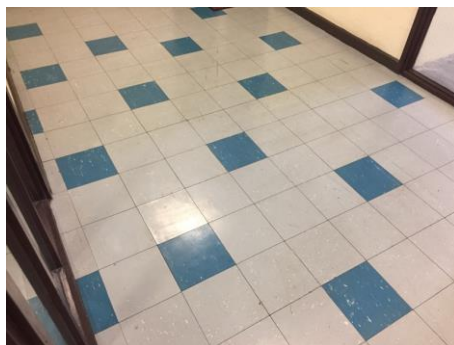
Condition..... **Low Damage**

Blue and grey floor tiles.

The material was seen to be in fair condition at the time of the initial inspection.

The condition of the material should be managed by a competent person/company and its presence made aware to those at risk, as part of a Control of Asbestos Regulations (CAR) 2012 compliant management strategy.

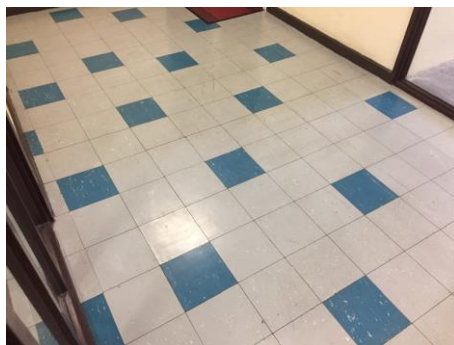
Level: **Second Floor**

Condition **Low Damage**

The material was seen to be in fair condition at the time of the initial inspection.

The condition of the material should be managed by a competent person/company and its presence made aware to those at risk, as part of a Control of Asbestos Regulations (CAR) 2012 compliant management strategy.

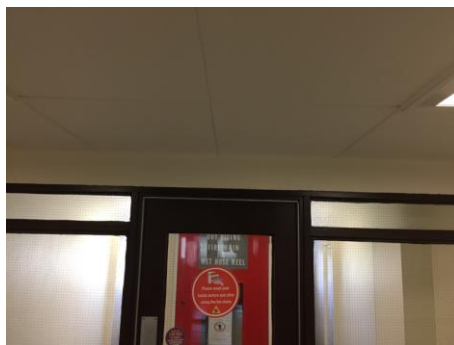
Supalux transom panels over doors to lobbies.

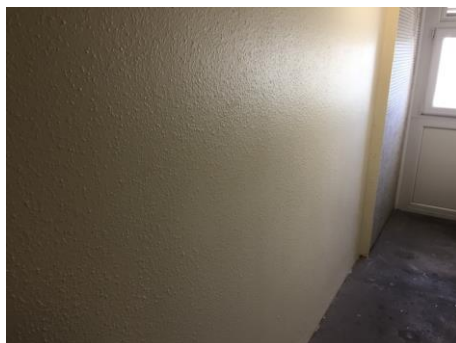
Level: **Second Floor**

Condition **Low Damage**

The material was seen to be in fair condition at the time of the initial inspection.

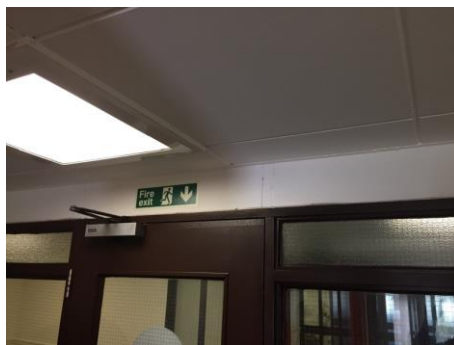
Supalux transom panels over doors.

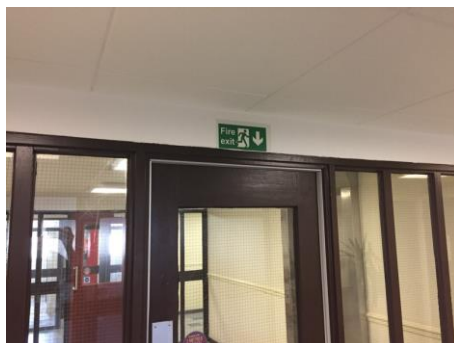
Supalux transom panels over doors to lobbies.

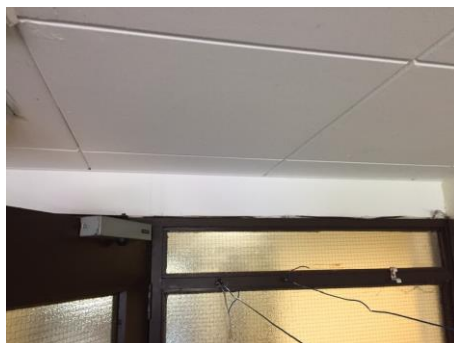
Supalux transom panels over door.

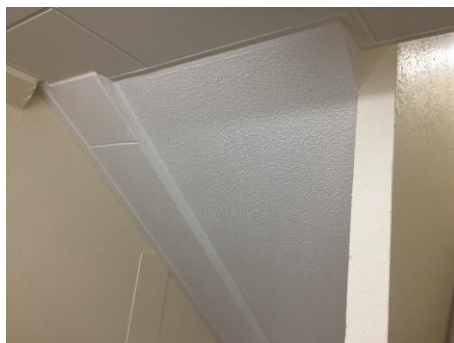
Spatter pattern textured coating.

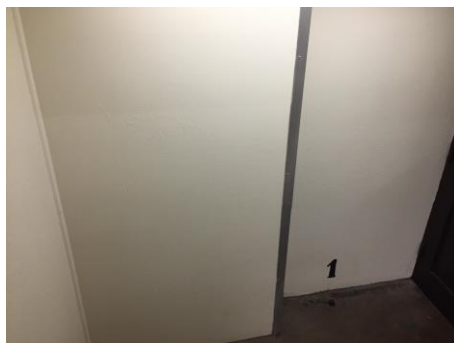
Insulating board panel to back of timber riser panel.

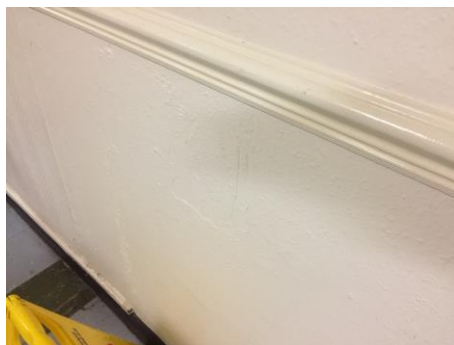
Spatter pattern textured coating behind embossed glass fibre wallpaper.

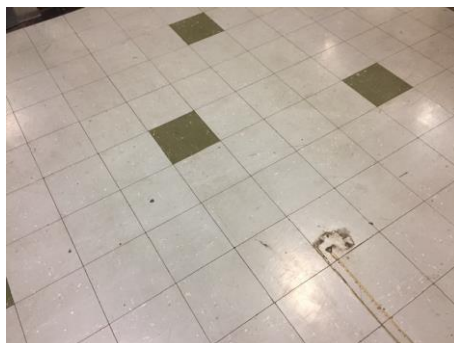
Condition **Low Damage**

The material was seen to be in fair condition at the time of the initial inspection.

The condition of the material should be managed by a competent person/company and its presence made aware to those at risk, as part of a Control of Asbestos Regulations (CAR) 2012 compliant management strategy.

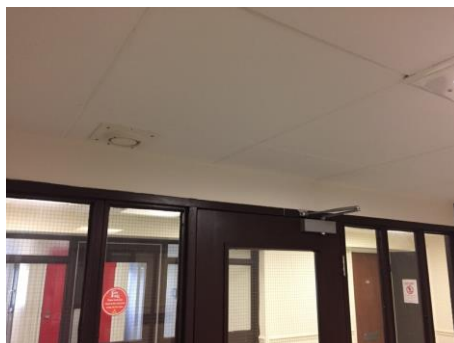
Supalux transom panels over doors to lobbies.

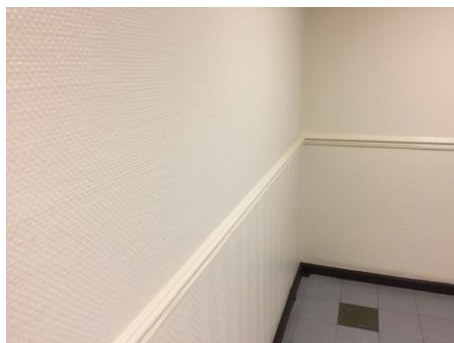
Condition **Low Damage**

The material was seen to be in fair condition at the time of the initial inspection.

The condition of the material should be managed by a competent person/company and its presence made aware to those at risk, as part of a Control of Asbestos Regulations (CAR) 2012 compliant management strategy.

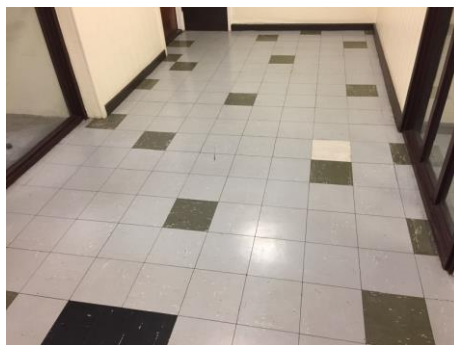
Condition..... **Low Damage**

The material was seen to be in fair condition at the time of the initial inspection.

The condition of the material should be managed by a competent person/company and its presence made aware to those at risk, as part of a Control of Asbestos Regulations (CAR) 2012 compliant management strategy.

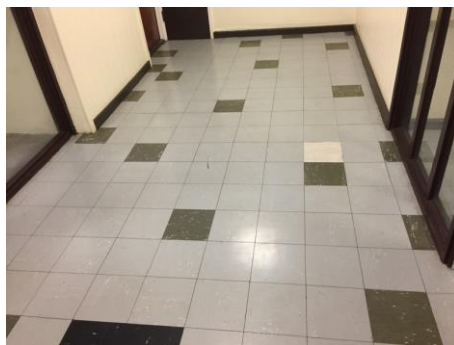
Condition..... **Low Damage**

The material was seen to be in fair condition at the time of the initial inspection.

The condition of the material should be managed by a competent person/company and its presence made aware to those at risk, as part of a Control of Asbestos Regulations (CAR) 2012 compliant management strategy.

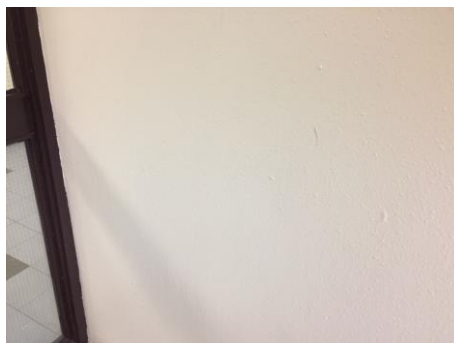
Condition **Low Damage**

The material was seen to be in fair condition at the time of the initial inspection.

The condition of the material should be managed by a competent person/company and its presence made aware to those at risk, as part of a Control of Asbestos Regulations (CAR) 2012 compliant management strategy.

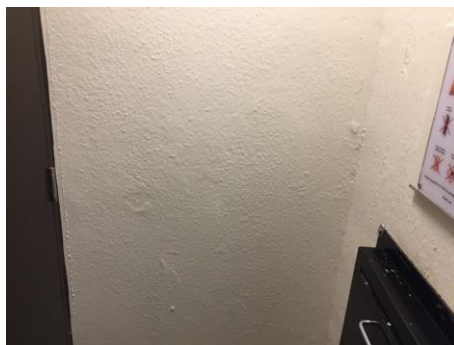
Condition **Low Damage**

The material was seen to be in fair condition at the time of the initial inspection.

The condition of the material should be managed by a competent person/company and its presence made aware to those at risk, as part of a Control of Asbestos Regulations (CAR) 2012 compliant management strategy.

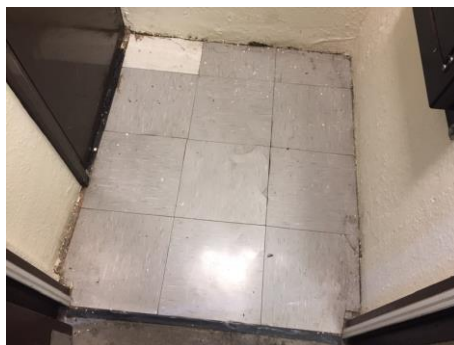
Condition **Low Damage**

The material was seen to be in fair condition at the time of the initial inspection.

The condition of the material should be managed by a competent person/company and its presence made aware to those at risk, as part of a Control of Asbestos Regulations (CAR) 2012 compliant management strategy.

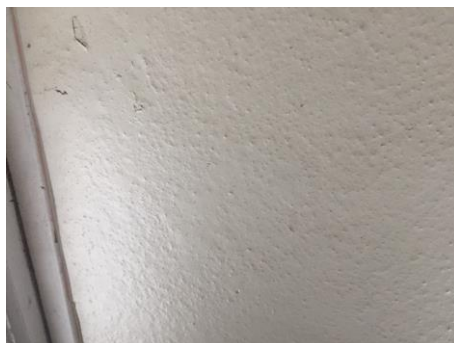
Condition..... **Low Damage**

The material was seen to be in fair condition at the time of the initial inspection.

The condition of the material should be managed by a competent person/company and its presence made aware to those at risk, as part of a Control of Asbestos Regulations (CAR) 2012 compliant management strategy.

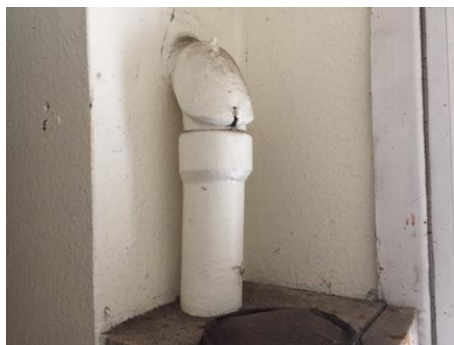
Condition **Low Damage**

Cement flue for Bunnie incinerator.

The material was seen to be in fair condition at the time of the initial inspection.

The condition of the material should be managed by a competent person/company and its presence made aware to those at risk, as part of a Control of Asbestos Regulations (CAR) 2012 compliant management strategy.

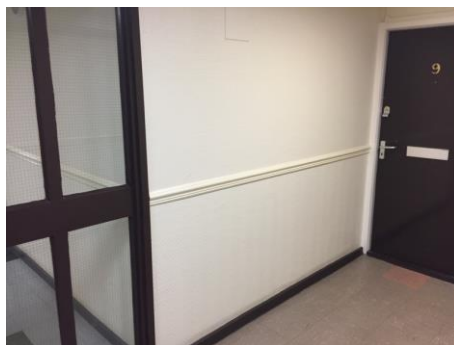
Condition **Low Damage**

The material was seen to be in fair condition at the time of the initial inspection.

The condition of the material should be managed by a competent person/company and its presence made aware to those at risk, as part of a Control of Asbestos Regulations (CAR) 2012 compliant management strategy.

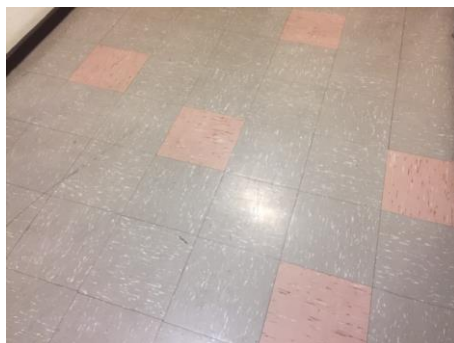
Condition..... **Low Damage**

The material was seen to be in fair condition at the time of the initial inspection.

The condition of the material should be managed by a competent person/company and its presence made aware to those at risk, as part of a Control of Asbestos Regulations (CAR) 2012 compliant management strategy.

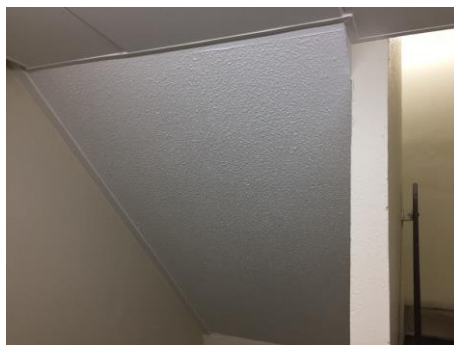
Condition..... **Low Damage**

The material was seen to be in fair condition at the time of the initial inspection.

The condition of the material should be managed by a competent person/company and its presence made aware to those at risk, as part of a Control of Asbestos Regulations (CAR) 2012 compliant management strategy.

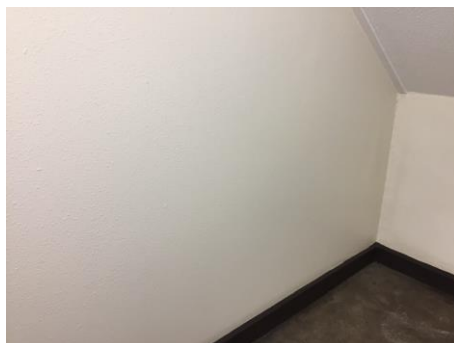
Condition **Low Damage**

The material was seen to be in fair condition at the time of the initial inspection.

The condition of the material should be managed by a competent person/company and its presence made aware to those at risk, as part of a Control of Asbestos Regulations (CAR) 2012 compliant management strategy.

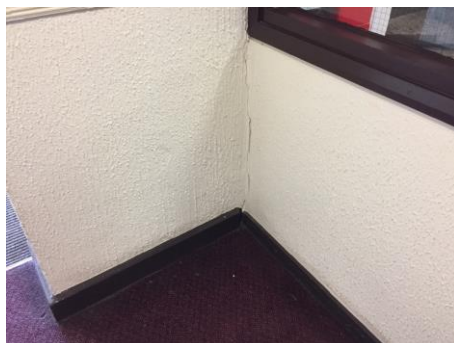
Condition..... **Low Damage**

The material was seen to be in fair condition at the time of the initial inspection.

The condition of the material should be managed by a competent person/company and its presence made aware to those at risk, as part of a Control of Asbestos Regulations (CAR) 2012 compliant management strategy.

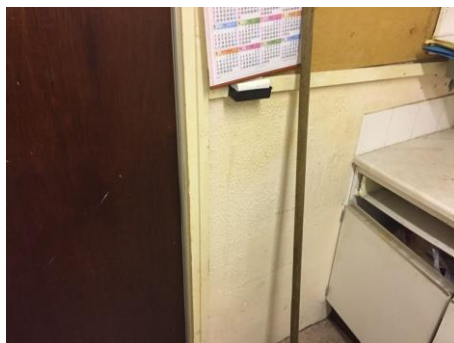
Condition..... **Low Damage**

The material was seen to be in fair condition at the time of the initial inspection.
