Fire Risk Assessment

Property assessed: 1-65 Avoncroft House Winchester Drive Birmingham B37 5QH
Client: Solihull Community Housing
UPRN: 139470000A
Property Classification: Level 1
Document Print Date: 16/12/2020

FRA Inspection Date: 03/11/2020
FRA Issued to Client: 16/12/2020
FRA valid to: 16/12/2021
FRA completed by: Savills (UK) Ltd,
33 Margaret Street, London W1G 0JD
T: 020 7409 8737
E: fireriskhousing@savills.com

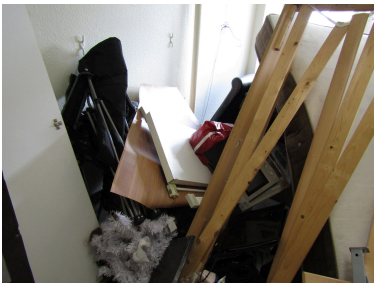
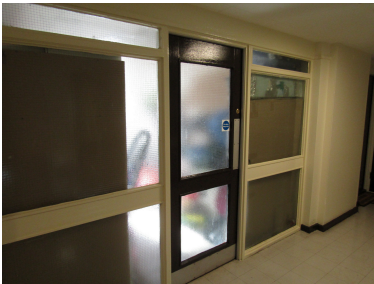
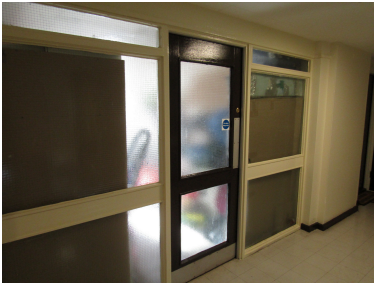
Question - G.6: Are all other house-keeping issues satisfactory?				No
<p>Comment: Other house-keeping issues notes at the time of inspection include - The drying rooms have been provided on each upper floor. Unable to access all drying rooms, but those accessed on the second, sixth & eight floors, have storage and waste within. The drying room on the second floor had a considerable amount of fire loading within. This was reported to Alex Robson at the time of the inspection.</p>				
<p>Recommendation: The combustible storage noted within the drying rooms on the second, sixth and eighth should be removed and the area kept clear.</p>				
Priority: Man1	Known Quantity: 1	Potential Quantity: 1	Action ID: 573016	
<p>Recommendation: Management should confirm/ensure that a policy is in place and communicated to residents which covers the use of the drying rooms.</p>				
Priority: Man2	Known Quantity: 1	Potential Quantity: 1	Action ID: 573017

<p>Recommendation: Management should undertake a check of all other drying rooms for storage - and regularly inspect for issues relating to storage in the drying rooms.</p>				
Priority: Man2	Known Quantity: 1	Potential Quantity: 1	Action ID: 573018

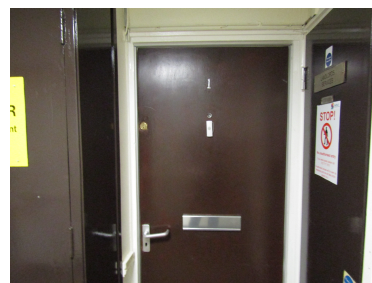
Comment: No access was possible to any of the flat entrance doors to confirm that they are fitted with adequate self-closing devices.

Recommendation: Management should establish an ongoing rolling programme of checks to all flat entrance doors to confirm that self-closers are fitted and remain effective.

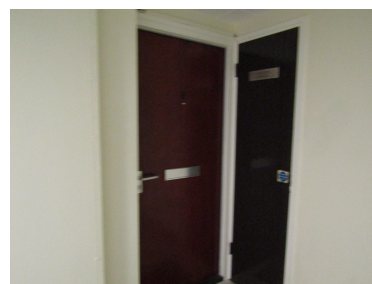
Comment: There was no access possible to any of the flat entrance doors to confirm that they are fitted with intumescent strips and cold smoke seals.

Recommendation: Management should establish an ongoing rolling programme of checks to all flat entrance doors to confirm that strips and seals are fitted and remain effective.

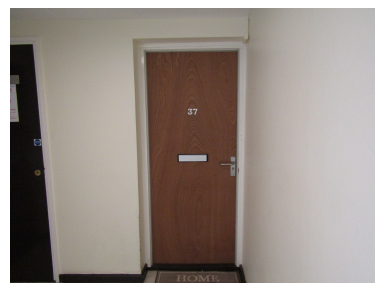
Comment: No access was possible to any of the flats to confirm that they are fitted with an adequate smoke alarm system.

Recommendation: All flats should be checked to confirm provision and working condition of at least Grade D LD3 smoke alarm systems to BS 5839-6:2019. An ongoing rolling programme of checks should be confirmed to be in place. If new systems are required to be installed these should be to Grade D1 LD2 standard.

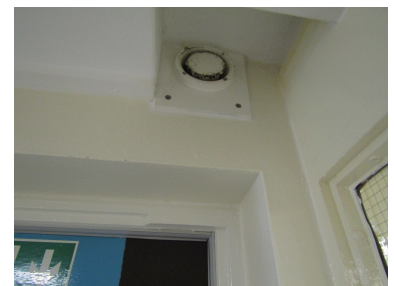
Comment: There are circular vents above the fire lobby doors to the stairs on all upper floors within the lift lobby.

Recommendation: The mechanical ventilation system should be confirmed as being designed and installed to prevent the transfer of fire and smoke through the building.

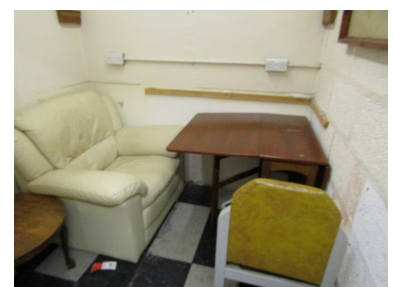
Comment: From sample inspection, soft furnishings noted in the common area are of domestic standard (labels cite the Furniture and Furnishings Fire Safety Regulations 1988) and are not suitable for these premises. Soft furnishing is the staff-only area.

Recommendation: The inappropriately located soft furnishings should be removed - staff-only area.

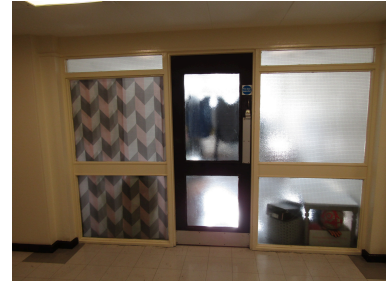
Comment: Compartmentation would not appear to be adequate. There are ventilation grills present from the flats into the waste hopper lobby and into the drying rooms sampled. Unable to access all drying rooms.

Recommendation: Check the locked drying rooms for ventilation grills.

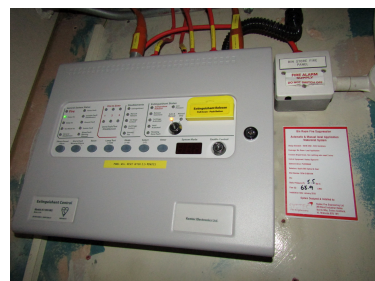
Comment: No evidence was available on-site to confirm regular inspection, testing and servicing of the system is being carried out.

Recommendation: Management should confirm/ensure that the L5 common area fire detection system (provided for control of the waste chute room sprinkler system) is tested and serviced as required in accordance with BS 5839-1 and records kept on-site or in a central database. This should be carried out in conjunction with routine testing of the smoke ventilation system - see V.7. (See photo of fire detection panel)

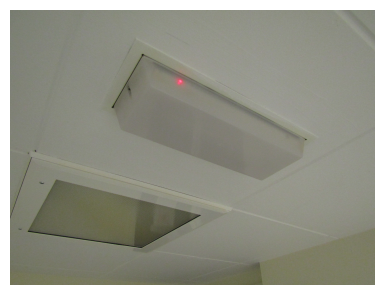
Comment: No evidence was available on-site to confirm regular inspection, testing and servicing of the system is being carried out.

Recommendation: Management should confirm/ensure that the common area emergency lighting system is tested monthly and serviced annually in accordance with BS 5266-8:2004 and records kept on-site or in a central database.

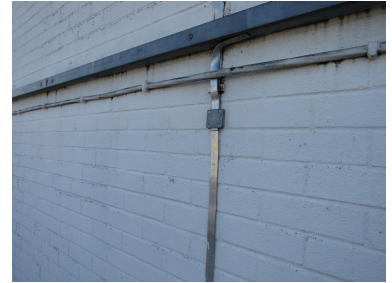
Comment: No evidence was available on-site to confirm regular inspection, testing and servicing of the system is being carried out.

Recommendation: Management should confirm/ensure that the lightning protection system is tested and serviced annually in accordance with BS EN 62305 and records kept on-site or in a central database.

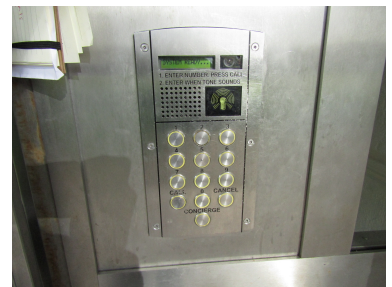
Comment: No evidence was available on-site to confirm regular inspection, testing and servicing of the system is being carried out.

Recommendation: Management should confirm/ensure that the access control system is inspected, tested and serviced in accordance with relevant guidance and records kept on-site or in a central database.

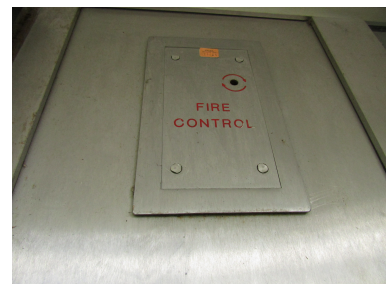
Comment: No evidence was available on-site to confirm regular inspection, testing and servicing of the system is being carried out.

Recommendation: Management should confirm/ensure that the drop key override switch facilities for Fire and Rescue Service access are inspected, tested and serviced in accordance with relevant guidance and records kept on-site or in a central database.

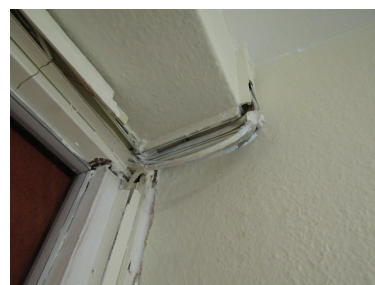
Comment: Surface mounted wiring systems contained within plastic trunking were present within the common escape routes but it was not possible to determine if the cables within were adequately supported with fire resisting fixings to prevent premature collapse. Trunking over flat doors - the plastic covers are missing in some sections.

Recommendation: The cable fixings, conduit or trunking as noted within the common escape route should be replaced with a cable support system which ensures that wiring is not liable to premature collapse in event of a fire (unless the existing clipping system can be confirmed as adequate).
