Fire Risk Assessment

Property assessed: 1-59 (no 13) Cheshunt House
Moorend Avenue Birmingham B37
5TB

Client: Solihull Community Housing

FRA Inspection Date: 04/11/2020
FRA Issued to Client: 16/12/2020
FRA valid to: 16/12/2021
FRA completed by: Savills (UK) Ltd,
33 Margaret Street, London W1G 0JD
T: 020 7409 8737
E: fireriskhousing@savills.com

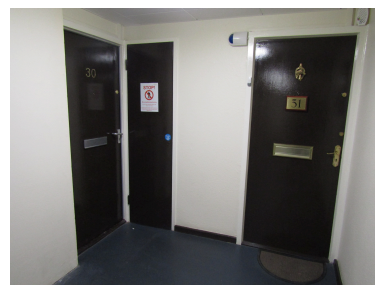
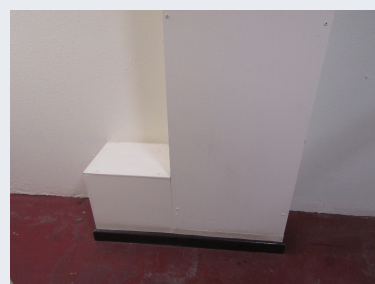
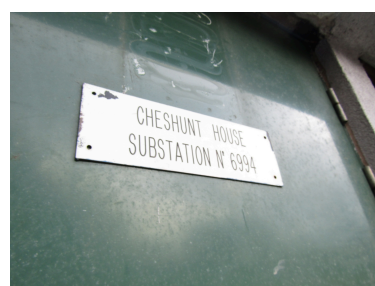
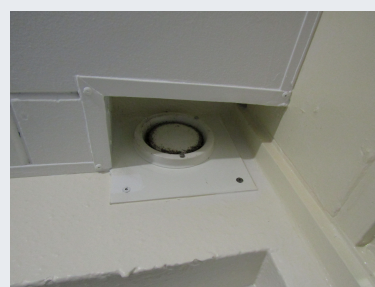
| Question | Q.2 | Comment: It was not possible to sample inspect the hidden voids identified without causing damage or requiring opening up. (a) Boxed-in areas on the stairs (b) Flush service risers in both flat lobbies on all upper floors (c) Metal trunking throughout the building within the risers (d) Over the false ceiling tiles (e) Boxed-in areas in the waste/ dry riser lobbies. | |

| Quantity | | Recommendation: Management should undertake an intrusive inspection of the hidden voids noted to confirm/ ensure that compartmentation within is adequate. | |

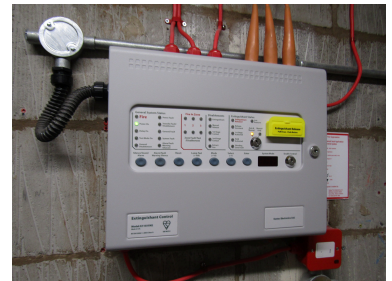
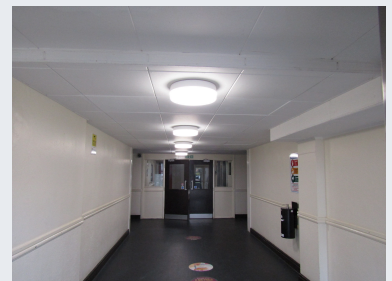
| Question | V.5 | Comment: No evidence was available on-site to confirm regular inspection, testing and servicing of the system is being carried out. | | |

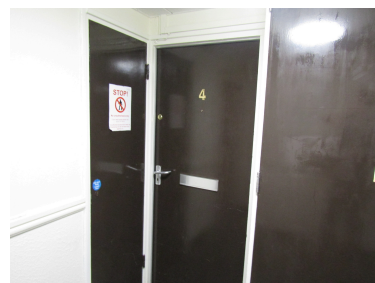
Comment: No access was possible to any of the flat entrance doors to confirm that they are fitted with adequate self-closing devices.

Recommendation: Management should establish an ongoing rolling programme of checks to all flat entrance doors to confirm that self-closers are fitted and remain effective.

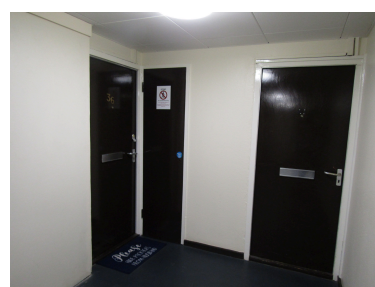
Comment: There was no access possible to any of the flat entrance doors to confirm that they are fitted with intumescent strips and cold smoke seals.

Recommendation: Management should establish an ongoing rolling programme of checks to all flat entrance doors to confirm that strips and seals are fitted and remain effective.

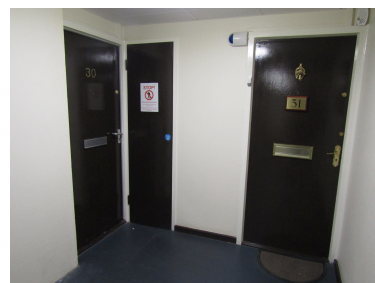
Comment: No access was possible to any of the flats to confirm that they are fitted with an adequate smoke alarm system.

Recommendation: All flats should be checked to confirm provision and working condition of at least Grade D LD3 smoke alarm systems to BS 5839-6:2019. An ongoing rolling programme of checks should be confirmed to be in place. If new systems are required to be installed these should be to Grade D1 LD2 standard.

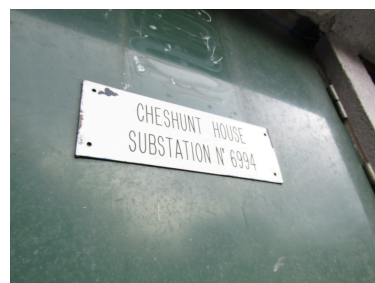
Comment: No access was possible to check fire resistance and firestopping within the electrical sub-station due to a non-standard lock being fitted. From sample inspection, other services risers/cupboards appear to be adequately fire-resisting and firestopped. For information, the fire paste installed in some areas is not applied evenly.

Recommendation: Management should check within the electrical sub-station as noted to confirm that they are appropriately enclosed with fire resisting construction and adequately fire-stopped.

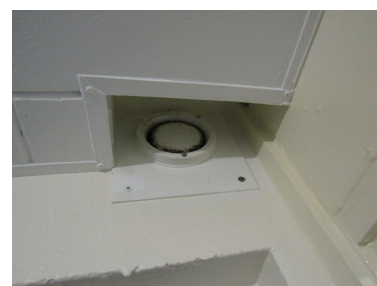
Comment: There are circular vents above the fire lobby doors to the stairs on all upper floors within the lift lobby.

Recommendation: The mechanical ventilation system should be confirmed as being designed and installed to prevent the transfer of fire and smoke through the building.

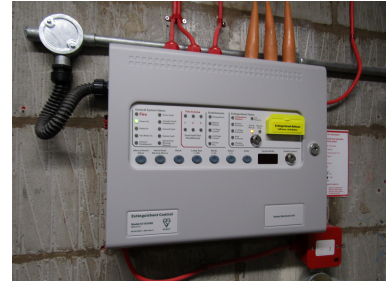
Comment: No evidence was available on-site to confirm regular inspection, testing and servicing of the system is being carried out.

Recommendation: Management should confirm/ensure that the L5 common area fire detection system (provided for control of the waste chute room sprinkler system) is tested and serviced as required in accordance with BS 5839-1 and records kept on-site or in a central database.

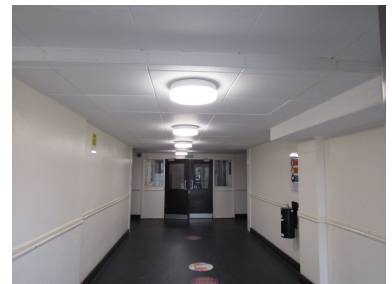
Comment: No evidence was available on-site to confirm regular inspection, testing and servicing of the system is being carried out.

Recommendation: Management should confirm/ensure that the common area emergency lighting system is tested monthly and serviced annually in accordance with BS 5266-8:2004 and records kept on-site or in a central database.

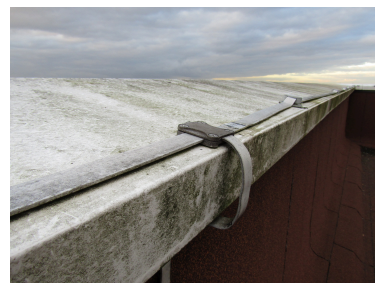
Comment: No evidence was available on-site to confirm regular inspection, testing and servicing of the system is being carried out.

Recommendation: Management should confirm/ensure that the lightning protection system is tested and serviced annually in accordance with BS EN 62305 and records kept on-site or in a central database.

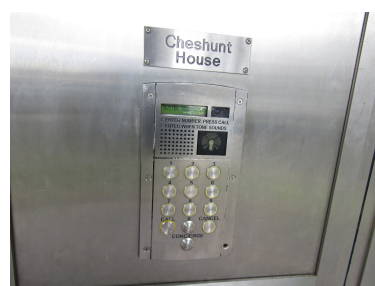
Comment: No evidence was available on-site to confirm regular inspection, testing and servicing of the system is being carried out.

Recommendation: Management should confirm/ensure that the access control system is inspected, tested and serviced in accordance with relevant guidance and records kept on-site or in a central database.

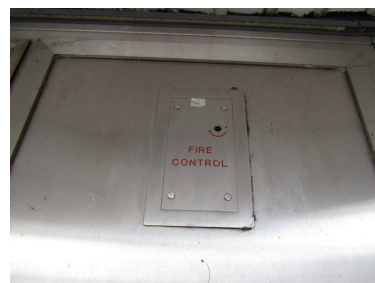
Comment: No information was available to confirm that the drop key switch is inspected tested and maintained in accordance with relevant guidance. The switch did not work satisfactorily when tested.

Recommendation: Management should confirm/ensure that the drop key override switch facilities for Fire and Rescue Service access are inspected, tested and serviced in accordance with relevant guidance and records kept on-site or in a central database.
