Fire Risk Assessment

Property assessed: 1-36 Wingfield House Kingshurst Way Birmingham B37 6DZ
Client: Solihull Community Housing
UPRN: 257910000A
Property Classification: Level 1
Document Print Date: 16/12/2020

FRA Inspection Date: 06/11/2020
FRA Issued to Client: 16/12/2020
FRA valid to: 16/12/2021
FRA completed by: Savills (UK) Ltd,
33 Margaret Street, London W1G 0JD
T: 020 7409 8737
E: fireriskhousing@savills.com

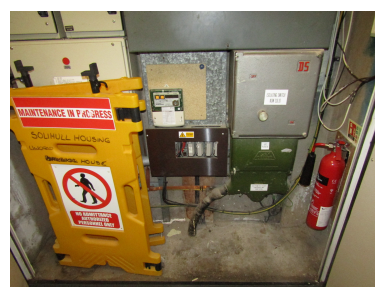
Comment: There was no evidence on site to confirm the last inspection and testing date of the common area fixed electrical installation.

Recommendation: Management should confirm/ensure that the common area fixed electrical installation has been inspected and tested within the last five years in accordance with BS 7671:2018 (as amended).

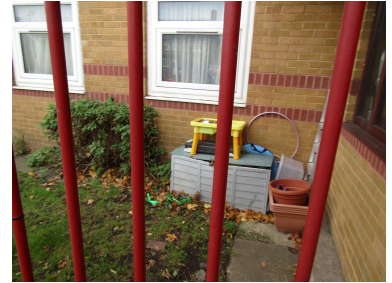
Comment: There was unnecessary fire load noted close to the building at the time of inspection. Some storage against the front of the building.

Recommendation: The combustible items noted should be disposed of or removed a safe distance away from the exterior walls of the building.

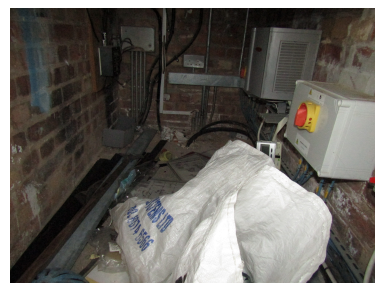
Comment: Combustible items were noted close to an ignition source. Minor combustibles in the services cupboard on the flat roof. This issue should be dealt with as soon as possible.

Recommendation: All combustible items should be removed from the services cupboard on the flat roof as soon as possible and the door kept locked.

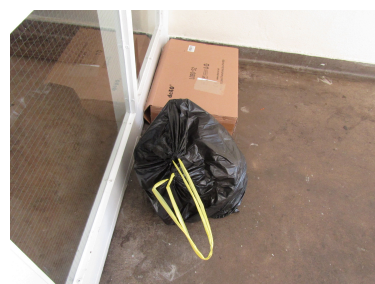
Comment: There were combustible items or waste materials in the escape routes. Bin bags on the fourth and fifth floors. Also a bike on the fourth floor. As the quantity involved is relatively minor this can be dealt with via written contact with the residents.

Recommendation: Management should contact residents to advise that the common area/escape routes should be kept free from all combustibles and trip hazards. A programme of regular checks should be put in place to ensure that the common area is kept clear.

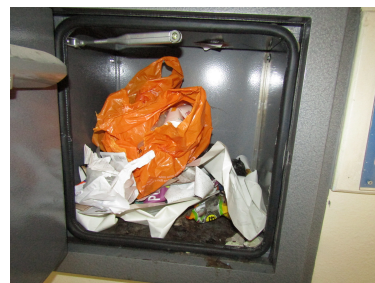
Comment: Other house-keeping issues noted at the time of inspection include - the ground and first-floor waste hoppers were blocked with rubbish.

Recommendation: Clear the waste within the ground floor waste hopper. Regular checks should be undertaken to ensure waste hoppers are kept clear.

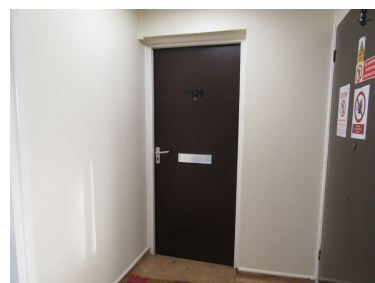
Comment: No access was possible to any of the flat entrance doors to confirm that they are fitted with adequate self-closing devices.

Recommendation: Management should establish an ongoing rolling programme of checks to all flat entrance doors to confirm that self-closers are fitted and remain effective.

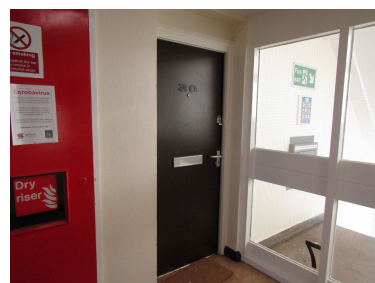
Comment: There was no access possible to any of the flat entrance doors to confirm that they are fitted with intumescent strips and cold smoke seals.

Recommendation: Management should establish an ongoing rolling programme of checks to all flat entrance doors to confirm that strips and seals are fitted and remain effective.

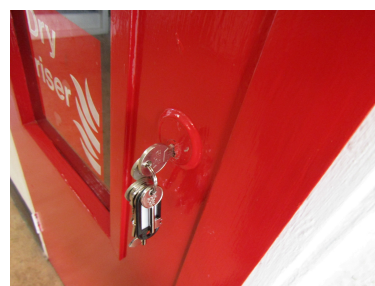
| Question | M.2 | Comment: (a) Door to the AFA cupboard is split at the top (b) Firestopping was missing or inadequate to the back of the frame of common area fire doors as noted:- Service riser doors on the ground, second, third, fifth, sixth and eighth floors. (b) No access to the services riser on the fourth floor. | |

Recommendation: A check should be made of the fourth fire door service risers not sampled to confirm that firestopping behind the frames is present and adequate.

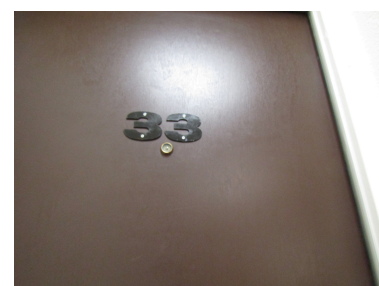
Comment: The resident of Flat 33 stated that her smoke alarm was dated to replace on July 2019. This was not seen by the inspector. The resident was concerned. No access to flats.

Recommendation: A Grade D1 LD2 smoke alarm system to BS 5839-6:2019 should be installed in the flat noted - Flat 33.

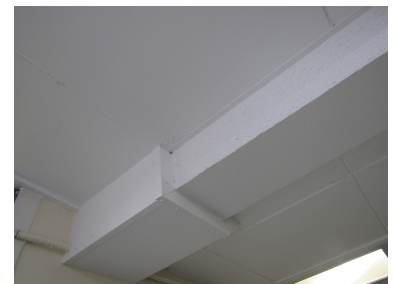
Comment: It was not possible to sample inspect the hidden voids identified without causing damage or requiring opening up. (a) Boxed-in areas on the stair (b) Metal trunking throughout the building within the risers (c) Over the false ceiling tiles

Recommendation: Management should undertake an intrusive inspection of the hidden voids noted to confirm/ensure that compartmentation within is adequate - (a) Boxed-in areas on the stair (b) Metal trunking throughout the building within the risers (c) Over the false ceiling tiles

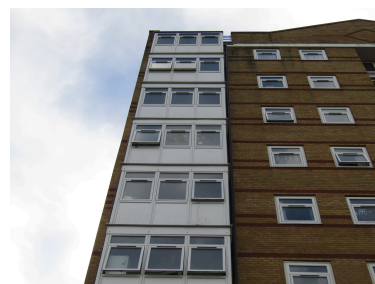
Comment: The exterior envelope of the premises is predominately masonry but there are vertical glazed/curtain wall sections rising full height which contain window spandrel panels of unknown combustibility. Current regulations require such spandrel panels to achieve a reaction to fire class of A2-s1, d0 or class A1. No information was available on site to confirm if the spandrel panels met this requirement of the Building Regulations with regards to limited combustibility and surface fire spread requirements - There appear to be former open flat balconies on all corners of the building and stair window spandrels on both sides of the building.

Recommendation: Management should confirm that the window spandrel panels incorporated in the exterior envelope of the block meet current Building Regulations requirements with regards to limited combustibility and surface fire spread properties - former open flat balconies on all corners of the building and stair window spandrels on both sides of the building.

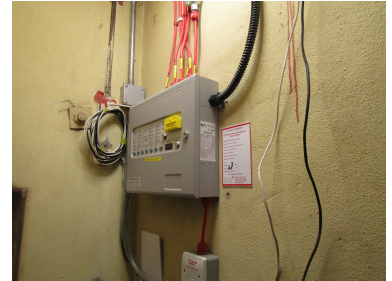
Comment: No evidence was available on-site to confirm regular inspection, testing and servicing of the system is being carried out.

Recommendation: Management should confirm/ensure that the L5 common area fire detection system (provided for control of the waste chute room sprinkler system) is tested and serviced as required in accordance with BS 5839-1 and records kept on-site or in a central database. This should be carried out in conjunction with routine testing of the smoke ventilation system - see V.7.

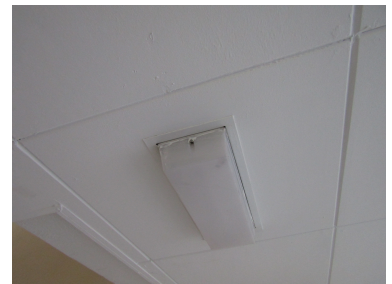
Comment: No evidence was available on-site to confirm regular inspection, testing and servicing of the system is being carried out.

Recommendation: Management should confirm/ensure that the common area emergency lighting system is tested monthly and serviced annually in accordance with BS 5266-8:2004 and records kept on-site or in a central database.

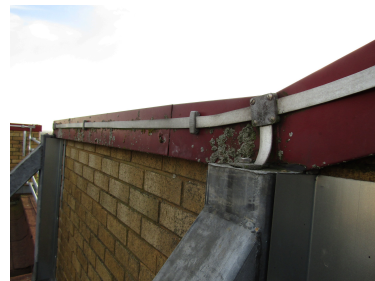
Comment: No evidence was available on-site to confirm regular inspection, testing and servicing of the system is being carried out.

Recommendation: Management should confirm/ensure that the lightning protection system is tested and serviced annually in accordance with BS EN 62305 and records kept on-site or in a central database.

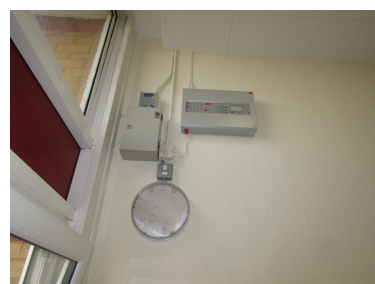
Comment: No evidence was available on-site to confirm regular inspection, testing and servicing of the system is being carried out.

Recommendation: Management should confirm/ensure that the smoke control system is actuated and inspected weekly, receives a full operational test quarterly, and is serviced and certified annually in accordance BS 9999 and records kept on-site or in a central database.

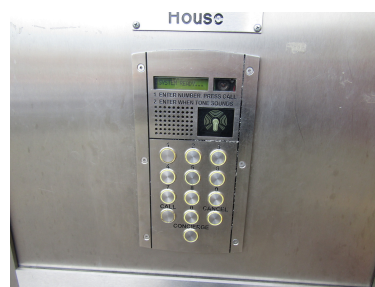
Comment: No evidence was available on-site to confirm regular inspection, testing and servicing of the system is being carried out.

Recommendation: Management should confirm/ensure that the access control system is inspected, tested and serviced in accordance with relevant guidance and records kept on-site or in a central database.

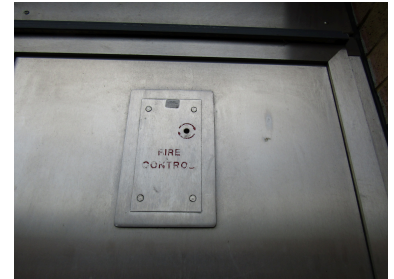
Comment: No information was available to confirm that the drop key switch is inspected tested and maintained in accordance with relevant guidance. The switch did not work satisfactorily when tested.

Recommendation: Management should confirm/ensure that the drop key override switch facilities for Fire and Rescue Service access are inspected, tested and serviced in accordance with relevant guidance and records kept on-site or in a central database.
