# Risk Assessment and Management Plan

**Prepared For:** Kingsgate House  
Winchester Drive, Chelmsley Wood,  
Birmingham, West Mids,  
B37 5PX, GB

**RA Report:** Assessed by: Craig Westley (CWESTLEY)  
Assessed Date(s): 07/03/2020  
Suggested Review Date: 07/03/2022  
UPRN# : 139490000A

# Water Treatment Services

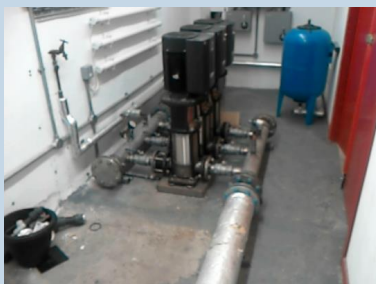
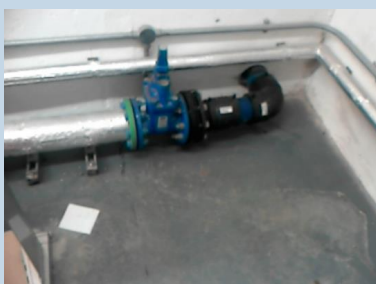
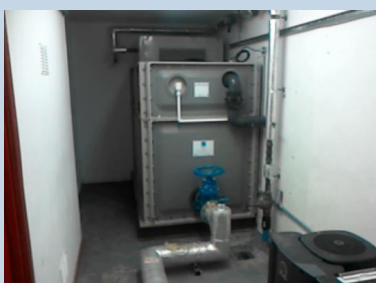
#### Process Water 1

**PCW 1**

**Landlord Boosted - Avoncroft House**

| Condition | <b>Good</b> | Labelled | <b>No</b> |

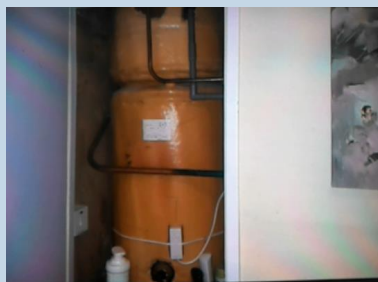
#### LPHWSC 12 (Low Pressure hot water storage cylinder)

| Asset | <b>LPHWSC 12</b> |
| Location | <b>Bathroom Cupboard</b> |

| Insulation Condition | <b>Good</b> | Inspection Hatch | <b>No</b> |

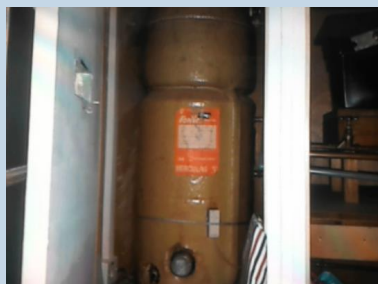
#### LPHWSC 14 (Low Pressure hot water storage cylinder)

**LPHWSC 14**

| Insulation Condition | <b>Good</b> | Inspection Hatch | <b>No</b> |

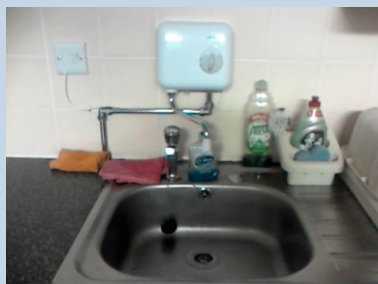
#### IHWH 1 (Instantaneous Water Heater)

| Asset | <b>IHWH 1</b> |
| Location | <b>Above Sink Unit</b> |

| Insulation Condition | <b>Good</b> | Pipework Insulated | <b>No</b> |

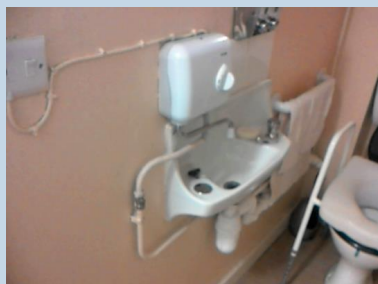
#### IHWH 2 (Instantaneous Water Heater)

| Asset | <b>IHWH 2</b> |
| Location | <b>Above WHB Unit</b> |

| Insulation Condition | <b>Good</b> | Pipework Insulated | <b>No</b> |

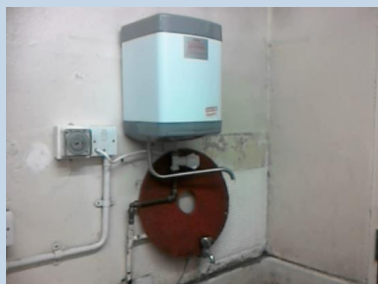
#### REWH 4 (Remote Electric Water Heater)

| Asset | <b>REWH 4</b> |
| Location | <b>Above Sink Unit</b> |

| Insulation Condition | <b>Good</b> | Pipework Insulated | <b>No</b> |
| CFP Material | <b>Copper</b> | HFP Material | <b>Stainless Steel</b> |

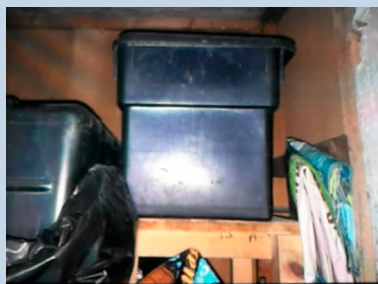
#### FETNK 12 (F & E Tank)

| Asset | <b>FETNK 12</b> |
| Location | <b>Kitchen Cupboard</b> |

| Condition | <b>Good</b> | | |

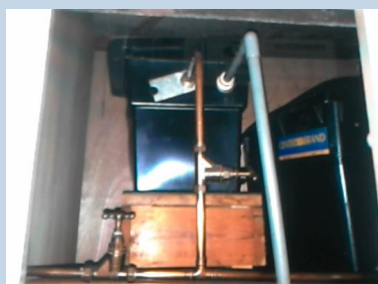
#### FETNK 14 (F & E Tank)

| Asset | <b>FETNK 14</b> |
| Location | <b>Kitchen Cupboard</b> |

| Condition | <b>Good</b> | | |

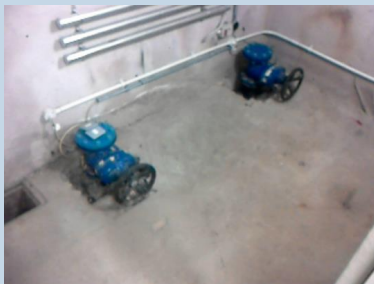
| OTH 4 (Other) | | | |

| OTH 4 (Other) | | | |
|---|---|---|---|
| | Asset | | OTH 4 |
| | Location | | Old Incoming Mains Supply |
| Condition | N/A | | |

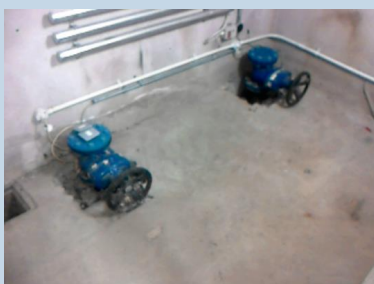
| OTH 5 (Other) | | | |

| OTH 5 (Other) | | | |
|---|---|---|---|
| | Asset | OTH 5 | |
| | Location | Old Incoming Mains Supply | |
| Condition | N/A | | |

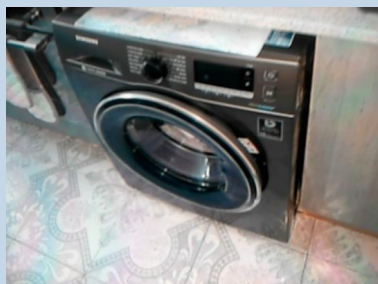
#### WMC 12 (Washing Machine)

| Asset | <b>WMC 12</b> |
| Location | <b>Kitchen</b> |

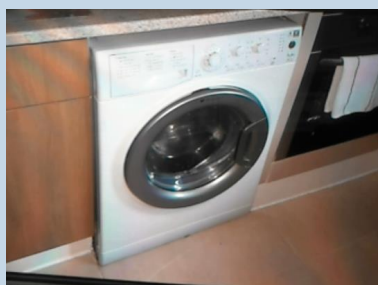
#### WMC 13 (Washing Machine)

| Asset | <b>WMC 13</b> |
| Location | <b>Kitchen</b> |

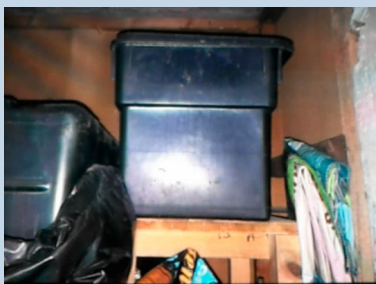
#### Infrequent Outlet 1

| Asset | <b>FETNK 12</b> |
| Location | <b>Kitchen Cupboard</b> |

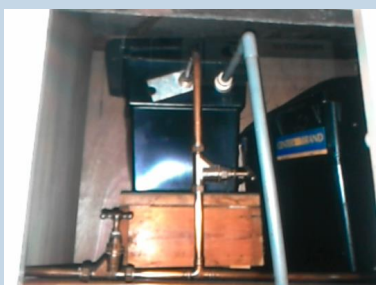
#### Infrequent Outlet 2

| Asset | <b>FETNK 14</b> |
| Location | <b>Kitchen Cupboard</b> |

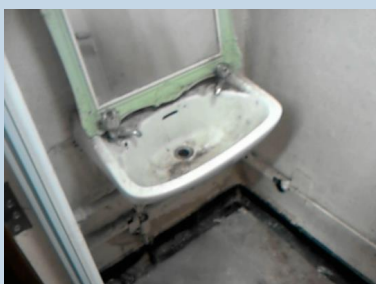
#### Infrequent Outlet 3

| Asset | <b>TCWO 5</b> |
| Location | <b>WHB</b> |
