# Site ID: **a-307635**

## Management with Targeted Refurbishment Survey – PART 1

1-83 Bangor House  
Forth Drive  
Chelmsley Wood  
Solihull  
B37 6PH  
United Kingdom

**27th May 2021**

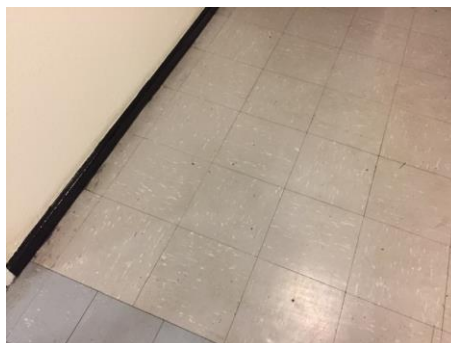
Grey floor tiles.

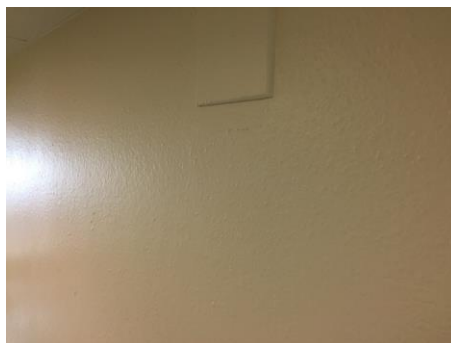
Spatter pattern textured coating.

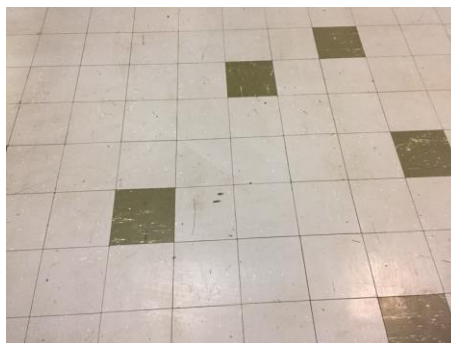
Blue and grey floor tiles.

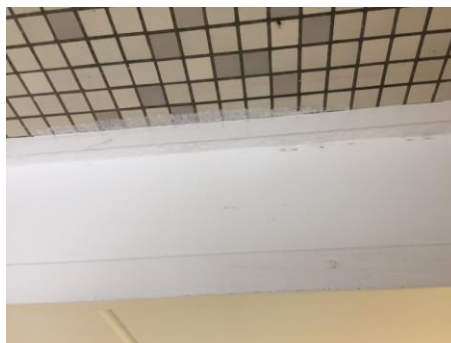
Spatter pattern textured coating above suspended ceiling.

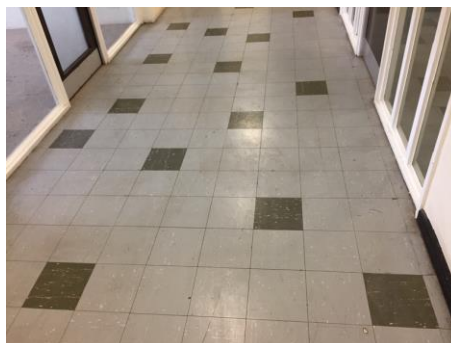
Green and grey floor tiles.

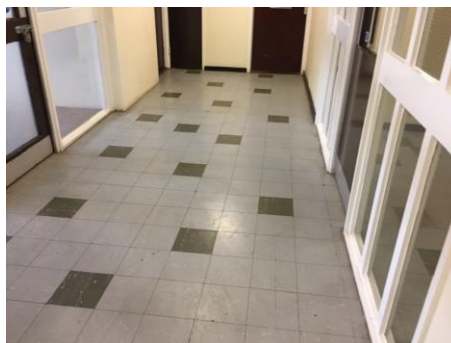
Bitumen adhesive beneath floor tiles.

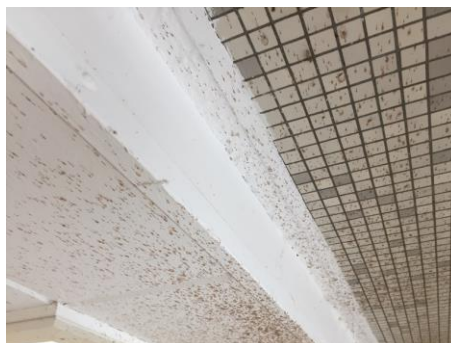
Spatter pattern textured coating above suspended ceiling.

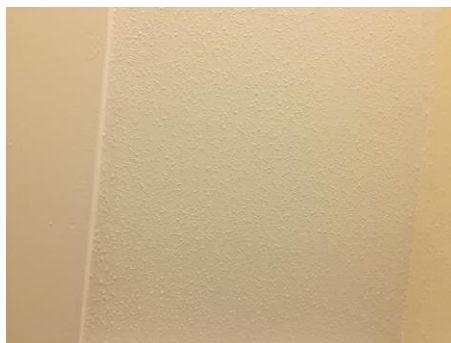
Spatter pattern textured coating.

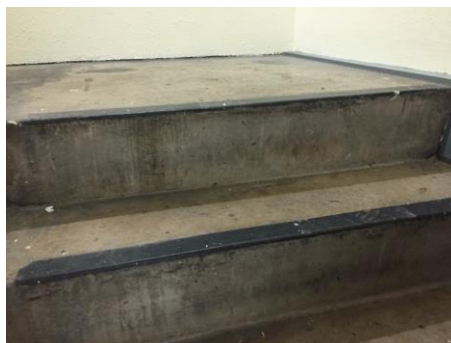
Resin nosing to edge of stairs.

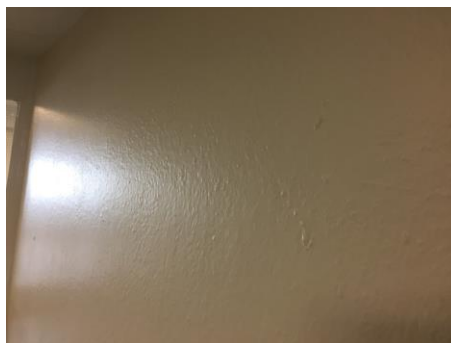
Spatter pattern textured coating.

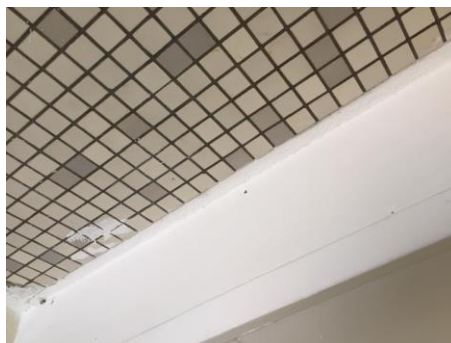
Spatter pattern textured coating above suspended ceiling.

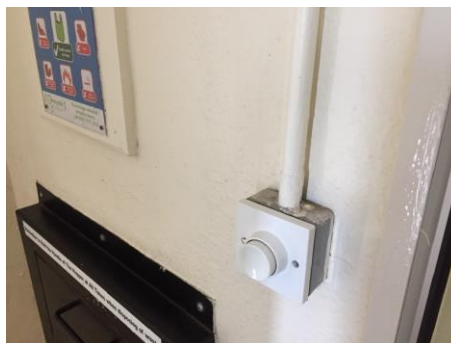
Spatter pattern textured coating.

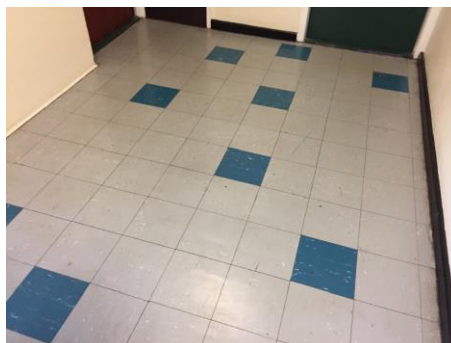
Blue and grey floor tiles.

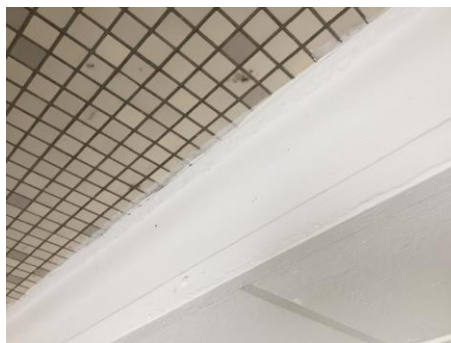
Spatter pattern textured coating above suspended ceiling.

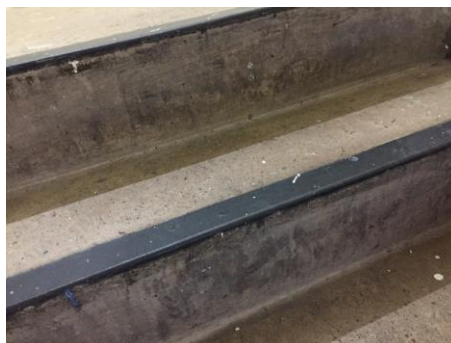
Resin nosing to edge of stairs.

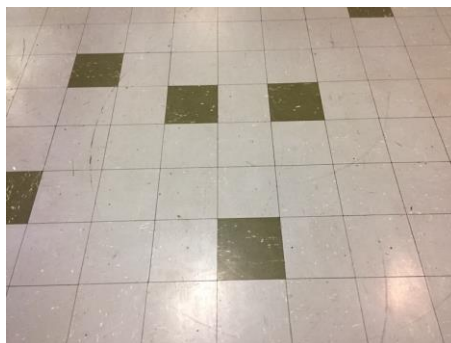
Bitumen adhesive beneath floor tiles.

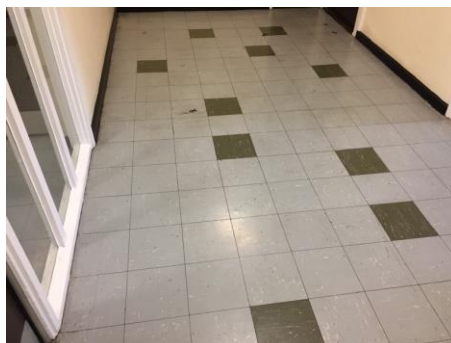
Green and grey floor tiles.

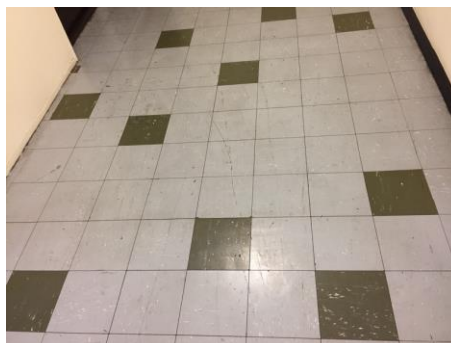
Bitumen adhesive beneath floor tiles.

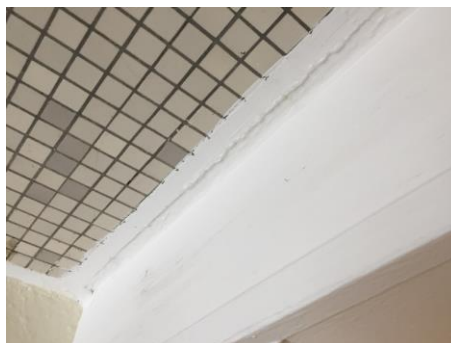
Spatter pattern textured coating above suspended ceiling.

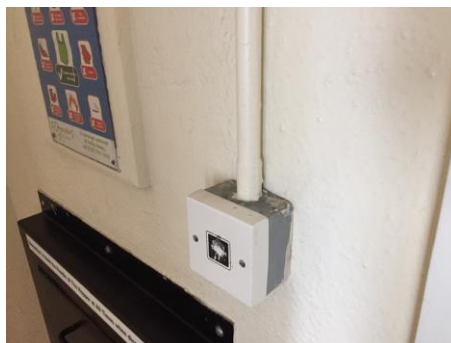
Spatter pattern textured coating.

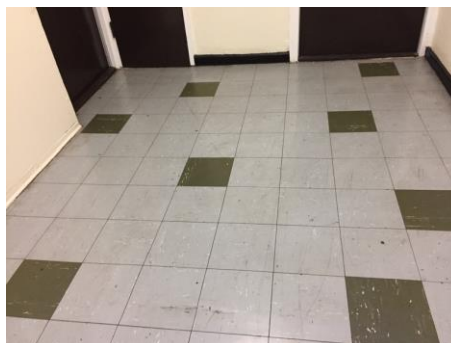
Green and grey floor tiles.

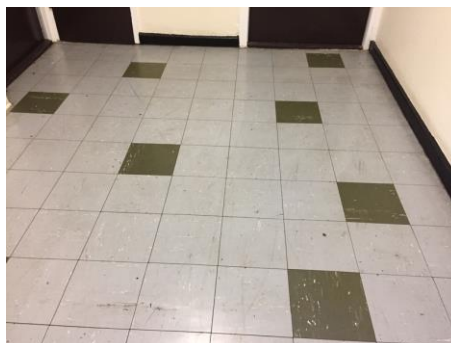
Bitumen adhesive beneath floor tiles.

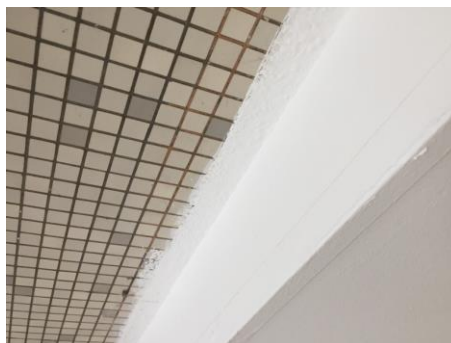
Spatter pattern textured coating above suspended ceiling.

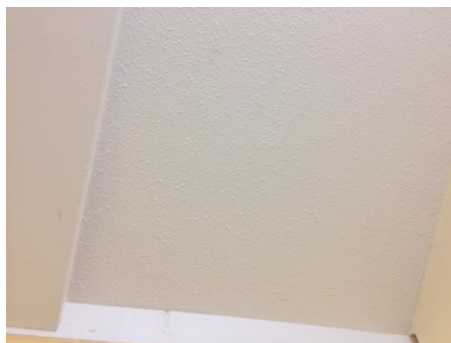
Spatter pattern textured coating.

The material was seen to be in fair condition at the time of the initial inspection.

The condition of the material should be managed by a competent person/company and its presence made aware to those at risk, as part of a Control of Asbestos Regulations (CAR) 2012 compliant management strategy.

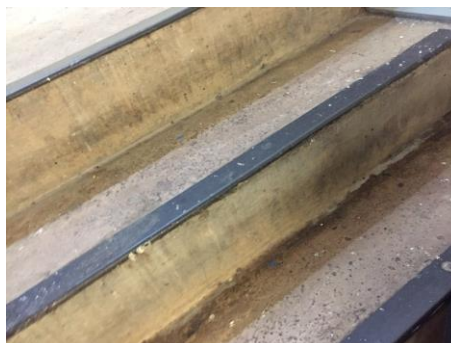
Resin nosing to edge of stairs.

The material was seen to be in fair condition at the time of the initial inspection.

The condition of the material should be managed by a competent person/company and its presence made aware to those at risk, as part of a Control of Asbestos Regulations (CAR) 2012 compliant management strategy.

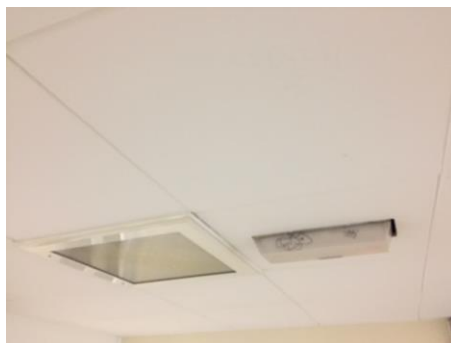
Spatter pattern textured coating above suspended ceiling.

The material was seen to be in fair condition at the time of the initial inspection.

The condition of the material should be managed by a competent person/company and its presence made aware to those at risk, as part of a Control of Asbestos Regulations (CAR) 2012 compliant management strategy.

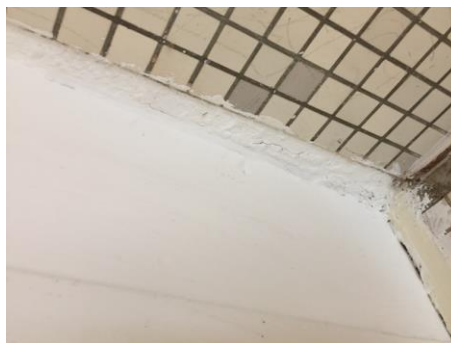
Spatter pattern textured coating above suspended ceiling.

The material was seen to be in fair condition at the time of the initial inspection.

The condition of the material should be managed by a competent person/company and its presence made aware to those at risk, as part of a Control of Asbestos Regulations (CAR) 2012 compliant management strategy.

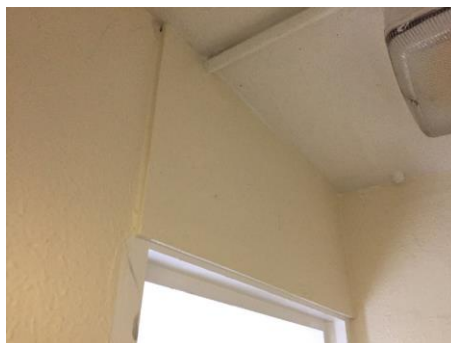
Insulating board transom panels both sides.

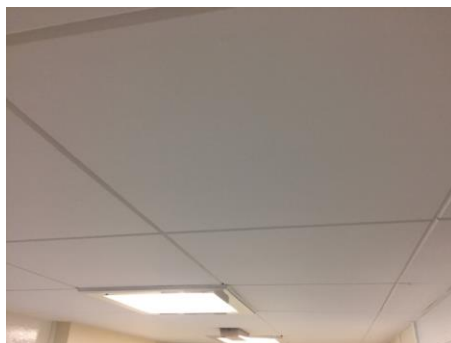
Spatter pattern textured coating above suspended ceiling.

The material was seen to be in fair condition at the time of the initial inspection.

The condition of the material should be managed by a competent person/company and its presence made aware to those at risk, as part of a Control of Asbestos Regulations (CAR) 2012 compliant management strategy.

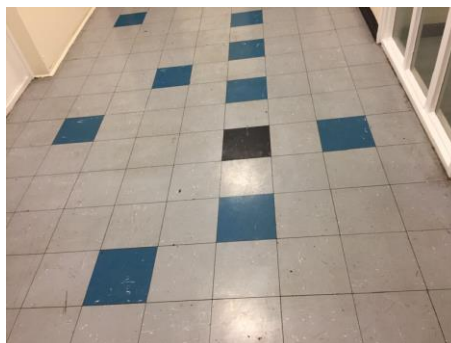
Blue and grey floor tiles.

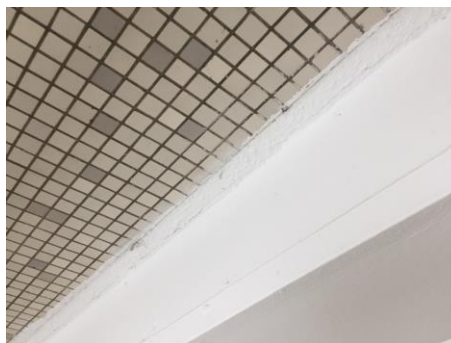
Spatter pattern textured coating above suspended ceiling.

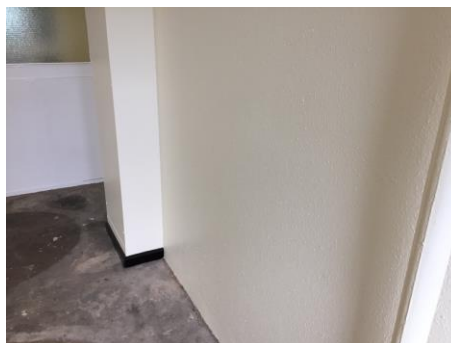
Spatter pattern textured coating.

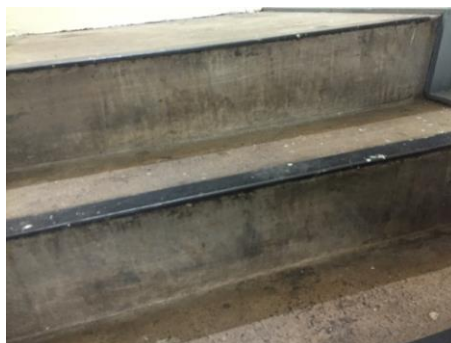
Resin nosing to edge of stairs.

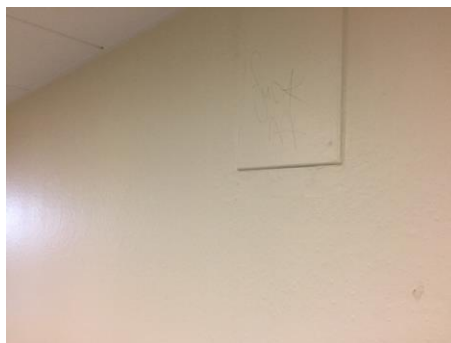
Spatter pattern textured coating.

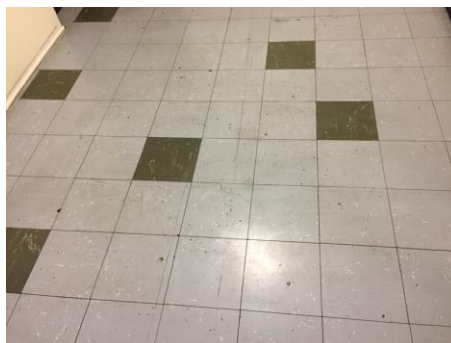
Bitumen adhesive beneath floor tiles.

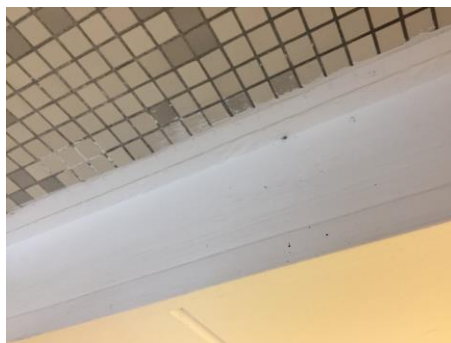
Spatter pattern textured coating above suspended ceiling.
