Site ID: **a-308038**

Management with Targeted Refurbishment Survey – PART 2

1-83 Bangor House
Forth Drive
Chelmsley Wood
Solihull
B37 6PH
United Kingdom

27th May 2021

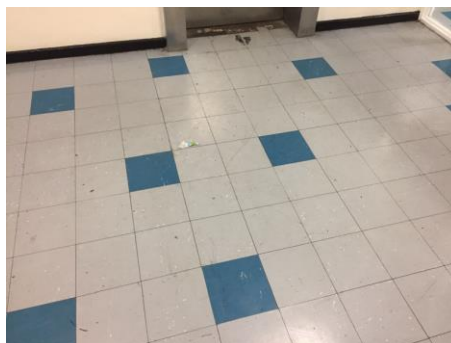
Blue and grey floor tiles.

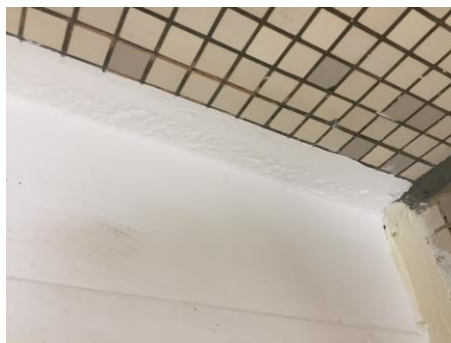
Spatter pattern textured coating above suspended ceiling.

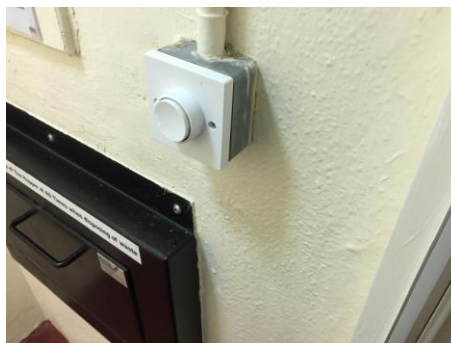
Spatter pattern textured coating.

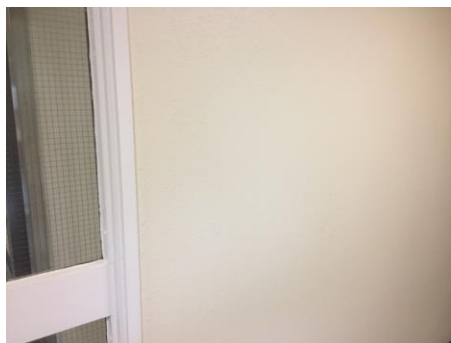
Spatter pattern textured coating.

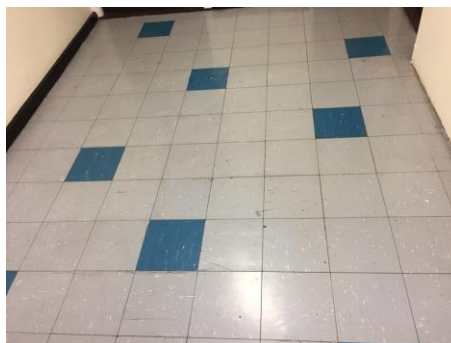
Blue and grey floor tiles.

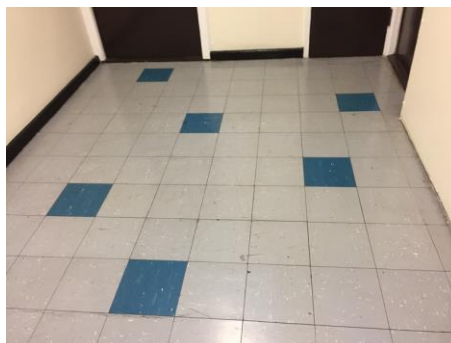
Bitumen adhesive beneath floor tiles.

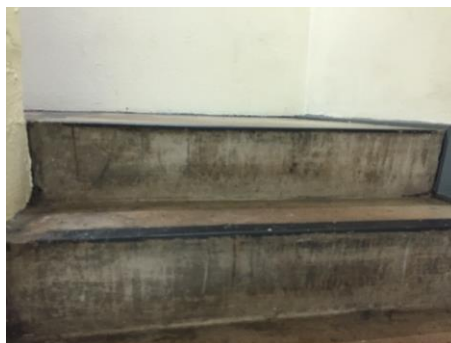
Resin nosing to edge of stairs.

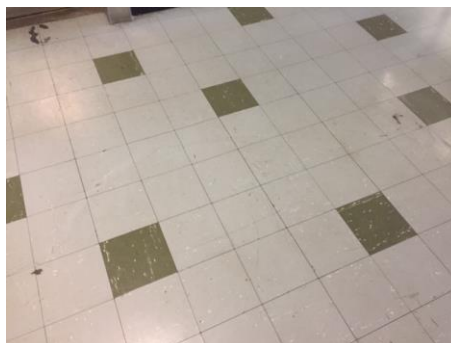
Green and grey floor tiles.

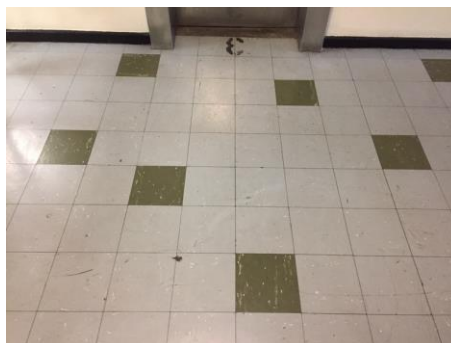
Bitumen adhesive beneath floor tiles.

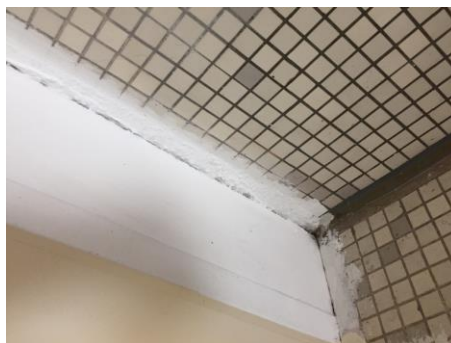
Spatter pattern textured coating above suspended ceiling.

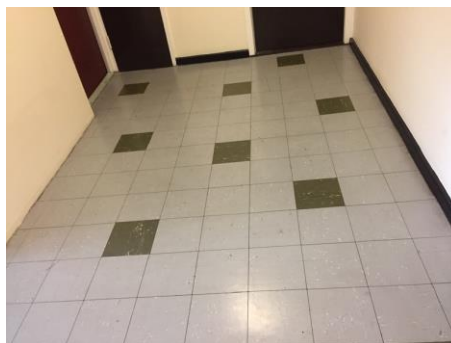
Bitumen adhesive beneath floor tiles.

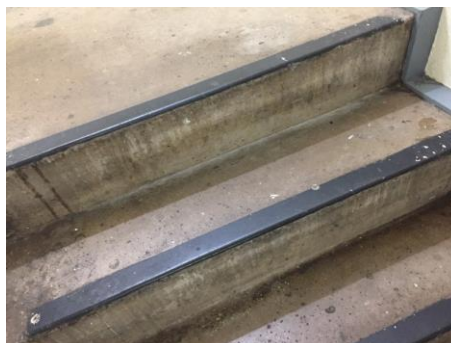
Resin nosing to edge of stairs.

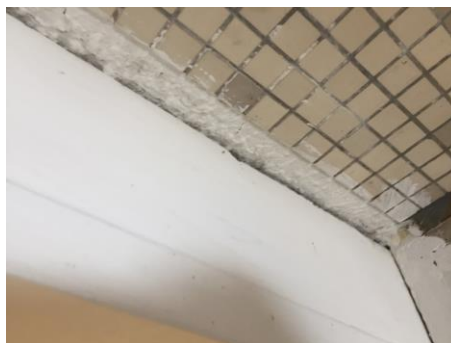
Spatter pattern textured coating above suspended ceiling.

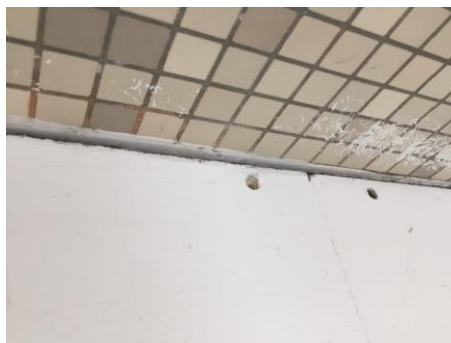
Spatter pattern textured coating above suspended ceiling.

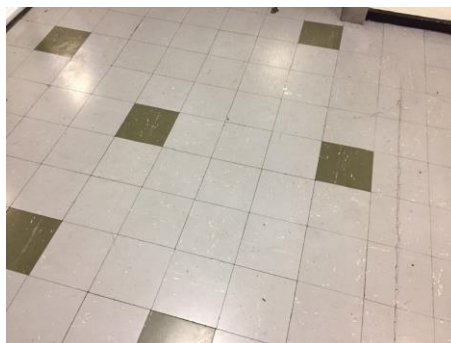
Green and grey floor tiles.

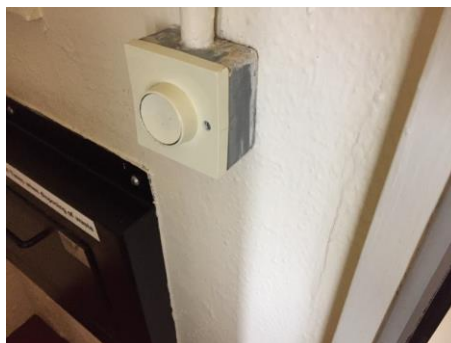
Spatter pattern textured coating.

The material was seen to be in fair condition at the time of the initial inspection.

The condition of the material should be managed by a competent person/company and its presence made aware to those at risk, as part of a Control of Asbestos Regulations (CAR) 2012 compliant management strategy.

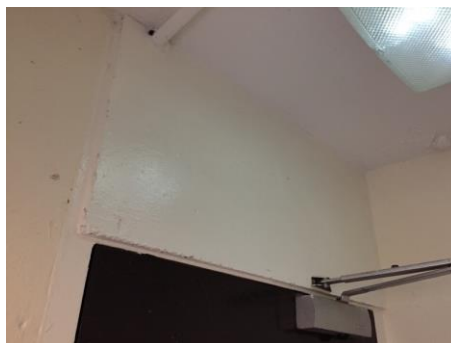
Insulating board transom panel.

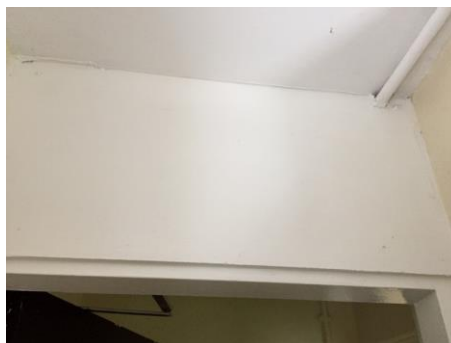
Insulating board transom panel.

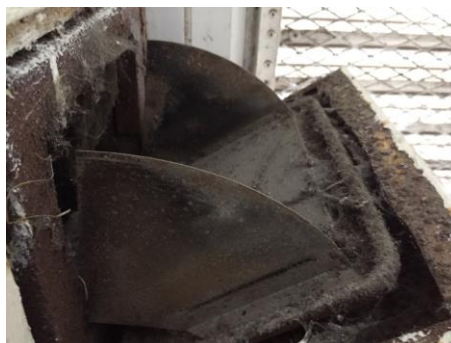
Cement panel within incinerator.

The material was seen to be in fair condition at the time of the initial inspection.

The condition of the material should be managed by a competent person/company and its presence made aware to those at risk, as part of a Control of Asbestos Regulations (CAR) 2012 compliant management strategy.

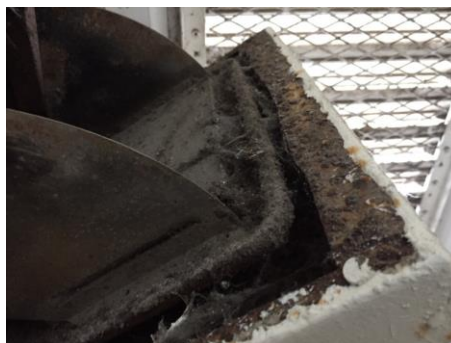
Rope seal within incinerator.

The material was seen to be in fair condition at the time of the initial inspection.

The condition of the material should be managed by a competent person/company and its presence made aware to those at risk, as part of a Control of Asbestos Regulations (CAR) 2012 compliant management strategy.

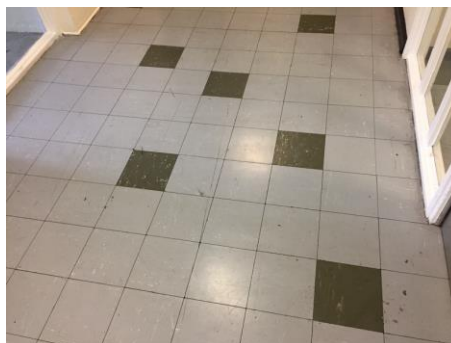
Green and grey floor tiles.

The material was seen to be in fair condition at the time of the initial inspection.

The condition of the material should be managed by a competent person/company and its presence made aware to those at risk, as part of a Control of Asbestos Regulations (CAR) 2012 compliant management strategy.

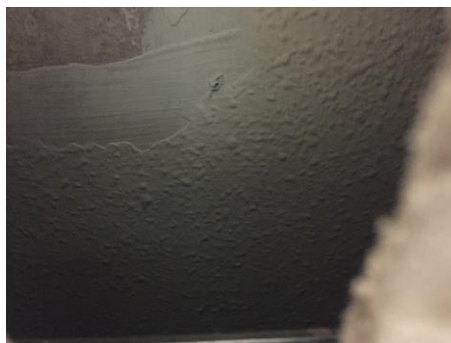
Spatter pattern textured coating above suspended ceiling.

The material was seen to be in fair condition at the time of the initial inspection.

The condition of the material should be managed by a competent person/company and its presence made aware to those at risk, as part of a Control of Asbestos Regulations (CAR) 2012 compliant management strategy.

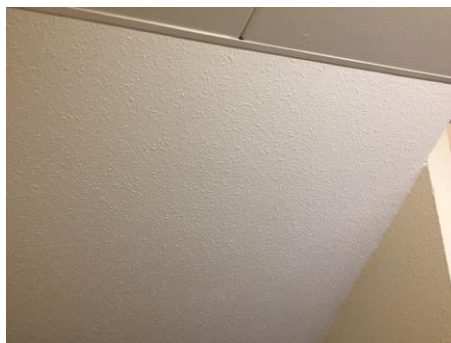
Spatter pattern textured coating.

The material was seen to be in fair condition at the time of the initial inspection.

The condition of the material should be managed by a competent person/company and its presence made aware to those at risk, as part of a Control of Asbestos Regulations (CAR) 2012 compliant management strategy.

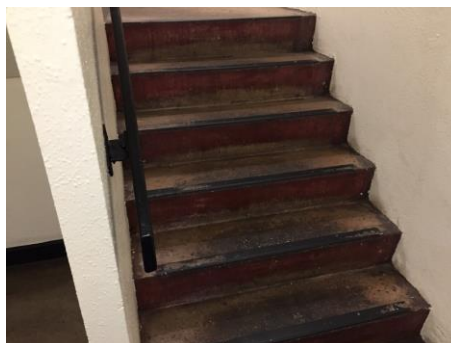
Resin nosing to edge of stairs.

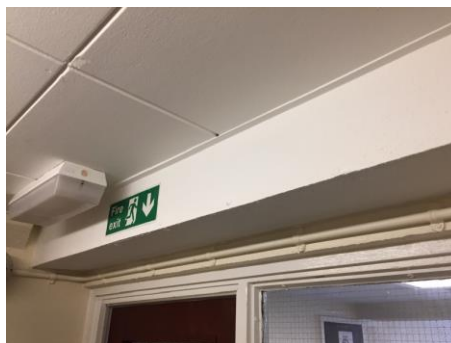
Cement boxing over door.

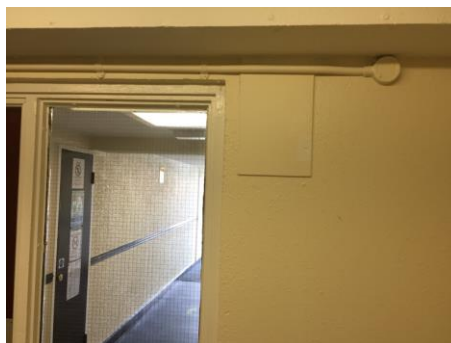
Insulating board infill to wall.

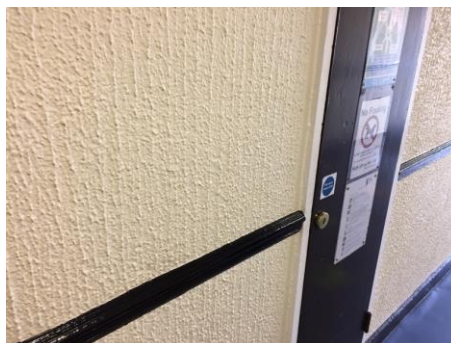
Lined stipple pattern textured coating.

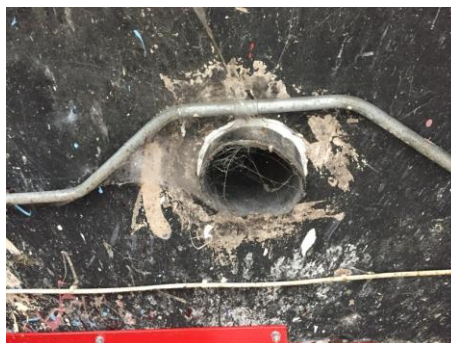
Bottom of cement incinerator flue.

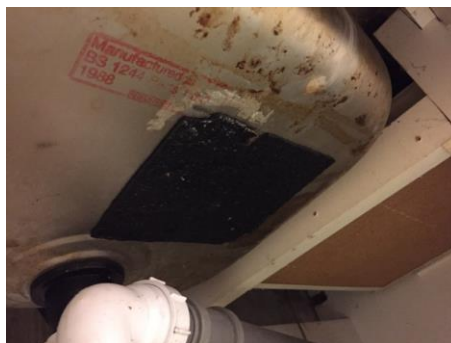
Pad to underside of sink unit.

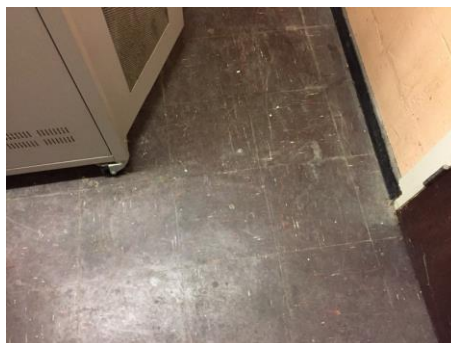
Bitumen adhesive beneath floor tiles.

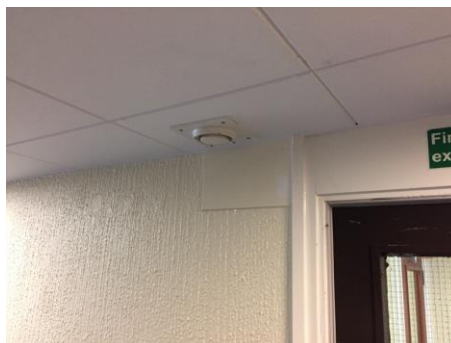
Insulating board infill to wall.
