Solihull Community Housing

Asbestos Management Survey Report

**I-43 (Communal) Keble House
Moat Croft
Solihull
B37 5HD**

Date of Report: 14 Jan 2013

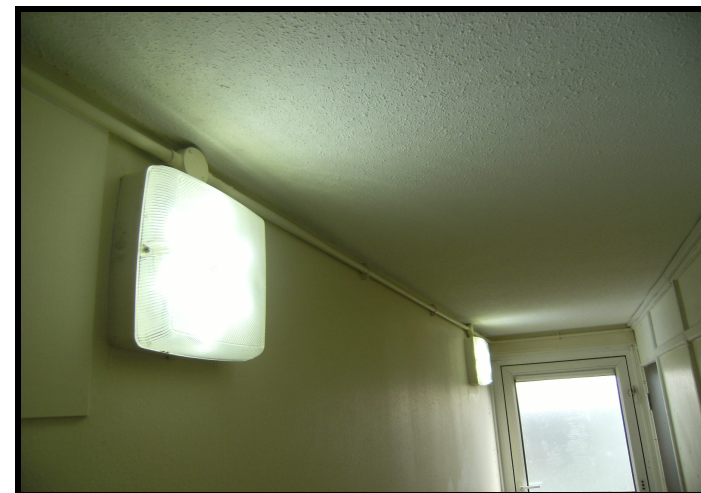
SAMPLE REFERENCE 014

Asbestos detected in Sample

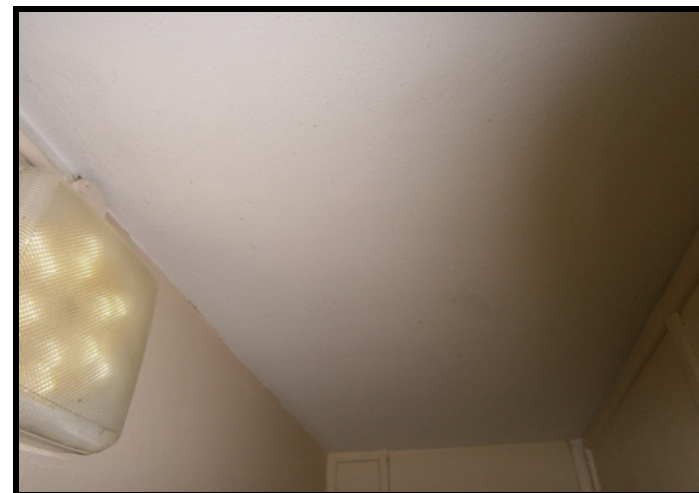
SAMPLE REFERENCE 019

Asbestos Presumed in Sample

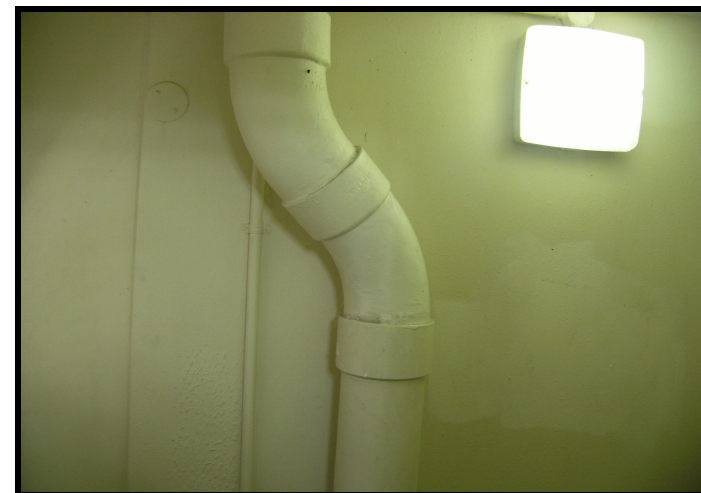
SAMPLE REFERENCE 020

Asbestos detected in Sample

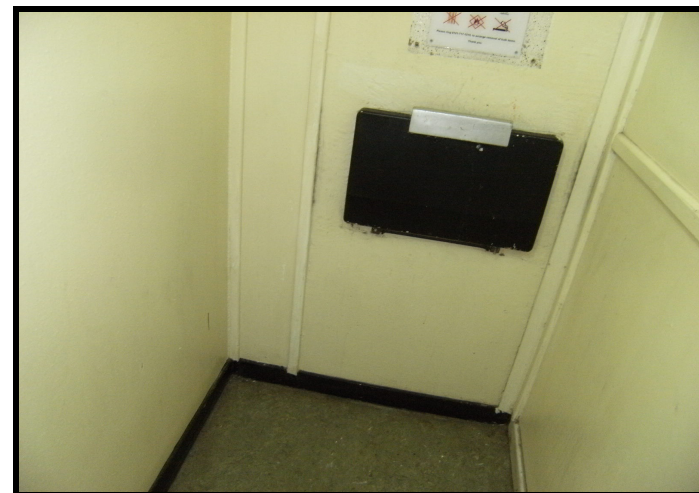
SAMPLE REFERENCE 021

Asbestos detected in Sample

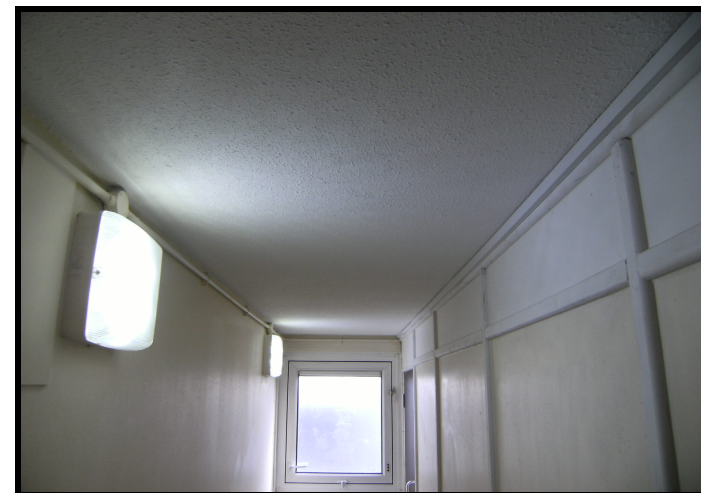
SAMPLE REFERENCE 040

040	Main (Ninth Floor)	Bin Chute Lobby	Ceiling	Textured Coating	Chrysotile	5.00m2	Good condition	Textured Coating	2	1	3	LABEL & MONITOR	22 Mar 2012
041	Main (Ninth Floor)	Bin Chute Lobby	Floor	Floor Tiles	No Asbestos Detected	2.00m2	Good condition	Composite materials	-	-	-	NO ACTION REQUIRED	
042	Main (Ninth Floor)	Bin Chute Lobby	Wall	Cement Board	Chrysotile	1.00m2	Good condition	Sealed (Cement products)	0	0	0	LABEL & MONITOR	22 Mar 2012

Asbestos Presumed in Sample

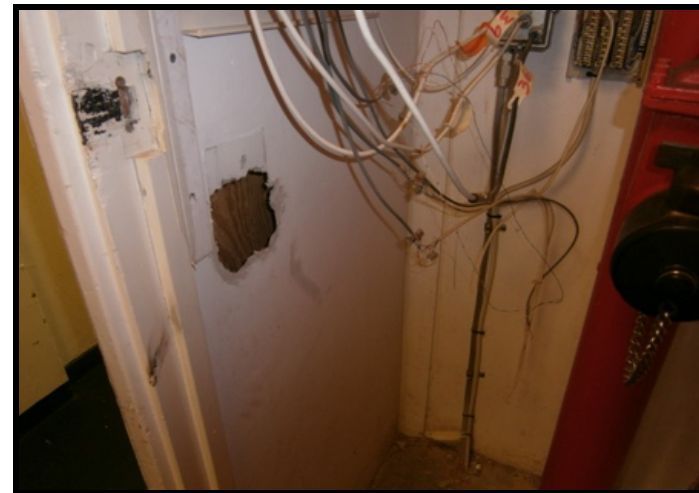
SAMPLE REFERENCE 043

Asbestos Presumed in Sample

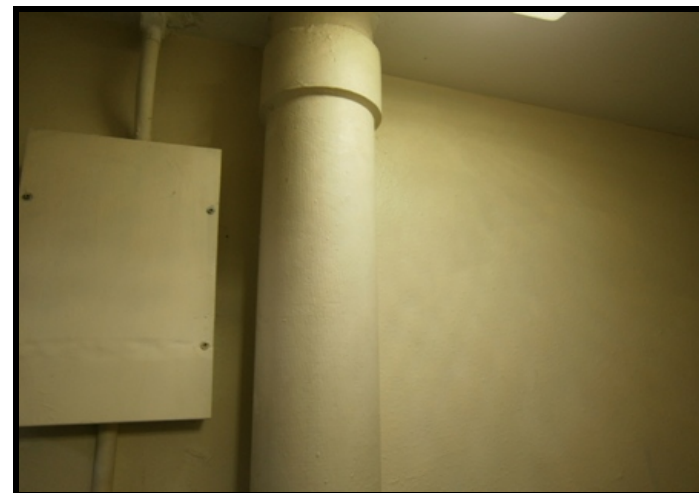
SAMPLE REFERENCE 047

Asbestos Presumed in Sample

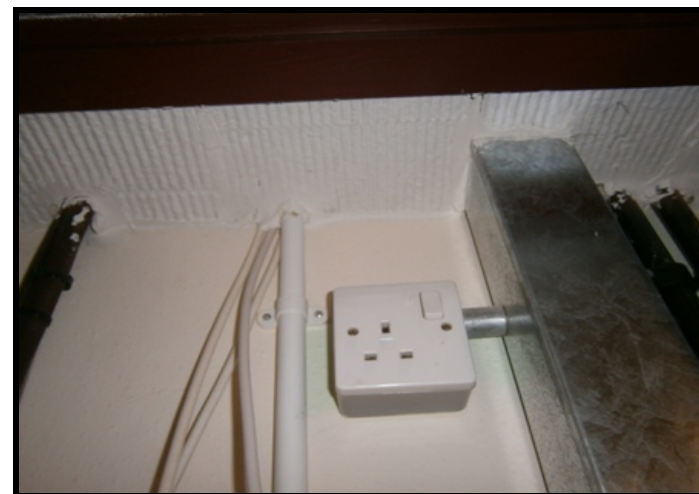
SAMPLE REFERENCE 058

Asbestos Presumed in Sample

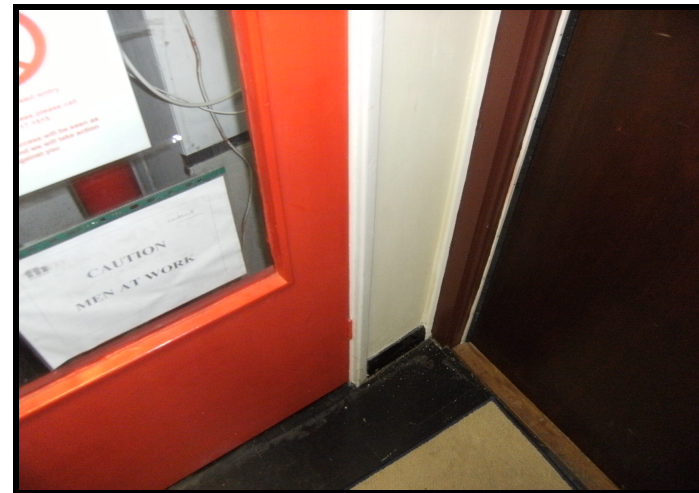
SAMPLE REFERENCE 062

Asbestos Presumed in Sample

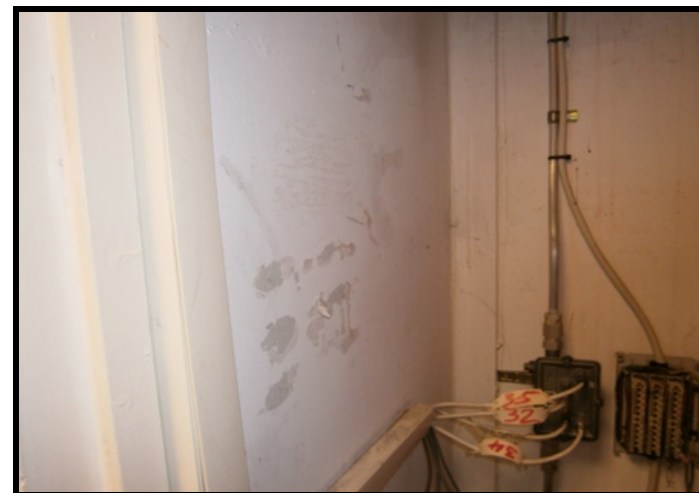
SAMPLE REFERENCE 064

063	Main (Eighth Floor)	Bin Chute Lobby	Ceiling	Textured Coating	Chrysotile	5.00m2	Good condition	Textured Coating	2	1	3	LABEL & MONITOR	22 Mar 2012
064	Main (Eighth Floor)	Dry Riser	Wall	Board	Amosite	6.00m2	Low damage	Sealed Board (Encapsulated)	6	1	7	ENCAPSULATE, LABEL & MONITOR	22 Sep 2011
065	Main (Eighth Floor)	Bin Chute	Wall	Textured Coating	No Asbestos Detected	2.00m2	Good condition	Textured Coating	-	-	-	NO ACTION REQUIRED

Asbestos Presumed in Sample

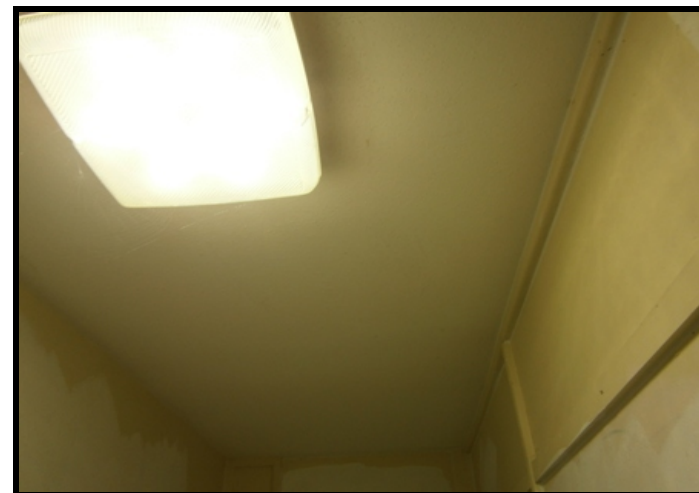
SAMPLE REFERENCE 067

Asbestos Presumed in Sample

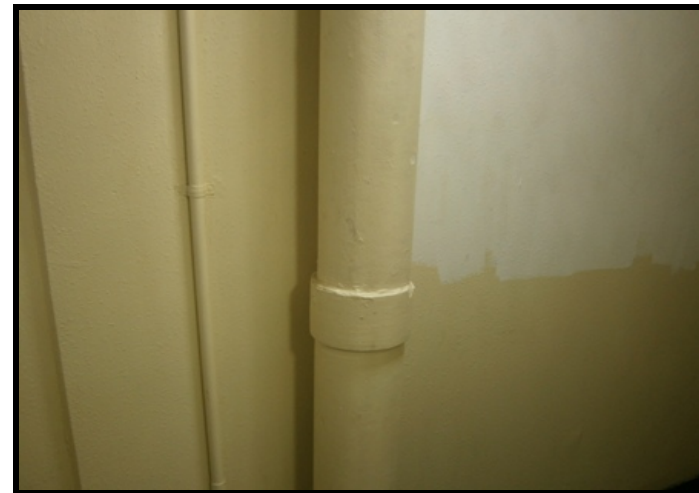
SAMPLE REFERENCE 068

Asbestos Presumed in Sample

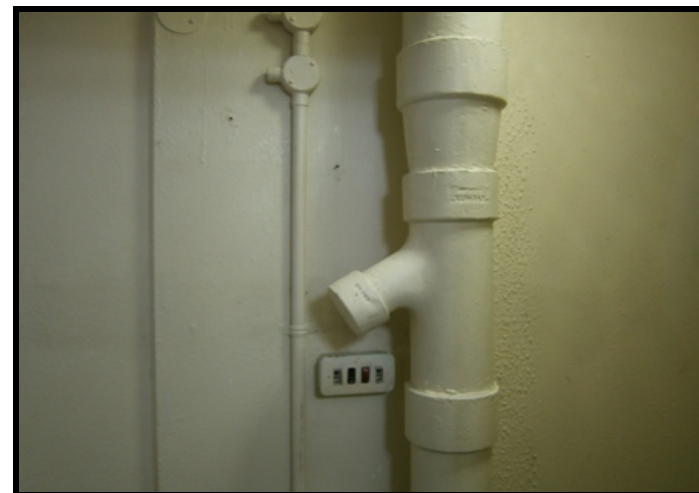
SAMPLE REFERENCE 086

Asbestos Presumed in Sample

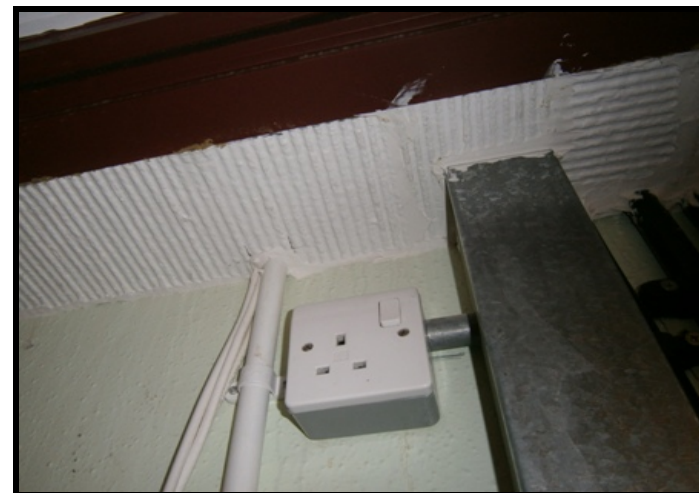
SAMPLE REFERENCE 100

Asbestos Presumed in Sample

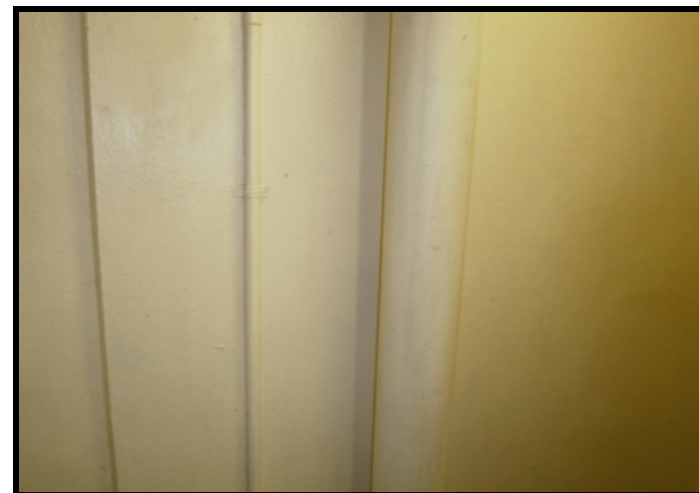
SAMPLE REFERENCE I10

Asbestos Presumed in Sample

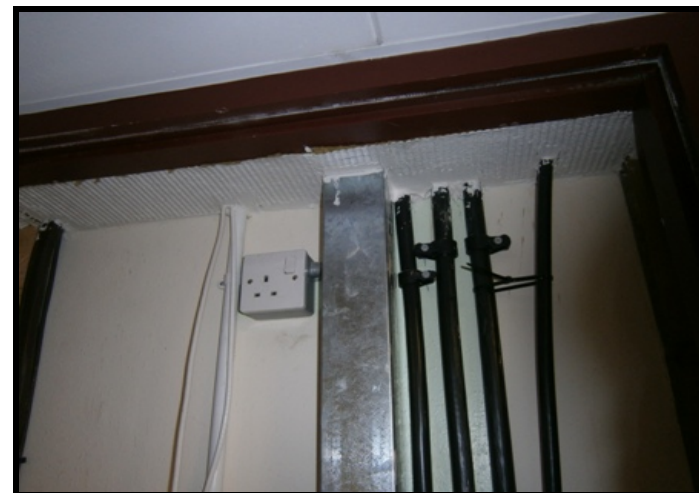
SAMPLE REFERENCE 121

Asbestos Presumed in Sample

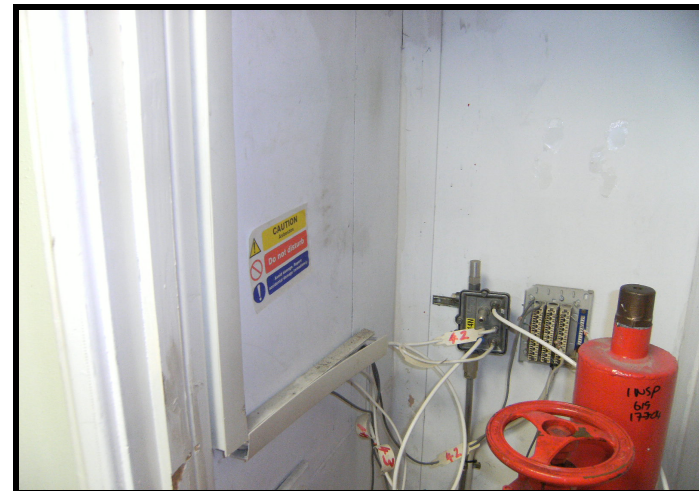
SAMPLE REFERENCE 127

Asbestos Presumed in Sample

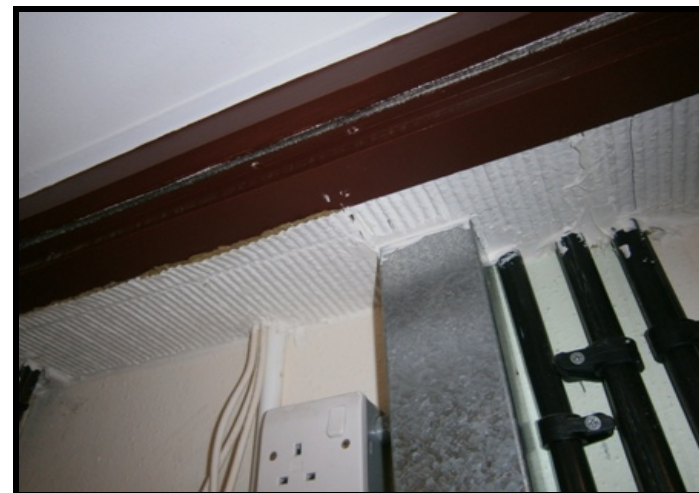
SAMPLE REFERENCE I42

Asbestos Presumed in Sample

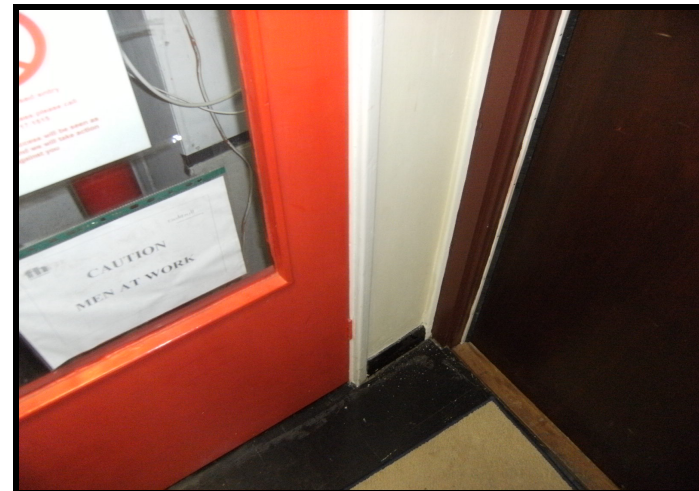
SAMPLE REFERENCE I47

Asbestos Presumed in Sample

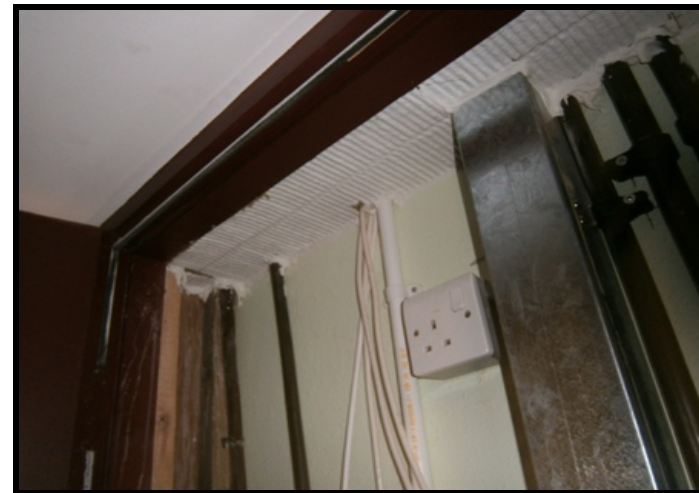
SAMPLE REFERENCE I63

Asbestos Presumed in Sample

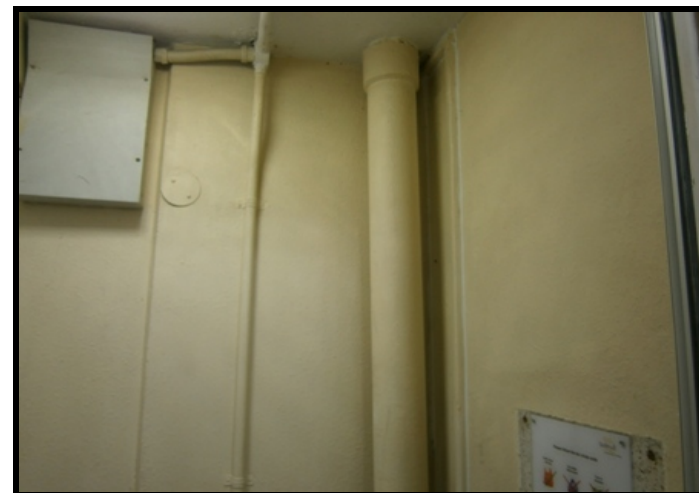
SAMPLE REFERENCE 173

Asbestos Presumed in Sample

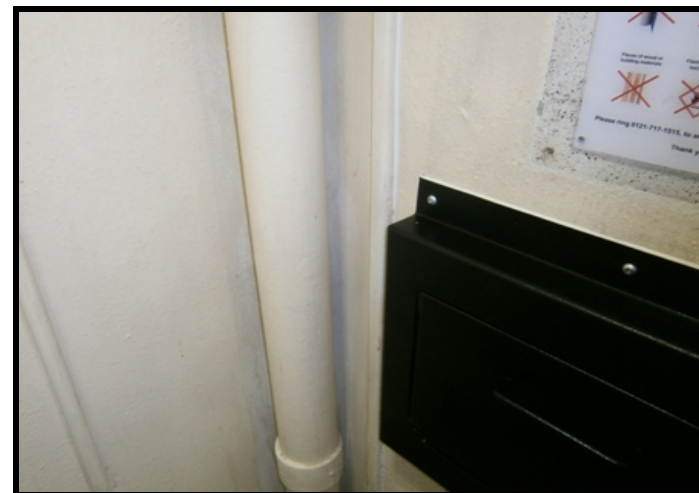
SAMPLE REFERENCE 174

Asbestos Presumed in Sample

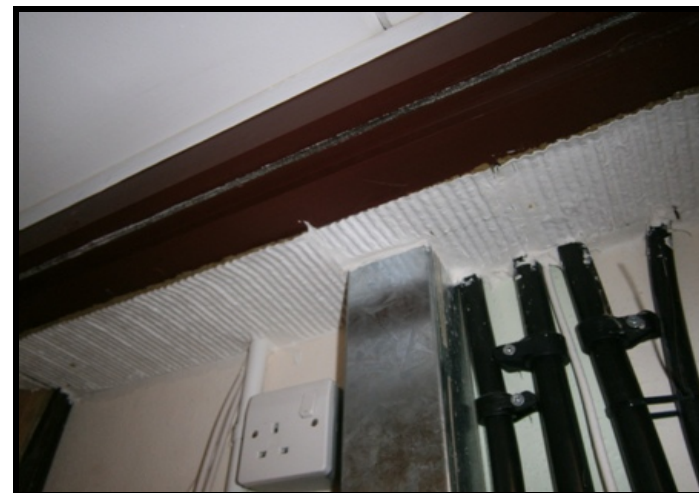
SAMPLE REFERENCE 184

Asbestos Presumed in Sample

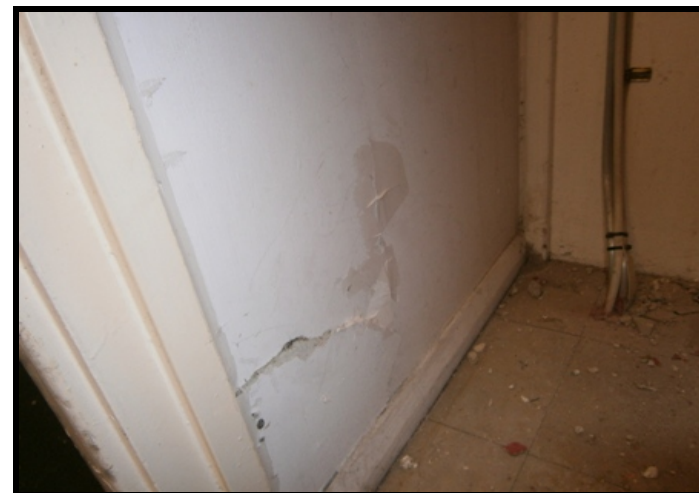
SAMPLE REFERENCE 190

Asbestos Presumed in Sample

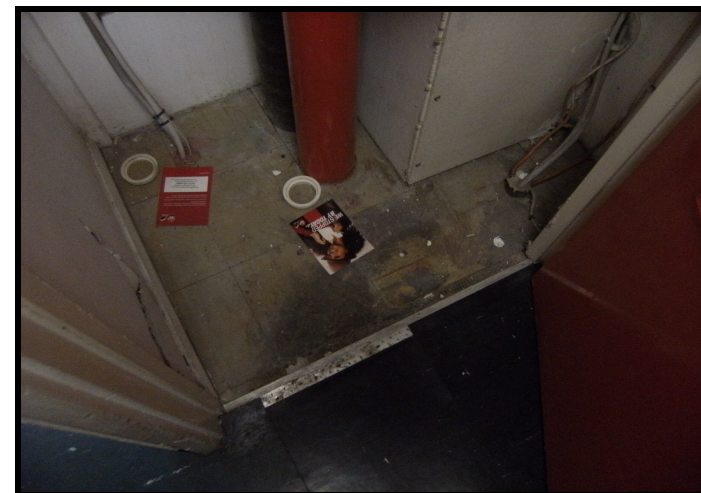
SAMPLE REFERENCE 191

Asbestos detected in Sample

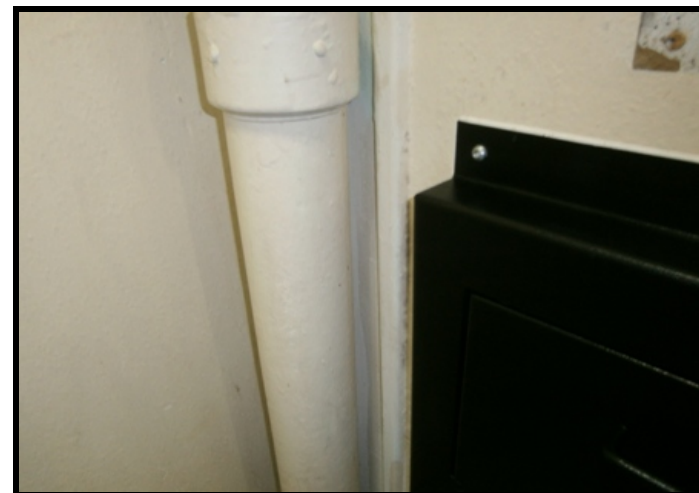
SAMPLE REFERENCE 196

Asbestos Presumed in Sample

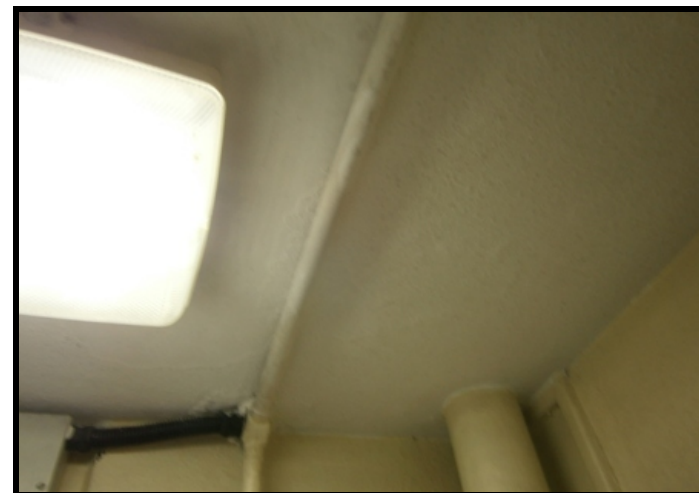
SAMPLE REFERENCE I97a

Asbestos Presumed in Sample

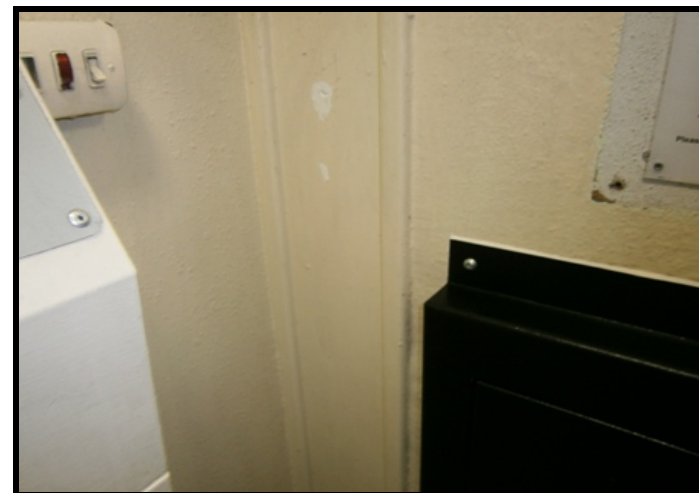
SAMPLE REFERENCE I97c

Asbestos Presumed in Sample

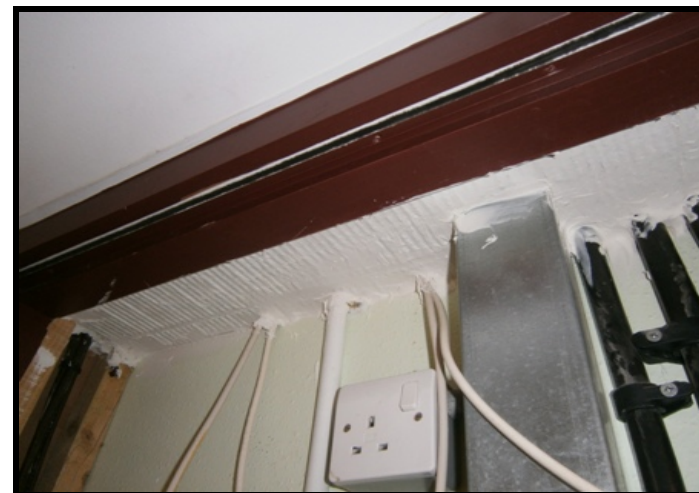
SAMPLE REFERENCE 206

Asbestos Presumed in Sample

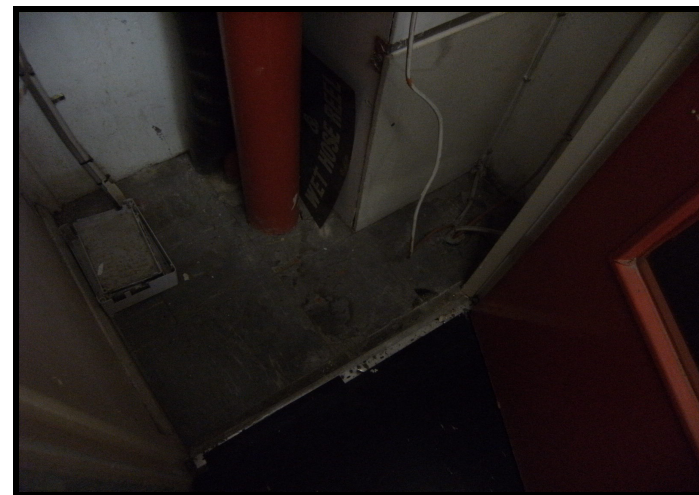
SAMPLE REFERENCE 214

Asbestos detected in Sample
