# Solihull Community Housing

## Asbestos Management Survey Report

**AVONCROFT HOUSE  
(COMMUNAL)  
WINCHESTER DRIVE  
SOLIHULL  
B37 5QH**

Date of Report: 29 Jan 2015

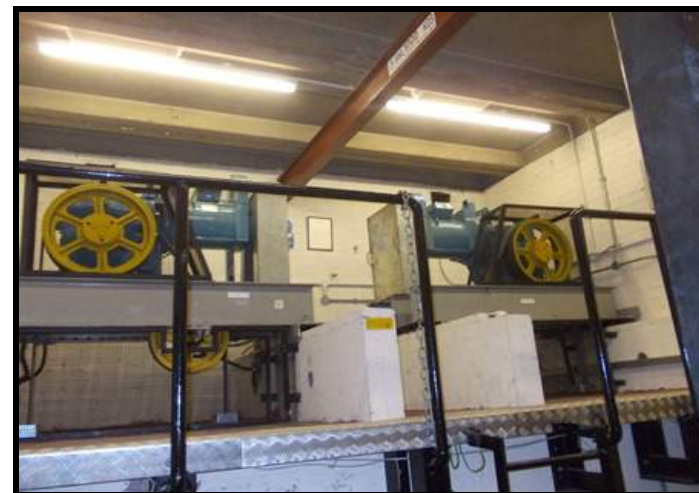
## SAMPLE REFERENCE 001

001	Main (Roof)	Lift Motor	Lift Motor	Gasket	Presumed ACM	1.00m2	Low damage	Unsealed (1)	7	0	7	LABEL & MONITOR	12 Jan 2016	
002	Main (Roof)	Roof	All Areas	Not Applicable	Not Applicable	N/A	Not Applicable	Not Applicable	-	-	-	NOT APPLICABLE		
003	Main (Roof)	Store	All Areas	Not Applicable	Not Applicable	N/A	Not Applicable	Not Applicable	-	-	-	NOT APPLICABLE		
004	Main (Tenth Floor)	Roof Access	All Areas	Not Applicable	Not Applicable	N/A	Not Applicable	Not Applicable	-	-	-	NOT APPLICABLE

Asbestos Presumed

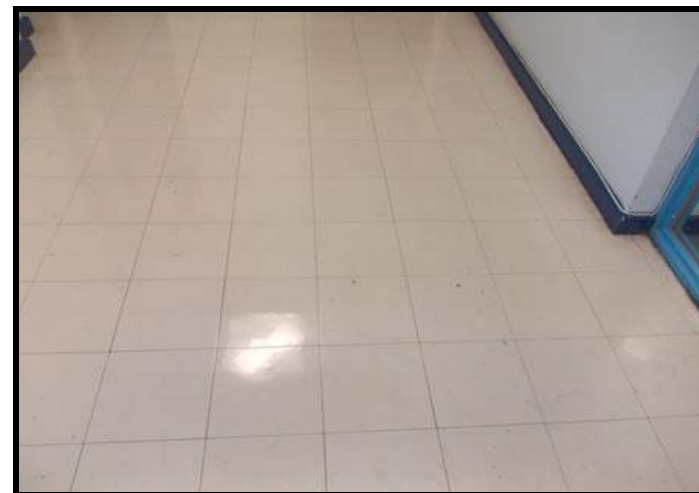
## SAMPLE REFERENCE 005

**Asbestos detected in Sample**

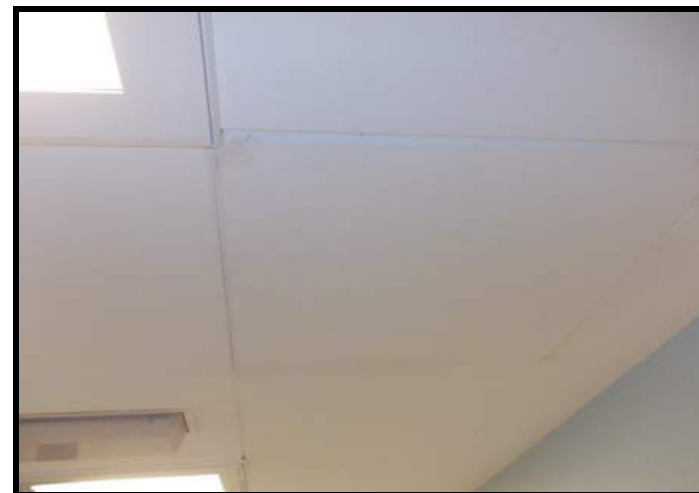
## SAMPLE REFERENCE 006

**Asbestos not detected in Sample**

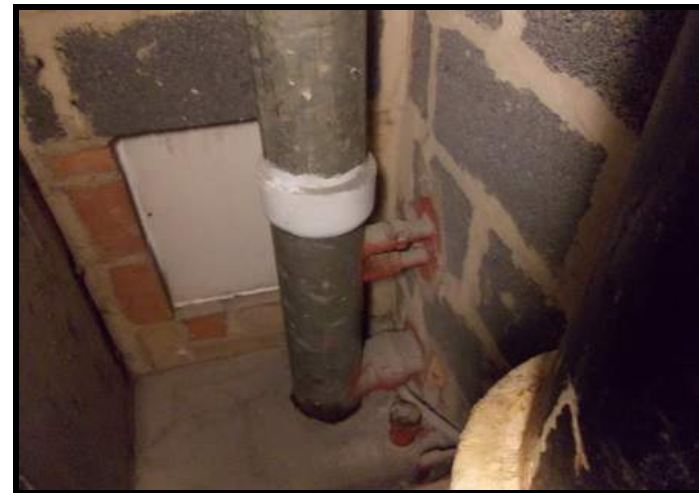
## SAMPLE REFERENCE 007

Asbestos detected in Sample

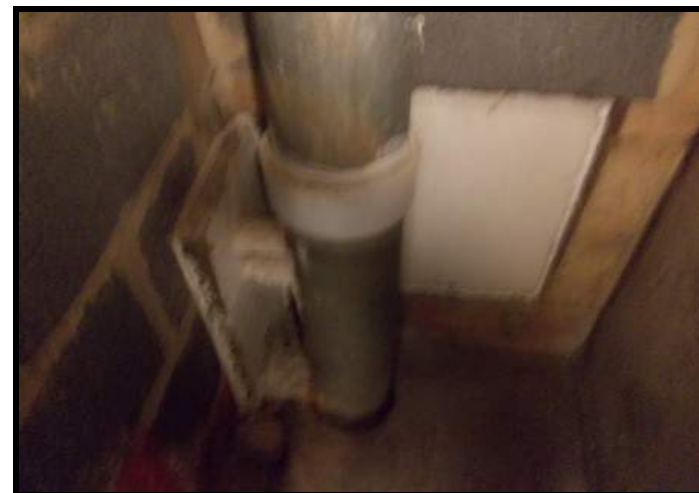
## SAMPLE REFERENCE 008

Asbestos detected in Sample

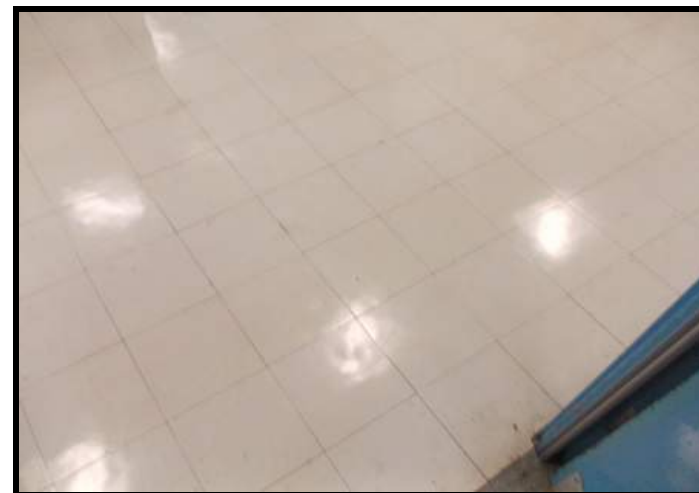
## SAMPLE REFERENCE 010

Asbestos Presumed

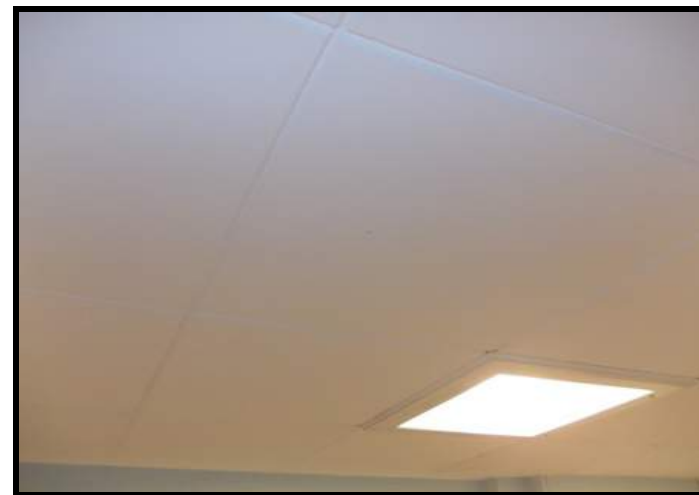
## SAMPLE REFERENCE 011

**No Asbestos Presumed in Sample**

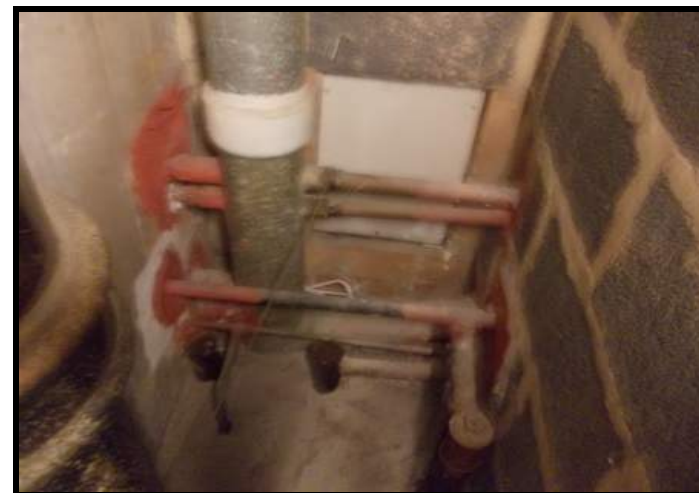
## SAMPLE REFERENCE 013

**Asbestos detected in Sample**

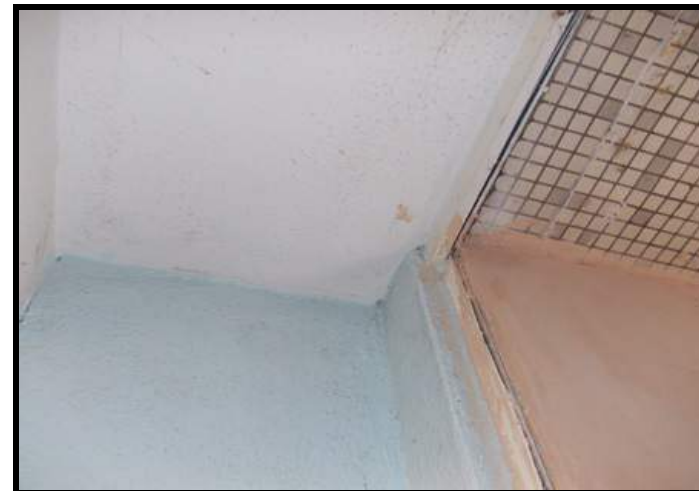
## SAMPLE REFERENCE 015a

**Asbestos detected in Sample**

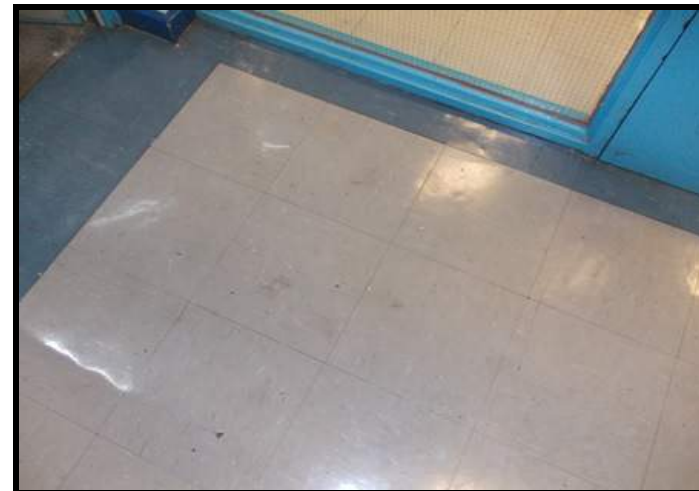
## SAMPLE REFERENCE 015d

Asbestos not detected in Sample

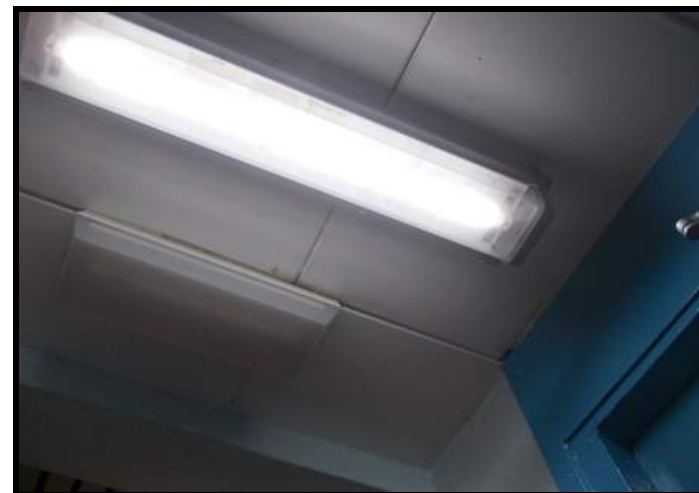
## SAMPLE REFERENCE 016

**No Asbestos Presumed in Sample**

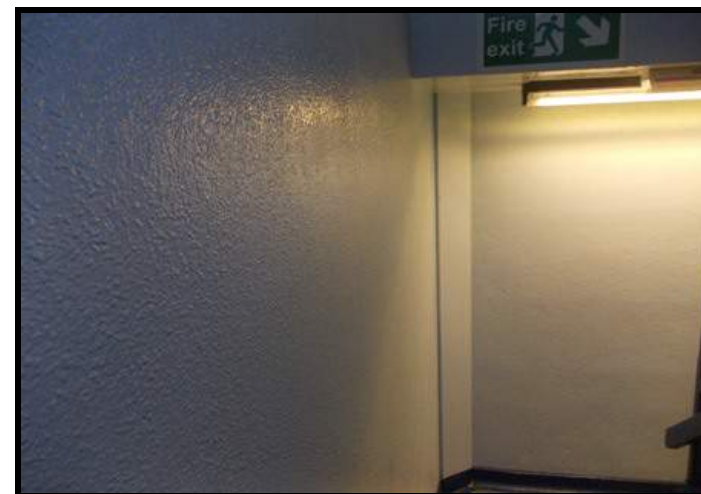
## SAMPLE REFERENCE 017

**Asbestos Presumed**

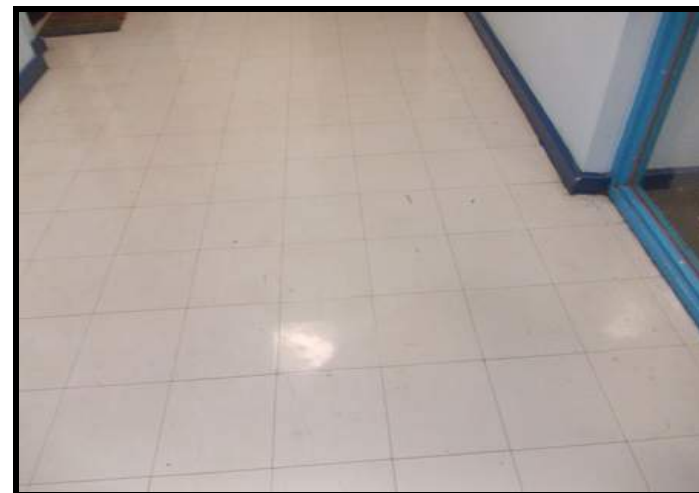
## SAMPLE REFERENCE 018

Asbestos Presumed

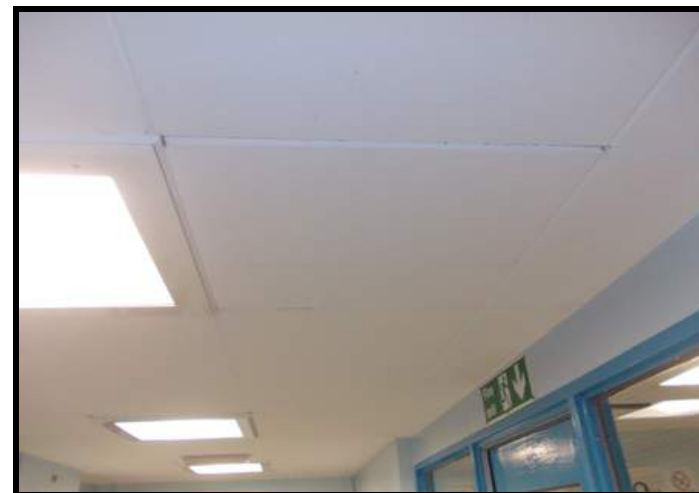
## SAMPLE REFERENCE 019

**No Asbestos Presumed in Sample**

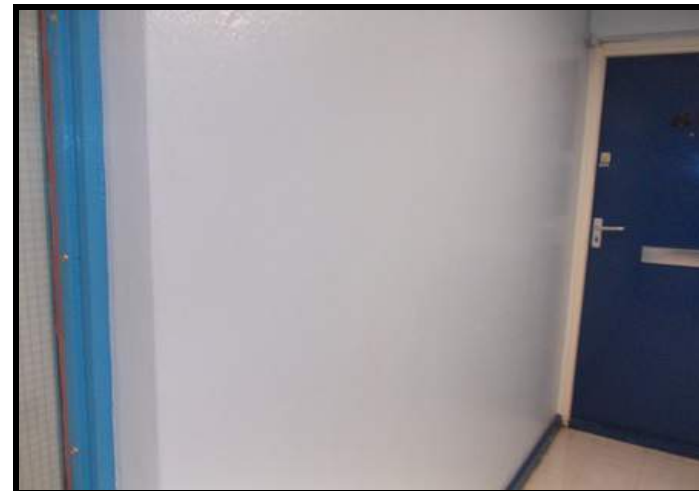
## SAMPLE REFERENCE 020

**Asbestos Presumed**

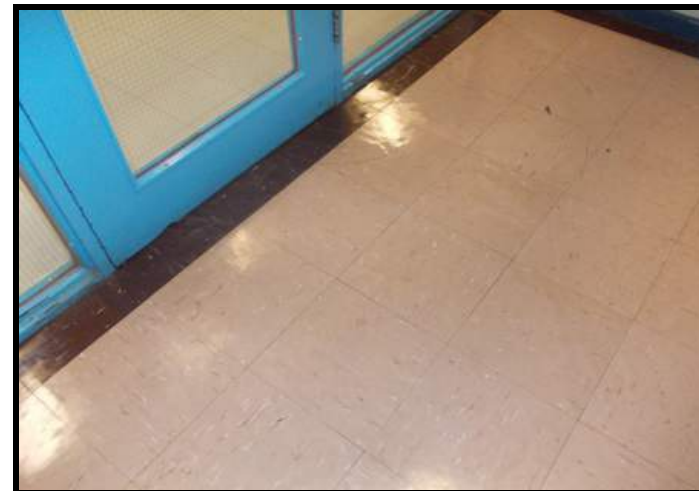
## SAMPLE REFERENCE 020a

**Asbestos not detected in Sample**

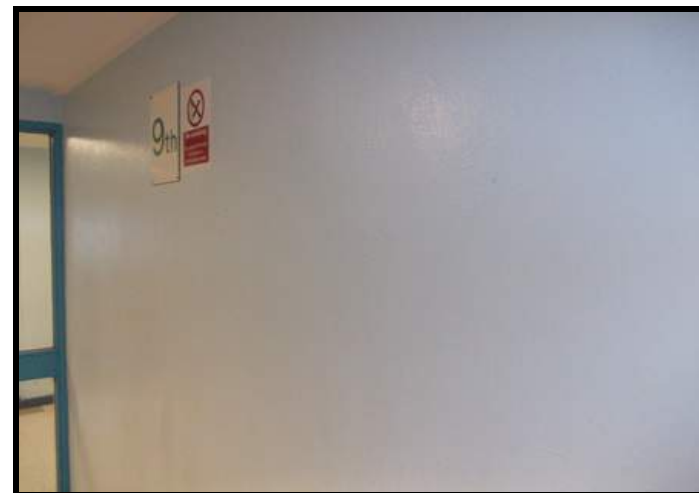
## SAMPLE REFERENCE 020c

**Asbestos Presumed**

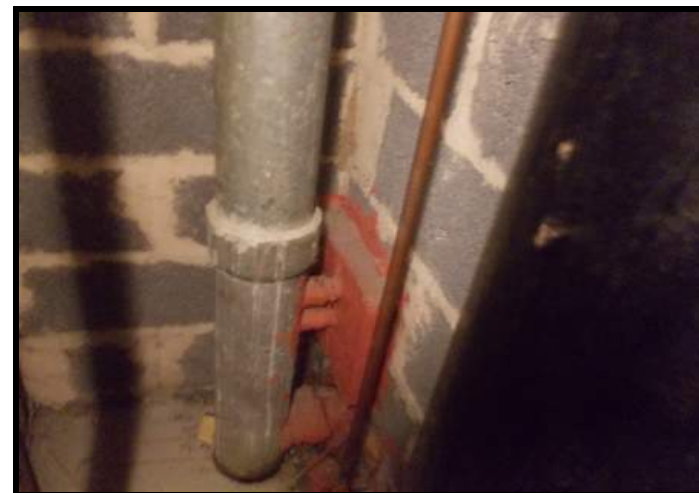
## SAMPLE REFERENCE 021

Asbestos Presumed

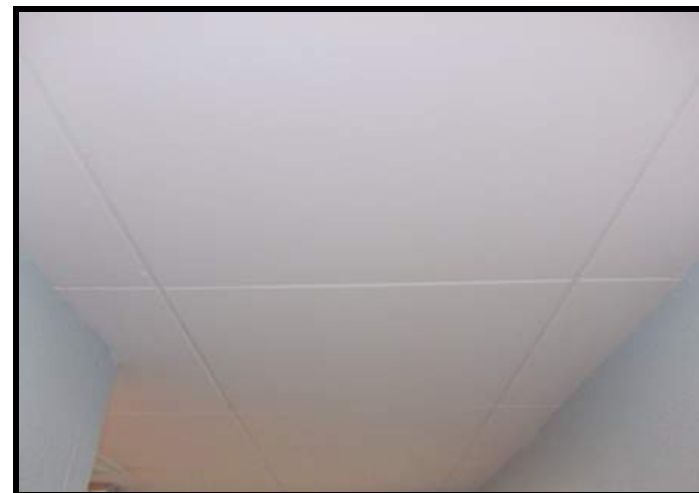
SAMPLE REFERENCE 024b

**No Asbestos Presumed in Sample**

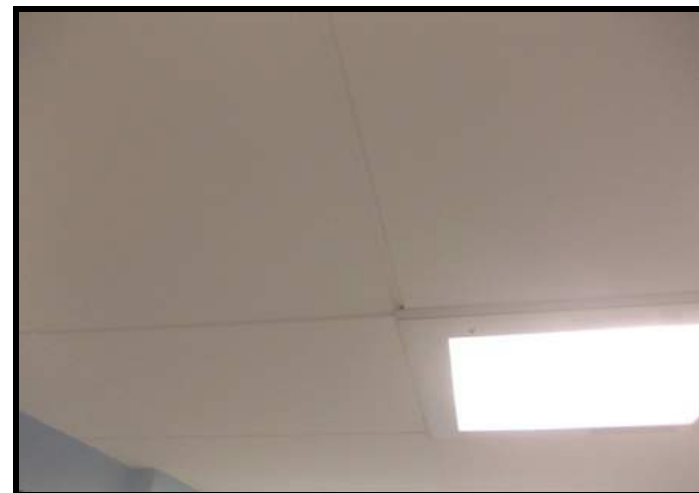
## SAMPLE REFERENCE 026

**No Asbestos Presumed in Sample**

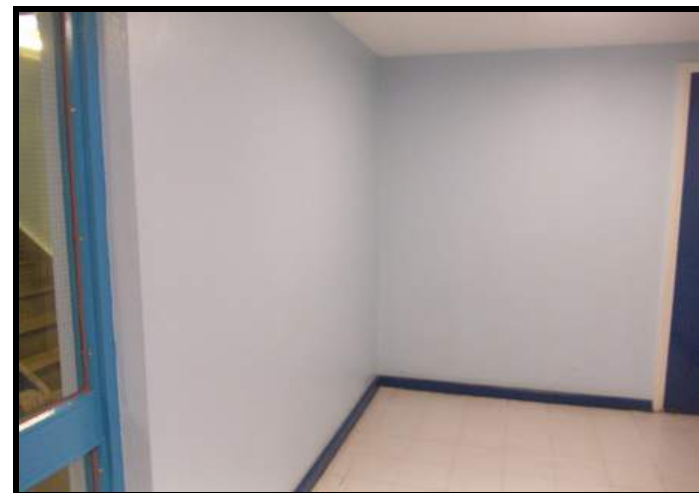
## SAMPLE REFERENCE 027

Asbestos Presumed

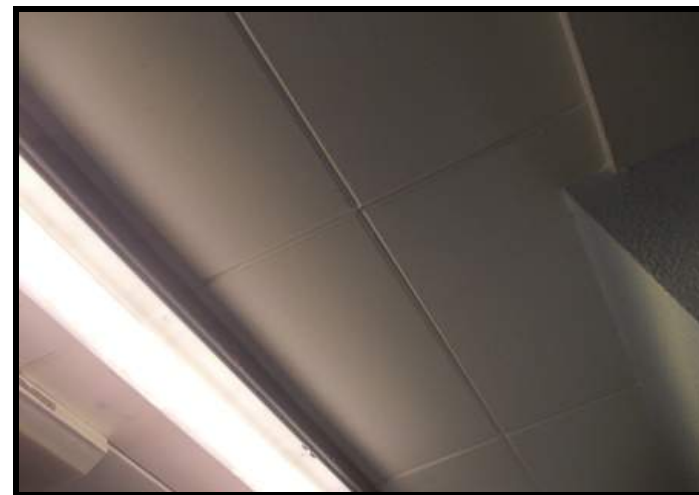
## SAMPLE REFERENCE 031

**No Asbestos Presumed in Sample**

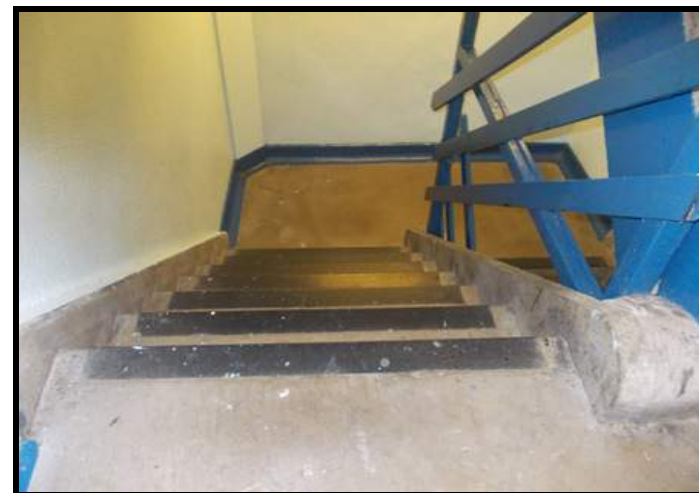
## SAMPLE REFERENCE 031a

**Asbestos Presumed**

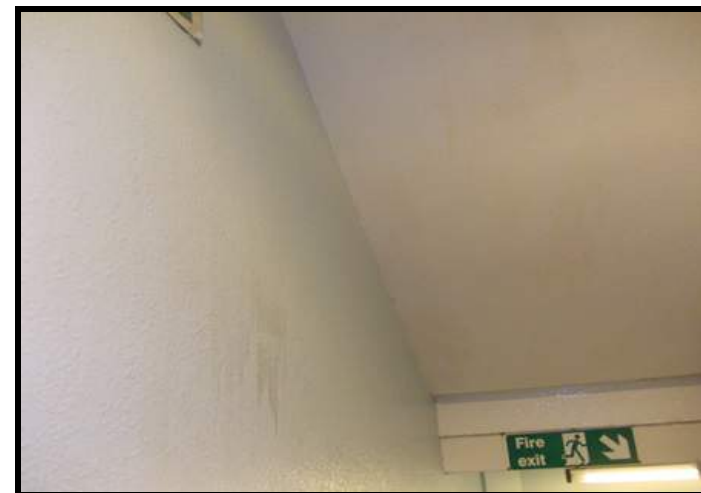
## SAMPLE REFERENCE 032

**Asbestos Presumed**

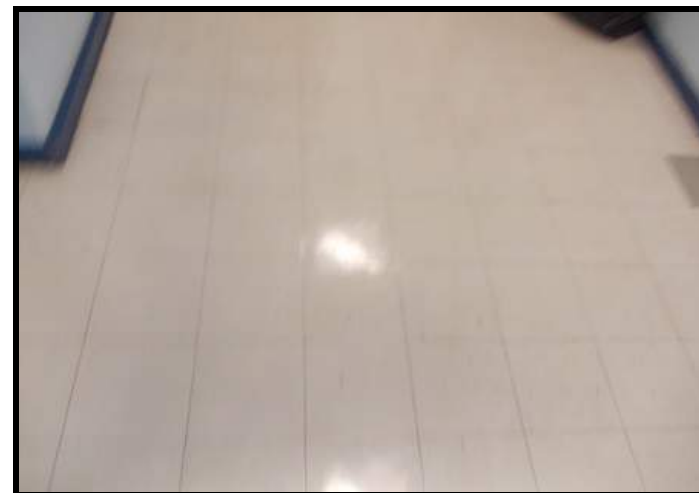
## SAMPLE REFERENCE 033

Asbestos Presumed

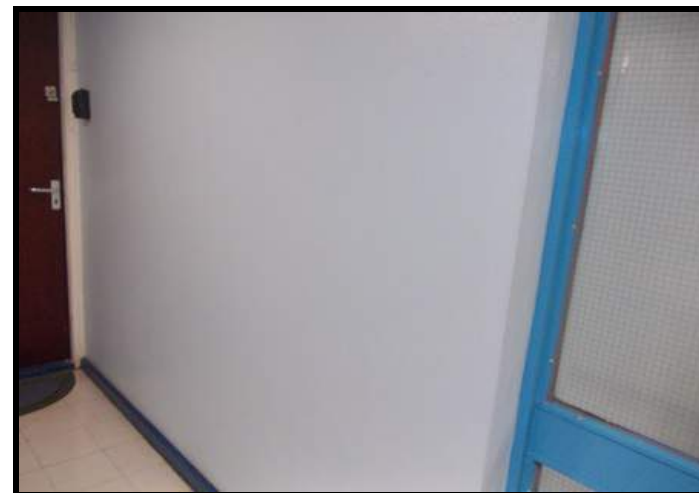
## SAMPLE REFERENCE 035

**Asbestos Presumed**

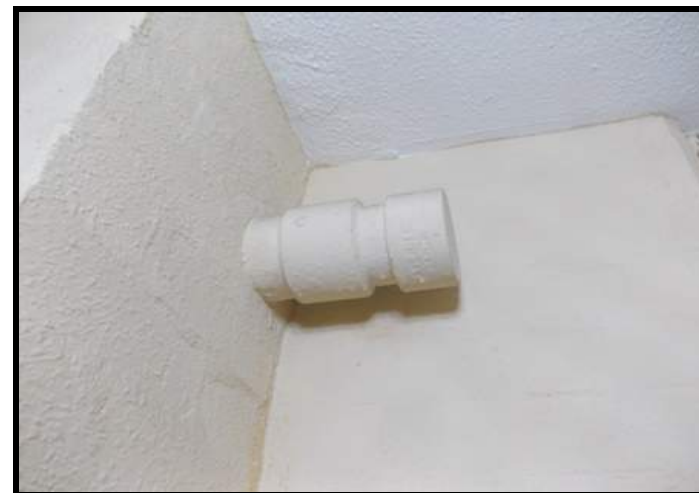
## SAMPLE REFERENCE 035a

Asbestos detected in Sample

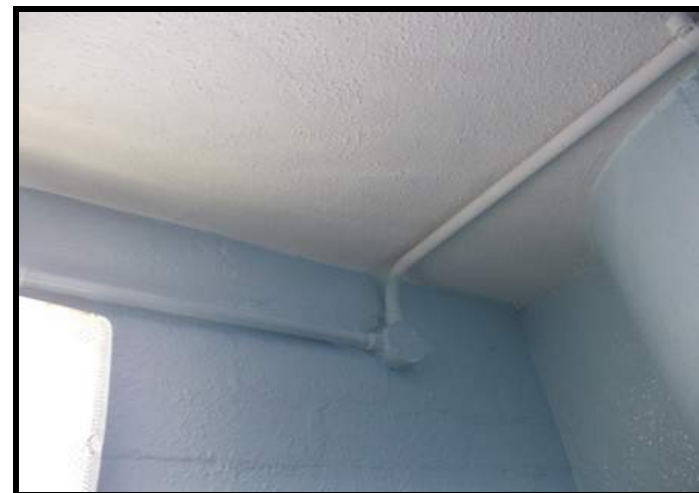
## SAMPLE REFERENCE 039

**Asbestos Presumed**

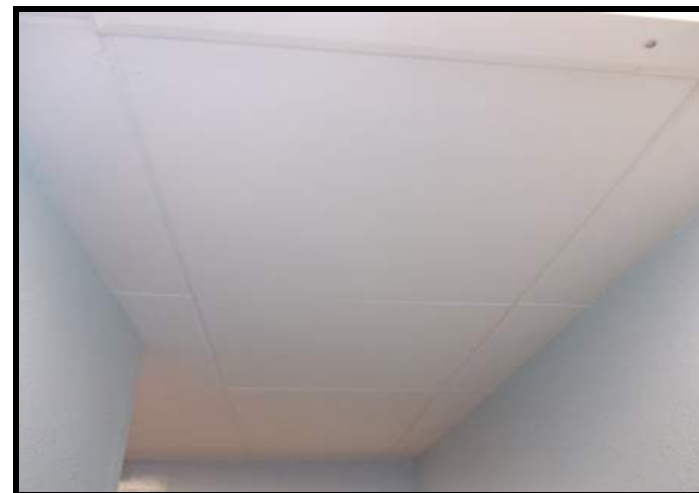
## SAMPLE REFERENCE 039b

**No Asbestos Presumed in Sample**

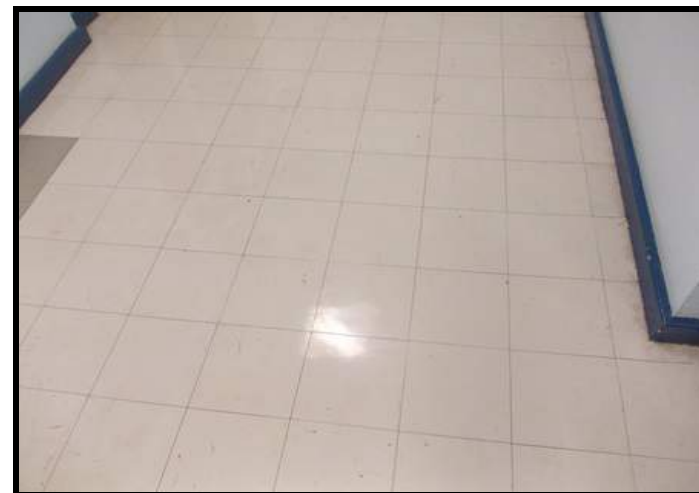
## SAMPLE REFERENCE 040

**Asbestos Presumed**

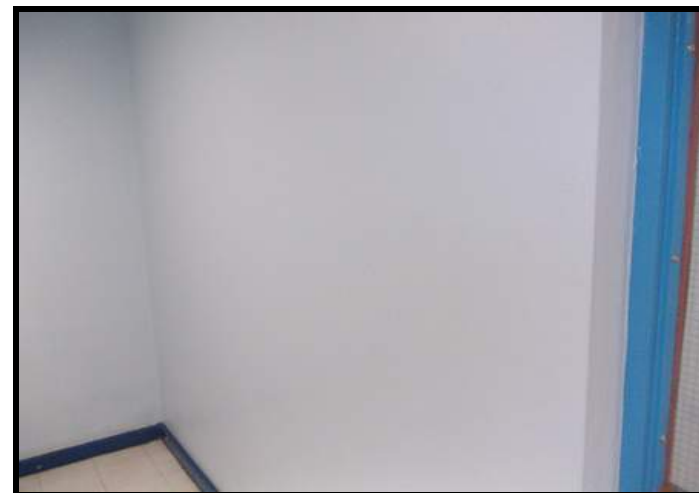
## SAMPLE REFERENCE 042

Asbestos Presumed

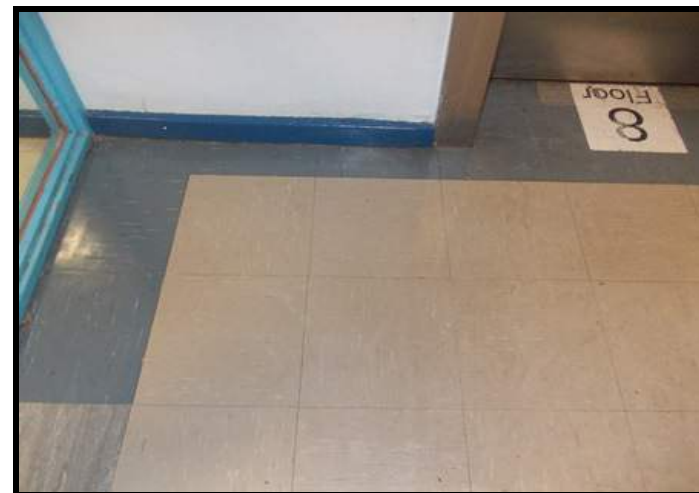
## SAMPLE REFERENCE 045b

**No Asbestos Presumed in Sample**

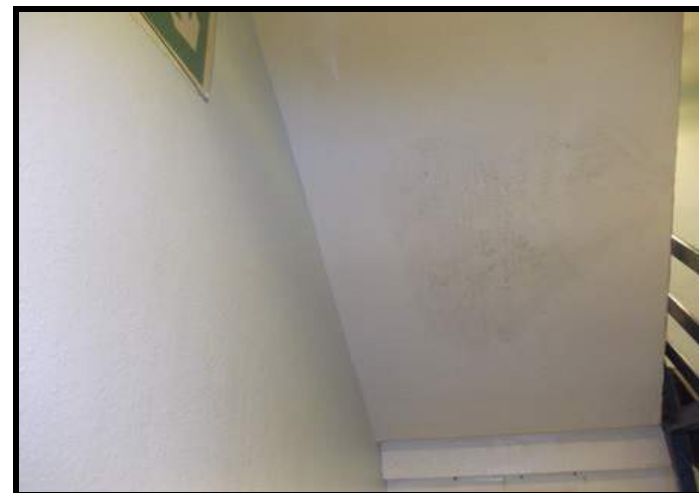
## SAMPLE REFERENCE 047

**Asbestos Presumed**

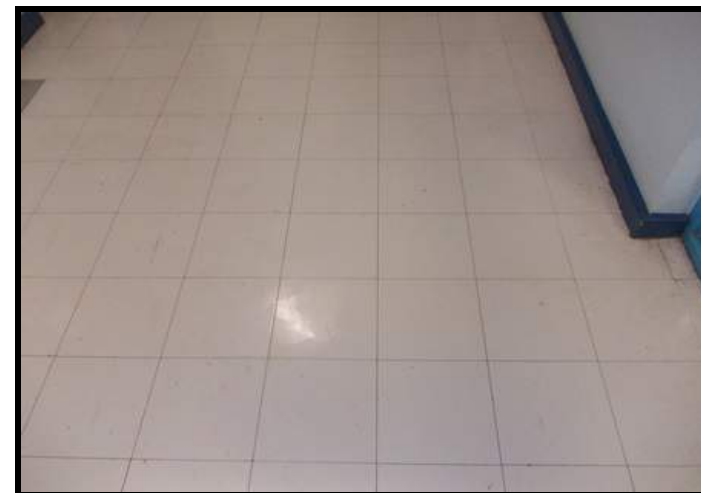
## SAMPLE REFERENCE 048

Asbestos Presumed

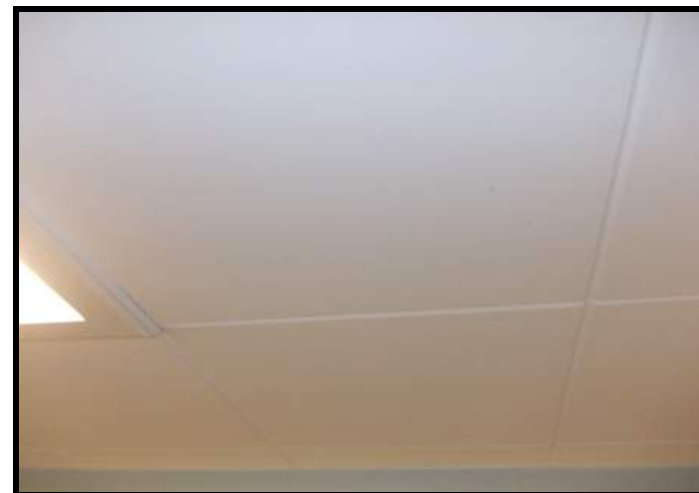
## SAMPLE REFERENCE 049

**No Asbestos Presumed in Sample**

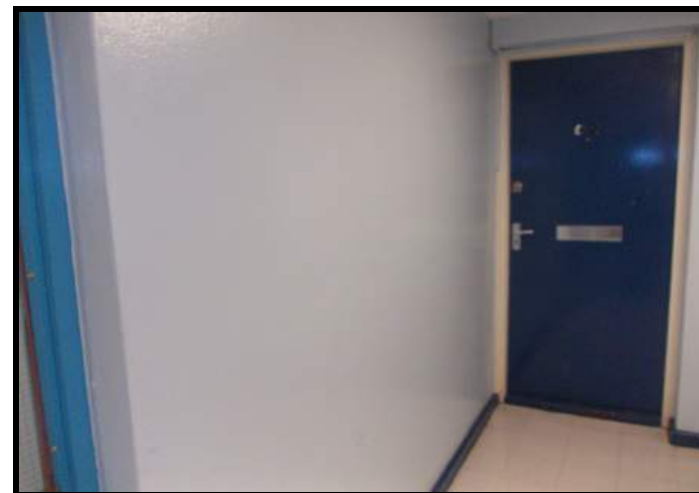
## SAMPLE REFERENCE 050

Asbestos Presumed

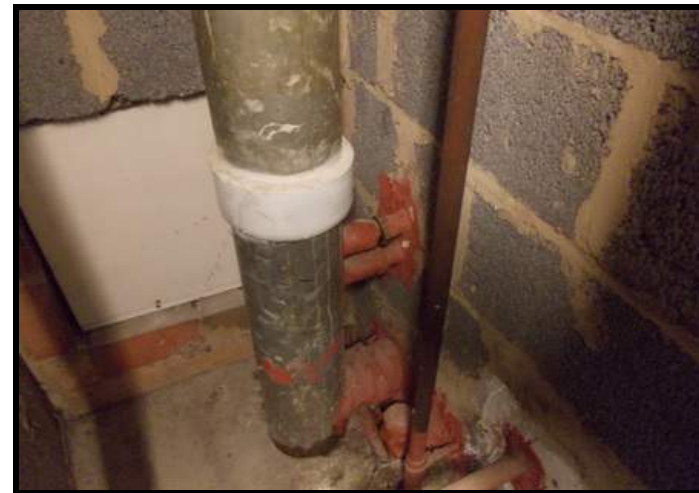
## SAMPLE REFERENCE 051

Asbestos Presumed

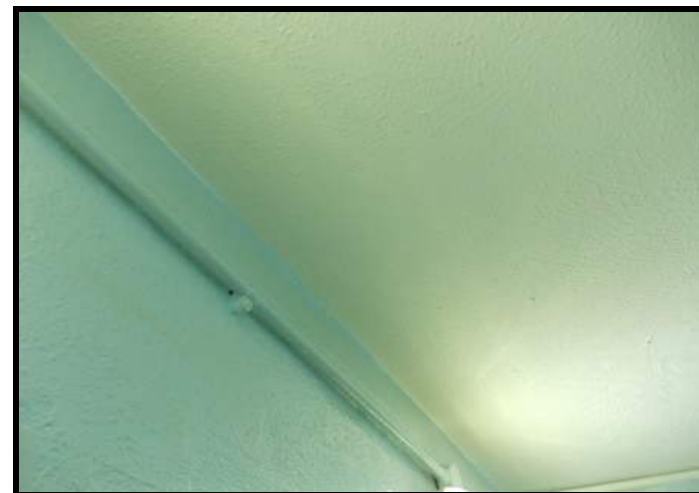
## SAMPLE REFERENCE 054

**Asbestos Presumed**

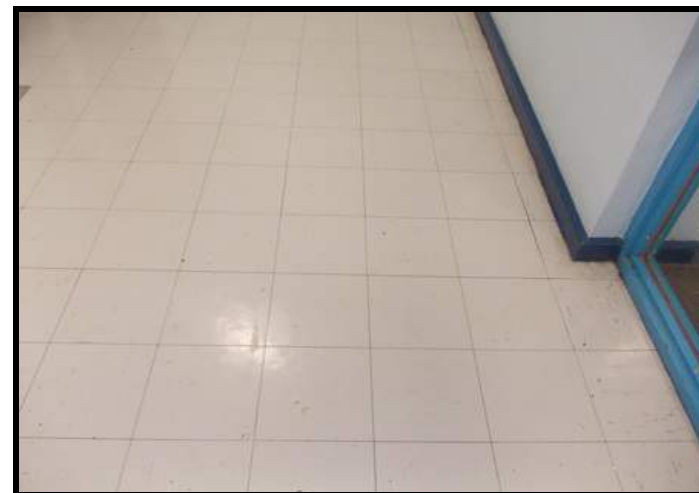
## SAMPLE REFERENCE 055

Asbestos Presumed

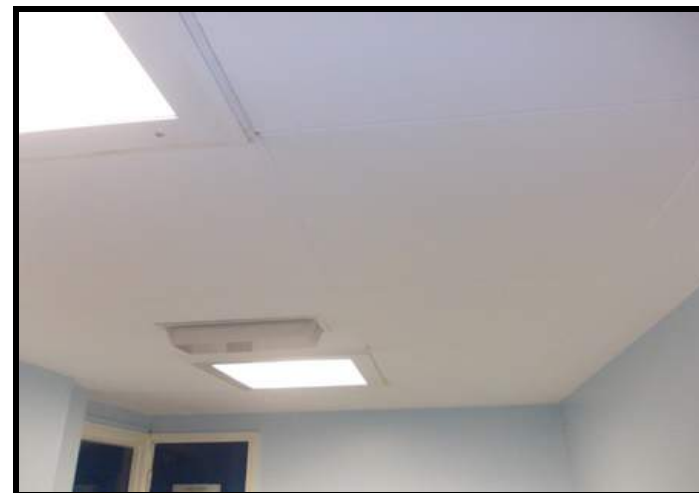
## SAMPLE REFERENCE 056

**No Asbestos Presumed in Sample**

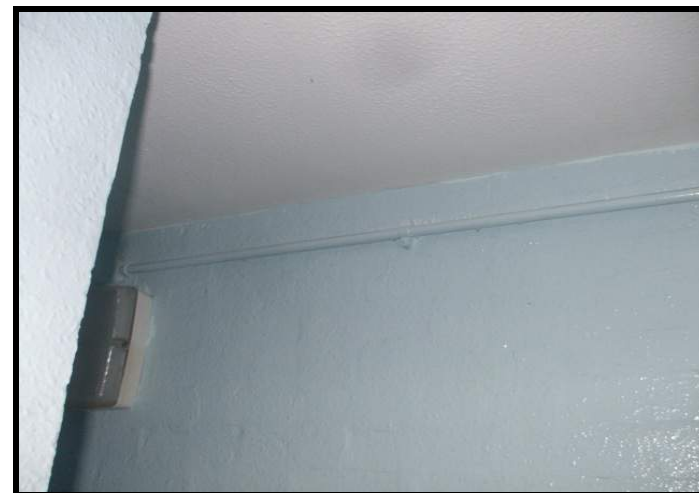
## SAMPLE REFERENCE 057

Asbestos Presumed

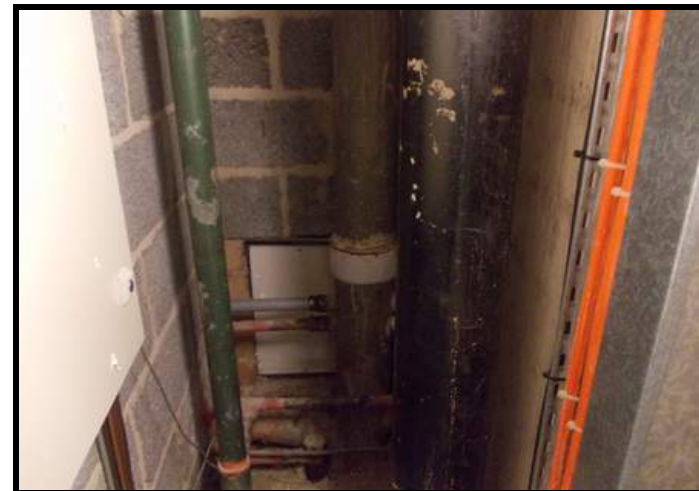
## SAMPLE REFERENCE 058

Asbestos Presumed

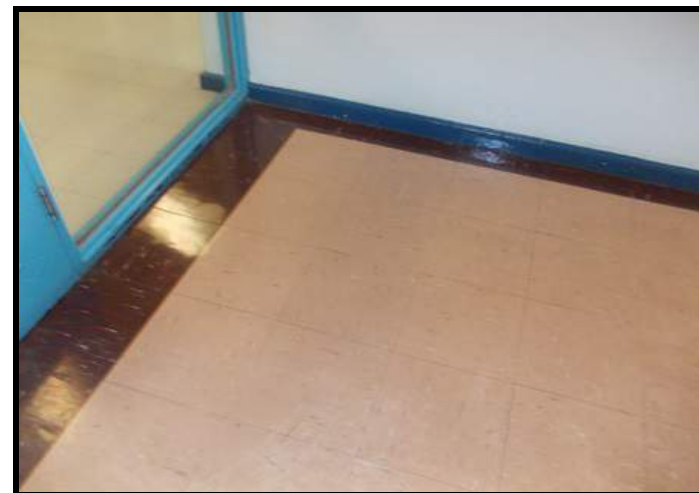
## SAMPLE REFERENCE 060b

**No Asbestos Presumed in Sample**

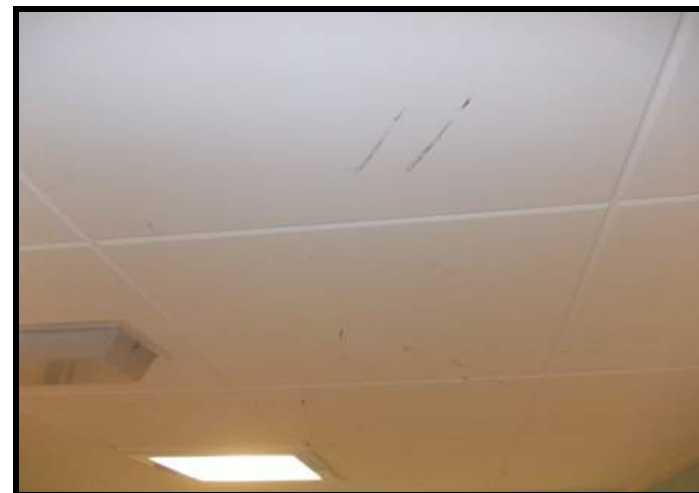
## SAMPLE REFERENCE 060d

**No Asbestos Presumed in Sample**

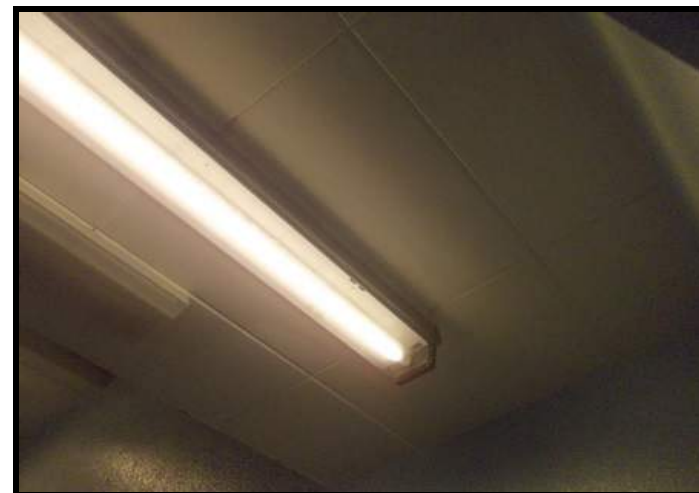
## SAMPLE REFERENCE 061

**No Asbestos Presumed in Sample**

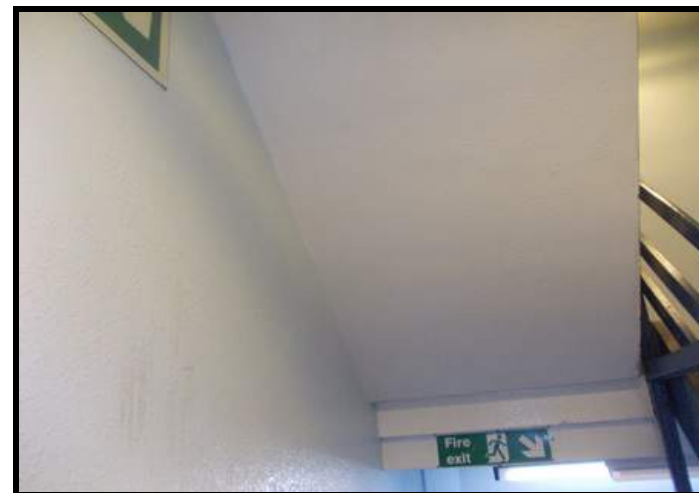
## SAMPLE REFERENCE 062

**Asbestos Presumed**

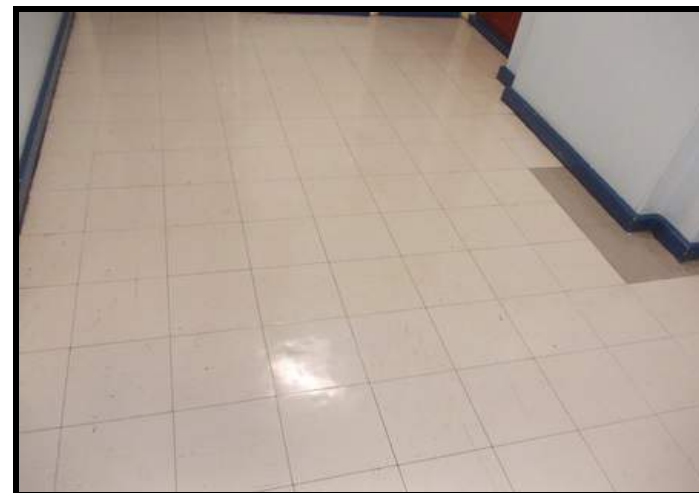
## SAMPLE REFERENCE 063

Asbestos Presumed

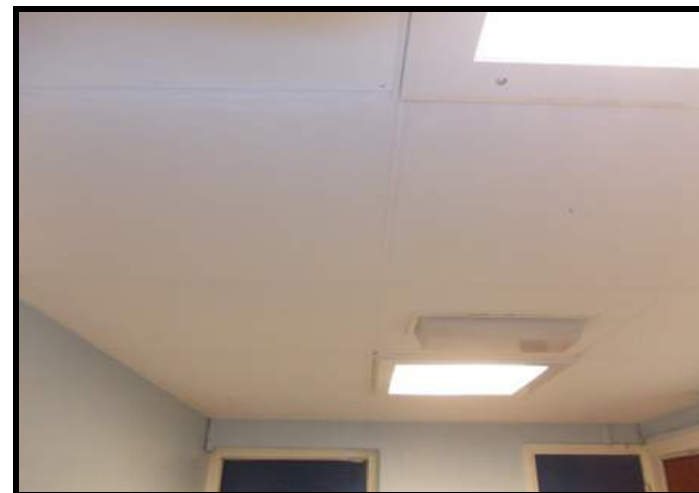
## SAMPLE REFERENCE 064

**No Asbestos Presumed in Sample**

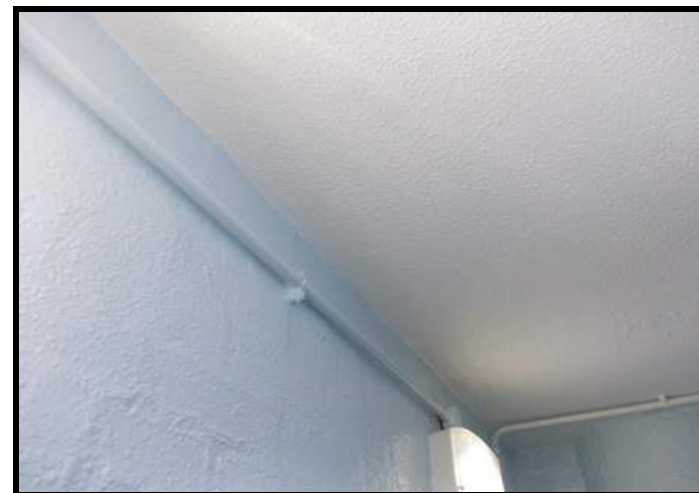
## SAMPLE REFERENCE 069

**Asbestos Presumed**

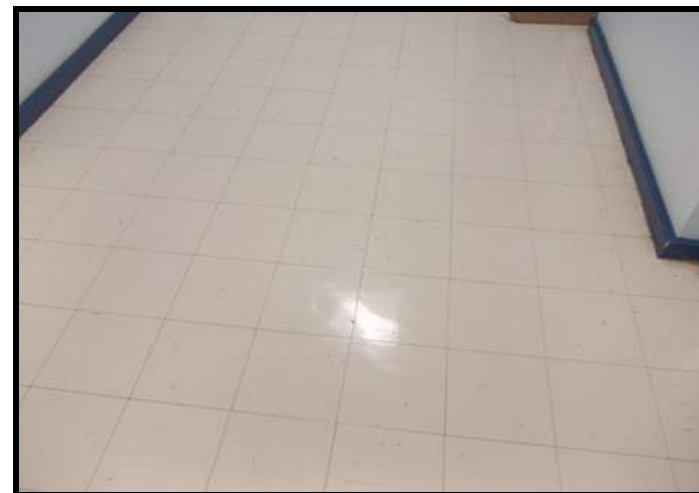
## SAMPLE REFERENCE 070

Asbestos Presumed

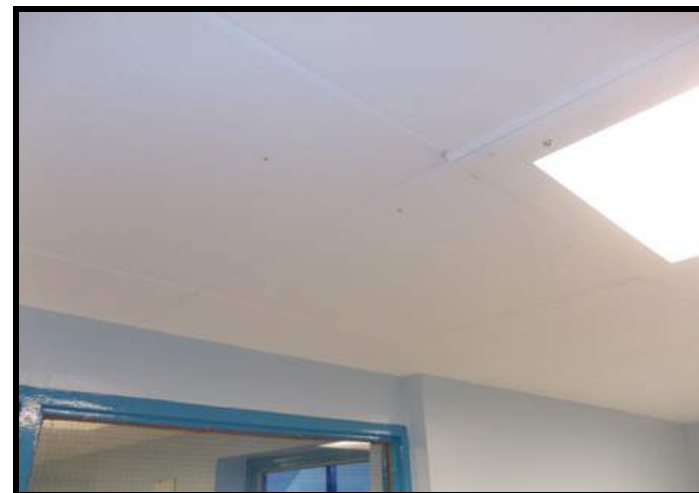
## SAMPLE REFERENCE 071

**No Asbestos Presumed in Sample**

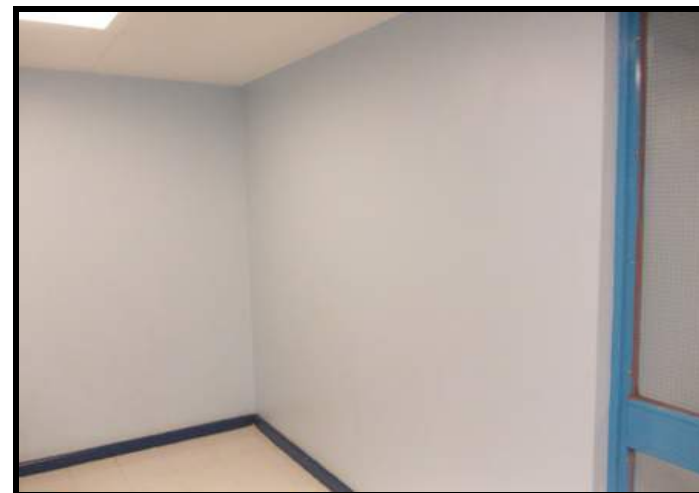
## SAMPLE REFERENCE 072

**Asbestos Presumed**

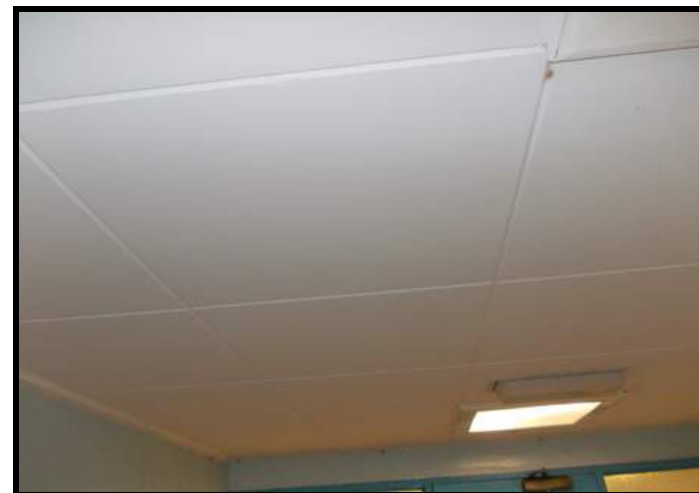
## SAMPLE REFERENCE 075a

**No Asbestos Presumed in Sample**

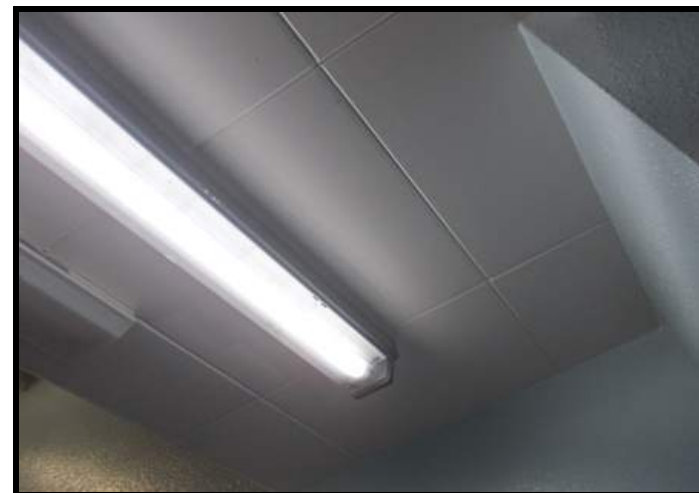
## SAMPLE REFERENCE 076

**No Asbestos Presumed in Sample**

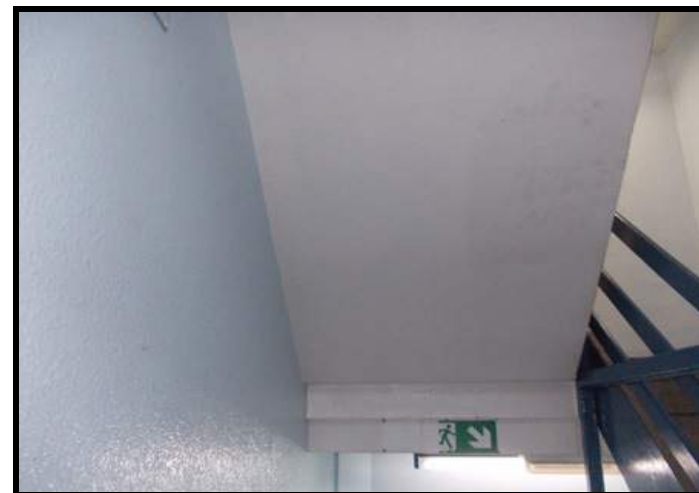
## SAMPLE REFERENCE 077

**Asbestos Presumed**

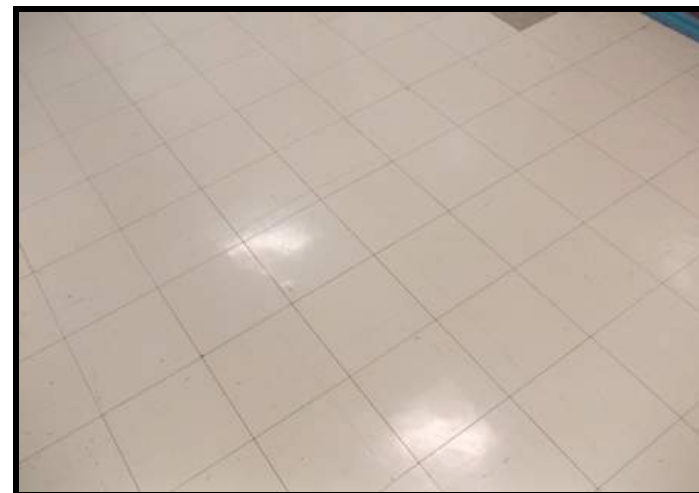
## SAMPLE REFERENCE 078

Asbestos Presumed

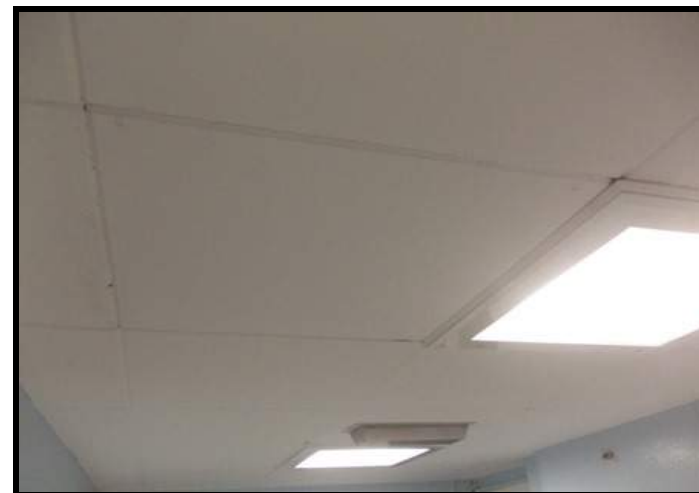
## SAMPLE REFERENCE 079

**No Asbestos Presumed in Sample**

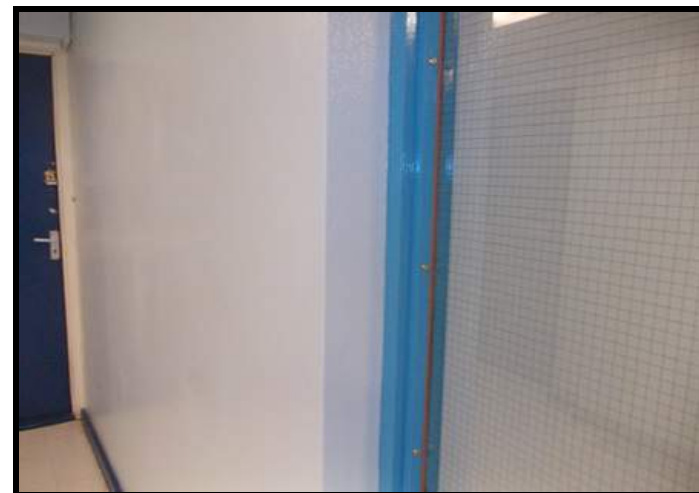
## SAMPLE REFERENCE 080

Asbestos Presumed

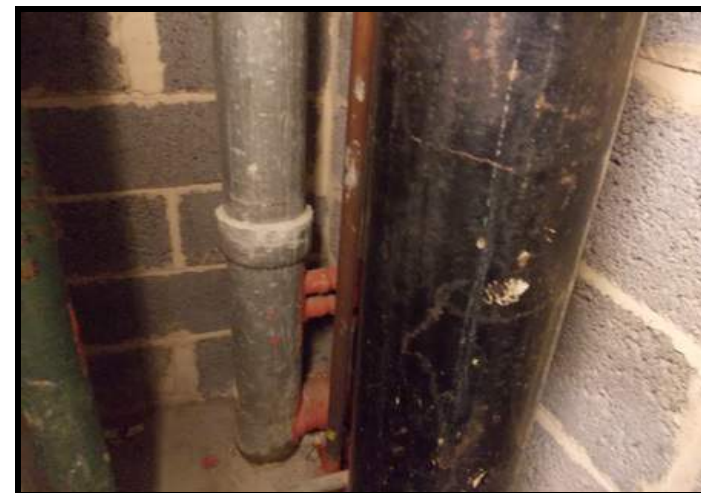
## SAMPLE REFERENCE 081

Asbestos Presumed

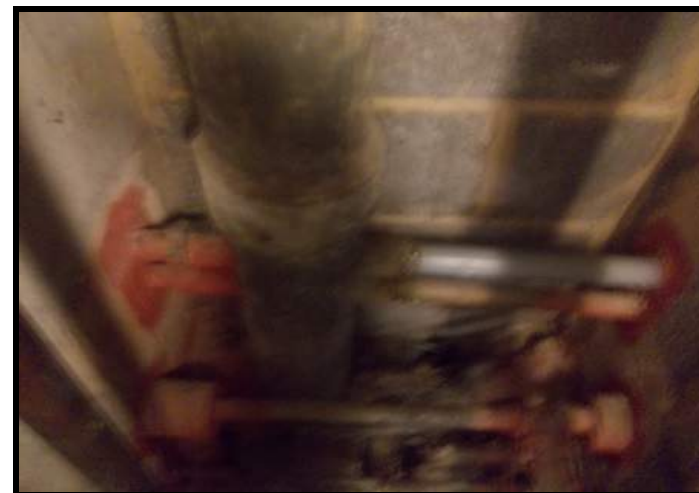
## SAMPLE REFERENCE 082

Asbestos Presumed

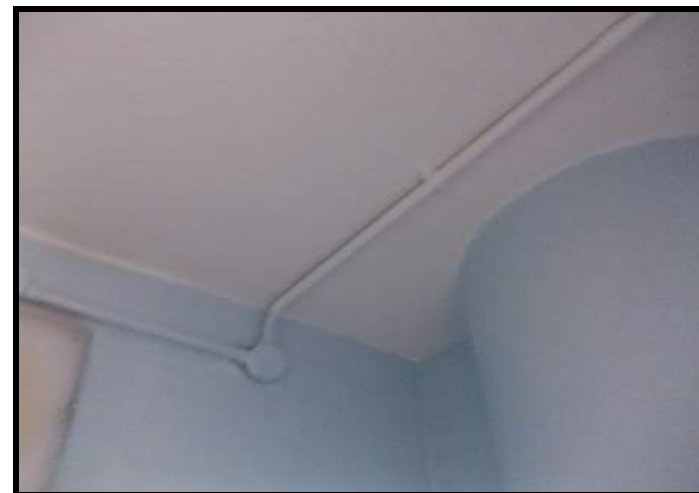
## SAMPLE REFERENCE 084

Asbestos Presumed

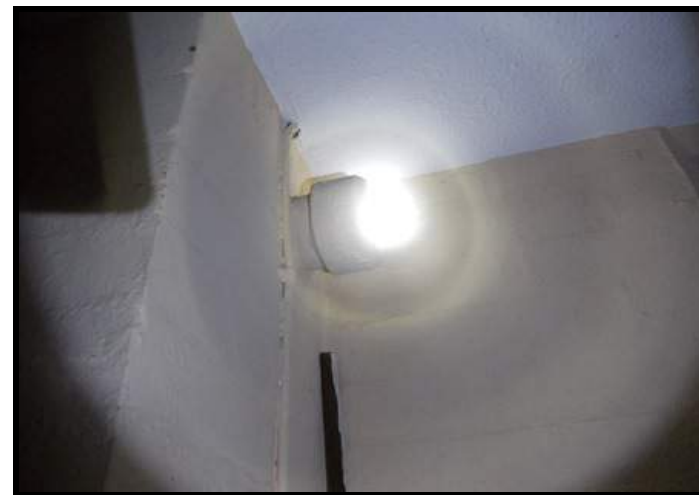
## SAMPLE REFERENCE 084b

**Asbestos Presumed**

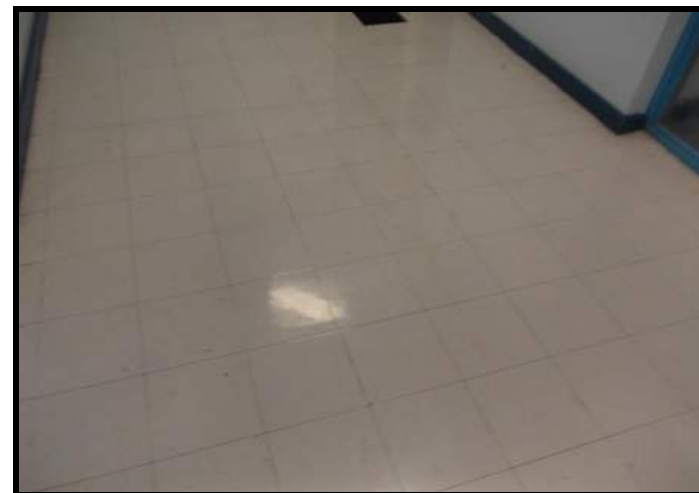
## SAMPLE REFERENCE 085

Asbestos Presumed

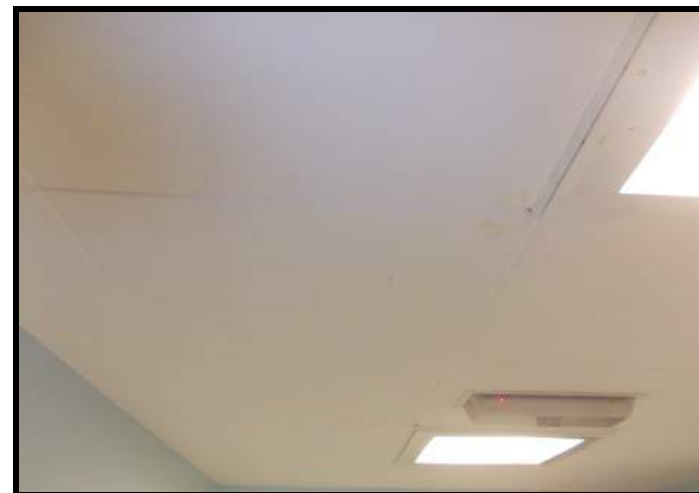
## SAMPLE REFERENCE 086

**No Asbestos Presumed in Sample**
