# Solihull Community Housing

## Asbestos Management Survey Report

**AVONCROFT HOUSE  
(COMMUNAL)  
WINCHESTER DRIVE  
SOLIHULL  
B37 5QH**

Date of Report: 29 Jan 2015

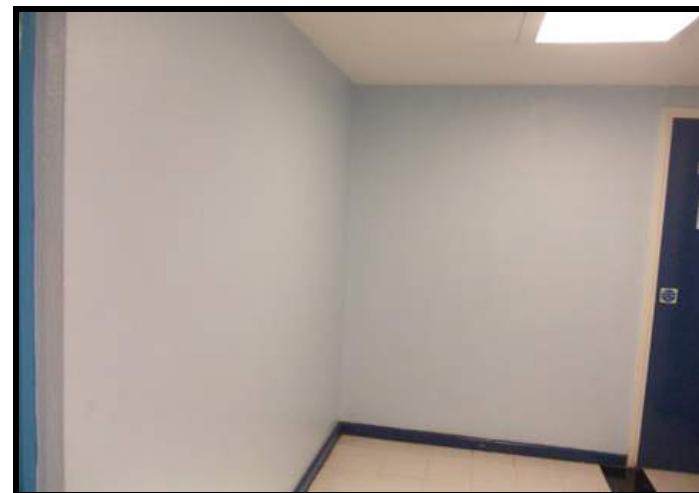
## SAMPLE REFERENCE 087

Asbestos Presumed

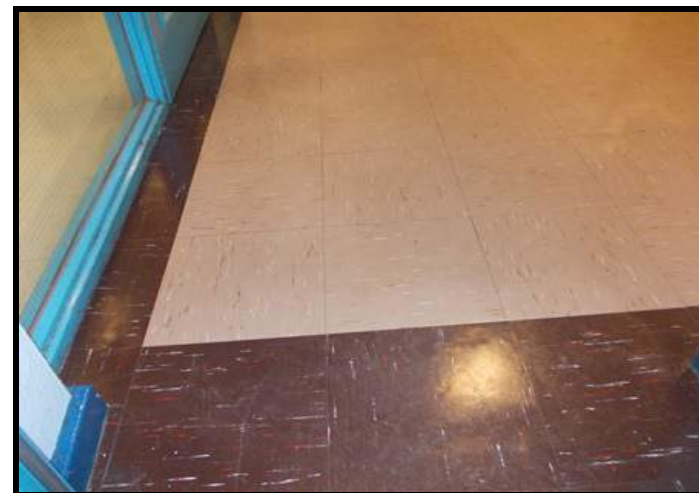
## SAMPLE REFERENCE 089a

**No Asbestos Presumed in Sample**

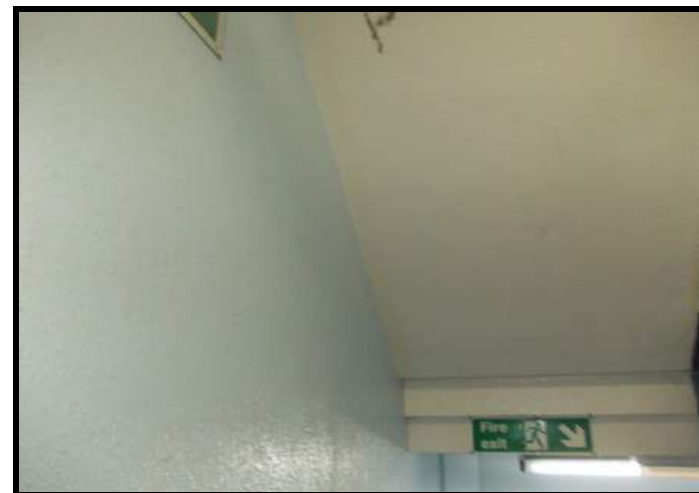
## SAMPLE REFERENCE 092

Building	Floor	Room	Location		
Main	Fifth to Fourth Floor	Stairwell	Ceiling And Walls		
Description	NO ACCESS WITHIN TIMBER ELECTRIC BOXING TO ALL FLOORS.				
MATERIAL ASSESSMENT					SCORE
Product Type	Textured Coating	Extent of Damage	Low damage		3
Asbestos Type	Chrysotile	Surface Treatment	Textured Coating		
PRIORITY ASSESSMENT					SCORE
Occupant Activity	Not Applicable	Extent / Amount	30.00 m2		1
Accessibility	Occasionally disturb	Location	Not Applicable		
Avg Time in Use	Not Applicable	Frequency of Use	Not Applicable		
No. of Occupants	Not Applicable	Secondary Activity	Not Applicable		
Maintenance	Not Applicable	Maintenance Frequency	Not Applicable		
MANAGEMENT ACTION					SCORE
Recommendation	LABEL & MONITOR				4
Recommendation Due		Next Inspection	12 Jan 2016		
Apply Labels	No	Permit to Work Required	No		
Survey Type	Management	Lead Surveyor	Gavin Hooper		
Survey Date	12 Jan 2015	UKAS Laboratory	NOT SAMPLED (Cross Referenced)

**Asbestos Presumed**

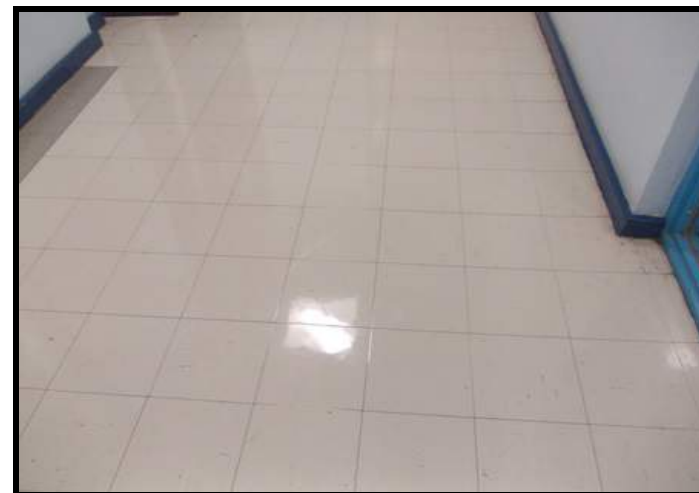
## SAMPLE REFERENCE 093

Building	Floor	Room	Location			
Main	Fourth Floor	Lobby I	Floor			
Description	NO ACCESS WITHIN TIMBER ELECTRIC BOXING TO ALL FLOORS.					
MATERIAL ASSESSMENT				SCORE		
Product Type	Floor Tiles	Extent of Damage	Low damage		3	
Asbestos Type	Chrysotile	Surface Treatment	Composite materials			
PRIORITY ASSESSMENT				SCORE		
Occupant Activity	Not Applicable	Extent / Amount	20.00 m2		1	
Accessibility	Occasionally disturb	Location	Not Applicable			
Avg Time in Use	Not Applicable	Frequency of Use	Not Applicable			
No. of Occupants	Not Applicable	Secondary Activity	Not Applicable			
Maintenance	Not Applicable	Maintenance Frequency	Not Applicable			
MANAGEMENT ACTION				SCORE		
Recommendation	LABEL & MONITOR			4		
Recommendation Due		Next Inspection	12 Jan 2016			
Apply Labels	No	Permit to Work Required	No			
Survey Type	Management	Lead Surveyor	Gavin Hooper			
Survey Date	12 Jan 2015	UKAS Laboratory	NOT SAMPLED (Cross Referenced)

Asbestos Presumed

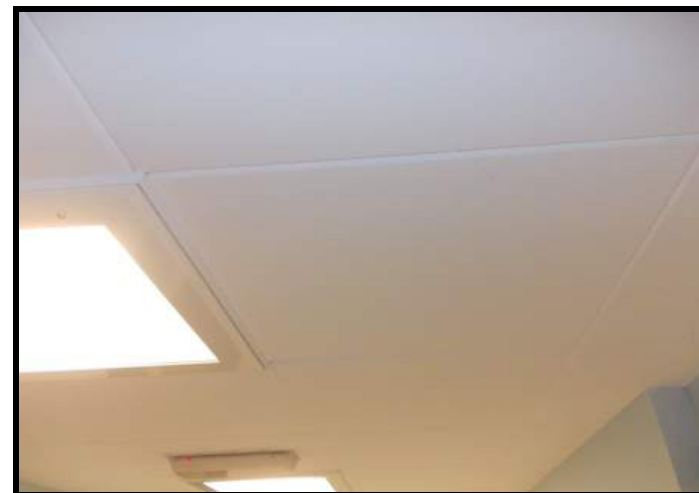
## SAMPLE REFERENCE 094

Building	Floor	Room	Location		
Main	Fourth Floor	Lobby I	Ceiling		
Description	NO ACCESS WITHIN TIMBER ELECTRIC BOXING TO ALL FLOORS.				
MATERIAL ASSESSMENT					SCORE
Product Type	Insulation Board	Extent of Damage	Low damage		-
Asbestos Type	No Asbestos Detected	Surface Treatment	Sealed Board (Encapsulated)		
PRIORITY ASSESSMENT					SCORE
Occupant Activity	Not Applicable	Extent / Amount	20.00 m2		-
Accessibility	Easily disturbed	Location	Not Applicable		
Avg Time in Use	Not Applicable	Frequency of Use	Not Applicable		
No. of Occupants	Not Applicable	Secondary Activity	Not Applicable		
Maintenance	Not Applicable	Maintenance Frequency	Not Applicable		
MANAGEMENT ACTION					SCORE
Recommendation	NOT APPLICABLE				-
Recommendation Due		Next Inspection	None		
Apply Labels	No	Permit to Work Required	No		
Survey Type	Management	Lead Surveyor	Gavin Hooper		
Survey Date	12 Jan 2015	UKAS Laboratory	NOT SAMPLED (Cross Referenced)

**No Asbestos Presumed in Sample**

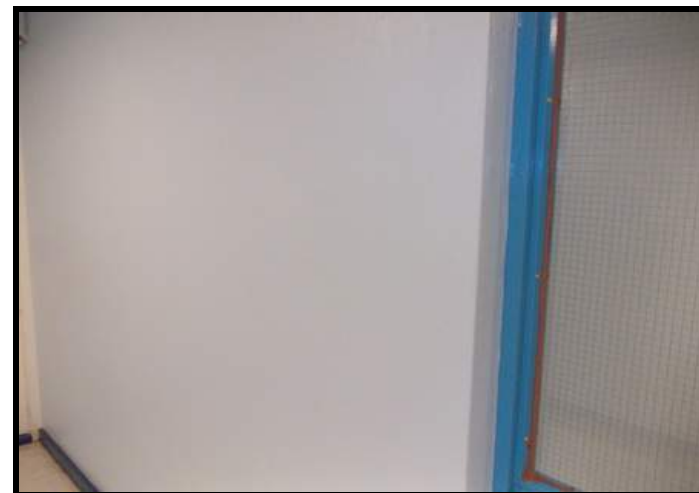
## SAMPLE REFERENCE 095

Building	Floor	Room	Location		
Main	Fourth Floor	Lobby I	Ceiling And Walls		
Description	NO ACCESS WITHIN TIMBER ELECTRIC BOXING TO ALL FLOORS.				
MATERIAL ASSESSMENT					SCORE
Product Type	Textured Coating	Extent of Damage	Low damage		3
Asbestos Type	Chrysotile	Surface Treatment	Textured Coating		
PRIORITY ASSESSMENT					SCORE
Occupant Activity	Not Applicable	Extent / Amount	12.00 m2		1
Accessibility	Occasionally disturb	Location	Not Applicable		
Avg Time in Use	Not Applicable	Frequency of Use	Not Applicable		
No. of Occupants	Not Applicable	Secondary Activity	Not Applicable		
Maintenance	Not Applicable	Maintenance Frequency	Not Applicable		
MANAGEMENT ACTION					SCORE
Recommendation	NOT APPLICABLE				4
Recommendation Due		Next Inspection	12 Jan 2016		
Apply Labels	No	Permit to Work Required	No		
Survey Type	Management	Lead Surveyor	Gavin Hooper		
Survey Date	12 Jan 2015	UKAS Laboratory	NOT SAMPLED (Cross Referenced)

**Asbestos Presumed**

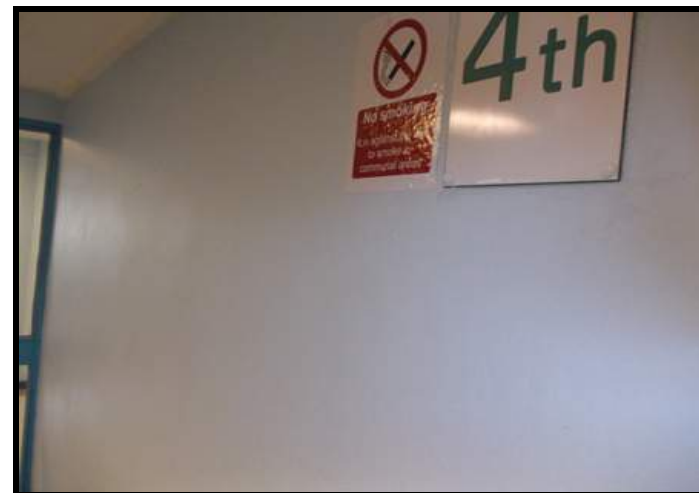
## SAMPLE REFERENCE 095c

MATERIAL ASSESSMENT				SCORE
Product Type	Textured Coating	Extent of Damage	Low damage	3
Asbestos Type	Chrysotile	Surface Treatment	Textured Coating

Asbestos Presumed

MANAGEMENT ACTION				SCORE
Recommendation	LABEL & MONITOR			4
Recommendation Due		Next Inspection	None	
Apply Labels	No	Permit to Work Required	No

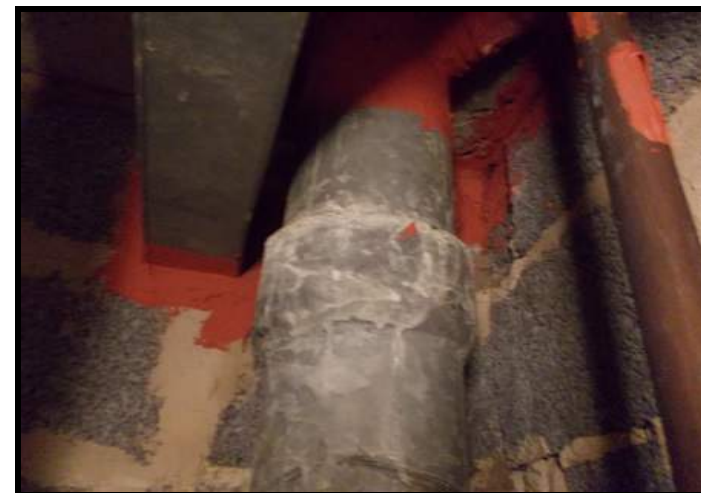
## SAMPLE REFERENCE 096

Building	Floor	Room	Location
Main	Fourth Floor	Riser 1	Pipe Work
Description			
MATERIAL ASSESSMENT			
Product Type	Lagging	Extent of Damage	Low damage
Asbestos Type	Amosite / Chrysotile	Surface Treatment	Sealed (0)
SCORE			
6			
PRIORITY ASSESSMENT			
Occupant Activity	Not Applicable	Extent / Amount	1.00 m2
Accessibility	Occasionally disturb	Location	Not Applicable
Avg Time in Use	Not Applicable	Frequency of Use	Not Applicable
No. of Occupants	Not Applicable	Secondary Activity	Not Applicable
Maintenance	Not Applicable	Maintenance Frequency	Not Applicable
SCORE			
1			
MANAGEMENT ACTION			
Recommendation	LABEL & MONITOR		
Recommendation Due		Next Inspection	12 Jul 2015
Apply Labels	No	Permit to Work Required	No
SCORE			
7			
Survey Type	Management	Lead Surveyor	Gavin Hooper
Survey Date	12 Jan 2015	UKAS Laboratory	NOT SAMPLED (Cross Referenced)
Site Reference	I39470000A	Licensed Material	Yes
		Notifiable Non Licensed Work	No

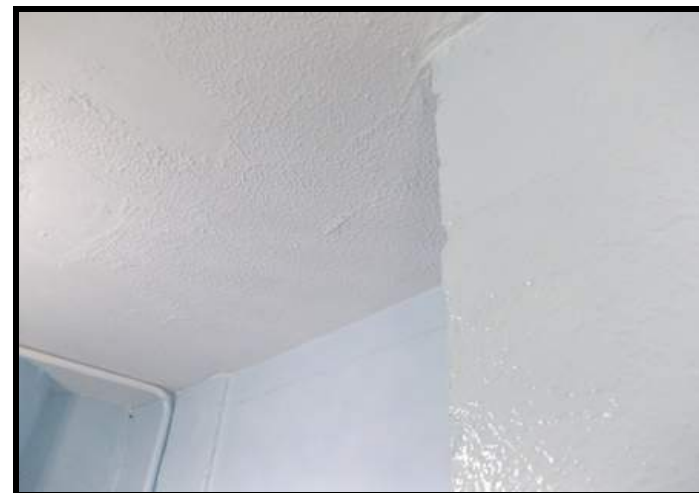
## SAMPLE REFERENCE 099

Building	Floor	Room	Location			
Main	Fourth Floor	Bin Chute	Ceiling And Walls			
Description	NO ACCESS WITHIN TIMBER ELECTRIC BOXING TO ALL FLOORS.					
MATERIAL ASSESSMENT				SCORE		
Product Type	Textured Coating	Extent of Damage	Low damage		3	
Asbestos Type	Chrysotile	Surface Treatment	Textured Coating			
PRIORITY ASSESSMENT				SCORE		
Occupant Activity	Not Applicable	Extent / Amount	12.00 m2		1	
Accessibility	Occasionally disturb	Location	Not Applicable			
Avg Time in Use	Not Applicable	Frequency of Use	Not Applicable			
No. of Occupants	Not Applicable	Secondary Activity	Not Applicable			
Maintenance	Not Applicable	Maintenance Frequency	Not Applicable			
MANAGEMENT ACTION				SCORE		
Recommendation	LABEL & MONITOR			4		
Recommendation Due		Next Inspection	12 Jan 2016			
Apply Labels	No	Permit to Work Required	No			
Survey Type	Management	Lead Surveyor	Gavin Hooper			
Survey Date	12 Jan 2015	UKAS Laboratory	NOT SAMPLED (Cross Referenced)

**Asbestos Presumed**

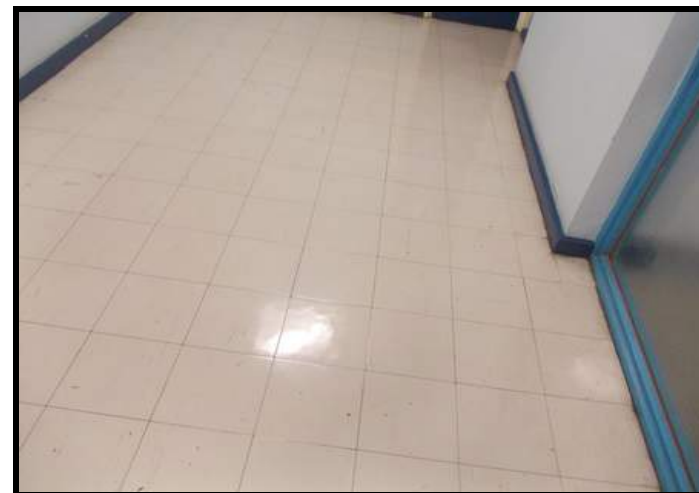
## SAMPLE REFERENCE 100

Building	Floor	Room	Location			
Main	Fourth Floor	Lobby 2	Floor			
Description	NO ACCESS WITHIN TIMBER ELECTRIC BOXING TO ALL FLOORS.					
MATERIAL ASSESSMENT				SCORE		
Product Type	Floor Tiles	Extent of Damage	Low damage		3	
Asbestos Type	Chrysotile	Surface Treatment	Composite materials			
PRIORITY ASSESSMENT				SCORE		
Occupant Activity	Not Applicable	Extent / Amount	20.00 m2		1	
Accessibility	Occasionally disturb	Location	Not Applicable			
Avg Time in Use	Not Applicable	Frequency of Use	Not Applicable			
No. of Occupants	Not Applicable	Secondary Activity	Not Applicable			
Maintenance	Not Applicable	Maintenance Frequency	Not Applicable			
MANAGEMENT ACTION				SCORE		
Recommendation	LABEL & MONITOR			4		
Recommendation Due		Next Inspection	12 Jan 2016			
Apply Labels	No	Permit to Work Required	No			
Survey Type	Management	Lead Surveyor	Gavin Hooper			
Survey Date	12 Jan 2015	UKAS Laboratory	NOT SAMPLED (Cross Referenced)

Asbestos Presumed

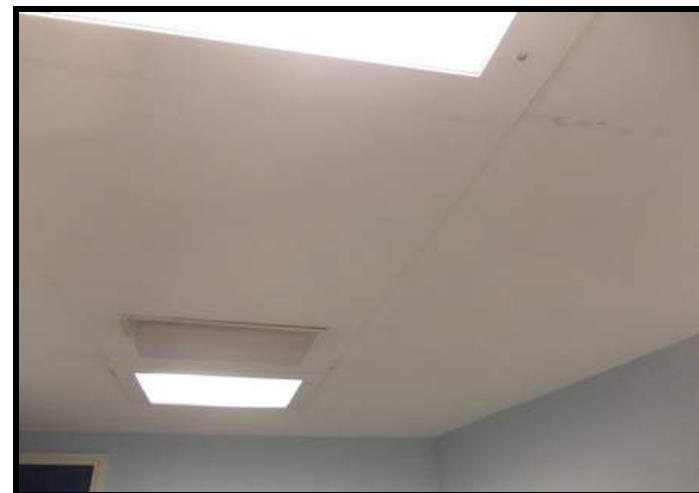
## SAMPLE REFERENCE 101

Building	Floor	Room	Location		
Main	Fourth Floor	Lobby 2	Ceiling		
Description	NO ACCESS WITHIN TIMBER ELECTRIC BOXING TO ALL FLOORS.				
MATERIAL ASSESSMENT					SCORE
Product Type	Insulation Board	Extent of Damage	Low damage		-
Asbestos Type	No Asbestos Detected	Surface Treatment	Sealed Board (Encapsulated)		
PRIORITY ASSESSMENT					SCORE
Occupant Activity	Not Applicable	Extent / Amount	20.00 m2		-
Accessibility	Easily disturbed	Location	Not Applicable		
Avg Time in Use	Not Applicable	Frequency of Use	Not Applicable		
No. of Occupants	Not Applicable	Secondary Activity	Not Applicable		
Maintenance	Not Applicable	Maintenance Frequency	Not Applicable		
MANAGEMENT ACTION					SCORE
Recommendation	NO ACTION REQUIRED				-
Recommendation Due		Next Inspection	None		
Apply Labels	No	Permit to Work Required	No		
Survey Type	Management	Lead Surveyor	Gavin Hooper		
Survey Date	12 Jan 2015	UKAS Laboratory	NOT SAMPLED (Cross Referenced)

**No Asbestos Presumed in Sample**

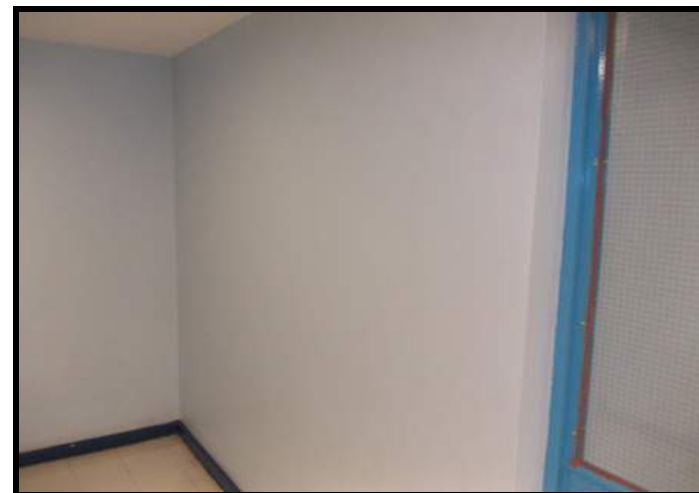
## SAMPLE REFERENCE 102

Building	Floor	Room	Location			
Main	Fourth Floor	Lobby 2	Ceiling And Walls			
Description	NO ACCESS WITHIN TIMBER ELECTRIC BOXING TO ALL FLOORS.					
MATERIAL ASSESSMENT				SCORE		
Product Type	Textured Coating	Extent of Damage	Low damage		3	
Asbestos Type	Chrysotile	Surface Treatment	Textured Coating			
PRIORITY ASSESSMENT				SCORE		
Occupant Activity	Not Applicable	Extent / Amount	12.00 m2		1	
Accessibility	Occasionally disturb	Location	Not Applicable			
Avg Time in Use	Not Applicable	Frequency of Use	Not Applicable			
No. of Occupants	Not Applicable	Secondary Activity	Not Applicable			
Maintenance	Not Applicable	Maintenance Frequency	Not Applicable			
MANAGEMENT ACTION				SCORE		
Recommendation	LABEL & MONITOR			4		
Recommendation Due		Next Inspection	12 Jan 2016			
Apply Labels	No	Permit to Work Required	No			
Survey Type	Management	Lead Surveyor	Gavin Hooper			
Survey Date	12 Jan 2015	UKAS Laboratory	NOT SAMPLED (Cross Referenced)

**Asbestos Presumed**

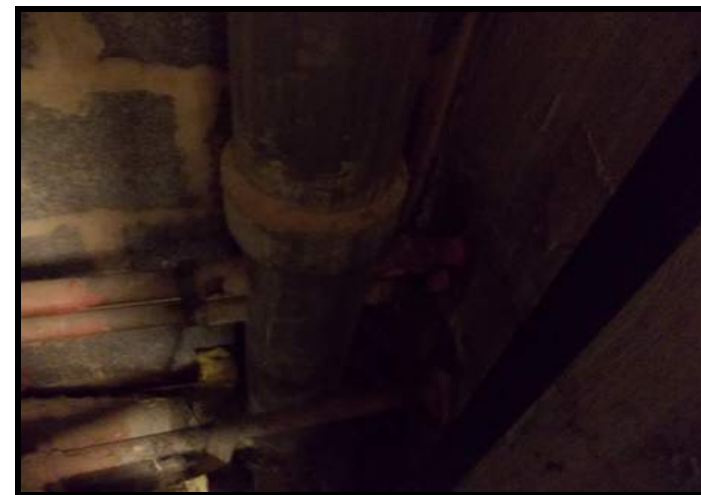
## SAMPLE REFERENCE 103

Building	Floor	Room	Location		
Main	Fourth Floor	Riser 3	Pipe Work		
Description					
MATERIAL ASSESSMENT				SCORE	
Product Type	Lagging	Extent of Damage	Low damage	6	
Asbestos Type	Amosite / Chrysotile	Surface Treatment	Sealed (0)		
PRIORITY ASSESSMENT				SCORE	
Occupant Activity	Not Applicable	Extent / Amount	1.00 m2	1	
Accessibility	Occasionally disturb	Location	Not Applicable		
Avg Time in Use	Not Applicable	Frequency of Use	Not Applicable		
No. of Occupants	Not Applicable	Secondary Activity	Not Applicable		
Maintenance	Not Applicable	Maintenance Frequency	Not Applicable		
MANAGEMENT ACTION				SCORE	
Recommendation	LABEL & MONITOR			7	
Recommendation Due		Next Inspection	12 Jul 2015		
Apply Labels	No	Permit to Work Required	No		
Survey Type	Management	Lead Surveyor	Gavin Hooper		
Survey Date	12 Jan 2015	UKAS Laboratory	NOT SAMPLED (Cross Referenced)		
Site Reference	I39470000A	Licensed Material	Yes	Notifiable Non Licensed Work	No

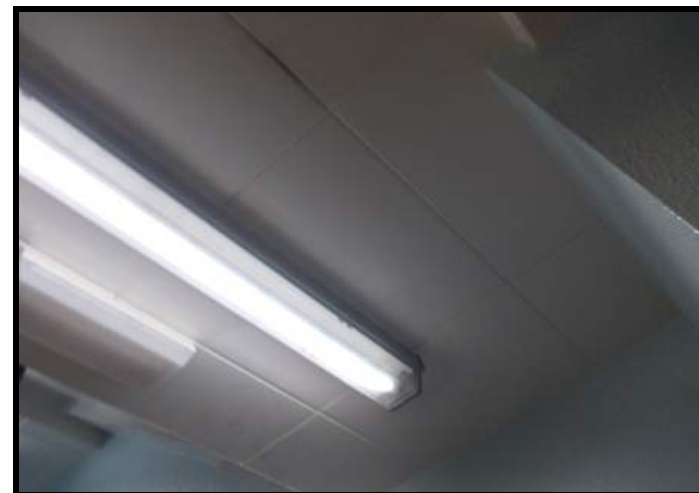
## SAMPLE REFERENCE 106

Building	Floor	Room	Location		
Main	Fourth to Third floor	Stairwell	Ceiling		
Description	NO ACCESS WITHIN TIMBER ELECTRIC BOXING TO ALL FLOORS.				
MATERIAL ASSESSMENT					SCORE
Product Type	Insulation Board	Extent of Damage	Low damage		-
Asbestos Type	No Asbestos Detected	Surface Treatment	Sealed Board (Encapsulated)		
PRIORITY ASSESSMENT					SCORE
Occupant Activity	Not Applicable	Extent / Amount	6.00 m2		-
Accessibility	Easily disturbed	Location	Not Applicable		
Avg Time in Use	Not Applicable	Frequency of Use	Not Applicable		
No. of Occupants	Not Applicable	Secondary Activity	Not Applicable		
Maintenance	Not Applicable	Maintenance Frequency	Not Applicable		
MANAGEMENT ACTION					SCORE
Recommendation	NOT APPLICABLE				-
Recommendation Due		Next Inspection	None		
Apply Labels	No	Permit to Work Required	No		
Survey Type	Management	Lead Surveyor	Gavin Hooper		
Survey Date	12 Jan 2015	UKAS Laboratory	NOT SAMPLED (Cross Referenced)

**No Asbestos Presumed in Sample**

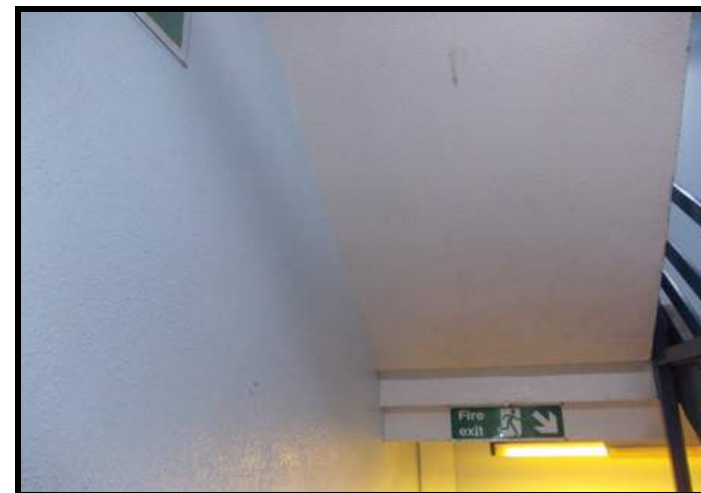
## SAMPLE REFERENCE 107

Building	Floor	Room	Location			
Main	Fourth to Third floor	Stairwell	Ceiling And Walls			
Description	NO ACCESS WITHIN TIMBER ELECTRIC BOXING TO ALL FLOORS.					
MATERIAL ASSESSMENT				SCORE		
Product Type	Textured Coating	Extent of Damage	Low damage		3	
Asbestos Type	Chrysotile	Surface Treatment	Textured Coating			
PRIORITY ASSESSMENT				SCORE		
Occupant Activity	Not Applicable	Extent / Amount	30.00 m2		1	
Accessibility	Occasionally disturb	Location	Not Applicable			
Avg Time in Use	Not Applicable	Frequency of Use	Not Applicable			
No. of Occupants	Not Applicable	Secondary Activity	Not Applicable			
Maintenance	Not Applicable	Maintenance Frequency	Not Applicable			
MANAGEMENT ACTION				SCORE		
Recommendation	LABEL & MONITOR			4		
Recommendation Due		Next Inspection	12 Jan 2016			
Apply Labels	No	Permit to Work Required	No			
Survey Type	Management	Lead Surveyor	Gavin Hooper			
Survey Date	12 Jan 2015	UKAS Laboratory	NOT SAMPLED (Cross Referenced)

**Asbestos Presumed**

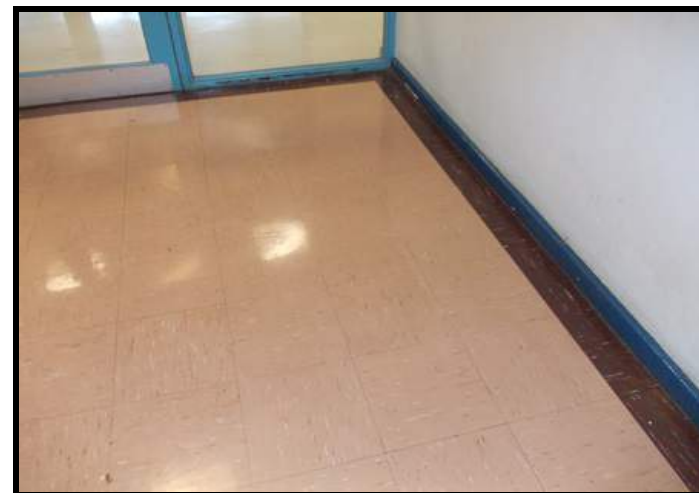
## SAMPLE REFERENCE I I0a

**No Asbestos Presumed in Sample**

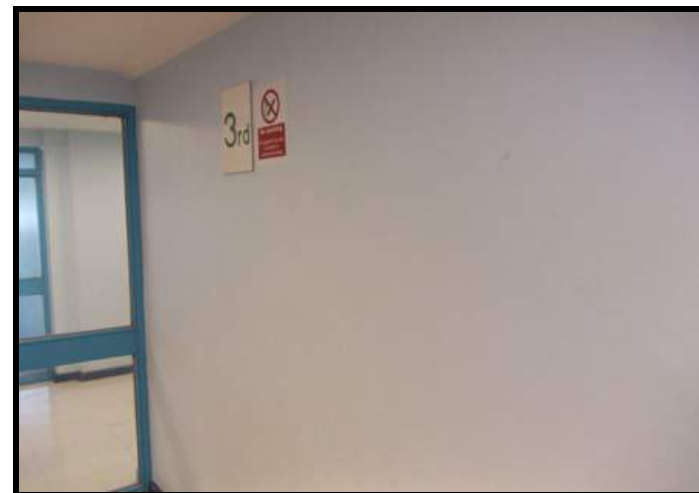
## SAMPLE REFERENCE I10c

**Asbestos Presumed**

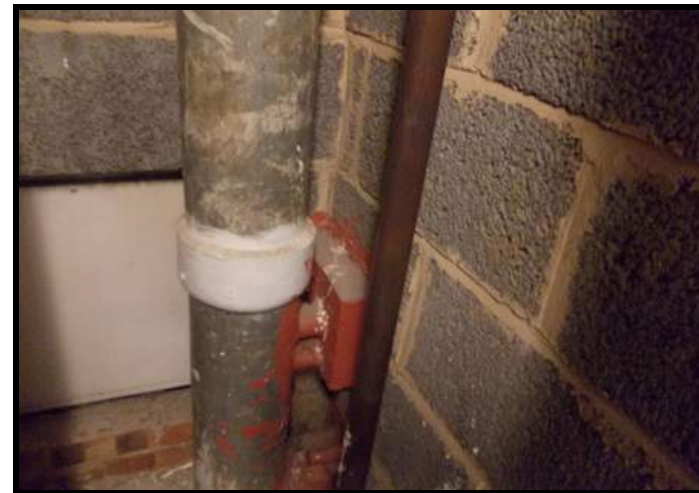
## SAMPLE REFERENCE III

Asbestos Presumed

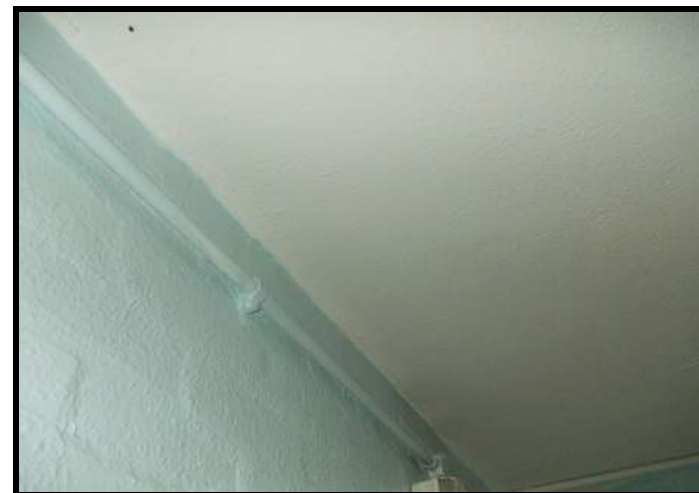
## SAMPLE REFERENCE I I 4

**Asbestos Presumed**

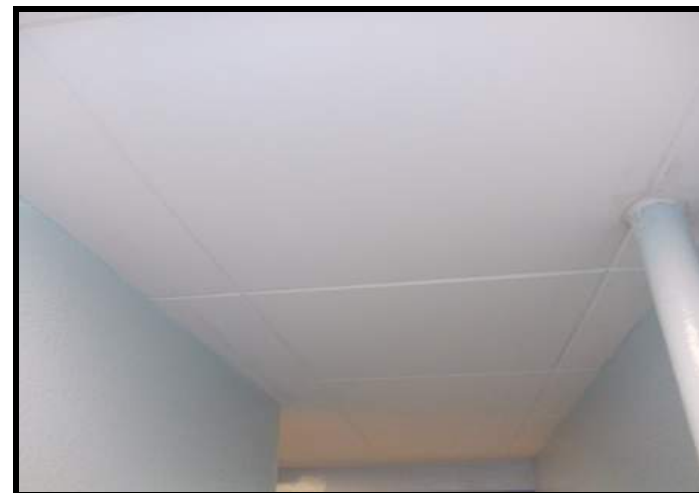
## SAMPLE REFERENCE I I 4a

**No Asbestos Presumed in Sample**

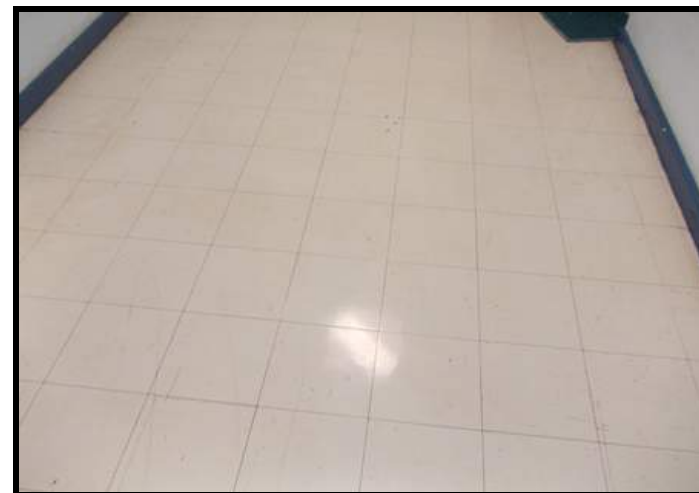
## SAMPLE REFERENCE I I 5

**Asbestos Presumed**

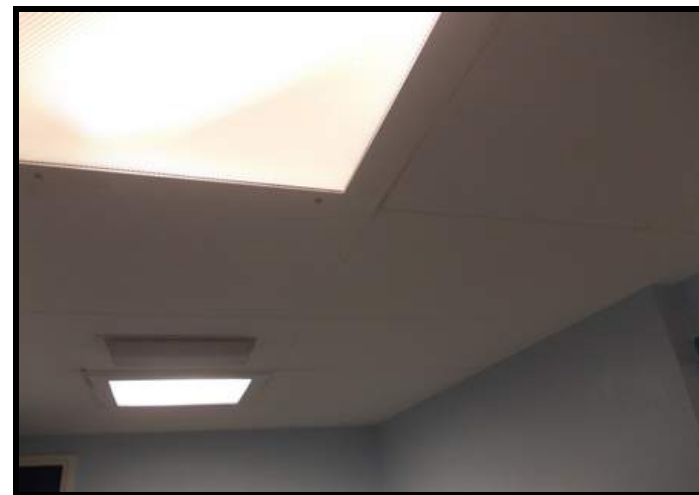
## SAMPLE REFERENCE I I 6

**No Asbestos Presumed in Sample**

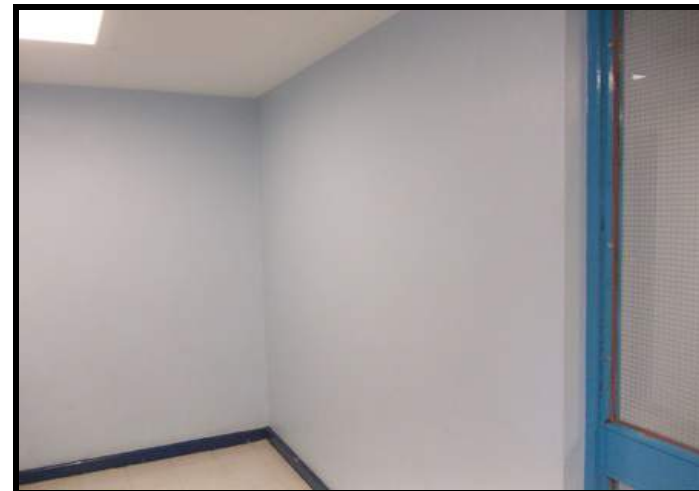
## SAMPLE REFERENCE I I 7

**Asbestos Presumed**

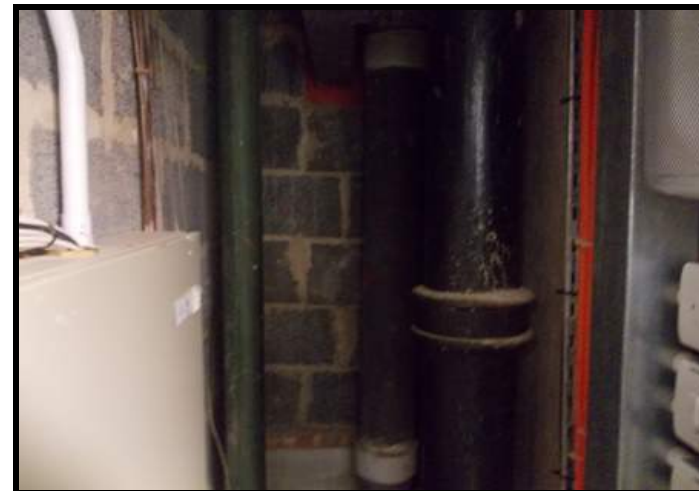
## SAMPLE REFERENCE I 18

Asbestos Presumed

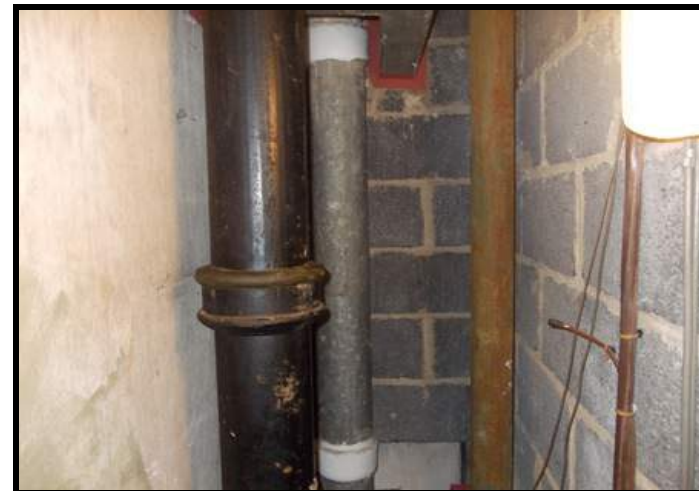
## SAMPLE REFERENCE I 19

Asbestos Presumed

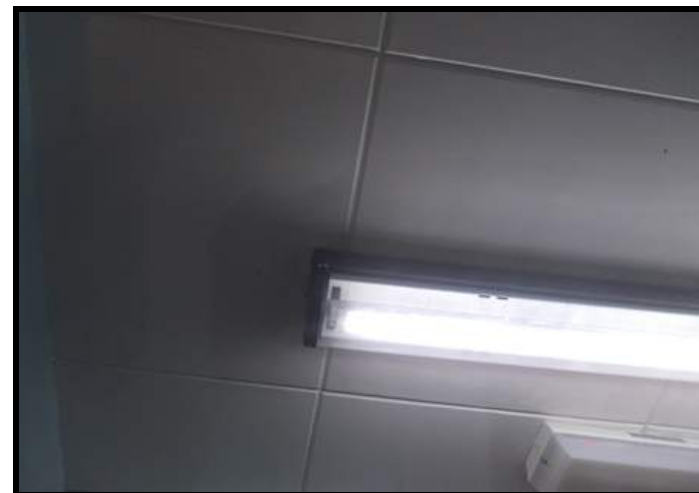
## SAMPLE REFERENCE 121

**No Asbestos Presumed in Sample**

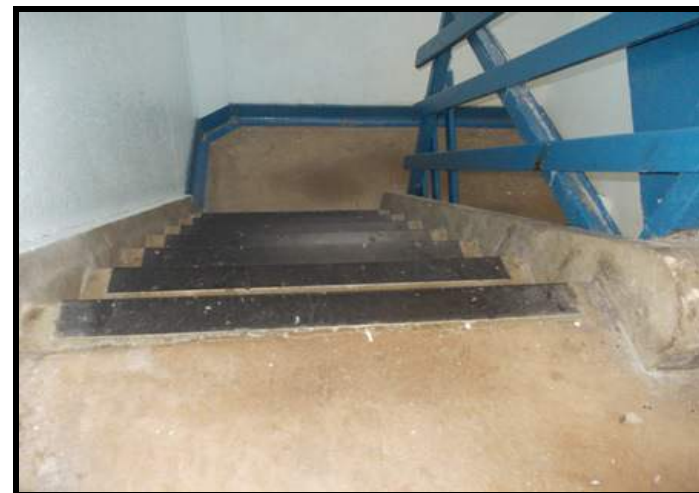
## SAMPLE REFERENCE I21a

**Asbestos Presumed**

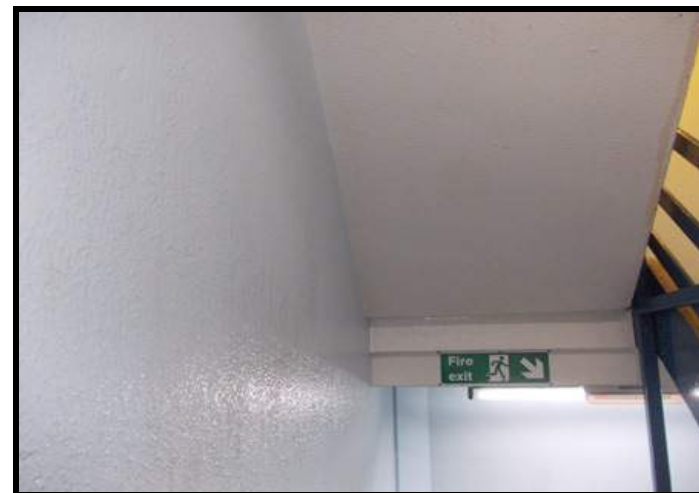
## SAMPLE REFERENCE 122

Asbestos Presumed

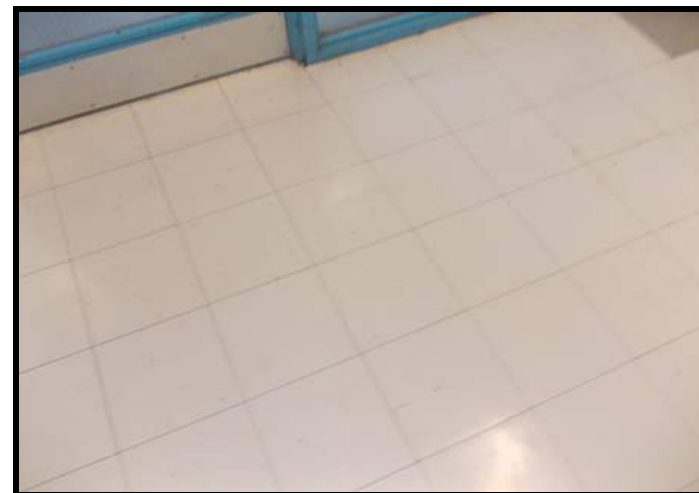
## SAMPLE REFERENCE 123

Asbestos Presumed

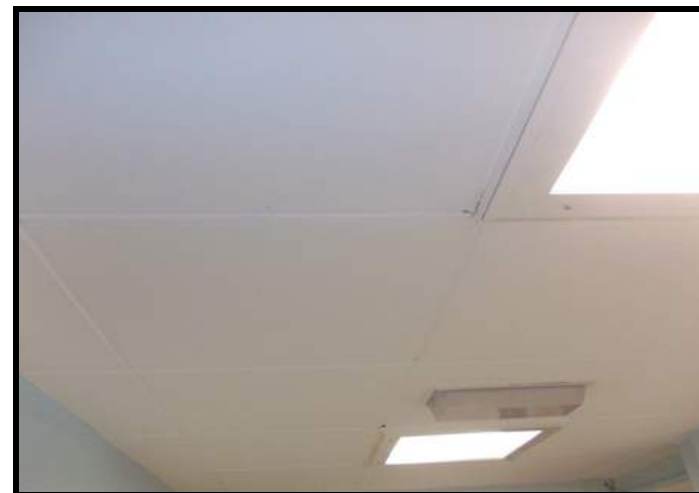
## SAMPLE REFERENCE 124

**No Asbestos Presumed in Sample**

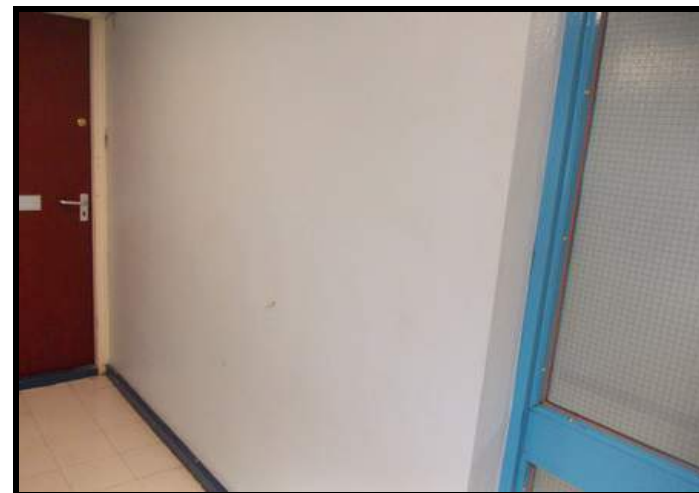
## SAMPLE REFERENCE 125

**Asbestos Presumed**

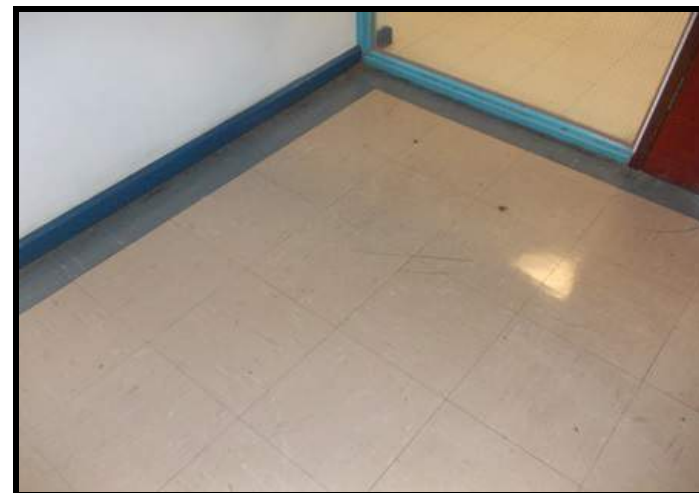
## SAMPLE REFERENCE I25a

**No Asbestos Presumed in Sample**

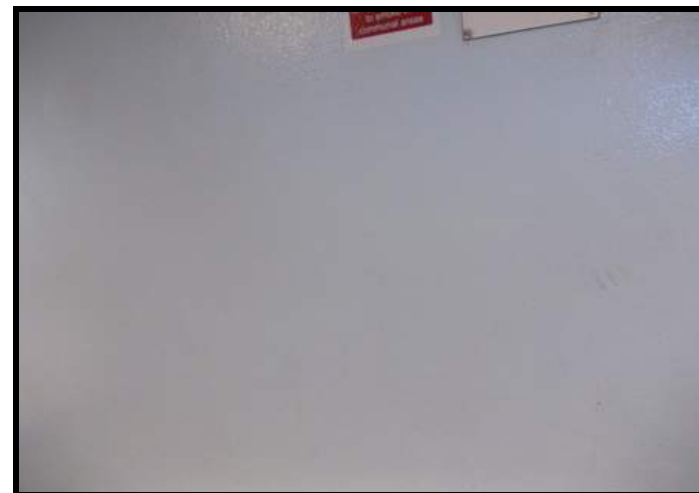
## SAMPLE REFERENCE I25b

**Asbestos Presumed**

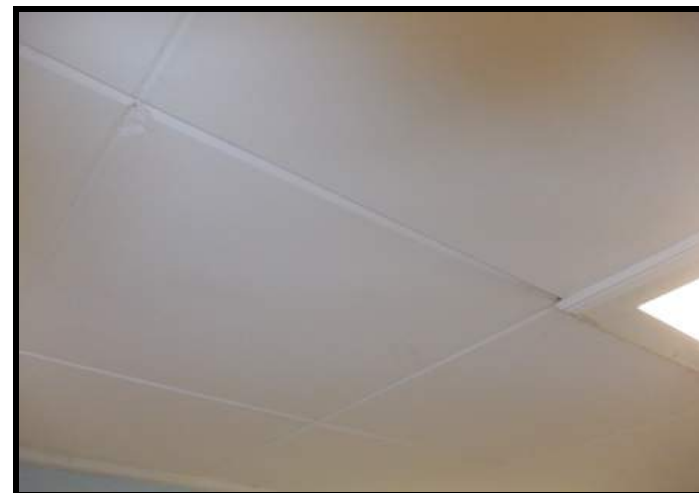
## SAMPLE REFERENCE I25c

**No Asbestos Presumed in Sample**

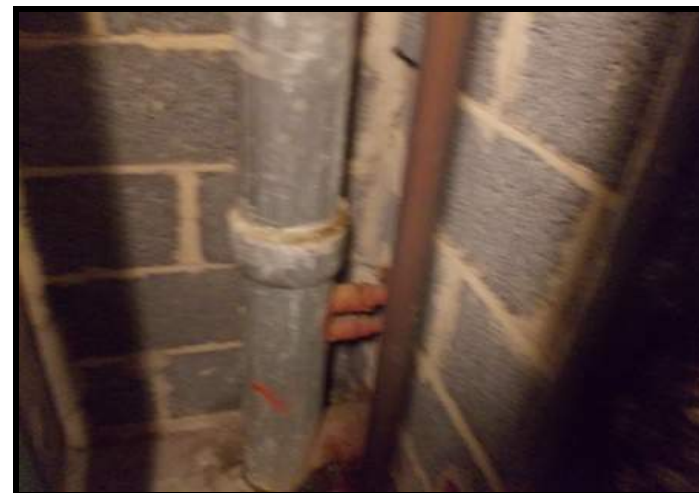
## SAMPLE REFERENCE 126

Asbestos Presumed

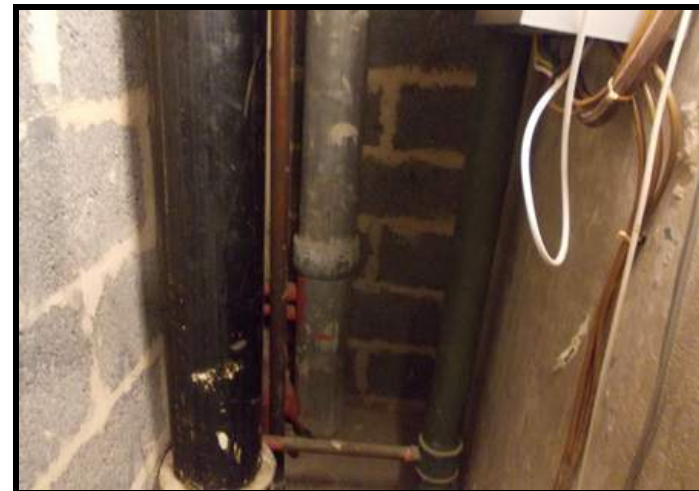
## SAMPLE REFERENCE 127

Asbestos Presumed

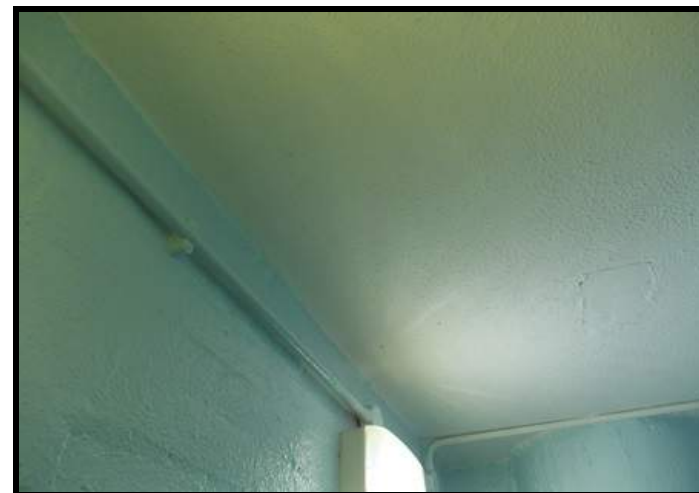
## SAMPLE REFERENCE 129

**Asbestos Presumed**

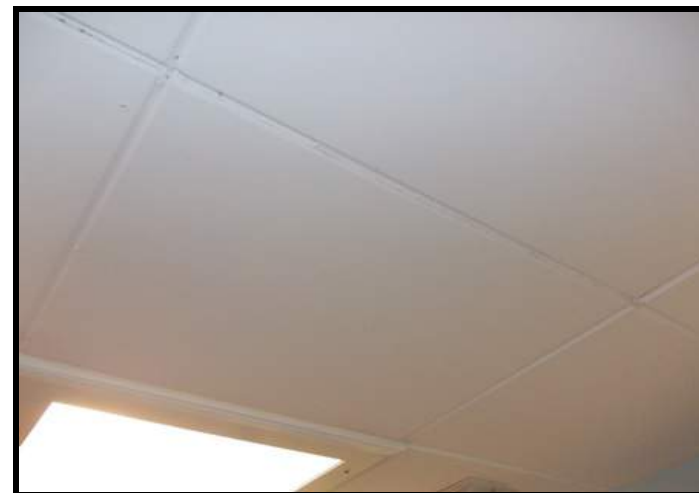
## SAMPLE REFERENCE I29b

**No Asbestos Presumed in Sample**

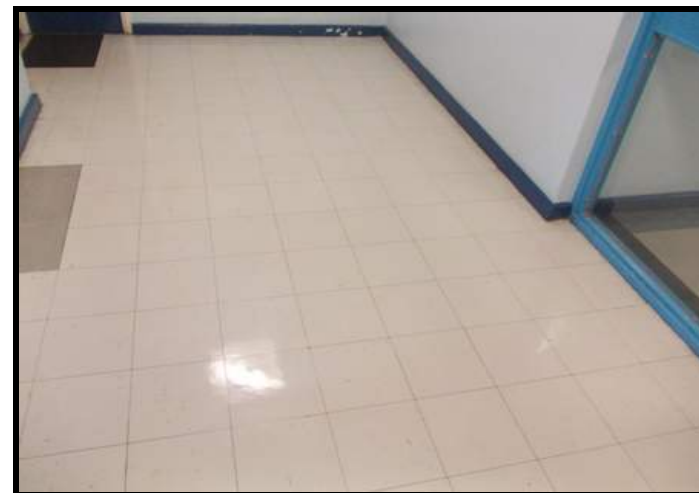
## SAMPLE REFERENCE 130

Asbestos Presumed

Building	Floor	Room	Location		
Main	Second Floor	Lobby 2	Ceiling		
Description	NO ACCESS WITHIN TIMBER ELECTRIC BOXING ON EACH FLOOR.				
MATERIAL ASSESSMENT				SCORE	
Product Type	Insulation Board	Extent of Damage	Low damage		-
Asbestos Type	No Asbestos Detected	Surface Treatment	Sealed Board (Encapsulated)		
PRIORITY ASSESSMENT				SCORE	
Occupant Activity	Not Applicable	Extent / Amount	20.00 m2		-
Accessibility	Easily disturbed	Location	Not Applicable		
Avg Time in Use	Not Applicable	Frequency of Use	Not Applicable		
No. of Occupants	Not Applicable	Secondary Activity	Not Applicable		
Maintenance	Not Applicable	Maintenance Frequency	Not Applicable		
MANAGEMENT ACTION				SCORE	
Recommendation	NO ACTION REQUIRED				-
Recommendation Due		Next Inspection	None		
Apply Labels	No	Permit to Work Required	No		
Survey Type	Management	Lead Surveyor	Gavin Hooper		
Survey Date	12 Jan 2015	UKAS Laboratory	NOT SAMPLED (Cross Referenced)

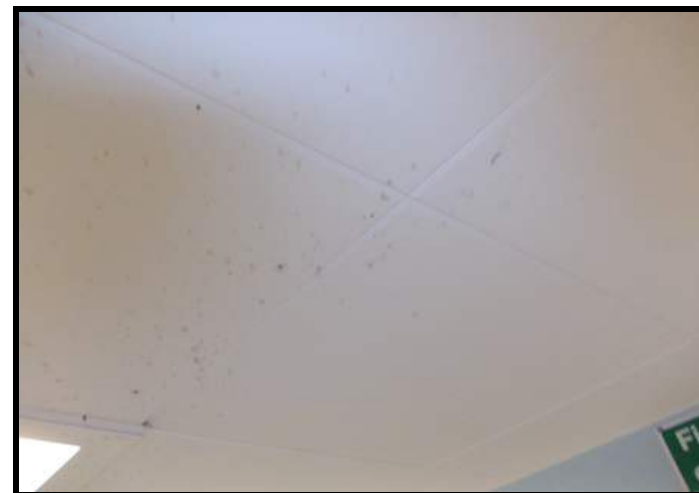
## SAMPLE REFERENCE I3I

**No Asbestos Presumed in Sample**

Building	Floor	Room	Location			
Main	Second Floor	Lobby 2	Ceiling And Walls			
Description	NO ACCESS WITHIN TIMBER ELECTRIC BOXING ON EACH FLOOR.					
MATERIAL ASSESSMENT				SCORE		
Product Type	Textured Coating	Extent of Damage	Low damage		3	
Asbestos Type	Chrysotile	Surface Treatment	Textured Coating			
PRIORITY ASSESSMENT				SCORE		
Occupant Activity	Not Applicable	Extent / Amount	12.00 m2		1	
Accessibility	Occasionally disturb	Location	Not Applicable			
Avg Time in Use	Not Applicable	Frequency of Use	Not Applicable			
No. of Occupants	Not Applicable	Secondary Activity	Not Applicable			
Maintenance	Not Applicable	Maintenance Frequency	Not Applicable			
MANAGEMENT ACTION				SCORE		
Recommendation	LABEL & MONITOR			4		
Recommendation Due		Next Inspection	12 Jan 2016			
Apply Labels	No	Permit to Work Required	No			
Survey Type	Management	Lead Surveyor	Gavin Hooper			
Survey Date	12 Jan 2015	UKAS Laboratory	NOT SAMPLED (Cross Referenced)

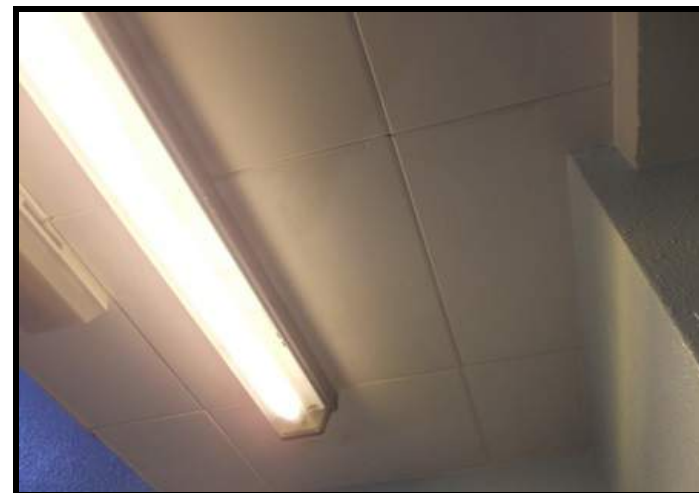
## SAMPLE REFERENCE I36

**No Asbestos Presumed in Sample**

MATERIAL ASSESSMENT				SCORE
<b>Product Type</b>	Bitumen	<b>Extent of Damage</b>	Low damage	<b>3</b>
<b>Asbestos Type</b>	<b>Chrysotile</b>	<b>Surface Treatment</b>	Composite materials

MANAGEMENT ACTION				SCORE
<b>Recommendation</b>	LABEL & MONITOR			<b>4</b>
<b>Recommendation Due</b>		<b>Next Inspection</b>	12 Jan 2016	
<b>Apply Labels</b>	No	<b>Permit to Work Required</b>	No

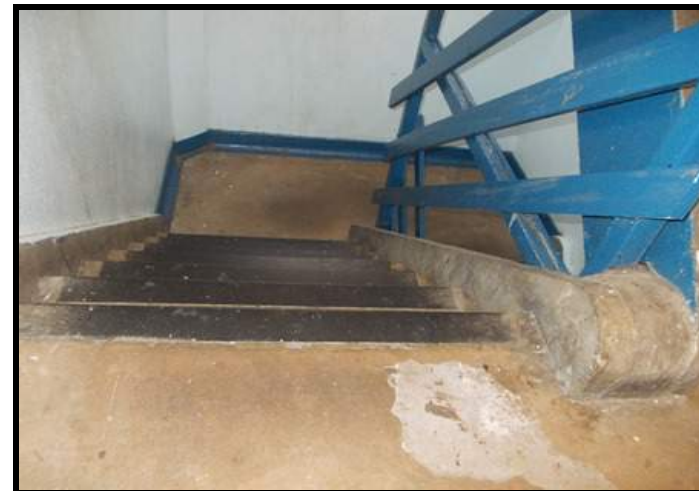
## SAMPLE REFERENCE I36a

**Asbestos Presumed**

Building	Floor	Room	Location			
Main	Second To First Floor	Stairwell	Ceiling And Walls			
Description	NO ACCESS WITHIN TIMBER ELECTRIC BOXING ON EACH FLOOR.					
MATERIAL ASSESSMENT				SCORE		
Product Type	Textured Coating	Extent of Damage	Low damage		3	
Asbestos Type	Chrysotile	Surface Treatment	Textured Coating			
PRIORITY ASSESSMENT				SCORE		
Occupant Activity	Not Applicable	Extent / Amount	30.00 m2		1	
Accessibility	Occasionally disturb	Location	Not Applicable			
Avg Time in Use	Not Applicable	Frequency of Use	Not Applicable			
No. of Occupants	Not Applicable	Secondary Activity	Not Applicable			
Maintenance	Not Applicable	Maintenance Frequency	Not Applicable			
MANAGEMENT ACTION				SCORE		
Recommendation	LABEL & MONITOR			4		
Recommendation Due		Next Inspection	12 Jan 2016			
Apply Labels	No	Permit to Work Required	No			
Survey Type	Management	Lead Surveyor	Gavin Hooper			
Survey Date	12 Jan 2015	UKAS Laboratory	NOT SAMPLED (Cross Referenced)

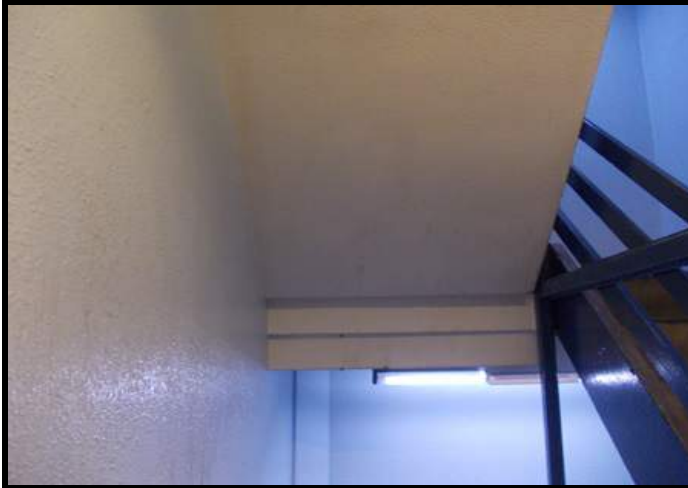
SAMPLE REFERENCE 137

SURVEYORS COMMENTS	
<p><b>Asbestos Presumed</b></p>

Building	Floor	Room	Location			
Main	First Floor	Lobby I	Floor			
Description	NO ACCESS WITHIN TIMBER ELECTRIC BOXING ON EACH FLOOR.					
MATERIAL ASSESSMENT				SCORE		
Product Type	Floor Tiles	Extent of Damage	Low damage		3	
Asbestos Type	Chrysotile	Surface Treatment	Composite materials			
PRIORITY ASSESSMENT				SCORE		
Occupant Activity	Not Applicable	Extent / Amount	20.00 m2		1	
Accessibility	Occasionally disturb	Location	Not Applicable			
Avg Time in Use	Not Applicable	Frequency of Use	Not Applicable			
No. of Occupants	Not Applicable	Secondary Activity	Not Applicable			
Maintenance	Not Applicable	Maintenance Frequency	Not Applicable			
MANAGEMENT ACTION				SCORE		
Recommendation	LABEL & MONITOR			4		
Recommendation Due		Next Inspection	12 Jan 2016			
Apply Labels	No	Permit to Work Required	No			
Survey Type	Management	Lead Surveyor	Gavin Hooper			
Survey Date	12 Jan 2015	UKAS Laboratory	NOT SAMPLED (Cross Referenced)

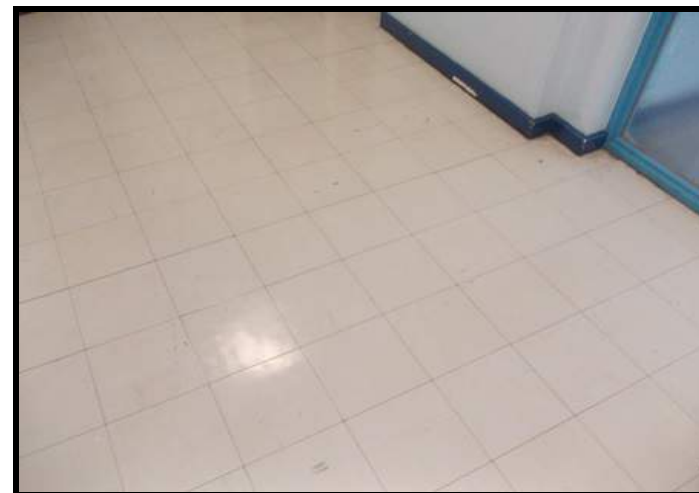
## SAMPLE REFERENCE I38

Asbestos Presumed

Building	Floor	Room	Location		
Main	First Floor	Lobby I	Ceiling		
Description	NO ACCESS WITHIN TIMBER ELECTRIC BOXING ON EACH FLOOR.				
MATERIAL ASSESSMENT					SCORE
Product Type	Insulation Board	Extent of Damage	Low damage		-
Asbestos Type	No Asbestos Detected	Surface Treatment	Sealed Board (Encapsulated)		
PRIORITY ASSESSMENT					SCORE
Occupant Activity	Not Applicable	Extent / Amount	20.00 m2		-
Accessibility	Occasionally disturb	Location	Not Applicable		
Avg Time in Use	Not Applicable	Frequency of Use	Not Applicable		
No. of Occupants	Not Applicable	Secondary Activity	Not Applicable		
Maintenance	Not Applicable	Maintenance Frequency	Not Applicable		
MANAGEMENT ACTION					SCORE
Recommendation	NO ACTION REQUIRED				-
Recommendation Due		Next Inspection	None		
Apply Labels	No	Permit to Work Required	No		
Survey Type	Management	Lead Surveyor	Gavin Hooper		
Survey Date	12 Jan 2015	UKAS Laboratory	NOT SAMPLED (Cross Referenced)

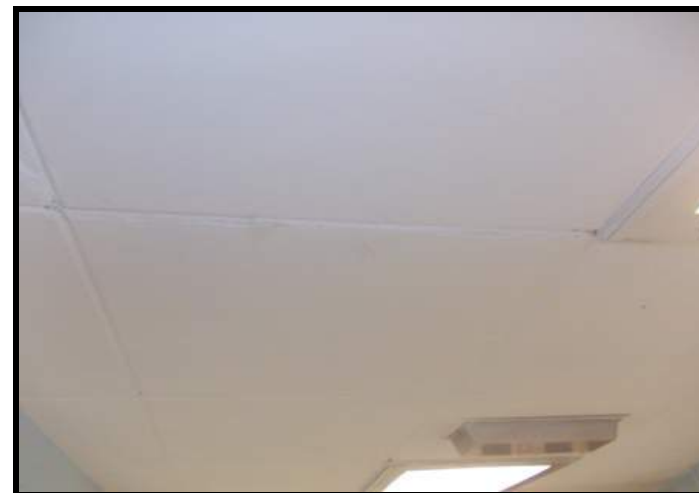
## SAMPLE REFERENCE I39

**No Asbestos Presumed in Sample**

Building	Floor	Room	Location			
Main	First Floor	Lobby I	Ceiling And Walls			
Description	NO ACCESS WITHIN TIMBER ELECTRIC BOXING ON EACH FLOOR.					
MATERIAL ASSESSMENT				SCORE		
Product Type	Textured Coating	Extent of Damage	Low damage		3	
Asbestos Type	Chrysotile	Surface Treatment	Textured Coating			
PRIORITY ASSESSMENT				SCORE		
Occupant Activity	Not Applicable	Extent / Amount	12.00 m2		1	
Accessibility	Occasionally disturb	Location	Not Applicable			
Avg Time in Use	Not Applicable	Frequency of Use	Not Applicable			
No. of Occupants	Not Applicable	Secondary Activity	Not Applicable			
Maintenance	Not Applicable	Maintenance Frequency	Not Applicable			
MANAGEMENT ACTION				SCORE		
Recommendation	LABEL & MONITOR			4		
Recommendation Due		Next Inspection	12 Jan 2016			
Apply Labels	No	Permit to Work Required	No			
Survey Type	Management	Lead Surveyor	Gavin Hooper			
Survey Date	12 Jan 2015	UKAS Laboratory	NOT SAMPLED (Cross Referenced)

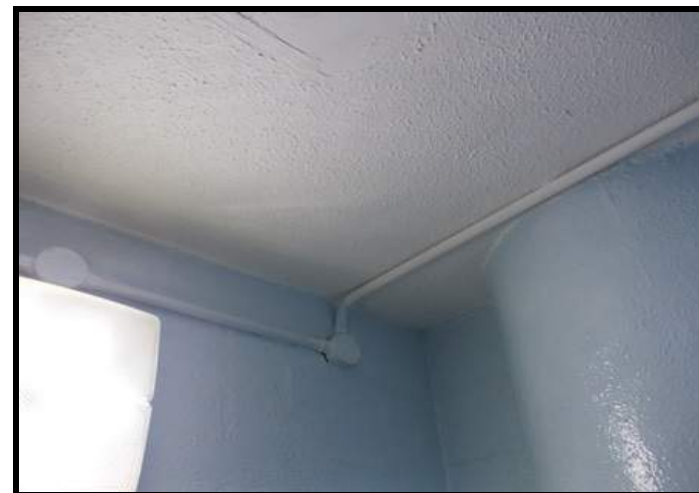
## SAMPLE REFERENCE 144

**Asbestos Presumed**

MATERIAL ASSESSMENT				SCORE
<b>Product Type</b>	Textured Coating	<b>Extent of Damage</b>	Low damage	<b>3</b>
<b>Asbestos Type</b>	<b>Chrysotile</b>	<b>Surface Treatment</b>	Textured Coating

MANAGEMENT ACTION				SCORE
<b>Recommendation</b>	LABEL & MONITOR			<b>4</b>
<b>Recommendation Due</b>		<b>Next Inspection</b>	12 Jan 2016	
<b>Apply Labels</b>	No	<b>Permit to Work Required</b>	No

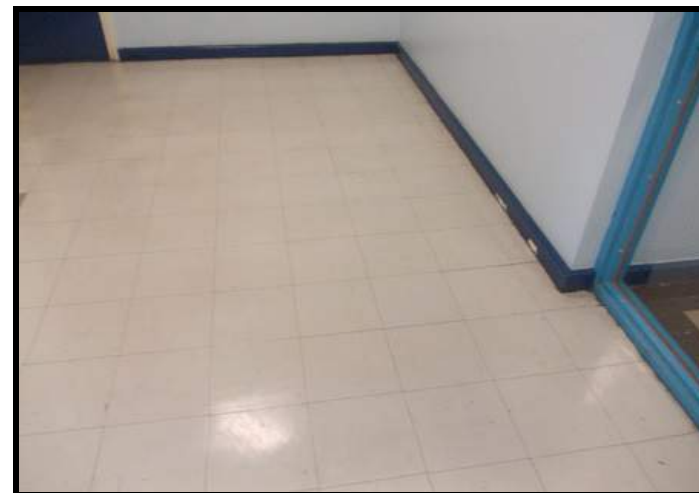
## SAMPLE REFERENCE 145

Asbestos Presumed

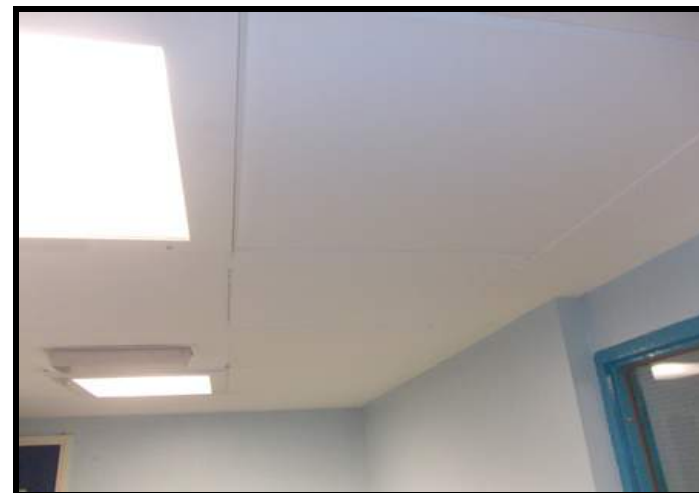
## SAMPLE REFERENCE I46

**No Asbestos Presumed in Sample**

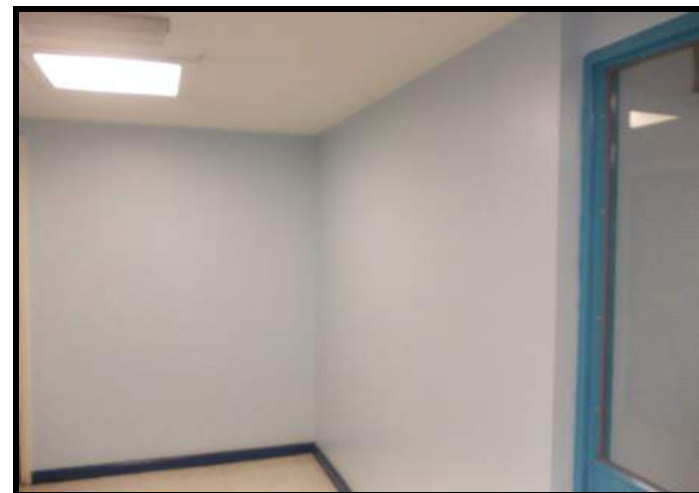
## SAMPLE REFERENCE 147

**Asbestos Presumed**
