# Solihull Community Housing

## Asbestos Management Survey Report

**AVONCROFT HOUSE  
(COMMUNAL)  
WINCHESTER DRIVE  
SOLIHULL  
B37 5QH**

Date of Report: 29 Jan 2015

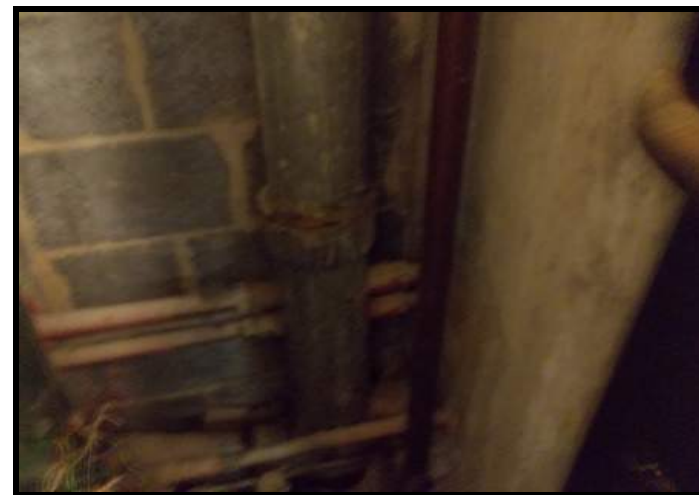
## SAMPLE REFERENCE I48

Asbestos Presumed

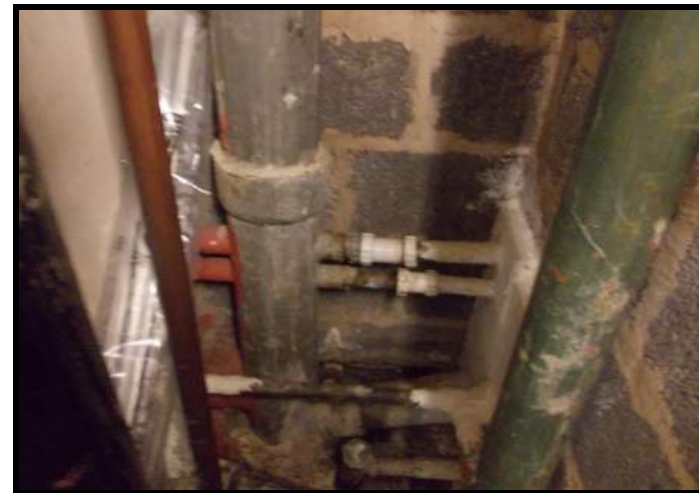
## SAMPLE REFERENCE 149

Asbestos Presumed

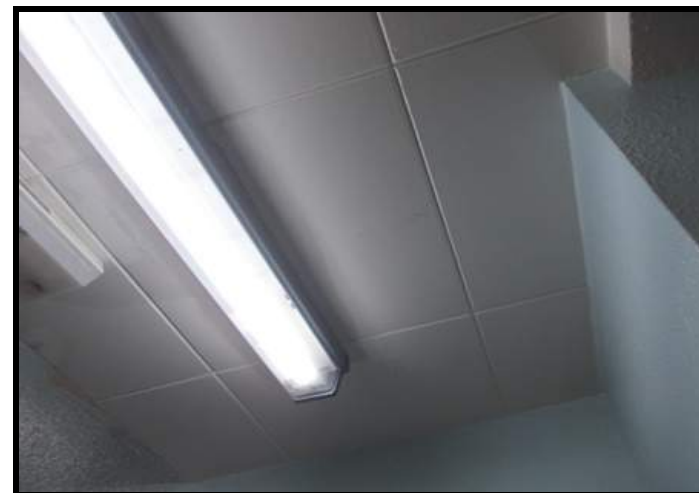
## SAMPLE REFERENCE 151

**No Asbestos Presumed in Sample**

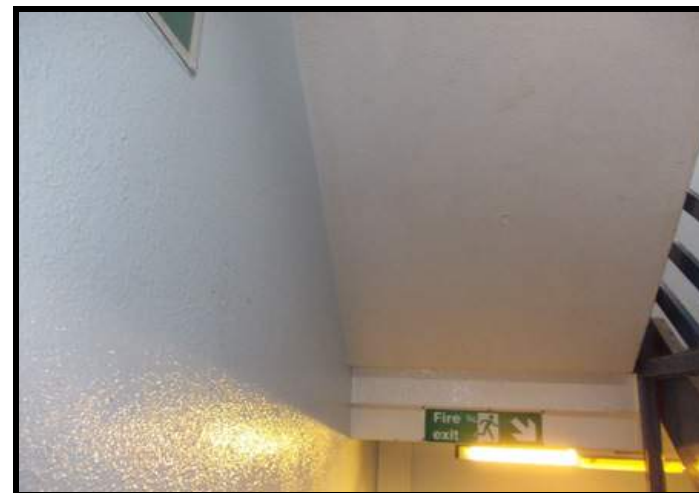
## SAMPLE REFERENCE 152

**Asbestos Presumed**

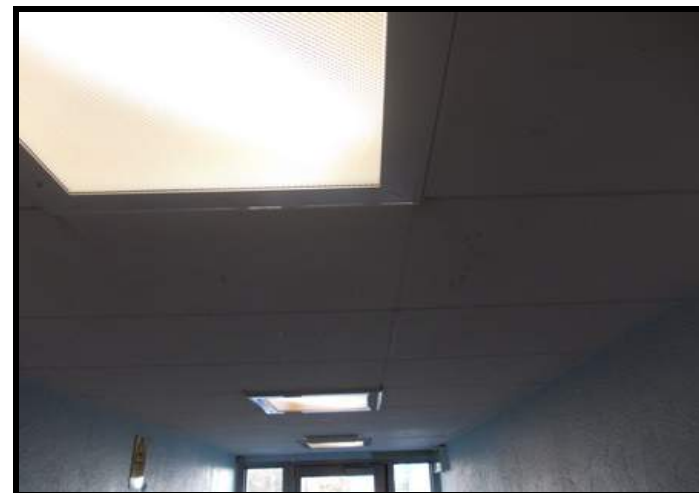
## SAMPLE REFERENCE 153

**No Asbestos Presumed in Sample**

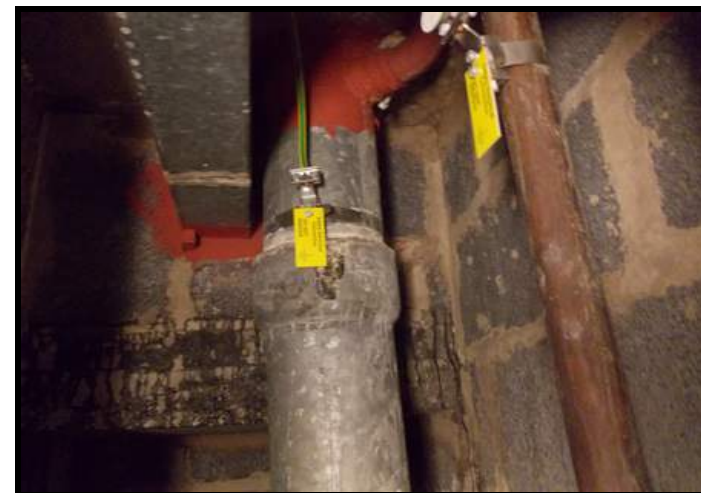
## SAMPLE REFERENCE 155

**Asbestos Presumed**

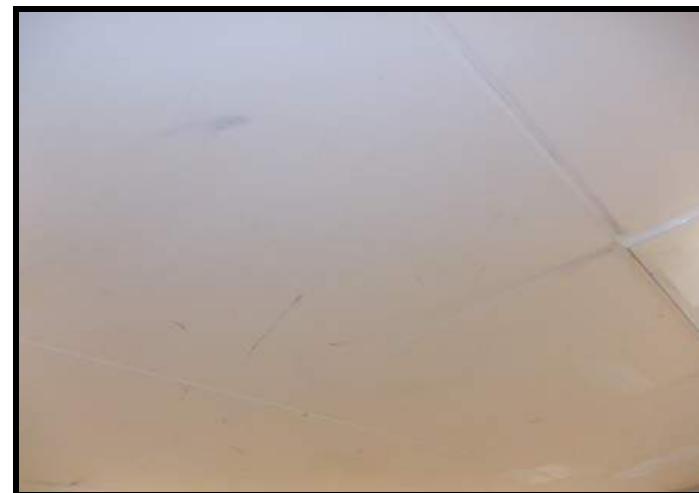
## SAMPLE REFERENCE 156

**No Asbestos Presumed in Sample**

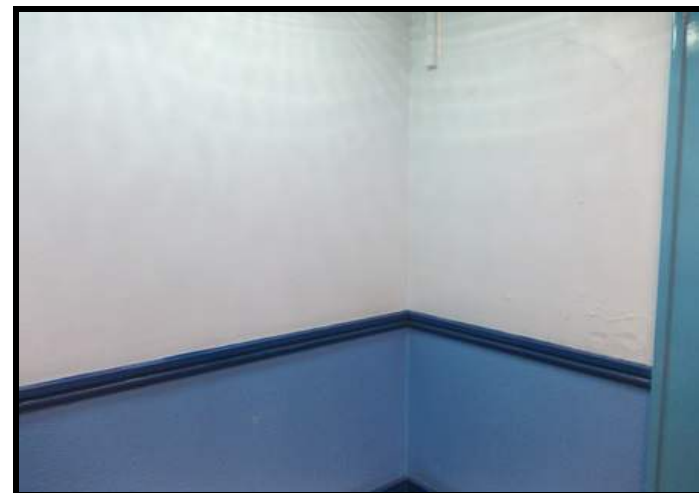
## SAMPLE REFERENCE 157

Asbestos Presumed

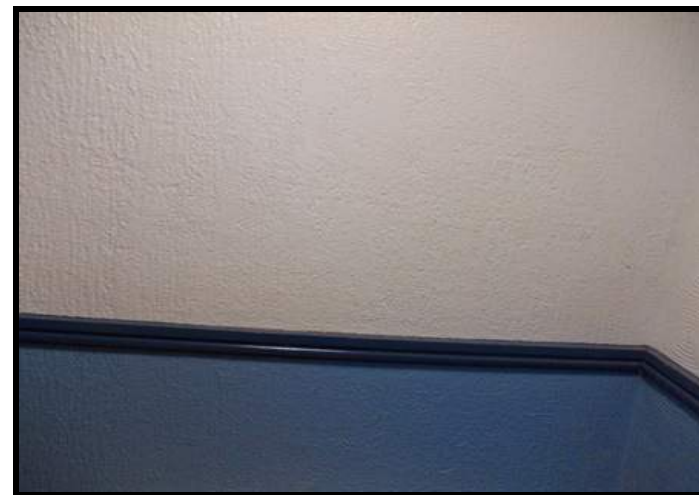
## SAMPLE REFERENCE I60

**Asbestos Presumed**

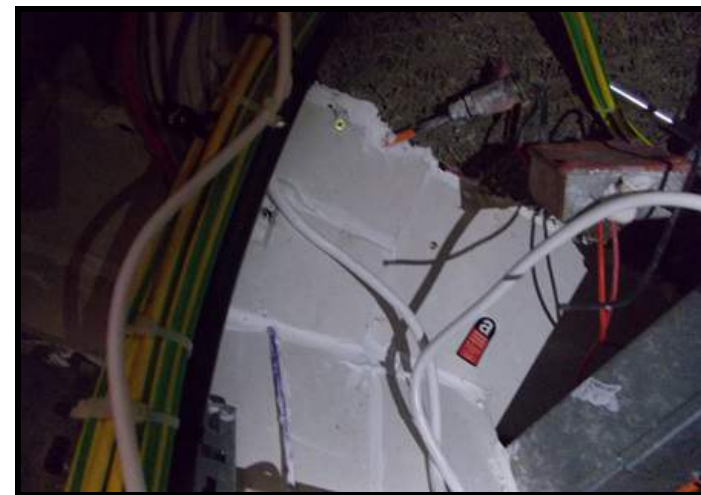
## SAMPLE REFERENCE I62

**Asbestos detected in Sample**

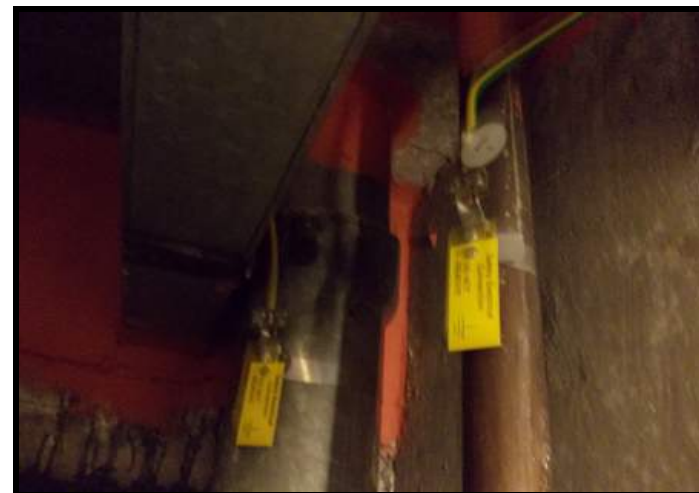
## SAMPLE REFERENCE I 62a

**Asbestos Presumed**

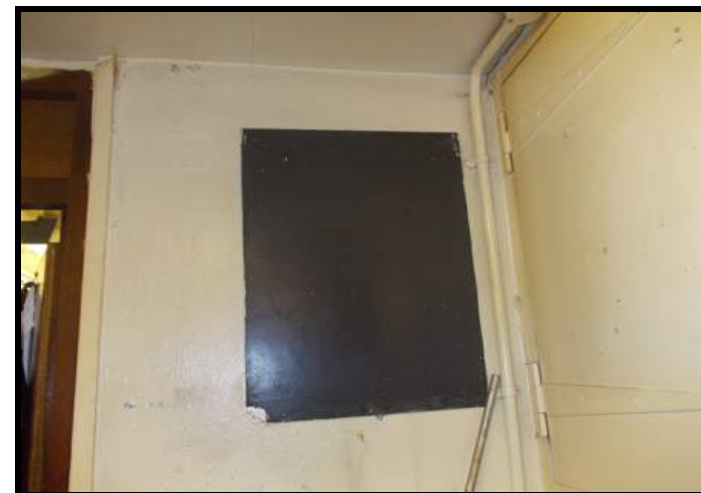
## SAMPLE REFERENCE 164

Asbestos detected in Sample

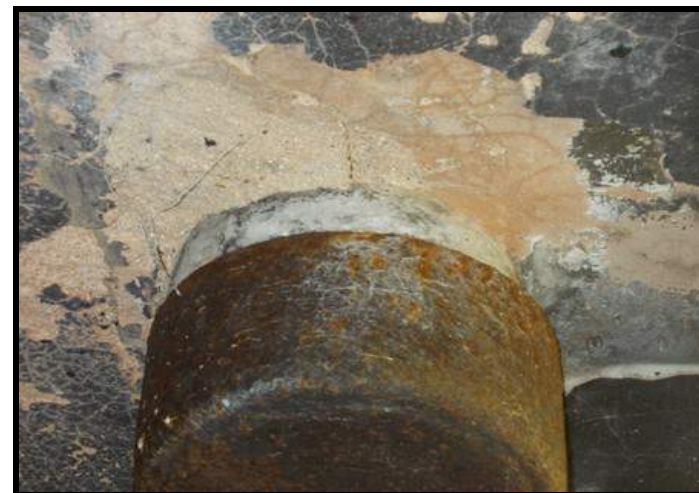
## SAMPLE REFERENCE 173

Asbestos Presumed

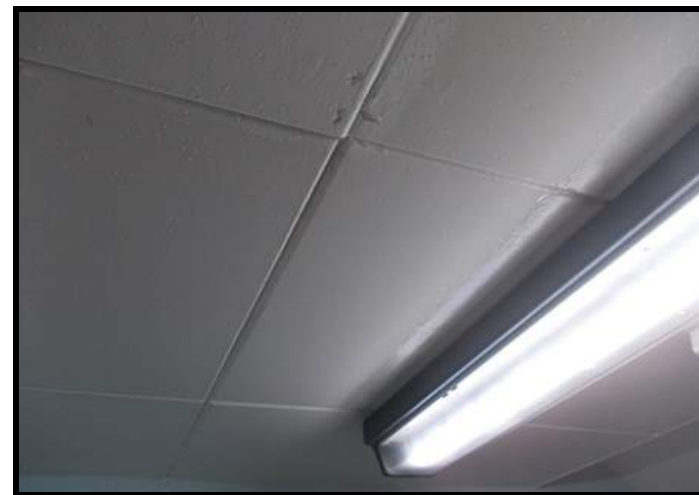
## SAMPLE REFERENCE I74a

**No Asbestos Presumed in Sample**
