Management with Targeted Refurbishment Survey

Solihull Community Housing

1-59 Bedford House
Sanda Croft
Chelmsley Wood
Solihull
B36 0NG
United Kingdom

12th June 2021

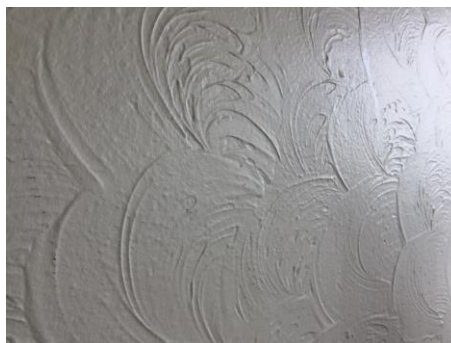
Spatter pattern textured coating beneath more modern swirl pattern texture.

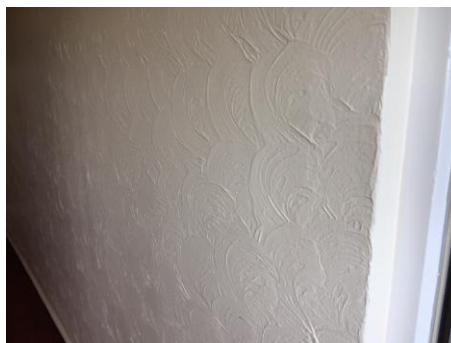
Spatter pattern textured coating beneath more modern swirl pattern texture.

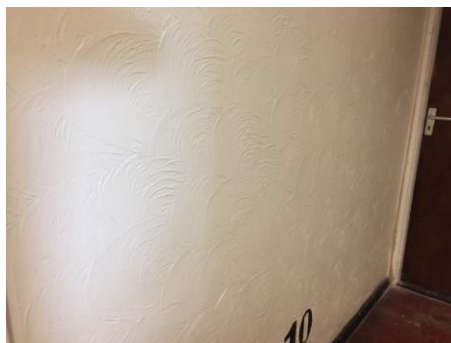
Spatter pattern textured coating beneath more modern swirl pattern texture.

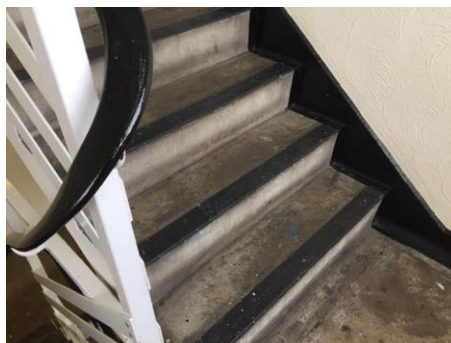
Resin nosing to edge of stairs.

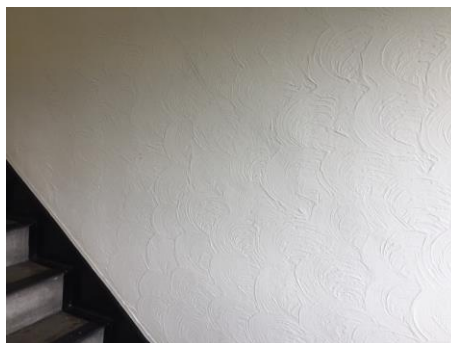
Spatter pattern textured coating beneath more modern swirl pattern texture.

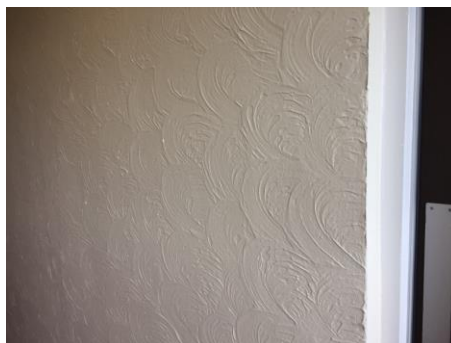
Spatter pattern textured coating beneath more modern swirl pattern texture.

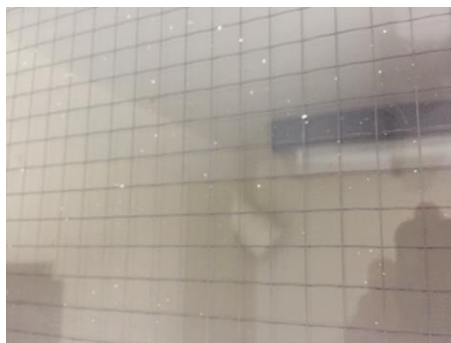
Cement flue cutoff from previously removed incinerator. Visible through window.

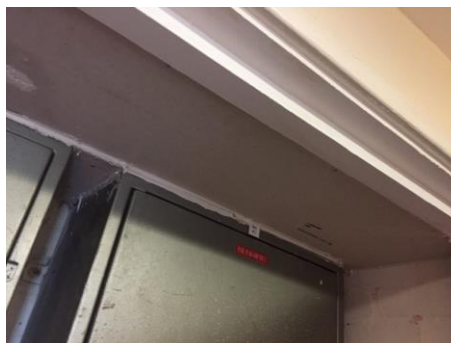
Insulating board panel ceiling.

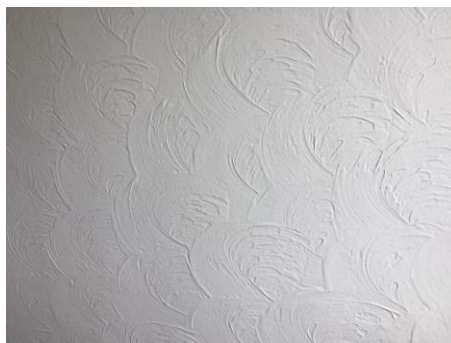
Spatter pattern textured coating beneath more modern swirl pattern texture.

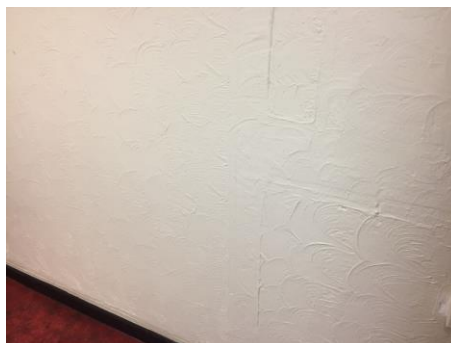
Spatter pattern textured coating beneath more modern swirl pattern texture.

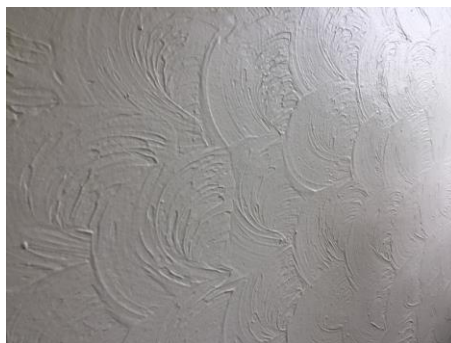
Spatter pattern textured coating beneath more modern swirl pattern texture.

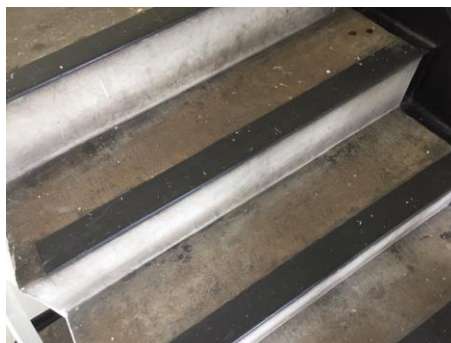
Resin nosing to edge of stairs.

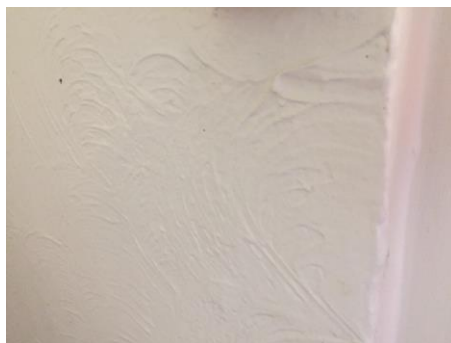
Spatter pattern textured coating beneath more modern swirl pattern texture.

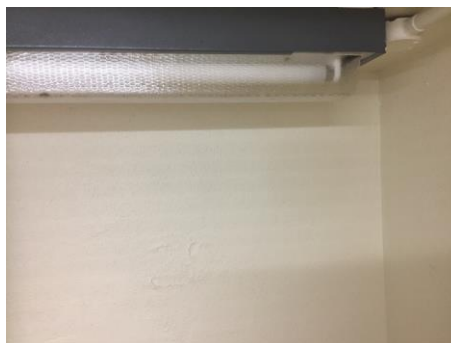
Spatter pattern textured coating. Visible through window.

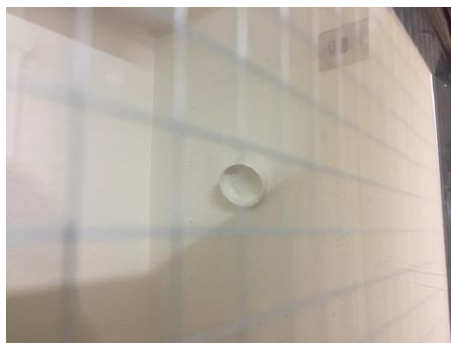
Cement flue cutoff from previously removed incinerator. Visible through window.

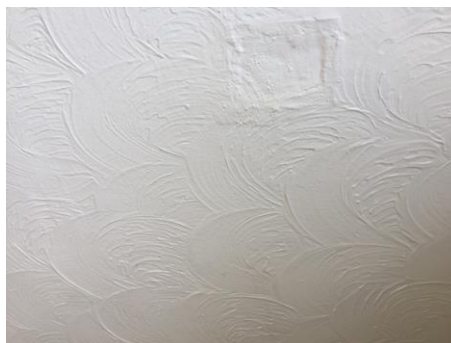
Spatter pattern textured coating beneath more modern swirl pattern texture.

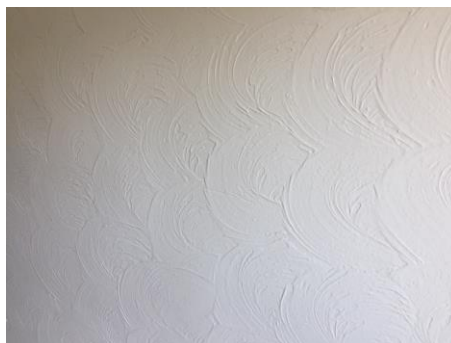
Spatter pattern textured coating beneath more modern swirl pattern texture.

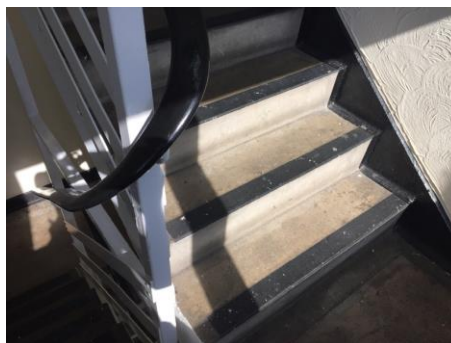
Resin nosing to edge of stairs.

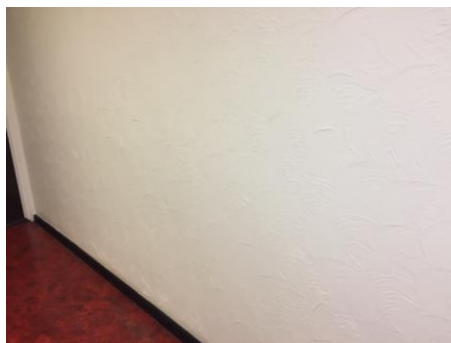
Spatter pattern textured coating beneath more modern swirl pattern texture.

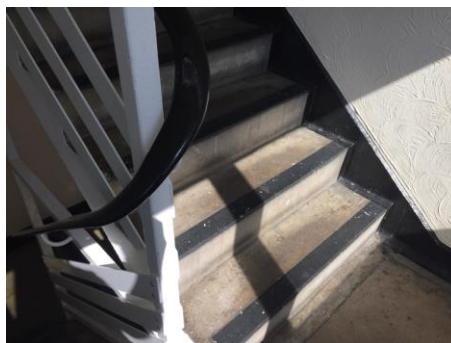
Resin nosing to edge of stairs.

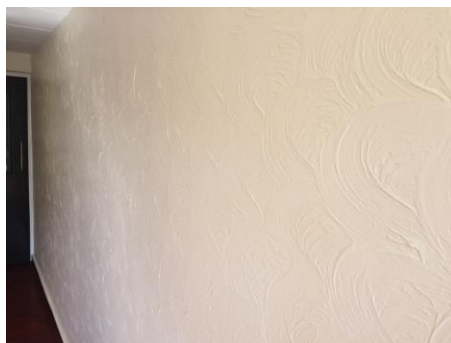
Spatter pattern textured coating beneath more modern swirl pattern texture.

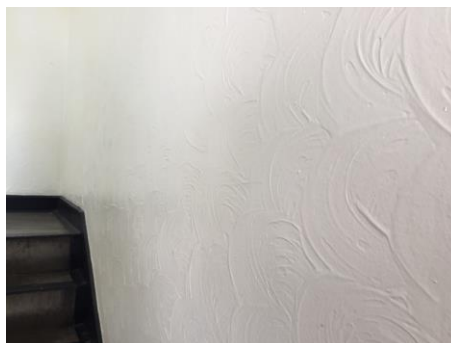
Spatter pattern textured coating beneath more modern swirl pattern texture.

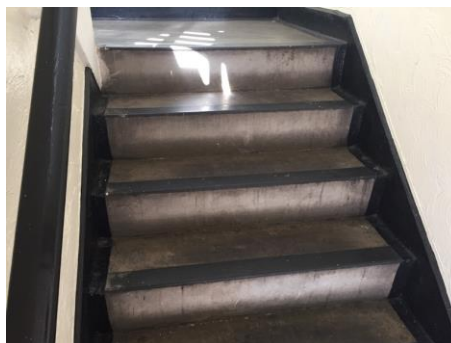
Resin nosing to edge of stairs.

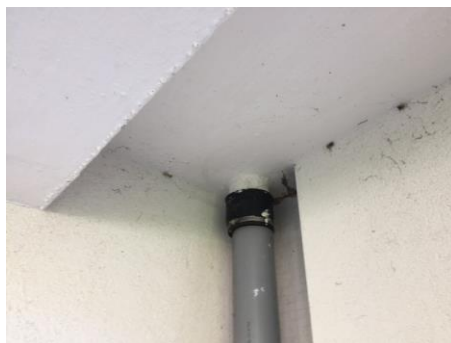
Cement down pipe collar.

The material was seen to be in fair condition at the time of the initial inspection.

The condition of the material should be managed by a competent person/company and its presence made aware to those at risk, as part of a Control of Asbestos Regulations (CAR) 2012 compliant management strategy.
