Management with Targeted Refurbishment Survey

1-51 Birkbeck House
Guernsey Drive
Chelmsley Wood
Solihull
Solihull
B36 0PG
United Kingdom

16th June 2021

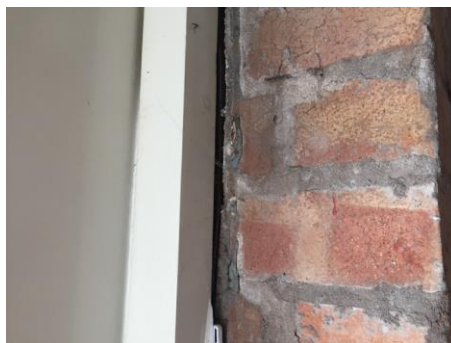
Sealant around timber door frames.

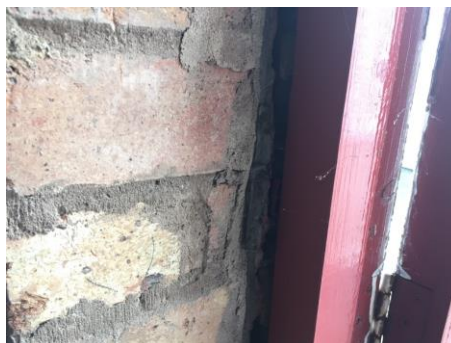
Sealant around timber door frames.

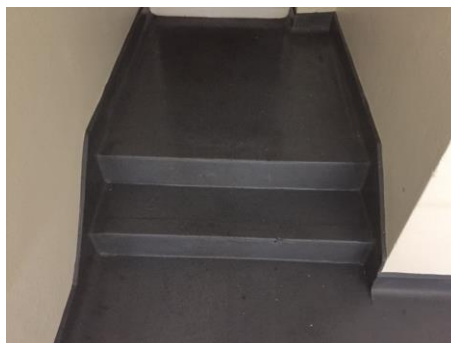
Resin nosing to edge of stairs.

The material was seen to be in fair condition at the time of the initial inspection.

The condition of the material should be managed by a competent person/company and its presence made aware to those at risk, as part of a Control of Asbestos Regulations (CAR) 2012 compliant management strategy.

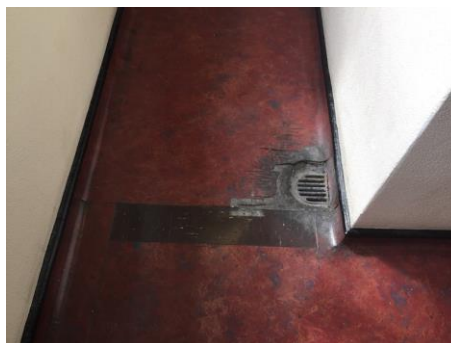
Brown floor tile by drain.

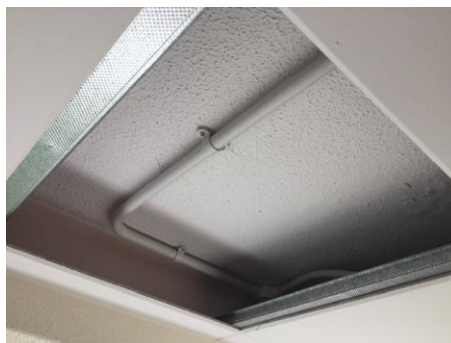
Spatter pattern textured coating above suspended ceiling.

The material was seen to be in fair condition at the time of the initial inspection.

The condition of the material should be managed by a competent person/company and its presence made aware to those at risk, as part of a Control of Asbestos Regulations (CAR) 2012 compliant management strategy.

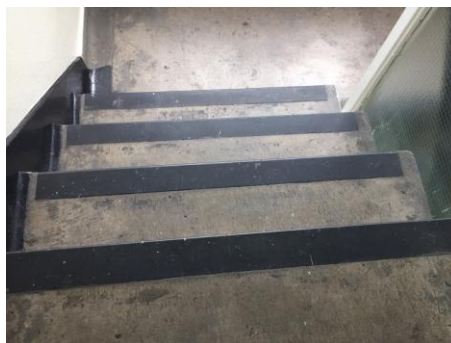
Resin nosing to edge of stairs.

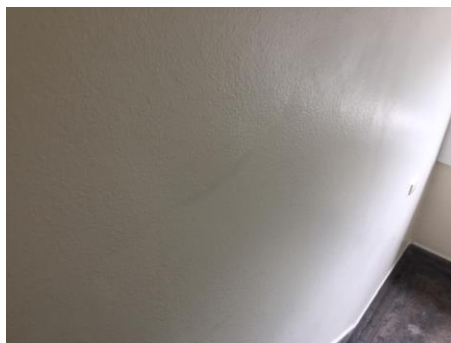
Stipple pattern textured coating.

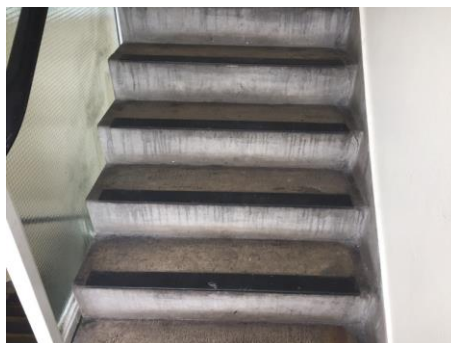
Resin nosing to edge of stairs.

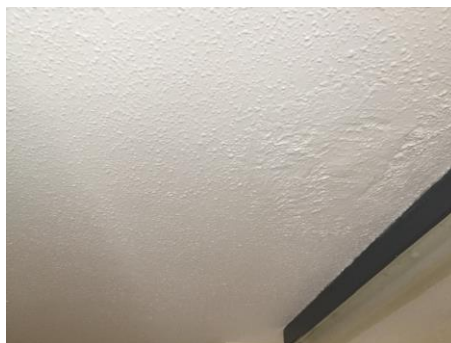
Spatter pattern textured coating.

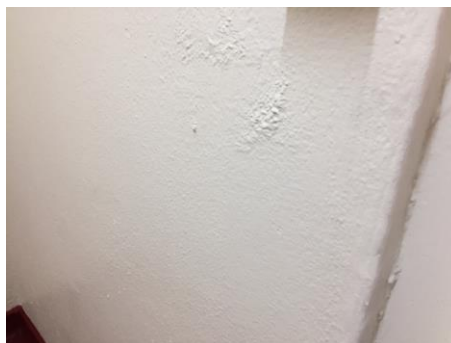
Stipple pattern textured coating.

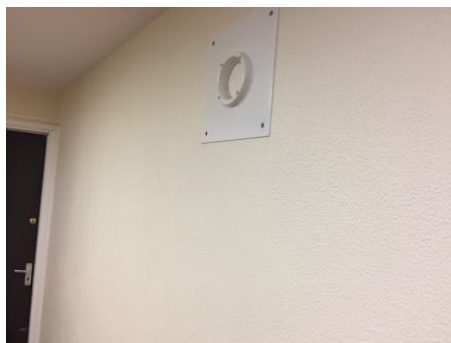
Stipple pattern textured coating.

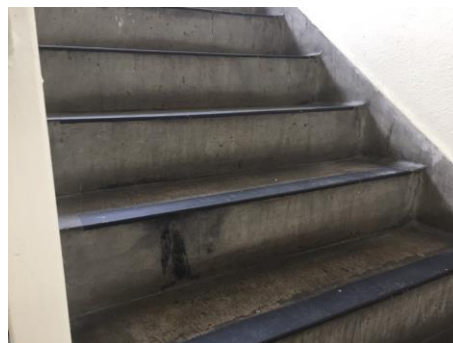
Resin nosing to edge of stairs.

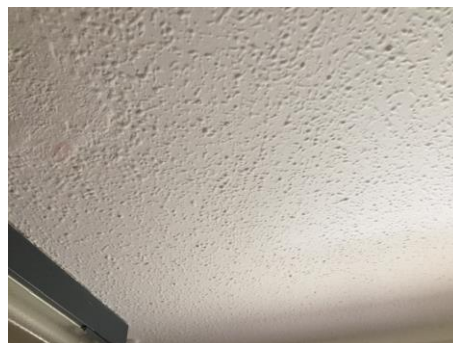
Spatter pattern textured coating.

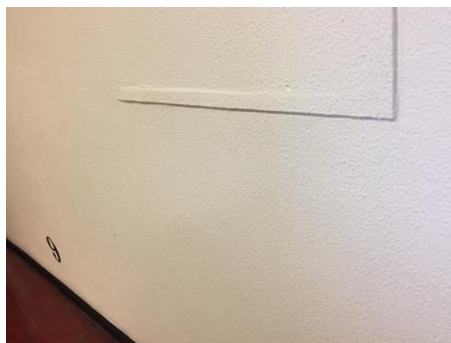
Stipple pattern textured coating.

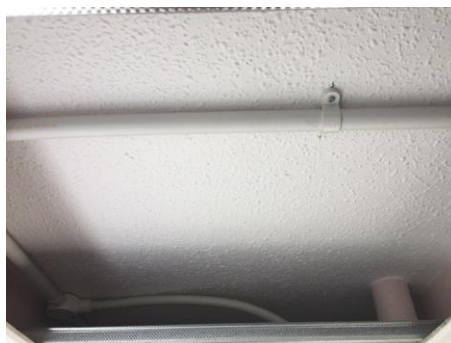
Spatter pattern textured coating above suspended ceiling.

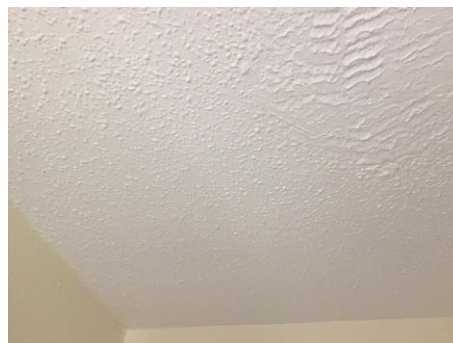
Spatter pattern textured coating.

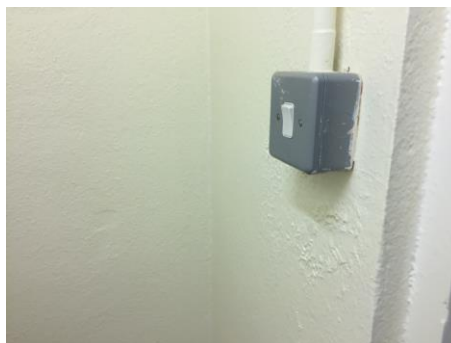
Stipple pattern textured coating.

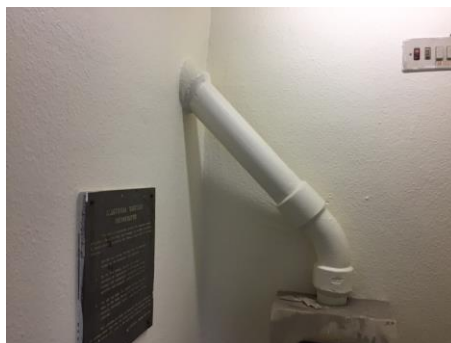
Cement incinerator flue.

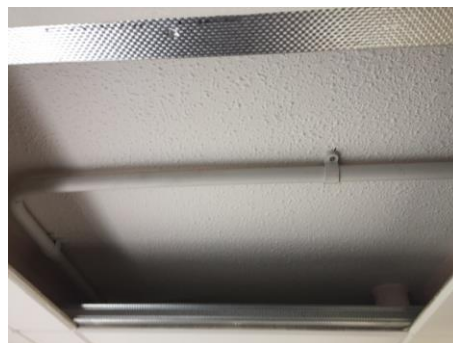
Spatter pattern textured coating above suspended ceiling.

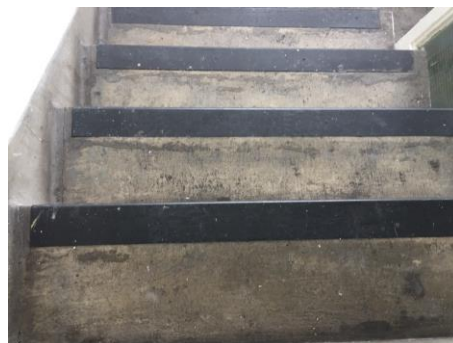
Resin nosing to edge of stairs.

The material was seen to be in fair condition at the time of the initial inspection.

The condition of the material should be managed by a competent person/company and its presence made aware to those at risk, as part of a Control of Asbestos Regulations (CAR) 2012 compliant management strategy.

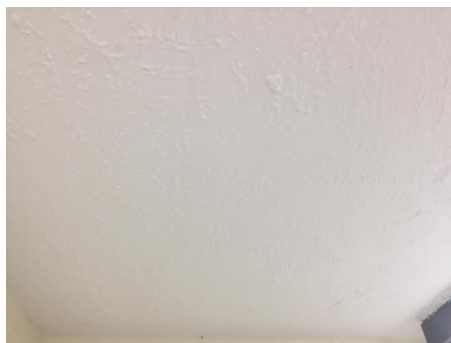
Spatter pattern textured coating beneath more modern stipple pattern.

The material was seen to be in fair condition at the time of the initial inspection.

The condition of the material should be managed by a competent person/company and its presence made aware to those at risk, as part of a Control of Asbestos Regulations (CAR) 2012 compliant management strategy.

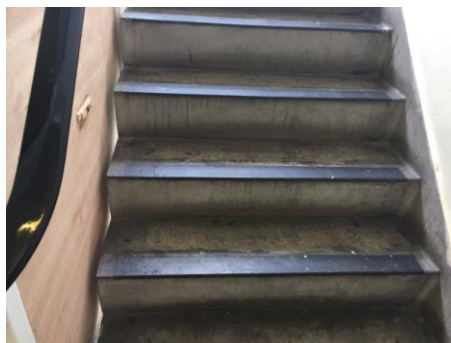
Resin nosing to edge of stairs.

The material was seen to be in fair condition at the time of the initial inspection.

The condition of the material should be managed by a competent person/company and its presence made aware to those at risk, as part of a Control of Asbestos Regulations (CAR) 2012 compliant management strategy.

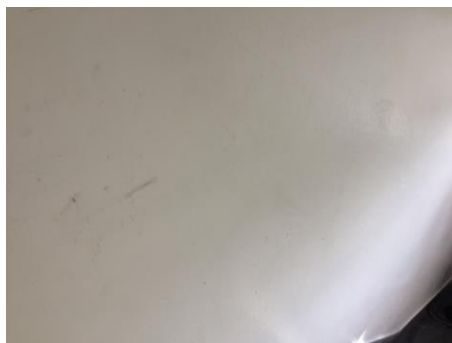
Stipple pattern textured coating.

The material was seen to be in fair condition at the time of the initial inspection.

The condition of the material should be managed by a competent person/company and its presence made aware to those at risk, as part of a Control of Asbestos Regulations (CAR) 2012 compliant management strategy.

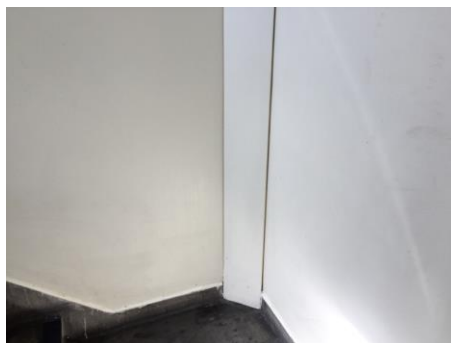
Possible insulating board riser panel hidden behind modern wood fibre panel.

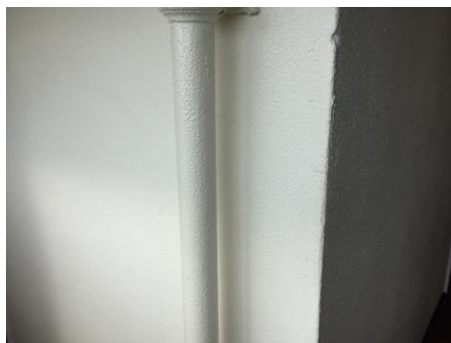
Stipple pattern textured coating.

The material was seen to be in fair condition at the time of the initial inspection.

The condition of the material should be managed by a competent person/company and its presence made aware to those at risk, as part of a Control of Asbestos Regulations (CAR) 2012 compliant management strategy.

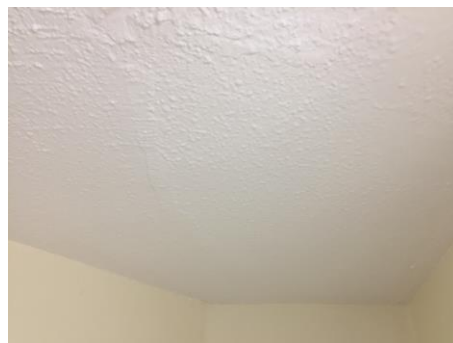
Spatter pattern textured coating.

The material was seen to be in fair condition at the time of the initial inspection.

The condition of the material should be managed by a competent person/company and its presence made aware to those at risk, as part of a Control of Asbestos Regulations (CAR) 2012 compliant management strategy.

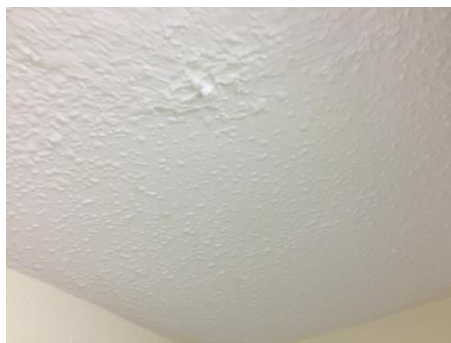
Spatter pattern textured coating.

The material was seen to be in fair condition at the time of the initial inspection.

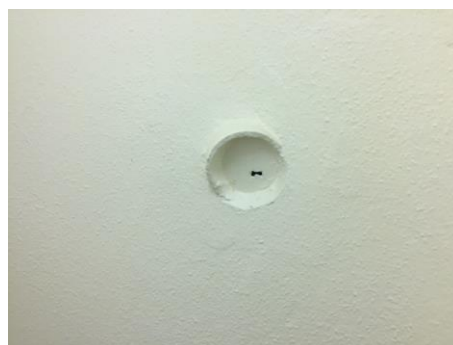
Cement incinerator flue cutoff.

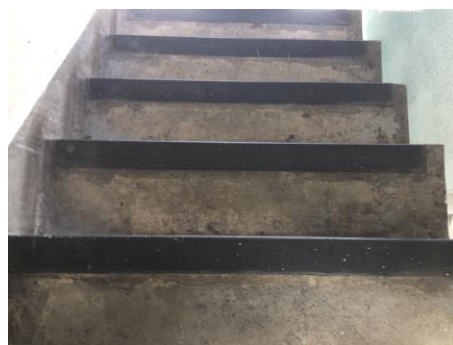
Resin nosing to edge of stairs.

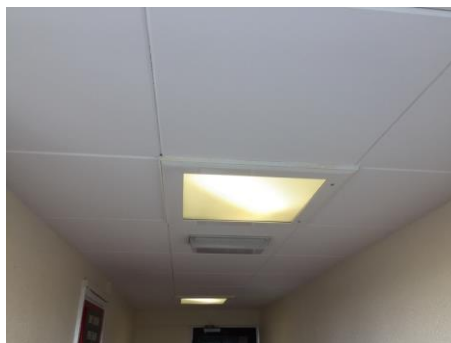
Spatter pattern textured coating above suspended ceiling.

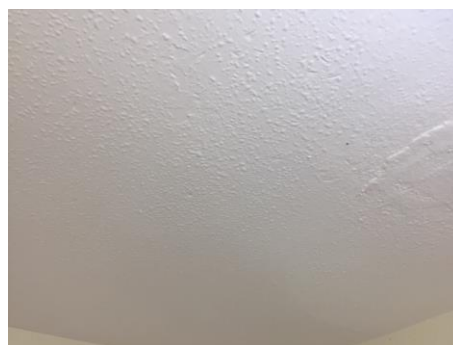
Spatter pattern textured coating beneath more modern stipple pattern.

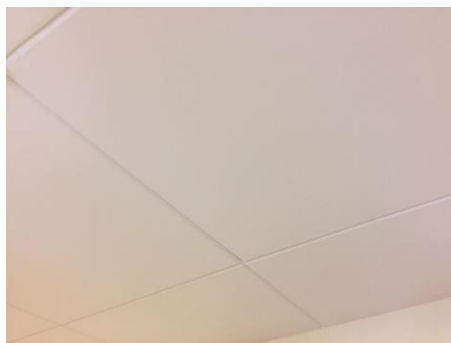
Spatter pattern textured coating above suspended ceiling.

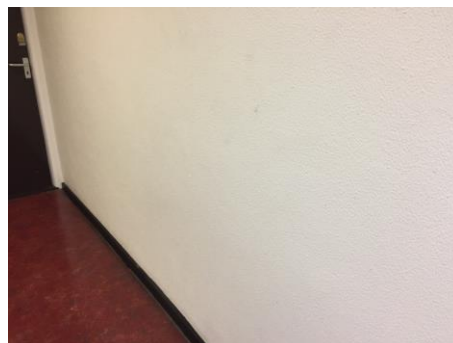
Stipple pattern textured coating.

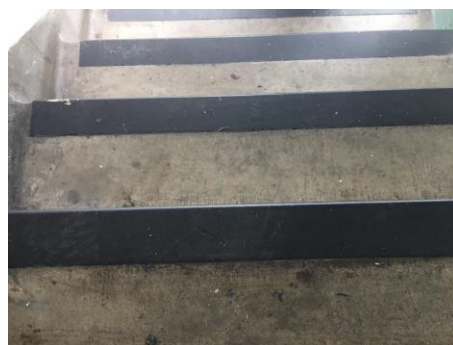
Resin nosing to edge of stairs.

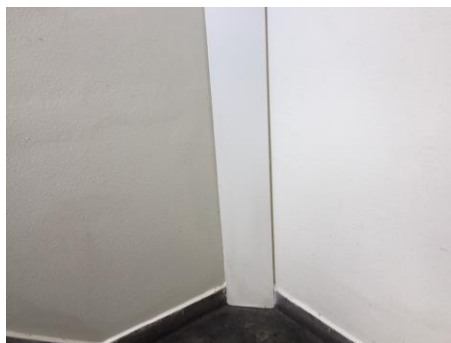
Possible insulating board riser panel hidden behind modern wood fibre panel.

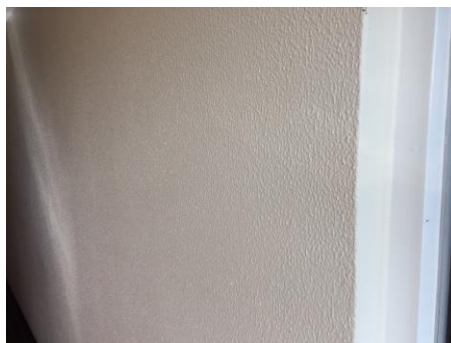
Stipple pattern textured coating.

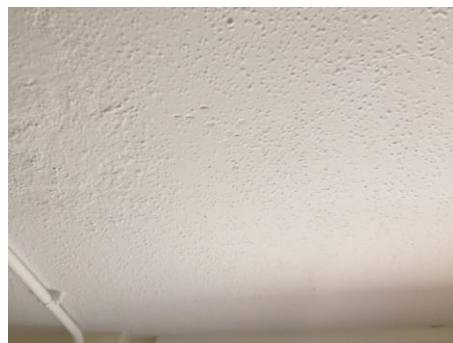
Spatter pattern textured coating beneath more modern stipple pattern.

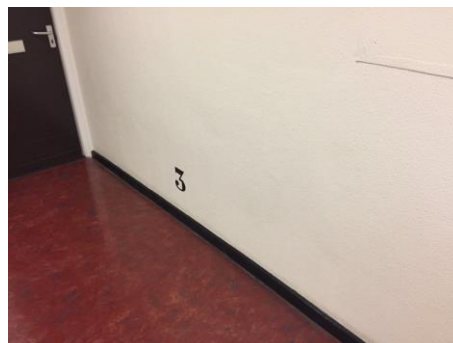
Stipple pattern textured coating.

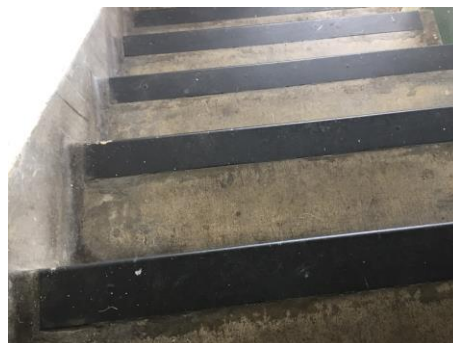
Resin nosing to edge of stairs.

The material was seen to be in fair condition at the time of the initial inspection.

The condition of the material should be managed by a competent person/company and its presence made aware to those at risk, as part of a Control of Asbestos Regulations (CAR) 2012 compliant management strategy.

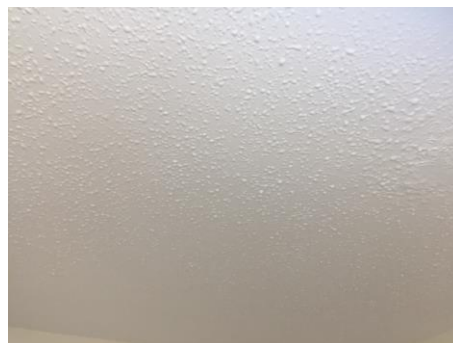
Spatter pattern textured coating beneath more modern stipple pattern.

The material was seen to be in fair condition at the time of the initial inspection.

The condition of the material should be managed by a competent person/company and its presence made aware to those at risk, as part of a Control of Asbestos Regulations (CAR) 2012 compliant management strategy.

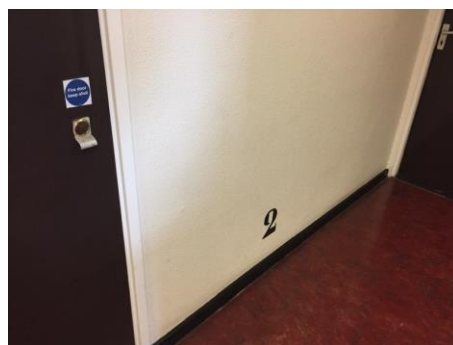
Stipple pattern textured coating.

The material was seen to be in fair condition at the time of the initial inspection.

The condition of the material should be managed by a competent person/company and its presence made aware to those at risk, as part of a Control of Asbestos Regulations (CAR) 2012 compliant management strategy.

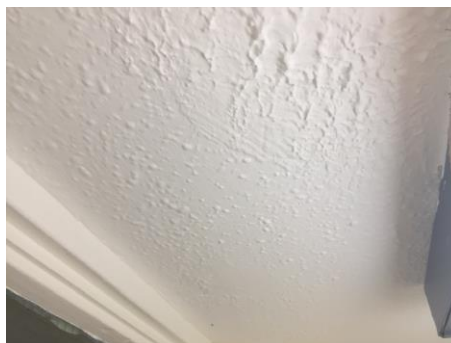
Spatter pattern textured coating.

The material was seen to be in fair condition at the time of the initial inspection.

The condition of the material should be managed by a competent person/company and its presence made aware to those at risk, as part of a Control of Asbestos Regulations (CAR) 2012 compliant management strategy.

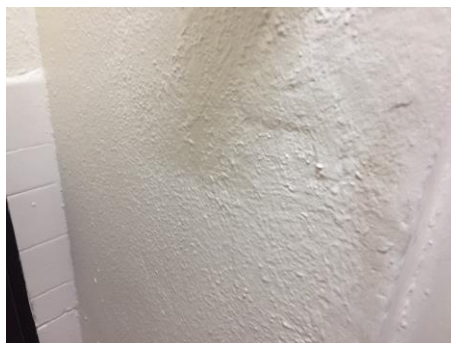
Stipple pattern textured coating.

The material was seen to be in fair condition at the time of the initial inspection.

The condition of the material should be managed by a competent person/company and its presence made aware to those at risk, as part of a Control of Asbestos Regulations (CAR) 2012 compliant management strategy.

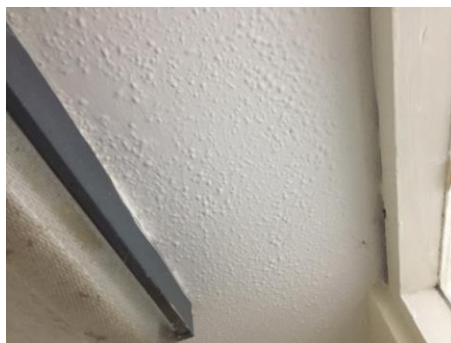
Spatter pattern textured coating.

The material was seen to be in fair condition at the time of the initial inspection.

The condition of the material should be managed by a competent person/company and its presence made aware to those at risk, as part of a Control of Asbestos Regulations (CAR) 2012 compliant management strategy.

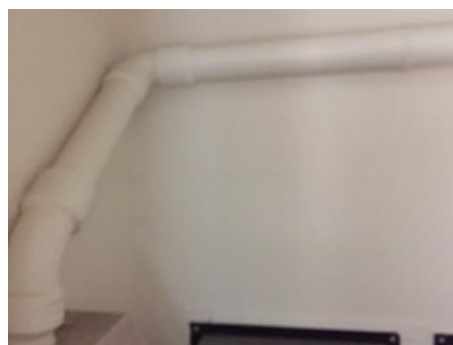
Cement incinerator flue.

The material was seen to be in fair condition at the time of the initial inspection.

The condition of the material should be managed by a competent person/company and its presence made aware to those at risk, as part of a Control of Asbestos Regulations (CAR) 2012 compliant management strategy.

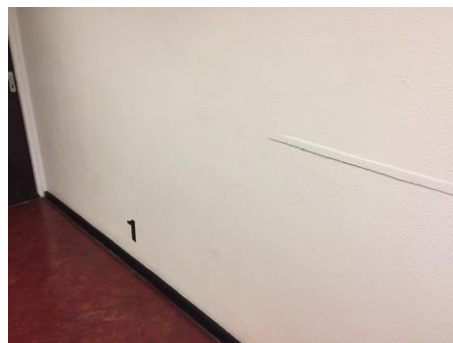
Stipple pattern textured coating.

The material was seen to be in fair condition at the time of the initial inspection.

The condition of the material should be managed by a competent person/company and its presence made aware to those at risk, as part of a Control of Asbestos Regulations (CAR) 2012 compliant management strategy.

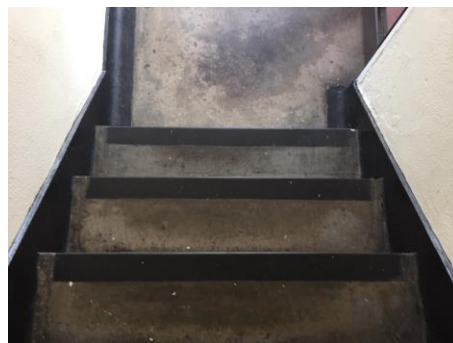
Level: **Ground Floor**

The material was seen to be in fair condition at the time of the initial inspection.

The condition of the material should be managed by a competent person/company and its presence made aware to those at risk, as part of a Control of Asbestos Regulations (CAR) 2012 compliant management strategy.

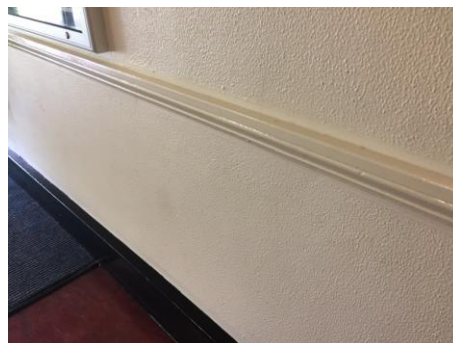
Stipple pattern textured coating.

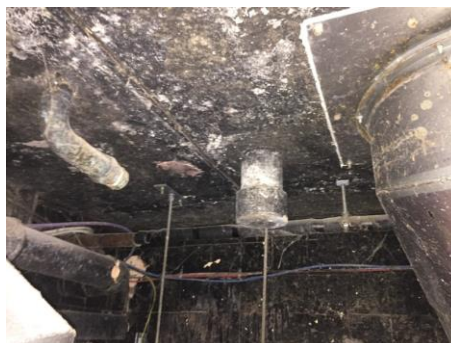
Cement flue end and cap.

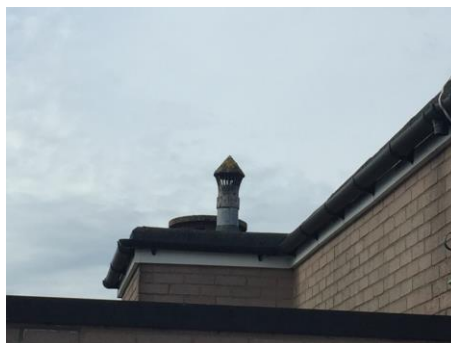
Cement flue cowl on roof.

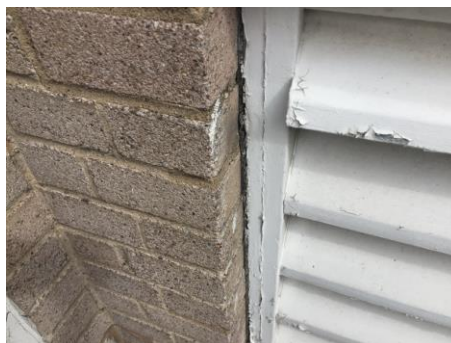
Sealant around door frames and timber louvres.

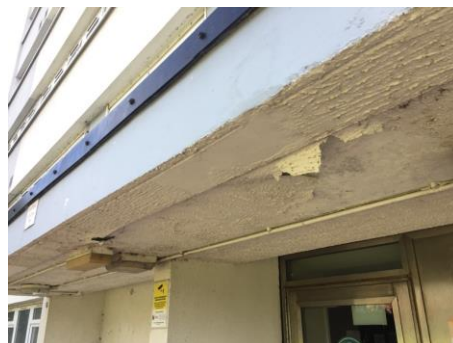
Stipple pattern textured coating to front canopy.
