# **Solihull Community Housing**

## **Asbestos Management Survey Report**

**Chester Court  
Hedingham Grove  
Chelmsley Wood  
B37 7TN**

**Date of Report: 16 May 2012**

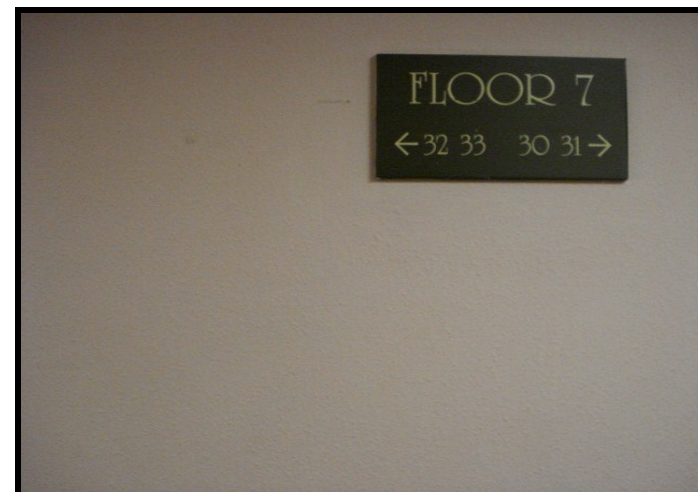
## SAMPLE REFERENCE 029

**No Asbestos Presumed in Sample**

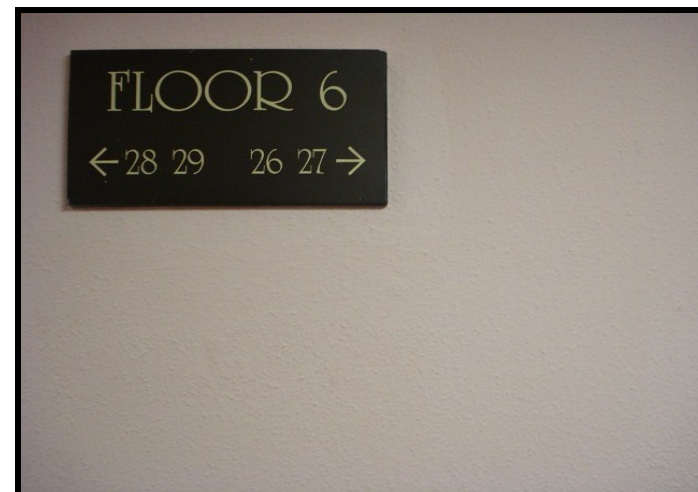
## SAMPLE REFERENCE 039

**No Asbestos Presumed in Sample**

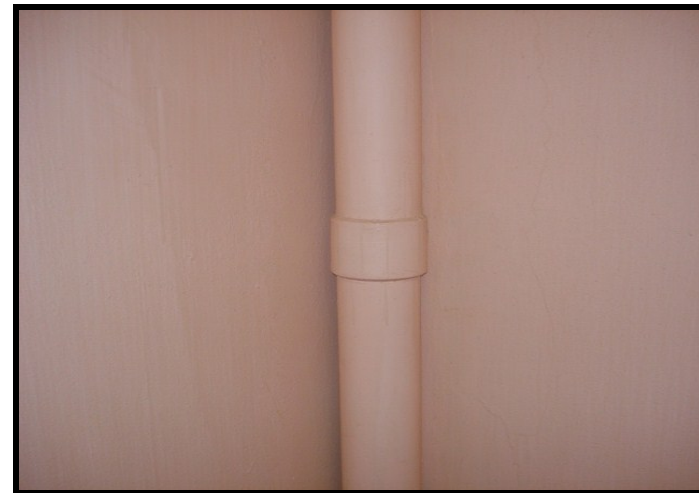
## SAMPLE REFERENCE 079

Asbestos Presumed in Sample

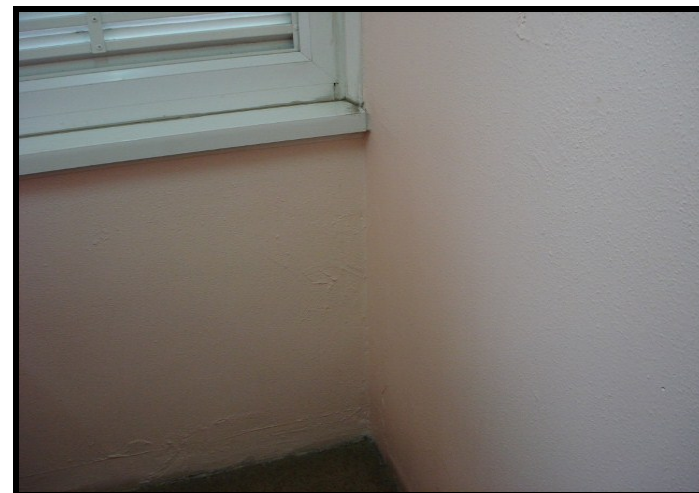
## SAMPLE REFERENCE 086

**No Asbestos Presumed in Sample**

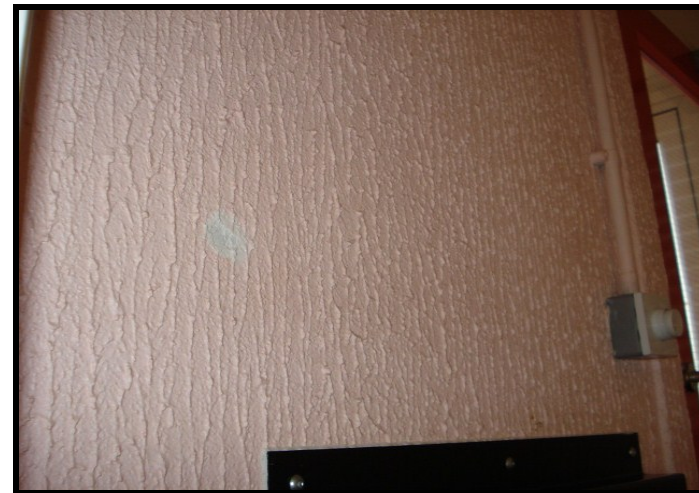
## SAMPLE REFERENCE 087

Asbestos not detected in Sample

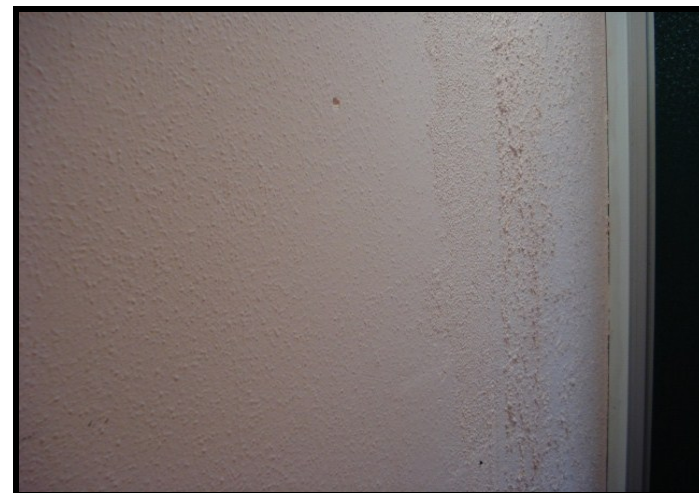
## SAMPLE REFERENCE 099

**No Asbestos Presumed in Sample**

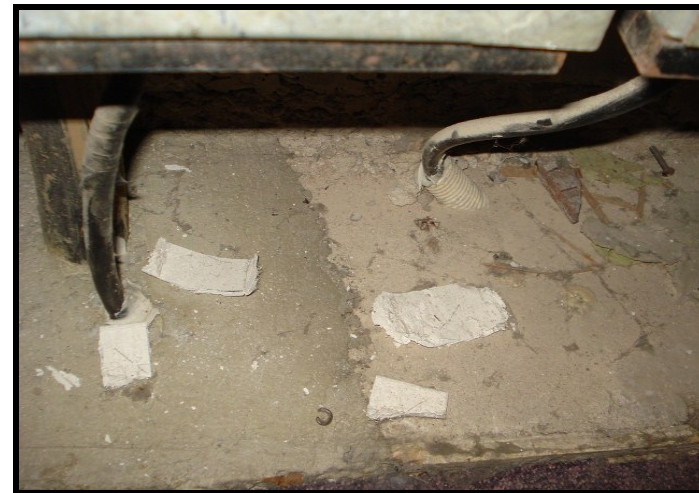
## SAMPLE REFERENCE 108

**No Asbestos Presumed in Sample**

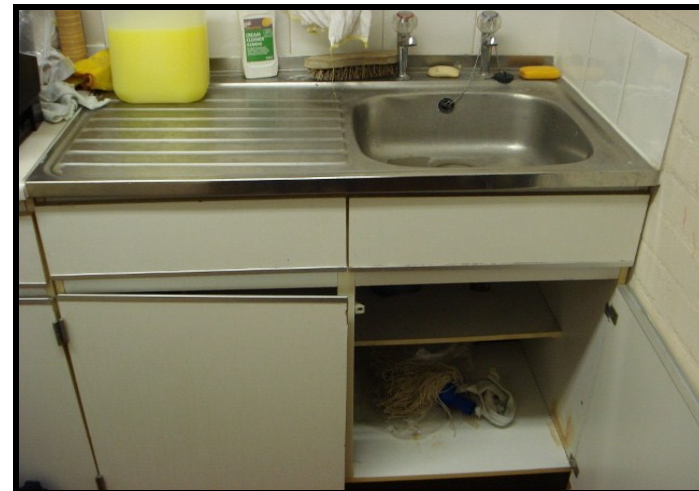
## SAMPLE REFERENCE I I 3

**Asbestos not detected in Sample**
