Management with Targeted Refurbishment Survey – PART 1

1-61 Clare House, Barle Grove
Chelmsley Wood
Solihull
B36 0UB
United Kingdom

3rd June 2021

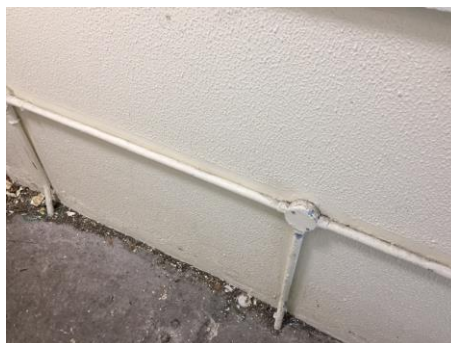
Stipple pattern textured coating.

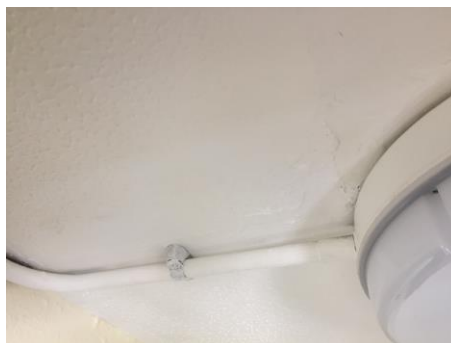
Stipple pattern textured coating.

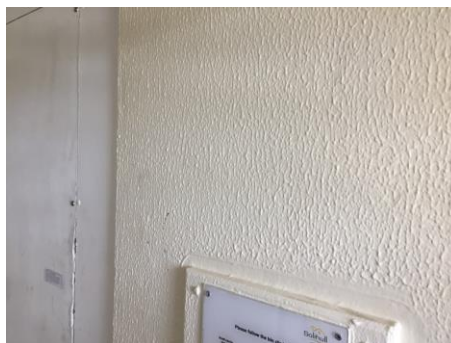
Stipple pattern textured coating.

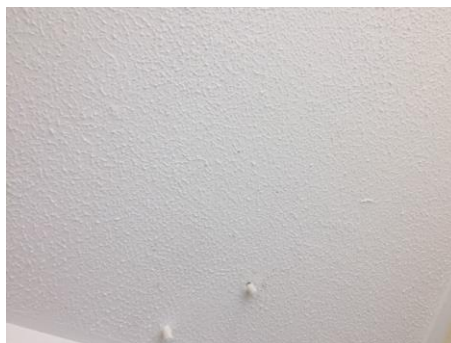
Stipple pattern textured coating.

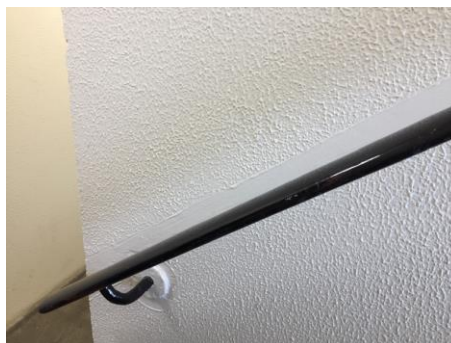
Stipple pattern textured coating.

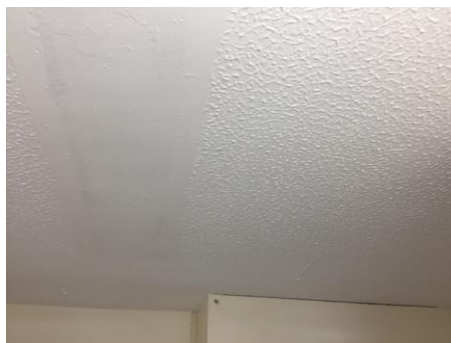
Stipple pattern textured coating.

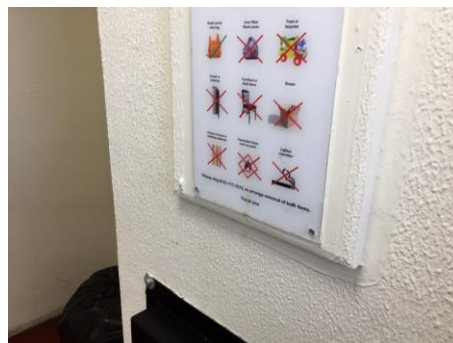
Stipple pattern textured coating.

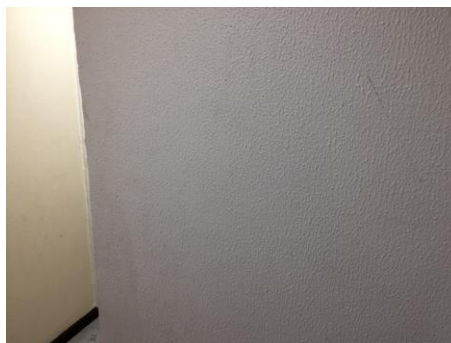
Stipple pattern textured coating.

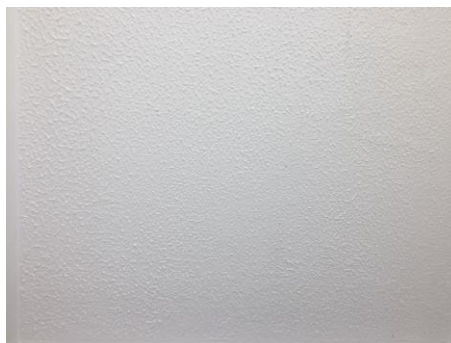
Stipple pattern textured coating.

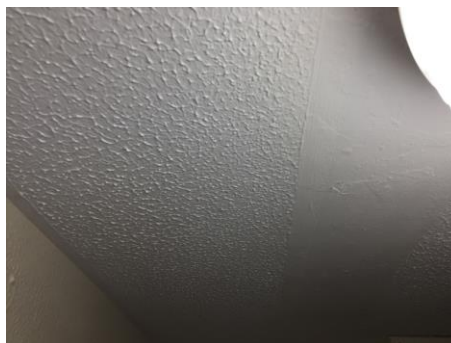
Stipple pattern textured coating.

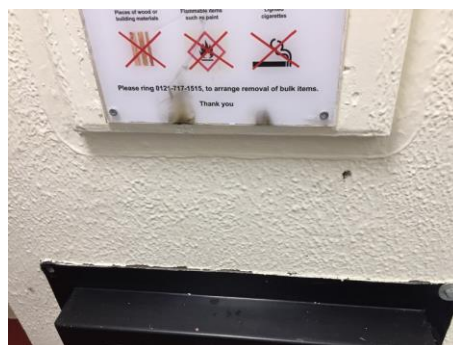
Stipple pattern textured coating.

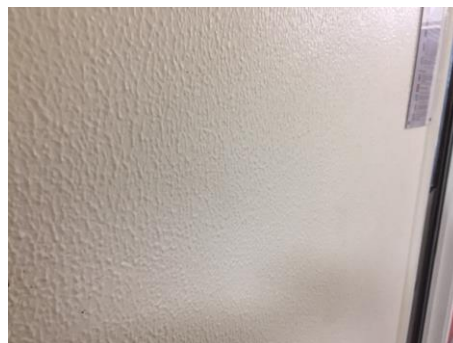
Stipple pattern textured coating.

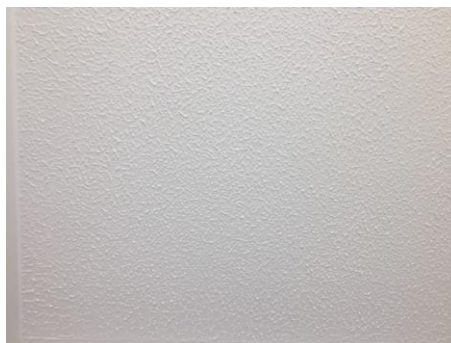
Stipple pattern textured coating.

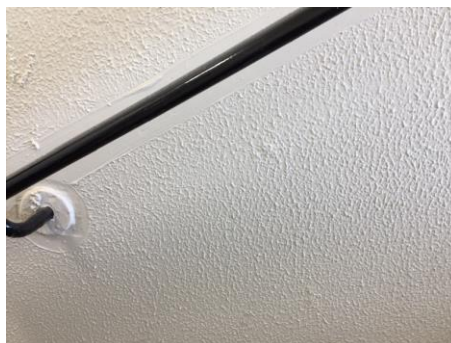
Stipple pattern textured coating.

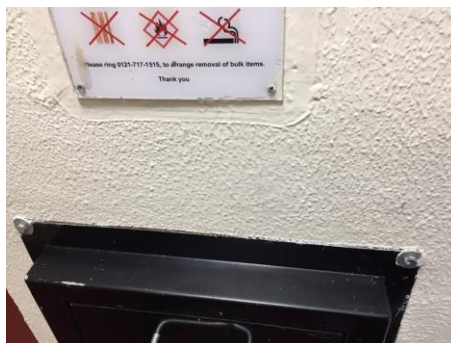
Stipple pattern textured coating.

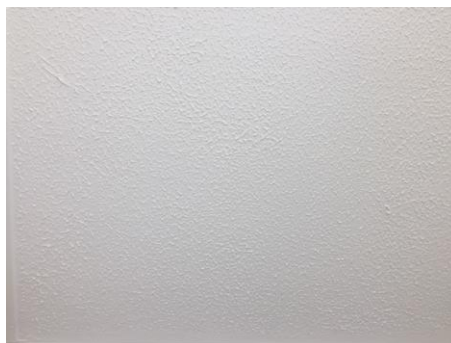
Stipple pattern textured coating.

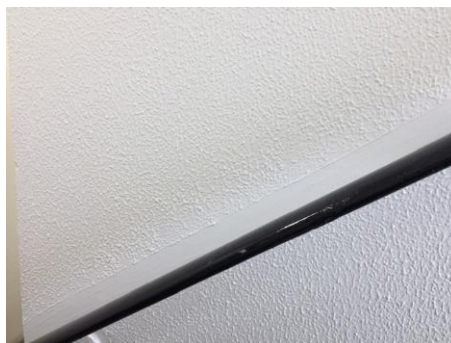
Stipple pattern textured coating.

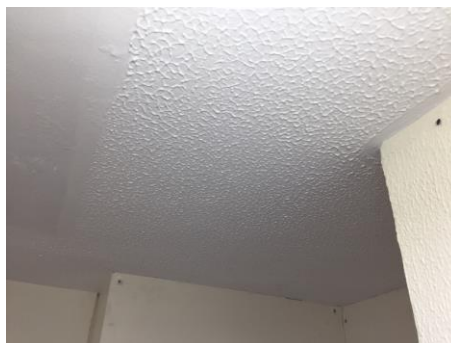
Stipple pattern textured coating.

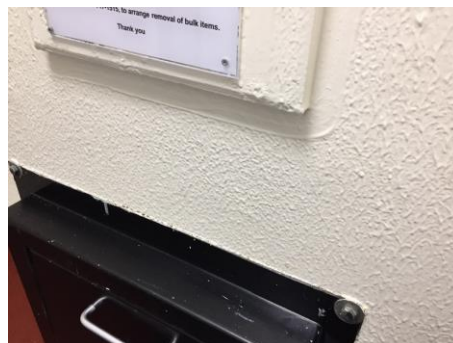
Stipple pattern textured coating.

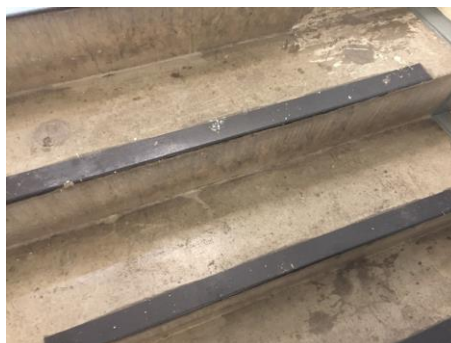
Resin nosing to edge of stairs.

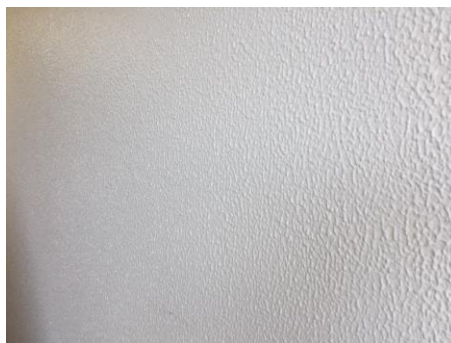
Stipple pattern textured coating.

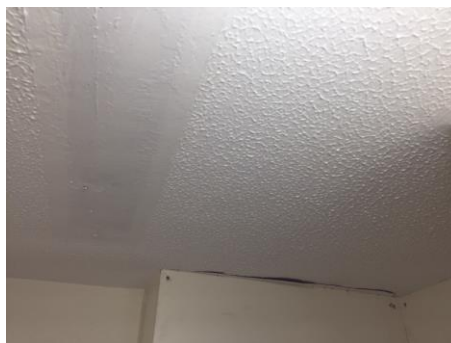
Stipple pattern textured coating.

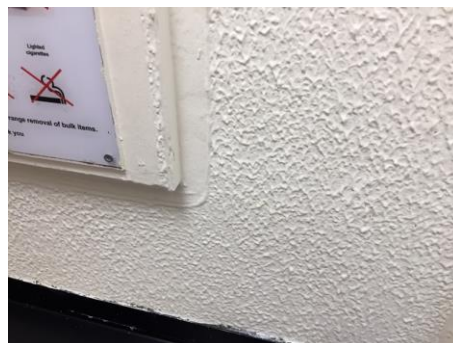
Stipple pattern textured coating.

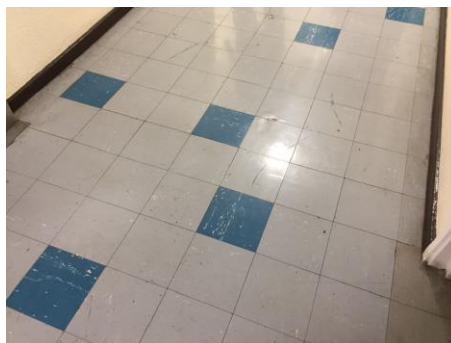
Blue and grey floor tiles.

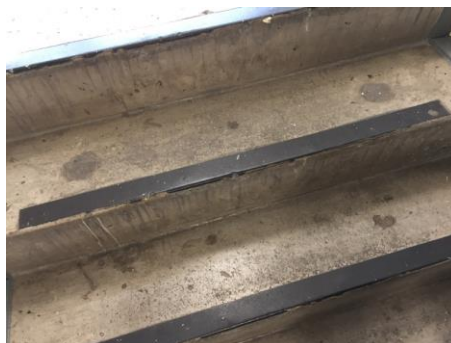
Condition **Low Damage**

Resin nosing to edge of stairs.

The material was seen to be in fair condition at the time of the initial inspection.

The condition of the material should be managed by a competent person/company and its presence made aware to those at risk, as part of a Control of Asbestos Regulations (CAR) 2012 compliant management strategy.

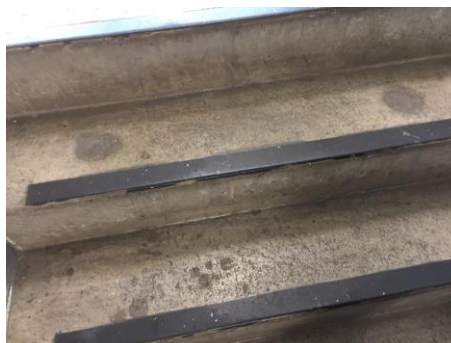
Condition **Low Damage**

Resin nosing to edge of stairs.

The material was seen to be in fair condition at the time of the initial inspection.

The condition of the material should be managed by a competent person/company and its presence made aware to those at risk, as part of a Control of Asbestos Regulations (CAR) 2012 compliant management strategy.

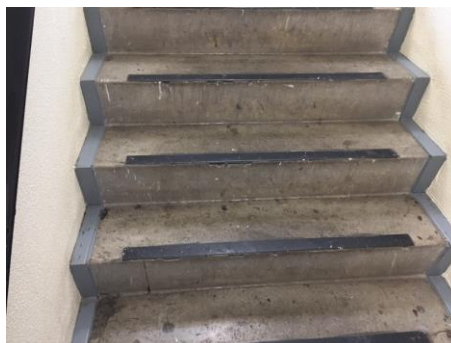
Condition **Low Damage**

Resin nosing to edge of stairs.

The material was seen to be in fair condition at the time of the initial inspection.

The condition of the material should be managed by a competent person/company and its presence made aware to those at risk, as part of a Control of Asbestos Regulations (CAR) 2012 compliant management strategy.
