# Solihull Community Housing

## Asbestos Management Survey Report

**Demontfort House I-36  
(Communal)  
Shirral Grove  
Solihull  
B37 6JR**

**Date of Report: 25 Feb 2015**

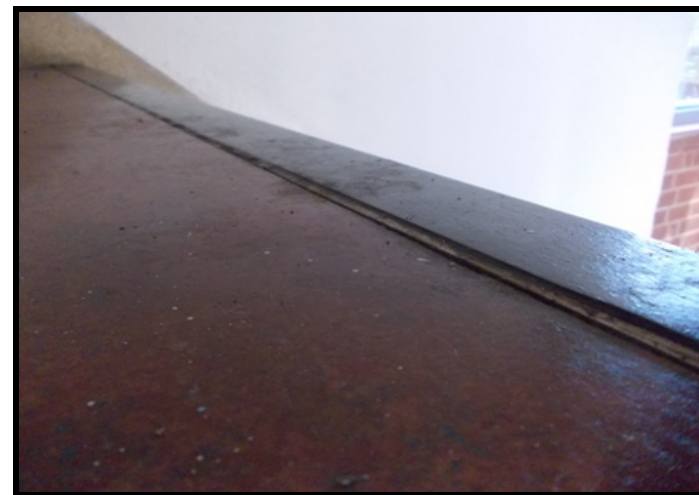
## SAMPLE REFERENCE 010g

Building	Floor	Room	Location
Main Building	Ground Floor	Rear Entrance	Staircase
Description			
MATERIAL ASSESSMENT			
Product Type	Bitumen	Extent of Damage	Good condition
Asbestos Type	<b>Chrysotile</b>	Surface Treatment	Composite materials
PRIORITY ASSESSMENT			
Occupant Activity	Not Applicable	Extent / Amount	5.00 m2
Accessibility	Occasionally disturb	Location	Not Applicable
Avg Time in Use	Not Applicable	Frequency of Use	Not Applicable
No. of Occupants	Not Applicable	Secondary Activity	Not Applicable
Maintenance	Not Applicable	Maintenance Frequency	Not Applicable
MANAGEMENT ACTION			
Recommendation	LABEL & MONITOR		
Recommendation Due		Next Inspection	09 Feb 2016
Apply Labels	No	Permit to Work Required	No
Survey Type	Management	Lead Surveyor	Gavin Hooper
Survey Date	09 Feb 2015	UKAS Laboratory	NOT SAMPLED (Cross Referenced)
Site Reference	257980000A	Licensed Material	No
		Notifiable Non Licensed Work	No

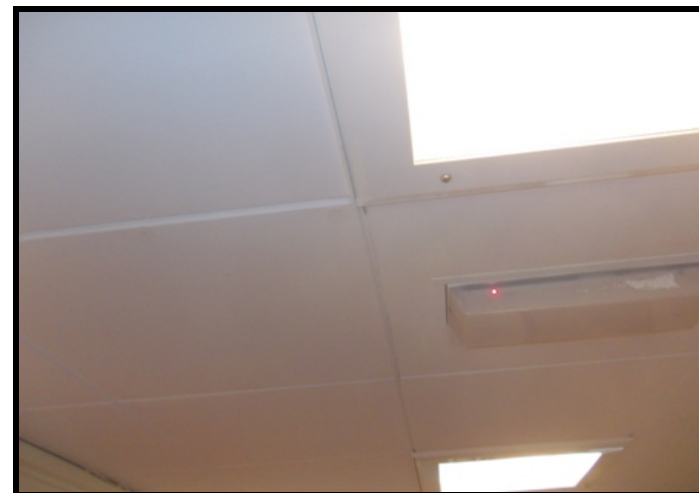
## SAMPLE REFERENCE 011

**No Asbestos Presumed in Sample**

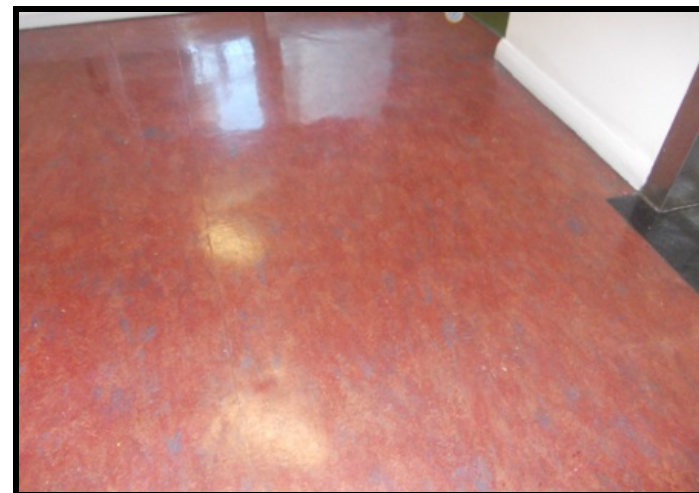
## SAMPLE REFERENCE 012

**No Asbestos Presumed in Sample**

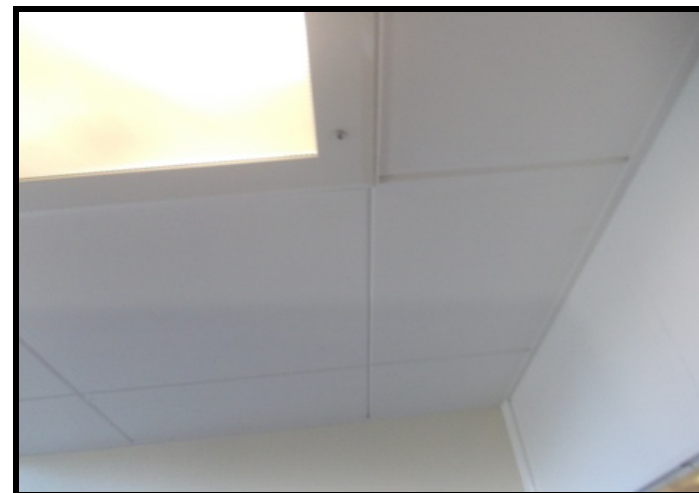
## SAMPLE REFERENCE 014

**No Asbestos Presumed in Sample**

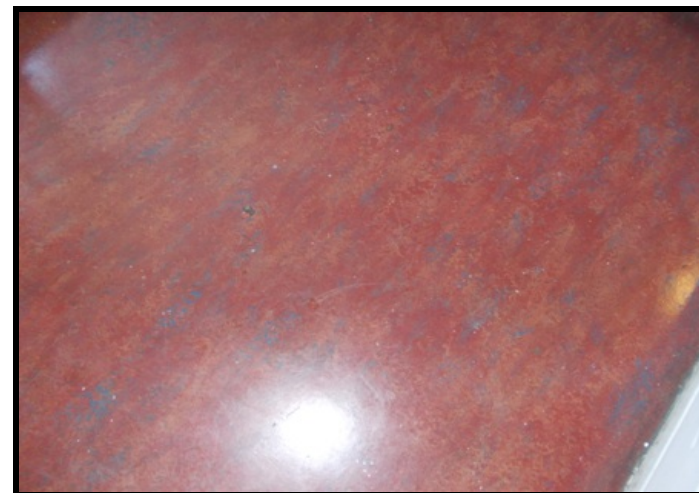
## SAMPLE REFERENCE 015

**No Asbestos Presumed in Sample**

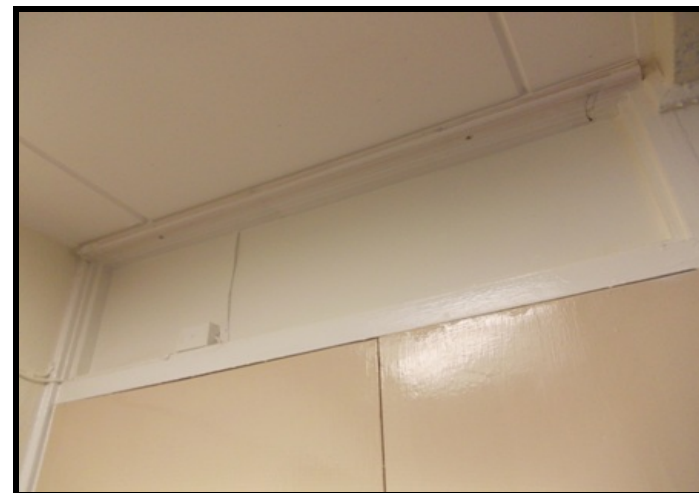
## SAMPLE REFERENCE 019

**No Asbestos Presumed in Sample**

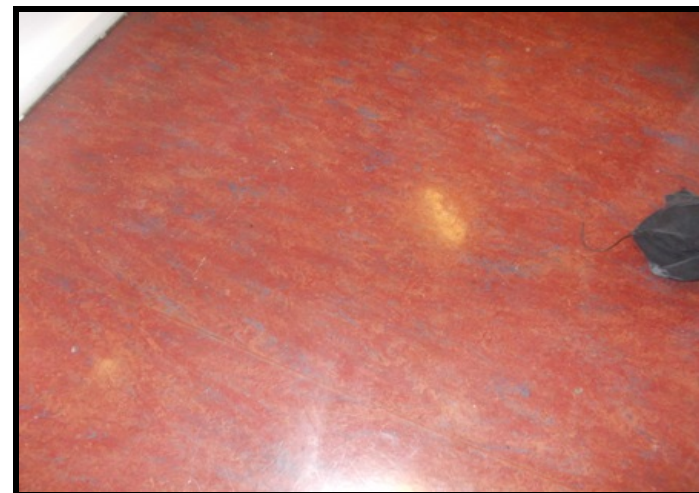
## SAMPLE REFERENCE 022

**No Asbestos Presumed in Sample**

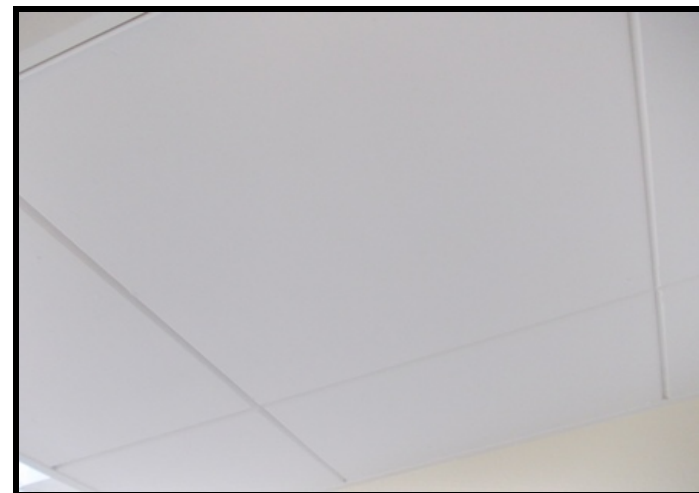
## SAMPLE REFERENCE 024

**No Asbestos Presumed in Sample**

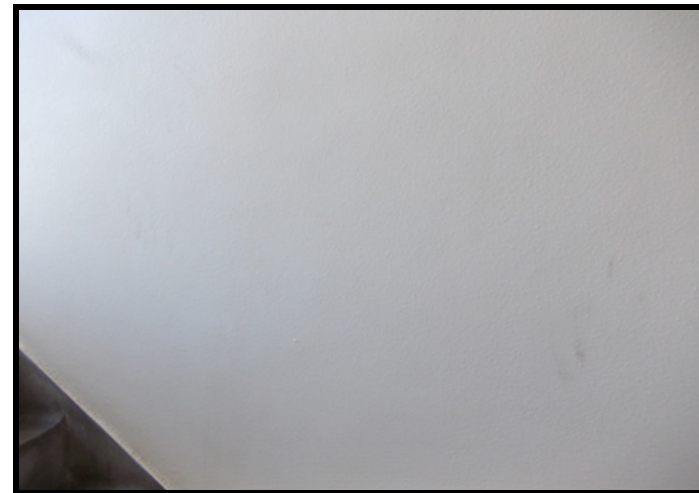
## SAMPLE REFERENCE 027

**No Asbestos Presumed in Sample**

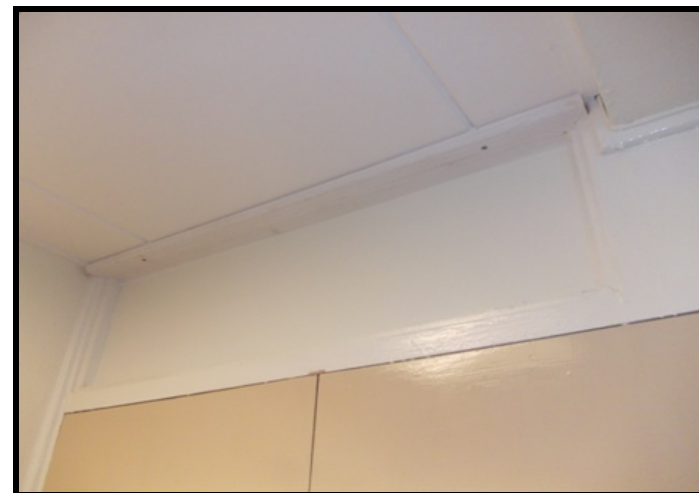
## SAMPLE REFERENCE 028

**No Asbestos Presumed in Sample**

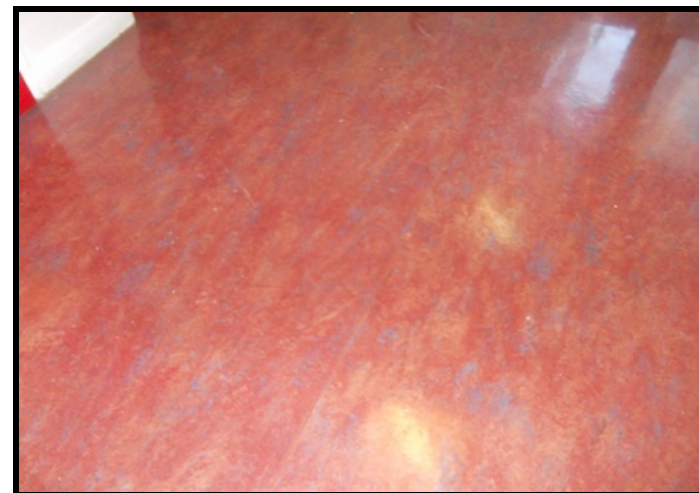
## SAMPLE REFERENCE 031

**No Asbestos Presumed in Sample**

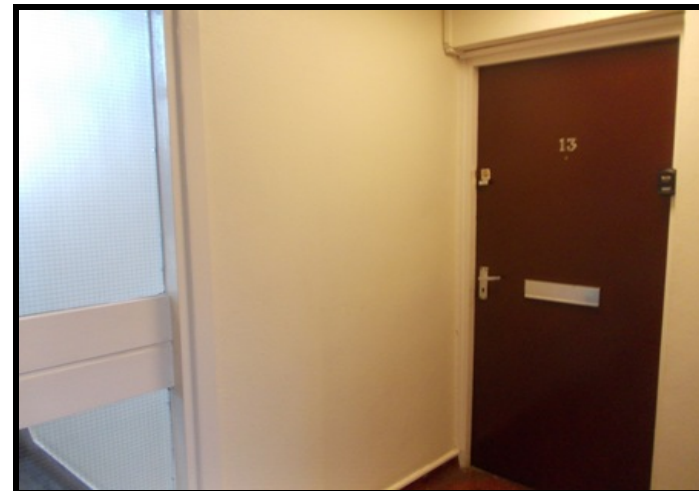
## SAMPLE REFERENCE 032

**No Asbestos Presumed in Sample**

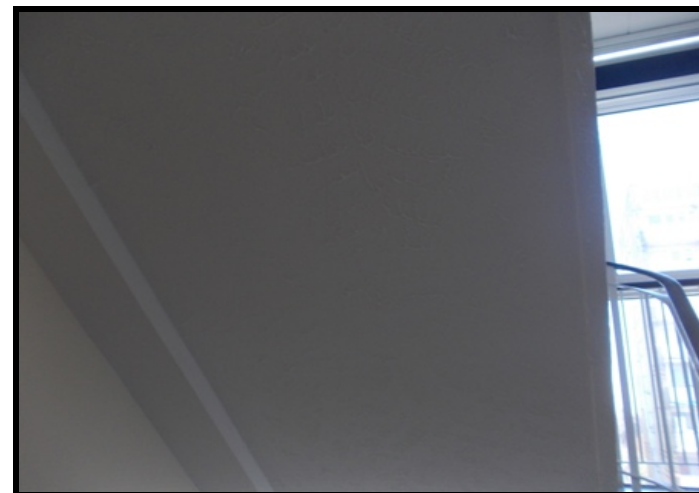
## SAMPLE REFERENCE 035

**No Asbestos Presumed in Sample**

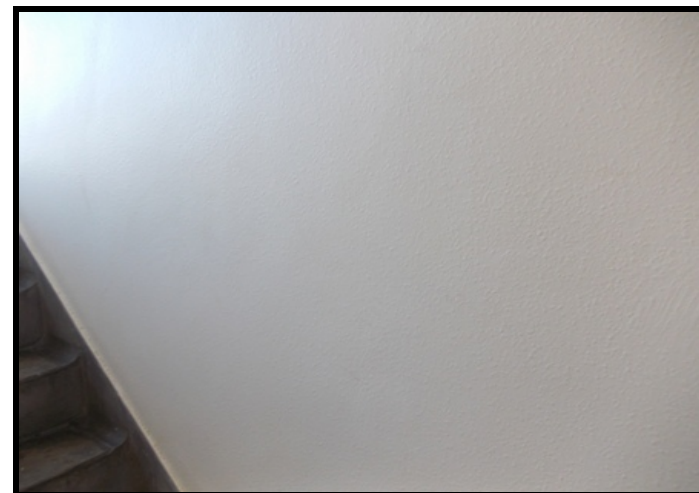
## SAMPLE REFERENCE 036

**No Asbestos Presumed in Sample**

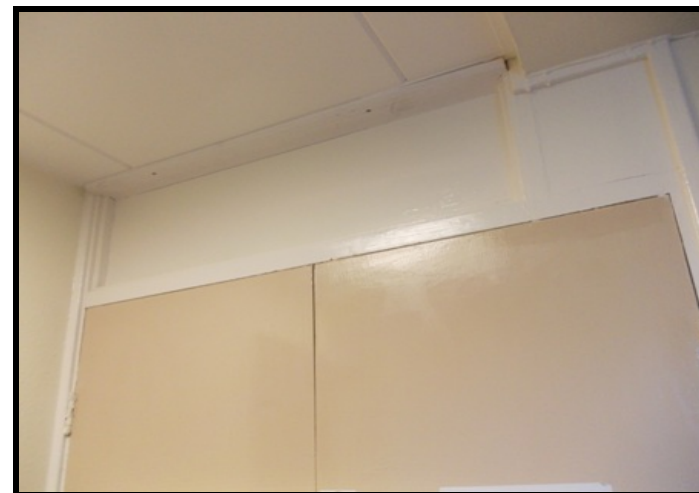
## SAMPLE REFERENCE 037

**No Asbestos Presumed in Sample**

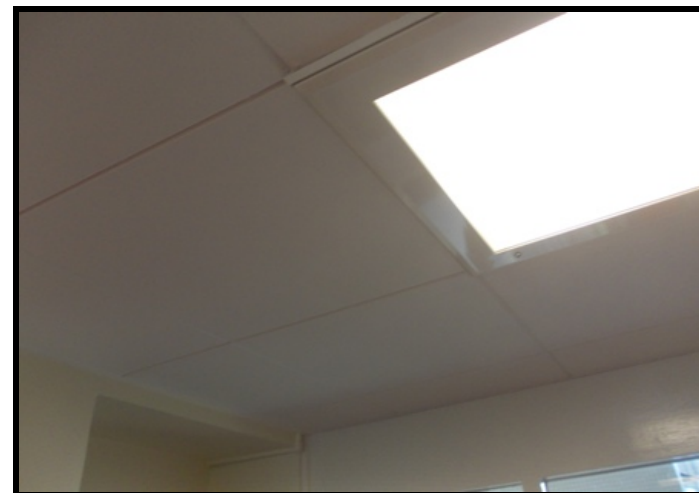
## SAMPLE REFERENCE 039

**No Asbestos Presumed in Sample**

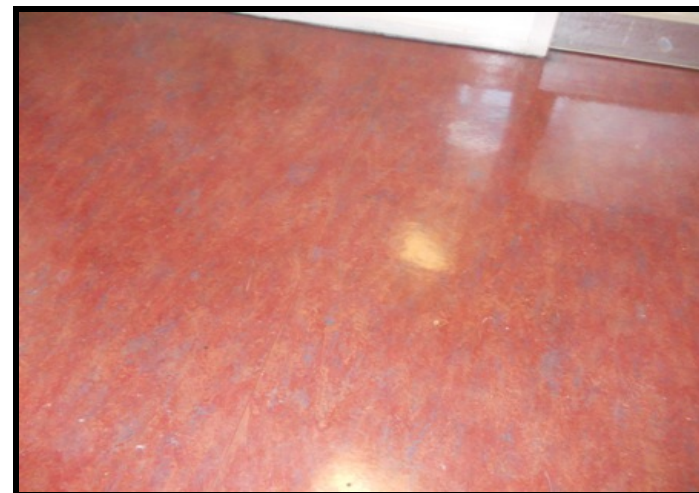
## SAMPLE REFERENCE 040

**No Asbestos Presumed in Sample**

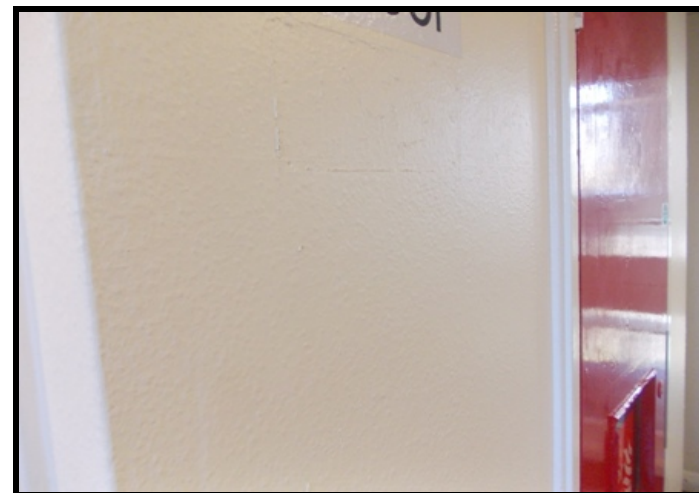
## SAMPLE REFERENCE 041

**No Asbestos Presumed in Sample**

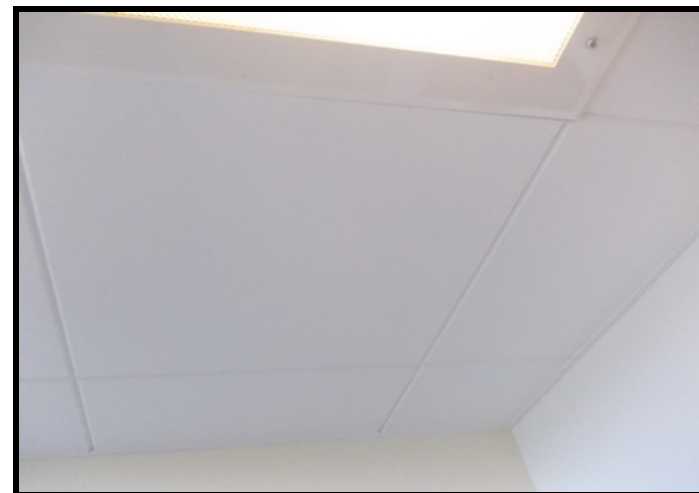
## SAMPLE REFERENCE 042

**No Asbestos Presumed in Sample**

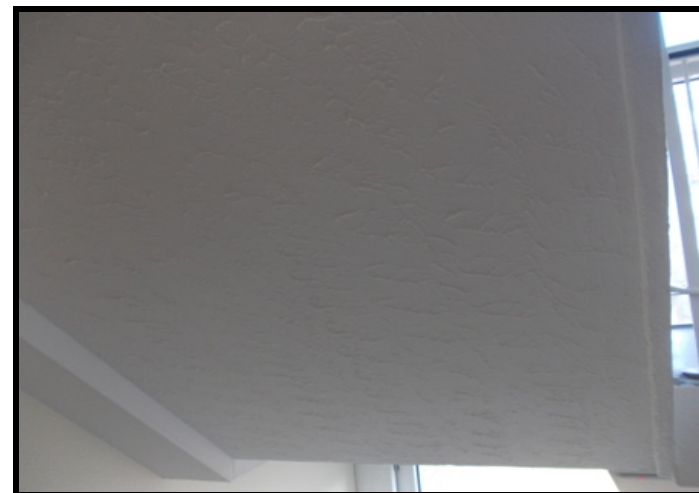
## SAMPLE REFERENCE 044

**No Asbestos Presumed in Sample**

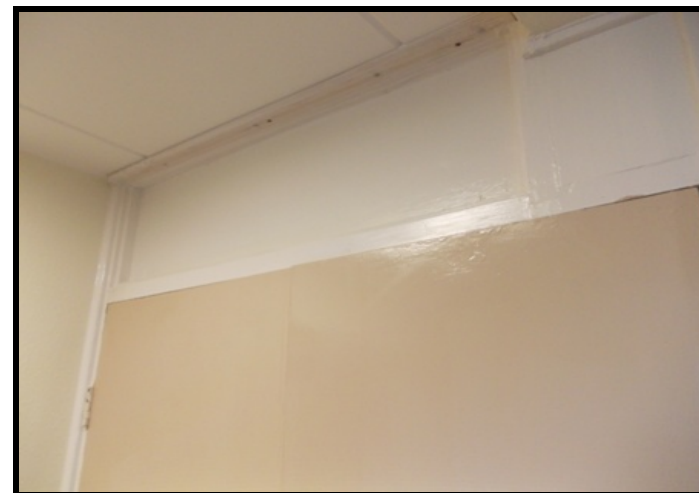
## SAMPLE REFERENCE 045

**No Asbestos Presumed in Sample**

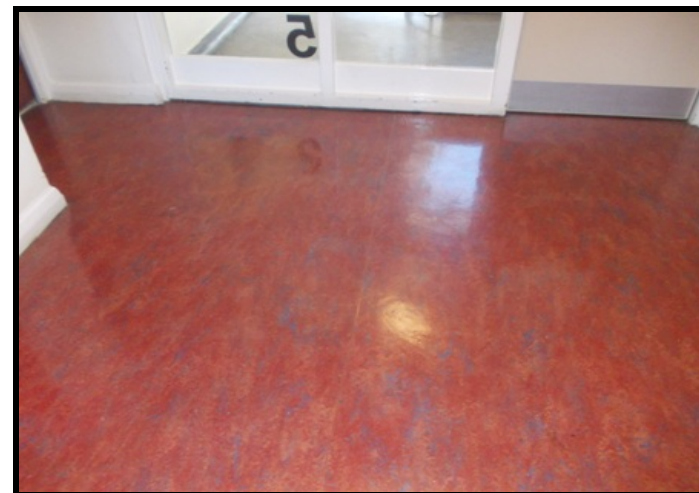
## SAMPLE REFERENCE 048

**No Asbestos Presumed in Sample**

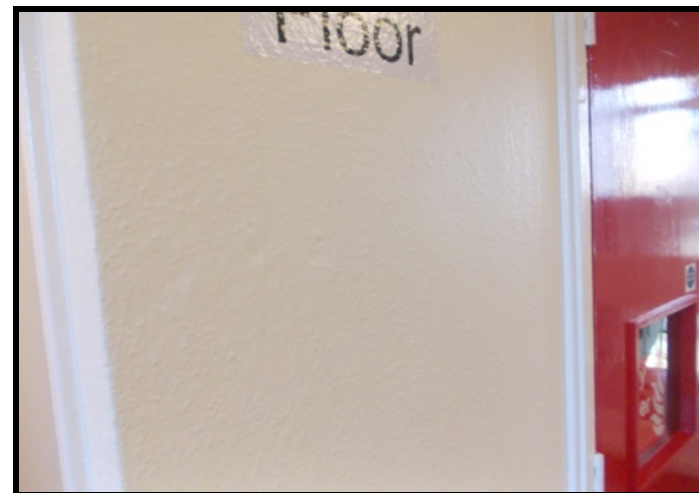
## SAMPLE REFERENCE 049

**No Asbestos Presumed in Sample**

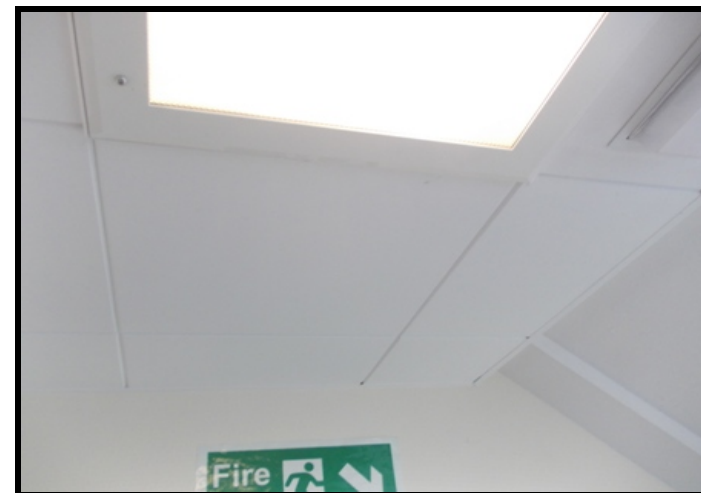
## SAMPLE REFERENCE 050

**No Asbestos Presumed in Sample**

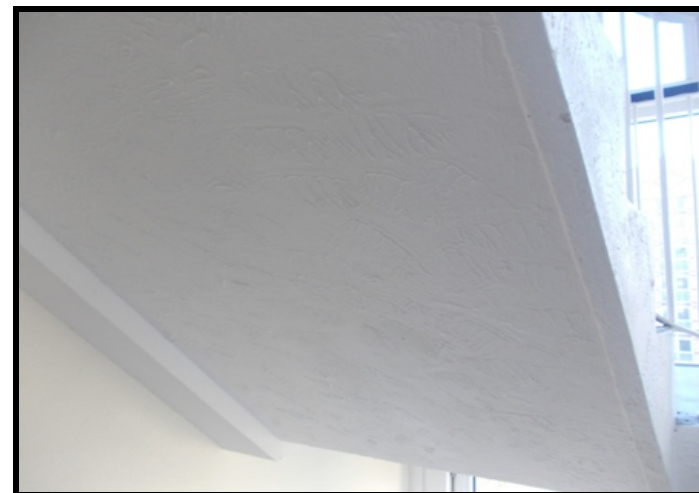
## SAMPLE REFERENCE 052

**No Asbestos Presumed in Sample**

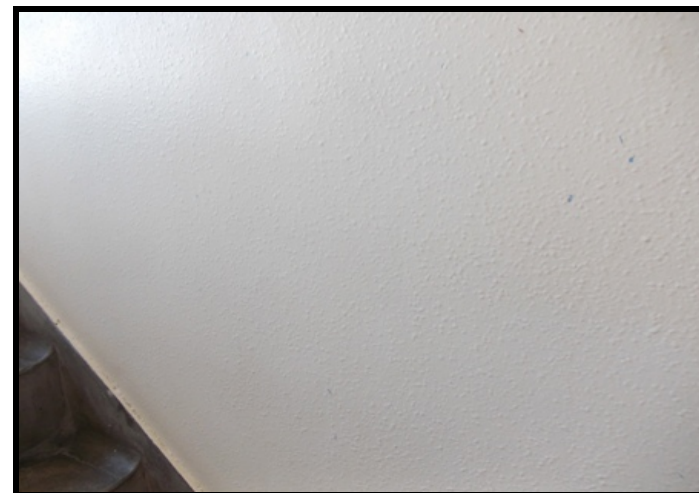
## SAMPLE REFERENCE 053

**No Asbestos Presumed in Sample**

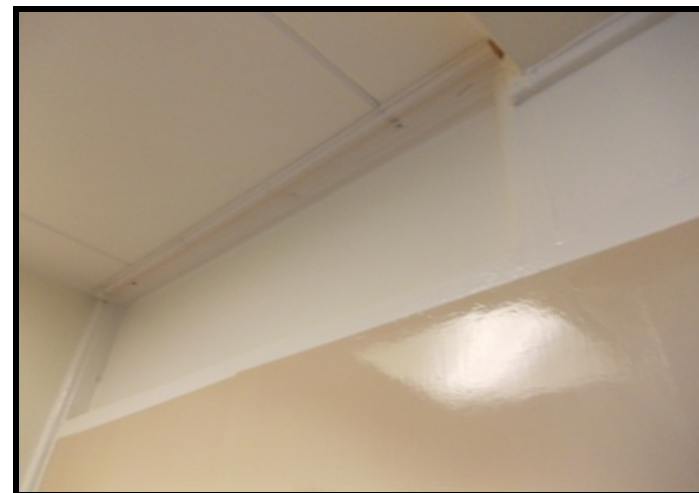
## SAMPLE REFERENCE 054

**No Asbestos Presumed in Sample**

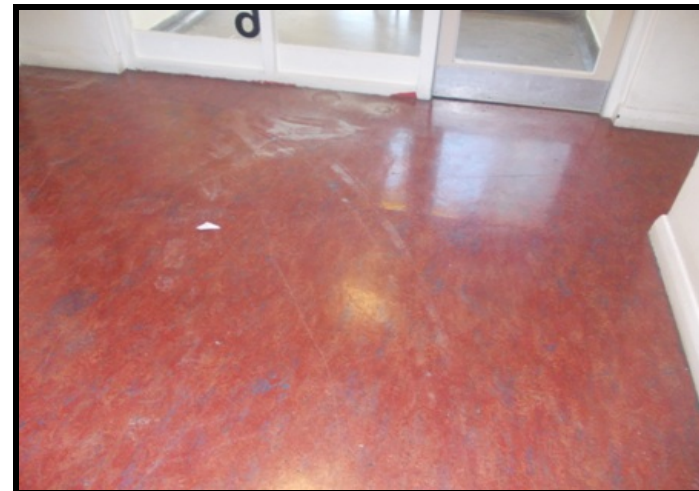
## SAMPLE REFERENCE 057

Building	Floor	Room	Location
Main Building	Sixth Floor	Landing	Floor
<b>Description</b>			
<b>MATERIAL ASSESSMENT</b>			
<b>Product Type</b>	Paper	<b>Extent of Damage</b>	Good condition
<b>Asbestos Type</b>	<b>No Asbestos Detected</b>	<b>Surface Treatment</b>	Sealed (0)
<b>PRIORITY ASSESSMENT</b>			
<b>Occupant Activity</b>	Not Applicable	<b>Extent / Amount</b>	10.00 m2
<b>Accessibility</b>	Occasionally disturb	<b>Location</b>	Not Applicable
<b>Avg Time in Use</b>	Not Applicable	<b>Frequency of Use</b>	Not Applicable
<b>No. of Occupants</b>	Not Applicable	<b>Secondary Activity</b>	Not Applicable
<b>Maintenance</b>	Not Applicable	<b>Maintenance Frequency</b>	Not Applicable
<b>MANAGEMENT ACTION</b>			
<b>Recommendation</b>	NO ACTION REQUIRED		
<b>Recommendation Due</b>		<b>Next Inspection</b>	None
<b>Apply Labels</b>	No	<b>Permit to Work Required</b>	No
<b>Survey Type</b>	Management	<b>Lead Surveyor</b>	Gavin Hooper

**No Asbestos Presumed in Sample**

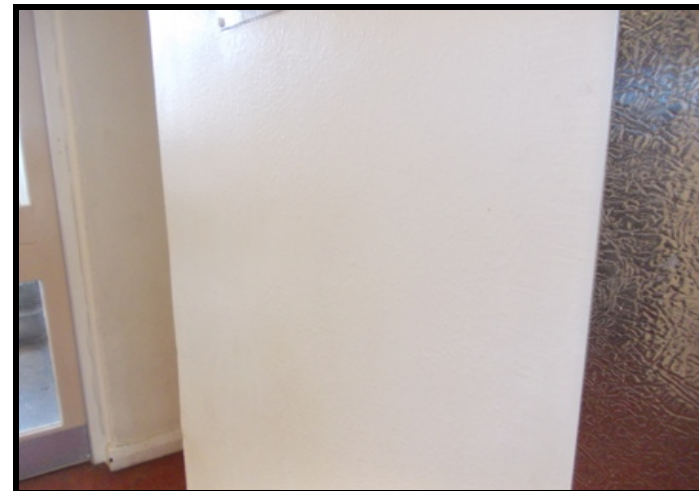
## SAMPLE REFERENCE 058

Building	Floor	Room	Location		
Main Building	Sixth Floor	Landing	Wall		
Description					
MATERIAL ASSESSMENT					SCORE
Product Type	Textured Coating	Extent of Damage	Good condition		-
Asbestos Type	No Asbestos Detected	Surface Treatment	Textured Coating		
PRIORITY ASSESSMENT					SCORE
Occupant Activity	Not Applicable	Extent / Amount	15.00 m2		-
Accessibility	Occasionally disturb	Location	Not Applicable		
Avg Time in Use	Not Applicable	Frequency of Use	Not Applicable		
No. of Occupants	Not Applicable	Secondary Activity	Not Applicable		
Maintenance	Not Applicable	Maintenance Frequency	Not Applicable		
MANAGEMENT ACTION					SCORE
Recommendation	NO ACTION REQUIRED				-
Recommendation Due		Next Inspection	None		
Apply Labels	No	Permit to Work Required	No		
Survey Type	Management	Lead Surveyor	Gavin Hooper		
Survey Date	09 Feb 2015	UKAS Laboratory	NOT SAMPLED (Cross Referenced)		
Site Reference	257980000A	Licensed Material	N/A	Notifiable Non Licensed Work	N/A

**No Asbestos Presumed in Sample**

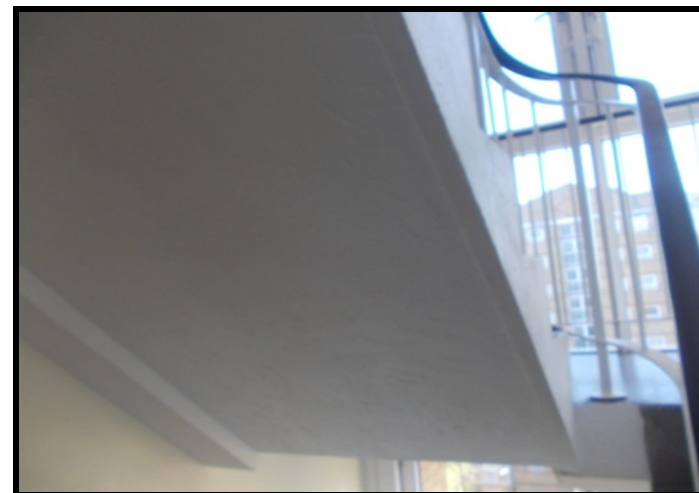
## SAMPLE REFERENCE 061

Building	Floor	Room	Location		
Main Building	Sixth Floor	Stairs	Ceiling		
Description	No access within timber boxing				
MATERIAL ASSESSMENT				SCORE	
Product Type	Textured Coating	Extent of Damage	Good condition		-
Asbestos Type	No Asbestos Detected	Surface Treatment	Textured Coating		
PRIORITY ASSESSMENT				SCORE	
Occupant Activity	Not Applicable	Extent / Amount	4.00 m2		-
Accessibility	Occasionally disturb	Location	Not Applicable		
Avg Time in Use	Not Applicable	Frequency of Use	Not Applicable		
No. of Occupants	Not Applicable	Secondary Activity	Not Applicable		
Maintenance	Not Applicable	Maintenance Frequency	Not Applicable		
MANAGEMENT ACTION				SCORE	
Recommendation	NO ACTION REQUIRED				-
Recommendation Due		Next Inspection	None		
Apply Labels	No	Permit to Work Required	No		
Survey Type	Management	Lead Surveyor	Gavin Hooper		
Survey Date	09 Feb 2015	UKAS Laboratory	NOT SAMPLED (Cross Referenced)		
Site Reference	257980000A	Licensed Material	N/A	Notifiable Non Licensed Work	N/A

**No Asbestos Presumed in Sample**

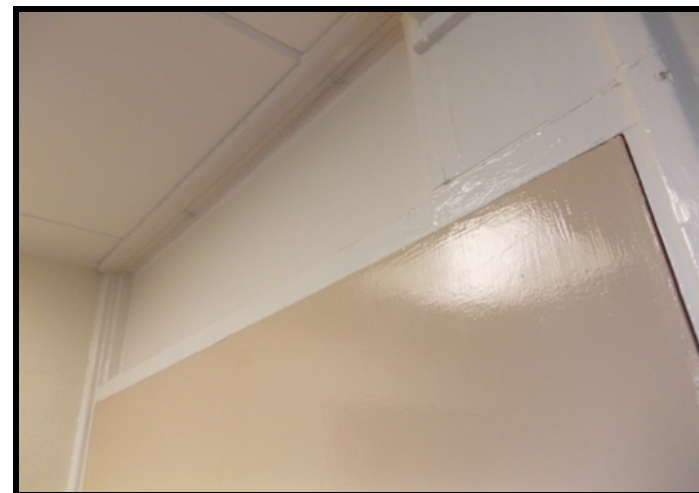
## SAMPLE REFERENCE 063

MATERIAL ASSESSMENT				SCORE
<b>Product Type</b>	Insulation Board	<b>Extent of Damage</b>	Good condition	-
<b>Asbestos Type</b>	<b>No Asbestos Detected</b>	<b>Surface Treatment</b>	Sealed Board (Encapsulated)

**No Asbestos Presumed in Sample**

MANAGEMENT ACTION				SCORE
<b>Recommendation</b>	NO ACTION REQUIRED			-
<b>Recommendation Due</b>		<b>Next Inspection</b>	None	
<b>Apply Labels</b>	No	<b>Permit to Work Required</b>	No

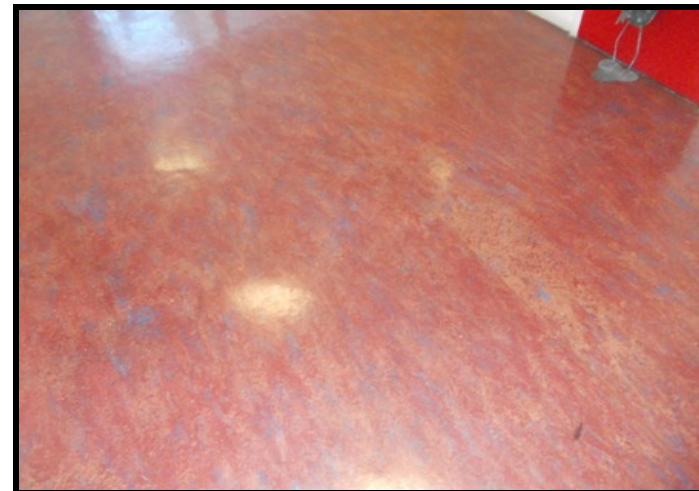
## SAMPLE REFERENCE 066

MATERIAL ASSESSMENT				SCORE
<b>Product Type</b>	Paper	<b>Extent of Damage</b>	Good condition	-
<b>Asbestos Type</b>	<b>No Asbestos Detected</b>	<b>Surface Treatment</b>	Sealed (0)

**No Asbestos Presumed in Sample**

MANAGEMENT ACTION				SCORE
<b>Recommendation</b>	NO ACTION REQUIRED			-
<b>Recommendation Due</b>		<b>Next Inspection</b>	None	
<b>Apply Labels</b>	No	<b>Permit to Work Required</b>	No

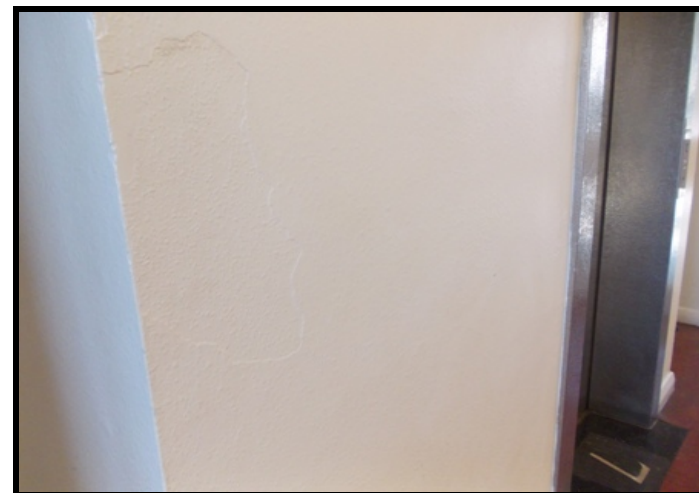
## SAMPLE REFERENCE 067

MATERIAL ASSESSMENT				SCORE
<b>Product Type</b>	Textured Coating	<b>Extent of Damage</b>	Good condition	-
<b>Asbestos Type</b>	No Asbestos Detected	<b>Surface Treatment</b>	Textured Coating

**No Asbestos Presumed in Sample**

MANAGEMENT ACTION				SCORE
<b>Recommendation</b>	NO ACTION REQUIRED			-
<b>Recommendation Due</b>		<b>Next Inspection</b>	None	
<b>Apply Labels</b>	No	<b>Permit to Work Required</b>	No

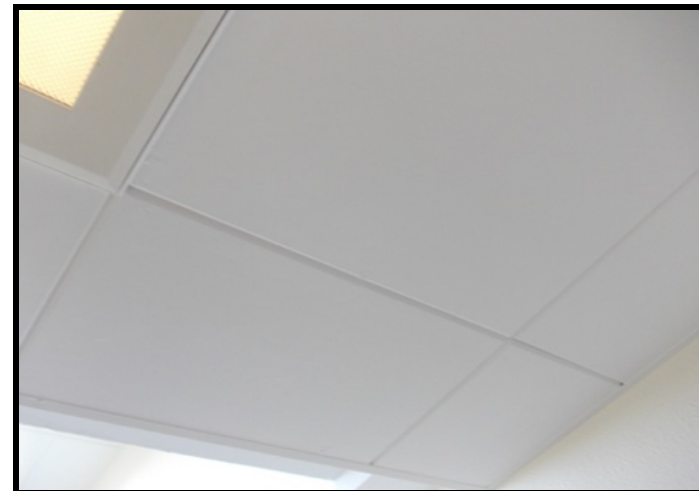
## SAMPLE REFERENCE 068

MATERIAL ASSESSMENT				SCORE
<b>Product Type</b>	Insulation Board	<b>Extent of Damage</b>	Good condition	-
<b>Asbestos Type</b>	<b>No Asbestos Detected</b>	<b>Surface Treatment</b>	Sealed Board (Encapsulated)

**No Asbestos Presumed in Sample**

MANAGEMENT ACTION				SCORE
<b>Recommendation</b>	NO ACTION REQUIRED			-
<b>Recommendation Due</b>		<b>Next Inspection</b>	None	
<b>Apply Labels</b>	No	<b>Permit to Work Required</b>	No

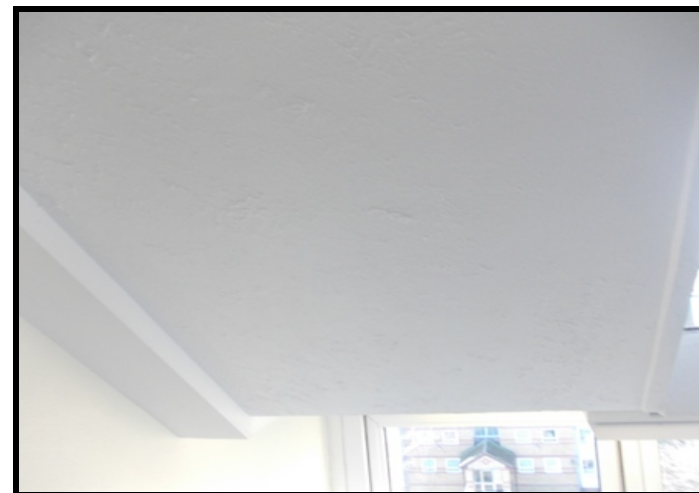
## SAMPLE REFERENCE 070

Building	Floor	Room	Location		
Main Building	Seventh Floor	Stairs	Ceiling		
Description	No access within timber boxing				
MATERIAL ASSESSMENT				SCORE	
Product Type	Textured Coating	Extent of Damage	Good condition		-
Asbestos Type	No Asbestos Detected	Surface Treatment	Textured Coating		
PRIORITY ASSESSMENT				SCORE	
Occupant Activity	Not Applicable	Extent / Amount	4.00 m2		-
Accessibility	Occasionally disturb	Location	Not Applicable		
Avg Time in Use	Not Applicable	Frequency of Use	Not Applicable		
No. of Occupants	Not Applicable	Secondary Activity	Not Applicable		
Maintenance	Not Applicable	Maintenance Frequency	Not Applicable		
MANAGEMENT ACTION				SCORE	
Recommendation	NO ACTION REQUIRED				-
Recommendation Due		Next Inspection	None		
Apply Labels	No	Permit to Work Required	No		
Survey Type	Management	Lead Surveyor	Gavin Hooper		
Survey Date	09 Feb 2015	UKAS Laboratory	NOT SAMPLED (Cross Referenced)

**No Asbestos Presumed in Sample**

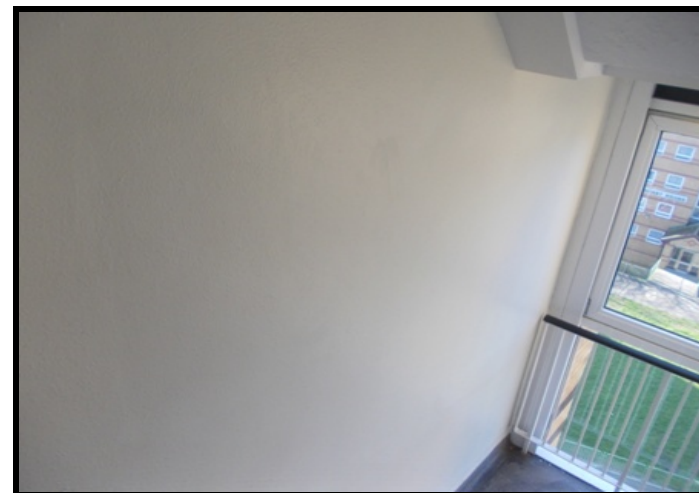
## SAMPLE REFERENCE 071

Building	Floor	Room	Location			
Main Building	Seventh Floor	Stairs	Wall			
Description	No access within timber boxing					
MATERIAL ASSESSMENT				SCORE		
Product Type	Textured Coating	Extent of Damage	Good condition		-	
Asbestos Type	No Asbestos Detected	Surface Treatment	Textured Coating			
PRIORITY ASSESSMENT				SCORE		
Occupant Activity	Not Applicable	Extent / Amount	15.00 m2		-	
Accessibility	Easily disturbed	Location	Not Applicable			
Avg Time in Use	Not Applicable	Frequency of Use	Not Applicable			
No. of Occupants	Not Applicable	Secondary Activity	Not Applicable			
Maintenance	Not Applicable	Maintenance Frequency	Not Applicable			
MANAGEMENT ACTION				SCORE		
Recommendation	NO ACTION REQUIRED			-		
Recommendation Due		Next Inspection	None			
Apply Labels	No	Permit to Work Required	No			
Survey Type	Management	Lead Surveyor	Gavin Hooper			
Survey Date	09 Feb 2015	UKAS Laboratory	NOT SAMPLED (Cross Referenced)

**No Asbestos Presumed in Sample**

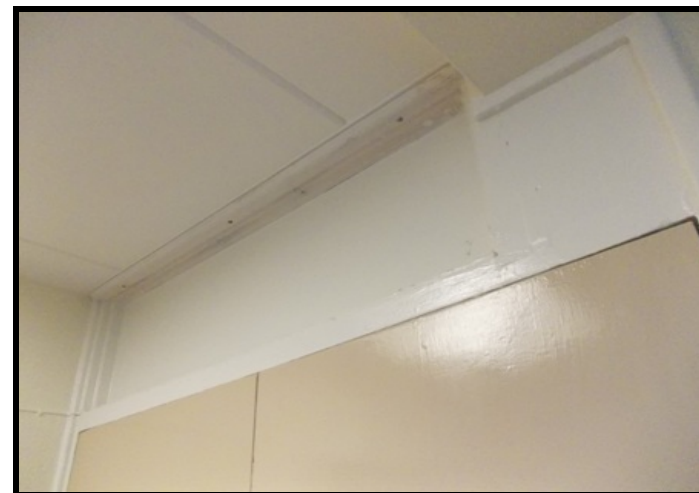
## SAMPLE REFERENCE 072

Building	Floor	Room	Location		
Main Building	Seventh Floor	Electric Riser Cupboard	Transom Panel		
Description					
MATERIAL ASSESSMENT					SCORE
Product Type	Insulation Board	Extent of Damage	Good condition		-
Asbestos Type	No Asbestos Detected	Surface Treatment	Sealed Board (Encapsulated)		
PRIORITY ASSESSMENT					SCORE
Occupant Activity	Not Applicable	Extent / Amount	1.00 m2		-
Accessibility	Occasionally disturb	Location	Not Applicable		
Avg Time in Use	Not Applicable	Frequency of Use	Not Applicable		
No. of Occupants	Not Applicable	Secondary Activity	Not Applicable		
Maintenance	Not Applicable	Maintenance Frequency	Not Applicable		
MANAGEMENT ACTION					SCORE
Recommendation	NO ACTION REQUIRED				-
Recommendation Due		Next Inspection	None		
Apply Labels	No	Permit to Work Required	No		
Survey Type	Management	Lead Surveyor	Gavin Hooper		
Survey Date	09 Feb 2015	UKAS Laboratory	NOT SAMPLED (Cross Referenced)

**No Asbestos Presumed in Sample**

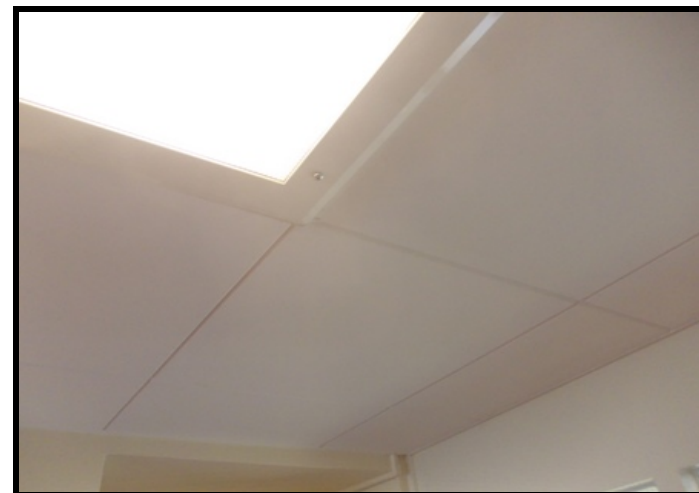
## SAMPLE REFERENCE 074

Building	Floor	Room	Location
Main Building	Eighth Floor	Landing	Ceiling
<b>Description</b>			
<b>MATERIAL ASSESSMENT</b>			
<b>Product Type</b>	Insulation Board	<b>Extent of Damage</b>	Good condition
<b>Asbestos Type</b>	<b>No Asbestos Detected</b>	<b>Surface Treatment</b>	Sealed Board (Encapsulated)
<b>PRIORITY ASSESSMENT</b>			
<b>Occupant Activity</b>	Not Applicable	<b>Extent / Amount</b>	10.00 m2
<b>Accessibility</b>	Occasionally disturb	<b>Location</b>	Not Applicable
<b>Avg Time in Use</b>	Not Applicable	<b>Frequency of Use</b>	Not Applicable
<b>No. of Occupants</b>	Not Applicable	<b>Secondary Activity</b>	Not Applicable
<b>Maintenance</b>	Not Applicable	<b>Maintenance Frequency</b>	Not Applicable
<b>MANAGEMENT ACTION</b>			
<b>Recommendation</b>	NO ACTION REQUIRED		
<b>Recommendation Due</b>		<b>Next Inspection</b>	None
<b>Apply Labels</b>	No	<b>Permit to Work Required</b>	No
<b>Survey Type</b>	Management	<b>Lead Surveyor</b>	Gavin Hooper

**No Asbestos Presumed in Sample**

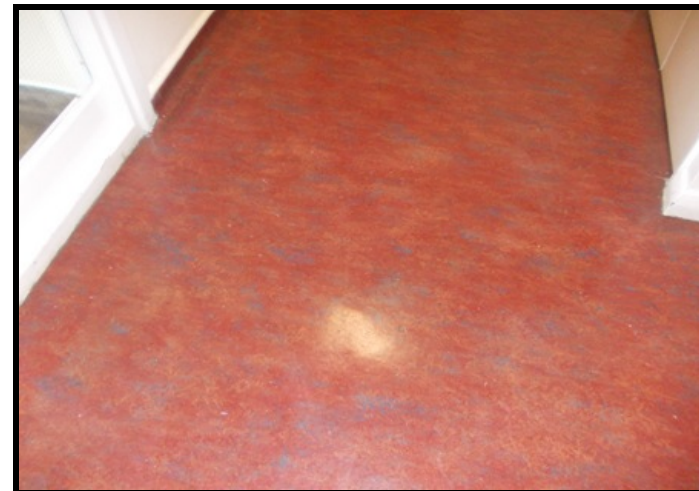
## SAMPLE REFERENCE 075

MATERIAL ASSESSMENT				SCORE
<b>Product Type</b>	Paper	<b>Extent of Damage</b>	Good condition	-
<b>Asbestos Type</b>	No Asbestos Detected	<b>Surface Treatment</b>	Sealed (0)

**No Asbestos Presumed in Sample**

MANAGEMENT ACTION				SCORE
<b>Recommendation</b>	NO ACTION REQUIRED			-
<b>Recommendation Due</b>		<b>Next Inspection</b>	None	
<b>Apply Labels</b>	No	<b>Permit to Work Required</b>	No

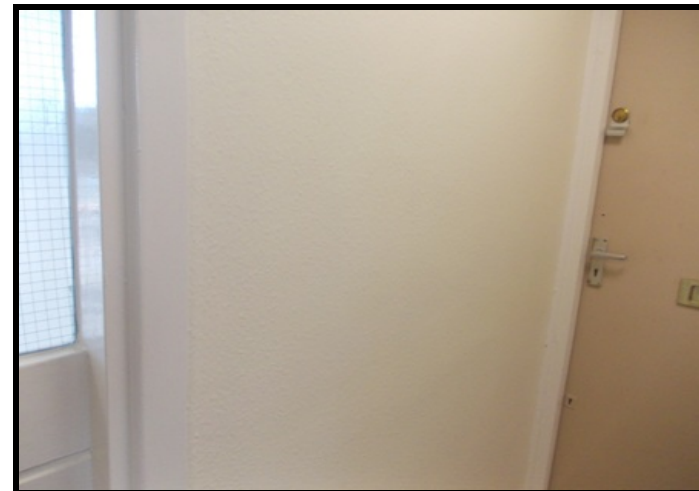
## SAMPLE REFERENCE 076

MATERIAL ASSESSMENT				SCORE
<b>Product Type</b>	Textured Coating	<b>Extent of Damage</b>	Good condition	-
<b>Asbestos Type</b>	<b>No Asbestos Detected</b>	<b>Surface Treatment</b>	Textured Coating

**No Asbestos Presumed in Sample**

MANAGEMENT ACTION				SCORE
<b>Recommendation</b>	NO ACTION REQUIRED			-
<b>Recommendation Due</b>		<b>Next Inspection</b>	None	
<b>Apply Labels</b>	No	<b>Permit to Work Required</b>	No

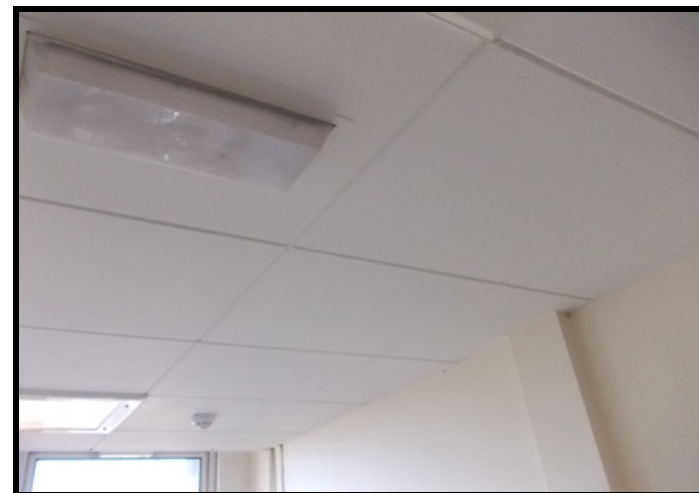
## SAMPLE REFERENCE 077

Building	Floor	Room	Location
Main Building	Eighth Floor	Stairs	Ceiling
<b>Description</b>	No access within timber boxing		
MATERIAL ASSESSMENT			
<b>Product Type</b>	Insulation Board	<b>Extent of Damage</b>	Good condition
<b>Asbestos Type</b>	<b>No Asbestos Detected</b>	<b>Surface Treatment</b>	Sealed Board (Encapsulated)
PRIORITY ASSESSMENT			
<b>Occupant Activity</b>	Not Applicable	<b>Extent / Amount</b>	10.00 m2
<b>Accessibility</b>	Occasionally disturb	<b>Location</b>	Not Applicable
<b>Avg Time in Use</b>	Not Applicable	<b>Frequency of Use</b>	Not Applicable
<b>No. of Occupants</b>	Not Applicable	<b>Secondary Activity</b>	Not Applicable
<b>Maintenance</b>	Not Applicable	<b>Maintenance Frequency</b>	Not Applicable
MANAGEMENT ACTION			
<b>Recommendation</b>	NO ACTION REQUIRED		
<b>Recommendation Due</b>		<b>Next Inspection</b>	None
<b>Apply Labels</b>	No	<b>Permit to Work Required</b>	No
<b>Survey Type</b>	Management	<b>Lead Surveyor</b>	Gavin Hooper

**No Asbestos Presumed in Sample**

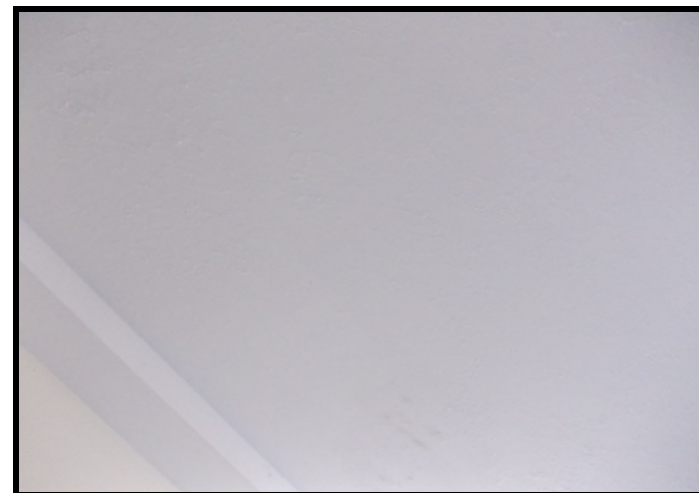
## SAMPLE REFERENCE 079

Building	Floor	Room	Location			
Main Building	Eighth Floor	Stairs	Ceiling			
Description	No access within timber boxing					
MATERIAL ASSESSMENT				SCORE		
Product Type	Textured Coating	Extent of Damage	Good condition		-	
Asbestos Type	No Asbestos Detected	Surface Treatment	Textured Coating			
PRIORITY ASSESSMENT				SCORE		
Occupant Activity	Not Applicable	Extent / Amount	4.00 m2		-	
Accessibility	Occasionally disturb	Location	Not Applicable			
Avg Time in Use	Not Applicable	Frequency of Use	Not Applicable			
No. of Occupants	Not Applicable	Secondary Activity	Not Applicable			
Maintenance	Not Applicable	Maintenance Frequency	Not Applicable			
MANAGEMENT ACTION				SCORE		
Recommendation	NO ACTION REQUIRED			-		
Recommendation Due		Next Inspection	None			
Apply Labels	No	Permit to Work Required	No			
Survey Type	Management	Lead Surveyor	Gavin Hooper			
Survey Date	09 Feb 2015	UKAS Laboratory	NOT SAMPLED (Cross Referenced)

**No Asbestos Presumed in Sample**

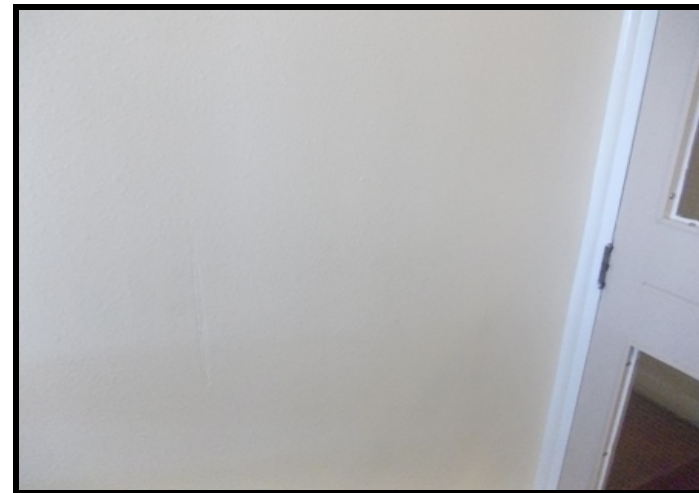
## SAMPLE REFERENCE 080

Building	Floor	Room	Location		
Main Building	Eighth Floor	Stairs	Wall		
Description	No access within timber boxing				
MATERIAL ASSESSMENT				SCORE	
Product Type	Textured Coating	Extent of Damage	Good condition		-
Asbestos Type	No Asbestos Detected	Surface Treatment	Textured Coating		
PRIORITY ASSESSMENT				SCORE	
Occupant Activity	Not Applicable	Extent / Amount	15.00 m2		-
Accessibility	Easily disturbed	Location	Not Applicable		
Avg Time in Use	Not Applicable	Frequency of Use	Not Applicable		
No. of Occupants	Not Applicable	Secondary Activity	Not Applicable		
Maintenance	Not Applicable	Maintenance Frequency	Not Applicable		
MANAGEMENT ACTION				SCORE	
Recommendation	NO ACTION REQUIRED				-
Recommendation Due		Next Inspection	None		
Apply Labels	No	Permit to Work Required	No		
Survey Type	Management	Lead Surveyor	Gavin Hooper		
Survey Date	09 Feb 2015	UKAS Laboratory	NOT SAMPLED (Cross Referenced)		
Site Reference	257980000A	Licensed Material	N/A	Notifiable Non Licensed Work	N/A

**No Asbestos Presumed in Sample**

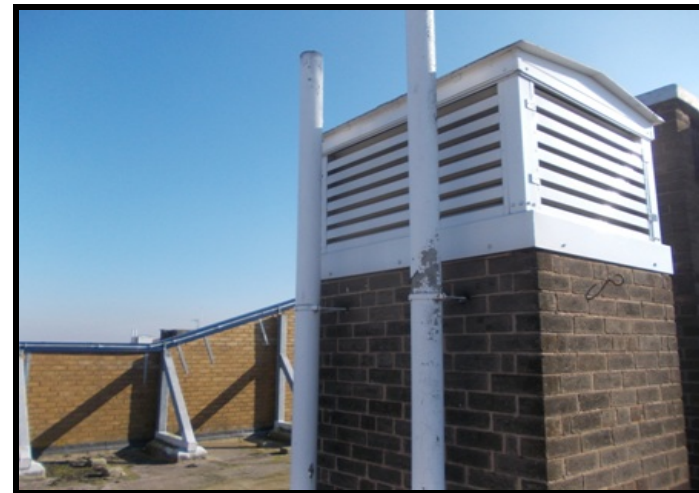
## SAMPLE REFERENCE 084

Building	Floor	Room	Location			
Main Building	Roof	Roof Area	Pipe Work			
Description	Cement pipes x2. No access within cupboard to side of lift motor room					
MATERIAL ASSESSMENT				SCORE		
Product Type	Cement	Extent of Damage	Good condition		3	
Asbestos Type	Chrysotile	Surface Treatment	Sealed (Cement products)			
PRIORITY ASSESSMENT				SCORE		
Occupant Activity	Not Applicable	Extent / Amount	12.00 m2		1	
Accessibility	Occasionally disturb	Location	Not Applicable			
Avg Time in Use	Not Applicable	Frequency of Use	Not Applicable			
No. of Occupants	Not Applicable	Secondary Activity	Not Applicable			
Maintenance	Not Applicable	Maintenance Frequency	Not Applicable			
MANAGEMENT ACTION				SCORE		
Recommendation	LABEL & MONITOR			4		
Recommendation Due		Next Inspection	09 Feb 2016			
Apply Labels	No	Permit to Work Required	No			
Survey Type	Management	Lead Surveyor	Gavin Hooper			
Survey Date	09 Feb 2015	UKAS Laboratory	DMW Environmental Safety Ltd / [A-15179]

Asbestos detected in Sample
