Solihull Community Housing

Asbestos Management Survey Report

**Downing House
Willow Way
Chelmsley Wood
B37 7PN**

Date of Report: 26 Jan 2015

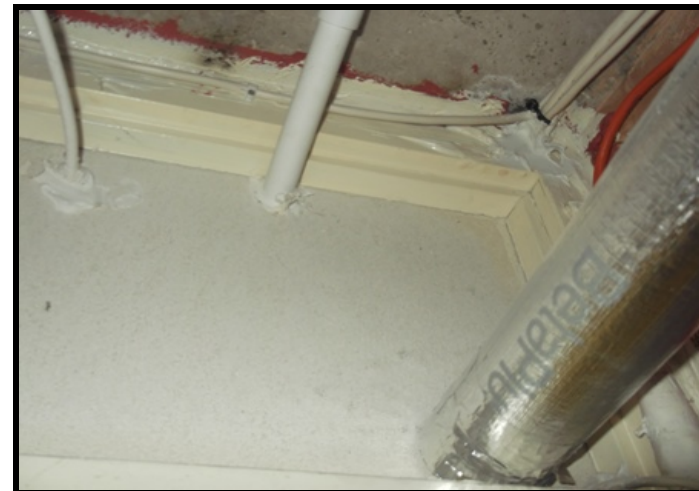
SAMPLE REFERENCE 029

No Asbestos Presumed in Sample

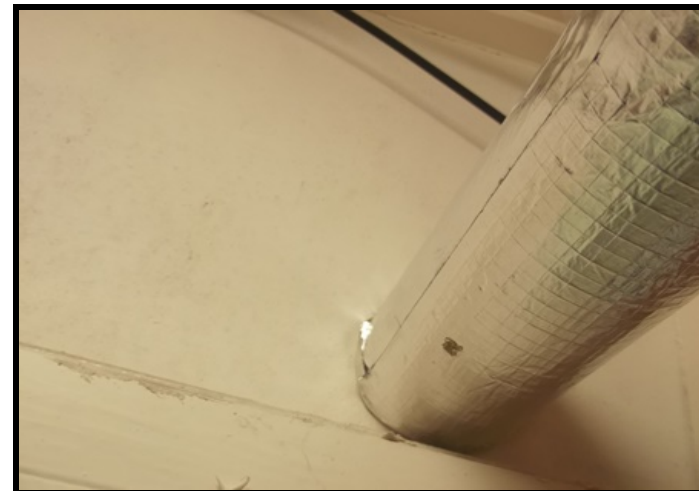
SAMPLE REFERENCE 048

No Asbestos Presumed in Sample

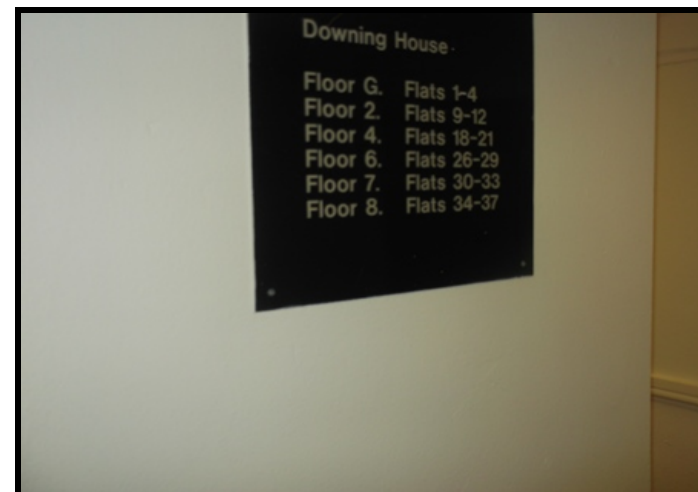
SAMPLE REFERENCE 080

No Asbestos Presumed in Sample

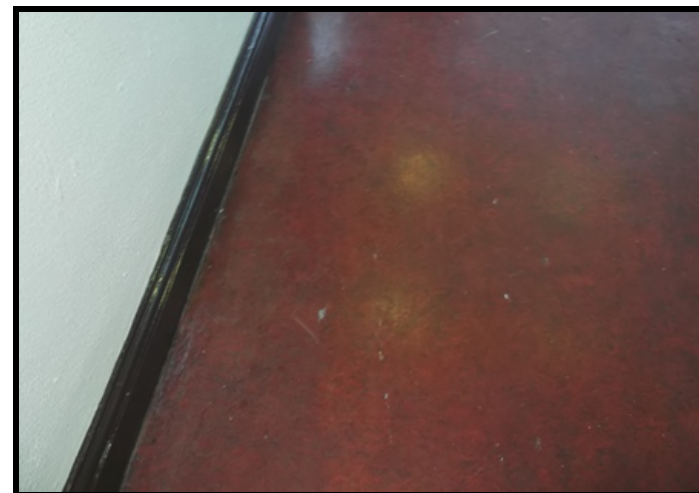
SAMPLE REFERENCE 082

No Asbestos Presumed in Sample

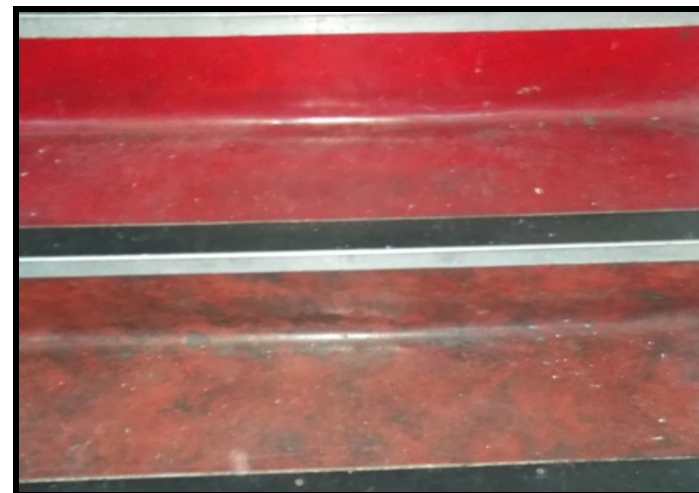
SAMPLE REFERENCE 083

No Asbestos Presumed in Sample

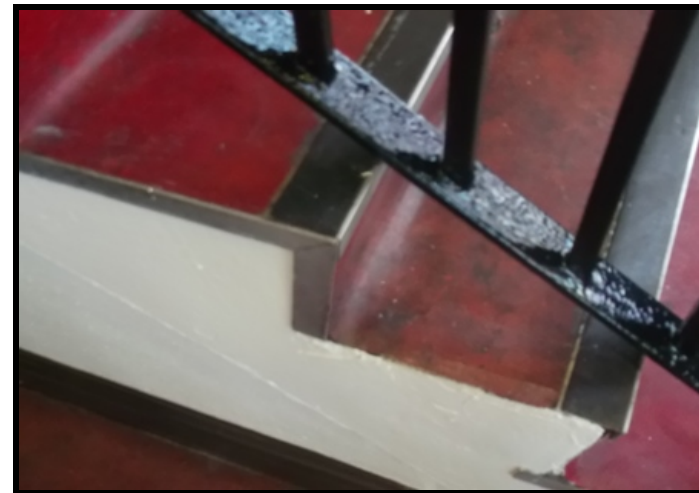
SAMPLE REFERENCE 084

Asbestos not detected in Sample

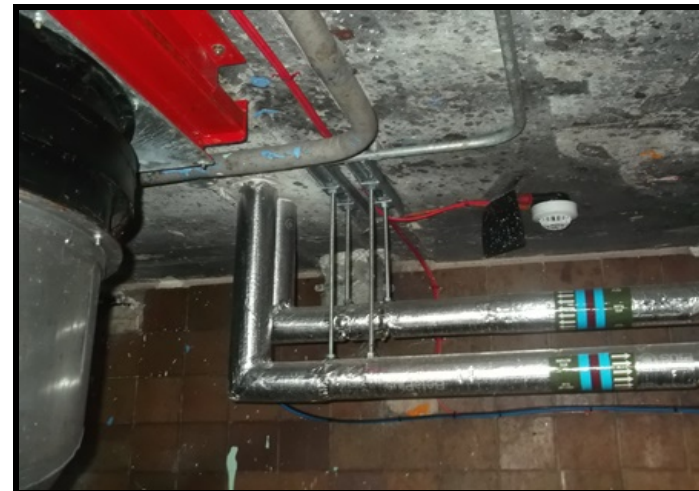
SAMPLE REFERENCE 085

Asbestos detected in Sample

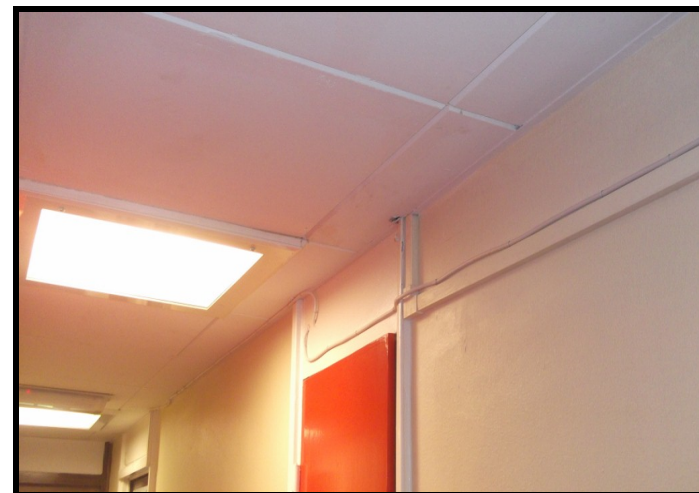
SAMPLE REFERENCE 092

No Asbestos Presumed in Sample

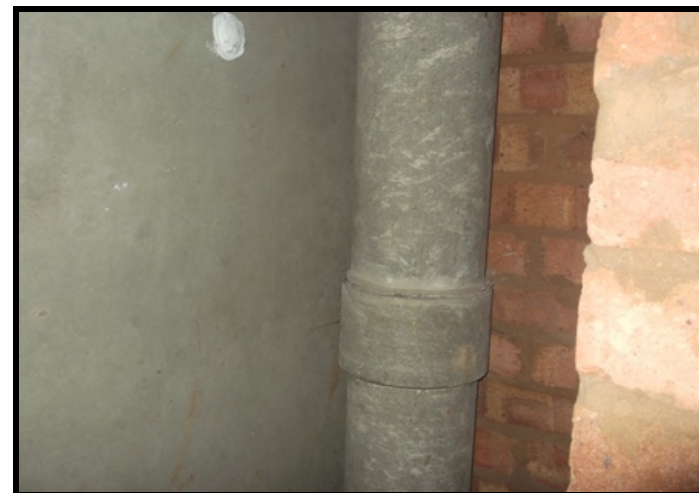
SAMPLE REFERENCE 093a

Asbestos detected in Sample

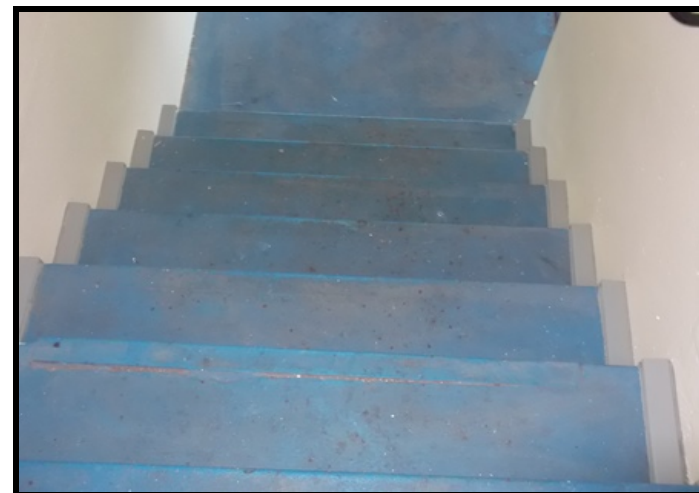
SAMPLE REFERENCE 093c

Asbestos detected in Sample
