# Solihull Community Housing

## Asbestos Management Survey Report

**Greyfriars House  
Kington Gardens  
Chelmsley Wood  
B37 5HY**

**Survey Ref: 129250000A**

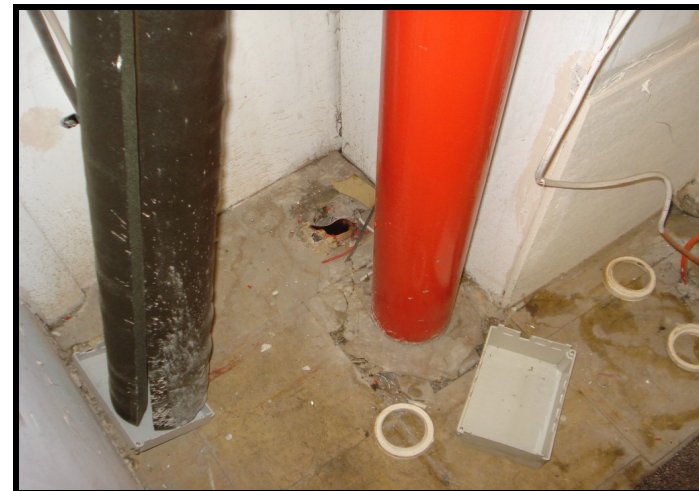
## SAMPLE REFERENCE 014

| Unique Sample No. | Building Reference (Floor) | Room Area | Description of Location | Product Description | Asbestos Type | Approx. Quantity | Material Condition | Surface Treatment | Material Risk Score | Priority Risk Score | Total Risk Score | Management Action | Next Review Date |
|---|---|---|---|---|---|---|---|---|---|---|---|---|---|
| 014 | Main Building (Eighth Floor) | Dry Riser | Floor | Floor Tiles | Chrysotile | 2.00m2 | Medium damage | Composite materials | 4 | 1 | 5 | REMOVAL BY LICENSED CONTRACTOR | |

Asbestos Presumed in Sample

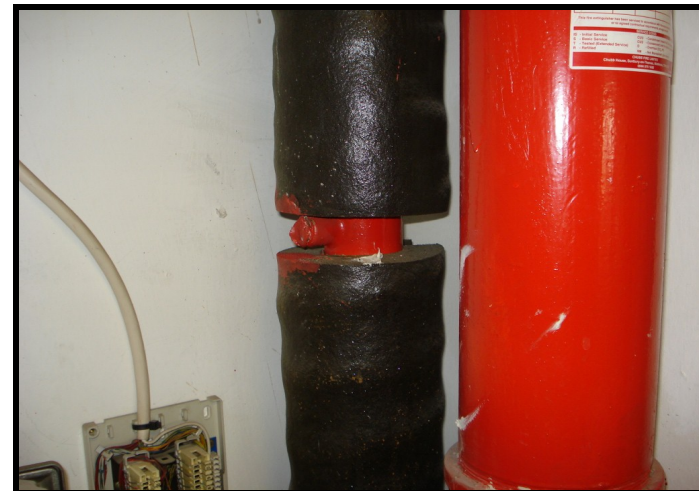
## SAMPLE REFERENCE 029

| Unique Sample No. | Building Reference (Floor) | Room Area | Description of Location | Product Description | Asbestos Type | Approx. Quantity | Material Condition | Surface Treatment | Material Risk Score | Priority Risk Score | Total Risk Score | Management Action | Next Review Date |
|---|---|---|---|---|---|---|---|---|---|---|---|---|---|
| 029 | Main Building (Seventh Floor) | Dry Riser | Riser | Paint | No Asbestos Detected | 3.00small item(s) | Good condition | Sealed (1) | - | - | - | NO ACTION REQUIRED | |

**No Asbestos Presumed in Sample**

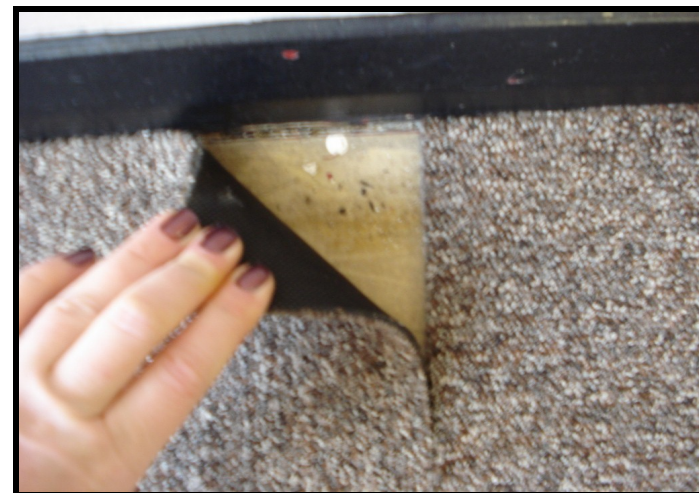
## SAMPLE REFERENCE 047

**Asbestos Presumed in Sample**

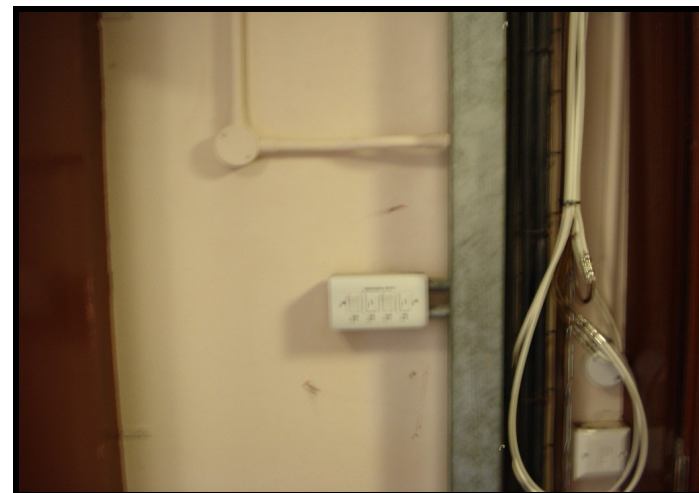
## SAMPLE REFERENCE 048

**No Asbestos Presumed in Sample**

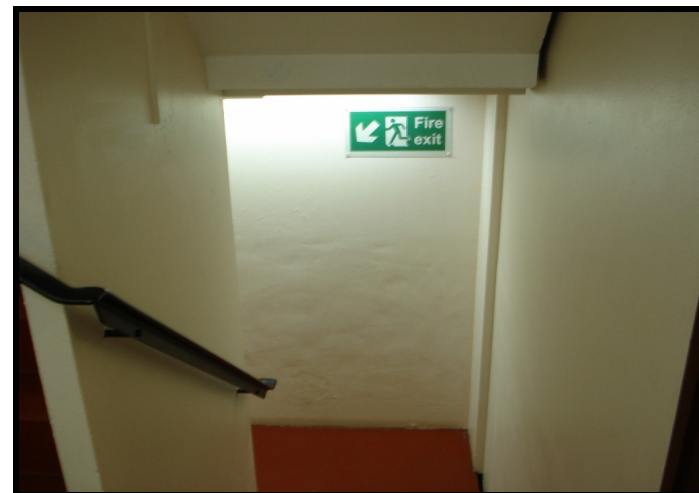
## SAMPLE REFERENCE 049

**No Asbestos Presumed in Sample**

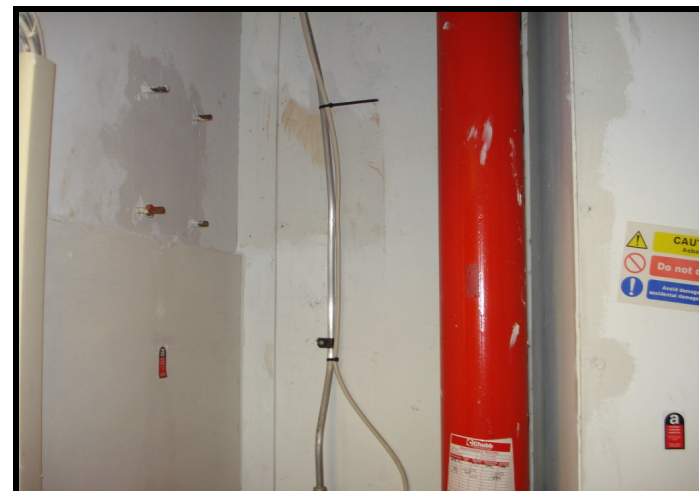
## SAMPLE REFERENCE 050

Asbestos Presumed in Sample

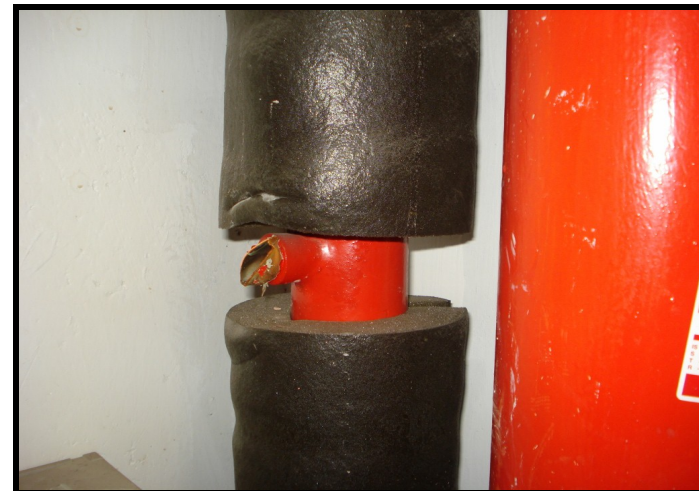
## SAMPLE REFERENCE 051

**No Asbestos Presumed in Sample**

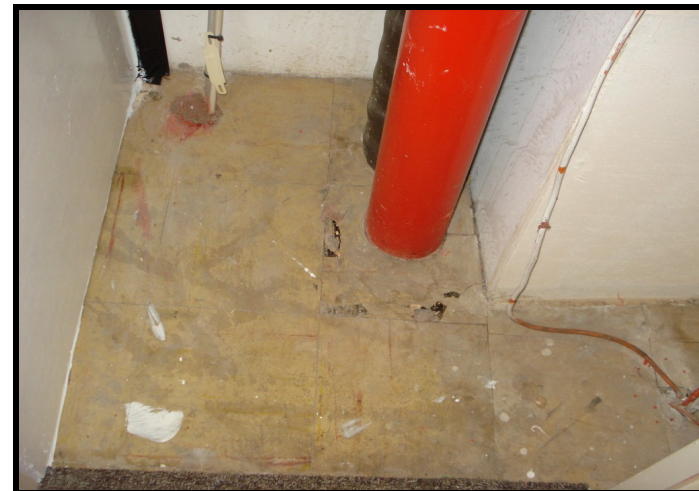
## SAMPLE REFERENCE 052

**Asbestos Presumed in Sample**

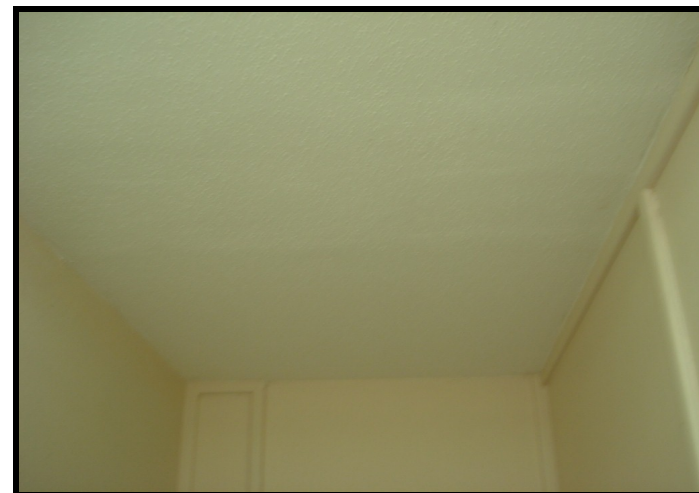
## SAMPLE REFERENCE 053

**No Asbestos Presumed in Sample**

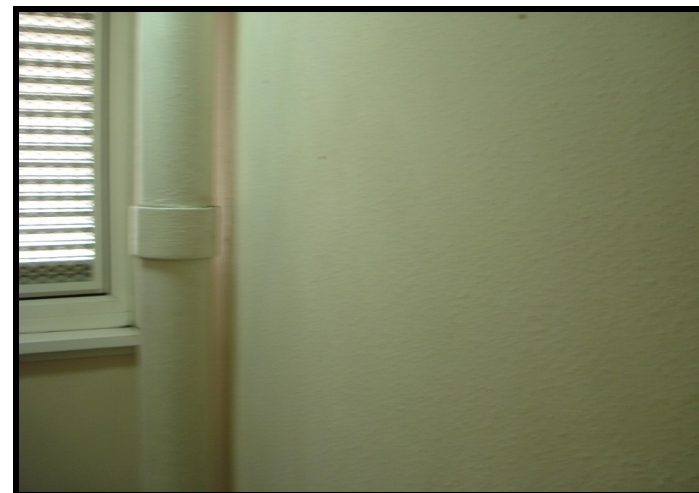
## SAMPLE REFERENCE 054

**No Asbestos Presumed in Sample**

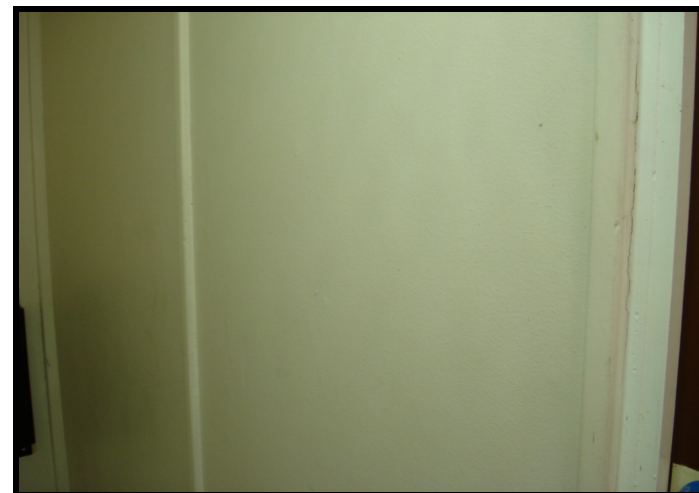
## SAMPLE REFERENCE 055

**Asbestos Presumed in Sample**

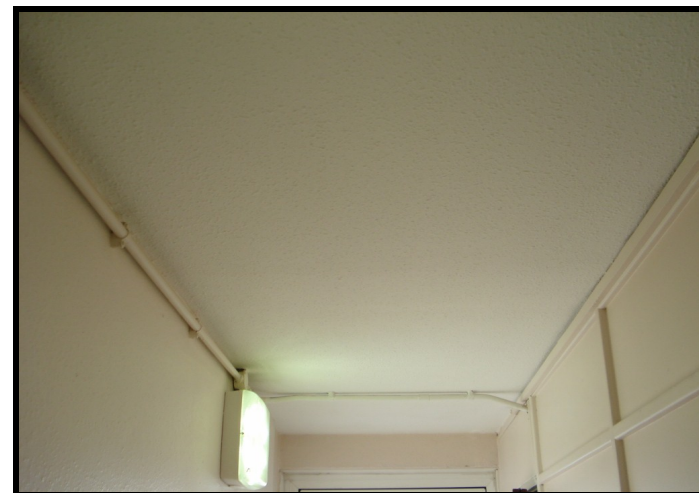
## SAMPLE REFERENCE 056

**No Asbestos Presumed in Sample**

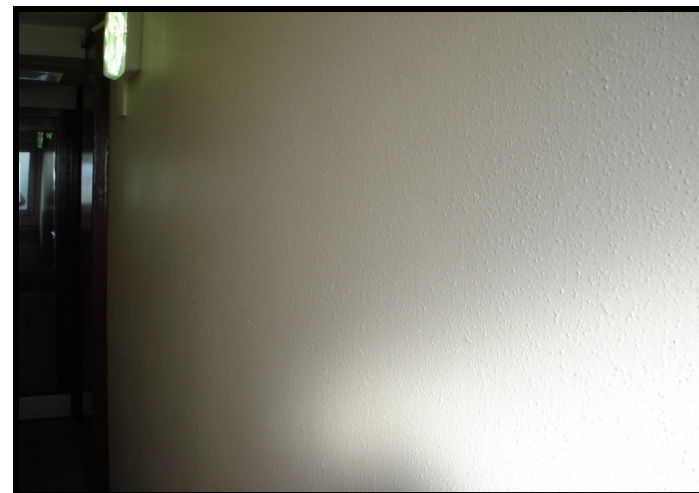
## SAMPLE REFERENCE 057

**No Asbestos Presumed in Sample**

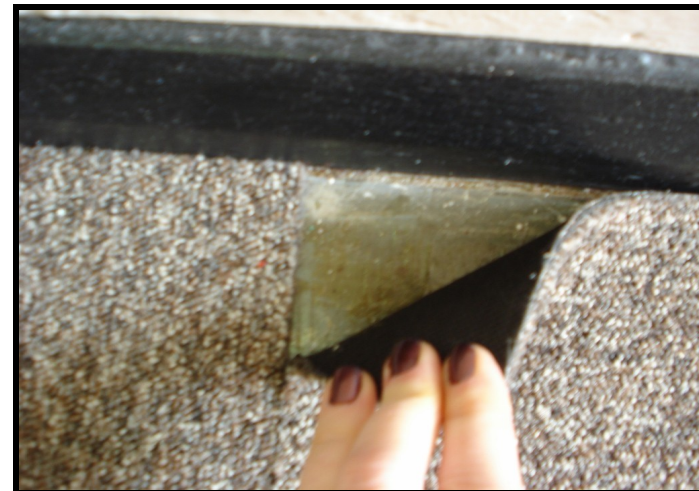
## SAMPLE REFERENCE 059

Asbestos Presumed in Sample

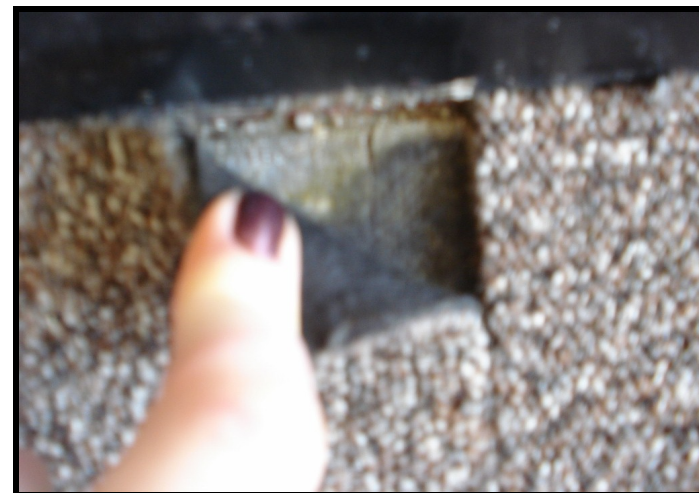
## SAMPLE REFERENCE 062

Asbestos Presumed in Sample

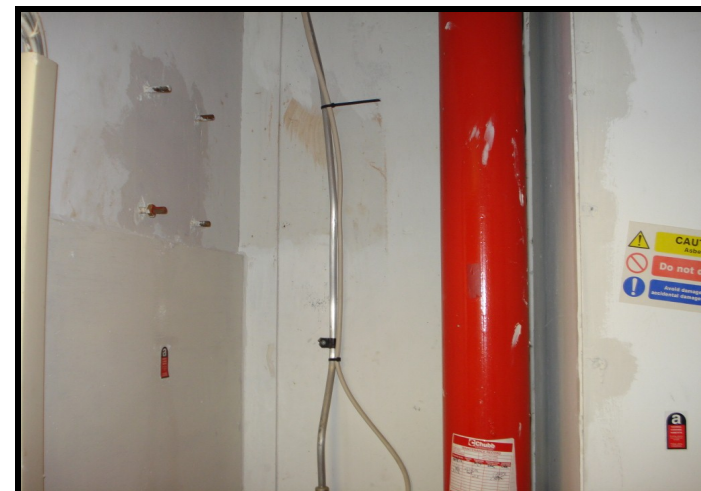
## SAMPLE REFERENCE 065

Asbestos Presumed in Sample

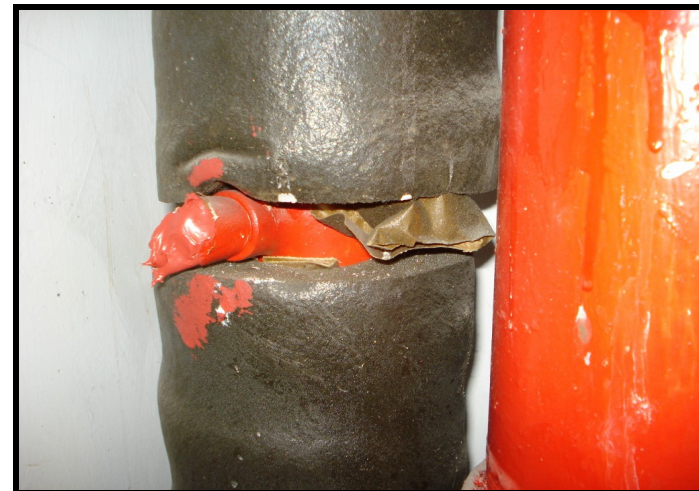
## SAMPLE REFERENCE 069

**No Asbestos Presumed in Sample**

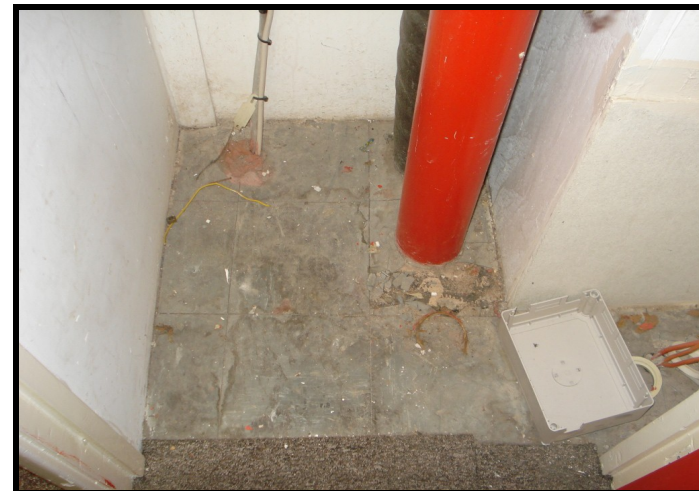
## SAMPLE REFERENCE 070

Asbestos Presumed in Sample

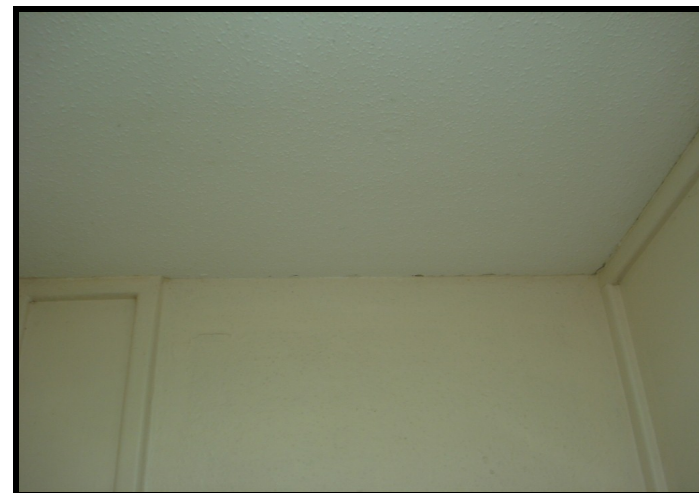
## SAMPLE REFERENCE 071

**No Asbestos Presumed in Sample**

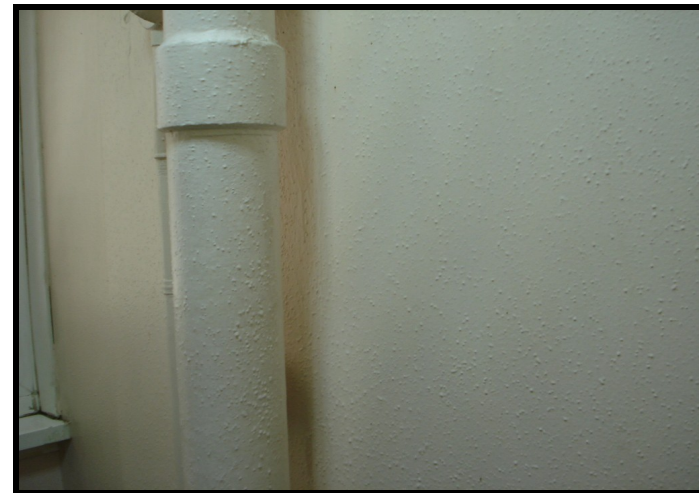
## SAMPLE REFERENCE 072

**No Asbestos Presumed in Sample**

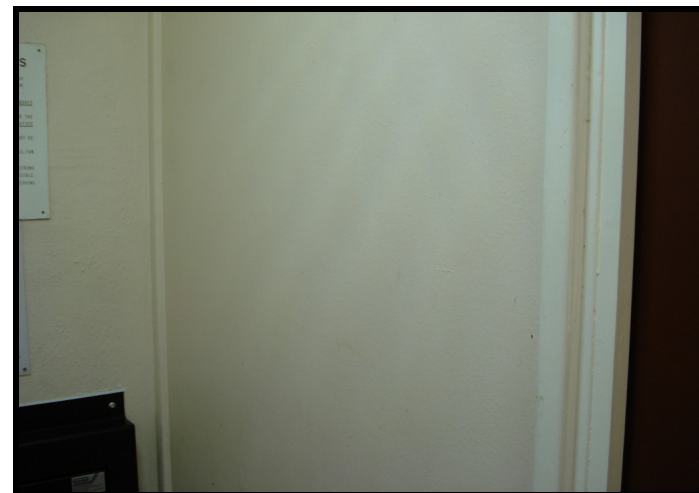
## SAMPLE REFERENCE 073

Asbestos Presumed in Sample

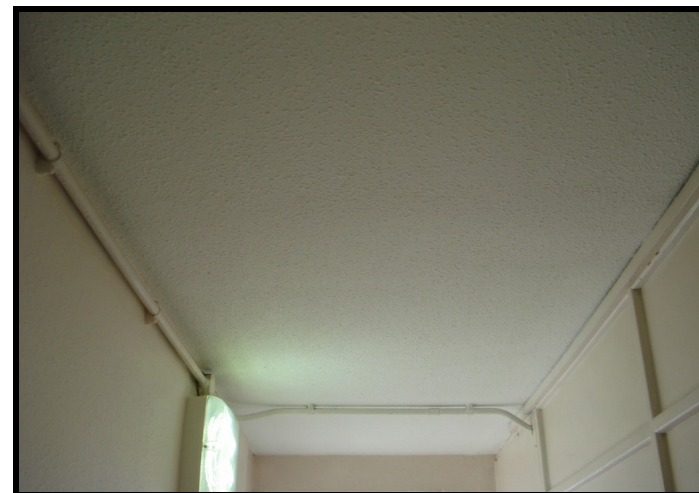
## SAMPLE REFERENCE 074

Asbestos Presumed in Sample

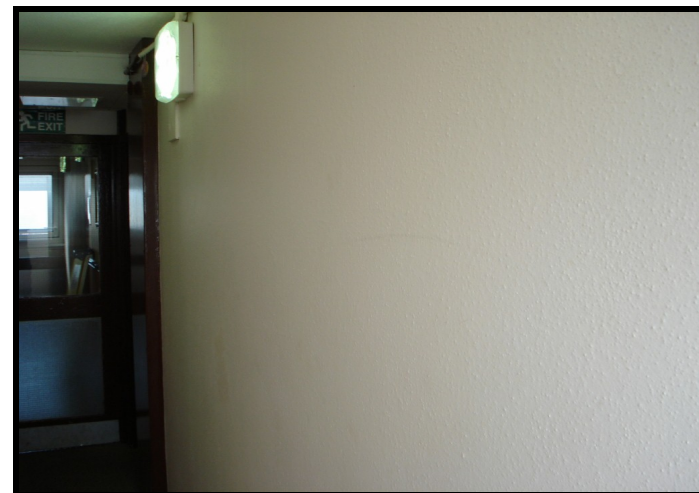
## SAMPLE REFERENCE 075

Asbestos Presumed in Sample

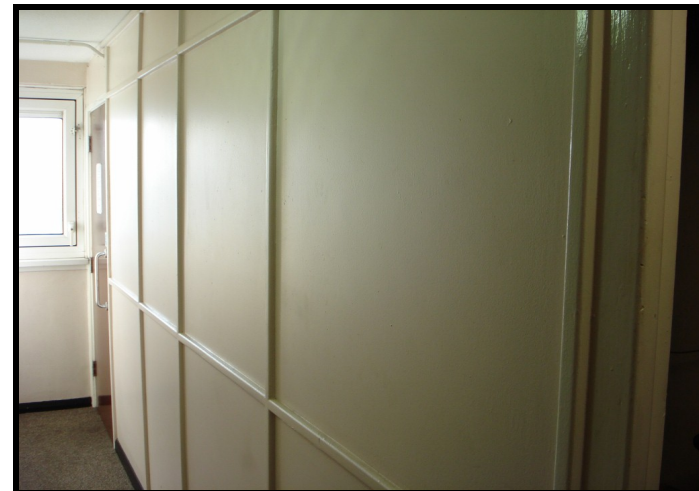
## SAMPLE REFERENCE 076

**No Asbestos Presumed in Sample**

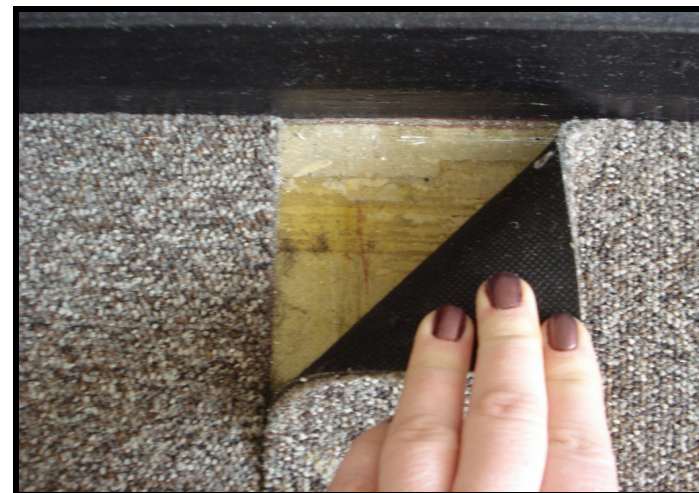
## SAMPLE REFERENCE 077

Asbestos Presumed in Sample

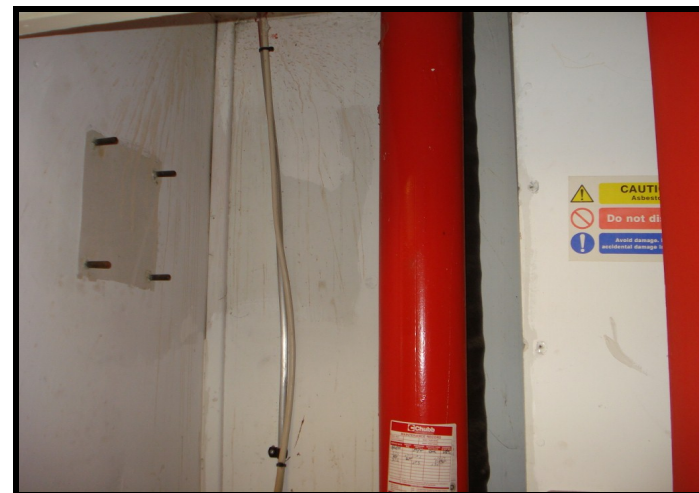
## SAMPLE REFERENCE 078

**No Asbestos Presumed in Sample**

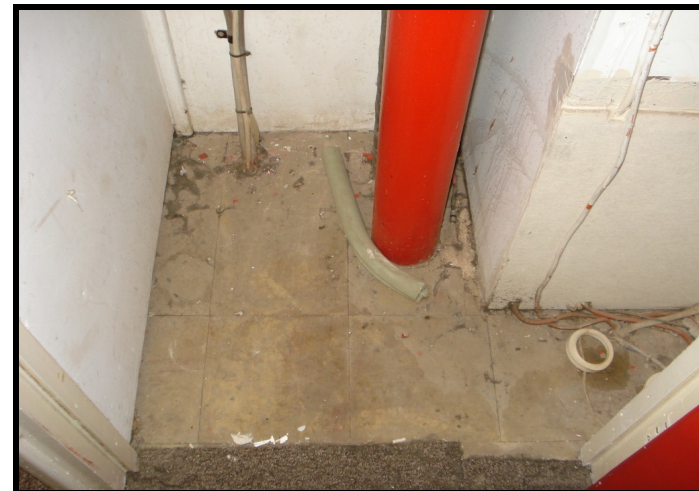
## SAMPLE REFERENCE 080

**No Asbestos Presumed in Sample**

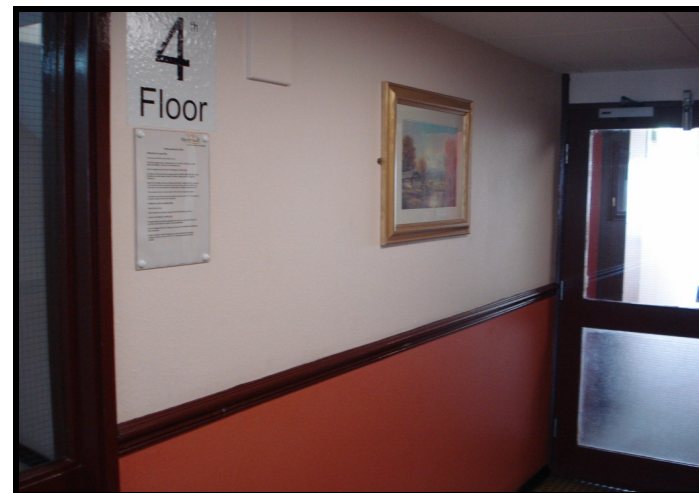
## SAMPLE REFERENCE 081

Asbestos Presumed in Sample

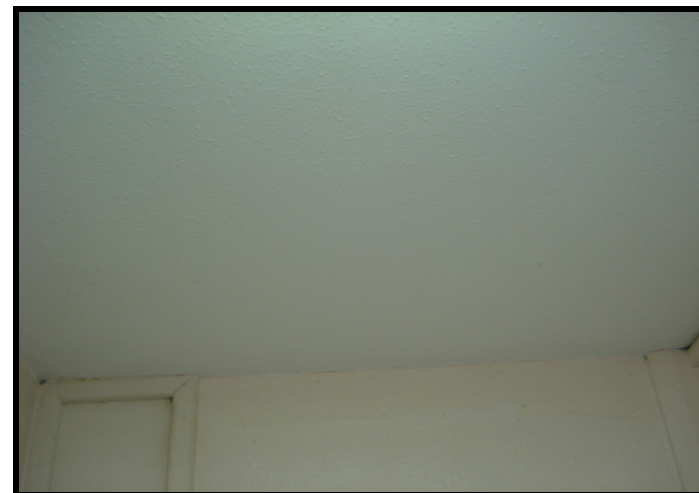
## SAMPLE REFERENCE 088

**No Asbestos Presumed in Sample**

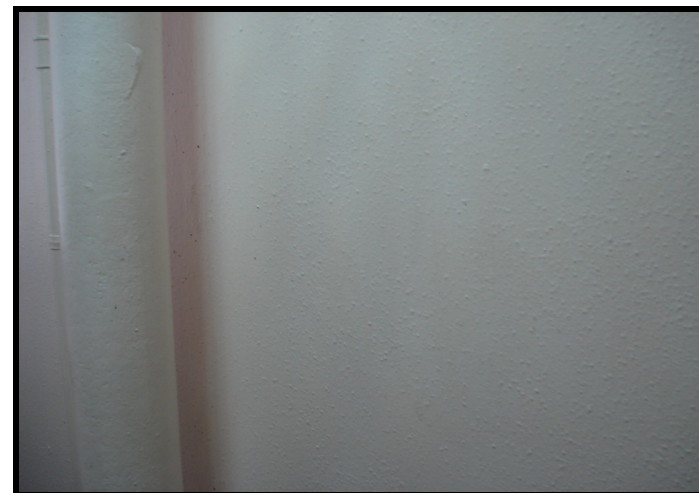
## SAMPLE REFERENCE 089

**No Asbestos Presumed in Sample**

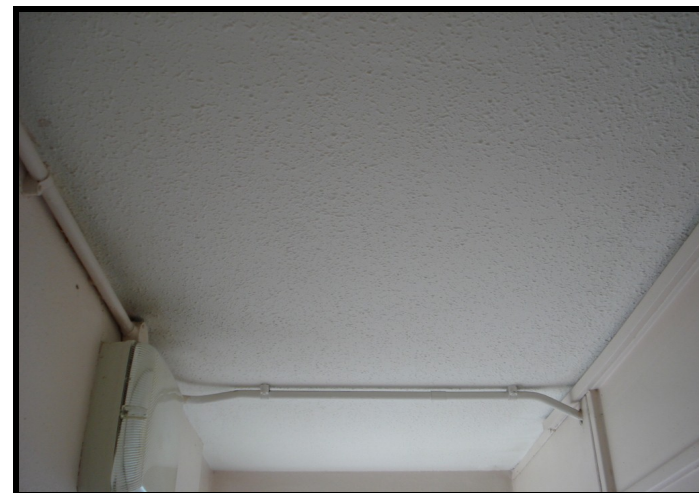
## SAMPLE REFERENCE 091

**Asbestos Presumed in Sample**

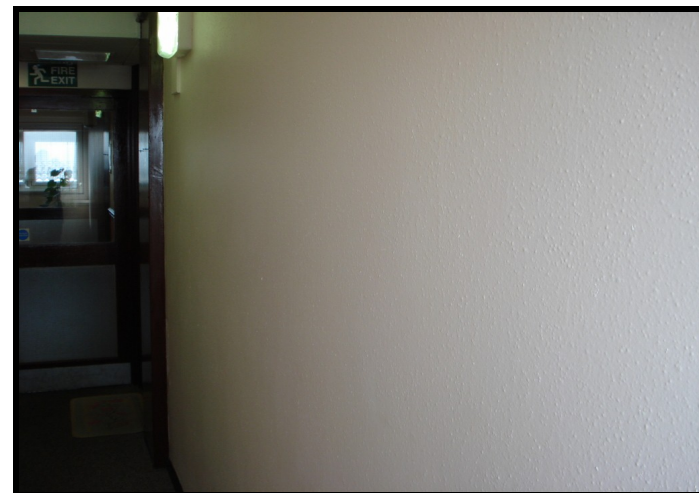
## SAMPLE REFERENCE 092

**Asbestos Presumed in Sample**

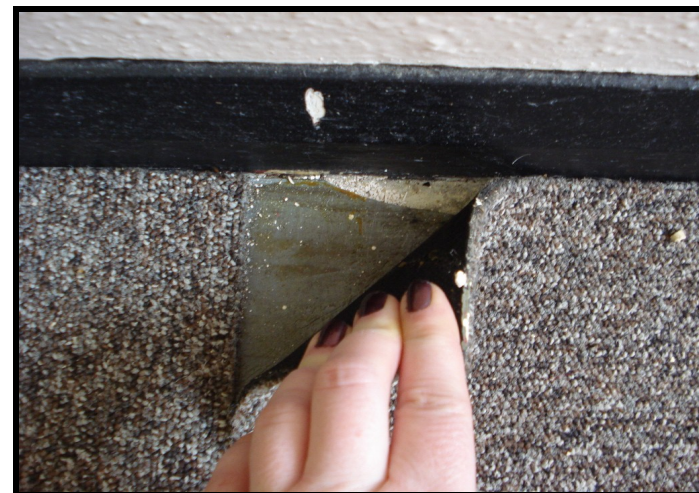
## SAMPLE REFERENCE 094

Asbestos Presumed in Sample

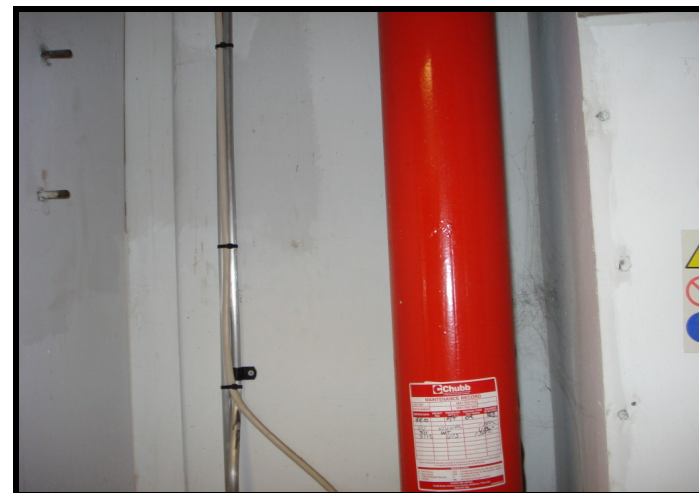
## SAMPLE REFERENCE 095

**No Asbestos Presumed in Sample**

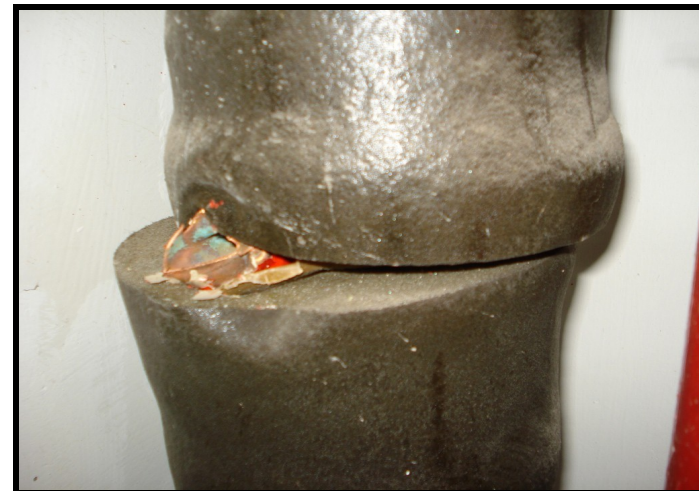
## SAMPLE REFERENCE 096

**No Asbestos Presumed in Sample**

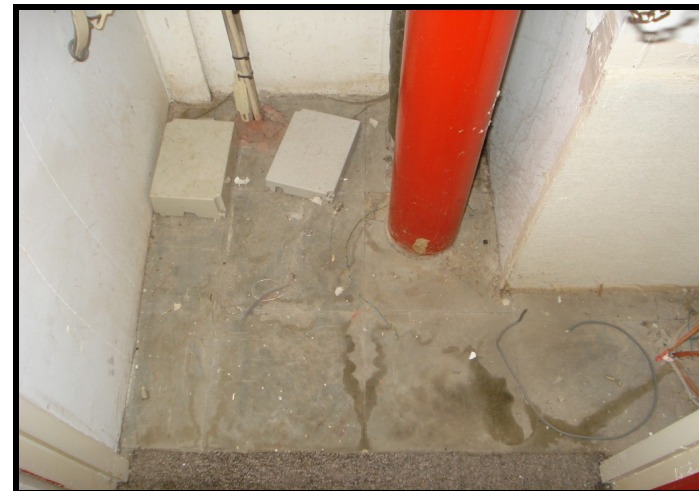
## SAMPLE REFERENCE 097

Asbestos Presumed in Sample

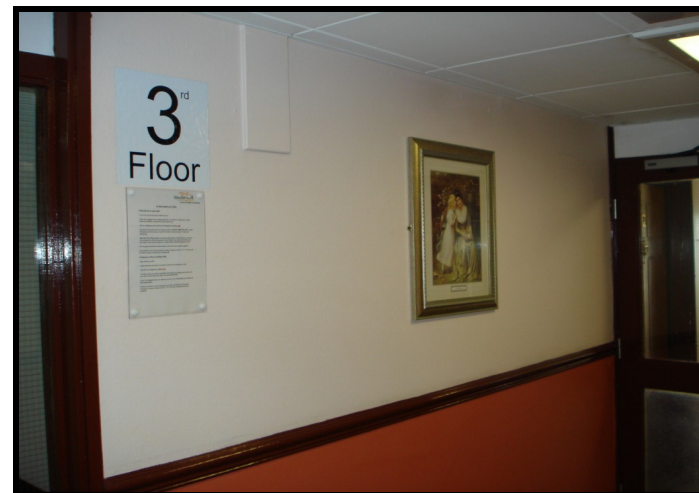
## SAMPLE REFERENCE 098

**No Asbestos Presumed in Sample**

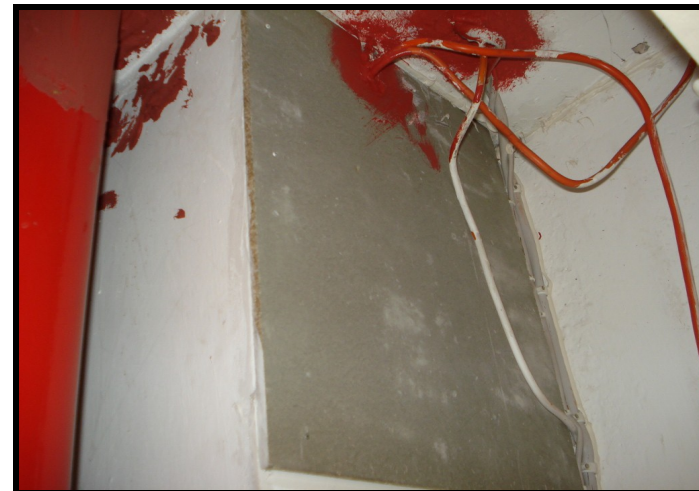
## SAMPLE REFERENCE 102

Asbestos Presumed in Sample

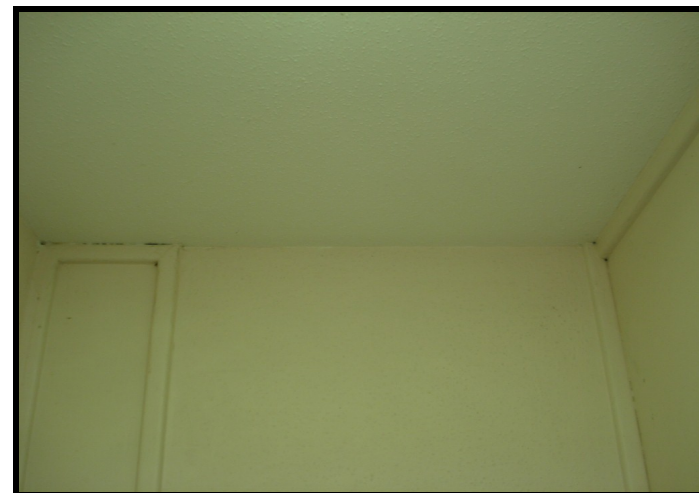
## SAMPLE REFERENCE 103

**No Asbestos Presumed in Sample**

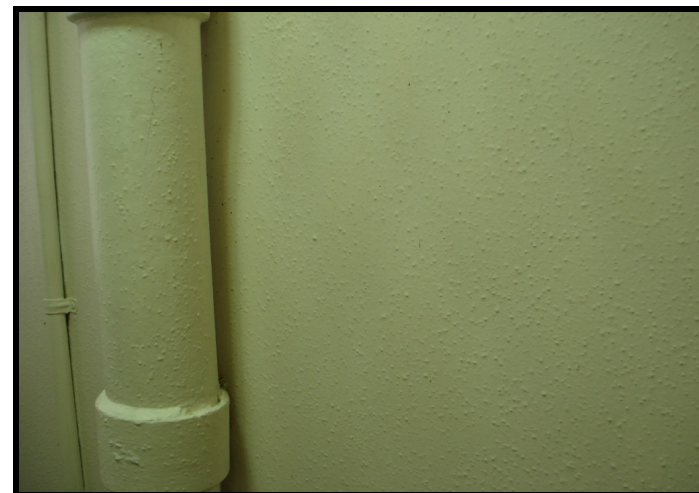
## SAMPLE REFERENCE 104

**No Asbestos Presumed in Sample**

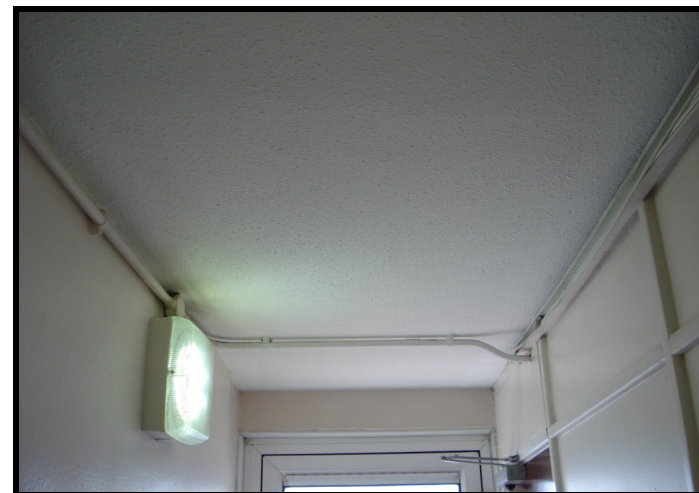
## SAMPLE REFERENCE 122

Asbestos Presumed in Sample

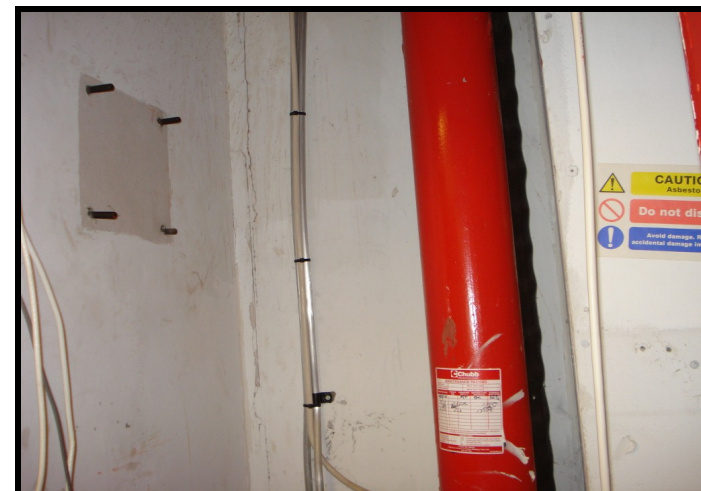
## SAMPLE REFERENCE 126

**No Asbestos Presumed in Sample**

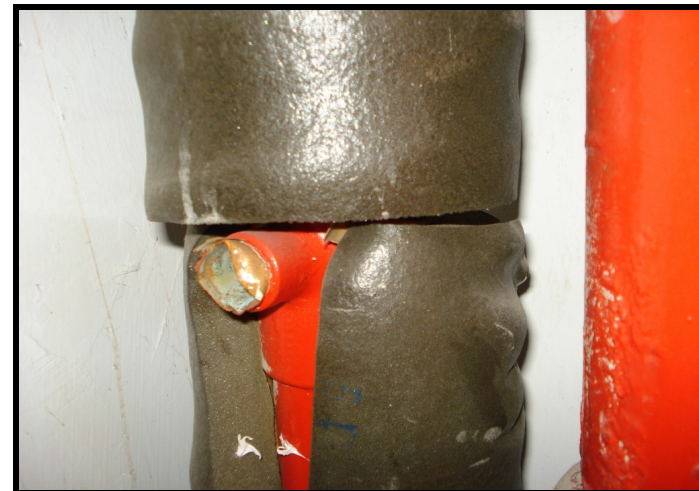
## SAMPLE REFERENCE 127

**No Asbestos Presumed in Sample**

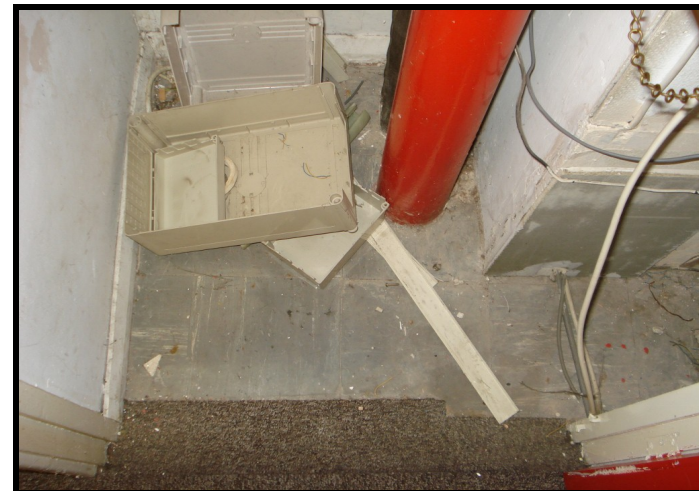
## SAMPLE REFERENCE 128

Asbestos Presumed in Sample

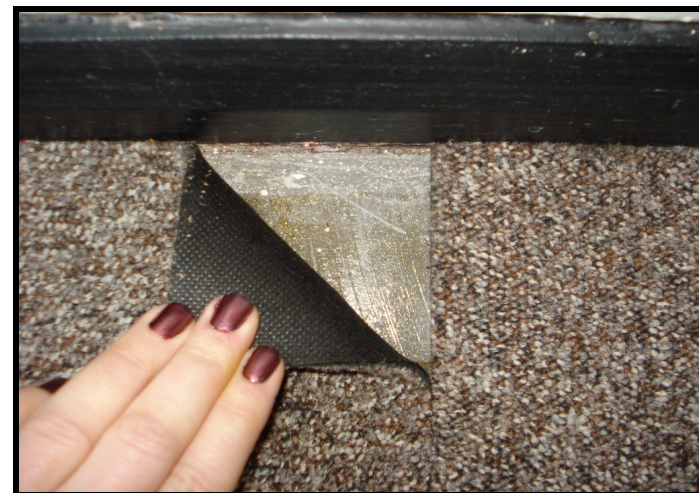
## SAMPLE REFERENCE I33

**Asbestos not detected in Sample**

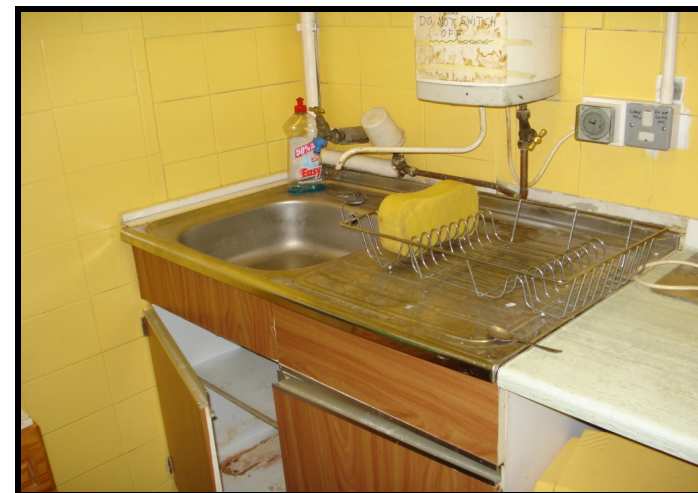
## SAMPLE REFERENCE I35

**Asbestos not detected in Sample**

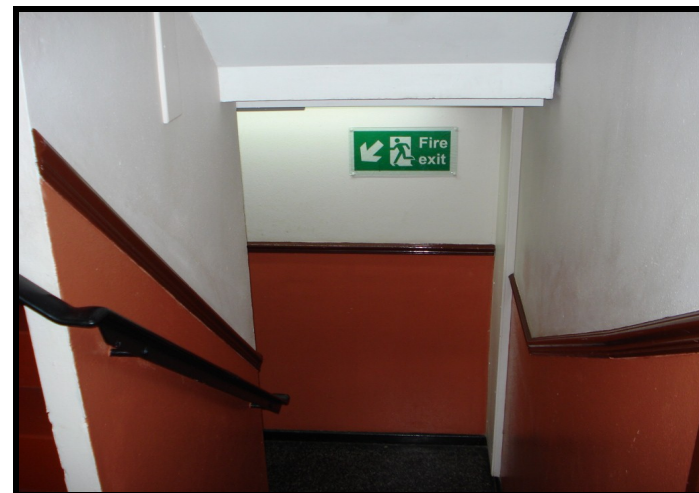
## SAMPLE REFERENCE 136

**Asbestos not detected in Sample**

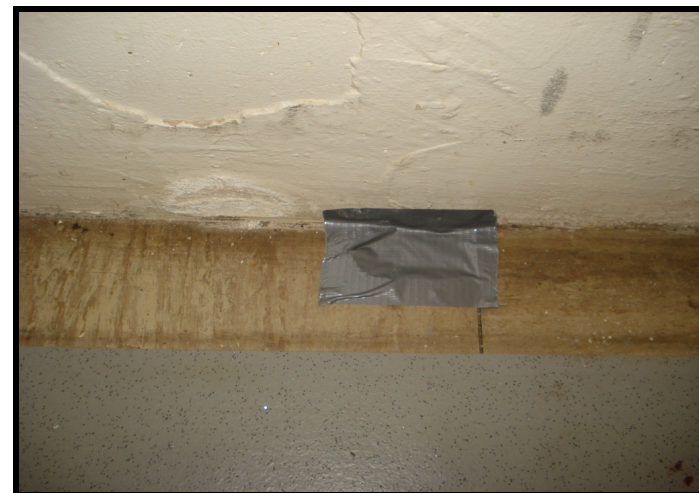
## SAMPLE REFERENCE I37

**No Asbestos Presumed in Sample**

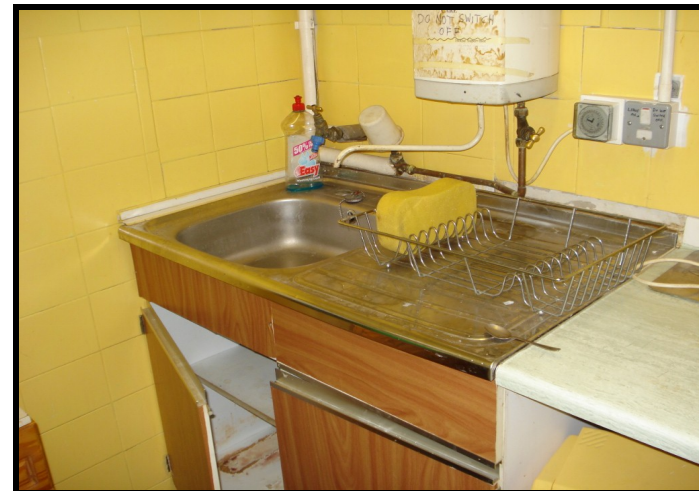
## SAMPLE REFERENCE I38

**No Asbestos Presumed in Sample**

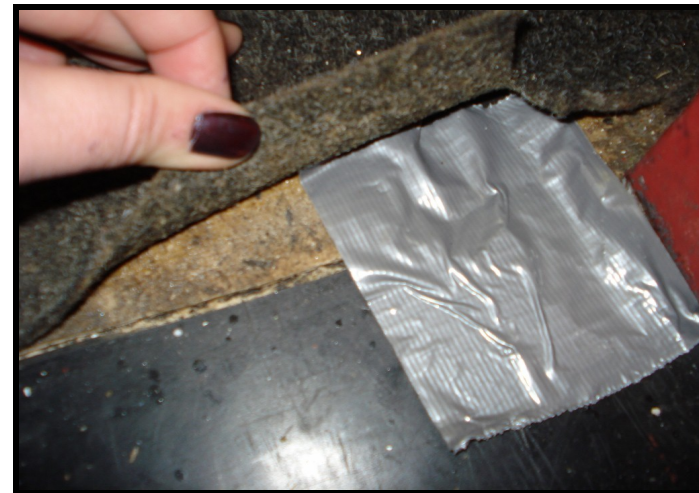
## SAMPLE REFERENCE 139

**Asbestos not detected in Sample**

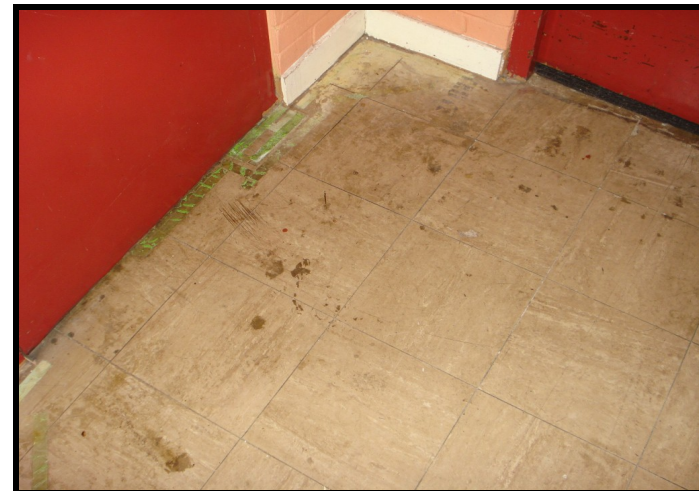
SAMPLE REFERENCE I43

**No Asbestos Presumed in Sample**

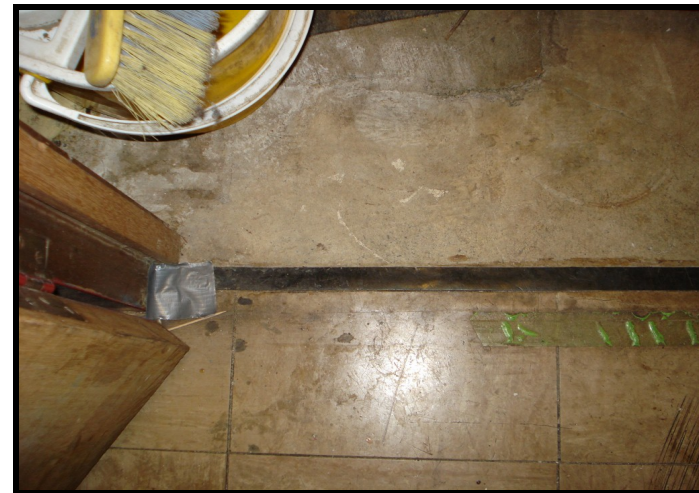
## SAMPLE REFERENCE 144

Asbestos not detected in Sample
