# Site ID: **a-306148**

## Management with Targeted Refurbishment Survey – PART 1

1-83 Keele House  
Forth Drive  
Chelmsley Wood  
Solihull  
West Midlands  
B37 6PN  
United Kingdom

**25th May 2021**

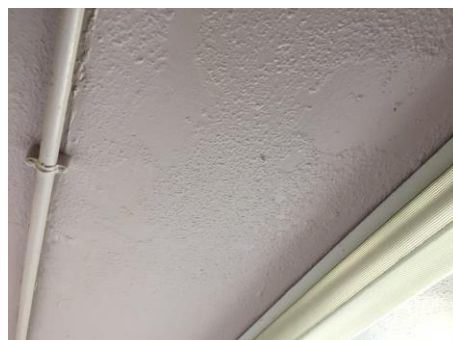
Level: ..... **Fourteenth Floor**

Condition ..... **Low Damage**

The material was seen to be in fair condition at the time of the initial inspection.

The condition of the material should be managed by a competent person/company and its presence made aware to those at risk, as part of a Control of Asbestos Regulations (CAR) 2012 compliant management strategy.

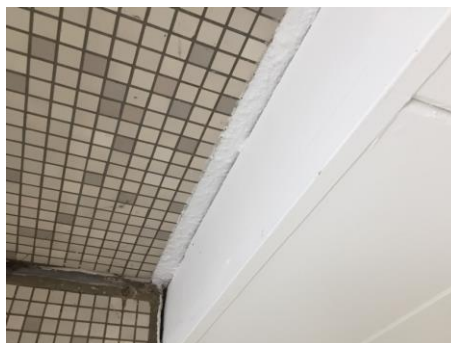
Spatter pattern textured coating above suspended ceiling.

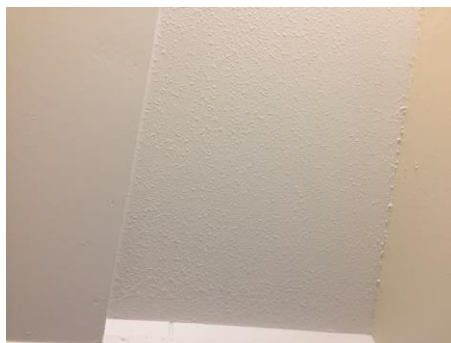
Spatter pattern textured coating.

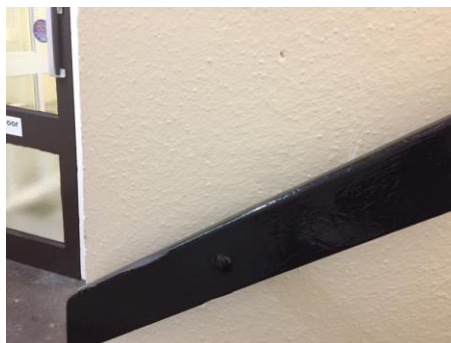
Spatter pattern textured coating.

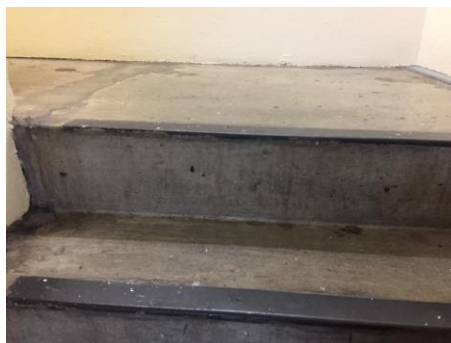
Resin nosing to edge of stairs.

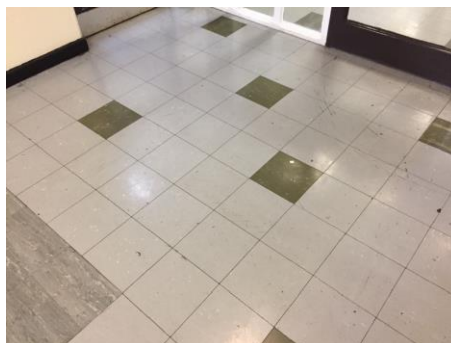
Bitumen adhesive beneath floor tiles.

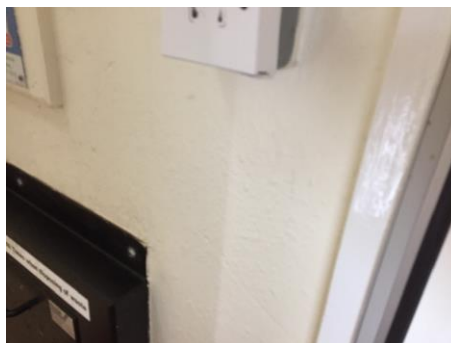
Spatter pattern textured coating.

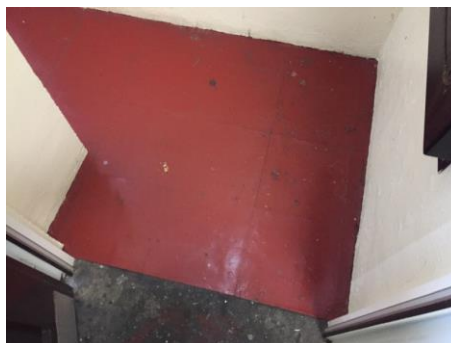
Bitumen adhesive beneath floor tiles.

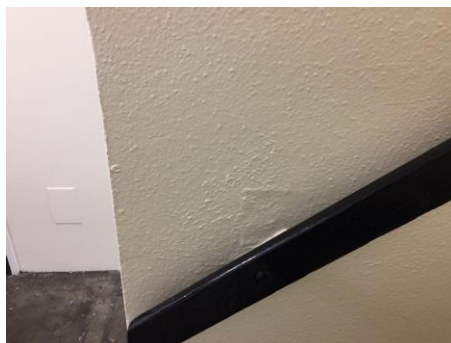
Spatter pattern textured coating.

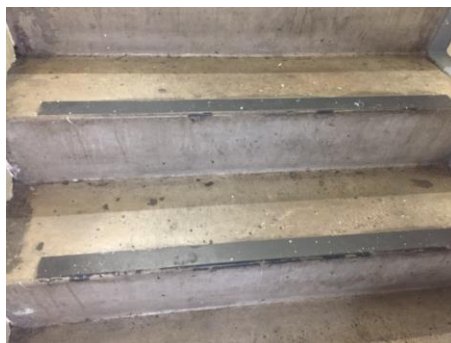
Resin nosing to edge of stairs.

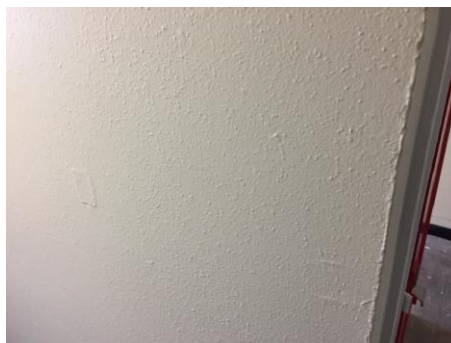
Spatter pattern textured coating.

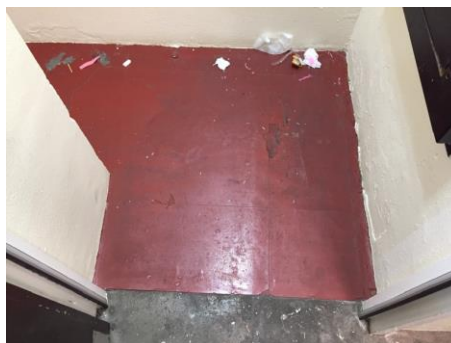
Brown floor tiles painted red.

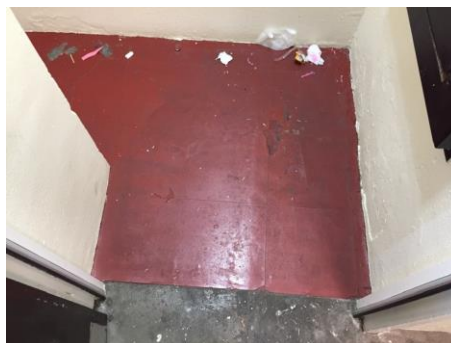
Bitumen adhesive beneath floor tiles.

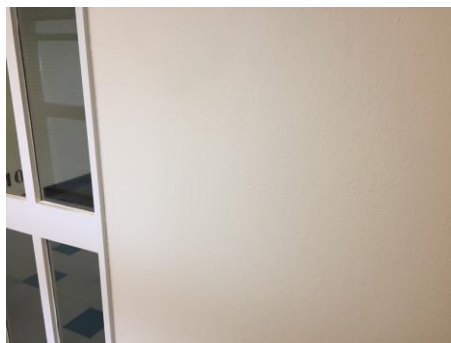
Spatter pattern textured coating.

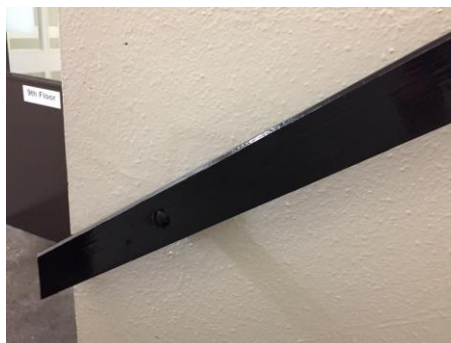
Spatter pattern textured coating.

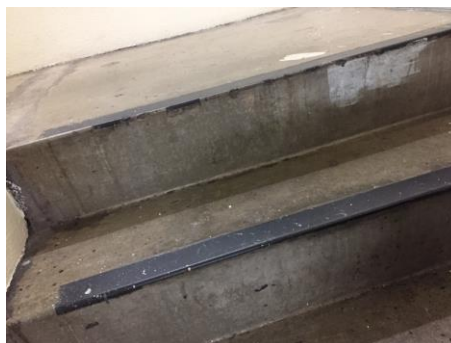
Resin nosing to edge of stairs.

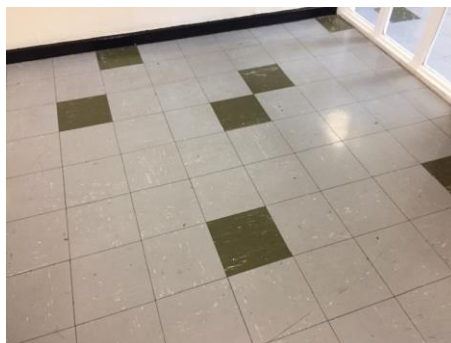
Bitumen adhesive beneath floor tiles.

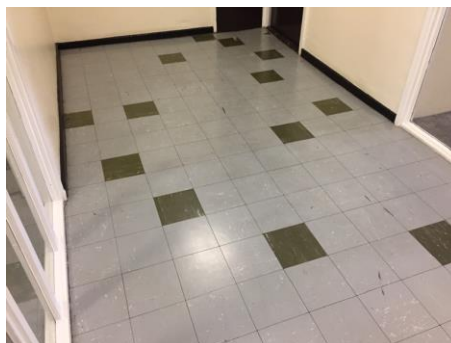
Bitumen adhesive beneath floor tiles.

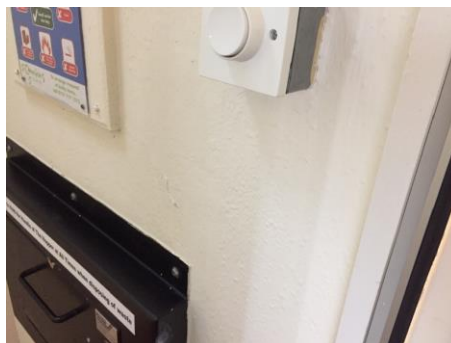
Spatter pattern textured coating.

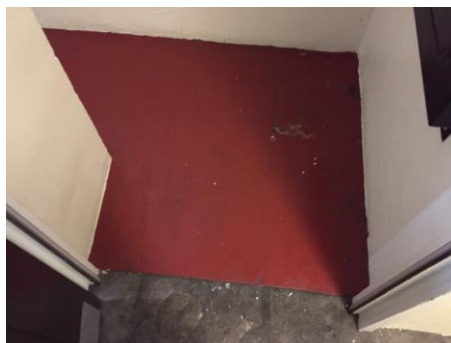
Brown floor tiles painted red.

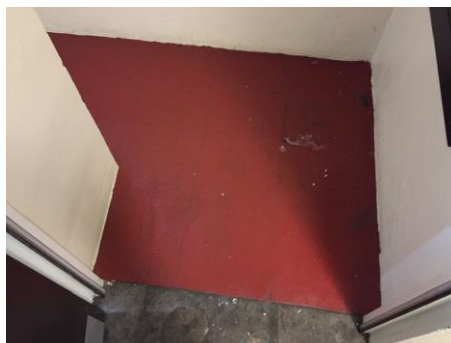
Bitumen adhesive beneath floor tiles.

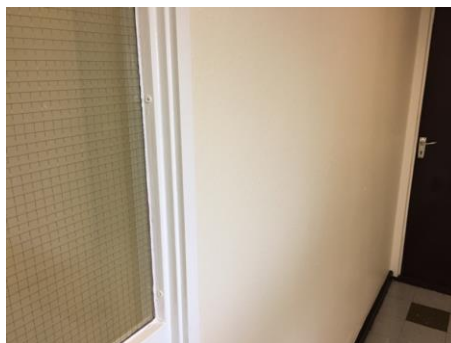
Spatter pattern textured coating.

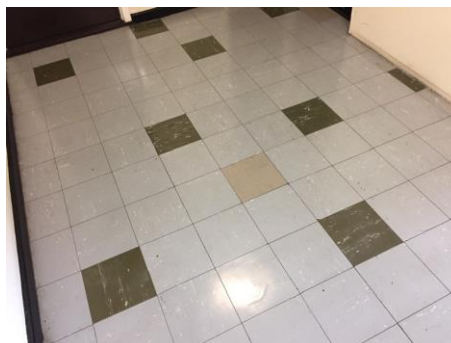
Green and grey floor tiles.

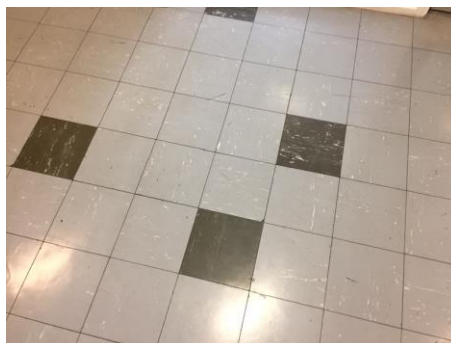
Bitumen adhesive beneath floor tiles.

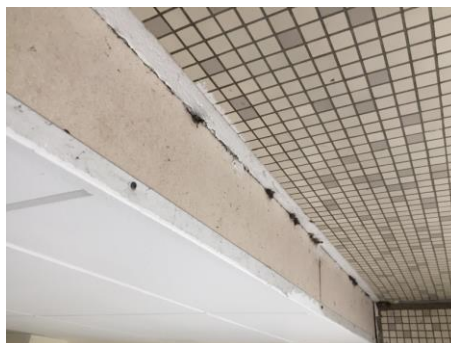
Spatter pattern textured coating above suspended ceiling.

The material was seen to be in fair condition at the time of the initial inspection.

The condition of the material should be managed by a competent person/company and its presence made aware to those at risk, as part of a Control of Asbestos Regulations (CAR) 2012 compliant management strategy.

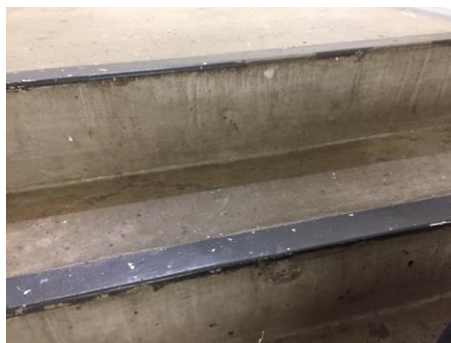
Resin nosing to edge of stairs.

The material was seen to be in fair condition at the time of the initial inspection.

The condition of the material should be managed by a competent person/company and its presence made aware to those at risk, as part of a Control of Asbestos Regulations (CAR) 2012 compliant management strategy.

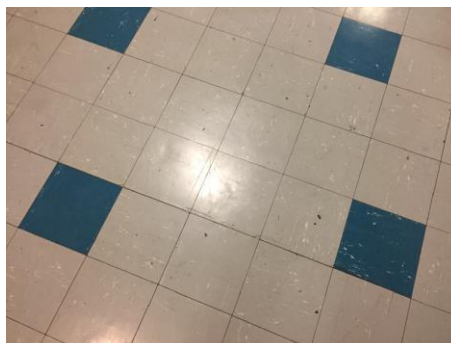
Bitumen adhesive beneath floor tiles.

The material was seen to be in fair condition at the time of the initial inspection.

The condition of the material should be managed by a competent person/company and its presence made aware to those at risk, as part of a Control of Asbestos Regulations (CAR) 2012 compliant management strategy.

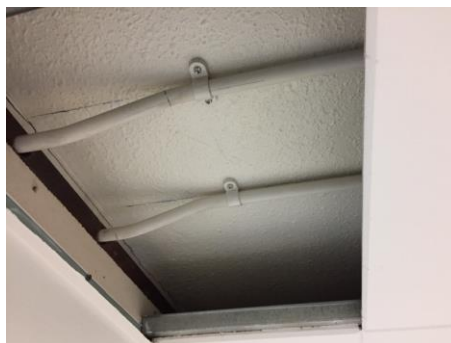
Spatter pattern textured coating above suspended ceiling.

The material was seen to be in fair condition at the time of the initial inspection.

The condition of the material should be managed by a competent person/company and its presence made aware to those at risk, as part of a Control of Asbestos Regulations (CAR) 2012 compliant management strategy.

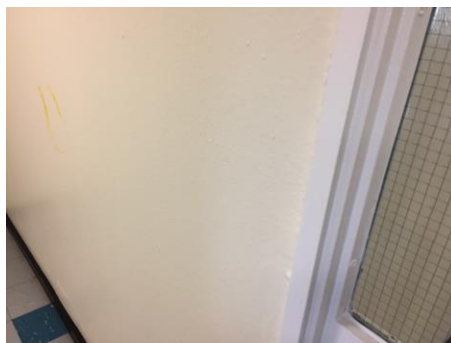
Spatter pattern textured coating.

The material was seen to be in fair condition at the time of the initial inspection.

The condition of the material should be managed by a competent person/company and its presence made aware to those at risk, as part of a Control of Asbestos Regulations (CAR) 2012 compliant management strategy.

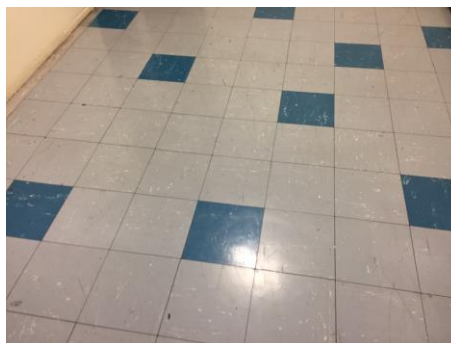
Bitumen adhesive beneath floor tiles.

The material was seen to be in fair condition at the time of the initial inspection.

The condition of the material should be managed by a competent person/company and its presence made aware to those at risk, as part of a Control of Asbestos Regulations (CAR) 2012 compliant management strategy.

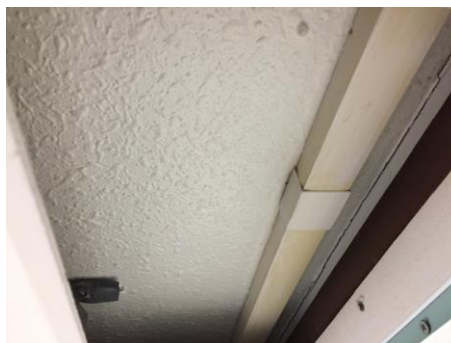
Spatter pattern textured coating above suspended ceiling.

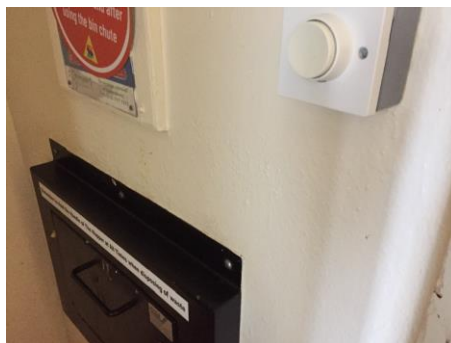
Spatter pattern textured coating.

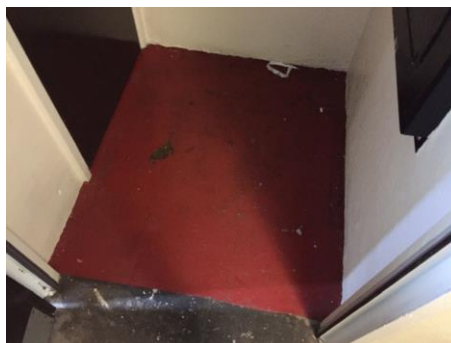
Bitumen adhesive beneath floor tiles.

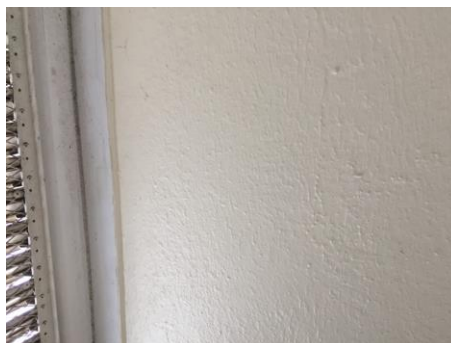
Spatter pattern textured coating.

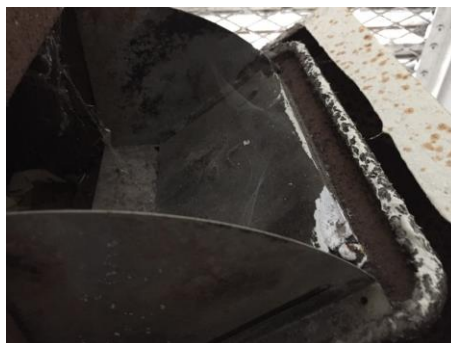
Cement panel within incinerator.

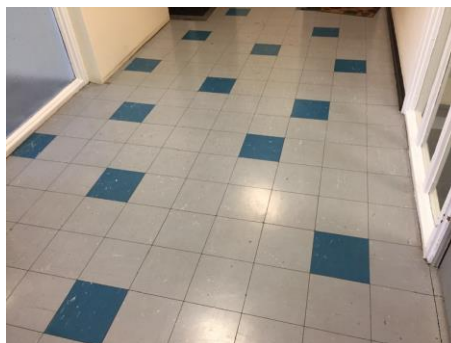
Bitumen adhesive beneath floor tiles.
