# Site ID: **a-307203**

## Management with Targeted Refurbishment Survey – PART 2

1-83 Keele House  
Forth Drive  
Chelmsley Wood  
Solihull  
B37 6PN  
United Kingdom

**26th May 2021**

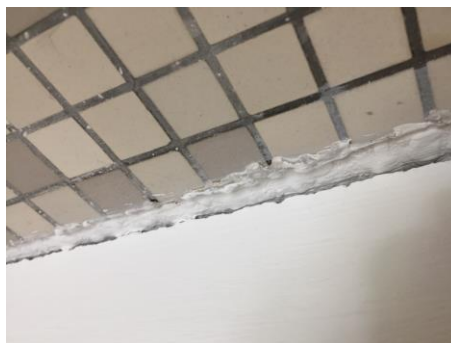
Spatter pattern textured coating.

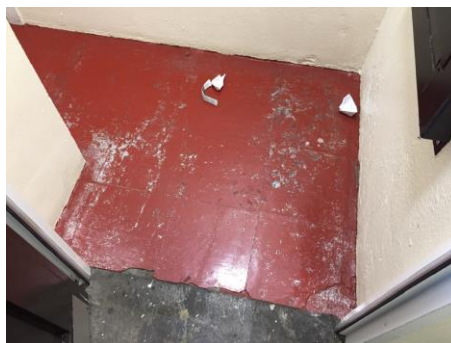
Brown floor tiles painted red.

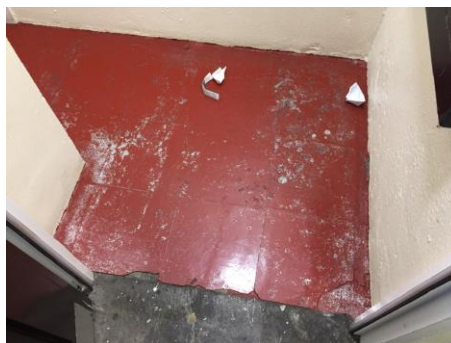
Bitumen adhesive beneath floor tiles.

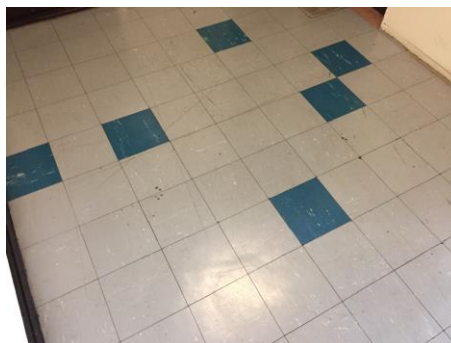
Blue and grey floor tiles.

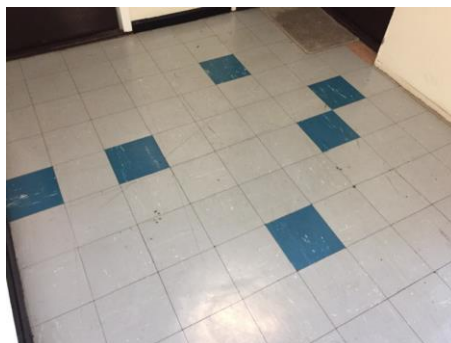
Bitumen adhesive beneath floor tiles.

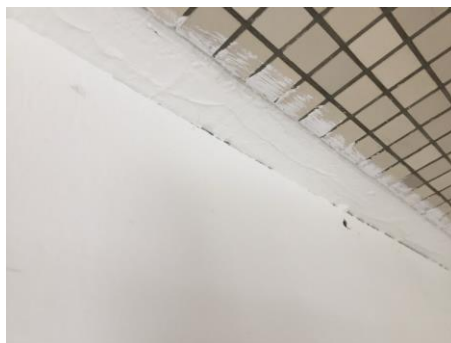
Spatter pattern textured coating.

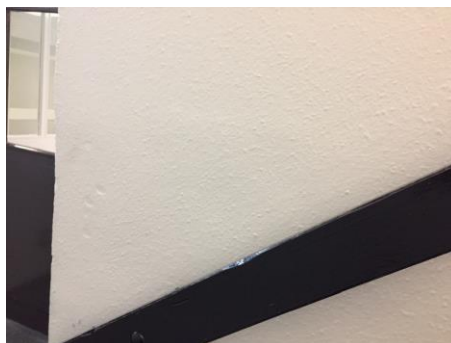
Spatter pattern textured coating.

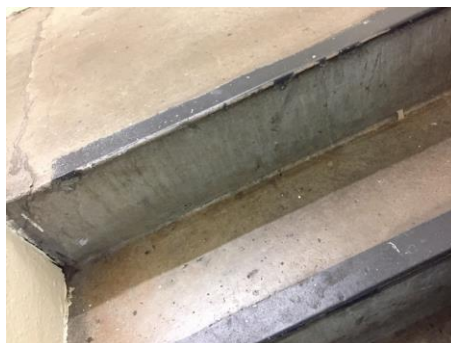
Resin nosing to edge of stairs.

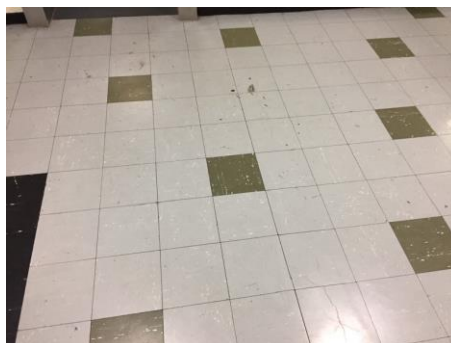
Bitumen adhesive beneath floor tiles.

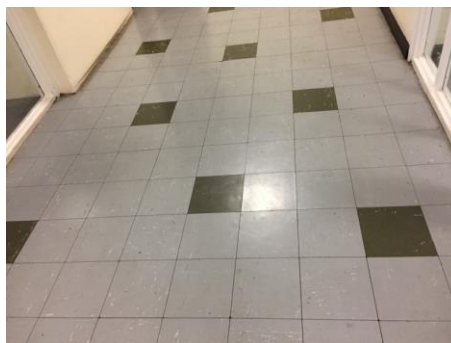
Green and grey floor tiles.

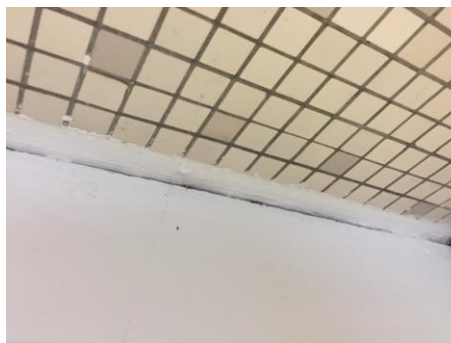
Spatter pattern textured coating.

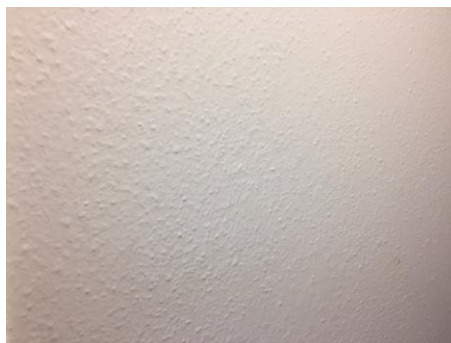
Spatter pattern textured coating.

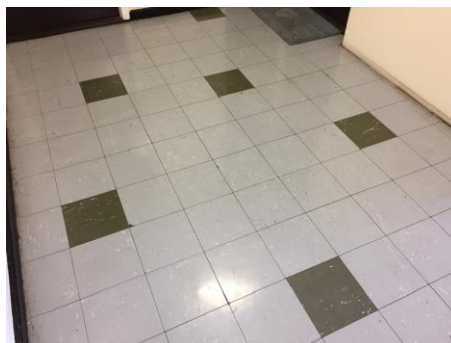
Bitumen adhesive beneath floor tiles.

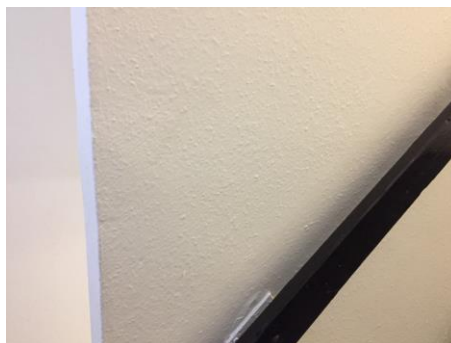
Spatter pattern textured coating.

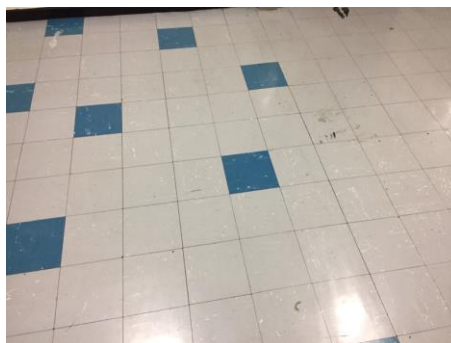
Blue and grey floor tiles.

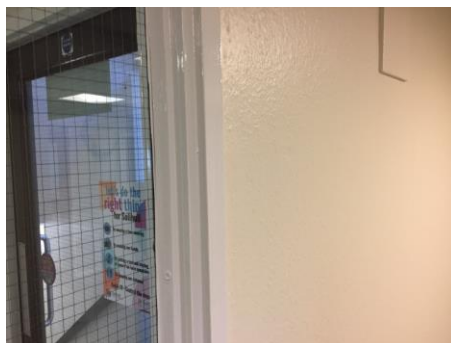
Spatter pattern textured coating.

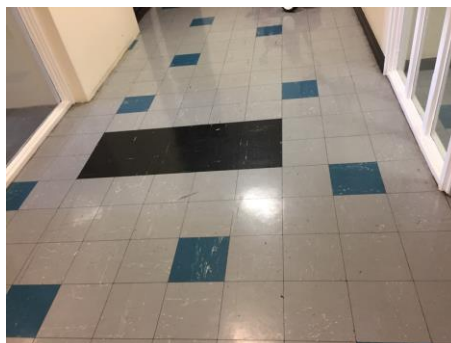
Bitumen adhesive beneath floor tiles.

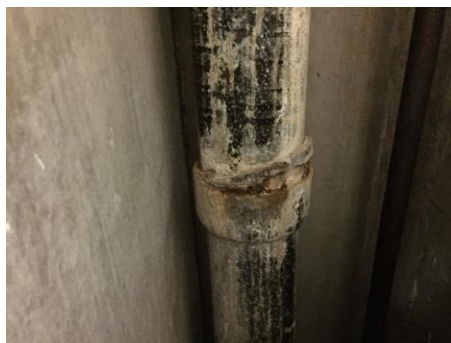
Fibrous packing material visible as joint weld has been lifted previously.

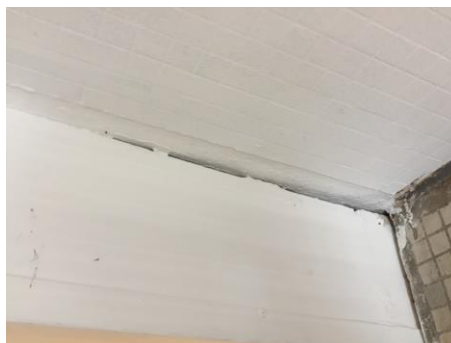
Spatter pattern textured coating.

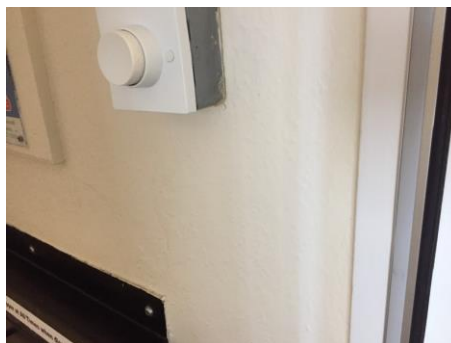
Spatter pattern textured coating.

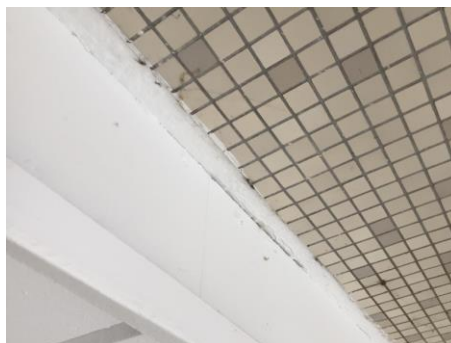
Spatter pattern textured coating.

The material was seen to be in fair condition at the time of the initial inspection.

The condition of the material should be managed by a competent person/company and its presence made aware to those at risk, as part of a Control of Asbestos Regulations (CAR) 2012 compliant management strategy.

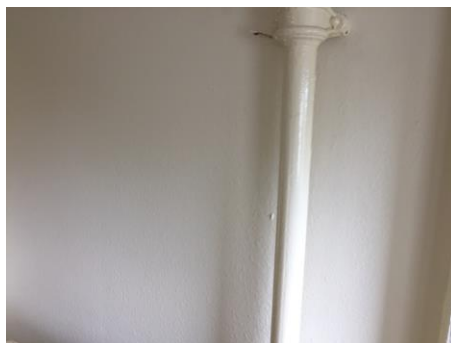
Spatter pattern textured coating.

The material was seen to be in fair condition at the time of the initial inspection.

The condition of the material should be managed by a competent person/company and its presence made aware to those at risk, as part of a Control of Asbestos Regulations (CAR) 2012 compliant management strategy.

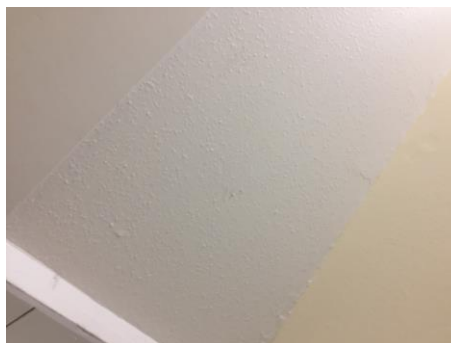
Spatter pattern textured coating.

The material was seen to be in fair condition at the time of the initial inspection.

The condition of the material should be managed by a competent person/company and its presence made aware to those at risk, as part of a Control of Asbestos Regulations (CAR) 2012 compliant management strategy.

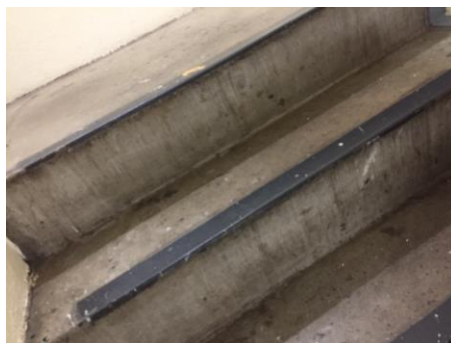
Resin nosing to edge of stairs.

The material was seen to be in fair condition at the time of the initial inspection.

The condition of the material should be managed by a competent person/company and its presence made aware to those at risk, as part of a Control of Asbestos Regulations (CAR) 2012 compliant management strategy.

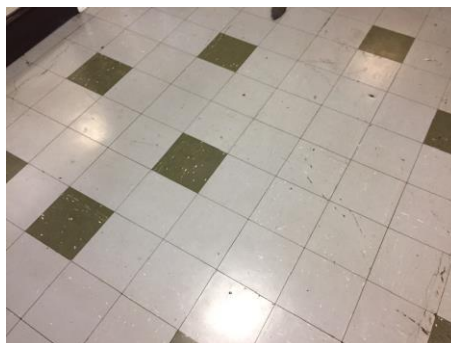
Bitumen adhesive beneath floor tiles.

The material was seen to be in fair condition at the time of the initial inspection.

The condition of the material should be managed by a competent person/company and its presence made aware to those at risk, as part of a Control of Asbestos Regulations (CAR) 2012 compliant management strategy.

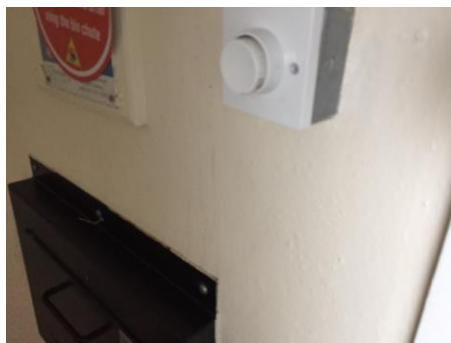
Spatter pattern textured coating.

The material was seen to be in fair condition at the time of the initial inspection.

The condition of the material should be managed by a competent person/company and its presence made aware to those at risk, as part of a Control of Asbestos Regulations (CAR) 2012 compliant management strategy.

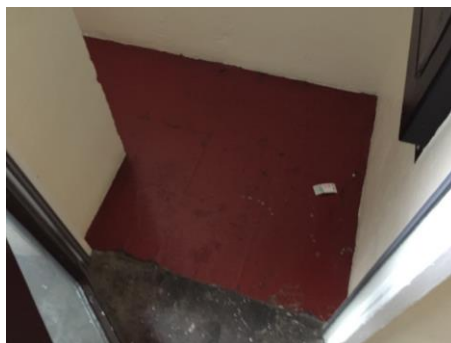
Bitumen adhesive beneath floor tiles.

The material was seen to be in fair condition at the time of the initial inspection.

The condition of the material should be managed by a competent person/company and its presence made aware to those at risk, as part of a Control of Asbestos Regulations (CAR) 2012 compliant management strategy.

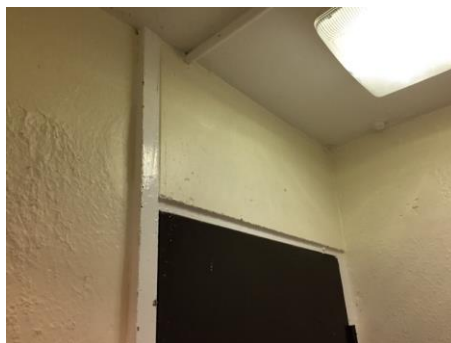
Insulating board transom panel over Incinerator room door.

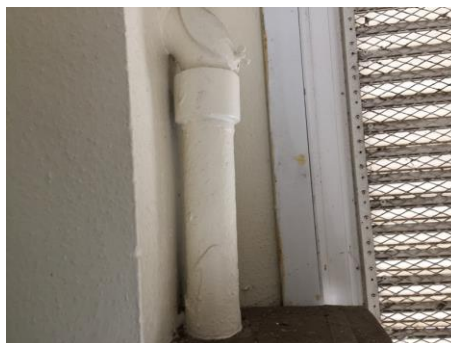
Cement flue for incinerator.

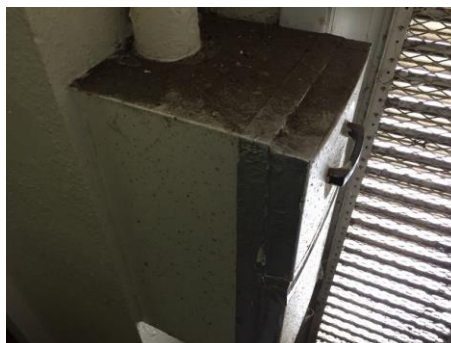
Cement panel within sealed incinerator unit.

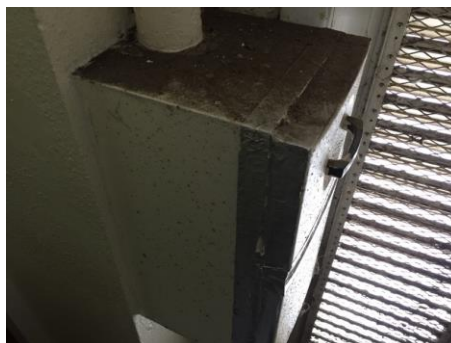
Rope seal within sealed incinerator unit.

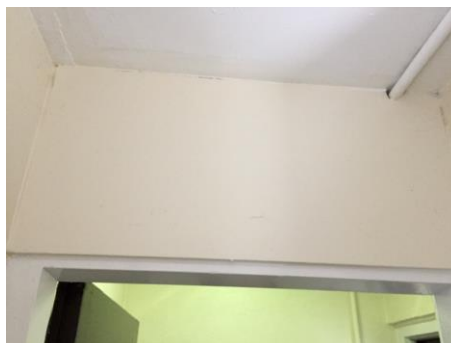
Insulating board transom panel.

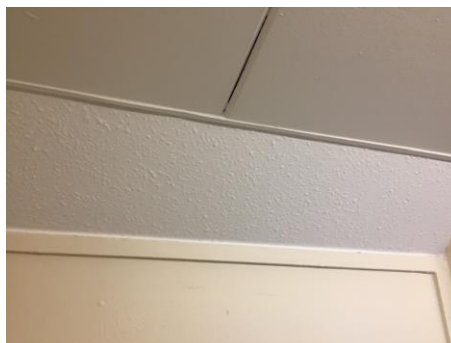
Condition ..... **Low Damage**

Spatter pattern textured coating.

The material was seen to be in fair condition at the time of the initial inspection.

The condition of the material should be managed by a competent person/company and its presence made aware to those at risk, as part of a Control of Asbestos Regulations (CAR) 2012 compliant management strategy.

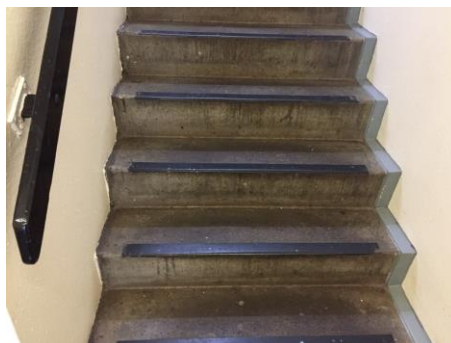
Condition ..... **Low Damage**

Resin nosing to edge of stairs.

The material was seen to be in fair condition at the time of the initial inspection.

The condition of the material should be managed by a competent person/company and its presence made aware to those at risk, as part of a Control of Asbestos Regulations (CAR) 2012 compliant management strategy.

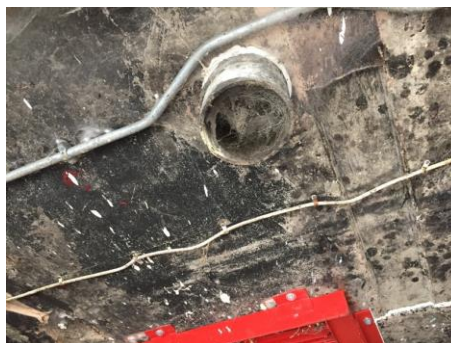
Condition ..... **Low Damage**

Bottom of cement incinerator flue.

The material was seen to be in fair condition at the time of the initial inspection.

The condition of the material should be managed by a competent person/company and its presence made aware to those at risk, as part of a Control of Asbestos Regulations (CAR) 2012 compliant management strategy.
