Site ID: **a-303622**

Management with Targeted Refurbishment Survey – PART 1

1-65 Kingsgate House
Winchester Drive
Chelmsley Wood
Solihull
West Midlands
B37 5PX
United Kingdom

22nd April 2021

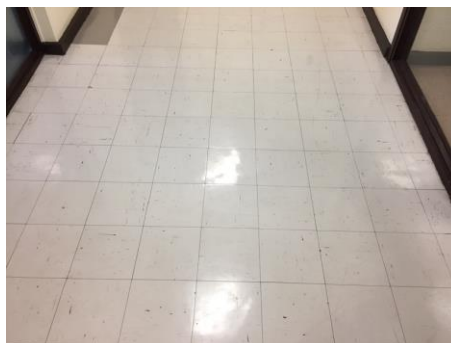
Bitumen adhesive beneath floor tiles.

The material was seen to be in fair condition at the time of the initial inspection.

The condition of the material should be managed by a competent person/company and its presence made aware to those at risk, as part of a Control of Asbestos Regulations (CAR) 2012 compliant management strategy.

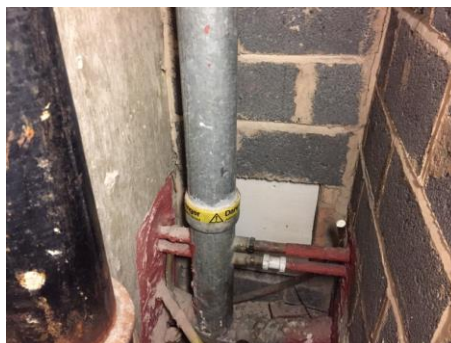
Lagging packing to joints of metal soil pipe.

The material was seen to be in fair condition at the time of the initial inspection.

The condition of the material should be managed by a competent person/company and its presence made aware to those at risk, as part of a Control of Asbestos Regulations (CAR) 2012 compliant management strategy.

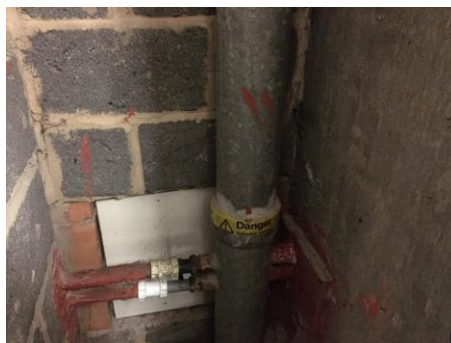
Lagging packing to joints of metal soil pipe.

The material was seen to be in fair condition at the time of the initial inspection.

The condition of the material should be managed by a competent person/company and its presence made aware to those at risk, as part of a Control of Asbestos Regulations (CAR) 2012 compliant management strategy.

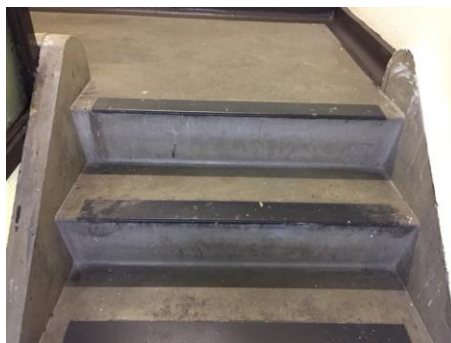
Resin stair nosing to edge of stairs.

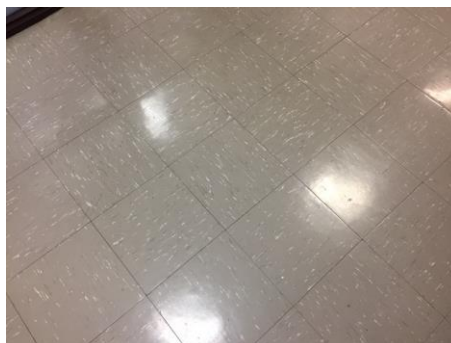
Grey floor tiles.

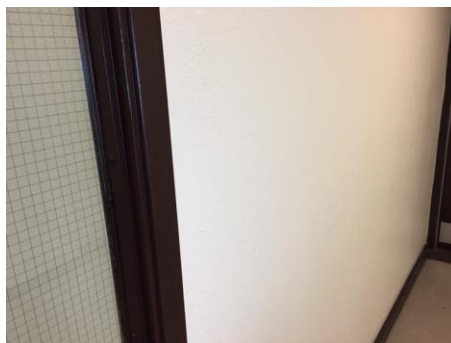
Spatter pattern textured coating.

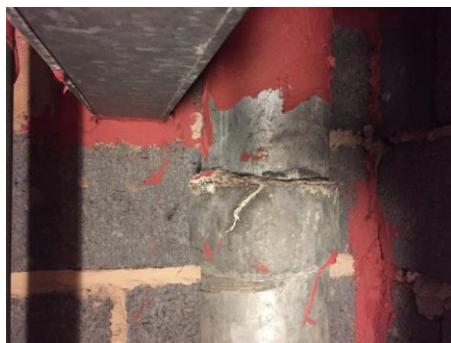
Lagging packing to joints of metal soil pipe.

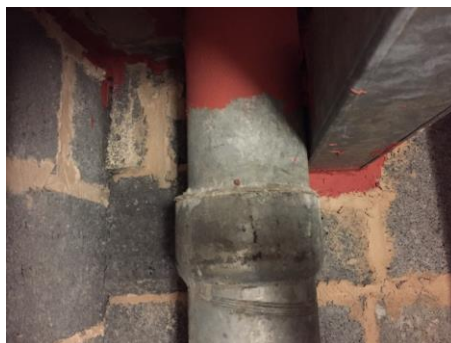
Lagging packing to joints of metal soil pipe.

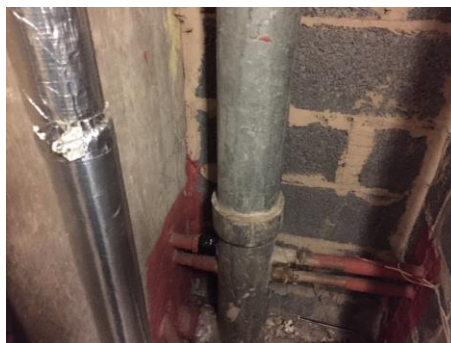
Lagging packing to joints of metal soil pipe.

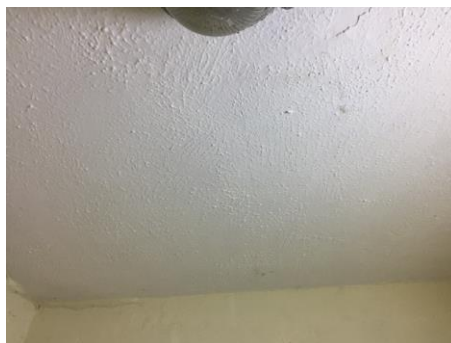
Stipple pattern textured coating.

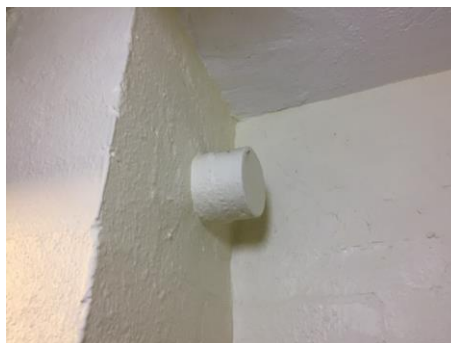
Cutoff cement flue.

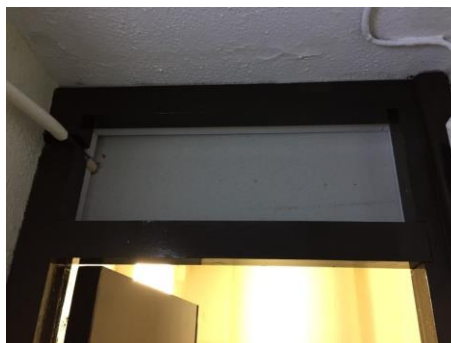
Insulating board transom panel.

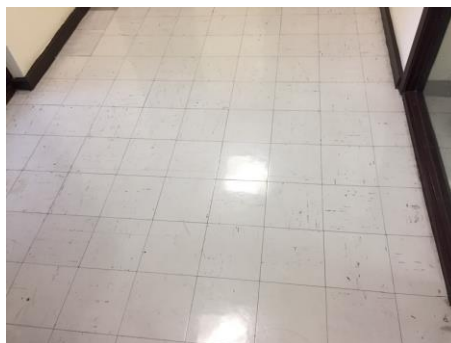
Grey floor tiles.

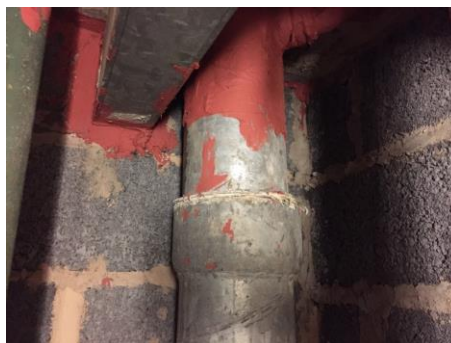
Lagging packing to joints of metal soil pipe.

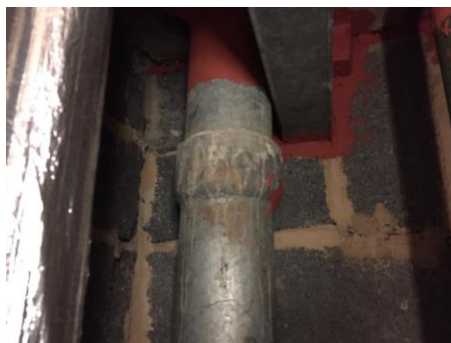
Lagging packing to joints of metal soil pipe.

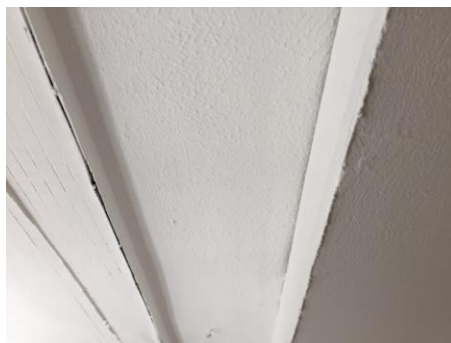
Stipple pattern textured coating.

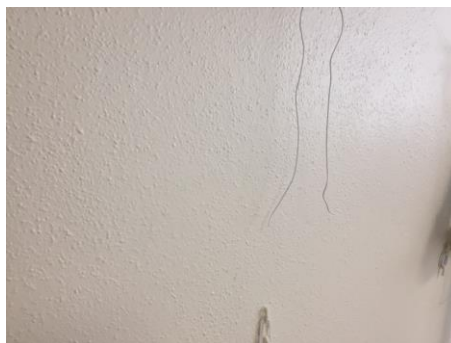
Spatter pattern textured coating.

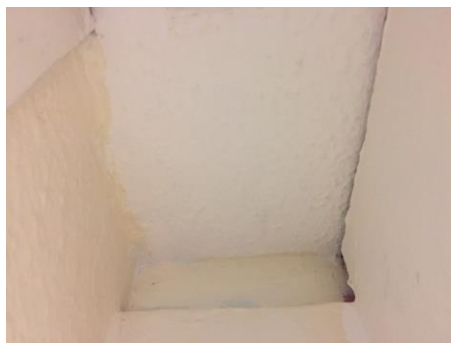
Stipple pattern textured coating visible above extractor.

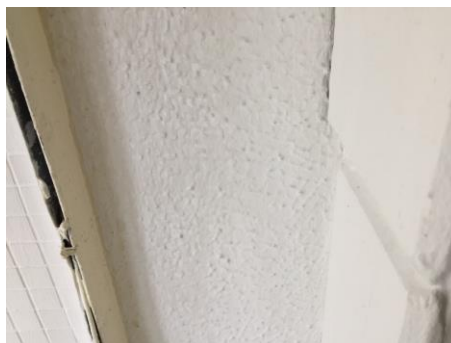
Stipple pattern textured coating.

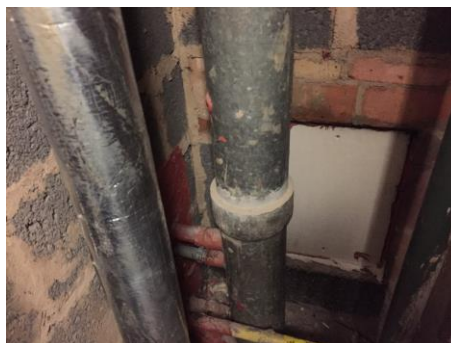
Lagging packing to joints of metal soil pipe.

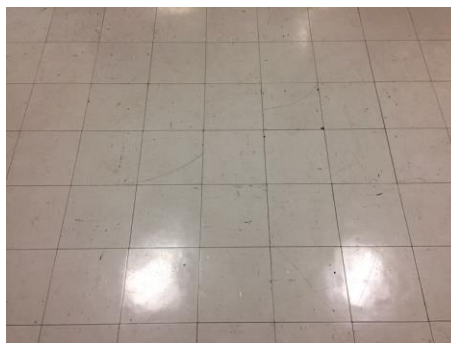
Grey floor tiles.

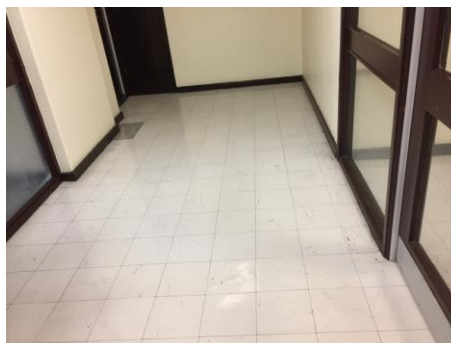
Grey floor tiles.

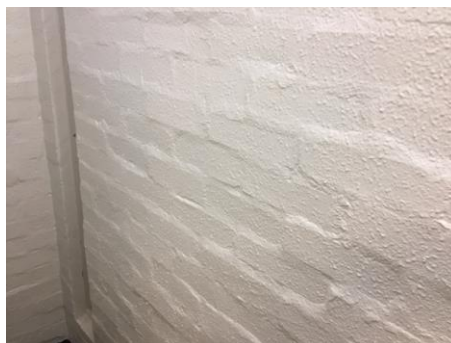
Spatter pattern textured coating.

The material was seen to be in fair condition at the time of the initial inspection.

The condition of the material should be managed by a competent person/company and its presence made aware to those at risk, as part of a Control of Asbestos Regulations (CAR) 2012 compliant management strategy.

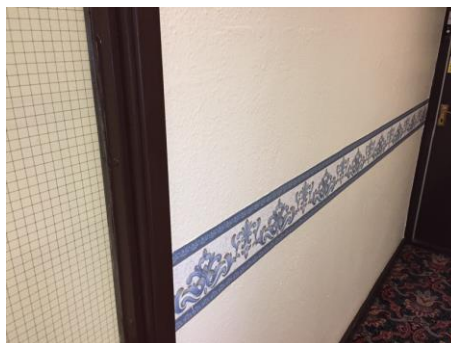
Spatter pattern textured coating.

The material was seen to be in fair condition at the time of the initial inspection.

The condition of the material should be managed by a competent person/company and its presence made aware to those at risk, as part of a Control of Asbestos Regulations (CAR) 2012 compliant management strategy.

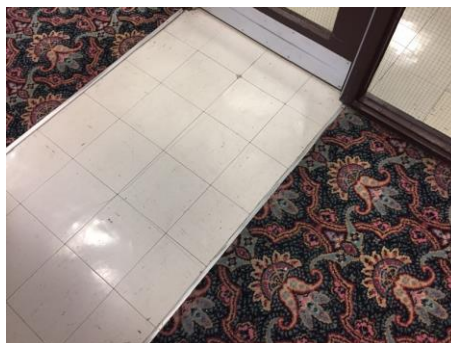
Bitumen adhesive beneath floor tiles.

The material was seen to be in fair condition at the time of the initial inspection.

The condition of the material should be managed by a competent person/company and its presence made aware to those at risk, as part of a Control of Asbestos Regulations (CAR) 2012 compliant management strategy.

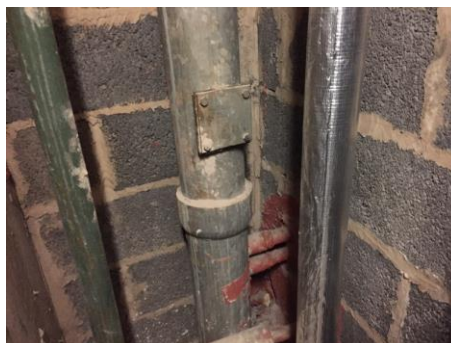
Lagging packing to joints of metal soil pipe.

The material was seen to be in fair condition at the time of the initial inspection.

The condition of the material should be managed by a competent person/company and its presence made aware to those at risk, as part of a Control of Asbestos Regulations (CAR) 2012 compliant management strategy.

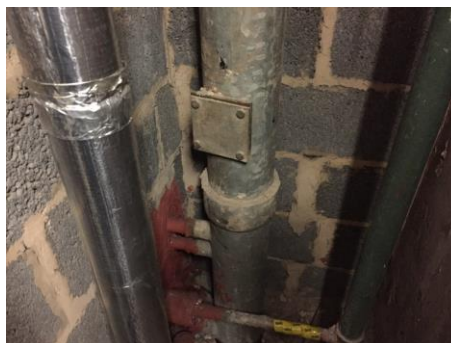
Lagging packing to joints of metal soil pipe.

The material was seen to be in fair condition at the time of the initial inspection.

The condition of the material should be managed by a competent person/company and its presence made aware to those at risk, as part of a Control of Asbestos Regulations (CAR) 2012 compliant management strategy.

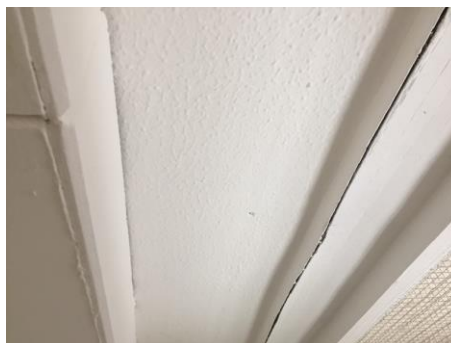
Stipple pattern textured coating.

The material was seen to be in fair condition at the time of the initial inspection.

The condition of the material should be managed by a competent person/company and its presence made aware to those at risk, as part of a Control of Asbestos Regulations (CAR) 2012 compliant management strategy.
