Management with Targeted Refurbishment Survey – PART 2

1-65 Kingsgate House
Winchester Drive
Chelmsley Wood
Solihull
West Midlands
B37 5PX
United Kingdom

28th April 2021

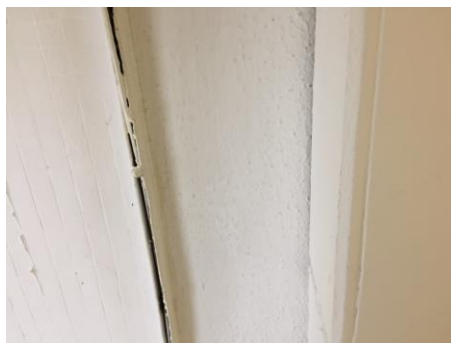
Spatter pattern textured coating.

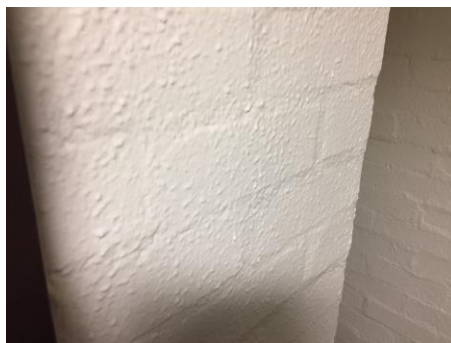
Spatter pattern textured coating.

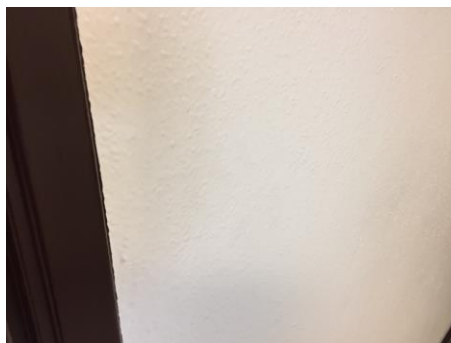
Spatter pattern textured coating.

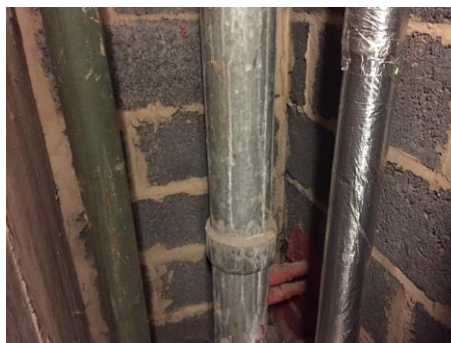
Lagging packing to joints of soil pipe.

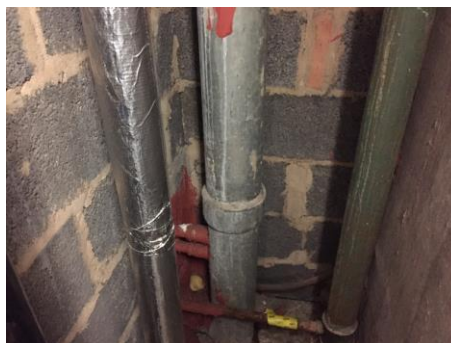
Lagging packing to joints of soil pipe.

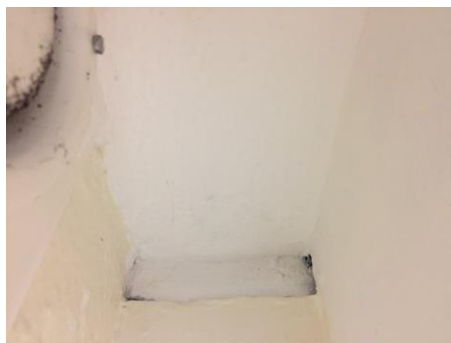
Stipple pattern textured coating visible above extractor.

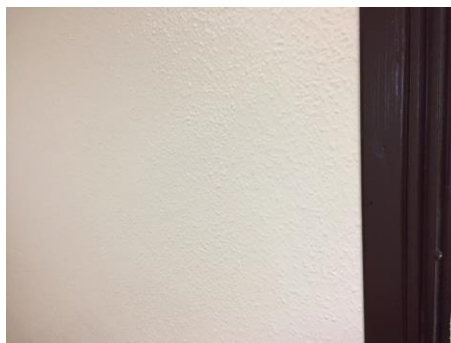
Spatter pattern textured coating.

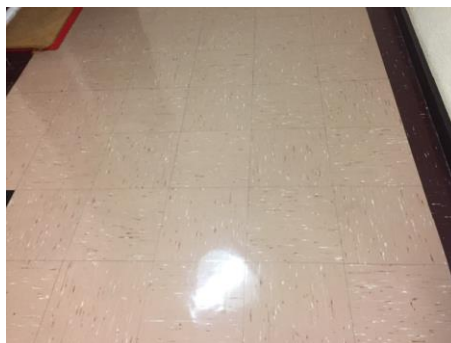
Pink floor tiles.

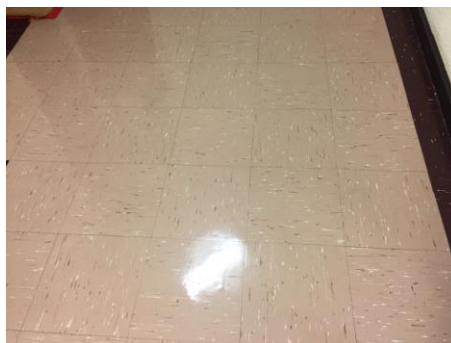
Bitumen adhesive beneath floor tiles.

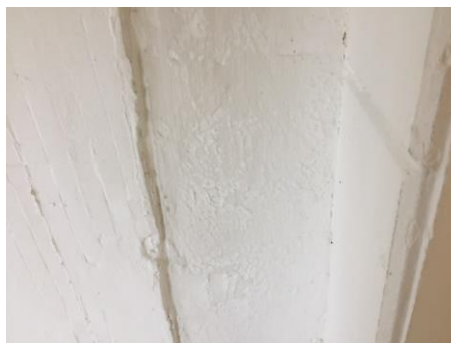
Stipple pattern textured coating.

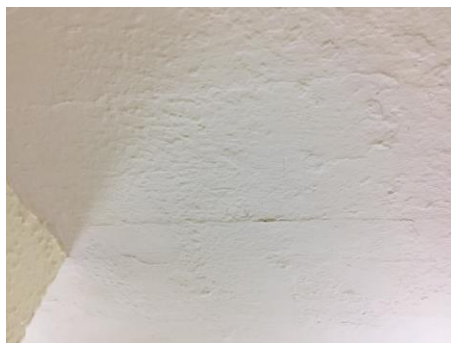
Stipple pattern textured coating.

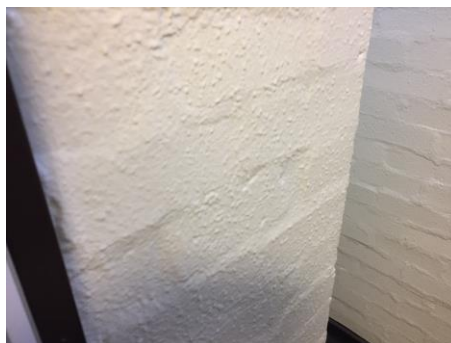
Spatter pattern textured coating.

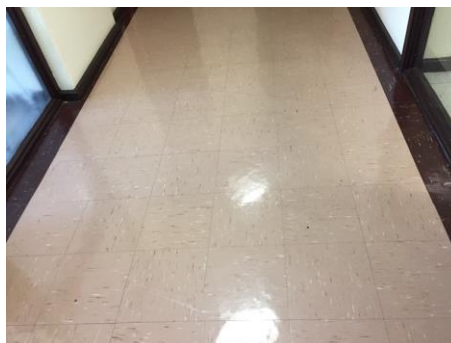
Bitumen adhesive beneath floor tiles.

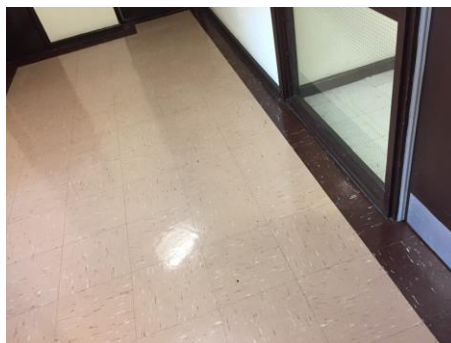
Brown floor tiles to edges.

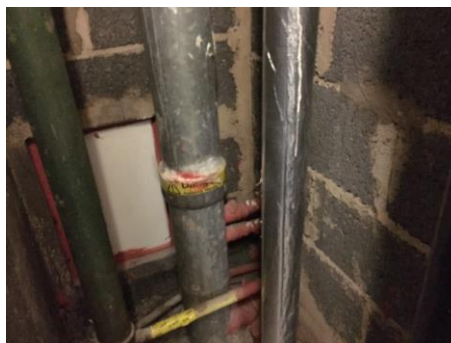
Lagging packing to joints of soil pipe.

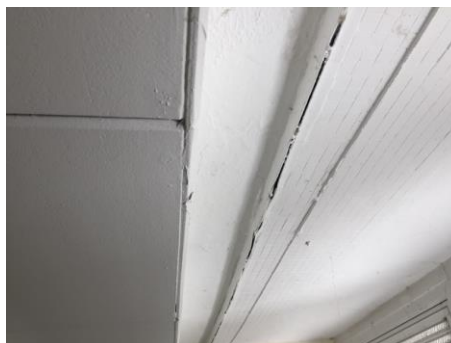
Stipple pattern textured coating.

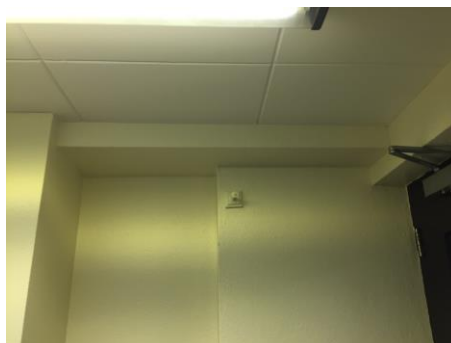
Insulating board boxing by door.

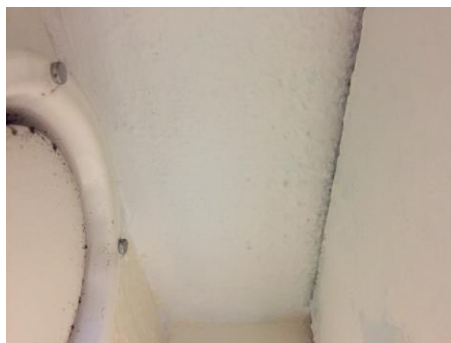
Stipple pattern textured coating visible above extractor.

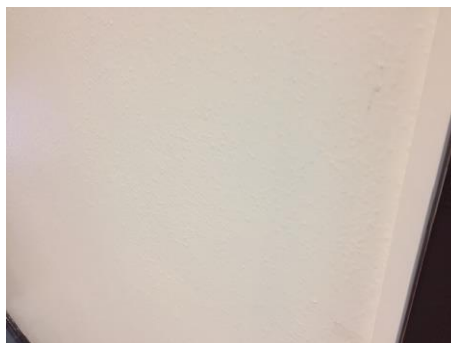
Spatter pattern textured coating.

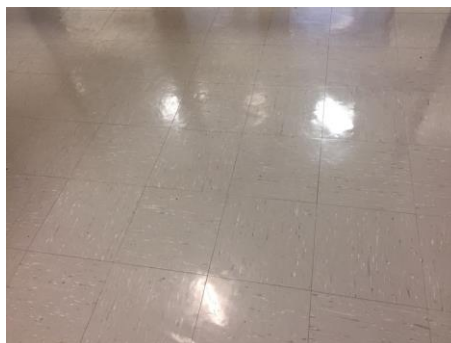
Bitumen adhesive beneath floor tiles.

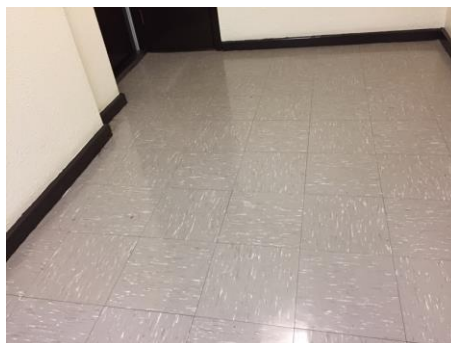
Grey floor tiles.

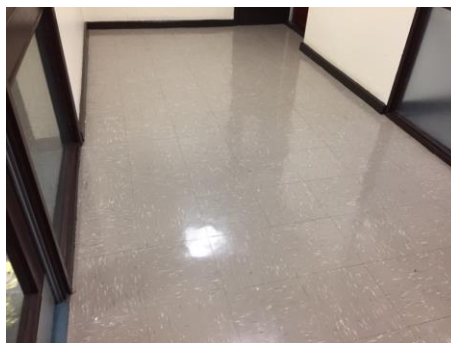
Bitumen adhesive beneath floor tiles.

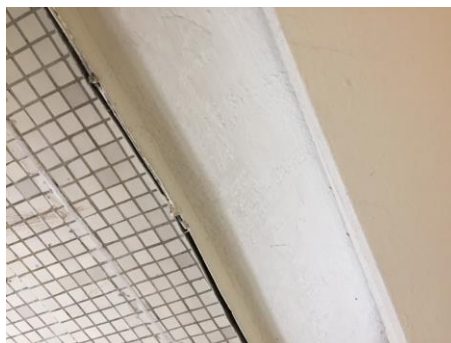
Stipple pattern textured coating.

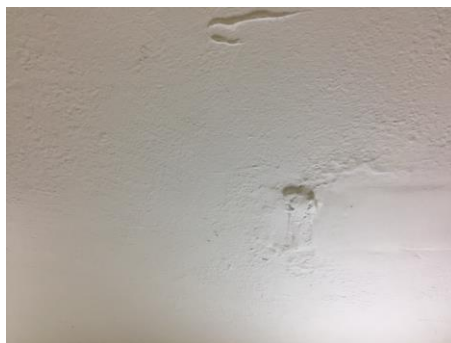
Stipple pattern textured coating.

The material was seen to be in fair condition at the time of the initial inspection.

The condition of the material should be managed by a competent person/company and its presence made aware to those at risk, as part of a Control of Asbestos Regulations (CAR) 2012 compliant management strategy.

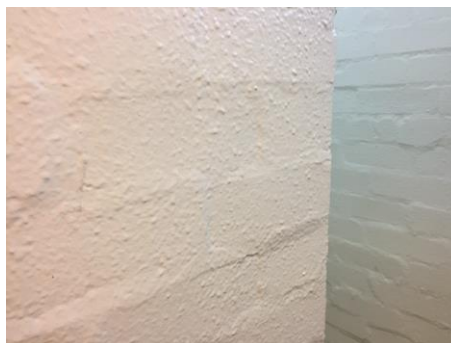
Spatter pattern textured coating.

The material was seen to be in fair condition at the time of the initial inspection.

The condition of the material should be managed by a competent person/company and its presence made aware to those at risk, as part of a Control of Asbestos Regulations (CAR) 2012 compliant management strategy.

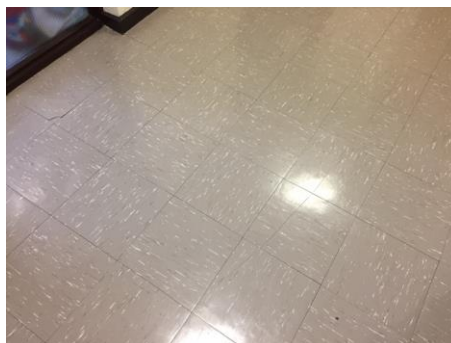
Bitumen adhesive beneath floor tiles.

The material was seen to be in fair condition at the time of the initial inspection.

The condition of the material should be managed by a competent person/company and its presence made aware to those at risk, as part of a Control of Asbestos Regulations (CAR) 2012 compliant management strategy.

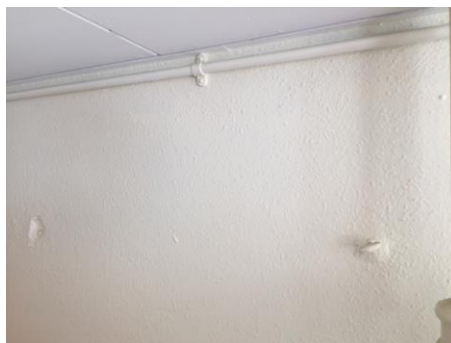
Spatter pattern textured coating.

The material was seen to be in fair condition at the time of the initial inspection.

The condition of the material should be managed by a competent person/company and its presence made aware to those at risk, as part of a Control of Asbestos Regulations (CAR) 2012 compliant management strategy.

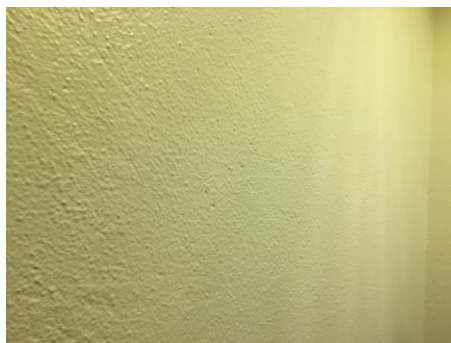
Spatter pattern textured coating.

The material was seen to be in fair condition at the time of the initial inspection.

The condition of the material should be managed by a competent person/company and its presence made aware to those at risk, as part of a Control of Asbestos Regulations (CAR) 2012 compliant management strategy.

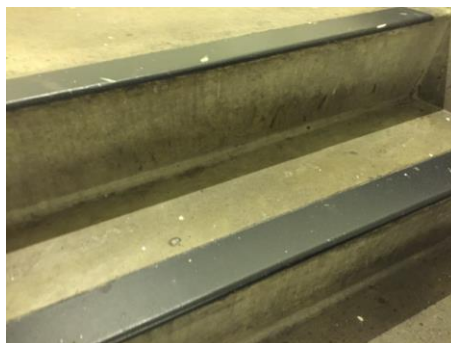
Resin nosing to edge of stairs.

The material was seen to be in fair condition at the time of the initial inspection.

The condition of the material should be managed by a competent person/company and its presence made aware to those at risk, as part of a Control of Asbestos Regulations (CAR) 2012 compliant management strategy.

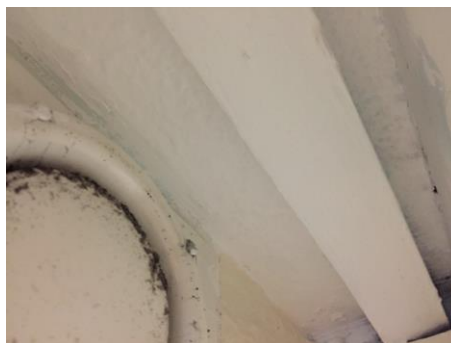
Stipple pattern textured coating visible above extractor.

The material was seen to be in fair condition at the time of the initial inspection.

The condition of the material should be managed by a competent person/company and its presence made aware to those at risk, as part of a Control of Asbestos Regulations (CAR) 2012 compliant management strategy.

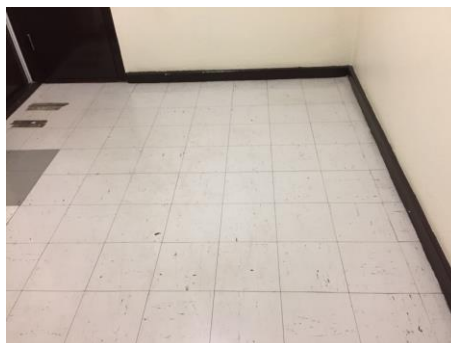
Bitumen adhesive beneath floor tiles.

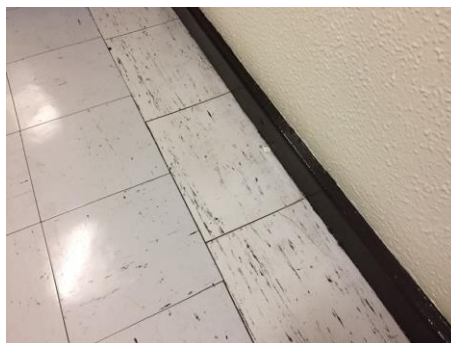
White floor tiles.

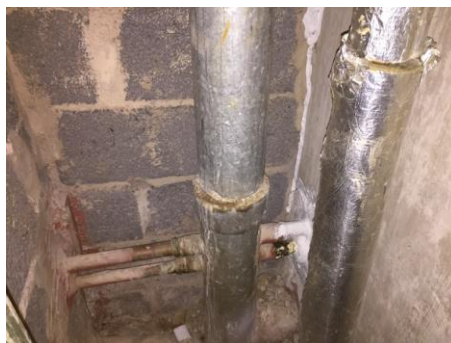
Lagging packing to joints of soil pipe.

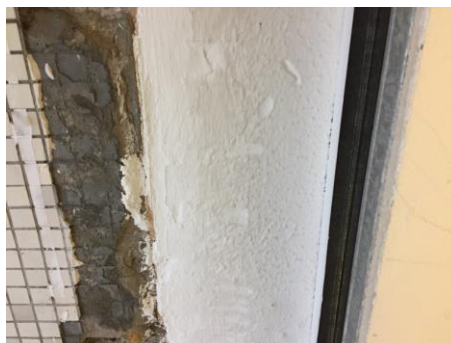
Stipple pattern textured coating.

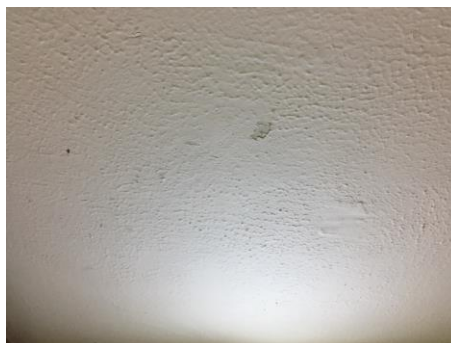
Stipple pattern textured coating.

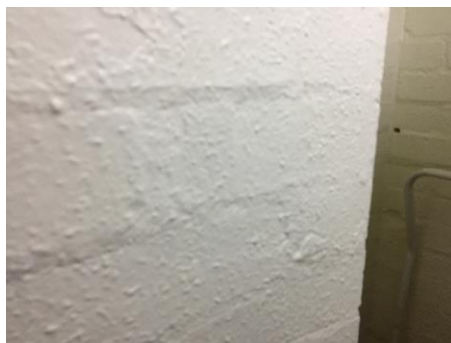
Spatter pattern textured coating.

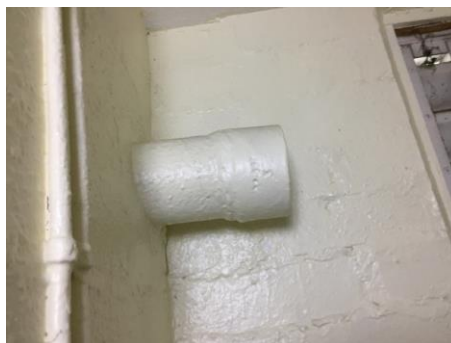
Cutoff cement flue.

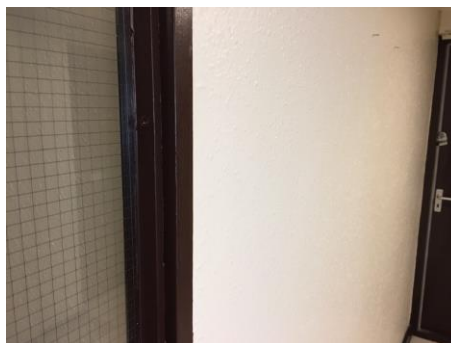
Spatter pattern textured coating.

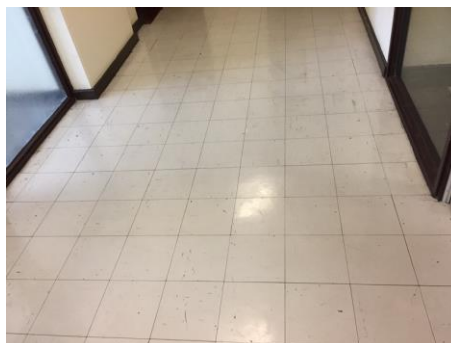
Grey floor tiles.

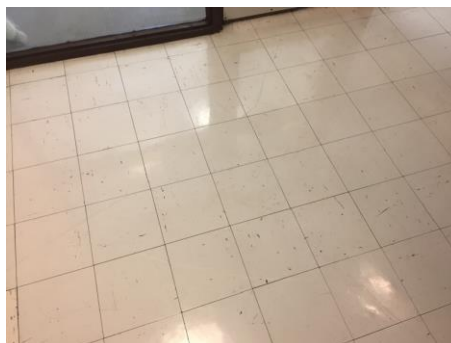
Bitumen adhesive beneath floor tiles.

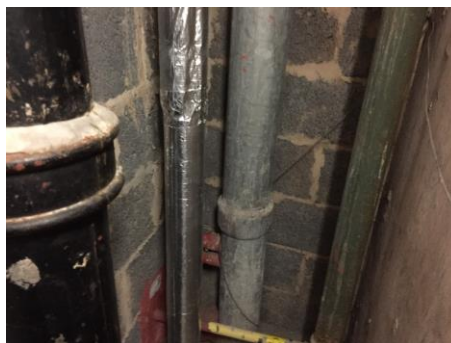
Lagging packing to joints of soil pipe.

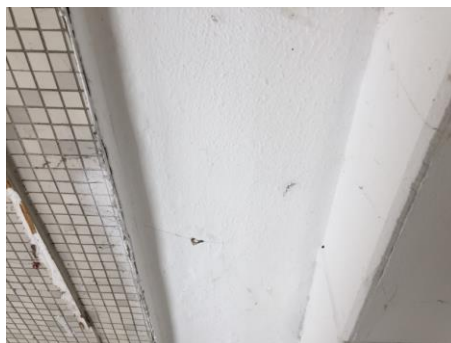
Stipple pattern textured coating.

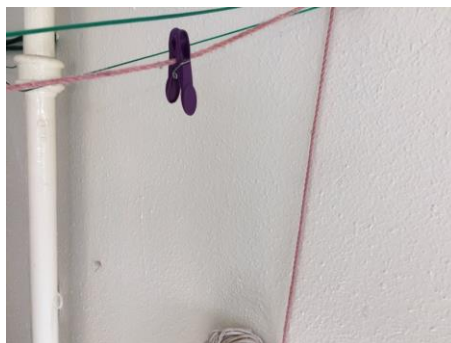
Spatter pattern textured coating.

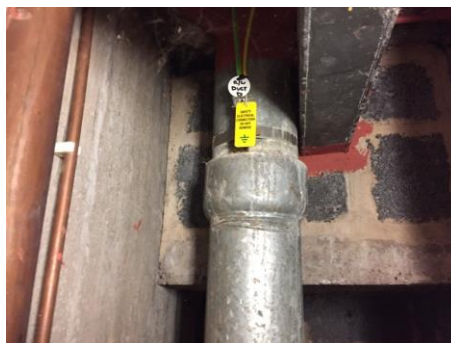
Lagging packing to joints of soil pipe.

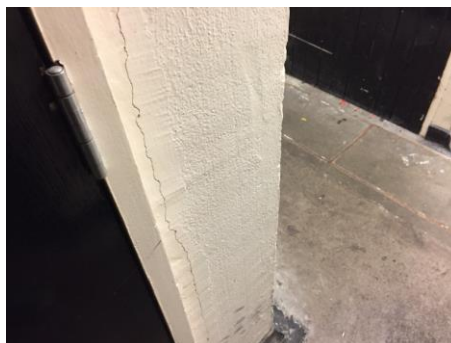
Stipple pattern textured coating.

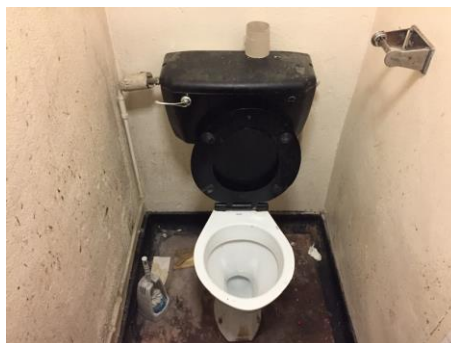
Resin toilet cistern and seat.

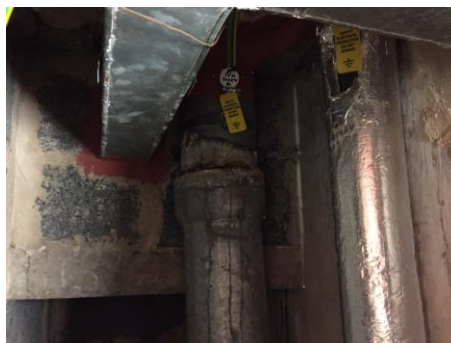
Lagging packing to joints of soil pipe.

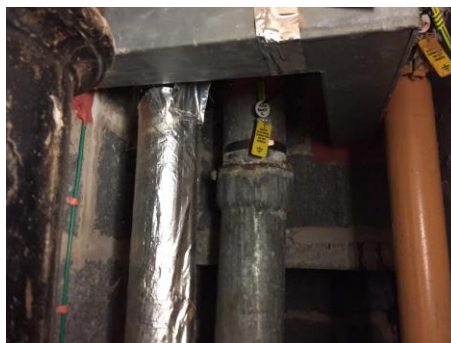
Lagging packing to joints of soil pipe.
