# **Solihull Community Housing**

## **Asbestos Management Survey Report**

**I - 37 (Communal) Kingshurst  
House  
Stonebridge Croft  
Solihull  
B37 6JP**

**Date of Report: 20 Jan 2015**  
**Survey Ref: 257890000A**

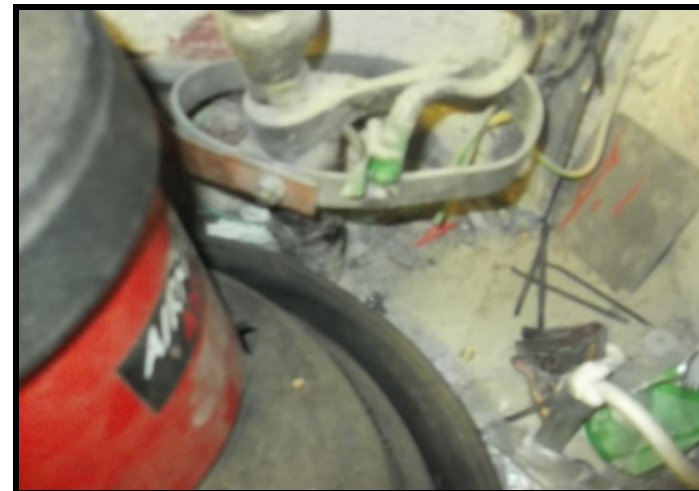
## SAMPLE REFERENCE 011a

Asbestos not detected in Sample

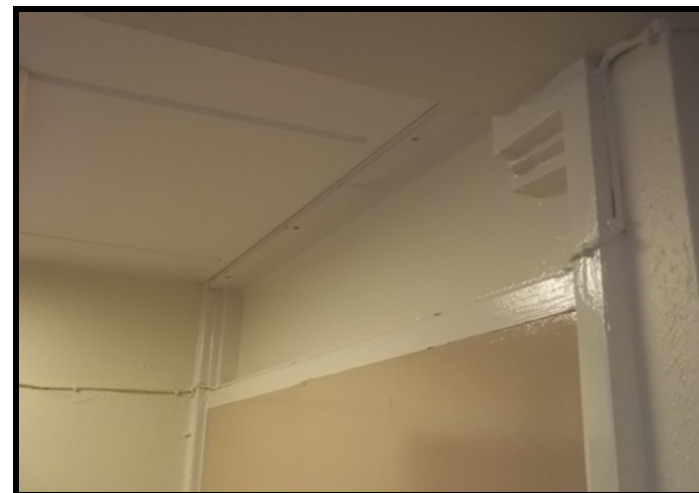
## SAMPLE REFERENCE 051

**No Asbestos Presumed in Sample**

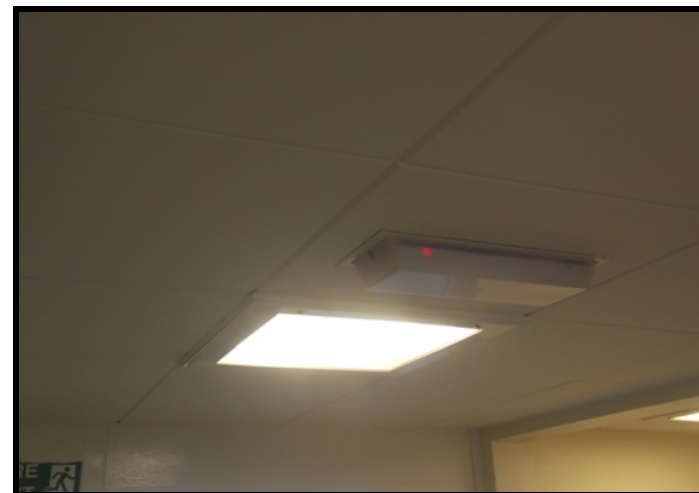
## SAMPLE REFERENCE 052

**No Asbestos Presumed in Sample**

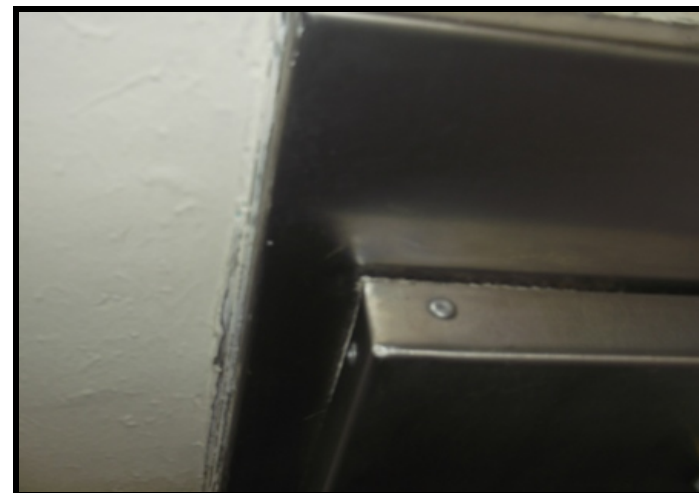
## SAMPLE REFERENCE 054a

**No Asbestos Presumed in Sample**

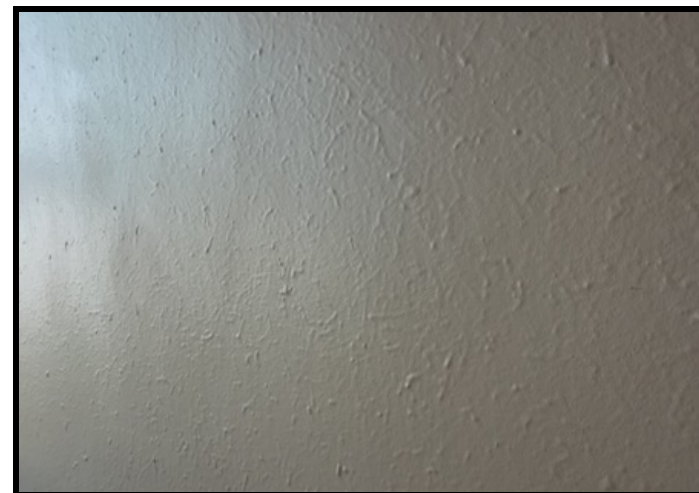
## SAMPLE REFERENCE 056

**No Asbestos Presumed in Sample**

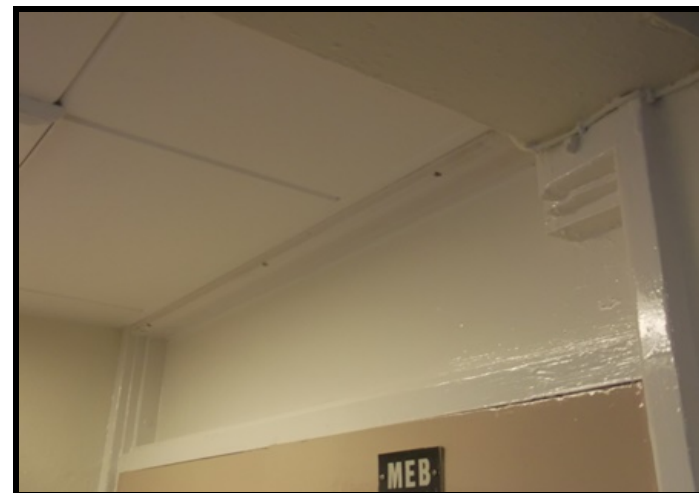
## SAMPLE REFERENCE 059

**No Asbestos Presumed in Sample**

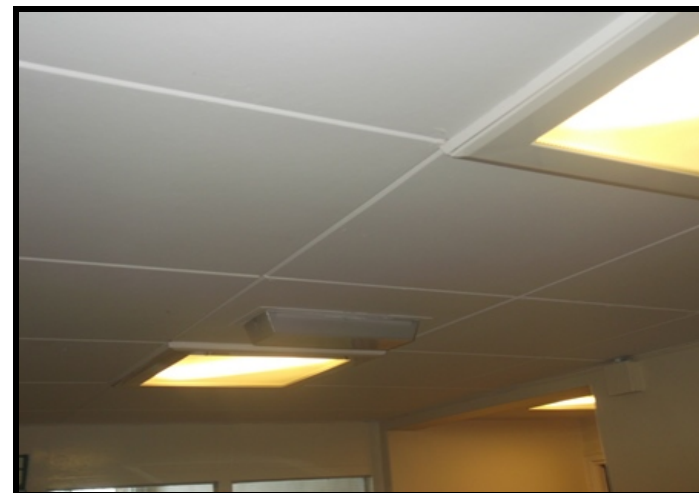
## SAMPLE REFERENCE 060

**No Asbestos Presumed in Sample**

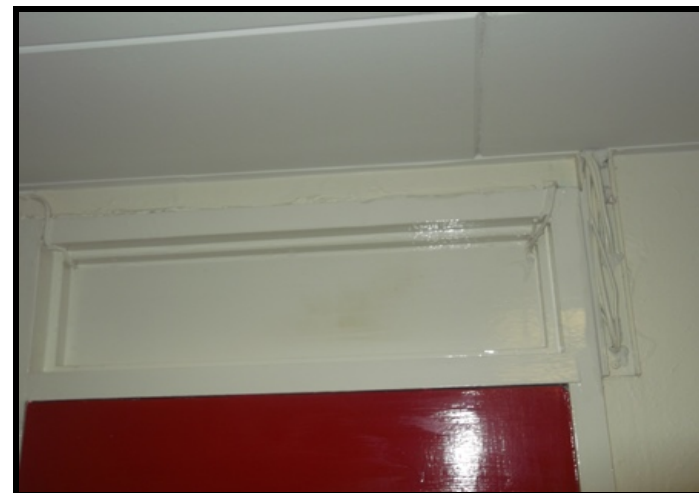
## SAMPLE REFERENCE 066

**No Asbestos Presumed in Sample**

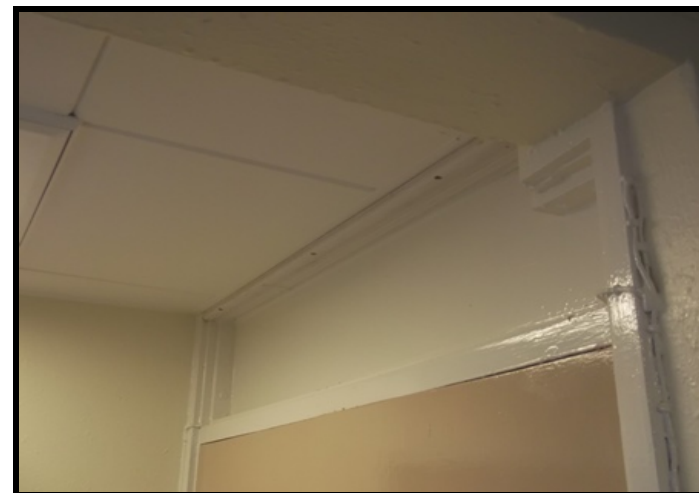
## SAMPLE REFERENCE 067

**No Asbestos Presumed in Sample**

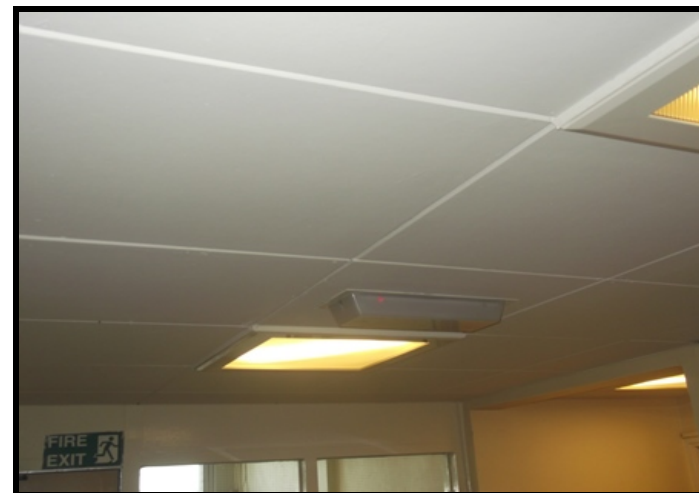
## SAMPLE REFERENCE 068

**No Asbestos Presumed in Sample**

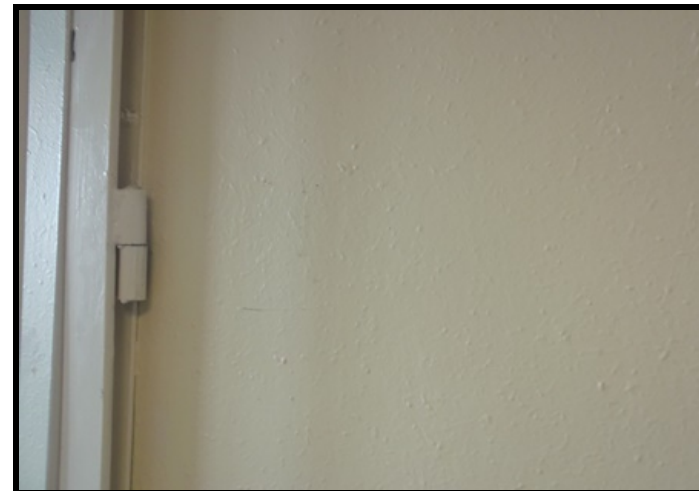
## SAMPLE REFERENCE 072

**No Asbestos Presumed in Sample**

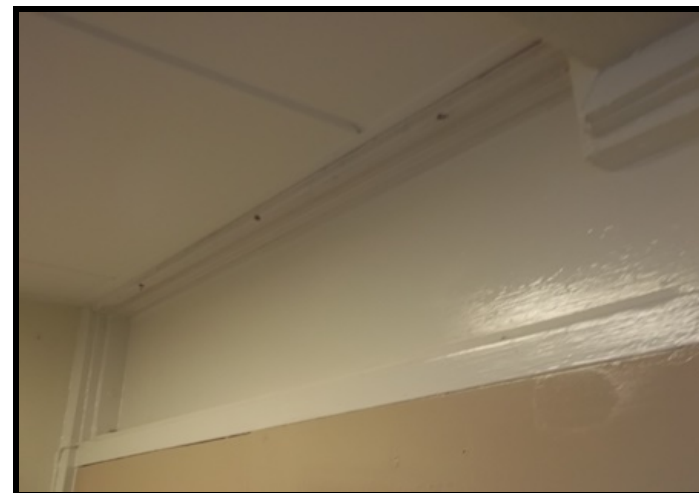
## SAMPLE REFERENCE 075

**No Asbestos Presumed in Sample**

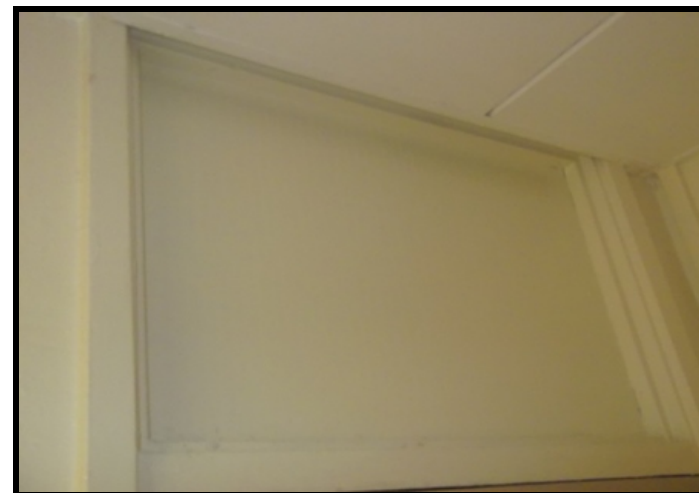
## SAMPLE REFERENCE 076

**No Asbestos Presumed in Sample**

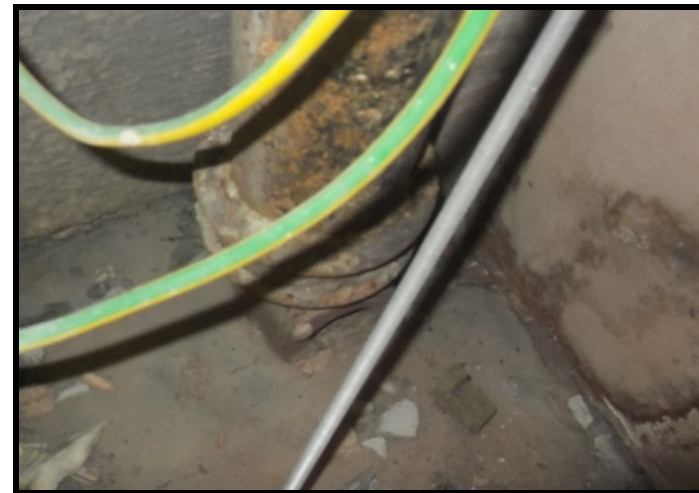
## SAMPLE REFERENCE 077a

Asbestos detected in Sample

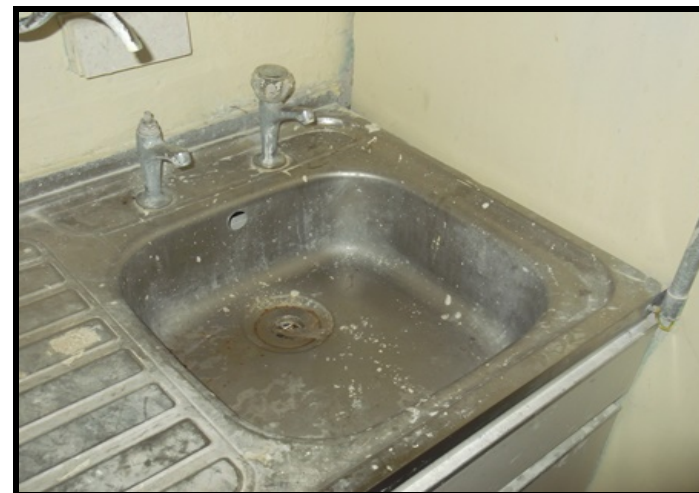
SAMPLE REFERENCE 086a

**Asbestos not detected in Sample**

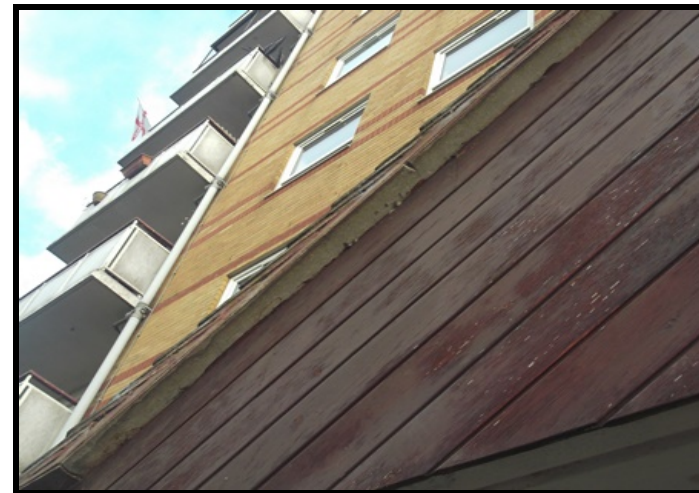
## SAMPLE REFERENCE 089

**Asbestos detected in Sample**

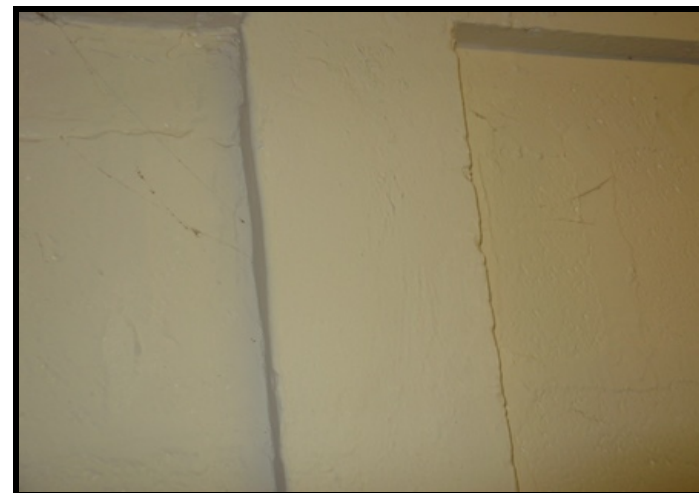
## SAMPLE REFERENCE 090

**Asbestos not detected in Sample**
