Solihull Community Housing

Asbestos Management Survey Report

**Linacre House
Heathmere Drive
Chelmsley Wood
B37 5EW**

Date of Report: 25 Apr 2012

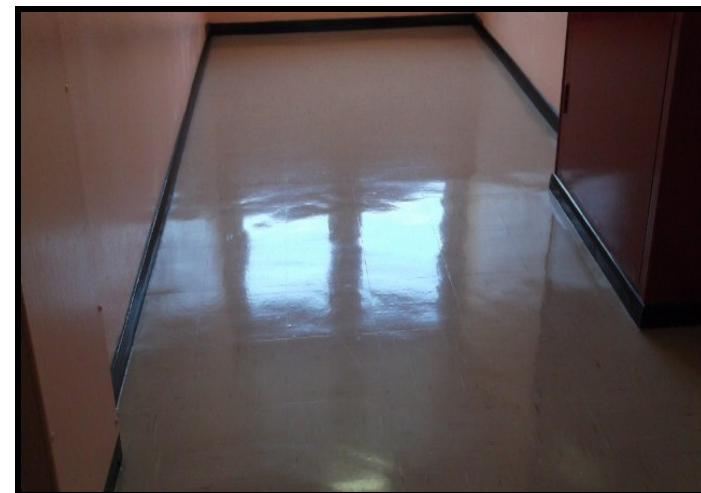
SAMPLE REFERENCE 009

No Asbestos Presumed in Sample

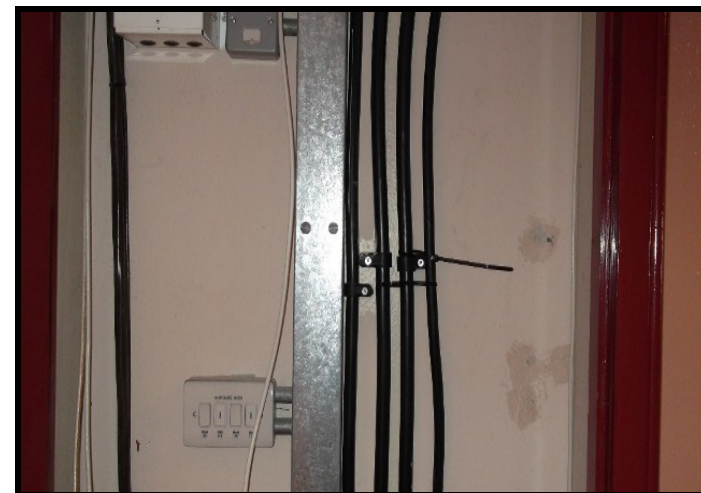
SAMPLE REFERENCE 010

No Asbestos Presumed in Sample

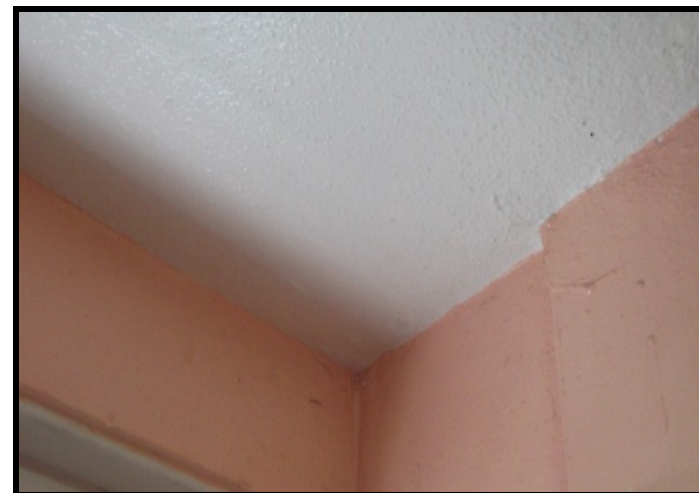
SAMPLE REFERENCE 014

Asbestos not detected in Sample

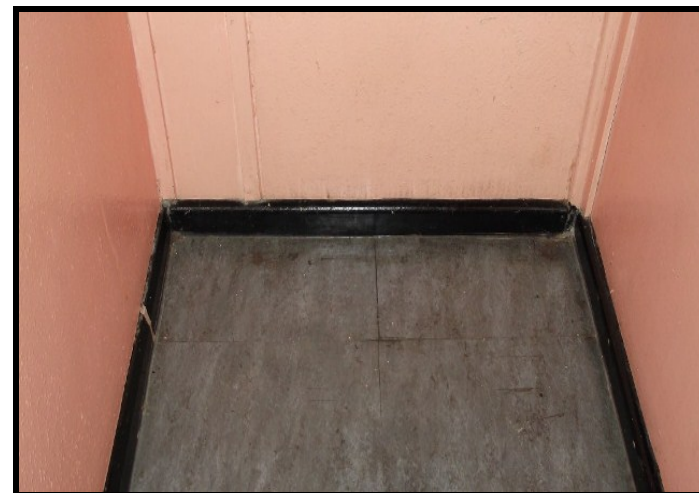
SAMPLE REFERENCE 016

No Asbestos Presumed in Sample

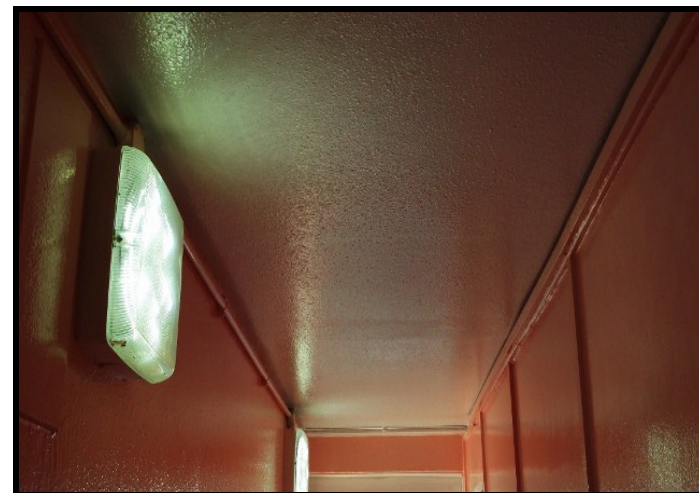
SAMPLE REFERENCE 017

No Asbestos Presumed in Sample

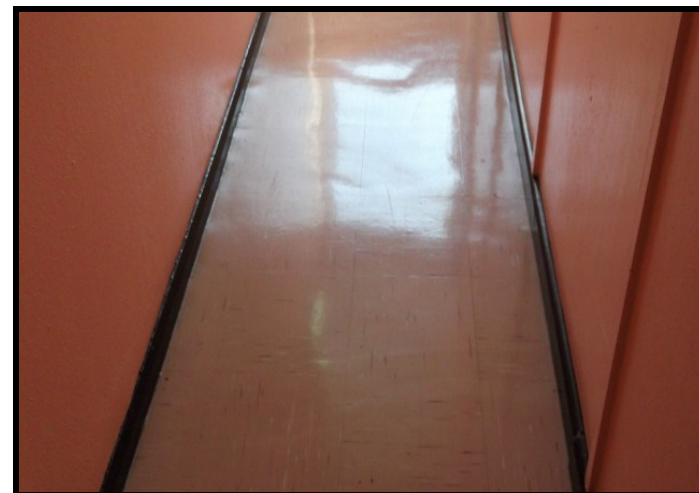
SAMPLE REFERENCE 019

No Asbestos Presumed in Sample

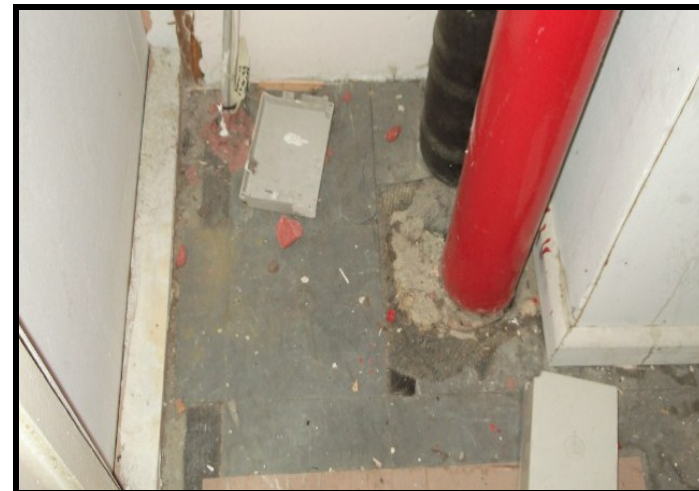
SAMPLE REFERENCE 020

Asbestos detected in Sample

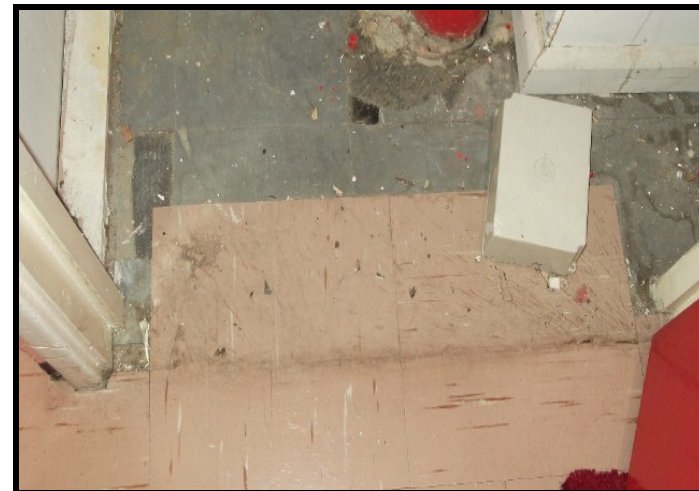
SAMPLE REFERENCE 021

No Asbestos Presumed in Sample

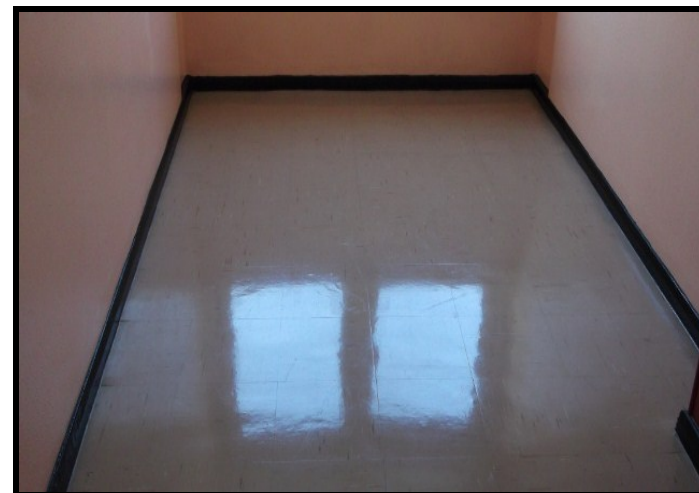
SAMPLE REFERENCE 024

No Asbestos Presumed in Sample

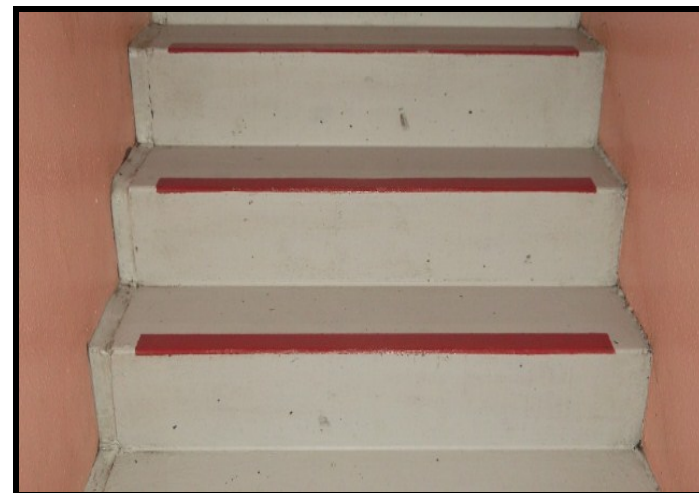
SAMPLE REFERENCE 027

Asbestos Presumed in Sample

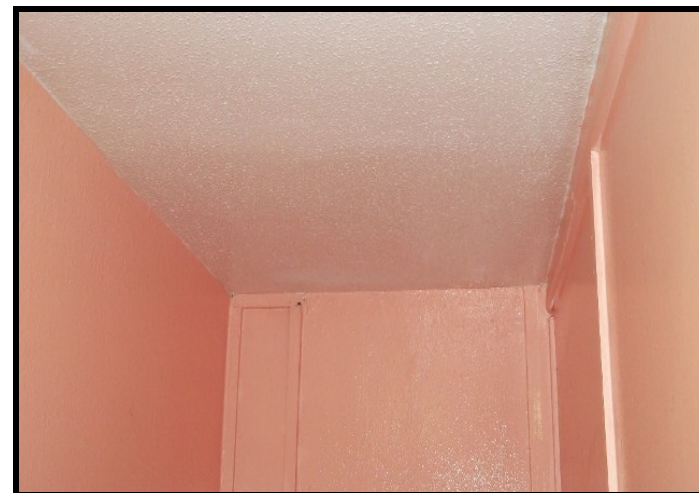
SAMPLE REFERENCE 028

No Asbestos Presumed in Sample

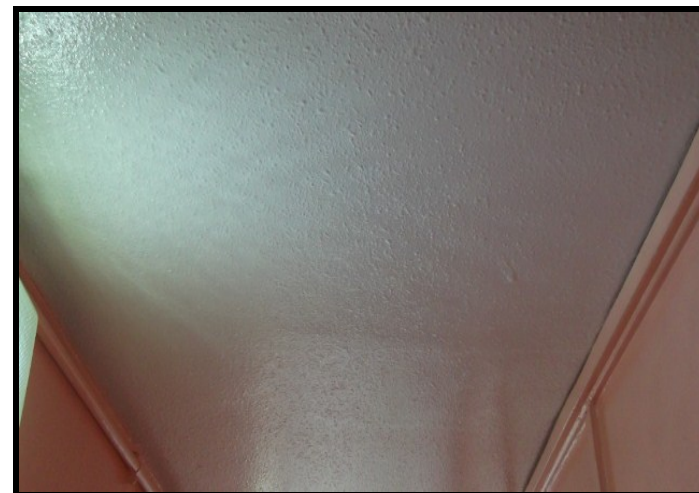
SAMPLE REFERENCE 03 I

No Asbestos Presumed in Sample

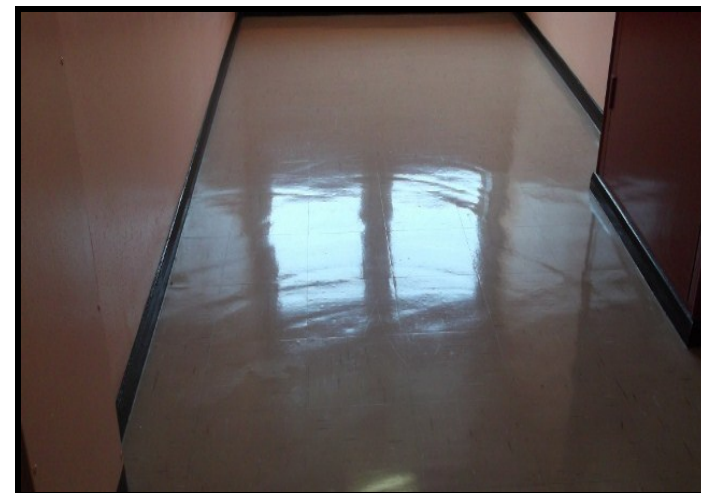
SAMPLE REFERENCE 037

No Asbestos Presumed in Sample

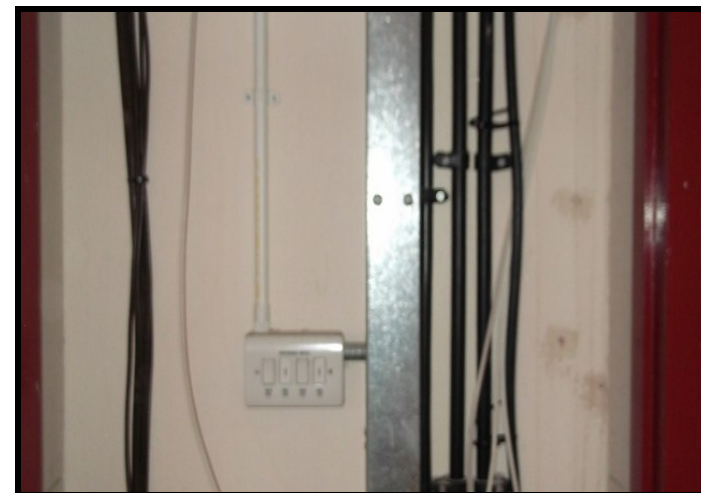
SAMPLE REFERENCE 038

No Asbestos Presumed in Sample

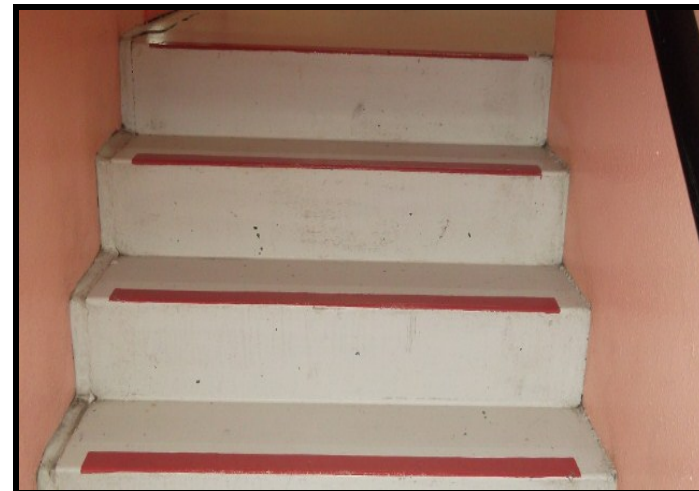
SAMPLE REFERENCE 040

Asbestos Presumed in Sample

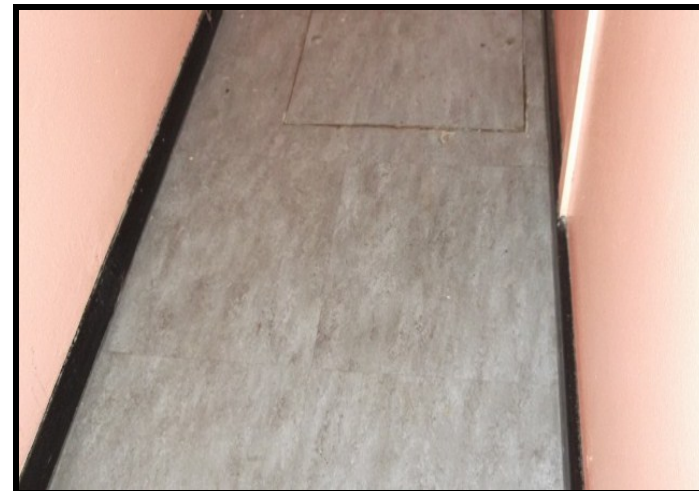
SAMPLE REFERENCE 043

No Asbestos Presumed in Sample

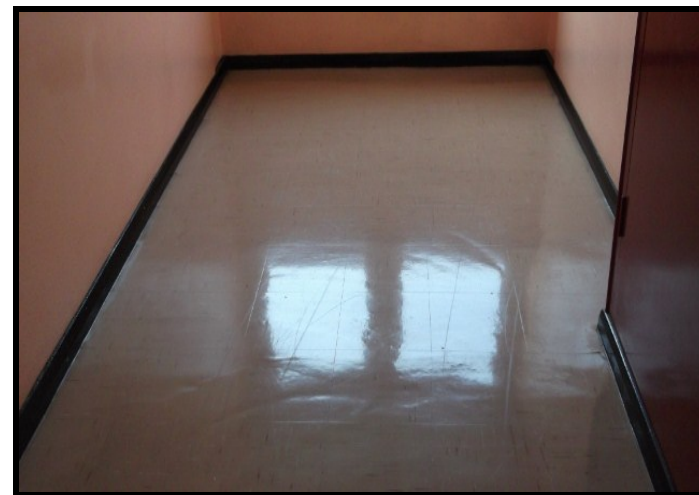
SAMPLE REFERENCE 050

No Asbestos Presumed in Sample

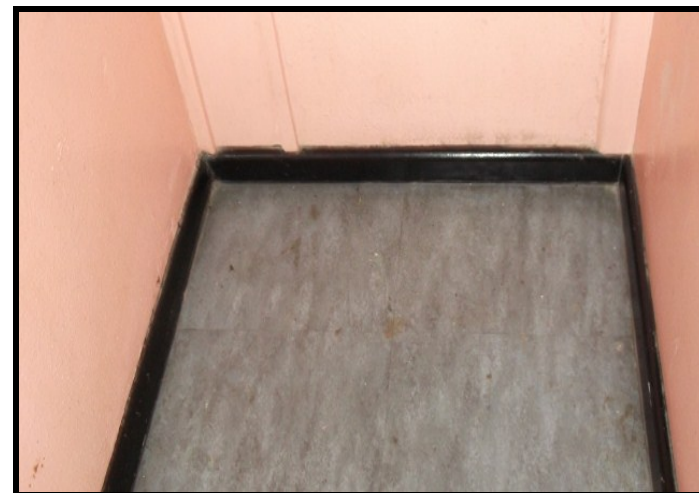
SAMPLE REFERENCE 056

No Asbestos Presumed in Sample

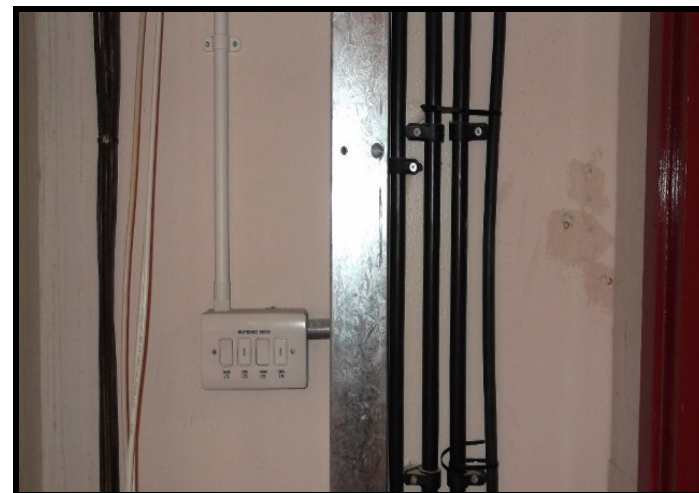
SAMPLE REFERENCE 063

No Asbestos Presumed in Sample

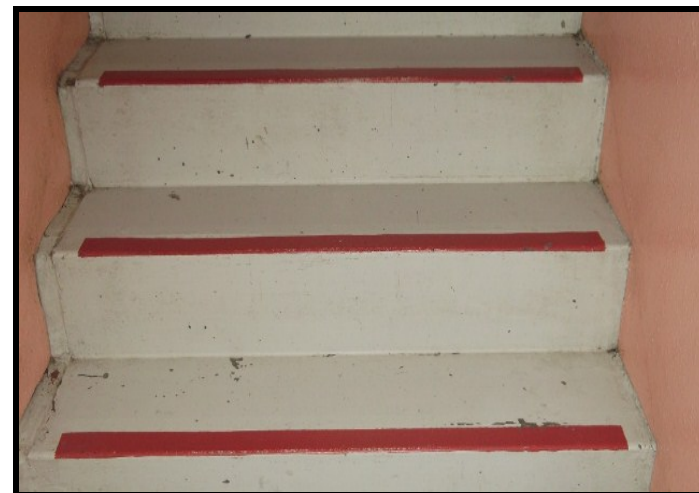
SAMPLE REFERENCE 065

Asbestos Presumed in Sample

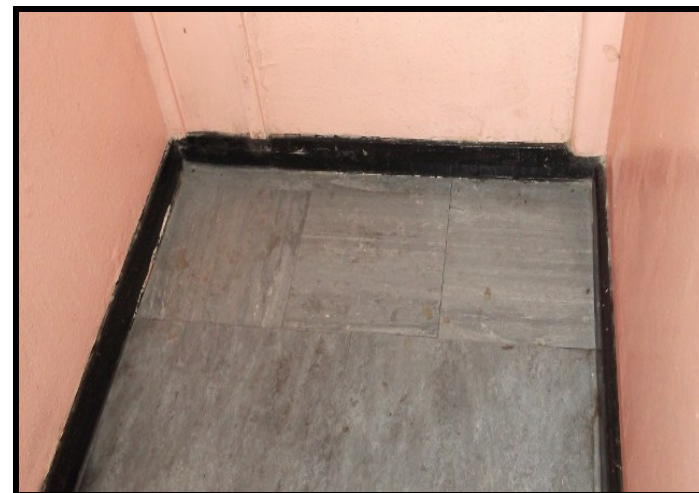
SAMPLE REFERENCE 069

No Asbestos Presumed in Sample

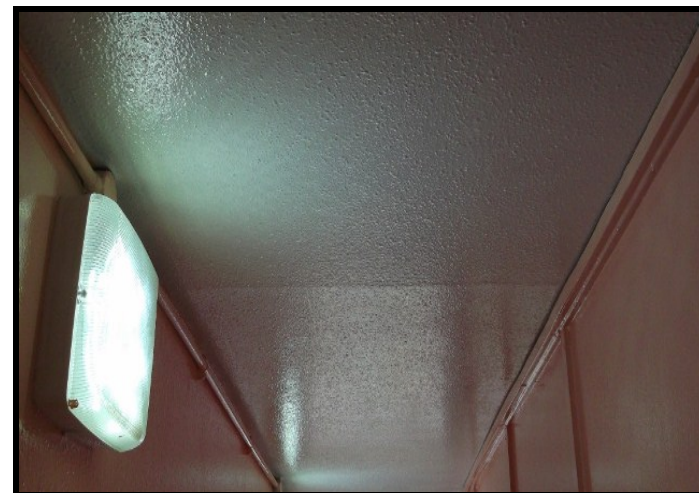
SAMPLE REFERENCE 070

No Asbestos Presumed in Sample

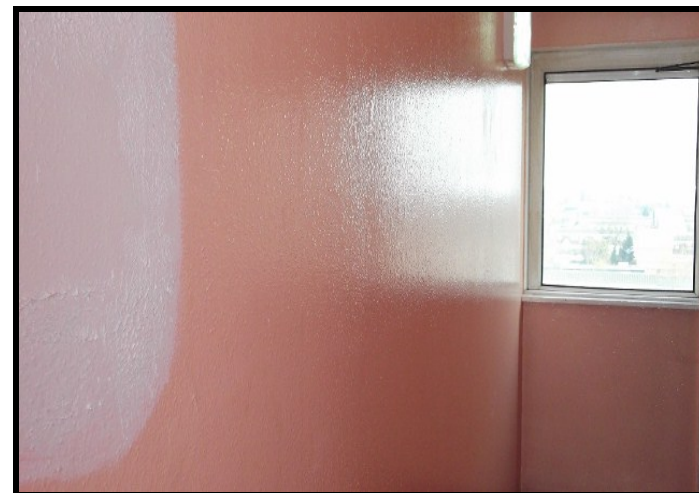
SAMPLE REFERENCE 071

No Asbestos Presumed in Sample

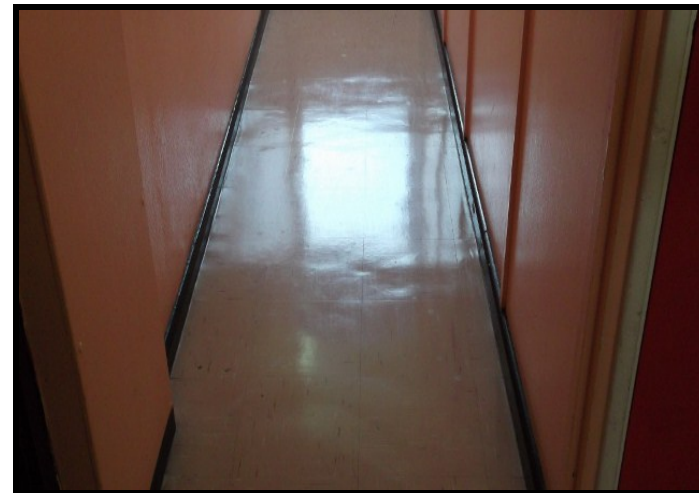
SAMPLE REFERENCE 072

Asbestos not detected in Sample

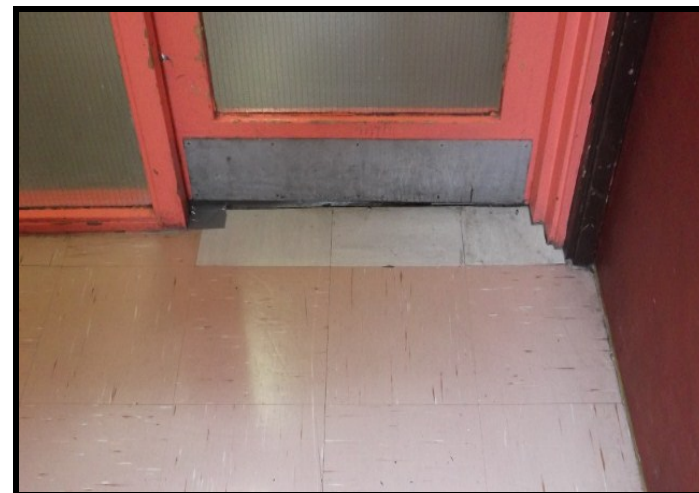
SAMPLE REFERENCE 073

Asbestos not detected in Sample

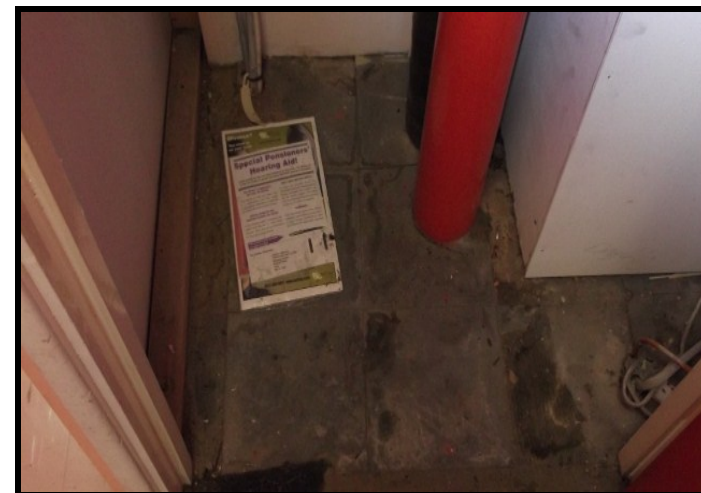
SAMPLE REFERENCE 074

074	Main Building (Fifth Floor)	Dry Riser	Floor	Floor Tiles	Chrysotile	1.00m2	Medium damage	Composite materials	4	1	5	LABEL & MONITOR	22 Mar 2013
075	Main Building (Fifth Floor)	Lift Lobby	Walls	Paint	No Asbestos Detected	15.00m2	Good condition	Sealed (1)	-	-	-	NO ACTION REQUIRED	
076	Main Building (Fifth Floor)	Corridor 2	Walls	Paint	No Asbestos Detected	8.00m2	Good condition	Sealed (1)	-	-	-	NO ACTION REQUIRED

Asbestos Presumed in Sample

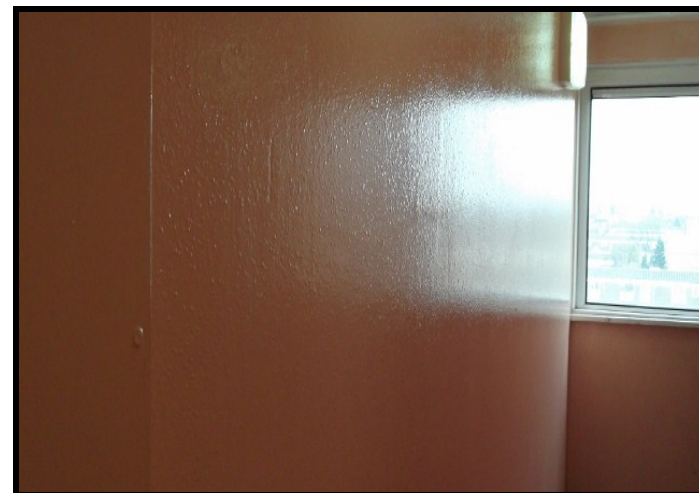
SAMPLE REFERENCE 085

No Asbestos Presumed in Sample

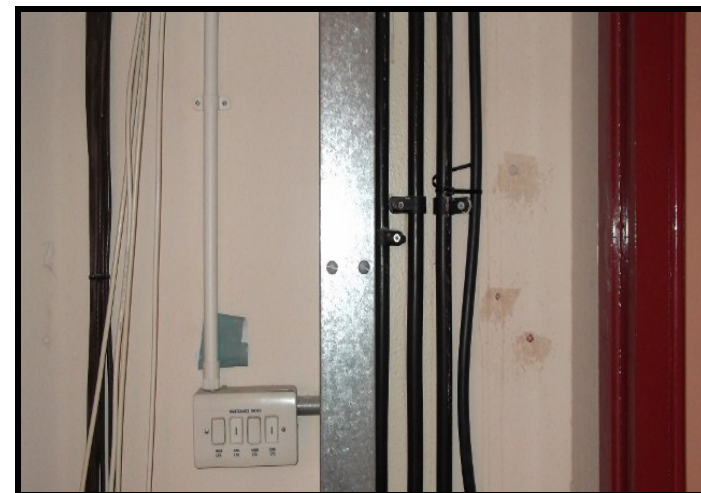
SAMPLE REFERENCE 091

No Asbestos Presumed in Sample

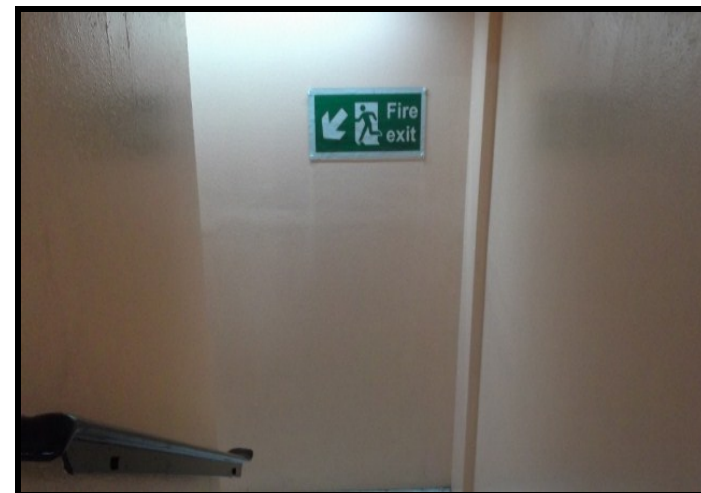
SAMPLE REFERENCE 092

No Asbestos Presumed in Sample

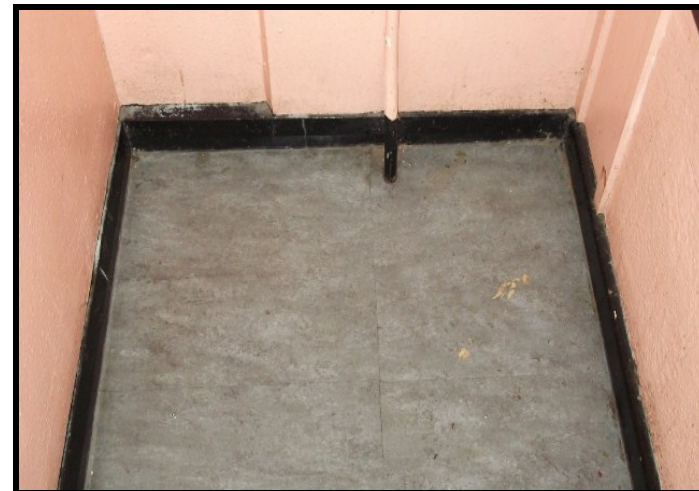
SAMPLE REFERENCE 096

No Asbestos Presumed in Sample

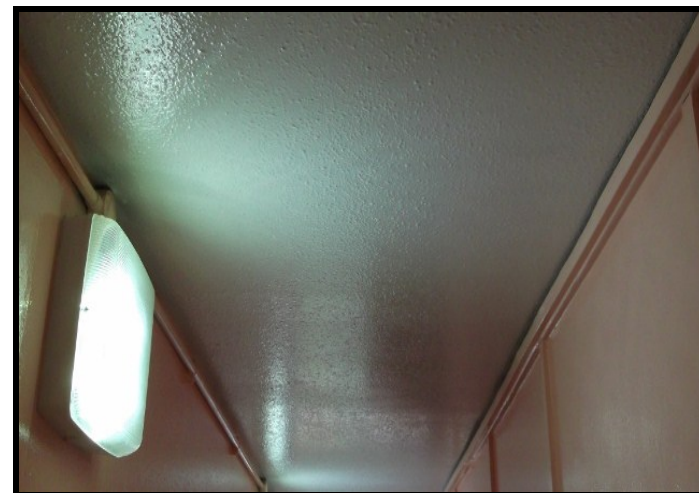
SAMPLE REFERENCE 097

No Asbestos Presumed in Sample

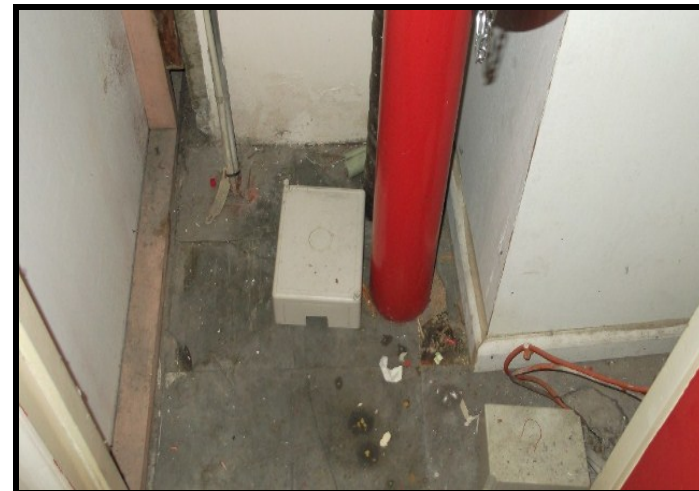
SAMPLE REFERENCE 100

MATERIAL ASSESSMENT				SCORE
Product Type	Floor Tiles	Extent of Damage	Low damage	3
Asbestos Type	Chrysotile	Surface Treatment	Composite materials

Asbestos Presumed in Sample

MANAGEMENT ACTION				SCORE
Recommendation	LABEL & MONITOR			4
Recommendation Due		Next Inspection	22 Mar 2013	
Apply Labels	No	Permit to Work Required	No

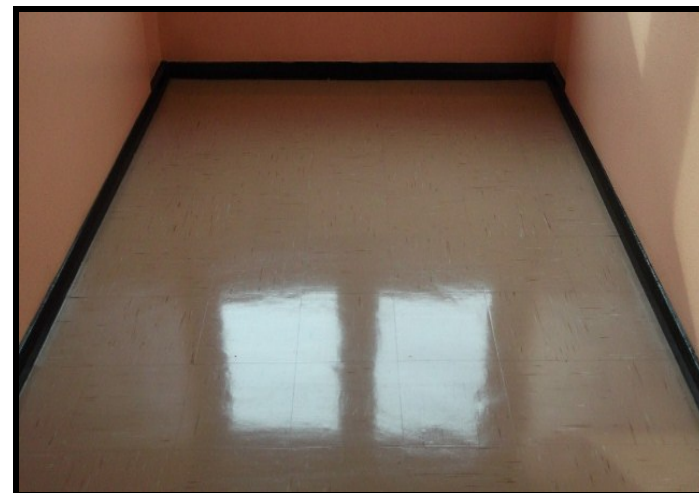
SAMPLE REFERENCE 103

No Asbestos Presumed in Sample

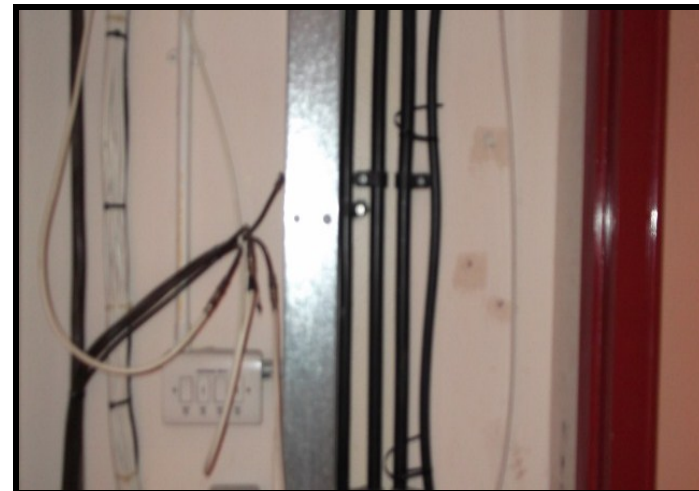
SAMPLE REFERENCE 104

No Asbestos Presumed in Sample

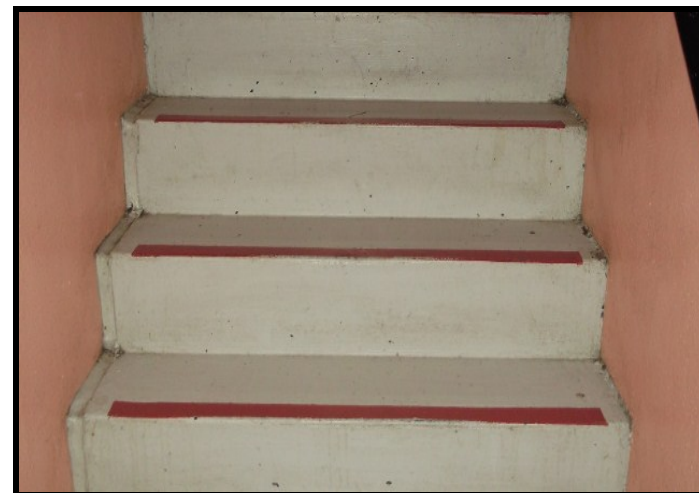
SAMPLE REFERENCE 106

MATERIAL ASSESSMENT				SCORE
Product Type	Bitumen	Extent of Damage	Low damage	3
Asbestos Type	Chrysotile	Surface Treatment	Composite materials

Asbestos Presumed in Sample

MANAGEMENT ACTION				SCORE
Recommendation	LABEL & MONITOR			3
Recommendation Due		Next Inspection	22 Mar 2013	
Apply Labels	No	Permit to Work Required	No

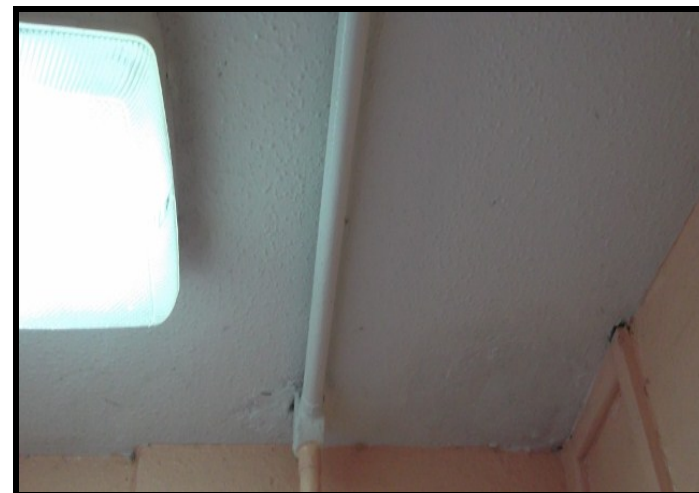
SAMPLE REFERENCE 107

Asbestos not detected in Sample

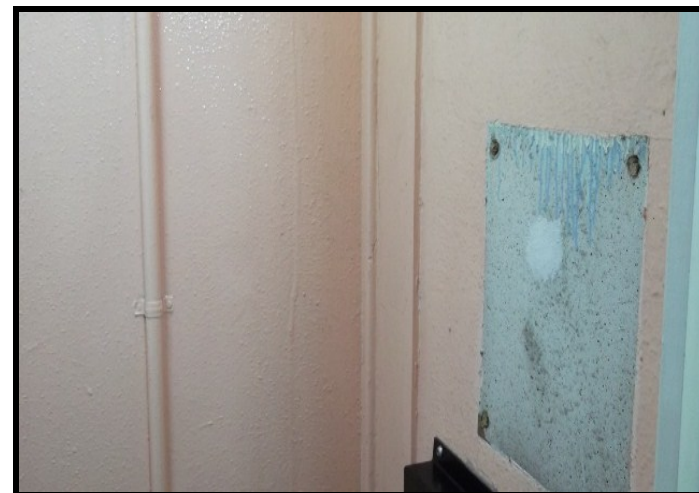
SAMPLE REFERENCE 108

Asbestos not detected in Sample

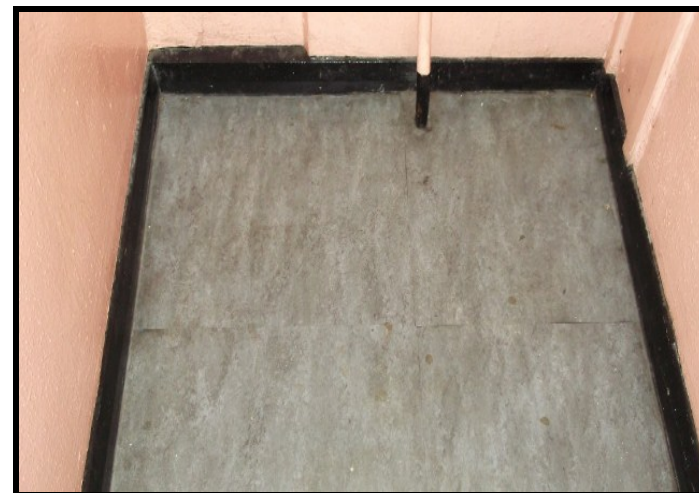
SAMPLE REFERENCE 109

No Asbestos Presumed in Sample

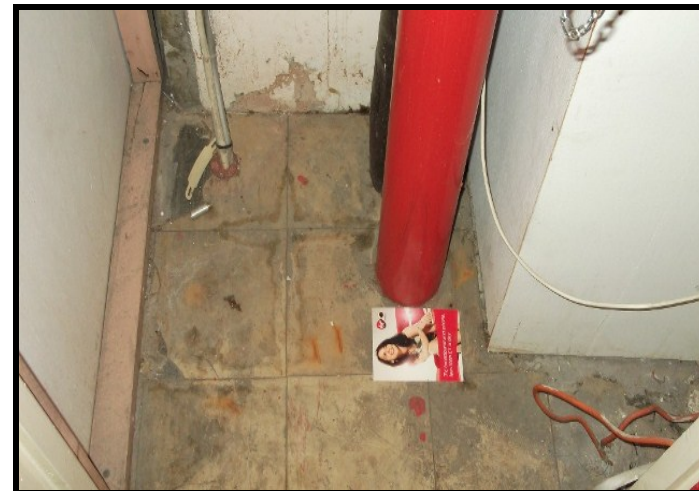
SAMPLE REFERENCE I 13

Asbestos Presumed in Sample

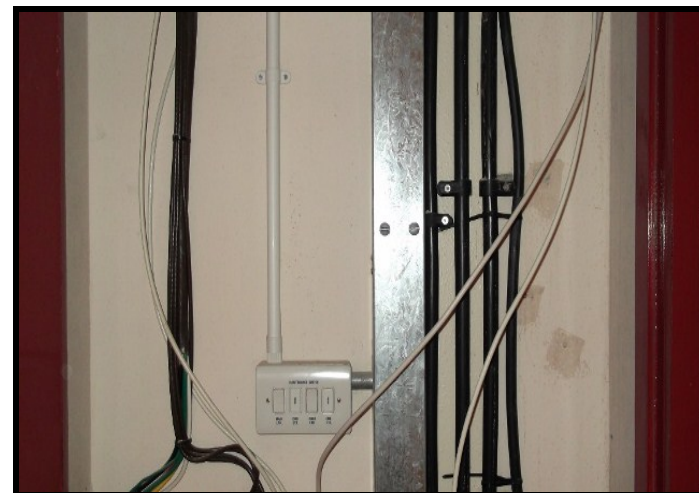
SAMPLE REFERENCE I I 7

No Asbestos Presumed in Sample

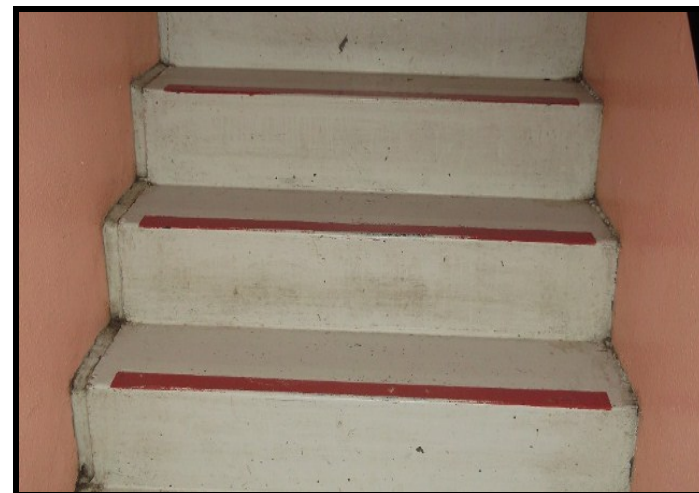
SAMPLE REFERENCE I 19

Asbestos Presumed in Sample

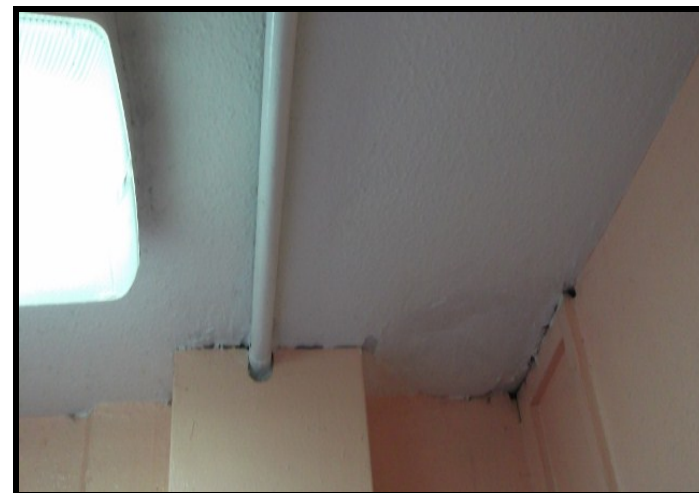
SAMPLE REFERENCE 120

No Asbestos Presumed in Sample

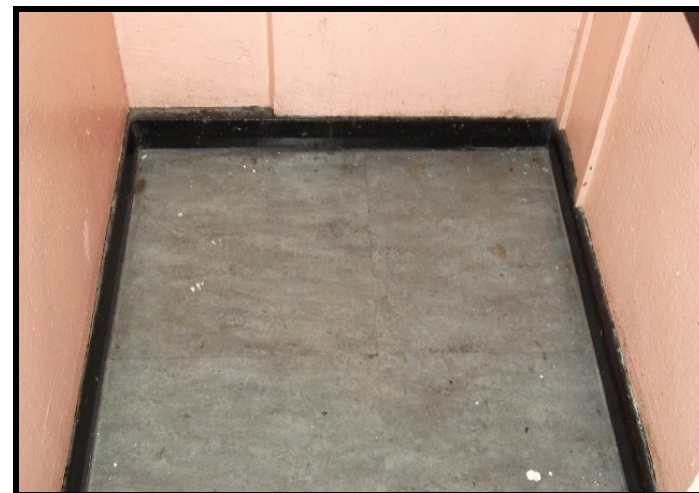
SAMPLE REFERENCE 122

No Asbestos Presumed in Sample

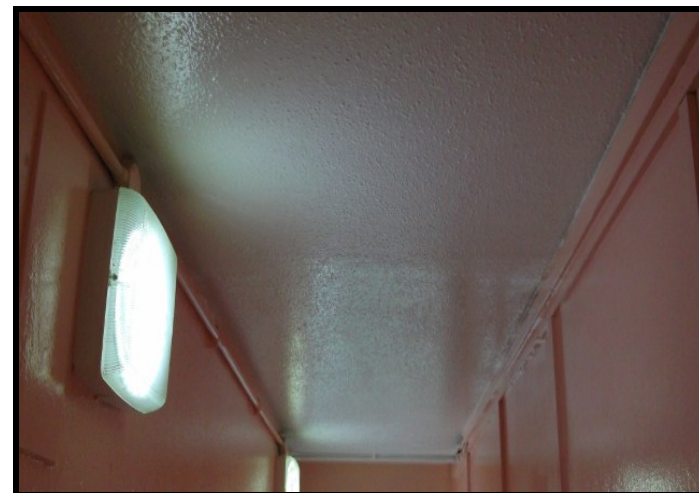
SAMPLE REFERENCE I23

No Asbestos Presumed in Sample

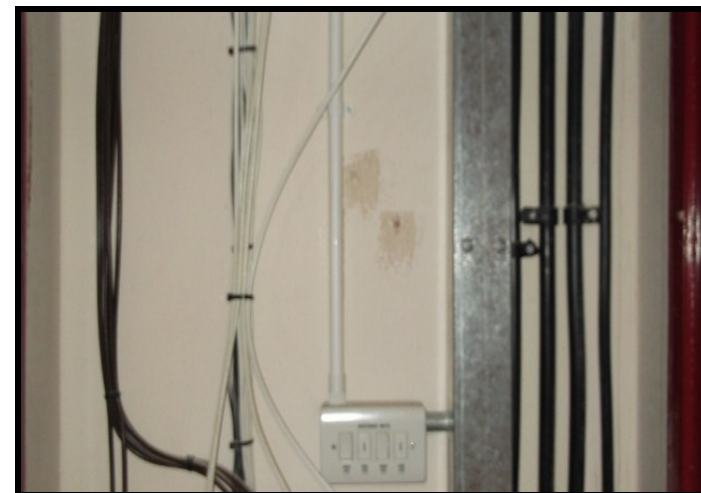
SAMPLE REFERENCE I30

No Asbestos Presumed in Sample

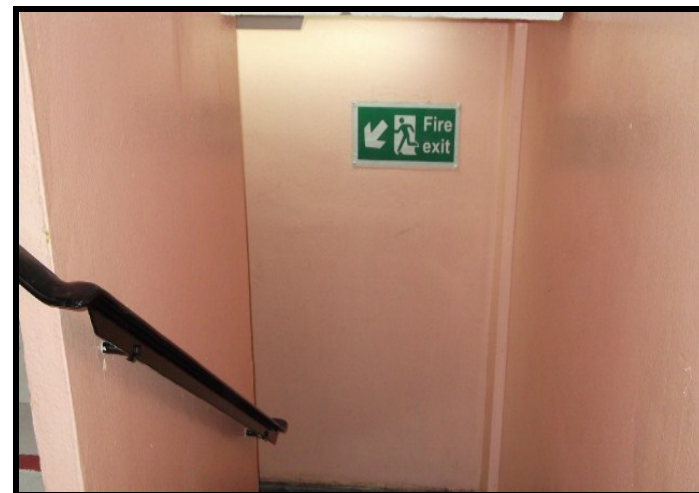
SAMPLE REFERENCE 131

No Asbestos Presumed in Sample

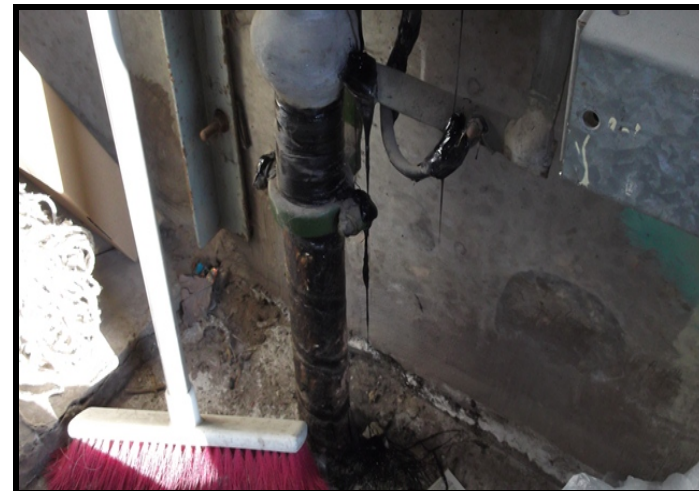
SAMPLE REFERENCE I32

Building	Floor	Room	Location
Main Building	Ground Floor	Plant Room	Cable
Description			
MATERIAL ASSESSMENT			
Product Type	Bitumen	Extent of Damage	Good condition
Asbestos Type	Presumed ACM	Surface Treatment	Composite materials
PRIORITY ASSESSMENT			
Occupant Activity	Not Applicable	Extent / Amount	1.00 m2
Accessibility	Occasionally disturb	Location	Not Applicable
Avg Time in Use	Not Applicable	Frequency of Use	Not Applicable
No. of Occupants	Not Applicable	Secondary Activity	Not Applicable
Maintenance	Not Applicable	Maintenance Frequency	Not Applicable
MANAGEMENT ACTION			
Recommendation	LABEL & MONITOR		
Recommendation Due		Next Inspection	22 Mar 2013
Apply Labels	No	Permit to Work Required	No
Survey Type	Management	Lead Surveyor	Jane Openshaw
Survey Date	22 Mar 2012	UKAS Laboratory	NOT SAMPLED
Site Reference	I23350000A	Licensed Material	No

Asbestos Presumed in Sample

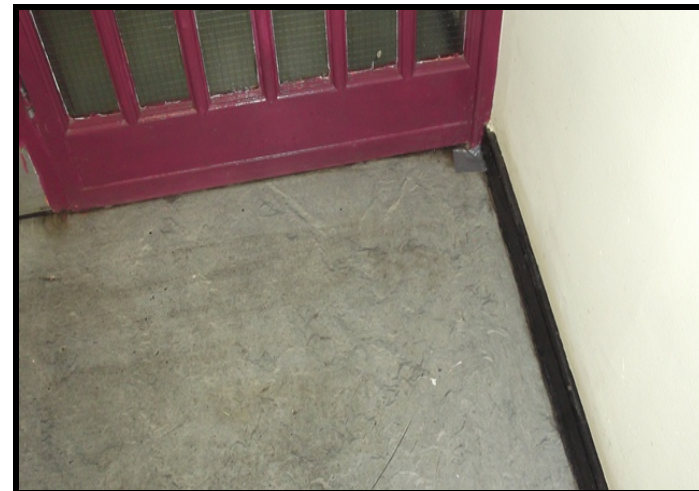
SAMPLE REFERENCE 141

Asbestos not detected in Sample
