# **Solihull Community Housing**

## **Asbestos Management Survey Report**

**Mansfield House I-45 (Communal)  
Woodlands Way  
Solihull  
B37 6RT**

**Date of Report: 25 Feb 2015**

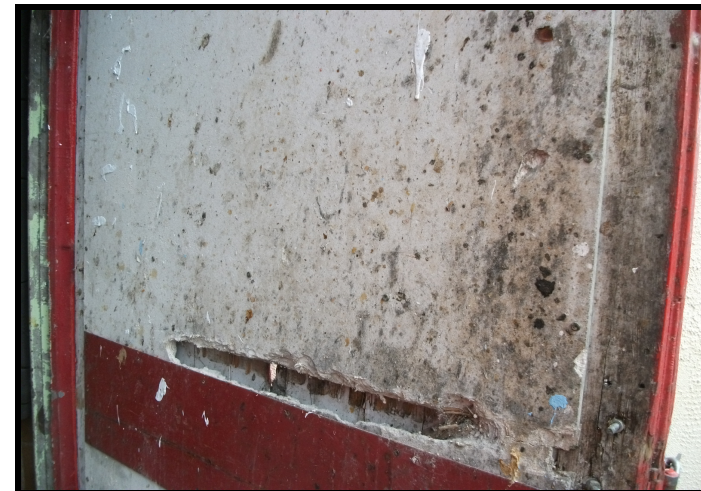
## SAMPLE REFERENCE 007

| Unique Sample No. | Building Reference (Floor) | Room Area | Description of Location | Product Description | Asbestos Type | Approx. Quantity | Material Condition | Surface Treatment | Material Risk Score | Priority Risk Score | Total Risk Score | Management Action | Next Review Date |
|---|---|---|---|---|---|---|---|---|---|---|---|---|---|
| 007 | Main Building (Ground Floor) | Bin Store | Door | Insulation Board | No Asbestos Detected | 6.00m2 | Medium damage | Unsealed (Board) | - | - | - | NO ACTION REQUIRED | |

Asbestos not detected in Sample

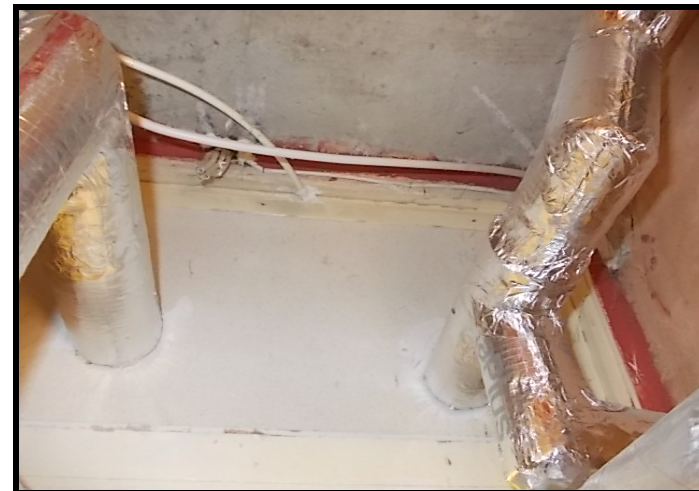
## SAMPLE REFERENCE 014

| Unique Sample No. | Building Reference (Floor) | Room Area | Description of Location | Product Description | Asbestos Type | Approx. Quantity | Material Condition | Surface Treatment | Material Risk Score | Priority Risk Score | Total Risk Score | Management Action | Next Review Date |
|---|---|---|---|---|---|---|---|---|---|---|---|---|---|
| 014 | Main Building (First Floor) | Service Cupboard 2 | Transom Panel | Insulation Board | No Asbestos Detected | 1.00m2 | Good condition | Sealed Board (Encapsulated) | - | - | - | NO ACTION REQUIRED | |

**No Asbestos Presumed in Sample**

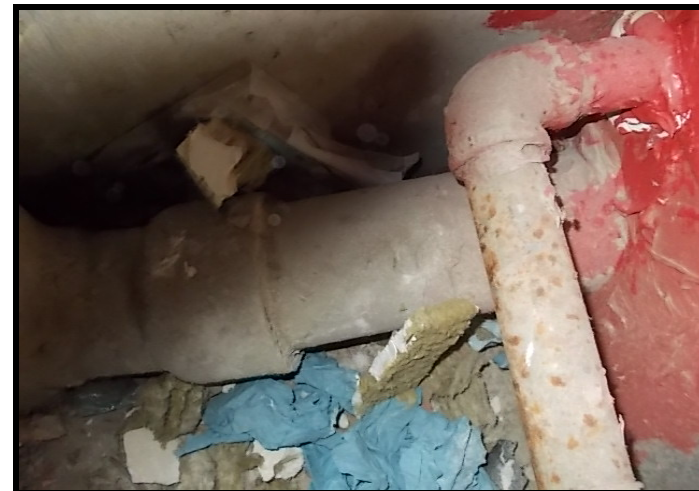
## SAMPLE REFERENCE 014b

| Unique Sample No. | Building Reference (Floor) | Room Area | Description of Location | Product Description | Asbestos Type | Approx. Quantity | Material Condition | Surface Treatment | Material Risk Score | Priority Risk Score | Total Risk Score | Management Action | Next Review Date |
|---|---|---|---|---|---|---|---|---|---|---|---|---|---|
| 014b | Main Building (First Floor) | Service Cupboard 1 | Pipe Work | Cement | Amosite / Chrysotile / Crocidolite | 2.00m2 | Low damage | Unsealed (Cement products) | 6 | 0 | 6 | LABEL & MONITOR | 02 Dec 2015 |

**Asbestos detected in Sample**

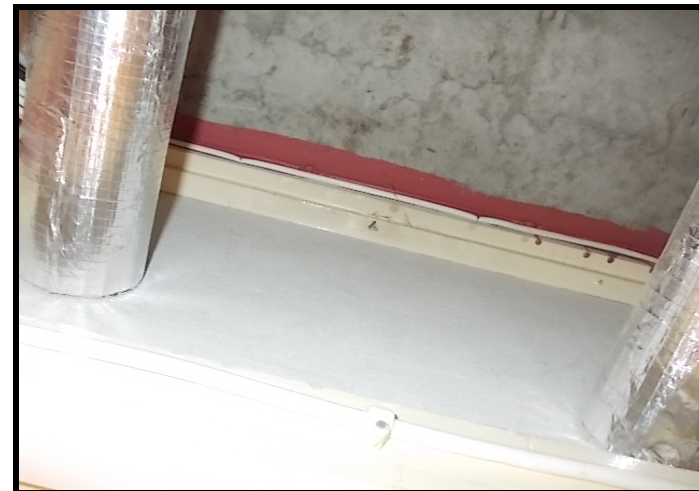
## SAMPLE REFERENCE 036

**No Asbestos Presumed in Sample**

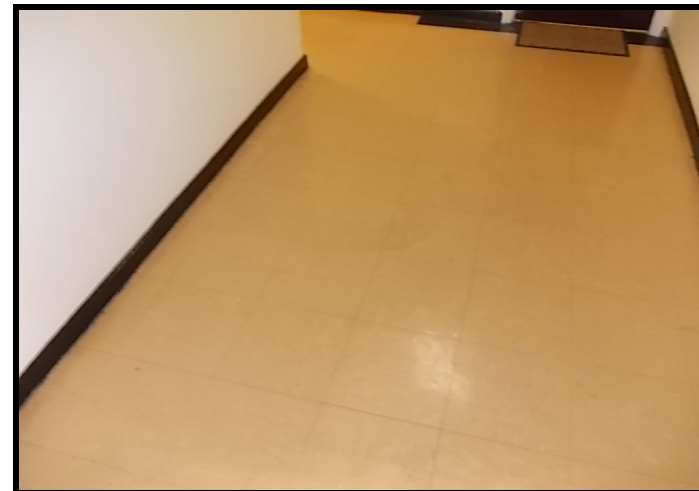
## SAMPLE REFERENCE 056

**No Asbestos Presumed in Sample**

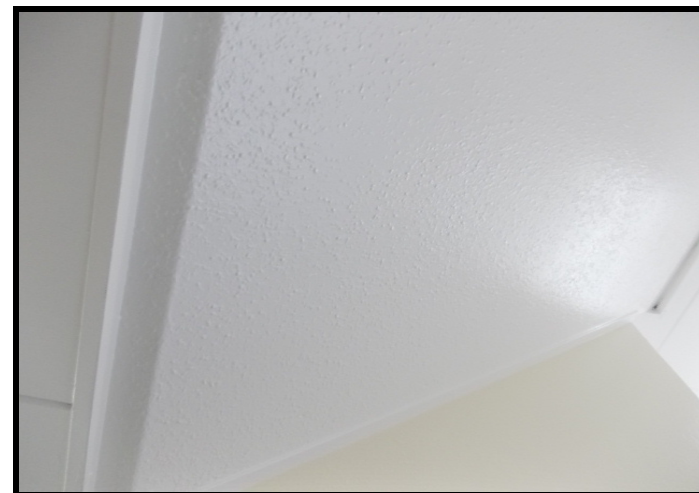
## SAMPLE REFERENCE 063

**No Asbestos Presumed in Sample**

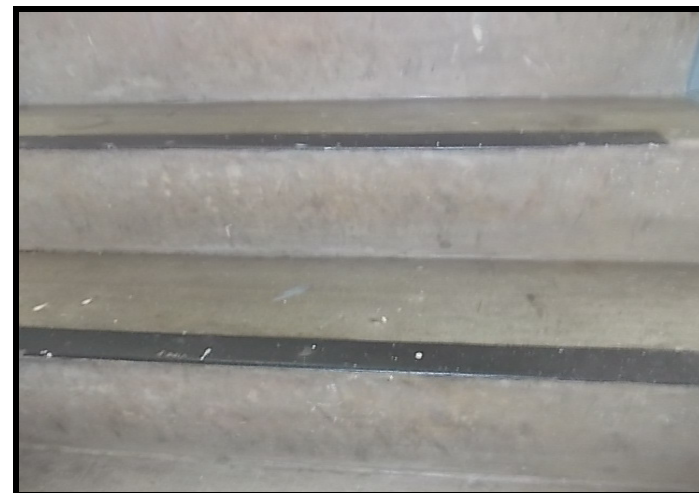
## SAMPLE REFERENCE 063a

**Asbestos Presumed**

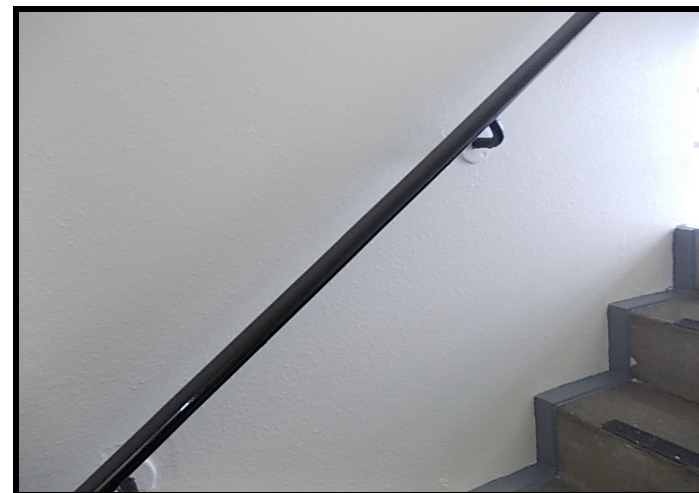
## SAMPLE REFERENCE 064

**No Asbestos Presumed in Sample**

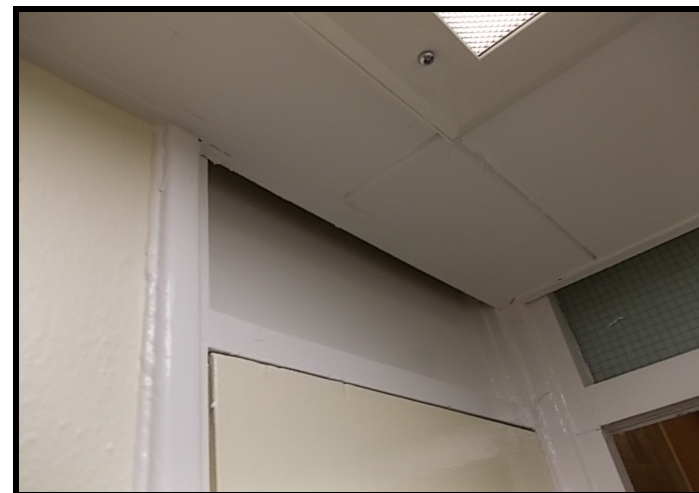
## SAMPLE REFERENCE 068

**No Asbestos Presumed in Sample**

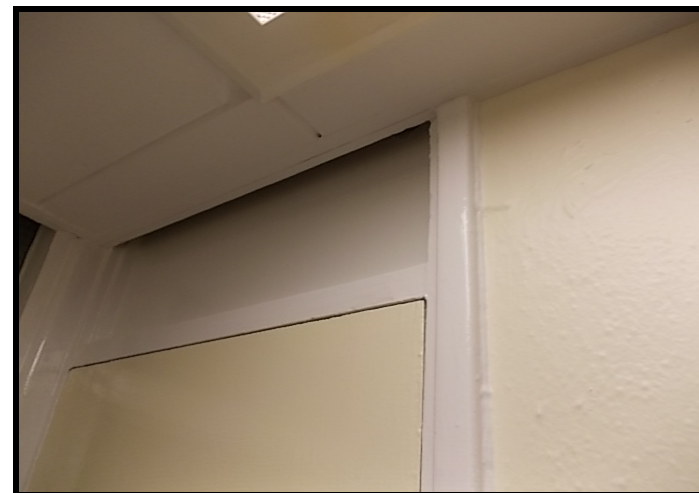
## SAMPLE REFERENCE 069

**No Asbestos Presumed in Sample**

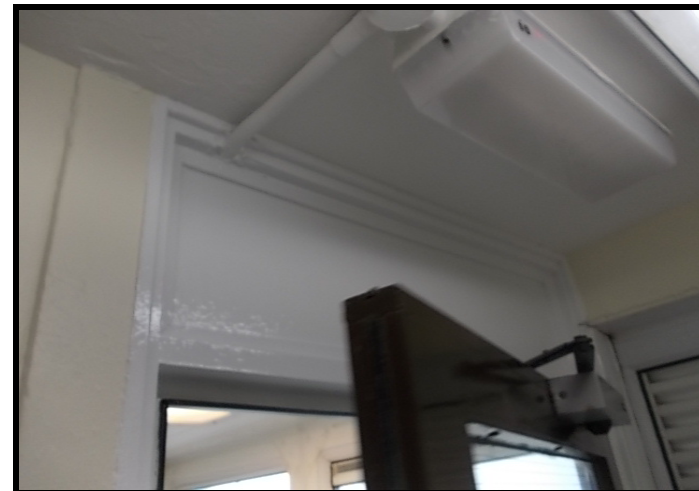
## SAMPLE REFERENCE 072

**No Asbestos Presumed in Sample**

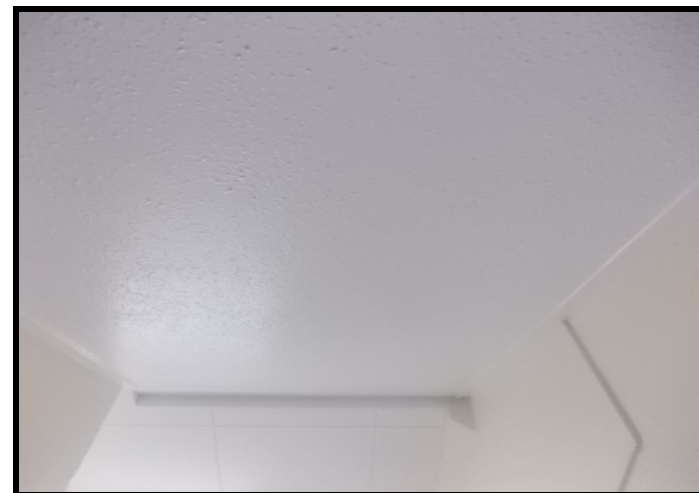
## SAMPLE REFERENCE 074

**No Asbestos Presumed in Sample**

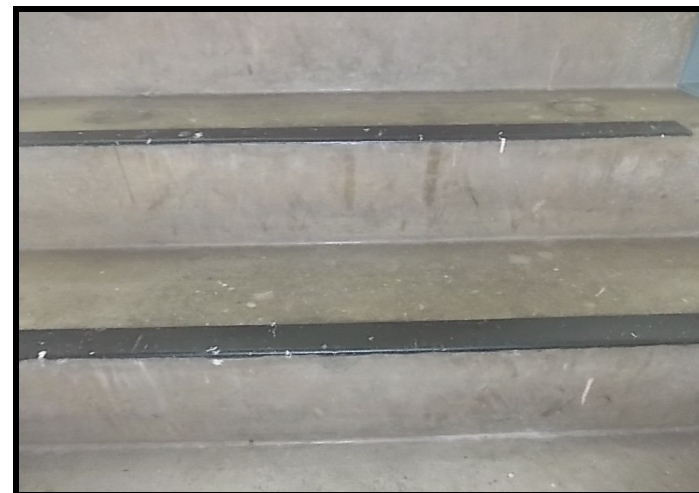
## SAMPLE REFERENCE 074a

**Asbestos Presumed**

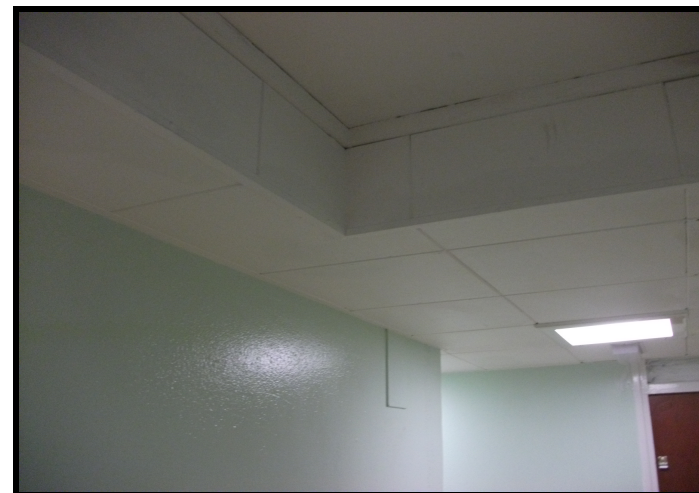
## SAMPLE REFERENCE 076

**No Asbestos Presumed in Sample**

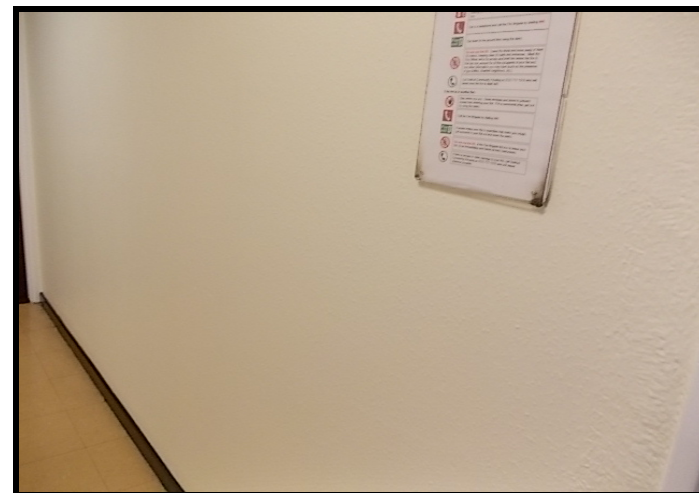
## SAMPLE REFERENCE 077

**No Asbestos Presumed in Sample**

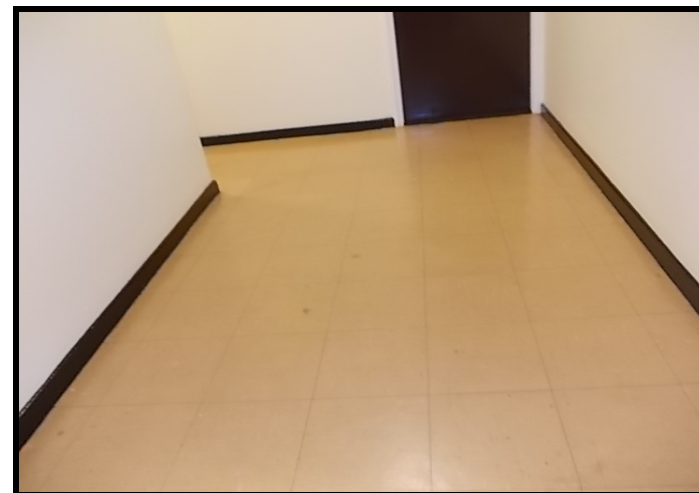
SAMPLE REFERENCE 078

**No Asbestos Presumed in Sample**

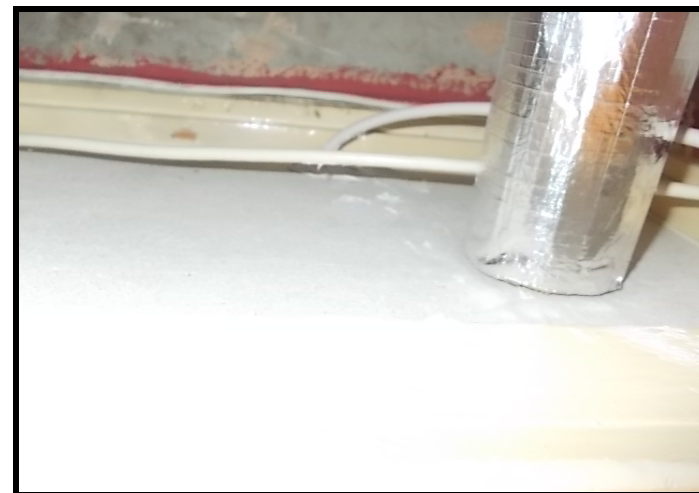
## SAMPLE REFERENCE 079

**No Asbestos Presumed in Sample**

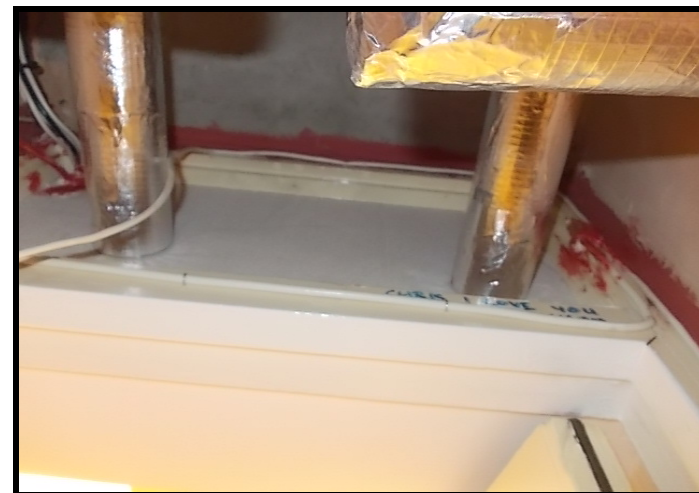
## SAMPLE REFERENCE 080

**No Asbestos Presumed in Sample**

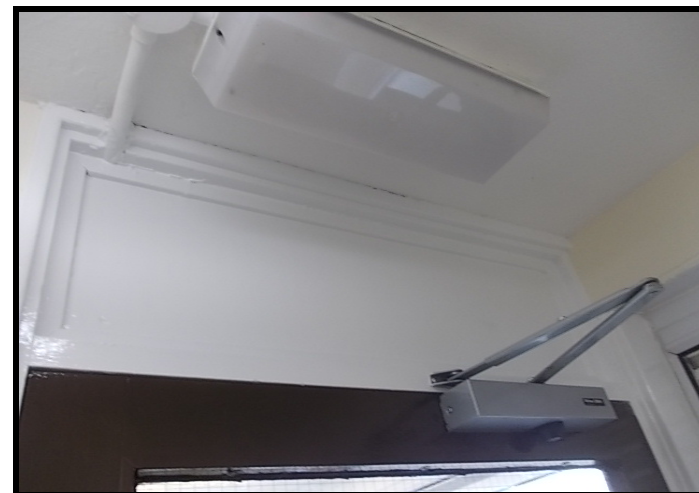
## SAMPLE REFERENCE 083

**No Asbestos Presumed in Sample**

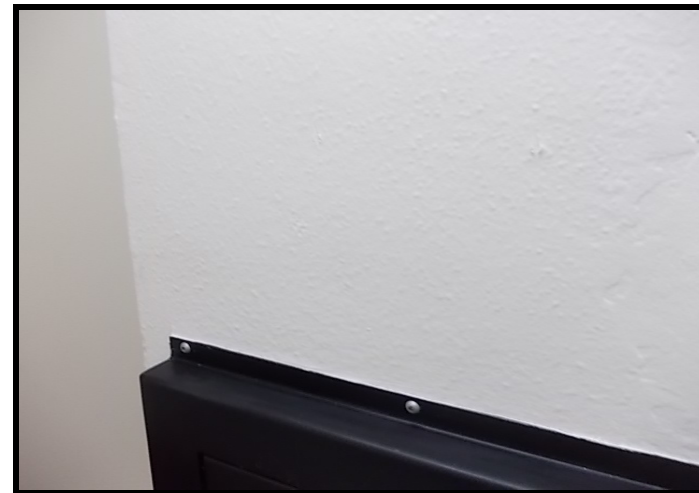
## SAMPLE REFERENCE 084

**No Asbestos Presumed in Sample**

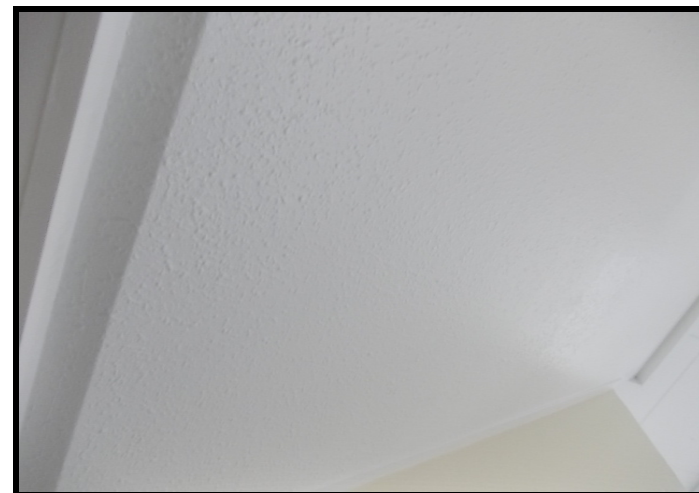
## SAMPLE REFERENCE 085

**No Asbestos Presumed in Sample**

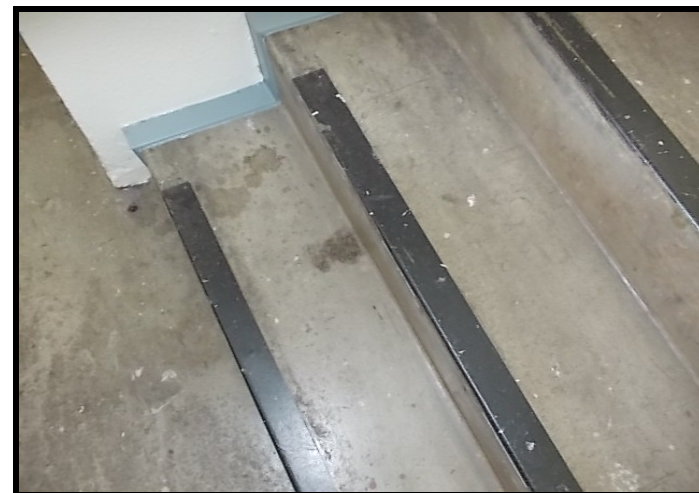
## SAMPLE REFERENCE 085a

**Asbestos Presumed**

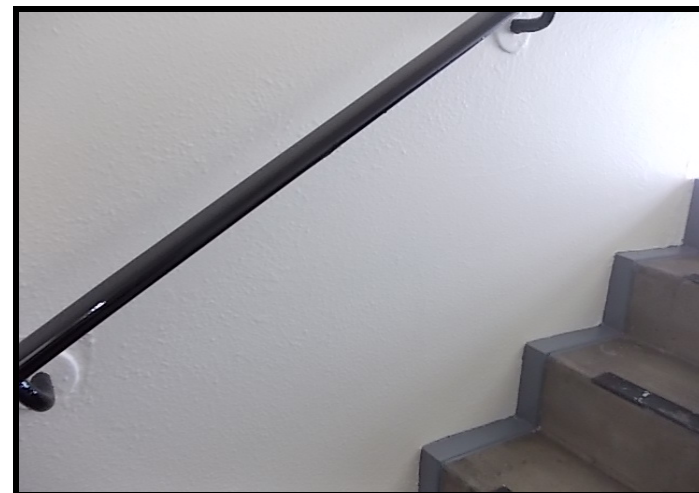
## SAMPLE REFERENCE 086

**No Asbestos Presumed in Sample**

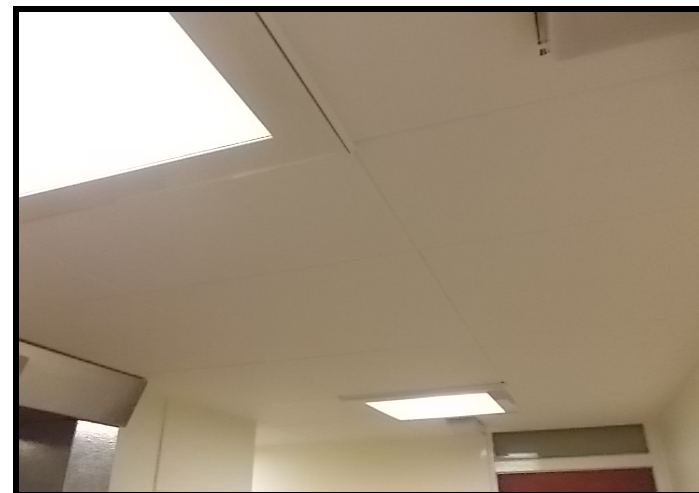
## SAMPLE REFERENCE 087

**No Asbestos Presumed in Sample**

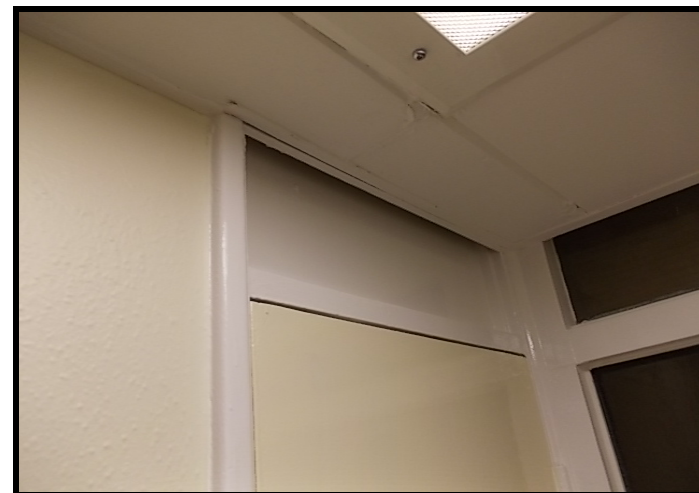
## SAMPLE REFERENCE 090

**No Asbestos Presumed in Sample**

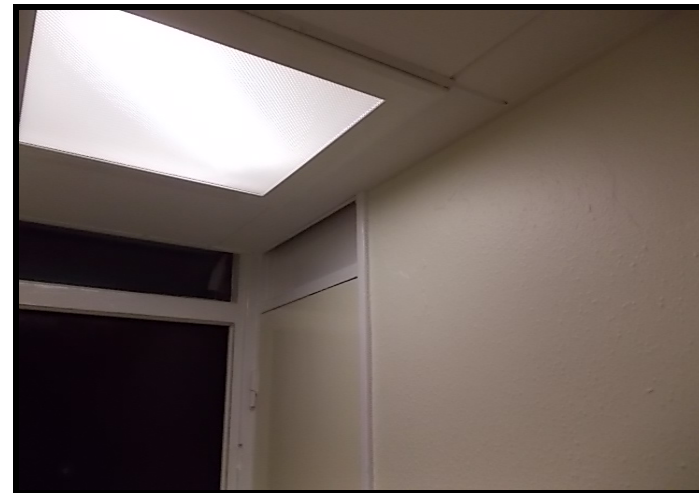
## SAMPLE REFERENCE 091

**No Asbestos Presumed in Sample**

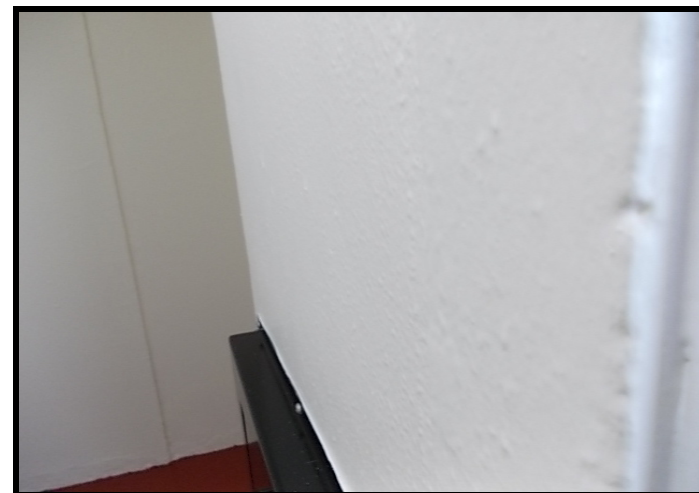
## SAMPLE REFERENCE 095

**No Asbestos Presumed in Sample**

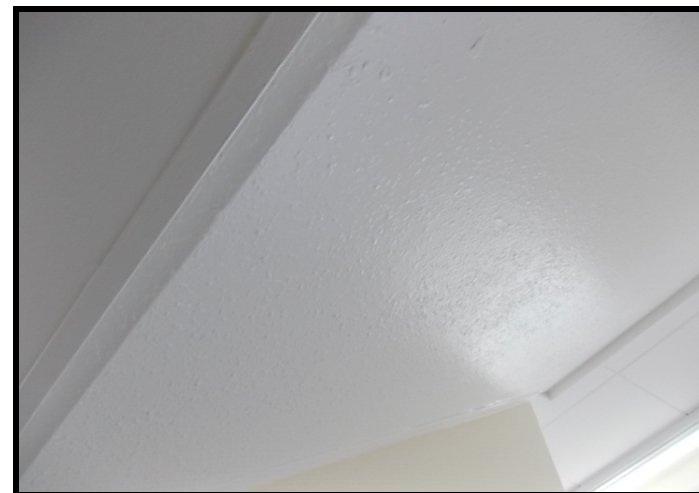
## SAMPLE REFERENCE 096

**No Asbestos Presumed in Sample**

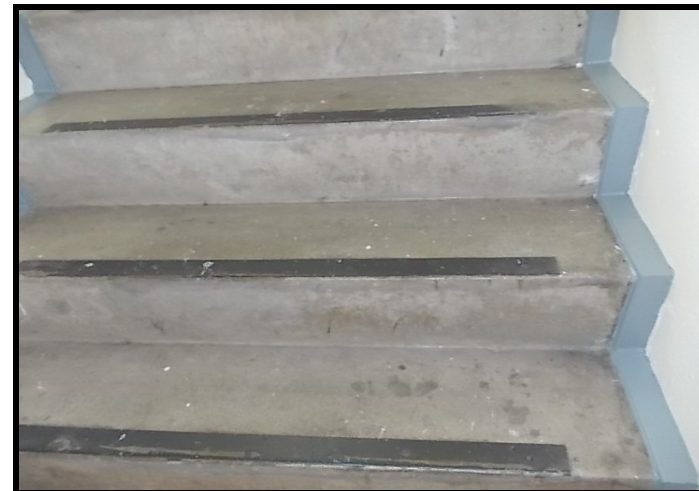
## SAMPLE REFERENCE 096a

Asbestos Presumed

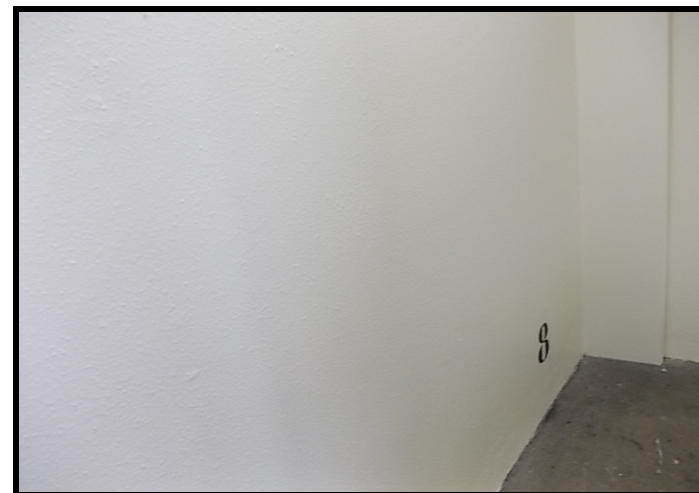
## SAMPLE REFERENCE 097

**No Asbestos Presumed in Sample**

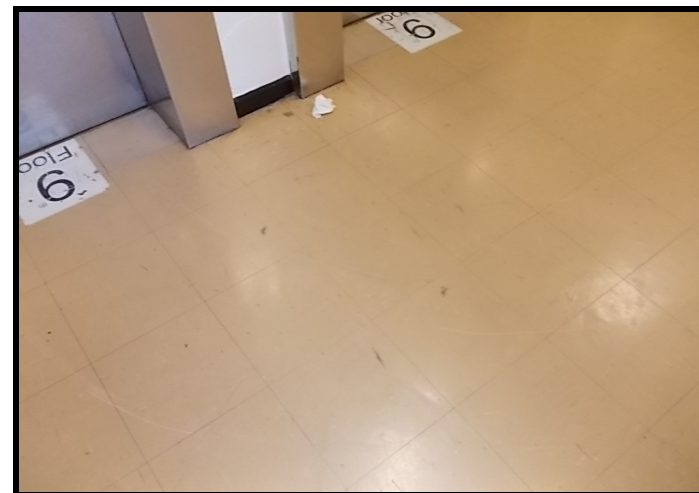
## SAMPLE REFERENCE 100

**No Asbestos Presumed in Sample**

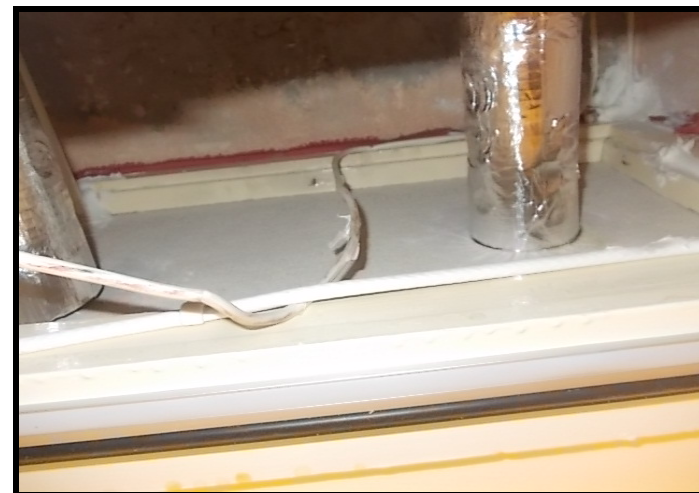
## SAMPLE REFERENCE 101

**No Asbestos Presumed in Sample**

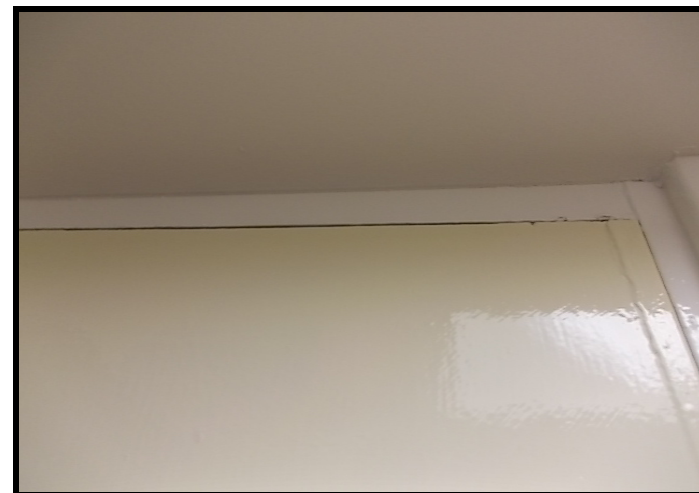
## SAMPLE REFERENCE 102

**No Asbestos Presumed in Sample**

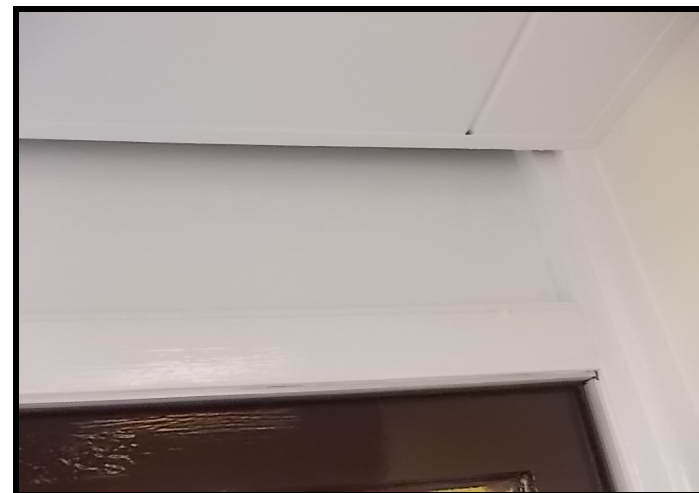
## SAMPLE REFERENCE 105

**No Asbestos Presumed in Sample**

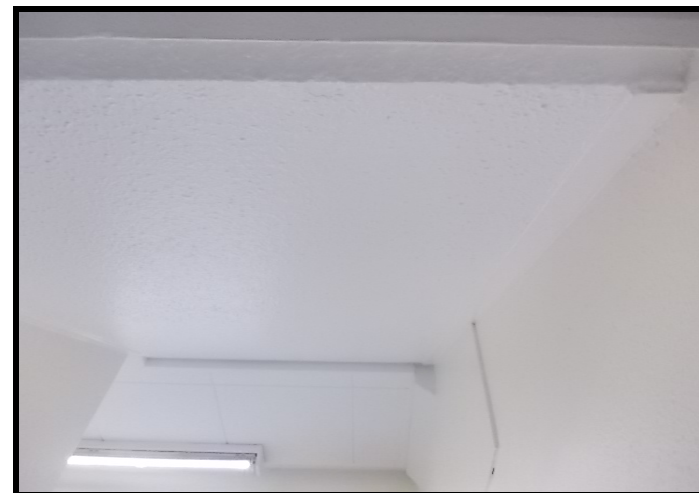
## SAMPLE REFERENCE 107

**No Asbestos Presumed in Sample**

| Building | Floor | Room | Location |
|---|---|---|---|
| <b>Product Type</b> | Resin | <b>Extent of Damage</b> | Low damage |

| Building | Floor | Room | Location |
|---|---|---|---|
| <b>Recommendation</b> | LABEL & MONITOR | | |

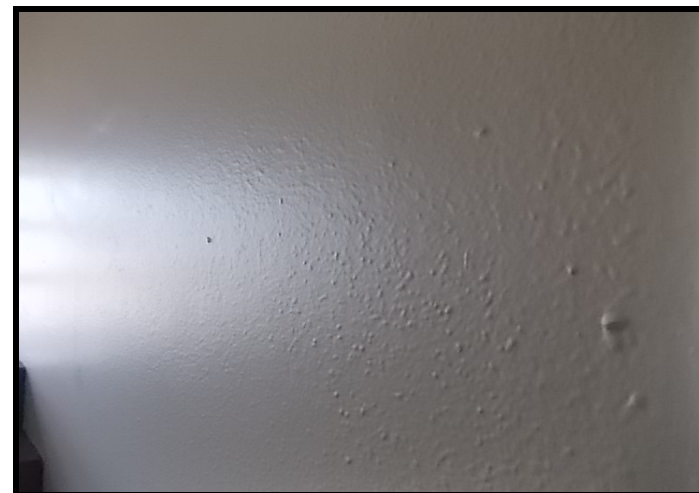
## SAMPLE REFERENCE 108

**No Asbestos Presumed in Sample**

| Building | Floor | Room | Location | | |
|---|---|---|---|---|---|
| Product Type | Insulation Board | Extent of Damage | Good condition | | - |

| Building | Floor | Room | Location | | |
|---|---|---|---|---|---|
| Recommendation | NO ACTION REQUIRED | | | | - |

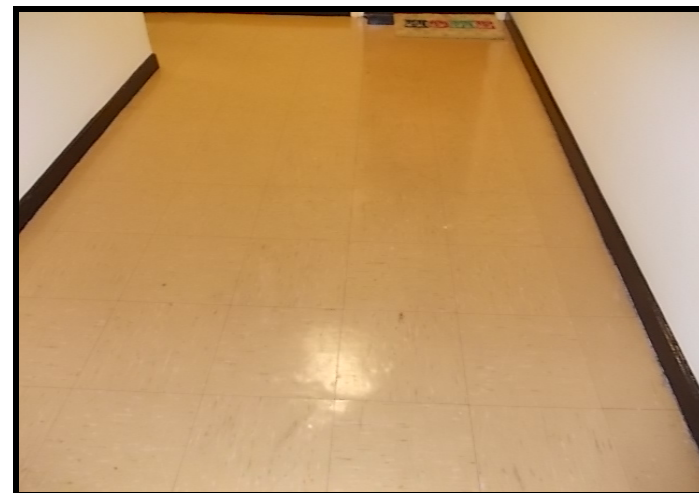
## SAMPLE REFERENCE I I I

**No Asbestos Presumed in Sample**

| Building | Floor | Room | Location | | | |
|---|---|---|---|---|---|--|
| Product Type | Insulation Board | Extent of Damage | Good condition | | - | |

| Building | Floor | Room | Location | | | |
|---|---|---|---|---|---|--|
| Recommendation | NO ACTION REQUIRED | | | - | | |

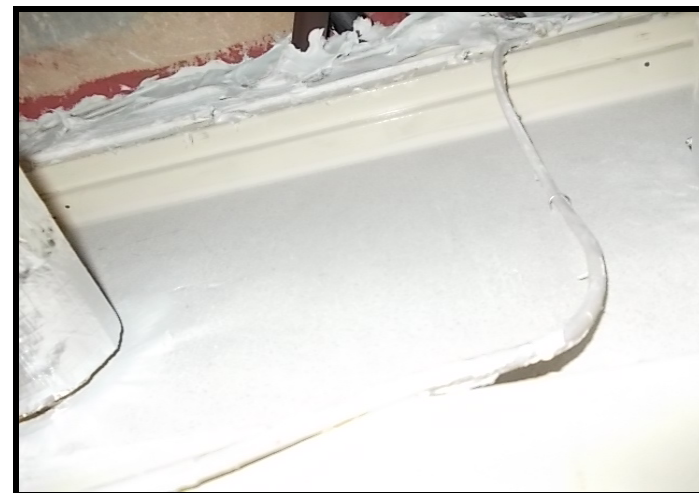
## SAMPLE REFERENCE I I 2

**No Asbestos Presumed in Sample**

| MATERIAL ASSESSMENT | | | | SCORE |
|---|---|---|---|---|
| <b>Product Type</b> | Cement | <b>Extent of Damage</b> | Low damage | 6 |

| MANAGEMENT ACTION | | | | SCORE |
|---|---|---|---|---|
| <b>Recommendation</b> | LABEL & MONITOR | | | 6 |

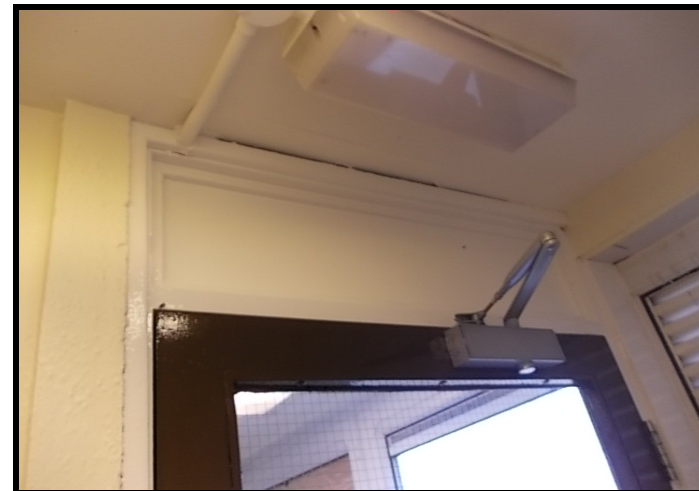
## SAMPLE REFERENCE I I 6

**No Asbestos Presumed in Sample**

| MATERIAL ASSESSMENT | | | | SCORE |
|---|---|---|---|---|
| <b>Product Type</b> | Textured Coating | <b>Extent of Damage</b> | Good condition | - |

| MANAGEMENT ACTION | | | | SCORE |
|---|---|---|---|---|
| <b>Recommendation</b> | NO ACTION REQUIRED | | | - |

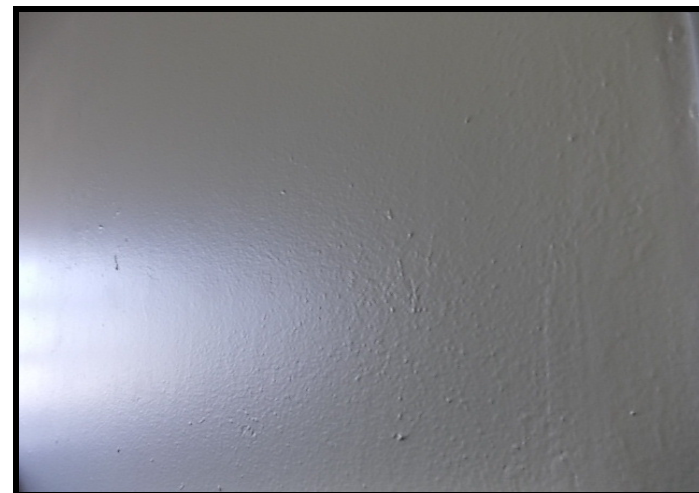
## SAMPLE REFERENCE I I 9

**No Asbestos Presumed in Sample**

| MATERIAL ASSESSMENT | | | | SCORE |
|---|---|---|---|---|
| <b>Product Type</b> | Cement Flue | <b>Extent of Damage</b> | Good condition | <b>3</b> |

| MANAGEMENT ACTION | | | | SCORE |
|---|---|---|---|---|
| <b>Recommendation</b> | LABEL & MONITOR | | | <b>4</b> |

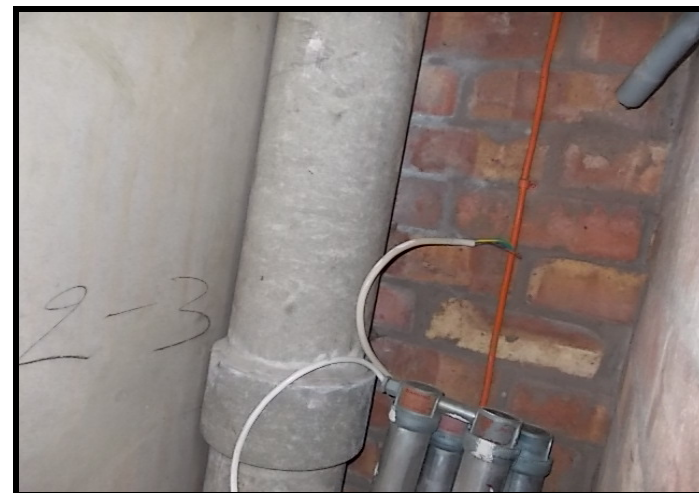
## SAMPLE REFERENCE 120

**Asbestos detected in Sample**

| Building | Floor | Room | Location |
|---|---|---|---|
| Product Type | Gasket | Extent of Damage | Low damage |

| Building | Floor | Room | Location |
|---|---|---|---|
| Recommendation | LABEL & MONITOR | | |

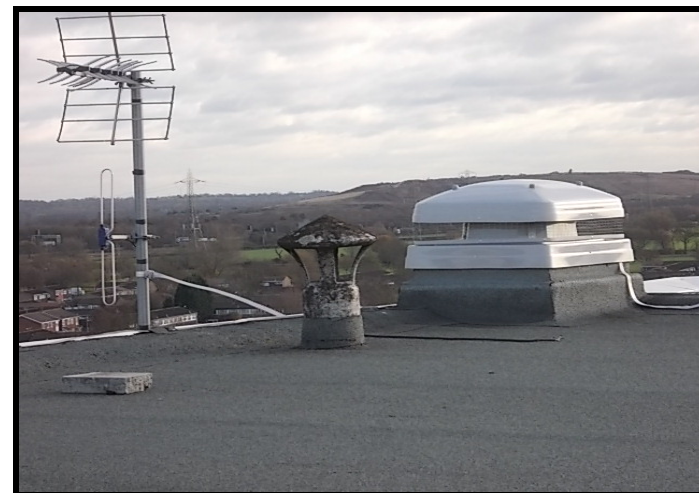
## SAMPLE REFERENCE I21b

Asbestos detected in Sample
